Preliminary Report on Phase II Testing

Grover's Creek Cove Site

July 1997

L. E. Babits, Catherine Fach and Ryan Harris

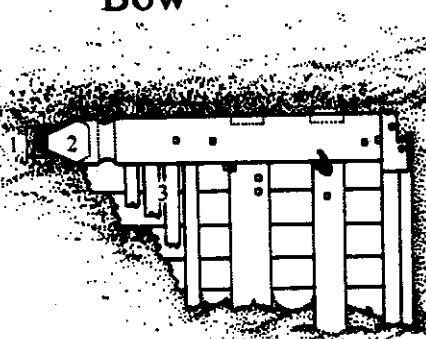
Bow

The bow was composed of several timbers (Fig. 1). The upper portions of the bow were missing, especially the diagnostic features on Chesapeake Bay vessels originating in a log boat building tradition (Brewington 1963:45). Only the lower portions were present. These included the stem, apron, and stemson (Mansir 1980:21). A drift pin indicated some missing additional elements. A possible cutwater with bobstay eyebolt lay about five feet further forward along the baseline and a disarticulated hawse pipe rested off to the starboard. The bow plan view and perspective drawing show the frames to be much more closely spaced in the bow with no cant frames, a bug-eye feature (Brewington 1963:45). Mortises cut into the starboard side of the bow

assembly once held the shorter bow frames in place.

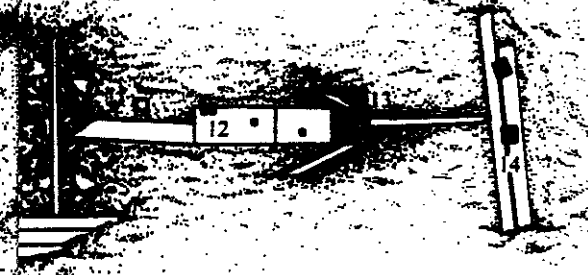
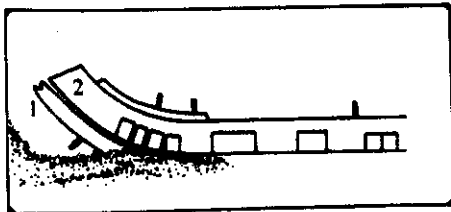
Stern

The composite sternpost (Fig. 1) was nine inches wide and composed of two timbers. The aft timber was six inches sided. The top end was damaged but 5.5 feet still remained. It rested on the keel. The stern assembly included an inner sternpost 4 inches sided and 8 inches molded. The deadwood had a rabbet to accept the outer hull planking which was fastened by up to five nails at the butt ends of the outer hull planks. No stealer planks were

noted (Mansir 1980:12), perhaps because not enough of the stern exterior was exposed.

The keel at the stern was 9 inches wide and 5 inches thick. It had a shoe two inches thick that extended aft forming a skeg. The rudder was 3 feet long by 3 inches thick. The rudder was 5.5 feet high. The top edge was badly damaged, probably by the drag line clearing operation. There were two iron pintle straps. These extended 1.5 feet fore and aft on the rudder. The pintle straps were two inches wide and ca 3/8 inch thick. The rudder portion of the strap appeared to have the pintle while the stern post was mounted with the socket, poor visibility and corrosion made it difficult to tell (Mansir 1983:25).

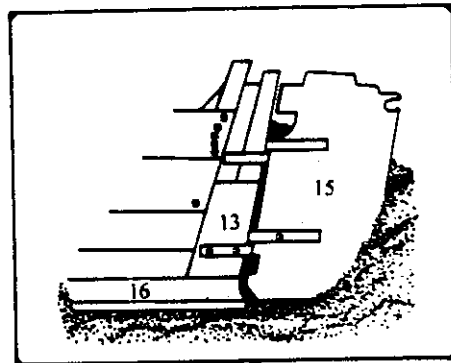
Stern profile (port side)

Planking consisted of three types, outer hull, ceiling and sole in the stern cabin area. The longitudinal outer hull planking was not examined except at the stern where the planks were of varying widths (7 inches to 15 inches). The planks were 2 inches thick. At the stern, the hull planks were fastened using multiple nails. Hull planking was fastened to the midships frames using a combination of three bolts at the butt ends and two nails at other frames.

stern post and deadwood. Due to the ballast stone overburden and sole planking, the interior was not explored to any great extent. The exterior stern was partially recorded on the port side where four planks were still extant.
