Matthew A. Russell. AN HISTORICAL AND ARCHAEOLOGICAL INVESTIGATION OF THREE BEACHED SHIPWRECK SCATTERS AT CHANNEL ISLANDS NATIONAL PARK. (Under the direction of Dr. Bradley A. Rodgers) Department of History, January 1996.

AN HISTORICAL AND ARCHAEOLOGICAL INVESTIGATION
OF THREE BEACHED SHIPWRECK SCATTERS AT
CHANNEL ISLANDS NATIONAL PARK

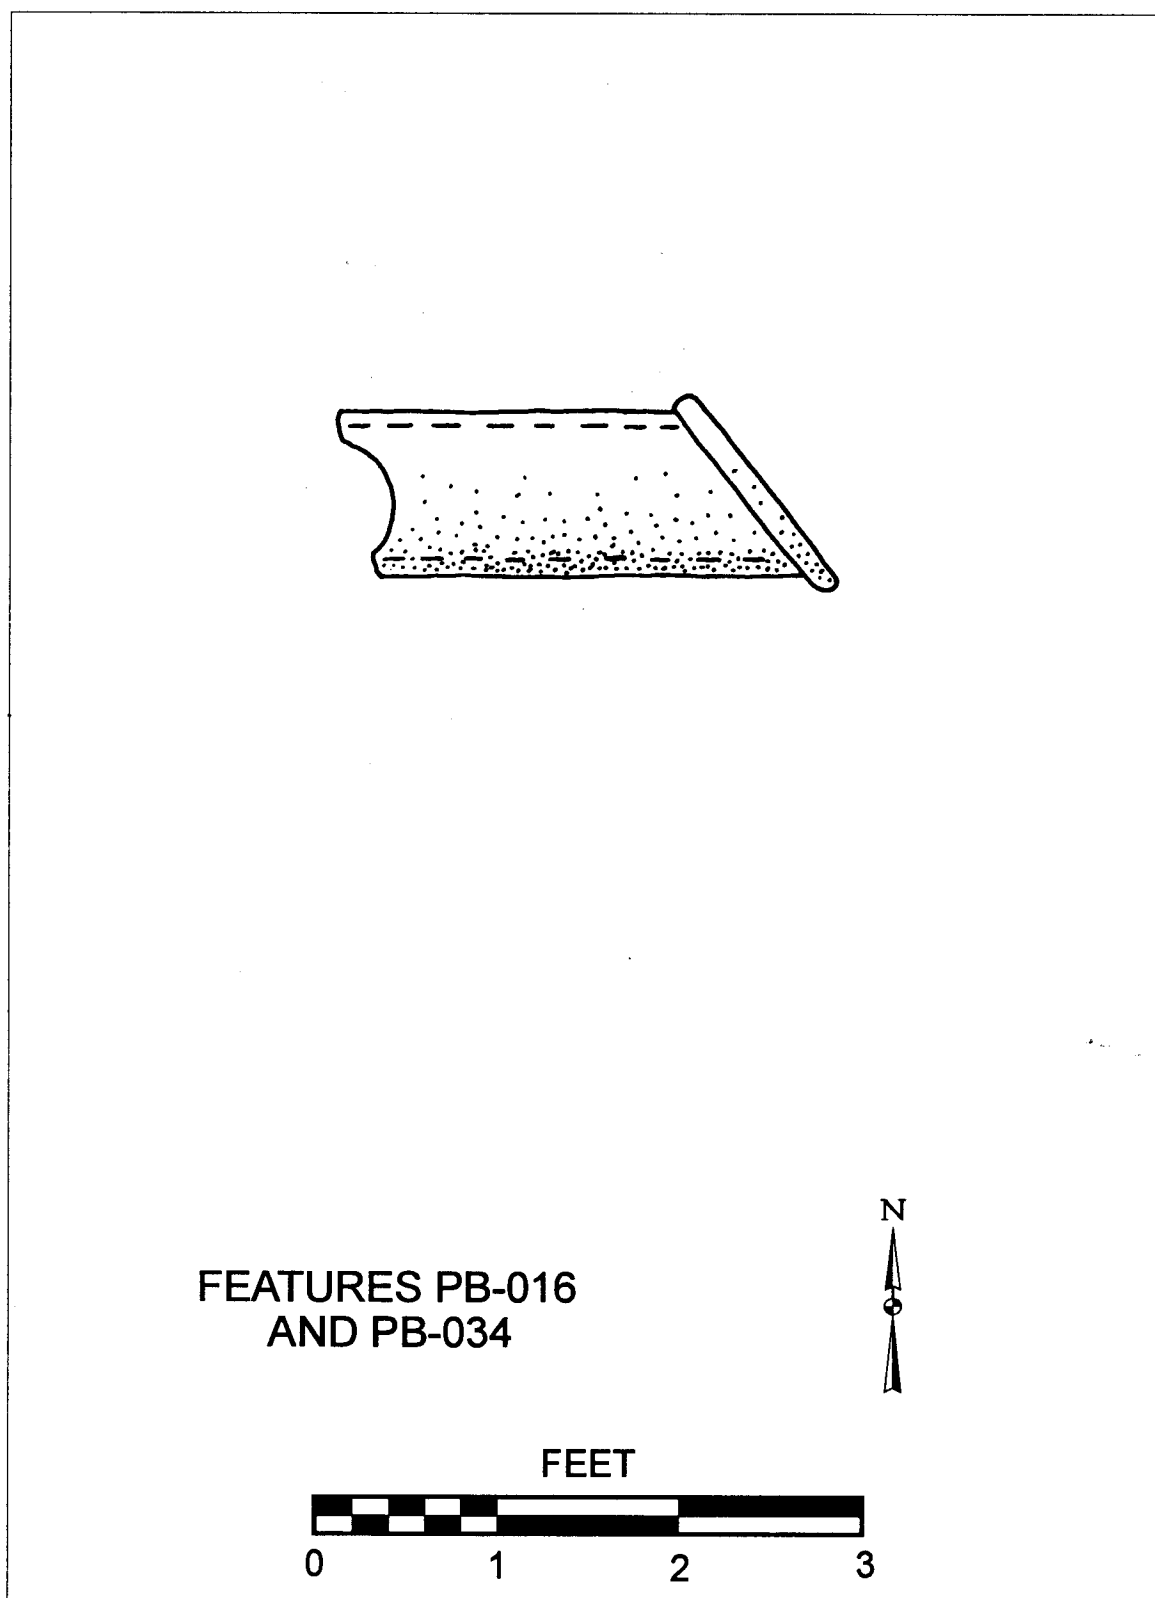
Figure 7

The most diagnostic objects in the intertidal zone are two hawse pipes, features PB-016 and PB-034, of identical dimensions (Figure 7). Hawse pipes were located on each side of vessel's bow, and allowed the chain cable to pass through the hull. Hawse pipes are distinguishable from mooring pipes (which allowed mooring lines to pass through the bulwarks on the main deck) and chain pipes (which allowed the chain cable to pass through the main deck into the chain locker) by their length and their sloping outer faces, which must conform to a bow's compound curves. PB-034 is located 50 feet 6 inches northwest of PB-016. The two hawse pipes have the same dimensions, which, combined with their proximity, indicate that they likely came from the same vessel. The pipes have an overall length of 2 feet 11 inches, an outside diameter of 11 inches and an inside diameter of 9 inches.

What makes these items particularly diagnostic is that classification rules specified hawse pipe size used in a vessel be based on anchor chain cable size; and the size of the chain cable was specified for vessels based on registered tonnage (chain was measured by the diameter of the link). *J. M. Colman* had a registered tonnage of 463 gross tons and 389 net tons. *Desmond* (1919) includes tables showing specifications for chain cable size based on tonnage, and showing hawse pipe size based on chain cable

size. A wooden sailing vessel of 400 tons was required to carry a chain cable at least $1 \frac{5}{16}$ inches in diameter, which required a hawse pipe between $11 \frac{1}{2}$ and $12 \frac{1}{2}$ inches in diameter.⁴ As mentioned before, features PB-016 and PB-034 have outside diameters of 11 inches, so the size of the hawse pipes in Northwest Cove match reasonably well the size of *J. M. Colman*.

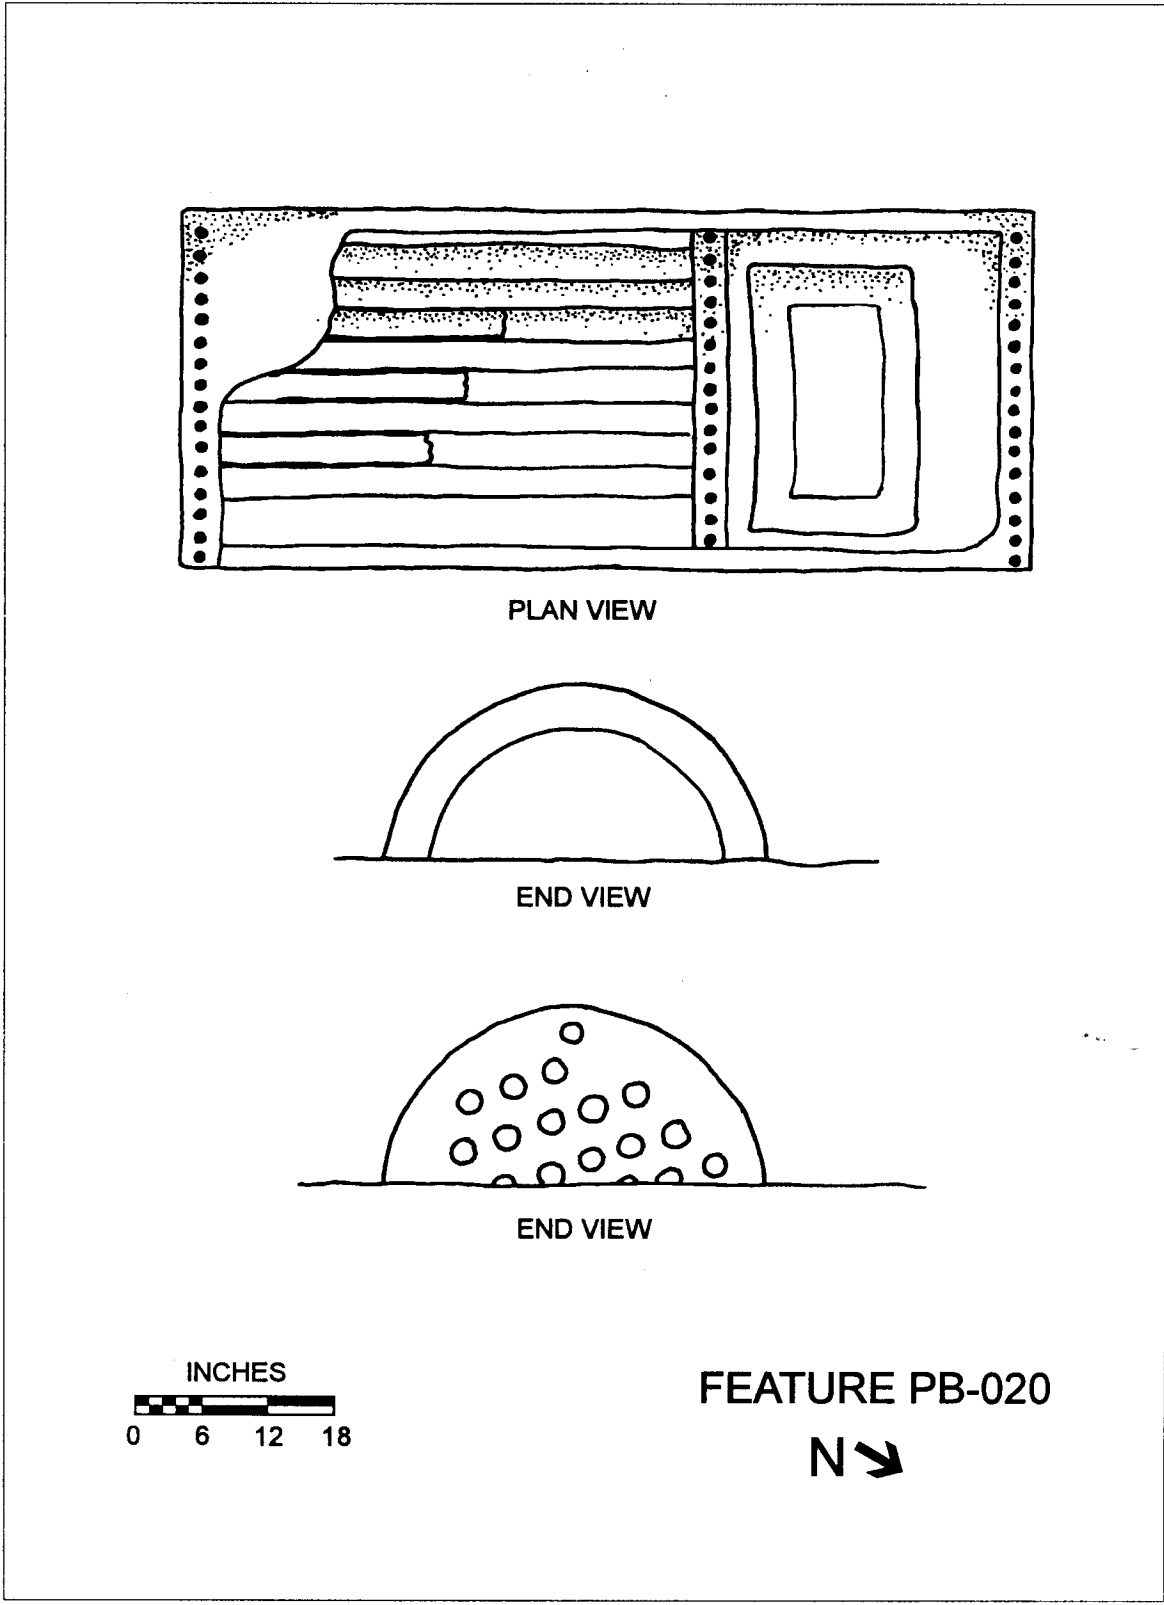
Figure 8

Feature PB-020 is another readily identifiable object, likely a steam donkey engine boiler (Figure 8). It is a cylinder approximately 6 feet 6 inches long and 3 feet in diameter; its interior filled with $2 \frac{3}{4}$ -inch diameter tubes for about $\frac{2}{3}$ of its length. Donkey engines, or "steam donkeys" as they were known, were found aboard coastal lumber schooners after the early 1880s.⁵ They were used for a variety of purposes, including loading and unloading cargo, hoisting the sails, and running the ship's pumps. The donkey engine was usually located in the forward deck house, as in the historic lumber schooner *C. A. Thayer*, which is on display at San Francisco Maritime National Historical Park. That vessel is a three-masted Pacific coast lumber schooner built in 1895 by Hans D. Bendixsen, and is very similar to *J. M. Colman*, *Comet*, and *Dora Bluhm*.

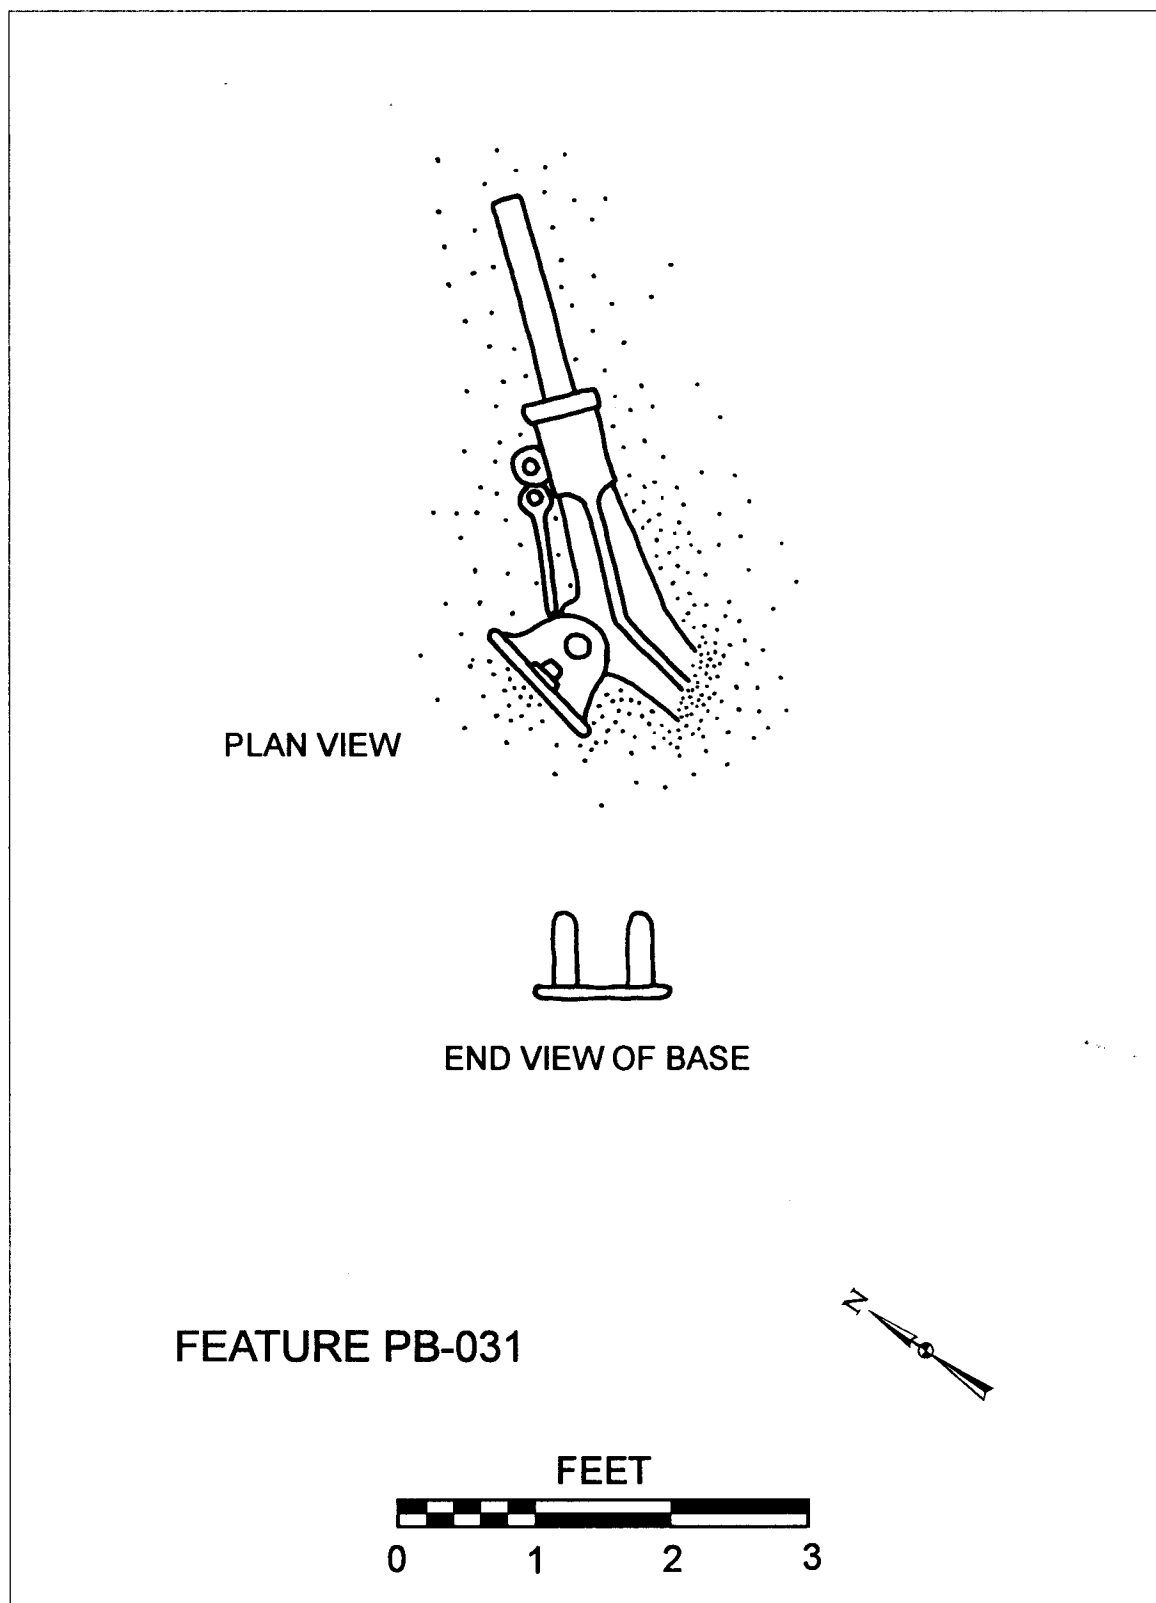
Figure 9

The only other object located in the intertidal zone that has been conclusively identified is PB-031 (Figure 9). This is the crosshead mechanism of a hand-operated, pump-brake windlass. An example of this mechanism can also be

seen on board *C. A. Thayer*, where it is mounted on the forecastle deck, directly forward the sampson post above the windlass. The crosshead was attached to the windlass by connecting rods, which passed through the forecastle deck and connected to the purchase rims of the windlass.⁶

Feature PB-031 is partially obscured by encrustation and marine growth, but it appears that a portion of one of the removable handles is present. The overall length of the piece is 4 feet. The base of the crosshead mechanism was secured to the forecastle deck with two iron fasteners, each 1 inch in diameter. The base itself is about 10 inches square and 6 1/2 inches tall. The size of this feature is similar to the crosshead mechanism found on *C. A. Thayer*.

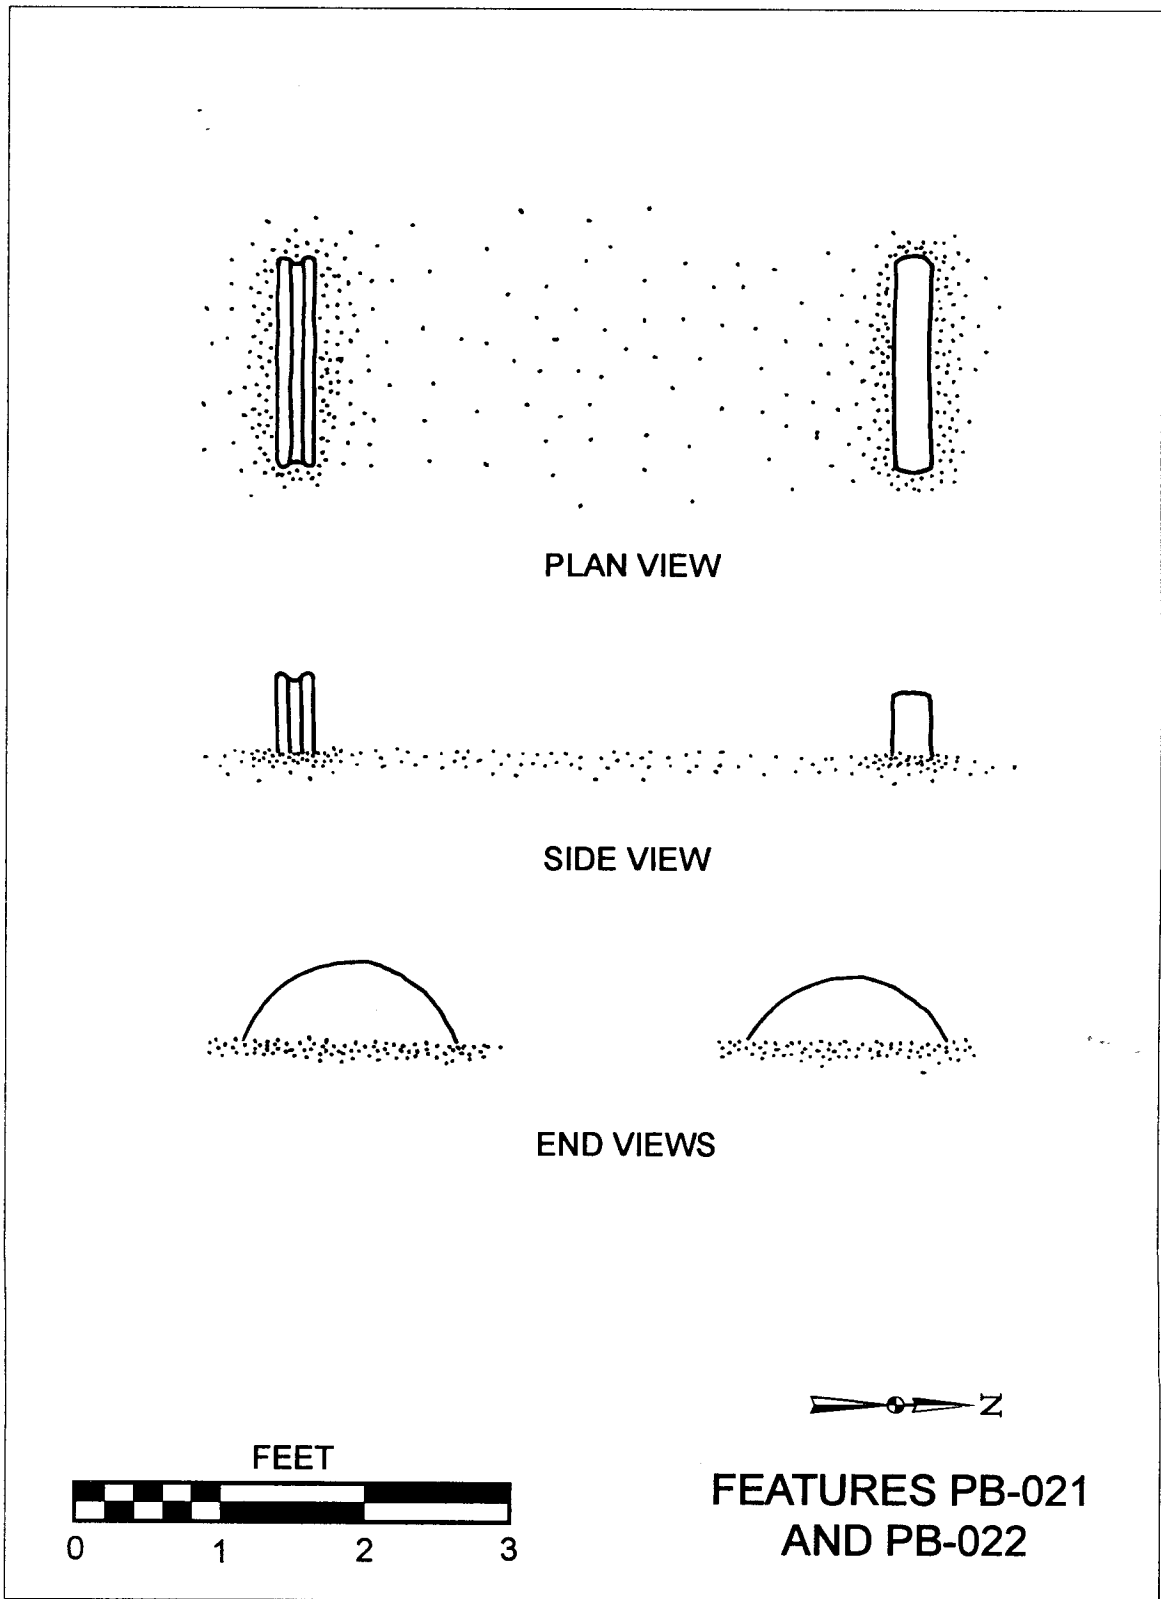
Figure 10

The rest of the iron material in the intertidal zone has not been identified, but there are some obvious possibilities. Features PB-021/022 (actually a single object) is likely part of a donkey engine (Figure 10). PB-021/022 are two circular iron pieces sticking upright out of the bottom, 4 feet apart, and connected by a shaft that could not be exposed (which is why they were given separate feature numbers). The circular iron pieces are 1 foot 6 inches in diameter. One of them (PB-021) is featureless, while the other (PB-022) is grooved along the edge.

Although positive identification is difficult, it is probably the drive spindle of a steam donkey engine.

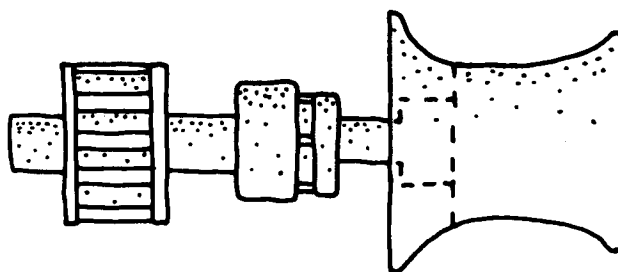
Figure 14

Features PB-026, 027, and 029 are also likely parts to either a windlass or a donkey engine. Both PB-027 (Figure 14) and PB-029 (Figure 15) contain warping hubs and geared mechanisms on shafts, likely parts from a windlass, a deck winch, or a donkey engine. PB-027 is 3 feet 9 inches in length, while PB-029 is 2 feet long. The warping hubs on each one are identical, each 1 foot 4 inches long, and 1

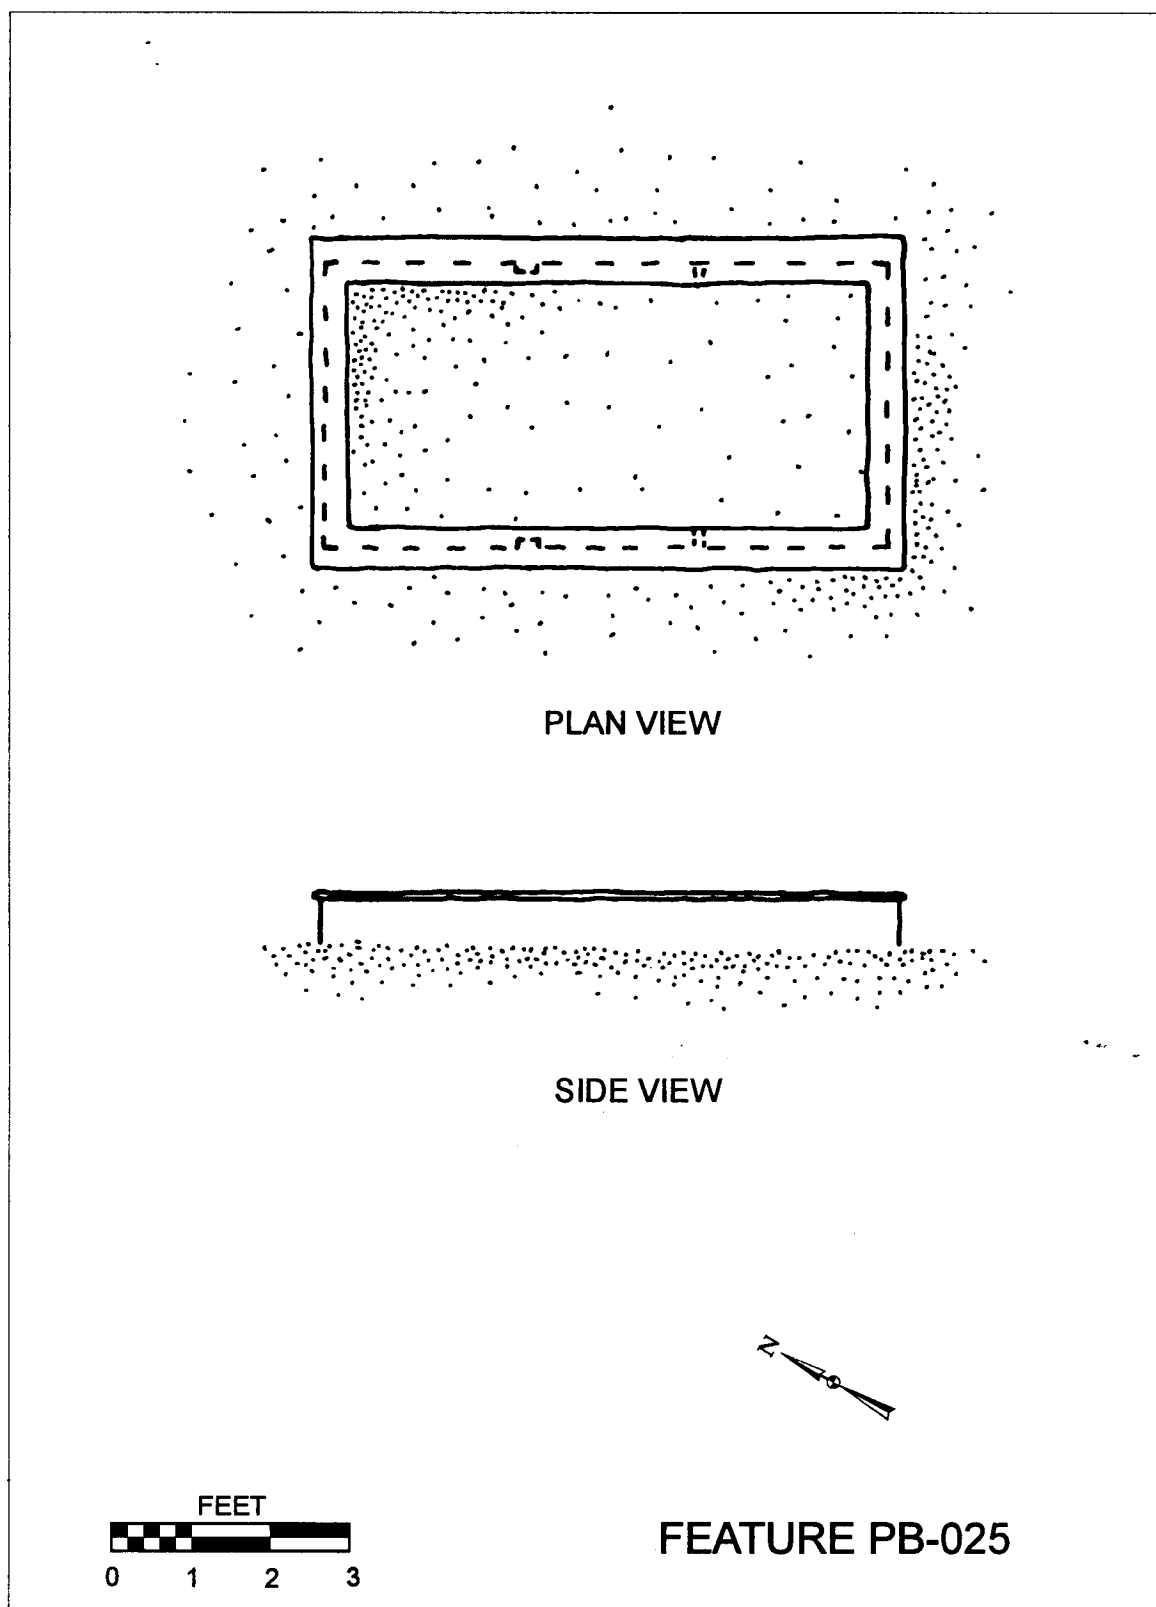
Figure 17

The second most conspicuous feature in the intertidal zone behind the boiler is PB-025, a large, rectangular-shaped iron structure encrusted to the bottom (Figure 17). It has an outside length of 7 feet 2 inches and an outside width of 4 feet 1 inch. The inside length is 6 feet 4 inches, while the inside width is 3 feet 1 inch. The object is 8 inches high. At first glance, the object appears to be some sort of hatch coaming. This is unlikely, however, as the cargo hatches on almost any ocean-going vessel would have been much larger and more probably constructed of wood. Feature PB-025 may be a machinery mount, possibly for the windlass or the donkey engine.

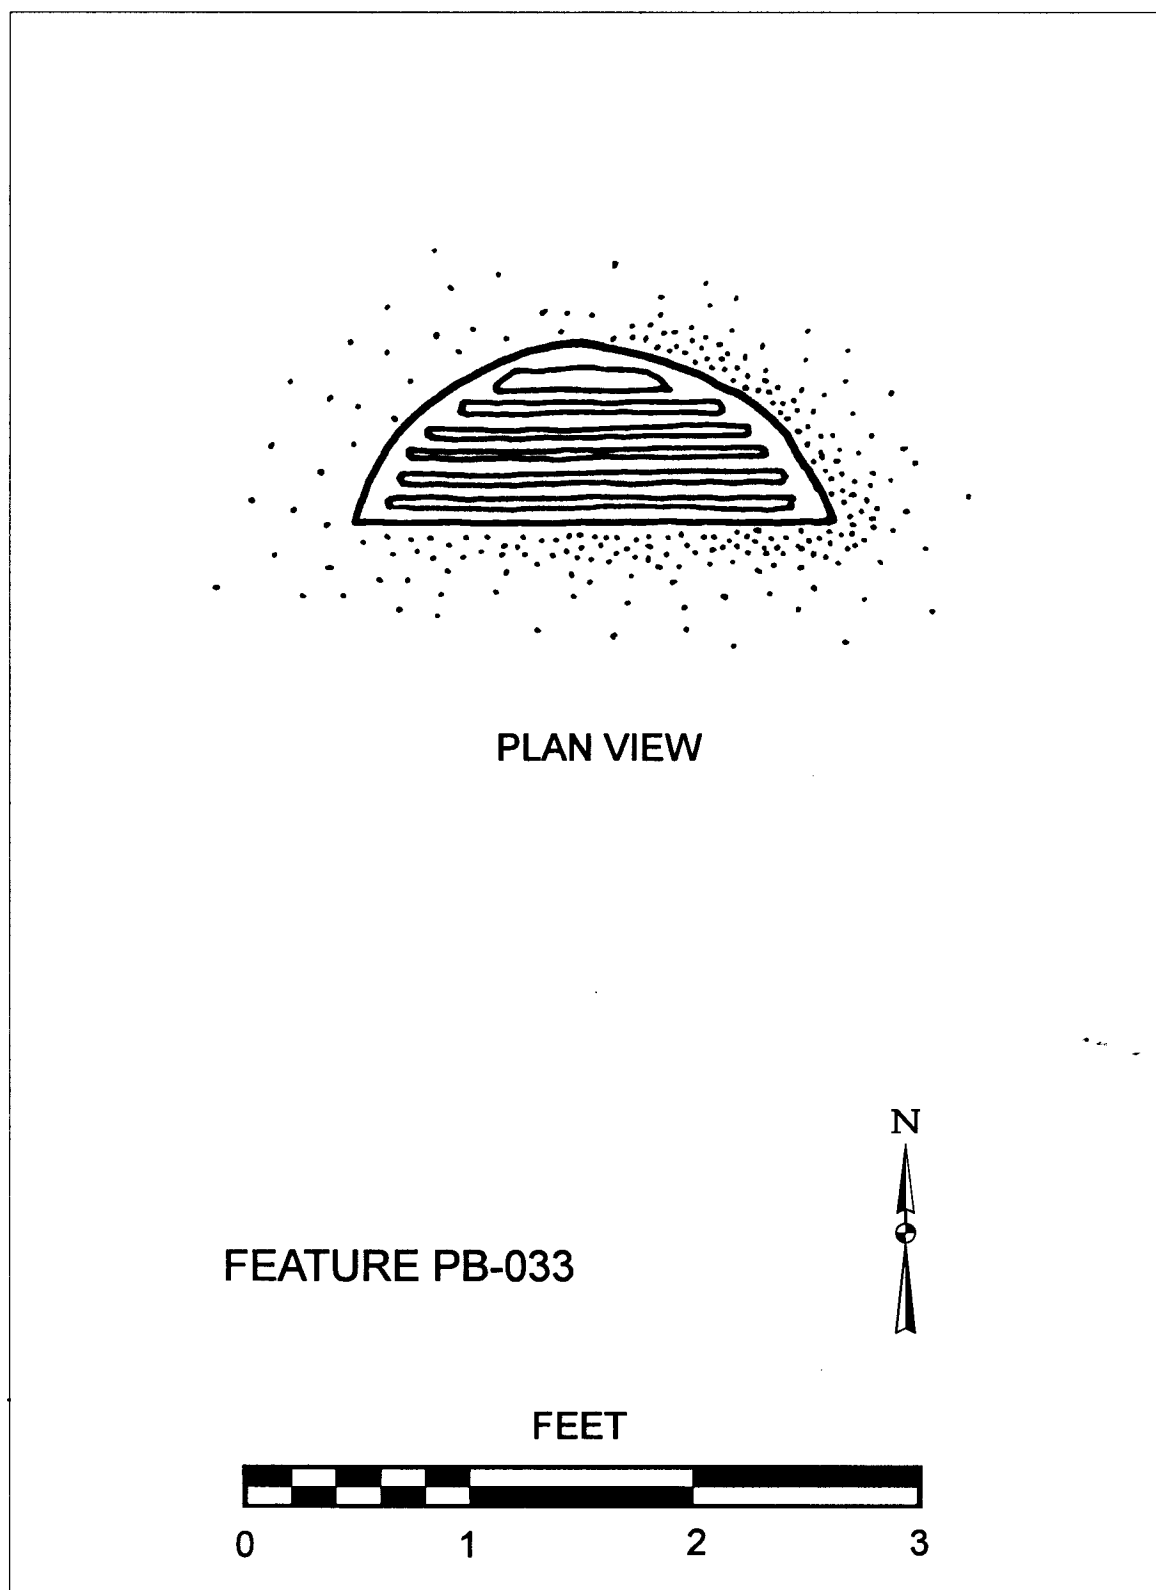
Figure 20

Feature PB-033 is a small, half-moon-shaped iron object (Figure 20). It is 2 feet 1 inch long across its base and just over 9 inches wide at the broadest point. It is 1 1/2 inches thick. The top surface has six shallow grooves running lengthwise. The grooves are 1/2 inch wide with

3/4-inch spaces between them. The bottom surface of the object is smooth.

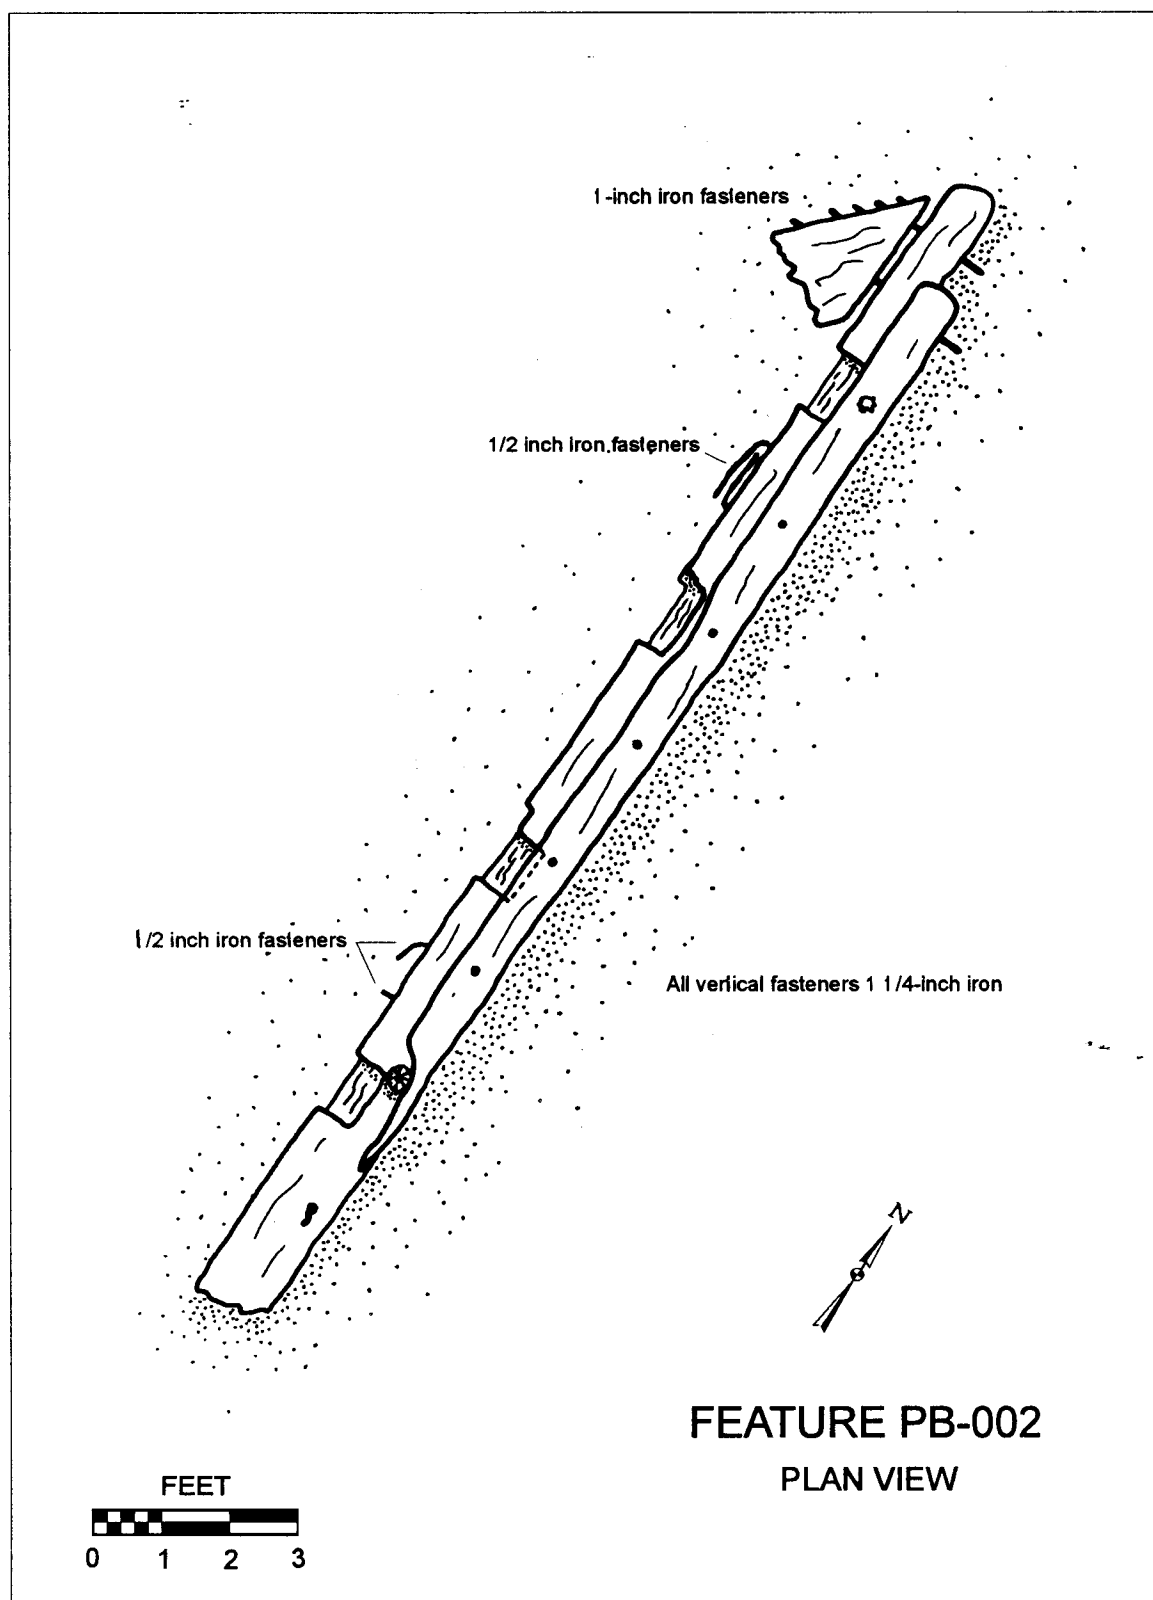
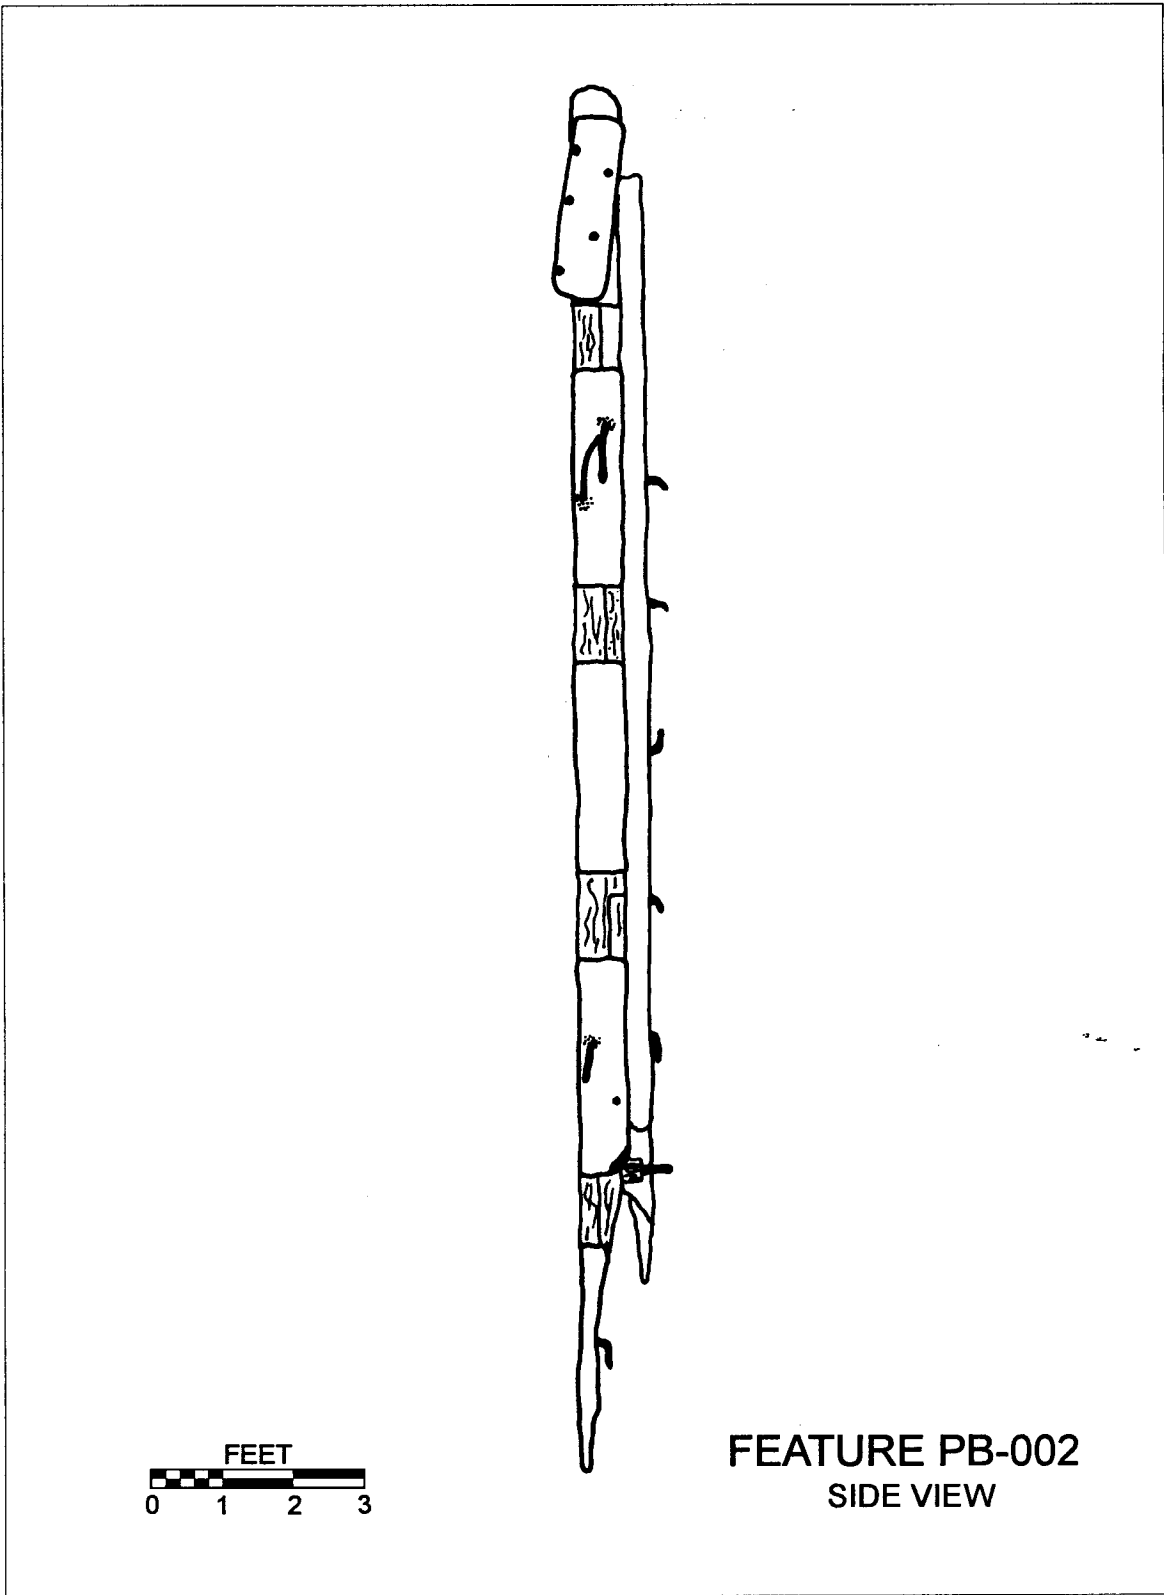
Figure 23

Another feature that is likely a scantling piece from a large, ocean-going vessel is PB-002 (Figures 23 and 24). This feature consists of three wooden components: two long, rectangular pieces, one on top of the other, and a small trapezoidal piece fastened to the bottom timber. Also present are numerous iron fasteners. The bottom timber's total length is 19 feet 8 inches, it is 1 foot 2 inches wide and 8 inches thick. This piece contains four mortises cut into its west side, which measure between 10 inches and 1 foot 1 inch long, 3 1/2 inches high, and 5 1/2 inches deep. The mortises are indented about 1 1/2 inches from the side. The top timber, which was originally fastened to the bottom piece with eight 1 1/4-inch diameter iron drift pins spaced 2 feet on center, is 15 feet 6 inches long, 8 inches wide, and 4 inches thick. On the feature's north end, a trapezoidal piece 2 feet 2 inches long, 1 foot 7 3/4 inches wide, and 8 inches thick is fastened to the lower timber with five iron, 1-inch diameter drift pins. In addition to these fasteners, the feature also has two pairs of

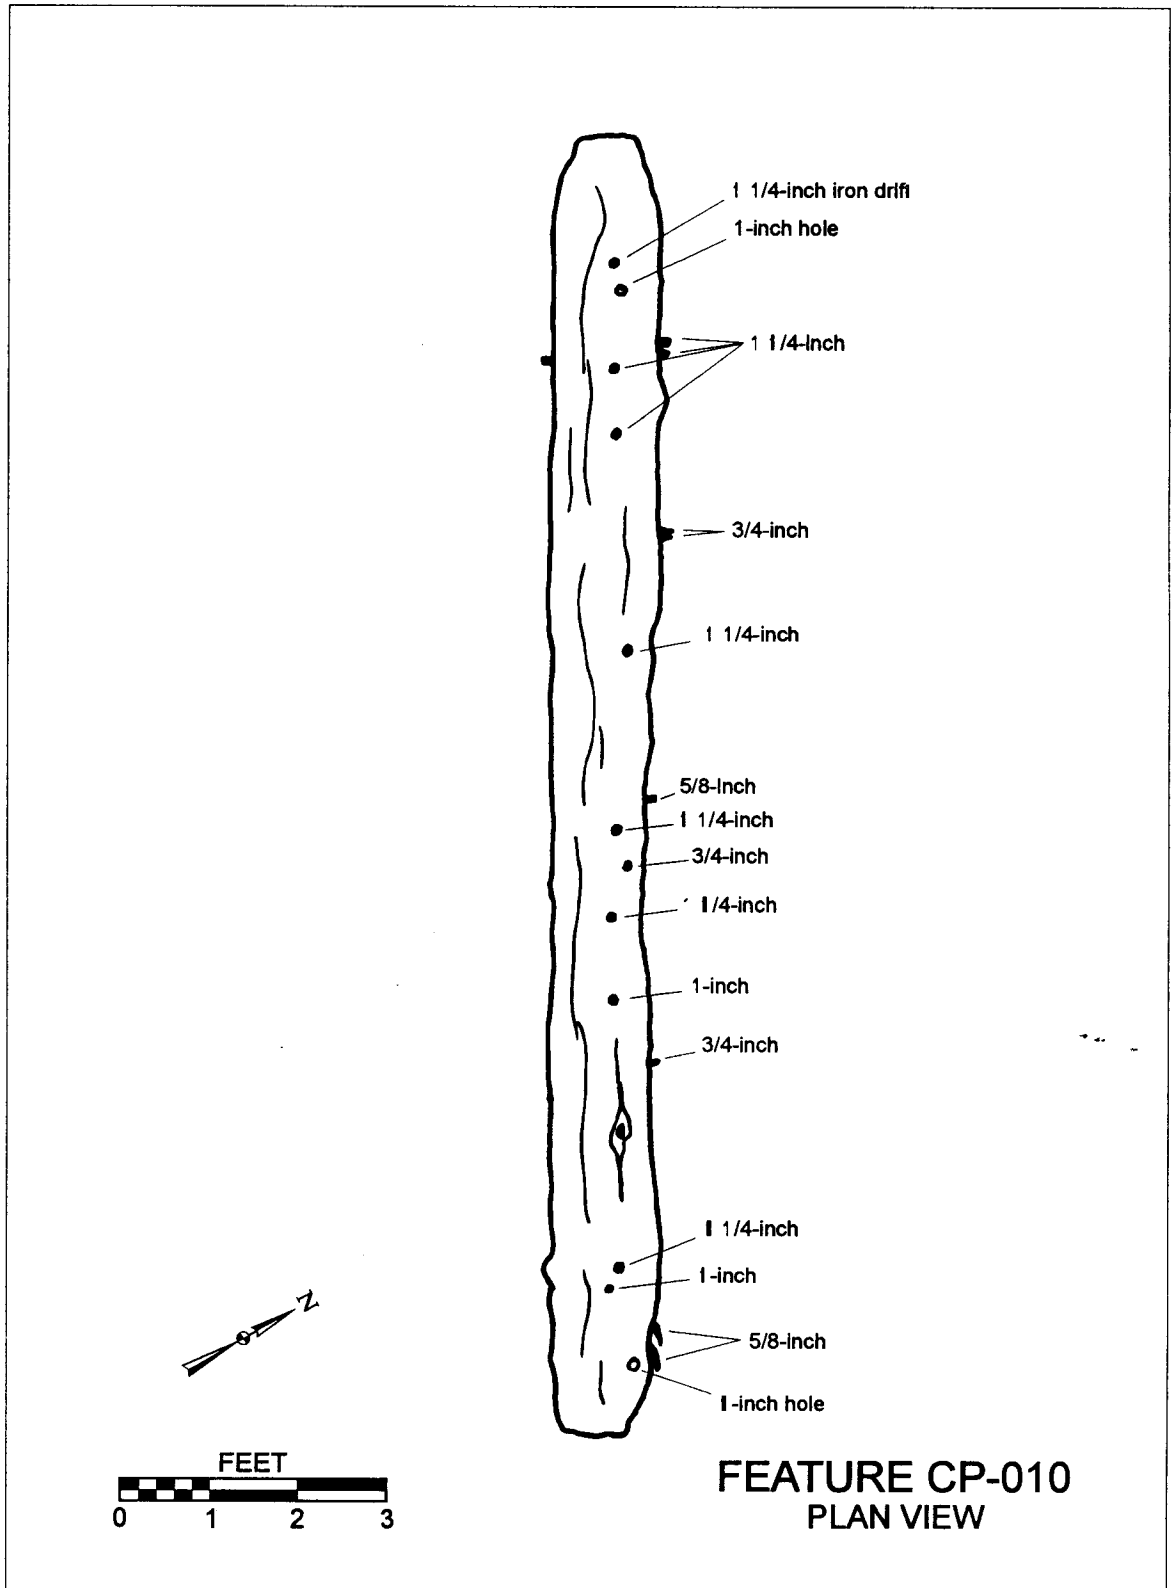
Figure 32

though somewhat deteriorated (Figure 32). It contains ten vertical iron drift pins along its length, and holes for two more. These fasteners (and holes) include seven 1 1/4-inch diameter pins, four 1-inch diameter pins, and a single 3/4-inch diameter pin. The piece also includes transverse fasteners: a pair of 1 1/4-inch diameter drift pins; a pair of 3/4-inch diameter drifts; a single 5/8-inch diameter drift; another, single 3/4-inch diameter drift; and a pair of 5/8-inch diameter drifts. There is no discernible pattern to fastener spacing.

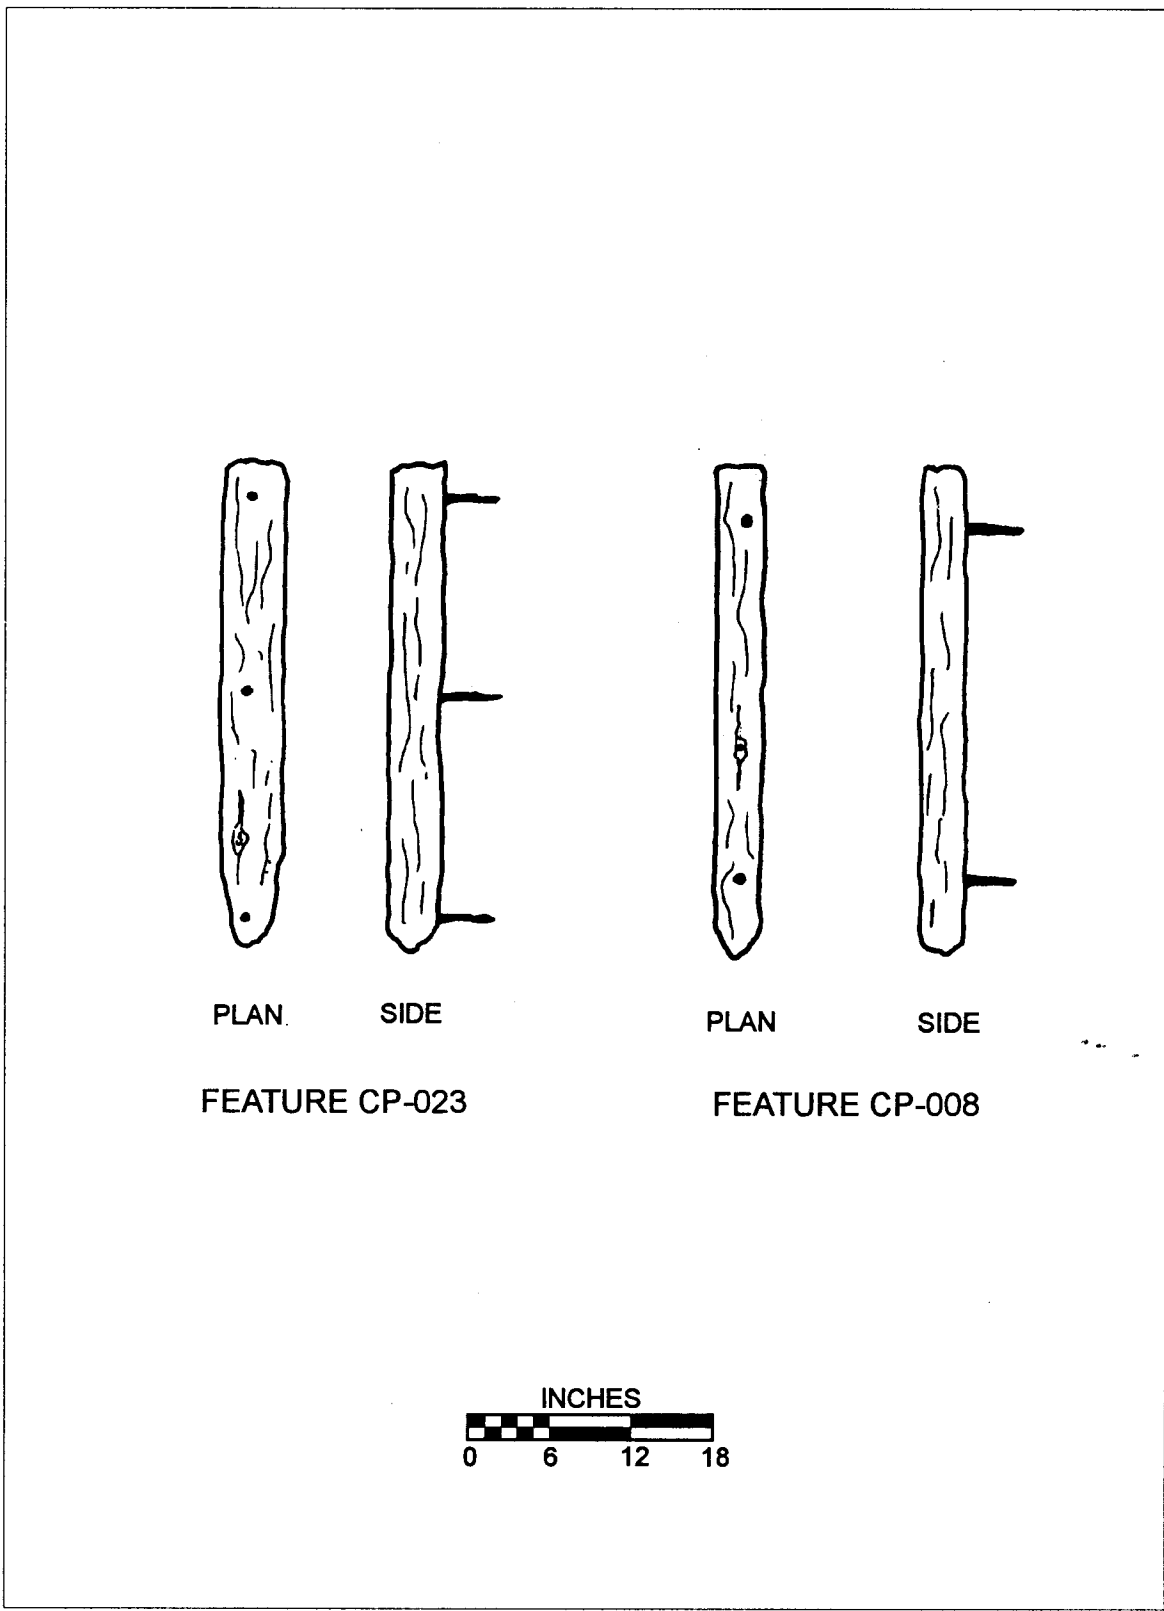
Figure 34

Two features that may represent small portions of structural members are features CP-008 and CP-023 (Figure 34). Both features are 3 feet long and nearly square in cross-section. Feature CP-008 is 3 1/2 inches wide and 3 1/4 inches thick; all its faces are extremely worn. It contains two round spikes 2 feet 2 1/2 inches apart. One is 3/4 inch in diameter and the other is 7/8 inch in diameter, though both are exfoliating badly. Feature CP-023 is slightly over 4 inches wide and 3 7/8 inches thick; all its faces are also very worn. It contains three iron spikes, all 1/2 inch in diameter. The first and second spikes are

spaced 1 foot 2 inches apart, while the second and third are 1 foot 5 inches apart.

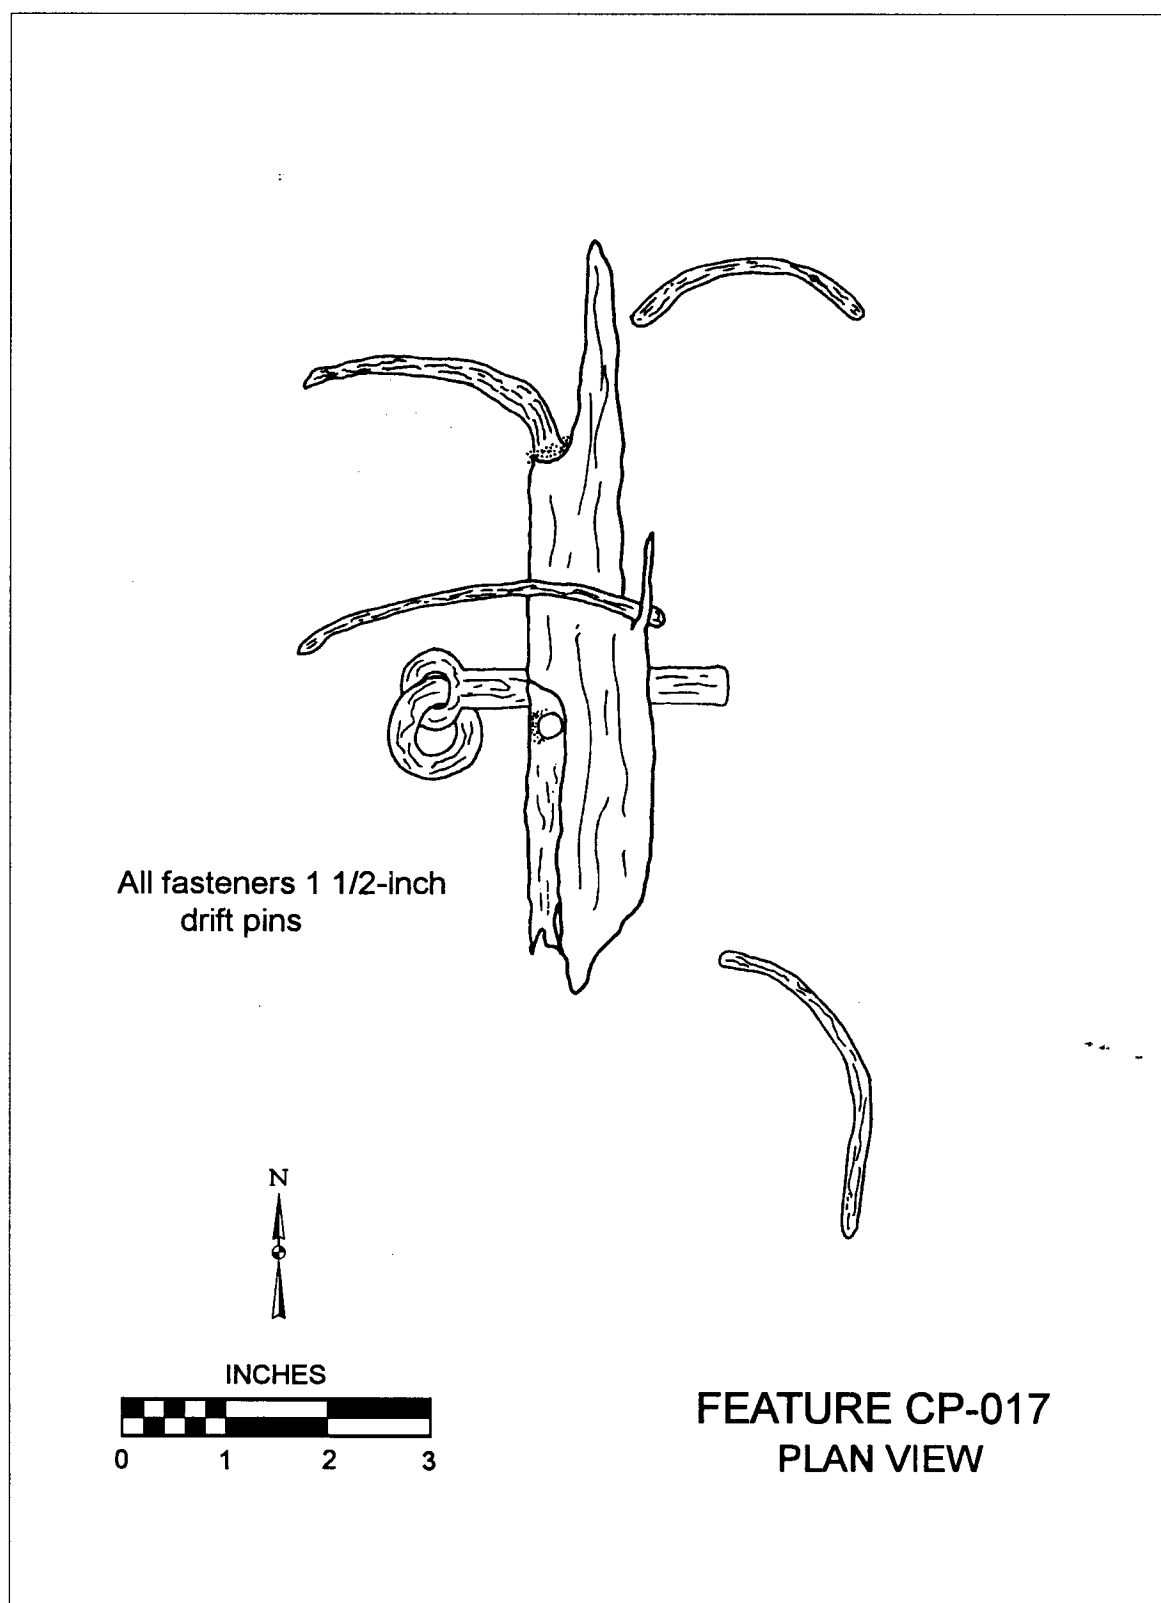
Figure 35

Feature CP-017 is also a structural member from a large, wooden sailing vessel (Figure 35). The extremely deteriorated wood fragment is 3 feet 4 inches long, 7 inches wide and 10 inches thick. It contains, however, five 1 1/2-inch diameter iron drift pins (the longest 3 feet long), and a 2-inch diameter iron eye-bolt with a 6 1/2-inch outside diameter ring attached. The eye-bolt and ring represents a tie-down point, which could have been placed in many locations on the vessel. The five fasteners' original measurements were considerably smaller, accounting for iron corrosion expansion. The largest fasteners required in *Dora Bluhm* contract were 1 1/8-inch drifts for the keel, keelson,

stem, and stern post. CP-017 likely represents a small portion of any of these components.
