Determining Seasonal Corrosion Rates in Ferrous-Hulled Shipwrecks:  
A Case Study of the USS *Huron*

DETERMINING SEASONAL CORROSION RATES IN FERROUS-HULLED  
SHIPWRECKS: A CASE STUDY OF THE USS *HURON*

A Thesis

East Carolina University

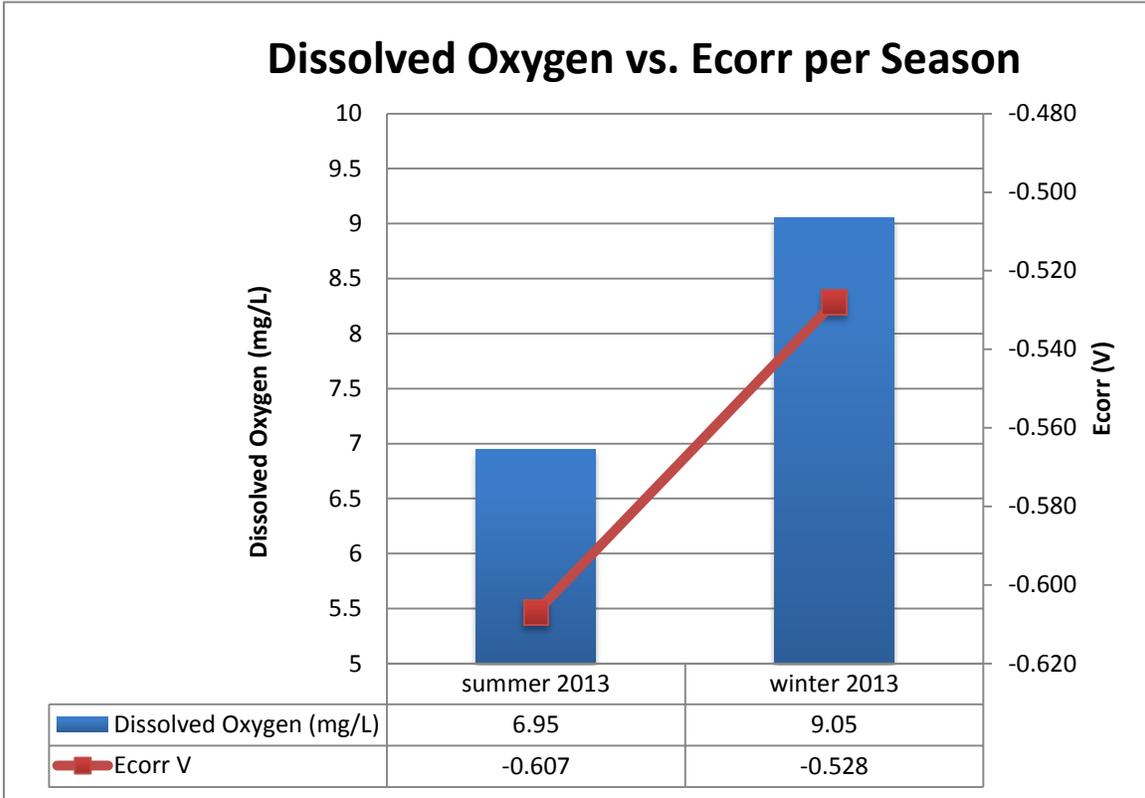
**Figure 39. Relative amounts of dissolved oxygen to average corrosion potential. Lower Ecorr readings (red) indicate higher corrosion environments. (Image by author, 2014).**

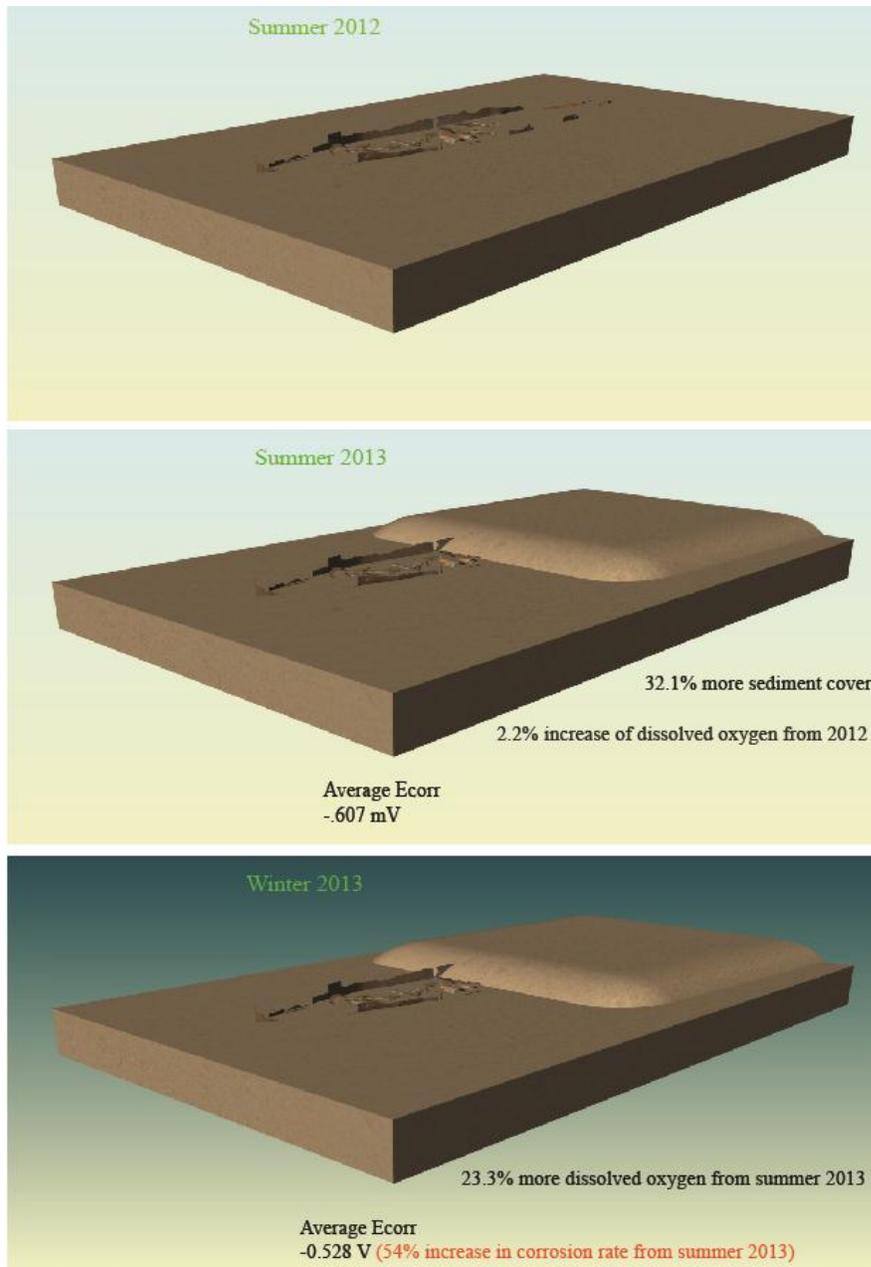
**Figure 40. Seasonal sediment model of the wreck site and resulting *Rhinoceros* area analysis. (Image by author, 2014.)**

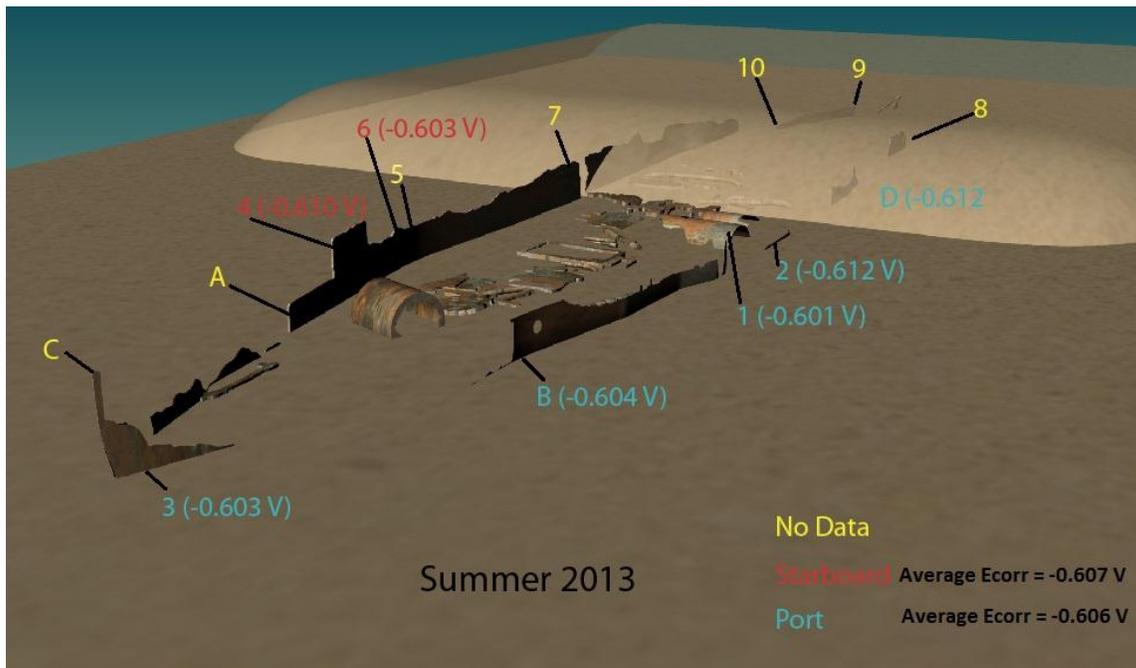
**Figure 42. Corrosion potential readings partitioned into port and starboard sides of the wreck. (Image by author, 2014.)**

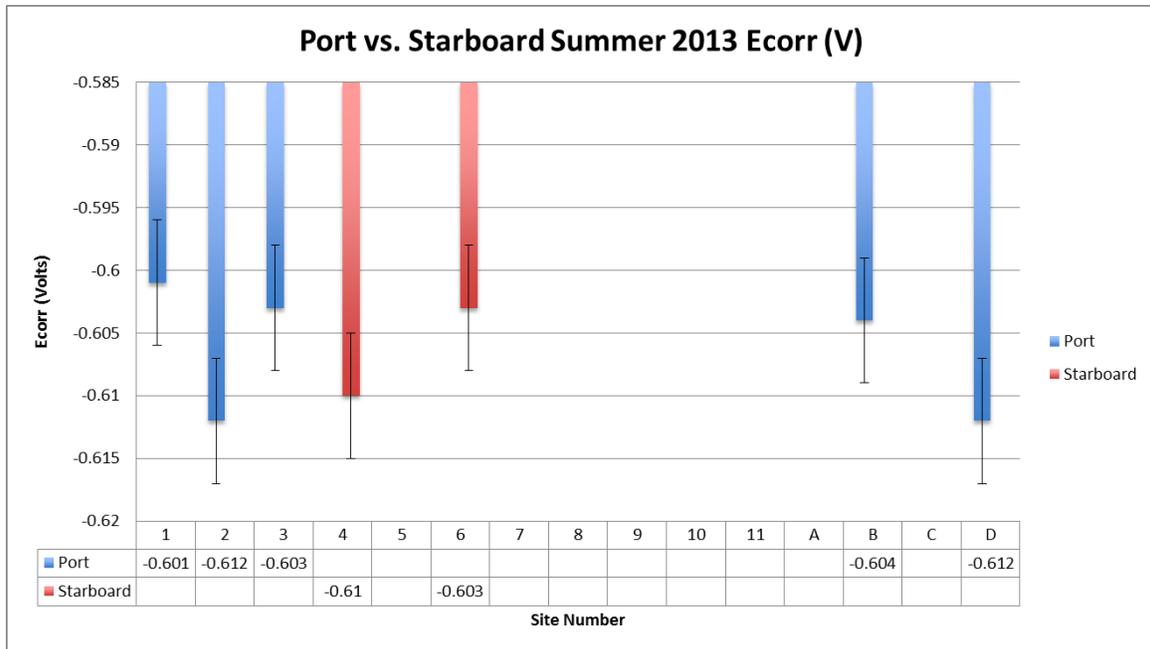
**Figure 43. Graph of port and starboard corrosion potentials (Ecorr) for summer 2013. (Image by author, 2014.)**

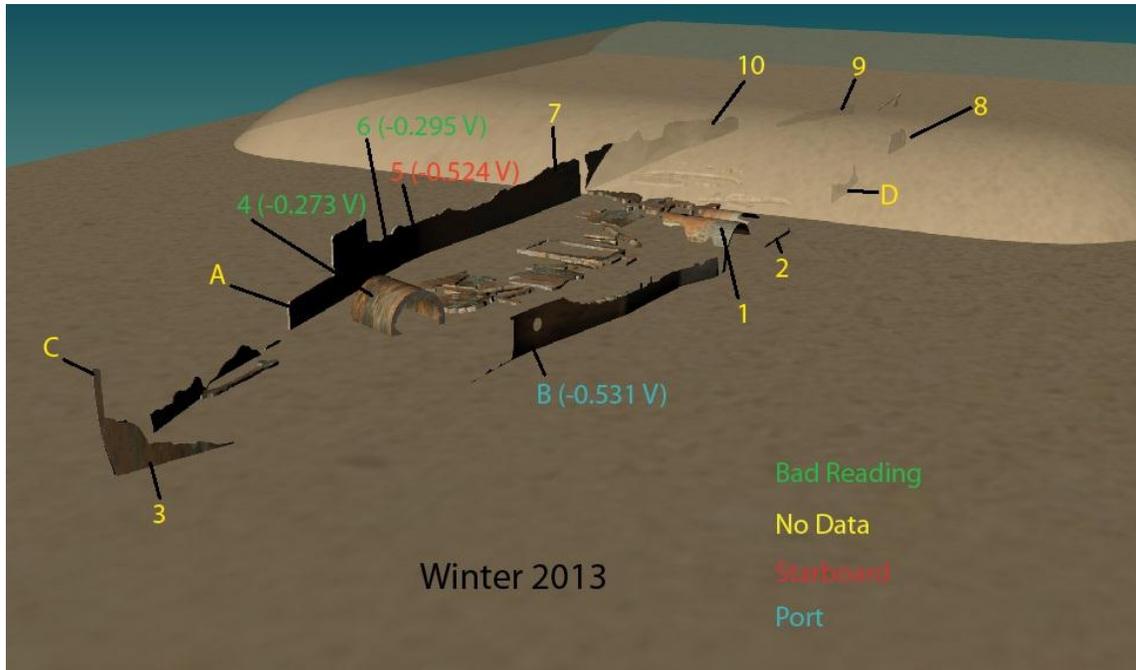
Figure 44. Corrosion potential readings partitioned into port and starboard sides of the wreck for winter 2013-2014. (Image by author, 2014.)

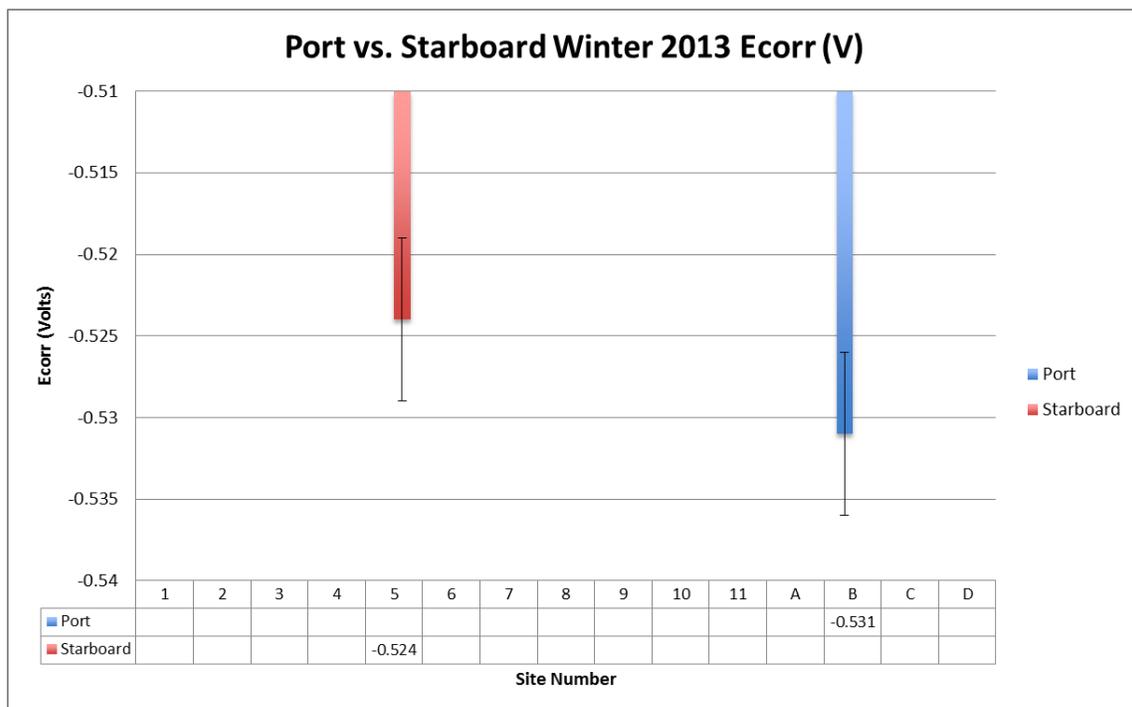
Figure 45. Graph of port and starboard side corrosion potentials ( $E_{corr}$ ) for winter 2013-2014. Invalid readings are not included. (Image by author, 2014.)

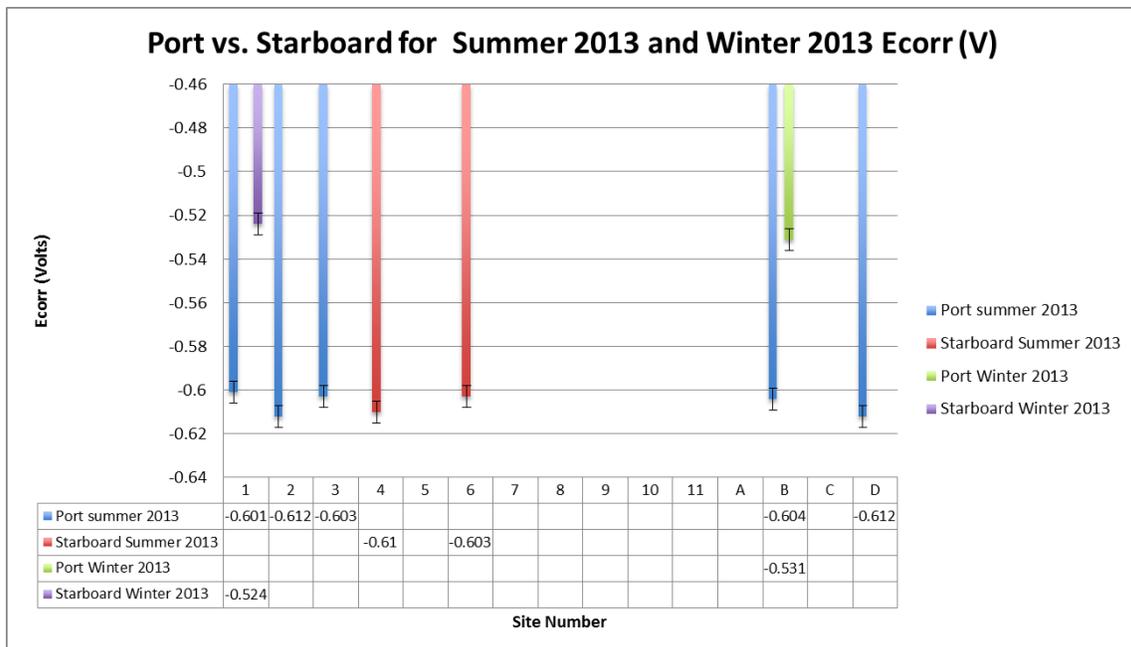
**Figure 46. Port versus starboard Ecorr for Summer 2013 and Winter 2013-2014. (Image by author, 2014.)**

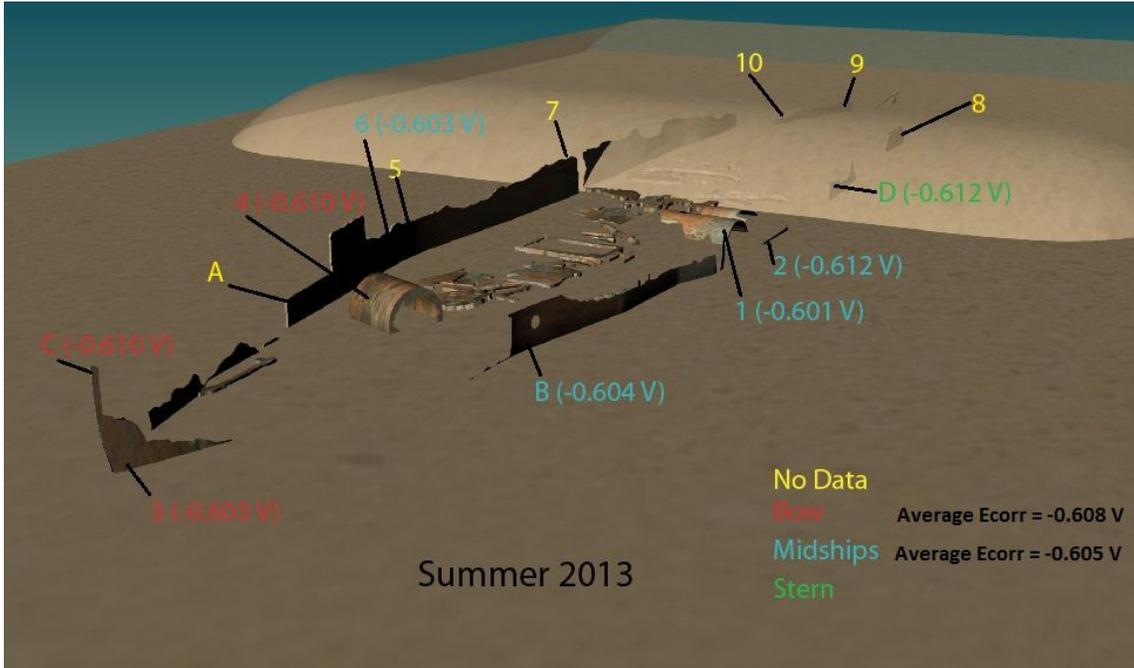
**Figure 47. Summer 2013 bow, midships, and stern section corrosion potential results. (Image by author, 2014.)**

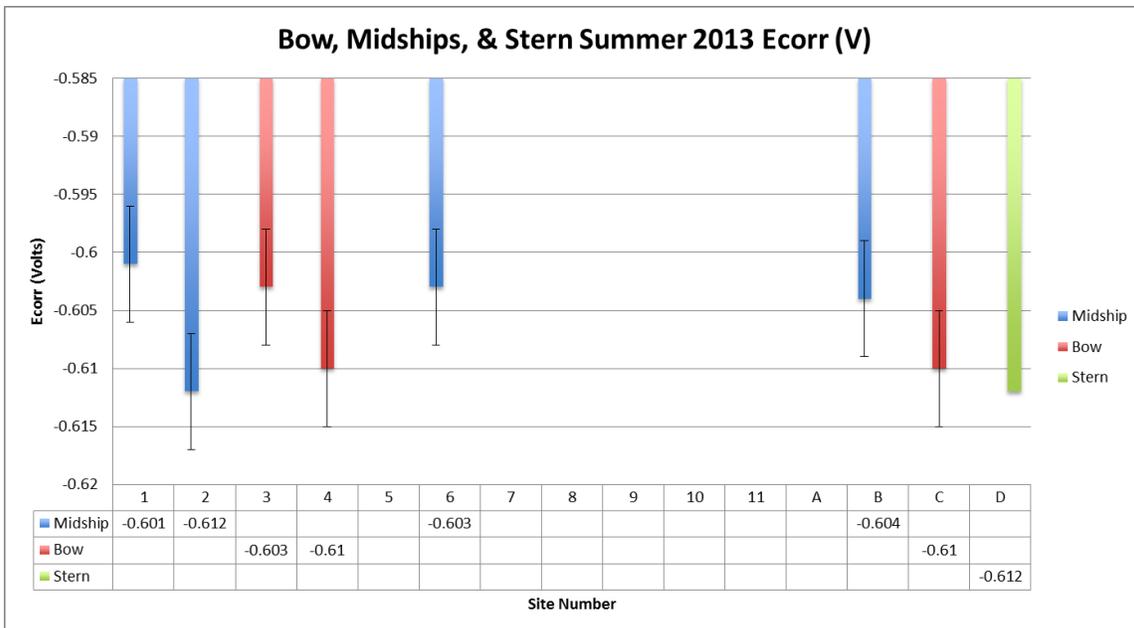
**Figure 48. Graph of the bow, midships, and stern corrosion potentials (Ecorr) from the summer 2013 sampling season. (Image by author, 2014.)**

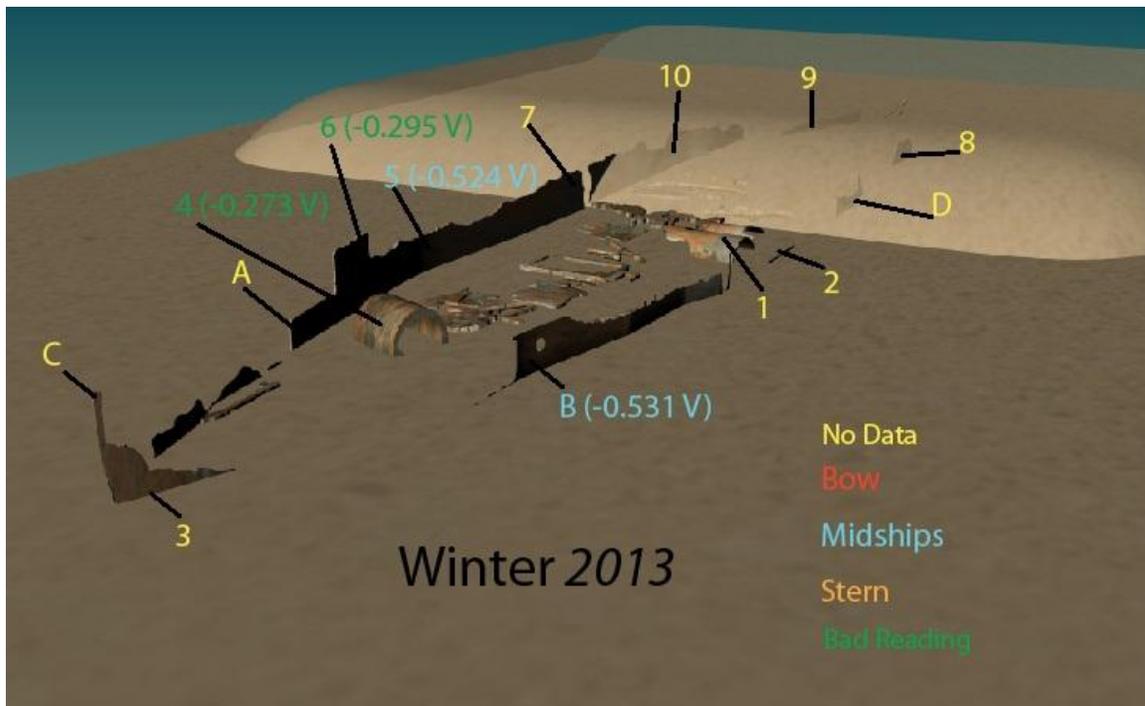
**Figure 49. Winter 2013-2014 bow, midships, and stern section corrosion potential results. (Image by author, 2014.)**

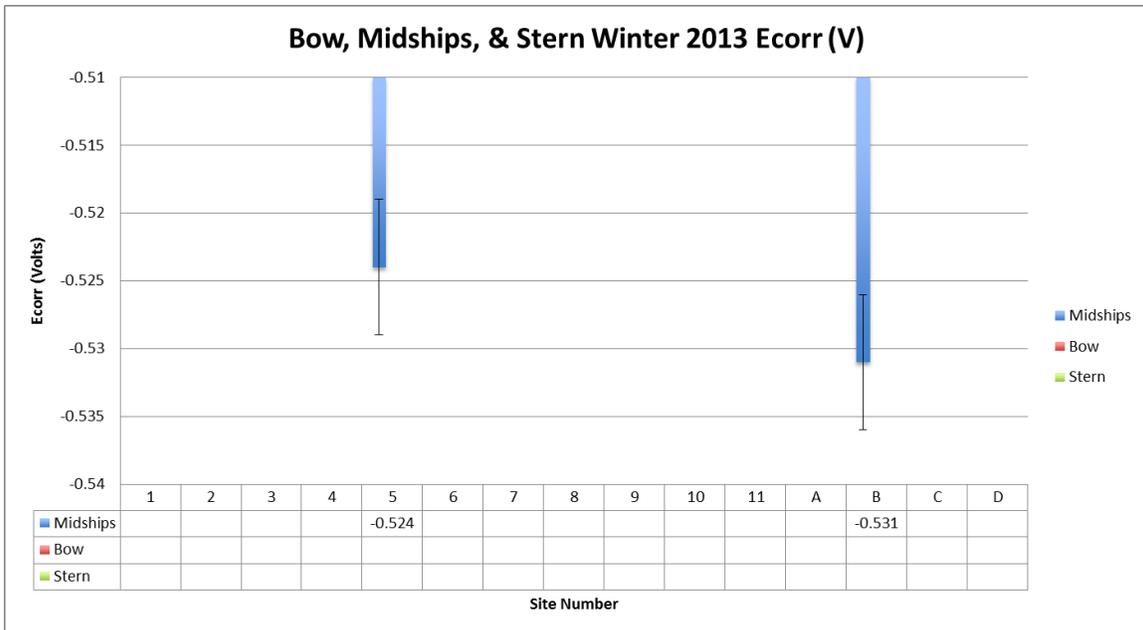
**Figure 50. Graph of the bow, midships, and stern corrosion potentials (E<sub>corr</sub>) from the summer 2013 sampling season. Invalid readings are not included. (Image by author, 2014.)**

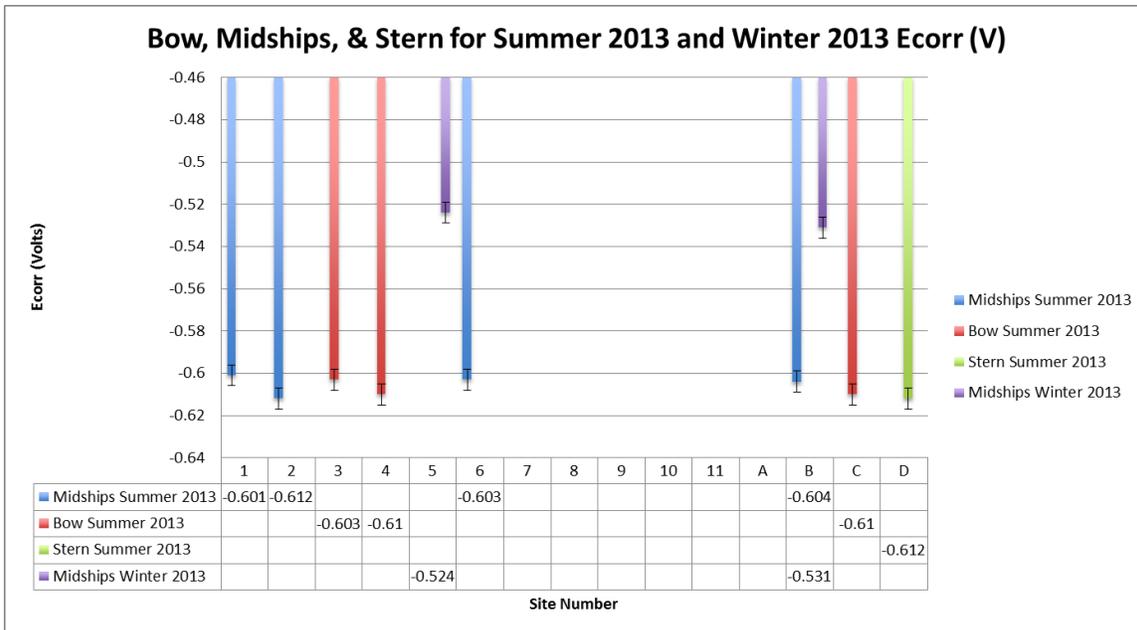
**Figure 51. Bow, midships, and stern Ecorr for summer 2013 and winter 2013-2014. (Image by author, 2014.)**

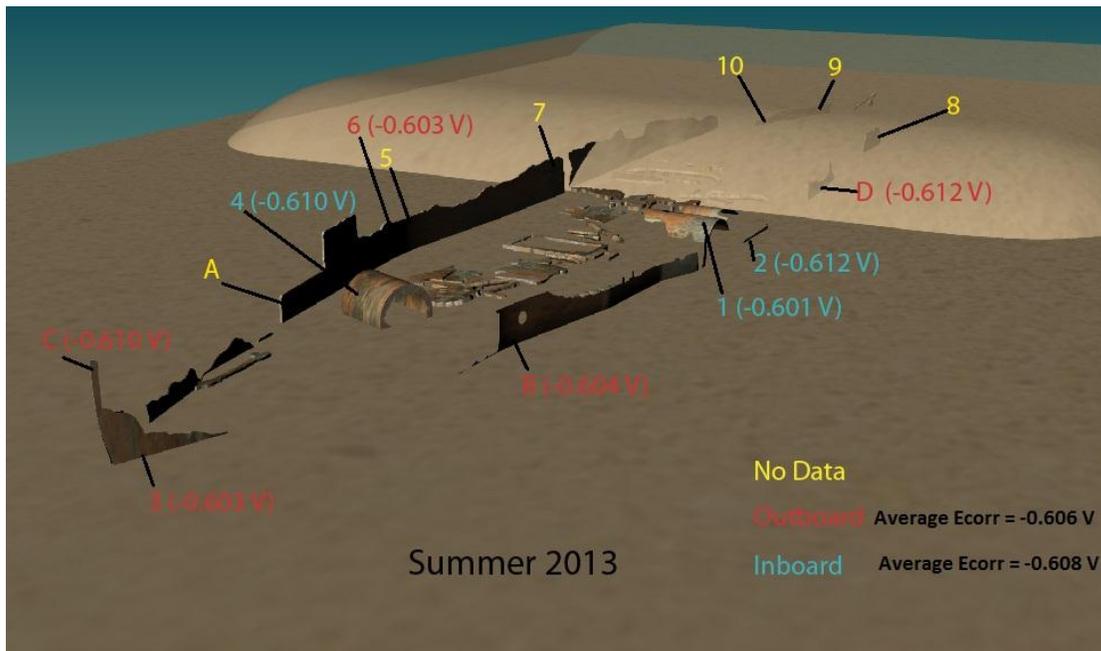
**Figure 52. Summer 2013 inboard versus outboard Ecorr comparison. (Image by author, 2014.)**

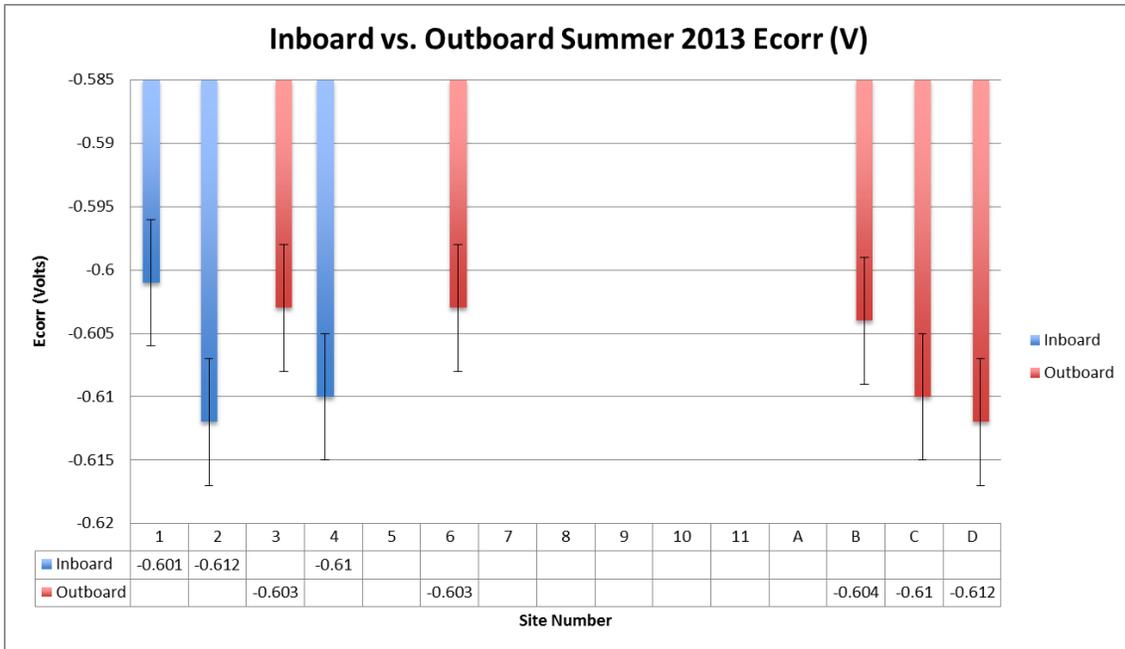
**Figure 53. Graph of the summer 2013 inboard versus outboard Ecorr. (Image by author, 2014.)**

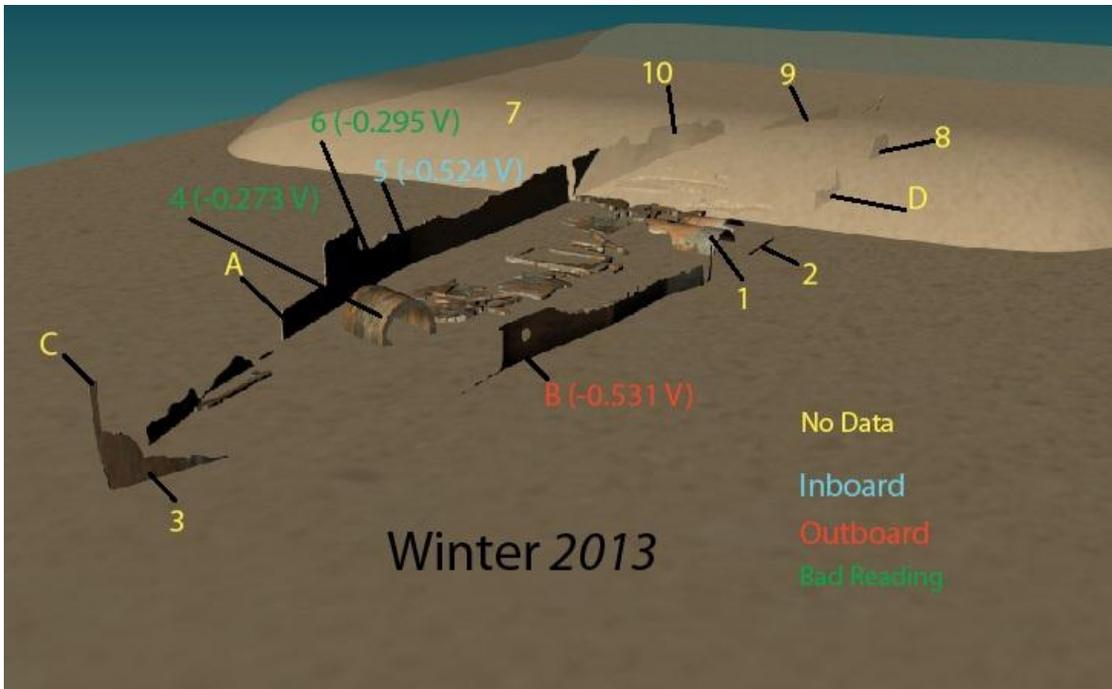
Figure 54. Winter 2013-2014 inboard versus outboard Ecorr comparison. (Image by author, 2014.)

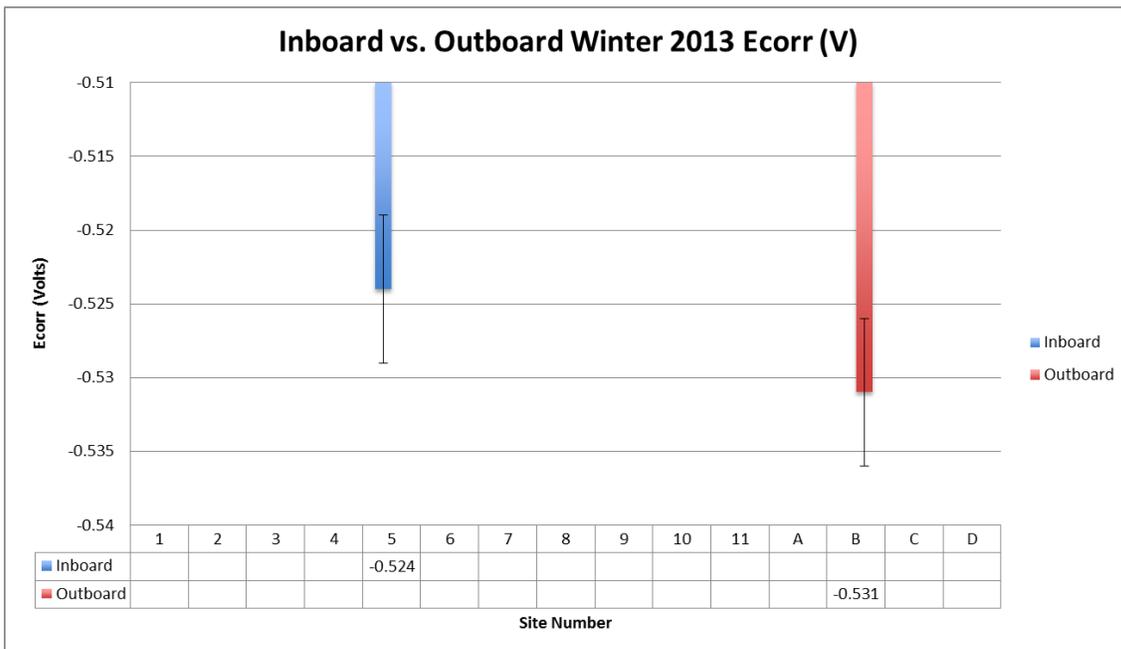
Figure 55. Graph of the winter 2013-2014 inboard versus outboard Ecorr. Invalid readings are not included. (Image by author, 2014.)

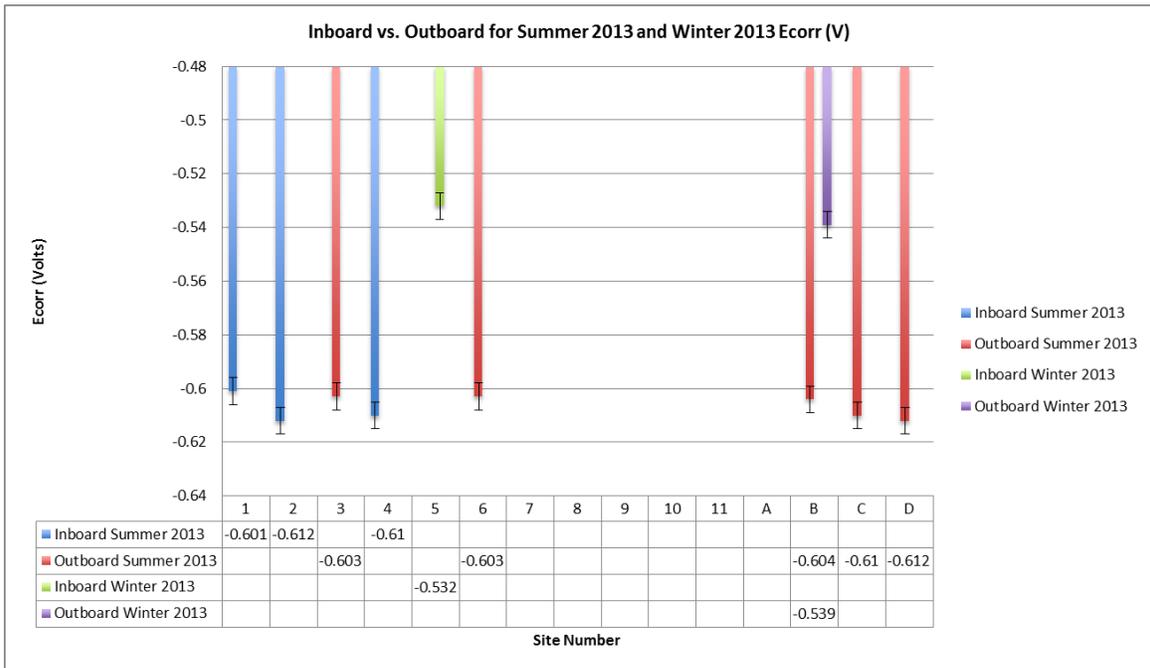
**Figure 56. Inboard versus outboard Ecorr for summer 2013 and winter 2013-2014. (Image by author, 2014.)**

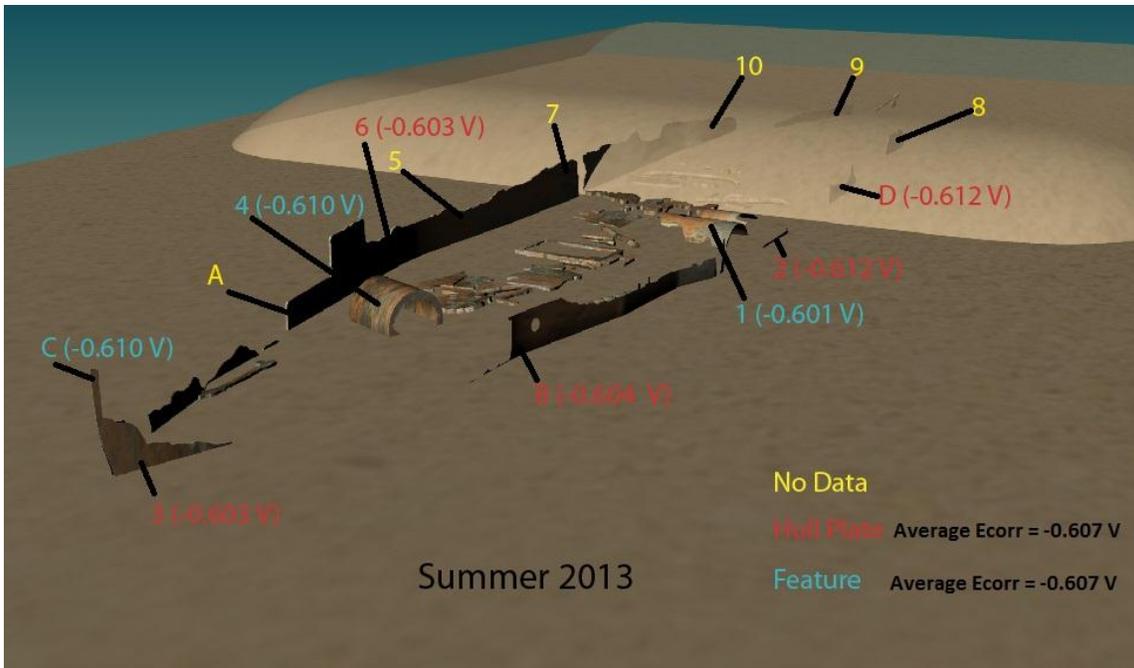
**Figure 57. Summer 2013 hull plate versus feature Ecorr comparison. (Image by author, 2014.)**

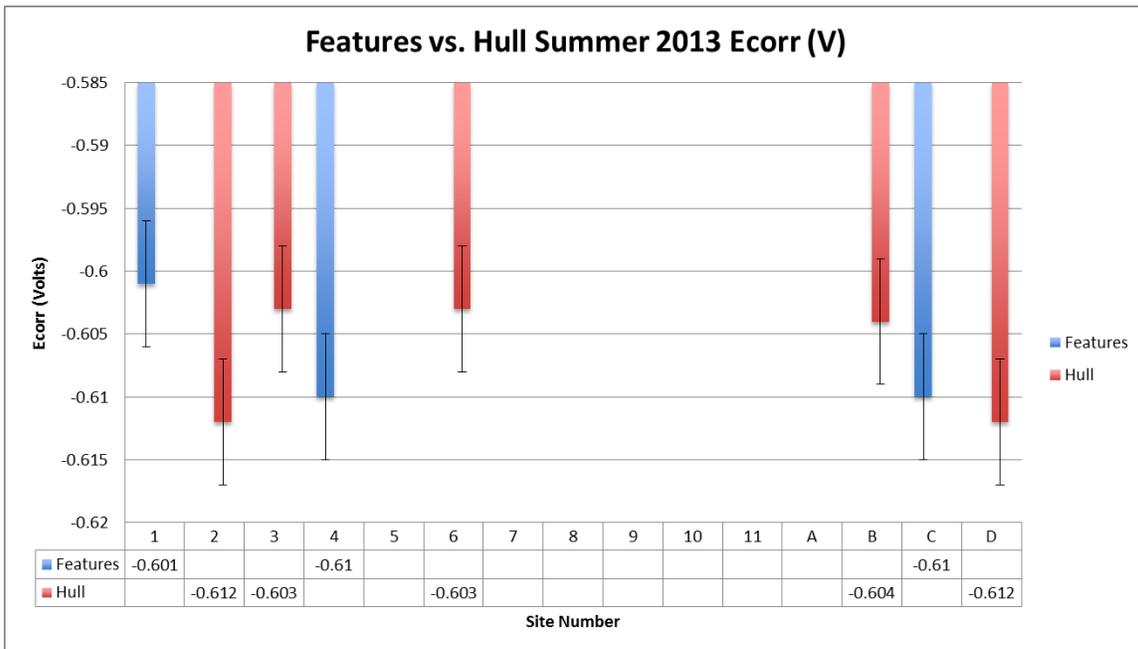
**Figure 58. Graph of the summer 2013 hull plates versus features Ecorr. (Image by author, 2014.)**
