SOUTH AFRICA'S BATTLE OF THE ATLANTIC: 1939-1945
A SURVEY OF THE CAPE PENINSULA'S WWII HERITAGE

February, 2019

Presented To the Faculty of the Department of History
East Carolina University

In Partial Fulfillment of the Requirements for the Degree
Master of Arts in Maritime Studies

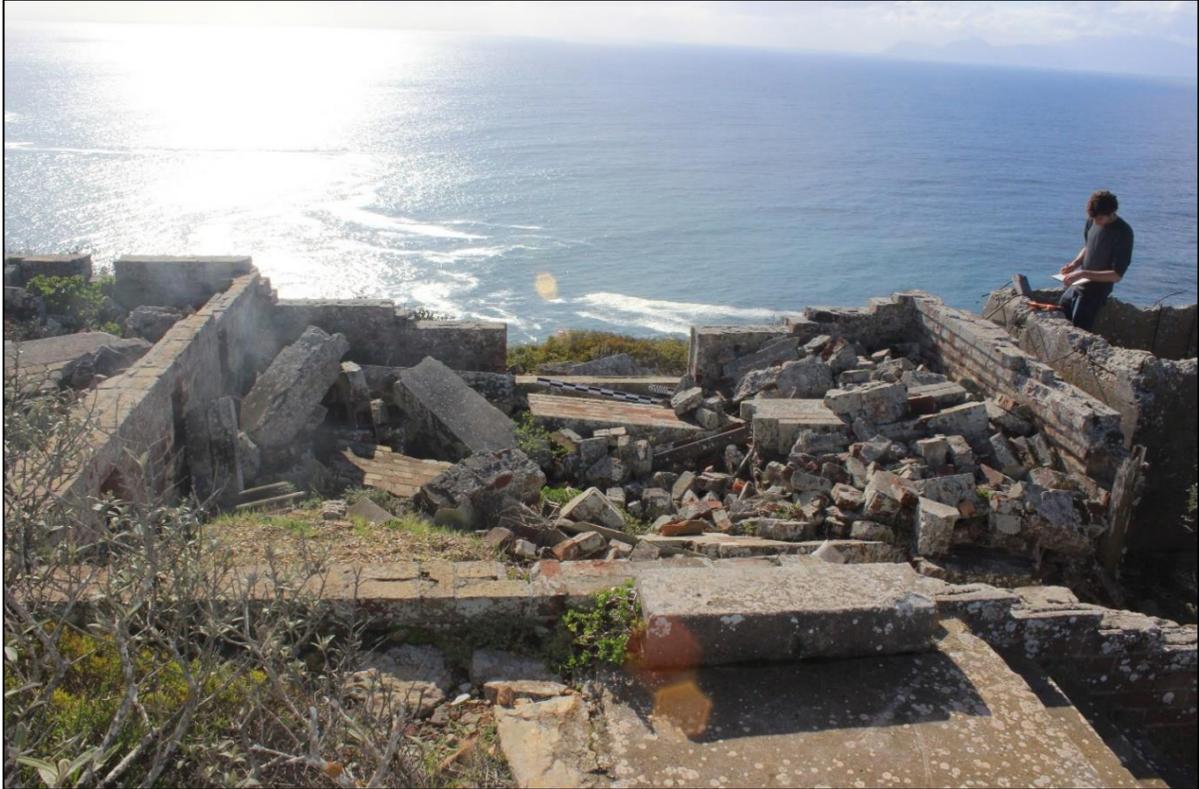
In terms of preservation, the Cape Point RDF Station is one of the more poorly preserved (Table 3). Aside from the two structures in complete ruins, the remaining structures show signs of severe degradation. The average score for structures on site is 21.1 (out of 35), or 20.6 if cisterns are excluded. It should be noted as well that this score is significantly buoyed by the nearly perfect condition of the two stone lookout platforms, if these are excluded as well, the average condition for the site drops to 11 of 35, an extremely low number indicating that structures have suffered several types of significant damage. Both of the cement cisterns have developed sizable cracks while the roof of the larger cistern seems to be on the verge of collapse. Though the BOP is in the best shape of the primary structures, it has weathered an extensive

Figure 8: Photo of Ian Harrison recording the main dormitory ruins at the Cape Point RDF Station. Photo by Elizabeth McAlister, 2017.

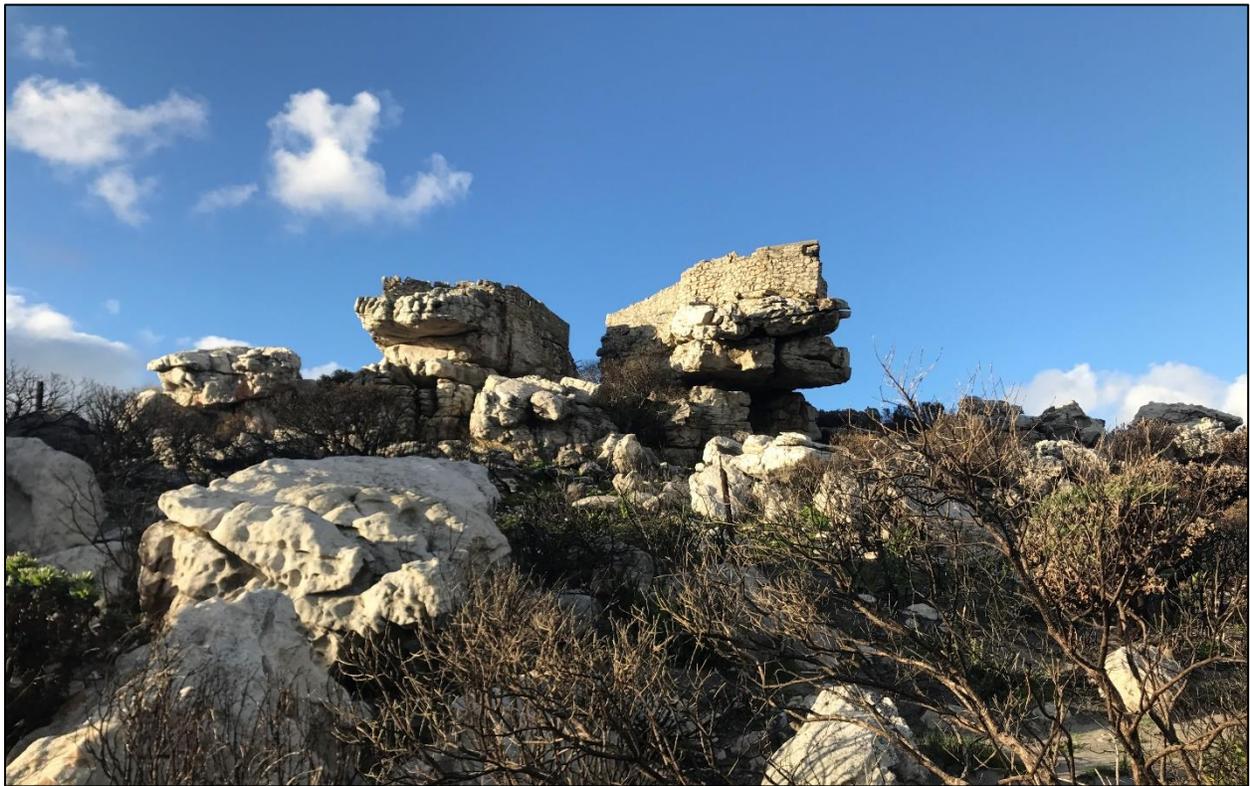
destabilization. It is unclear what mechanism was originally used to reach the observation towers, as at the time of visit the only way to scale the walls was with a rusted metal mattress frame that someone had left as an impromptu ladder. The cinderblock structures were covered with a coat of plaster that seems to have largely preserved the structural stability of the walls, though there is significant corrosion on the metal window frames and air vents. In addition, the floor of the larger structure is missing, revealing the wooden foundation beams below.

Figure 10: Image of the stone observation towers at the Castle Site. Image by author, 2017.

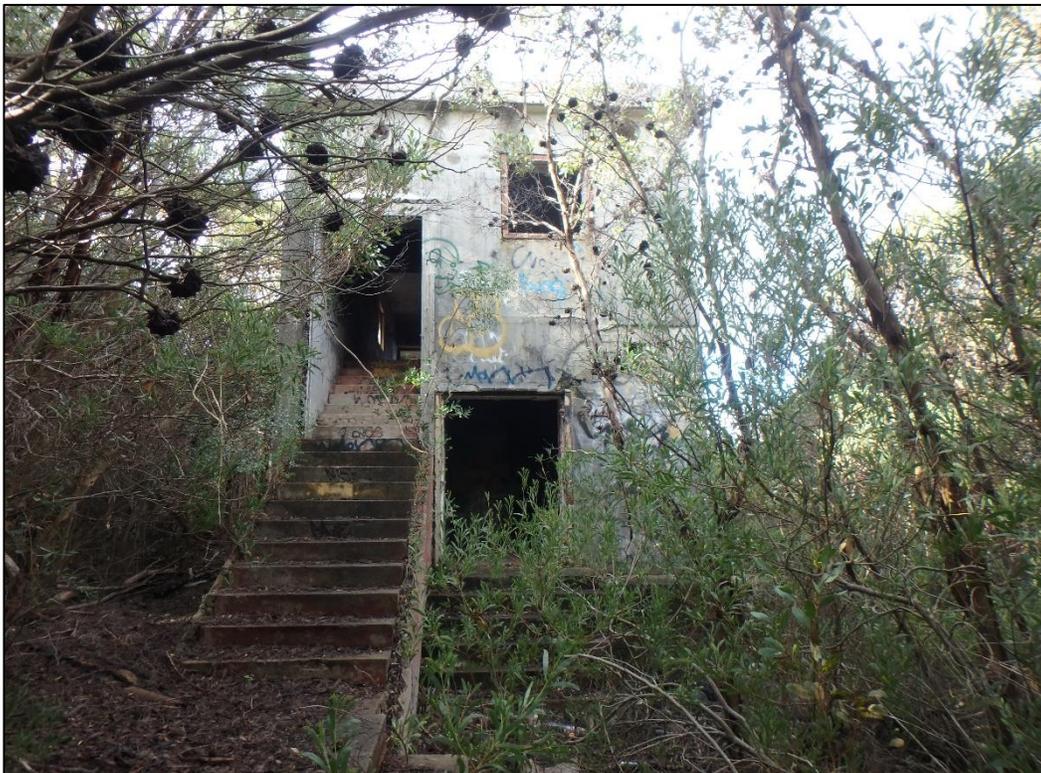
Given that the site is classified as NHRA >60 only, and is not receiving any type of conservation, this state of disrepair is somewhat unsurprising. In addition, the site's proximity to the town of Glencairn, and particularly to the residential neighborhoods nearby make it easily accessible to local visitation, and thereby highly vulnerable to cultural defacement. Finally, the area's natural overgrowth may help to protect the structures against wind damage, but will also likely contribute to further destabilization of the structures and their foundations over time.

Figure 12: Image of the rear face of the Glencairn Hill Battery Observation Post. Unique for its two-story design. Image by author, 2017.

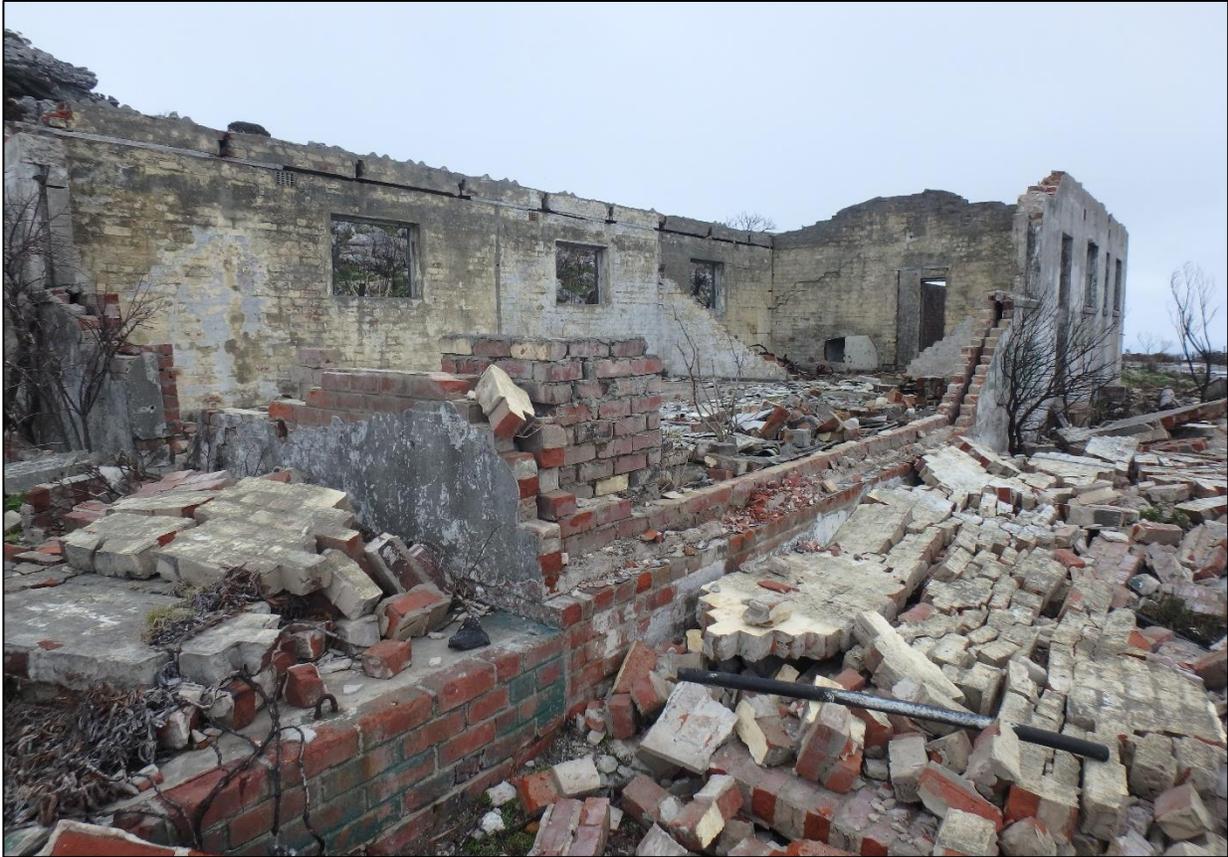
The site’s preservation is largely mixed (Table 6). The average structure score for the site is 24.4 of 35, or 23.6 of 35 if the cisterns are excluded from the calculation. While this is a moderate score for the site as a whole, it conceals the extensive damage that has been selectively suffered by certain structures. As can be seen in the figure below, the main dormitory is very

Figure 14: Photo of the Main Dormitory building at the Karbonkelberg RDF station. Photo by author, 2017.

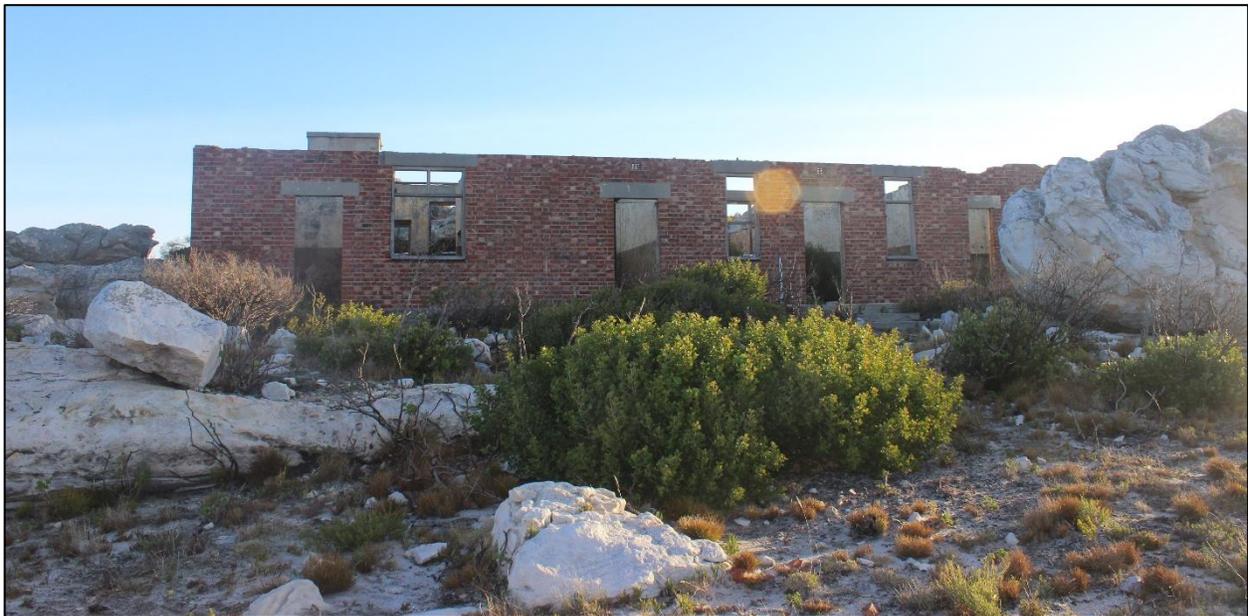
drops to 22 of 35, a significantly lower score. Generally, the three primary (non-cistern) structures on site have been significantly weathered by natural processes. The main dormitory structure is completely missing its roof, as well as nearly all of its windows and frames, though the brick walls remain intact. The battery observation post is in the best shape of the three, though has also sustained some minor cracking in its concrete structure, alongside the severe corrosion of its metal storm shutters. The lavatory has lost its roof and interior features, as well as several sections of its outer brick walls. The three cement cisterns (one of which could be an

Figure 18: Photo of the main dormitory structure at the Olifantsbos RDF Station, Cape Point National Park, Western Cape RSA. Poking out from above the dormitory on the left side is the square cement RDF equipment case or cistern Photo by author, 2017.

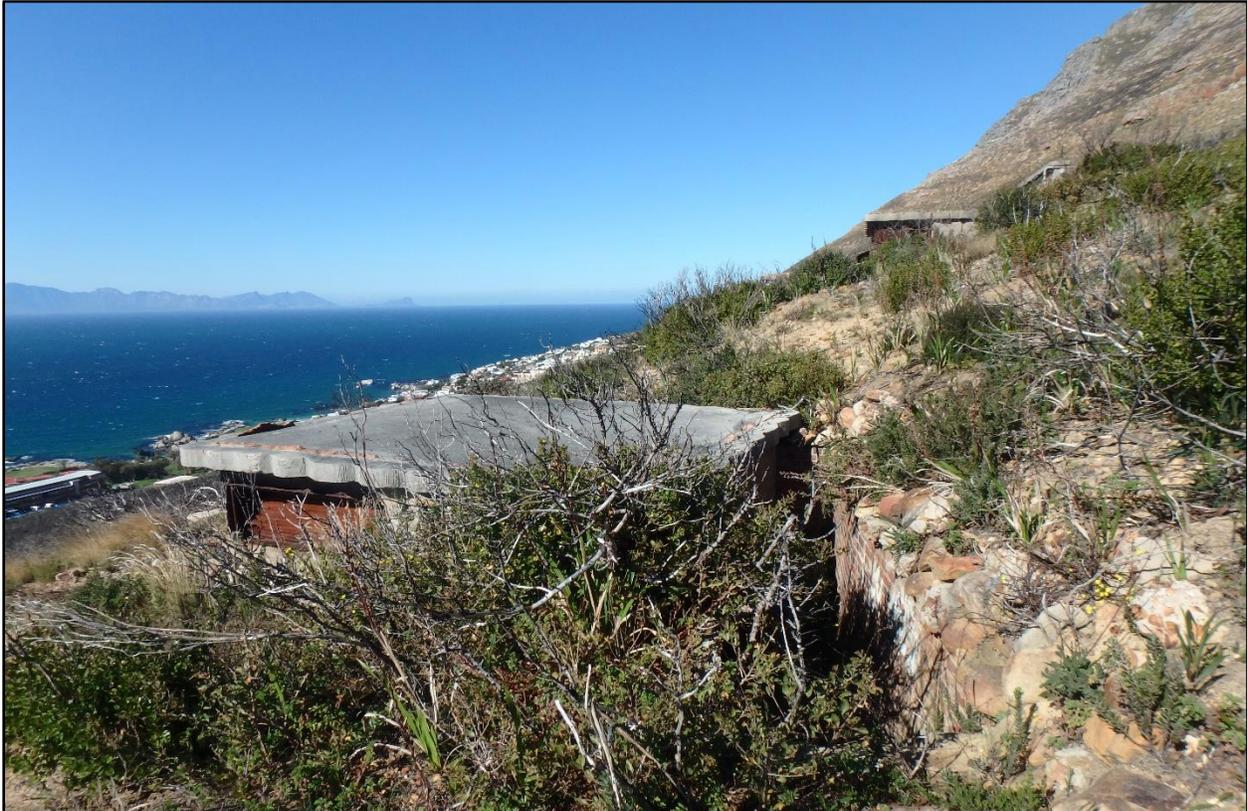
most severe damage, with structural cracks in its sub-surface walls. The storage shed attached to BOP #3 has collapsed in on itself, leaving a pile of rubble and metal sheeting. BOP #2 is in fairly good structural condition, though as with the others, the metal storm shutters have been heavily corroded.

Figure 22: Photo of BOPs number 2 (foreground) and number 3 (background right), at the Simon's Town Quarry Battery Observation Post. Simon's Town, Western Cape RSA. Image by author, 2017.

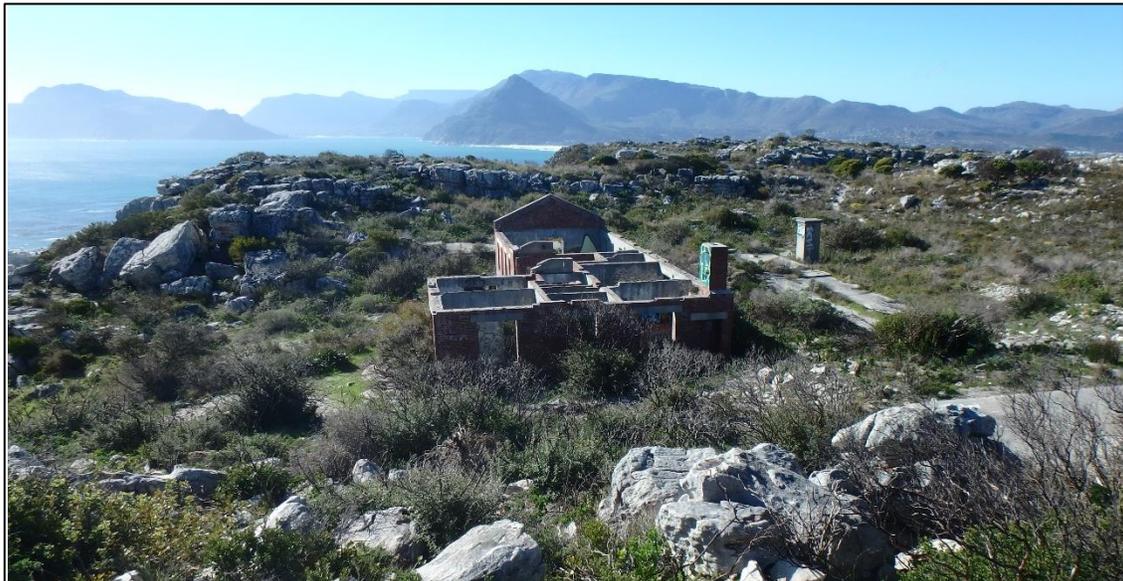
the calculation. This is rather low and indicates two or more areas of significant degradation. Structurally, most all of the buildings on site have sustained significant damage to crucial features such as roofs, walls, and floors. The main dormitory structure has lost its roof as well as most all of its windows and doors. The specially designed BOP is in extreme danger of collapse. The reinforced cement roofing slabs have already collapsed in over the windows, while the other load-bearing beams and supports are extensively cracked. The cliffside operations building is in better condition, though has still developed a network of cracks in its concrete façade. Meanwhile, the RDF structure is one of the better preserved, and shows little structural damage.

Figure 24: Photo of the main dormitory structure, Slangkop RDF Station, Western Cape RSA. Image by author, 2017.

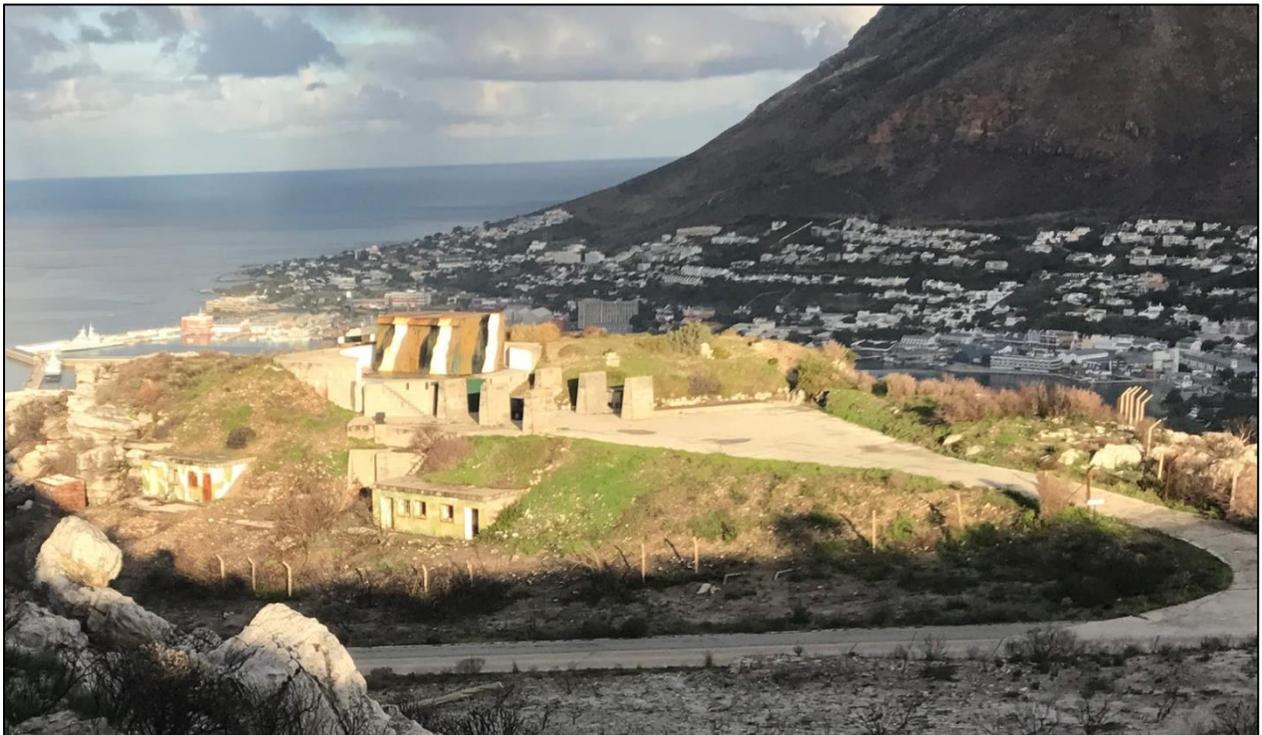
active maintenance and restoration by the Simon's Town Naval Museum and Naval Heritage Trust. The gun appears to be corroding substantially underneath its camouflage paint, but it is nevertheless well intact. The metal pivot on which the gun rests however has corroded significantly however, opening up a small gap in the metal plates. During the survey, this gap was used by a group of local children to (dangerously) crawl into the turret underworks. The two operations structures are in fair condition, with some cracking in the concrete in addition to several missing doors and windows. The lavatory has lost its roof, but the brickwork and electrical features remain largely intact. Thanks to the site's active management, (and perhaps proximity to the nearby military base) there are only limited amounts of cultural defacement throughout the site, primarily in the lower operations buildings.

Figure 26: Photo of the Upper North Battery (SCALA #1 Gun). The gun can be seen at the top of the hill, with the concrete driveway and pillars just below. Built into the hillside downslope are the two operations buildings and brick lavatory. The town of Simon's Town can be seen in the background. Simons Town, Western Cape RSA. Image by author, 2017.
