HULL PRESERVATION: PRESERVATION METHODS AND MANAGEMENT OF THE
BATTLESHIP NORTH CAROLINA MEMORIAL, WILMINGTON, NORTH CAROLINA

HULL PRESERVATION: PRESERVATION METHODS AND MANAGEMENT OF THE
BATTLESHIP NORTH CAROLINA MEMORIAL WILMINGTON, NORTH CAROLINA

Thesis Presented to the Faculty of
The Department of History
East Carolina University

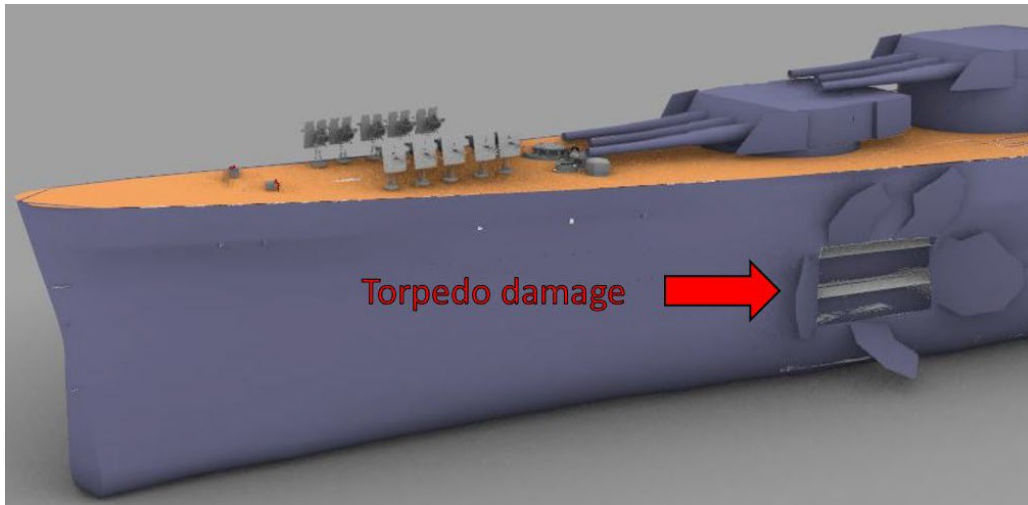
Figure 25. Model depiction of torpedo damage. Image by Author 2020.

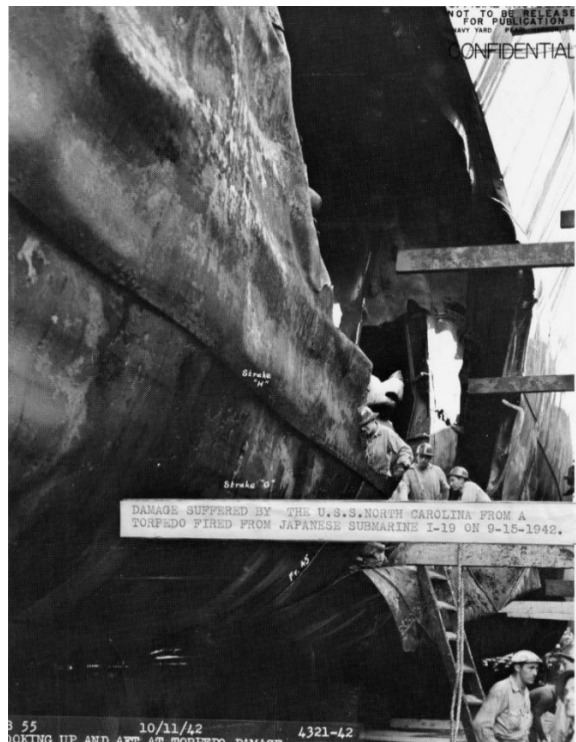
Figure 26. Image depicting torpedo damage taken at Pearl Harbor Navy Yard 10/11/1942.

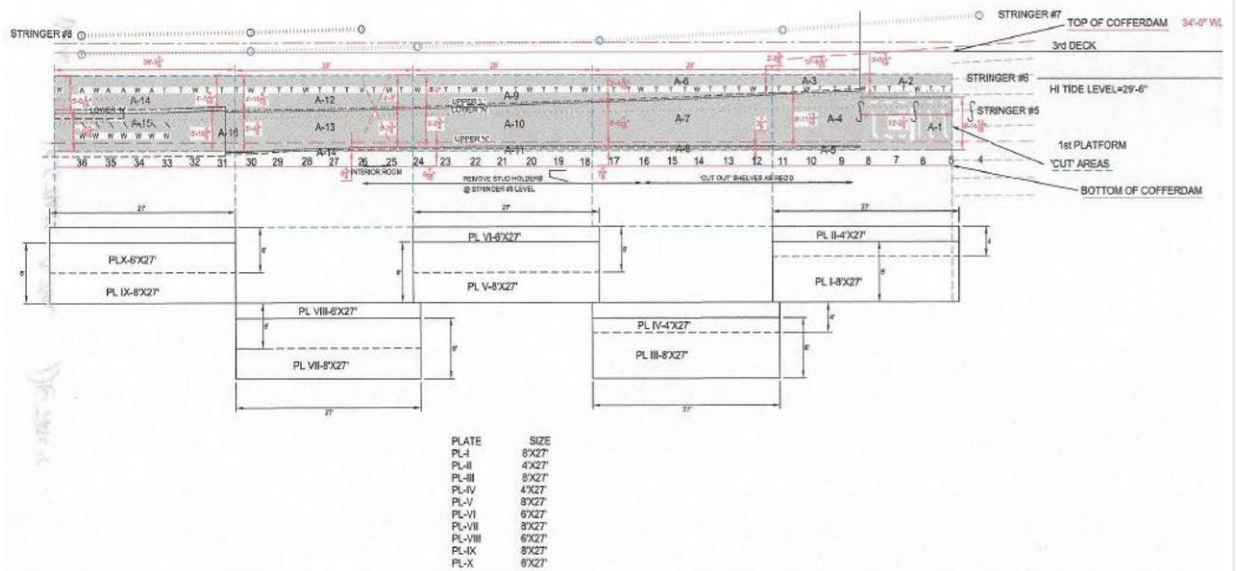
Shell Plate Repair Sequence, Frames 5 – 37

Figure 33. Diagram showing location of shell plates replaced in 2011 repairs. (Image from Ocean Technical Services LLC).

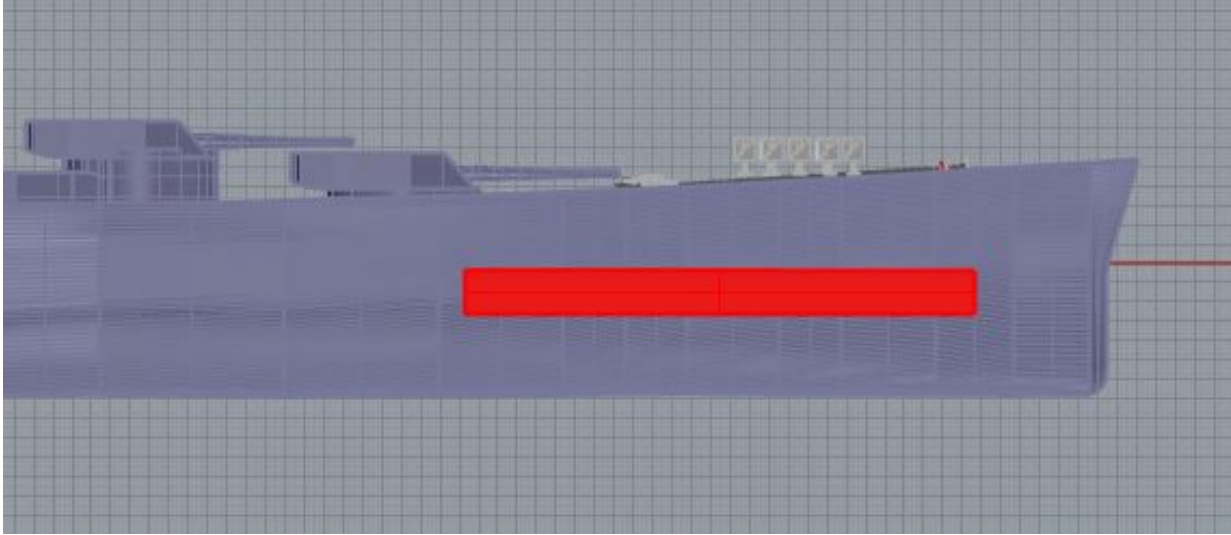
Figure 34. Image depicting location of hull repairs from the portable cofferdam project. Image by Author 2020.

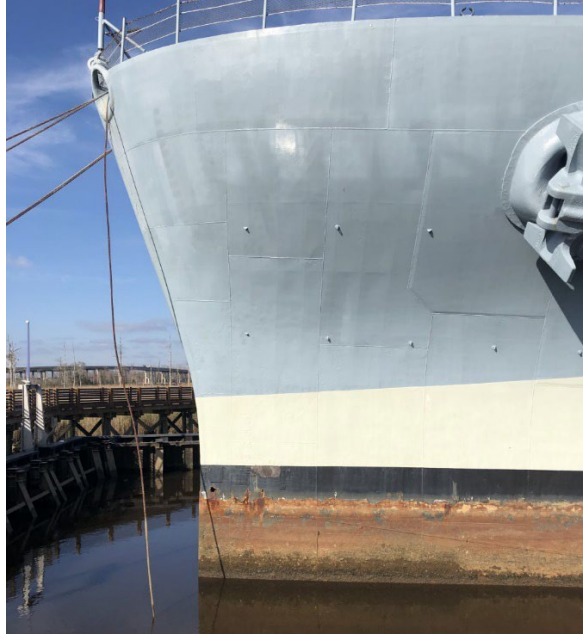
Figure 38. Image showing corrosion along the wind/waterline with a hole near the stem of the ship. (Image by Author 2020)

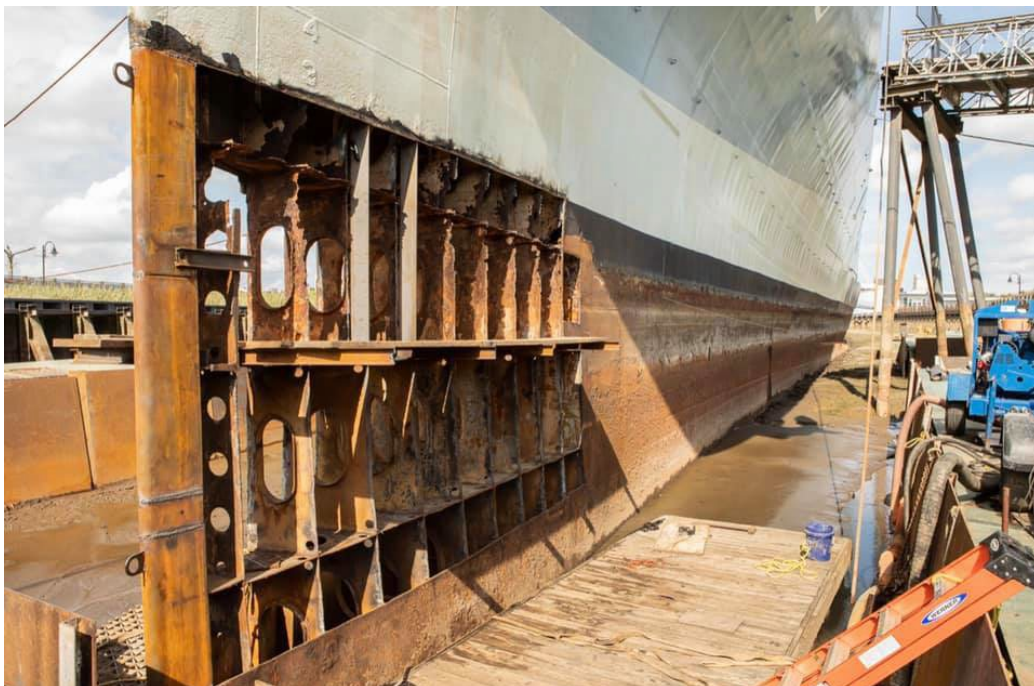
Figure 39. 3/4 view of current hull repairs along the bow of USS North Carolina. (Image by Joe Hollifield 2020)

Currently hull repairs have begun at the bow of the ship. The permanent cofferdam allowed the workers to drain the water surrounding the ship, and platforms were placed over the mud in the areas the repairs are occurring at. The bow of the ship showed the worst signs of corrosion as shown by Figure 38 taken by the author in January 2019 where a hole in the hull can be seen along the severely rusted wind/waterline. A post by Facebook user Joe Hollifield shared images that provided a progress update of these repairs (Figure 39-42). These repairs were not incorporated into the model as they occurred past completion of data collection, but it would be irresponsible to not inform the readers that they had begun.

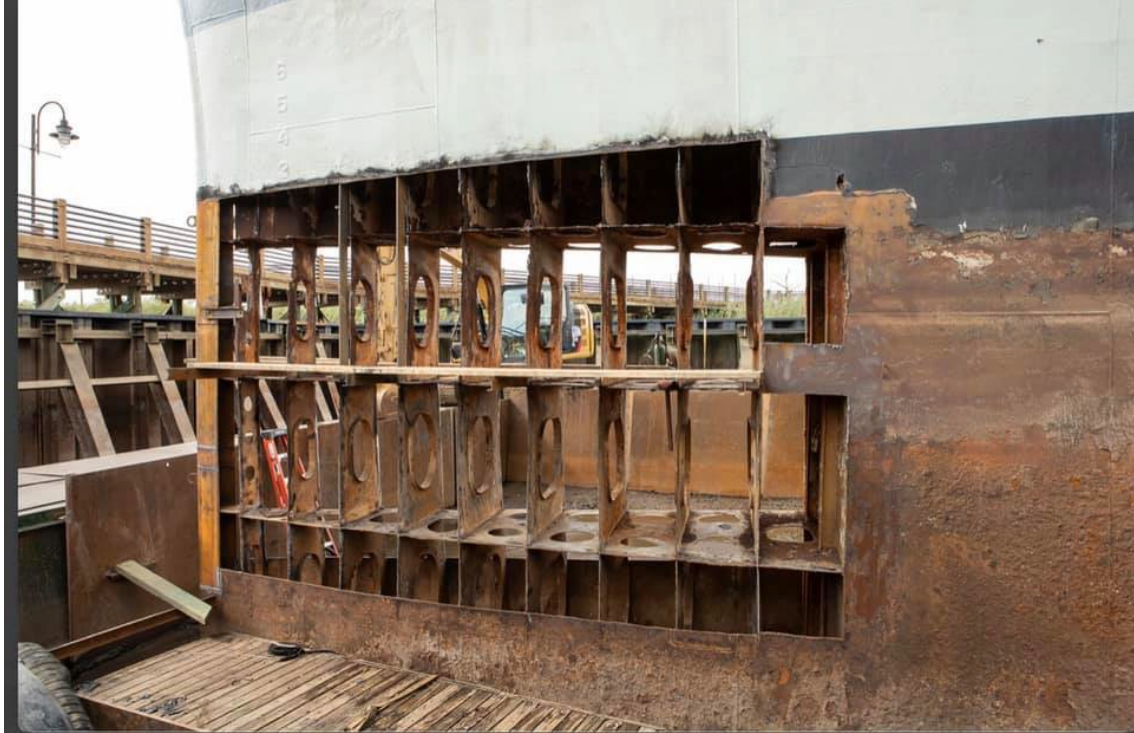
Figure 40. Port side view of current hull repairs along the bow. (Image by Joe Hollifield 2020)

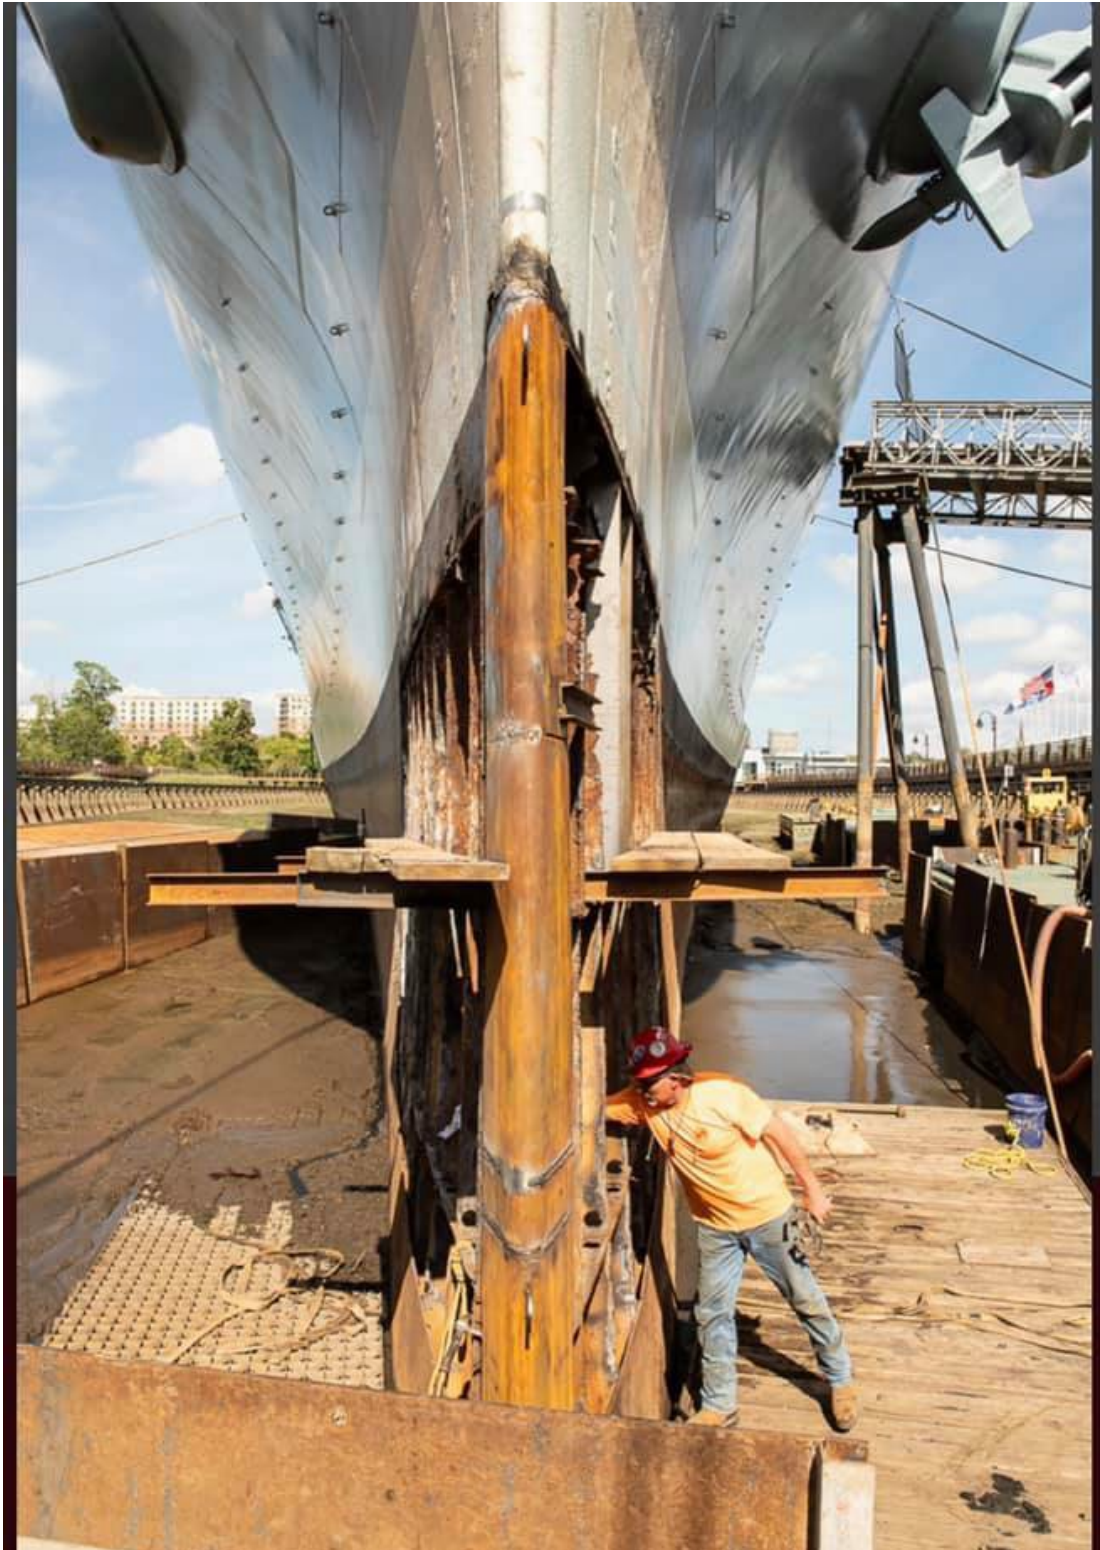
Figure 41. Front view of bow showing current hull replacement progress. (Image by Joe Hollifield 2020)

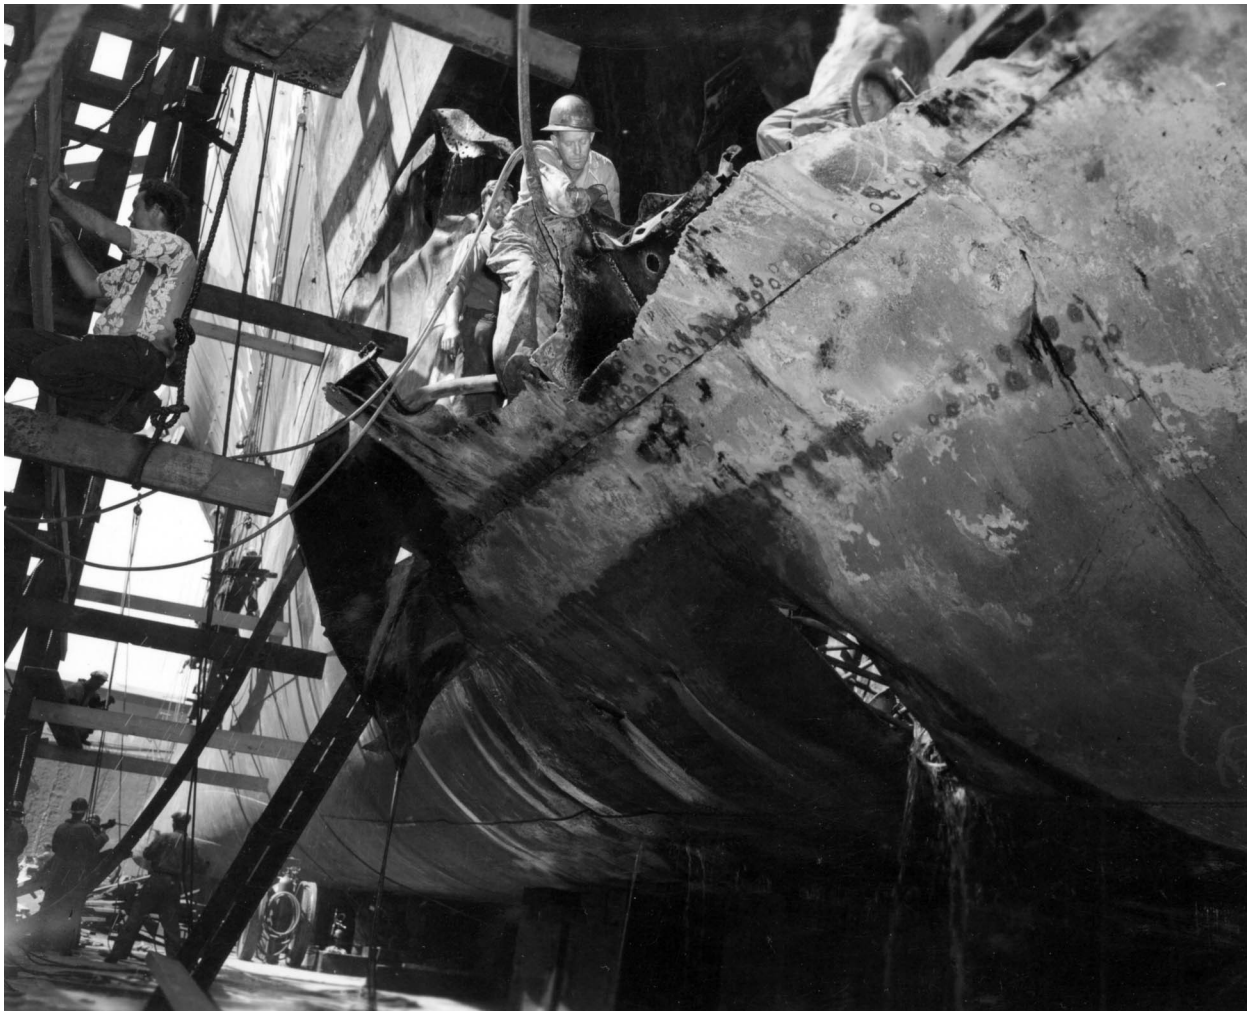
feet below the waterline and had a depth of 18 feet according to the damage report. That would mean that the hole extended 8 feet further up and would place the top of the steel replacement panel about ten feet from the average draft of the vessel. During active service, the wind/waterline was probably a greater area because of rough seas and constantly changing loads of the ship due to fuel, foodstuffs, and ammunition, but also more protected due to regular maintenance and repainting.

Figure 43. Workers at Pearl Harbor repairing damage to USS North Carolina suffered by a Japanese torpedo. (Battleship Memorial Archives 2019)

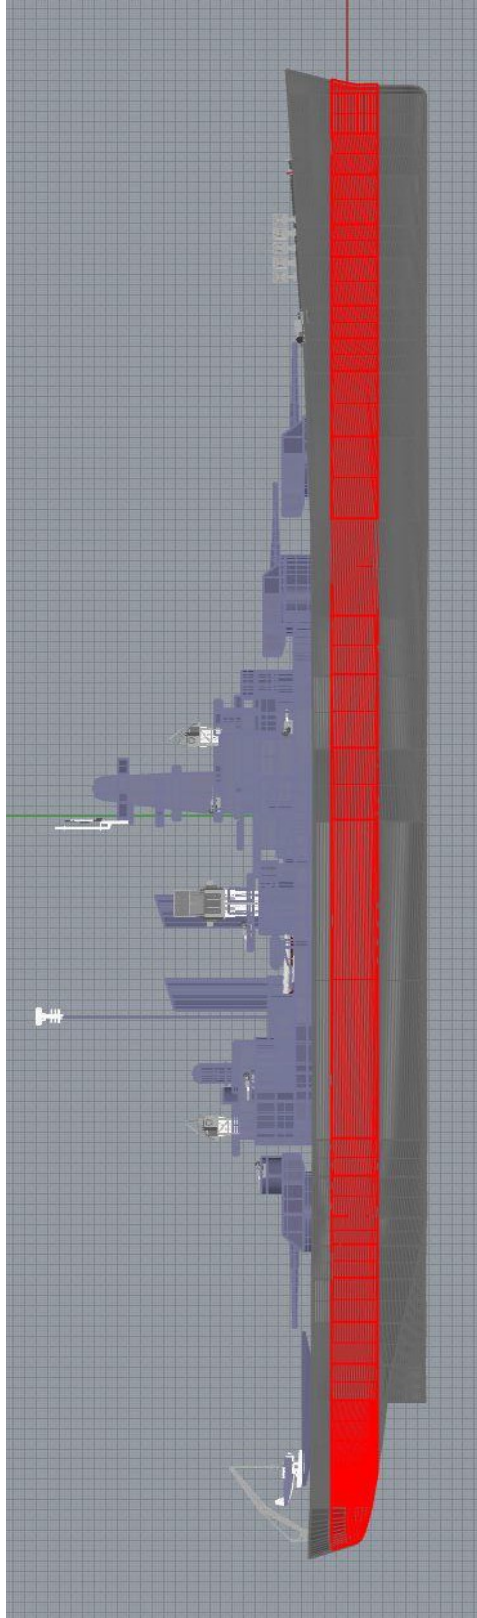
The ship transitioned into a museum ship in 1962, which would have put the last coating of hull paint at the end of its period of effectiveness. \$100,000 was spent to condition the ship for display, which would have included undoing many of the preservation measures implemented during the time the ship was mothballed, but also likely included applying new paint coatings as well. The ship was not drydocked during this time, so it is not likely that new protective coatings were applied to the underwater portions of the hull. While the bottom 25-feet of the hull were largely protected by the anaerobic environment created by the mud it settled in, the area from the mud to the wind-waterline was at a high risk for corrosion. “Occasional repainting” was conducted on the ship from 1962-2011, but it would have been difficult to apply new paint to the areas of the ship underwater since the ship could no longer be drydocked or the water level controlled to access these areas. The inability to repaint underwater areas of the ship, particularly the wind-waterline, shown in Figure 46, has created major preservation issues for the caretakers to deal with. In 2011, corrosion and holes in the ship’s hull on the starboard bow required replacing a portion of the bow using the temporary cofferdam. Even on visits to the ship the author took from 2017-2019, the ship had many holes and visible corrosion along the wind-waterline. This issue was addressed by the building of the permanent cofferdam, which allowed the caretakers of USS *North Carolina* to access and assess these areas. Currently, portions of the port bow are being replaced with other areas of risk scheduled to be repaired and repainted soon.

Figure 46. Image depicting wind/waterline of USS *North Carolina*. (Image by Author 2020)

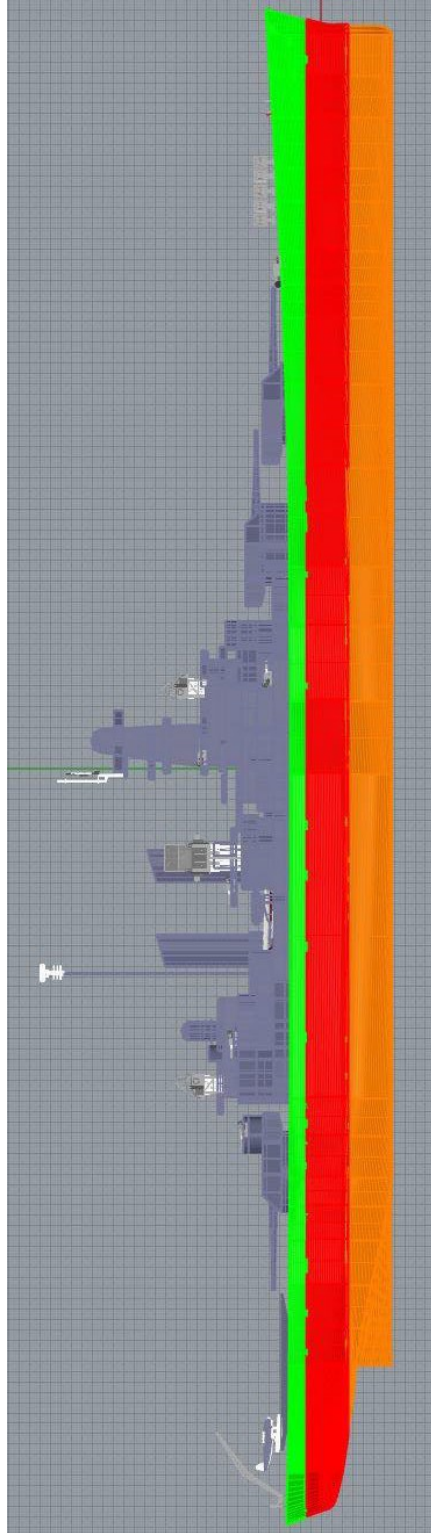
A variety of factors affect what areas suffer from preservation risks. The topics discussed above have shown that certain areas of the ship are at a higher risk of corrosion than others. The wind/waterline and portion of the ship below the mudline are at the highest risk for corrosion, with the wind/waterline being the highest risk. The freeboard portion of the hull is at lower risk of corrosion than the other two sections. The 3D model was used to show these areas of risk in Figure 47-50. The red area represents the highest zone of risk at the wind/water line and the orange area represents the portion of the hull beneath the mud. While the area below the mud is protected by a lack of oxygen, it is at medium risk because it is much harder to monitor for corrosion. The freeboard portion of the ship highlighted in green is at the lowest risk. Identifying and working to minimize the risk in these areas is crucial to museum ship preservation.

Figure 47. Image depicting degrees of corrosion risks on USS *North Carolina*. (Image by author 2020)

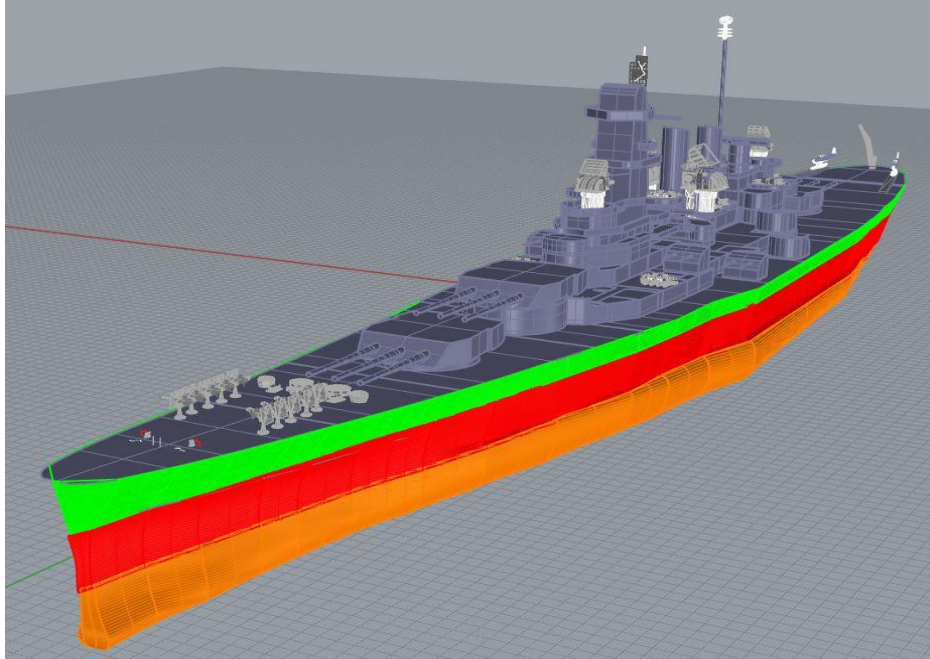
Figure 48. 3/4 Starboard bow view with color coding to show degrees of corrosion risk. (image by Author 2020)

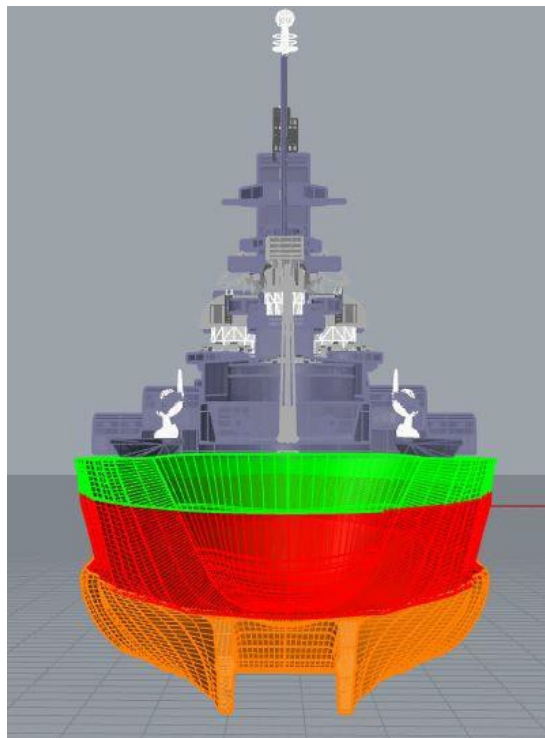
Figure 49. Stern view with color coding. (Image by Author 2020)

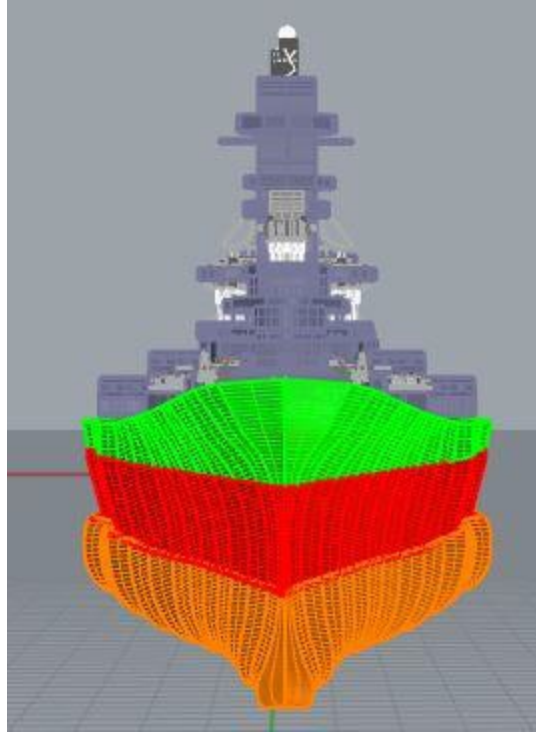
Figure 50. Bow view color coding. (Image by Author 2020)
