THE WEEPING MONUMENT:
A PRE AND POST DEPOSITIONAL SITE FORMATION STUDY
OF THE USS *ARIZONA*

Director of Thesis: Dr. Brad Rodgers

Major Department: Program in Maritime History and Archaeology

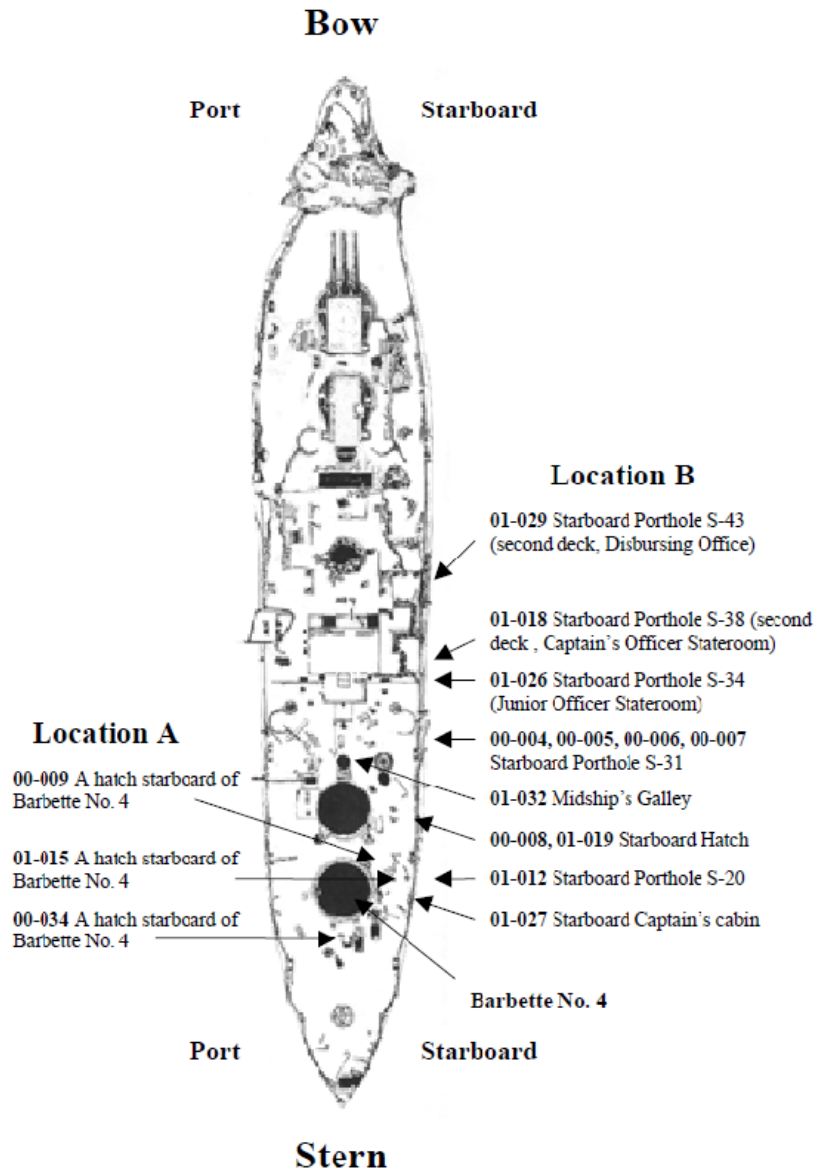
Figure 2

The oil currently leaking from the *Arizona* originates from 11 sites throughout the ship, mainly located on the starboard side (see figure 2).¹⁸ The oil that is escaping from the “B” sites is more weathered than the samples from the “A” sites. This means that the “B” samples generally have had more exposure to seawater, which intuitively shows that these drops are emanating from a location closer to the interior of the ship and thus have a longer distance to travel before collecting on the exterior of the hull.¹⁹ This degraded oil is generally believed to be coming from secondary oil accumulated in spaces confined within the hull, not in the original oil tanks. These spaces perhaps lie under the main and upper decks where oil may have pooled and stayed for a period of time. The only unweathered oil originated from the leakage points near barbette #4, designated in figure 2 as “Location A”. This oil most likely is leaking directly from

Figure 8.4. USS Arizona sample locations for oil leaking from the ship. Location A (stern starboard hatches) and B (stern starboard portholes) represent two different general areas of the ship.

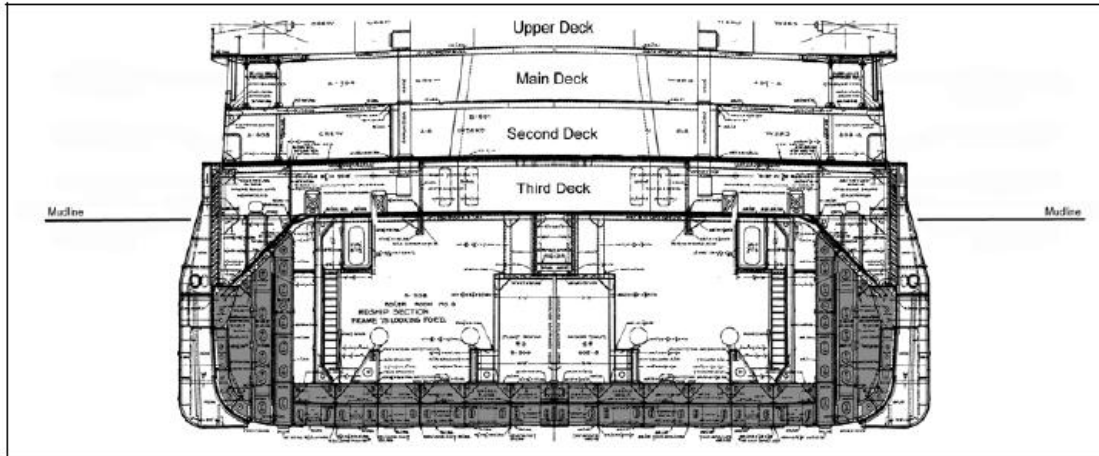
Figure 3

Figure 9. 2. *Arizona* hull cross-section at frame 75. Dark areas are oil bunkers and the line indicates the current seabed level relative to the hull (Graphic by NPS-SRC).

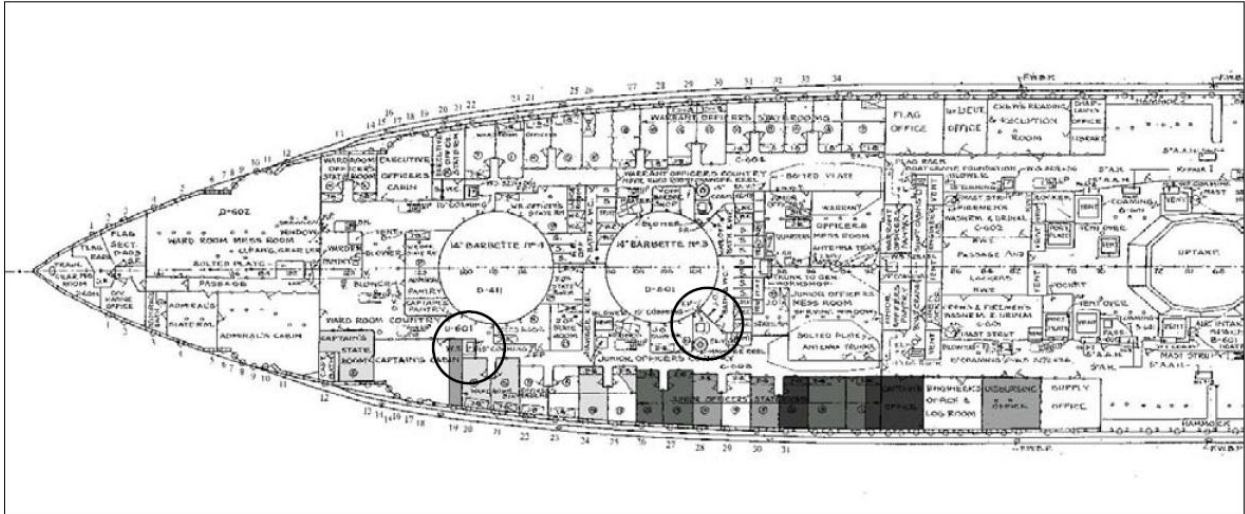
Figure 5

NPS-SRC. "Illustration of thickness of overhead oil on *Arizona's* starboard second deck (stern to left). Relative darkness represents thickness of oil in each cabin overhead, and hatches releasing oil are circled". *Long-Term Monitoring Program: Structure, Oil, Artifacts and Environment*. Santa Fe, New Mexico: National Park Service Submerged Resource Center, 2008.

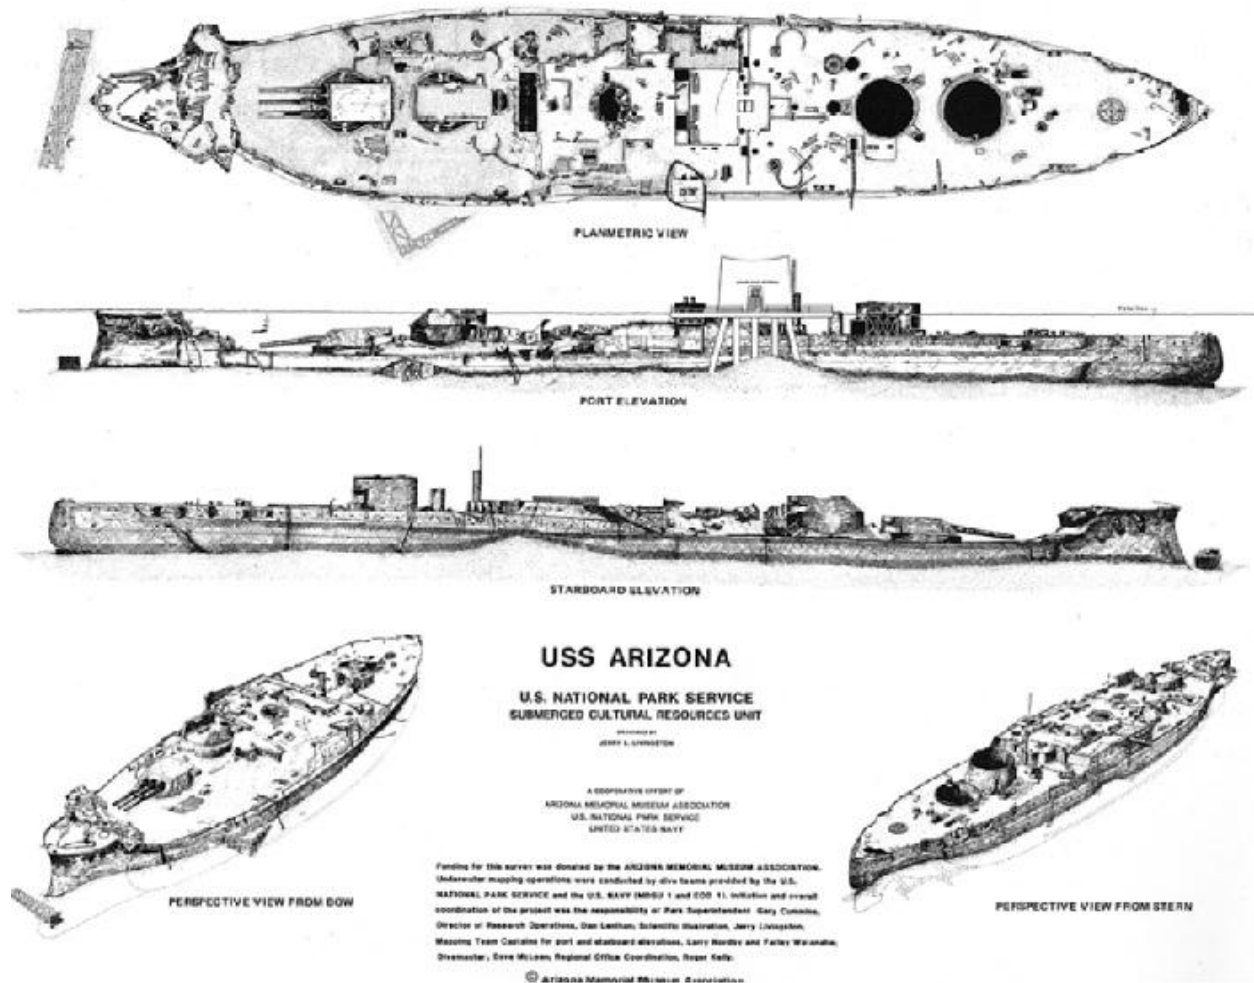
Image 11

Seventy years after the attack on Pearl Harbor, problems are continuing to occur at the site. In 1984, a visual study was conducted by the National Park Service to determine the hull's condition. This research is the basis for the current artistic representations of the ship. (see image 11).¹⁴⁸

Starting at the bow and moving aft, a diver at the site would see little damage until around frame 10, which is approximately 40 feet aft of the bow. Here, weather and forecastle decks are still present, as are portions of low-relief superstructure, such as deck fittings and fairleads. Moving aft of frame 10, the damage quickly becomes apparent, in the form of jagged

The No. 1 turret gunhouse and 14-inch gun tubes remain, although the structure sits 15 feet lower than it would have prior to December 7 because of the collapse of the No. 2 bulkhead below it. Surrounding the turret are remnants of teak decking and the forecastle deck. The general lack of identifiable remains here is a direct result of the damage the ship sustained during the attack. Despite this, there is also evidence of post-sinking human activity. On the port side, near the No. 1 turret, an access hatch remains open that was likely opened by salvage divers directly after the sinking. Other than some hatch combings, very little of the main or forecastle decks remains in the blast zone. This is mainly due to naval salvage efforts.¹⁵⁰

Thirty feet aft of the beginning of the blast site at turret two, the torpedo blisters bulge from the starboard and port sides, and apparent evidence of the work of naval divers can be seen. Due to this, a majority of the side armor, from the torpedo blister to the gunnel, is missing. Documentation confirms that significant salvage activity occurred in this area because of dangerous metal overhanging the port side. The kerf marks from the diver's torches are apparent, and help to differentiate the sections that were cut away, from those damaged by the blast.¹⁵¹

Damage continues past the primary blast site, although significantly less than in the previous area. At two points, approximately 80 and 112 feet (24.38 and 34.14 meters) aft of the bow, two large cracks present themselves, and continue through the torpedo blister into the mud line. According to Daniel Lenihan and Larry Murphy, these cracks likely represent major structural damage received during the Pearl Harbor attack, and subsequent sinking of the USS

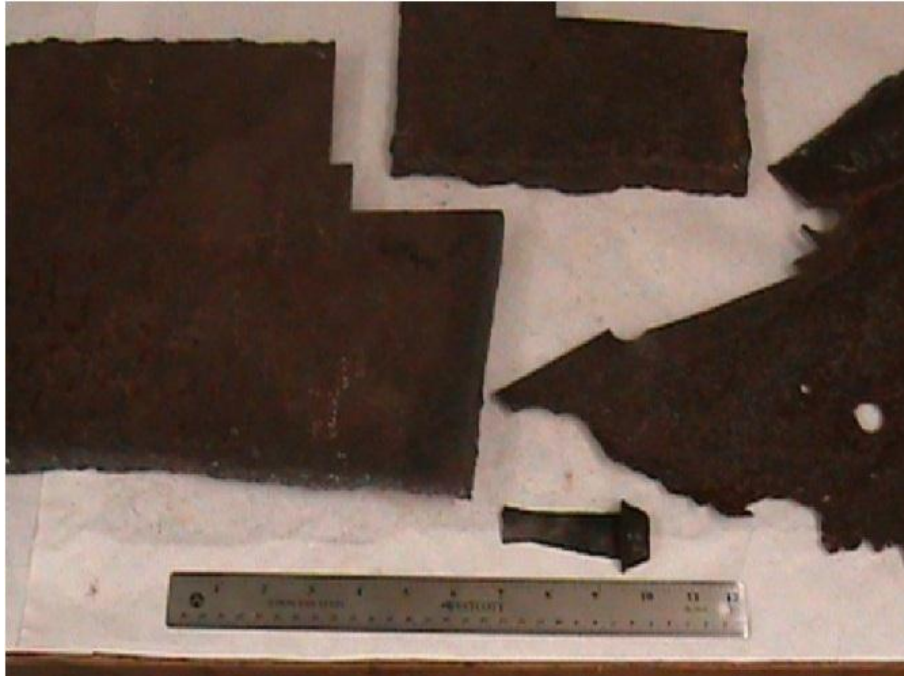
Image 15

Sample Type	Corrosion Rate (mpy)
Plate A-1	2.3
Plate A-2	4
Plate A-3	5.2
Rivet Head	5.3
Rivet Shaft	2.1

Saunders, Nathan and Elliot Hamilton. “USS Arizona’s Corroded Hull Plating and Rivets, Left: Plate A-1, Top: Plate A-2, Right: Plate A-3, Bottom: Rivet”, above, “Corrosion Data for the USS Arizona” below.

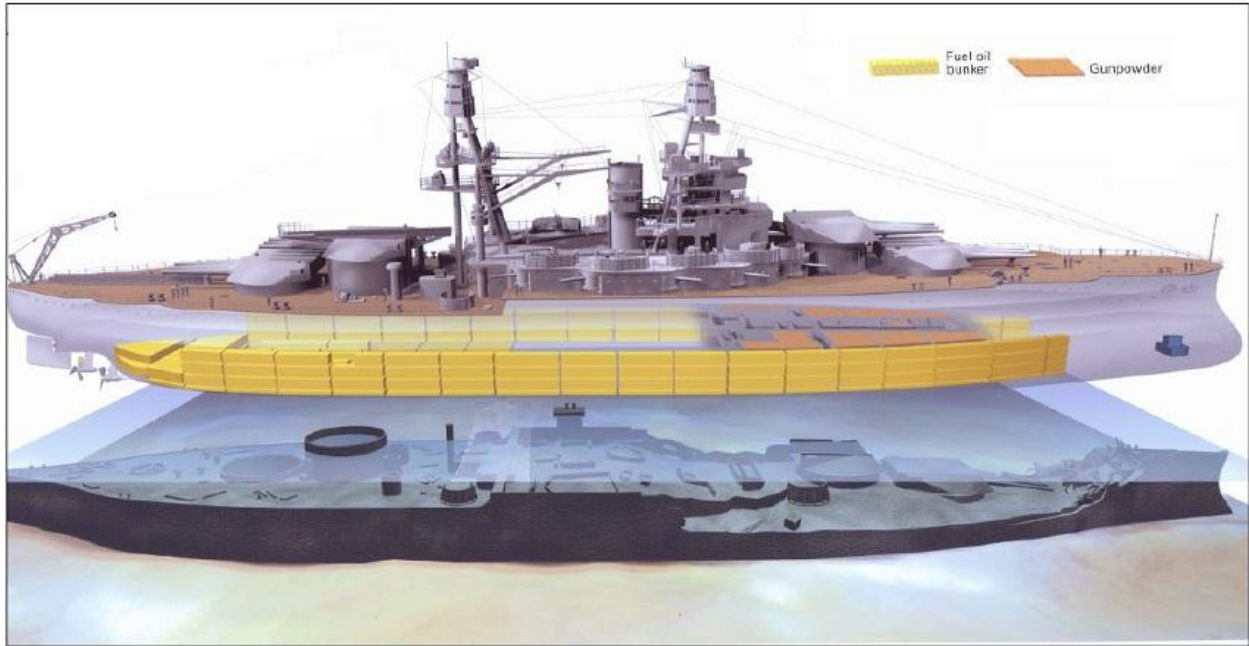
Image 20

National Geographic Society. “Graphic of *Arizona* Showing Oil Bunkers and Forward Magazine Locations in Relation to Hull Damage Mapped by SRC in the 1980’s”.

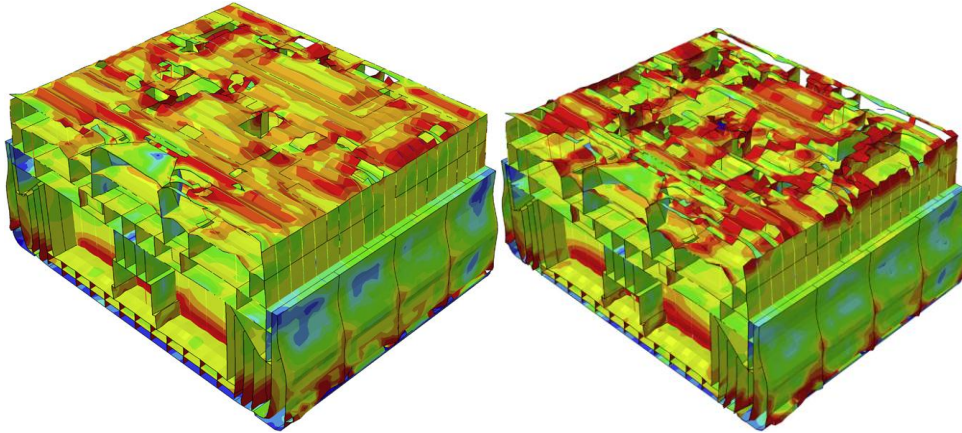
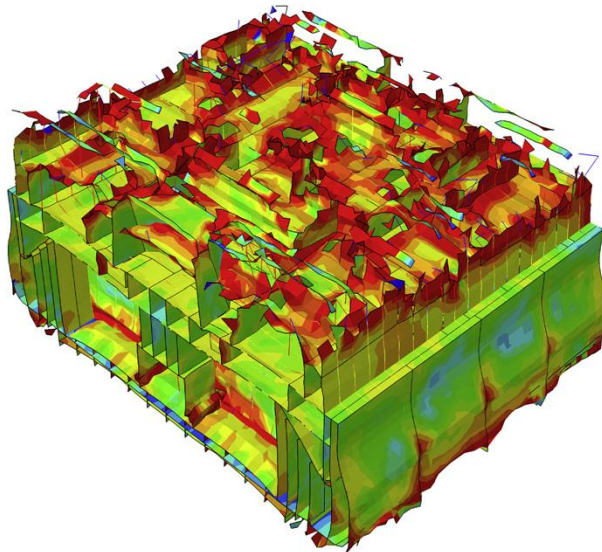
Image 23

Weight stresses after 60% thickness loss due to corrosion, approximate date=2150

Weight stresses after 70% thickness loss due to corrosion, approximate date= 2180

Weight stresses after 90% thickness loss due to corrosion, approximate date= 2240.

Foecke et. al., "FEA Models of Corrosion Over the Years, Stress levels <10% Dark Blue, 10-25% Green, 25-50% Yellow, 50-75% Orange, >75% Red". *Investigating Archaeological Site Formation Processes on the Battleship USS Arizona Using Finite Element Analysis.*, Journal of Archaeological Science. (2010)
