AMAKASU MARU NO. 1: AN ANALYSIS OF A REMOTELY OPERATED VEHICLE SURVEY ON A WWII JAPANESE REQUISITIONED SHIPWRECK IN THE PACIFIC

A Thesis

East Carolina University

Master of Arts in Maritime Studies

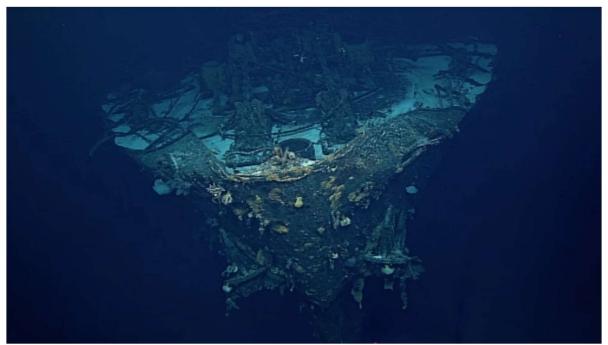
FIGURE 1.1. Screen capture of ROV footage of Amakasu Maru's bow with a slight list to starboard during the NOAA *Okeanos Explorer* mission to Wake island (NOAA 2016b)

Video footage captured by the ROV shows the vessel resting on sand with a slight list to starboard (FIGURE 1.1). There are two large holes on the lower portion of the hull which were potentially caused by torpedo damage from the vessel's sinking event. The vessel shows signs of deterioration including the collapse of masts and deformed cabin spaces. 'Rusticles' are abundant throughout the vessel indicating biological processes such as corrosion are impacting the site. While the primary objectives for the dive were archaeological in nature, researchers did note the presence of several biological species. Both the archaeological and biological data are important for the site formation survey conducted in this thesis.

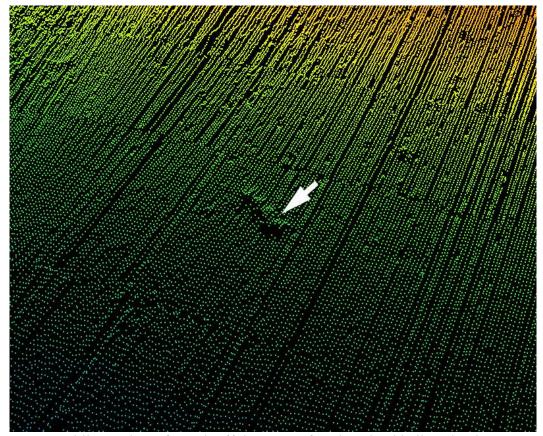
FIGURE 2.7. Multibeam data of wreck off the coast of Wake Island believed to be Japanese destroyer Hayate (Cantelas and Wagner 2016)

The vessel rests at a depth of approximately 840 meters on a primarily sandy seafloor. While approaching the vessel, the ROV spotted some debris. Researchers believed this to be wooden planks, potentially decking, from the vessel. Once the ROV reached the vessel, starboard and overhead video footage were collected. The current prevented survey of the port side of the vessel.

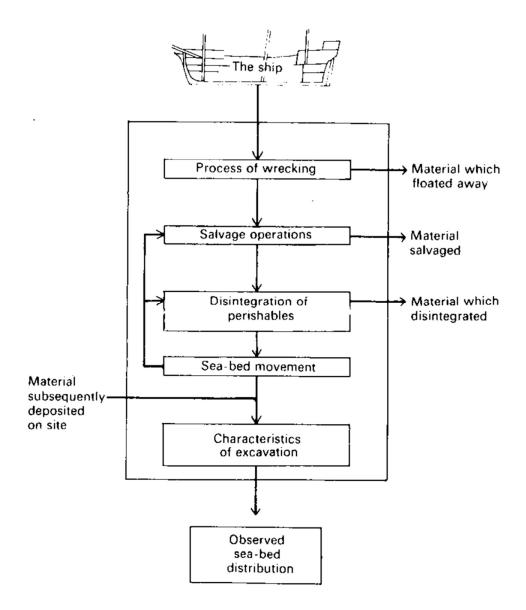
FIGURE 3.1. Muckelroy's flowchart representing the evolution of a shipwreck (Muckelroy 1978:269).

present for archaeological analysis. Finally, not all materials preserve at the same rate within the underwater environment. This variation leads to a biased array of artifacts as some materials may be fully deteriorated at the time of archaeological analysis (Muckelroy 1978:275-278).

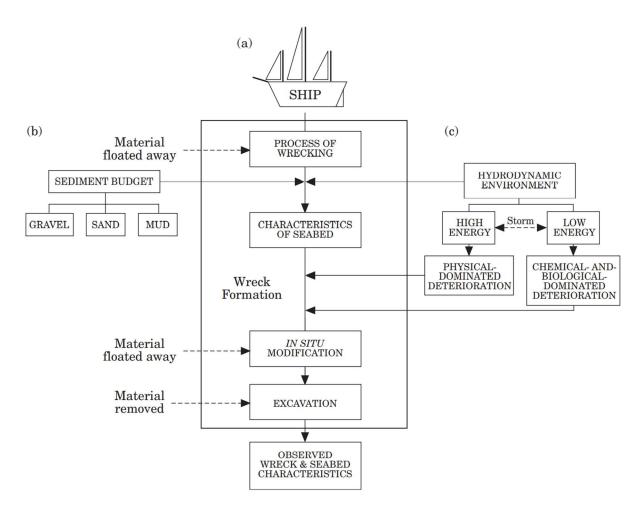
FIGURE 3.2. Flowchart depicting the various processes influencing wreck site formation (Ward et al. 1999).

This model stresses the importance of understanding the impacts of the natural environment on wreck site formation, specifically physical, biological, and chemical influences. The authors acknowledge the importance of variation among environments, though they state

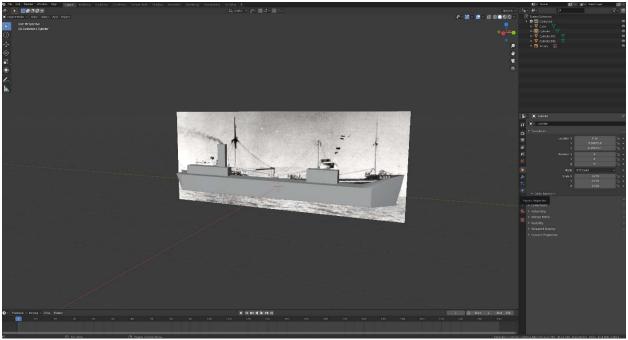
FIGURE 4.1, Initial Blender model constructed using the dimensions of Kisogawa Maru

The first step to making the model was placing a cube in the workspace with the *Kisogawa* photo intersecting it. This cube was then extended to the lengths of the vessel. The exact vessel dimensions were input for the X, Y, and Z axes to ensure the proper hull proportions were met. A segment was added to the middle of the object which allowed the stern to be manipulated to the correct shape. The same process was repeated to create the proper bow shape.

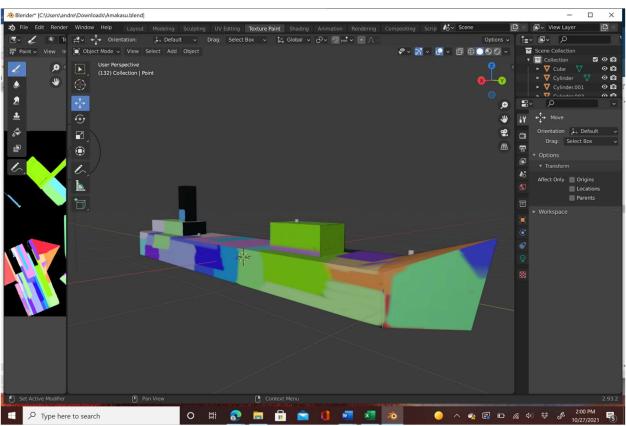
FIGURE 4.2. Blender model of *Amakasu Maru No. 1* mapping the areas of coverage by NOAA Okeanos Explorer 2016 expedition. All areas in black were not surveyed by the ROV.

The percentage of hull coverage was approximated. Due to the ability of the ROV to survey the starboard side of the vessel and most of the remaining deck and superstructure, it is

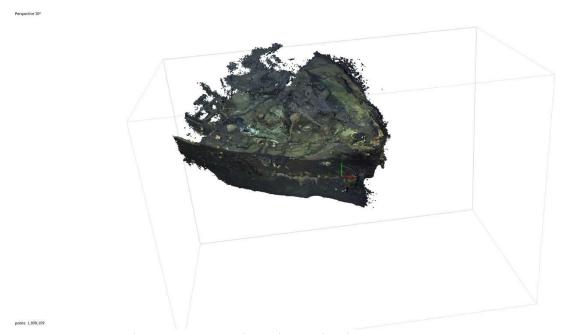
FIGURE 4.5. Amakasu Maru No. 1 bow dense cloud

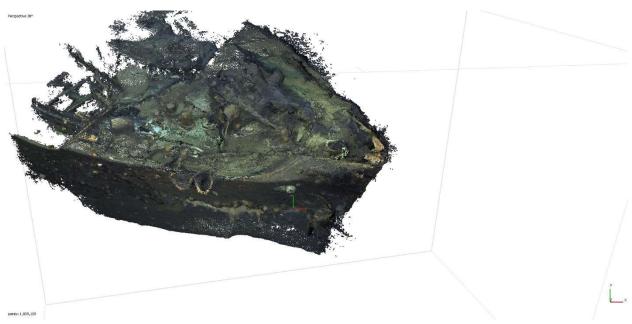
FIGURE 4.6. Amakasu Maru No. 1 bow mesh

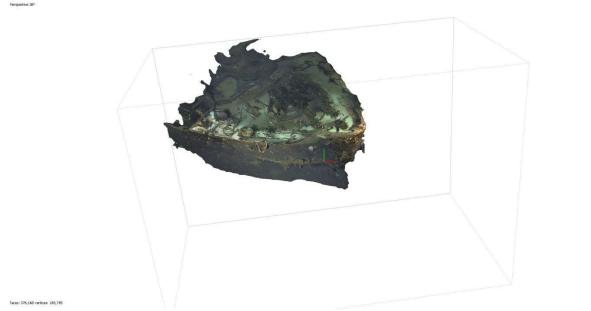
FIGURE 4.7. Amakasu Maru No. 1 bow texture

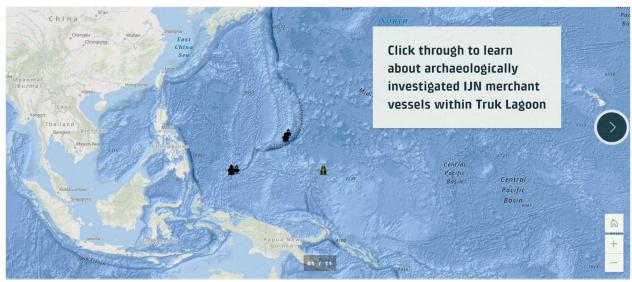
FIGURE 4.8. Title section of ArcGIS Story Map

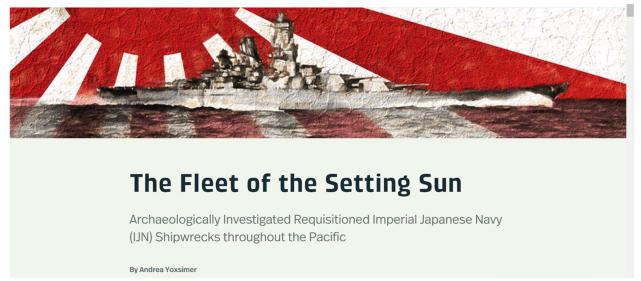
FIGURE 4.9. Maps demonstrating the locations of wrecks, along with historical and present day site descriptions are included for each site in the story map

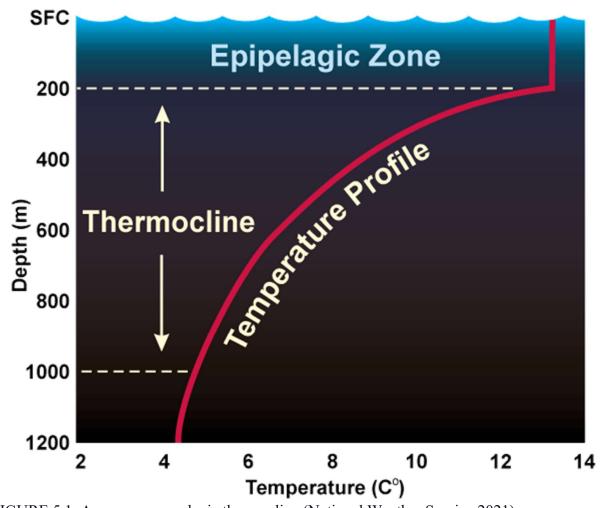
FIGURE 5.1. Average mesopelagic thermocline (National Weather Service 2021)

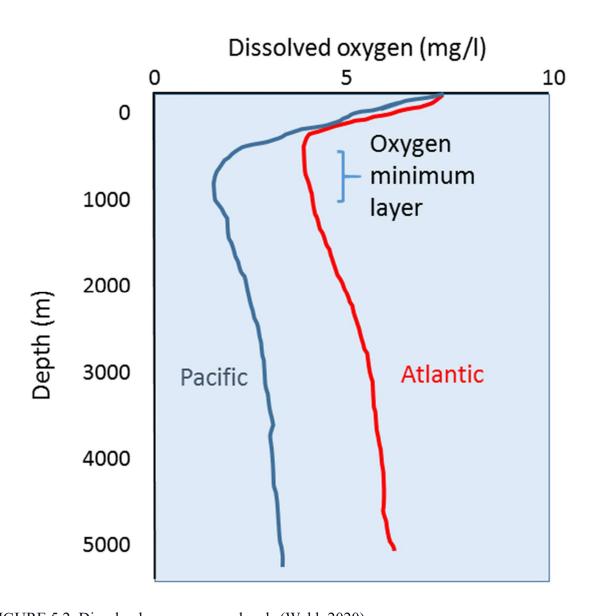
FIGURE 5.2. Dissolved oxygen ocean levels (Webb 2020)

because the higher the salinity, the lower the amount of dissolved oxygen in the water (Zakowski et al. 2014). This hypothesis is supported by the dissolved oxygen level recorded at the site. Average ocean level dissolved oxygen levels rest at approximately 8 mg/L (Webb 2020). This rate decreases with increased depth until reaching the oxygen minimum layer at 1000 meters (FIGURE 5.2). As *Amakasu Maru* rests at a depth of 825 meters, it is above this layer and therefore drastically decreased dissolved oxygen levels are expected.

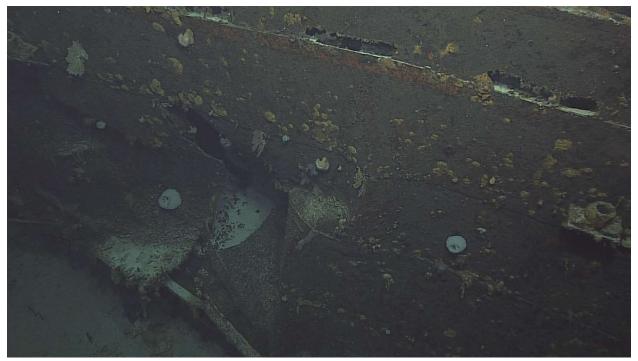
FIGURE 5.3. Lower aft hull damage most likely the result of a torpedo that struck the hull by USS *Triton* on 24 December 1942 leading to the vessel's sinking event (NOAA 2016b)

2016a:5). These features may have occurred during the vessel's wrecking event or post-wrecking due to corrosion processes.

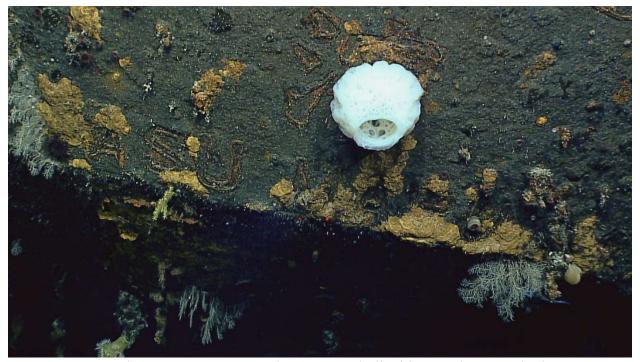
FIGURE 5.4. *Hyalonema* sponge on *Amakasu Maru's* hull with *Acanthogorgia* in the background (NOAA 2016b)

During the 2016 *Okeanos Explorer* survey of the site, researchers noted the presence of several biological species residing on and around the wreck. These included several "species of sponges (*Hyalenema* sp. and *Dictyaulus* sp), gorgonians including *Iridogorgia* sp, *Acanthogorgia* sp, and other unidentified species, anemones... and fishes (*Neoscopelus* sp, *Sladenia* sp, and an *ophidiid*)" (National Oceanic and Atmospheric Administration 2016a:5). Presence of corals and biological activity on the wreck is important as concretions that develop on the wreck help to reduce the rate of corrosion. This reduction in corrosive potential happens when organisms cover the reactive steel and therefore reduce the amount of hull exposed to dissolved oxygen (Mondal and Raghunathan 2017:99). Some of the biological inhabitants of the wreck are shown in FIGURES 5.4 and 5.6.

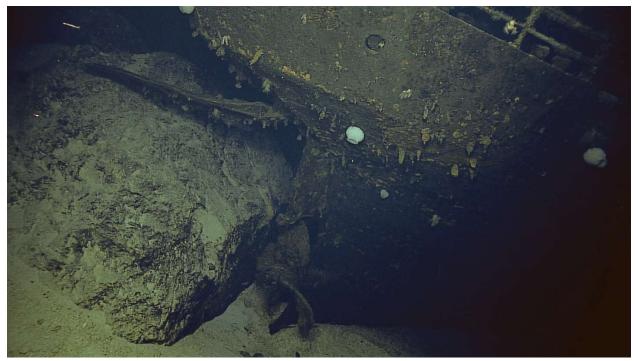
FIGURE 5.5. Rudder damage due to contact with boulder (NOAA 2016b)

surrounding the wreck that have caused damage. For instance, the propeller appears to have been damaged when coming into contact with a nearby boulder (FIGURE 5.5).

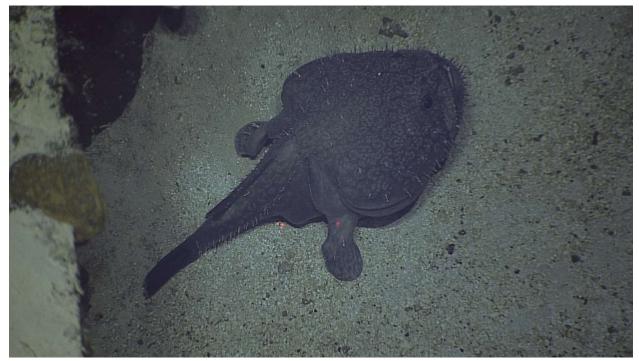
FIGURE 5.6. Sladenia fish resting on Amakasu Maru superstructure (NOAA 2016b)

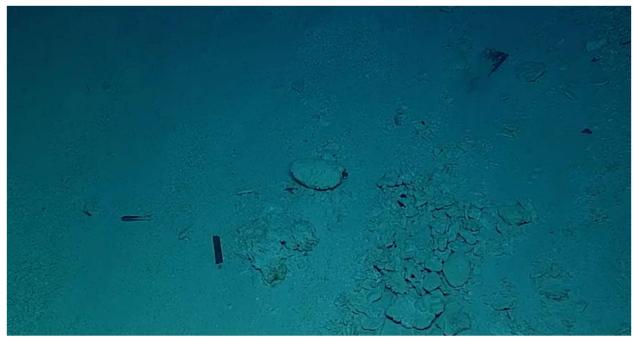
FIGURE 5.7. Screenshot from 2016 ROV footage showing wood planking in debris field (NOAA 2016b)

While approaching the wreck, researchers noted a scattered debris field containing wood fragments. This field seems to be near the wreck, though exact measurements were not taken. The wood appears to be shaped like planking and experts noted the presence of what appears to be teredo worm damage, increasing the likelihood it originated from the wreck (FIGURE 5.7). This field was relatively small. It contained minimal wood and no cargo or other materials associated with the vessel. Due to the small nature of the field, it is difficult to determine whether this scattering occurred at the time of wrecking or if currents carried these small fragments away from the site post-wrecking.

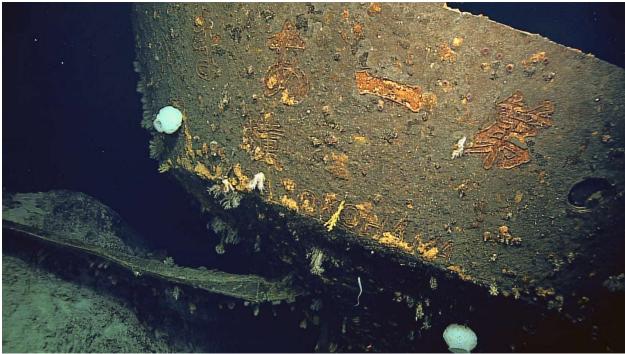
FIGURE 5.8. Amakasu Maru No. 1 listed in Japanese characters on the vessel's stern (NOAA 2016b)

The wreck was positively identified during the *Okeanos Explorer* mission. Researchers noted the ship name welded on the vessel's stern in both Japanese characters and the English alphabet. The vessel's English name is visible in FIGURE 5.4 under the *Hyalonema* sponge. The Japanese name is shown in FIGURE 5.8.

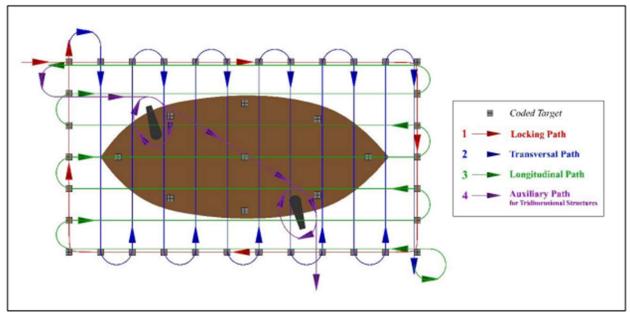
FIGURE 5.9. Potential ROV flight path for the development of a comprehensive photogrammetric site model (Yamafune 2016:28).

parameters regarding the flight path for a survey, consulting the photogrammetric software manual being used in post-processing is recommended.

As stated earlier, a comprehensive flight path is essential to ensuring sufficient image overlap. It is also recommended that "two consecutive photos have an 80% overlapping area with the forward image, and a 60% overlapping area with the adjacent image for successful photogrammetry coverage" (Yamafune 2016:14). Similarly, if video footage is being captured on the site, a high frame rate frequency is important for ensuring there will be enough quality still images to be extracted during post-processing to make a model (Drap et al. 2015:2). Along with continual capture, researchers must ensure the camera stays orthogonal to the surveyed object. Camera angles greater than 45 degrees may hinder reconstruction or lead to inaccuracies (Kwasnitschka et al. 2013:226). Perhaps unsurprisingly, avoiding sudden movements during the survey should also be considered. Unexpected movement may lead to imprecise images or images that do not have the necessary overlap to utilize in the model, leading to data gaps.

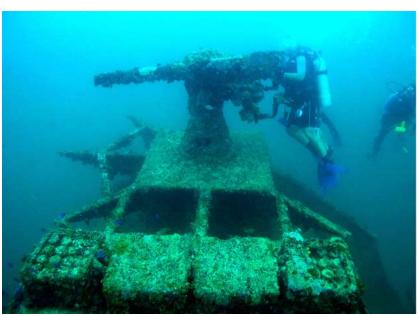
APPENDIX A 1.1. *Kitsugawa Maru* is a popular diving destination and human interaction with the site is common (Jeffery and Palmer 2017)

Toni Carrell and her team resurveyed the vessel during their 1990 survey of the area (Carrell 1991:376). The site was again surveyed in 2007 by Jeffery and Drew. During this survey, researchers noted both human and environmental impacts on the site. Most notably, a concrete block was dropped on the bow of the vessel, causing severe damage. This block was most likely intended to be part of a surface marker mooring (Jeffery and Palmer 2017:7). In a video discussing the features of the wreck, one diver Pete Peterson, stated that to find the wreck he and his colleagues would drag an anchor around the area until they "hooked it" (Peterson 2011).

FIGURE 6.1 demonstrates some of the human impact currently experienced on the site.

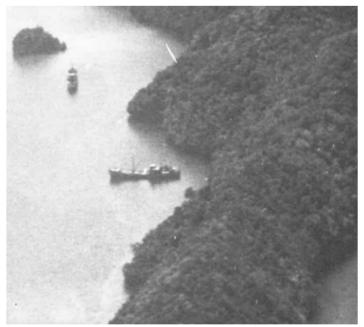
APPENDIX A 1.2. Unidentified Maru No. 3 in Malakal Harbor 30 March 1944 (Bailey 1991:153)
