Kimberly M. Smith. COMPARATIVE ANALYSIS OF CASK MATERIAL FROM LATE SIXTEENTH THROUGH EARLY NINETEENTH CENTURY SHIPWRECKS (Under the direction of Dr. Charles R. Ewen) Department of Anthropology, July 2009.

COMPARATIVE ANALYSIS OF CASK MATERIAL FROM LATE SIXTEENTH
THROUGH EARLY NINETEENTH CENTURY SHIPWRECKS

Master of Arts in Anthropology

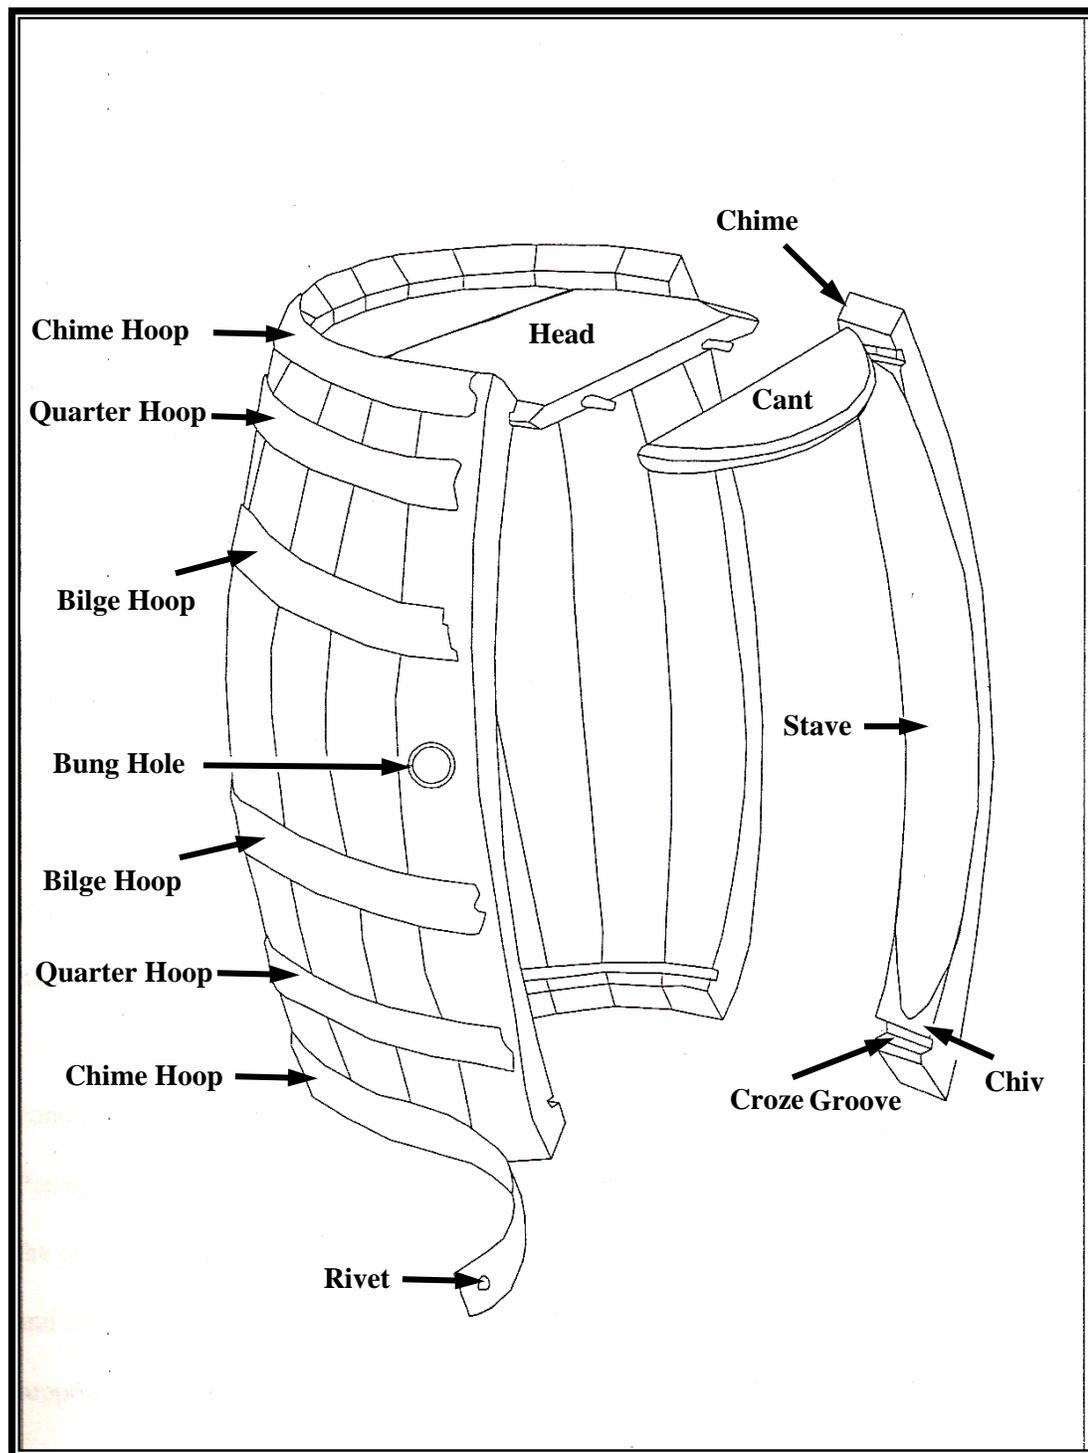
FIGURE 1.1. The components of a cask (after Shackelford 1988).

A cask, commonly and inaccurately referred to as a barrel, is a general term for all vessels formed of staves and heads and held together with hoops (Figure 1.1) (Kilby 1989:37; Boudriot 1986:108). Throughout history there have been many different cask sizes (Table 1.1 and Figure 1.2), all with different names, including, but not limited to: monkey, firkin, kilderkin, barrel, tierce, hogshead, puncheon, pipe/butt, and tun. The range of cask types, capacities, stave length and thickness, and minimum and maximum bilge diameters from the eighteenth century were collated and summarized in Table 1.1 (adapted from Watkins-Kenney 2006). The wine gallon or US gallon of 231 cubic inches was represented, rather than the imperial gallon of 277.3 cubic inches adopted by England in 1824 ((1) Walsh 1999:151-154, (2) Boudriot 1986:108-109; Babits 2005, pers. comm.; Rowlett 2005; (3) Shackelford 1996:21; (4) Bradley 1983, (5) Mitchell 1996b).

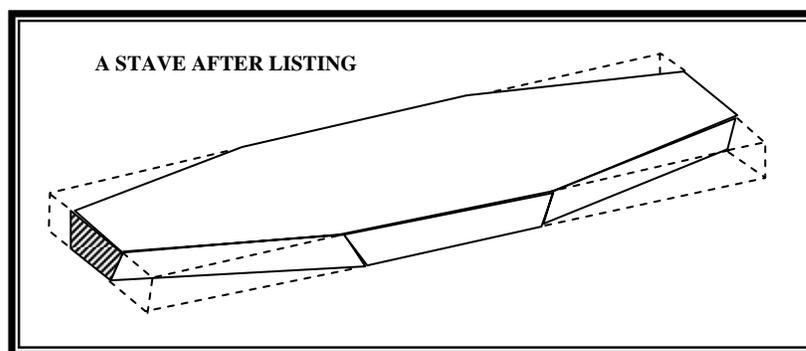
FIGURE 1.3. A drawing showing how a stave is listed. Note the dashed lined areas; these are the areas removed during listing (after Kilby 1989 and Kilby 2004).

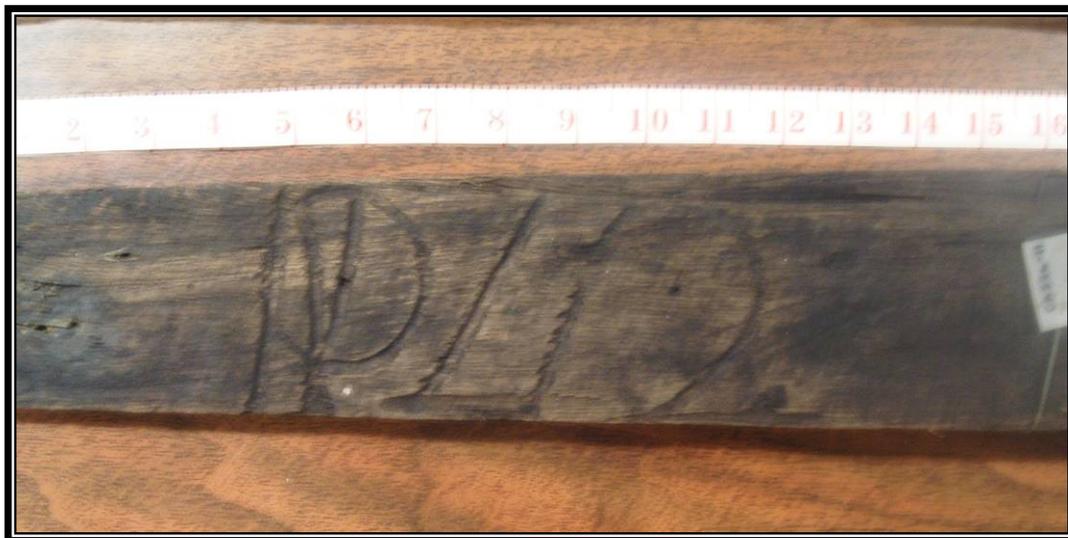
FIGURE 1.4. A stave recovered from the *Betsy* showing possible maker's, shipper's marks, assembly marks, and graffiti from the late eighteenth century (the scale shown above is in inches). (Photo by author 2006.)

During the manufacturing, assembly, and inspections, staves are often marked with lines and symbols (Figures 1.4 and 1.5). These include anything from assembly marks, coopers’ grading, inspection marks, shippers’ marks, and unknown marks that probably represent graffiti. Assembly marks are located on both the interior and the exterior of the staves and consist of lines, circles, and Roman numerals. These are engraved or branded in the cask to assist with the final assembly of the cask. Coopers’ marks (Figure 1.4) are the equivalent of maker’s marks and varied in shape, often with the cooperage name that constructed the cask branded into its head. On *San Juan*, a Spanish Basque whaling vessel wrecked in 1565 off the coast of Red Bay, Labrador, the coopers’ marks “consisted of a fine single curved line or double fine curved lines forming an “X”, “Y” or an “eye” shape” (Ross 1980b:101). Inspection marks also vary in shape or design, and are used to designate that the cask and contents had been inspected and approved. Shippers’ marks are typically located on the bilge area of the cask, the portion not covered by hoops, and are used to signify the owner of the cask and contents. Casks typically have several markings ranging from assembly marks to shippers’ marks. Often, additional marks are present which lack a purpose or may represent graffiti (Ross 1980b:101-102).

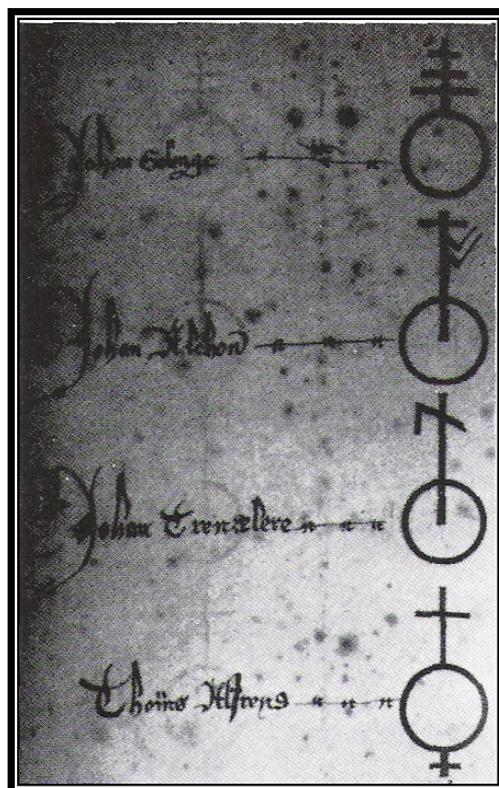
FIGURE 1.5. Examples of cooper's marks from the fifteenth century (Kilby 1989).

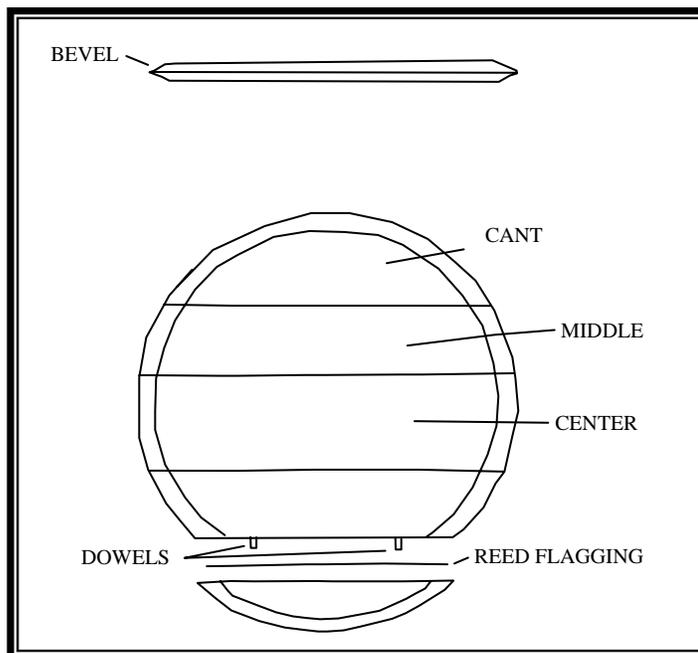
FIGURE 1.6. Cask head components (after Shackelford, et al. 1986).

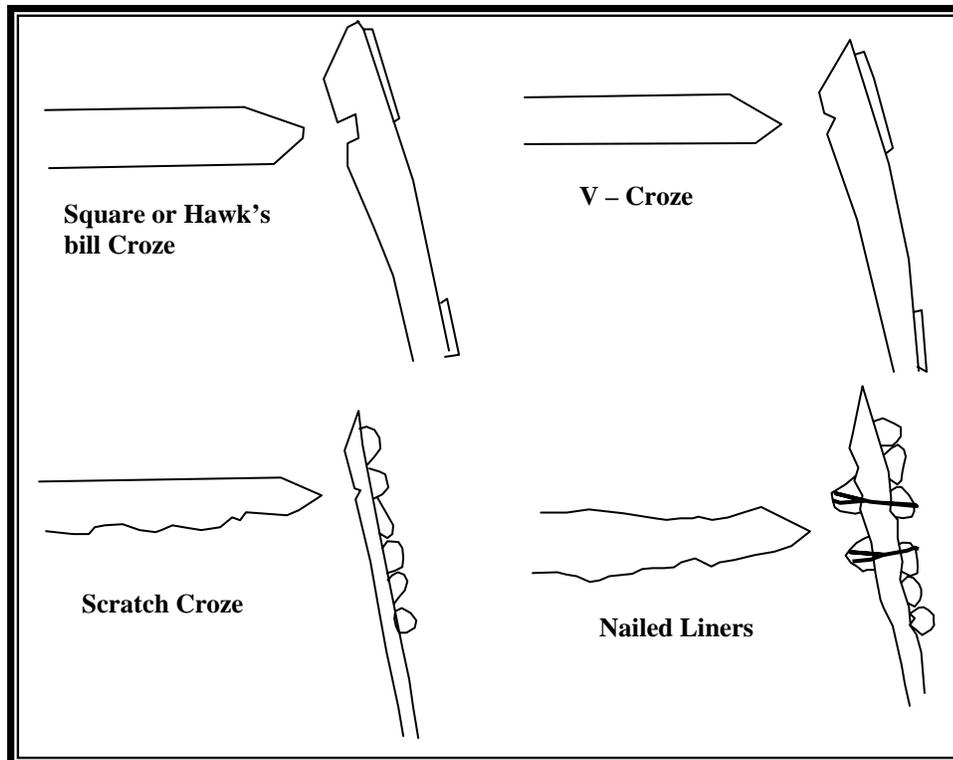
FIGURE 1.7. The four different types of croze found on staves recovered from eighteenth century shipwrecks (after Shackelford 1988).

There are three types of croze grooves (Figure 1.7): the hawksbill, a deep wide groove associated with casks for liquids; the scratch groove, a shallow groove used only in casks for dry provisions; and the V-groove for tight casks used with semi-liquids such as salt pork. Shackelford proposed that tight casks tend to have deeper and wider grooves, while slack casks had a narrow and shallow, or perhaps no groove at all (Shackelford 1996:12-13). Casks that lack a croze groove often have nailed liner hoops on the inside of the staves, such as several casks recovered from *Betsy* (Shackelford 1996:12). According to Shackelford there are several eighteenth-century references to heads being nailed into the casks, or to a nailed liner hoop found inside of the casks (Shackelford 1996:12). For example, Robert Gordon of the Victualling Office in England reported in 1779 that “for want of linning[sic] hoops in the heads, the heads sometimes work in, by which means whole barrels [of flour] were lost” (Shackelford 1988:47; Syrett 1970:142). Tobacco inspectors in Virginia were required to open and examine each cask of tobacco, requiring them to remove the old nails and then replace them to secure the head after inspection. William Allason, a merchant in Flamount, Virginia, documented in his record books the numerous occasions in which an inspector purchased a quantity of tenpenny nails “for heading up tobacco” (Allason Papers, M-1144). One cask from *Betsy* depicted this technique. The staves of *Betsy* Cask Assemblage (CA) 206 (a grouping of staves, heads, and hoops believed to be a single collapsed cask) had no groove; rather it had a series of nail holes around the chime indicative of liner hoops to hold the head in place.

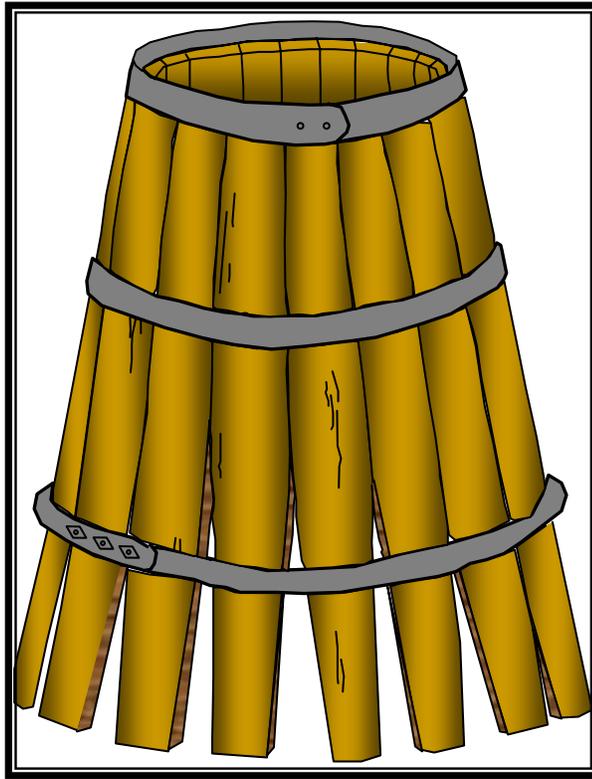
FIGURE 1.8. A drawing of a raised cask (after Kilby 1989; 2004).

Once the staves and heads are constructed, the staves are raised using wooden trusses, which provide the cask with its familiar shape. Raising the cask (Figure 1.8) involves placing the staves in a wood or metal truss hoop together and working them together (Kilby 1989:24). The raised staves are then shaped by burning a fire inside the cask, creating pressure and forcing the staves to succumb to the shape in which the trusses were forcing upon them. The interior surfaces of tight casks are typically scraped to prevent the taste of smoke from being transferred to the materials inside; however, this is not always the case. Tight cask staves recovered from the *Betsy* exhibit “everything from a light brown color to charred areas on the interior” as a result of such firing (Shackelford 1996:11; 1988:47). Slack casks are either fired to make the wood more pliable, but typically not scraped, or are not fired at all (Shackelford 1996:12; 1988:46). Tight casks are fired to hollow out the staves and are almost always scraped to prevent the tainting of the cask’s contents with a smoky taste or scent (Shackelford 1996). While the cask is still warm, the heads are worked in (Kilby 1989:24-25).

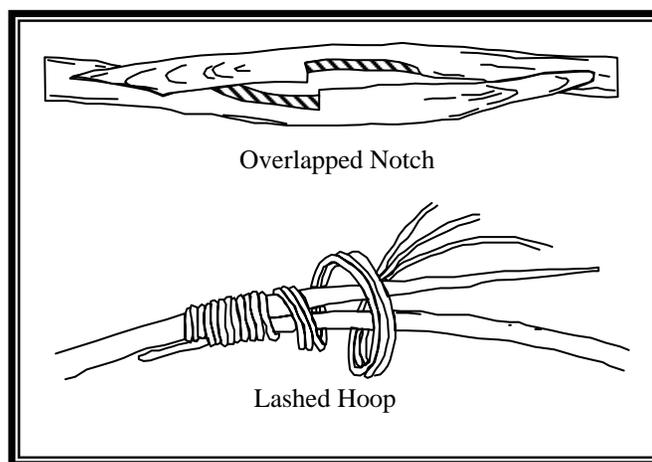
FIGURE 1.9. A drawing showing the two different types of wood hoop ends (after Shackelford 1988).

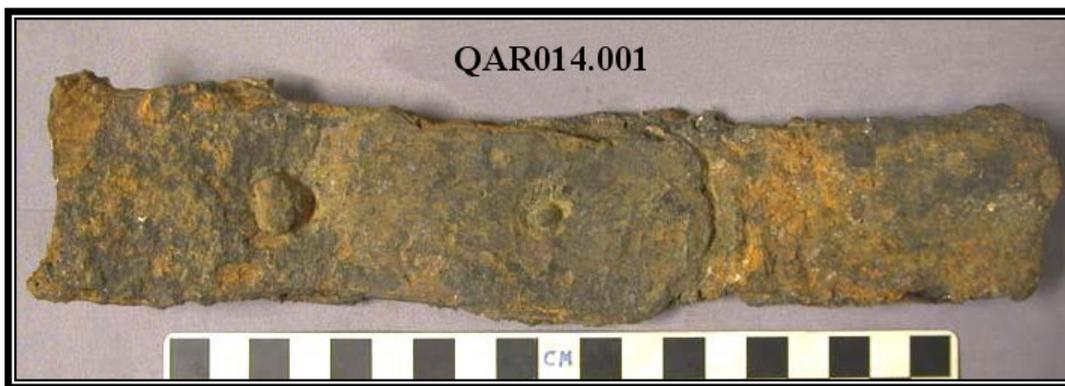
FIGURE 1.10. A cask hoop recovered from the Beaufort Inlet Wreck, showing a proper hoop overlap, with a nicely rounded end. (Photo Courtesy of NC Dept. Cultural Resources 2006.)

stowing the cask, many overlaps appeared carelessly splayed outward creating a more circular end (Figure 1.10). Several hoops recovered from the Beaufort Inlet Wreck also showed no sign of rounding the overlaps which possibly indicated a quick repair, or at the least, sloppy coopering (Scheetz 2006, pers. comm.).

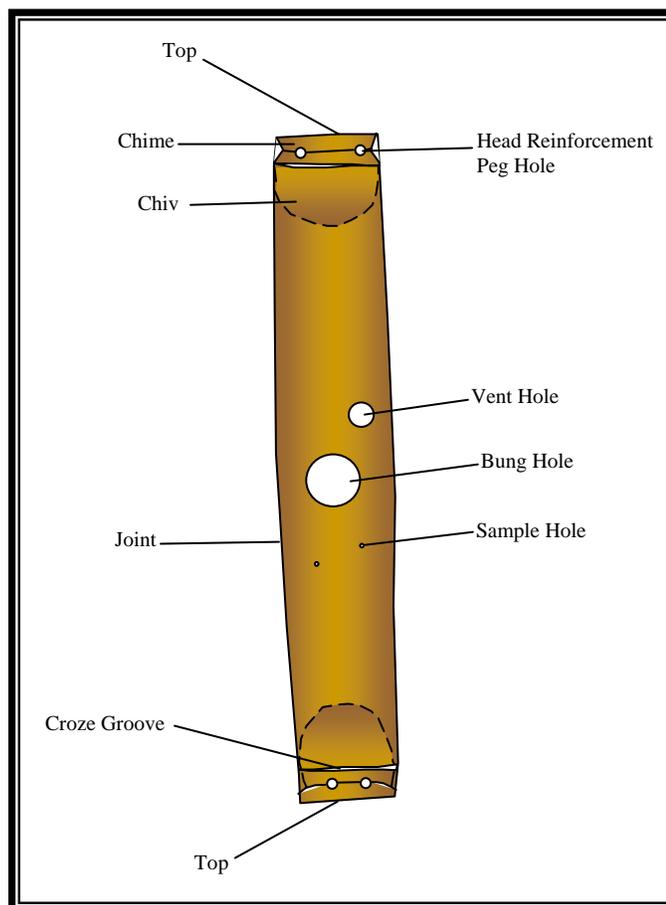
FIGURE 1.11. A drawing of a stave recovered from the *San Juan*. Note the vent hole and sample hole (after Ross 1985).

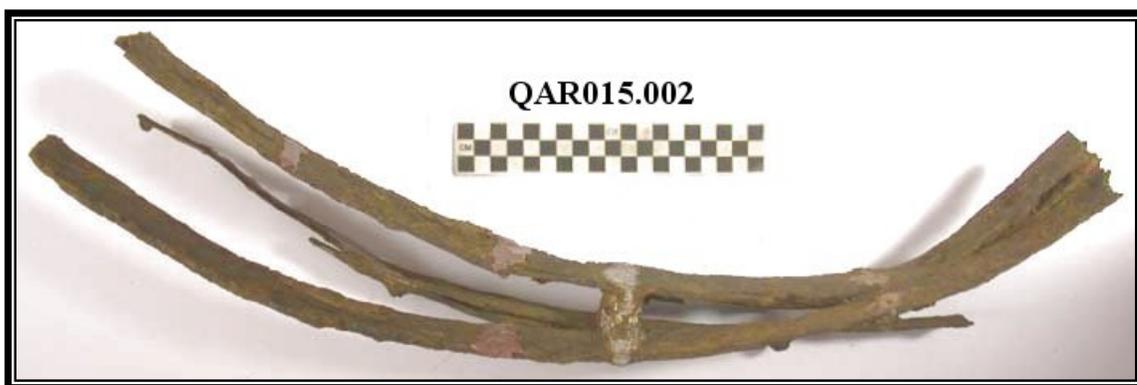
FIGURE 1.12. Cask hoops recovered from the Beaufort Inlet Wreck, all of which share the same diameter and may represent a shook, or at least a bundle of hoops. (Photo Courtesy of NC Dept. Cultural Resources 2006.)

One particular set of hoops recovered from the Beaufort Inlet Wreck, QAR 015.002, contained four different hoop fragments nesting on top of one another and had nearly the same diameter of 41-42 inches (Figure 1.12). The difference of one inch was nearly insignificant, as a single hoop varied by one inch depending on whether the minimum or maximum diameter was measured. In addition, this set of hoop fragments also contained a small fragment of rope between the hoops; thus, it may have represented a shook or a bundle of hoops at the least.

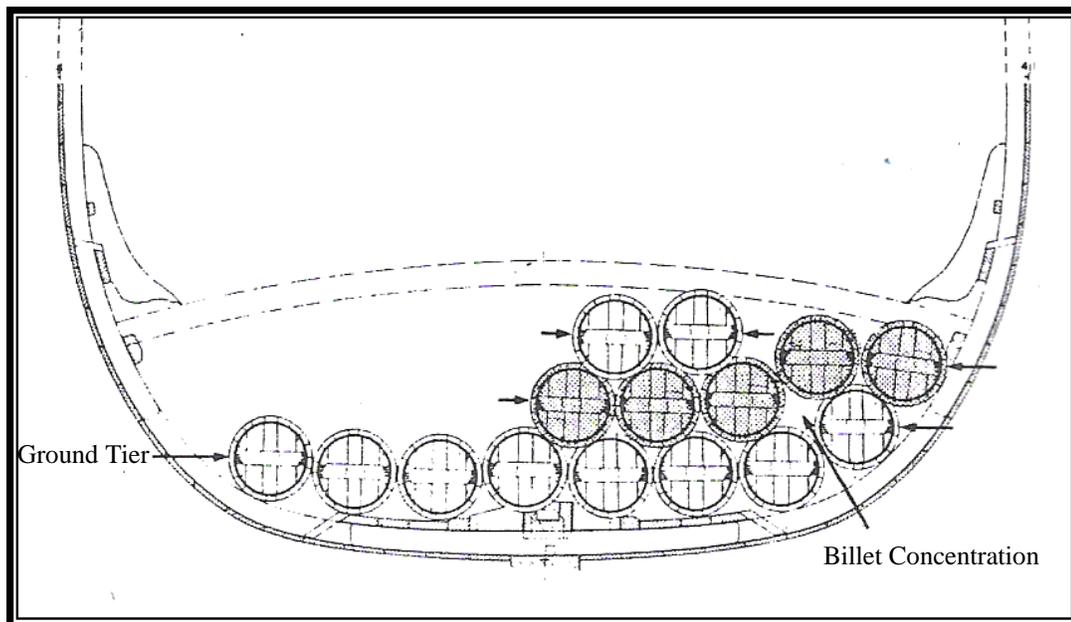
FIGURE 1.13. Picture showing the bilge and cantline cask stowage pattern (after Ringer and Audy 1982).

and Audy 1982:24). The bilge and cantline stowage method consists of placing a ground tier, or lower level of casks on beds, then placing the next tier of casks so that the bilge of each cask lay in the cantline, the hollow created by the four casks on which it was resting (Figures 1.13 and 1.14) (Staniforth 2001:70). The bilge and bilge method, alternatively, places the casks on top of one another so that, rather than having the upper tiers rest in the cantline, they were laid sideways so that the bilge of each cask touched. A-burton, is a term applied to the stowage of casks athwartship, in line with the deck beams. The vertical method of stowage consisted of placing the casks upright next to one another. The aim is to stow as many casks of water, wine, salt beef or pork, etc., as possible in a way in which they were readily accessible below decks and at the same time took up the least space.

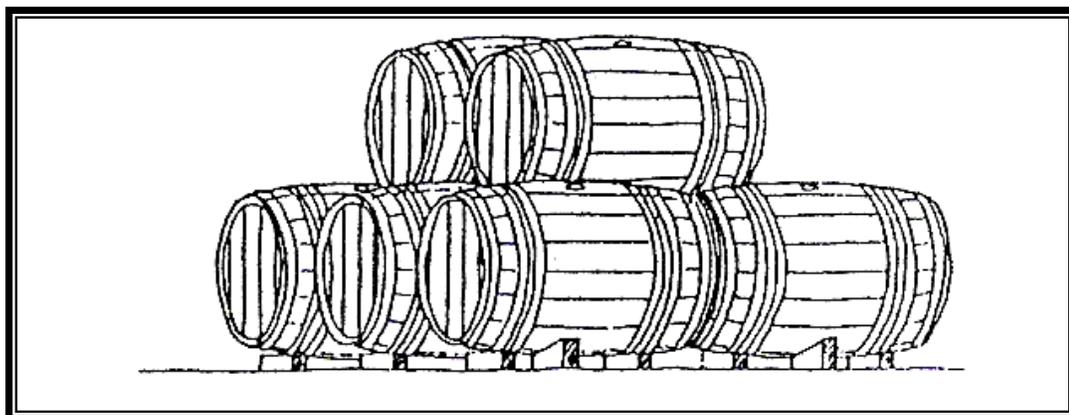
FIGURE 1.14. Picture showing the bilge and cantline cask stowage pattern (after Staniforth 1987).

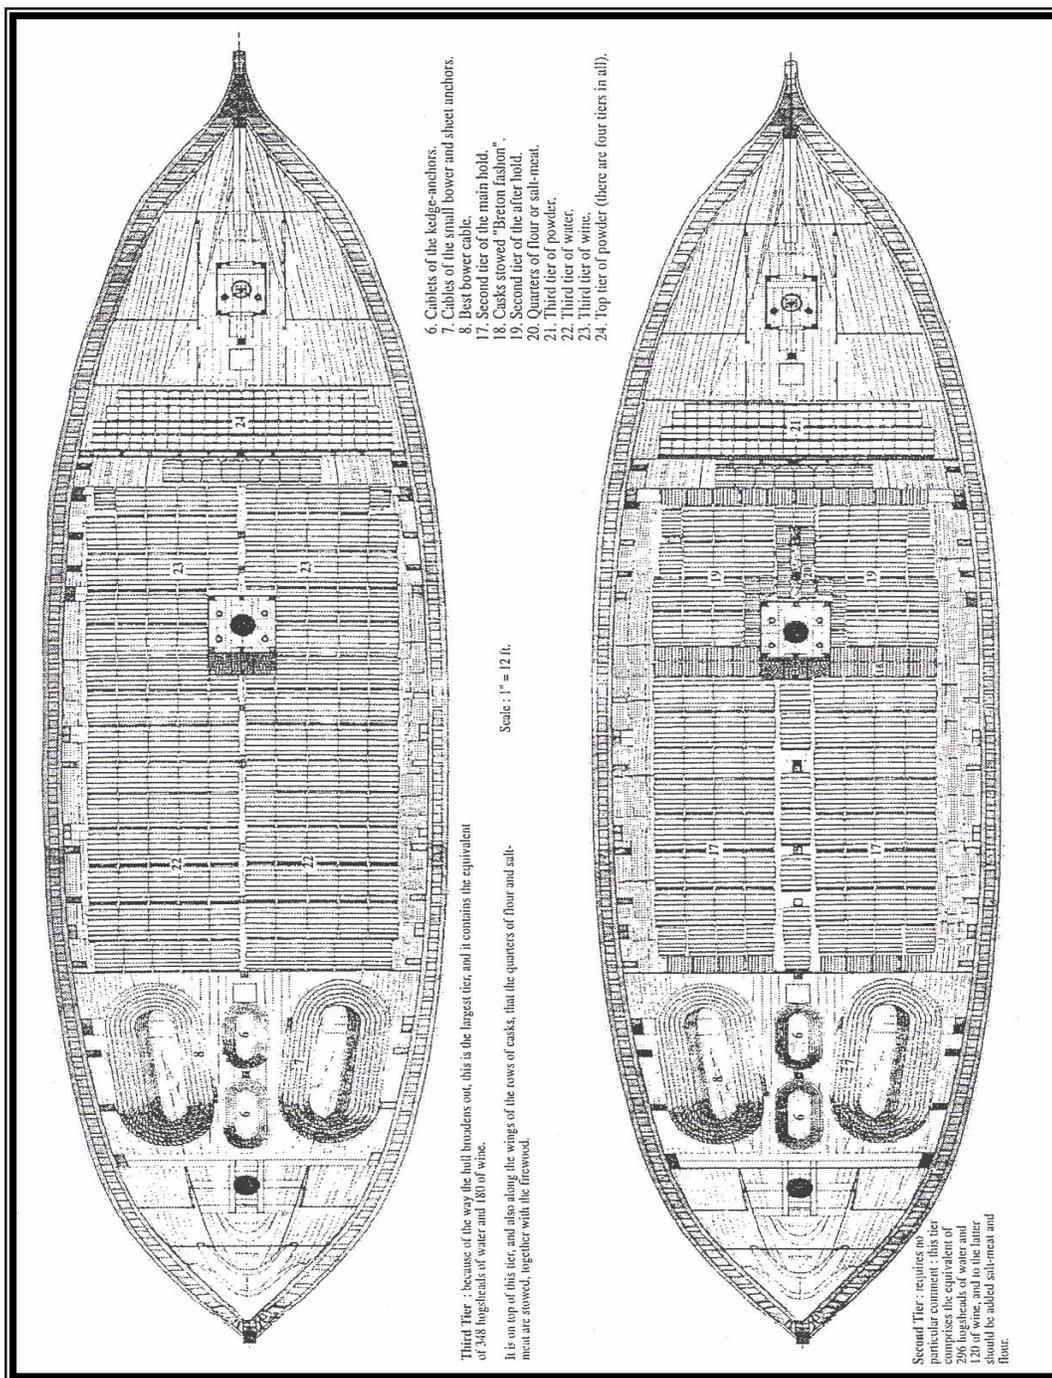
FIGURE 1.15. A picture showing the stowage of casks in a ship's cargo hold (after Boudriot 1986).

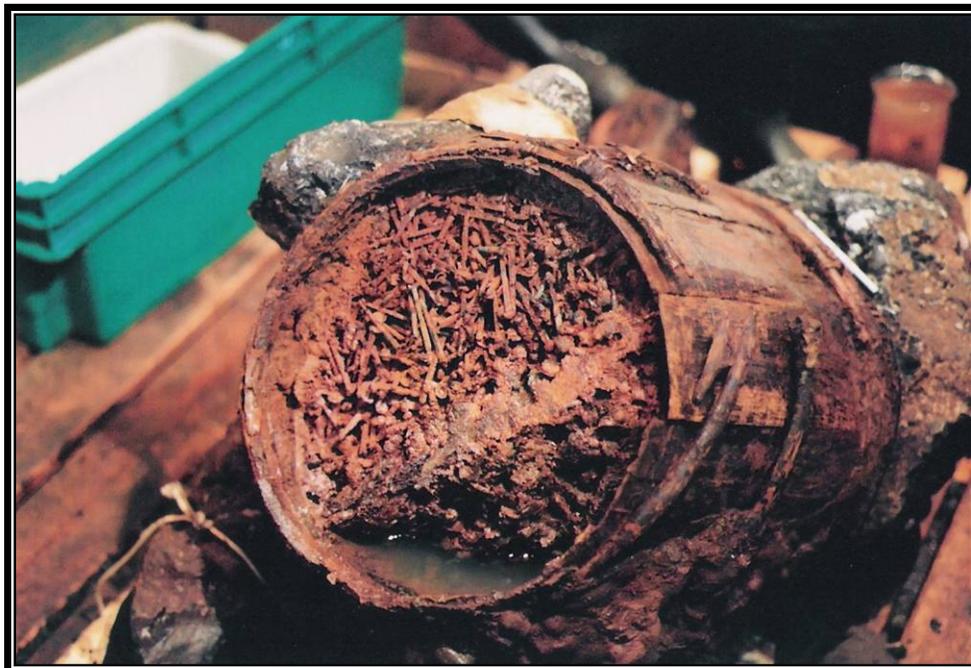
FIGURE 1.16. A picture showing a cask containing nails recovered from the *Whydah* (McNair-Lewis 2006, pers. comm.).

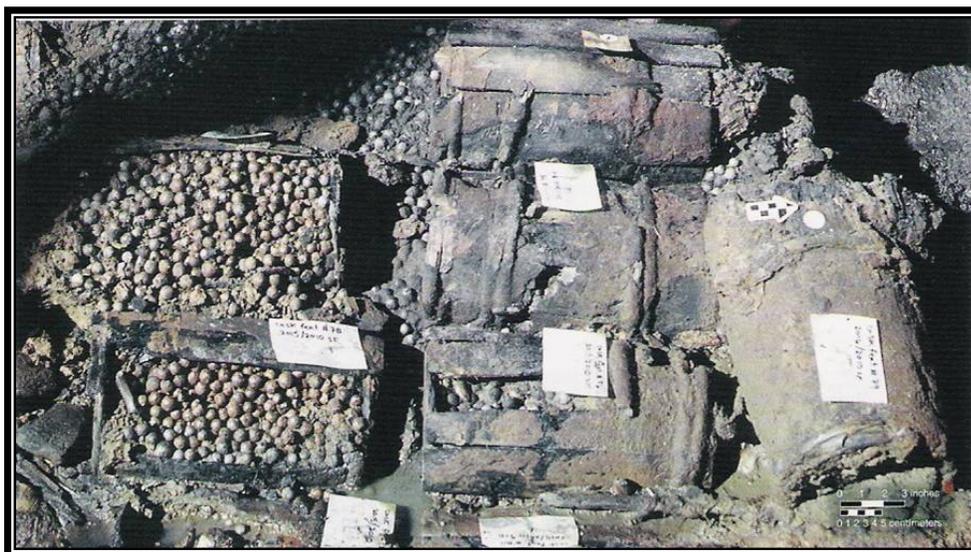
FIGURE 1.17. A picture showing casks recovered from the *La Belle* containing lead shot (Bruseth and Turner 2005).

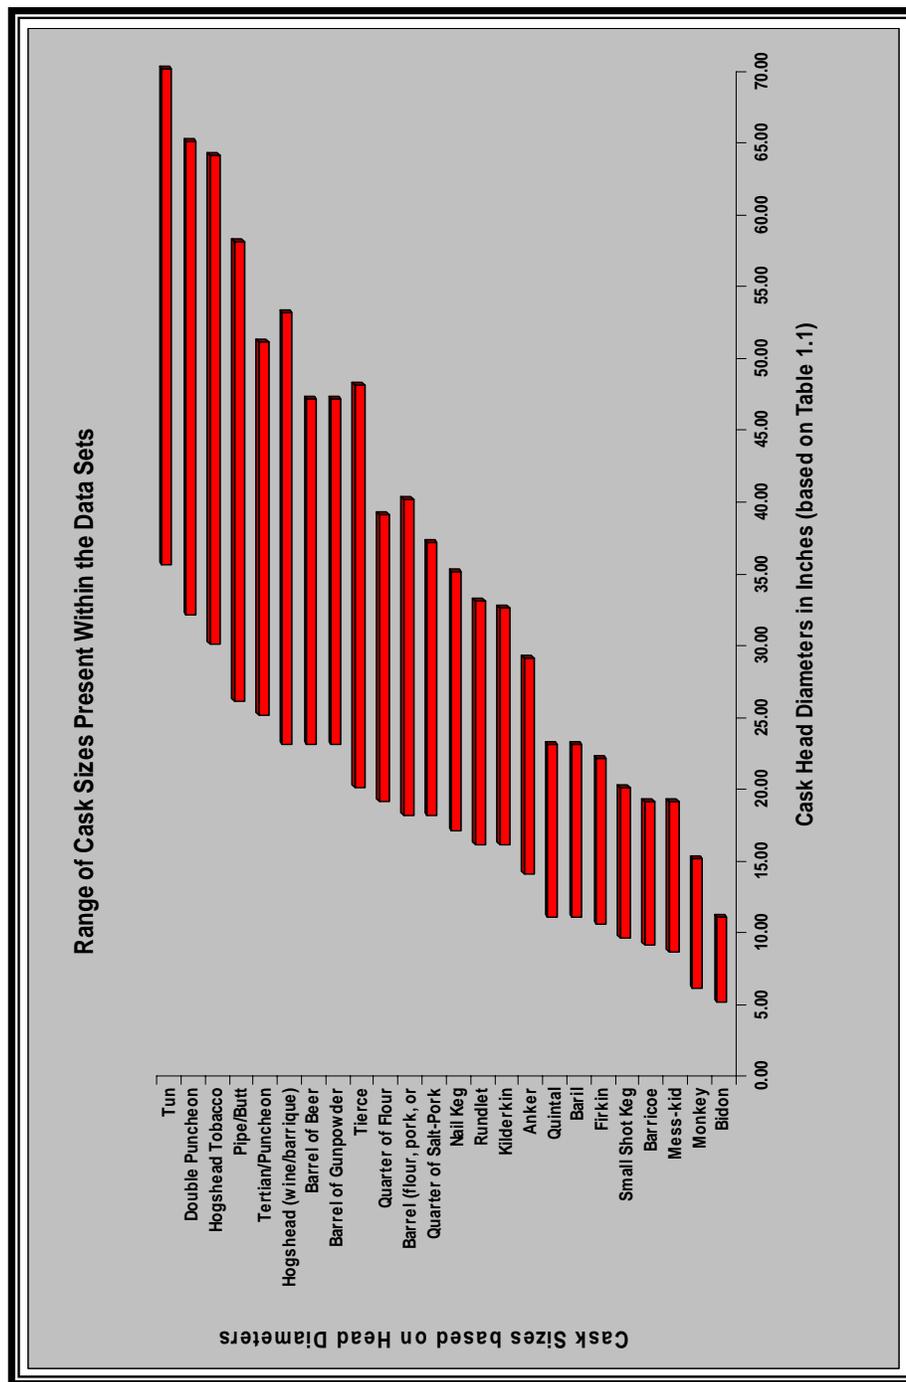
FIGURE 3.1. Graph showing the range of cask sizes, based on head diameters, represented on the varying shipwrecks utilized in this study (Cask head diameters were taken from Table 1.1).

represented. In order to determine the cask sizes probably represented, the histograms were compared to the graph provided in Figure 3.1. This graph represents the varying cask sizes, determined by the head diameters found in Table 1.1.

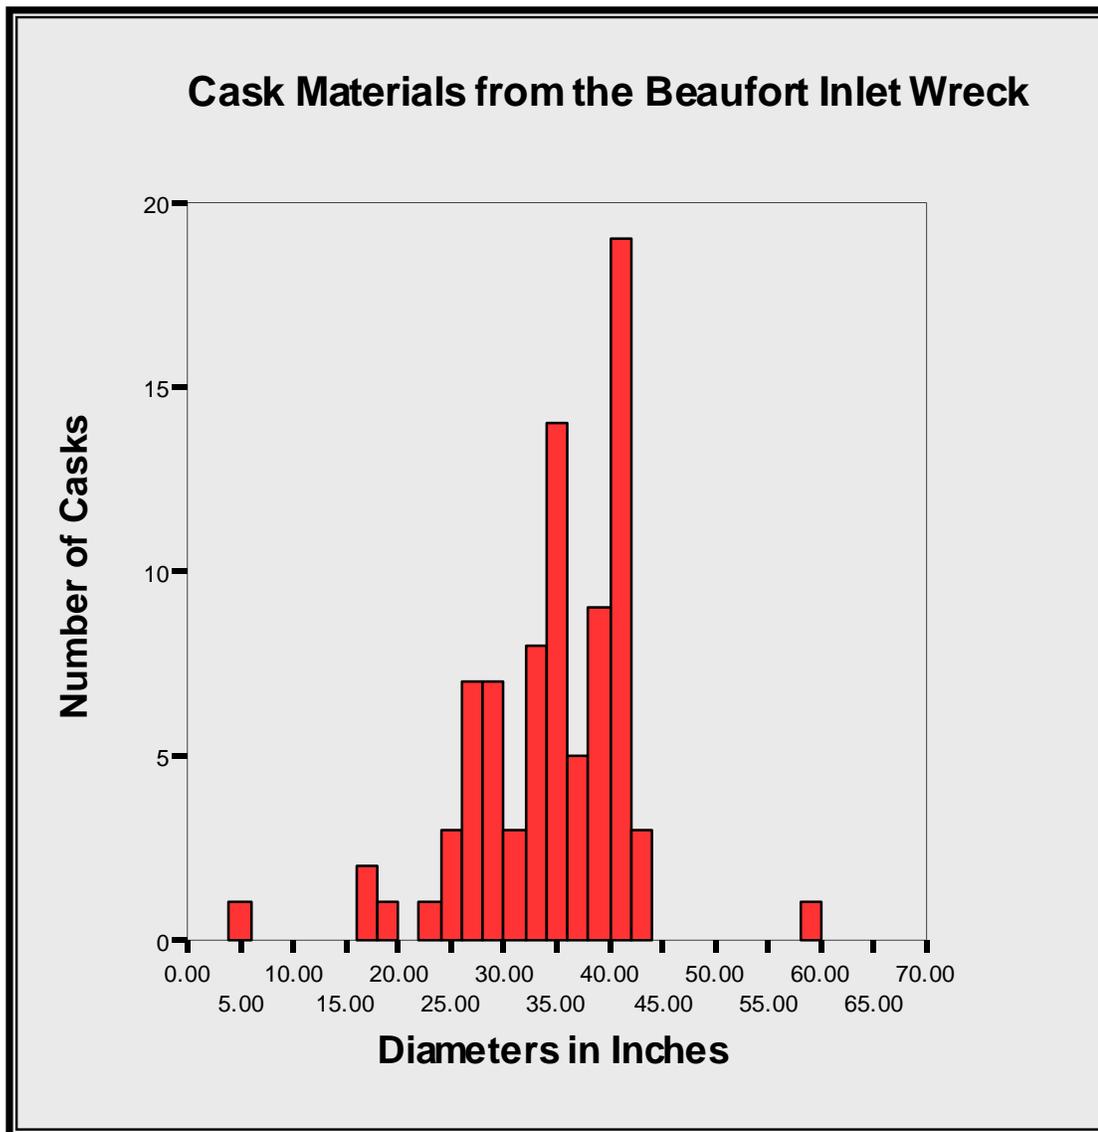
FIGURE 4.1. Histogram showing the range of cask diameters represented in the Beaufort Inlet Wreck cask assemblage. Diameters are based on head diameters found in Table 1.1 and are based on 2 inch increments.

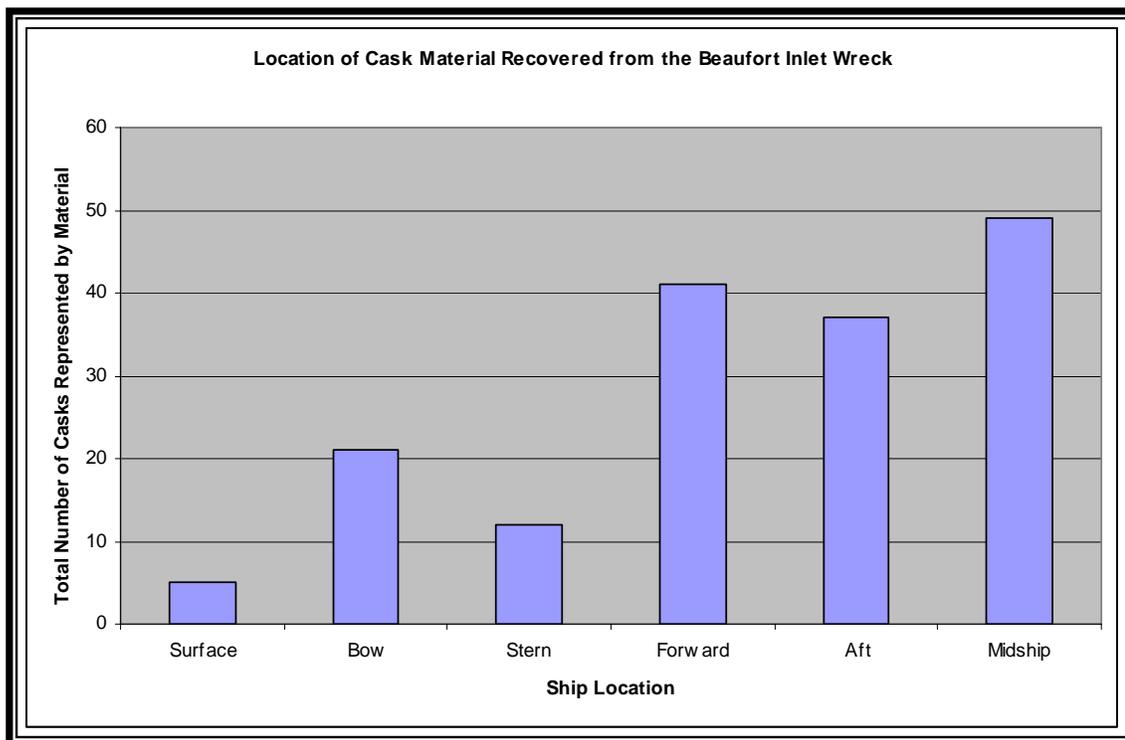
FIGURE 4.2. Bar graph showing the locations within the vessel where cask material was recovered.

Cask components were scattered across the site. It was uncertain if this was due to the wrecking process, natural/environmental factors, or if the material was in its original provenience from the time of wrecking. It was known that 12.72 % (n=21) of the materials recovered were found towards the bow, 7.27 % (n=12) near the stern, 28.48 % (n=41) near the forward area, 22.42 % (n=37) near the aft area, 29.69 % (n=49) near the midship area, and 3.03 % (n=5) were recovered on the surface and lack provenience (Figure 4.2).

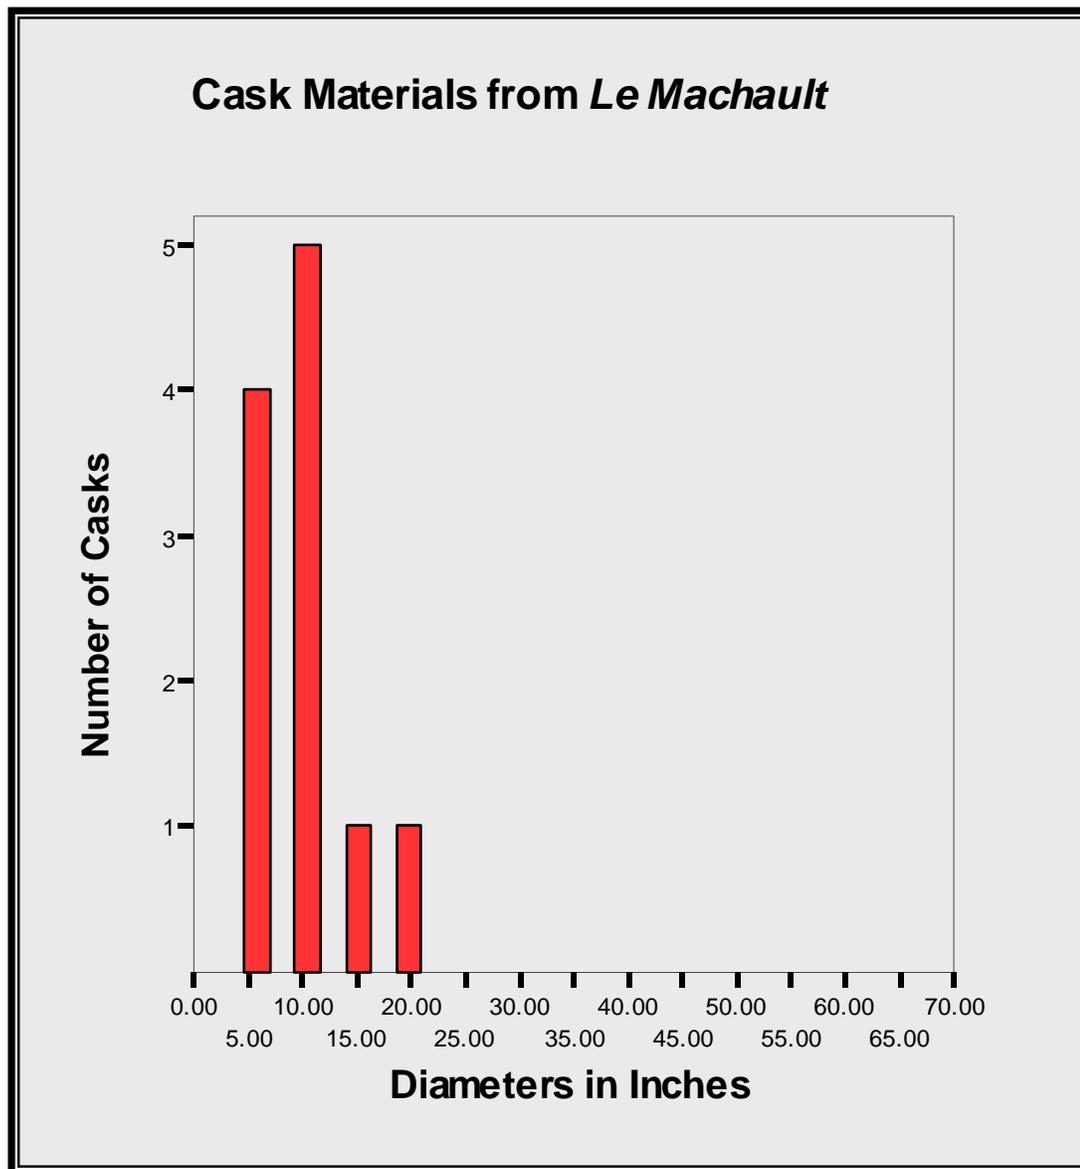
FIGURE 4.3. Histogram showing the range of cask diameters represented in the *Le Machault* cask assemblage. Diameters are abased on head diameters found in Table 1.1 and are based on 2 inch increments.

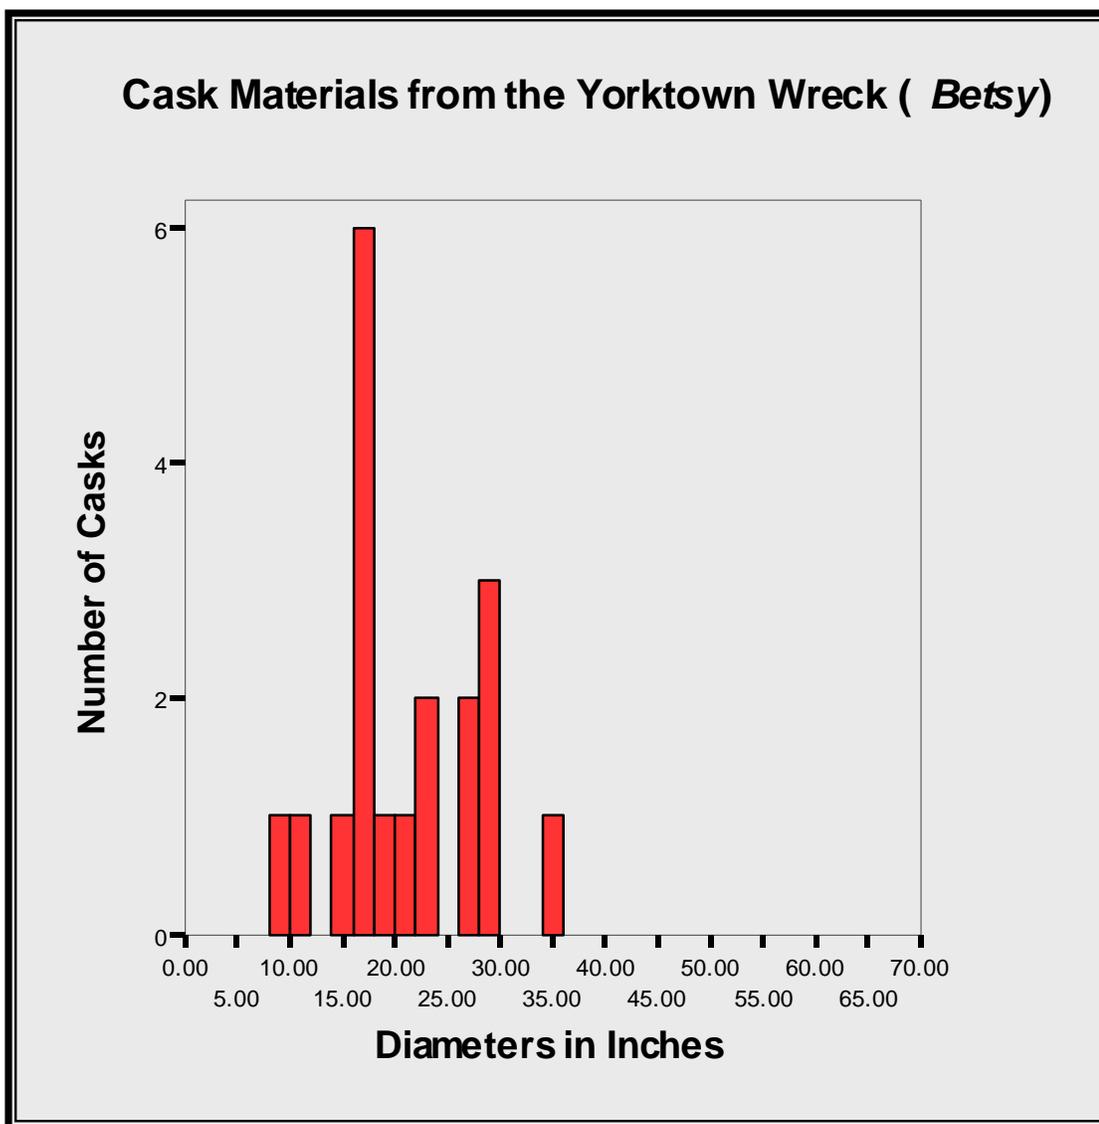
FIGURE 4.4. Histogram showing the range of cask diameters represented in the Yorktown Wreck (*Betsy*) cask assemblage. Diameters are abased on head diameters found in Table 1.1 and are based on 2 inch increments.

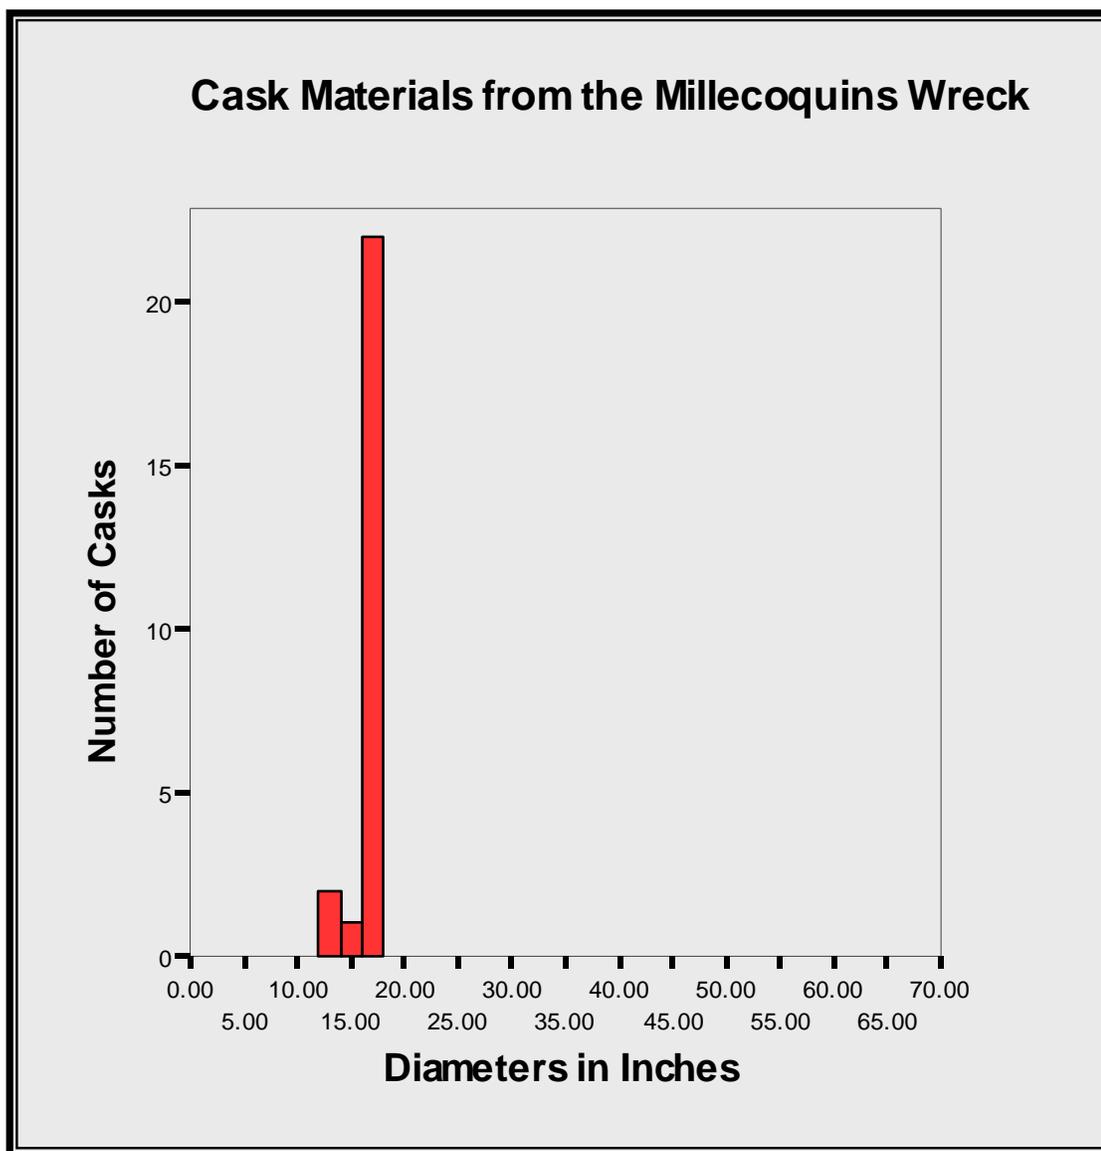
FIGURE 4.5. Histogram showing the range of cask diameters represented in the Millecoquins Wreck cask assemblage. Diameters are based on head diameters found in Table 1.1 and are based on 2 inch increments.

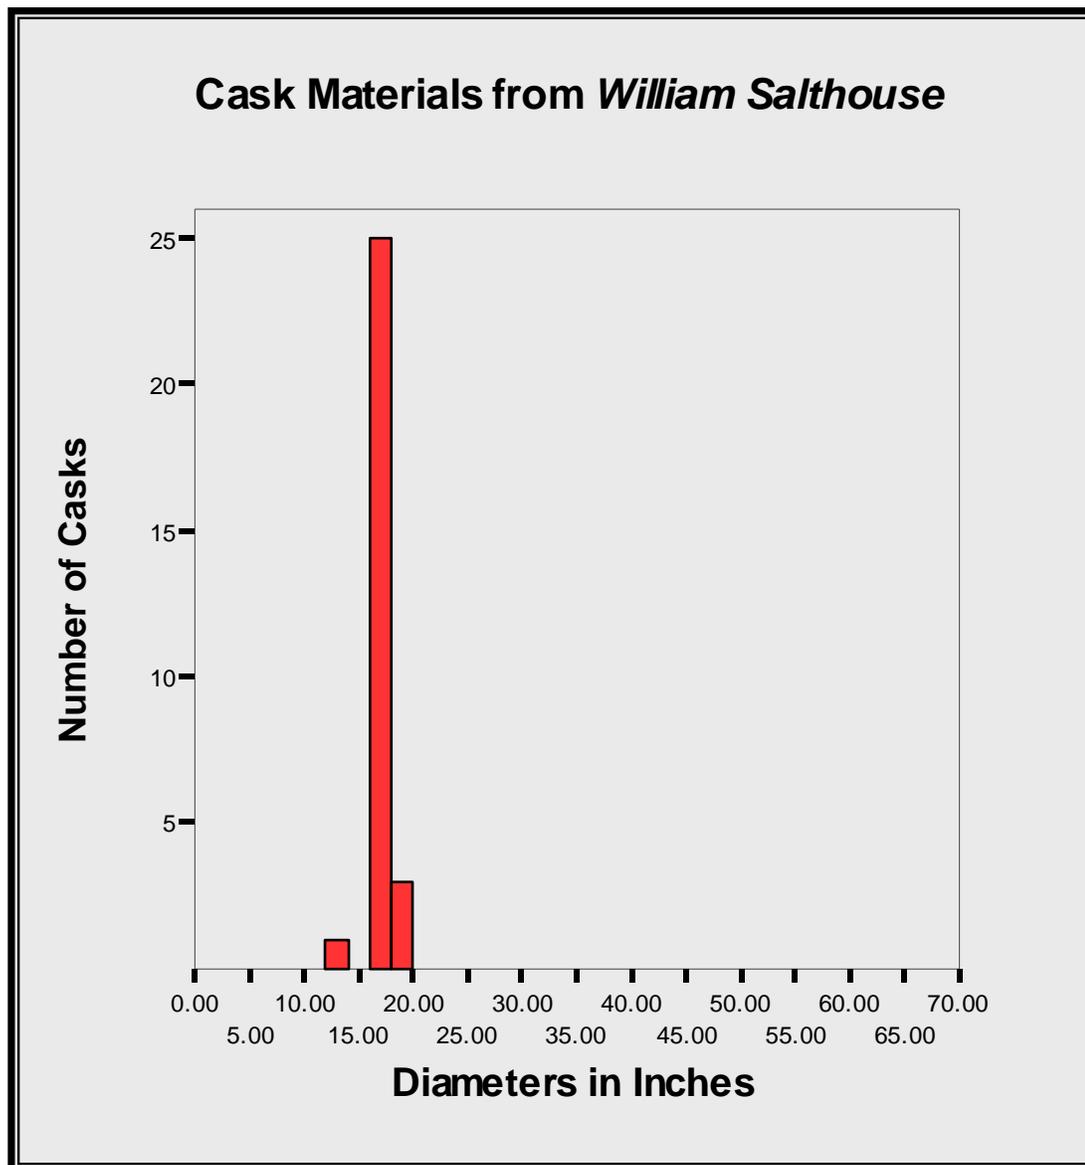
FIGURE 4.6. Histogram showing the potential casks represented in the *William Salthouse* cask assemblage. Diameters are based on head diameters found in Table 1.1 and are based on 2 inch increments.

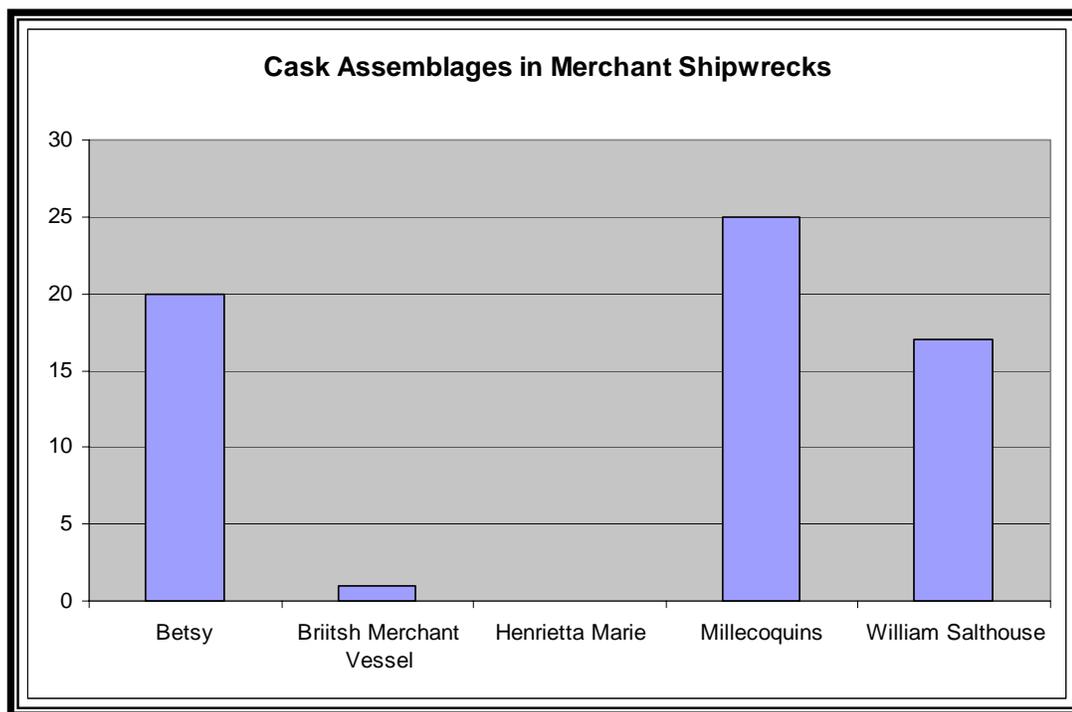
FIGURE 4.7. Bar graph showing the sum of the cask material recovered from the five merchant vessels analyzed in this study.
