Kimberly M. Smith. COMPARATIVE ANALYSIS OF CASK MATERIAL FROM LATE SIXTEENTH THROUGH EARLY NINETEENTH CENTURY SHIPWRECKS (Under the direction of Dr. Charles R. Ewen) Department of Anthropology, July 2009.

COMPARATIVE ANALYSIS OF CASK MATERIAL FROM LATE SIXTEENTH
THROUGH EARLY NINETEENTH CENTURY SHIPWRECKS

Master of Arts in Anthropology

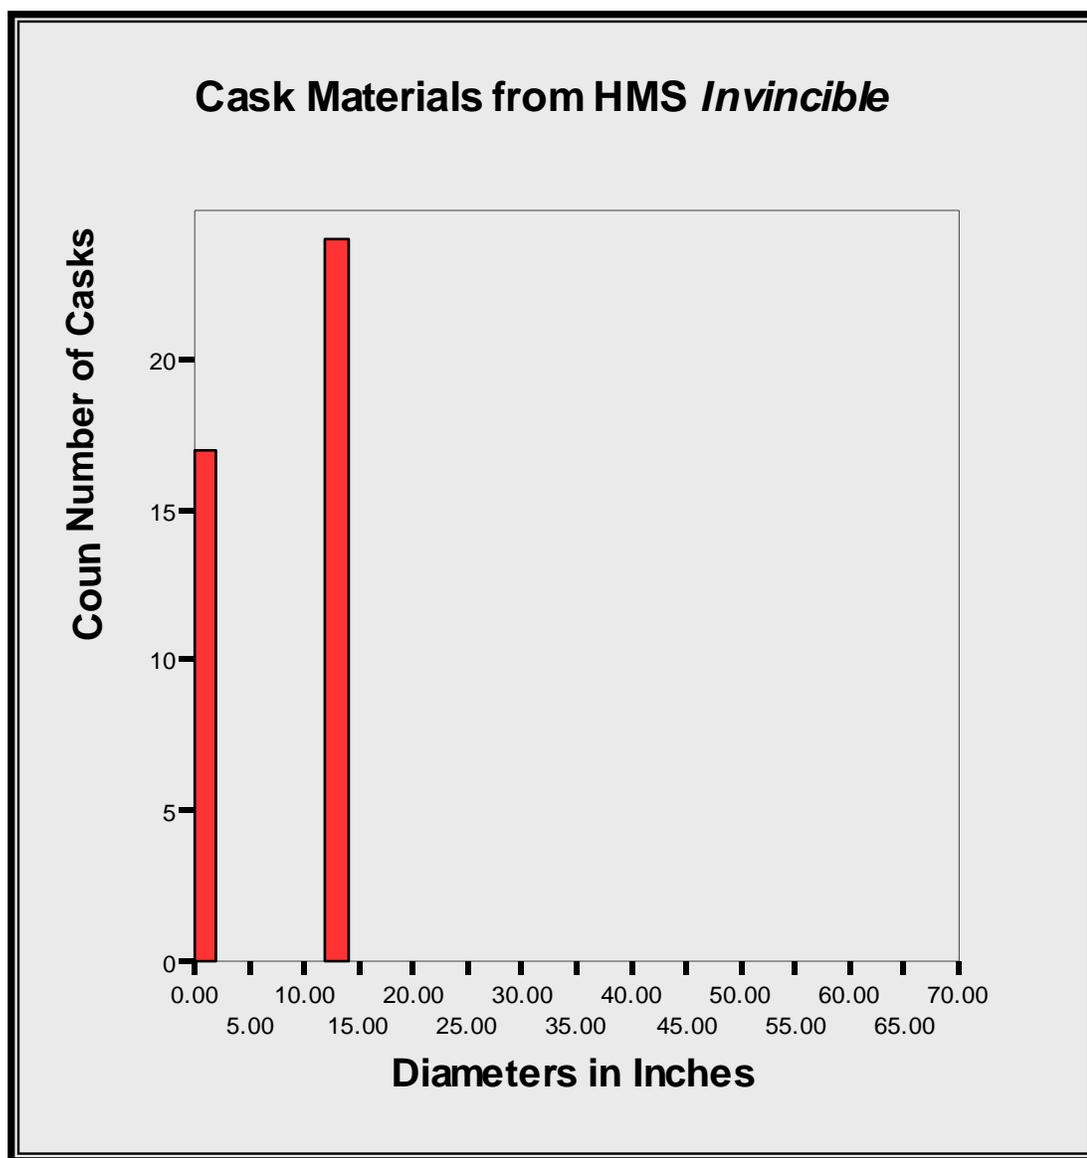
FIGURE 4.8. Histogram showing the range of cask diameters represented in the HMS *Invincible* cask assemblage. Diameters are based on head diameters found in Table 1.1 and are based on 2 inch increments.

4.8 and 4.22). HMS *Sirius* yielded what appeared to be salt pork casks, empty casks, iron hoops, and several copper hoops. Unfortunately, the exact dimensions, number of casks and hoops, and more specifics concerning the exact location of the cask remains within HMS *Sirius* were unavailable.

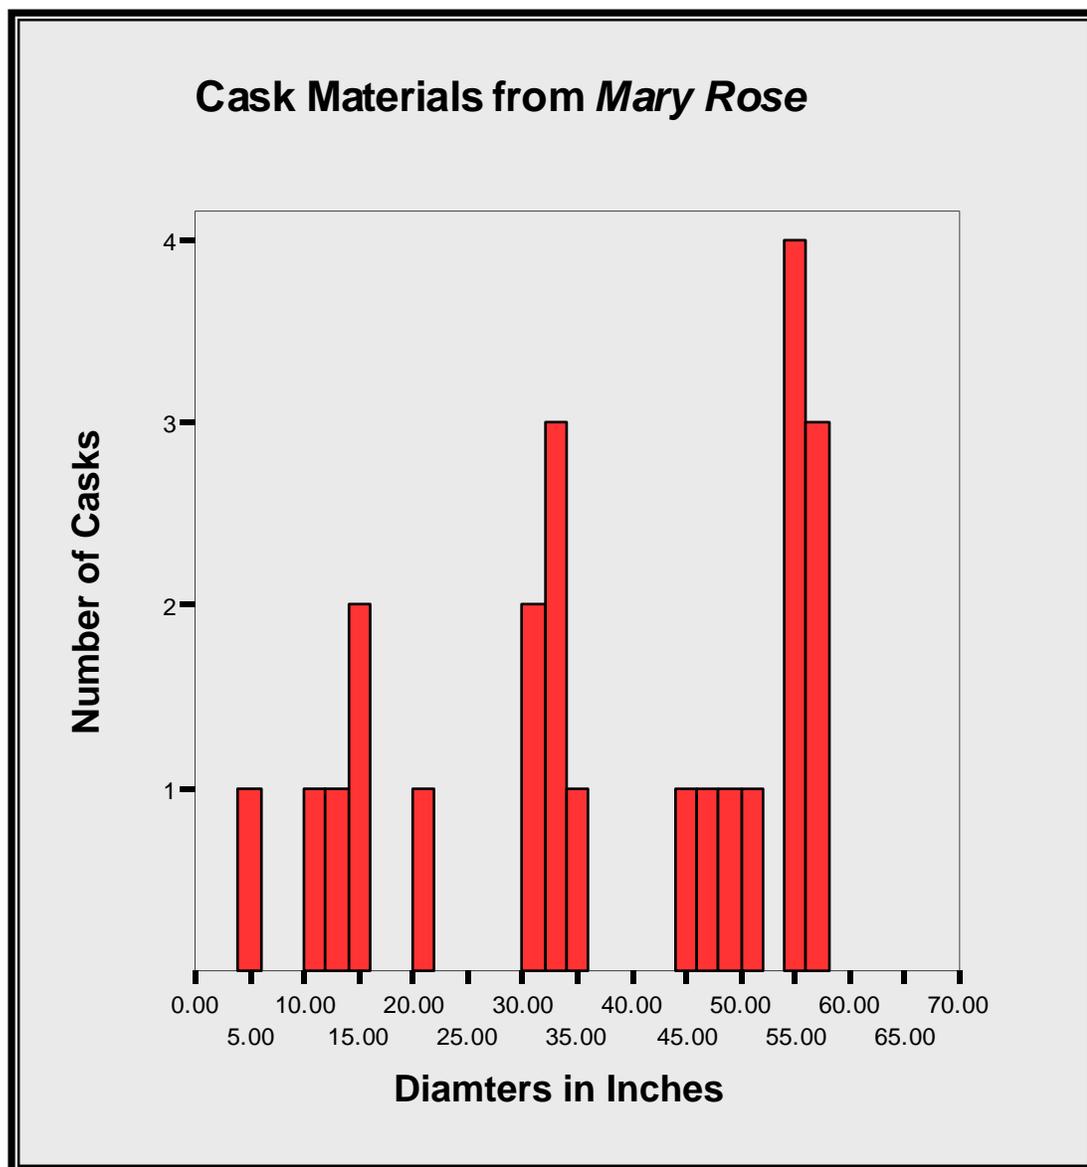
FIGURE 4.9. Histogram showing the range of cask diameters represented in the *Mary Rose* cask assemblage. Diameters are abased on head diameters found in Table 1.1 and are based on 2 inch increments.

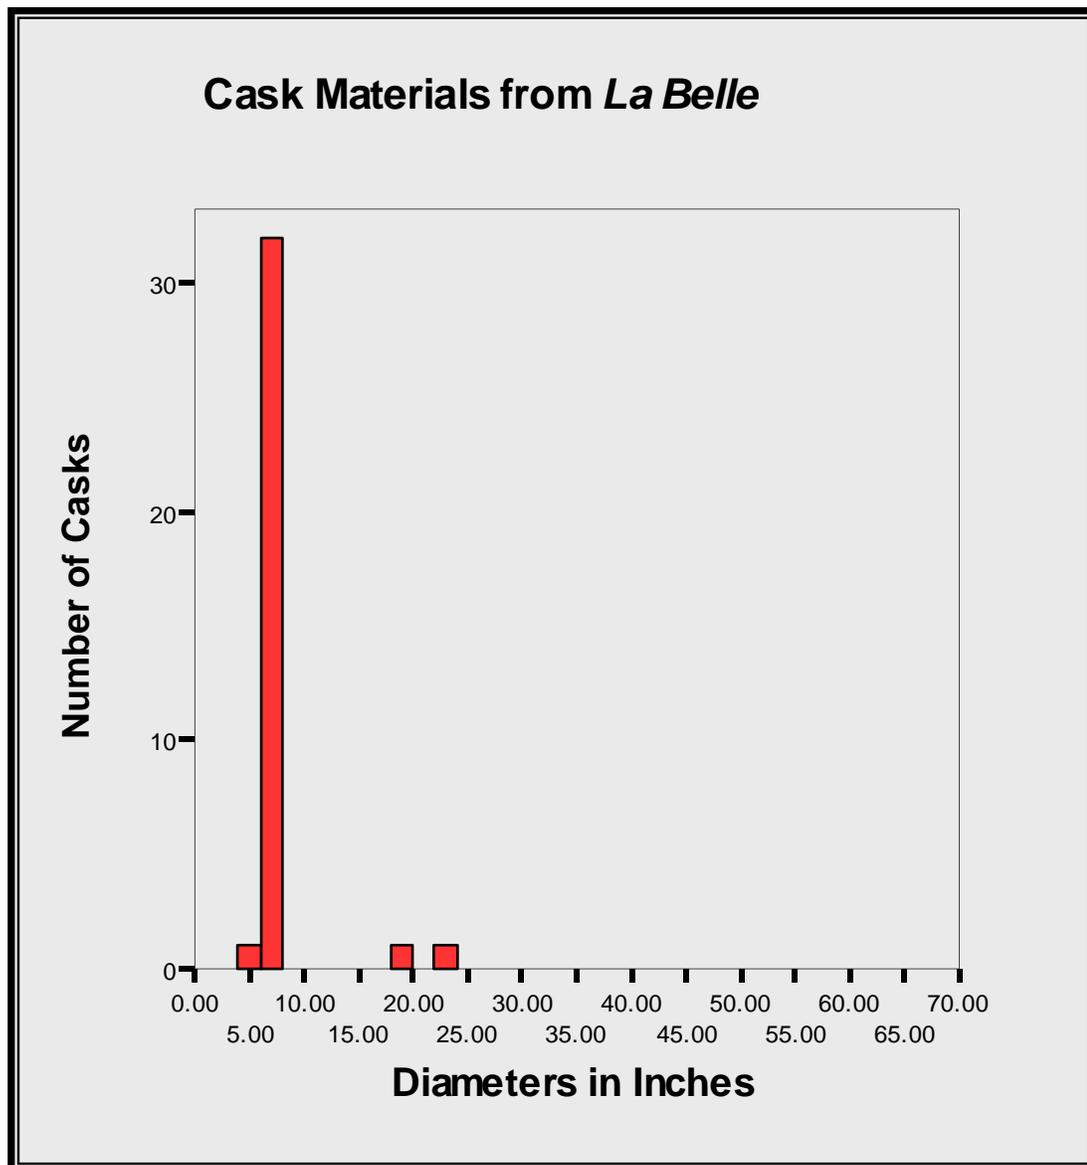
FIGURE 4.12. Histogram showing the range of cask diameters represented in the *La Belle* cask assemblage. Diameters are based on head diameters found in Table 1.1 and are based on 2 inch increments.

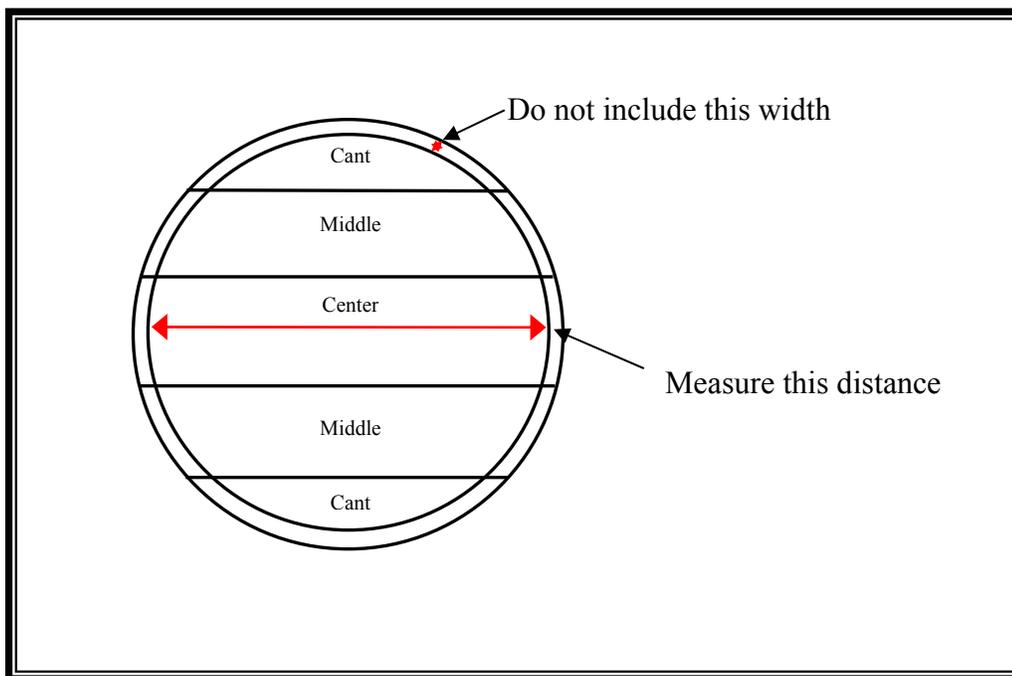
FIGURE 5.1. Drawing with the red arrow across the center head piece showing where to measure and the star in the beveled portion of the head showing what not to include in the head diameter measurement.

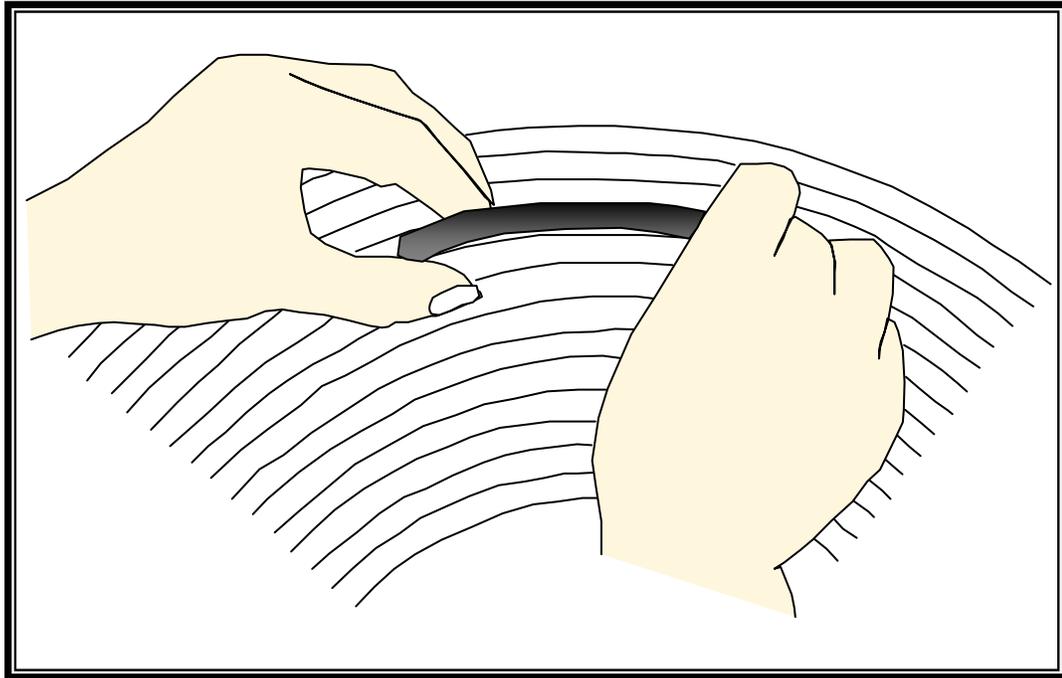
FIGURE 5.2. Drawing showing how to use a diameter chart when measuring the hoop fragment diameter.
