# **A 19<sup>th</sup> CENTURY FISHING SCHOONER IN THE 21<sup>st</sup> CENTURY: PRESERVING VIRGINIA FOR THE NEXT HUNDRED YEARS**

A Thesis

East Carolina University

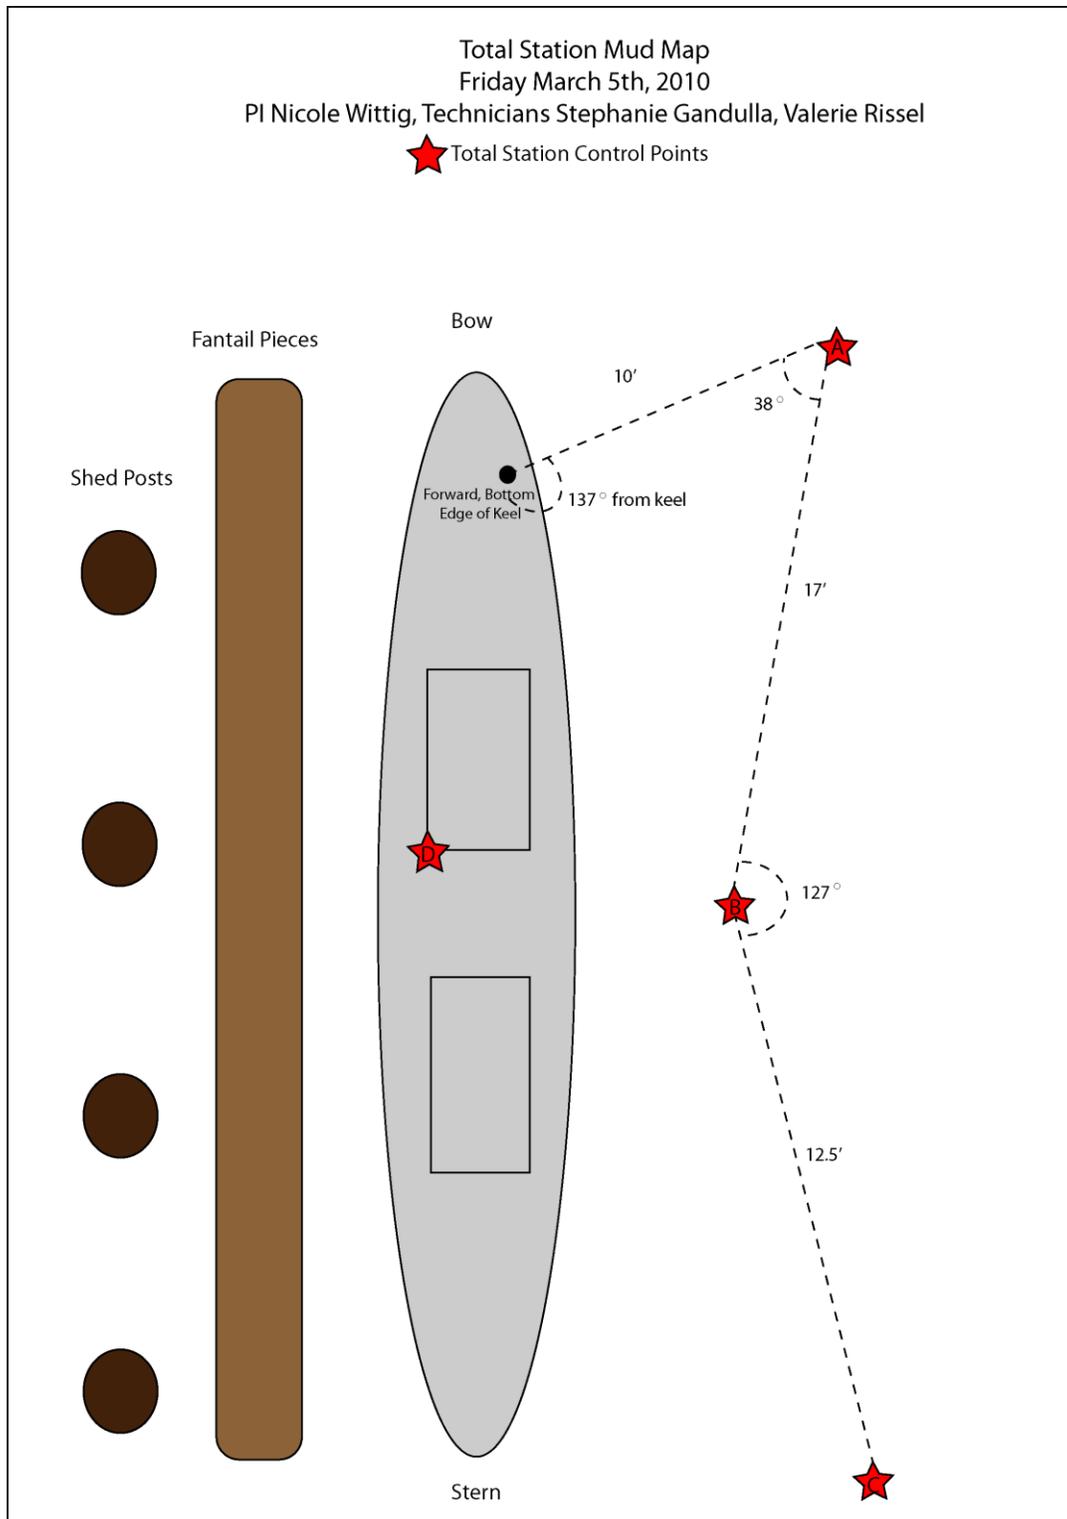
FIGURE 17. Position of total station control points in relation to *Virginia* (Illustration by author, 2011).

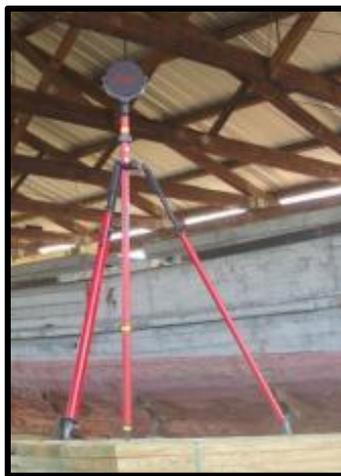
FIGURE 18. Scanning Target Set-up Amidships, Starboard of *Virginia* (Photo by author, 2011).

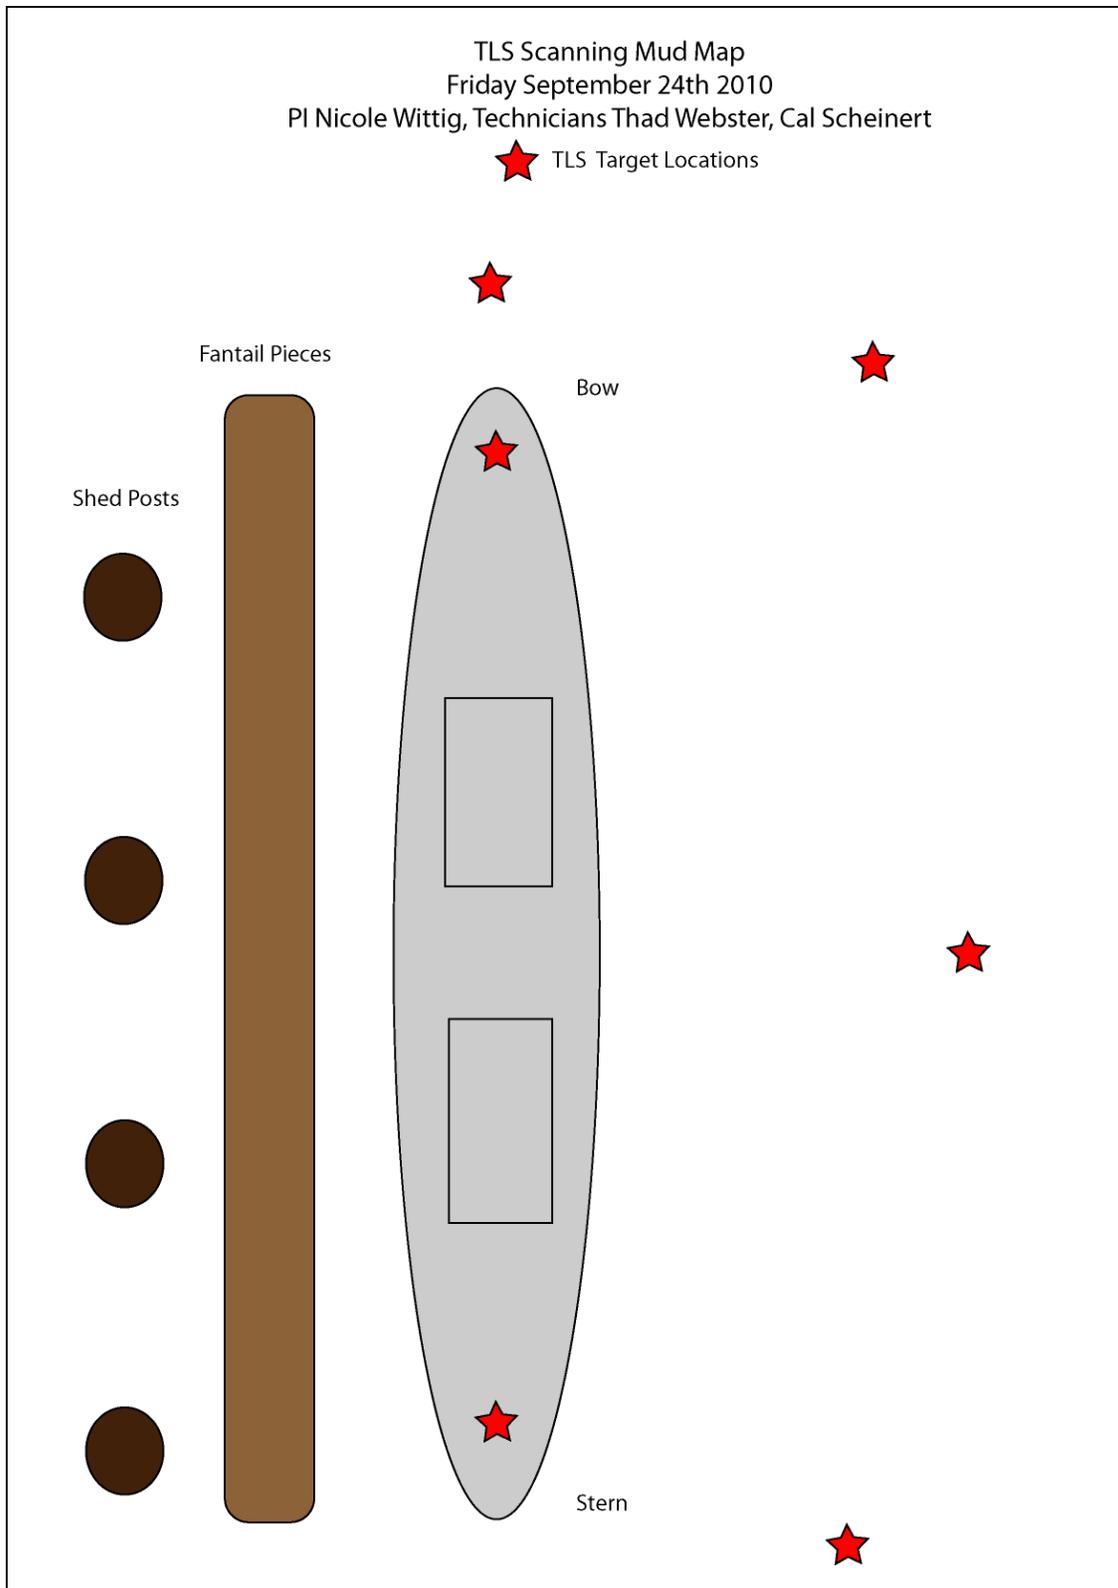
FIGURE 19. Position of TLS targets in relation to *Virginia* (Image by author, 2011).

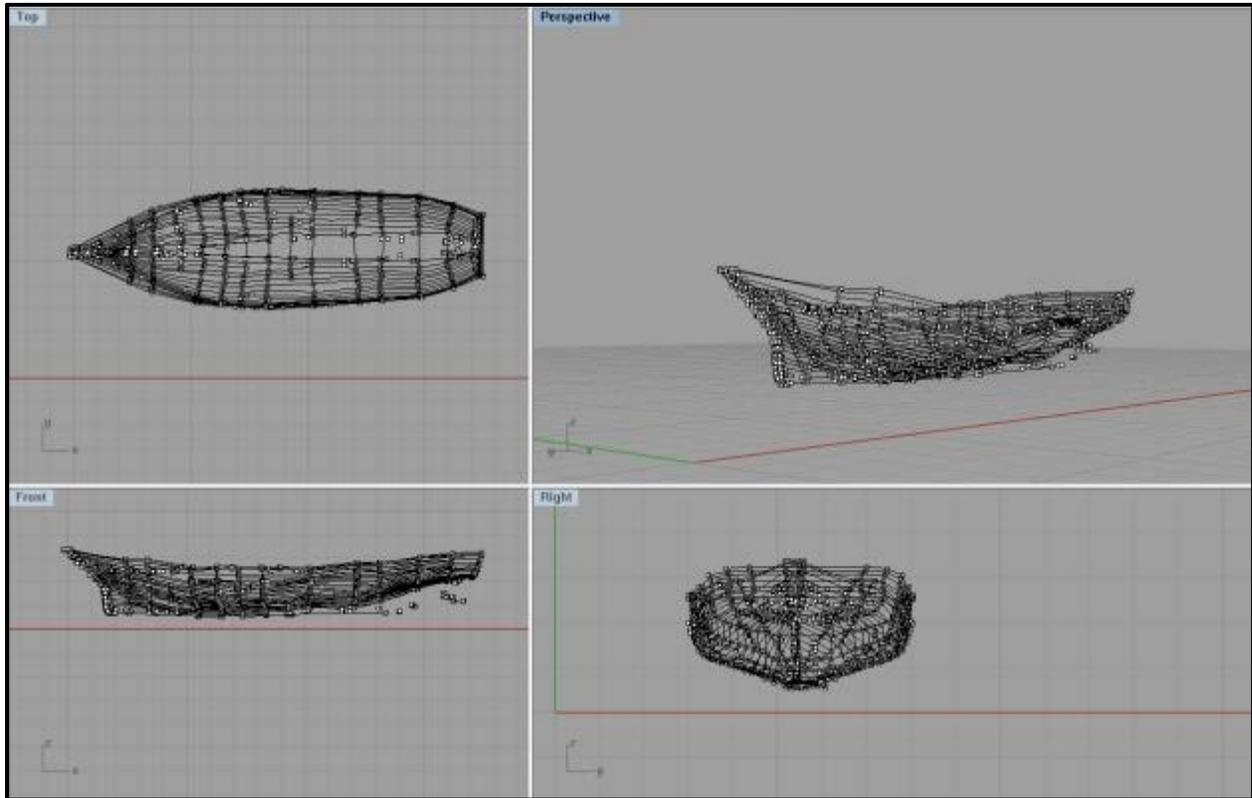
FIGURE 21. Four perspectives of the lines created in Rhinoceros (Image by author 2013).

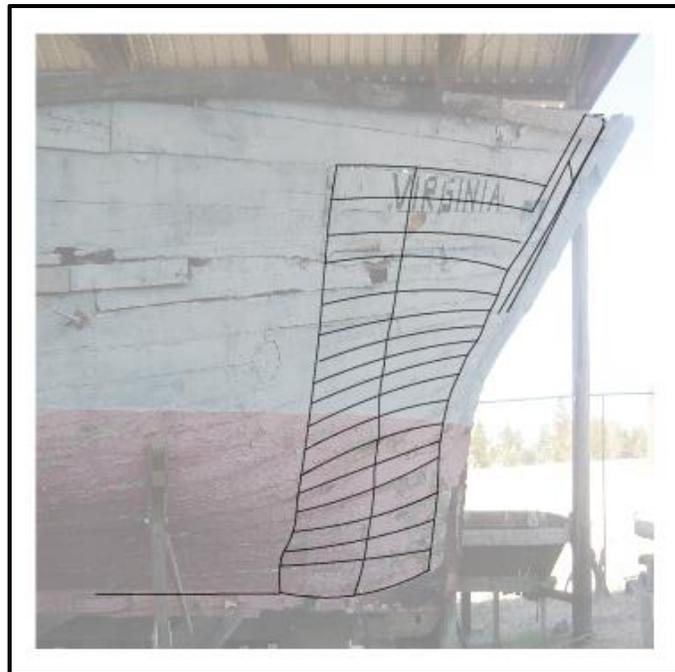
FIGURE 22. Rhinoceros lines overlaid on to an image of the starboard bow (Image by author, 2011).

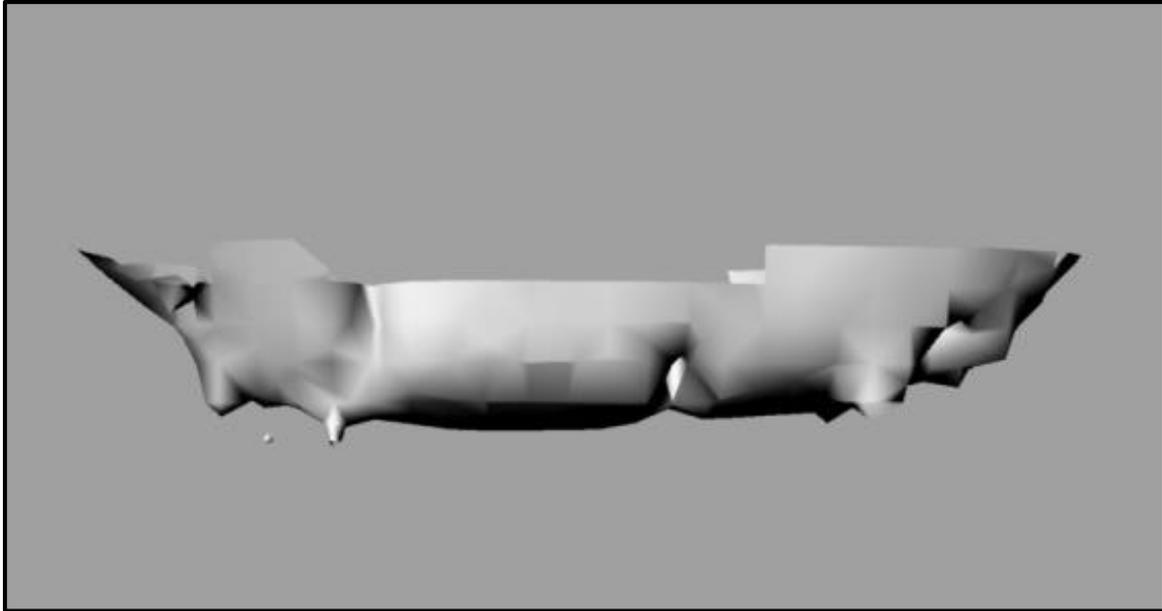
FIGURE 23. Rendered outer hull model from total station data (Image by author, 2013).

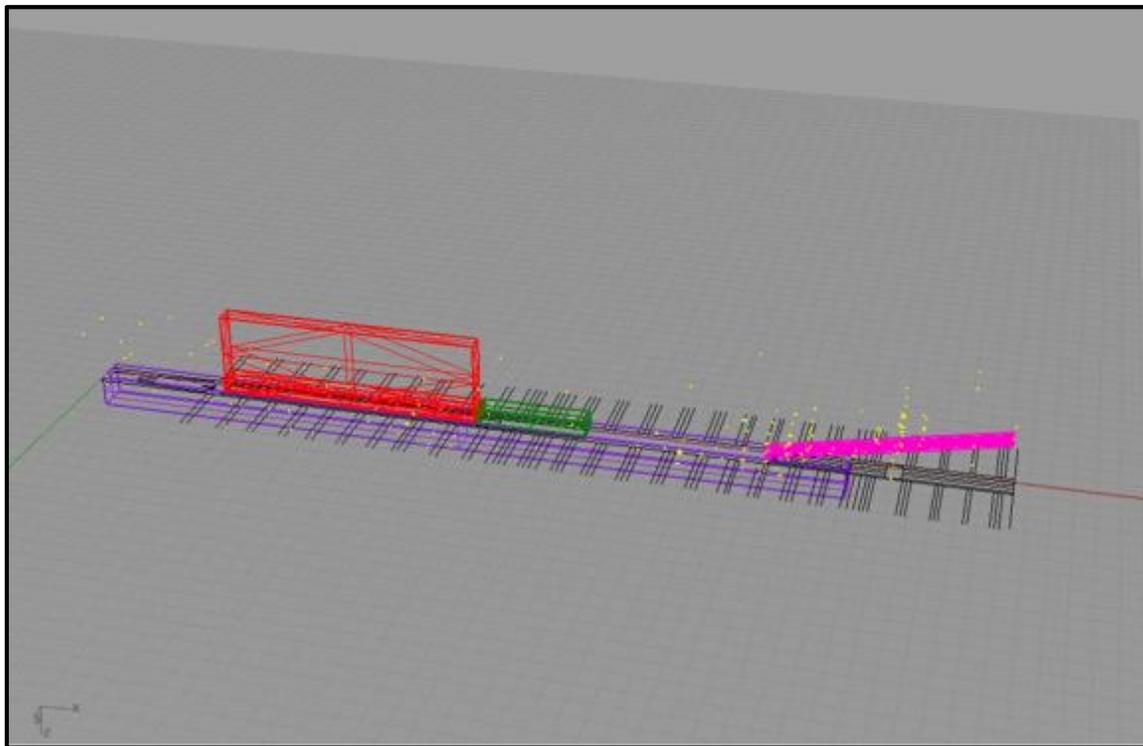
FIGURE 24. Combination of total station points, measured sketches, and reconstructed structural elements in Rhinoceros (Image by author 2013).

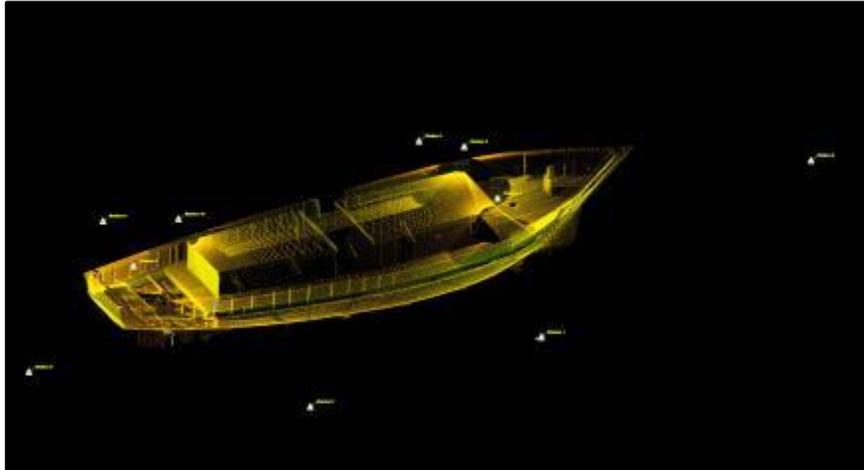
FIGURE 25. TLS point cloud after editing points to eliminate obstructions (Image by Thad Wester, 2010).

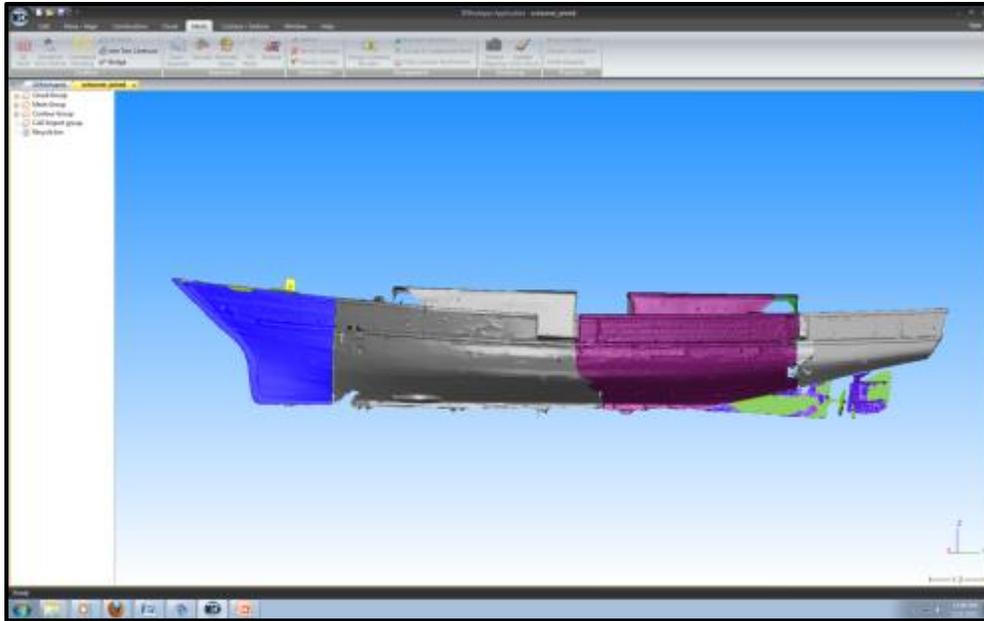
FIGURE 26. Rendering of *Virginia* port side from TLS data in 3DReshaper (Image by author, 2011).

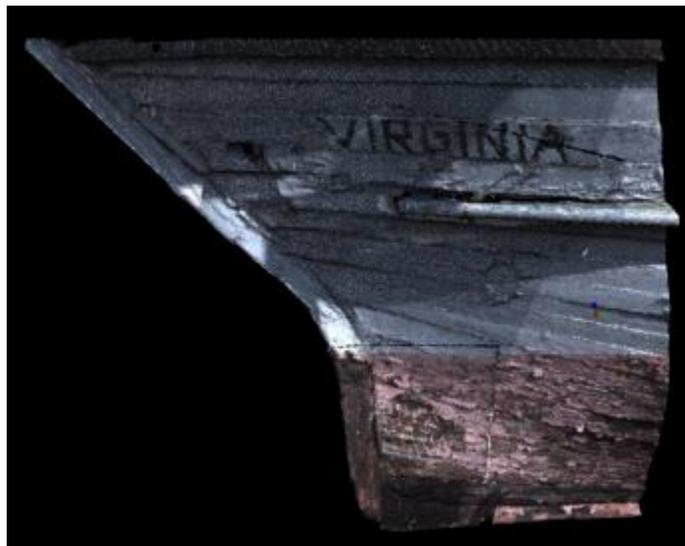
FIGURE 27. *Virginia*'s port-side stem with photograph layered over the model's surface (Image by Thad Wester, 2011).

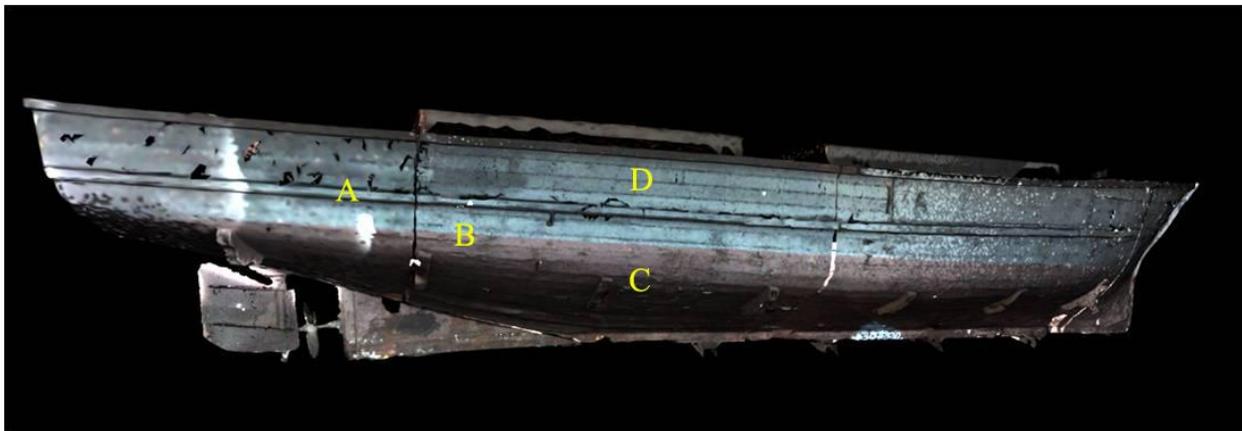
FIGURE 28. Complete outer hull, depicted in Clyclone, with digital images overlaid on TLS point cloud data showing the starboard side. Rubrail (A), waterline (B), and older (C) and newer hull planks (D) are visible (Image by Thad Wester, 2012).

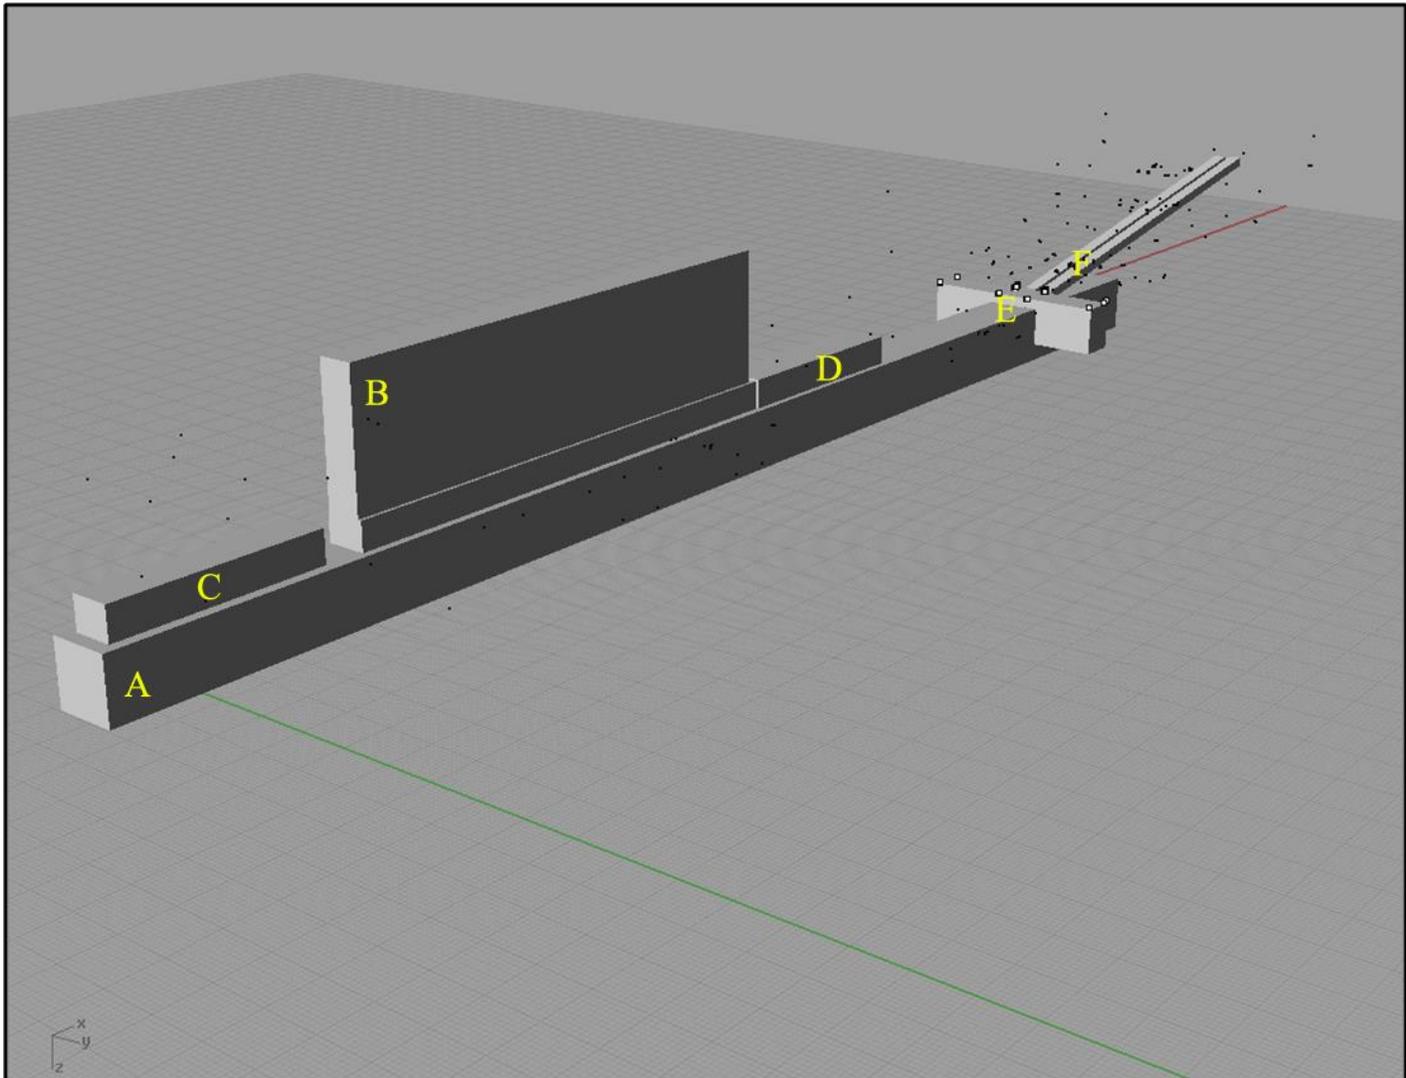
FIGURE 29. Rhinoceros rendered reconstruction of interior construction features along the keel: (A) keel, (B) centerboard trunk, (C) forward mast step, (D) aft mast step, (E) frame that the

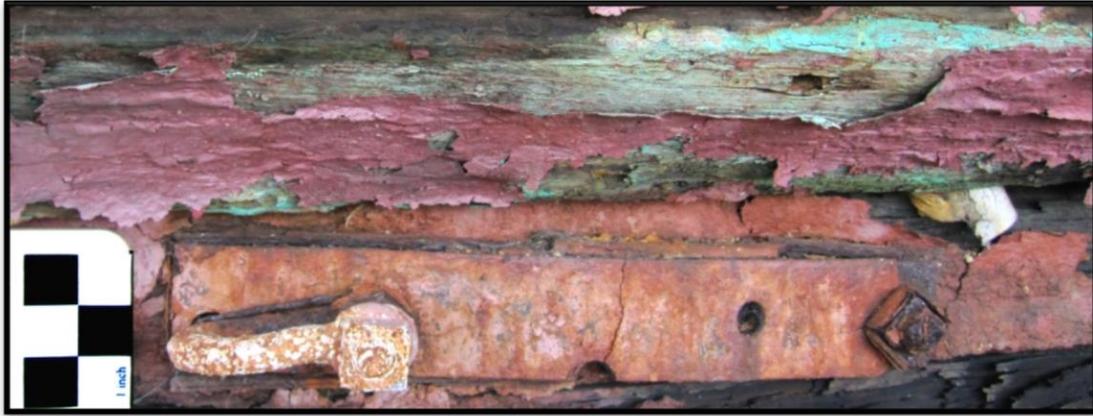
FIGURE 31. U-bolt plate detail port (Photo by author, 2011).

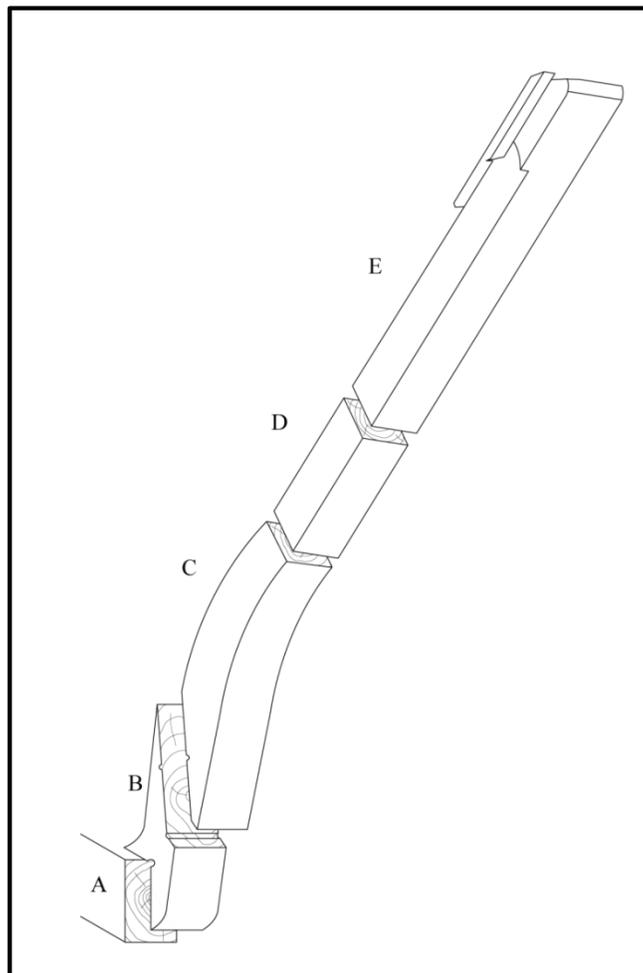
FIGURE 32. Exploded stem illustration, not to scale (Illustration by author, 2013).

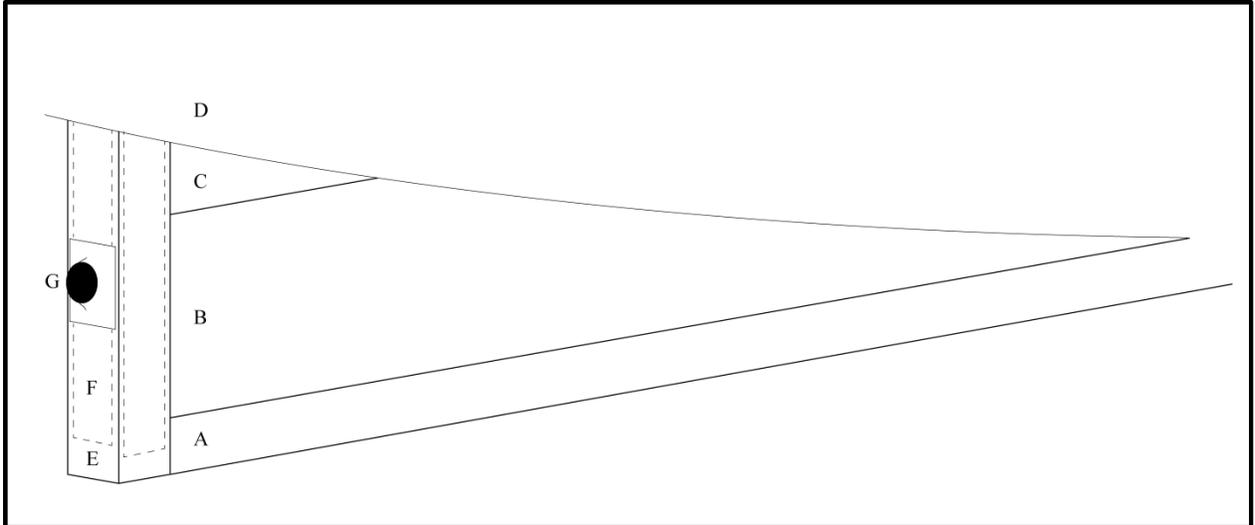
FIGURE 33. Deadwood and sternpost detail; (A) keel, (B) first deadwood piece, (C) second deadwood piece, (D) garboard strake, (E) sternpost, (F) iron plates, (G) bearing box, scale 1 in. = 4 in. (Illustration by author, 2013).

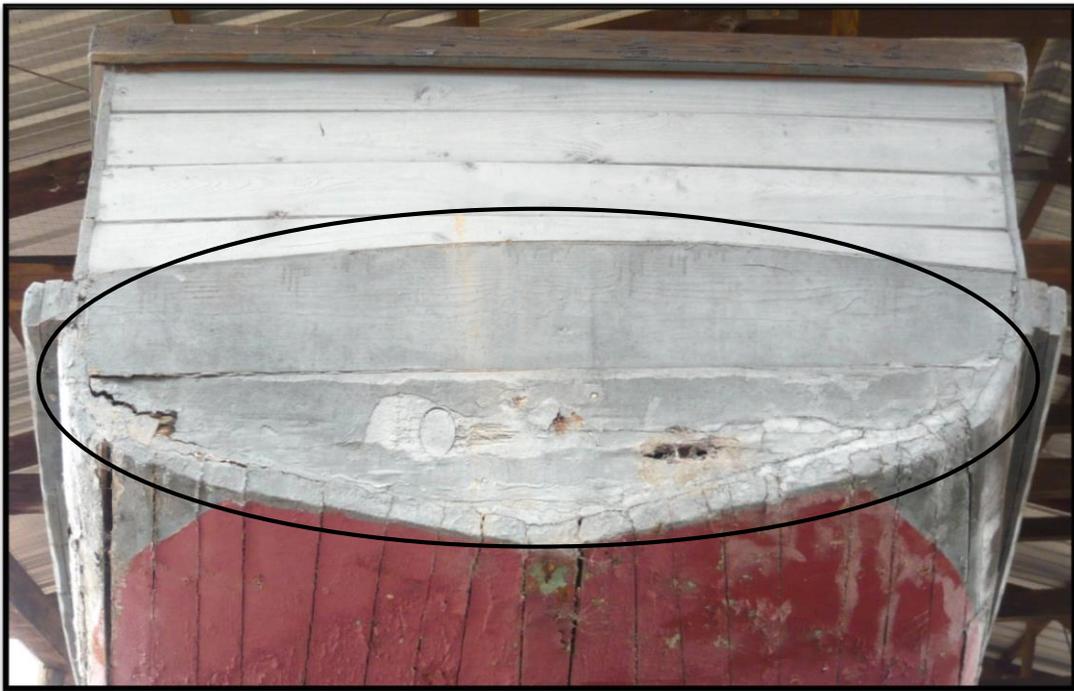
FIGURE 34. Transom detail with fantail shaped highlighted (Photo by author, 2011).

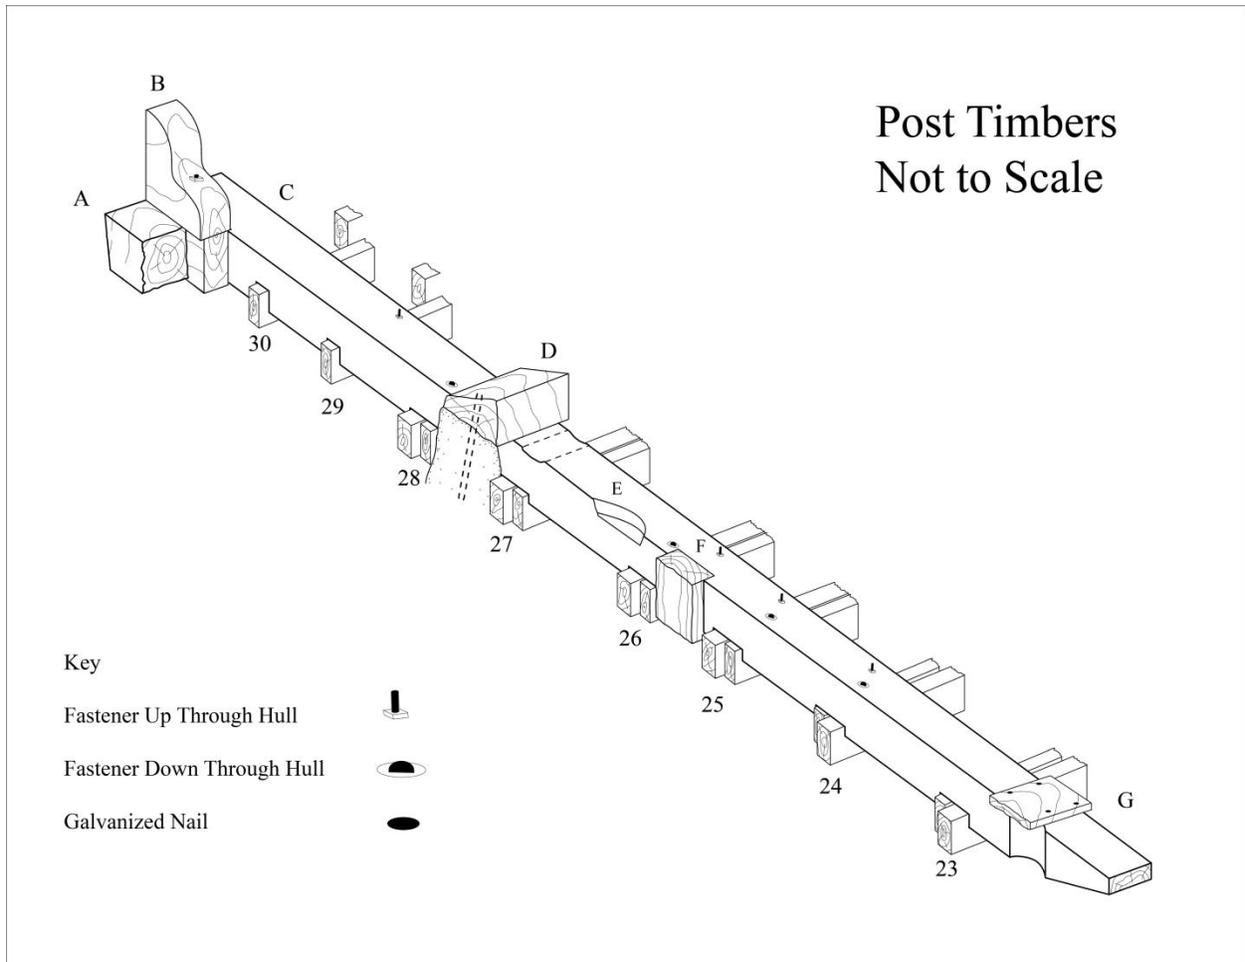
FIGURE 35. Port post timber, with numbered frames, construction illustration; (A) partial starboard post timber, (B) knee, (C) port post timber (D) rudder stock support, (E) circular impression, (F) square timber between post timbers, (G) circular cut covered by small board, not to scale (Illustration by author, 2012).

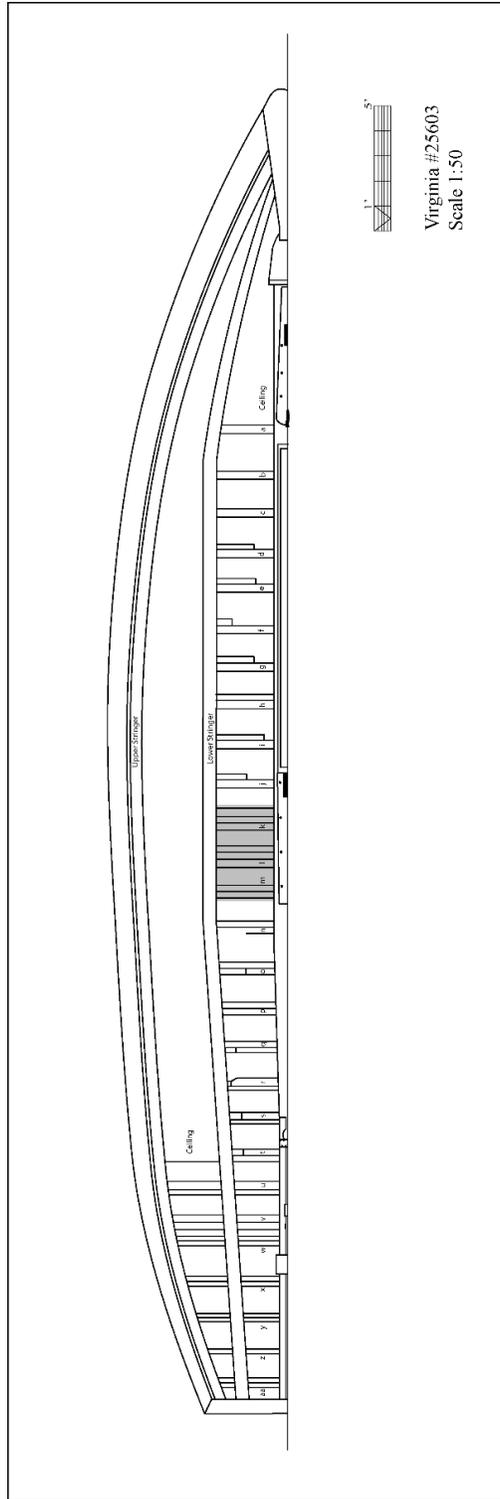
Figure 36: Plan view of port side frames (Illustration by author, 2013).

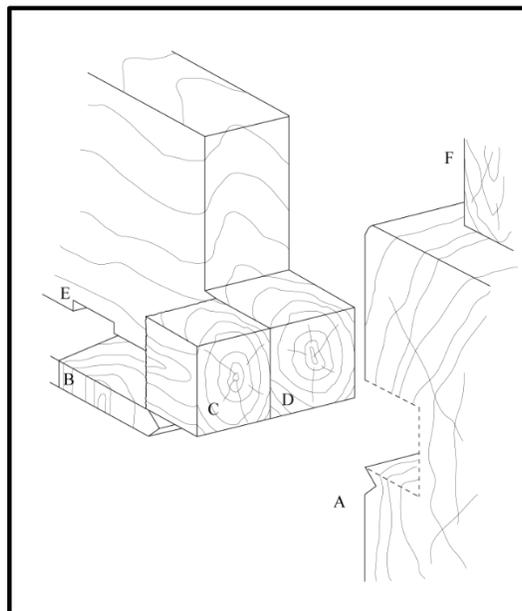
FIGURE 37. Exploded detail of port frames at centerboard trunk showing notch in keel; (A) keel, (B) garboard strake, (C) frame cut-off at keel, (D) frame, (E) limber, (F) bedlog of centerboard trunk, not to scale (Drawing by author, 2013).

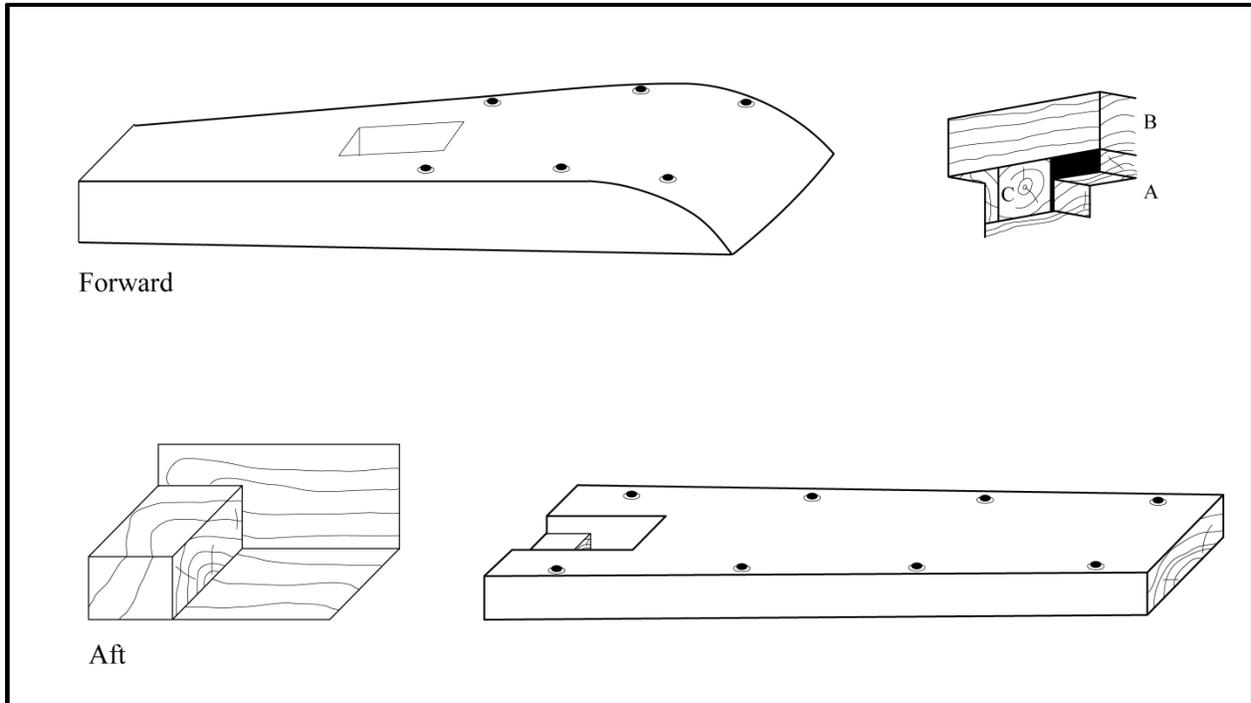
FIGURE 38. Mast steps illustration, scale 1 in. = 4 in. and 1 in. = 2 in. for notch details (Drawing by author, 2012).

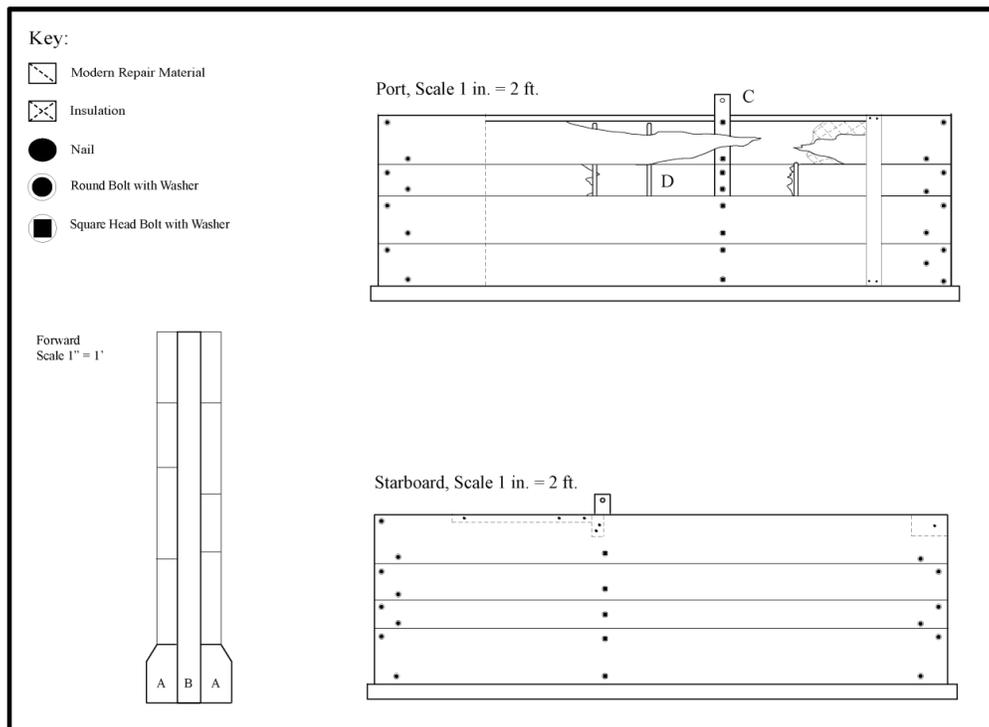
FIGURE 39. Centerboard trunk illustrations; (A) bedlog, (B) hedgeledge, (C) metal support for centerboard, (D) drifts (Drawing by author, 2012).

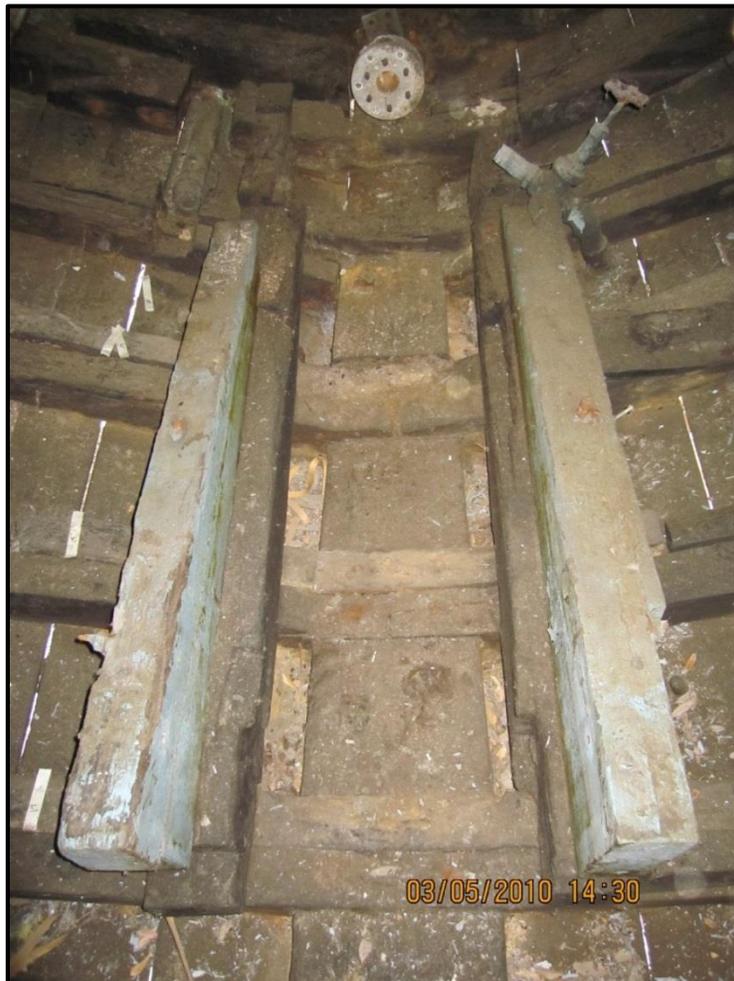
FIGURE 40. Engine bearers (Photograph by author, 2010).

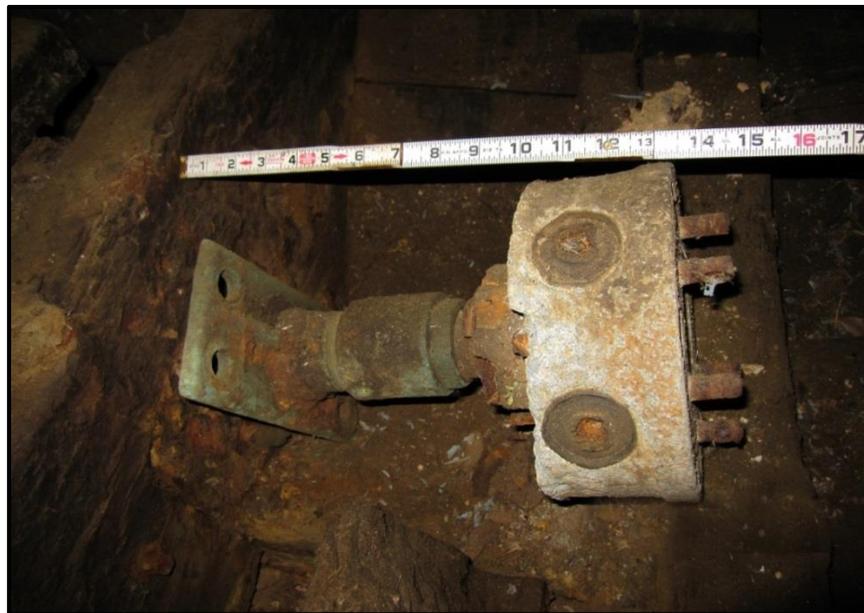
FIGURE 41. Stuffing box through floor 22 (Photograph by author 2010).

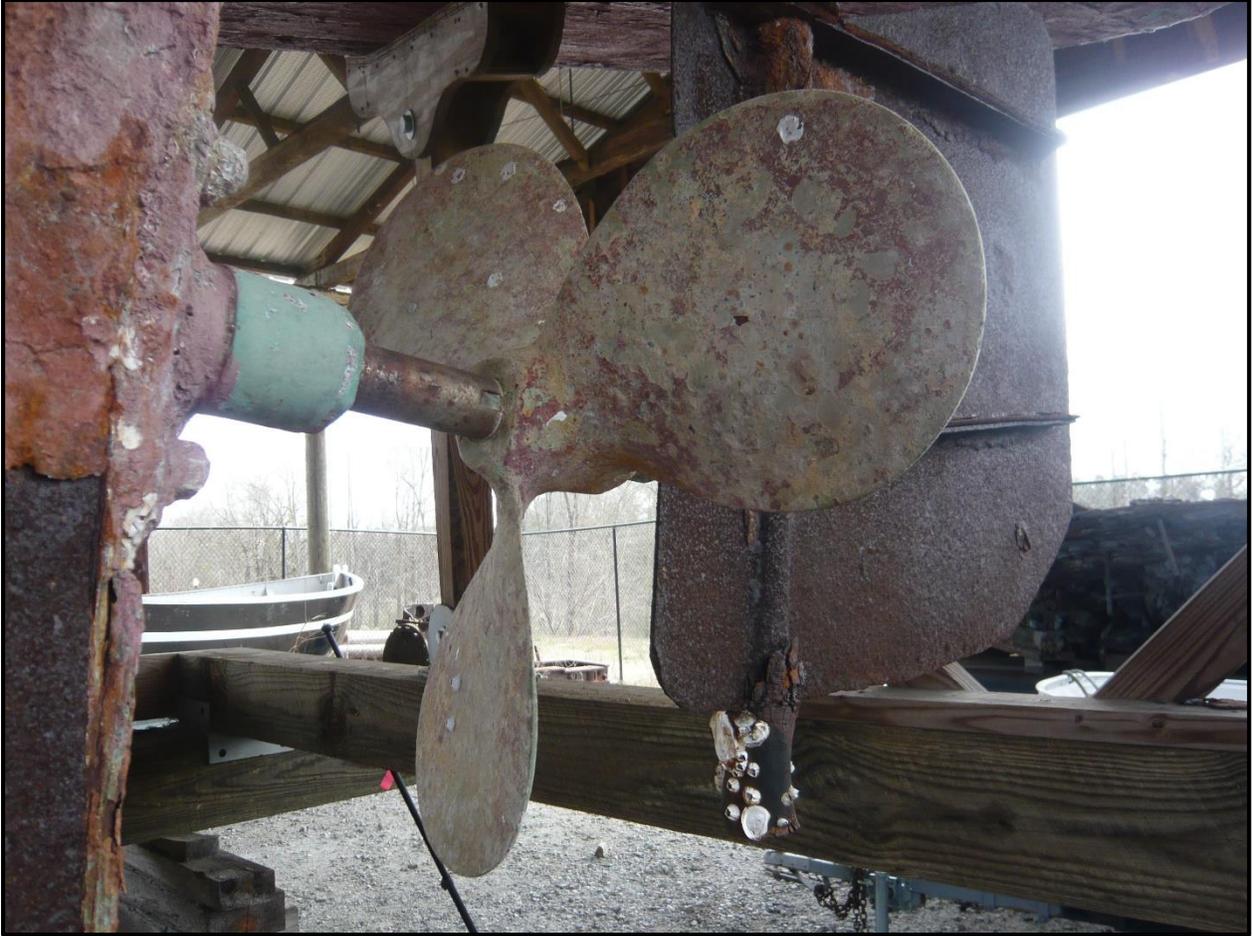
FIGURE 42. Rudder, port (Photograph by Valerie Rissel, 2010).

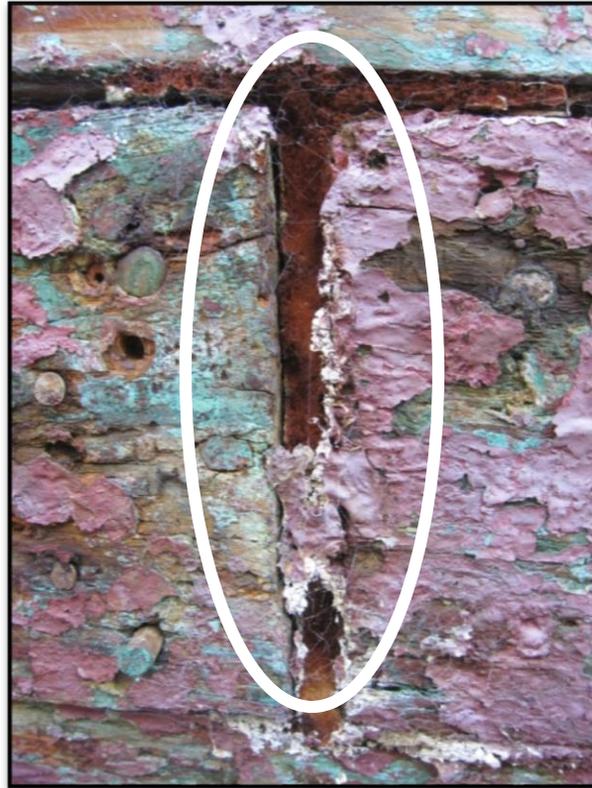
FIGURE 43. Detail of foam substitute between hull planks at port amidships (Photograph by author, 2011).

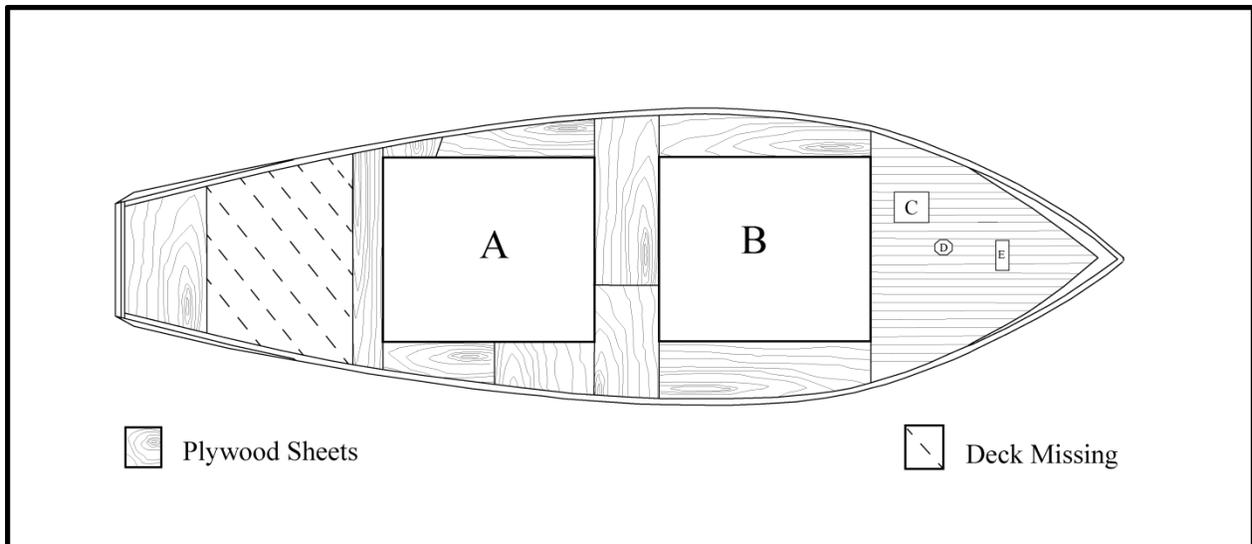
FIGURE 44. Current deck plan, (A) aft cabin, (B) forward cabin, (C) hatch, (D) mast saddle, (E) king post, not to scale (Drawing by author, 2013).

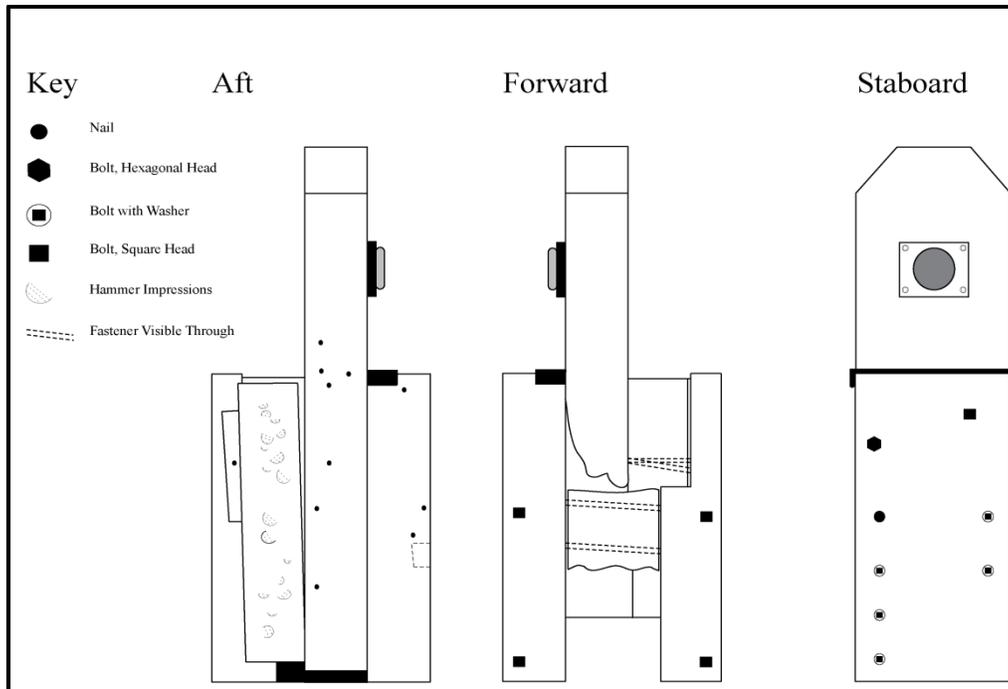
FIGURE 45. King post illustration, scale 1 in. = 6 in. (Illustration by author, 2012).

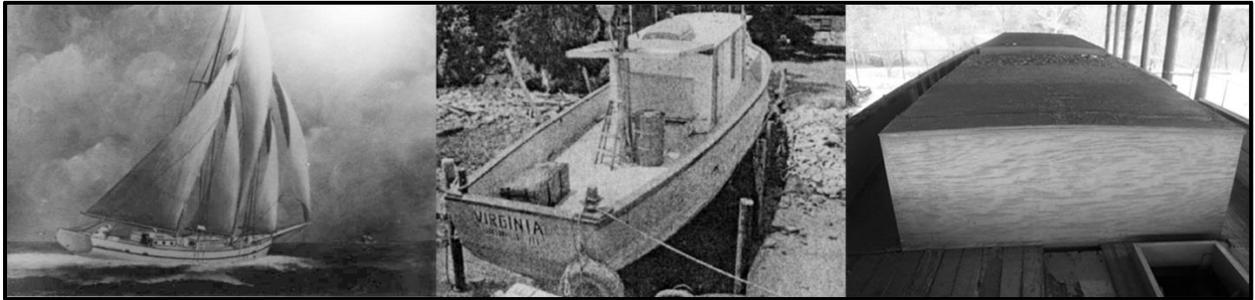
FIGURE 47. Cabin comparison to show restoration attempt; *left*, portrait of *Virginia* as schooner (Courtesy the National Civil War Naval Museum), *middle*, *Virginia* in the 1990s with single cabin (Courtesy the National Civil War Naval Museum), *right*, picture of *Virginia* today with two cabin configuration (Photo by Valerie Rissel, 2010).

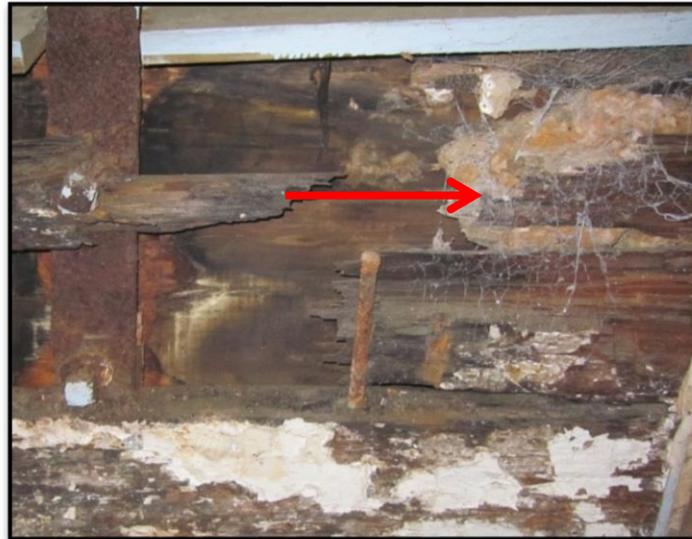
FIGURE 48. Centerboard trunk starboard profile with insulation indicated by red arrow. (Photograph by author, 2010).

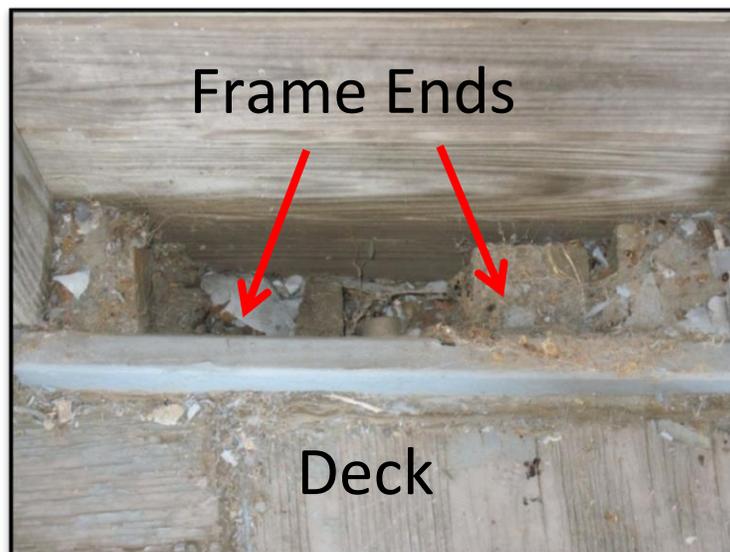
FIGURE 49. Degradation of frame ends (Photograph by author, 2011).
