# **A 19<sup>th</sup> CENTURY FISHING SCHOONER IN THE 21<sup>st</sup> CENTURY: PRESERVING VIRGINIA FOR THE NEXT HUNDRED YEARS**

A Thesis

East Carolina University

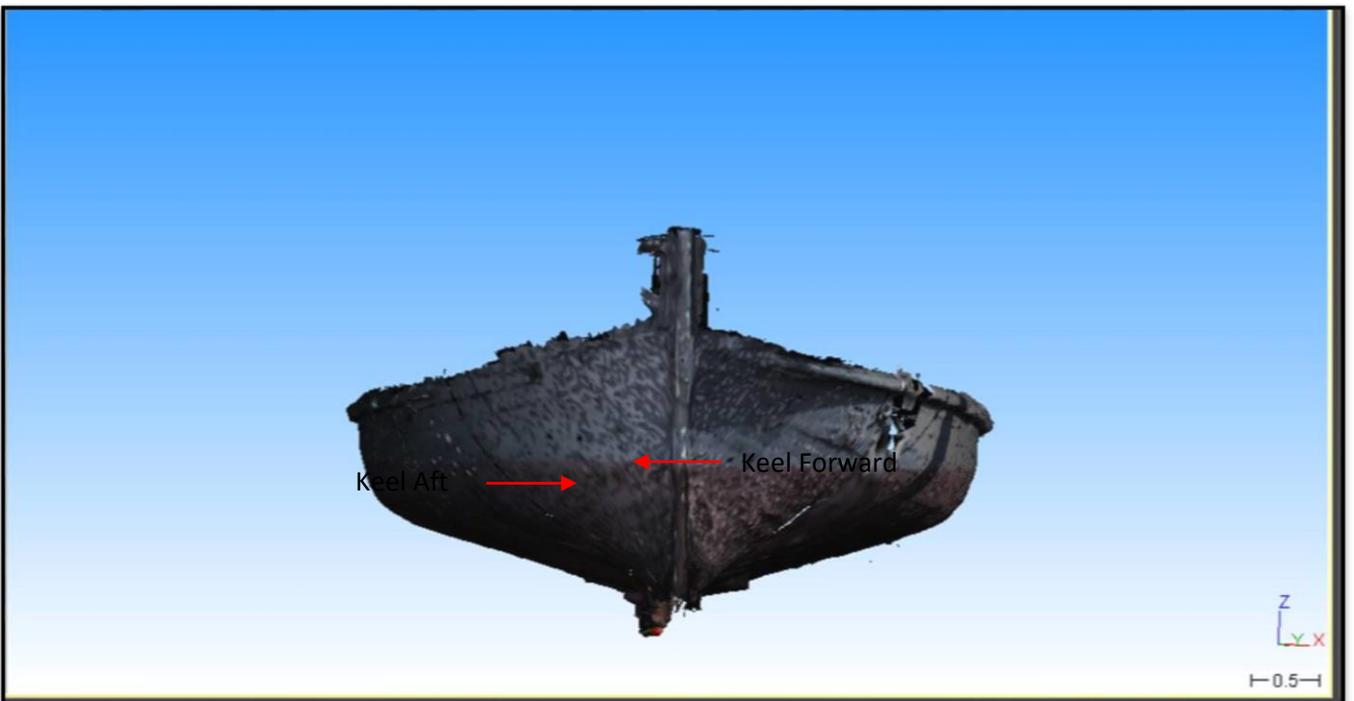
FIGURE 50. Keel deformation indicated by red arrows (Image by author, 2011).

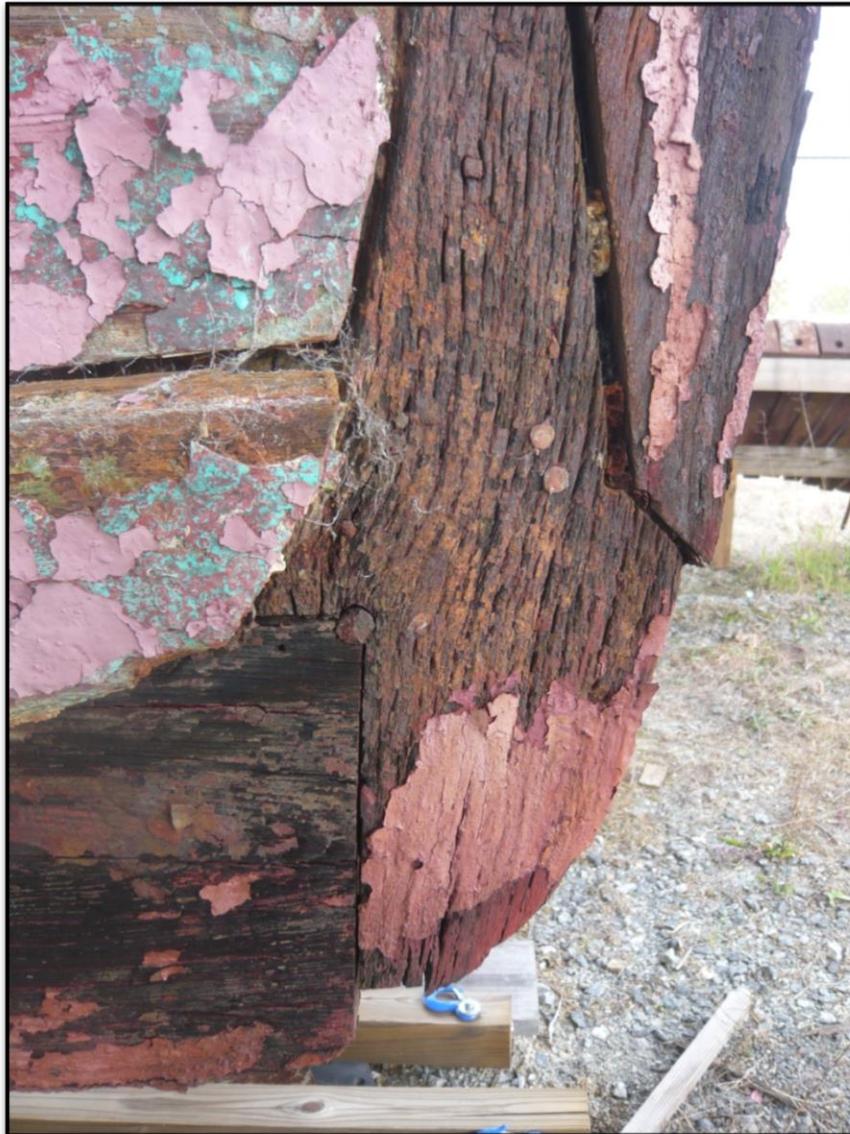
FIGURE 51. Stem starboard showing disarticulation (Photograph by author, 2011).

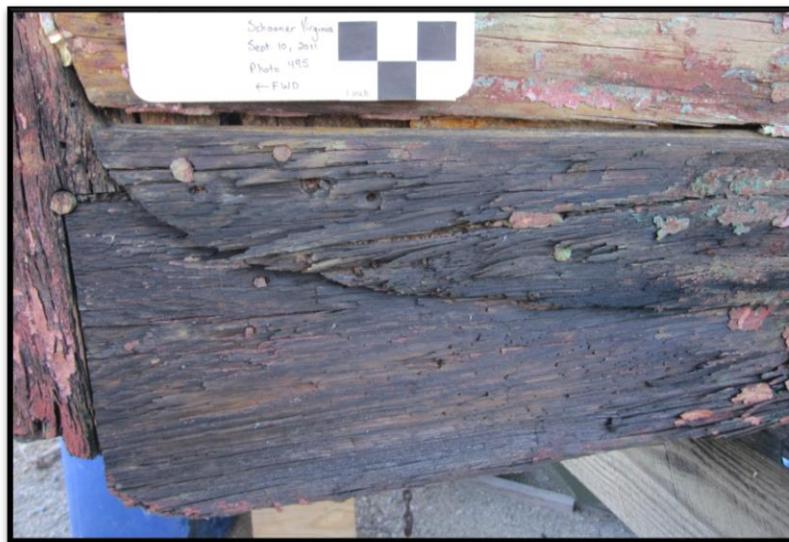
FIGURE 52. Splintering of the garboard and keel, port (Photograph by author, 2011).

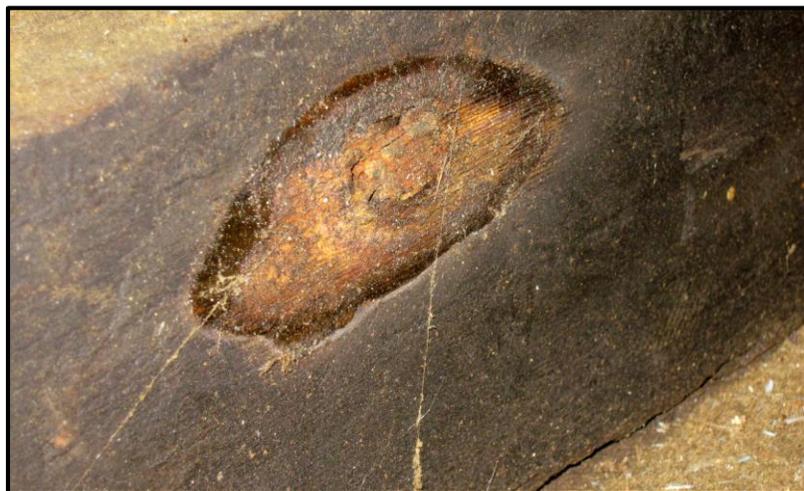
FIGURE 53. Metal impregnation in forward face of frame (Photograph by author, 2011).

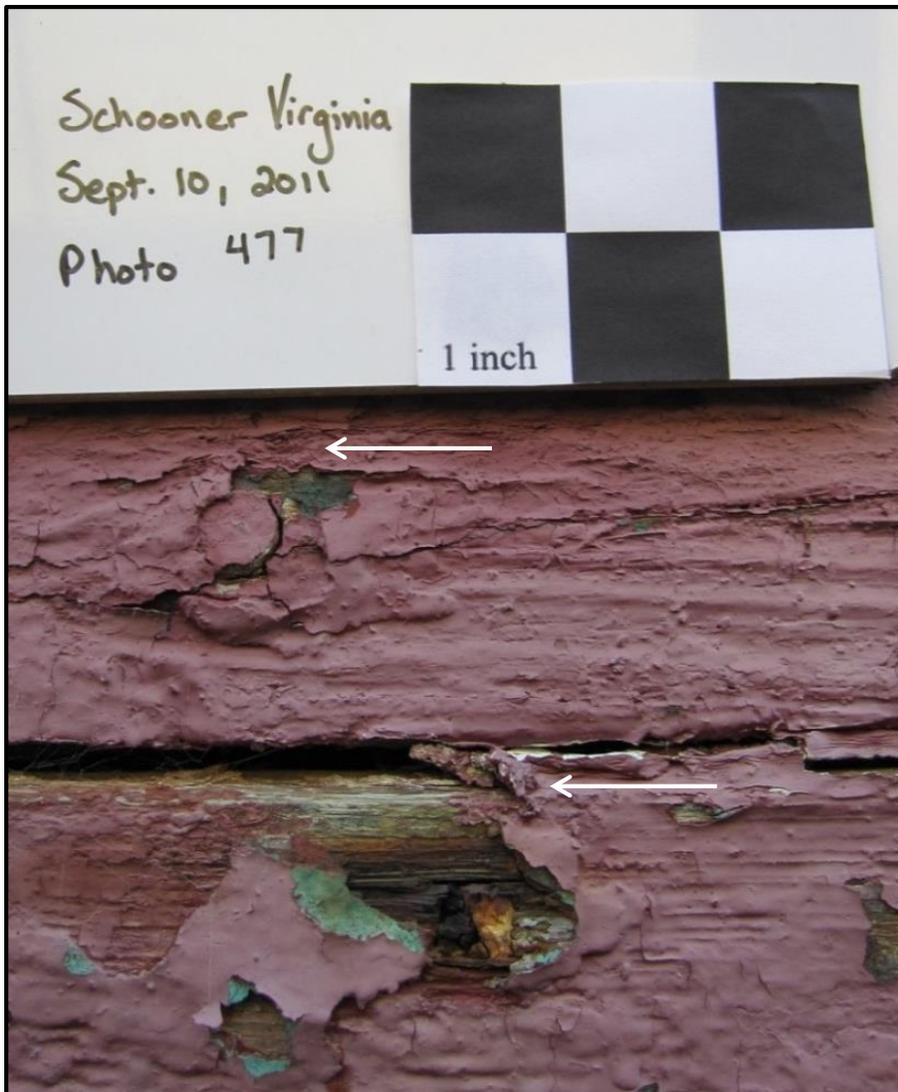
FIGURE 54. Outer hull fastener deterioration on port side, white arrows indicate dislodged paint due to corroding fasteners underneath. Photo by author, 2011.

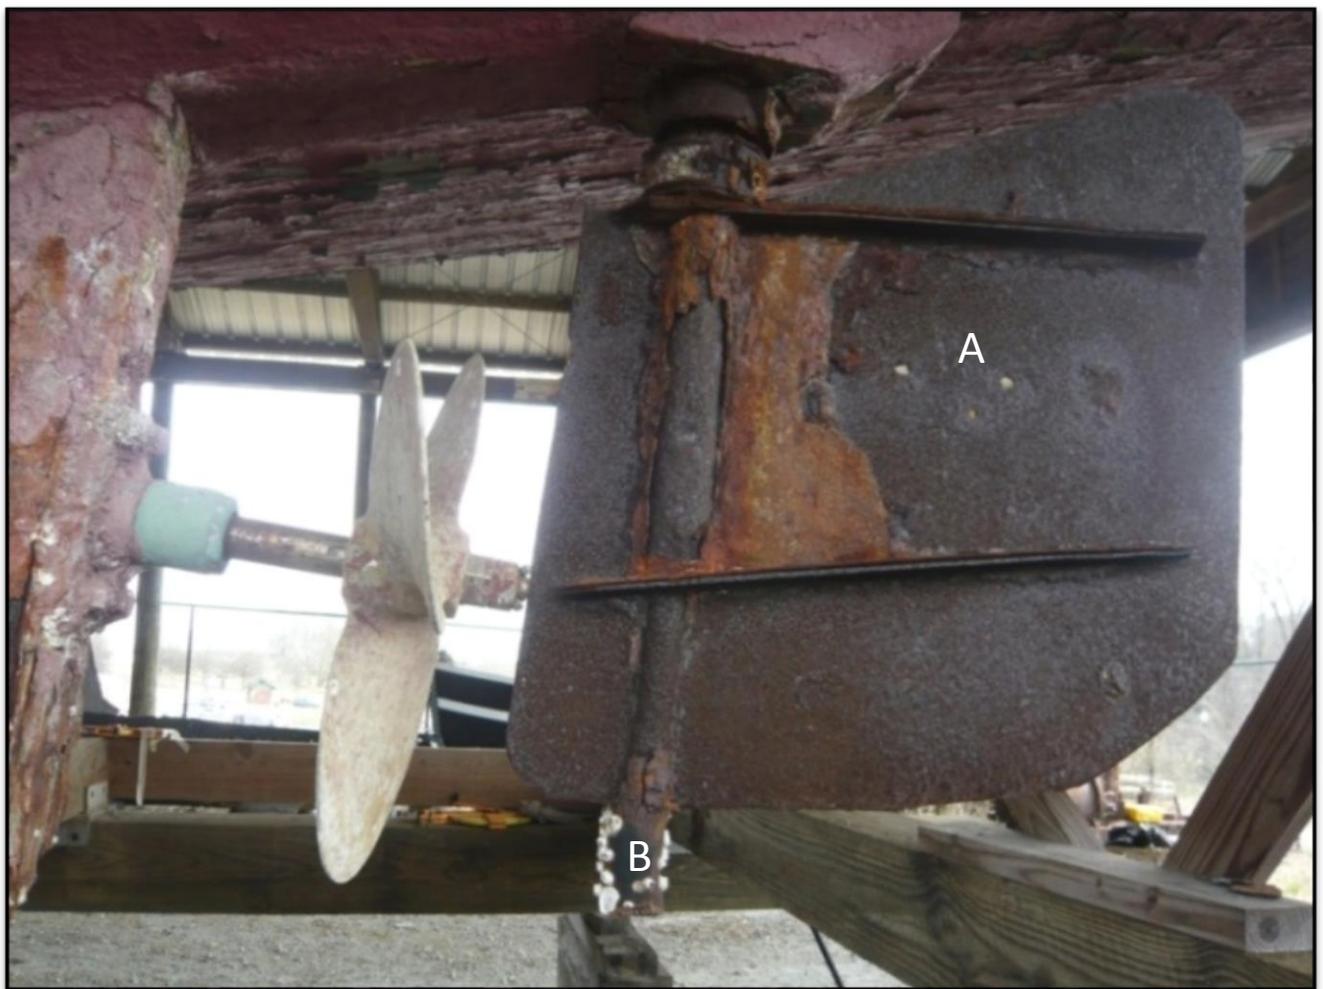
FIGURE 55. Rudder and propeller, A indicates areas where the steel rudder blade has corroded through the entire blade and B shows the location of rubber fittings with barnacles still attached (Photo by Valerie Rissel, 2010).

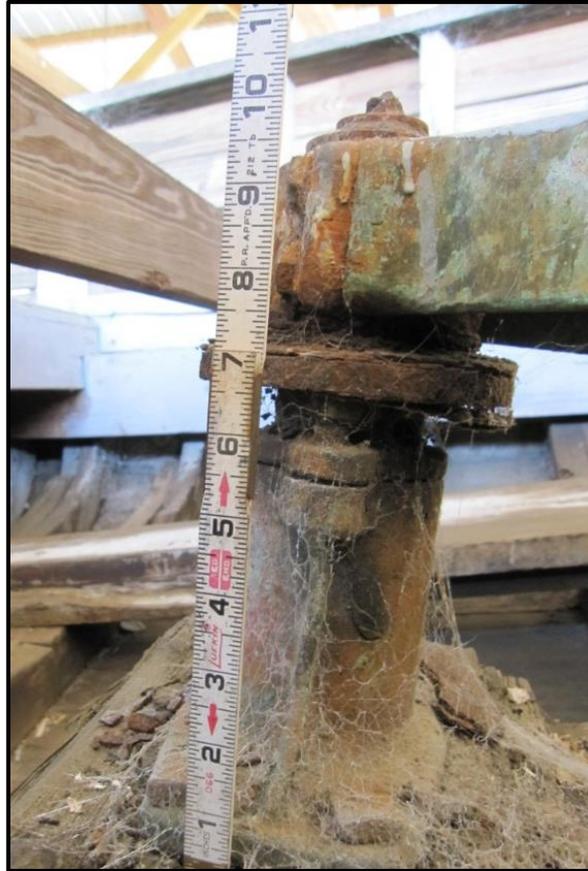
FIGURE 56. Rudder assembly above deck showing corrosion, specifically galvanic corrosion at the top of the rudder stock which is in contact with the brass head. Photo by author 2010.

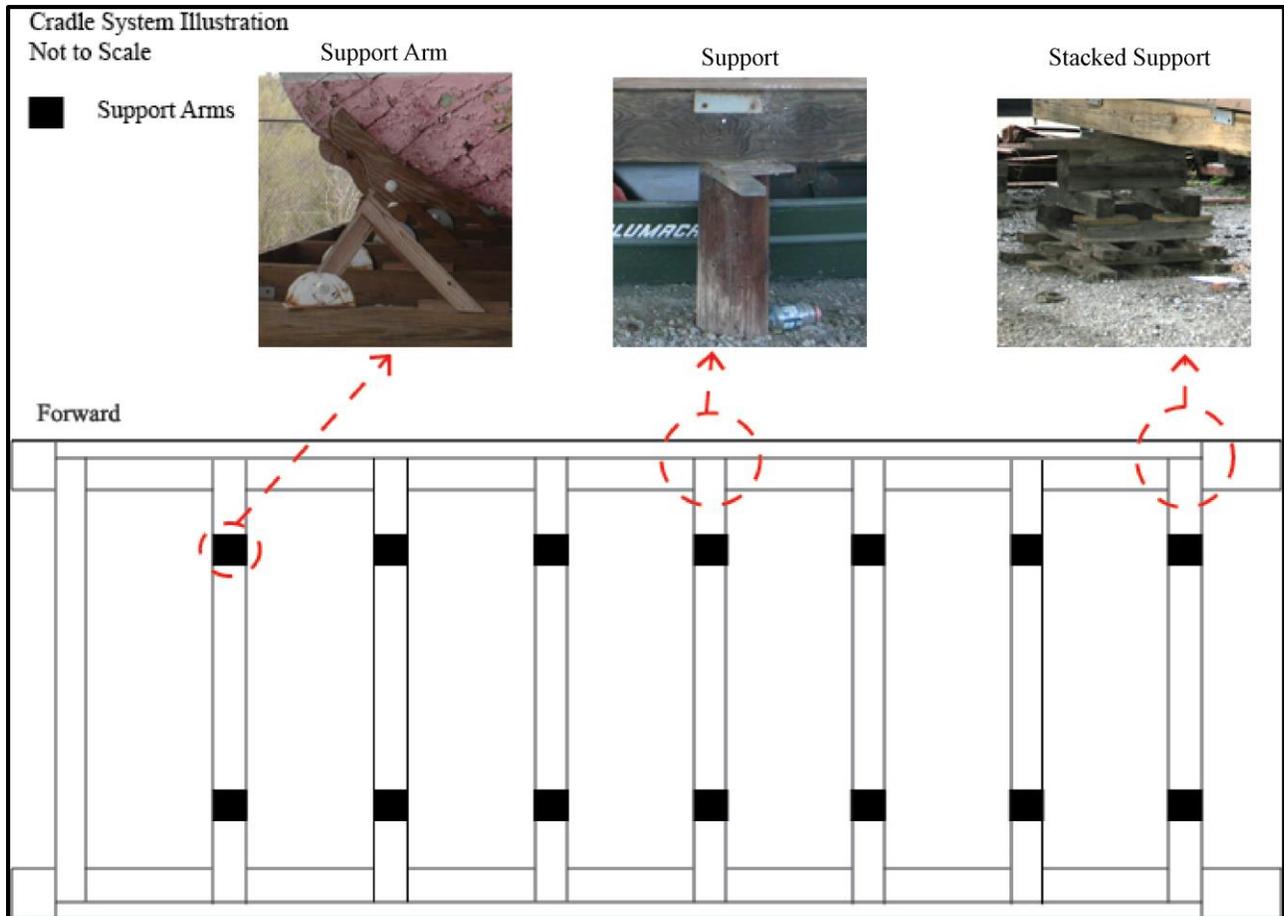
FIGURE 49. Plan view of cradle with corresponding photographs of components (Photographs and illustration by author, 2012).

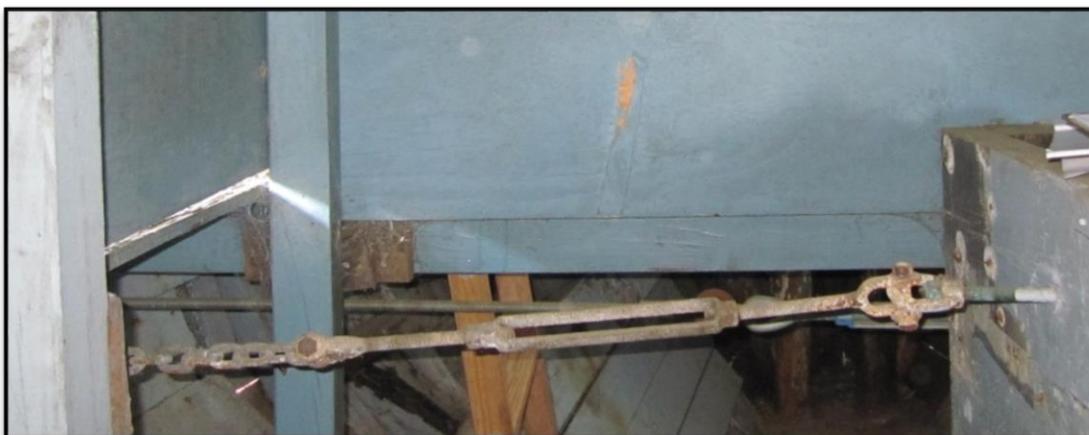
FIGURE 50. Through hull supports (Photo by author, 2010).

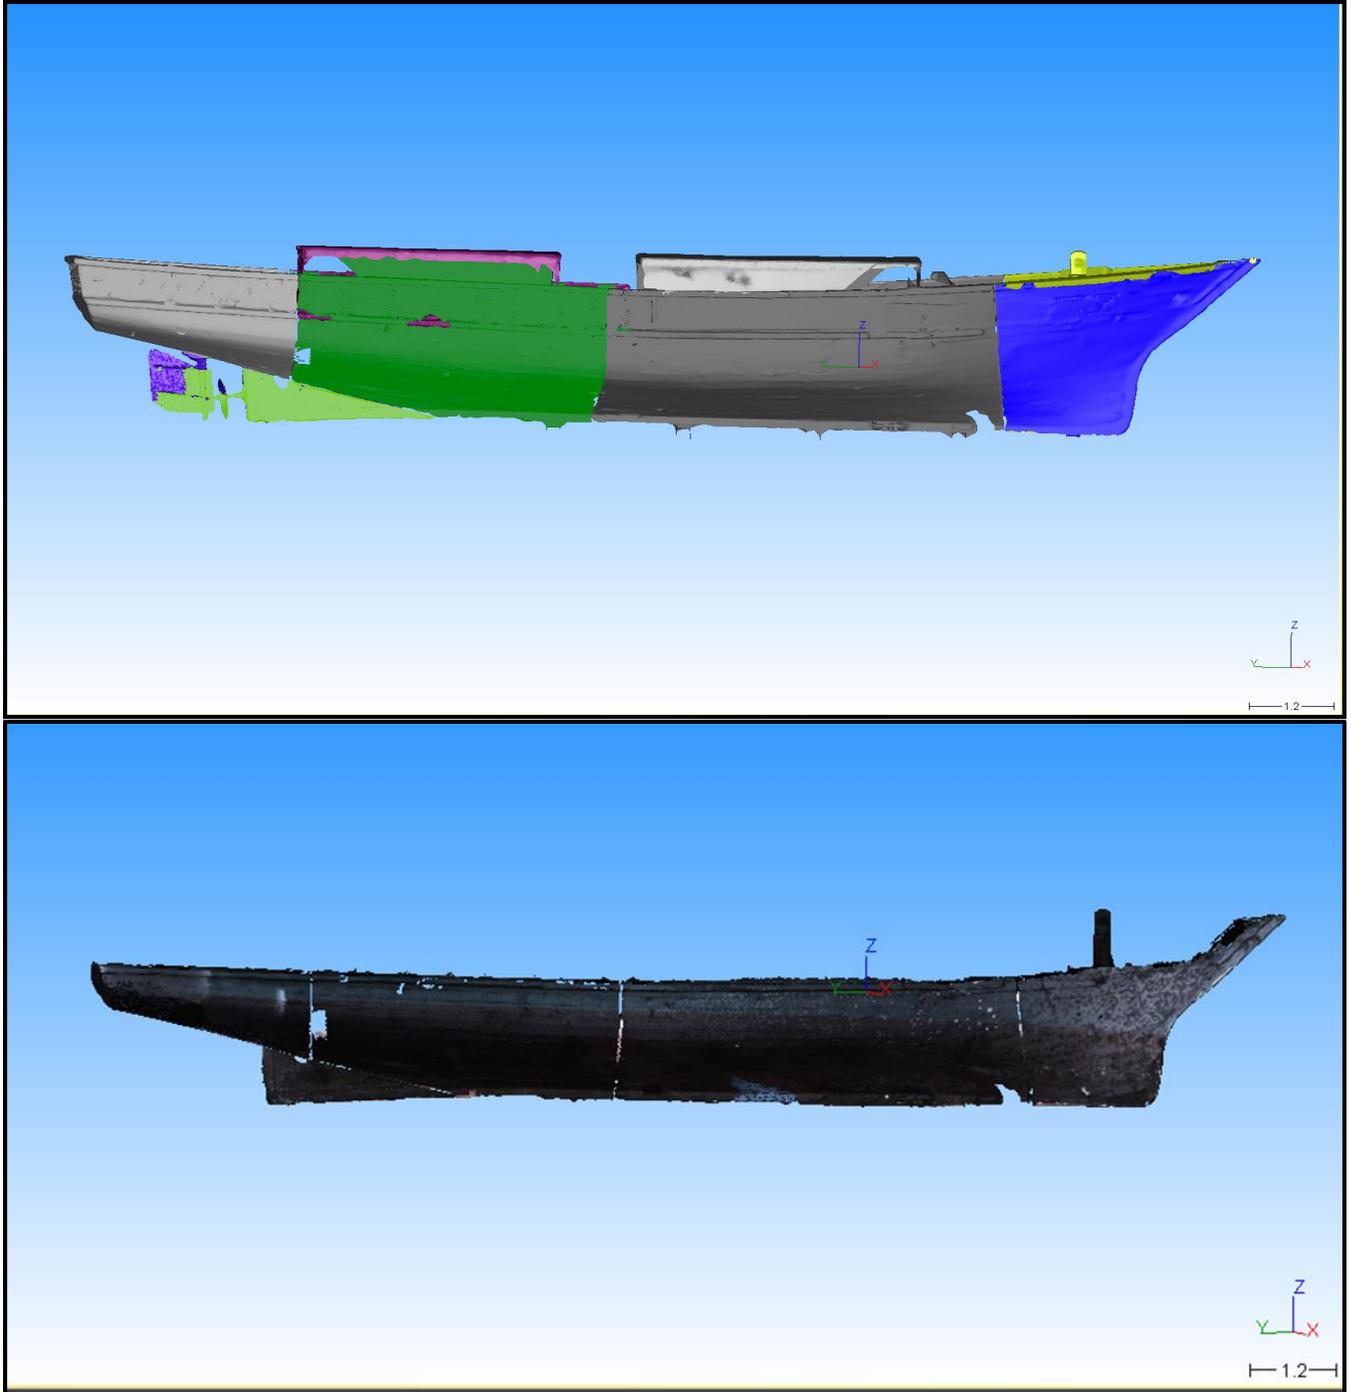
FIGURE 60. *Virginia* model, top is the overall model and the bottom image shows *Virginia* with modern materials removed to anticipate changes related to ship restoration. The rudder and propeller have also been removed to try and represent the schooner better (Images by author, 2011).

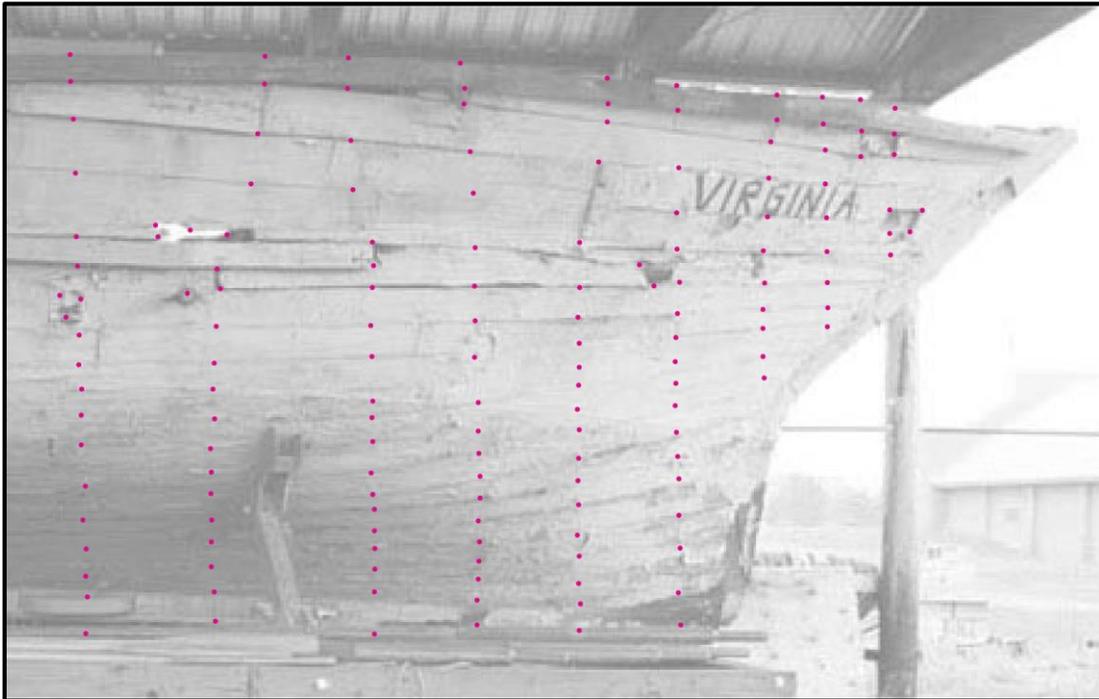
Forward starboard sheet with pre-assigned points at features and arbitrary survey lines (Image by author, 2010).

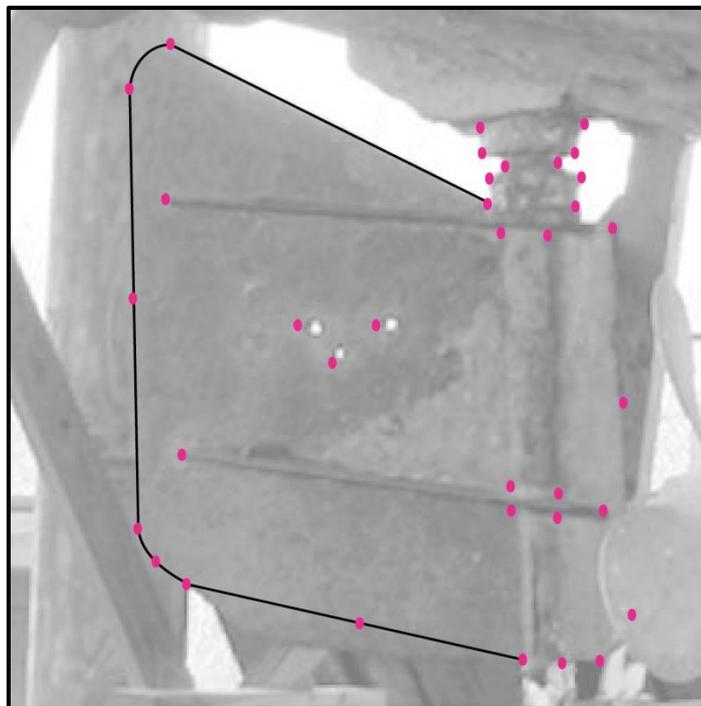
Rudder blade starboard side with pre-assigned survey points (Image by author, 2010).

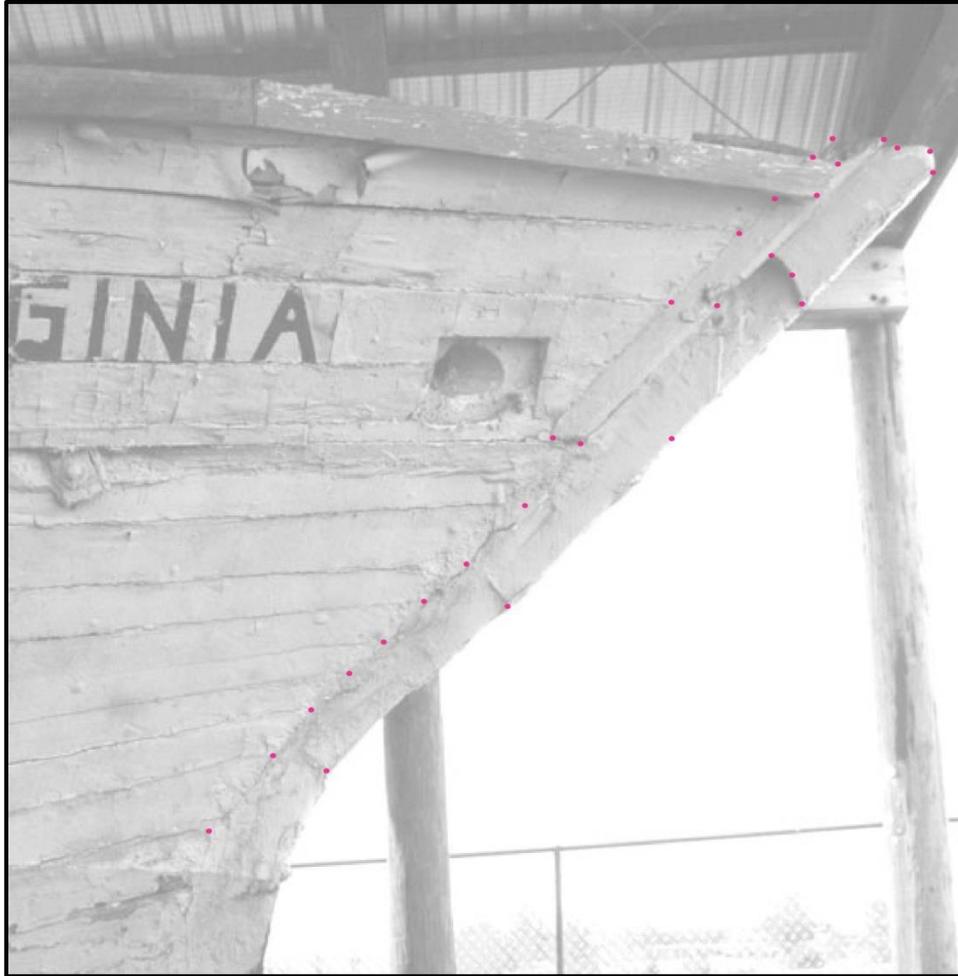
Starboard upper stem sheet (Image by author, 2010).

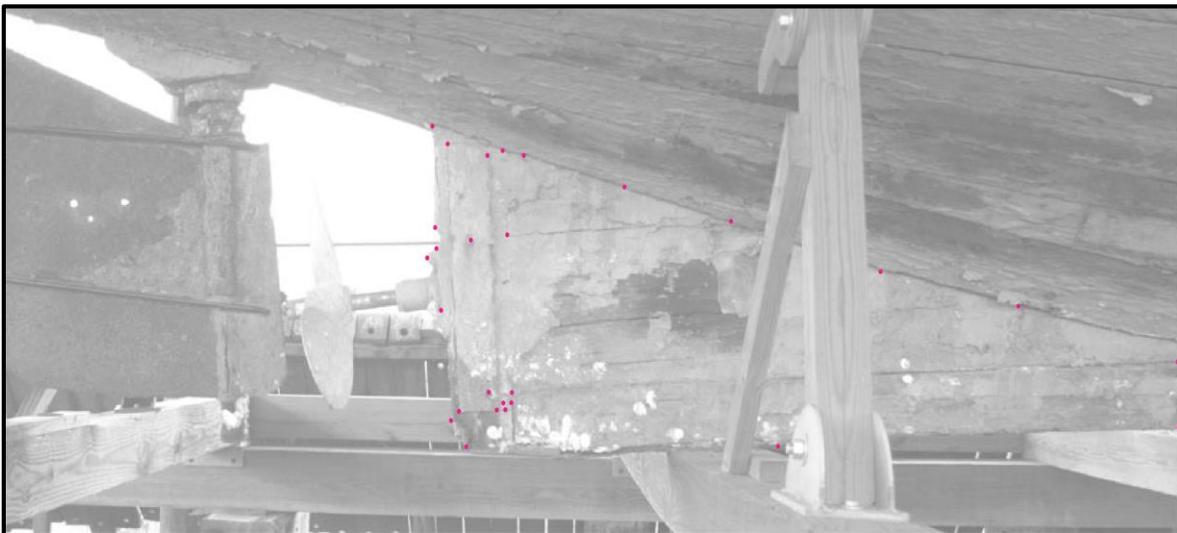
Starboard propeller and deadwood sheet (Image by author, 2010).

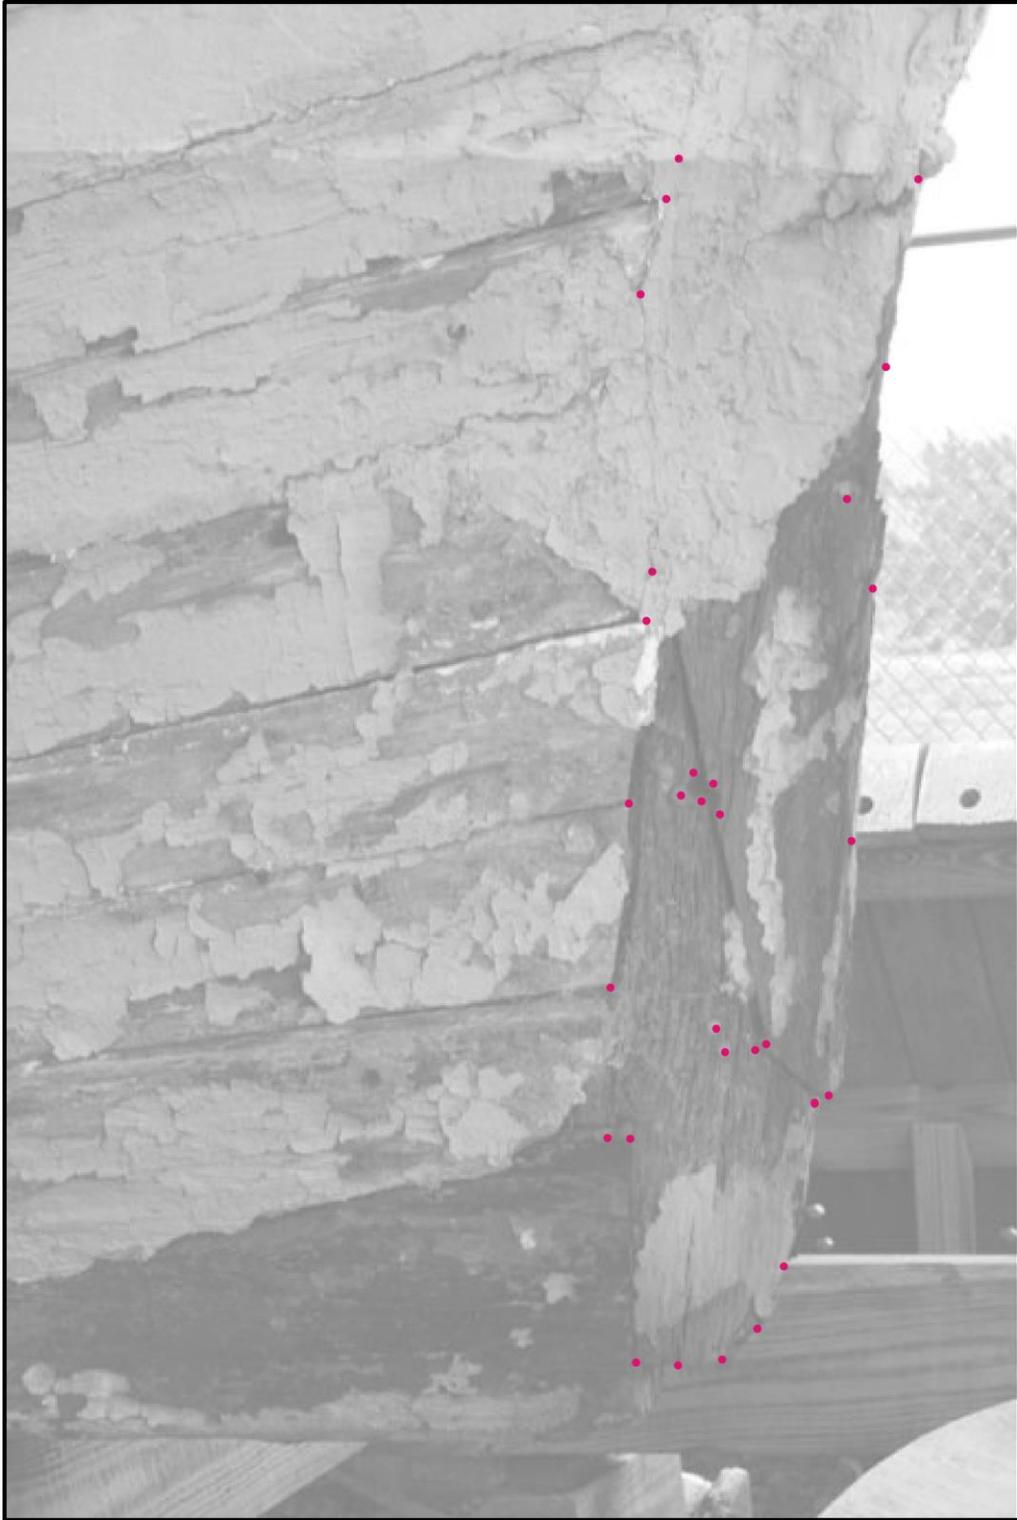
Lower starboard stem scarph pre-assigned points (Image by author, 2010).
