PB2Y CORONADO FLYING BOAT ARCHAEOLOGY AND SITE FORMATION STUDIES
TANAPAG LAGOON, SAIPAN

A Thesis

Presented To the Faculty of the Program in Maritime Studies of Department of History
East Carolina University

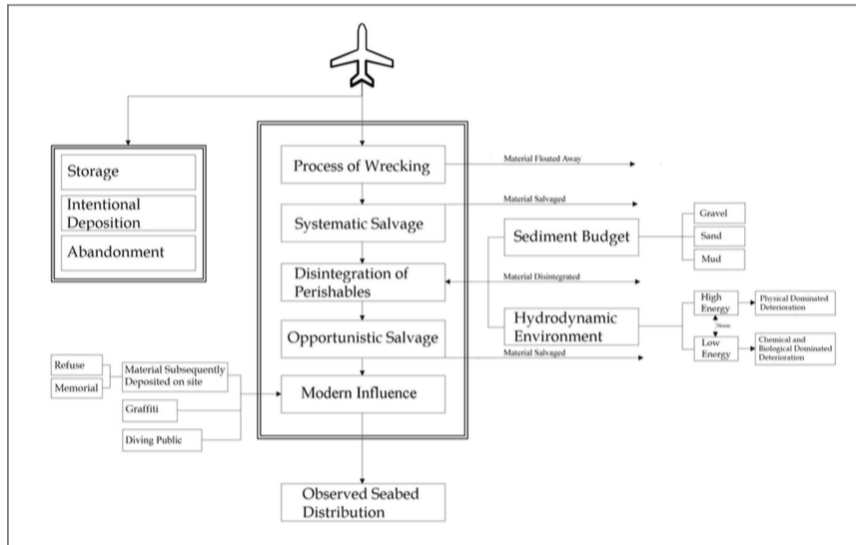
Figure 6. Flow diagram modified for application to submerged aircraft (Bell 2010:124).

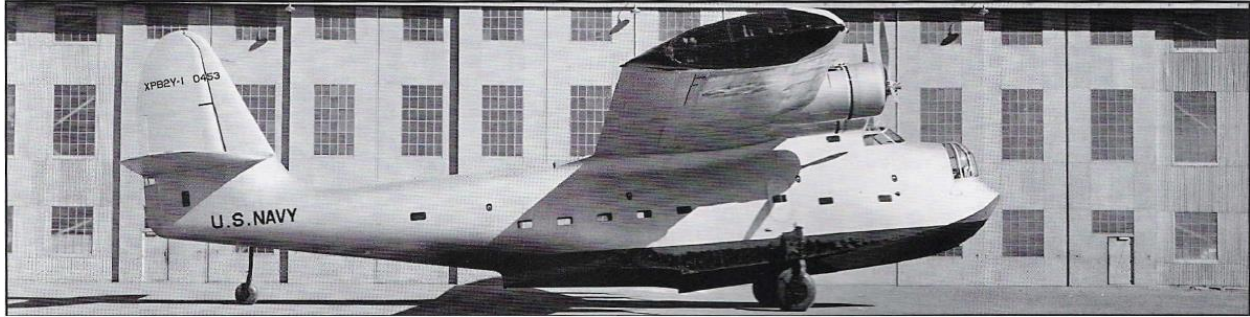
Figure 7. Original XPB2Y-1 tail configuration with single vertical stabilizer (Consolidated).

Consolidated's Model 29, rechristened the XPB2Y-1 and assigned BuNo 0453, first flew on 17 December 1937 (Creed 1985:15, 43). Despite starting development over a year later than the Sikorsky XPBS-1, Consolidated's test flight took place only three months after the XPBS-1 test flight (Hoffman 2009:1). The XPB2Y-1 suffered from control and directional stability problems. Consolidated's engineers traced the problems to the tail assembly. Originally designed with a single large vertical stabilizer and rudder (Figure 7), elliptical fins were attached to the horizontal stabilizer for the fourth test flight on 28 February 1938 (Figure 8).

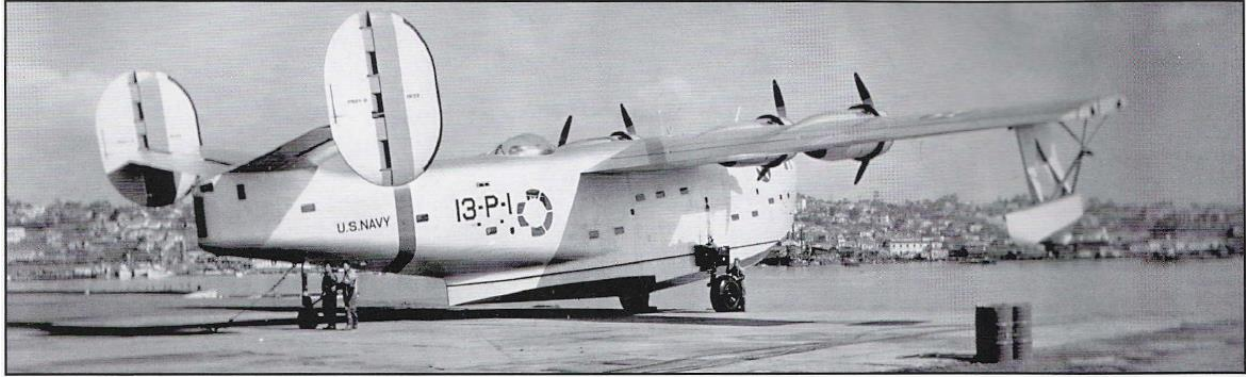
Figure 10. PB2Y-2 BuNo 1633 December 1940. Note the teardrop-shaped upper gun blister and the side waist windows: these were unique to the PB2Y-2 variant (Consolidated).

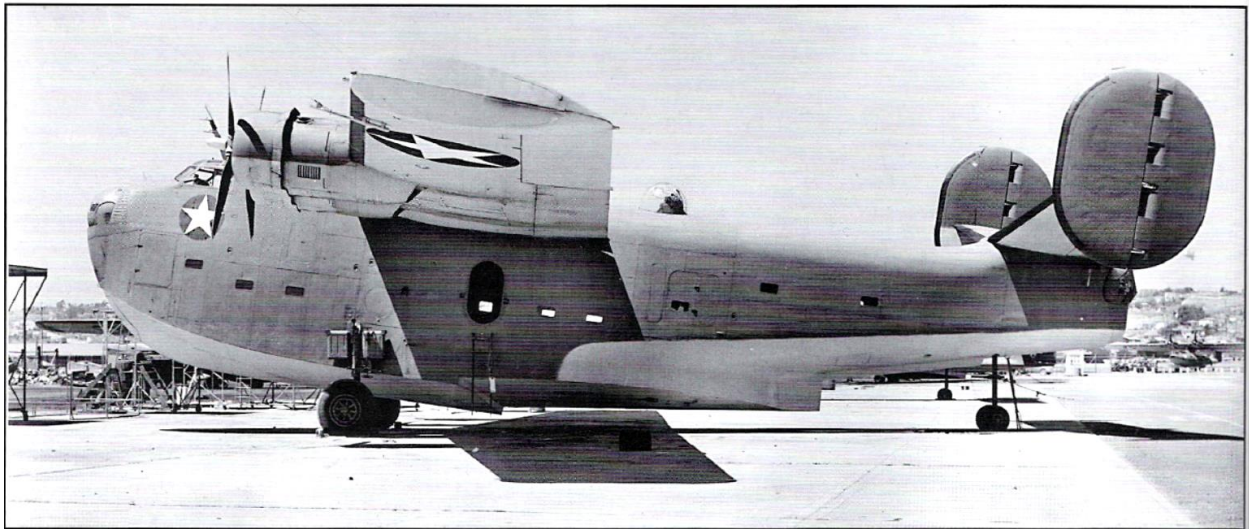
Figure 11. PB2Y-3. Note the new ball turret in the nose and upper waist, and the square rear waist hatch (National Archives).

twin mounted .50 caliber turrets replaced the single turrets in the nose and tail. The upper waist gun was yet again changed, this time switching the single-gun blister for a twin-mount ball turret. The side waist ball turrets were removed, replacing them with a wide cargo door with swing-out single gun turrets (Hoffman 2009:24). The total number of guns for this variation is listed as eight, which suggests that the tunnel position was removed (Holmes 2005:140). These modifications increased the empty weight to 18,568 kg (40,935 lbs.), gross weight to 40,935 kg (68,000 lbs.), and decreased range to 3,720 km (2310 mi.) (Budge 2007).

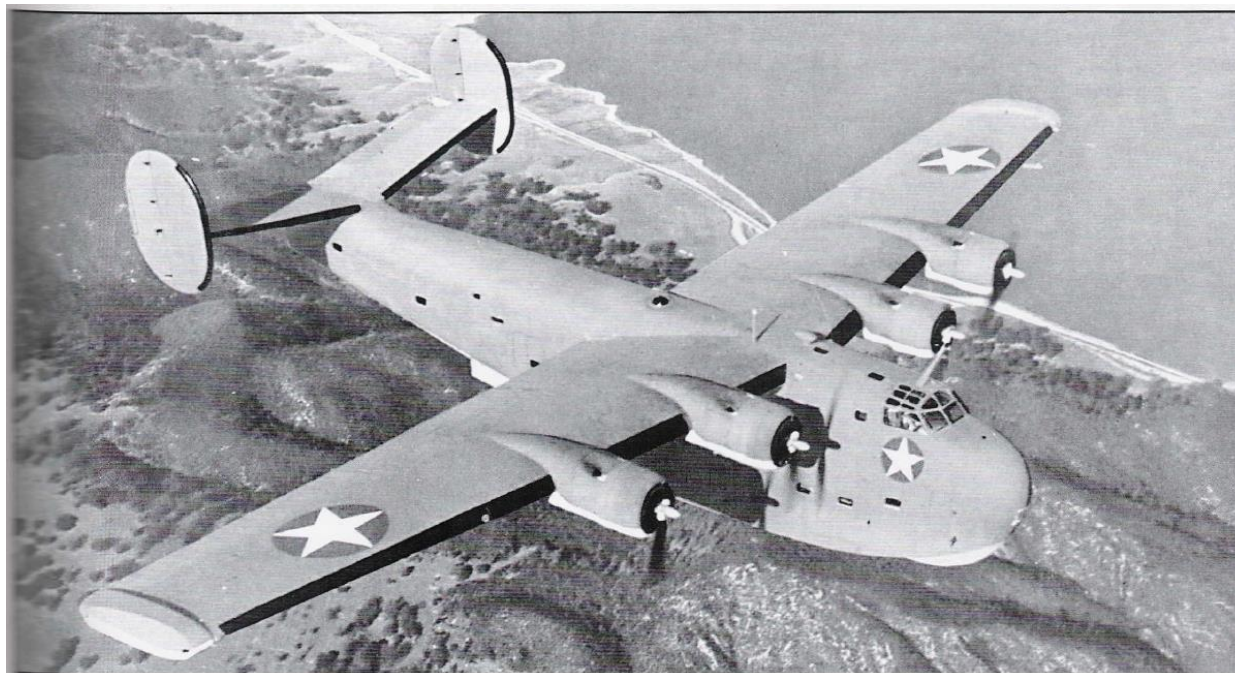
Figure 12. PB2Y-3R transport conversion. All guns have been removed (Consolidated).

The production of PB2Y-3 models totaled 210 aircraft (Polmar 2013:14–15). With the urgent need for transports, 29 of the first 60 were stripped of combat features and configured as transports (Figure 12), designated PB2Y-3R (the trailing “R” is the Navy suffix for “transport conversion” (Swanborough and Bowers 1976:16; Cornwell 1944)). Great Britain received 10 through the Lend-Lease Act, where they operated as long-range transports with the RAF Transport Command (Polmar 2013:14–15). One would join the XPB2Y-1 as a flag transport. VP-13 received 12 of the new model as the first combat squadron, while others were used in

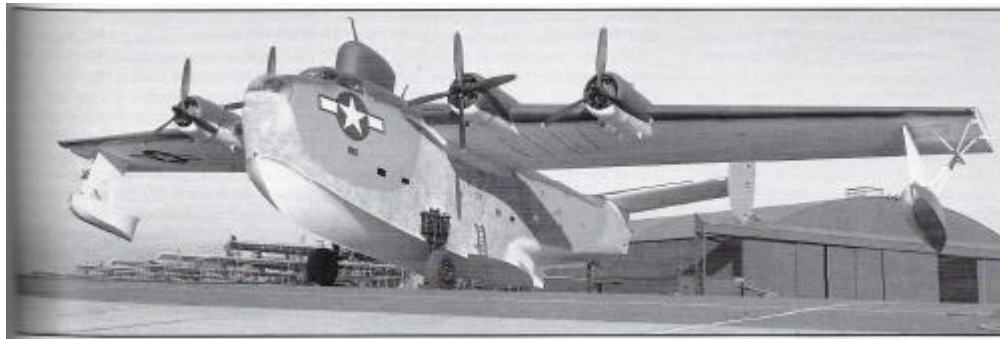
Figure 13. PB2Y-5 with radome installed above flight deck (US Navy).

PB2Y-5s received other upgrades during the conversion process besides new engines. Many aircraft were fitted with a radar dome directly behind the cockpit (Figure 13), which also required a modified interrupter cam on the top turret to prevent the dome from being accidentally shot. New or overhauled nose and top turrets were installed, and the tail turret was replaced with a new model. The electronics were updated by replacing the DZ direction finder with the following package: two Type 800-1C alternators, two Type A condensers, a SCR 522 VHF unit, AN/APN-1 radio altimeter, SCR 269-F automatic direction finder, and an RL-24C interphone (Hoffman 2009:32). The PB2Y-5 conversions were also modified for Jet Assisted Takeoff (JATO), which was regularly used to get heavily loaded Coronados off the water (Figure 14). The hull structure was reinforced, and eight pairs of brackets for attaching JATO canisters were installed to the outside of the hull, adjacent to the side waist gun hatches. Four switches and an indicator light was added to the pilot's pedestal for control of the system (Hoffman 2009:32–33, 188).

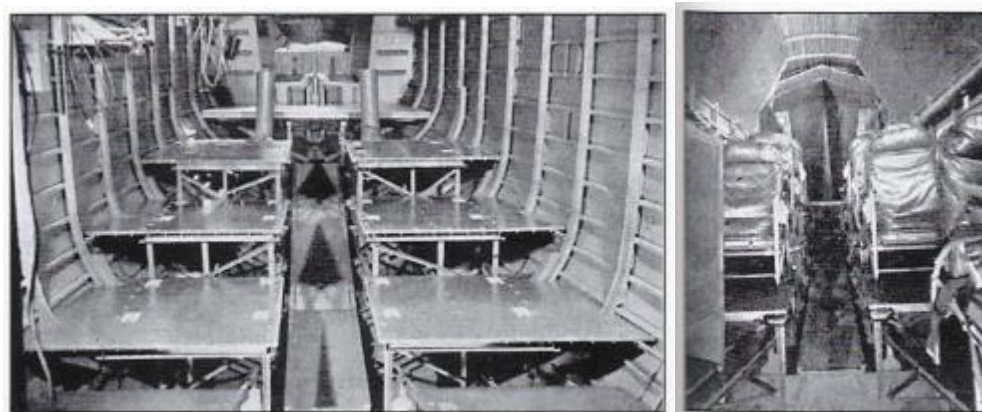
Figure 15. PB2Y-5R transport conversion interior. *Left*, cargo platforms; *right*, seats installed (US Navy).

platforms were built (Figure 15). Hoisting eyes located both inside and outside for loading and unloading as well as hundreds of tie-downs prepared the aircraft for its role as a transport. The mid-fuselage hatches were framed by larger cargo hatches. The galley, auxiliary power unit, rear cabin heater, and emergency water still were moved from the main cargo compartment to the “C” deck above the crew quarters. In the forward sleeping compartment, bunks were installed that could be let down during the day to form seats with backrests. Once converted, the PB2Y-5R weighed 3,630 kg (8,000 lbs.) less than the combat version (Hoffman 2009:26).

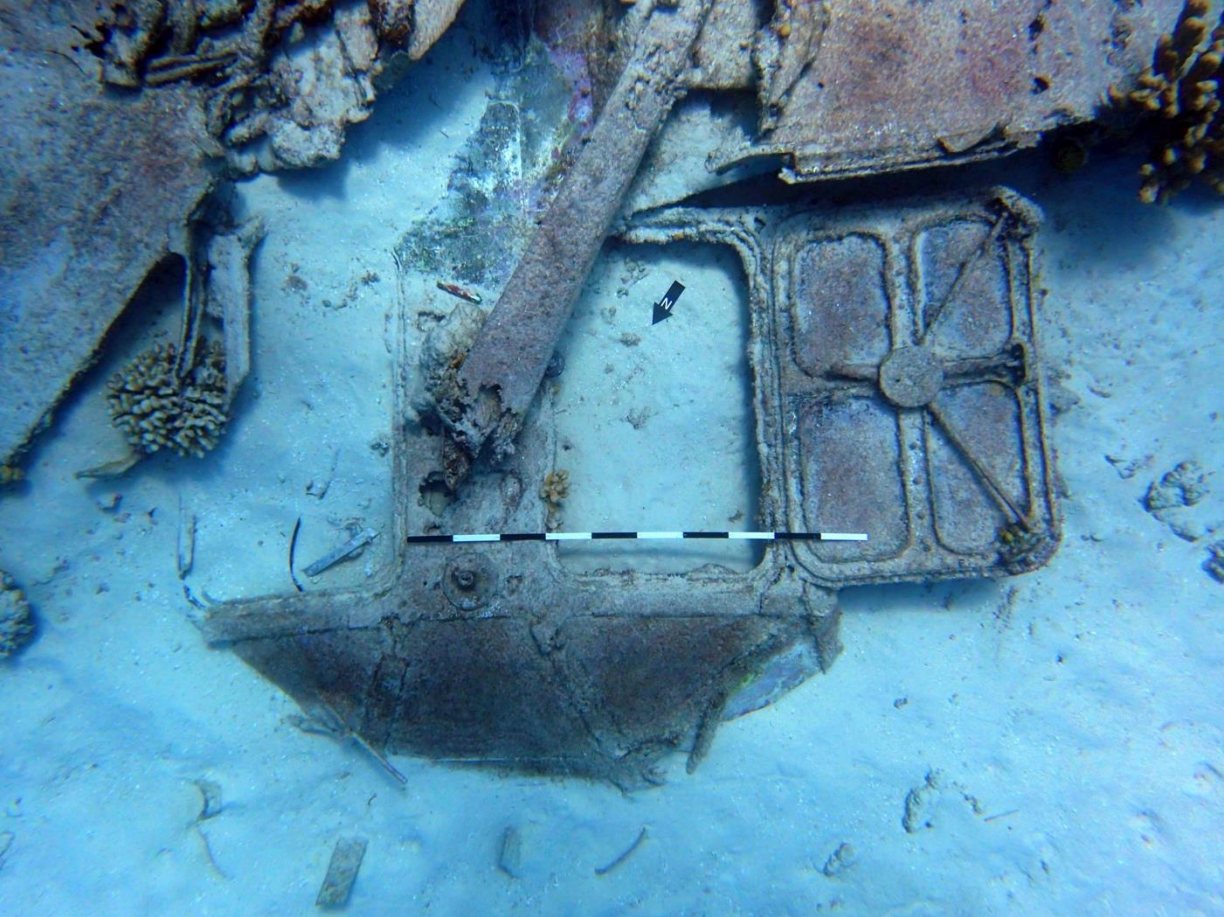
Figure 22. Feature 1. Cockpit canopy windows, pilot's escape hatch, and aerial mast. Plan view, 1 m scale.

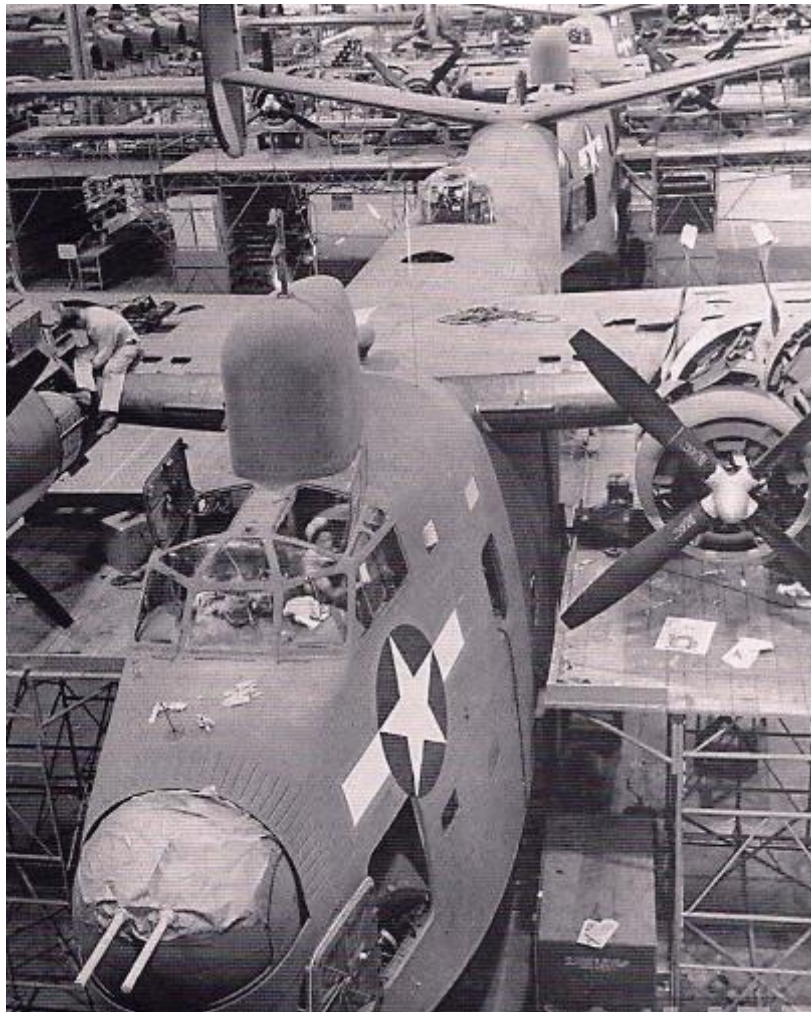
Figure 23. PB2Y-5 during conversion. Note cockpit windscreen window configuration and open escape hatches. Aerial mast is located on top of radome, aft of escape hatches; the Tanapag Lagoon Coronado was not equipped with a radome, so aerial mast was installed between escape hatches (Hoffman 2009:63).

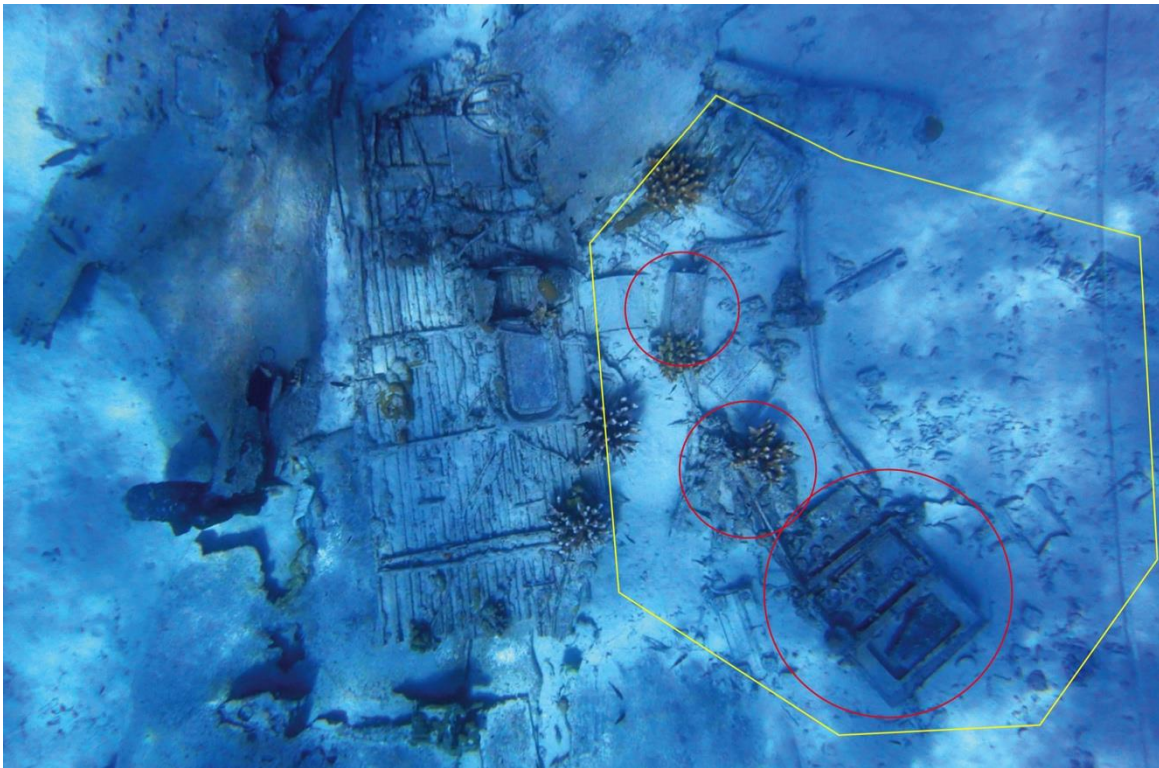
Figure 24. "Radio wall," Feature 2, *center*, and radio equipment scatter, *right*. Scatter is outlined in yellow, while individual units (Feature 3) are circled. Unscaled plan view.

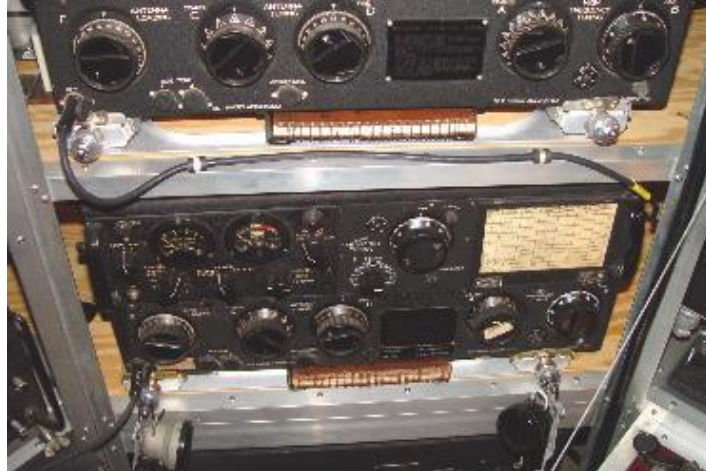
Figure 25. Contemporary ART-13B transmitters from B-29 flight deck (Photograph aafradio.org).

East of that wall (hereafter the "radio wall"), a variety of radio equipment lies scattered across a roughly 2 m by 2 m (7 ft. by 7 ft.) area (Figure 24). Whole components include a panel containing two transmitters and one unknown unit (Feature 3), two unknown units connected to each other with a third stacked on top, and an unknown unit lying on its side. Cables connect all units to the panel. Broken sections of radio equipment and individual electrical components such as large capacitors are strewn throughout the area. Most units are covered by marine growth and cannot be identified. The two transmitters in the radio panel can be recognized, as there are several areas around the controls and transmitter face where the original markings are still legible. Judging by the layout of controls, the units are ART-13B transmitters (Figure 25). A serial number is also present at the bottom of the panel (Figure 26).

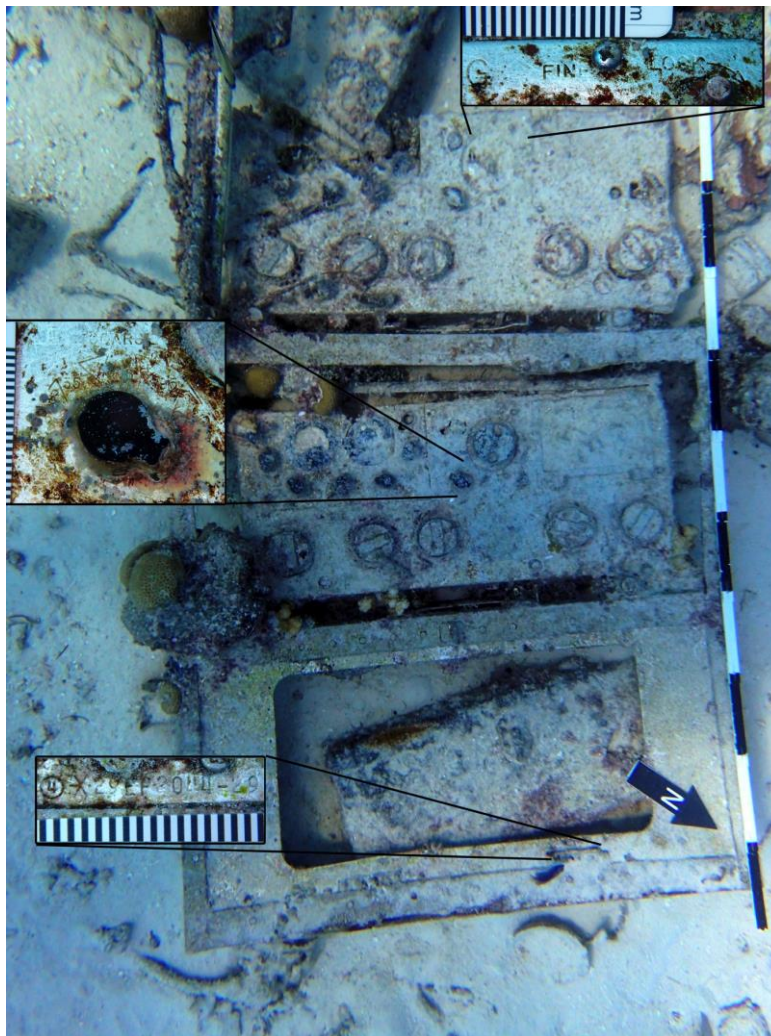
Figure 26. Radio panel (Feature 3) with two ART-13B transmitters. Details millimeter scale.

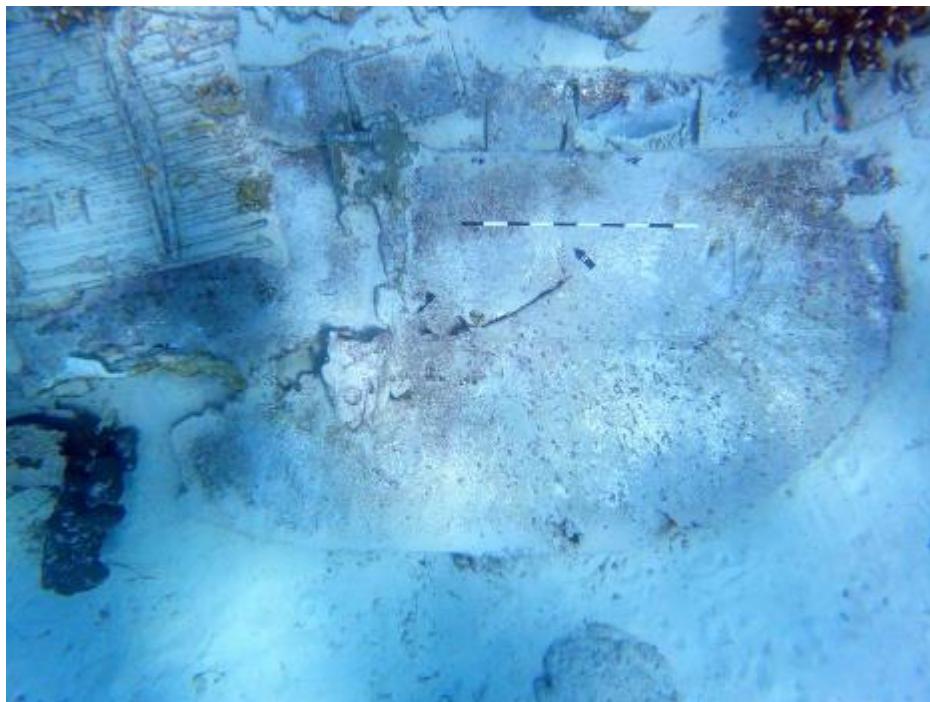
Figure 27. Port vertical stabilizer (Feature 4). Plan view, 1 m scale.

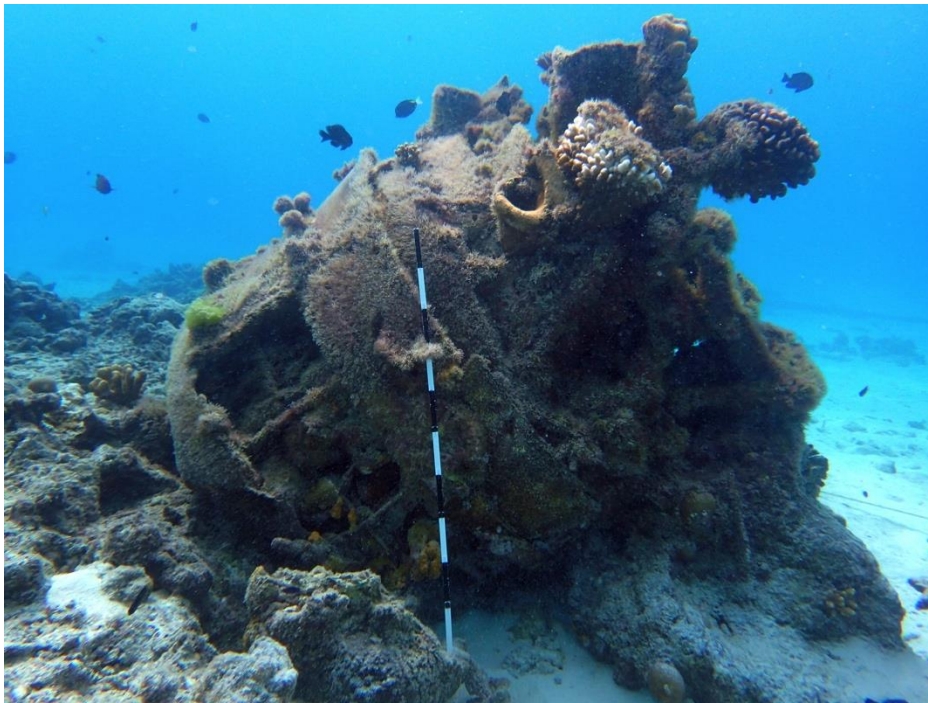
Figure 28. Engine (Feature 5). Profile view, facing south. 1 m scale.

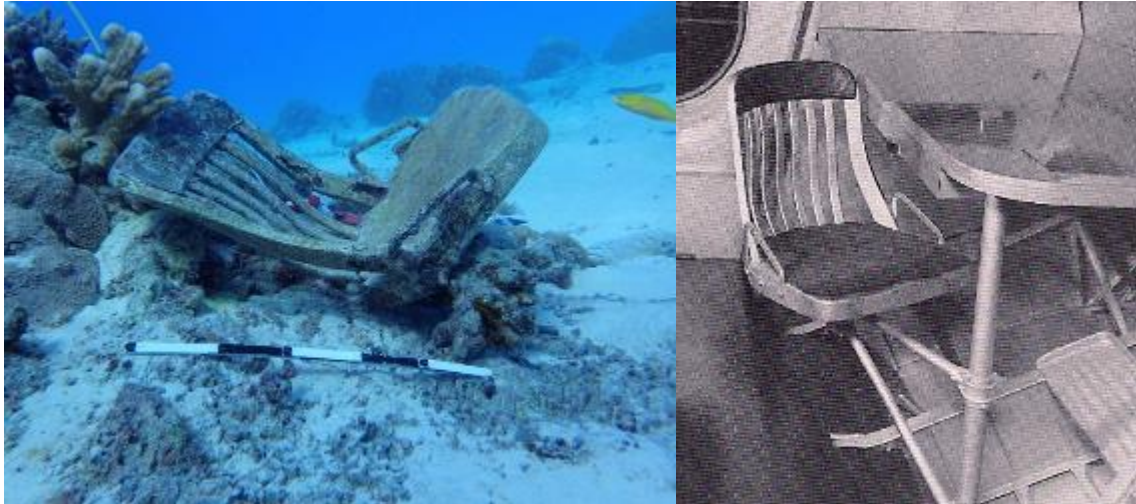
Figure 29. *Left*, seat leaning against reef, 50 cm scale (Feature 6). Profile view, facing west. *Right*, seat as temporarily installed at navigator's station in XPB2Y-1 (National Archives).

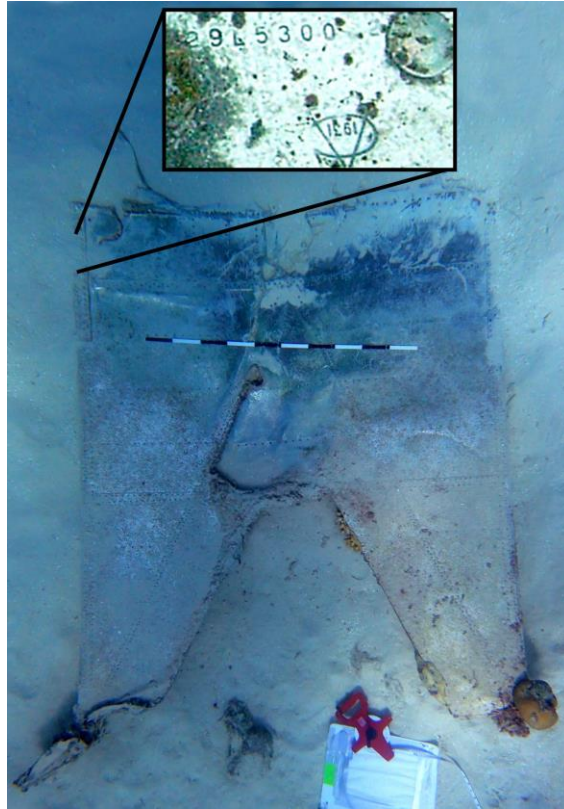
Figure 31. Float strut (Feature 7) with visible paint. *Inset*, serial number and Consolidated Aircraft Stamp (J. Carpenter 23 February 2012).

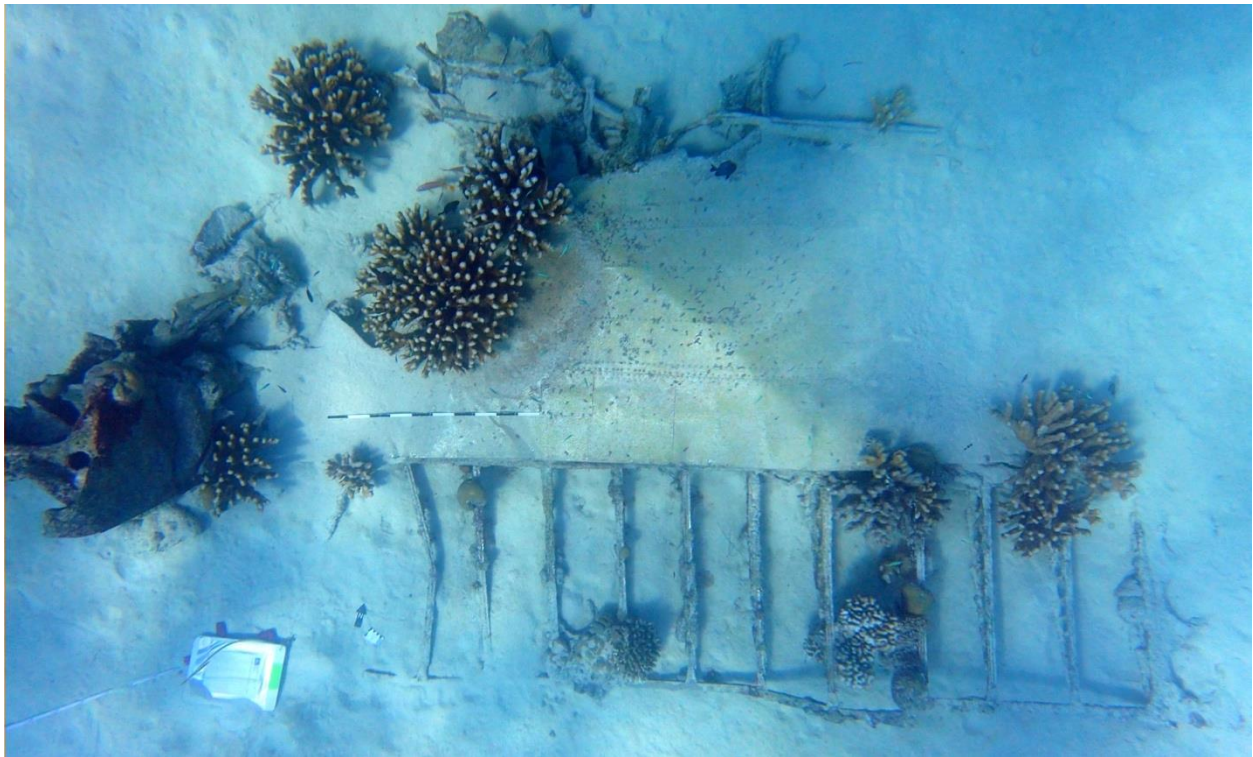
Figure 32. Wing (Feature 8). Plan view, 1 m scale.

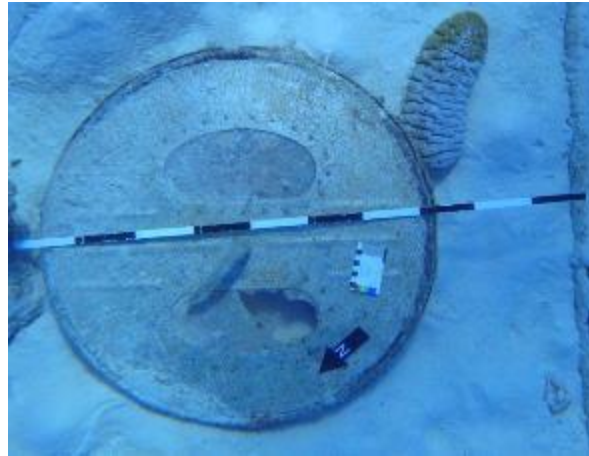
Figure 33. Hatch cover (Feature 9), plan view. 1 m scale.

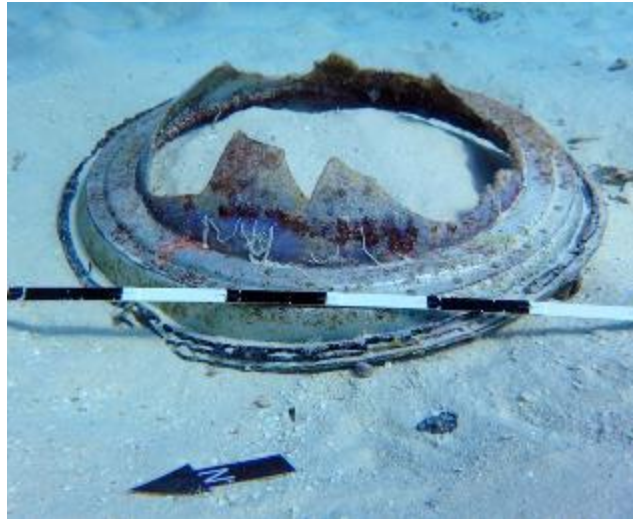
Figure 35. Navigator's astrodome (Feature 10). Oblique view, facing southeast. 60 cm scale.

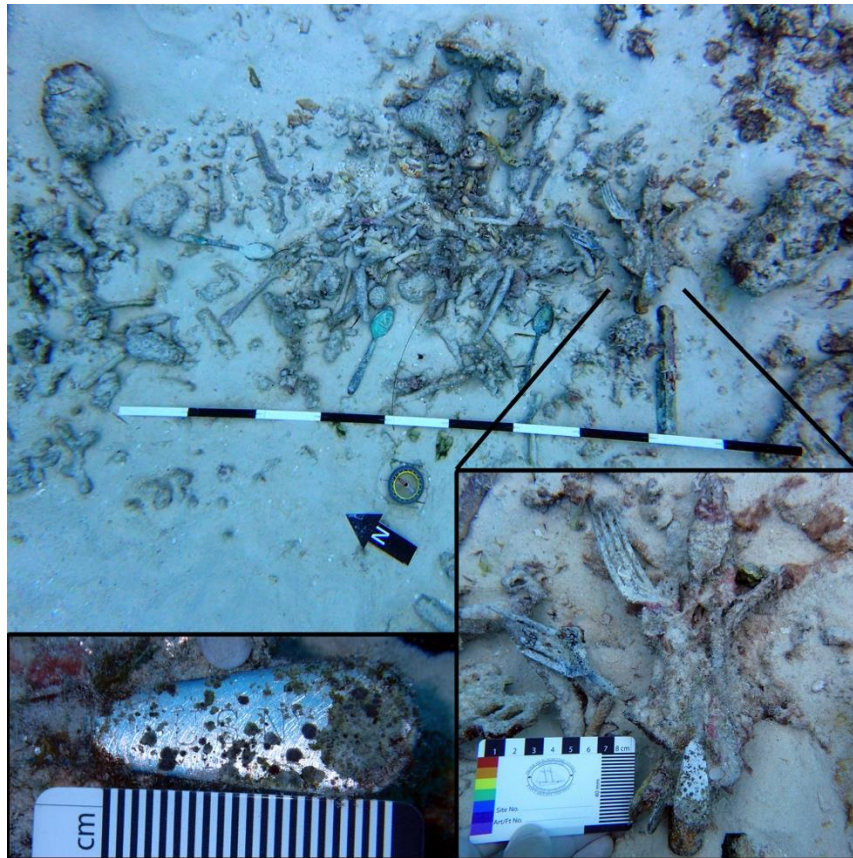
Figure 36. Forks and spoons (Feature 11). *Top*, entire scatter, 1 m scale. *Bottom right*, concreted forks, centimeter scale (top) and millimeter scale (right). *Bottom left*, detail of handle inscription, millimeter scale.

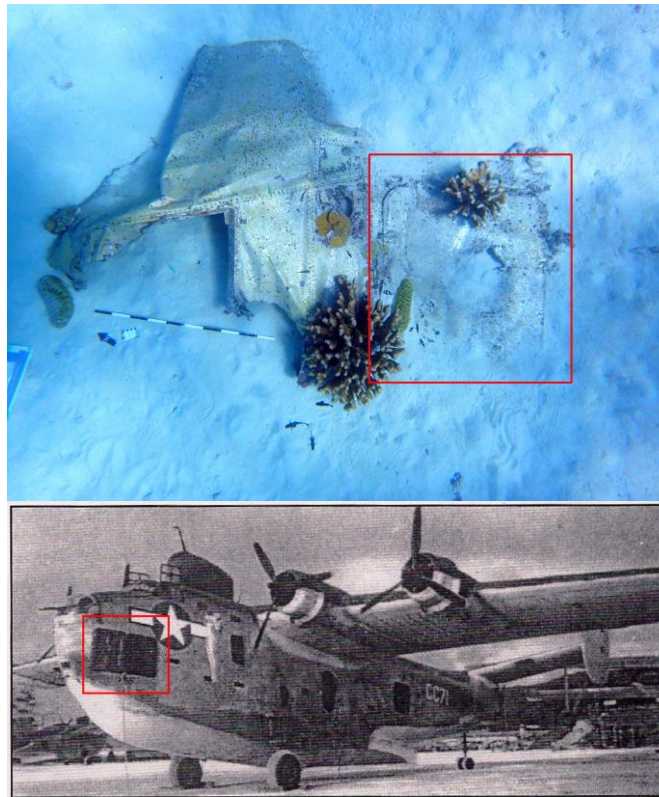
Figure 37. *Above*, hull section with port anchor hatch (Feature 12), closed, on right side. Panels missing on left. Plan view, 1 m scale. *Below*, position of anchor hatch, open, below and forward of the cockpit (National Museum of Naval Aviation).

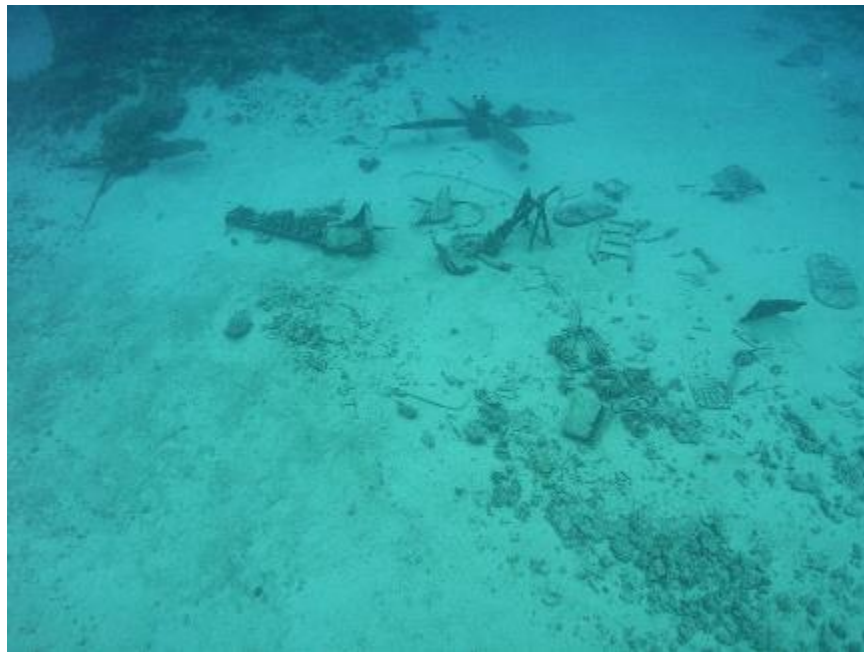
Figure 41. Faux wreck site overview, with two propellers (top left and center), two seats (center), a machine gun (center), various hatch covers, and ammunition scatter (center to bottom right). (Photograph J. Carpenter, 24 February 2012).

This author, upon surveying the site in November 2014, drew the same conclusion. The site contains a relatively small number of artifacts compared to the other aircraft wreck sites. More importantly, the site contains only easily identifiable artifacts, such as propellers, guns, seats, and hatches. Even the unknown section of fuselage has a window, which is a recognizable feature. Thus, this site contains only moveable objects that tourists, unfamiliar with aircraft, can understand when viewing from a distance through a viewport. Further, the entire site is in a location that is accessible by the submarine; no features are hidden, buried, or require maneuvering to be seen (Figure 42 and Figure 42).

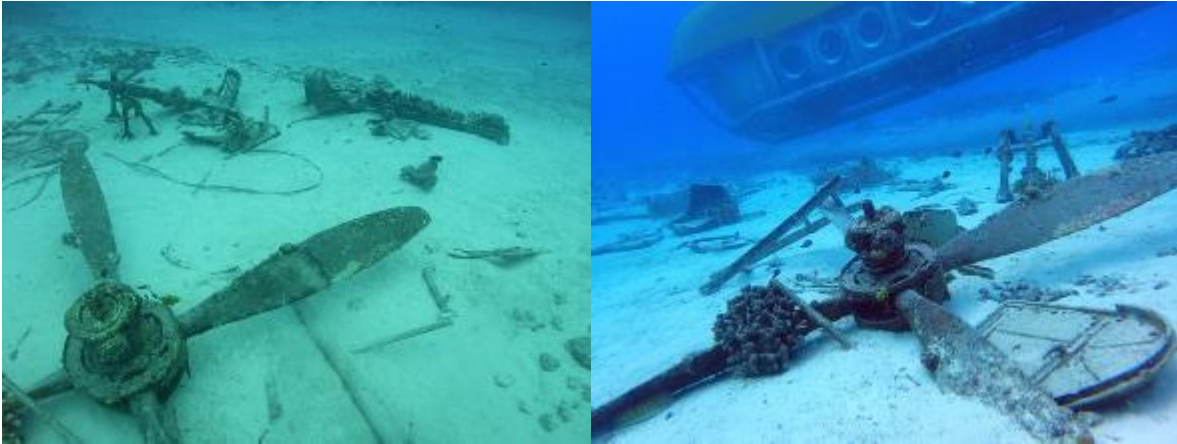
Figure 42. *Left*, faux site in 2012 (photograph J. Carpenter, 24 February 2012). *Right*, Similar view in 2014 with submarine in background. Note positions of seats, hatch covers, and machine gun have changed since 2012.

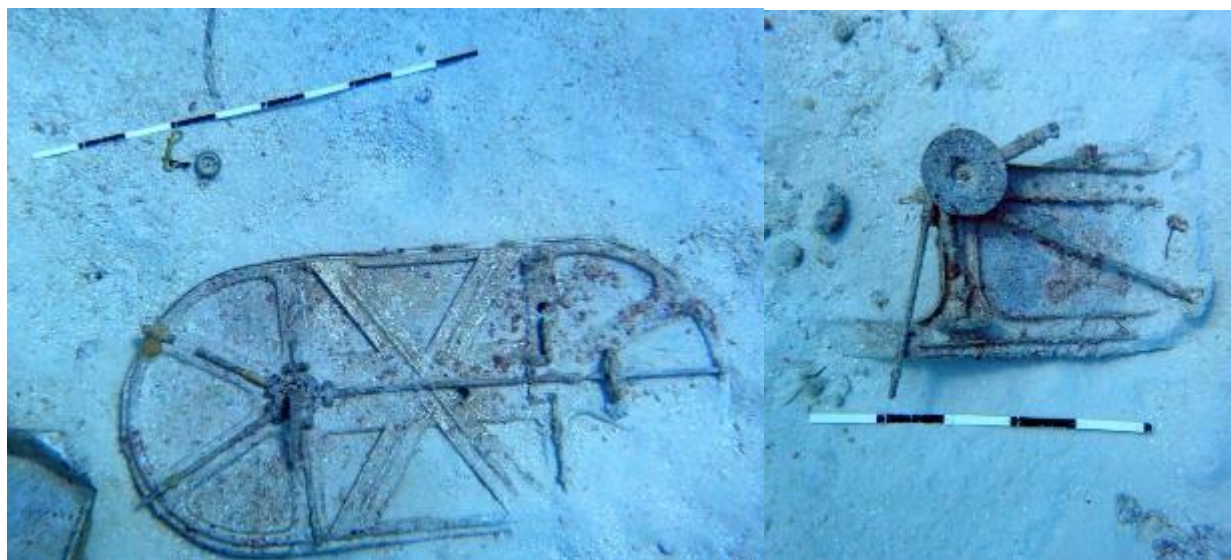
Figure 44. Examples of hatch covers on faux site. *Left*, oblong interior hatch, plan view, 1 m scale. *Right*, damaged escape hatch, plan view, 50 cm scale.

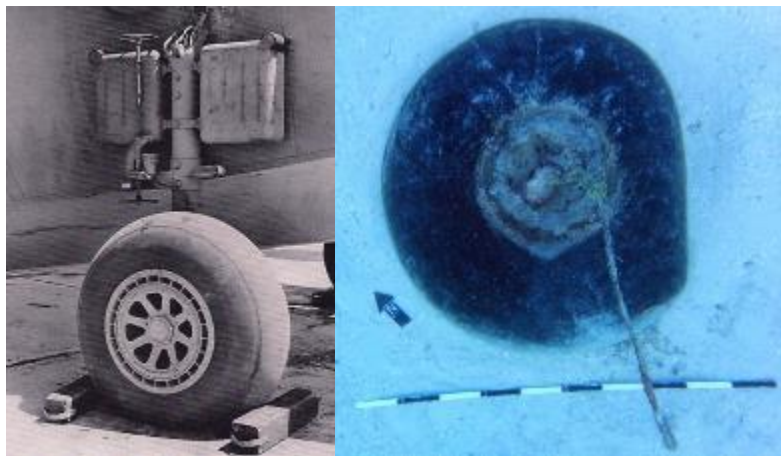
Figure 45. *Left*, front beaching gear attached to Coronado (Hoffman 2009:183). *Right*, beaching gear tire to north of faux site. Plan view, 1 m scale.

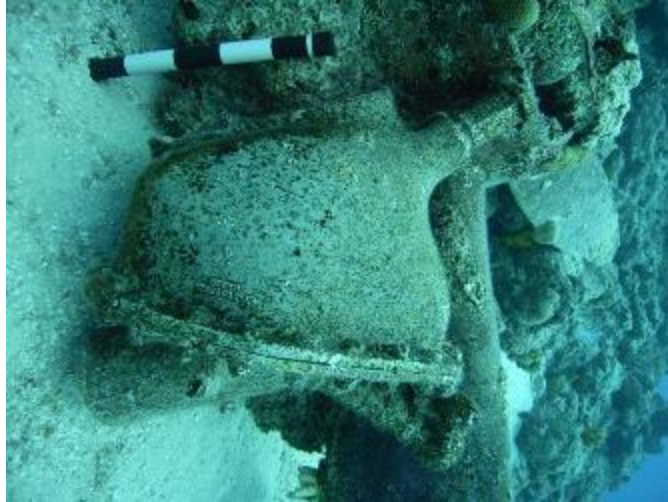
Figure 46. Unknown propeller hub component with serial number. Oblique view, 25 cm scale. (Photograph J. Carpenter, 24 February 2012).

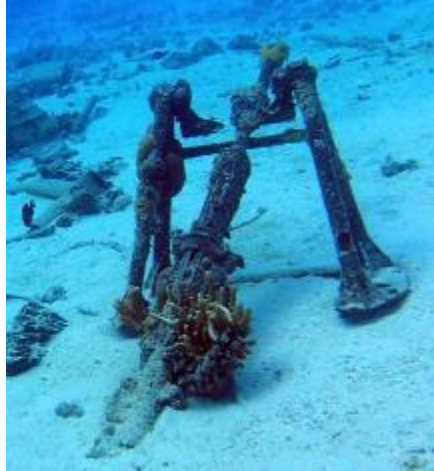
Figure 47. Unscaled view of machine gun from rear. Note that barrel of gun is resting on wreckage; the gun is not mounted.

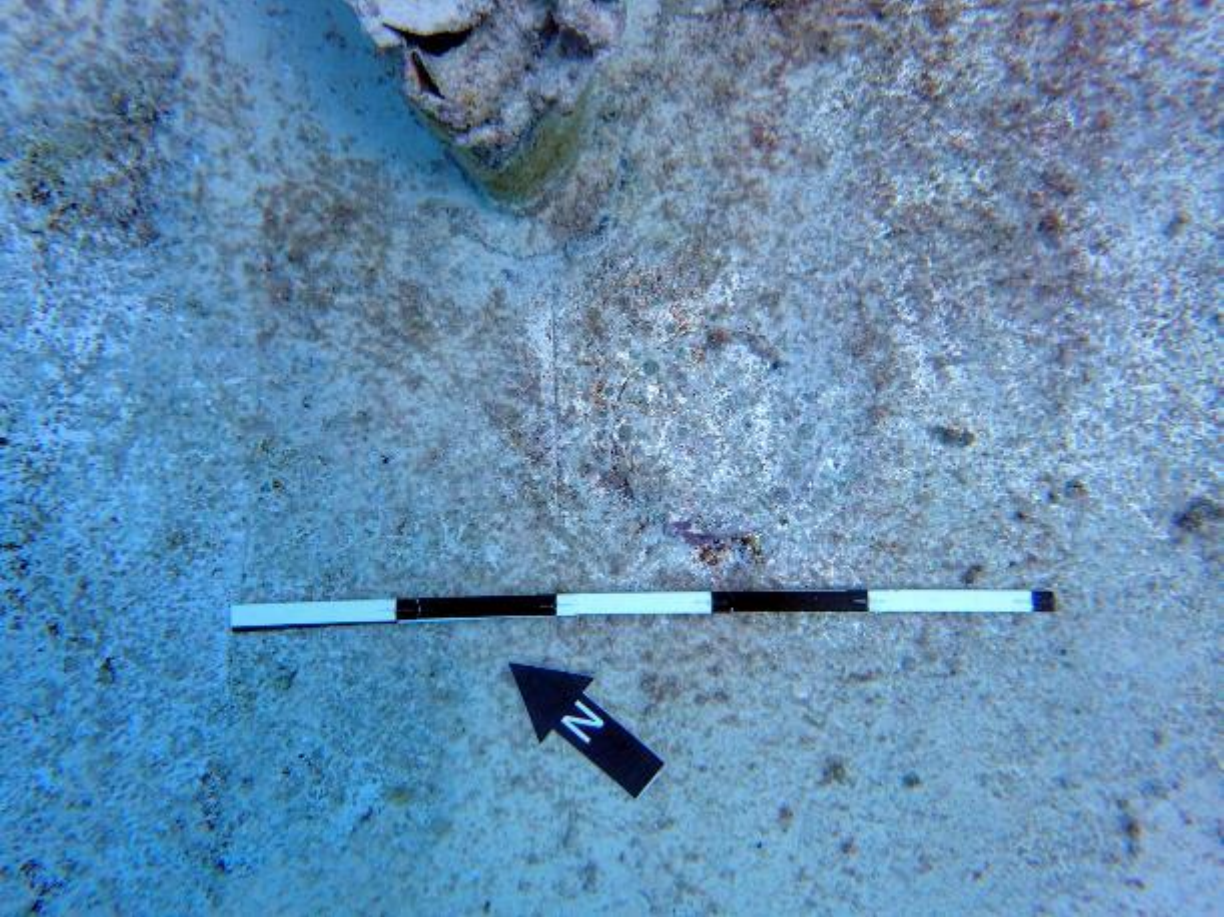
Figure 48. Detail of vertical stabilizer surface, showing sparse marine growth over bare aluminum; no paint remains. 50 cm scale.

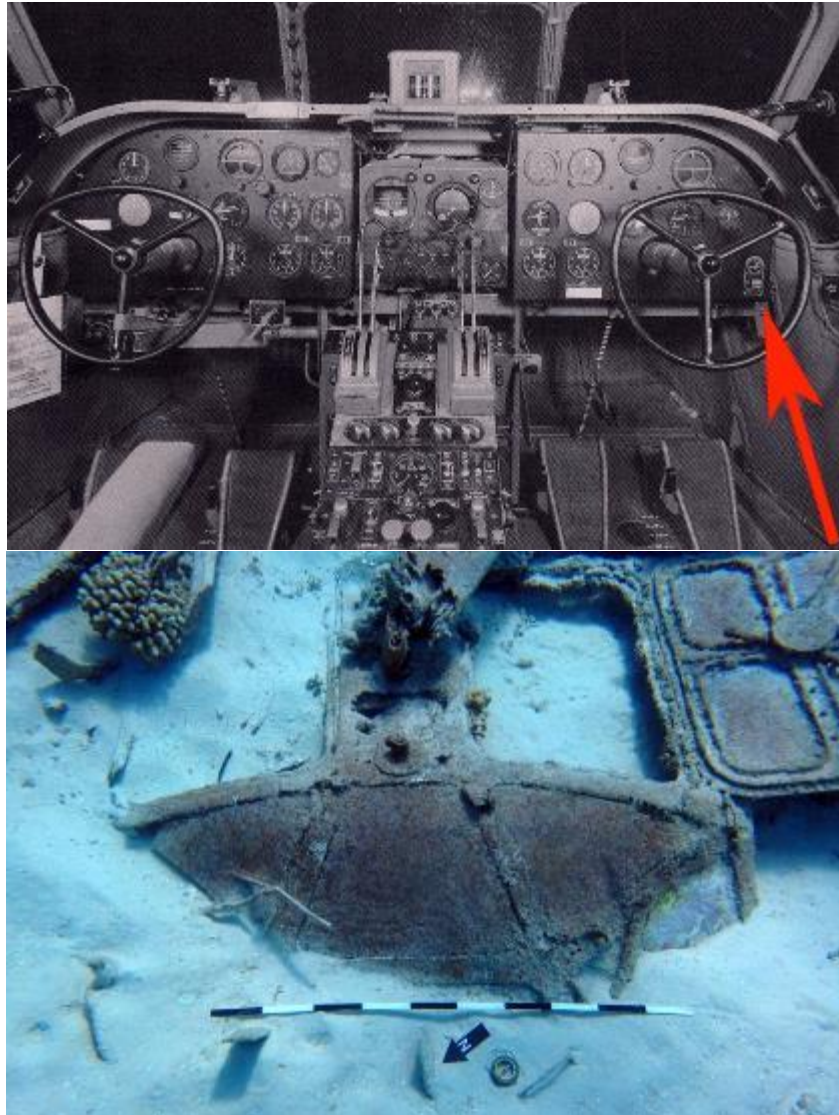
Figure 49. *Top*, location of manufacturer's data plate (Consolidated). *Bottom*, buried cockpit at Tanapag Lagoon Coronado site. Note top edge of starboard main cockpit window is not visible above sand. 1 m scale, oblique view facing southeast.

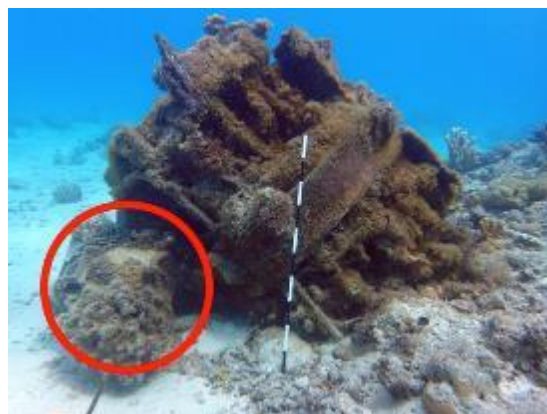
Figure 51. Engine with external oil cooler (circled). Profile view, facing north, 1 m scale.
