PB2Y CORONADO FLYING BOAT ARCHAEOLOGY AND SITE FORMATION STUDIES
TANAPAG LAGOON, SAIPAN

A Thesis

Presented To the Faculty of the Program in Maritime Studies of Department of History
East Carolina University

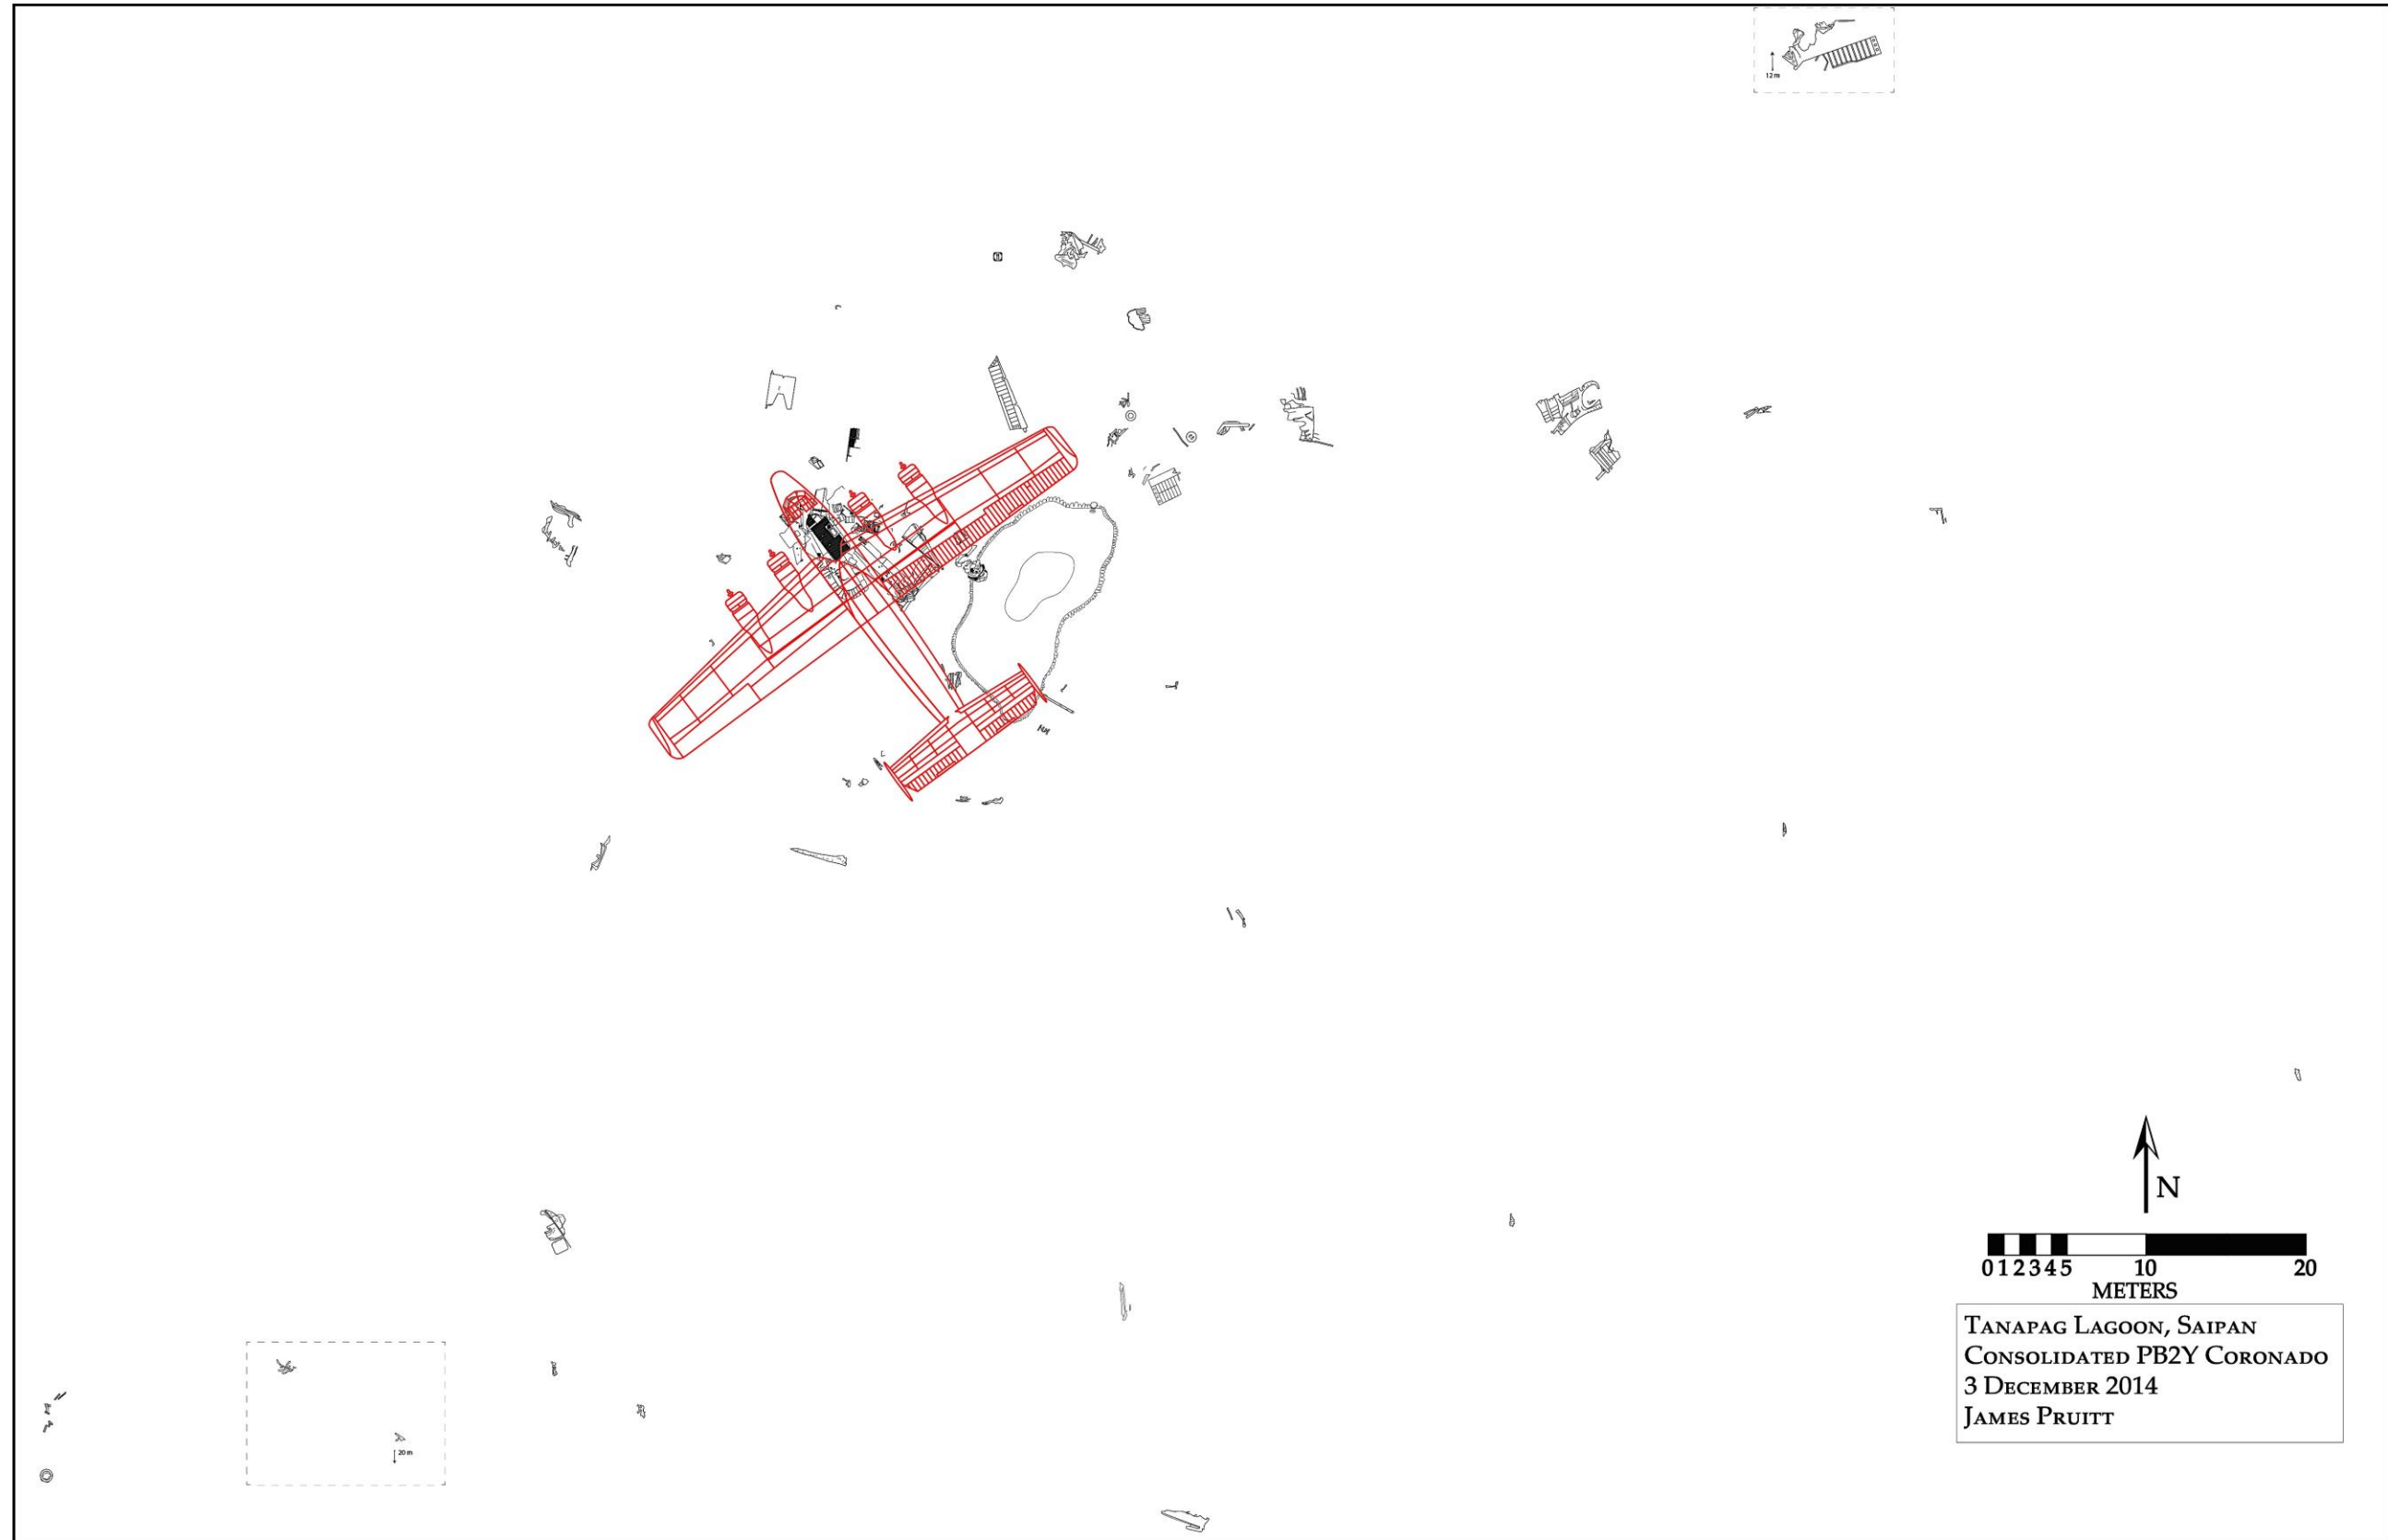
Figure 53. Comparison of site distribution (black) to scaled PB2Y Coronado line drawing (red overlay)

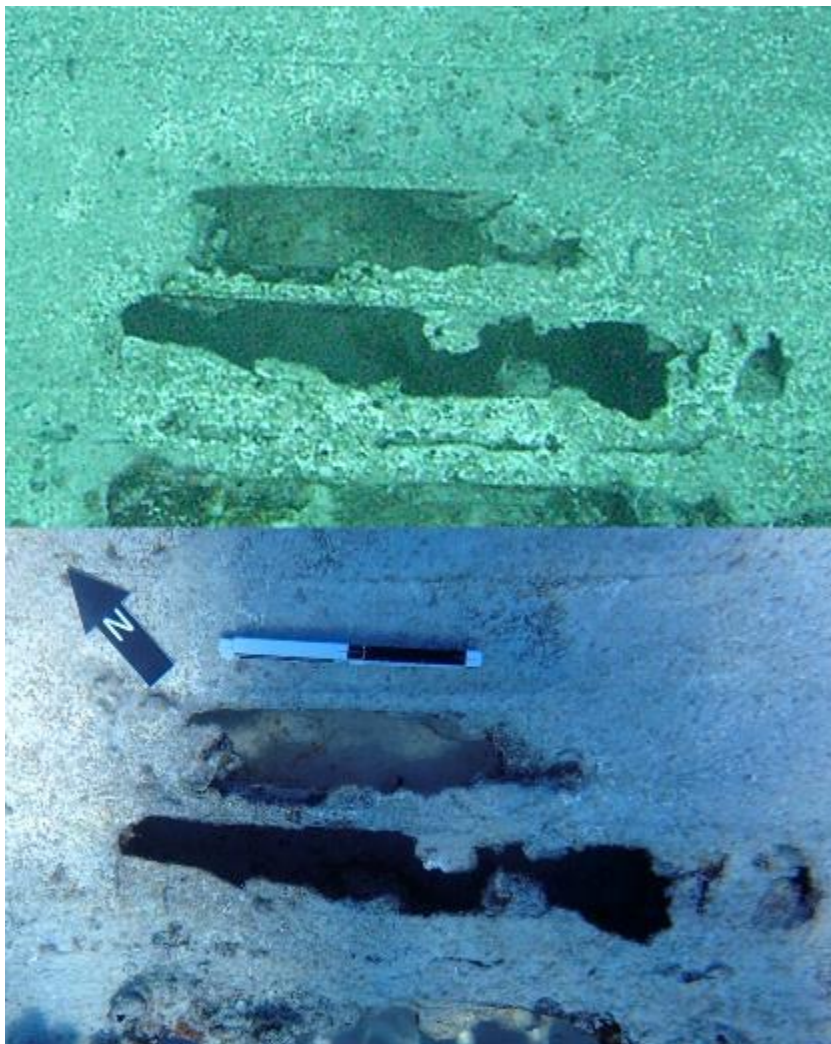
Figure 54. Deteriorated aluminum skin on suspected horizontal stabilizer. *Top*, 23 February 2012. (Photograph J. Carpenter). *Bottom*, 11 November 2014, 20 cm scale.

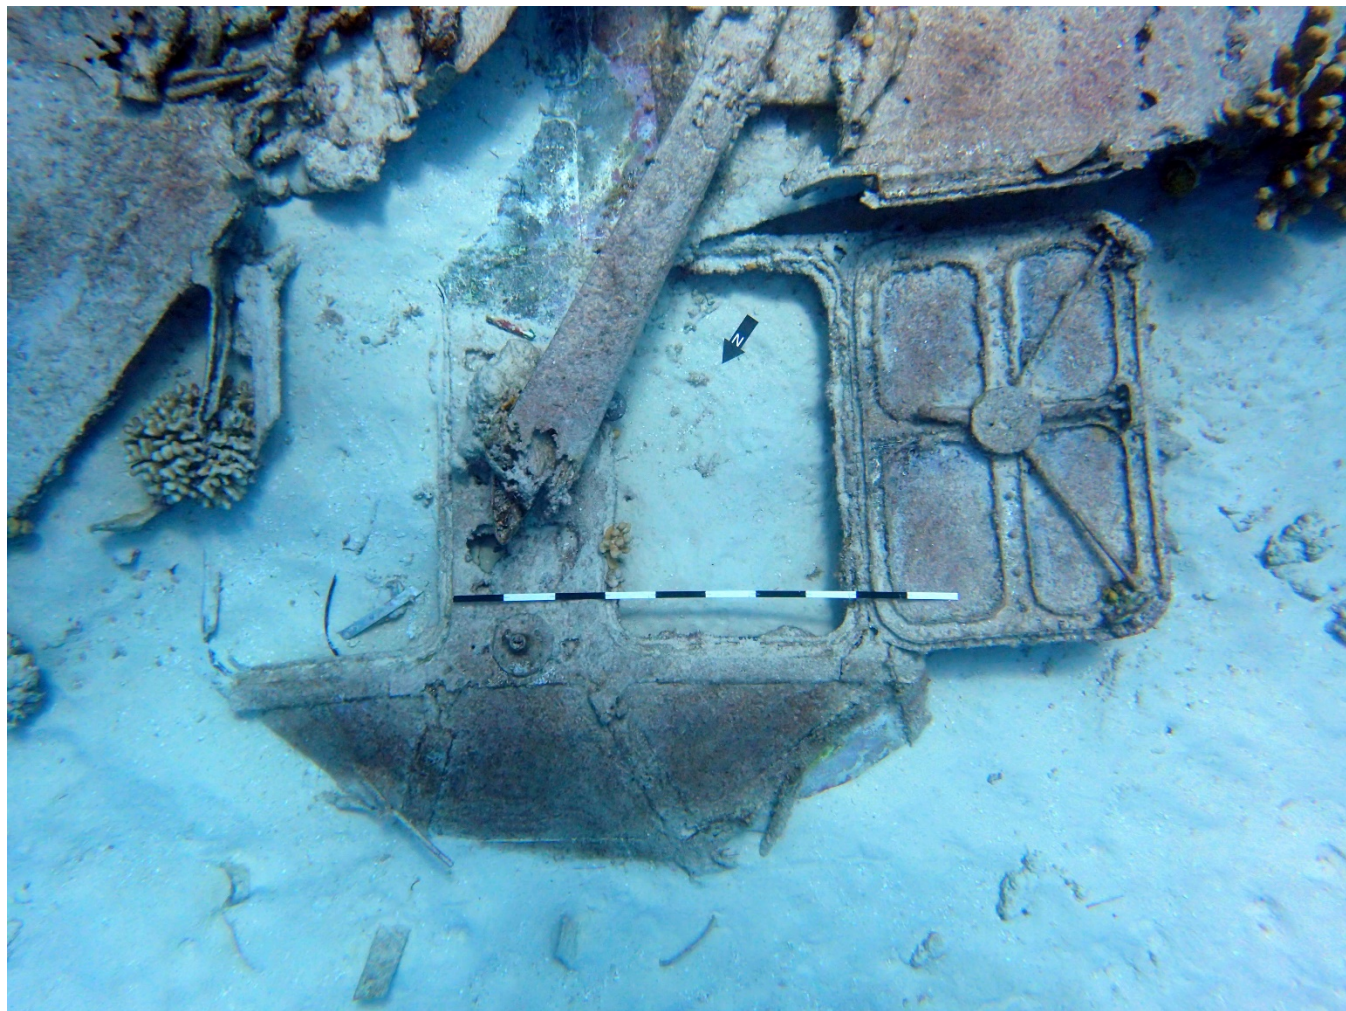
Figure 5

Cockpit canopy: The main feature of the site is the cockpit canopy (Figure 5). Situated directly above the pilot and copilot seats, the top three windscreen windows are exposed, while the very tops of the port and center main windscreen windows are visible above the sand. A windscreen wiper, with rubber blade still attached, emerges from the sand on the starboard side. Directly aft of the upper windows, the escape hatches open into sand 40 cm below. The port (pilot's) hatch cover is present and in the open position, while the starboard (copilot's) hatch sill is buried and the cover is missing.

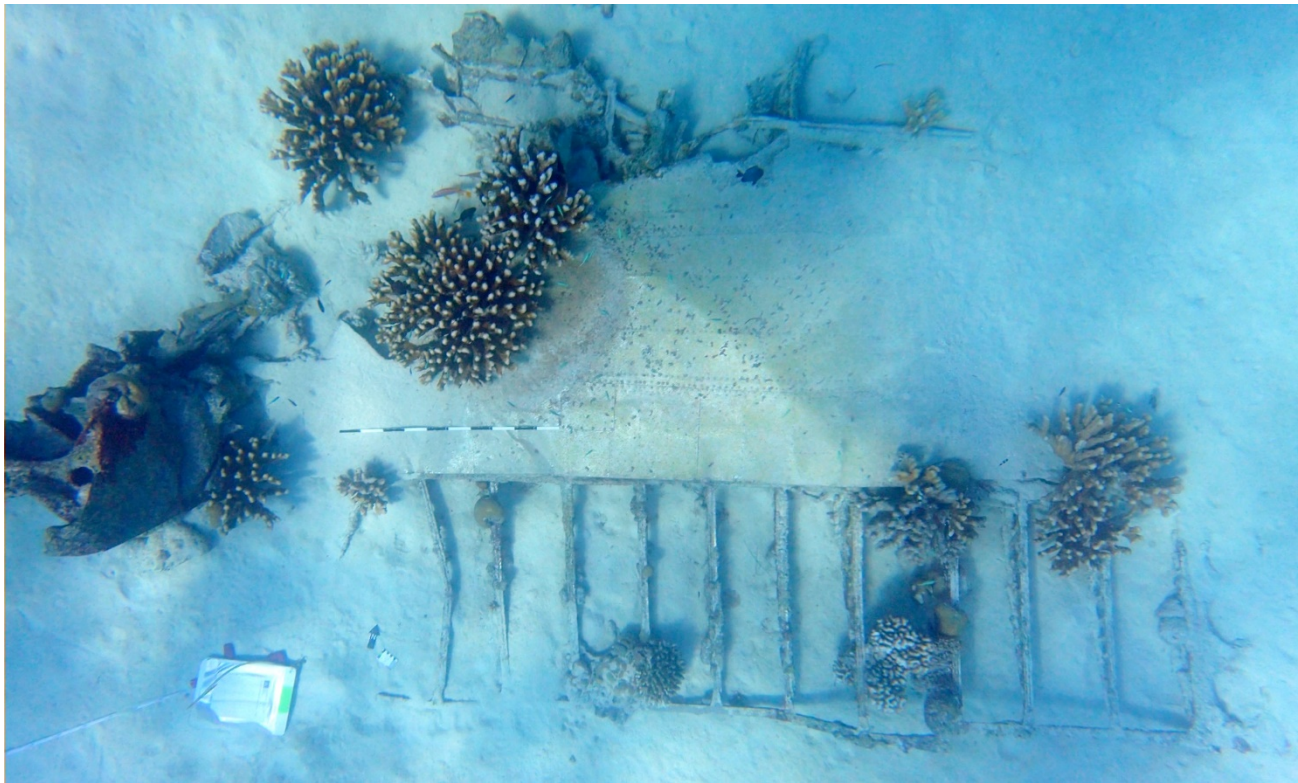
Figure 11

Wing: A large section of wing rests partially buried 65 m to the northeast of the cockpit canopy (Figure 11). This represents the largest section of wing present on the site; other pieces are

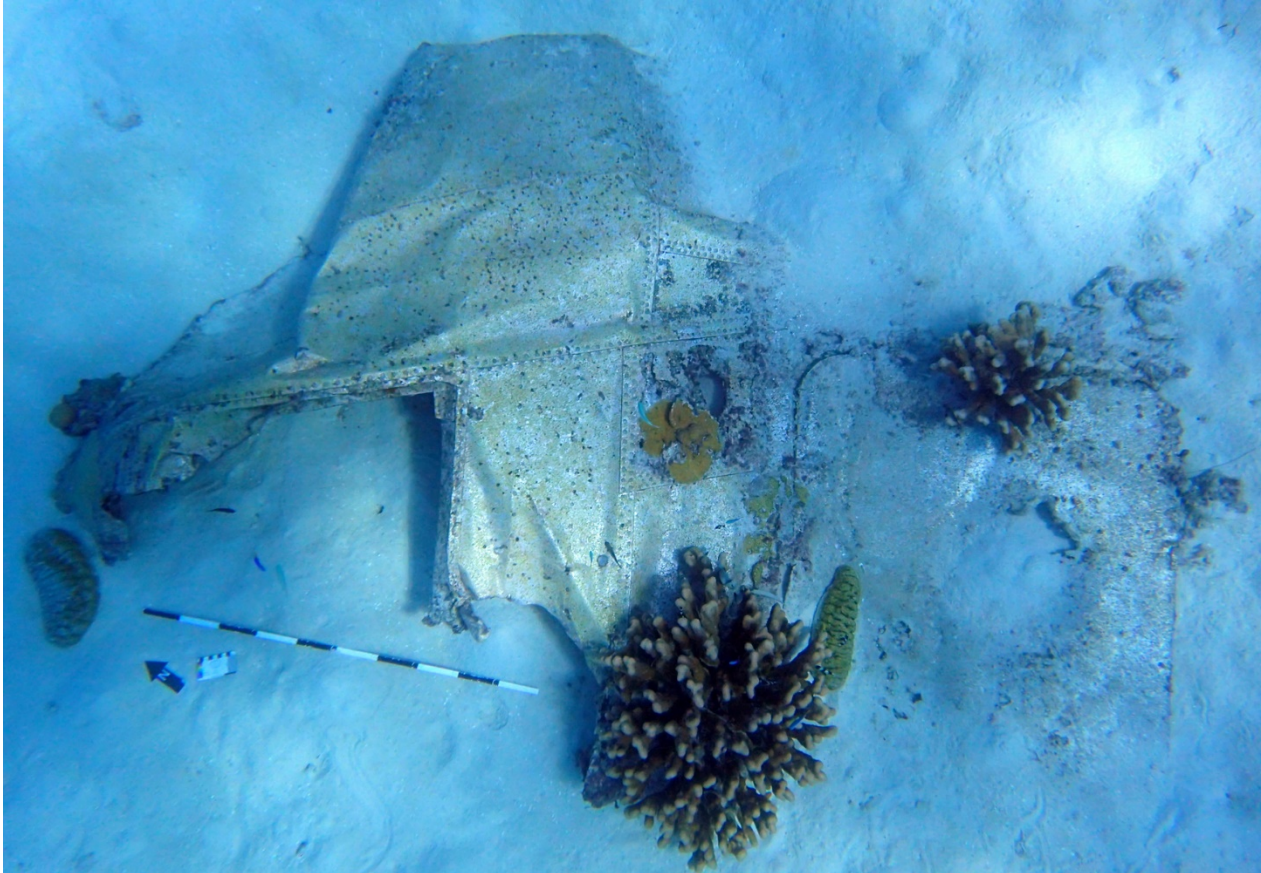
Figure 14

Port anchor hatch: Originally located beneath and forward of the cockpit, a section of fuselage containing the port anchor hatch (Figure 14) is located 45 m southwest of the cockpit canopy. This section of hull is warped and damaged, with at least one panel is missing completely. The hatch and hatch cover are both present.
