ANALYSIS OF INFRASTRUCTURE DAMAGE AFTER SUPERSTORM SANDY: A CASE STUDY OF LONG BEACH, NY

A Thesis

Presented to the Faculty of the Department of Geography, Planning, and Environment
East Carolina University

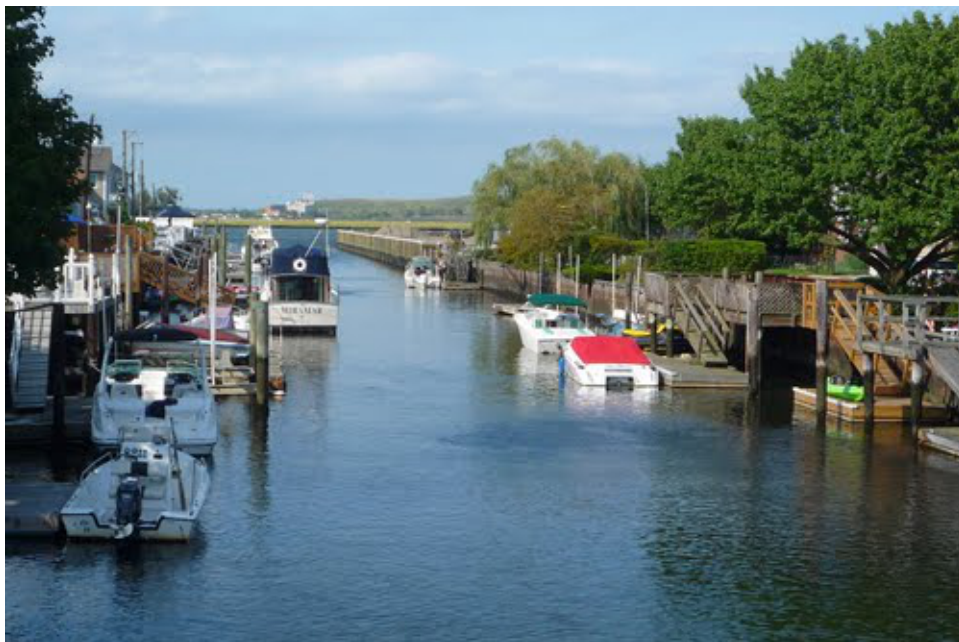
Figure 3.4. Photograph of a canal at ground level

Long Beach is densely developed and variations in the orientation of neighborhoods and housing density are pronounced (Figure 3.3). In some areas of the city, roads are tightly packed and oriented North-South, aligning perpendicular to the barrier island, whereas others are less dense and align East-West, aligning to the orientation of the beach. There is also a section of Long Beach where roads are irregular and align in neither direction. In the northeast portion of Long Beach, four canals facilitate boat access to the bay (Figure 3.4). These canals are immensely attractive to boaters looking for access to the ocean from their property. Nearly every house has a dock and a boat in the canal. This area is also identified as a region highly susceptible to flooding due in part to its low elevation but exacerbated by the presence of these canals (Tanski, 2007). Ultimately the canals provide a recreational outlet for a small number of properties situated on them but cause grievance and headache to a much larger area as they frequently exacerbate bay-side flood events.

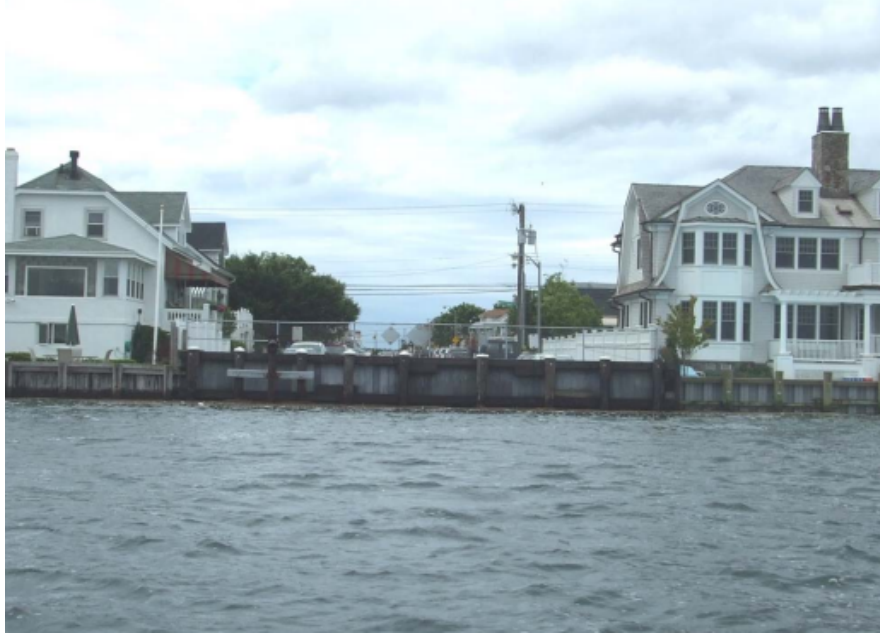
Figure 3.5: Bulkheads in the study area of differing elevations. Courtesy of Coastal Planning & Engineering: Bayside Flood Protection Plan 2009

It is well known the city has a problem with flooding from the bay-side of the barrier island after major storm events, from rainfall, surge, and tides alike. The 2009 Coastal Planning and Engineering “Bayside Flood Protection Plan,” submitted to the Long Beach government, notes that ongoing studies by the US Army Corps of Engineers had not considered bayside flooding as an issue in Long Beach. The 2009 plan recognizes issues with bulkheads being semi-continuous along the bay and being of insufficient heights to block out storm surge. Some areas are without bulkheads entirely whereas others are lined with bulkheads even up and down the canals. The bulkheads vary in elevation (Figure 3.5) others are inferior and are riddled with holes (Figure 3.6). It was determined that, for the system to be effective at all, all bulkheads should be elevated to 9 feet, continuous over the entire bay-side of the barrier island (Coastal Planning & Engineering, Inc., 2009). Some homeowners adjusted their own bulkheads accordingly, whereas others were maintained by the city. As of 2009, the city of Long Beach was focusing on elevating bulkheads along the canals and at street ends.

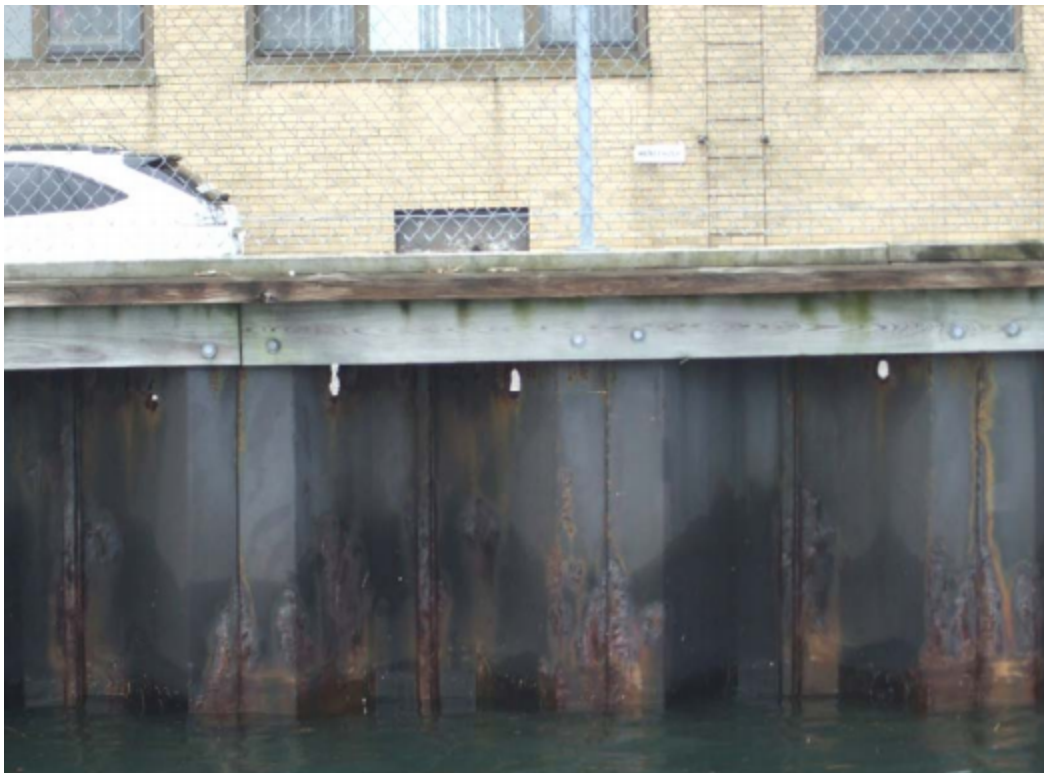
Figure 3.6: Bulkheads of inferior quality. Courtesy of Coastal Planning & Engineering: Bayside Flood Protection Plan 2009

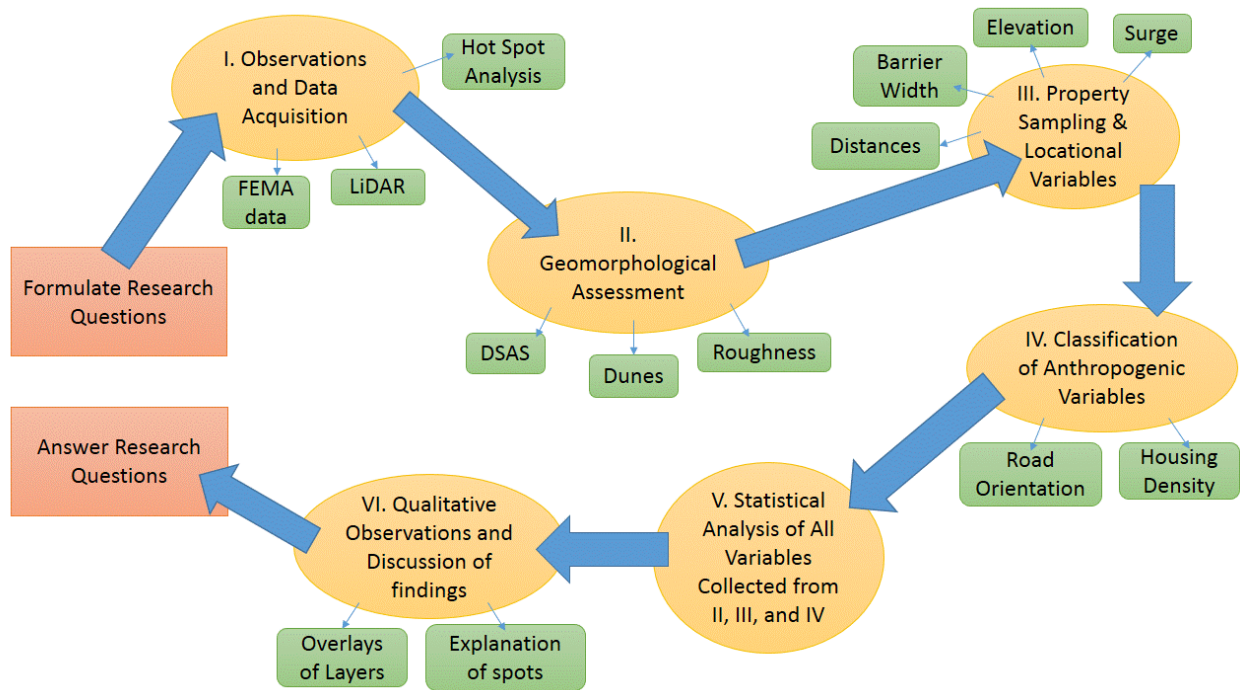
Figure 4.1: A flowchart of the process taken to complete this research.

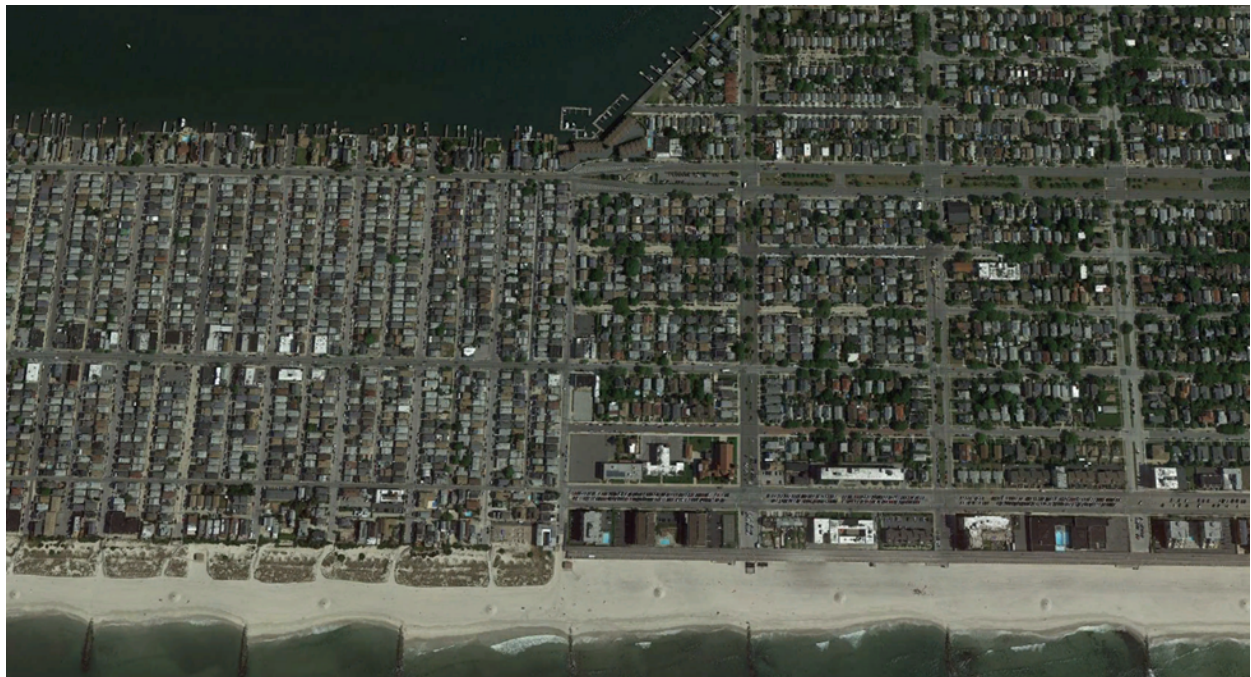
The road orientation was initially recorded as “north south,” “east west,” or “other.” Because only one property actually fell in a location where the road was oriented “Other,” the property was classified as “East West” because this more closely reflected its directionality and enabled use of a categorical variable (Figure 4.3 A & B).

Figure 4.3 A: Example of “North South” (left) and “East West” (right) road orientation

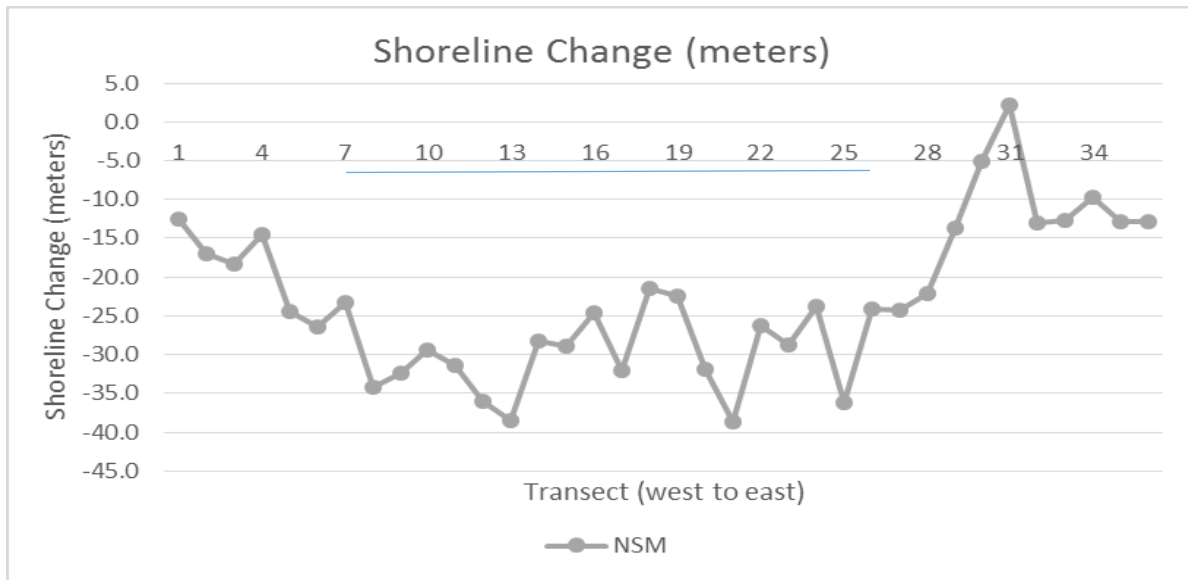
Figure 5.3: Net shoreline movement from West to East, with the boardwalk

Net Shoreline Movement, the variable collected by the DSAS tool, produced a significant and strong Pearson Correlation of .518. Because it was a continuous variable and also proved significant in the initial test, a T-Test was conducted against Net Shoreline Movement. The T-Test was selected because it explores whether the difference between the two variables was likely to have occurred by chance or randomly. A strong T-Test has a large sample size with minimal variation within each of the two. This was the case with Net Shoreline Movement. The T-Test produced a value of 8.8 (Table 5.2). This result suggests that net shoreline movement affected levels of infrastructure damage.
