DEVELOPING A SUPPLEMENTAL ARCHAEOLOGICAL METHODOLOGY:
A PHOTOGRAMMETRIC STUDY OF SHIPWRECKS
USING A LOW-COST ROV

A Thesis

Presented to the Faculty of the Program in Maritime Studies of Department of History
East Carolina University

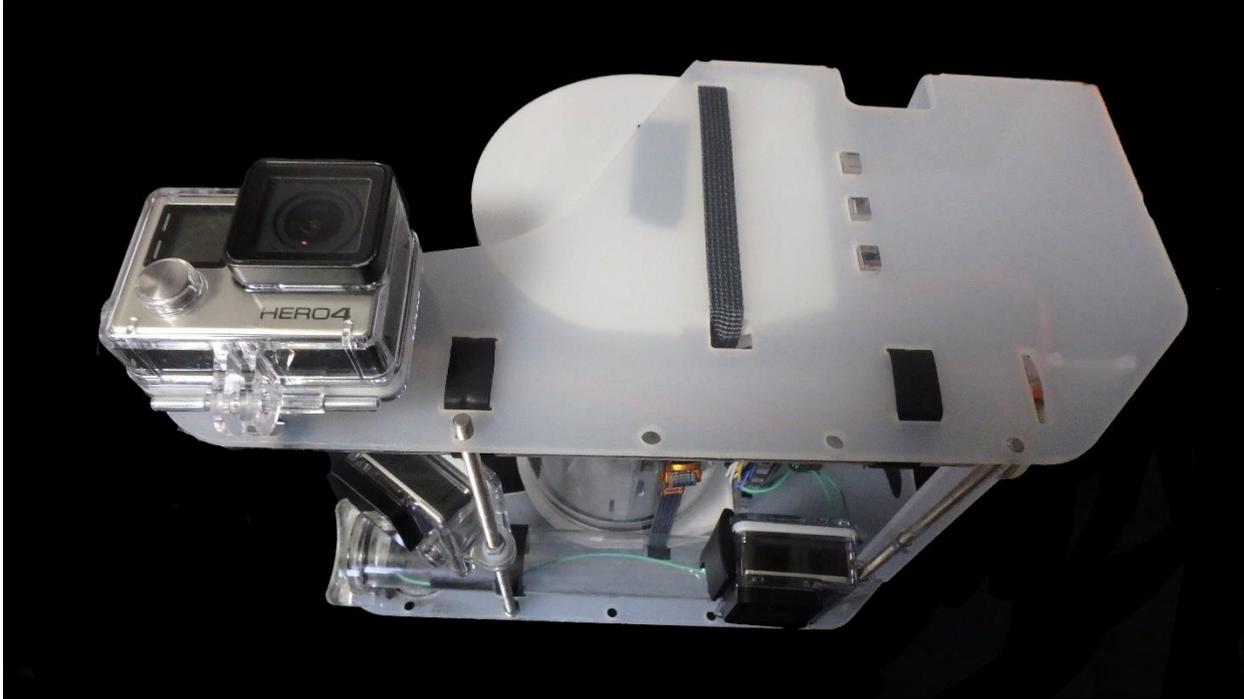
Figure 3. OpenROV 2.8 outfitted to capture profile view (K. Clevenger 2016).

The initial orientation of the GoPro cameras failed to acquire all the photographic images needed to create complete 3D models of the first two case studies. For the latter three case studies, the ROV GoPro configuration was adjusted to better capture profile data. A three ounce weight on the port side of the ROV was removed, and a GoPro was secured facing outwards in its place, thereby capturing profiles on the port side of the ROV. The second GoPro was placed on the aft threaded rod and set to capture footage directly below the ROV, while the forward GoPro position remained unchanged from the initial camera configuration (Figure 3).

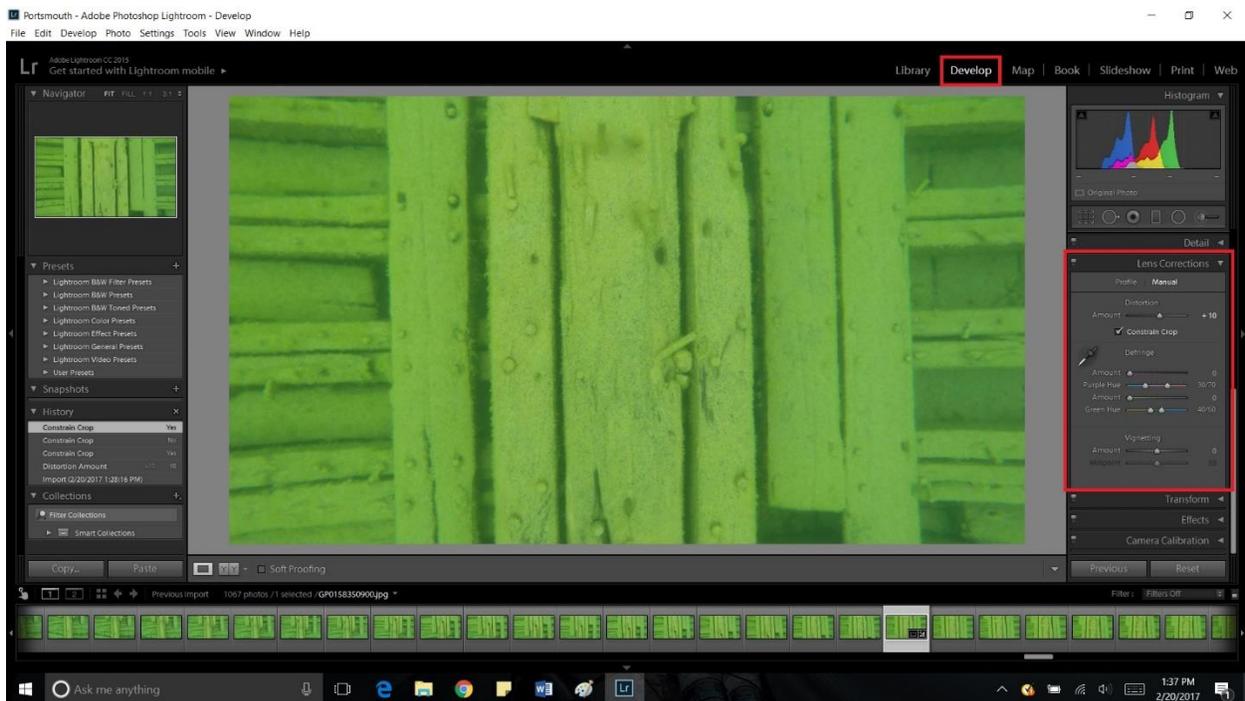
Figure 19. Correcting wide angle lens distortion in Lightroom (K. Clevenger 2017).

Creating a new catalog for each folder of still photographs kept images organized. After importing the images (Figure 18), lens distortion was corrected in one image by navigating to the "Develop" work pane, and under "Lens Correction," manually correcting the distortion in the image with the "Constrain Crop" feature (Figure 19). The lens correction setting used was "+10" for all images used in this project.

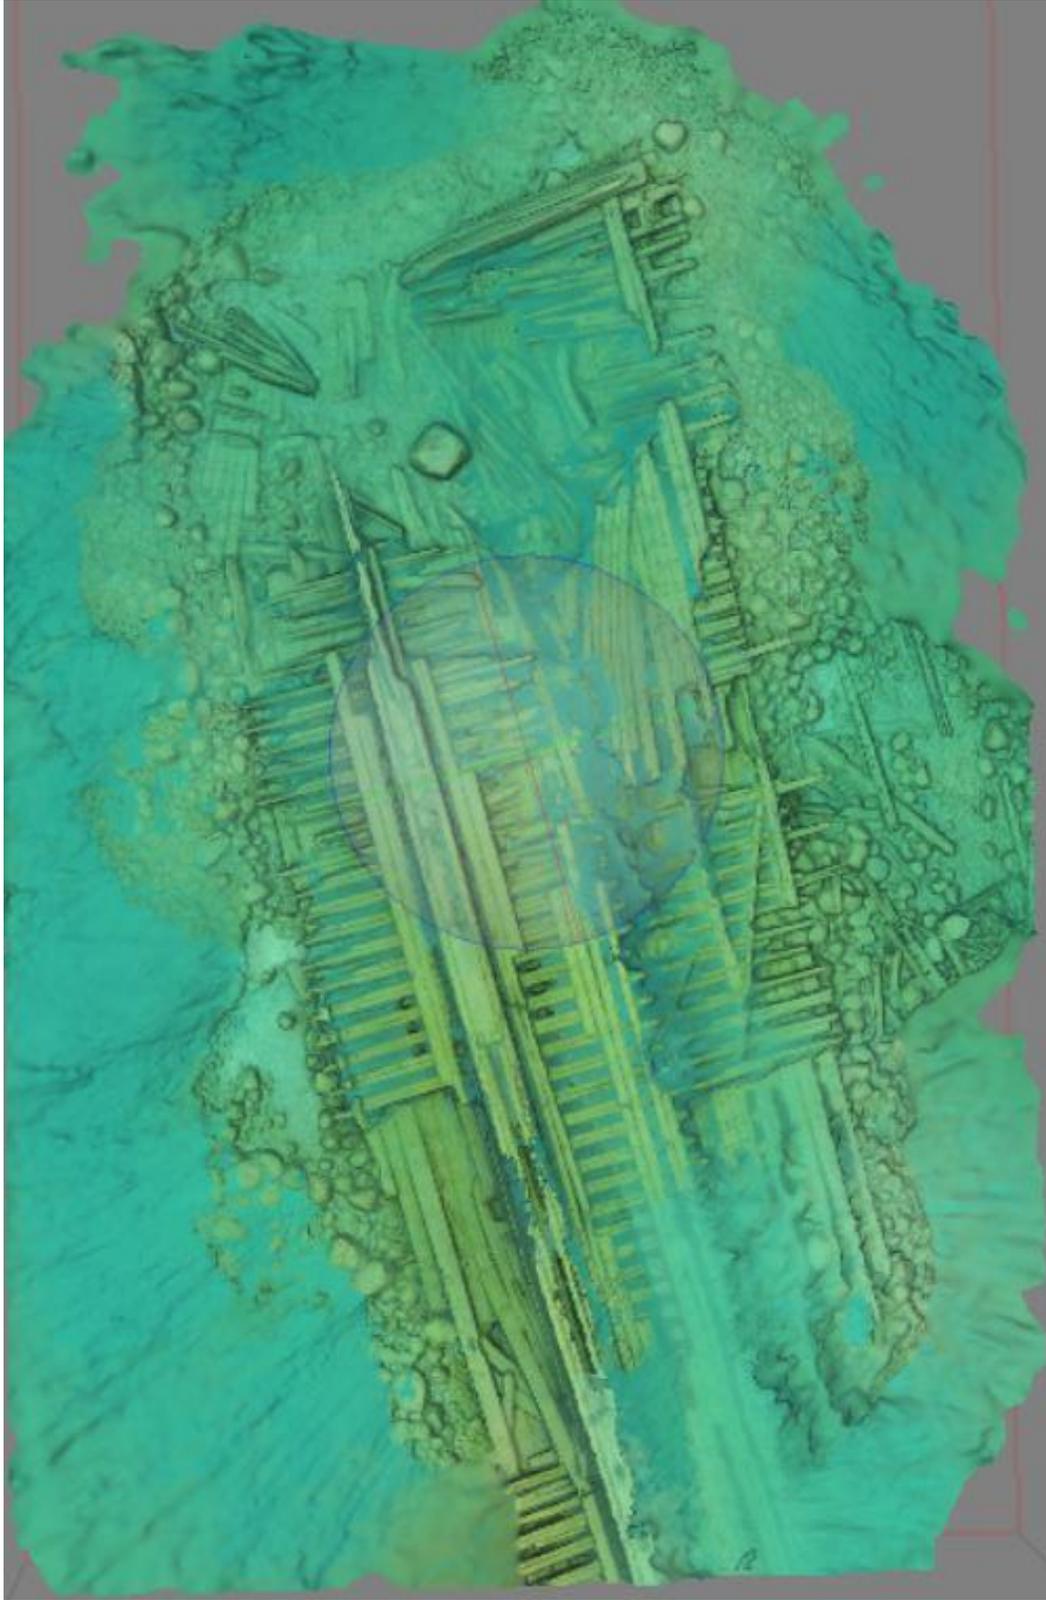
Figure 23. “Mesh” process of *Portland* from 1080p60 resolution in PhotoScan (K. Clevenger 2017).

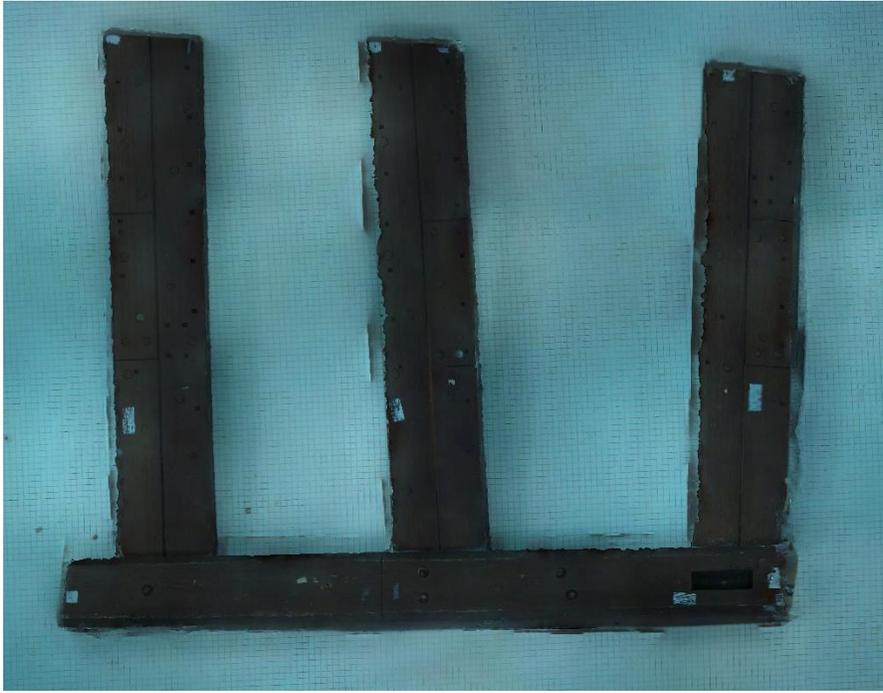
Figure 42. Orthophoto of *Sinkentine* from 4k30 resolution (K. Clevenger 2017).

The still photographs of both resolutions for *Sinkentine* were extracted at 1 fps, resulting in 481 still photographs from the 4k30 footage and 326 still photographs from the 1080p60 footage. The 4k30 *Sinkentine* model (Figure 42) achieved 63.8 percent alignment, while the 1080p60 model (Figure 43) attained 70.9 percent alignment. It is possible that the lower percentages of photo alignment are a result of the *Sinkentine*'s placement on a pool floor that slopes in a V-shape and resulted in shadows under the frames (Figure 44). Another possibility is the bright LED lights in the Minges Natatorium pointed directly at the water resulted in reflective areas in the video footage. The *Sinkentine* 4k30 model resulted in 1,726,596 faces and 865,961 vertices, while the 1080p60 model contained 252,287 faces and 126,826 vertices. In both 3D models of *Sinkentine*, tool marks and fasteners can be seen when the models are magnified.

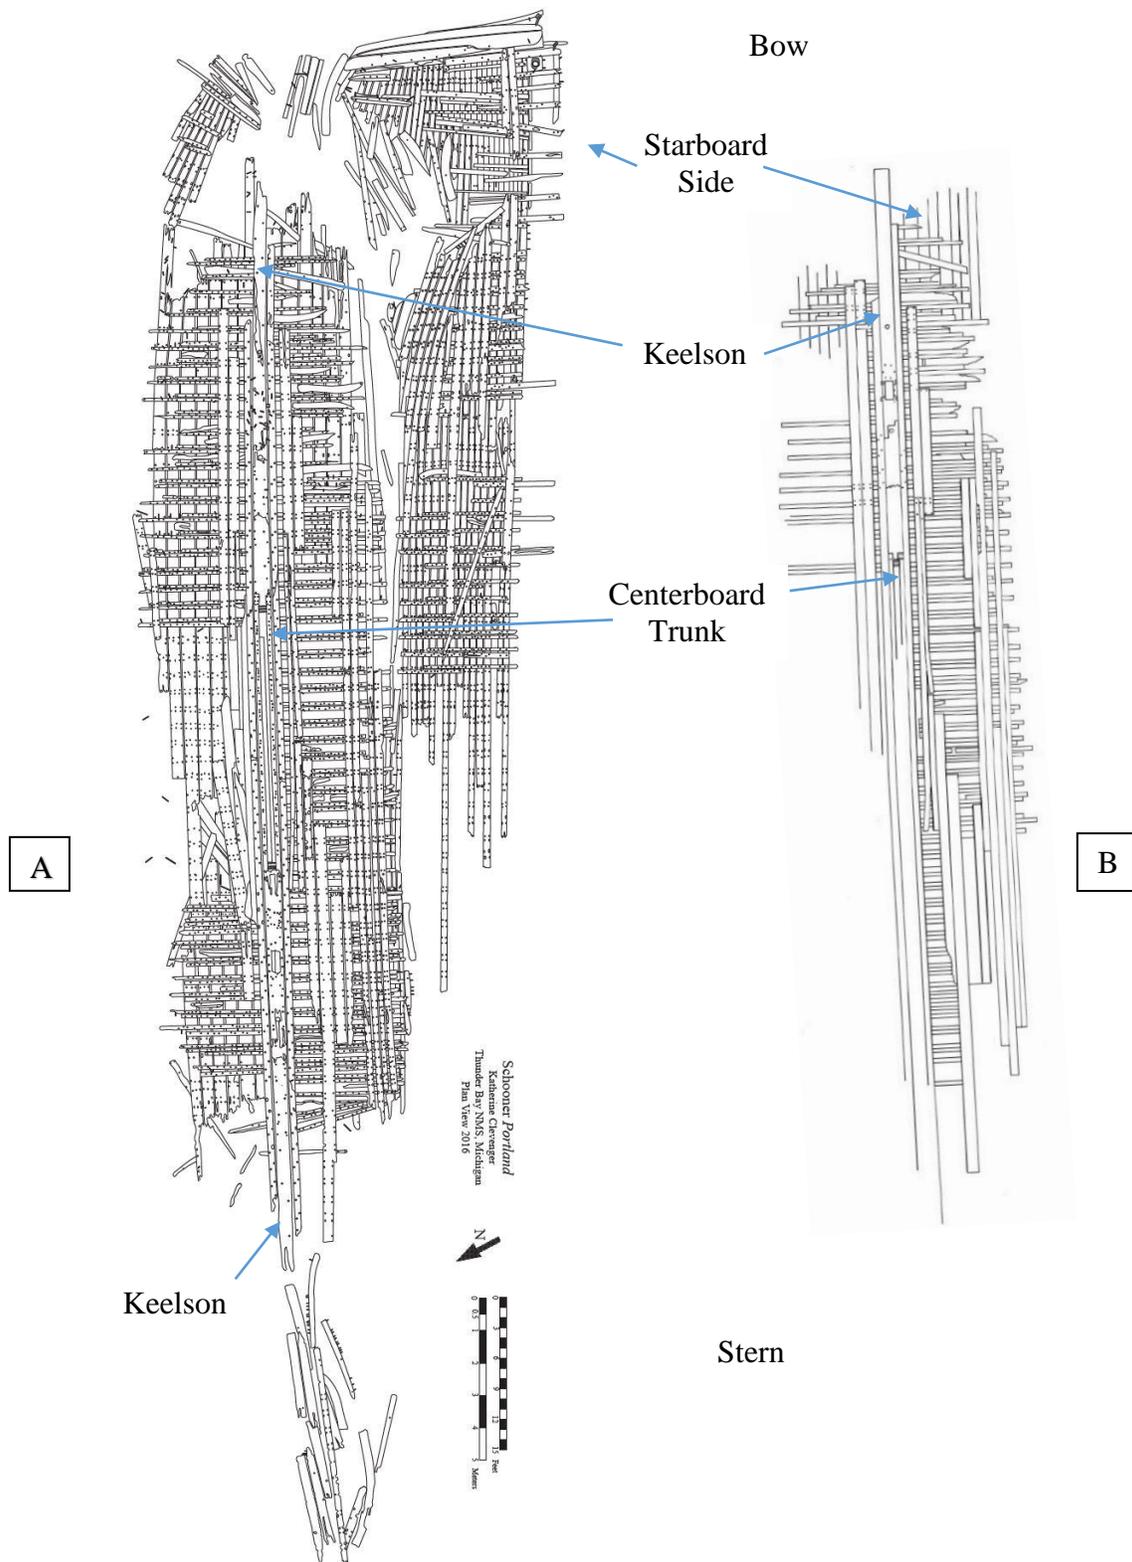
Figure 45. Comparison of *Portland's* site plans created using different mapping techniques (A: photogrammetry, B: traditional mapping) (W. Lusardi 2007, figure 45b; K. Cleverger 2017, figure 45a).

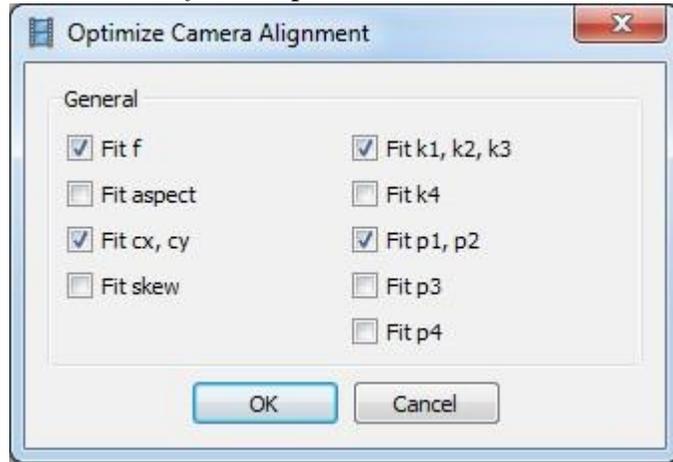
Select camera parameters you would like to optimize. Click *OK* button to start optimization process.

*Optimize* button on the *Reference* pane toolbar.

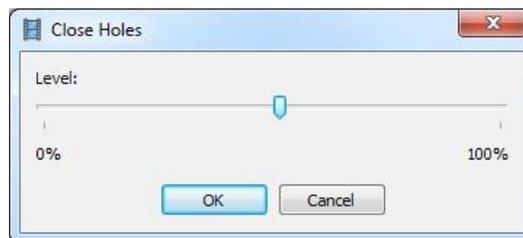
If the overlap of the original images was not sufficient, it may be required to use *Close Holes* command from the *Tools* menu at geometry editing stage to produced holeless model. In *Close Holes* dialog select the size of the largest hole to be closed (in percentage of the total model size).
