Illuminating the Lighthouse:

An Historical and Archaeological Examination of the Causes and Consequences of Economic and Social Change at the Currituck Beach Light Station

A Thesis

Master of Arts in Maritime Studies

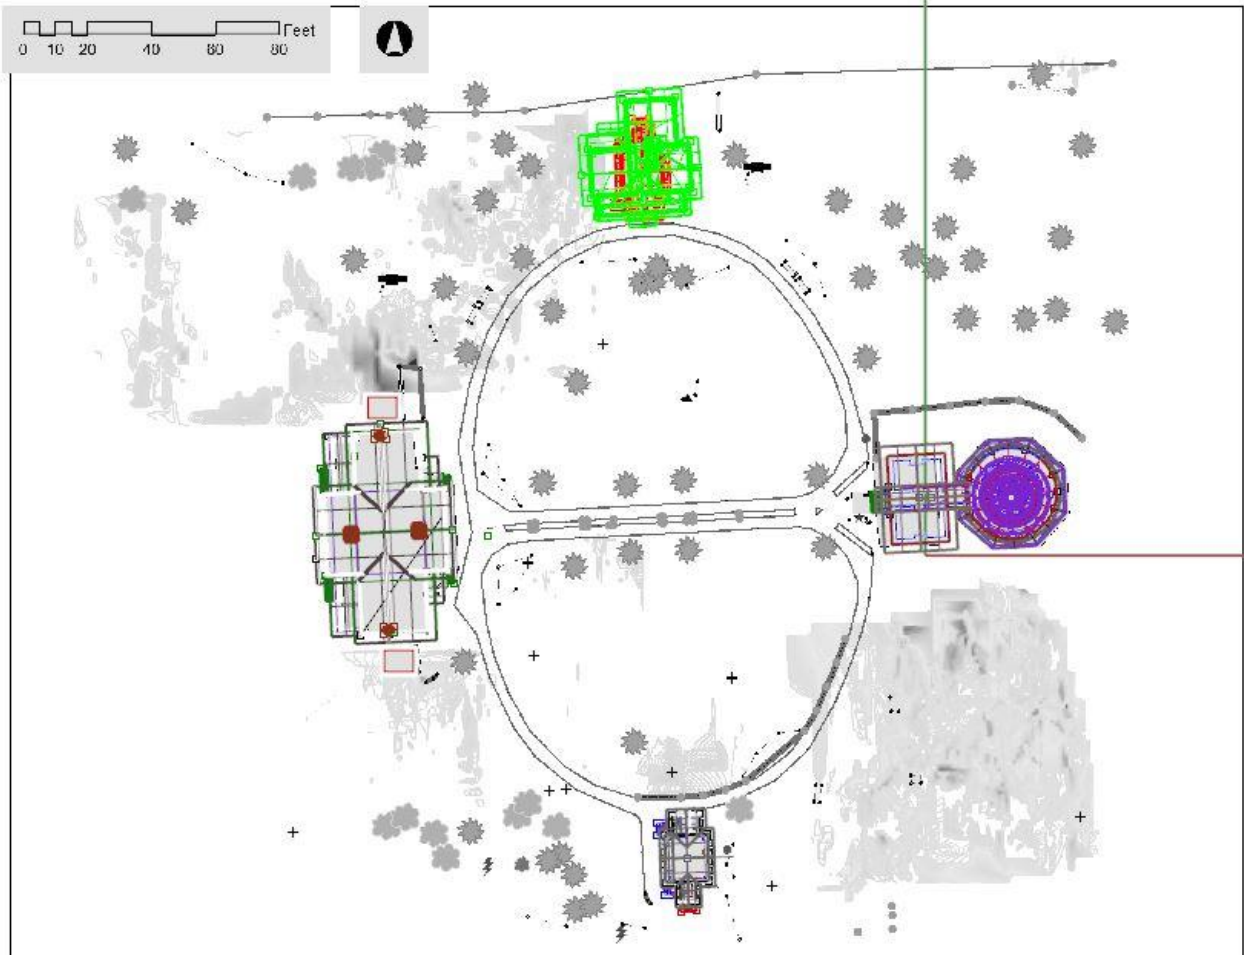
Figure 4.4. A *Rhino 5* software image of the location of the small light keeper's house (in green) over the foundation of the old north storage building (in red) (B. Scott Rose 2017).

when the small keeper's house was brought on site and placed in its current location (Figure 4.4) (NPS 1999:7.1). Areas were sampled based on historical photographs. The research team searched these areas for patterns of anomalies that would indicate the possible new location of the north storage building based on ingress/egress refuse deposits and foundation signatures. Evidence for temporary structures such as a blacksmith's shop, carpenter's shop, and cement shed may be evident in the analysis of resulting data.

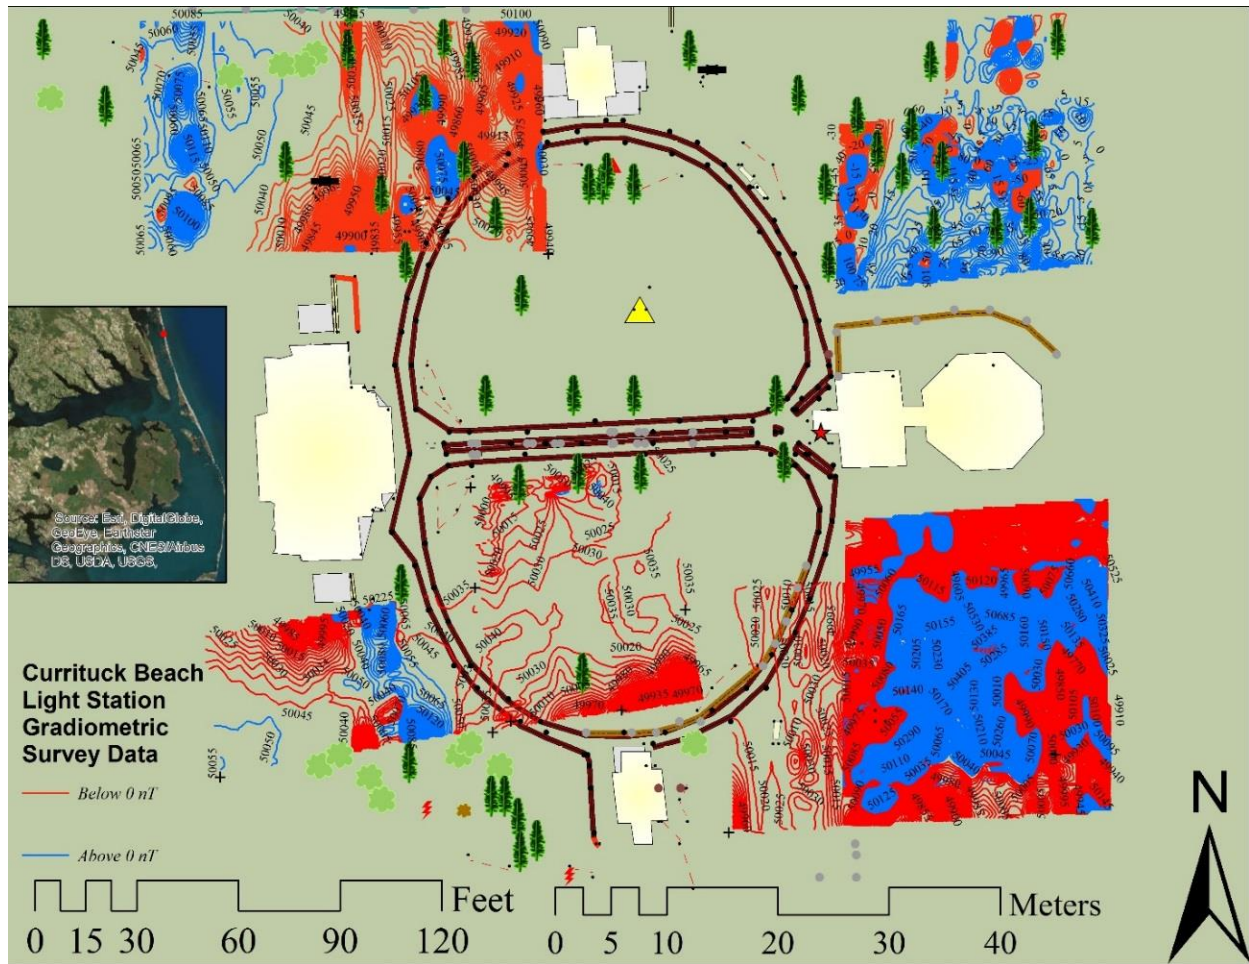
Figure 4.5. Map showing areas of gradiometric surveys conducted at the CBLs and unanalyzed data. (B. Scott Rose 2017).

The second area selected for survey was to the south of the first area and measured 24 m by 14 m. GPS signal acquisition continued to be a problem in this area due to foliage cover. Information such as the origin point, number of lines, length of lines, and direction of the survey were used to geographically rectify the exact location of the study area. The information recorded in the survey is accurate to one meter due to the GPS error and deviation of the technician from the path of survey line due to obstacle avoidance. Figure 4.5 illustrates the coverage area of each survey.

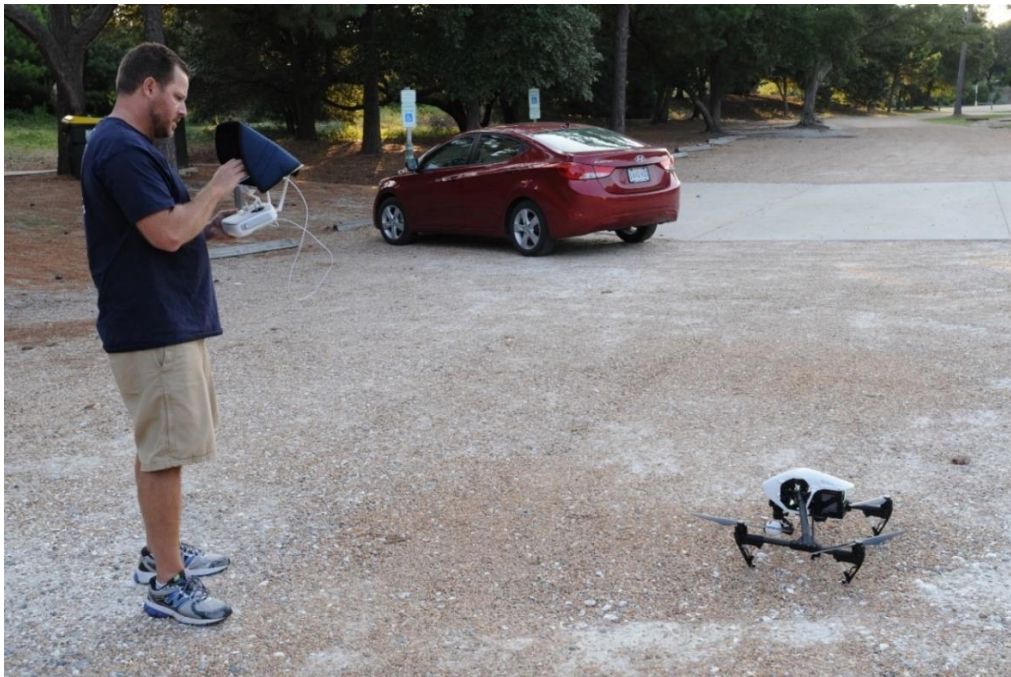
Figure 4.10. John McCord prepares a drone for a flight to capture photos of the lighthouse complex (Nathan Richards 2015).

The primary investigator and UNC-CSI provided the necessary photographic equipment required for data collection in this phase. A Samsung 16-megapixel cell-phone camera, a Sony Cybershot, a Nikon D300, and a DJI FC350 attached to a drone were used to capture images of the complex. The drone, which was a DJI Inspire 1, was provided and flown by John McCord from the USC-CSI (Figure 4.10).

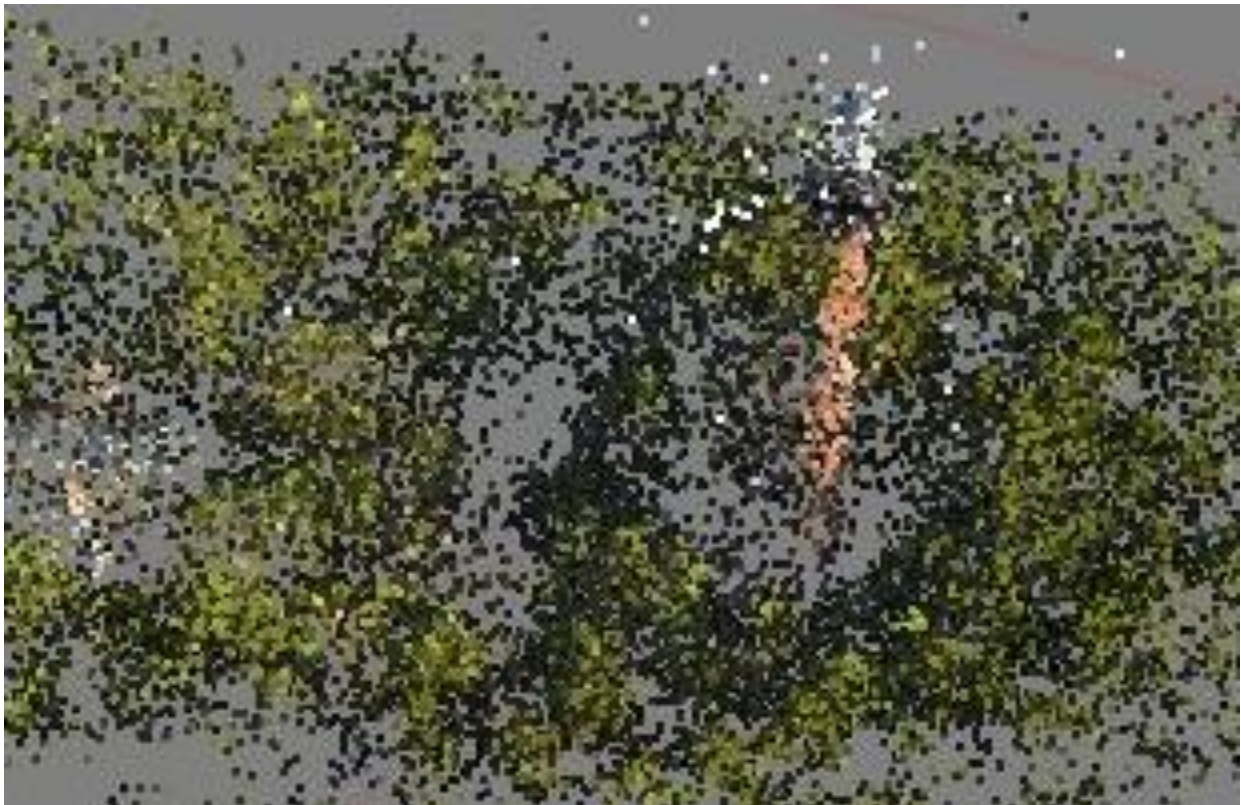
Figure 4.13. Sparse point cloud generated of CBLs of the complex using *Photoscan*. (B. Scott Rose 2017).

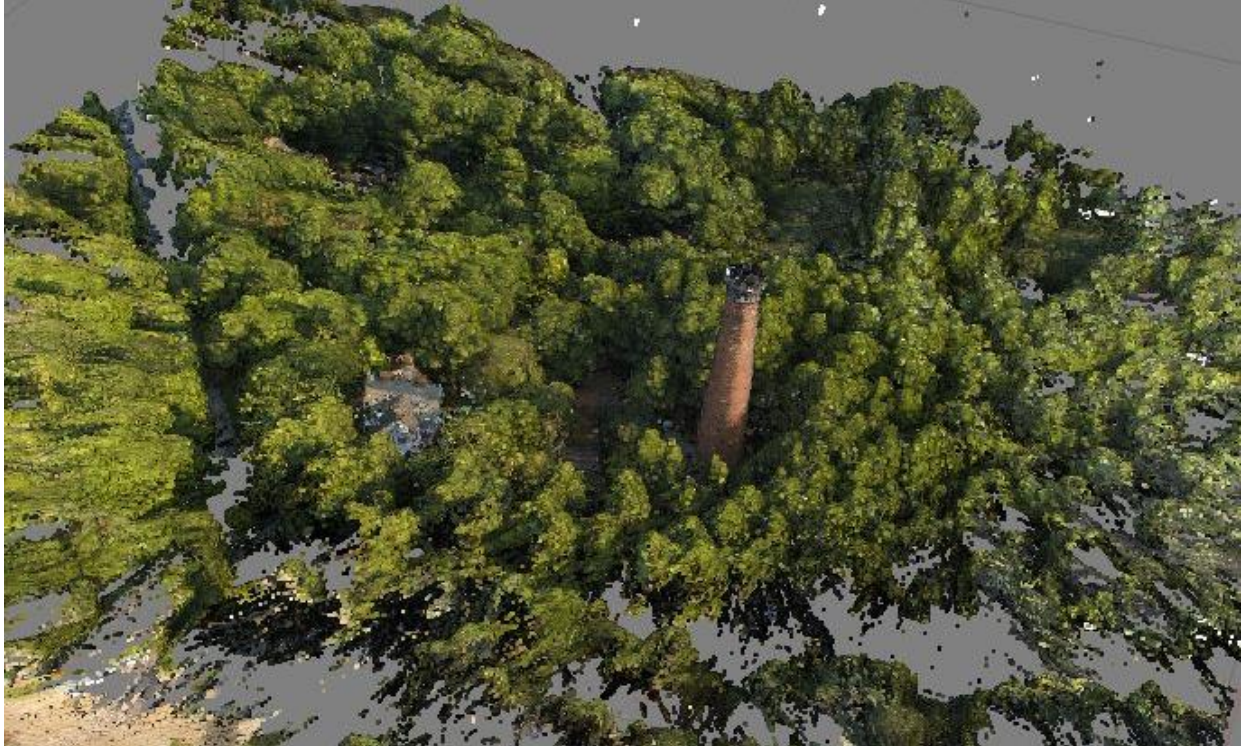
Figure 4.14. Dense point cloud generated of CBLS of the complex using *Photoscan*. (B. Scott Rose 2017).

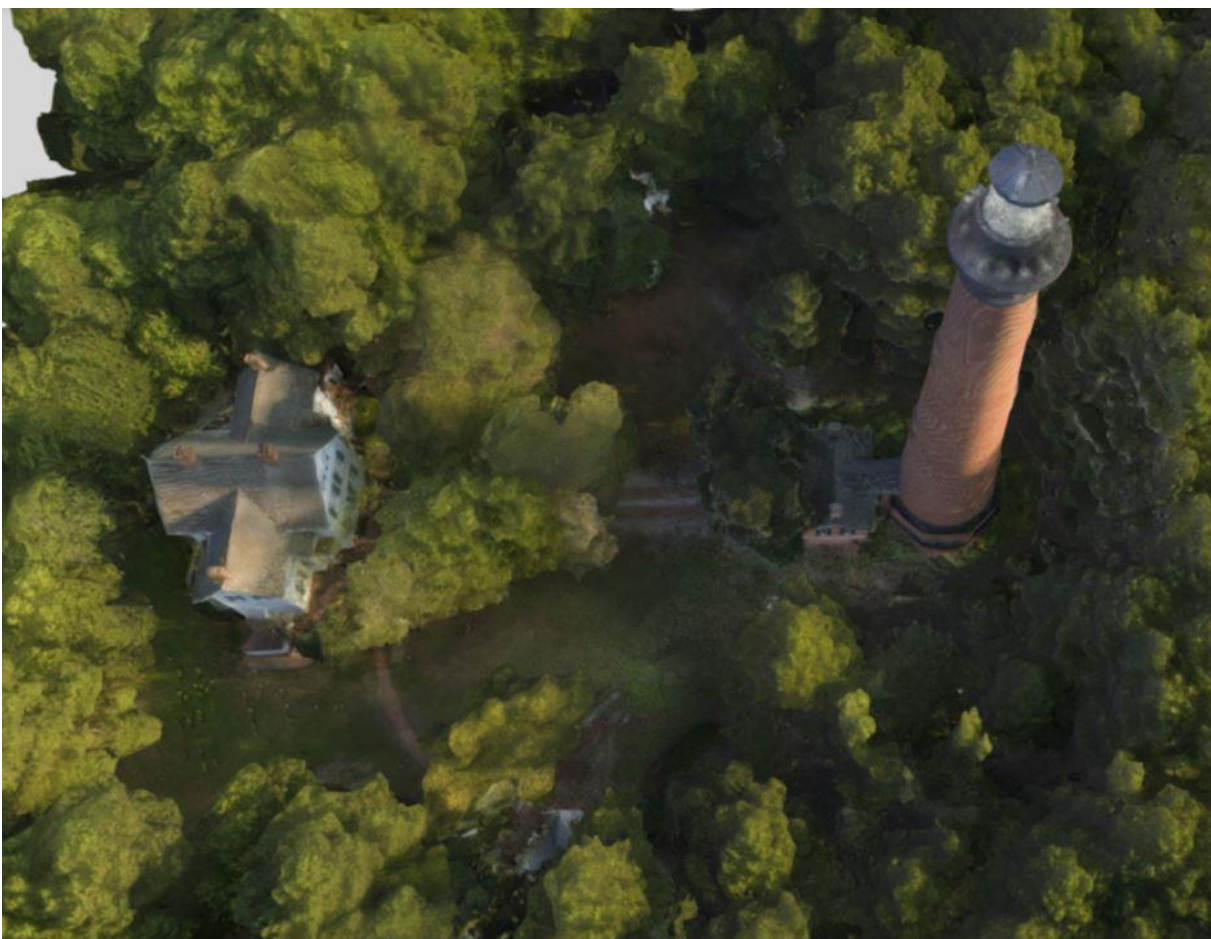
Figure 4.16. Photographic textures applied to wire frame model generated of CBLs over all complex using *Photoscan*. (B. Scott Rose 2017).

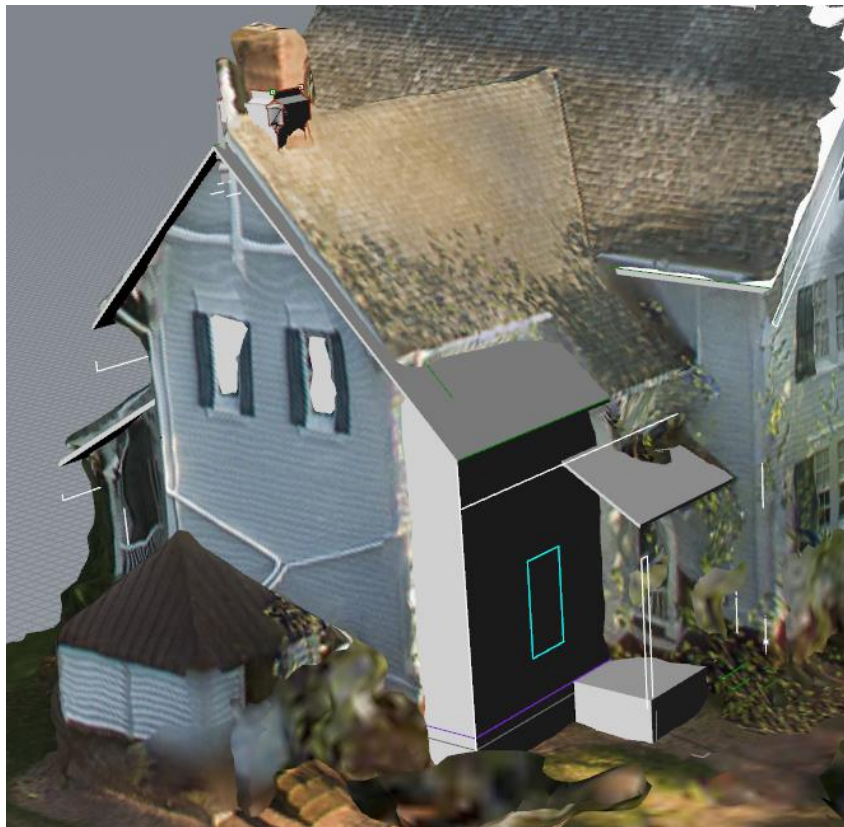
Figure 4.21. Photogrammetric and CAD virtual models of the CBLs big keeper's house combined. Both models are visible in this example (B. Scott Rose 2017).

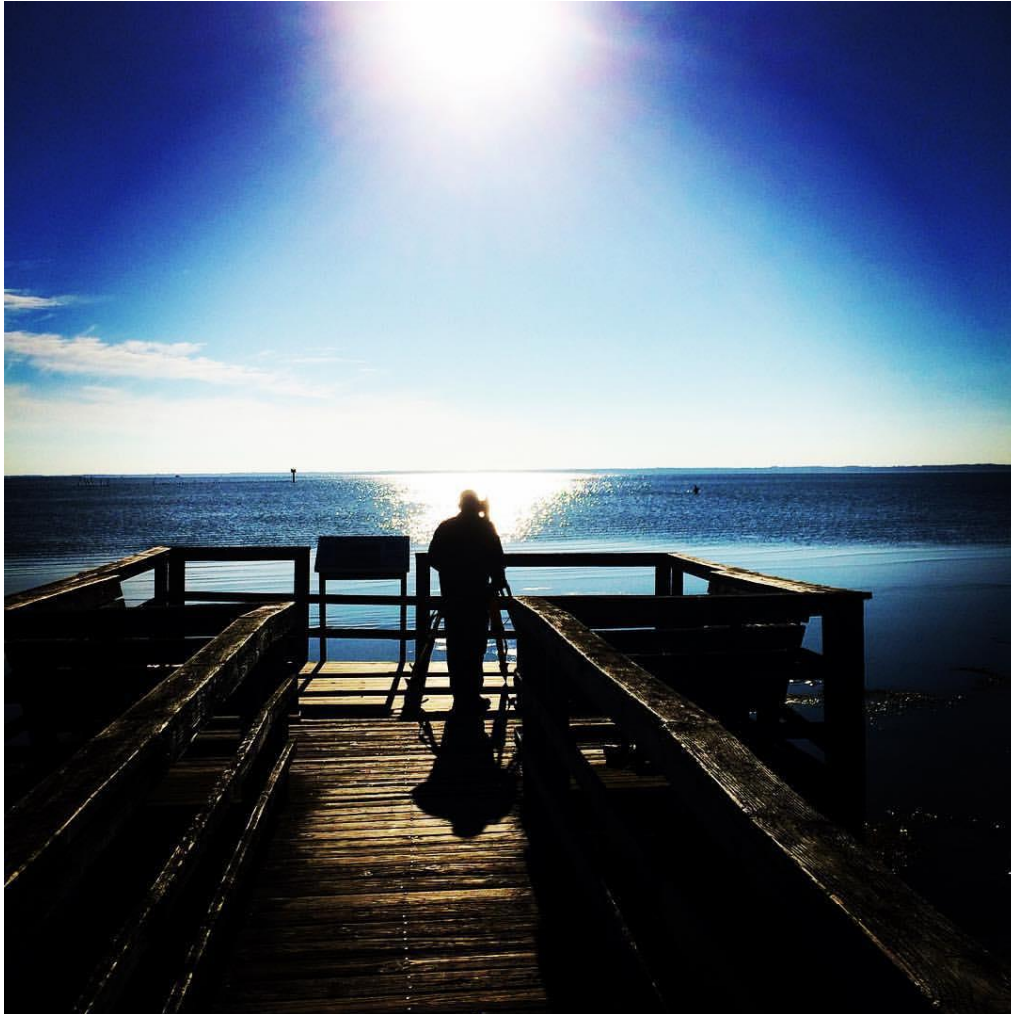
Figure 4.23. Parker works the total station as Rose holds reflective prism at located pilings in the distance (Ryan Bradley 2015).

The researchers conducted an in-water survey in the shallow water extending toward the sound from the still existent wharf pilings associated with the old Corolla lighthouse site (Figure 4.22). The team deployed a total station on the existing wharf structure (Figure 4.23). This apparatus was set into place, and a back-sight point was taken from the apex of the historic walk bridge that exists on the Whalehead property (McPherron 2005:6,7; McCoy 2009:276). The researchers chose this back-sight location for its potential longevity. Surveyors not only use geodetic

The shore team reset the total station on one occasion because of unintentional disturbance by a tourist. A series of three points were taken that repeated the last three before the disturbance. This duplication allowed for recalibration and realignment should it be required during processing and analysis. The researchers saved these points in the total station and noted them in the field notebook.

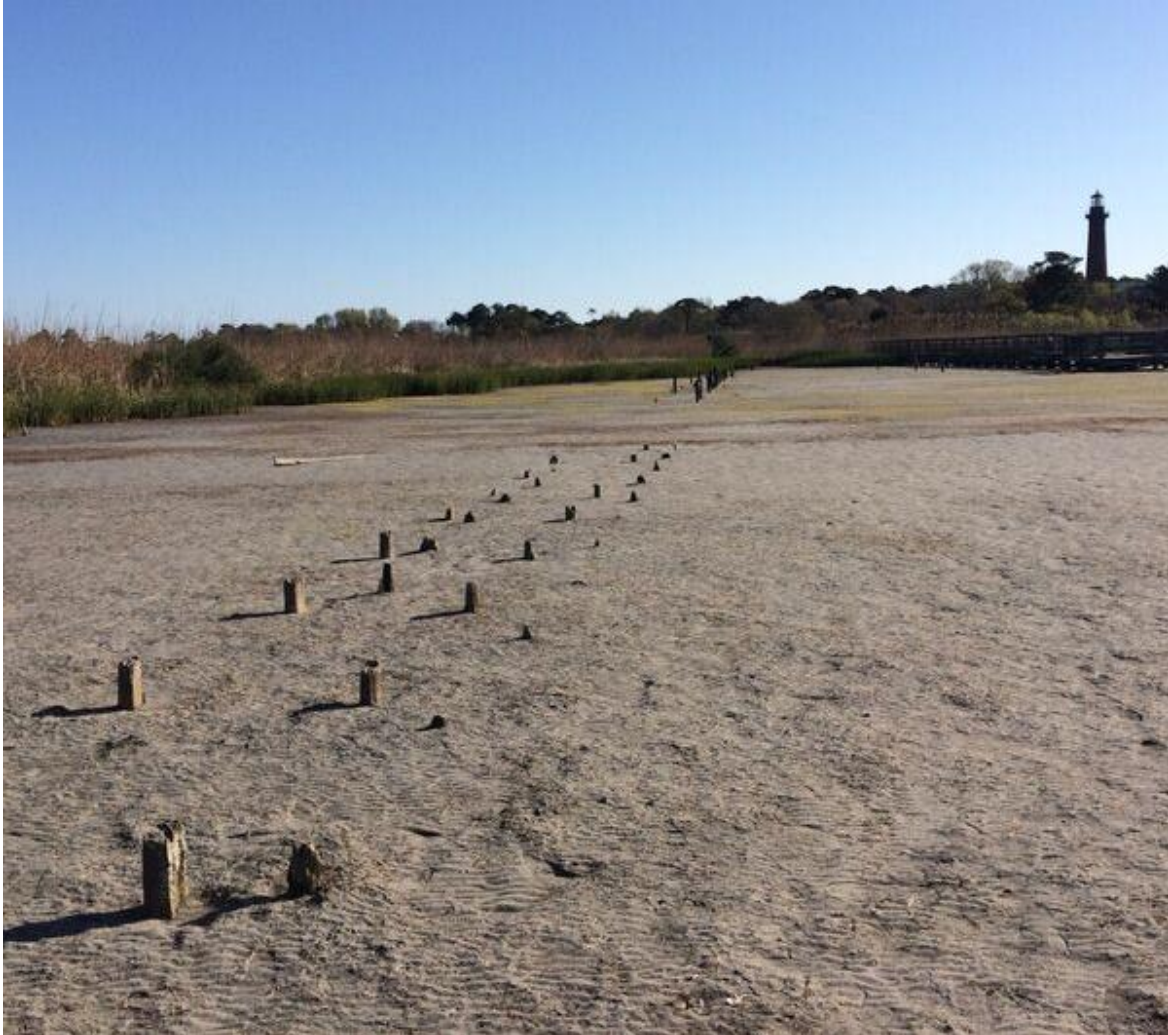
Figure 4.24. Photograph of remaining wharf pilings in Currituck Sound during a rare drying event (Meghan Agresto 2016).

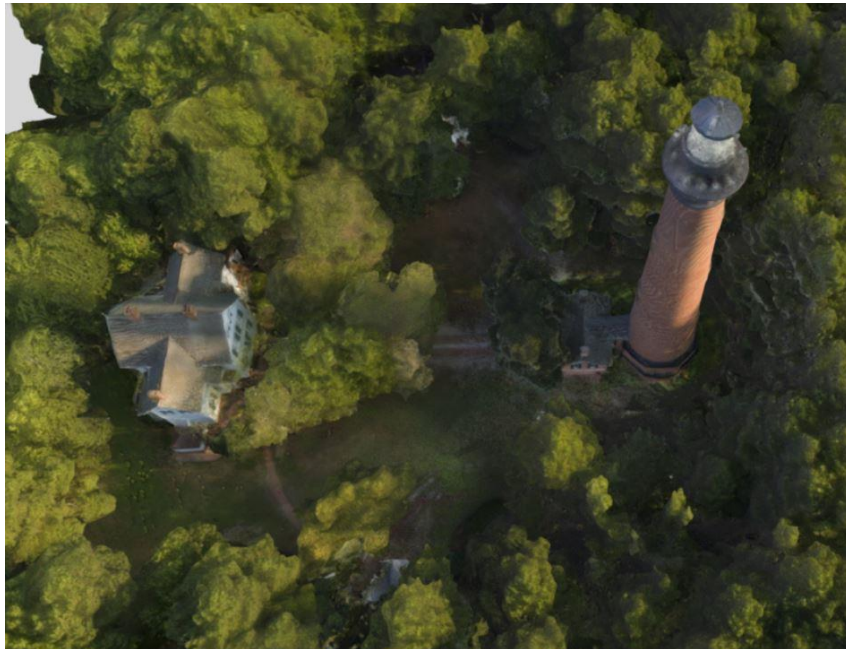
Figure 5.18. Virtual 3D model created using Agisoft *Photoscan* (B. Scott Rose 2017).

Hundreds of photographs were taken from several locations and compiled with aerial photographs for processing in photogrammetric software. Each existing structure was modeled. Due to the foliage cover, not all the photographs were usable for this application. Each model was placed in latitude and longitude coordinates based on known corners of each building in *Rhino 5*. Photogrammetric models were created for each of these and combined with the models from the original construction drawing that were completed using the program *Rhino 5*. After these models were combined, the author compared the actual construction of the buildings and changes to the buildings over time to the original intent of the designer. Eventually, all models were imported into GIS software for integration and illustration. The actual data collected from the photogrammetric process included photos coupled with GPS points and directional information. The completed compound model is illustrated in Figure 5.18 and 5.19. The big

There were issues with apparent holes in and sections missing from photogrammetric models due to foliage cover. These were remedied easily due to the symmetric quality of all structures on the site. The data produced from the virtual modeling effort did not affect the researcher's ability to use it in a qualitative manner to find differences between the architect's intent and the current status of structures on site. The model's accuracy on the map is based on the geodetic marker, which is accurate to within plus or minus three m (NGS 2016). The models are accurate to plus or minus one cm based on the total station data (Topcon 2011:23.1). Model accuracy is negligible due to the ability to constrain the model to a known measurement. This was accomplished using measurements taken of the south storage building.

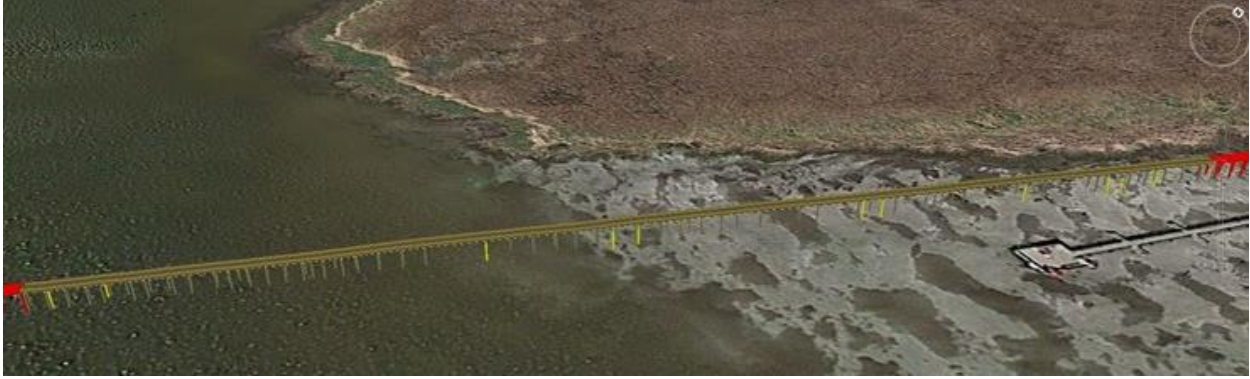
Figure 5.31. 3D virtual model created using existing wharf piles in *Rhino 5* overlaid on Google Earth image (B. Scott Rose 2017).

An original construction drawing supplied the dimensions of the wharf model. This drawing indicated the total quantity and size of each type of wood and metal fasteners needed in the construction of the pier. With these dimensions, the author developed a virtual reconstruction of the wharf section using *Rhino 5* (Figure 5.31).

The original construction plans of the wharf structure along with the data taken from the total station were consulted to reconstruct and accurately place the virtual model section of the pier in *Rhino 5*. In order to reconstruct the wharf section, the author referenced the existing piling locations, then created and placed in sequence each piece of the original supply list (Stetson 1877). Every *Rhino 5* model was created in virtual space using vector line graphics. All solid features are made from surface features. Each surface is made from line features traced from the original drawings. These models were created to compare structural interactions at different points in time.

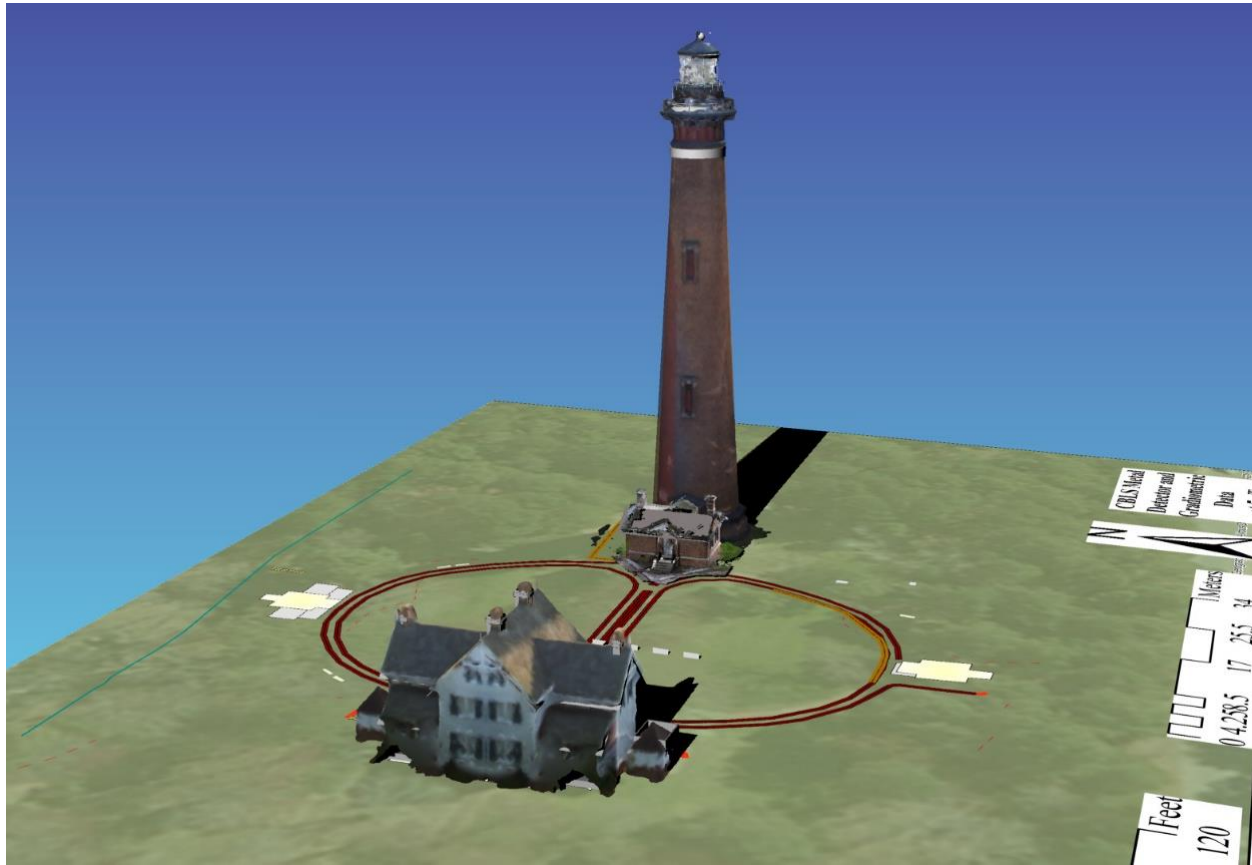
Figure 6.2. Virtual models of permanent structures including lighthouse tower and big keeper's house. (B. Scott Rose 2017).

The Currituck Beach Light Station as it exists today is represented in Figure 6.1. Two structures built during the first construction phase at the site exist today. The lighthouse and the big keeper's house were the first permanent structures to be completed on site. During the 1980s, several efforts and investments were made to reconstruct and maintain these two structures (Figure 6.2).

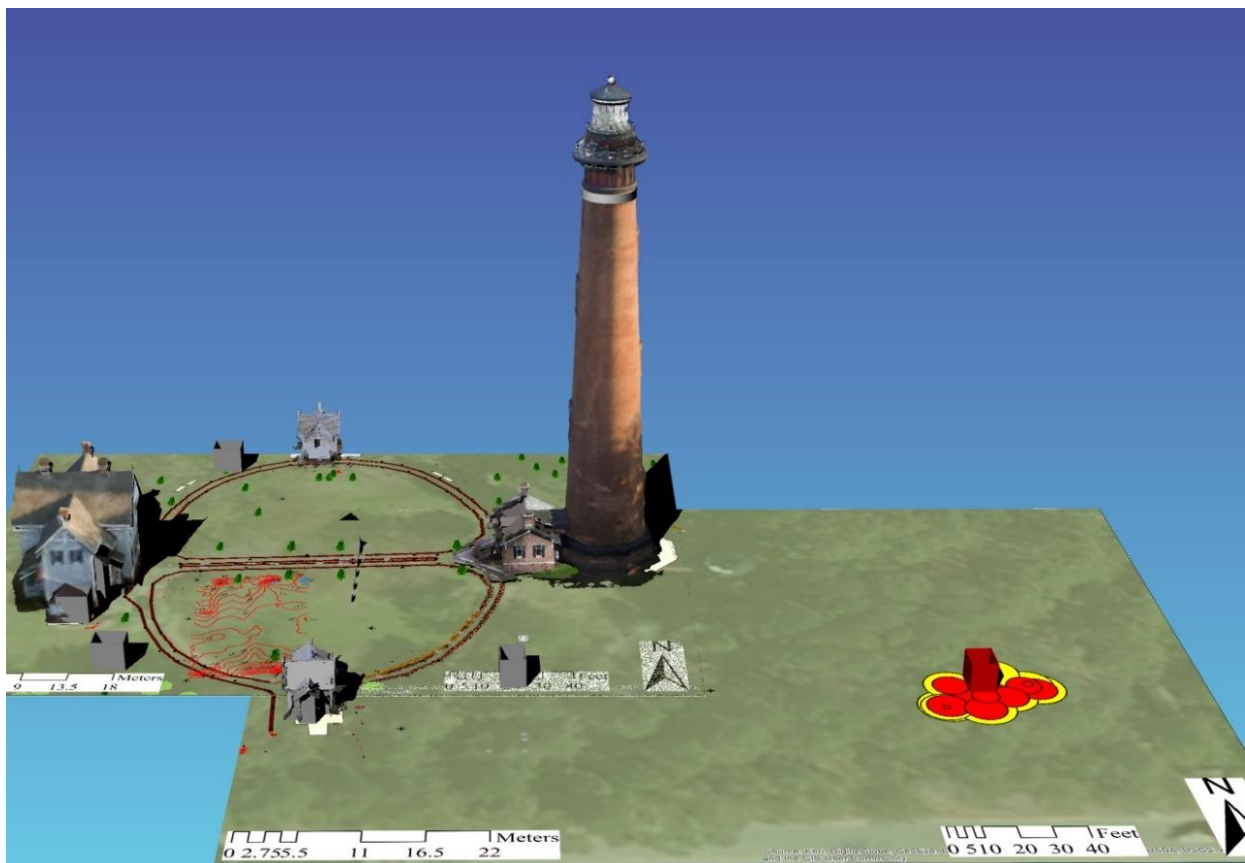
Figure 6.3. Virtual models of the southeast cistern placed based on metal detector contacts and photographic evidence. (B. Scott Rose 2017).

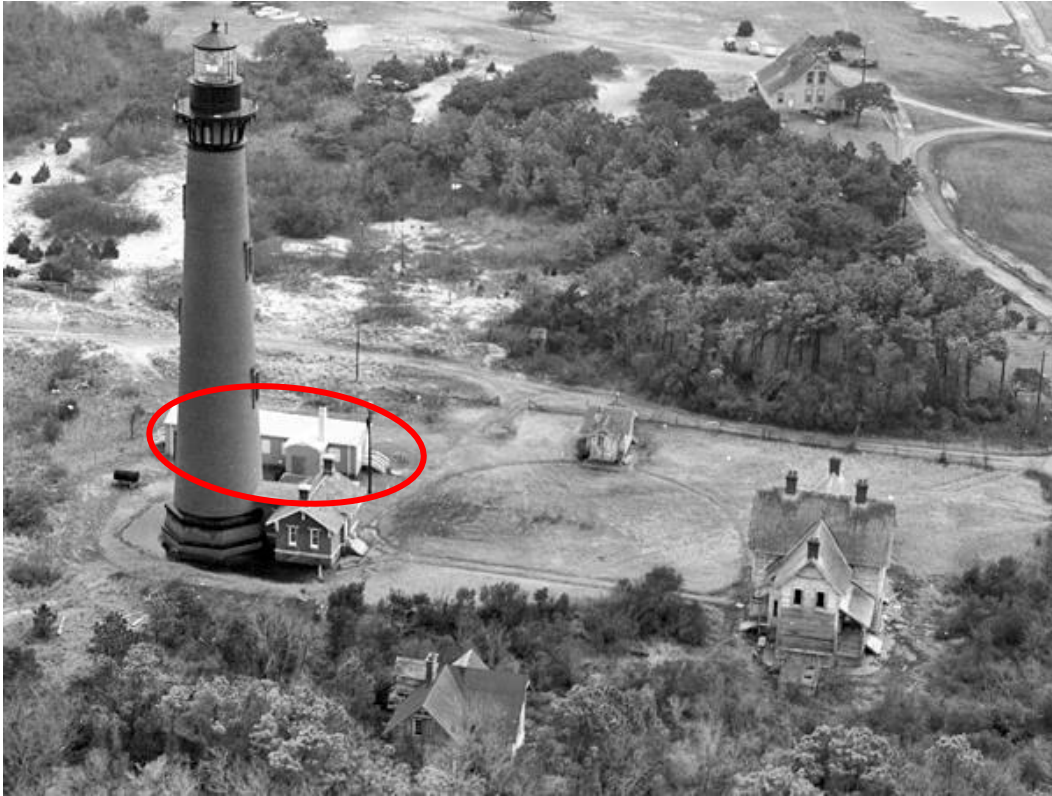
Figure 6.6. Historical photograph from ca. 1950 depicting a long barracks structure located to the south of the CBLS tower (Lighthouse Friends 2015).

The ca. 1936 CCC barracks is no longer on site. It has been located to the north of the complex and is being used as a private residence. It appears in the photographic record on site during the 1940s. Although complicated by the proximity of the lighthouse itself (a very large magnetic anomaly), the gradiometric data indicates a pattern consistent with a building's previous location. The model was placed in this area based on the photographic and gradiometric analysis (Figures 6.6 and 6.7).

The next structural change occurred sometime after 1955. The large barracks structure disappeared from the site (Lighthouse Friends 2015). It is now used as a private residence in the community, representing another instance of reuse. Research has not found evidence of the sale of the structure; however, this movement of the structure indicates a salvaging activity whether monetary exchanges occurred or not (Schiffer 1996:104).

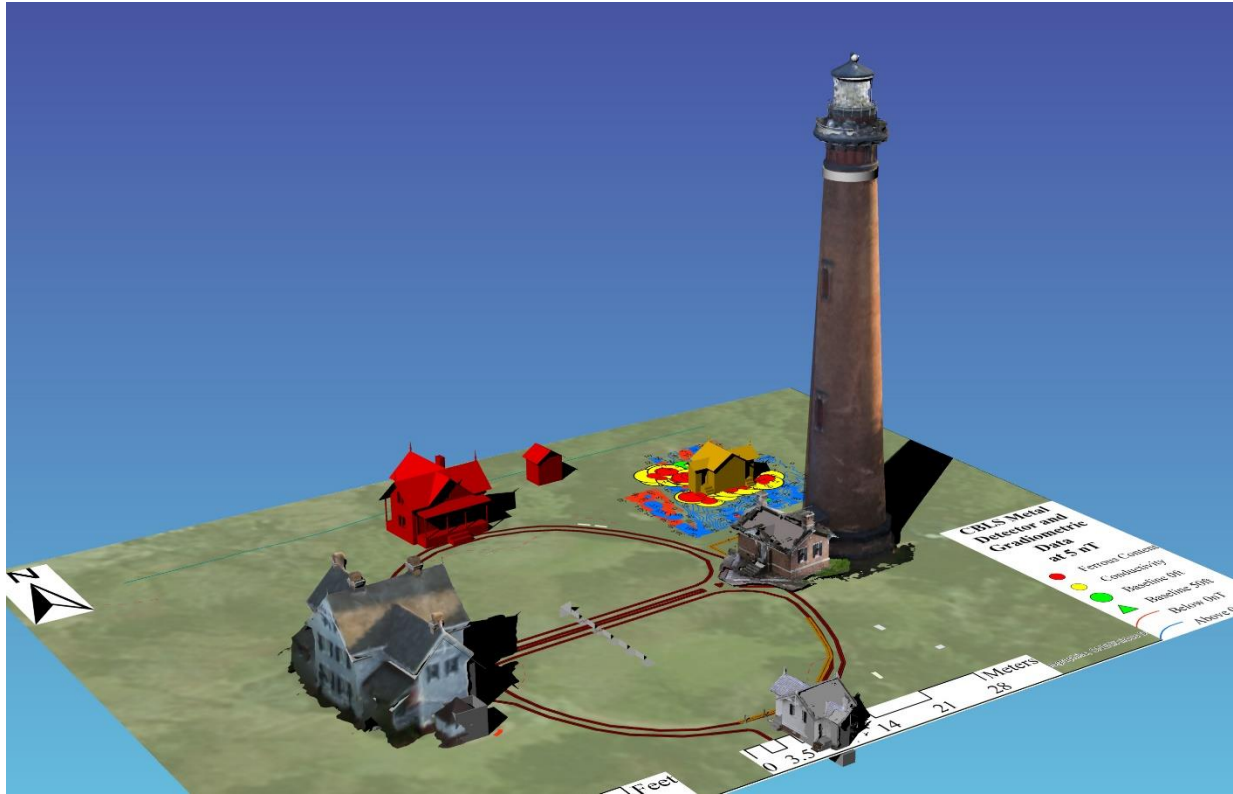
Figure 6.9. Virtual models depicting the placement of the small keeper's house, outhouse, and new location of the north storage building based on gradiometric and metal detector survey data. (B. Scott Rose 2017).

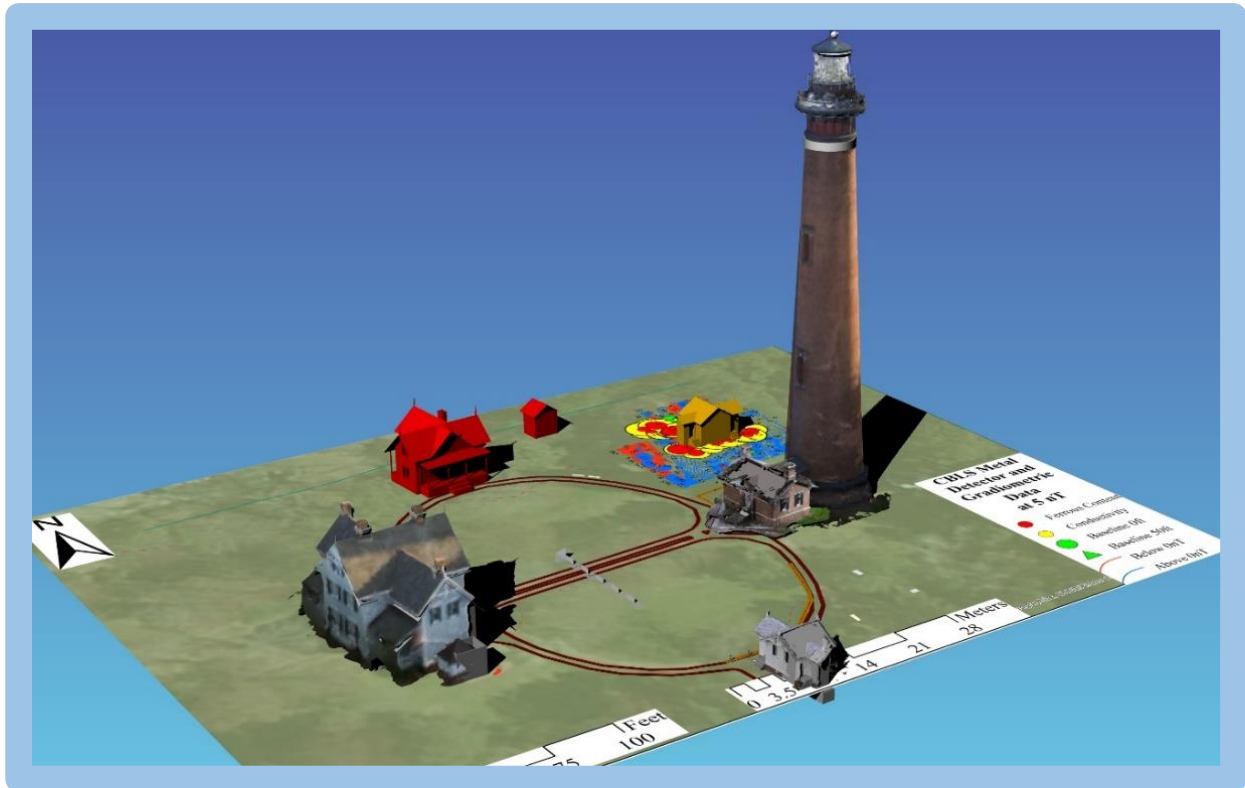
Figure 6.11. Virtual model depicting construction Phase II shows the probable movement of the north storage shed to the east and the newly arrived small keeper's house and outhouse. (B. Scott Rose 2017).

Phase II, or the *Upgrade Construction Phase*, includes the period from 1877 to 1922 (Figure 6.11). During this time, several structures were built in or moved to the community, and the north storage building was moved from its original location. The small keeper's house was

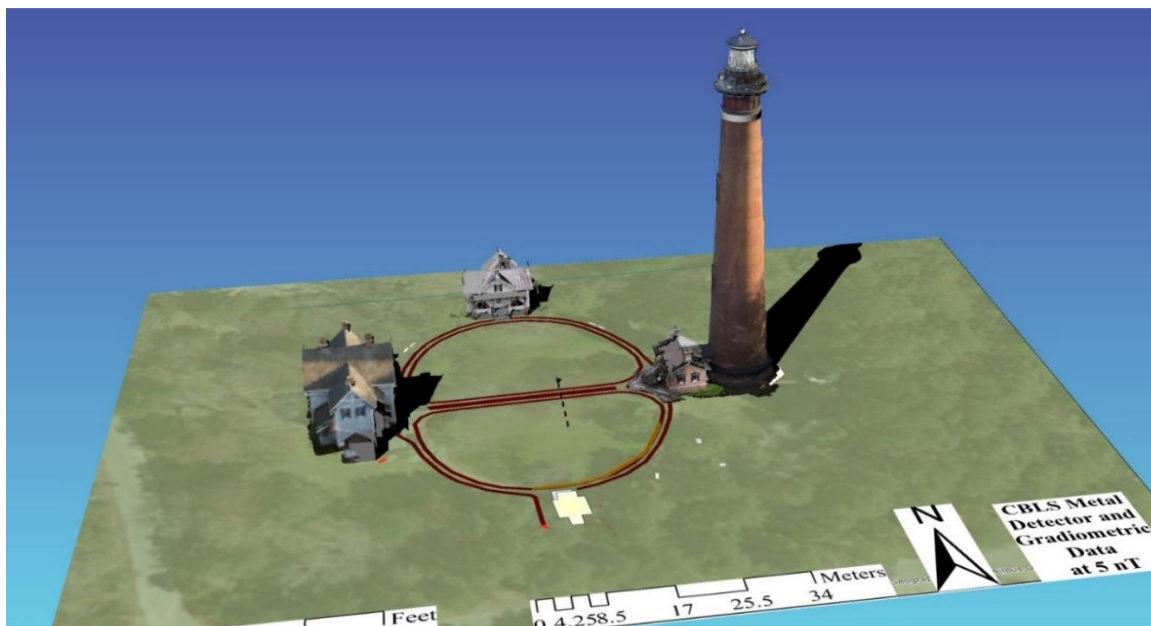
Figure 6.14. Virtual model depicting construction Phase IV shows a lack of structures, including both the north and south storage buildings and the barracks. (B. Scott Rose 2017).

Phase IV or the *Neglect Phase* is an era devoid of investment in the site (Figure 6.14). The community saw investments from the military, but the CBLS did not. These investments in the area include the construction of military barracks to the southeast of the site. Documentation pertaining to the monetary investment in this construction was not located by this researcher. The small keeper's house was used as a makeshift barn for hay storage during this time. This is a reuse pattern indicating the building's decreased cultural value. Photographic evidence from the 1940s depicted a lack of a structure at the location designated as the new temporary site of the

By the mid-1950s, both storage buildings disappeared from the photographic record. The south storage building disappeared before 1955, which indicates that salvage activity associated with structural reuse took place (Schiffer 1996:99, 2010:38). The structure was utilized as a storage facility for another resident in the community (NPS 1999:7.7). This structure was later returned to the property.

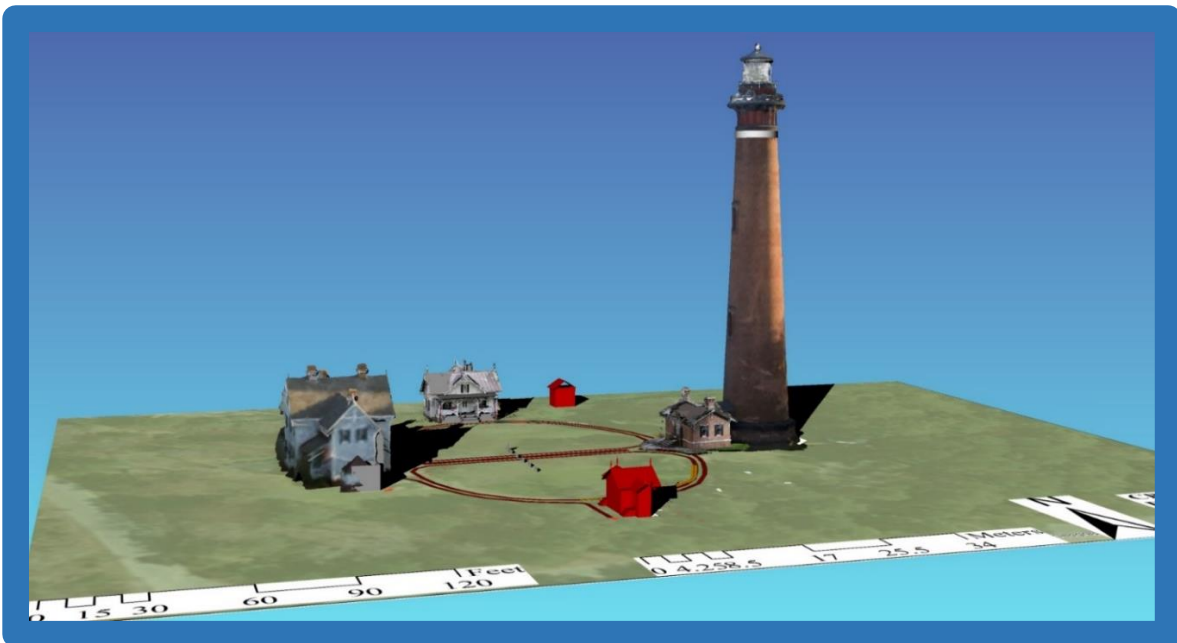
Figure 6.15. Virtual model depicting construction Phase V shows the re-incorporation of the south storage building and the reconstructed outhouse. (B. Scott Rose 2017).

Phase V, or the *Conservation Construction Phase* represents the largest investment era on the site (Figure 6.15). After 1980, a restoration effort began at the CBLs site. This effort involved reconstruction and repairs to several buildings and represented a reclamation activity (Schiffer 1996:104). At this point, the land on the Outer Banks was assigned new value based on wildlife and cultural heritage conservation and tourism. The tower was repaired first, then the large keeper's house. Next, the small keeper's house, cistern, and outhouse building was repaired. This structure is now the gift shop for the historical site. Finally, the south storage building was purchased from a neighbor and brought back to the site, placed back on its original foundation, and repaired. This structure is now being used by the Historical Site Manager as an office.
