Reading Between the Iron Lines:
An Analysis of Cannon Arrangement on Caribbean Shipwrecks

Department of History, Program in Maritime Studies

A Thesis

In Partial Fulfillment of the Requirements for the Degree
Master of Arts in Maritime Studies

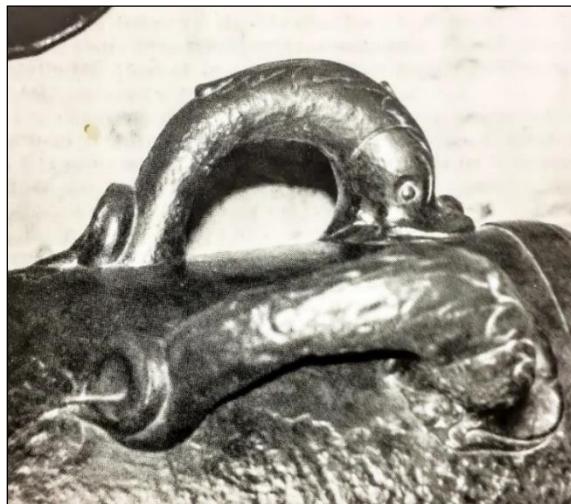
FIGURE 2.4. Image of Dolphins on a bronze cannon (Lavery 1987:90).

Eventually, improvements were made to cannon carriages to increase gun mobility. As a result, specific features of cannons became less useful and were discontinued. For example, naval historian Dr. Frank Howard wrote that “the general shape of carriage guns did not alter, but there were changes in detail. The loops for hoisting the gun (the dolphins) disappeared and so did the decoration” (Howard 1979:208). Dolphins were typically decorative, representative of creatures from the sea (Figure 2.4). This characteristic was strictly reserved for brass or bronze guns on essential ships.

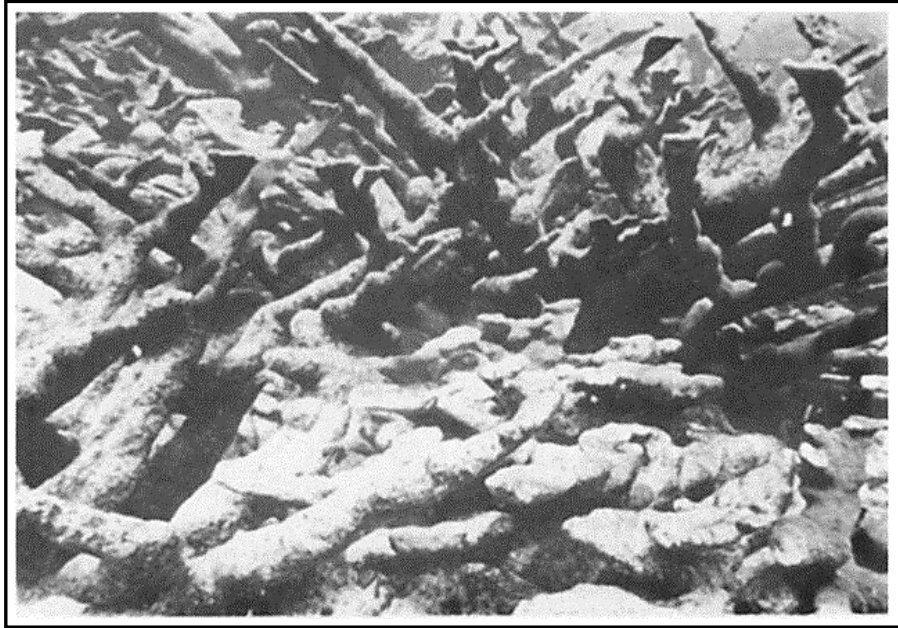
FIGURE 3.6. Photo of Coral Coverage Over Site 1 in Pedro Bank, Jamaica (Hoyt 1984:102).

forced the team to abandon the site as “a jungle of elk-horn coral,” measuring 2 m thick, which made examining site features difficult (Hoyt 1984:103). However, the team managed to remove a small piece of the concretion from what Hoyt believed to be covering the trunnion of a cannon.

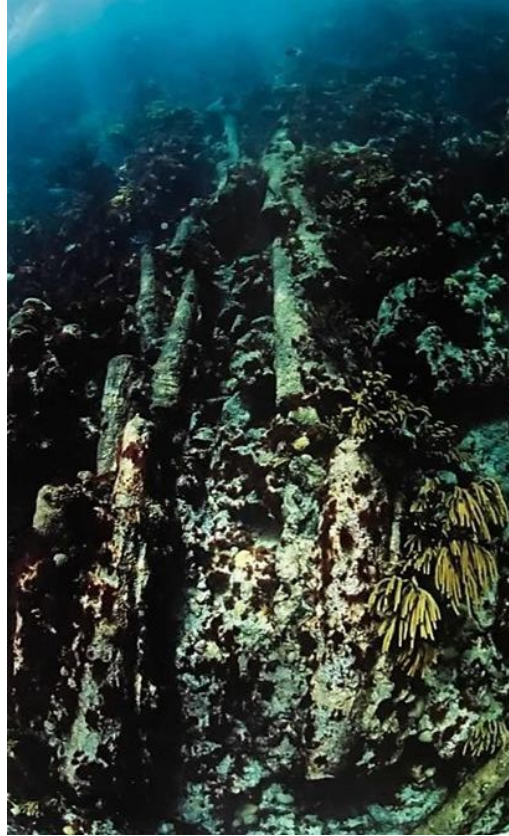
FIGURE 3.14. Photo of the Manilla Wreck (Watts and Steinhoff 2014:154).

Three sport divers discovered the Manilla shipwreck site (Figures 3.13 and 3.14) in January 1975. It is located approximately 11 km off the northern area of the East Pointers, a series of reefs that line the northeast portion of the Bermuda Platform and lay at a depth of roughly 6 m. The site contained a stone ballast pile that extended over an area of 28×5 m. Due to the site’s location in a high energy coastline with frequently strong ocean currents, there was little hull remaining. The site was called the Manilla Wreck because of its distinctive cargo which included brass bracelets and a wide array of beads (Karklins 1991:33).
