WHAT LIES BENEATH AT THE PINE STREET BARGE CANAL BREAKWATER SHIP
GRAVEYARD: SITE FORMATION PROCESSES AS A DOCUMENT OF CHANGE

IN BURLINGTON, VERMONT (C. 1830-1960)

A Thesis

In Partial Fulfillment of the Requirements for the Degree
Master of Arts in Maritime Studies

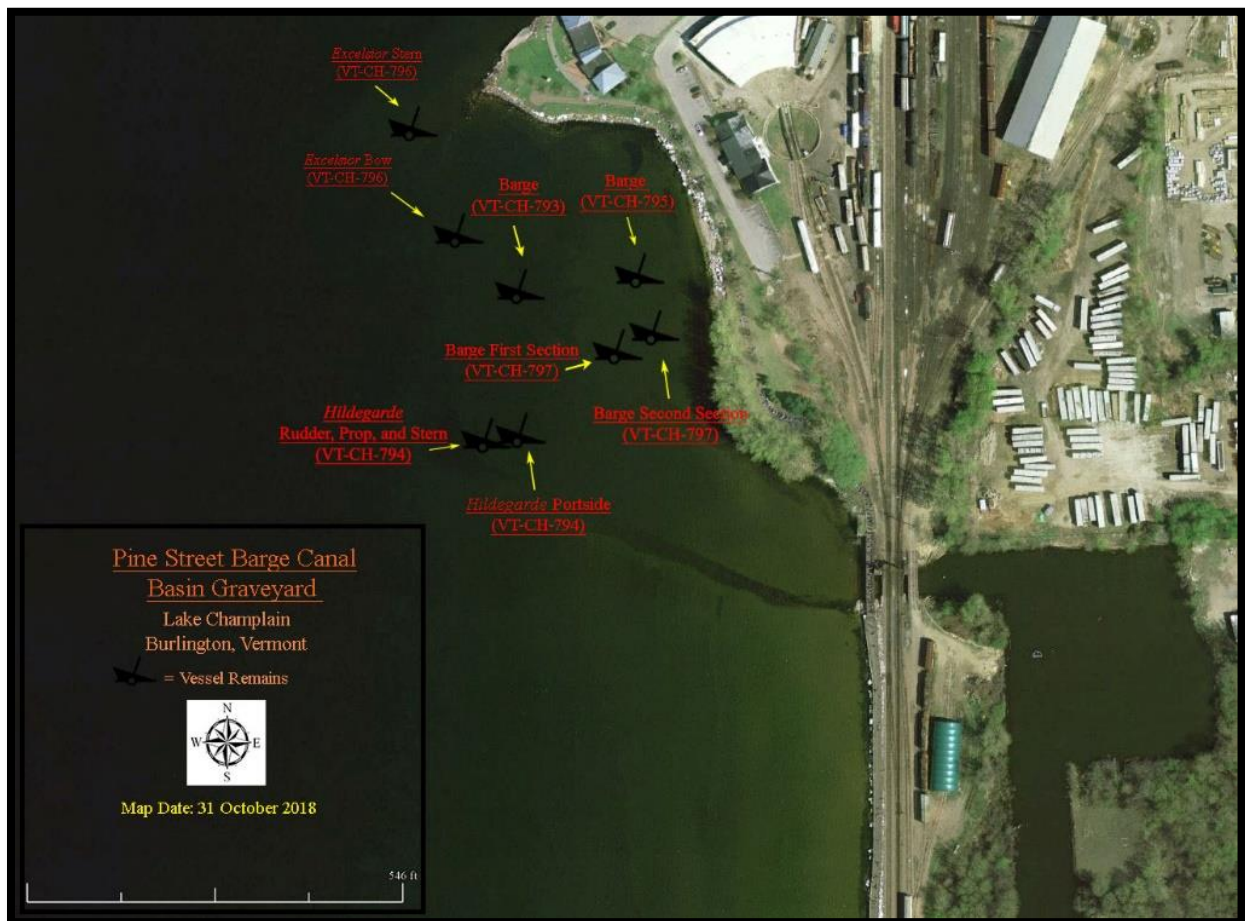
FIGURE 1.2. Field map of the Pine Street Barge Canal Basin Graveyard (Image by author and Google© Maps).

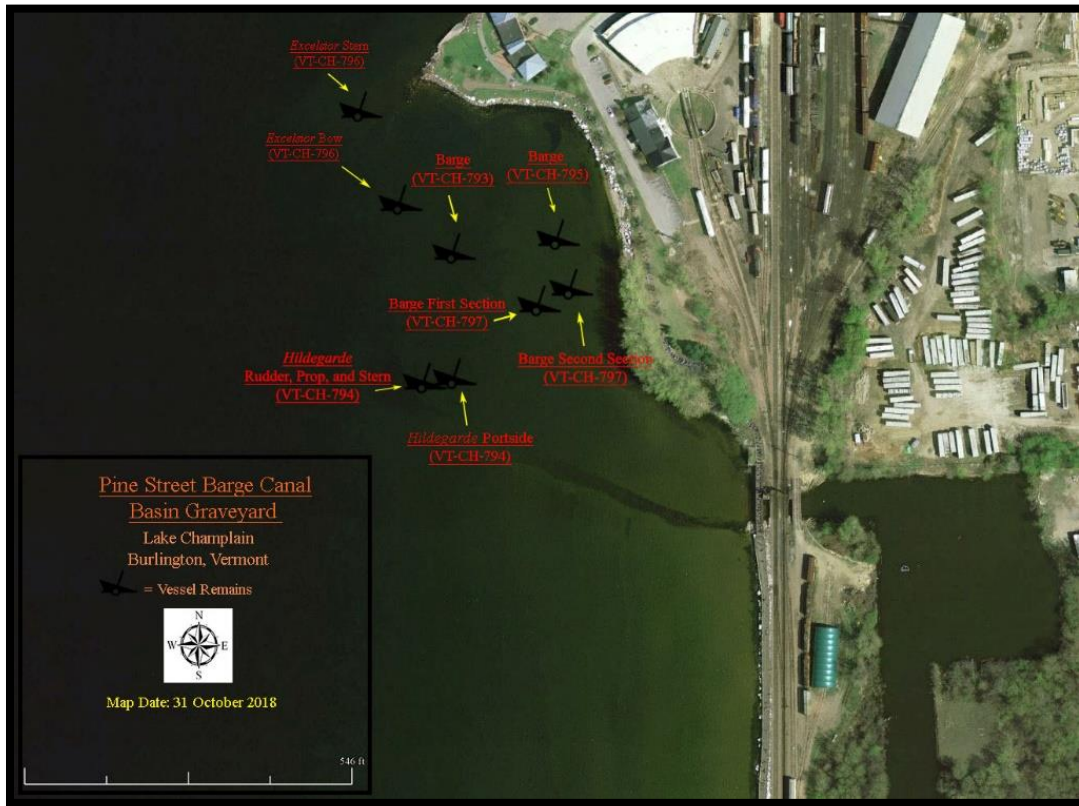
The Pine Street Canal Breakwater site lies just offshore of Burlington, Vermont adjacent to the Pine Street Barge Canal. The site is southwest of the sewage treatment plant and due west of the Vermont Railway Company offices as seen in Figure 2.9. Historically, the area is referenced to as “the cove,” where the location from Peterson's Brewery to the shore was lined with trees and the water came up to them so that vessels could enter the cove and tie up to them (Hemenway 1867:669). Hemenway remarks that stores belonging to the Master Builder Richard Fittock were kept near where the Rutland and Burlington railway depot is and that the beach formed a natural breakwater near the tree line. Fittock also ran lighter services to larger sloops and schooners out in deeper waters to collect cargo.

FIGURE 2.9. Field map of the Pine Street Barge Canal Basin Graveyard (Image by author and Google© Maps).

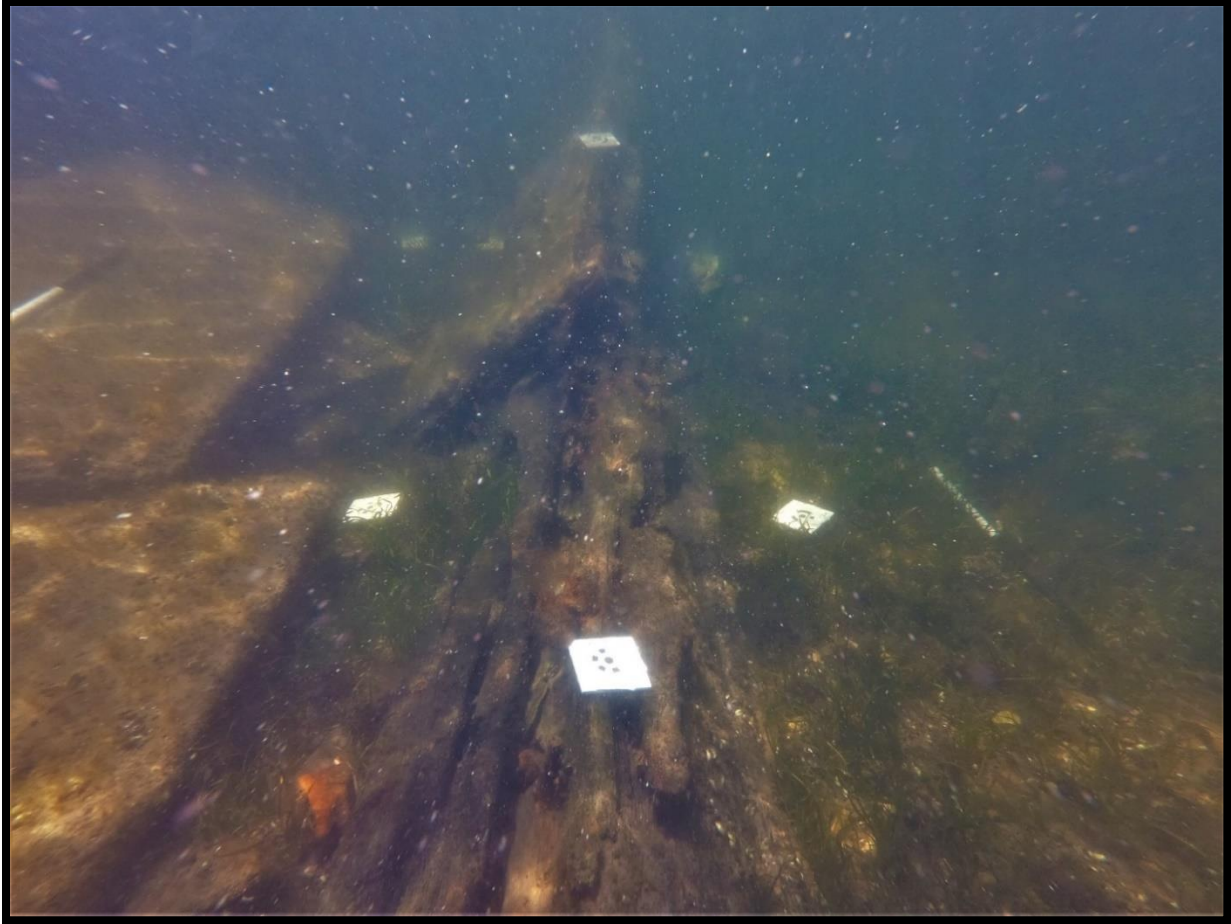
FIGURE 4.4. Coded targets and scale bars on the upside-down section of *Excelsior*'s stern (Image by Paul Willard Gates).

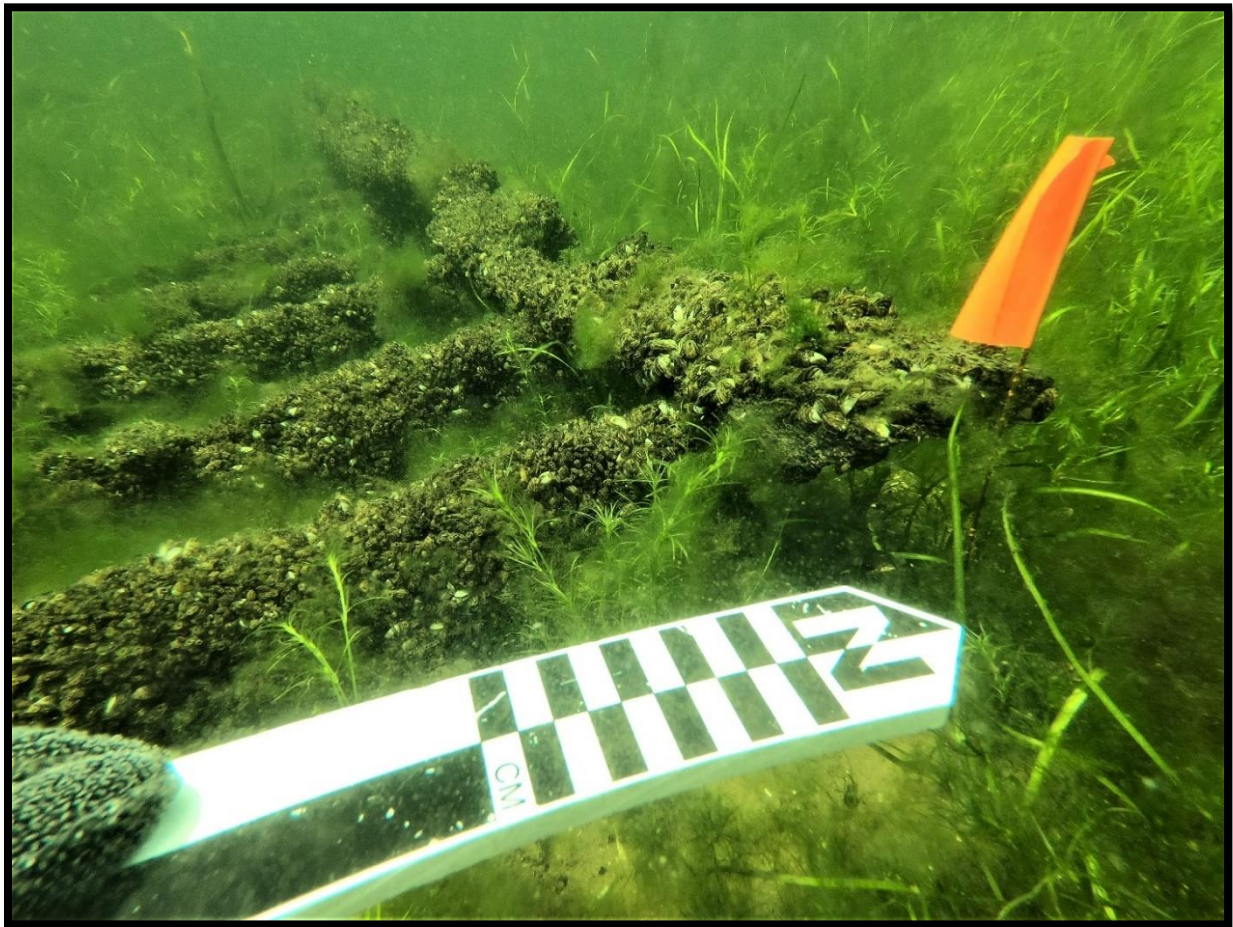
FIGURE 4.6. Example of site formation signature of *secondary salvage* on *Hildegarde*'s portside remains (Image by Paul Willard Gates).

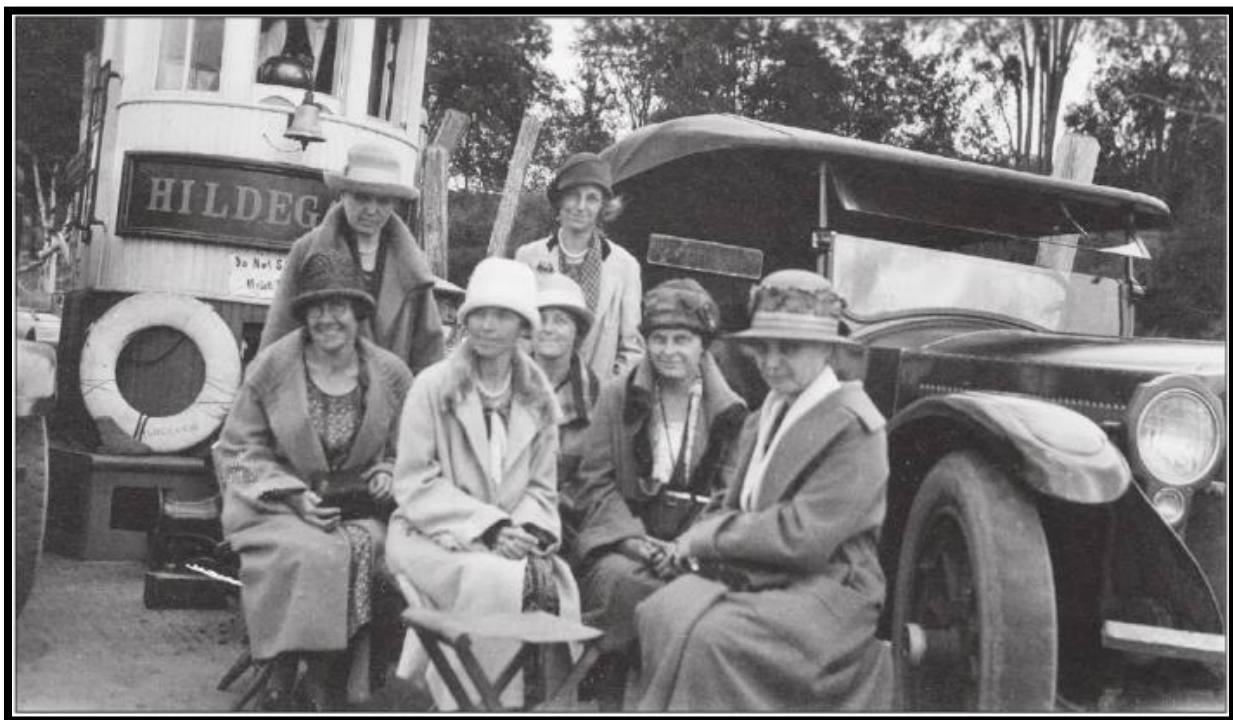
With similar dimensions to *Hildegarde*, *Pocahontas* competed at trail races in 1881 against the sloop yachts *Hildegarde*, *Gracie*, and *Mischief* (Gary 2019). The photographs in Figures 4.10 through 4.12 depicting *Hildegarde* as a steam ferry and tugboat was used along with the *Pocahontas* lines to create another representative model of the ship after it was converted from a sloop yacht. Drafting the architectural features for a representative model of the barges in their pre-depositional context was made using images in Figures 4.13 and 4.14.

FIGURE 4.10. *Hildegarde* with passengers and a car, early 1900s (Lake Champlain Maritime Museum 2014:52).

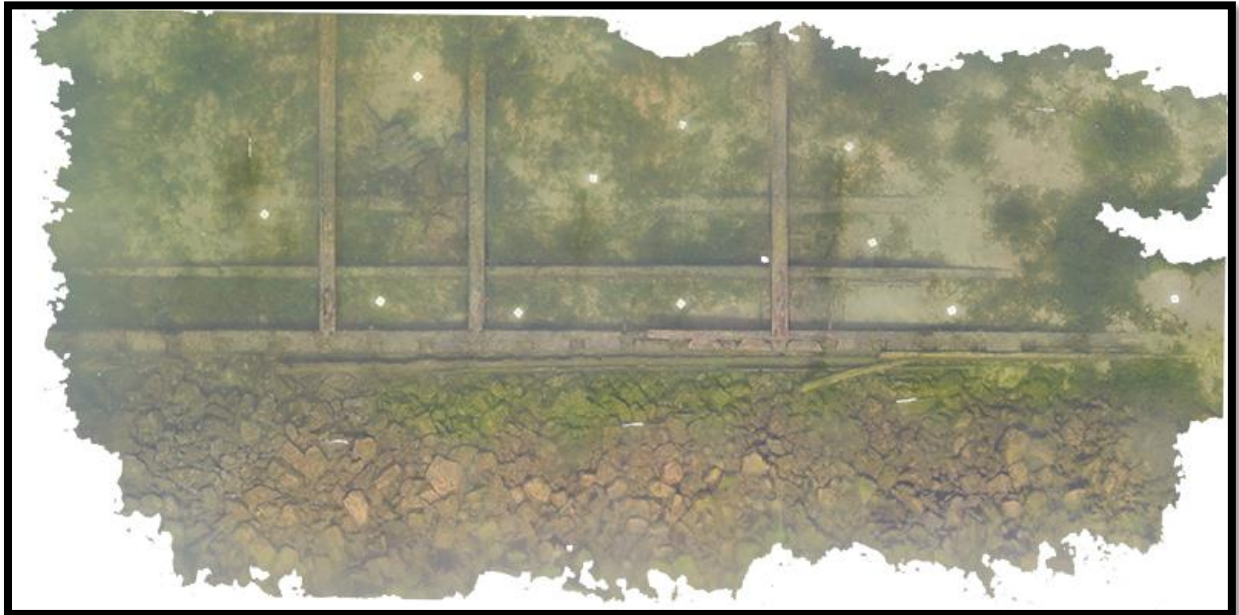
FIGURE 4.15. Orthometric photo of Turner & Breivogel barge VT-CH-793 (Image by Paul W. Gates and Nathan Richards).

Research and data gathered from the July 2018 fieldwork were processed to highlight *cultural* and *non-cultural* formation processes and the effects on the vessels in their post-depositional context. The vessels had individual site plans made in their post-abandonment context to demonstrate the extant architectural features before they enter their archaeological context. Using plans from comparative vessel types discussed above for pre-depositional context of each ship, scale post-depositional models of *Excelsior*, *Hildegarde*, and the Turner &

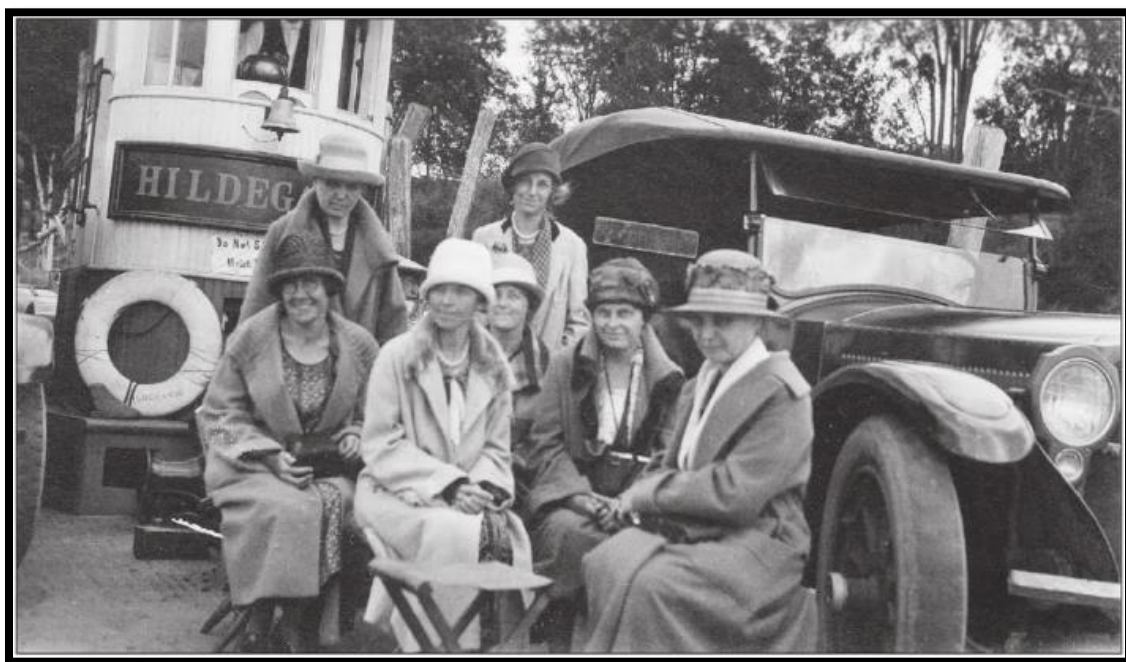
(Lloyds Register of Shipping 1906:259). The register from 1925 lists a new owner as the Westport – Vergennes Ferry Co. (N.Y) with a home port in Rouses Point, N.Y. and the address of the owner in Westport, N.Y. (United States Bureau of Navigation 1925:100-101). Figure 5.9 depicts *Hildegarde* as a converted ferry, most likely done by the Westport – Vergennes Ferry Company. In 1930, ownership of *Hildegarde* once again changed, listing the new and final owner as Herbert Pashby, who lived at 398 St. Paul Street in Burlington, V.T. (United States Bureau of Navigation 1930:88-89). Mr. Pashby operated the vessel as a tugboat for a stone barge from Fiske’s Landing in Isle La Motte to Burlington Harbor (Lake Champlain Maritime Museum 2014:52). Additional images of *Hildegarde* as a tugboat are shown in Figures 5.10 and 5.11.

FIGURE 5.9. *Hildegarde* with passengers and a car, early 1900s (Lake Champlain Maritime Museum 2014:52).

Additionally, the vessel had undergone physical changes in length, breadth, and depth. The increase in tonnage is another indicator that the vessel is changing in configuration over time in conjunction with a change in ownership. The purpose of the vessel also changed from a sloop yacht to a gas screw equipped ship, to steam screw ship listed for freight service. Within the systemic pre-depositional context, *Hildegarde* underwent primary and secondary modification and conversion processes (Richards 2008:102). These reuse processes are associated with secondary use, where the object (in this case a ship) assumes a new use and function due to modifications (Schiffer 1987:30). Modifications to *Hildegarde* would require a substantial amount of work, effort, time, and money in order to adapt it from a sailboat to a steamship. A representative model of *Hildegarde* in its pre-depositional context was made based off historic photographs in Figures 5.7, 5.9, and 5.10.

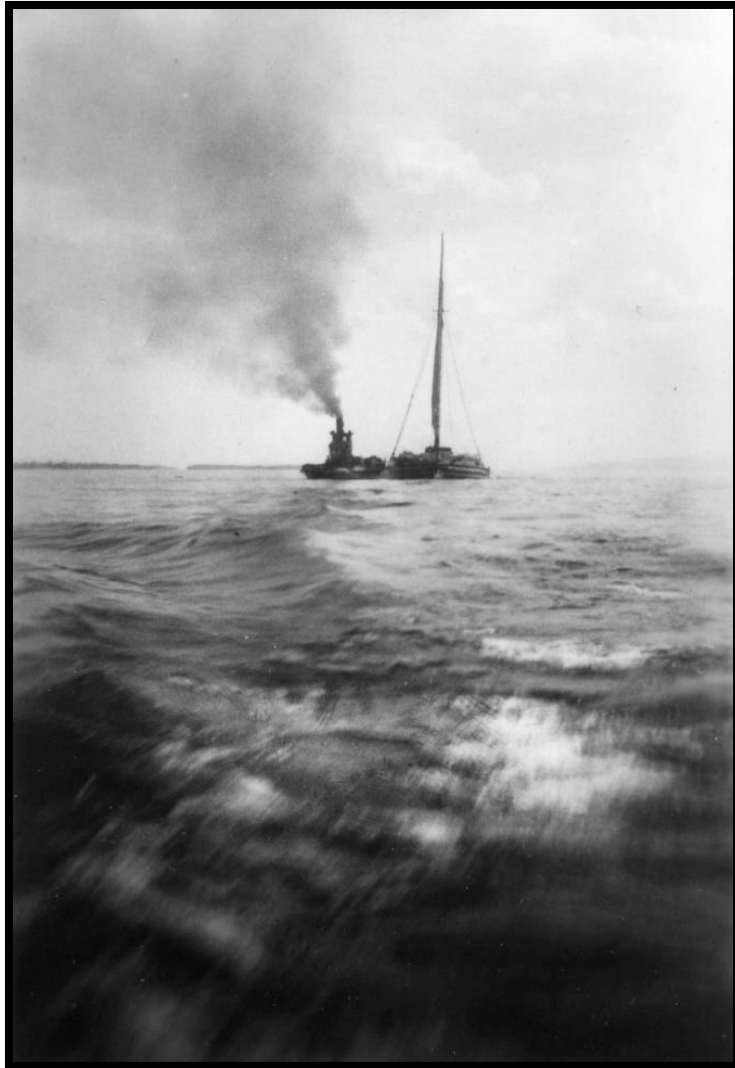
FIGURE 5.10. *Hildegarde* as a tug assisting a sail equipped barge, early 1930s (Photo courtesy of Arthur Cohn and the Lake Champlain Maritime Museum).

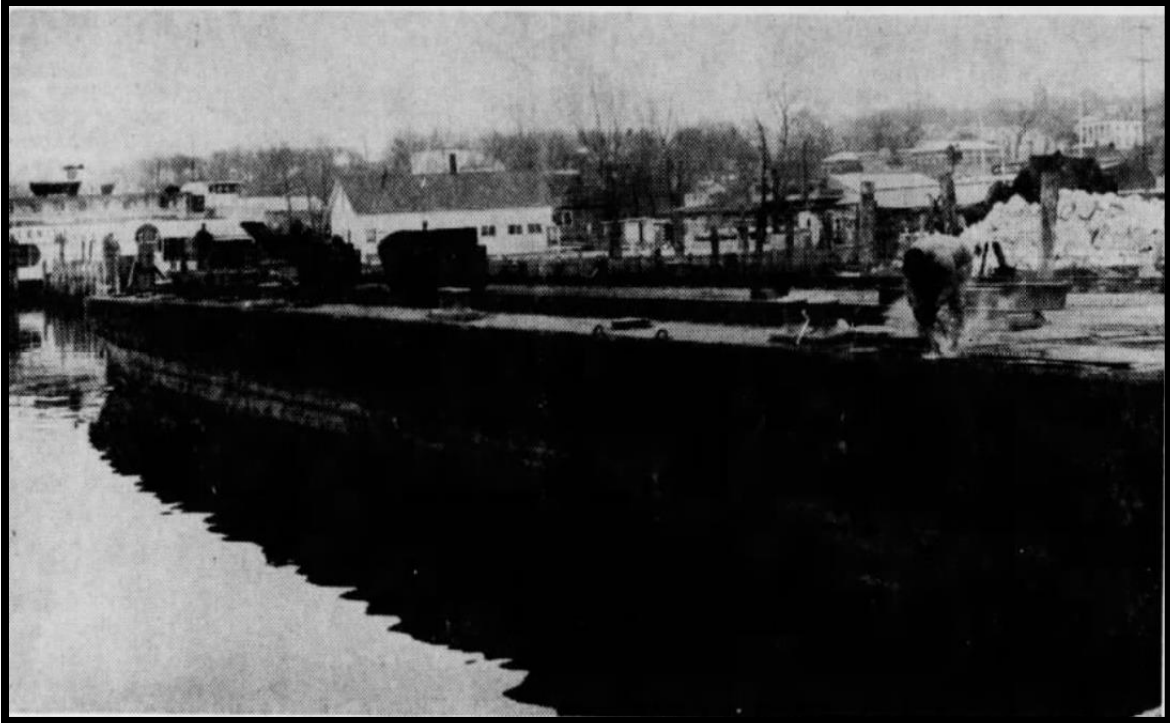
Divers and specialty equipment consisting of a 300 ft long barge and two cranes were needed to raise the sunken crane off the bottom of the lake (*The Burlington Free Press* 1963c:11). The crane was finally raised on 4 November 1963 by divers who had to cut off the boom of the crane before hoisting it up. The specialty barge mentioned above was brought in from New York City, where it was built in 1911 and used to ferry railroad cars across New York harbor. Figure 5.19 depicts the barge being cut in half after it helped to raise the crane.

FIGURE 5.19. Turner and Breivogel 285 ft barge being cut in half (Image by *The Burlington Free Press*).

Arthur Hallman, an engineer with Turner & Breivogel, mentioned that the barge was cut into two smaller barges to ferry stone to the breakwater (*The Burlington Free Press* 1963d:11). It is unclear if this barge is present in the ship graveyard.

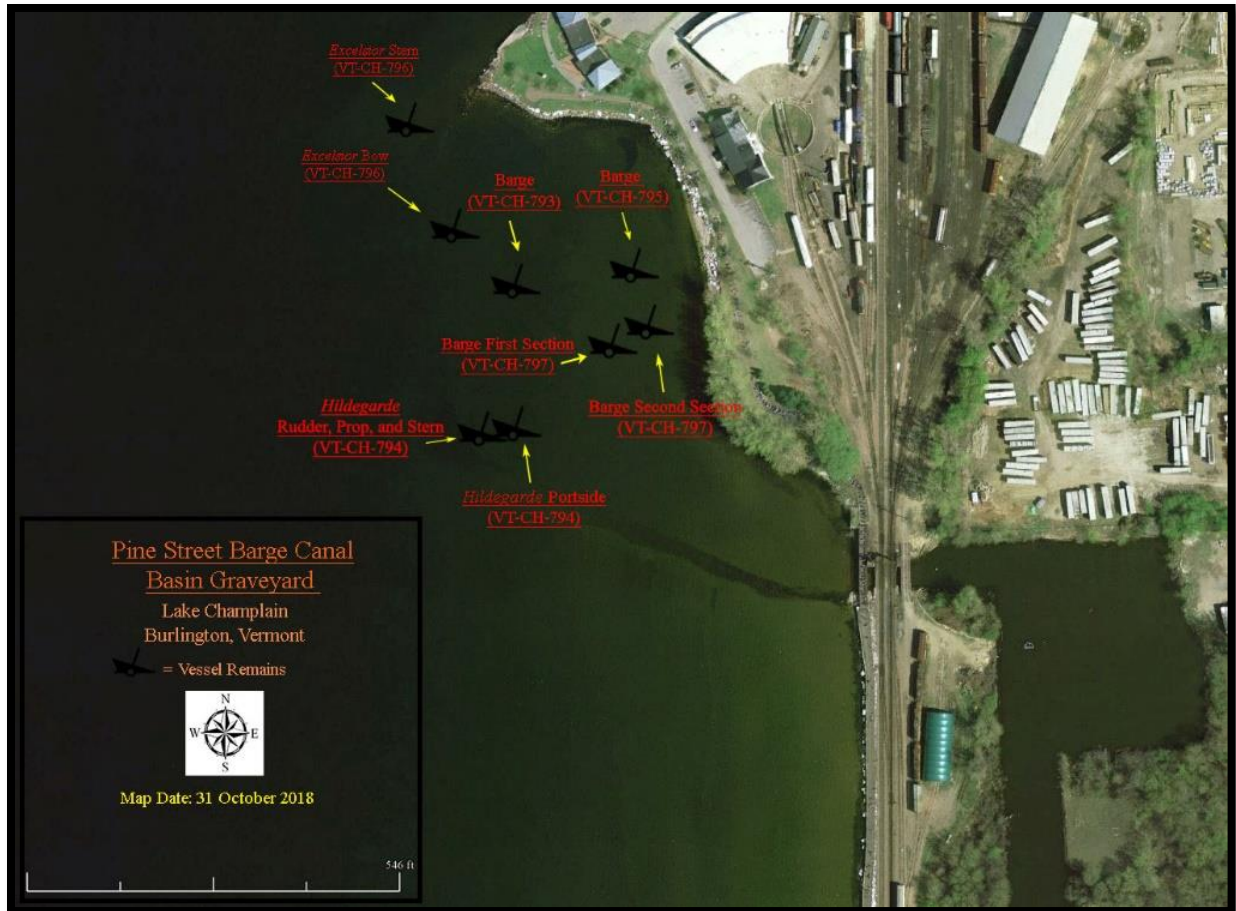
This chapter focuses on the analysis of the archaeological sites (abandoned ships) of the Pine Street Barge Canal Basin Graveyard in their post-depositional context. The data collected from each vessel is arranged on a site by site basis where each vessel has a description of the archaeological context. Each site has a catalog of observed and documented *cultural* and *non-cultural* site formation processes. The locations of the site formation processes are noted on archaeological site maps and referenced in tables. Annotated digital photographs of the observed site formation signatures on each site are included to highlight the processes. A final section includes an analysis of the potential correlation between ship Abandonment and Burlington's maritime commerce, with separate sections considering likely relationships between abandonment and salvage actions by people in Vermont and corresponding economic, population, technological and use trends. Figure 6.1 shows where the vessels were abandoned in the area.

FIGURE 6.1. Field map of the Pine Street Barge Canal Basin Graveyard (Image by author and Google© Maps).

Archaeological work done in July 2018 found much of the vessel remains in poor condition. Marked in Figure 6.1, it is located on the north side of the southern breakwater arm where the breakwater slants at a northern angle. The remains of *Hildegarde* are oriented with the stern section facing west and the portside remains face east. The unknown timber assemblage is just off the breakwater foundation wall, lying parallel to the portside remains in a west and east orientation. All extant remains are in a severe state of decay. Much more of the vessel may be buried underneath the sediment.

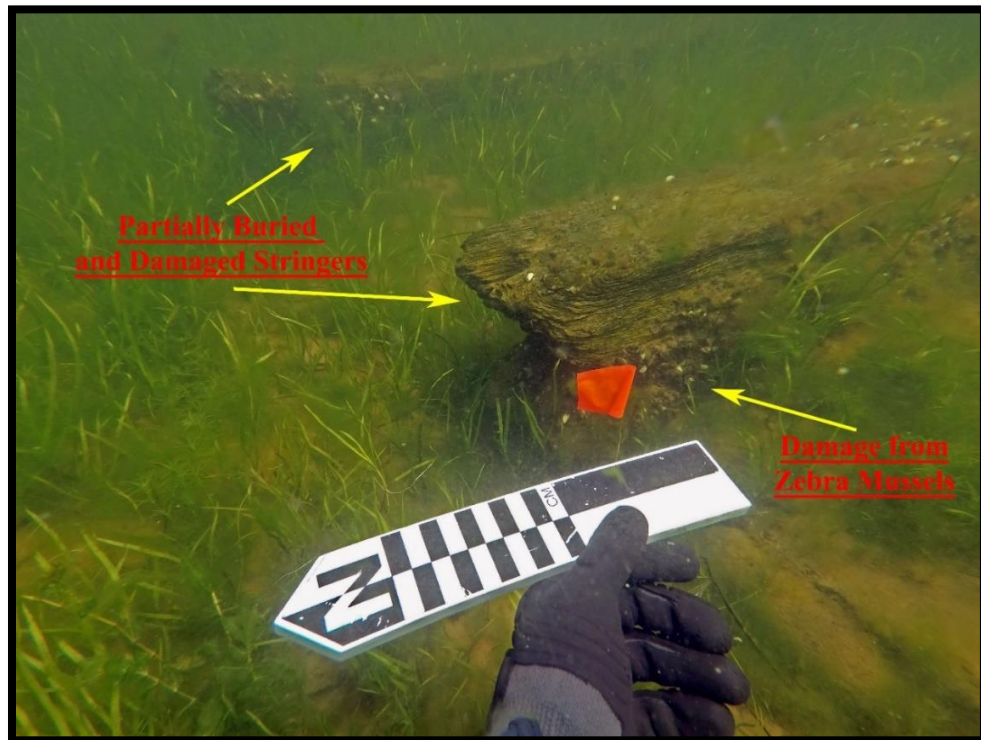
FIGURE 6.27. Site formation signature location 4, photo GOPR1154 (Photo by author, 13 July 2018).

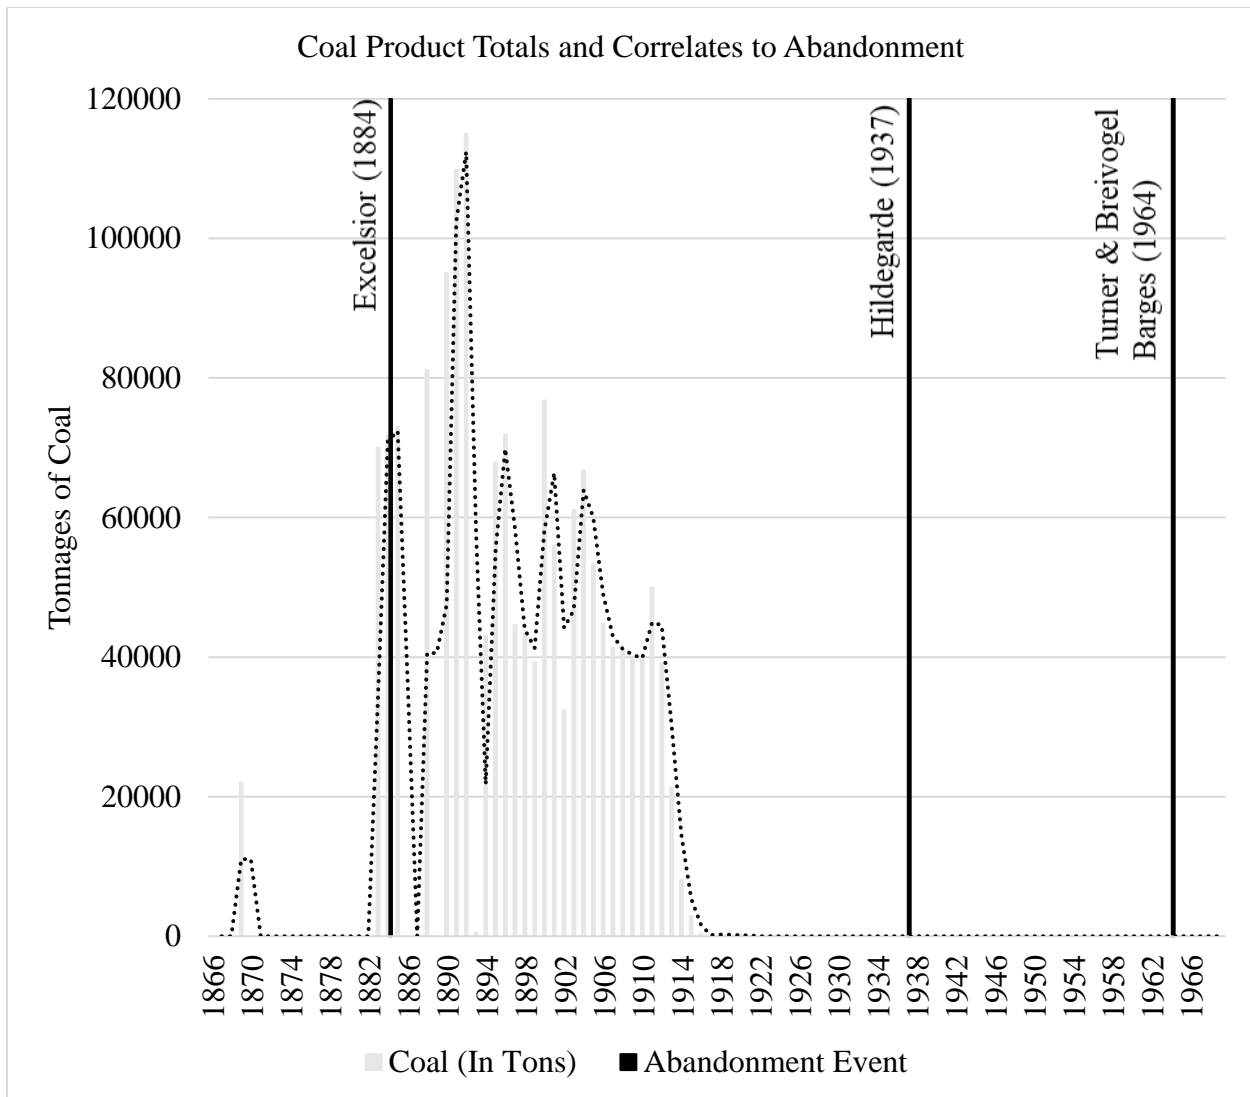
FIGURE 6.44. Data on Coal Totals and Correlates to Abandonment from 1866 to 1970 (*United States Army Corps of Engineers Annuals Report of 1866 to 1970*).

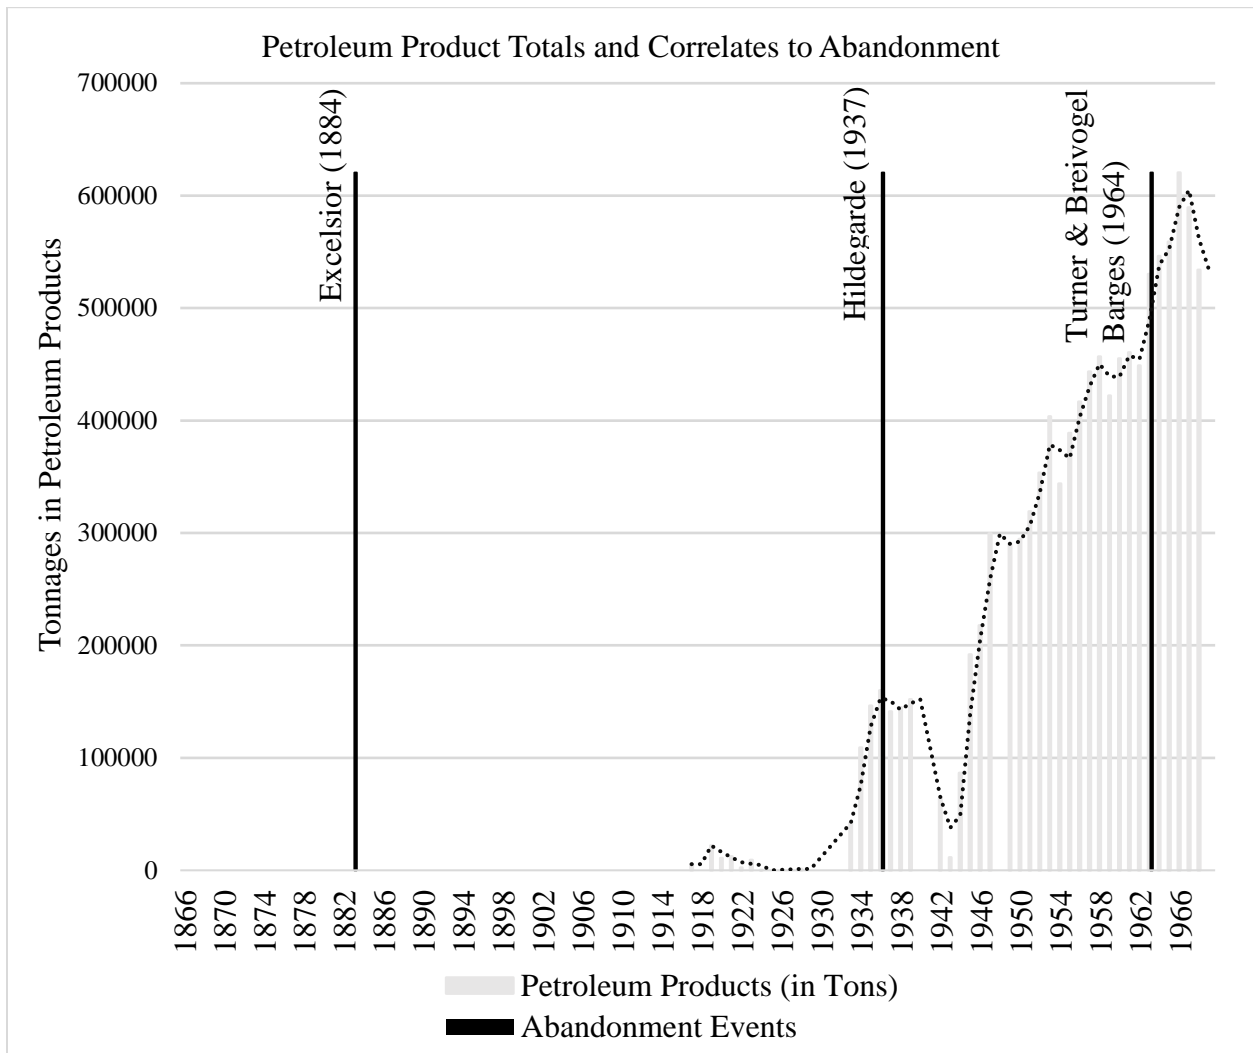
FIGURE 6.45. Data on Petroleum Product Correlates to Abandonment from 1866 to 1970 (*United States Army Corps of Engineers Annuals Report of 1866 to 1970*).
