WOOD AND STEEL:

USING MODELING TO ANALYZE SITE FORMATION OF THE EARLY TWENTIETH

CENTURY VESSEL *FRATERNITÉ*

A Thesis Presented to the Faculty of
The Department of History
East Carolina University

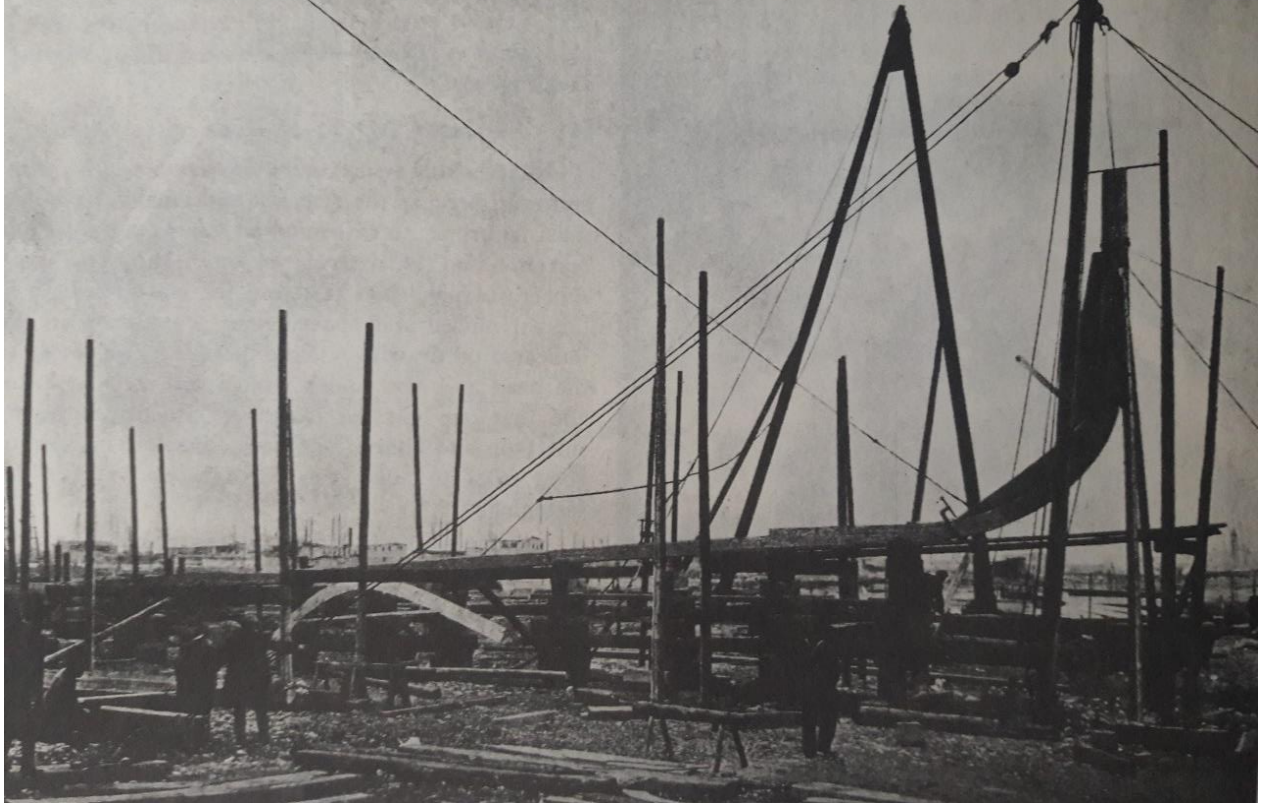
Figure 4. Keel set up (Desmond 1919:48).

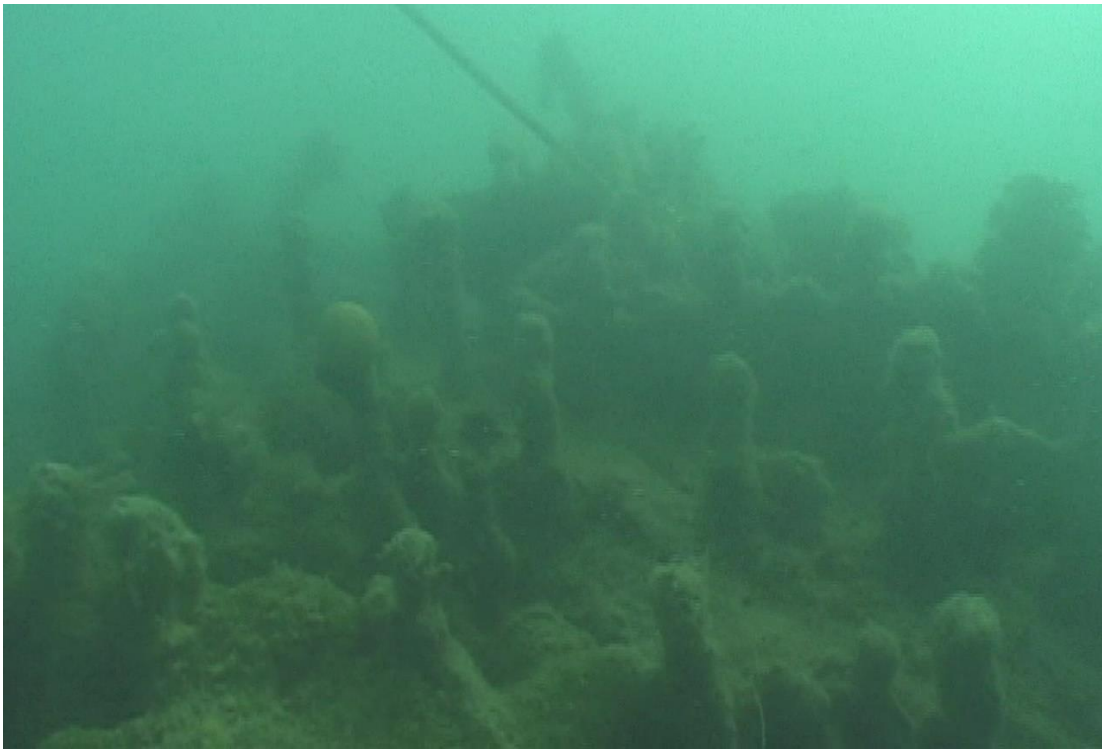
Figure 61. Concreted fasteners on *Fraternité* (Image from 2008 ECU archaeological survey).

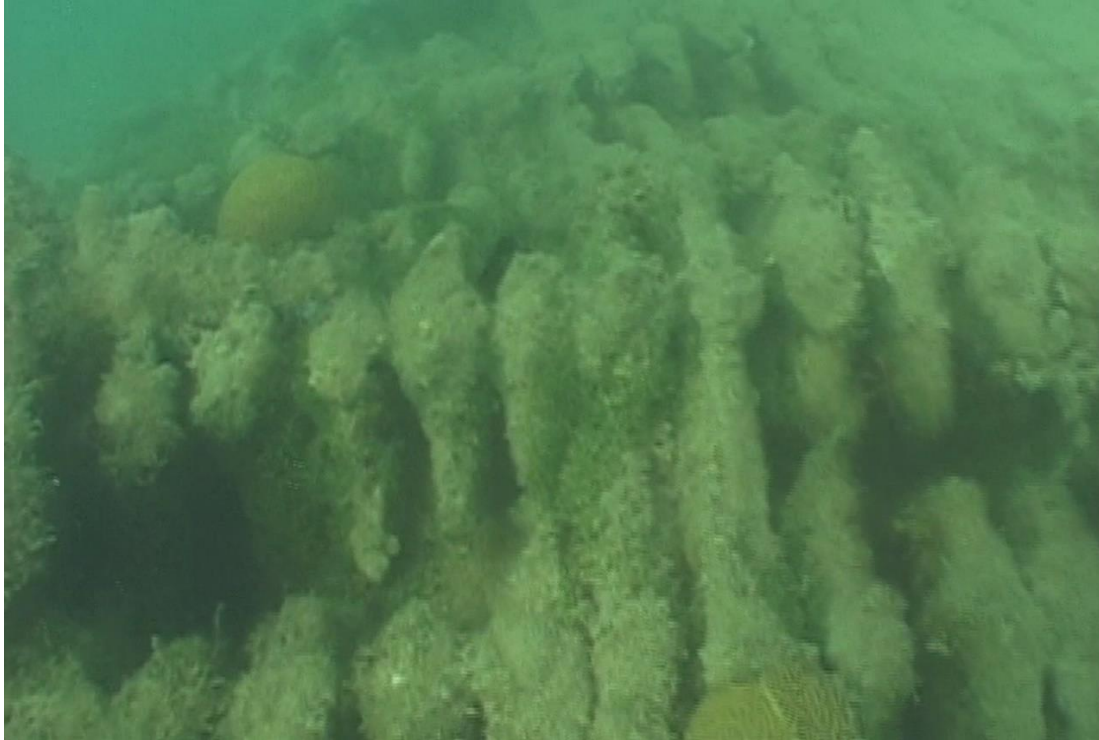
Figure 62. Corrosion from fasteners encompassing remnants of planking on *Fraternité* (Image from 2008 ECU archaeological survey).

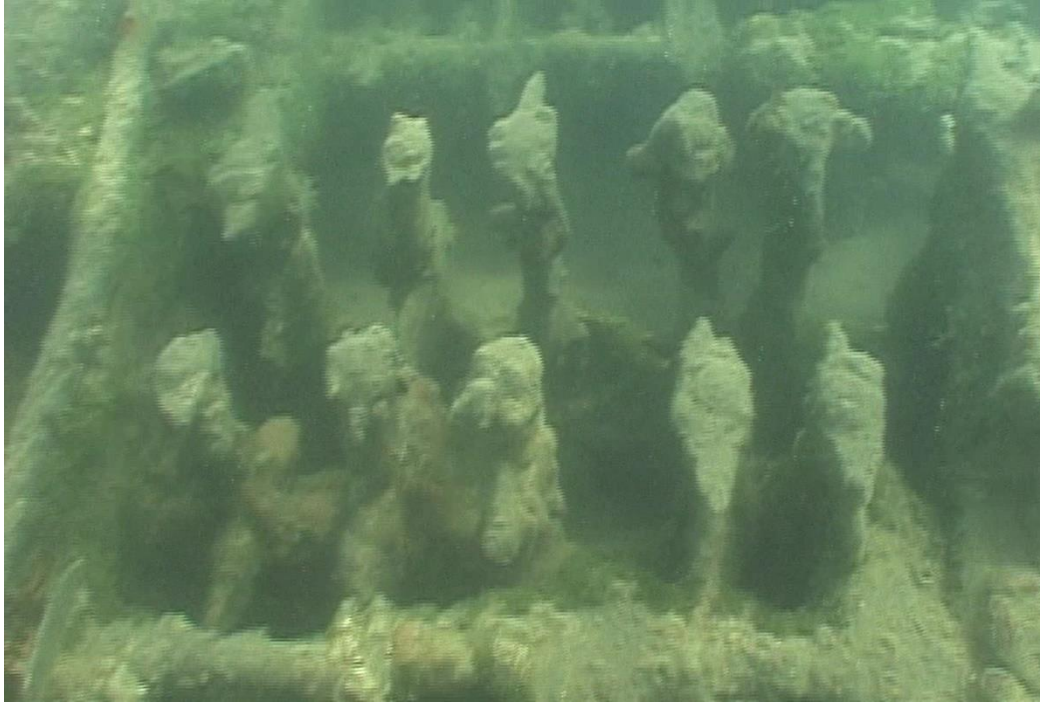
Figure 63. Fasteners that once held planking to the frames (Image from 2008 ECU archaeological survey).
