AW SHUCKS: AN ARCHAEOLOGICAL INVESTIGATION OF A POSSIBLE OYSTER FISHING VESSEL IN WASHINGTON, NORTH CAROLINA

A Thesis

Master of Arts in Maritime Studies

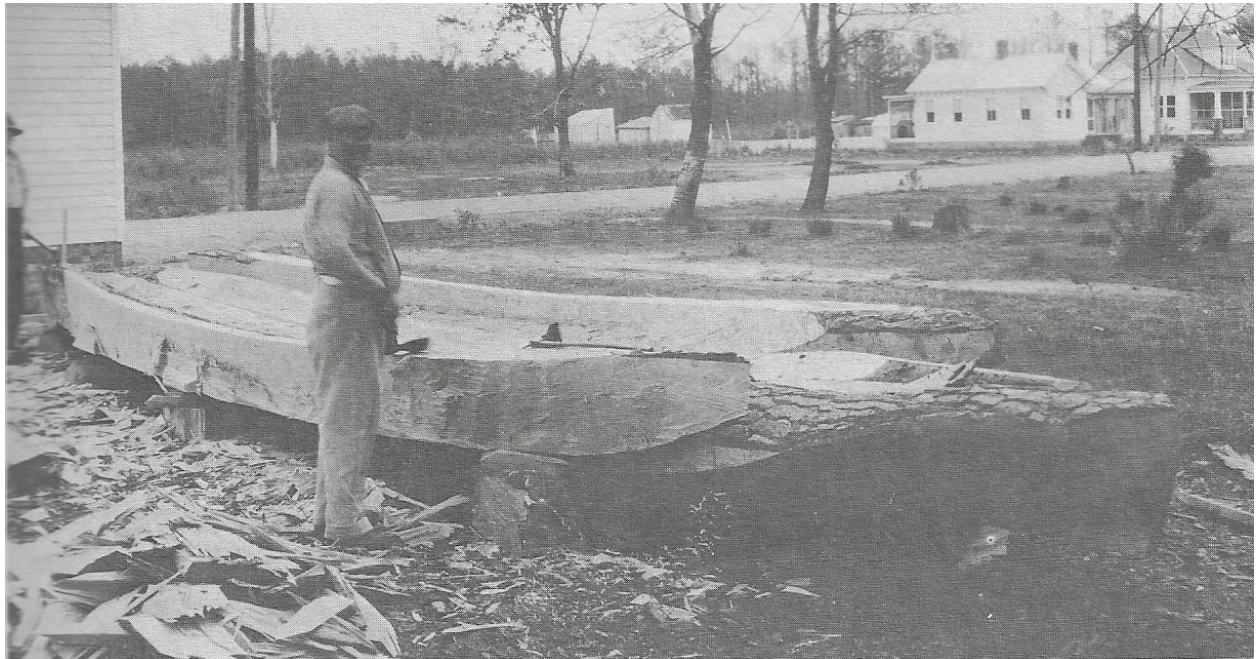
FIGURE 14. Photograph of a shipbuilder constructing a Poquoson canoe out of multiple logs (Brewington 1963:9).

As the colonies in the New World grew, the use of the dugout canoe spread, and the watercraft was designed to fit specific needs. Colonists connected two canoes together to form a more stable vessel to transport heavy cargo. The canoes developed into specific types such as the Poquoson and Pocomoke canoes. These canoes were made of several logs which were shaped by

the builder (FIGURE 14). Some included a keel log that was cut to contain a centerboard (Brewington 1963:7; Burgess 2005:2).

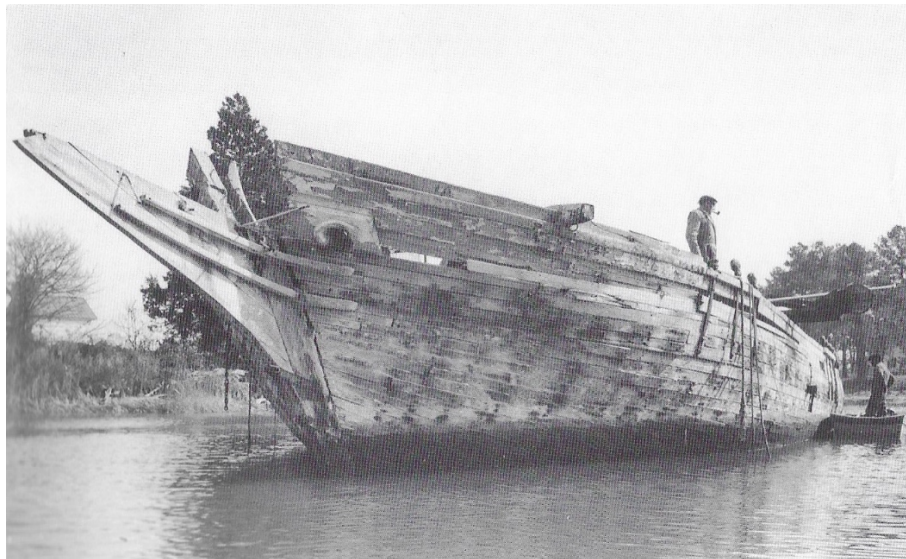
FIGURE 21. A photograph of the abandoned schooner *Bohemia* (Burgess 2005:95)

Historical photographs of *Bohemia* indicate that the vessel has obvious Chesapeake Bay construction elements including a slow rising stem, low freeboard amidships, and flat rounded hull. The schooner was equipped with two masts, with the mainmast offset of the keel. Interestingly, the vessel also contained a centerboard, which was offset on the opposite side of the keel as the mainmast (FIGURE 22). These construction features can be attributed to the shipbuilding traditions that developed in the Chesapeake Bay region (Burgess 2005:92-93).

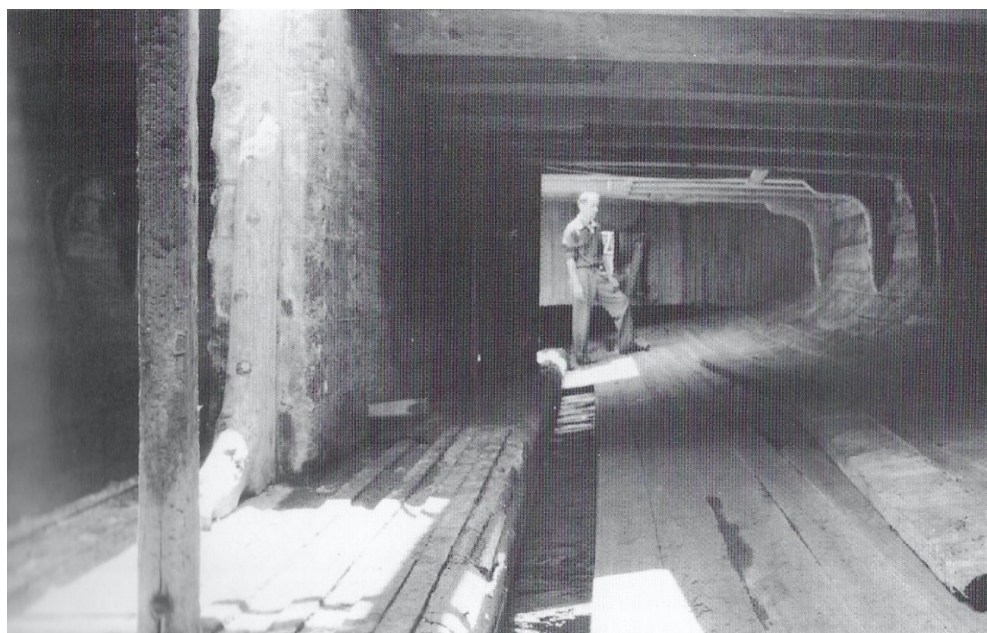
FIGURE 22. A photograph of the interior of *Bohemia*. The centerboard case can be seen slightly offset from the keelson (Burgess 2005:93).

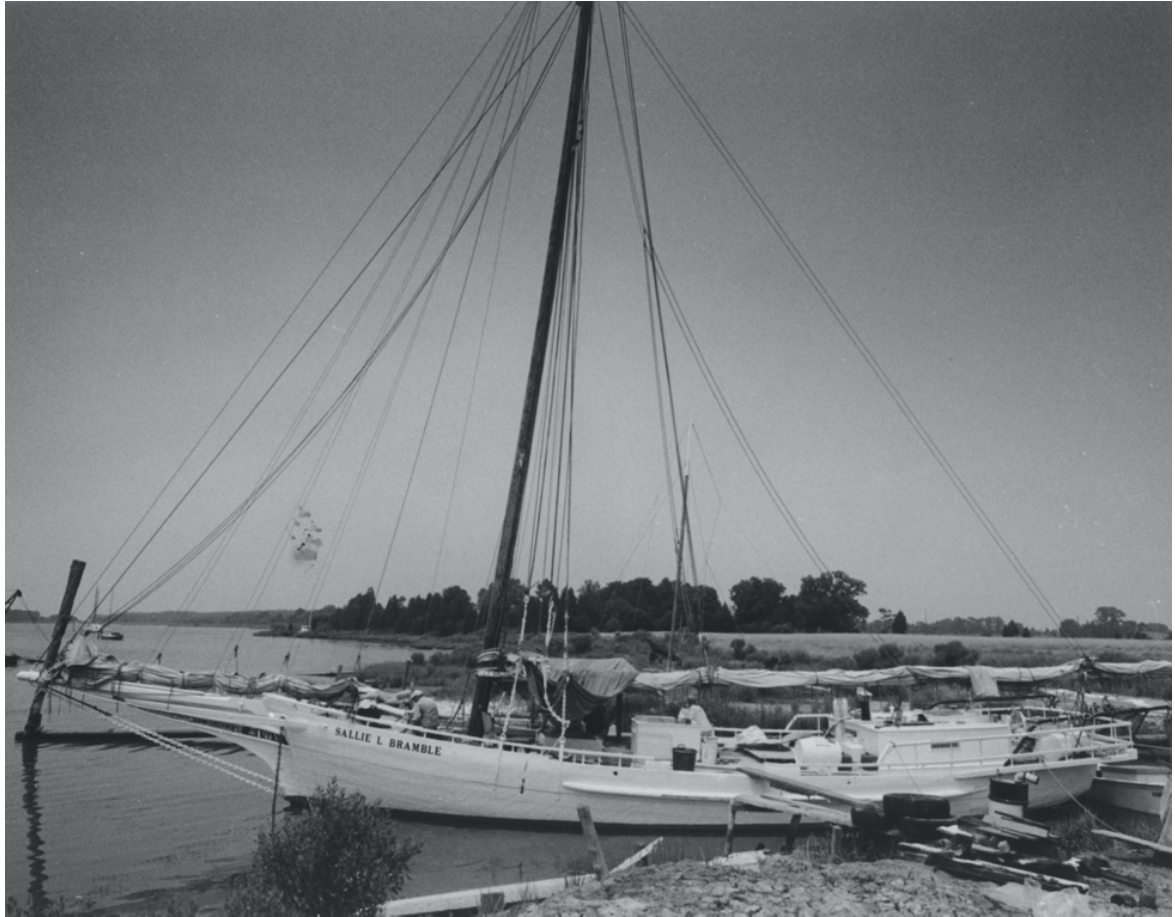
FIGURE 27. The single masted bugeye *Sallie L. Bramble* (Courtesy of the Chesapeake Bay Maritime Museum).

Even though all bug-eyes were built to have similar features, the final product depended on the shipbuilder and slight variations in bug-eye design developed throughout the Chesapeake Bay. Typically, bug-eyes had two masts and were often rigged with a leg of mutton sail configuration. There are, however, exceptions to this documented in the historical record. One masted bug-eyes did exist though they were rare (FIGURE 27) (Brewington 1963:78; Snediker and Jensen 1992:54-55).

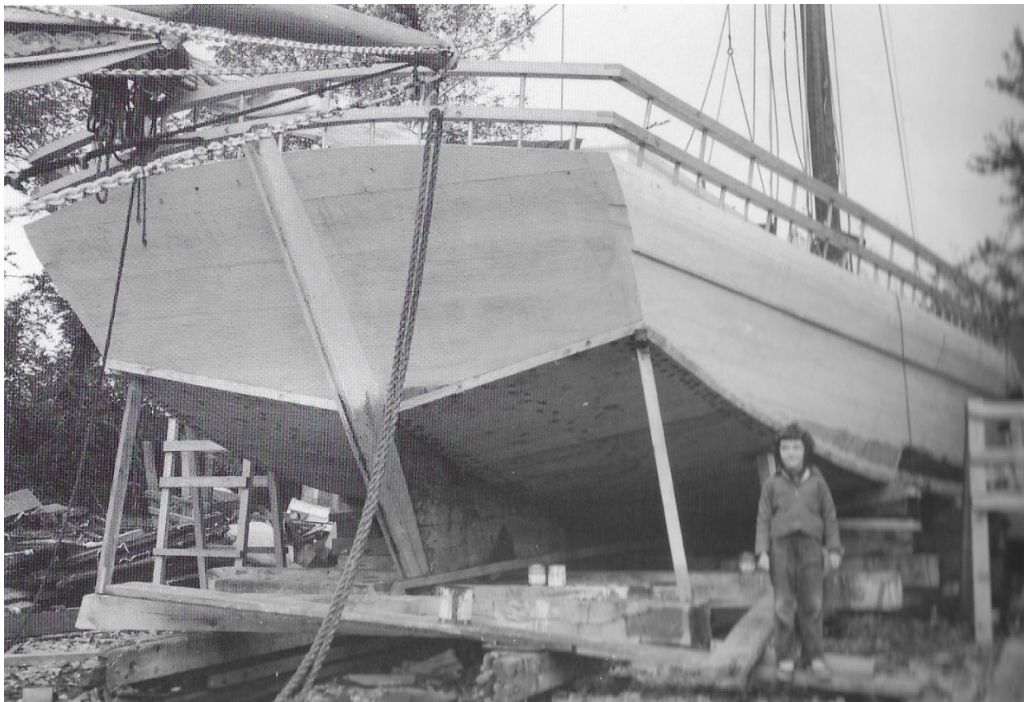
FIGURE 31. A photograph of the transom of the skipjack *Mamie A. Mister*. The v-bottom, sharp chine, and perpendicular bottom planking can also be seen (Burgess 2005:248).

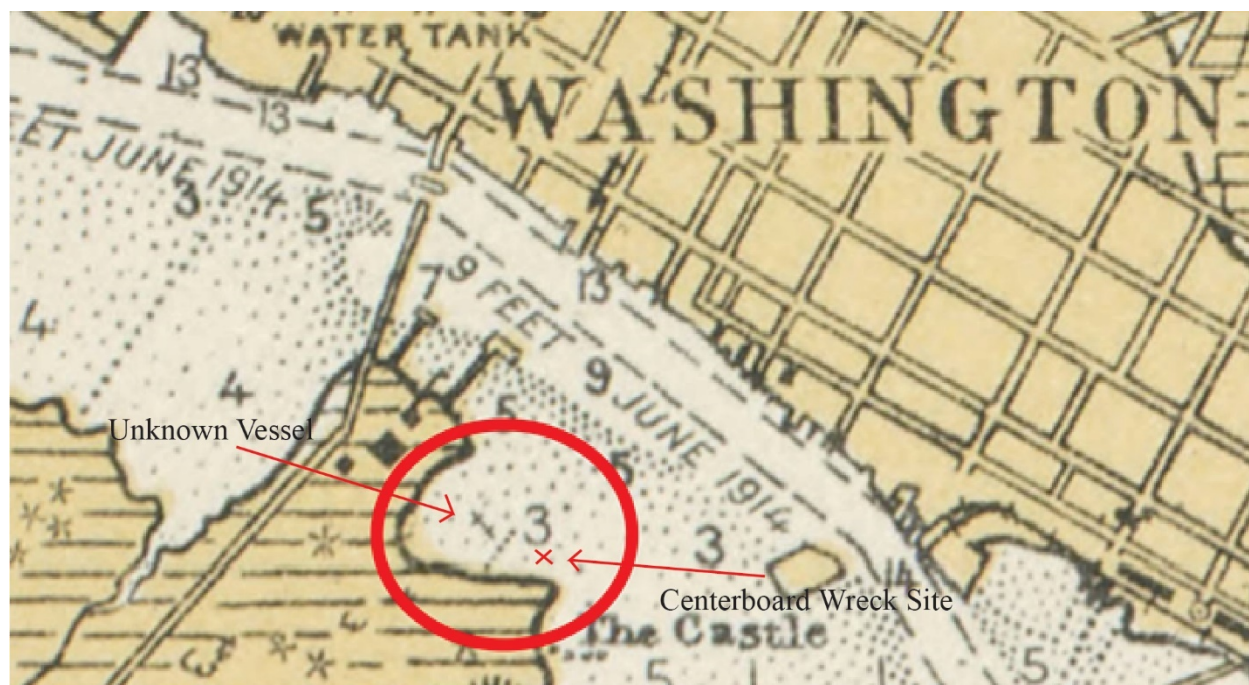
FIGURE 34. A 1915 Chart of Washington waterfront showing an abandoned pier and an unknown vessel. Note the Centerboard Site is located on the opposite side of the pier remnants and the shipwreck icon (Amended from U.S. Coast and Geodetic Survey 1915).

The Centerboard Wreck site is located off the south bank of the Pamlico River across from the historic port of Washington, North Carolina. The wreck is completely submerged in blackwater at high tide and the top of the centerboard case is exposed at low tide. The site is positioned within a small cove which also contains the remains of at least one historic pier and a

second shipwreck. The remains of the pier are noted on historic charts as early as 1872 and can be partially seen at low tide (FIGURE 34). The second shipwreck is disarticulated and has not been previously surveyed.

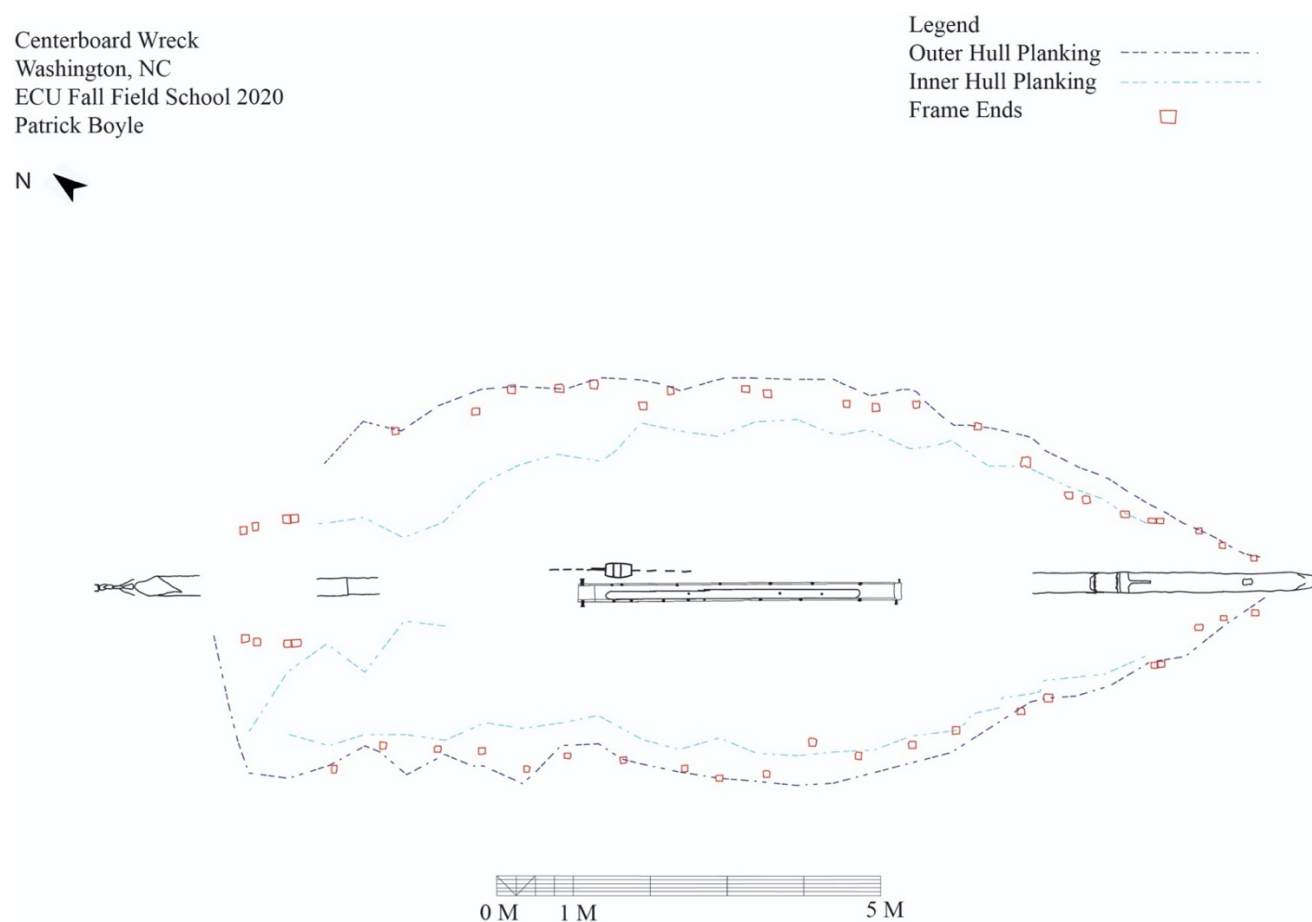
FIGURE 36. Highlighted depictions of the outer and inner hull planking as well as frame ends on the Centerboard Wreck. Note the inner hull planking is colored light blue while the outer hull planking is colored dark blue. The frame ends are colored in red (Drawing by author).

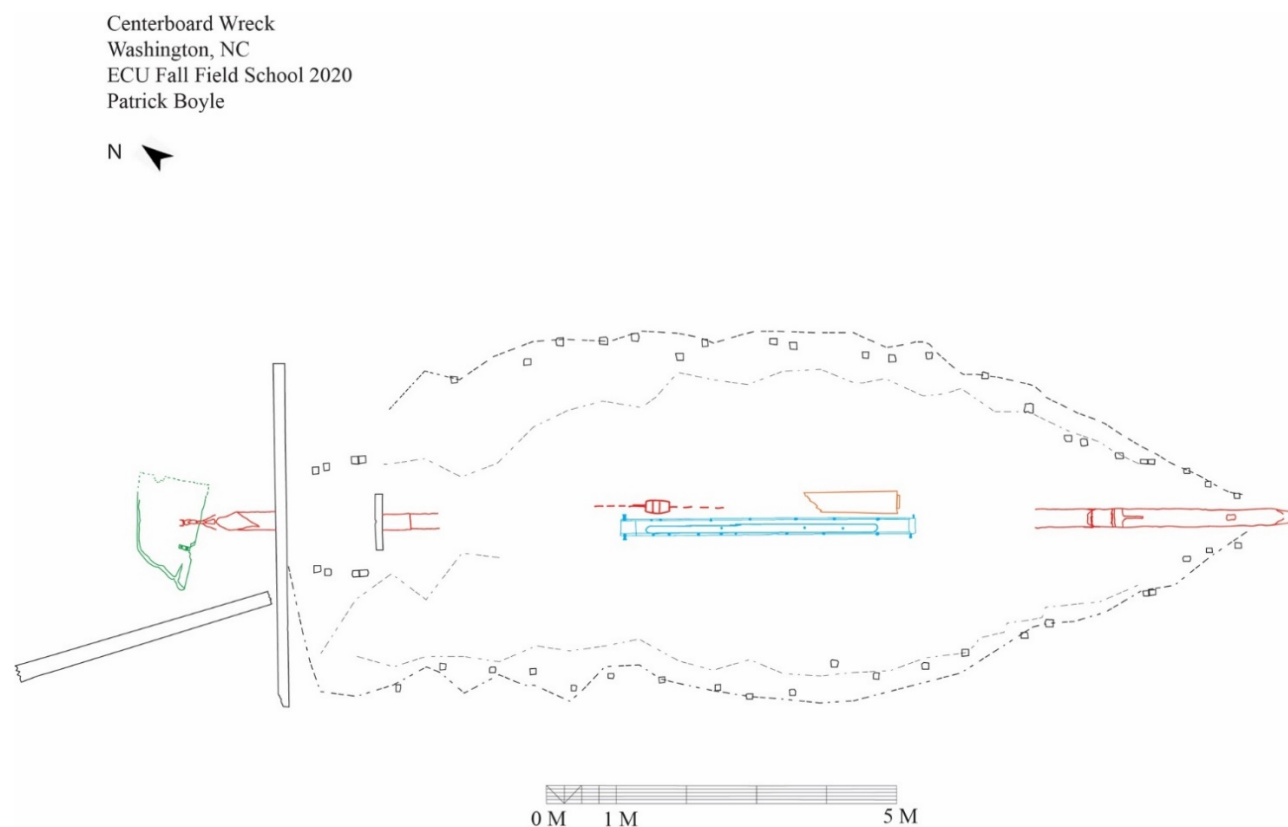
FIGURE 44. Highlighted depictions of the keelson (red), mast steps (red), centerboard case (blue), and rudder (green) on the Centerboard Wreck (Drawing by author).

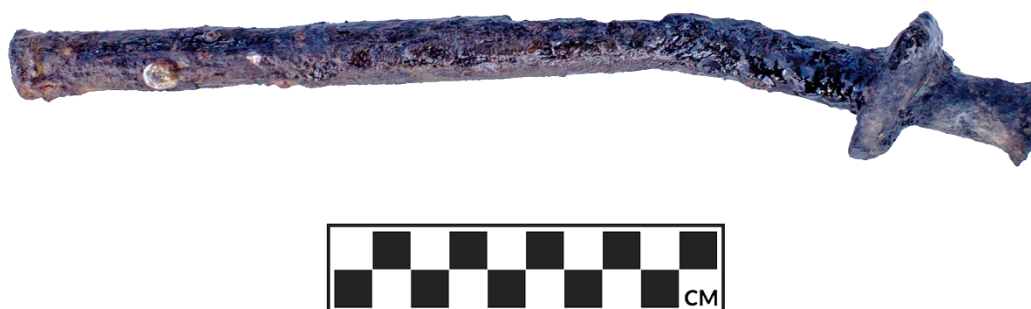
FIGURE 46. A copper bolt found on the centerboard case of the Centerboard Wreck (Photo by author).

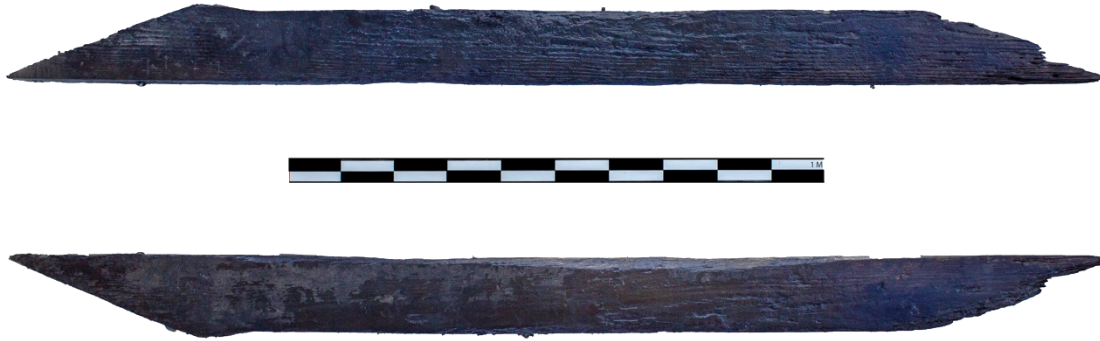
FIGURE 47. A bulkhead timber found aft of the forward mast step on the Centerboard Wreck (Photo by author).
Bobstay Fitting (62.20.001)

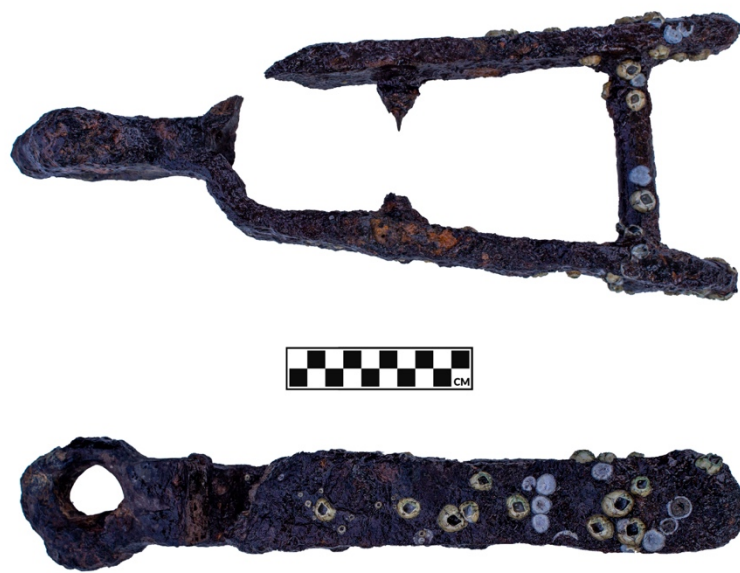
FIGURE 48. A bobstay fitting found near the stem assembly of the Centerboard Wreck (Photo by author).

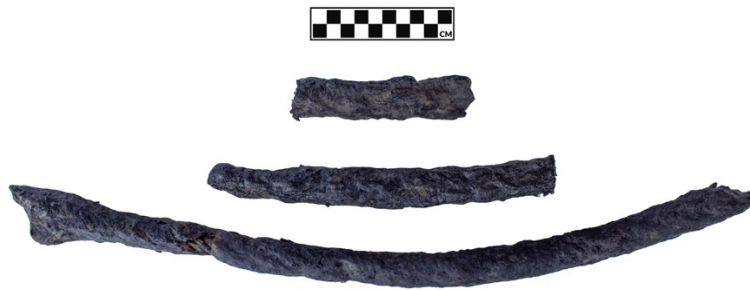
FIGURE 50. Wire rope pieces found on the Centerboard Wreck (Photo by author).

Three sections of wire rope were recorded on the site (FIGURE 50). Although they were slightly concreted, some exposed sections that showed the inner twisted strands of the cable. The largest piece of cable measured 52 cm (20.5 in.) in length and 3 cm (1.2 in.) in diameter. Strong wire rope first developed in Great Britain in the early 19th century and quickly replaced manilla line due to its higher tensile strength and versatility (Chapelle 1941:575; Martin 1992:101). The wire rope found on site was likely used in the rigging of the vessel, however, it may also have been used to for dredging.

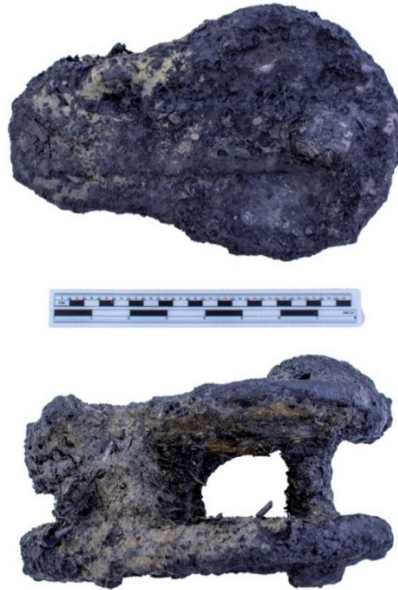
FIGURE 51. An iron pulley found on the Centerboard Wreck (Photo by author).

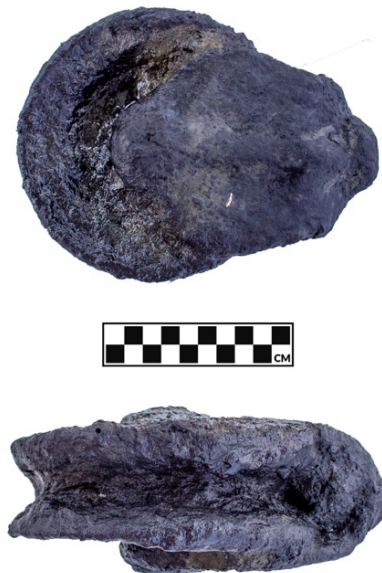
FIGURE 52. A different type of iron pulley found on the Centerboard Wreck (Photo by author).

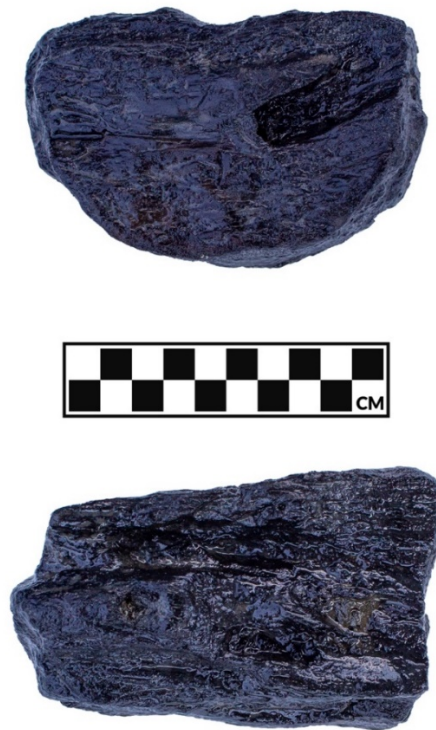
FIGURE 53. A piece of a possible deadeye found on the Centerboard Wreck. Note that only half of the object remains (Photo by author).

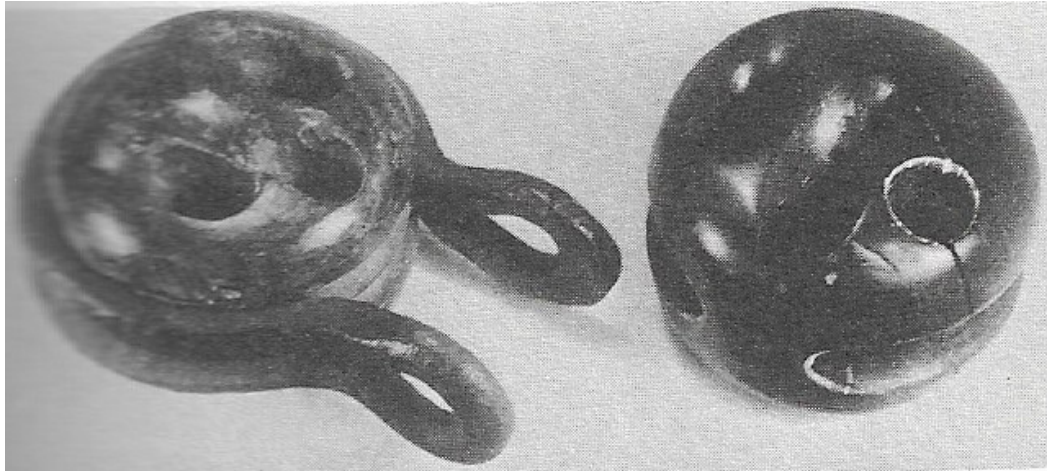
FIGURE 54. A photograph of a deadeye used on a Chesapeake Bay oyster vessel (Brewington 1963:65).

A possible deadeye, measuring 11 cm (4.3 in.) in length and 8 cm (3.1 in.) in width, was found near the mast of the Centerboard Wreck. The object is highly eroded and only half of it remains intact, however, it shares a strong resemblance to a wooden deadeye (FIGURE 53) (Chapelle 1941:542). Deadeyes were an important piece of the rigging used on wooden ships that helped guide ropes, lines, and cables (FIGURE 54). Deadeyes were built from wood and contained three holes or slots and were commonly used on chain plates. They were sometimes used in conjunction with a second deadeye to create a lanyard (Brewington 1963:65).

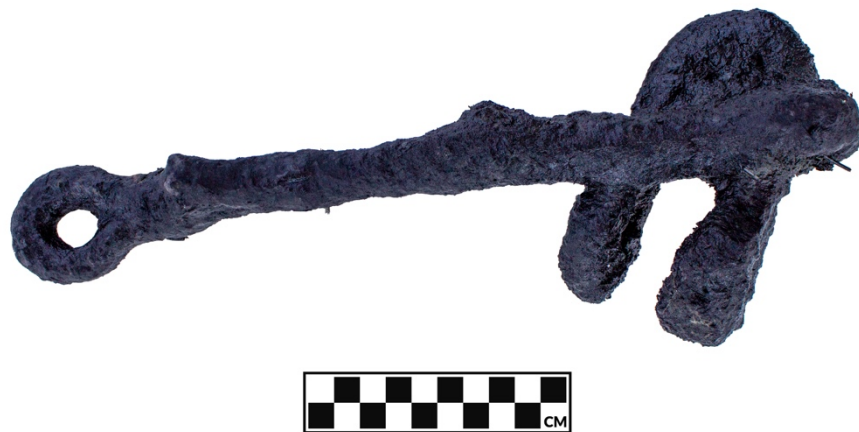
FIGURE 55. A possible purchase link found on the Centerboard Wreck (Photo by author).

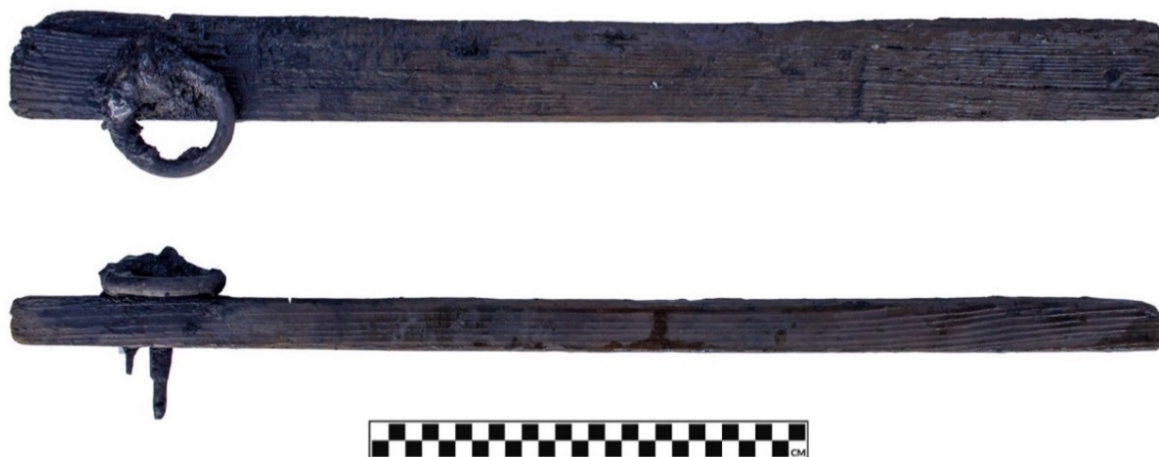
FIGURE 57. A piece of a hatch cover found on the Centerboard Wreck. Note the curved corner by the iron eyebolt (Photo by author).

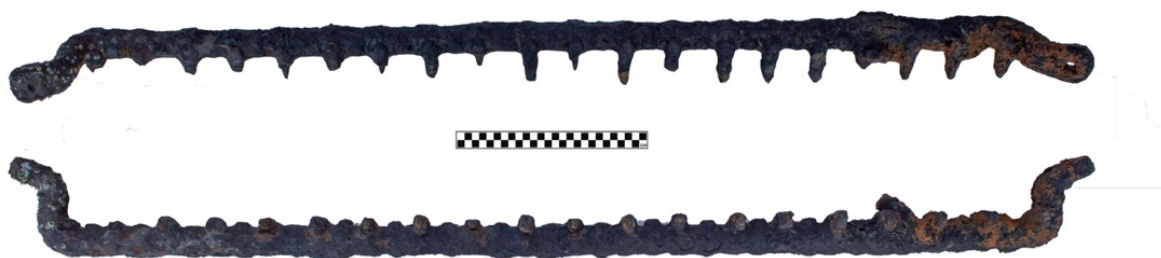
FIGURE 59. One of three dredge rakes found on the Centerboard Wreck site. Note the holes on either end which were used to attach the rake to the dredge (Photo by author).

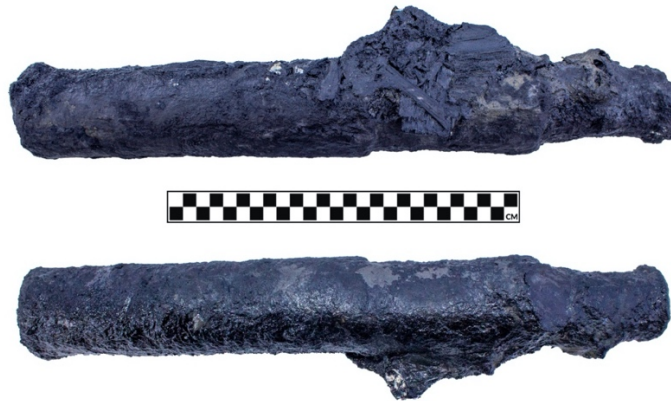
FIGURE 60. A vertical dredge roller found on the Centerboard Wreck (Photo by author).

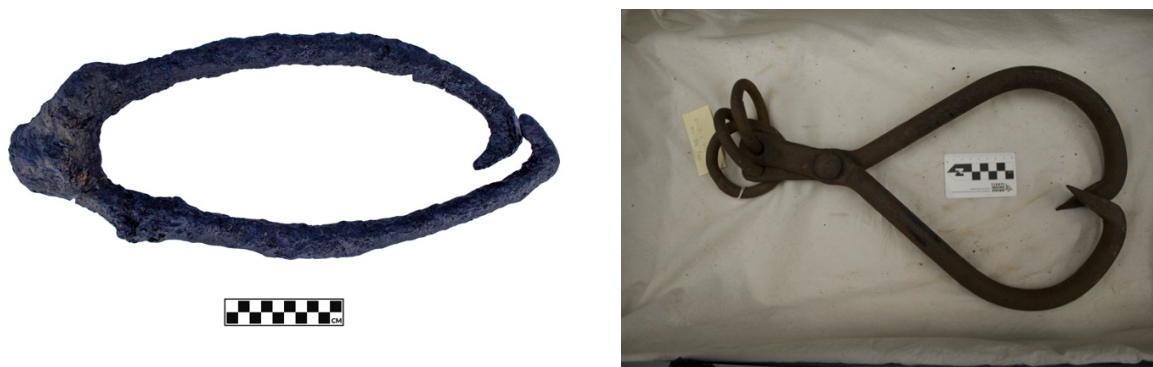
FIGURE 64. Ice tongs found on the Centerboard Wreck juxtaposed with a set taken from a Chesapeake Bay oyster boat (Photo courtesy of the Chesapeake Bay Maritime Museum).

A set of iron tongs measuring 46 cm (18.1 in.) in length were discovered within the wreck. Though missing handles, the teeth of this tool are still intact and suggest that it was used to move blocks of ice for an icebox. Ice was commonly used on fishing vessels in 19th century and is still used today to keep fish fresh on the journey back to port. Iceboxes were such an integral piece of a fishing vessel many boats were designed with iceboxes before the ship was even built. Typically, a simple insulated container with a hinged top, they varied drastically

between vessels (FIGURE 64). Since iceboxes were specifically designed to each vessel it is suggested that “no part of a boat is more revealing of the owner’s and designers’ sea experience” (Chapelle 1941:516). Although no icebox was identified at the Centerboard Wreck, it is highly likely the vessel contained one because of its potential involvement in a fishing industry and the discovery of these ice tongs offer support (Ingersoll 1881:198; Chapelle 1941:516-518).

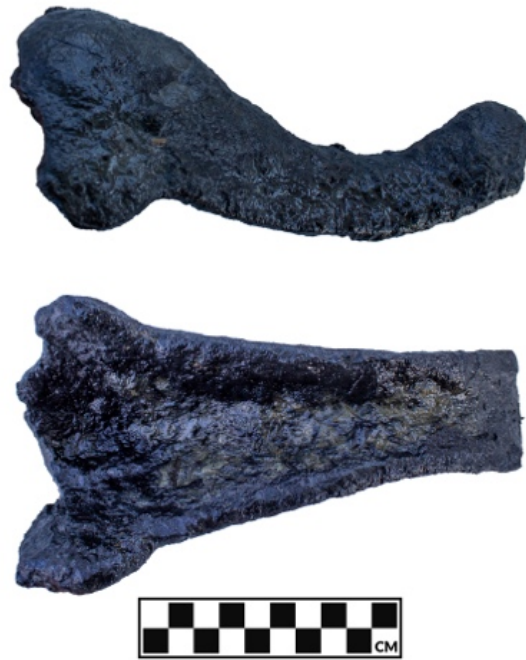
FIGURE 66. A broken leg from a small iron stove found on the Centerboard Wreck (Photo by author).

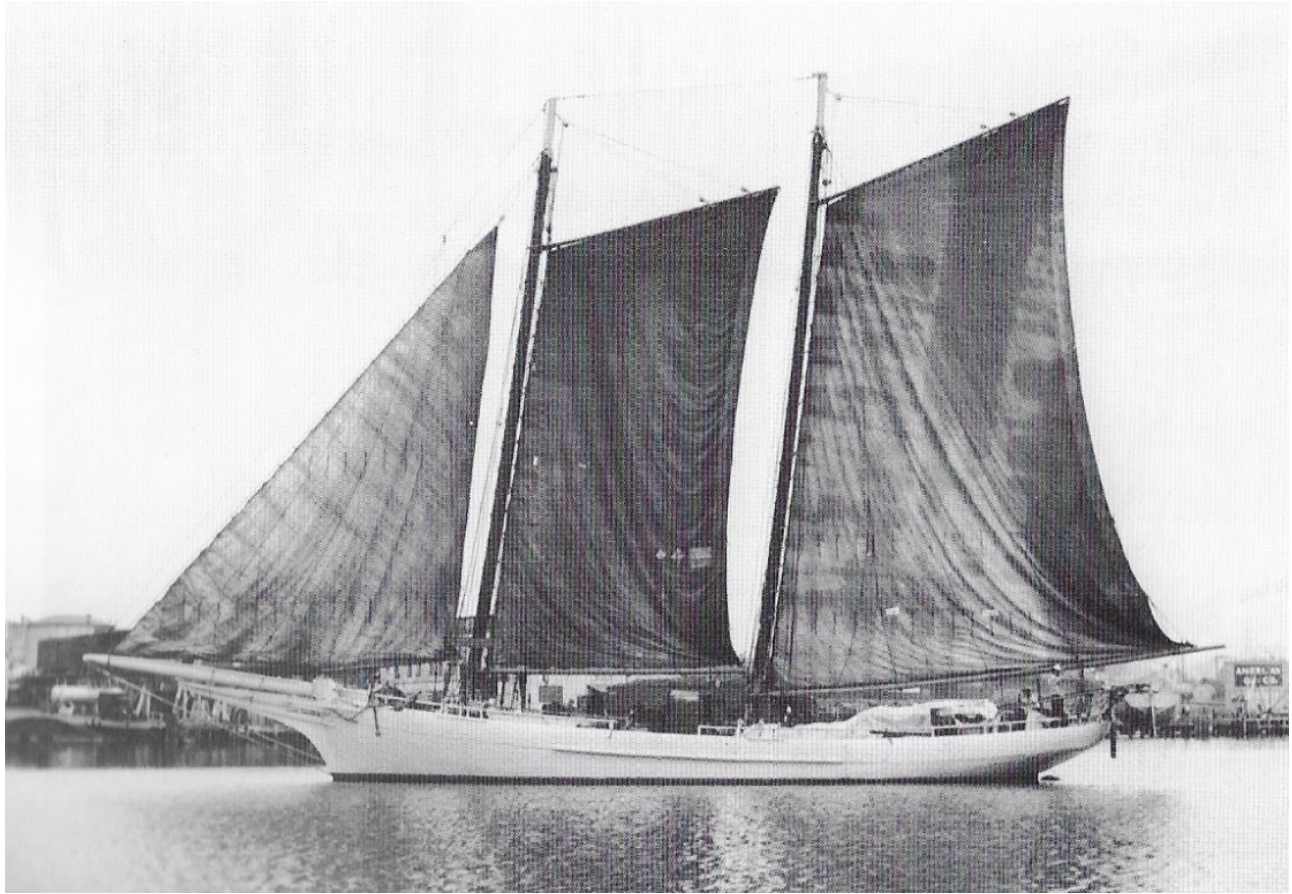
FIGURE 69. A photograph of the square rigged (gaff rigged) bugeye *Catherine* (Burgess 2005:19).

While the Centerboard Wreck has likely been known to ECU staff since the 1980s, the site was not thoroughly investigated until 2020 (Rodgers et al. 2016:129-130). It was only after archaeological data was collected and interpreted that a possible Chesapeake Bay connection was theorized. While centerboard vessels were common in both the Chesapeake Bay and Pamlico Sound regions, multiple construction features of the Centerboard Wreck suggest that the vessel was not built locally but was instead a specific Chesapeake Bay built fishing vessel known as a square rigged bugeye (FIGURE 69) (Rodgers et al. 2016:129-130).

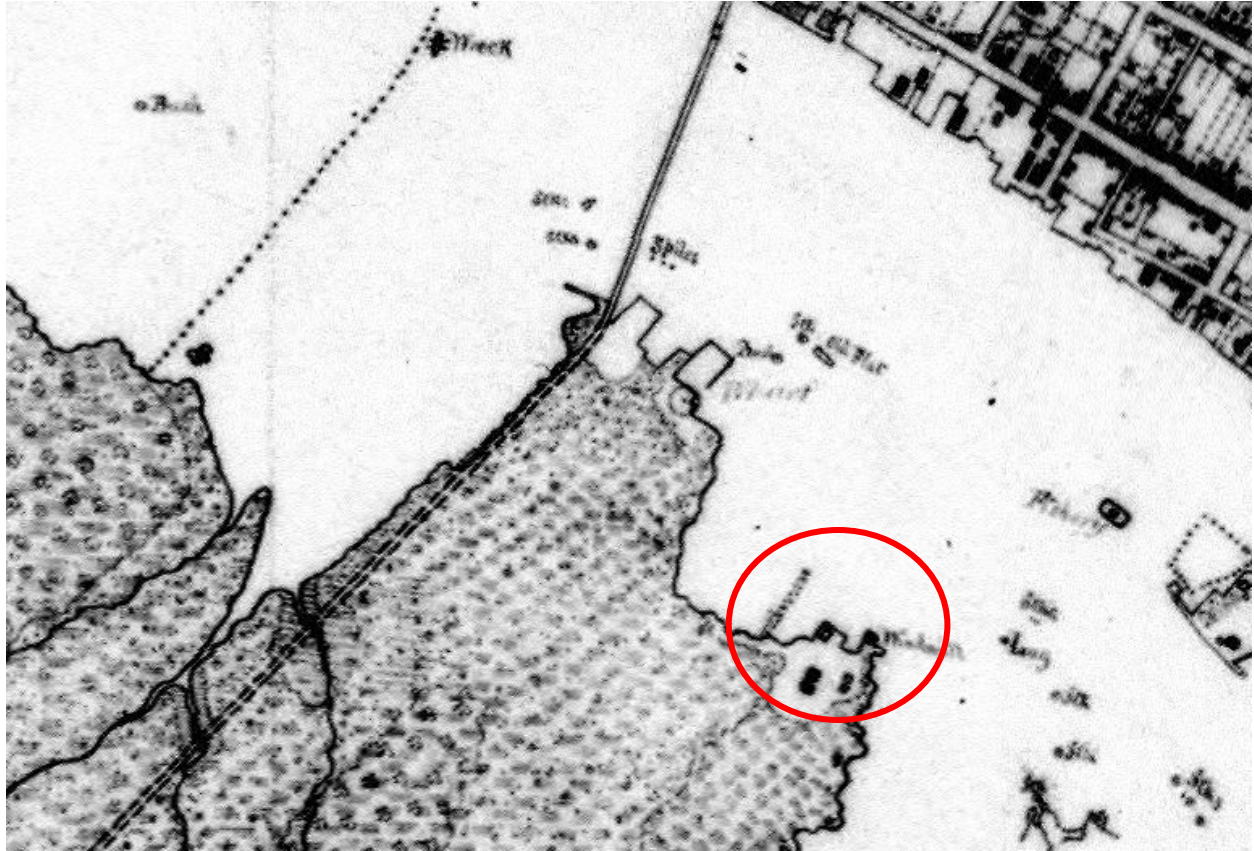
FIGURE 77. An 1872 map of Washington that shows a pier and structures in the vicinity of the Centerboard Wreck location (U.S. Coast Survey 1872).

The Centerboard Wreck is located on the east side of pier remains in a cove on the south shore of the Tar River across from Washington's waterfront. Closer to the pier, but on the west side, lies a second shipwreck that is not as articulated as the Centerboard Wreck. Although the pier is depicted on historical maps as early as 1872 (FIGURE 77), along with structures on land in the area, the exact use for this component of maritime infrastructure is unknown (U.S. Coast Survey 1872). By the year 1915, the terrestrial buildings at this location are no longer depicted on charts and the pier seems to have become derelict (U.S. Coast Survey 1915). Interestingly, this chart also shows a shipwreck icon on the west side of the pier in the same location as the second known wreck in the cove. A shipwreck icon for the Centerboard Wreck is noticeably missing from both the map and chart which suggests that ship possibly wrecked or was abandoned in the cove sometime after 1915. Although the exact cause of loss is unknown, there is no evidence to suggest the Centerboard Wreck collided with an object, land, or another vessel. Given the proximity of the wreck to known abandoned vessels, such as those at Castle Island, it is possible this vessel was simply abandoned.

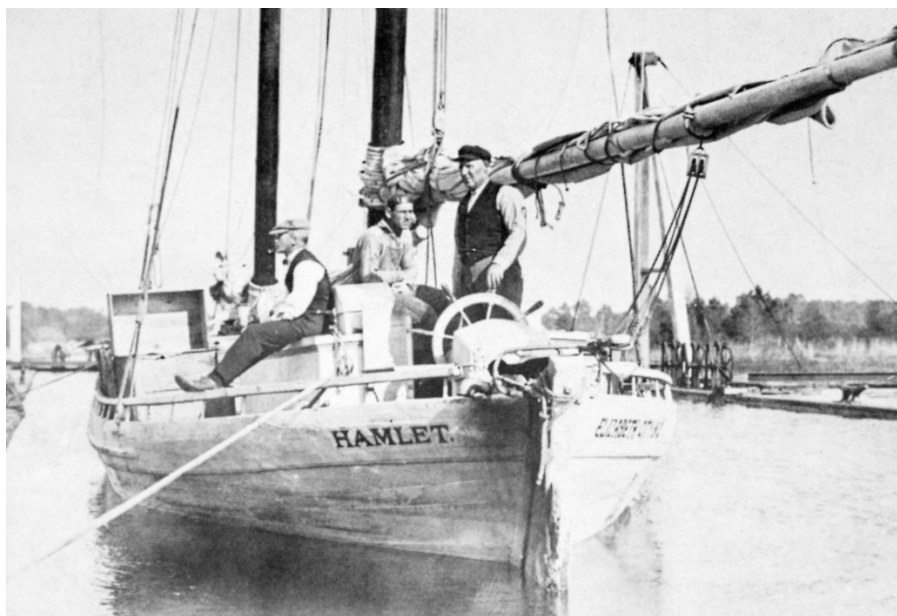
FIGURE 79. The bugeye *Hamlet* with its homeport stated as Elizabeth City, NC (Garrity-Blake and Amspacher 2017:155).

Hamlet has a long-recorded history and was used extensively in North Carolina (FIGURE 79). Built in Fishing, Maryland in 1890, it measured 17 m (56 ft.) long and 4.4 m (14.5 ft.) wide and was used in the oyster industry in both Maryland and North Carolina. In 1914, *Hamlet* famously aided the New York Aquarium in transporting live dolphins from North Carolina with the help of Captain Ethelbert Dozier Burrus. Burrus retired from trading cargo from the state to the West Indies sometime prior to 1915. Thereafter, he used *Hamlet* as a freight boat to carry

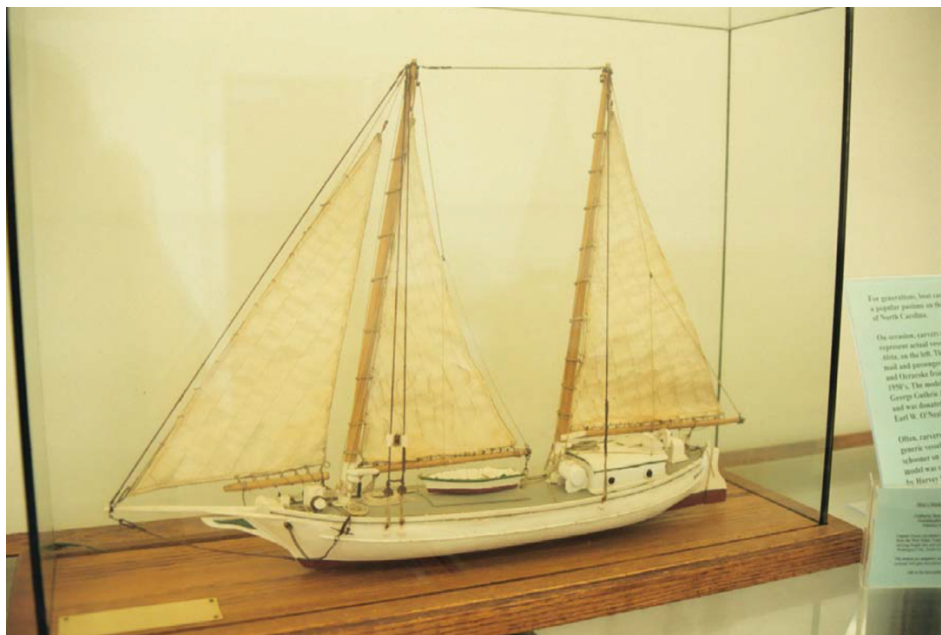
FIGURE 80. A model of the bugeye *Hamlet* located at the Graveyard of the Atlantic Museum (NPS 2005:323).

Although *Hamlet* is similar in size to the Centerboard Wreck and was likely abandoned in Washington, certain features of each vessel may prove that they are not the same. *Hamlet* was listed as a gas boat during multiple years of its lifespan but there is no evidence that the Centerboard Wreck ever utilized a motor. Furthermore, although *Hamlet* is among the known bugeye list, it is not registered as a square rigged bugeye. It is also difficult to determine from historic photographs if the main mast of *Hamlet* is offset to the port side or in line with the forward mast. A model of *Hamlet*, however, indicates that it was not square rigged and appears to be built as a traditional bugeye (FIGURE 80). Thus, since the Centerboard Wreck was not built as a traditional bugeye and shows no signs of conversion to a gas boat, it is unlikely to be the remains of *Hamlet*.
