ARCHAEOLOGICAL SITE FORMATION OF THE “SEA SCOUT WRECK”:
MALLOWS BAY, NANJEMOY, MARYLAND

A Thesis

In Partial Fulfillment of the Requirements for the Degree
Master of Arts in Maritime Studies

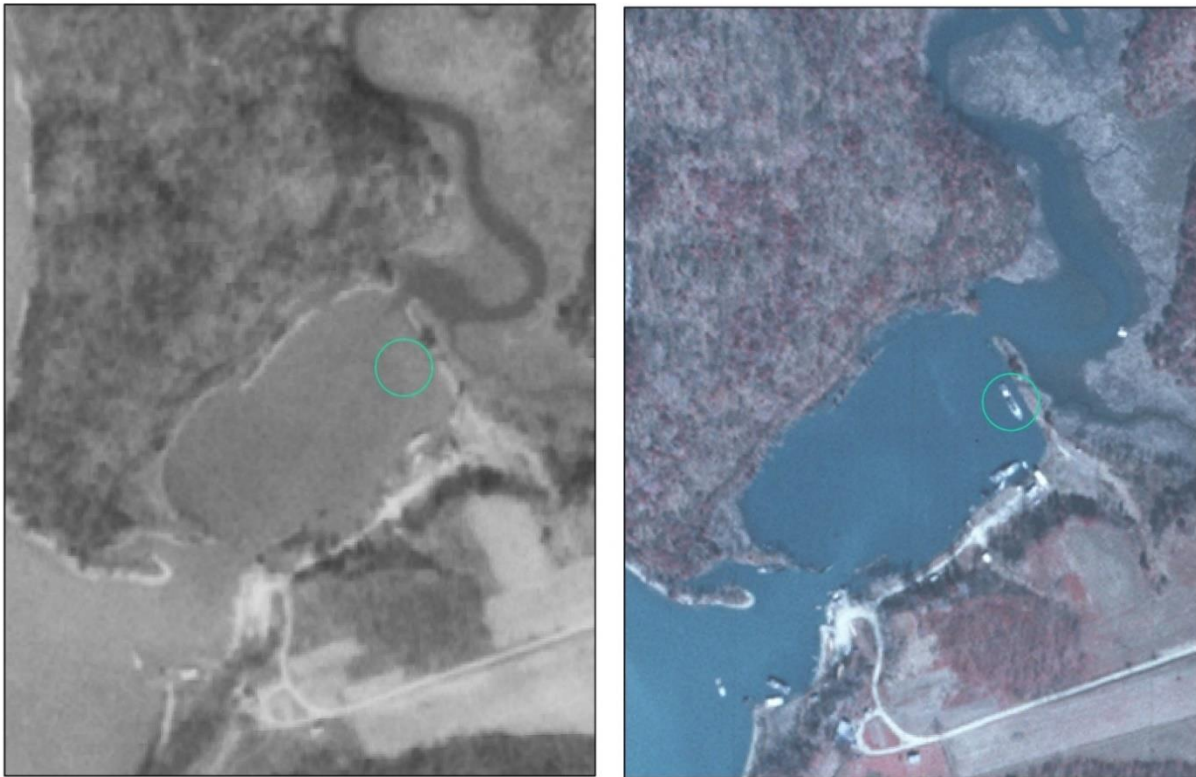
FIGURE 1.2 Side-by-Side Map of the Burning Basin on March 24, 1977 (Exposure number 4-49) and March 27, 1980 (Exposure number 17-186) (U.S.G.S. 2021)

On March 24, 1977, just eight days after the aerial photograph of the Alexandria Torpedo Factory was taken, an aerial photograph of Mallows Bay was taken. In this photograph (Figure 5.39) there are no vessels located in the Burning Basin. The next available aerial photograph of the area was taken on March 27, 1980, and shows a vessel with measurements matching a 104' ARB in the location now occupied by the Sea Scout Wreck (Figure 5.30). The next available aerial photograph that clearly shows the Alexandria Torpedo Factory was taken on April 2, 1981 (Figure 5.31). It shows that the 104' ARB is no longer docked there. This seems to support the current hypothesis that the Sea Scout Wreck is the same vessel docked at the torpedo factory in Alexandria, VA, that was moved sometime in the late 1970s, or early 1980; however, this only establishes that it was moved, and a 104' ARB was moved into the Burning Basin in Mallows Bay at approximately the same time. When examining the photographs of the Sea Scout Wreck provided by Dr. Susan Langley, there is additional material laying across the deck aft of the pilothouse that cannot have been produced from 104' ARB without modified deck features (Figure 5.32) (Susan Langley 2020, elec. comms.).

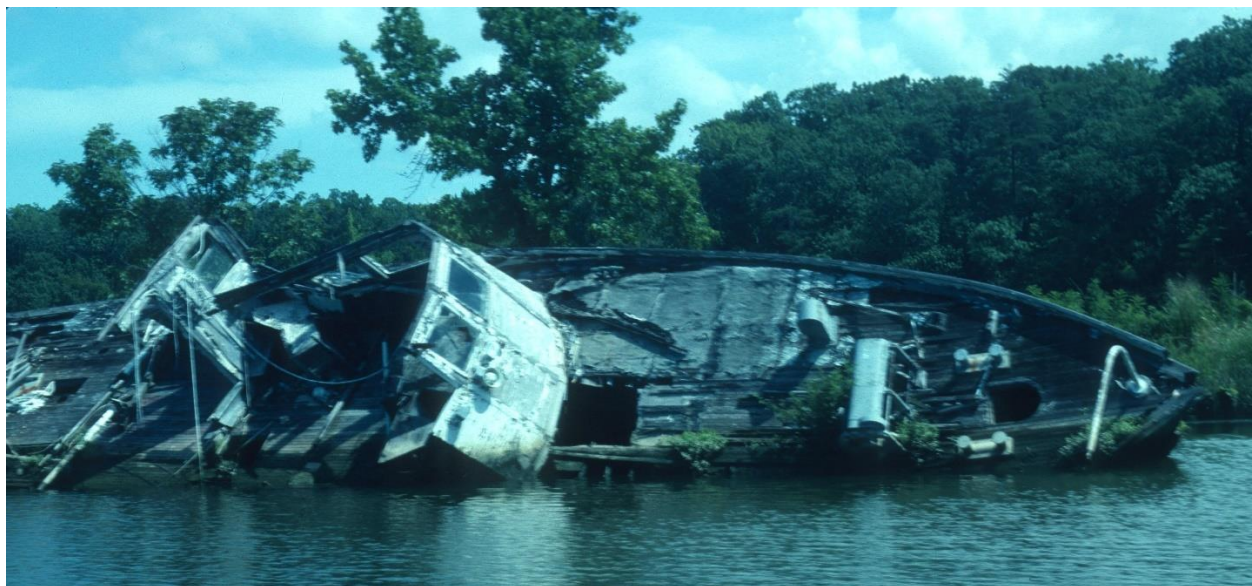
FIGURE 1.3 Picture of the Sea Scout Wreck taken in 1997 (Photo credit Susan Langley, 1997).

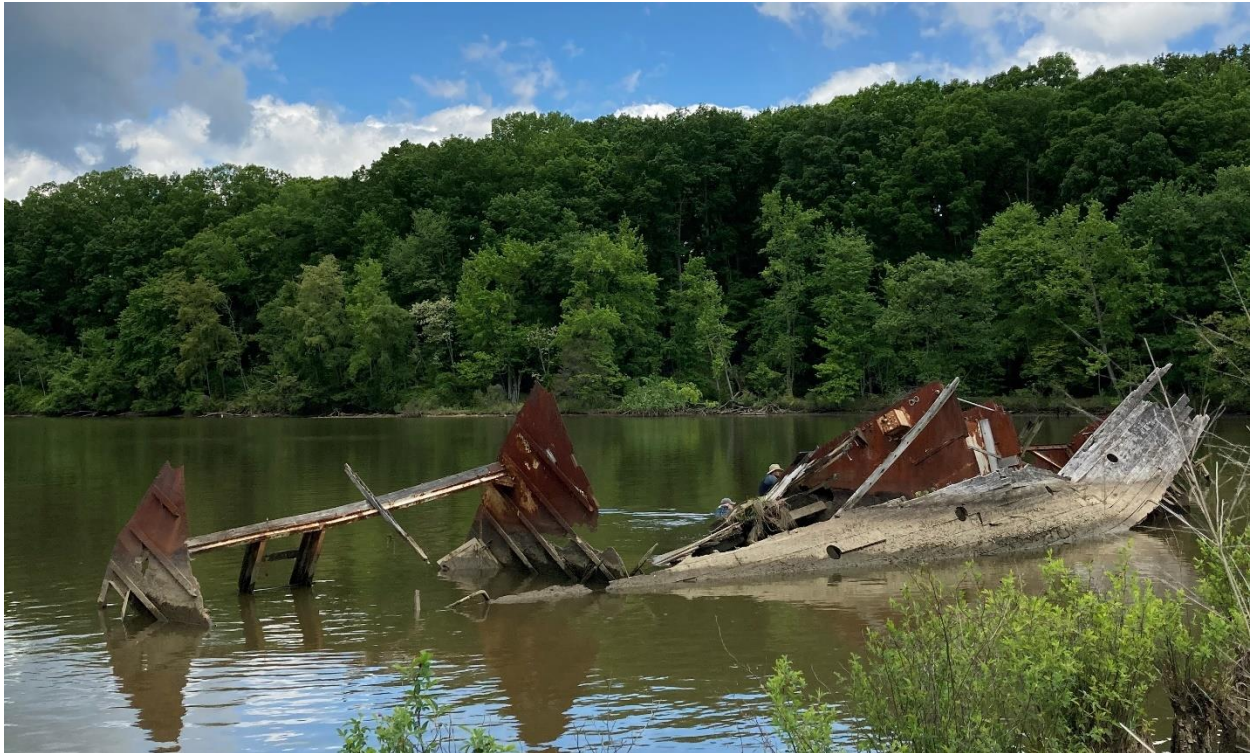
FIGURE 1.4 Sea Scout Wreck in May 2021 in a severely disintegrated state compared to Figure 1.2 (Photo credit Priscilla Delano, 2021).

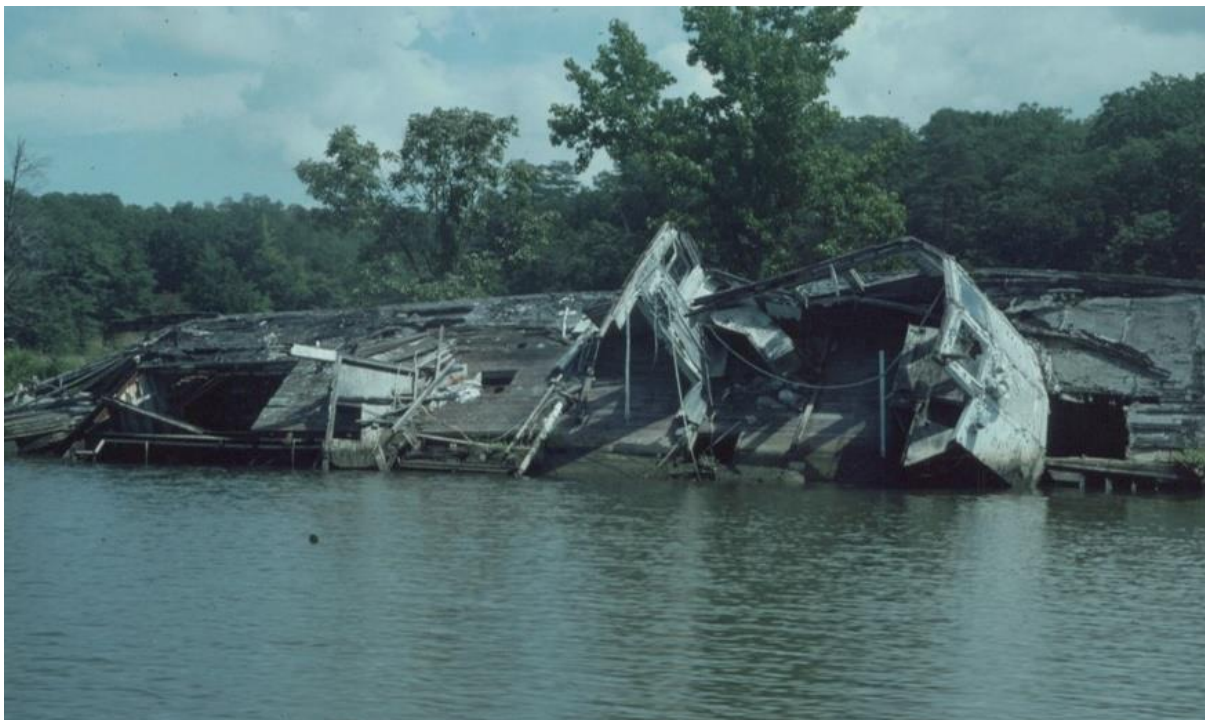
FIGURE 1.5 Middle Section of the Sea Scout Wreck in 1997 which shows the collapsed hull behind Bulkhead 6 (Photo credit: Susan Langley, 2020).

with "WPC 1945" stamped on it. Shomette believed this may be a date or a manufacturing serial number, although he stated that other components of the wreck are from a later construction date (Shomette 1998:426-427). Shomette recorded three different oral traditions regarding the identity of the vessel as being the remains of either a United States Navy (U.S.N.) patrol torpedo boat (PT-boat), or a fishing yacht that may have been used by the Sea Scouts (Shomette 1998:427). He also stated the vessel has only marginal historic significance, but there was a need for verification (Shomette 1998:49, 426). This assessment of the vessel's lack of significance is due to the investigation focusing on the impact caused by the reduction and salvaging of the EFC vessel and other abandoned craft in the bay (Shomette 1998:1). Despite being abandoned relatively recently compared to the other vessels in the ship graveyard, the Sea Scout Wreck has suffered from extensive disintegration since 1997 (Figures 1.2, 1.5, and 1.6).

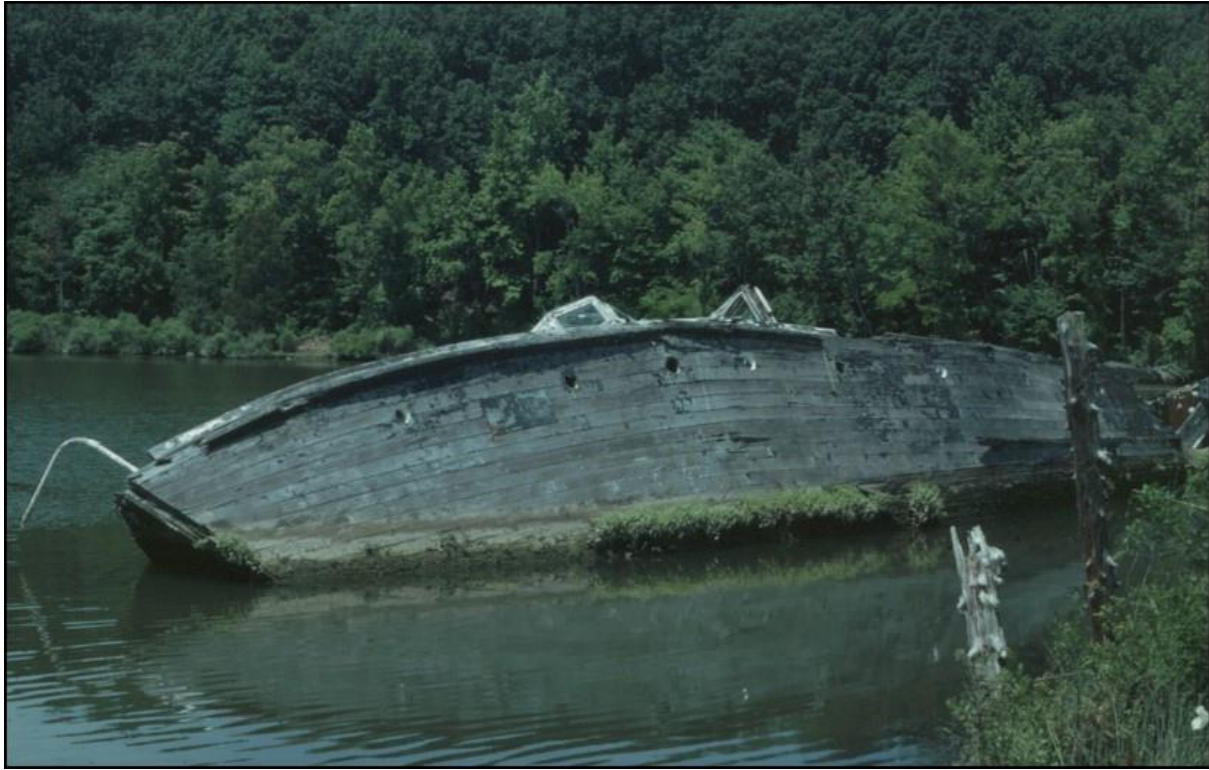
FIGURE 1.6 Portside view of the front section of the Sea Scout Wreck in 1997 (Photo credit: Susan Langley, 2020).

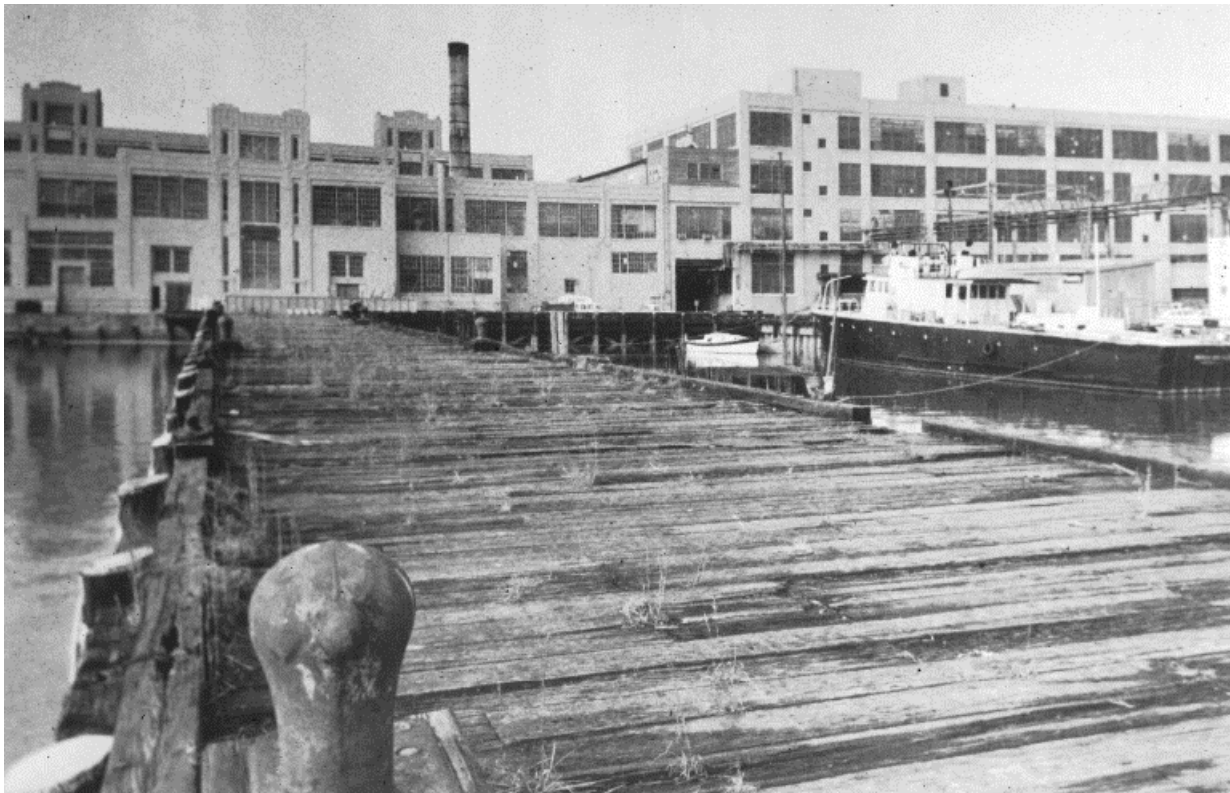
FIGURE 3.5 Photo of a 104' ARB, possibly N.C.S. *Morris Springer*, at the Torpedo Factory Art Center (Pandula 1976:41).

the report include two images that partially include a vessel in the location where the Sea Cadet's 104' ARB is reported to have been docked (Figures 3.5 and 3.6) (Pandula 1976:41, 52). Finally, to verify information about the vessel used by the Sea Cadets volumes of the *Merchant Vessels of the United States* for 1945-1952, 1955-1965, 1968-1979, 1981 were examined by searching the following key terms: Boys Scouts of America, Lexington Division, Morris Springer, Naval Cadet League, N.C.S. (NAME), P-#, Q-#, Ralph Mancill, S.E.S. (NAME), S.S.S. (NAME), Sea Cadets, Sea Explorers, and Sea Scouts, but could not find any information about the vessel in question. Neither physical nor digital copies were available for 1953, 1954, 1966, 1967, and 1980.

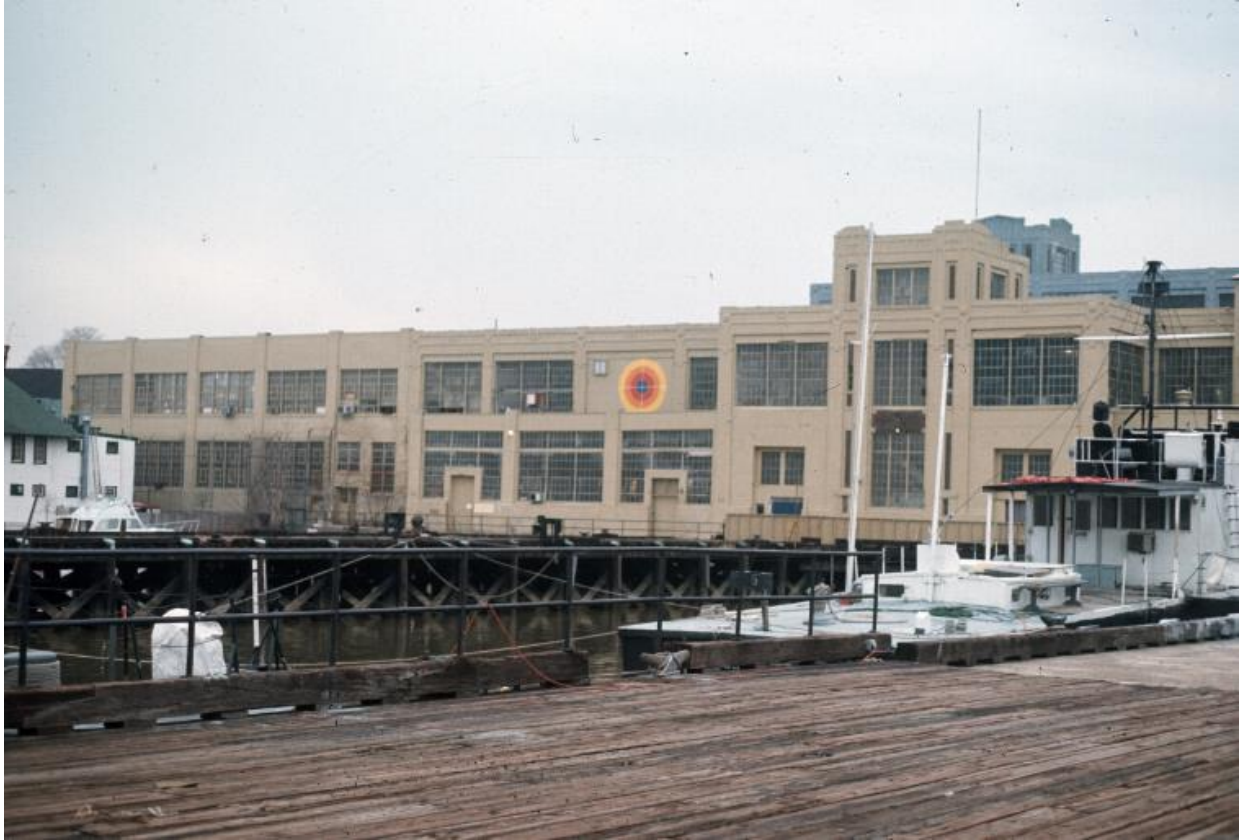
FIGURE 3.6 Photo of a 104' ARB, possibly N.C.S. *Morris Springer*, at the Torpedo Factory Art Center (Pandula 1976:52).

The most noticeable conversion is the 20-foot extension made to the aft side of the pilothouse (Pandula 1976:52). This extension of the pilothouse required the adjustment in the position of other superstructure components (Figure 6.6). The most notable change was the shift of the ladder from the aft side of the pilothouse to its starboard side, and metal supports to hold an overhang aft of the pilothouse (Figure 6.7 and 6.8) (Pandula 1976:52). While it is difficult to say for certain due to the quality of the pictures of 104' ARB, it appears that the top of the ladder's

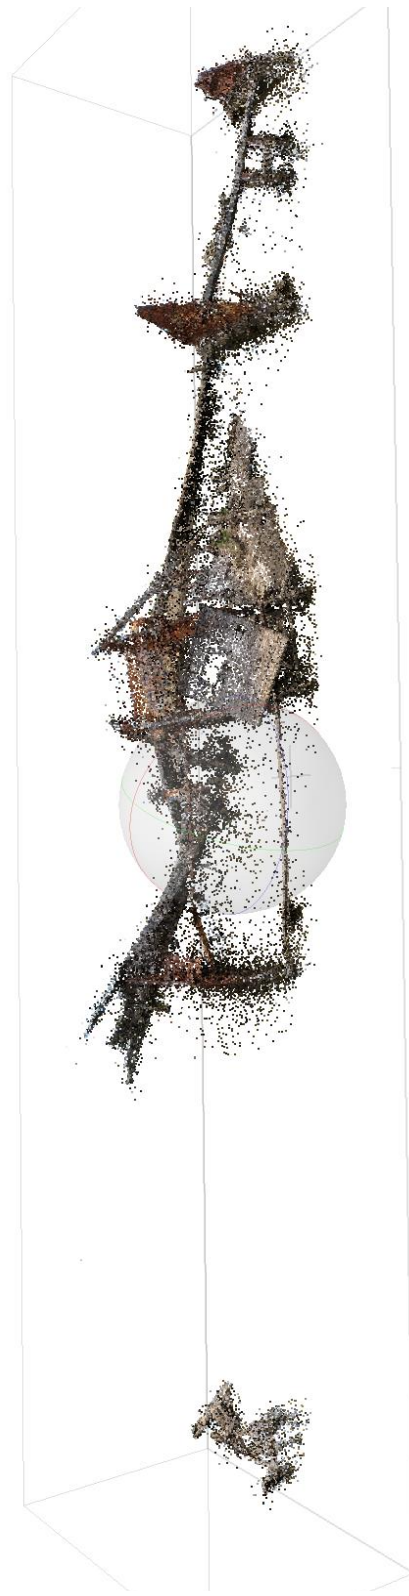
FIGURE 3.23 The sparse cloud showing the camera tie points for the aligned photos (Image by Taylor Picard, 2021).

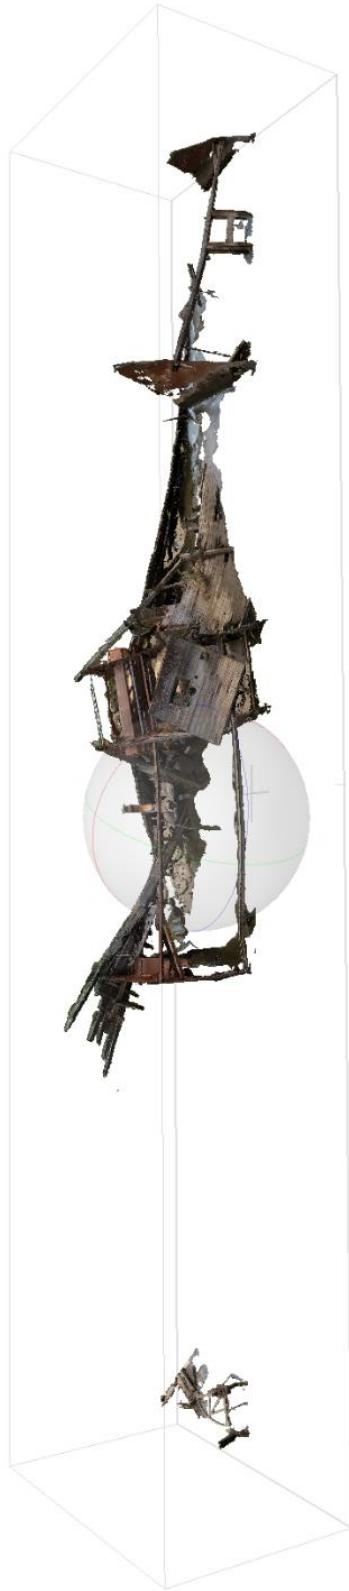
FIGURE 3.31 Results of the "Build Texture" command using the settings in Figure 4.34 (Image by Taylor Picard, 2021)

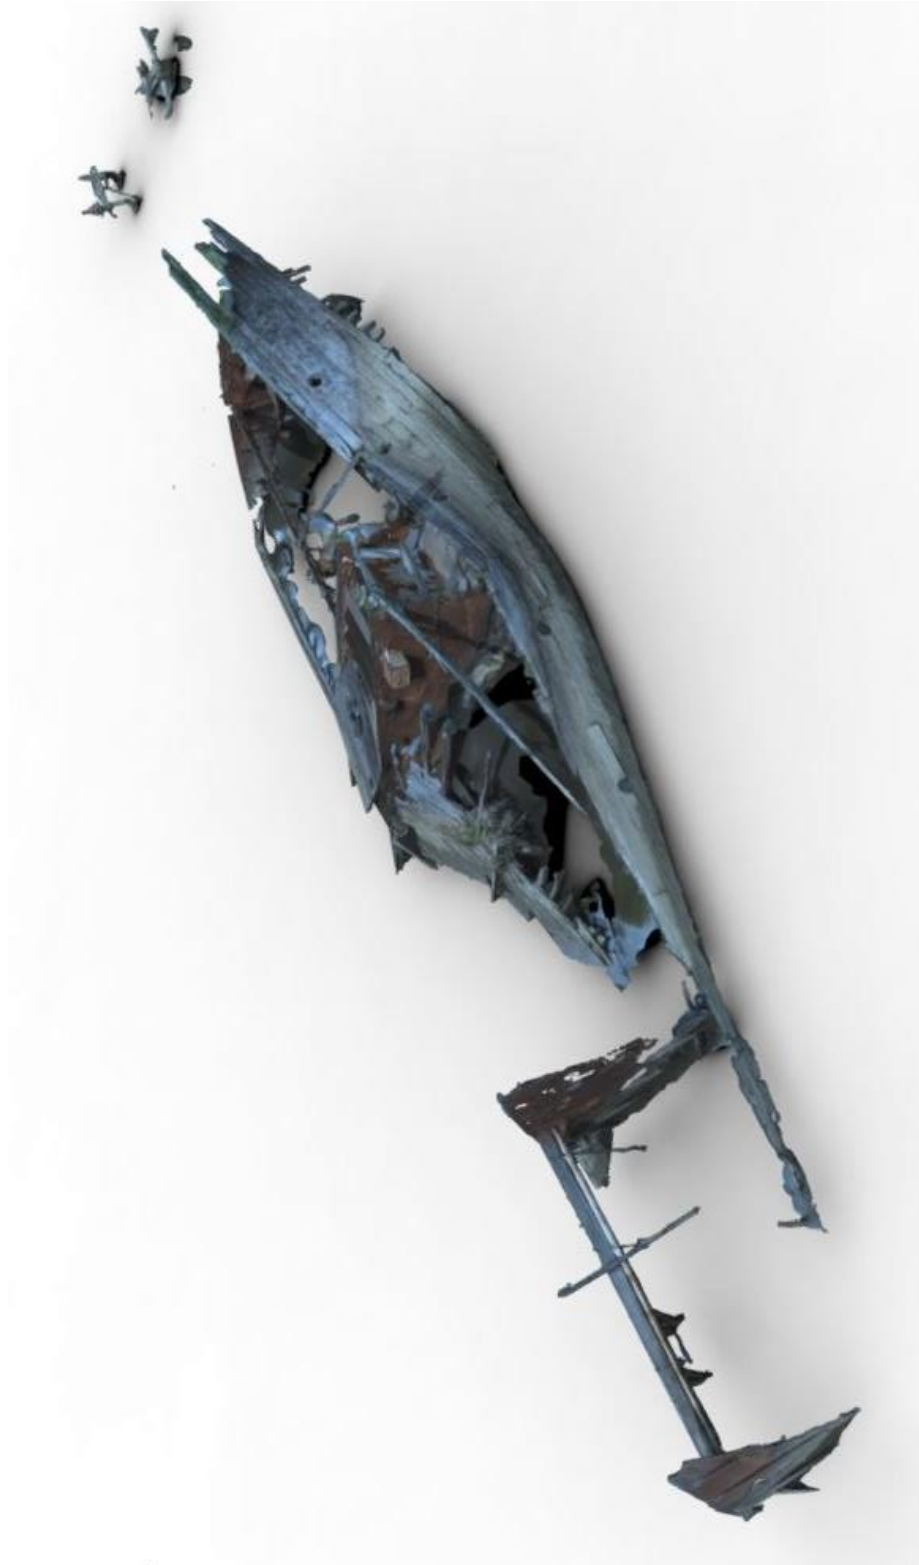
FIGURE 3.32 The final photogrammetric model of the Sea Scout Wreck in May 2021 using the steps and settings described above (Model created by Nathan Richards, 2021; Image by Taylor Picard, 2021).

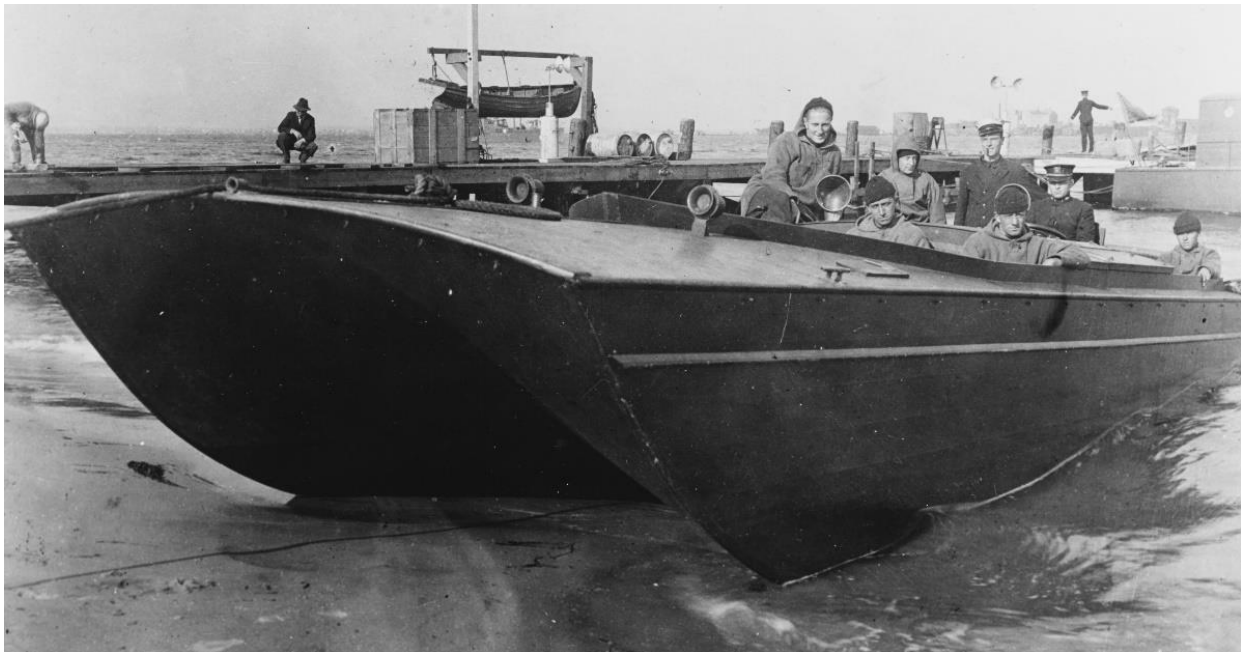
FIGURE 4.1 U.S. Navy Sea Sled at Rockaway, Long Island, on 19 November 1918 (Naval History and Heritage Command 2022; Photo Ownership: National Archives, 1918).

While the Air-Sea Rescue Boat (ARB) was the product of World War II, the need to rescue pilots from the water in an effective manner has been a concern since the full-scale use of naval aviation. The Italian Navy was the first to develop swift attack boats during World War I; known as *Motoscafo Armato Silurante* (MAS), motorboats armed with torpedoes. These crafts operated against the Austro-Hungarian fleet in the Adriatic Sea and were successful in sinking pre-dreadnought capital ships, such as SMS *Wein* and SMS *Szent Istvan*. Other missions included anti-submarine warfare, laying and sweeping for mines, conducting raids, deploying and recovering special operatives, but most importantly they tendered to and recovered seaplanes, as well as rescued downed pilots. Later in the war, the British developed Coastal Motorboats (CMBs) and Motor Torpedo Boats (MTBs) to attack the German torpedo boats in the Aegean Sea and on Lake Tanganyika, but it is unclear if they were used in air-sea rescue operations (Gray and Garn 2019:7, 9). When the United States entered the war in 1917, the U.S. Navy only had “sea sleds” for air-sea rescue missions (Figure 4.1). These were small boats with

an inverted-V shape and could achieve 30 to 40 knots depending on sea conditions; however, the vessels were only 32' in length and could not carry any armaments. Many of the sea sleds bought by the U.S. Navy during World War I, were swiftly sold off after the war (Friedman 1987:99, 105).

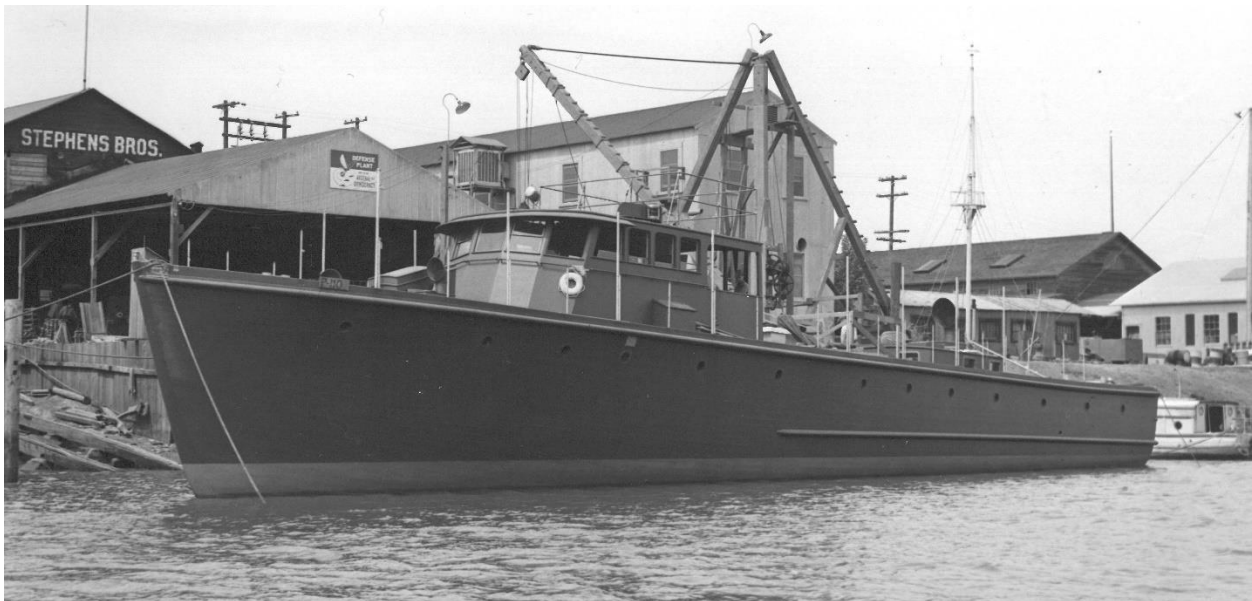
FIGURE 4.2 104' ARB (Design 235A) P-110 built by Stephen Bros. in June 1942 (Photo courtesy of Haggin Museum, 1942).

By the end of the war 740 of the 63' design, 140 of the 85' design, and 158 of the 104' design had been produced (Figure 4.2) (Gray and Garn 2019:10). A large number were sold to American allies through the Lend-Lease Act, including over 200 of the 63' type being sold to Russia, England, Australia, The Netherlands, and South Africa. The original crash boats were unarmed, but when the Luftwaffe began attacking them in the English Channel, they were armed with two twin-mounted .50-caliber machine guns (Friedman 1987:433; West 2018:41). Despite the added armament, speed and maneuverability served as the vessel's main defense in combat.

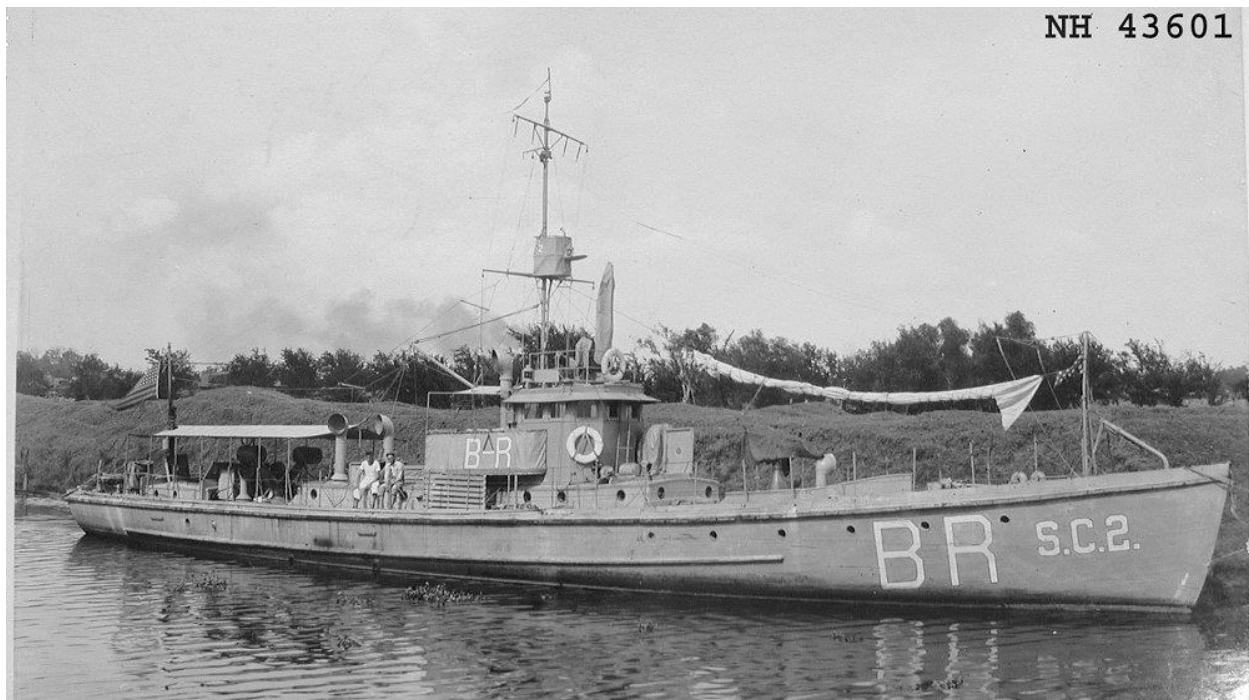
FIGURE 5.2 SC-2 which has a similar hull shape to the Sea Scout Wreck (Naval History and Heritage Command photo NH 43601, N.D.)

The first vessel examined through this study was based on previously mentioned oral traditions recorded by Shomette of the Sea Scout Wreck (Shomette 1998:426). The oral tradition he recorded states that it was a U.S. Navy (U.S.N.) patrol-torpedo (PT-) boat, a yacht used by the Sea Scouts before it was abandoned, and finally that it was fishing yacht (Shomette 1998:426). None of these leads are contradictory to each other as a decommissioned PT-boat could later be used by the Sea Scouts as well as for fishing. To evaluate the lead on PT-boats, Norman Friedman's *U.S. Small Combatants: Including PT-Boats, Subchasers, and the Brown-Water Navy* (1987) was consulted. The book found that while the hull shape may appear similar, the PT-boat was too small to be a candidate as there was only one experimental PT-boat built to be over 100' that was scrapped in 1968 (Friedman 1987:188-195; NavSource 2020a) (Figure 5.1). A new candidate, however, was revealed in his book. The SC-1 sub chaser built in World War I had a similar hull shape and was only 110 ft in overall length and a beam of 14 ft 9 in (Figure 5.2) (Friedman 1987:36; NavSource 2020b). While the hull shape and measurements of the SC-1

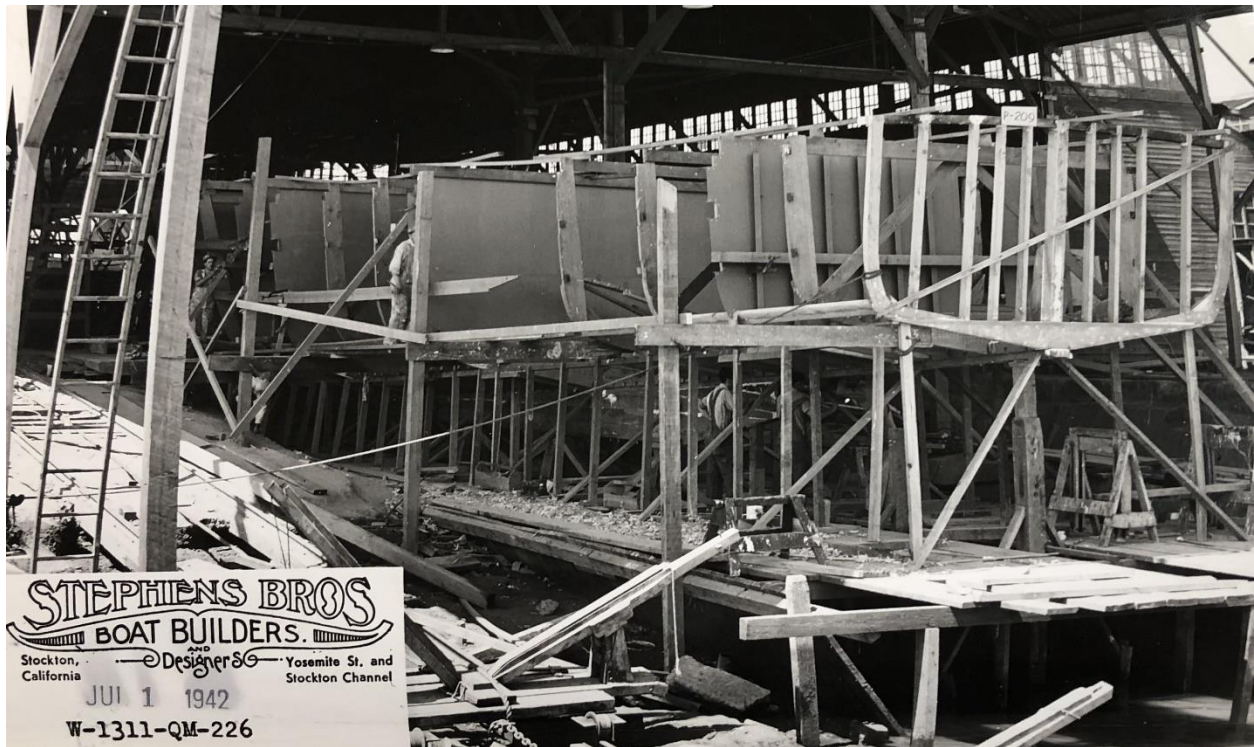
FIGURE 5.3 Photograph of bulkheads being installed on a 104' ARB (Probably a Design 235A based on the thin keel in the aft section) (Photo courtesy of Haggin Museum, 1942).

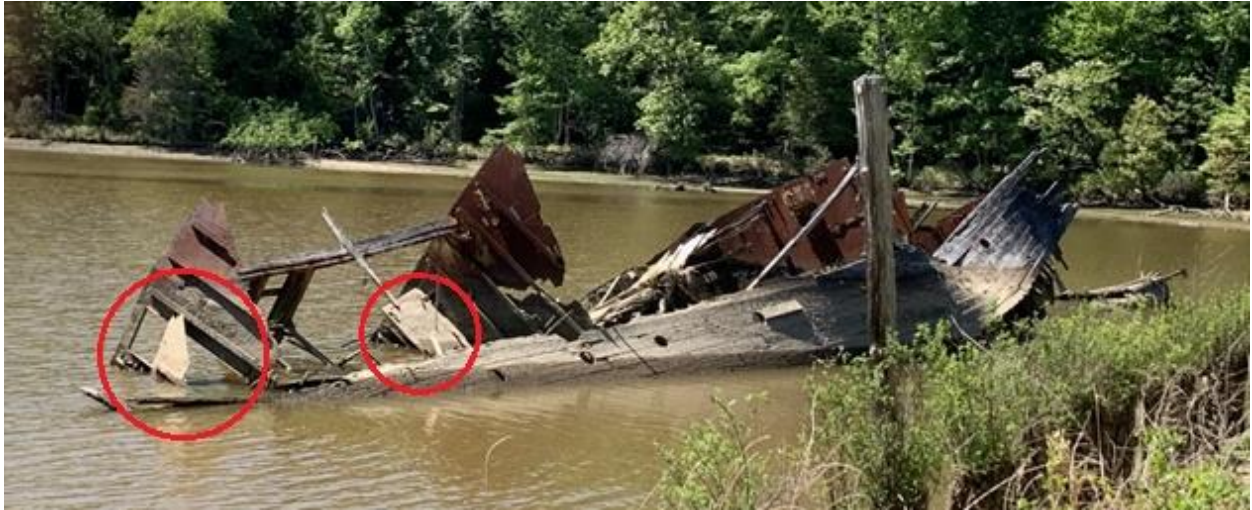
FIGURE 5.5 The Sea Scout Wreck with low water levels, revealing the bulkhead doors (circled in red) (Photo Credit: Frances Park, 2021).

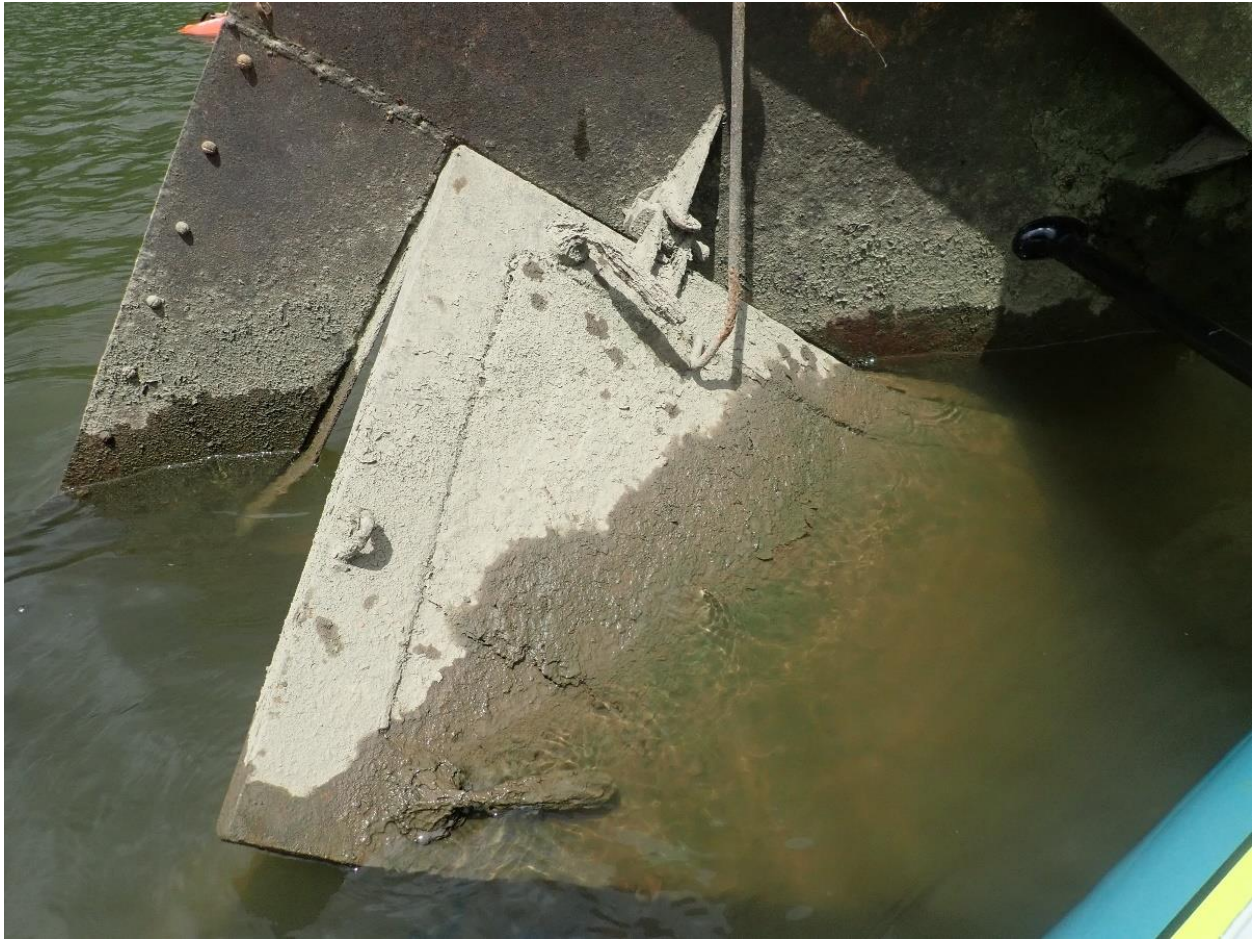
FIGURE 5.6 Close up of watertight bulkhead door in Bulkhead 3 (the right circle in Figure 5.9), take during the 2021 archaeological field work (Photo Credit: Nathan Richards, 2021)

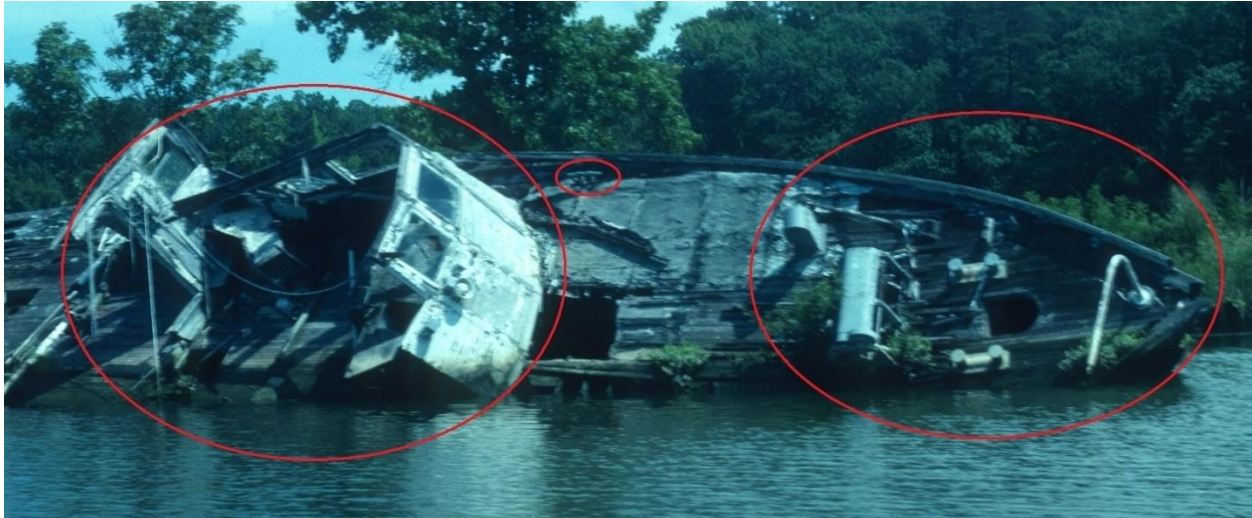
FIGURE 5.7 Photo of the forward section of the Sea Scout Wreck with the similarities to the 104' ARB Design 235A circled in red (Photo credit: Susan Langley, 1997).

Once the design plans for the 104's ARB were acquired from Haggin Museum and Lake Champlain Maritime Museum (LCMM), they were digitized into a 3D model. Immediately, many similarities and differences between the ARB model and the images provided by Dr. Langley were identified (Sometimes Interesting 2013; Chesapeake Conservancy 2020; Susan Langley 2020). From the pictures of the wreck in 1997 provided by Dr. Langley, notable superstructure features on the shipwreck that also appear in the model include the shape of the pilothouse, the location, and shape of the chart table, the position of the anchor davit and bitts, as well as location of hatches and vents appearing to be in the same position (Figures 5.7, 5.8 and 5.9). The two key features that are different from the model and the photos from 1997 are that there appears to be additional superstructure components aft of the pilothouse, and there is a speaker attached to the front of the pilothouse where a bell should be (Figures 5.10 and 5.11). Features that appear to be missing from the wreck include the weapons that a 104' ARB would have been armed with during wartime. This would be consistent with the nature of the oral traditions recorded by Donald Shomette, and that the timeframe for the vessel's abandonment was approximately 35 years after it would have been built and used by the U.S.A.A.F. during wartime. When the model was compared to more recent photos of the Sea Scout Wreck that show more of the internal structure of the wreck the location of the bulkheads on the wreck matched the location of the bulkheads in the 3D model (Figures 5.12, 5.13, and 5.14). While the aft-most bulkhead was not visible in the pictures of the wreck, it was detected by touch during the archaeological fieldwork.

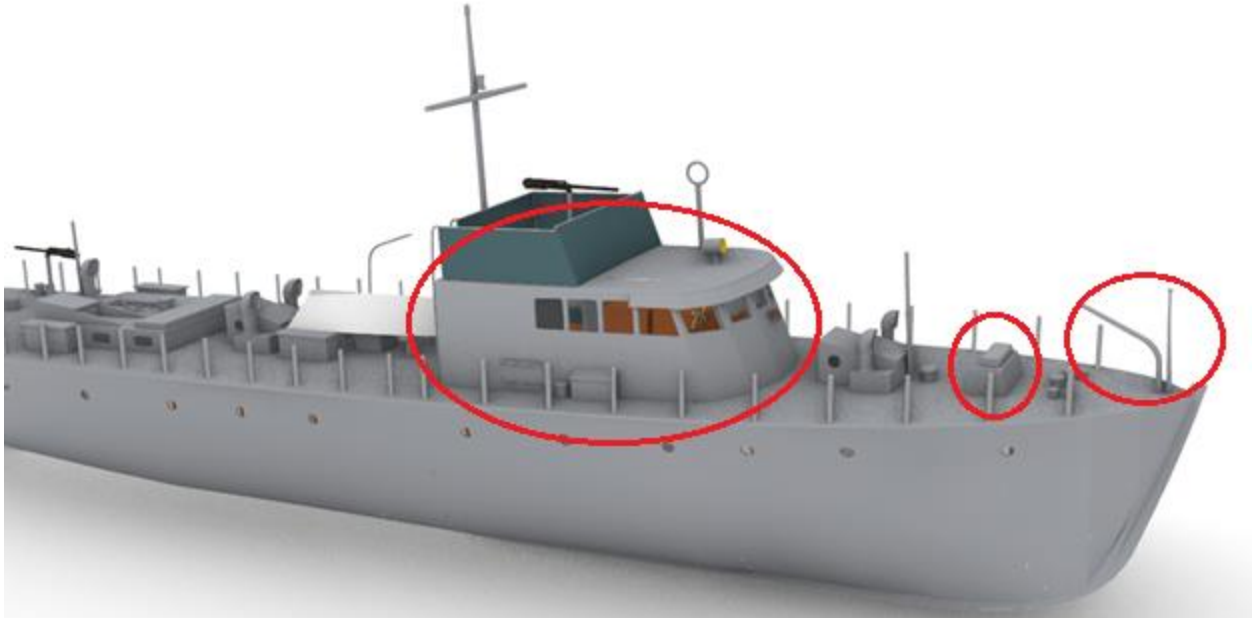
FIGURE 5.9 104' ARB (1942) model that show similarities to the Sea Scout Wreck circled in red (isometric view) (Model created by Taylor Picard).

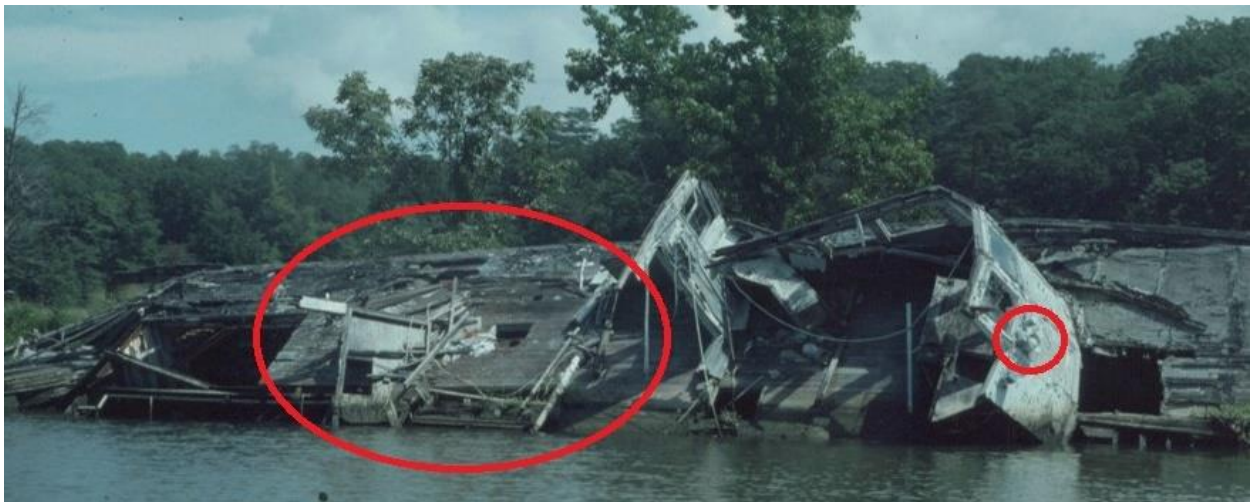
FIGURE 5.10 Photo of the Middle section of the Sea Scout Wreck with the difference to the 104' ARB Design 235A circled in red (Photo credit: Susan Langley, 1997).

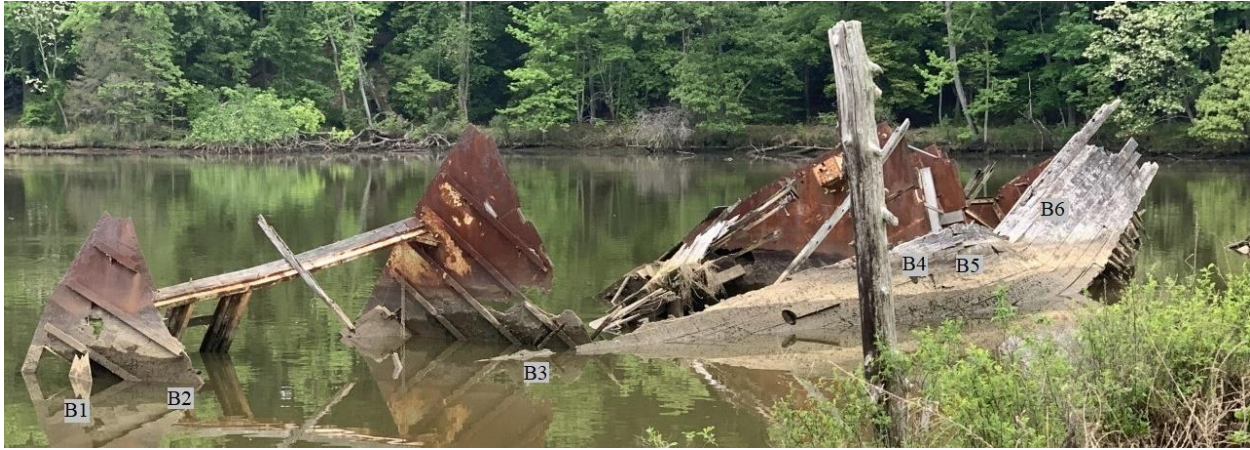
FIGURE 5.13 Picture of the Sea Scout Wreck showing the locations of bulkheads B1 through B6, B7 is present at the site but is not visible in this image (Photo credit: Frances Park, 2021).

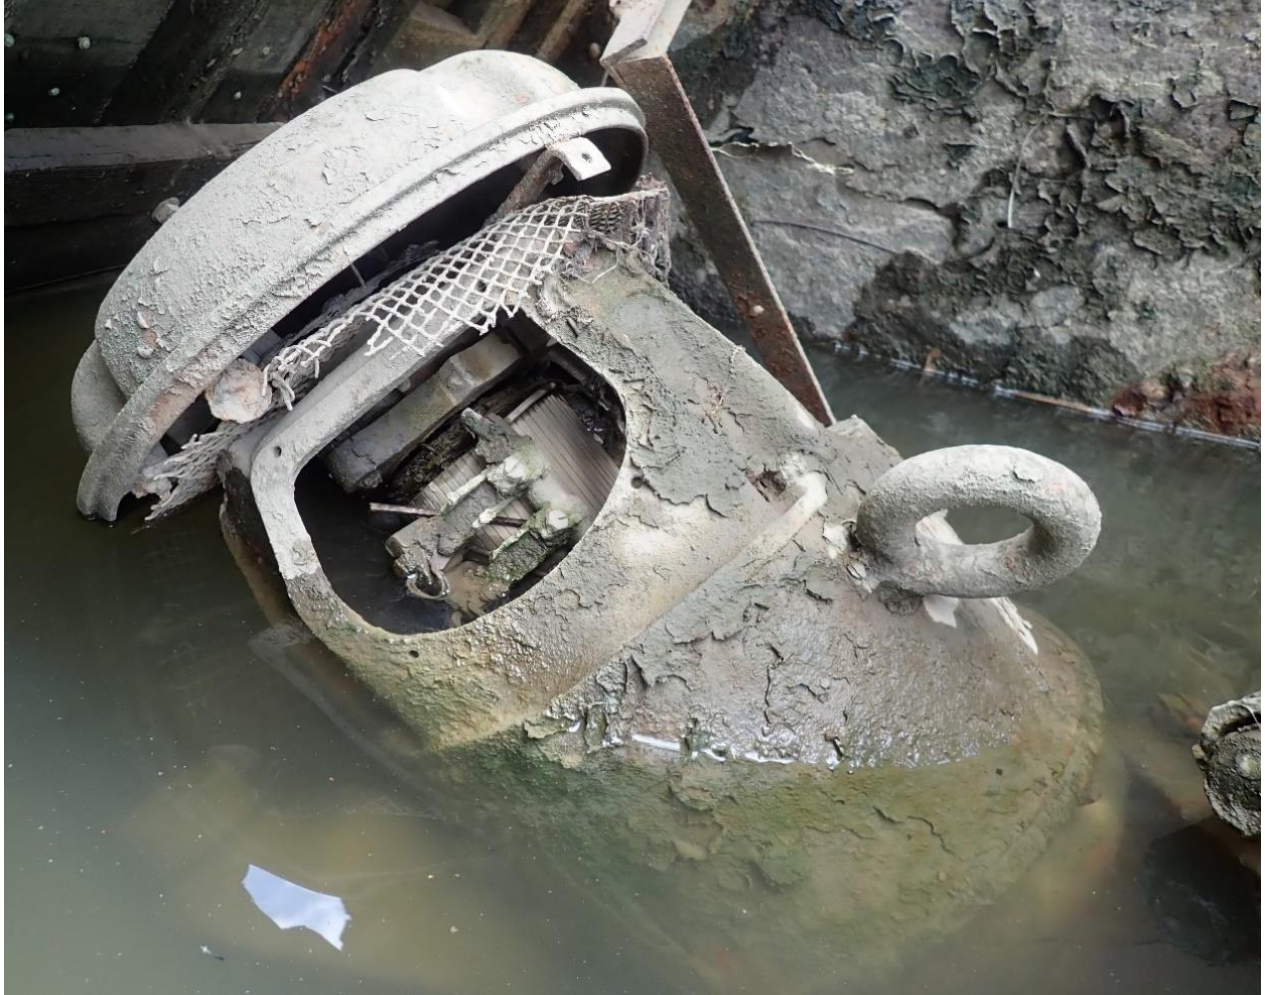
FIGURE 5.16 Generator plant found in the engine room of the Sea Scout Wreck (Photo Credit: Nathan Richards, 2021).

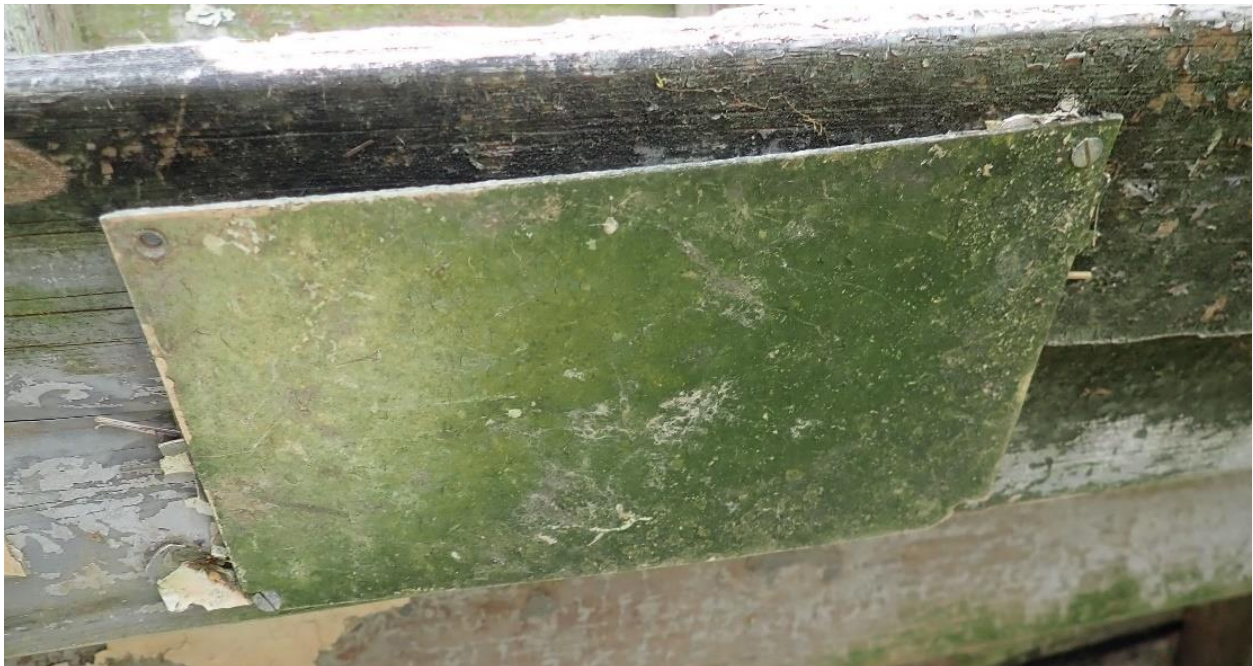
FIGURE 5.18 Plaque made of a plastic material, possibly bakelite, found in the engine room of the Sea Scout Wreck (Photo Credit: Nathan Richards, 2021)
