ARCHAEOLOGICAL SITE FORMATION OF THE “SEA SCOUT WRECK”:
MALLOWS BAY, NANJEMOY, MARYLAND

A Thesis

In Partial Fulfillment of the Requirements for the Degree
Master of Arts in Maritime Studies

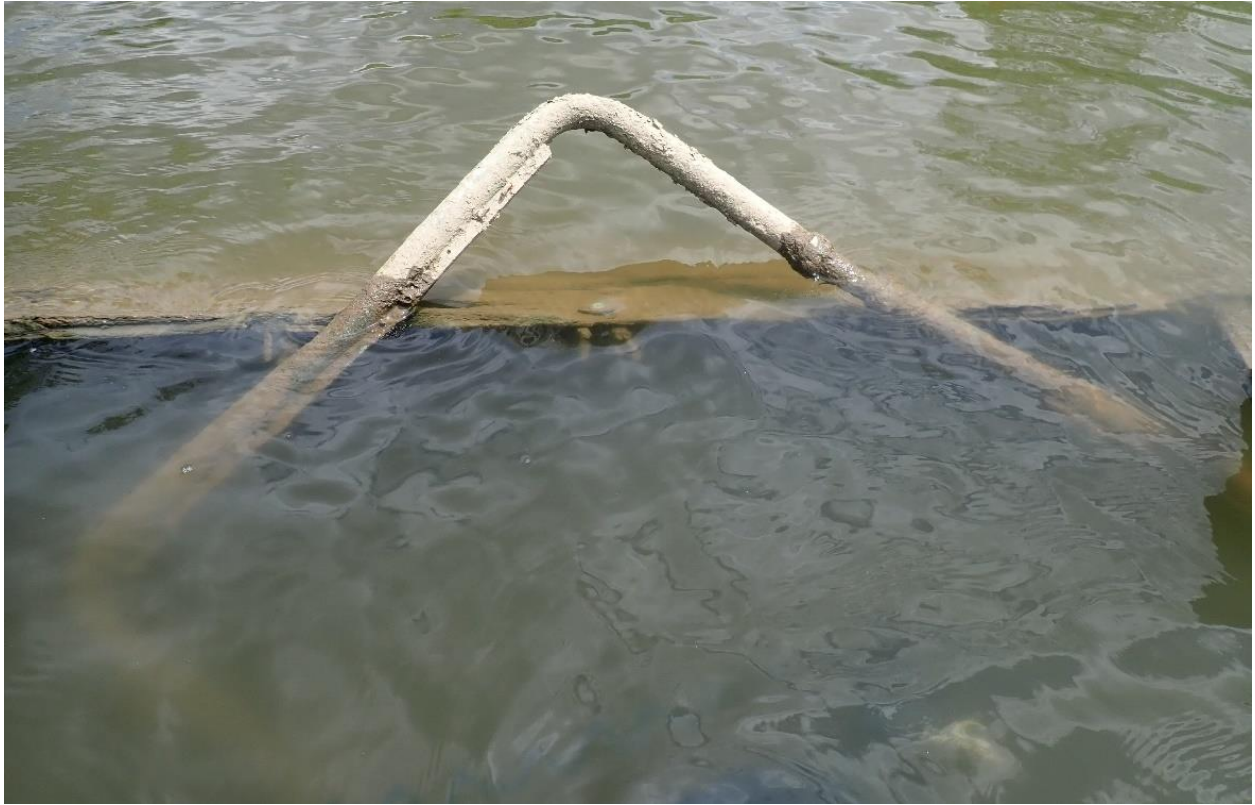
FIGURE 5.19 Pipe Berth found in the crew quarters of the Sea Scout Wreck (Photo Credit: Nathan Richards, 2021).

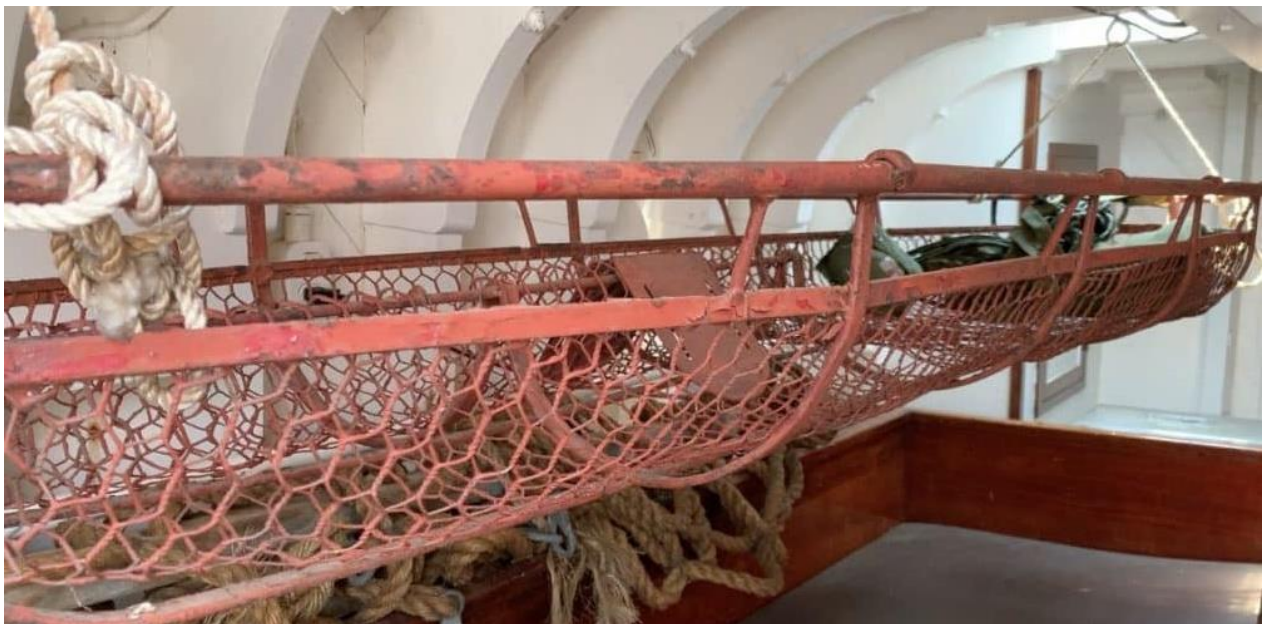
FIGURE 5.20 Pipe Berth from P-520, an 85' ARB that now operates as a floating museum (*Chesapeake Magazine*, 2021).

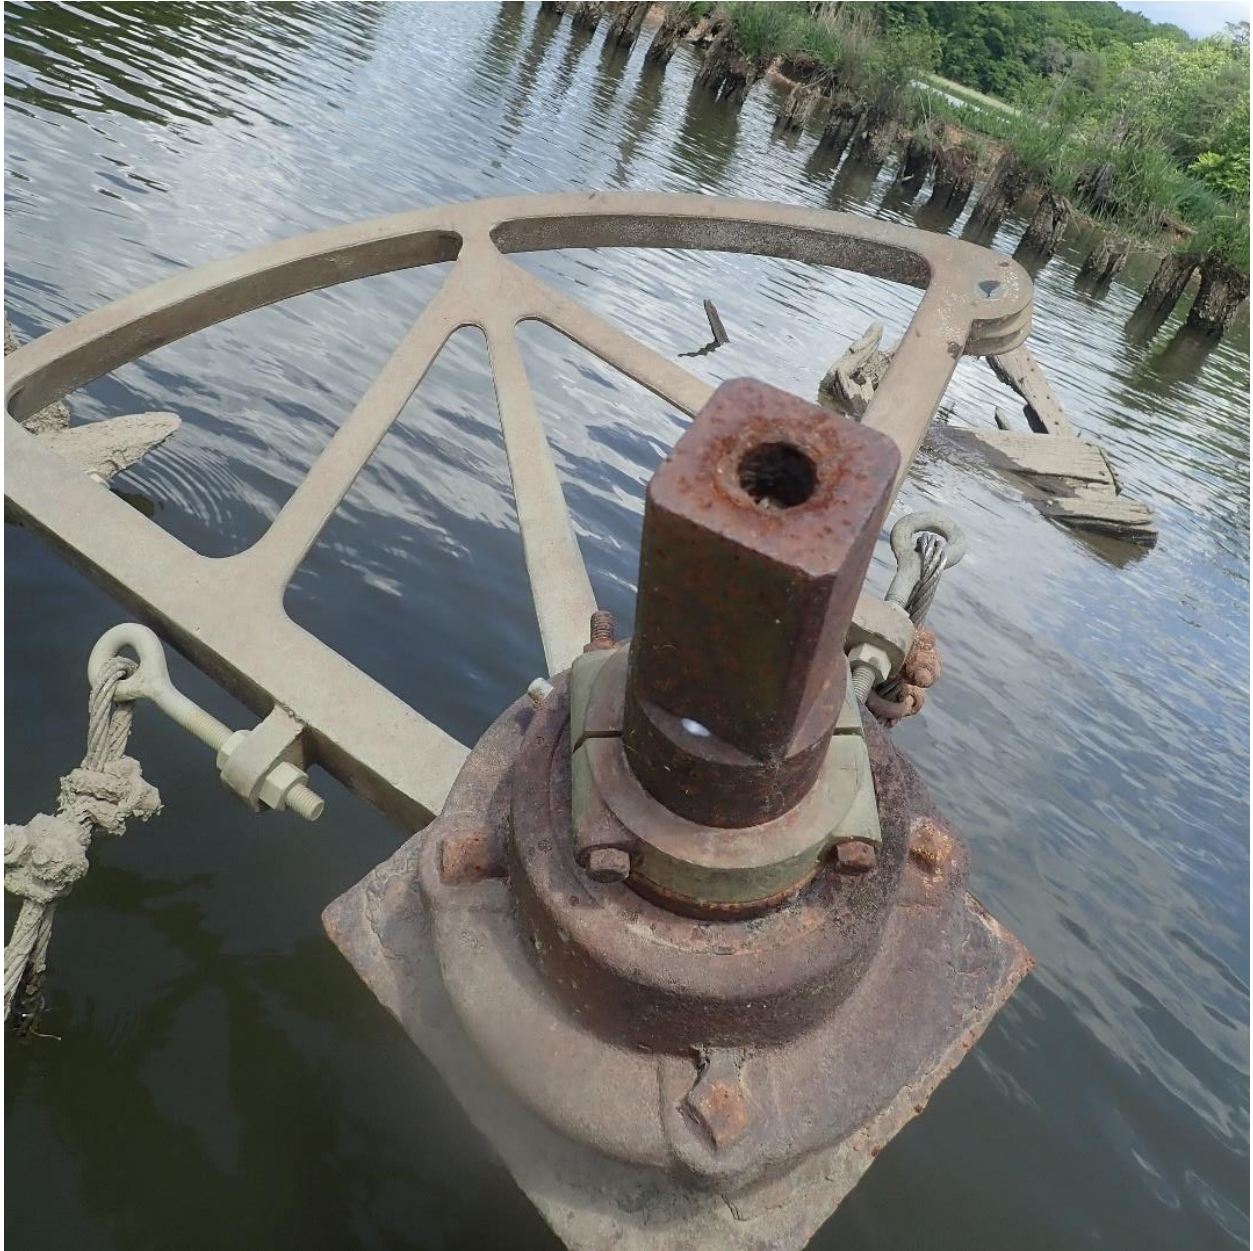
FIGURE 5.22 Rudder Post found at the aft end of the Sea Scout Wreck (Photo Credit: Nathan Richards, 2021).

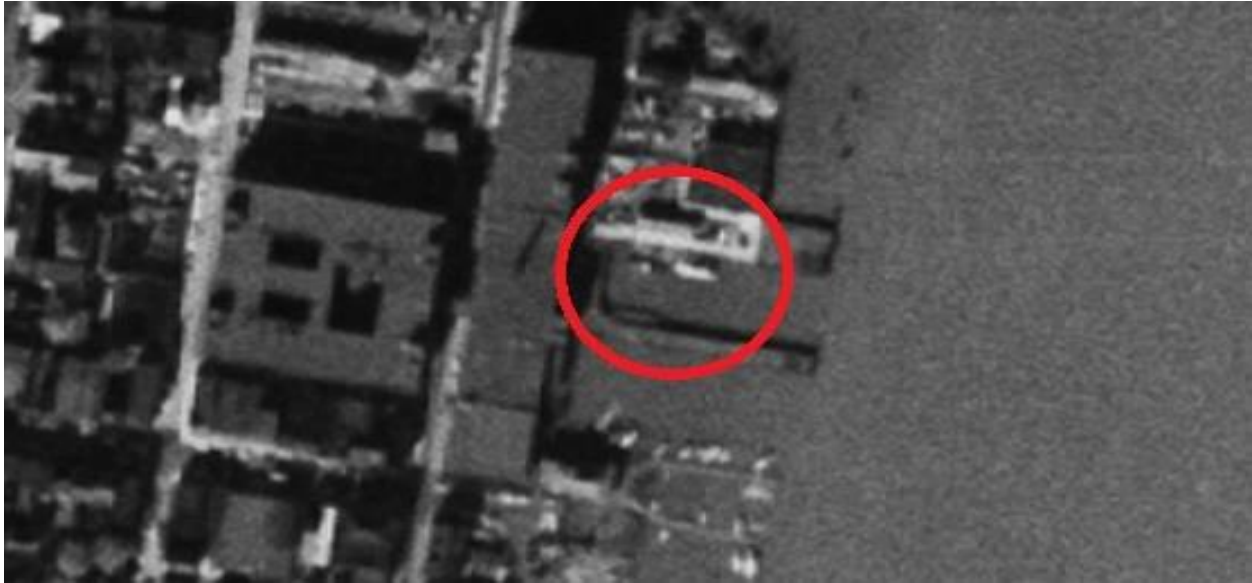
FIGURE 5.27 Alexandria Torpedo Factory on November 9, 1959, the first time a vessel matching the size of a 104' ARB is first seen (Exposure number 1736) (U.S.G.S. 2021).

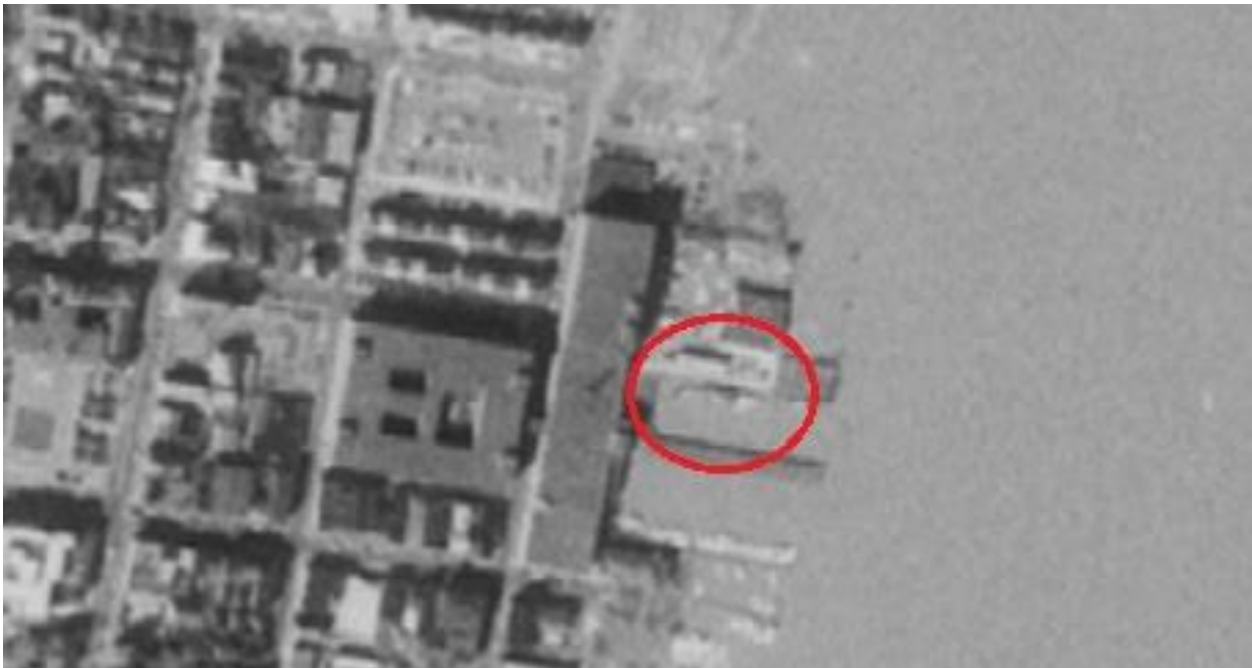
FIGURE 5.28 A vessel with measurements matching a 104's ARB, probably N.C.S. *Morris Springer*, at Alexandria Torpedo Factory on March 16, 1977 (Exposure number 3-116) (U.S.G.S. 2021).

On March 24, 1977, just eight days after the aerial photograph of the Alexandria Torpedo Factory was taken, an aerial photograph of Mallows Bay was taken. In this photograph (Figure 5.39) there are no vessels located in the Burning Basin. The next available aerial photograph of the area was taken on March 27, 1980, and shows a vessel with measurements matching a 104' ARB in the location now occupied by the Sea Scout Wreck (Figure 5.30). The next available aerial photograph that clearly shows the Alexandria Torpedo Factory was taken on April 2, 1981 (Figure 5.31). It shows that the 104' ARB is no longer docked there. This seems to support the current hypothesis that the Sea Scout Wreck is the same vessel docked at the torpedo factory in Alexandria, VA, that was moved sometime in the late 1970s, or early 1980; however, this only establishes that it was moved, and a 104' ARB was moved into the Burning Basin in Mallows Bay at approximately the same time. When examining the photographs of the Sea Scout Wreck provided by Dr. Susan Langley, there is additional material laying across the deck aft of the pilothouse that cannot have been produced from 104' ARB without modified deck features (Figure 5.32) (Susan Langley 2020, elec. comms.).

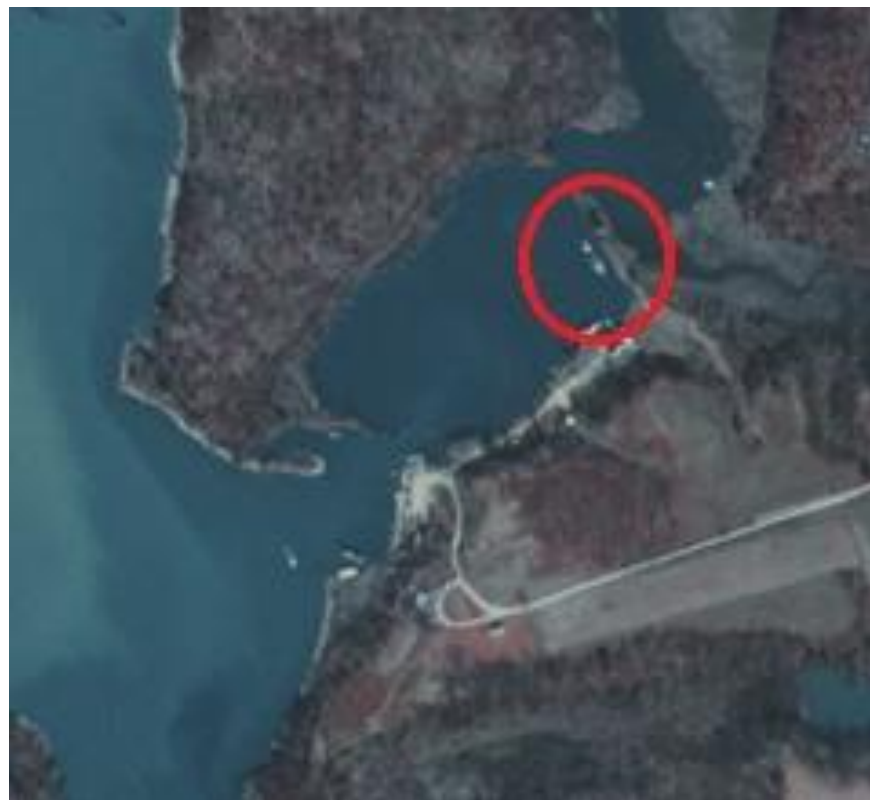
FIGURE 5.30 Aerial Photograph of Mallows Bay March 27, 1980, with a vessel that has measurements that match a 104' ARB occupying the present location of the Sea Scout Wreck (Exposure number 17-186) (U.S.G.S. 2021).

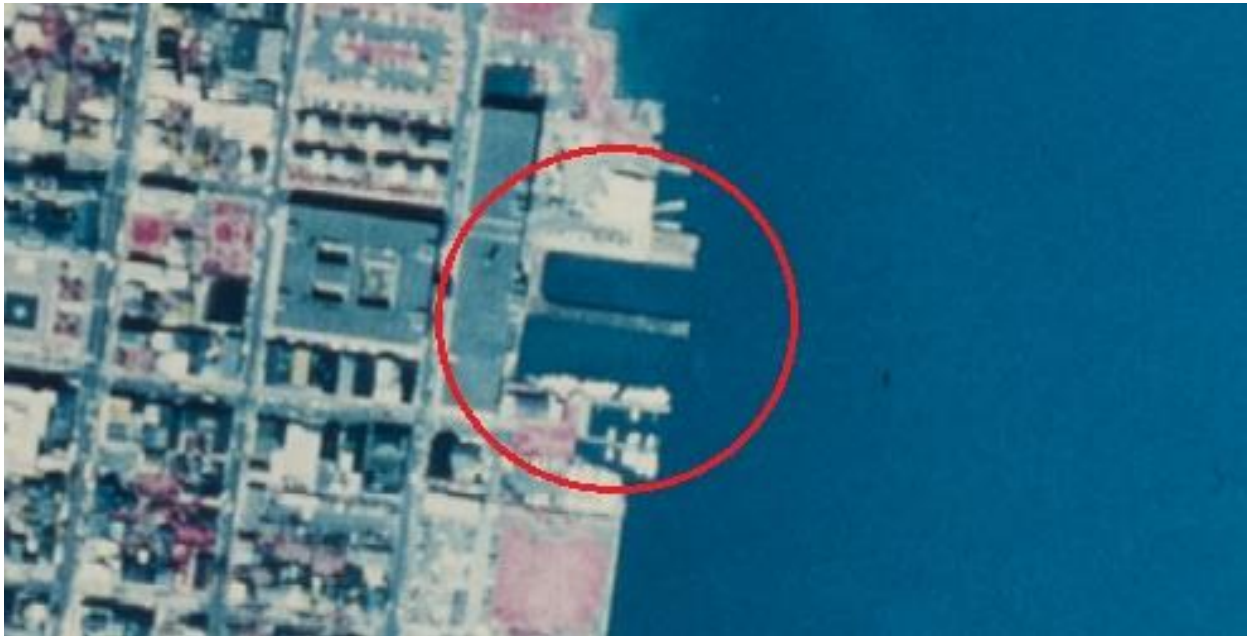
FIGURE 5.31 Aerial photograph from April 2, 1981 of Alexandria Torpedo Factory circled in red, showing the 104' ARB no longer docked there (Exposure number 439-21) (U.S.G.S. 2021).

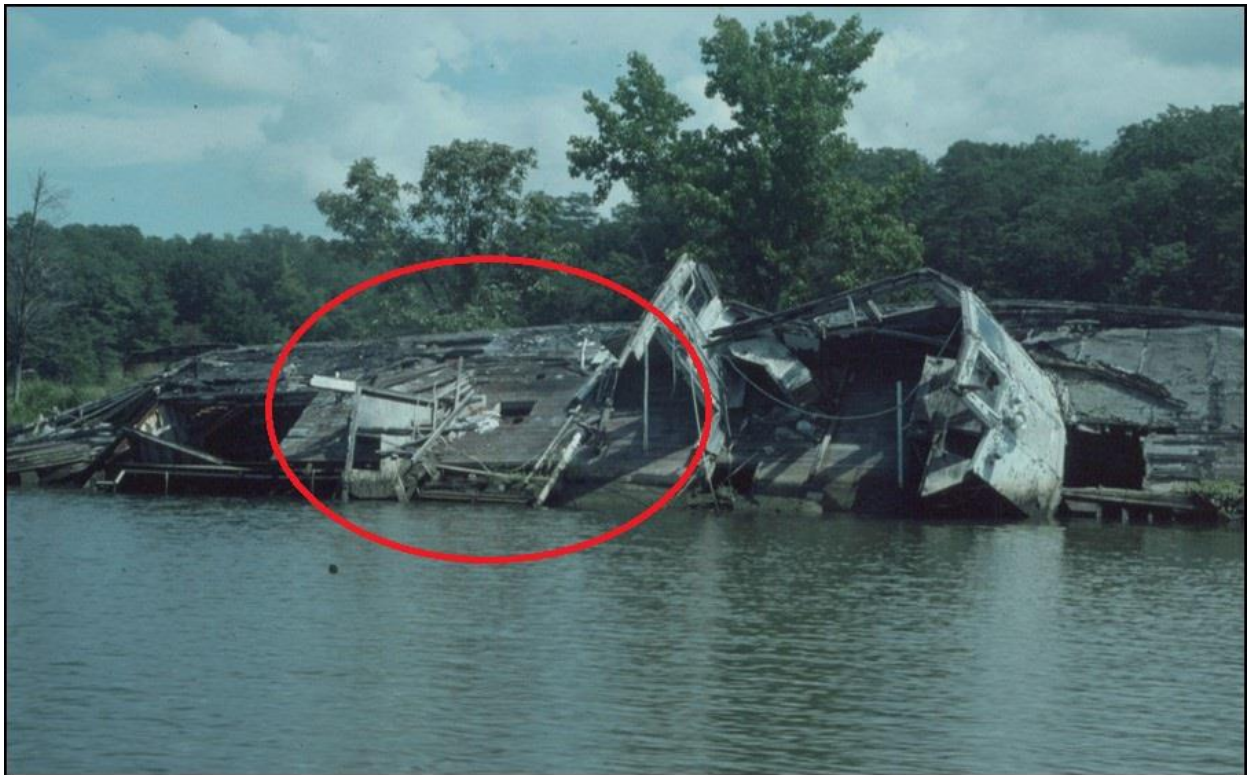
FIGURE 5.32 Photograph showing the excess deck material that could not be attributed to a standard 104' ARB Design 235A (Photo courtesy of Susan Langley, 1997).

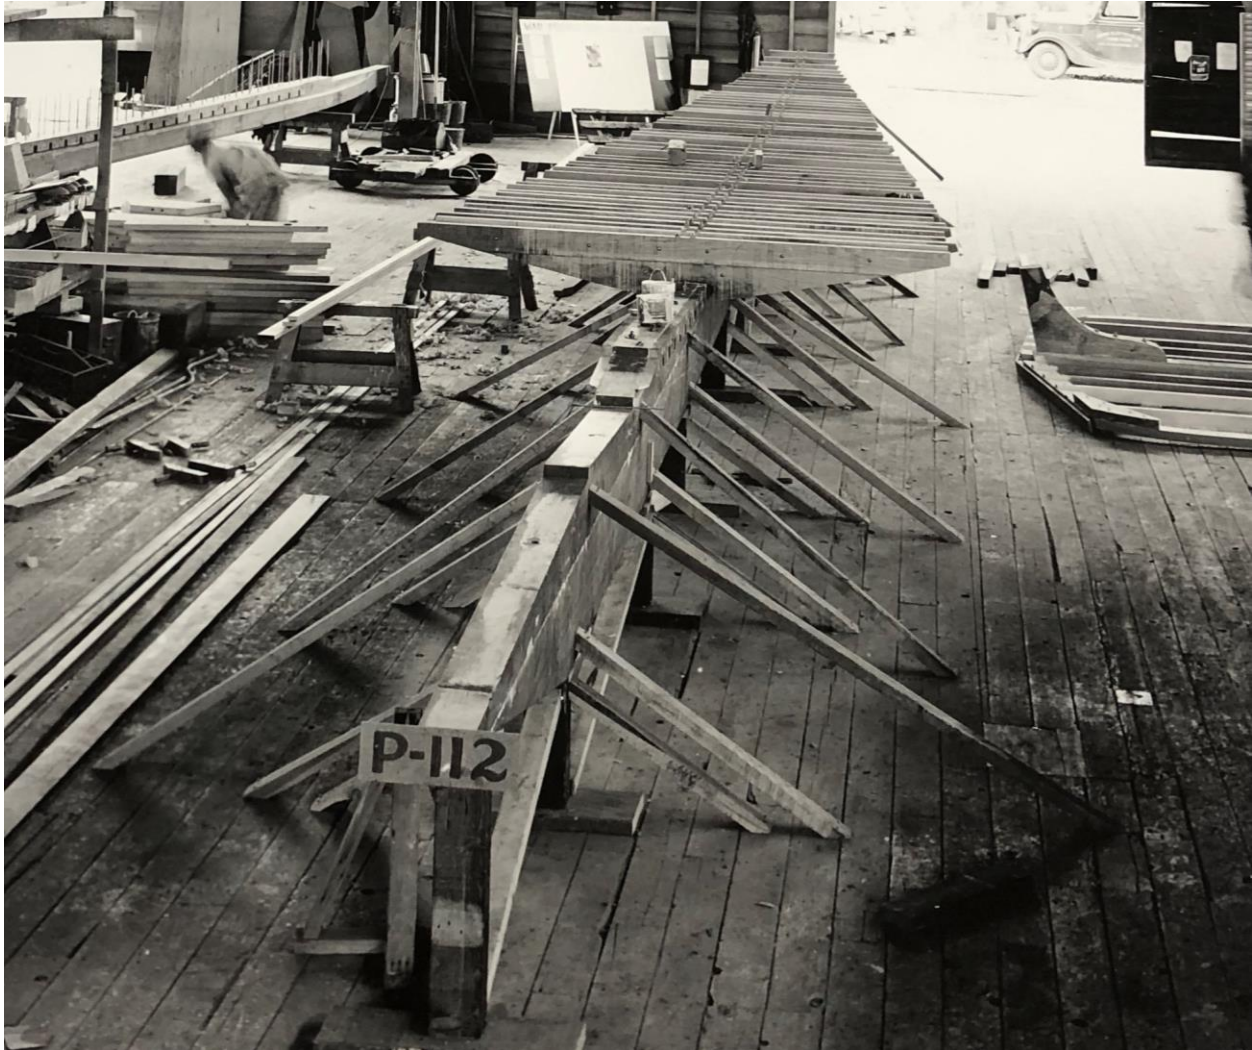
FIGURE 6.1 Construction of P-112, a 104' ARB Design 235A, at Stephen Bros. Ship Building Company, show a process that is consistent with construction of wooden vessels (Photo courtesy of Haggin Museum, 1942).

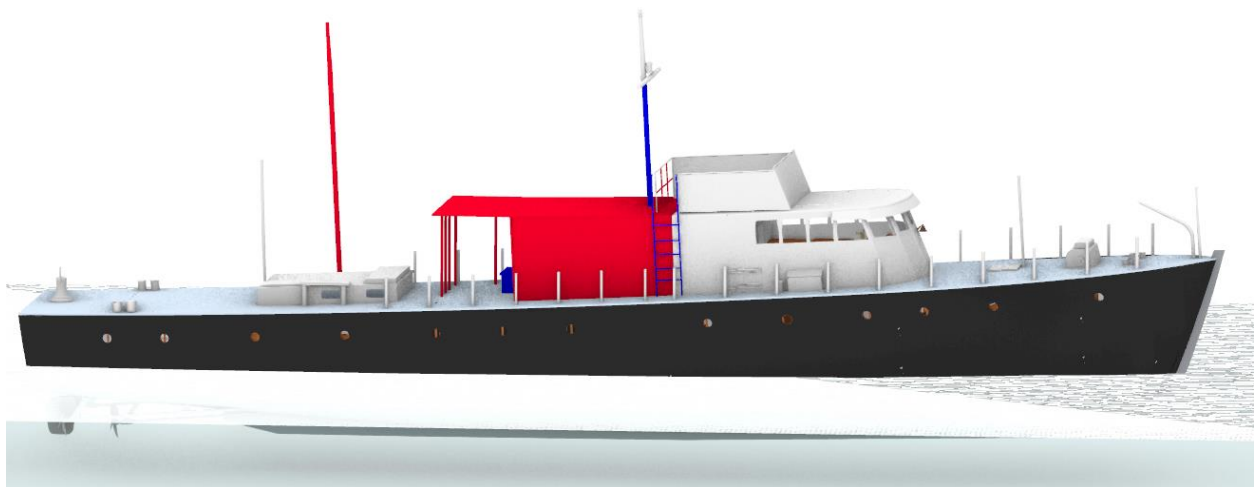
FIGURE 6.7 Alexandria 104' ARB (1976) showing the features that were altered in blue and added in red (Model created by Taylor Picard).

The most noticeable conversion is the 20-foot extension made to the aft side of the pilothouse (Pandula 1976:52). This extension of the pilothouse required the adjustment in the position of other superstructure components (Figure 6.6). The most notable change was the shift of the ladder from the aft side of the pilothouse to its starboard side, and metal supports to hold an overhang aft of the pilothouse (Figure 6.7 and 6.8) (Pandula 1976:52). While it is difficult to say for certain due to the quality of the pictures of 104' ARB, it appears that the top of the ladder's

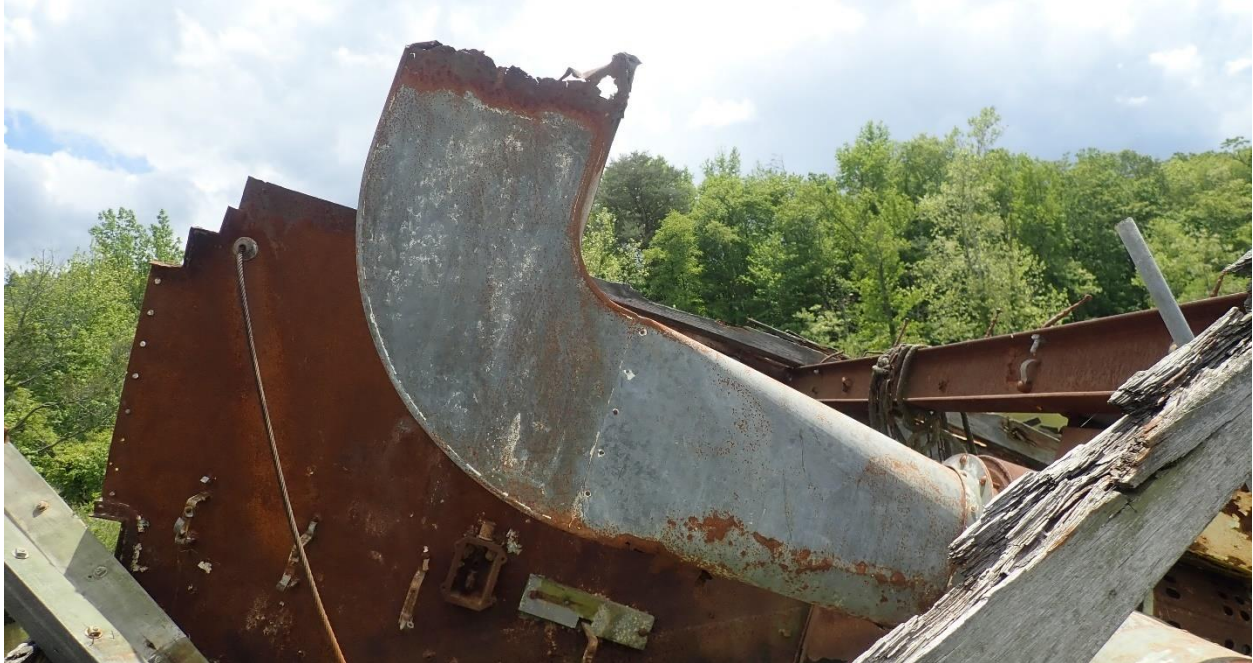
FIGURE 6.10 The ventilation shaft in the engine room of the Sea Scout Wreck. This appears to have originally lined up with the mushroom vent that would have been removed when the pilot house was extended (Photo Credit: Nathan Richards, 2021).

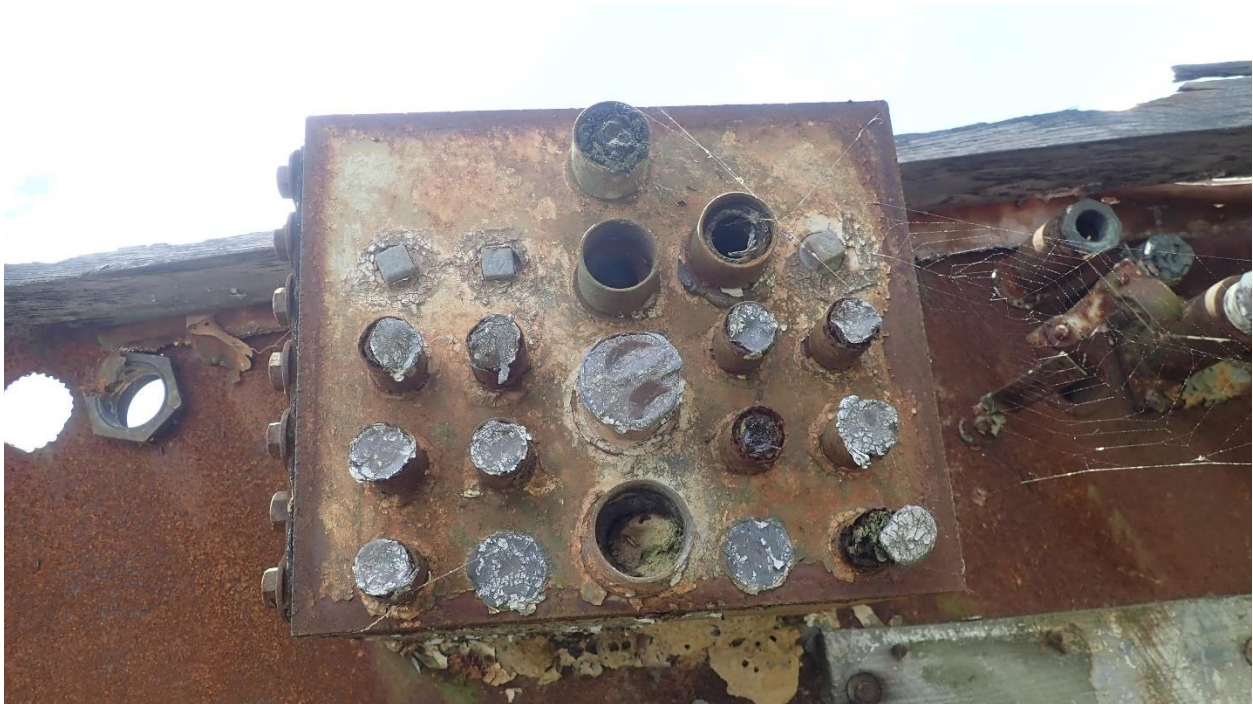
FIGURE 6.11 Original electrical paths in Bulkhead 6 of the Sea Scout Wreck that are capped or fitted with PVC pipes (Facing south) (Photo Credit: Nathan Richards, 2021).

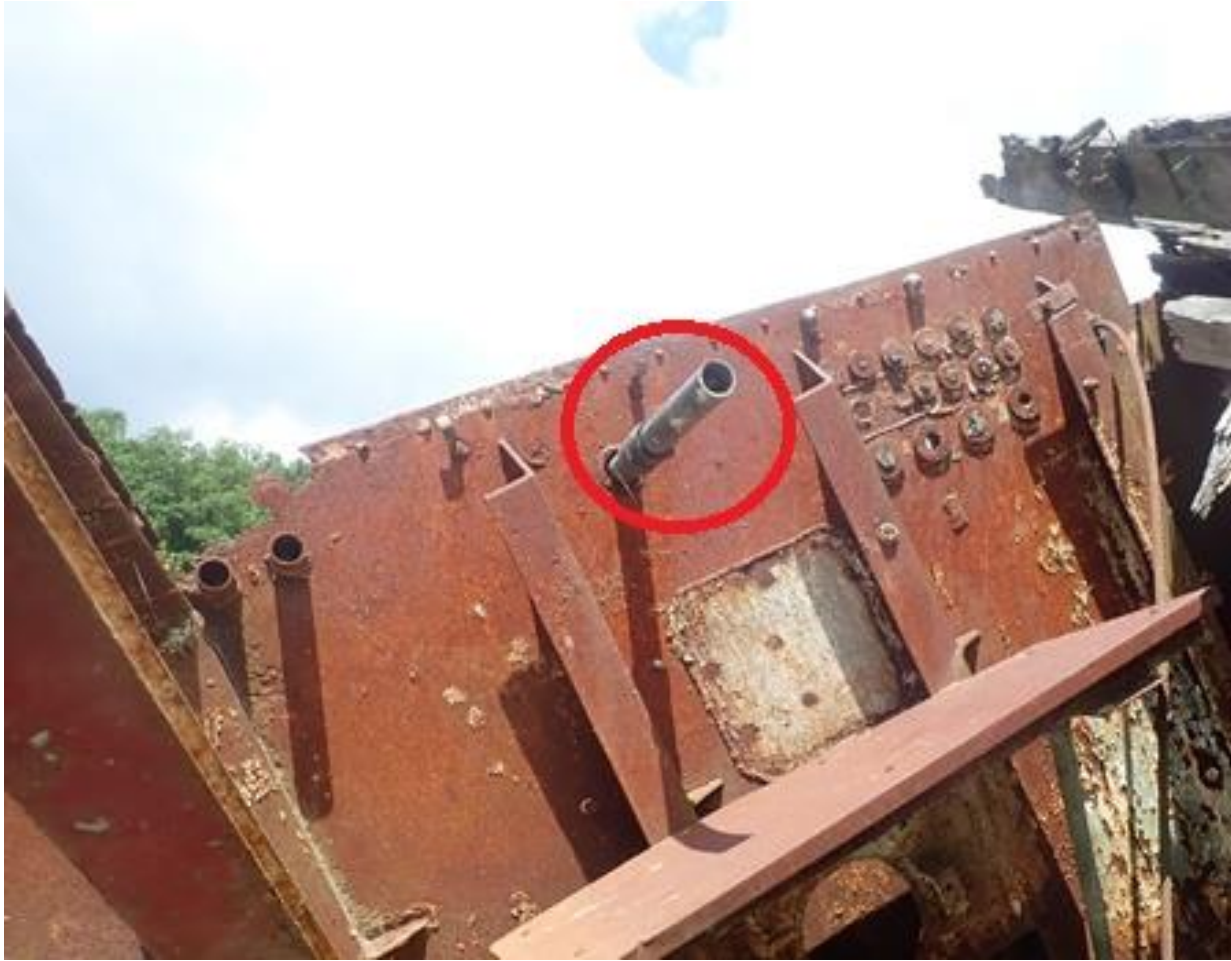
FIGURE 6.12 PVC pipe (circled in red) for electrical wire going through Bulkhead 6 of the Sea Scout Wreck (Facing northeast) (Photo Credit: Nathan Richards, 2021).

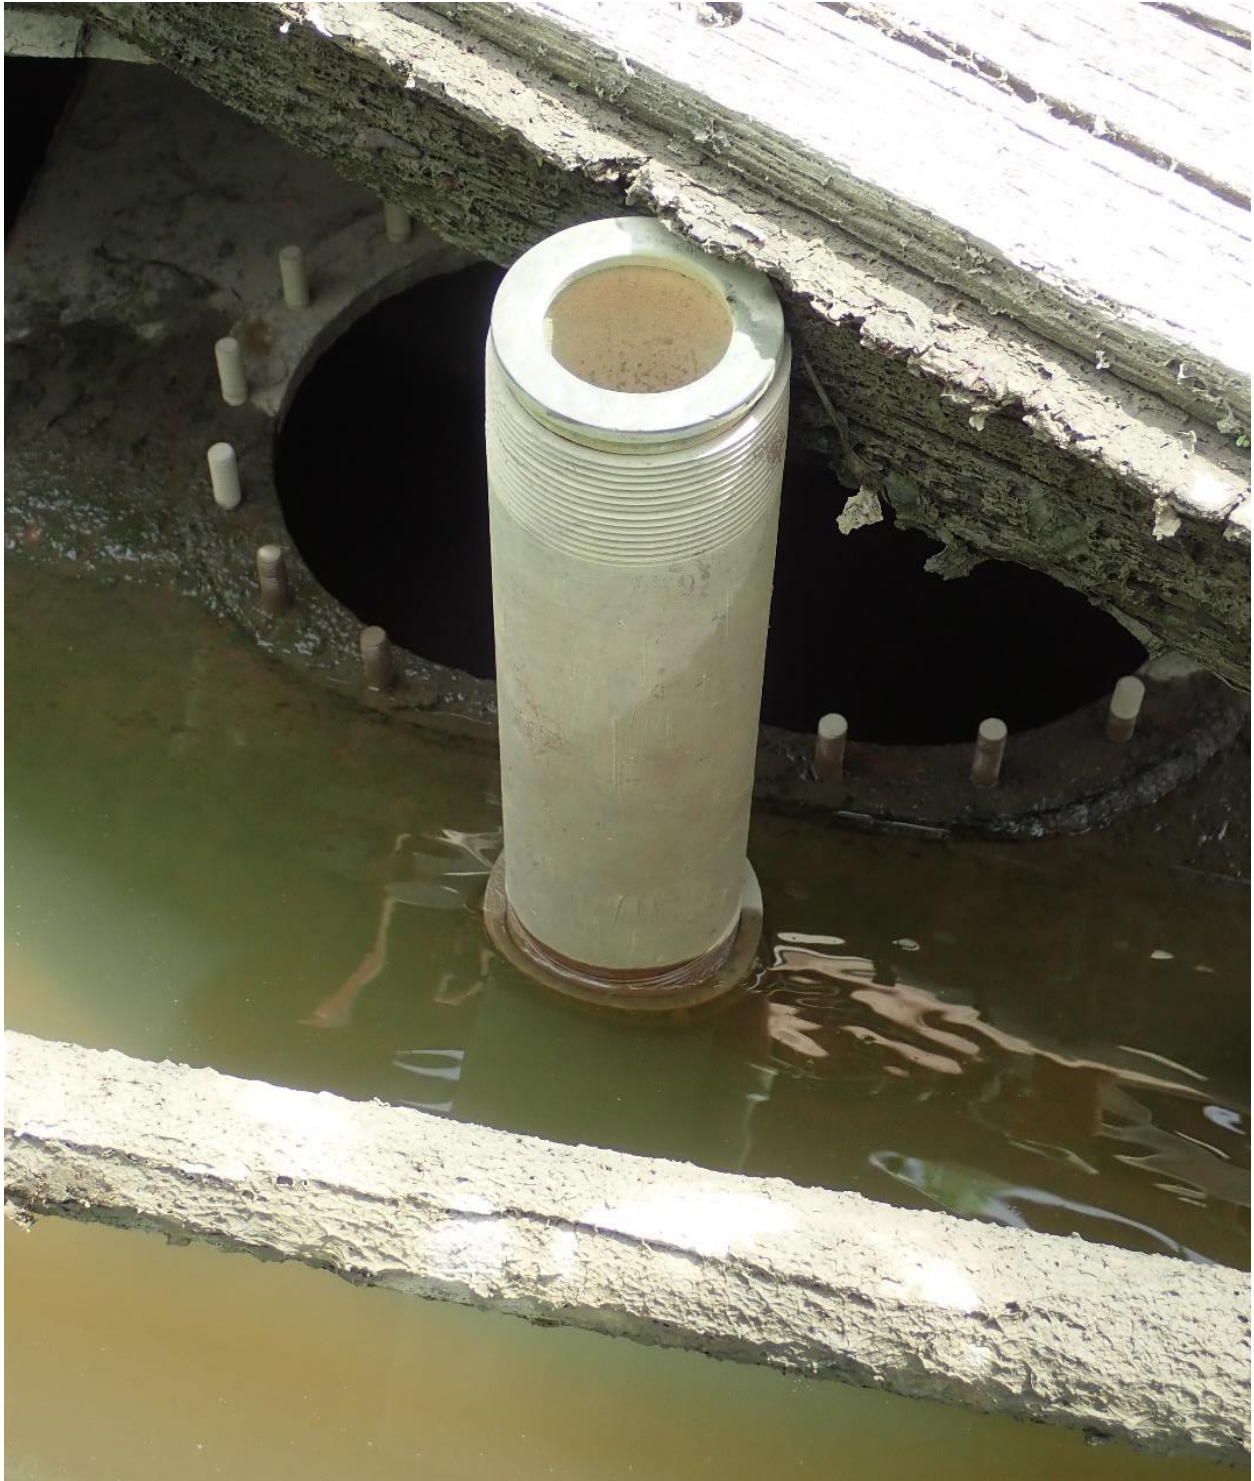
FIGURE 6.13 PVC pipe mounted to the top of the starboard fuel tank of the Sea Scout Wreck (Photo Credit: Nathan Richards, 2021).

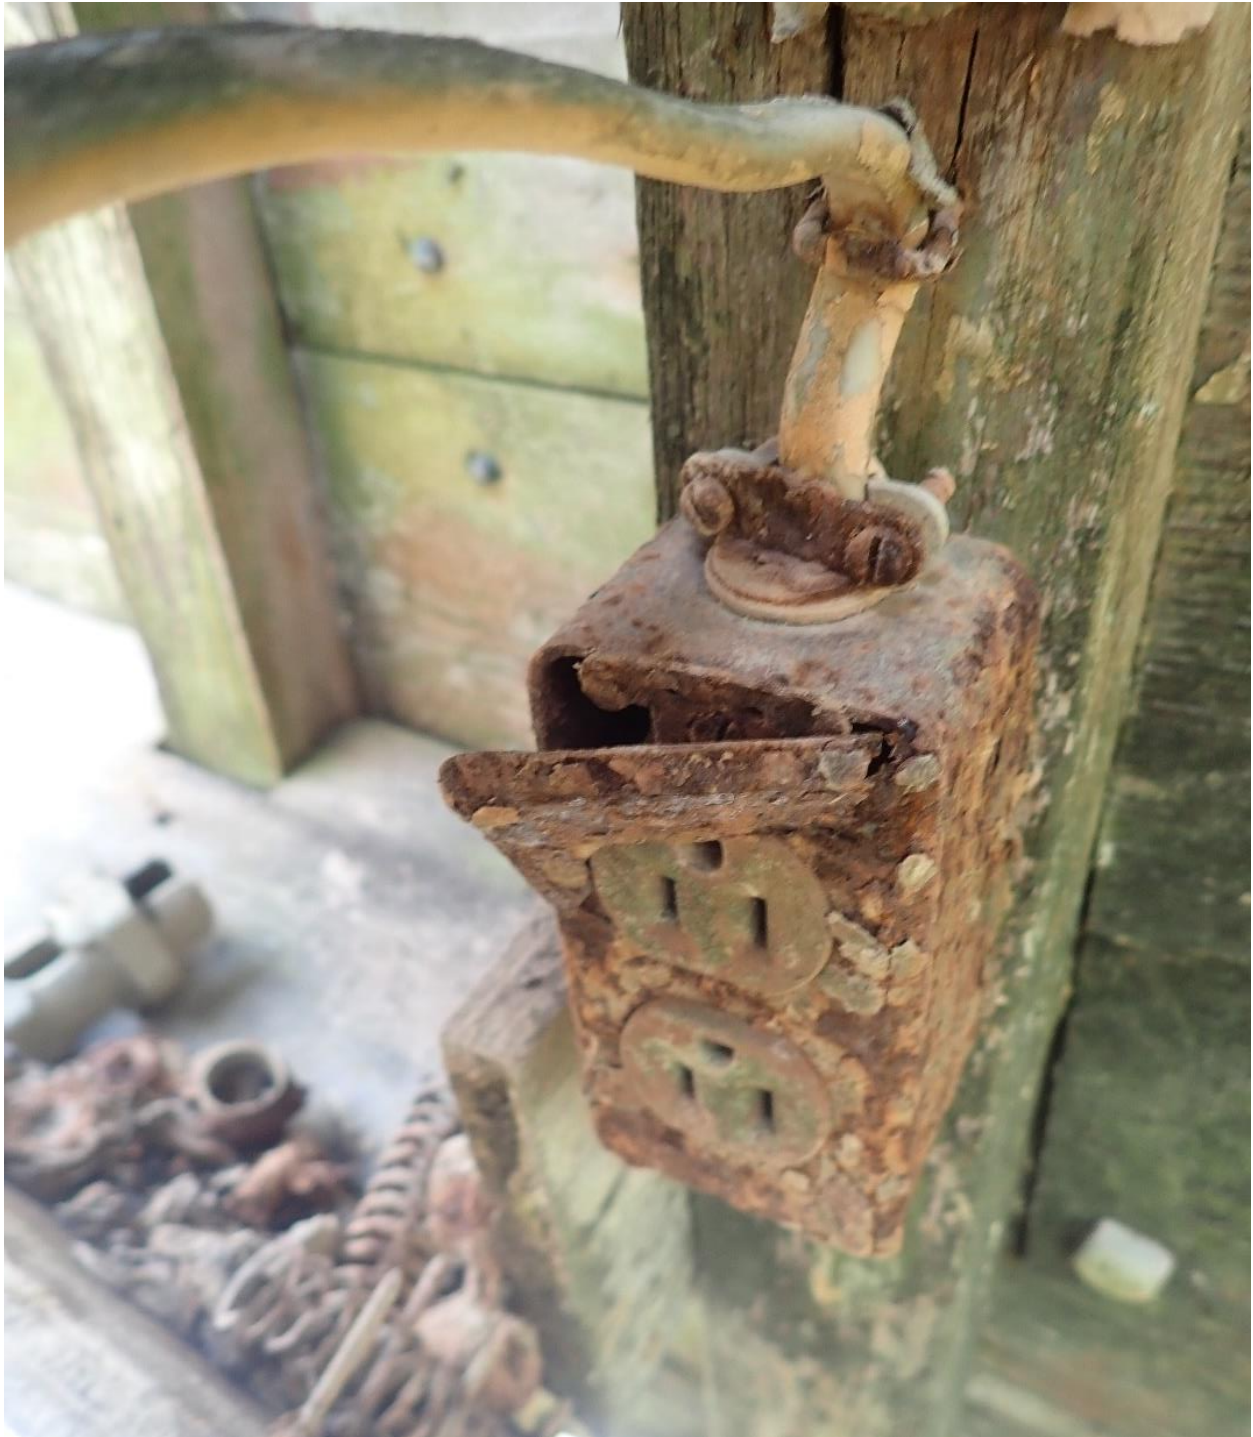
FIGURE 6.14 NEMA 5-15 AC electrical socket mounted to a hanging knee in the engine room of the Sea Scout Wreck (Photo Credit: Nathan Richards, 2021).

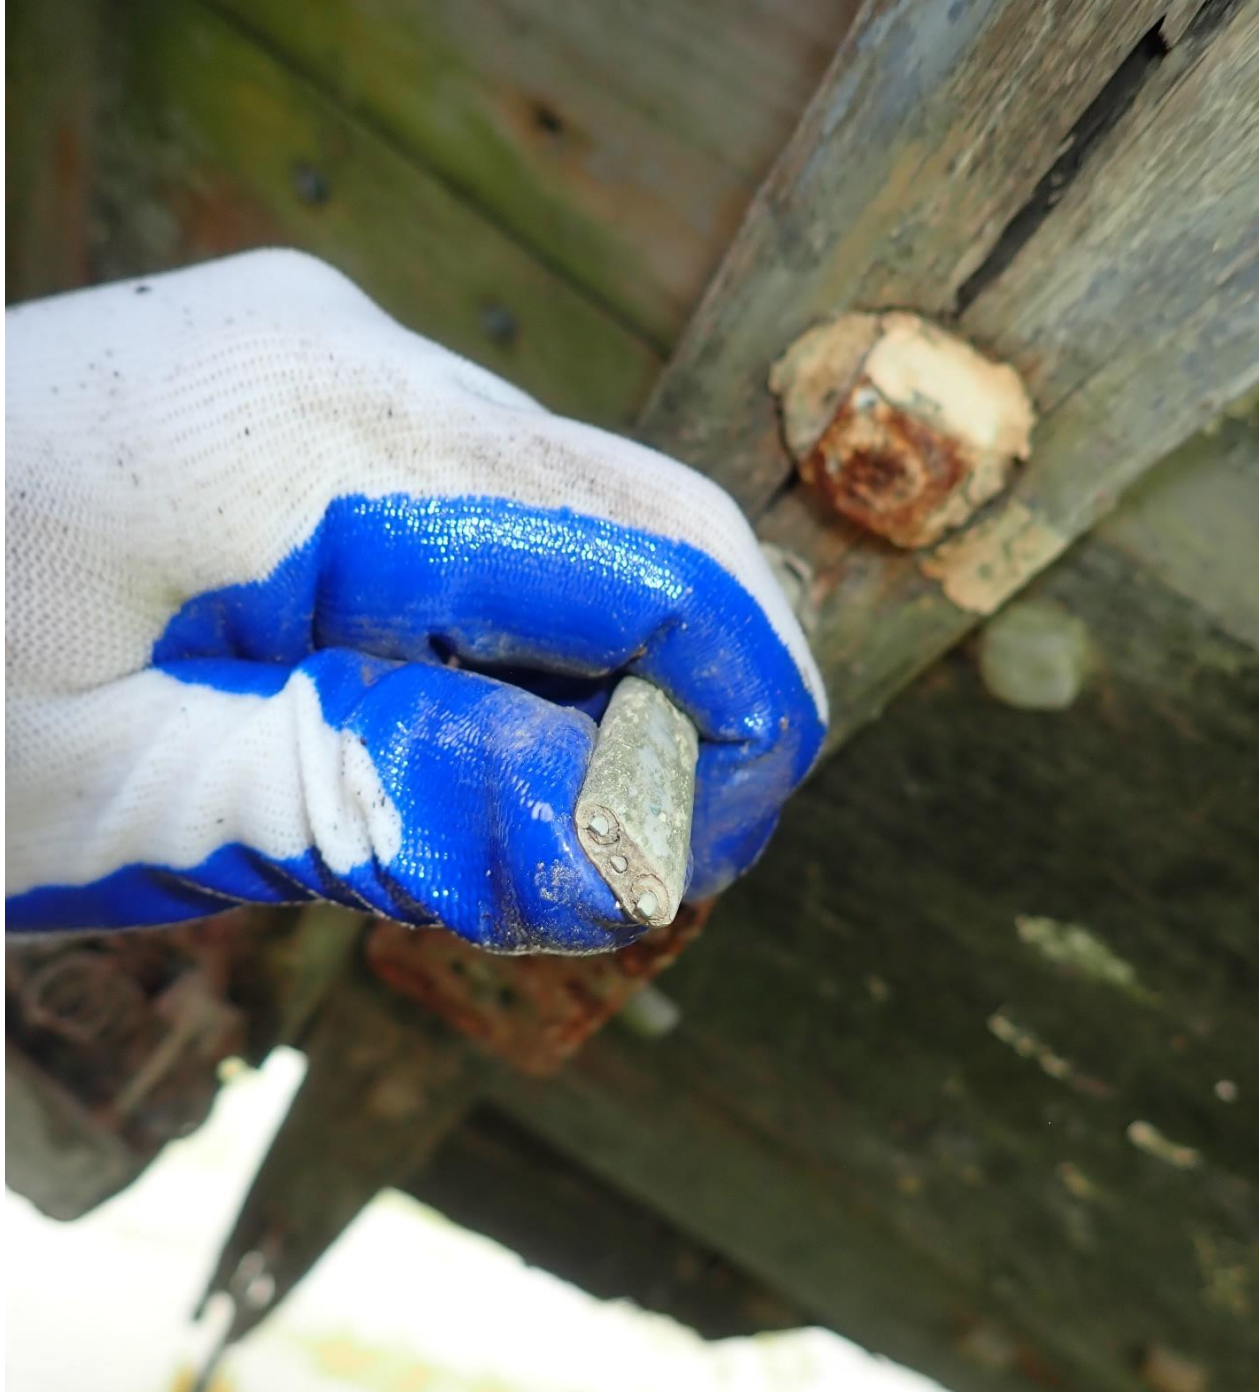
FIGURE 6.15 Insulated single strand aluminum electrical wire connected to the NEMA 5-15 socket seen in Figure 6.12 (Photo credit: Nathan Richards, 2021).

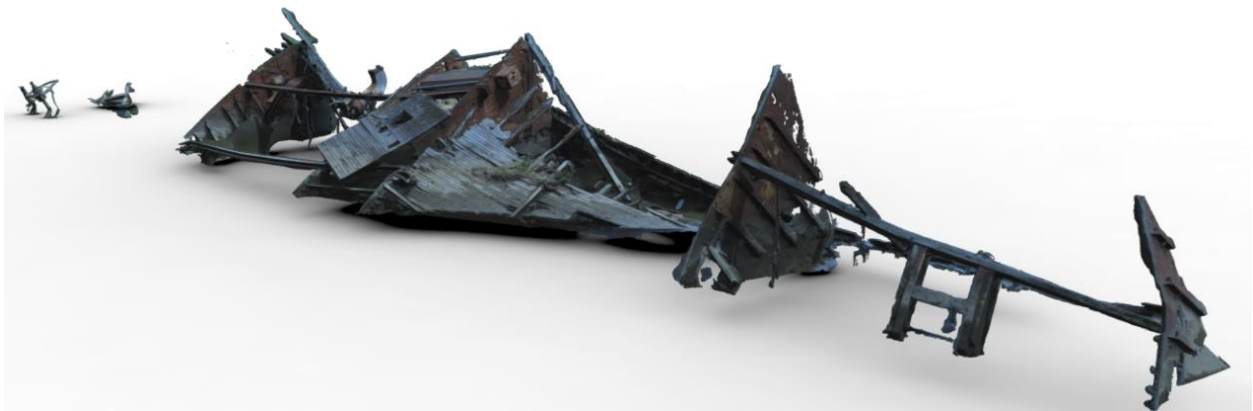
FIGURE 6.17 Photogrammetric Model of Sea Scout showing the most accurate positions of the bulkhead of the Sea Scout Wreck (isometric view) (Model created by Nathan Richards).

From 1997 to 2021, there has been a major shift in the positions of all the bulkheads of the Sea Scout Wreck (Figure 6.17, 6.18, and 6.19). The Bulkhead 1 has fallen aft onto Bulkhead 2 and has listed to starboard 75° (Figure 6.20). Bulkhead 2 has not fallen backward, as it is attached to the Bulkhead 3 by a steel I-beam, but has listed to starboard 65° (Figure 6.21).

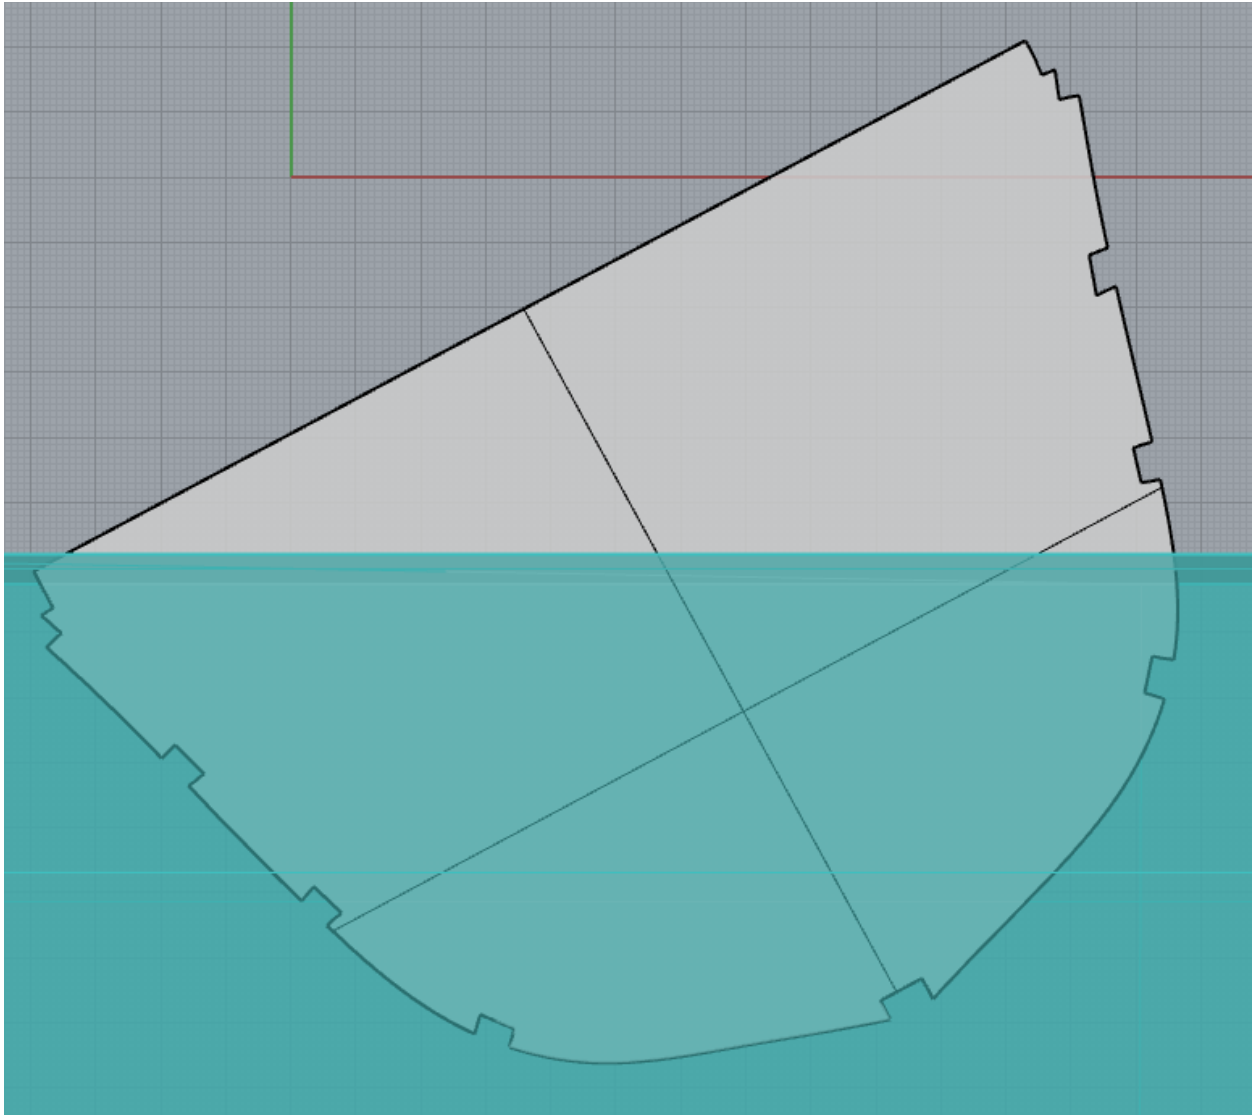
FIGURE 6.22 Bulkhead 4 from Sea Scout Wreck (2021) showing the 40° list to starboard (front view) (Model created by Taylor Picard).

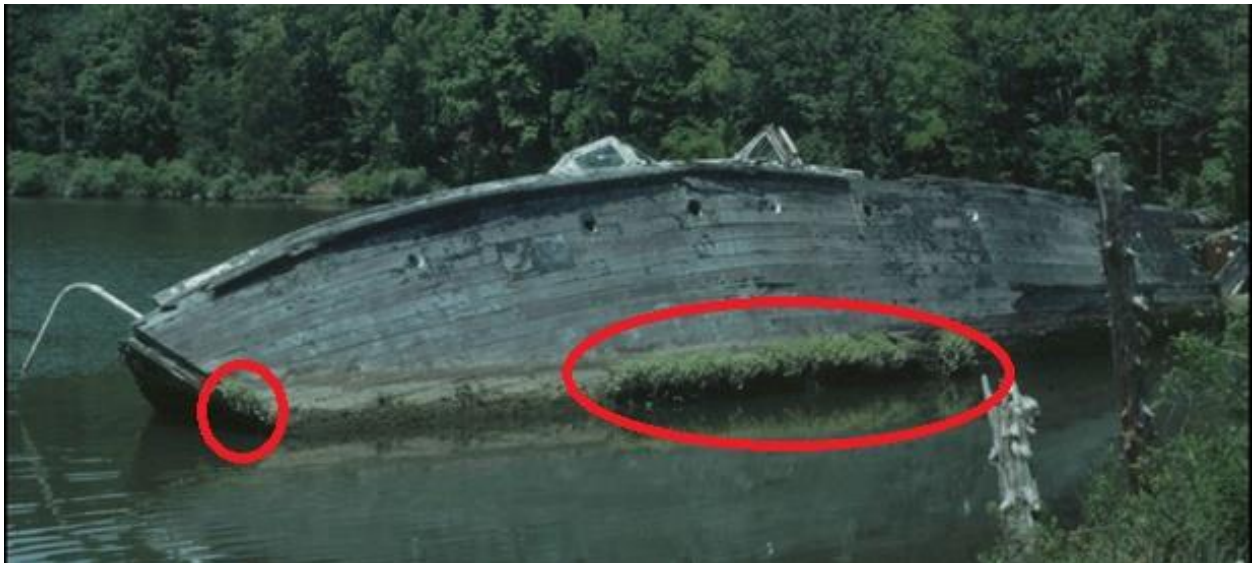
FIGURE 6.25 Port side of the Sea Scout Wreck in 1997 showing plant grown on the hull (circled in red) at the water level (Photo courtesy of Susan Langley, 1997).

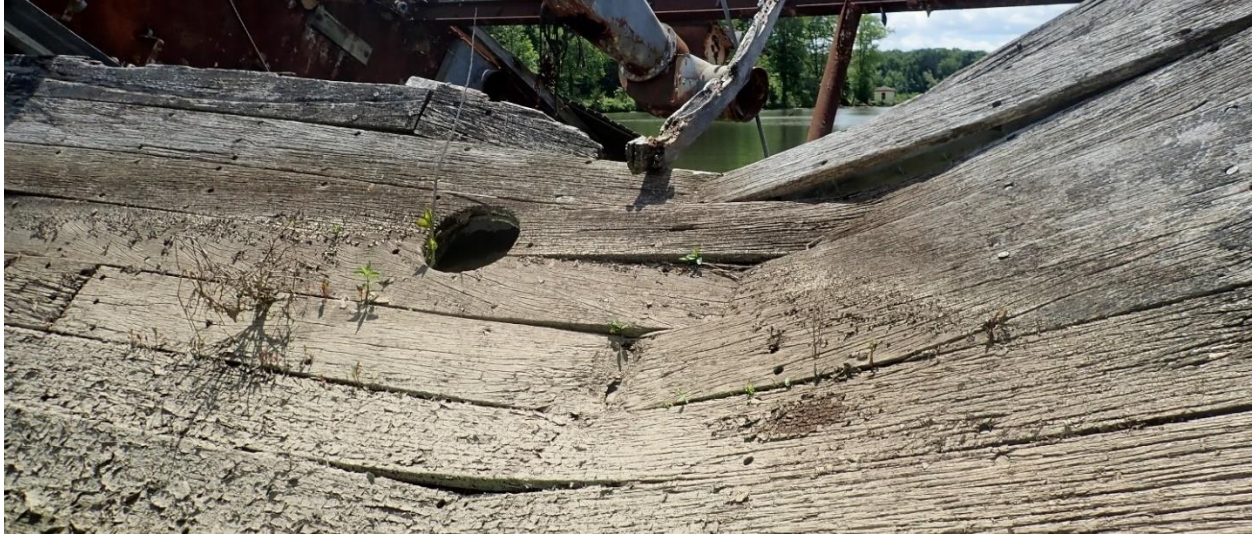
FIGURE 6.26 The port side hull of the Sea Scout Wreck in 2021 showing the grey-silver discoloration associated with the breakdown of lignin in the wood (Photo credit: Nathan Richards, 2021).
