ARCHAEOLOGICAL SITE FORMATION OF THE “SEA SCOUT WRECK”:
MALLOWS BAY, NANJEMOY, MARYLAND

A Thesis

In Partial Fulfillment of the Requirements for the Degree
Master of Arts in Maritime Studies

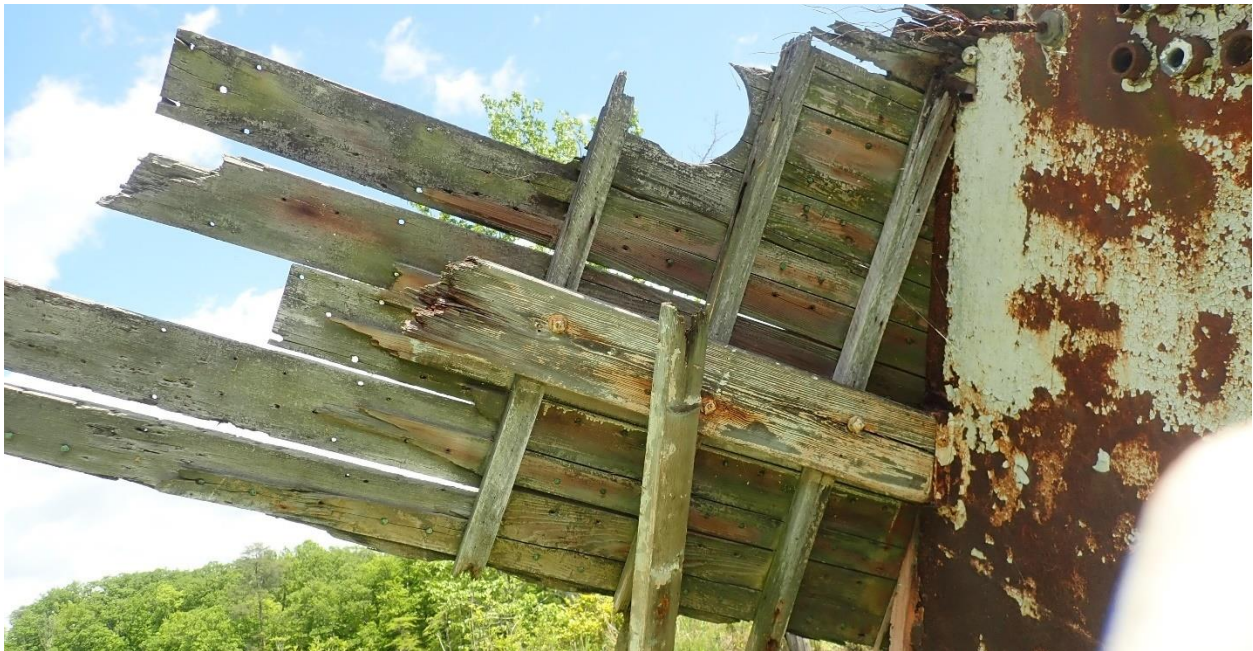
FIGURE 6.27 The interior of the outer hull planking behind Bulkhead 6 of the Sea Scout Wreck showing areas where the lignin in the wood has not yet broken down, but algae growth is present (Photo Credit: Nathan Richards, 2021).

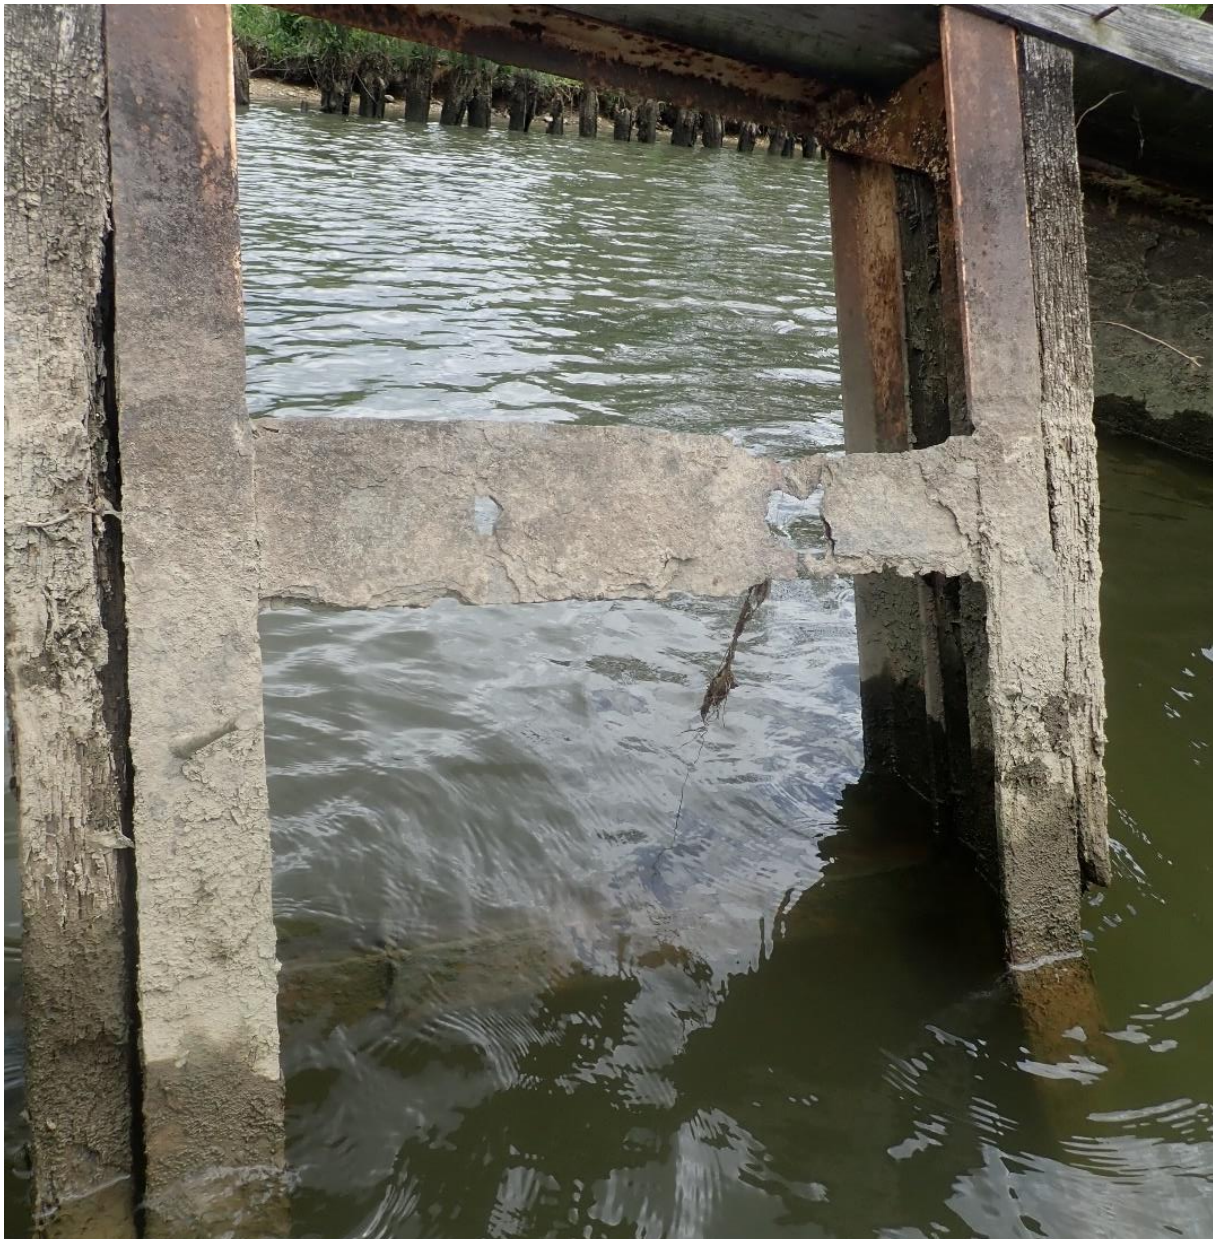
FIGURE 6.28 Metal cross bar showing extensive rust and formation of holes (Photo Credit: Nathan Richards, 2021).

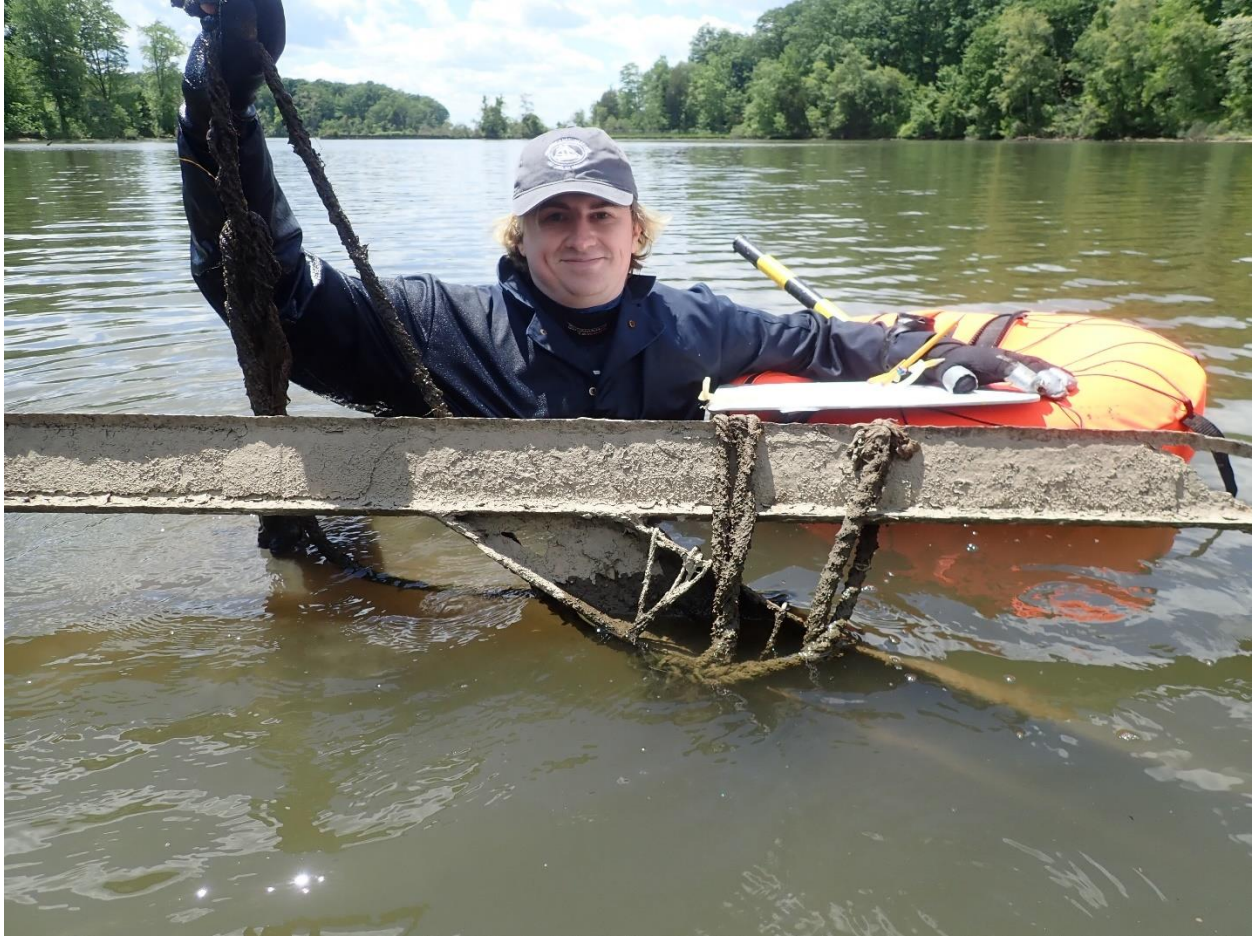
FIGURE 6.29 Taylor Picard holding up a length of broken rope attached to starboard I-beam between Bulkheads 5 and 6; note break in the I-beam on the right (Photo Credit: Nathan Richards, 2021).
