INFLUENCE OF PERMEABLE INTERLOCKING CONCRETE PAVER PERFORMANCE ON INFILTRATION AND TEMPERATURE IN AN URBAN WATERSHED

A Thesis

East Carolina University

Master of Science in Geology

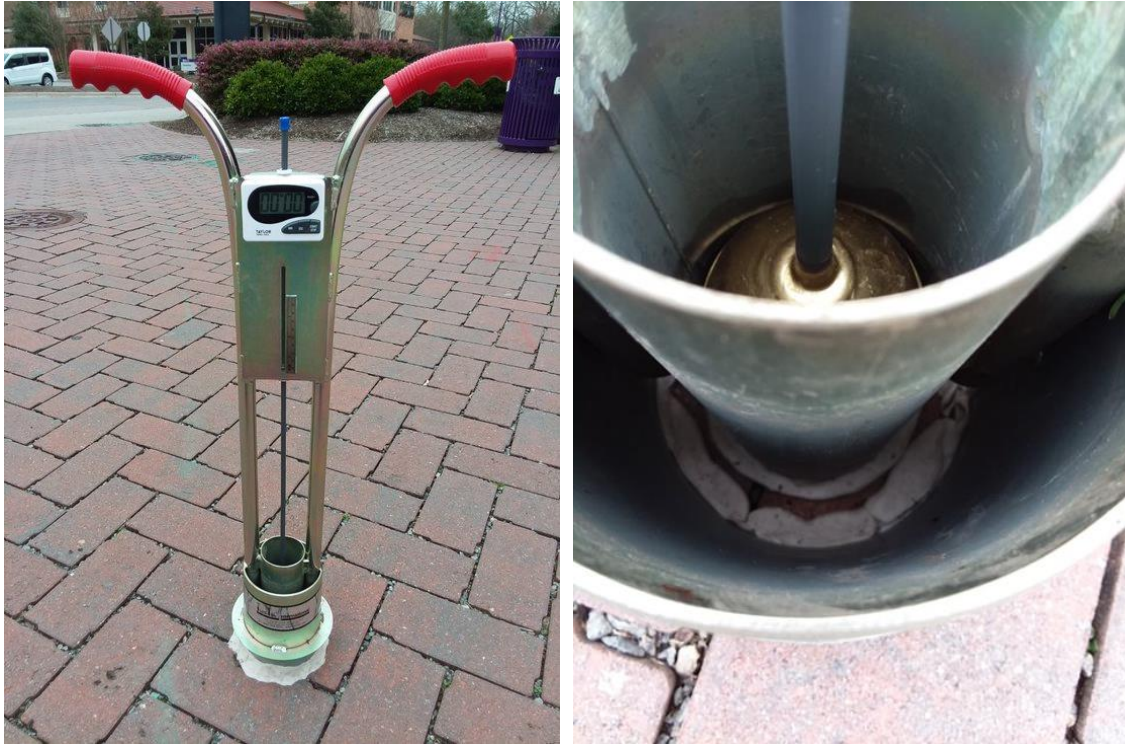
Figure 5. Typical setup of double-ring infiltrometer at PICP test sites.

Six PICP (n = 18) sites were tested to determine surface infiltration rates (Figure 4). A Turf-Tec® Double-Ring Infiltrometer was used to measure surface infiltration rates at each site (Figure 5). At each PICP site, three tests were conducted at different locations to determine variability in infiltration rates of permeable pavers based on existing surface conditions (Bean, 2005; Bean *et al.*, 2005; Bean *et al.*, 2007). Tests were performed between November 2019 and February 2020, and all tests were preceded by at least a 24-hour dry period (Appendix B). The test used for this study modified some of the methods and materials in ATSM D 3385 (ASTM, 2003) and ASTM C1781/C1781M (ASTM, 2014); the “Standard Test Method for Infiltration Rate of Soils in Field Using Double-Ring Infiltrometer” and the “Standard Test Method for Surface Infiltration Rate of Permeable Unit Pavement Systems”, respectively. The methods and materials as modified by Bean, were adapted to operate with a limited water supply (Bean, 2005; Bean *et al.*, 2005; Bean *et al.*, 2007). A volume of 19 L (5 gal) was transported at a time for each location.

To modify the ATSM D 3385 for a hard surface, the inner ring of the infiltrometer was sealed to the surface using a thin ring of plumber’s putty according to Bean *et al.*, 2005 and the ATSM C1718/C1781M (2014). Water was added to the inner ring to determine if any leakage to the outer ring existed, to prevent leakage both the inner and outer rings were sealed with putty

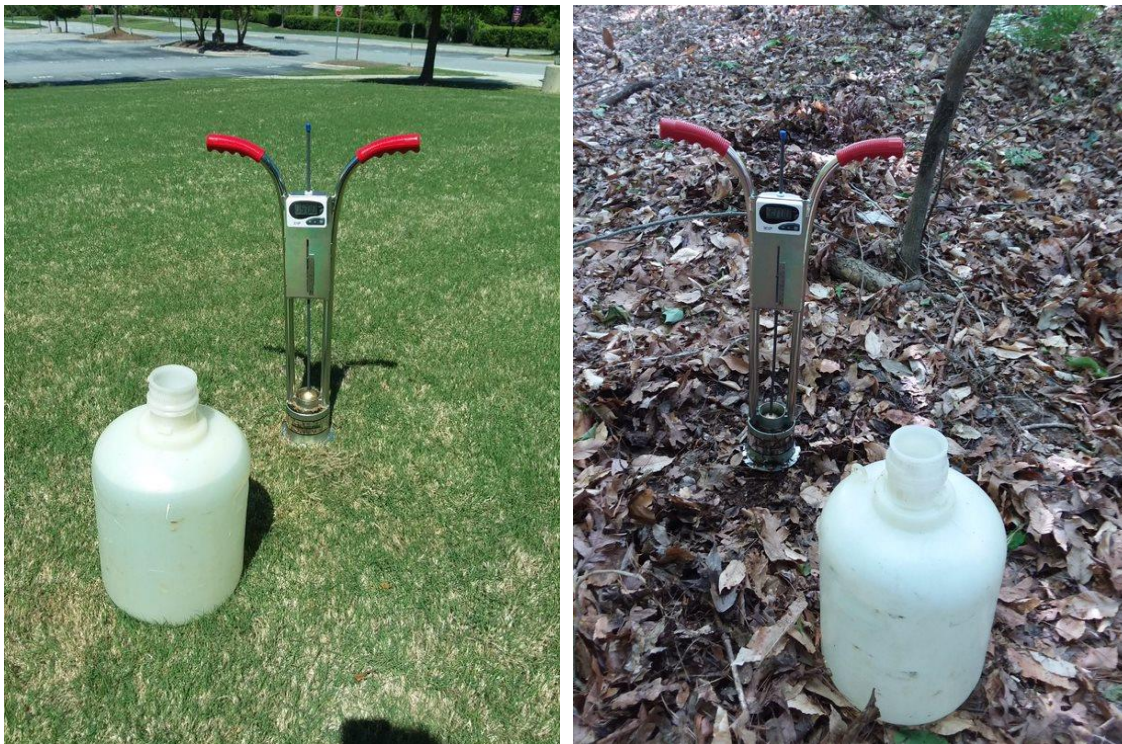
Figure 6. Typical Setup of double-ring infiltrometer at campus lawn (left) and forested test sites (right).

The double ring cutting blades were placed on the area to be tested and driven 2 inches into the ground until the Saturn ring was flush with the ground surface. The ground was saturated by filling the inner and outer rings 3 times, allowing infiltration between fillings and enough time for the soil to swell (EPA, 1980; Turf-Tec® International, 2020). After saturation, the initial water level in the inner ring and time were recorded. Both parameters were measured and recorded every 5 minutes. A test was considered complete when the water level drop stabilized, generally around 30 minutes.

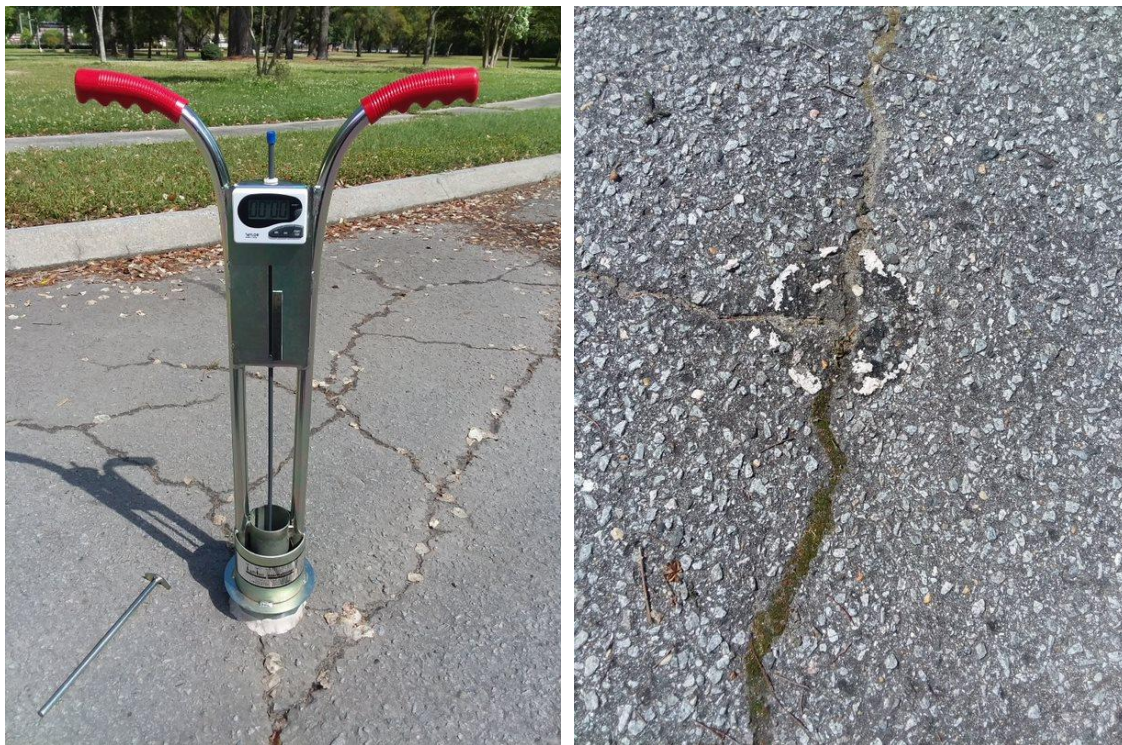
Figure 7. Typical setup of double-ring infiltrometer at asphalt sites.

To modify the ASTM D 3385 for a hard surface, the inner ring of the infiltrometer was sealed to the pavement at a fracture intersection using a thin ring of plumber’s putty (Wiles and Sharp, 2008; ASTM, 2014). The methods used are similar to those in the earlier section (Infiltration Rates of PICP). A test was considered complete around 5 minutes; however, if complete infiltration occurred in less than 5 minutes, the time for complete infiltration was recorded. Wiles and Sharp (2008) noted that infiltration rates generally decrease and level out within 5 minutes of infiltration on pavement surfaces.

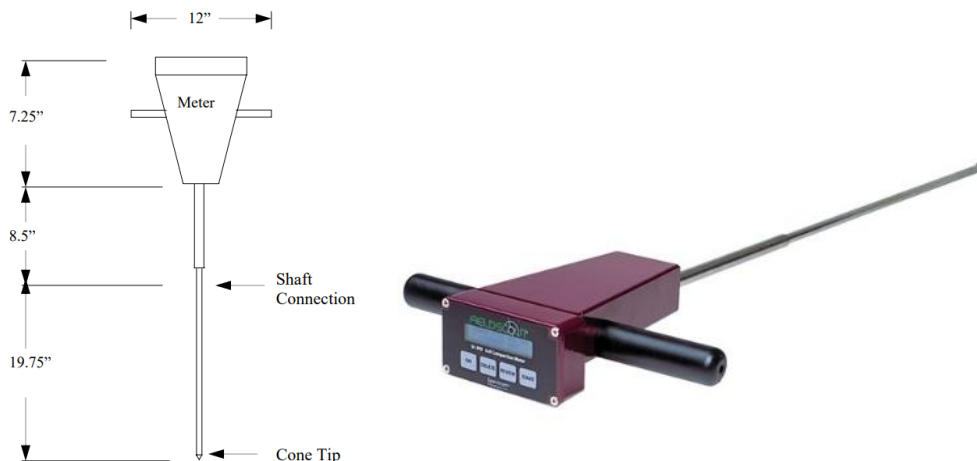
Figure 8. Spectrum™ FieldScout SC 900 cone penetrometer (Spectrum Technologies, Inc. Plainfield, Illinois 2009).

Soil compaction was measured at the forested ($n = 30$) and campus lawn ($n = 63$) site locations using a Spectrum™ FieldScout SC 900 cone penetrometer (Spectrum Technologies, Inc. Plainfield, Illinois) (Figure 8). Penetrometers measure soil strength on a cone index scale of 0-7,000 kPa (0-1,000 PSI) (± 103 kPa; Spectrum 2009). The tip of the penetrometer is placed on the soil surface and force is applied to push the probe deeper into the soil profile, for a depth up to 45 cm (18 in) (Spectrum 2009). As soil compaction values increase, bioturbation, plant root growth, and infiltration decrease. Based on the degree to which plant roots can penetrate soils, 2068 kPa (300 psi) is a commonly cited threshold for soil compaction at a depth of 7.62 cm (3 in) (Mangiafico, 2009; Pitt *et al.*, 1999). Three cone index measurements (kPa) were taken at each site where infiltration measurements were collected. Cone index measurements were recorded in increments of 2.5 cm (1 in) up to 15.2 cm (6 in).

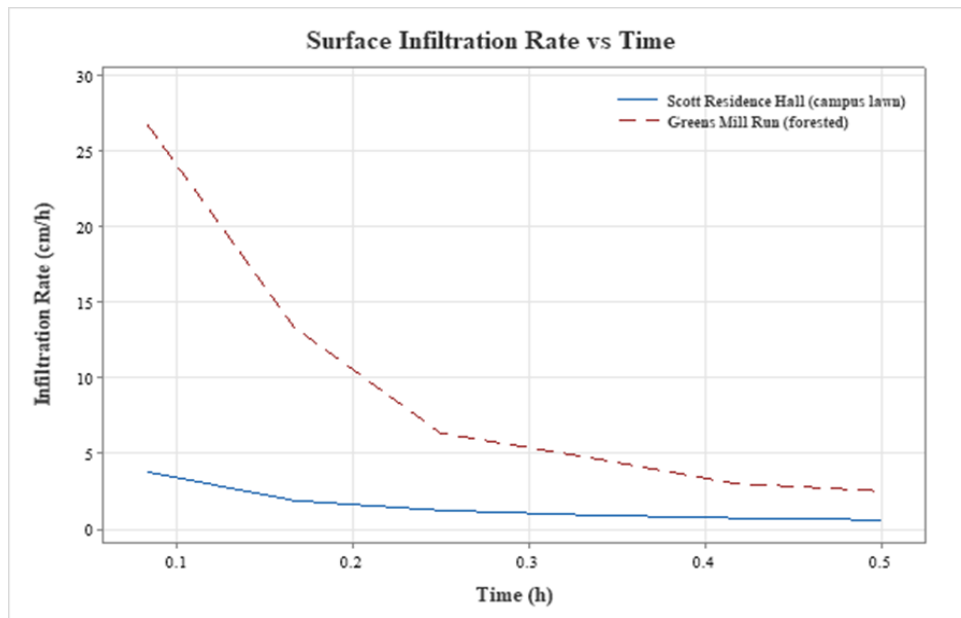
Figure 12. Typical graph of surface infiltration rates versus time for one test at the forested site (Greens Mill Run) and one test at a campus lawn site (Scott Residence Hall).

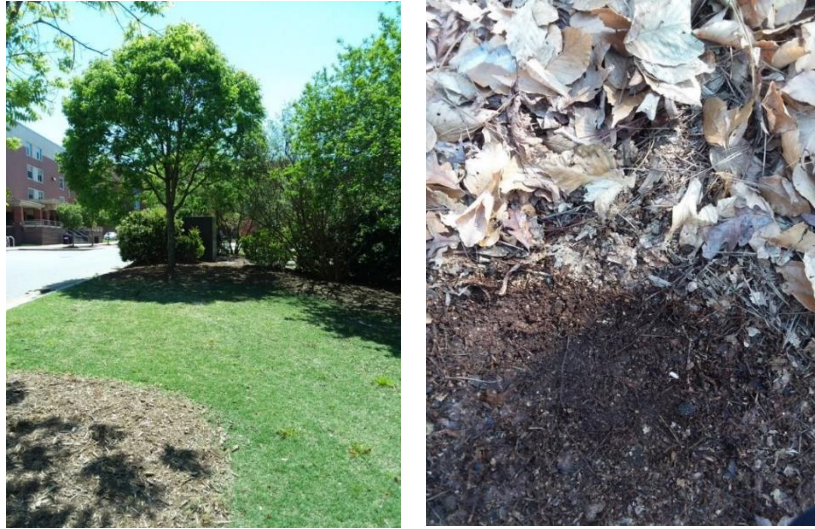
Figure 13. Images of land cover type for campus lawns (left) and forested soils (right). Scott Residence Hall (left) has lawn areas covered by well-maintained turfgrass. Greens Mill Run (right) is an urban forest covered with leaf litter.

Surface infiltration rates (SIR) were tested for six PICP, one forested soil, seven campus lawn, and four fractured asphalt sites across the ECU Main Campus using a Turf-Tec® Double-Ring Infiltrometer and falling head test. Three tests were performed at each site to determine the variability in infiltration rates based on existing conditions, and water levels were plotted as functions of time (Appendix C). Infiltration rates are typically highest at the beginning of a storm and decrease over time as soils swell and the storage capacity is depleted (Pitt *et al.*, 1999). SIRs were calculated by recording water level change in the inner ring over time until infiltration rates became stable ($I = \Delta H/t$) (Figure 12) (Appendix D). Figure 14 shows the land cover type for campus lawns (left) and forested soils (right).

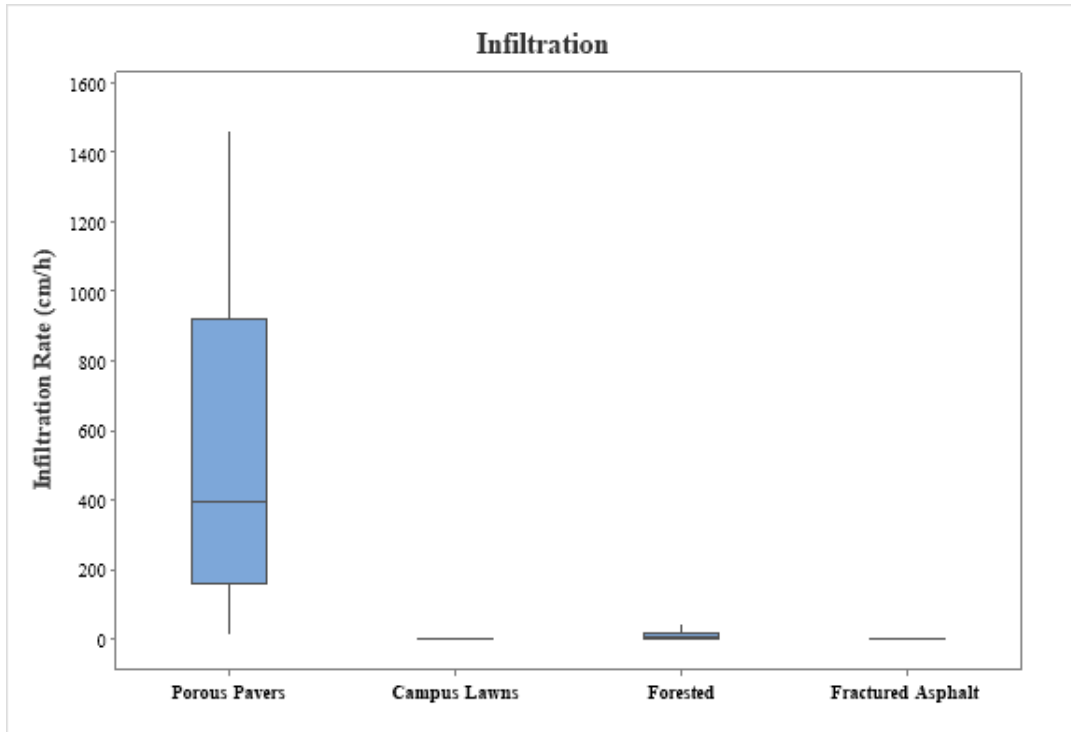
Figure 14. Comparison among surface infiltration rates of PICP, campus lawn, forested, and fractured asphalt sites.

The infiltration rates of the groups were significantly different ($p < 0.05$) (Figure 14). Table 3 lists average surface infiltration rates and R^2 values for PICP, Forested, and Campus Lawn sites. The median surface infiltration rate for PICPs was three orders of magnitude greater than campus lawns. Generally, it is assumed that impervious surfaces have infiltration rates close to 0, but SIR for asphalt were taken where fractures in the pavement intersected and do not represent effective infiltration for the entire pavement surface. Some data at the fractured asphalt sites were eliminated due to leakage around the base of the infiltrometer. The Willis building parking lot site was not used in analyses, and one measurement taken at 1900 Charles Blvd and two measurements taken at Dowdy-Ficklen Stadium were eliminated from the data set (Table 4). Surface infiltration rates of PICP varied across each location; however, most R^2 values for water level versus time relationships were greater than 0.9. Average SIRs for PICPs were compared to the year of installation to determine if infiltration decreased over time. Although, sites installed after 2015 had slightly higher infiltration rates, there was not a strong pattern in performance versus age for sites sampled (Figure 15).

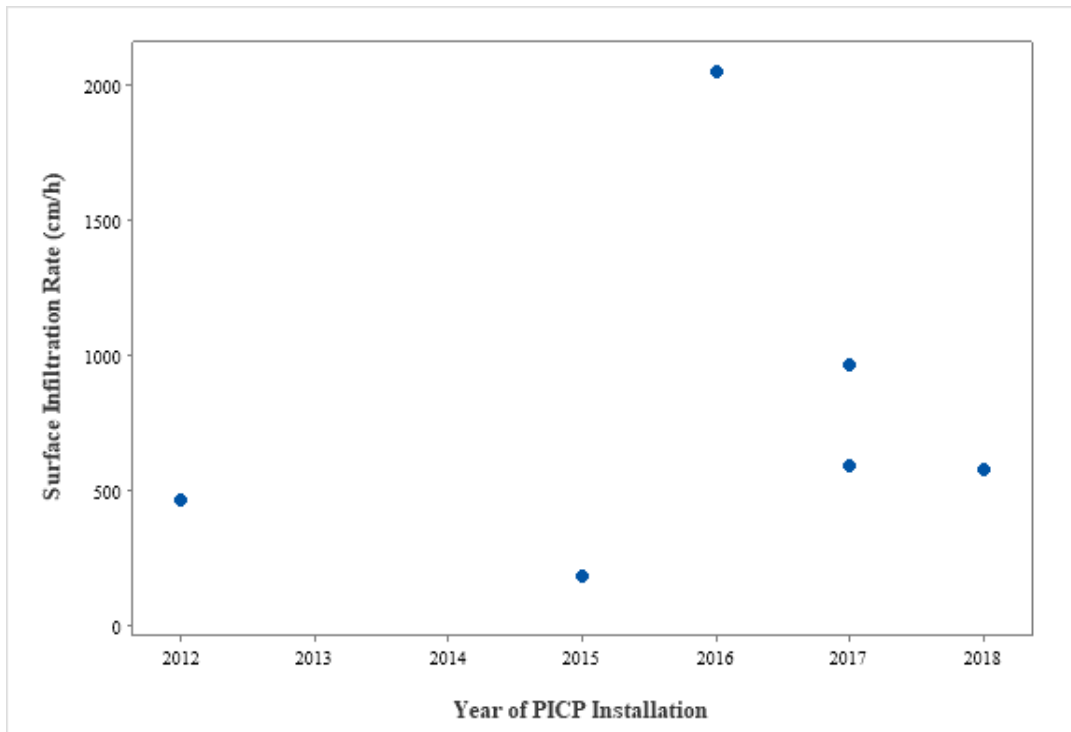
Figure 15. Average surface infiltration rate for each PICP site and year of installation.

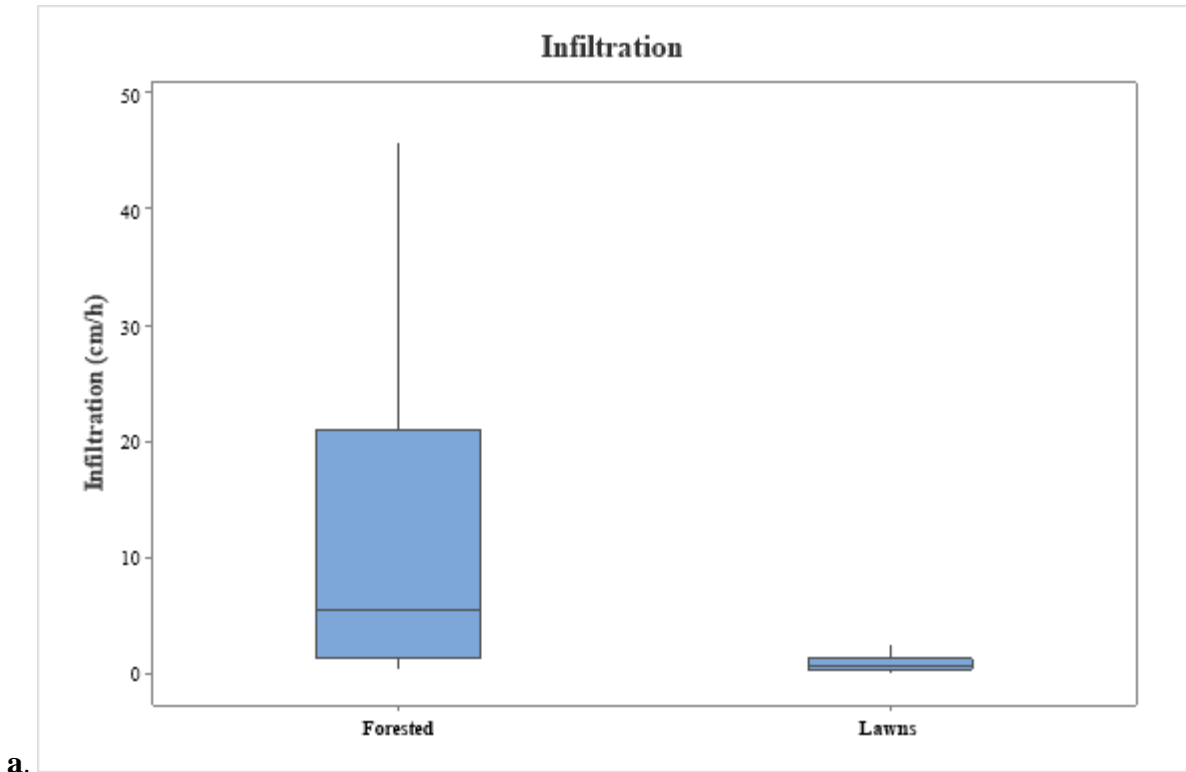
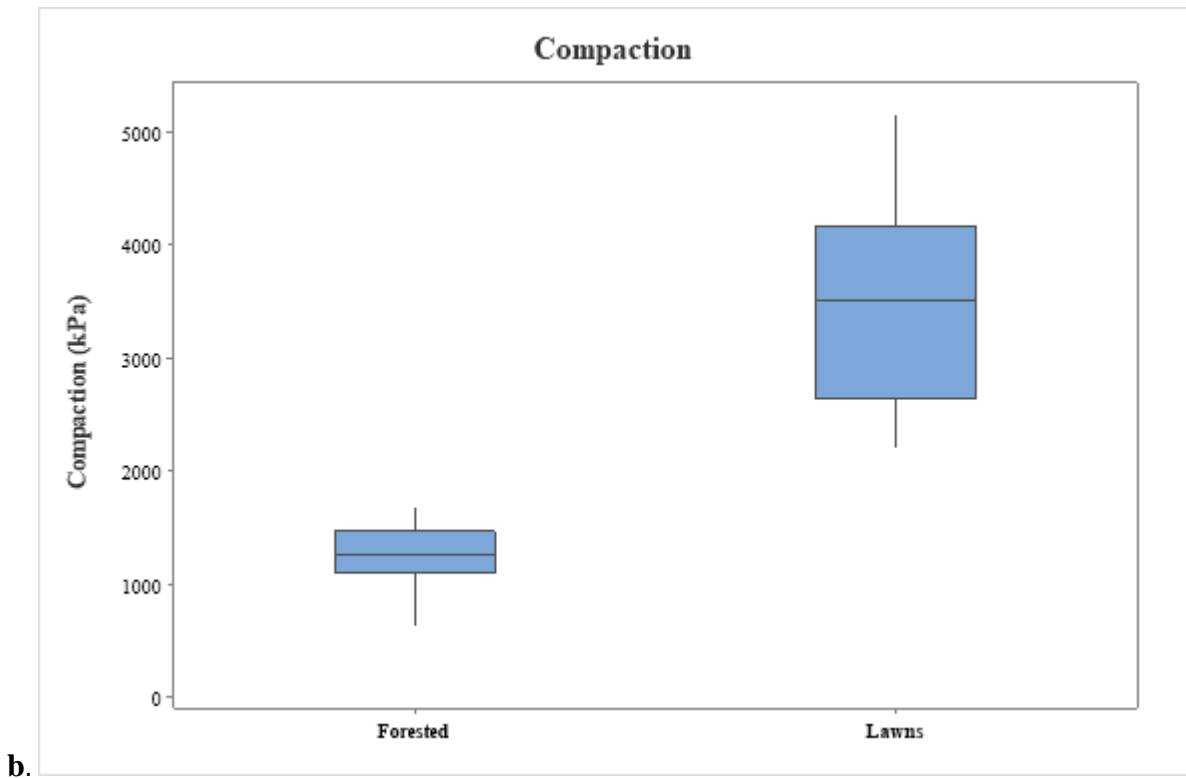
Figure 16. Infiltration rates (a) and maximum compaction values (b) at the forested and campus lawn sites (n = 10 for the forested site; n = 21 for campus lawn sites).

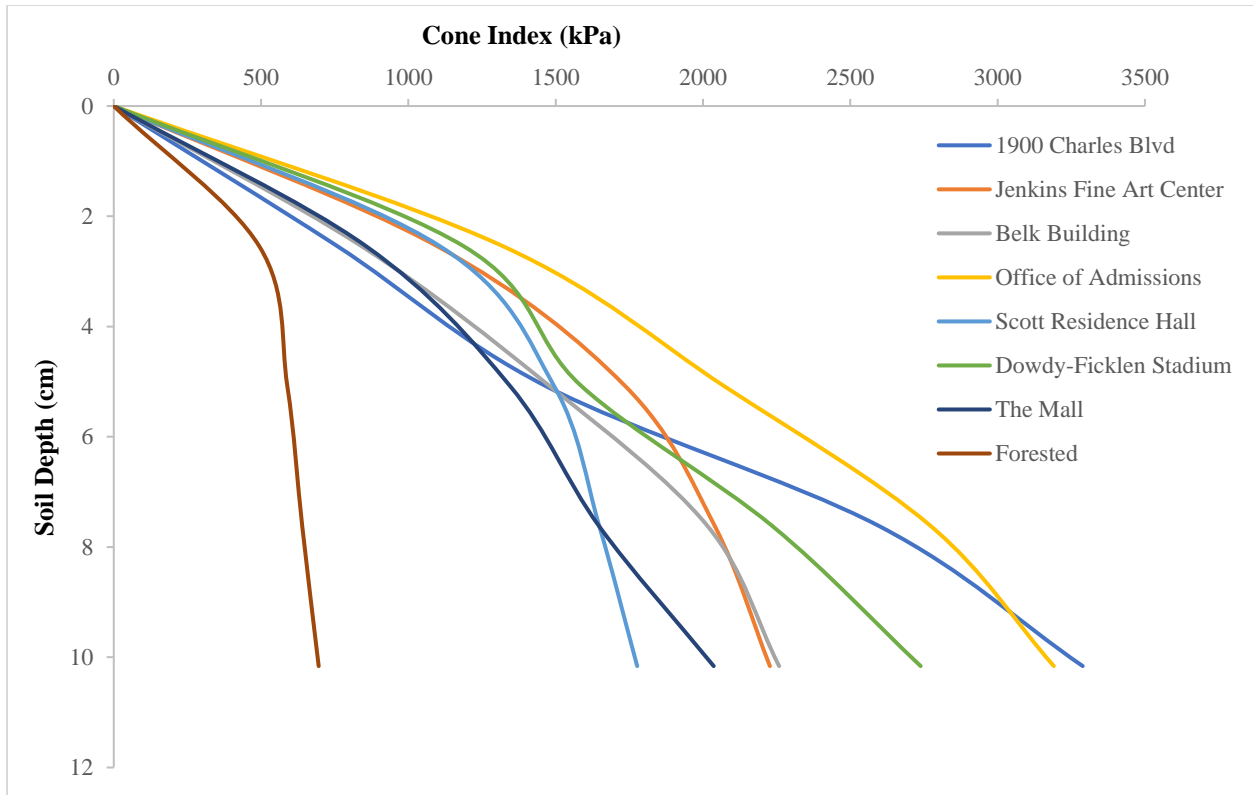
Figure 137. Average cone index values for the forested site (n = 30) and campus lawn sites (n = 9 at each site) (1 in = 2.54 cm).

Average cone index profiles in Figure 17 show relative compaction with soil depth up to 10.16 cm (4 inches). Nine cone index measurements were taken at each campus lawn site; however, four of the sites (1900 Charles Blvd., Belk Building, Office of Admissions, Dowdy-Ficklen Stadium) included at least one set of measurements that did not exceed a depth of 10.16 cm (4 in), and values greater than a depth of 10.16 cm were eliminated for averaging. Factors inhibiting cone penetrometer depth include the degree of compaction from foot traffic and maintenance vehicles, and plant roots. For the forested site (Greens Mill Run Greenway), the greatest compaction occurred within the top 3 cm (1.18 in) of soil, then remained relatively consistent with depth. Compaction continued to increase with depth for the campus lawn sites, with the greatest compaction occurring shallower than 10 cm (3.9 in). Campus lawn sites sampled in the current study are adjacent to highly trafficked walkways and recreation areas and may not represent all lawn space across campus.

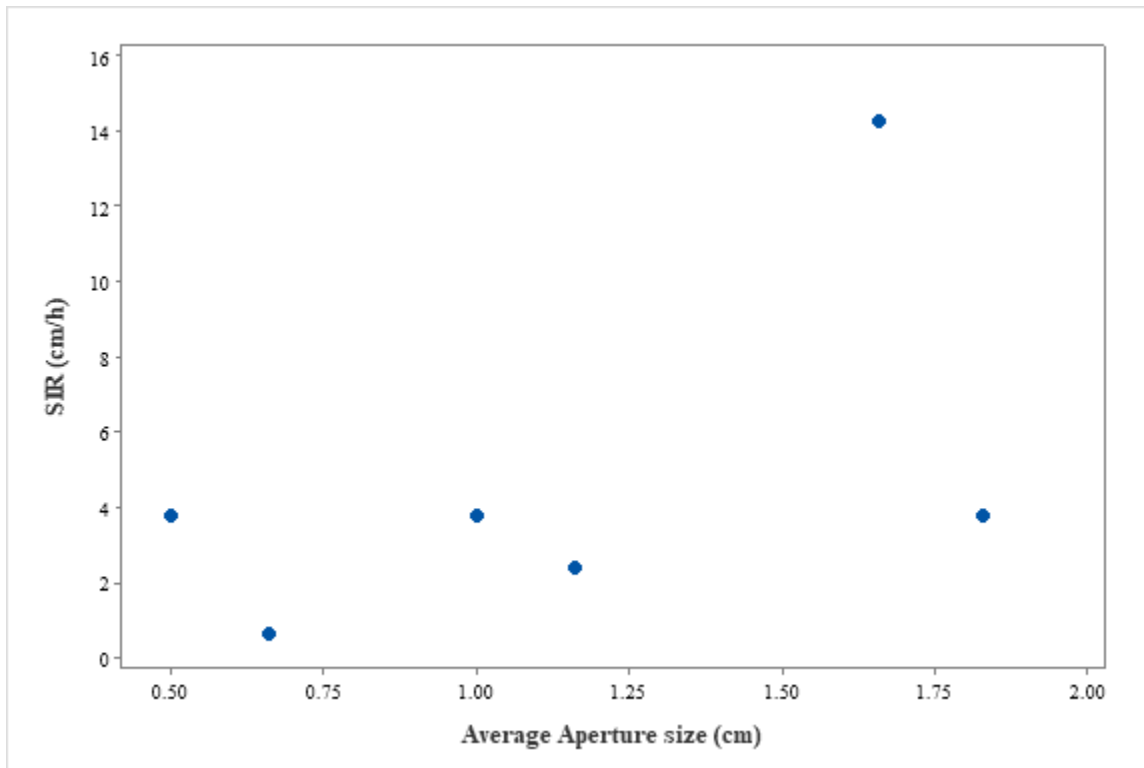
Figure 19. Surface infiltration rates are plotted against average fracture width in asphalt and demonstrate that there was no significant correlation across the sites sampled.

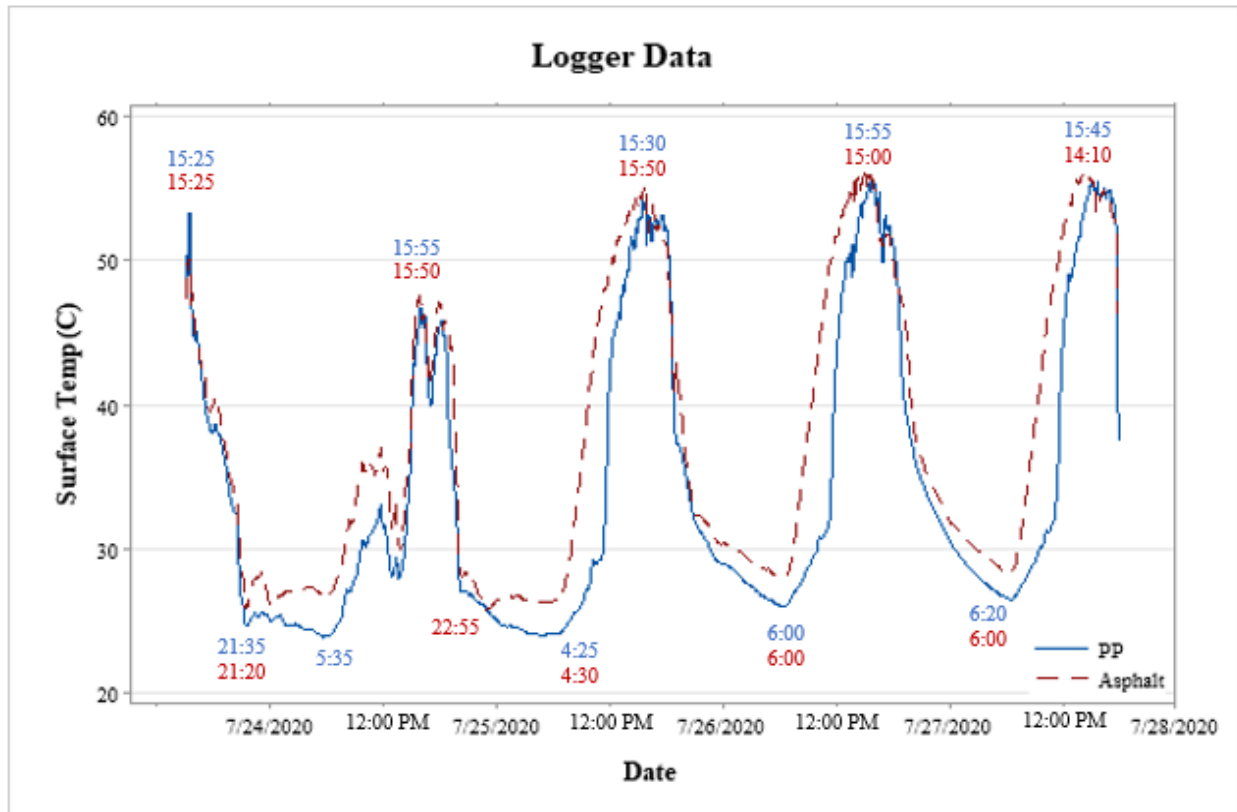
Figure 22. Time series plot of asphalt and PICP temperature data. Peak and minimum times Observed and labeled in blue (PICP) and red (asphalt). There was a significant difference in surface temperatures during the automatic monitoring period ($p < 0.05$).

Average daily air temperatures during the logger monitoring period were comparable to those during infrared testing (Table 11). Both surface types followed the trend of ambient air temperature, but maximum daily surface temperatures recorded for PICP were lower than RA four out of five monitoring days (Table 12). Although PICP and RA maximum daily temperatures were within 1°, PICP exhibited overall lower nighttime temperatures and were generally slower to warm than RA.

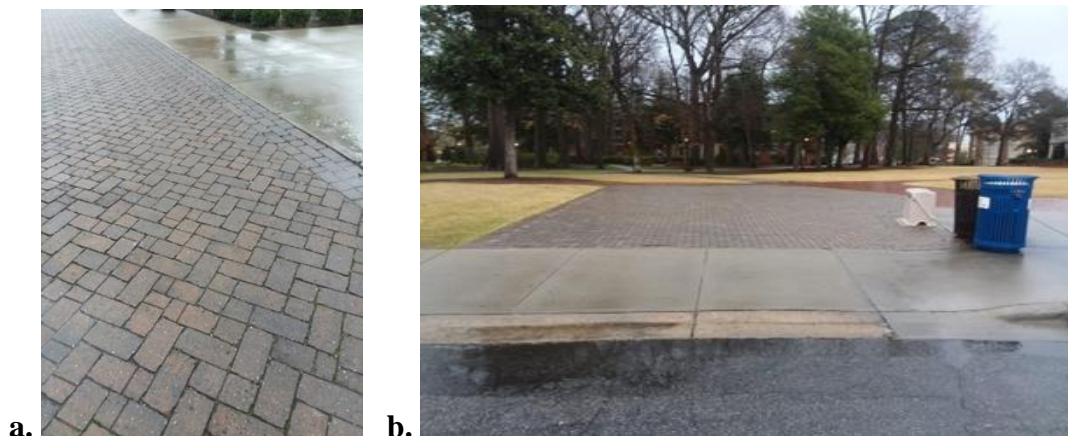
Figure 23. PICP sites show no runoff generation during rainfall events; (a) Student Plaza Drive on February 6, 2020 and (b) Band Shell Plaza on March 3, 2020.

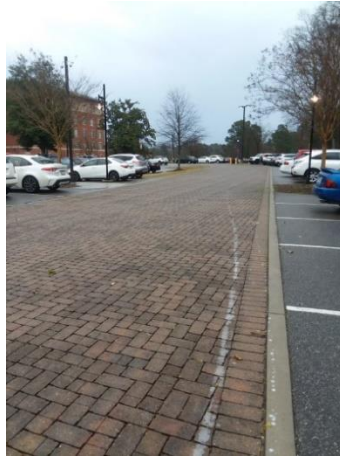
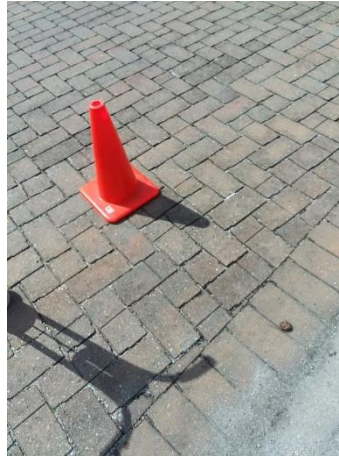
Appendix B 1

Site: E 14th Street Parking Lot

Use: Campus parking lot

Test #1	Test #2	Test #3	Average (cm/h)
476.25	742.95	171.45	463.55

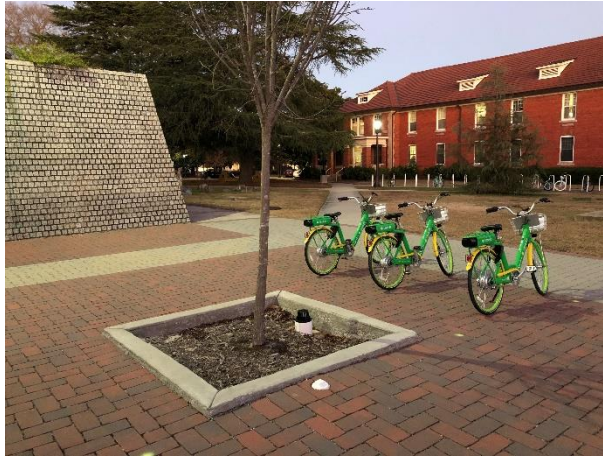
Appendix B 2

Site: Jenkins Fine Art Center
Use: Walking and Tree Box Filter
Approximate Pervious Area: 60 m²
 650 ft²
Approximate Drainage Area: 60 m²
 650 ft²
Construction Year: 2016
Test Date: February 3, 2020
Visual Assessment: Voids look clear of debris and fines.
Maintenance Practice: Sweeper truck and backpack blowers 2-3 times per week for surface debris; backpack blowers twice per year to remove fines within voids.
Existing Conditions Tests:

Test #1	Test #2	Test #3	Average (cm/h)
38.1	2438.4	3657.6	2044.7

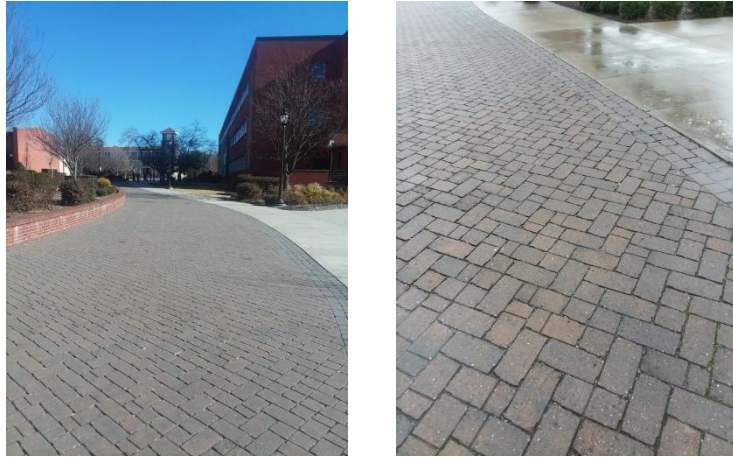
Appendix B 3

Site: Student Plaza Drive (walkway)

Use: Walking and light vehicular traffic (maintenance vehicles)

Test #1	Test #2	Test #3	Average (cm/h)
15.24	1463.04	304.8	594.36

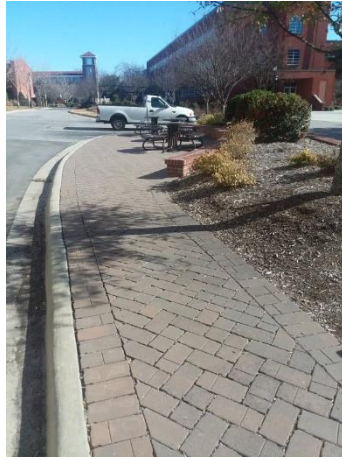
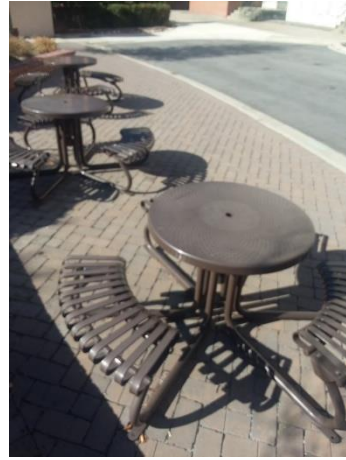
Appendix B 4

Site: Student Plaza Drive (picnic area)

Use: Outdoor seating and light foot traffic.

Test #1	Test #2	Test #3	Average (cm/h)
2438.4	320.04	137.16	965.2

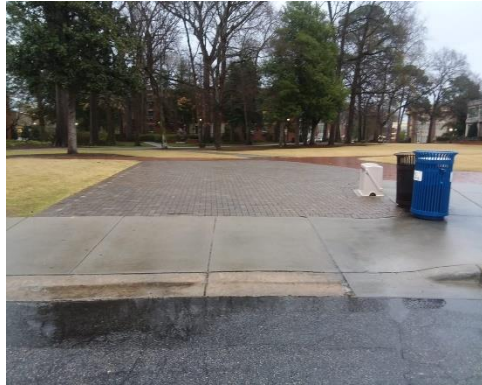
Appendix B 5

Site: Band Shell Plaza

Use: Walking and light vehicle traffic.

Test #1	Test #2	Test #3	Average (cm/h)
548.64	596.35	596.35	580.45

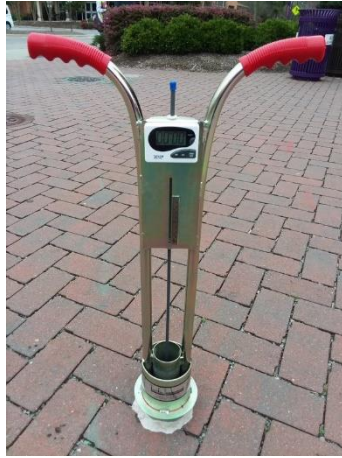
Appendix B 6

Site: Starbucks Mobile

Use: Mobile food truck parking pad.
