NORMAN AND GRECIAN:

A COMPARATIVE ARCHAEOLOGICAL SITE FORMATION ANALYSIS OF TWO
STEEL-HULLED GREATLAKES BULK CARRIERS IN LAKE HURON

A Thesis Presented to the Faculty of
The Department of History
East Carolina University

In Partial Fulfillment
Of the Requirements for the Degree
Master of Arts in Maritime Studies

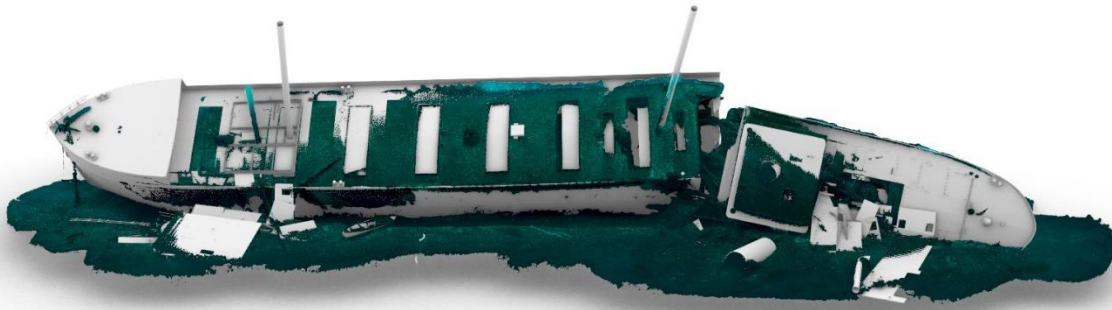
Figure 27: Norman wreck model overlaid with the photogrammetric model (Image by Caleb O'Brien).

Unlike the historical model, which was constructed from the ground up, the archaeological model of *Norman* was constructed by breaking down the historical model in comparison to the photogrammetric model depicted above (Figure 17). During the process of creating the archaeological model, historical sources were consulted to recreate the order in which the vessel deteriorated. For example, the split caused by the wrecking event was modeled before other changes that were caused after the wrecking event. After the historical sources were consulted and their effects rendered into the wreck, the model was completely broken down to fit the modern photogrammetric model of the site (Figure 27). This breaking down involved cutting, splitting, and bending objects to get them to as closely match the photogrammetric model and images of the wreck of *Norman*. During the breakdown of the historical model into the wreck model, several intermediate stages of the model were saved showing the various 'snap shots' of the transformation of *Norman*.

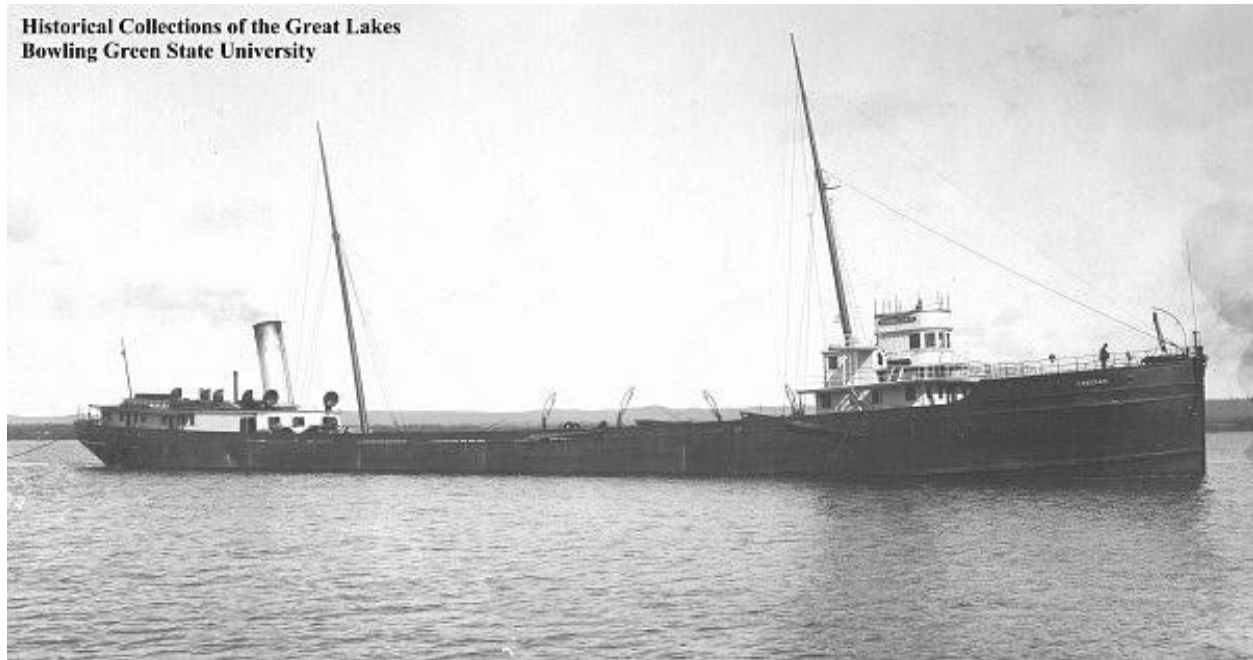
Figure 32: Image of Grecian (Circa 1900) (Courtesy of BGSU Libraries).

Grecian was the fifth bulk freighter of the Menominee Transit Company constructed by Globe Iron Works (Figure 32). Launched on 26 February 1891, *Grecian* had a length of 296.2 feet, a beam of 40.4 feet, a 21-foot depth of hold, and was registered at 2,348 gross tons, giving it a slightly greater capacity than *Norman*. Just like the *Norman*, *Grecian* was powered by a triple-expansion steam engine with 24-inch, 38-inch, and 61-inch cylinders with each having a 42-inch piston stroke (Globe Iron Works 1890; Bureau of Marine Inspection and Navigation 1891b). Per *Inland Lloyds Register* (1892:36) *Grecian* was constructed with steel, had a double-bottom hull, an iron boiler housing, and a steam pump well, like *Norman*.

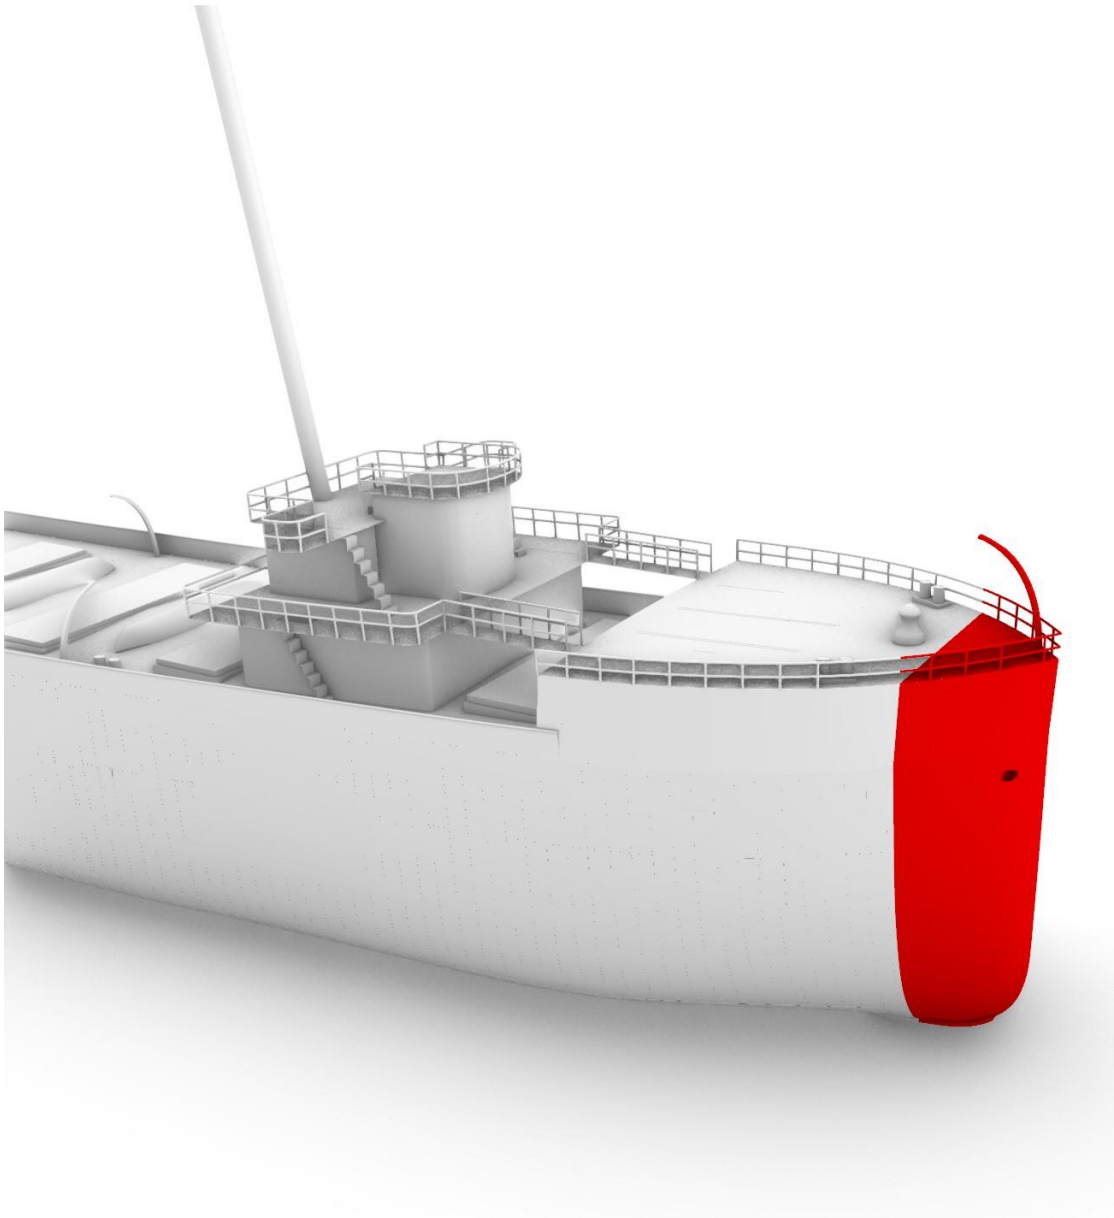
Figure 38: Model depicting damage to Norman's bow sustained as a result of the collision with Republic (Image by Caleb O'Brien).

Although *Norman* only was in service for five years, the vessel had one major cultural transformation that occurred. In 1892, *Norman* was involved in a collision with *Republic*, another Great Lakes bulk freighter. During this collision, it was reported that *Norman* was “cut down to the water’s edge ten feet back from the stem” (*Buffalo Enquirer* 1892). Although later reporting suggests that the damage was not as extensive as originally suggested, the vessel certainly took damage and was repaired (*Marine Review* 1892d). The potential extent of this damage is modeled below (Figure 38).

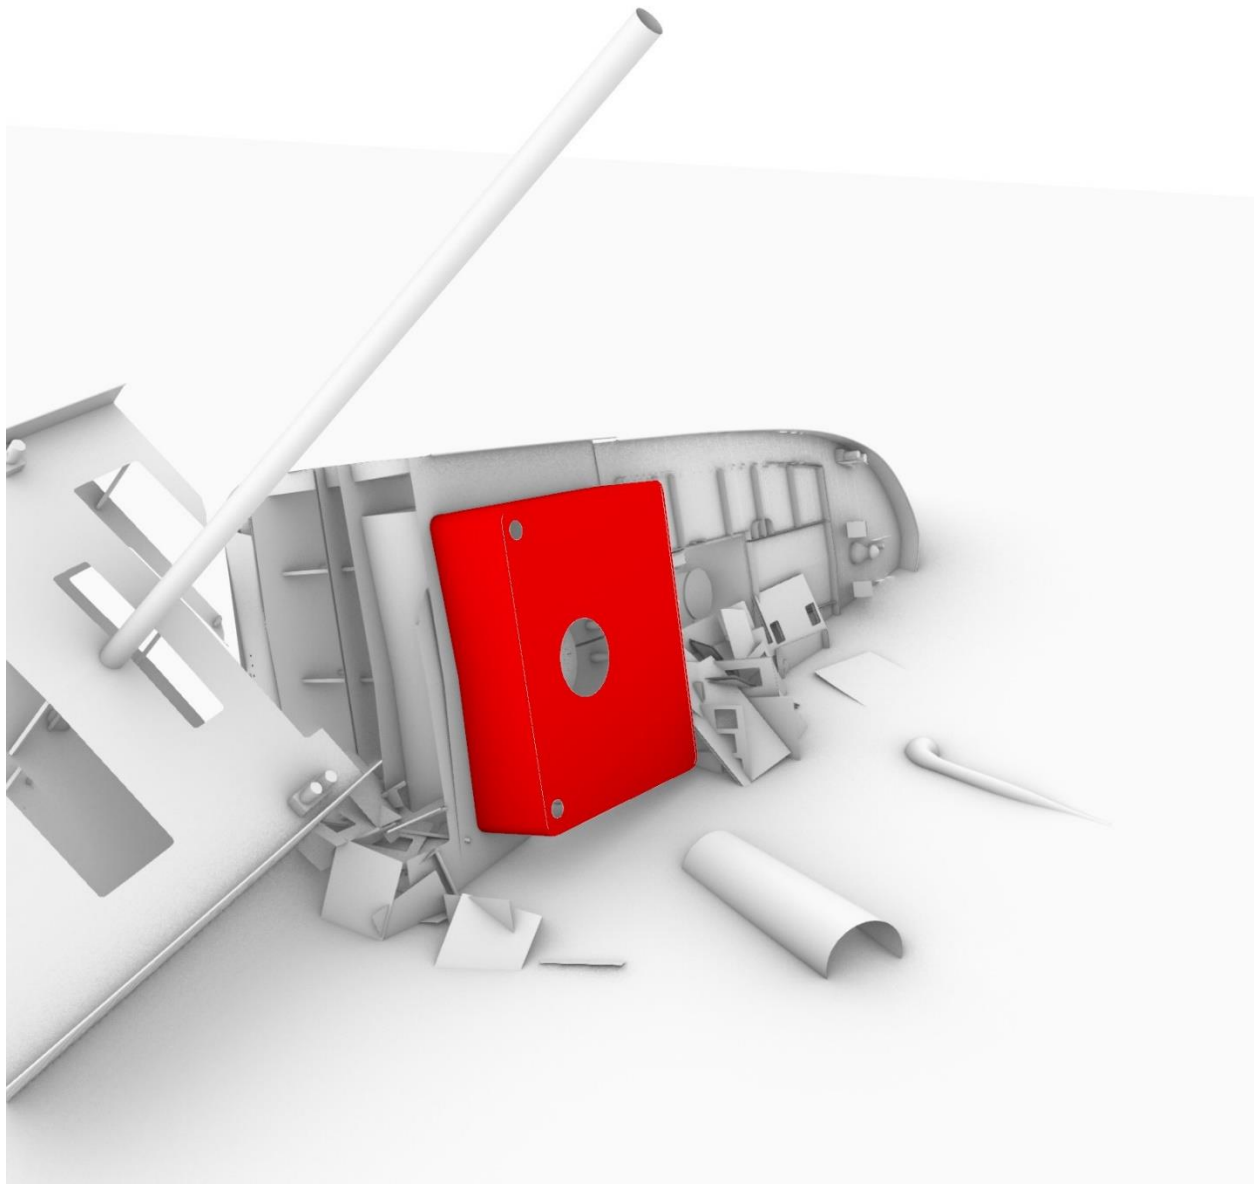
Figure 49: Present location of boiler house (Image by Caleb O'Brien).

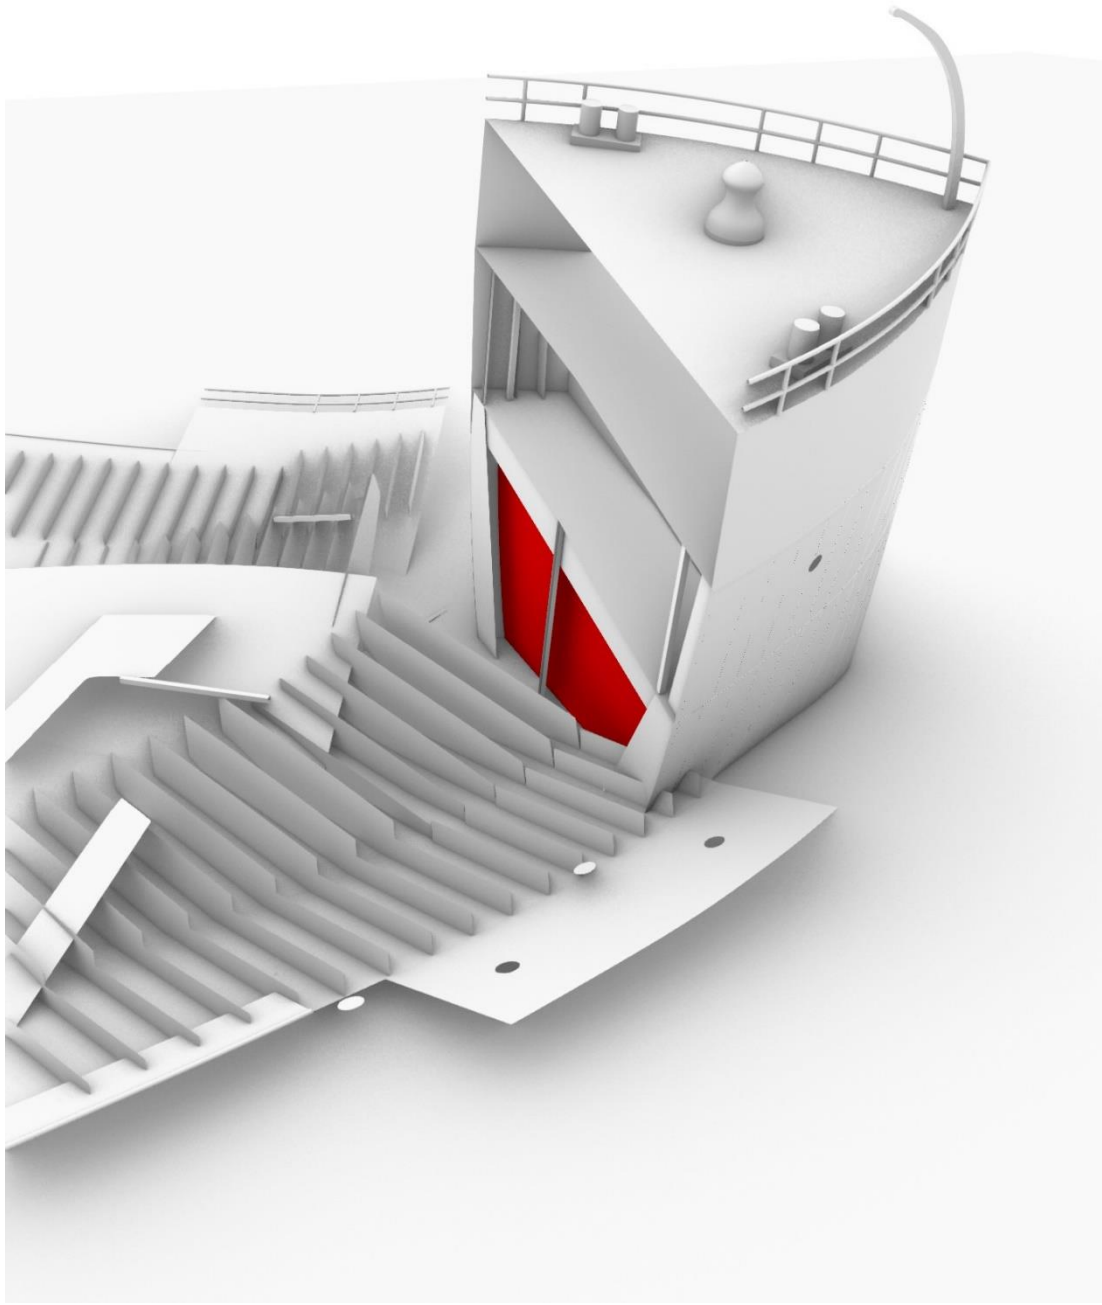
Figure 67: The collision bulkheads highlighted in red within the bow triangle (Image by Caleb O'Brien).

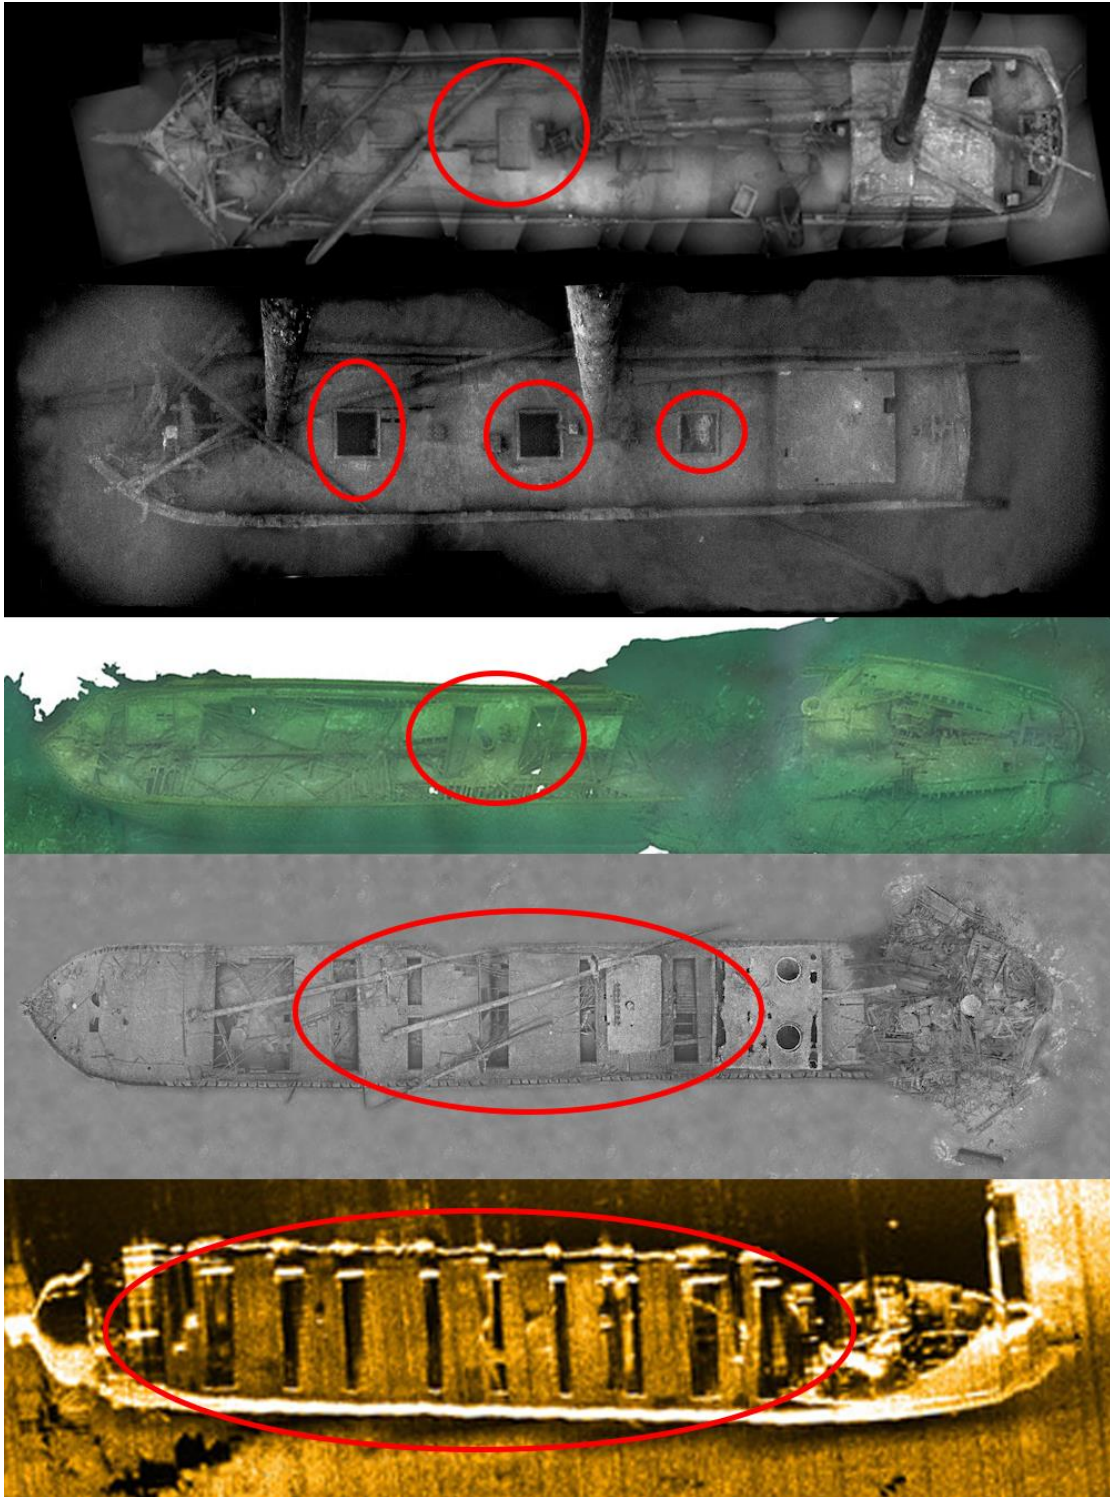
Figure 87: Missing cargo hatches seems to be the norm for intact wrecks in TBNMS (from top to bottom: Cornelia B. Windiate, Kyle Spangler, New Orleans, Florida, and W.C. Franz) (Images by TBNMS; Compiled by Caleb O'Brien).
