Nadine Kopp. *The Influence of the War of 1812 on Great Lakes Shipbuilding*. (Under the Direction of Dr. Bradley Rodgers) Department of History, January 2012.

THE INFLUENCE OF THE WAR OF 1812 ON GREAT LAKES SHIPBUILDING

A Thesis

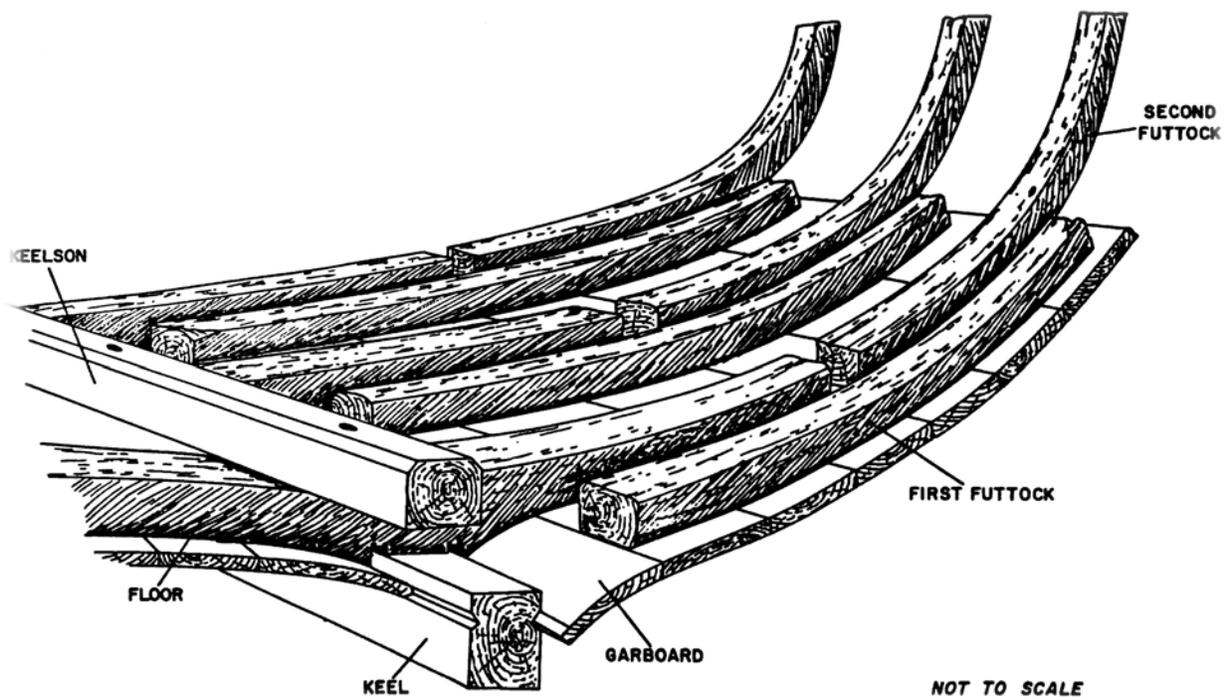
Figure 3-1: A schematic view of *Boscawen's* frame construction (Crisman 1985: 362).

The frames on *Boscawen* demonstrated the speedy construction of the sloop. The framing was composed of a total of 26 white oak floors, fastened to the keel with a single bolt, alternating with first futtocks. The spacing of the floors greatly varied, but their centers averaged 28 to 34 in. (71.1 to 86.4 cm). The floors averaged 5 to 10 in. (21.6 to 25.4 cm) sided and were molded 12 in. (30.5 cm) at the keel, decreasing to 7 in. (17.8 cm) molded at their heads. Every floor timber had two limber holes that permitted bilge water to pass under the frames to the pump well. The shipwrights that constructed *Boscawen* did not utilize a common method of frame construction during the eighteenth century whereby the floor and futtocks were fastened together to form a complete rib which was then mounted on to the keel. Instead, all the floor timbers were fastened to the keel, and the outside of the hull was planked (Figure 3-1). After several planking strakes

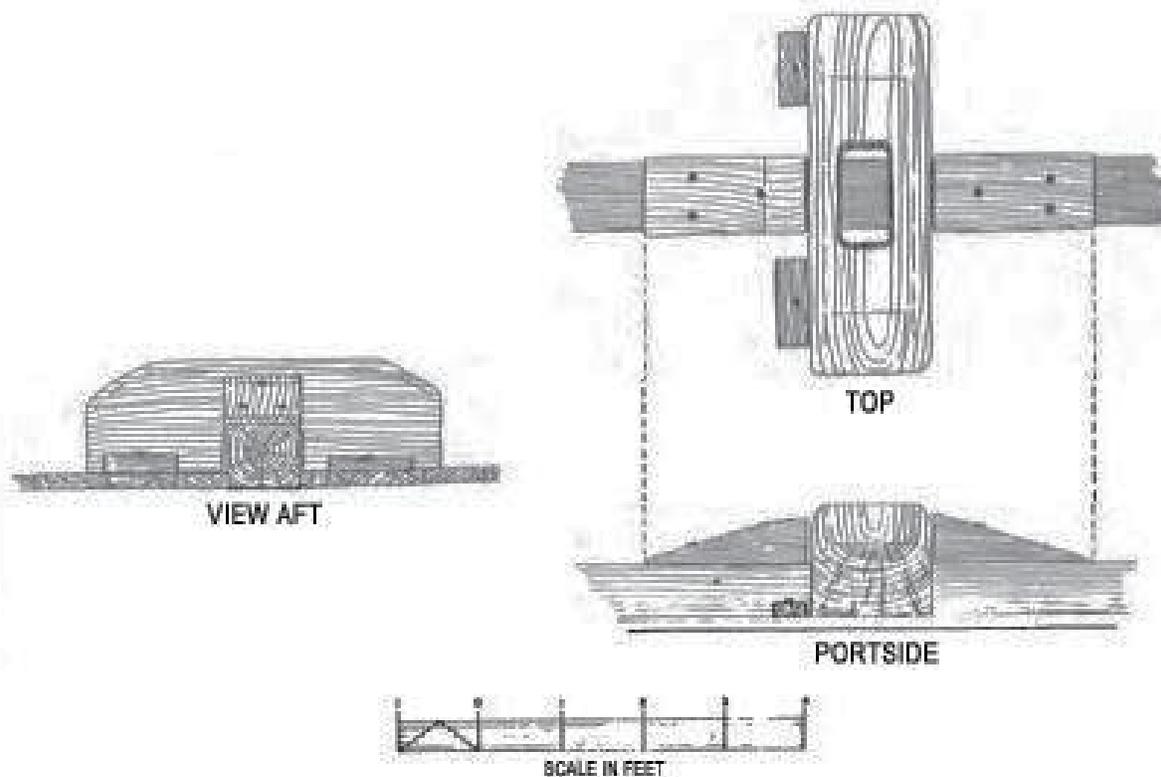
Figure 3-2: *Boscawen's* mast step (Crisman 1985: 366).

Boscawen had a single mast step on the keelson located one-third of the hull length aft of the stem (Figure 3-2). The step consisted of a large white oak block that was notched over the keelson. It measured 4 ft 3 in. (1.3 m) long, 18 in. (45.7 cm) wide, and 16 in. (40.6 cm) in height. Similar to a saddle mast step, it sat perpendicularly to the keelson and was secured in place by two wedges of wood on either side of the step, placed longitudinally along the keelson. To prevent the mast step from twisting, two chocks were attached to the ceiling forward of the step. The step's mortise, which took the heel of the mast, was 16 in. (40.6 cm) long, 8.5 in. (21.6 cm) wide, and was cut completely through the block to the keelson (Crisman 1985: 365).

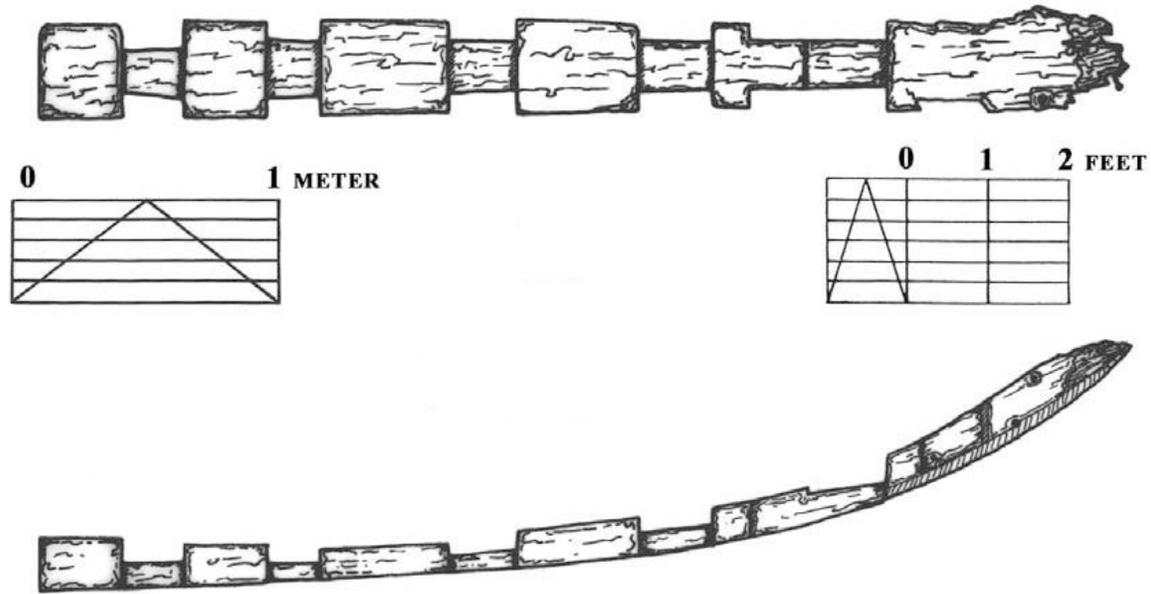
Figure 3-3: Plan and profile view of *Nancy's* apron (Sabick 2004: 91).

The stem assembly consisted of the stempost, apron, and gripe. The stempost was made from a single compass timber that measured 23.5 in. (59.7 cm) molded at its maximum and 7.25 in. (18.4 cm) sided. The stem of the vessel was hook scarfed to fit the keel and strengthened with two pairs of iron fishplates that were fastened through the sides of the keel-stem assembly. A 1 in. (2.5 cm) diameter stopwater was located at the after end of the scarf. On the starboard surface of the stempost, the Roman numerals IV and V are faintly visible. These were the draught marks that informed the crew how much water the vessel was drawing. The apron, keelson, and gripe were fastened to the stempost with iron bolts (Sabick 2004: 87). The apron measured 13 ft. (3.9 m) in length, 7 in. (17.8 cm) molded, and 15 in. (38.1 cm) sided and was cut from a single compass timber (Figure 3-3). It was notched on its sides and top to receive five floors, and on its upper end for cant frames (Sabick 2004: 91).

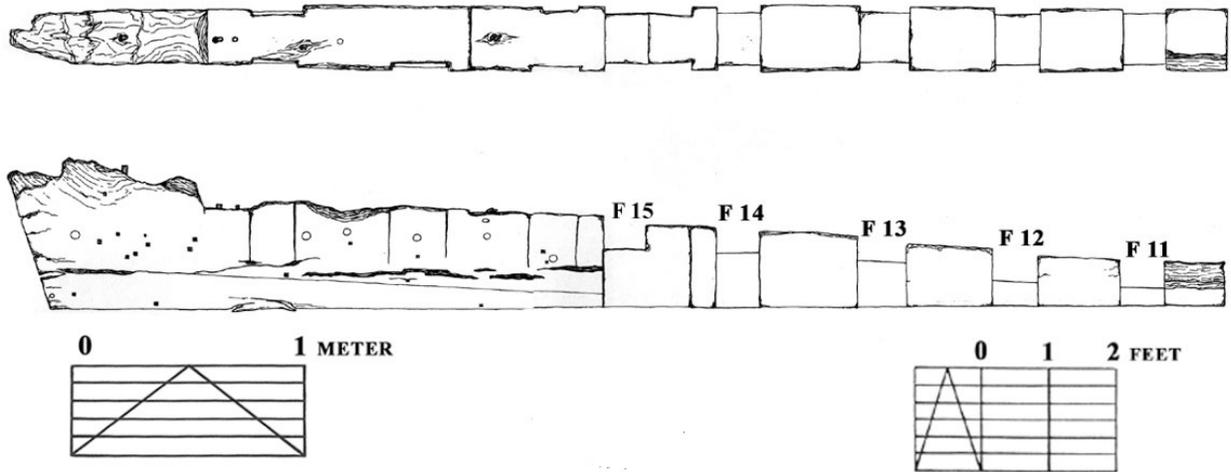
Figure 3-4: Plan and profile view of *Nancy's* stern deadwood (Sabick 2004: 90).

The sternpost and inner sternpost did not survive, but mortises in the keel indicate their positions. They were fastened with a pair of iron fishplates. The inner sternpost would have measured approximately 4 in. (10.1 cm) molded by 8 in (20.3 cm) sided. The main sternpost would have been approximately 12 in. (30.5 cm) molded and 8 in. (20.3 cm) sided, to match the dimensions of the keel. It is impossible to estimate the height of these timbers. A single deadwood timber buttressed the stern assembly (Figure 3-4). The timber was bolted to the top of the keel and notched to seat eight of the aftermost floors. It extended along the keel for 17 ft. 9 5/8 in. (5.4 m) ending 16 in. (40.6 cm) from the after end of the keel. Partway through the length of the timber, it was trapezoidal in section to form the rabbet for the garboard strake (Sabick 2004: 89-90).

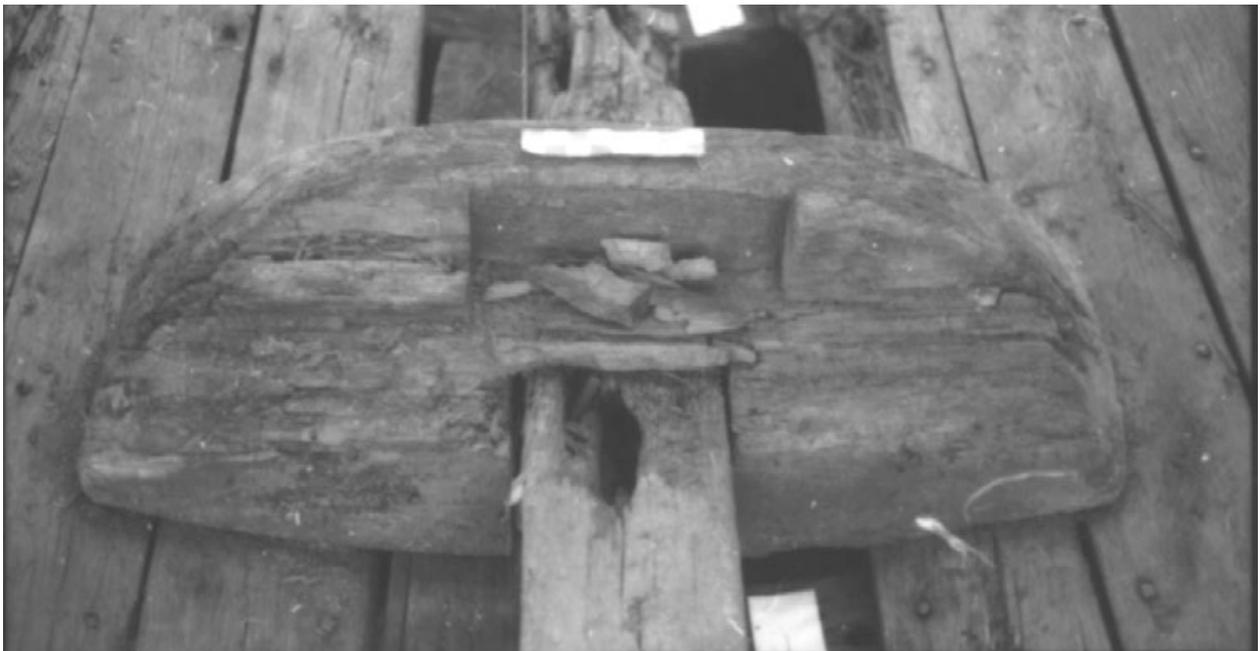
Figure 3-5: Image of *Nancy*'s mainmast step (Sabick 2004: 103).

Nancy had two mast steps. The foremast step was a simple mortise cut directly into the keelson. As this area was heavily damaged and eroded, it was impossible to determine its dimensions. The mainmast step consisted of a large, semicircular saddle mast step type that was placed perpendicular to the centerline and notched to fit over the keelson just forward of the pump well (Figure 3-5). The mortise to take the squared off heel of the mast was cut into the top of the step and measured 13 in. (33 cm) wide by 5 in. (12.7 cm) long by 4.75 in. (12.1 cm) deep and did not pass completely through the timber. The main mast step was not secured in place, which may indicate that it was not in its original location (Sabick 2004: 102).

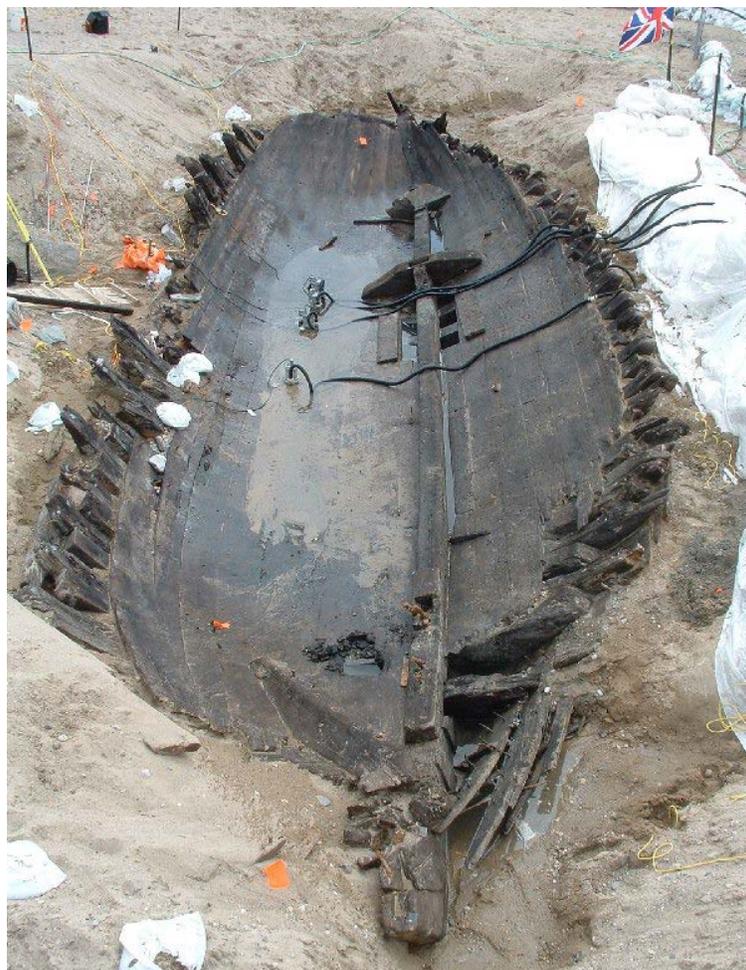
Figure 3-6: The exposed hull of *General Hunter* on Southampton Beach (From <http://www.chantryisland.com/Summary%20Weazel%20March%202nd,%202004.htm> Accessed September 2008).

The remains of *General Hunter* consist of the full length of the keel, preserved to a total length of 53 ft. 10 in. (16.41 m) (Figure 3-6). The starboard side is preserved to the turn of the bilge in some sections, while the port side is not as well preserved. At the midship frame, the width is 16 ft. 10 in. (5.14 m). The exterior of the vessel was not excavated except near the stern. The keel was molded 15 in. (38.1 cm) and sided 10 in. (25.4 cm). The keel was not notched for the frames (Cassavoy 2005: 27).

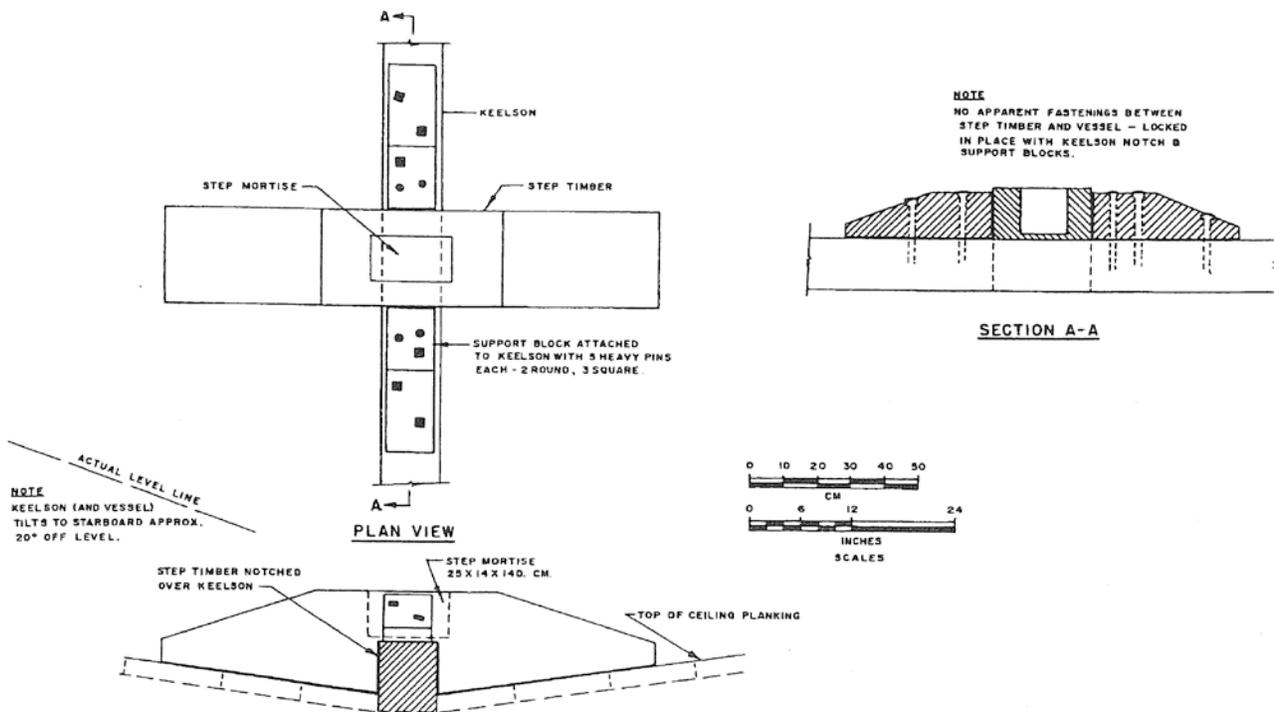
Figure 3-7: Saddle-type mainmast step of *General Hunter* that is held in place with two blocks (Cassavoy 2005: 30).

Two mast steps were located along the keelson of the vessel. The foremast consisted of a simple mortise cut into the keelson, which showed evidence of breakage and erosion. The main mast consisted of a saddle type mast step that was notched over the keelson and held in place with two large blocks (Figure 3-7). The two blocks were spiked into place with two round, and three square spikes. The step itself was not fastened to the keelson, which would have allowed for easy repositioning of the step for location or angle of the mast (Cassavoy 2005: 29-30).

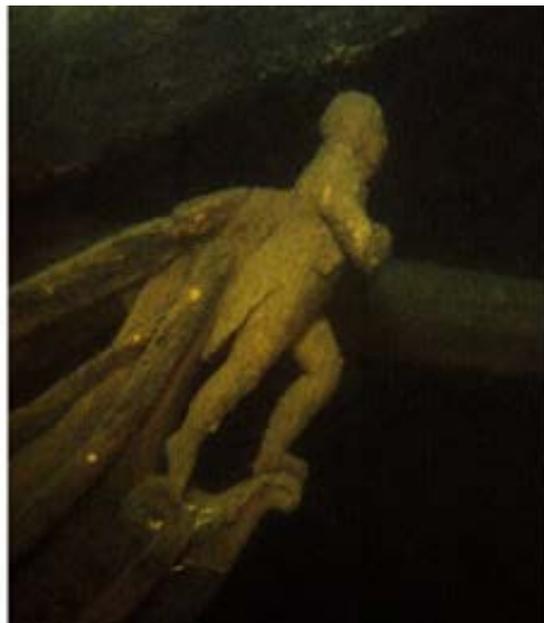
Both vessels demonstrated elaborate figureheads that embellished their bows. *Scourge* (originally *Lord Nelson*) displayed the striding figure Admiral Horatio Nelson on the prow of the vessel (Figure 3-8). Nelson died at the Battle of Trafalgar in 1805 and was the most celebrated contemporary naval hero. Although it was a well-known fact that Nelson lost his right arm in 1797, the figurehead was depicted with both arms. The striding pose of the figurehead is common in the 19th century (Cain 1983: 55). The figurehead of *Hamilton* (originally *Diana*) represented the classical goddess of the hunt and motherhood, Diana. On her left side, the goddess is portrayed with only her quiver and its strap, while she is portrayed in Empire dress on the right. Her hairstyle is suggestive of an ancient warrior's helmet. Partially-clad goddess figureheads were common throughout the 19th century, though typically in classical rather than contemporary dress (Cain 1983: 40).

Figure 3-8: Figure of Lord Horatio Nelson on the prow of the *Scourge* (originally *Lord Nelson*) (Cain 1983: 55).

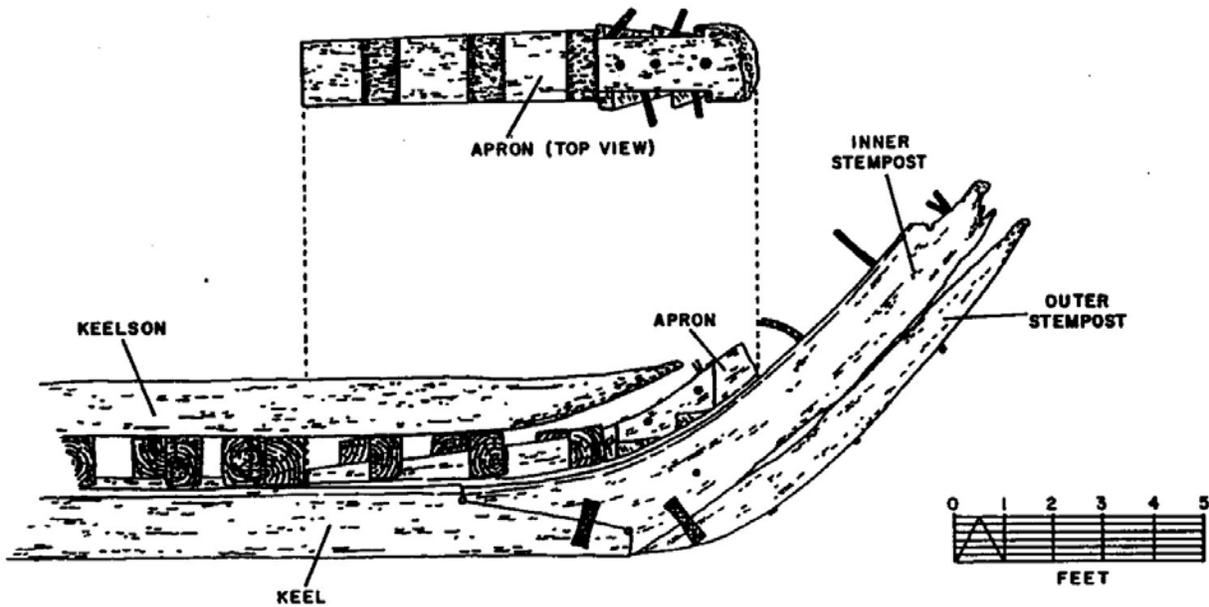
Figure 4-2: The stem of *Eagle* (Crisman 1987: 138).

maximum molded dimension of 12 in. (30.4 cm) and was sided 6 in. (15.2 cm) on the forward face and 8 in. (20.3 cm) on the after face (Crisman 1987: 138-139).

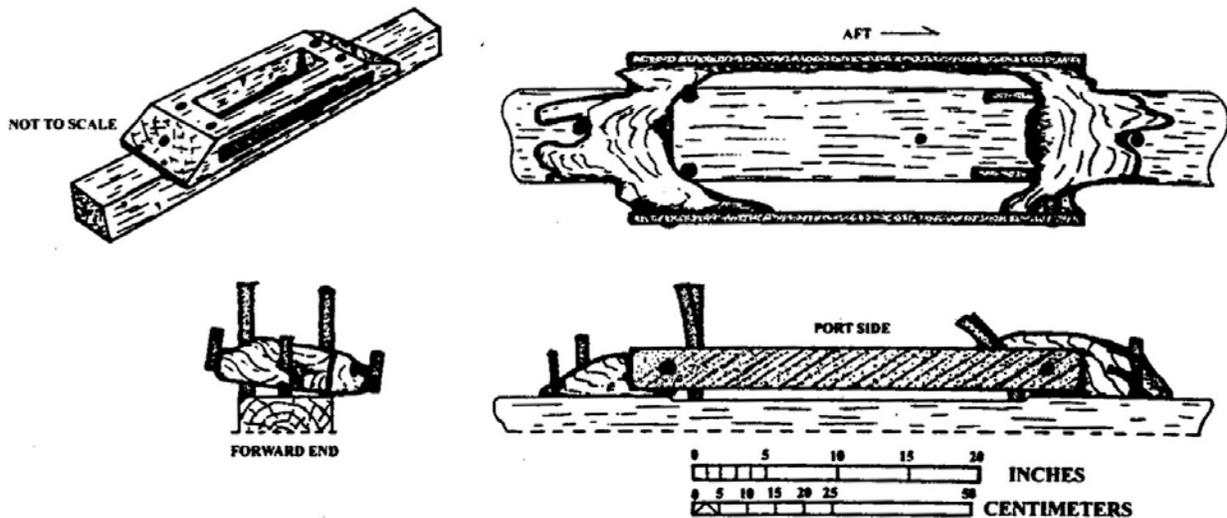
Figure 4-3: The mainmast step of *Linnet* with a reconstructed view in the upper left (Washburn 1998: 154).

The main mast step was a 3 ft. 8 ½ in. (1.13 m) long by 1 ft. (30.5 cm) wide block of oak that was located a third of the vessel's length forward of the stern (Figure 4-3). It was secured to the keelson with six 7/8 in. diameter (2.2 cm) iron bolts and four spikes. A rectangular mortise was cut into this block to receive the mast and was reinforced with an iron bar on each side that were fastened to the step with two bolts per side (Washburn 1998: 65). There was no discussion of the foremast step.

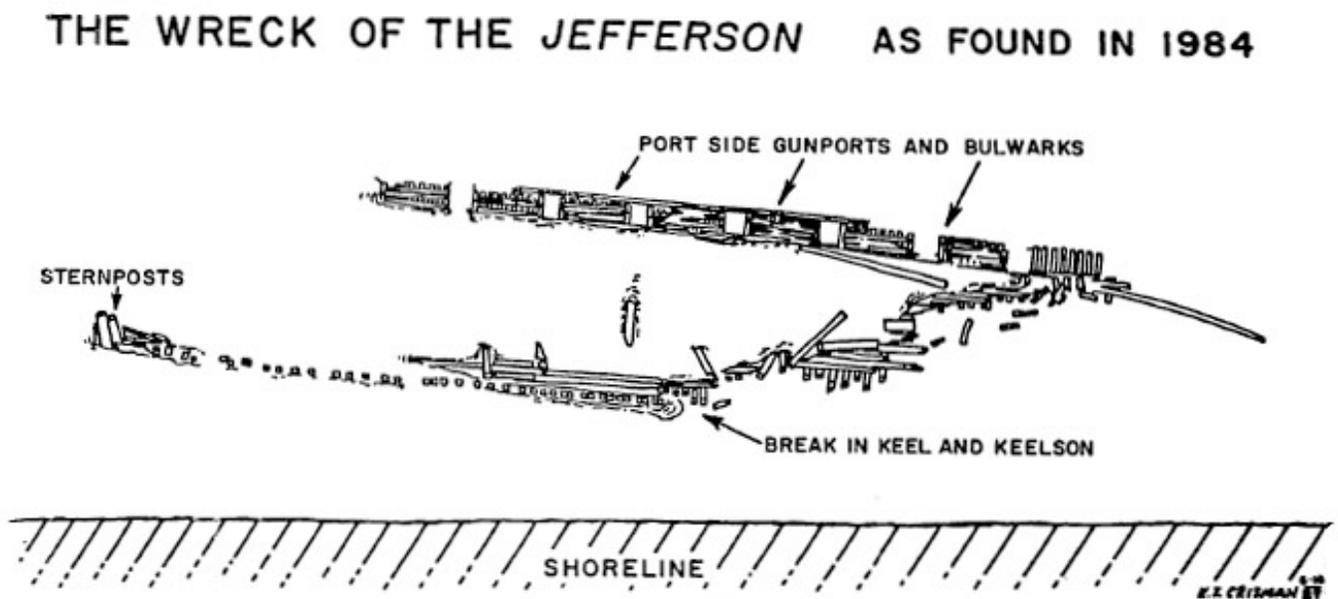
Figure 4-4: The 1984 site plan of *Jefferson* (Crisman 1989: 197).

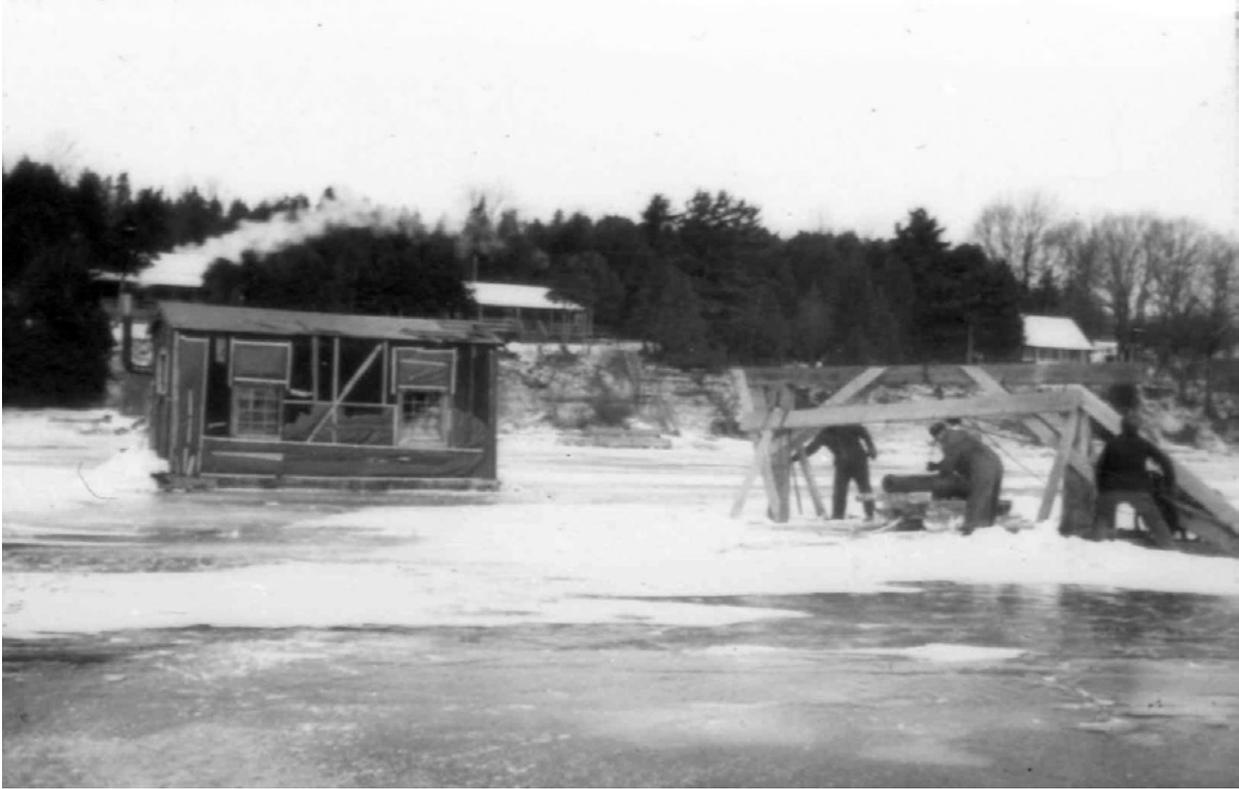
It was not until 1938 that the two wrecks in Deadman Bay were first investigated. Ronald Way, the Director of Fort Henry, built a platform over the wrecks in February of that year to enable a hard-hat diver to recover artifacts from the wrecks (Figure 4-5). In 1952, Dr. Richard Preston of the Royal Military College (RMC) wrote a paper on the vessels in Deadman Bay based on several dives by a RMC diver. At that time, the wrecks were so well preserved that the diver could enter below the lower deck of the *Prince Regent*. In 1987-1988, Preserve Our Wrecks, an organization dedicated to the preservation of the shipwrecks in the Kingston area, revisited the site and surveyed the wrecks. Between 1995 and 1998, a photographic survey of the wrecks was conducted by Jonathan Moore with stimulus from the introduction of zebra and quagga mussels to the Great Lakes (Moore 1998). By 2000-2001, Jonathan Moore had integrated historical research with data collected from further survey of the wrecks conducted by himself and Daniel Walker a Texas A&M graduate student, along with detailed measurements of the mast steps removed from *Princess Charlotte* by Ronald Way, now held by Fort Henry National Historic Site and the Marine Museum of the Great Lakes at Kingston, in order to establish the identities of the wrecks (Moore 2006).

Figure 4-5: Photograph of the 1938 salvage operations, hoisting a gun from *Princess Charlotte* through the ice (Fort Henry Museum, Kingston, Ontario).

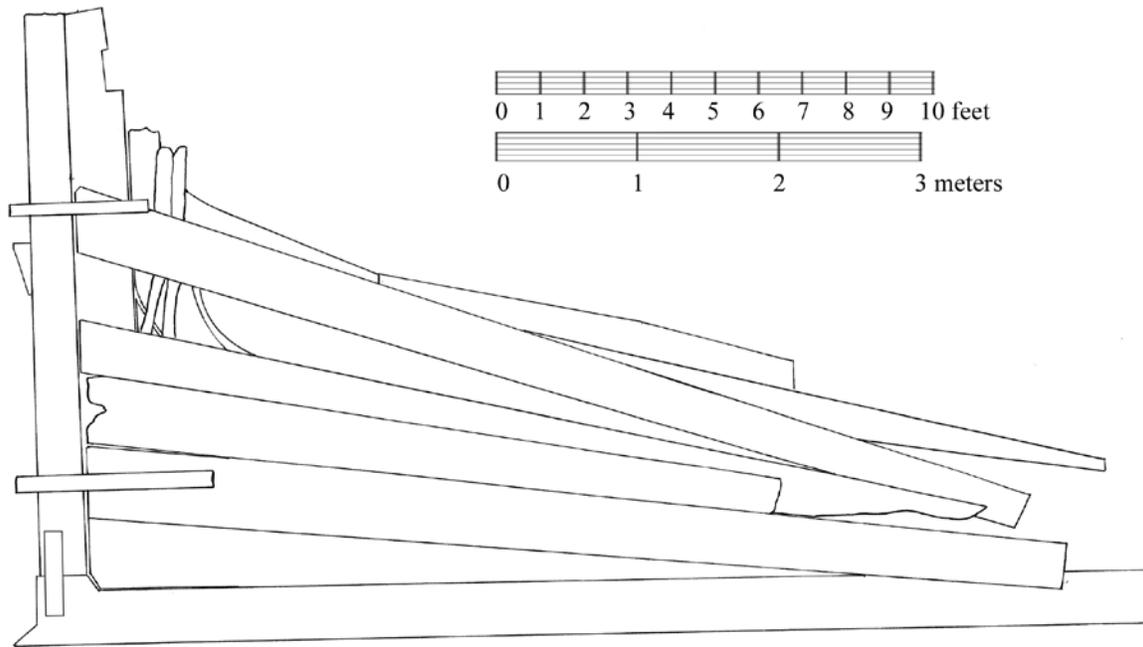
Figure 4-6: The stern assembly of *Princess Charlotte*, which is mostly obscured by the exterior planking (Walker 2006: 61).

Most of the stern deadwood construction was obscured from view by the exterior planking (Figure 4-6). The white oak stern post measured 13 1/8 in. (36 cm) molded, 12 in.(30 cm) sided, and rose 13 ft. 9 in. (4.2 m) from the keel. The inner sternpost was molded 15 in. (38 cm) and sided 12 in. (30 cm). It was notched at a height of 12 ft. 2 in. (3.7 m) for the first transom that was held in place with a 1 in. (2.5 cm) bolt. A deadwood knee rose to a height of 11 ft. 2 in. (3.4 m) on the inner sternpost and abutted the keelson on its forward edge. Two wrought iron gudgeons are intact on the sternpost at a height of 3 ft. 9 in (1.14 m) and 10 ft. 6 in. (3.2 m) from the base of the keel. Both gudgeons are 8 in. wide, though the straps of the lower one extended 5 ft. (1.52 m), while that of the upper one extended only 3 ft. 6 in. (1.07 m). A triangular pintle stop was located 7 in. (17.8 cm) beneath the upper gudgeon. The rudder is no longer present (Walker 2006: 61-62).

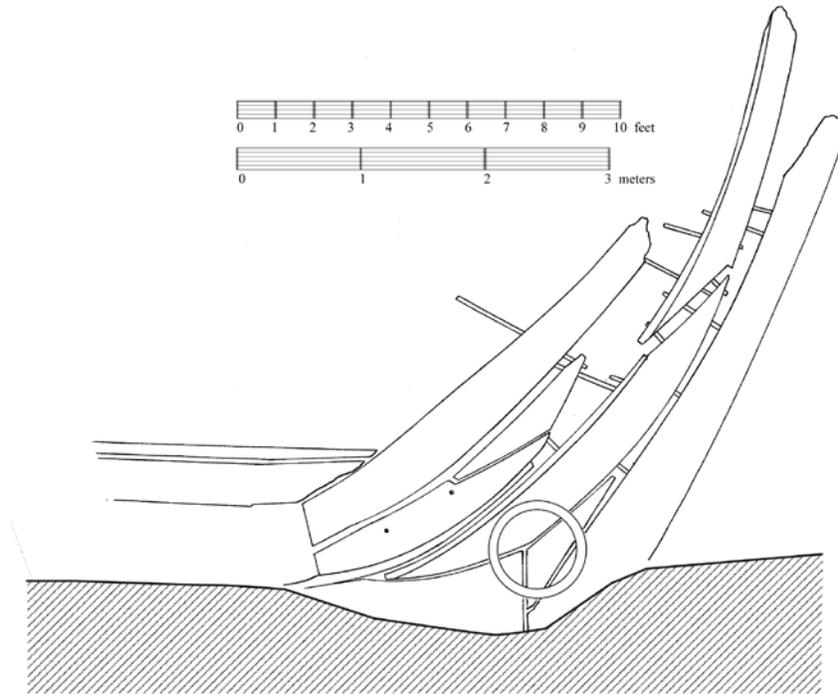
Figure 4-7: The bow assembly of *Princess Charlotte* (Walker 2006: 60).

The stem was assembled from eight large white oak timbers that were fastened with 1 in. (2.5 cm) diameter iron bolts (Figure 4-7). The gripe, stem post, knee of the head, and a wedge were fastened with a pair of circular iron bands bolted from opposite sides of the gripe. This band served a similar purpose to a horseshoe plate. Two apron timbers and a large stemson timber were present on the inner portion of the stem. Cant frames were fastened directly to the apron using 1 in. (2.5 cm) bolts. Compass timbers were not used in this assembly, but straight timbers that were shaped and joined. The two inner stemposts were rabbeted for the ends of the planking (Walker 2006: 59-60).

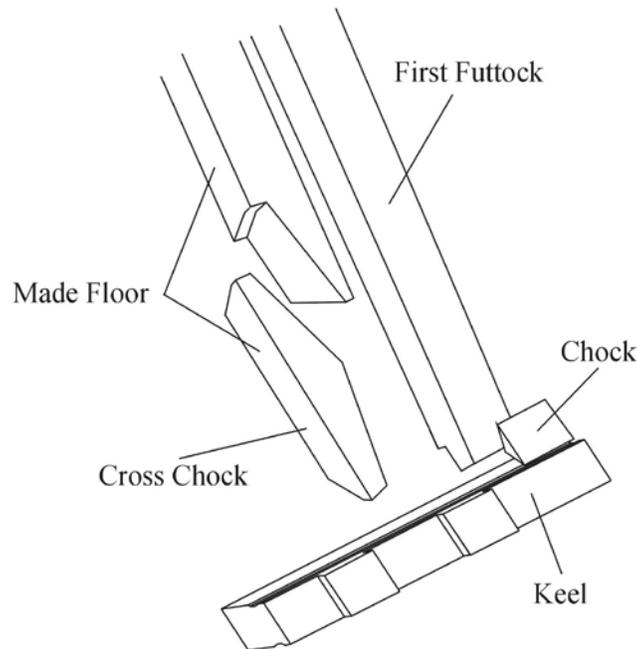
Figure 4-8: The frame assembly method on *Princess Charlotte* (Walker 2006: 66).

floors. The first futtocks were always located on the same side as the chocks, meaning that at midships, there is a single first futtocks between two floors. On the port side, the vessel is preserved to the third futtock. Frames were connected with simple butt joints except for the head of the first futtock and the heel of the third futtock that were reinforced with a chock. The system of cross chocks and frames that was used allowed for greater deadrise (Walker 2006: 63, 67).

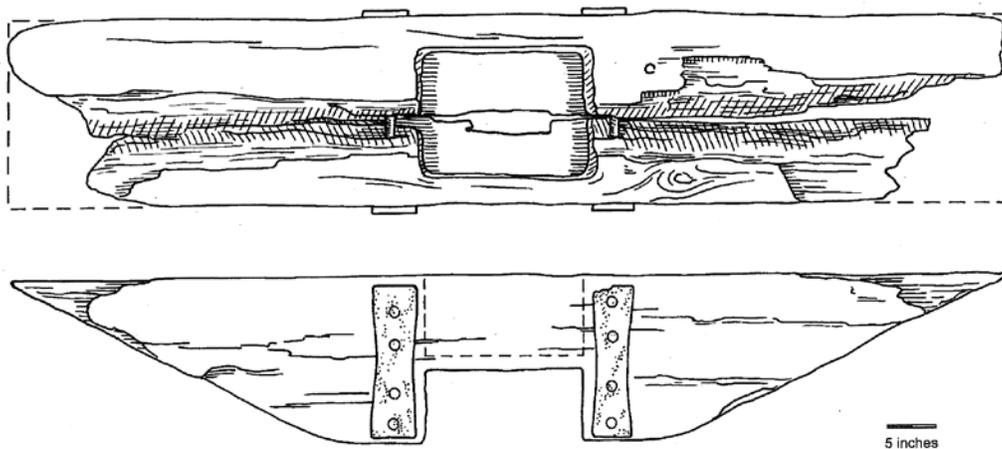
Figure 4-9: Plan and profile views of the mainmast steps salvaged from *Princess Charlotte* in 1938 (Moore 2006: 68).

The mainmast and foremast steps were removed from the wreck in 1938 by Ronald Way's salvage team. Both were saddle type mast steps that were notched to fit over the keelson and the outboard edge was angled to accommodate for the lateral shape of the ship (Figure 4-9). The mast steps were made from one solid piece of wood that measured 12 in. (30 cm) square with four fish plates with four 1 in. (2.5 cm) diameter bolts between each pair and four vertical bolts. The mast steps were fastened in place with four vertical bolts to the frames (Walker 2006: 73; Jonathan Moore pers. comm.).

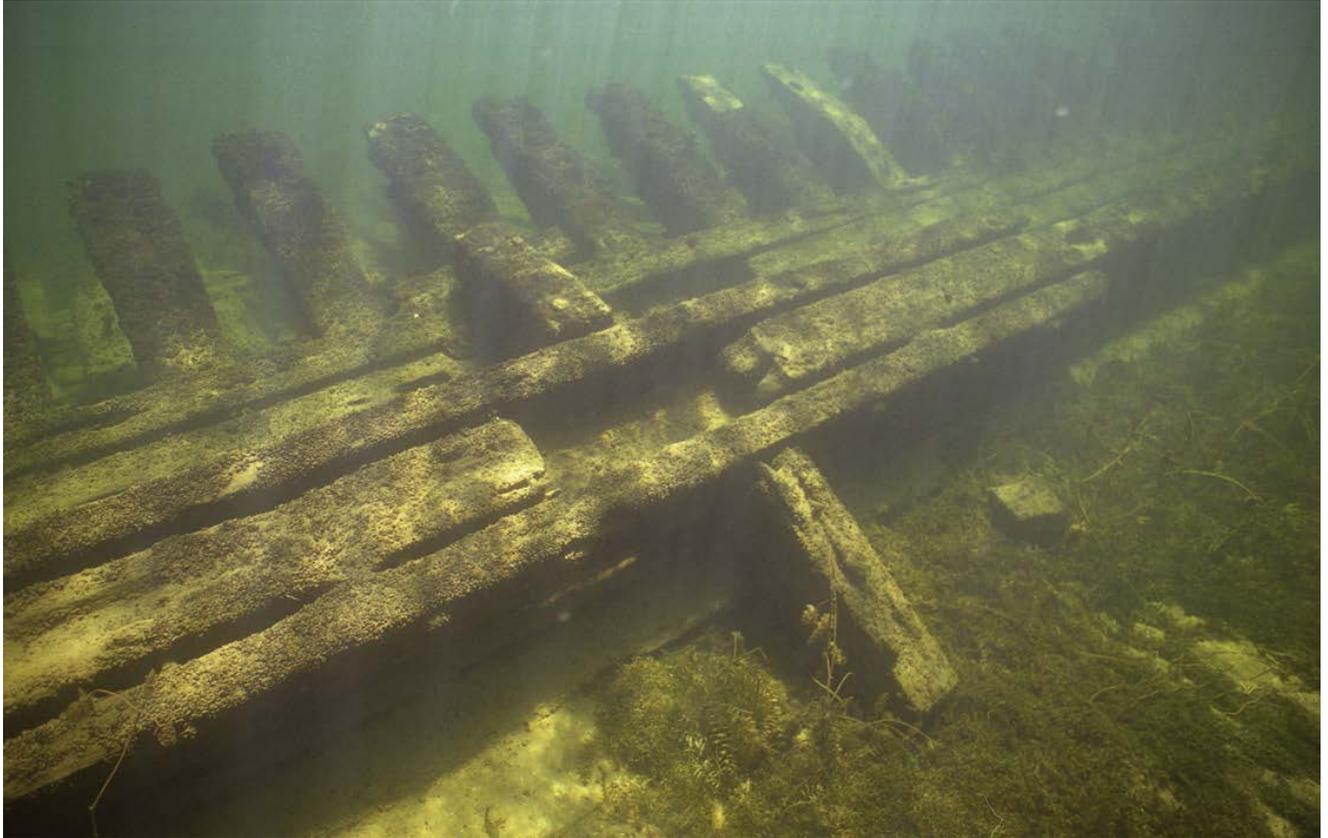
Figure 4-10: The unusual mast step assembly of HMS *Prince Regent* constructed of a break in the rider keelson with fore and aft timbers on either side (Photo courtesy Jonathan Moore, Parks Canada).

Three masts steps were located along the keelson that were all made in an unusual method. They were not made as saddle type mast steps, with timbers that fit over the keelson, but rather from the timbers of the keelson and rider keelson. Each step is delineated by a fore-aft break in the rider keelson with a fore-aft timber on either side bolted to the molded sides of the keelson and rider keelson (Figure 4-10). Large bolsters on either side of the step provided additional support. All three mast steps are 11 in. (27.9 cm) wide, or the width of the keelson. Aft of the main mast step is a small, rectangular step located in the rider keelson that likely served as a step for a deck beam, bulkhead stanchion, or the capstan. The ceiling planking near the main mast step is similarly mortised for stanchions for the shot locker or other bulkheads. Two bulkheads are located in these positions on the original lines plan of *Prince Regent* (Moore 2006: 50).

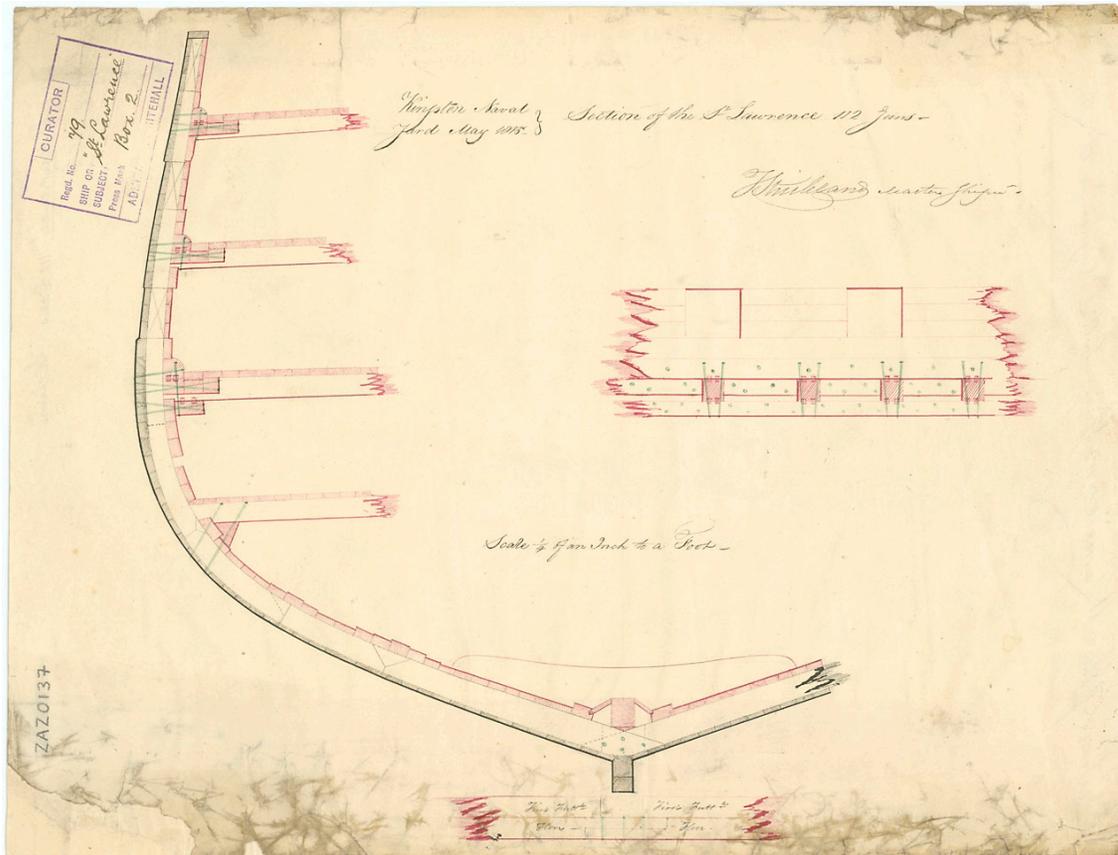
Figure 4-11: Cross section draft of HMS *St. Lawrence* shows the ‘kneeless’ system used in construction (National Maritime Museum, Greenwich, London, Regd No. 79).

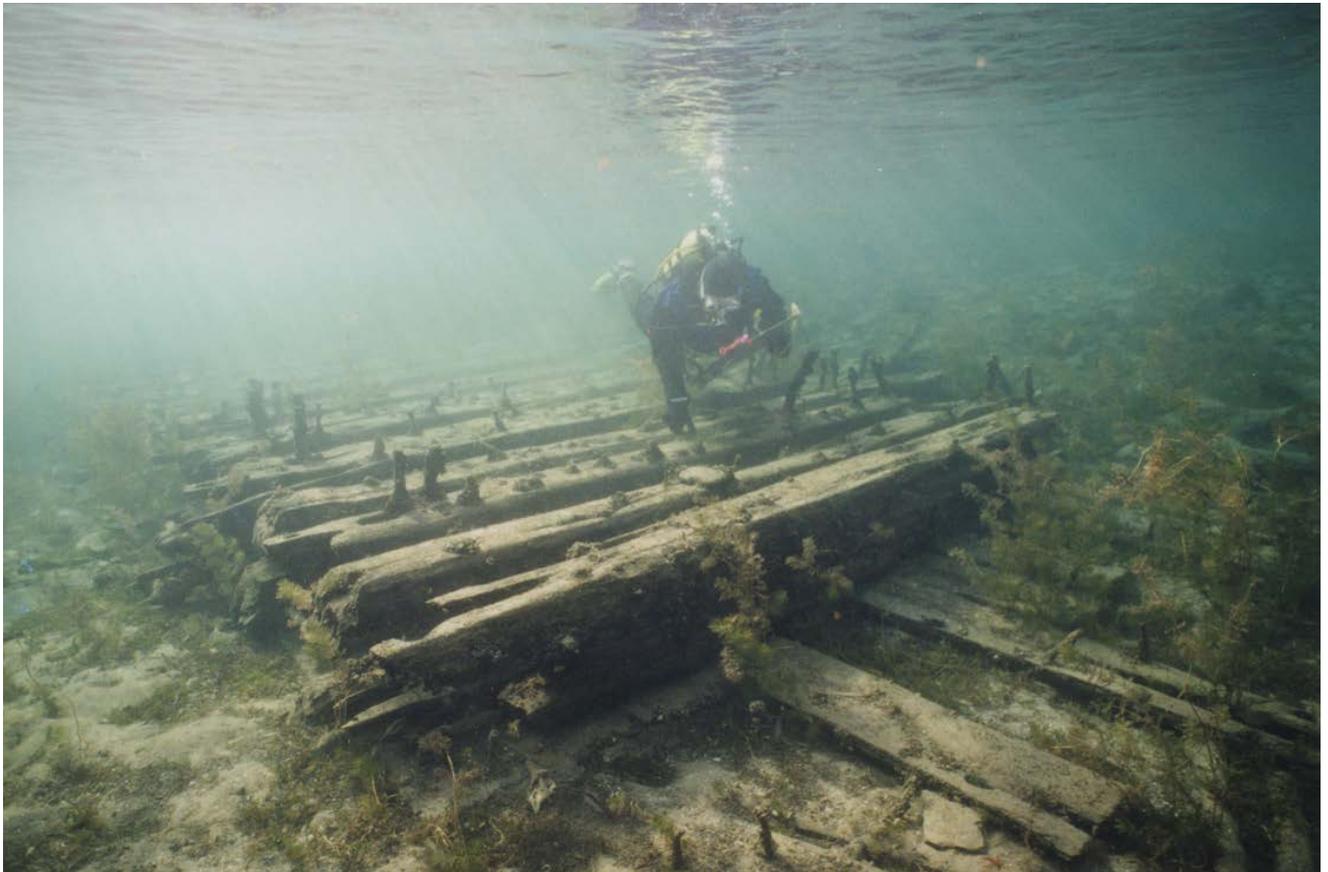
Figure 4-12: The remains of one side of the lower framing of HMS *St. Lawrence* (Photo courtesy of Jonathan Moore, Parks Canada).

frames include half-floors, first futtocks, and second futtocks. The recesses for chocks are visible at the terminal ends of some frames. The half-floor heels were attached to each other with a lap scarf and secured with four bolts with roves arranged in a diagonal pattern. The half-floor and futtocks are fastened with bolts with square shanks that were 1 ¼ in. (3.2 cm) thick. The first futtock heels would not have extended all the way to the keel, but would have terminated at the garboard strake. There is no evidence of limber holes within the half-floors or first futtocks. The frame spacing on the vessel measured 12 in. (30.5 cm) (Moore 2006: 70).

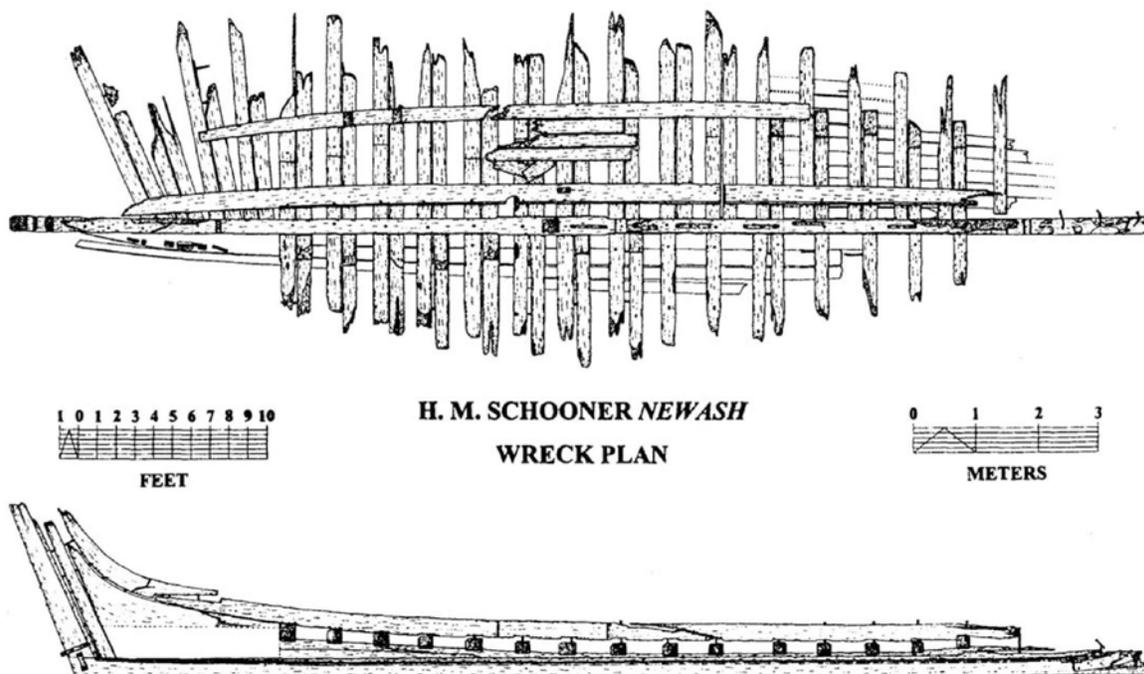
Figure 5-1: Plan of *Newwash* remains (Gordon 2009: 96).

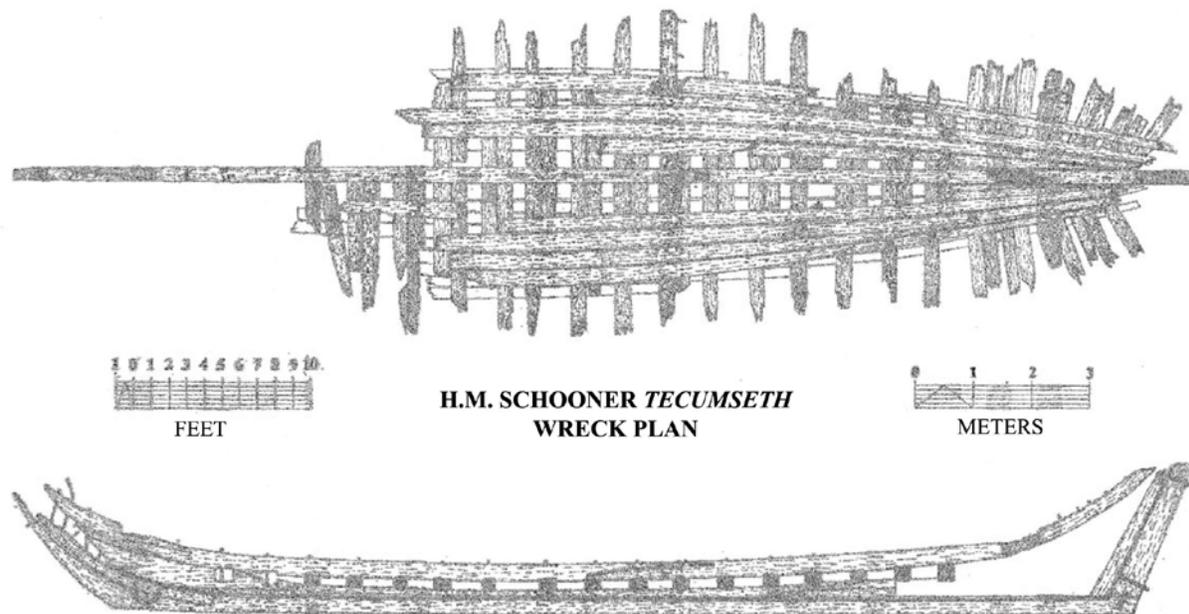
Figure 5-2: Plan of *Tecumseth* remains (Gordon 2009: 97).

be taken near the bow. It was sided 8-10 in. (20.3 to 25.4 cm) and molded 13 ¾ to 16 ½ in. (34.9 to 41.9 cm). No false keel was observed near the bow; however, two grooves along the bottom of the keel may demonstrate its existence and several iron bolts extended below the keel, which may have been used to attach the false keel (Gordon 2009: 101-102).

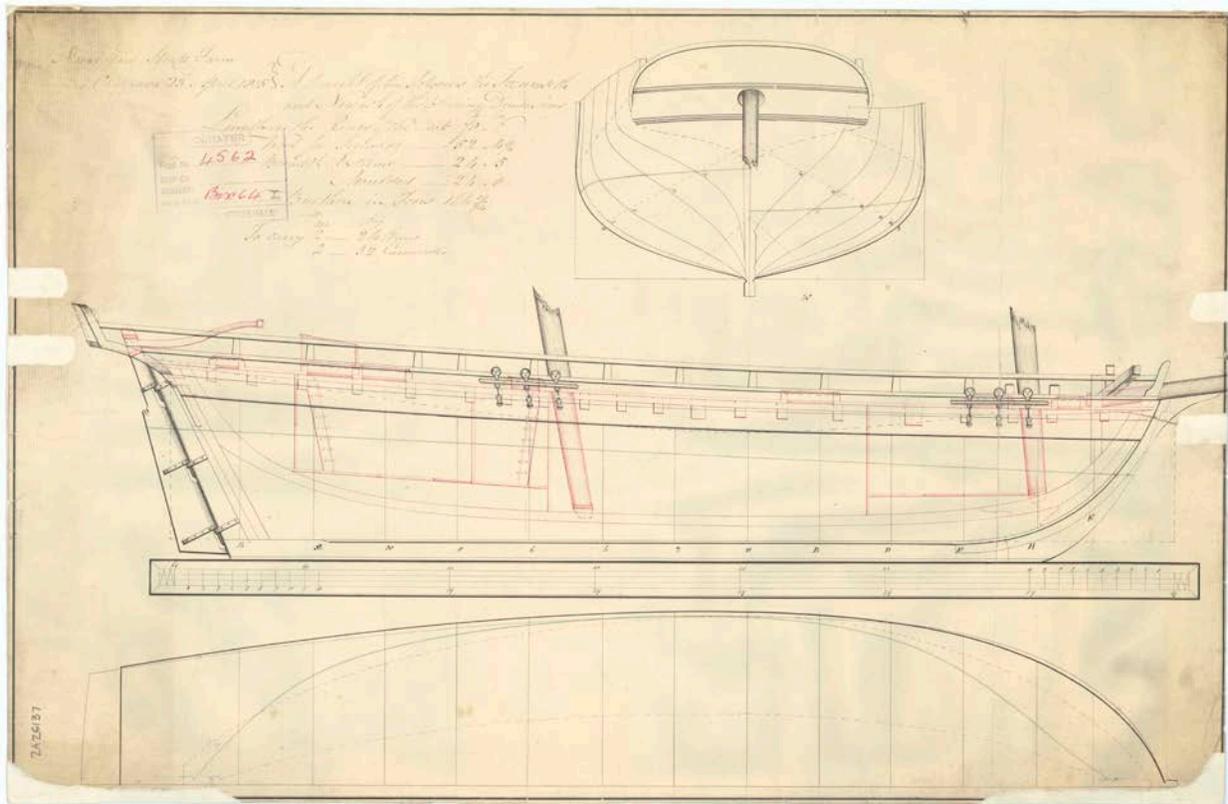
Figure 5-3: Admiralty lines plan of *Tecumseth* and *Newash* showing the foremast stepped far forward in the lower portion of the stemson (National Maritime Museum, Greenwich, London ZAZ6137).

Evidence of the forward mast steps could not be found on either of the wrecks; however bolts remained on *Tecumseth* that indicated its location far forward in the bow (Gordon 2009: 112). Since *Newash* was re-rigged as a brigantine and the foremast moved, the original location would have been equivalent to that of *Tecumseth*. The original drafts of the *Tecumseth* and *Newash* show the foremast stepped so far forward as to be in the lower portion of the stemson (National Maritime Museum 1815) (Figure 5-3). The extreme location forward of the foremast was presumably to compensate for the steeper rake of the schooner's masts.

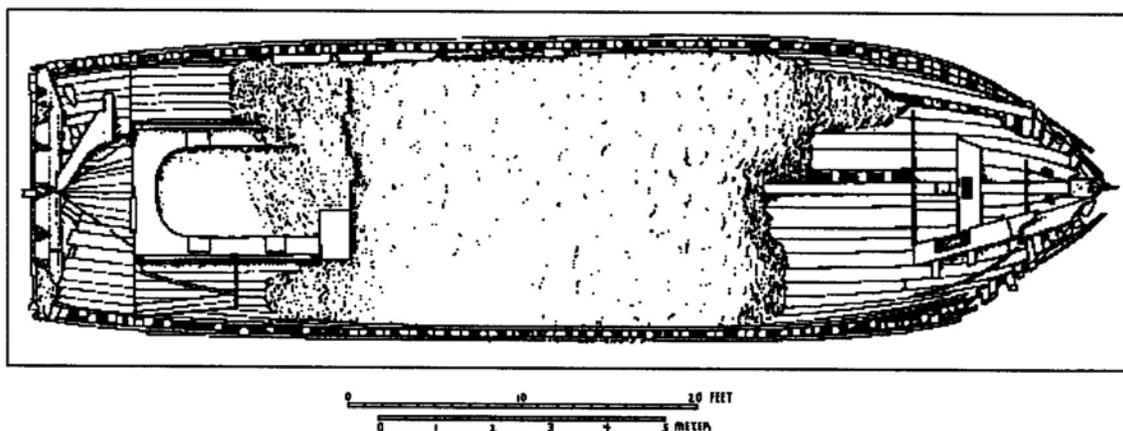
Figure 5-4: Plan of the Millecoquins wreck after the 1991 excavations (Whitesides 2003: 24).

The Millecoquins wreck was discovered in the spring of 1990 by two residents of Naubinway, Michigan in the Millecoquins River, approximately 1.5 miles from Naubinway. The Millecoquins River is located on Michigan's Upper Peninsula and flows into Lake Michigan approximately 50 miles west of the Straits of Mackinac. The wreck lies on the west bank of the river approximately 328 ft. (100 m) inland from the present Lake Michigan shoreline and is oriented generally east-west. The wreck is well preserved, as it remained intact below the sheer as well as the interior arrangement. Furthermore, still present are large portions of the ship's cargo, equipment, and crew's personal items. Three seasons of investigations were carried out on the Millecoquins wreck: a preliminary survey by John Halsey and Patrick Labadie in 1990, and two seasons of excavations conducted by East Carolina University in 1991 (Figure 5-4) and 1994 (Whitesides 2003: 18-19).
