Nadine Kopp. *The Influence of the War of 1812 on Great Lakes Shipbuilding*. (Under the Direction of Dr. Bradley Rodgers) Department of History, January 2012.

THE INFLUENCE OF THE WAR OF 1812 ON GREAT LAKES SHIPBUILDING

A Thesis

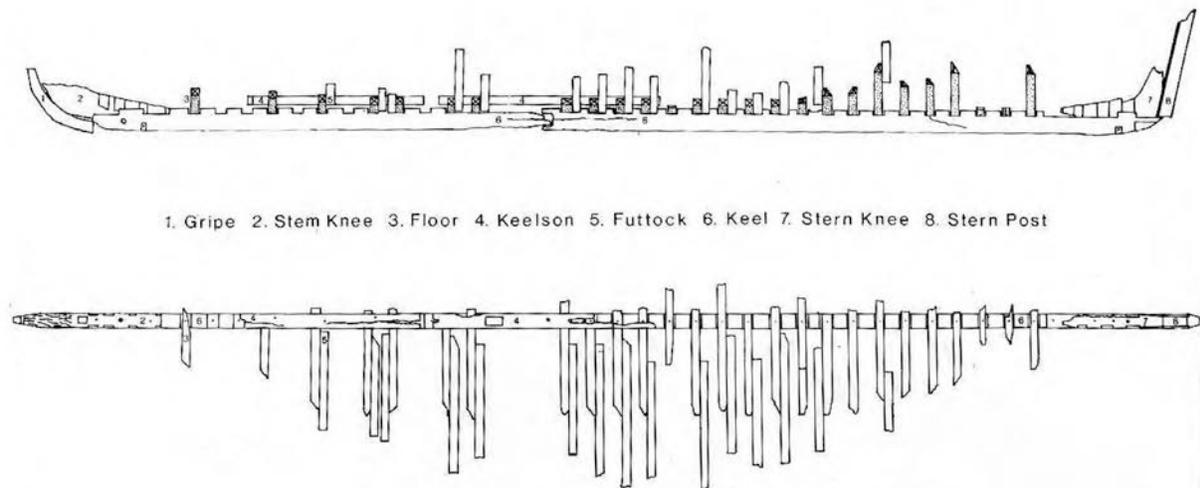
Figure 5-5: Plan and profile of Griffon Cove Wreck (Hundley 1980: 91).

In 1955, some timbers were removed from the wreck. It was not until 1978 that a team from Texas A&M photographed, drew, and catalogued the ship's timbers (Figure 5-5). A scale model was constructed to aid in understanding the vessel's construction. Archaeological investigations at the wreck site were conducted by the Fathom Five National Marine Park staff from June to September 1978. These included a site survey of the surrounding inner and outer coves, as well as the adjacent shoreline, followed by excavation of the wreck site. Alongside these excavations, students from Texas A&M returned to the wreck to examine and photograph the keel, stem, stern knee, and floor timbers (Hundley 1980: 2, 26-28).

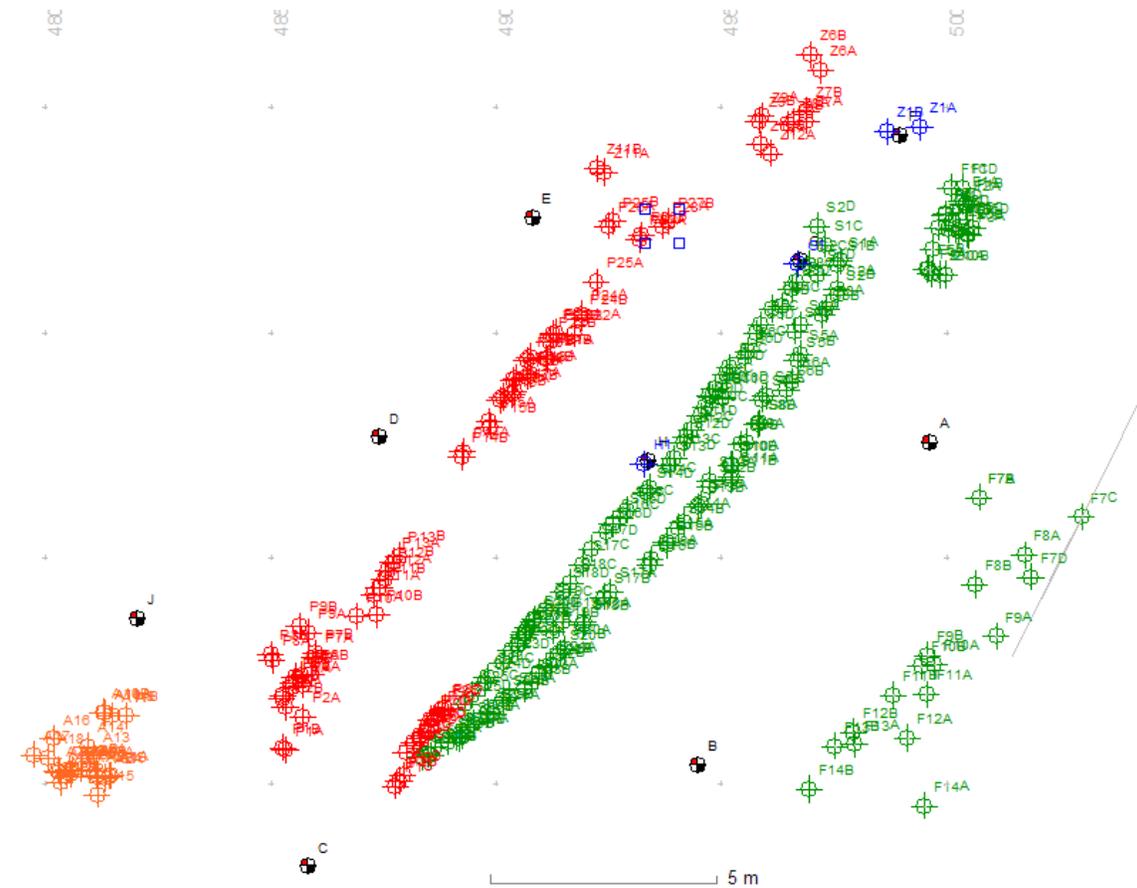
Figure 6-2: Screen shot from Site Recorder showing datum markers (letters) and points measured (color coded for easier data processing).

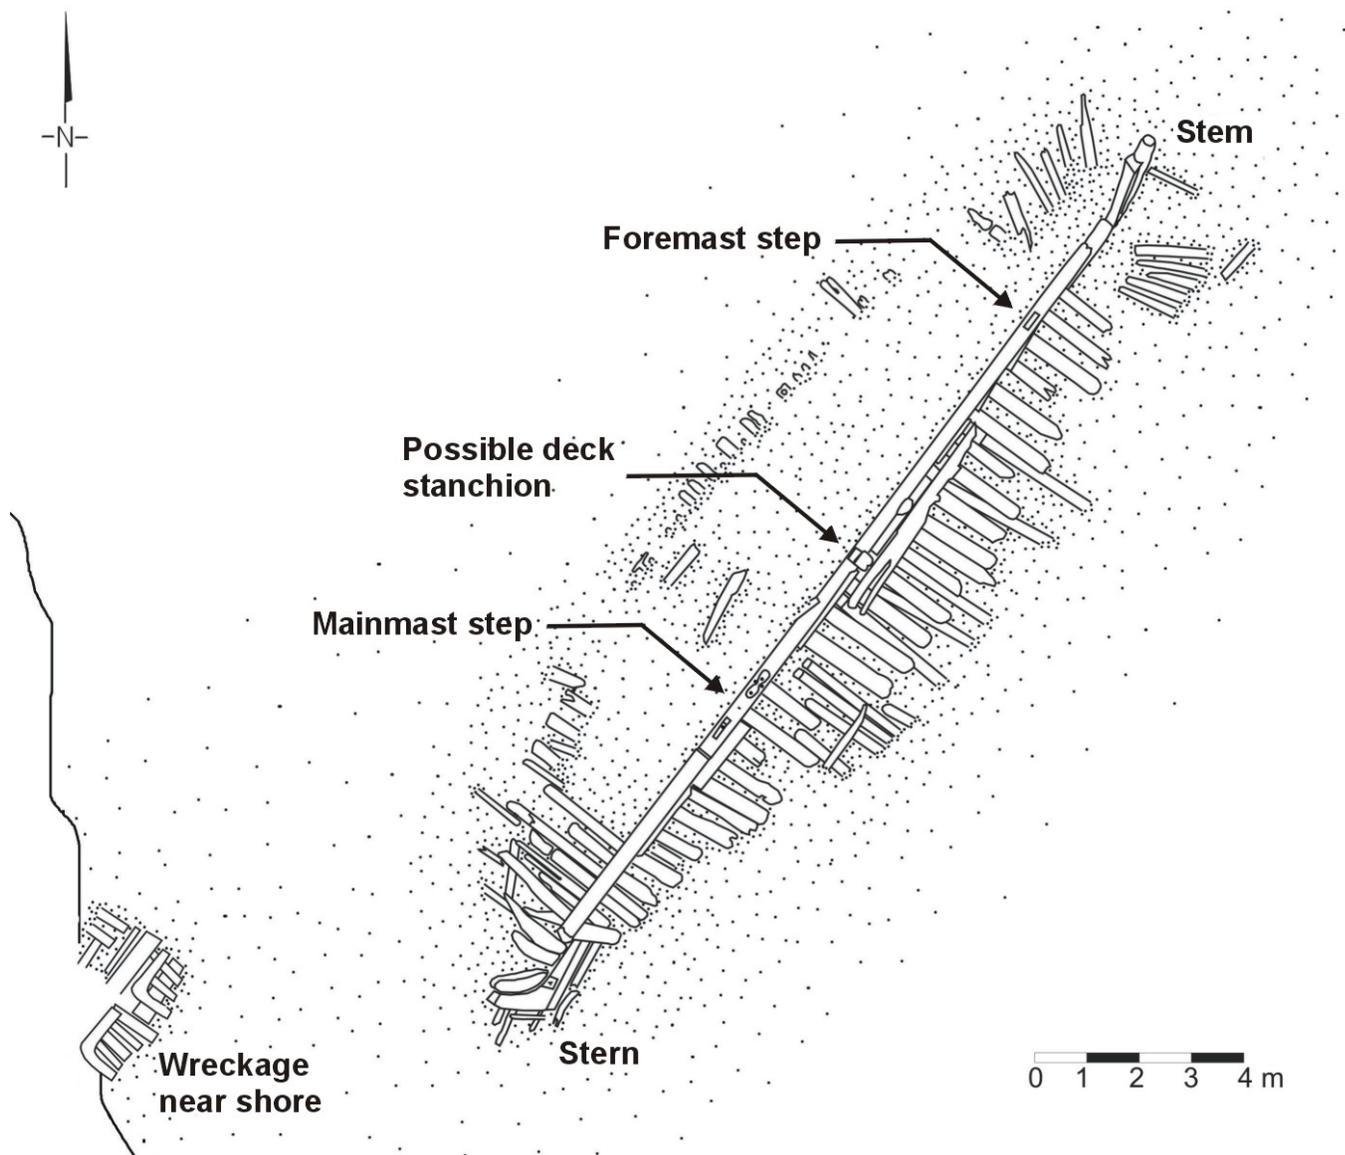
Figure 6-3: Navy Bay Wreck site plan (Kopp 2008).

Detailed drawings were made of both the stem and stern assemblies as well as features along the keelson. Unfortunately time did not allow the retrieval of molded and sided dimensions for all of the timbers on the wreck. A total of eight wood samples were taken from the keel, stem post, stern deadwood, floor, futtock, keelson, ceiling plank, and external planking. They were analyzed by the Analytical Section at the Ontario Service Centre of Parks Canada, all of which proved to be white oak (Appendix A). Photos and video were taken of the site.

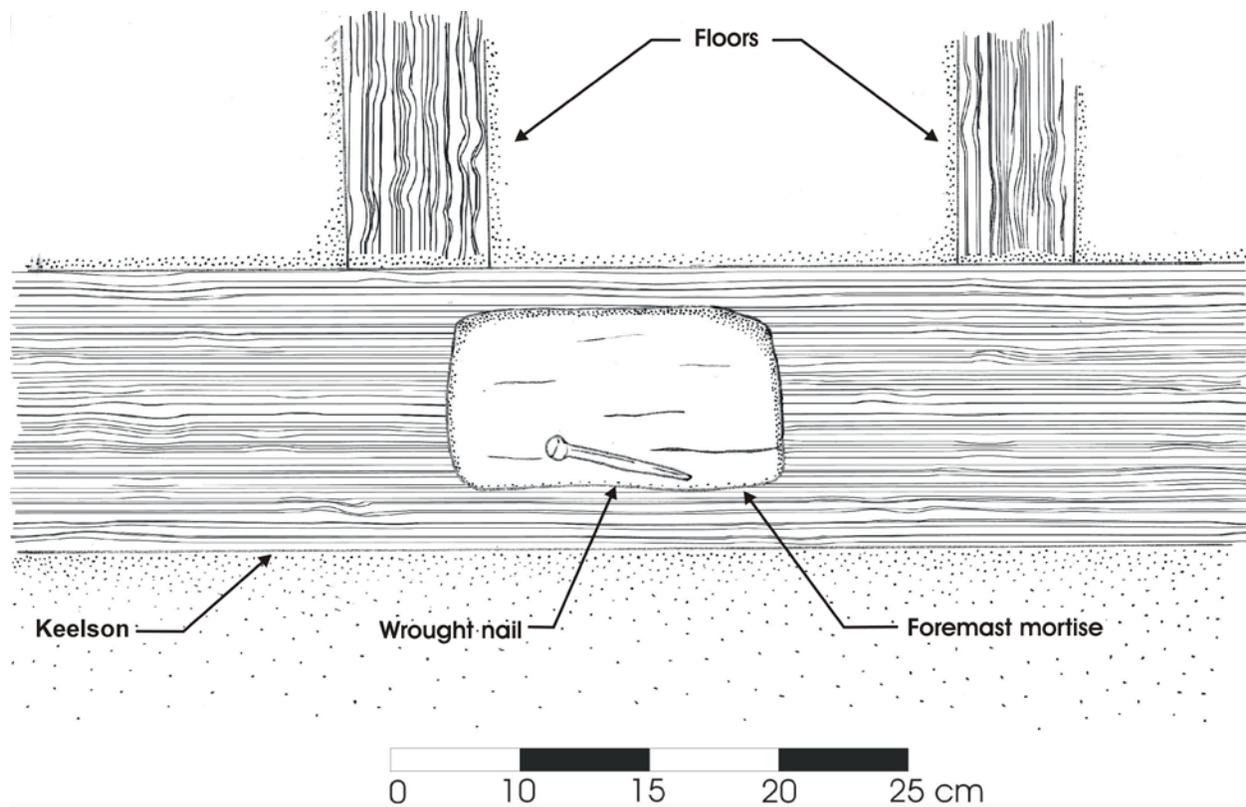
Figure 6-4: Navy Bay Wreck foremast step (Kopp 2011).

The keelson is sided 7.2 in. (18.5 cm) and molded 6.8 in. (17.5 cm), there is no rider keelson. It is scarfed in two places, just aft of the stem and aft of the main mast step. It is fastened to the keel with iron bolts located between every other frame. Three features were located along the keelson. The furthest forward is the forward mast step, located 6 ft. 10 in. (2.1 m) abaft the stem (Figure 6-4). It is a simple rectangular mortise cut directly into the keelson that measures 10.6 cm (4.2 in.) wide, 24.3 cm (9.6 in.) long, and 4.5 cm (1.8 in.) deep. The mast step is generally intact, except for erosion, and shows no sign of breakage from strain on the step. Chocks and buttresses might have originally existed as a part of this mast step assembly in order to reinforce the step, however, they are not present on the wreck. A loose wrought iron spike was found resting inside this mast step. Simple mortise cut mast steps appear to be typical of small to medium sized vessels constructed during the mid- to late-18th century.

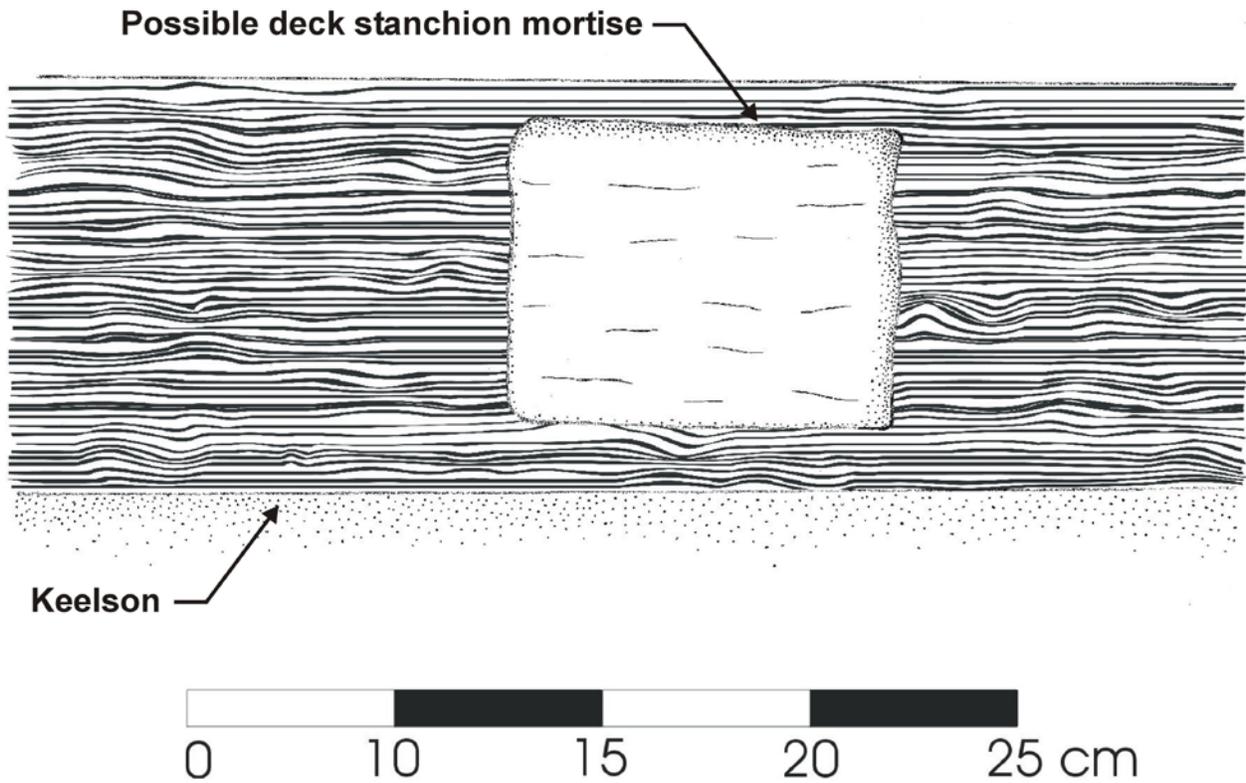
Figure 6-5: Possible deck beam stanchion mortise on the Navy Bay Wreck (Kopp 2011).

Clearly, these do not compare with the Navy Bay example; however, there was another notch located further aft on the keelson that was similar to the Navy Bay example. It measured 10.2 cm (4 in.) square and was very shallow (Crisman 1987: 147). While this notch better resembles the one seen on the Navy Bay Wreck, its purpose remains undetermined. Since it would have been an odd place for a capstan post, that possibility is ruled out although it could have been for a large stanchion at a main hatch opening. Dr. Crisman also suggested that another possibility, although lower probability, is a support stanchion under a pivot gun mounted between the masts (Kevin Crisman 2009, pers. comm.).

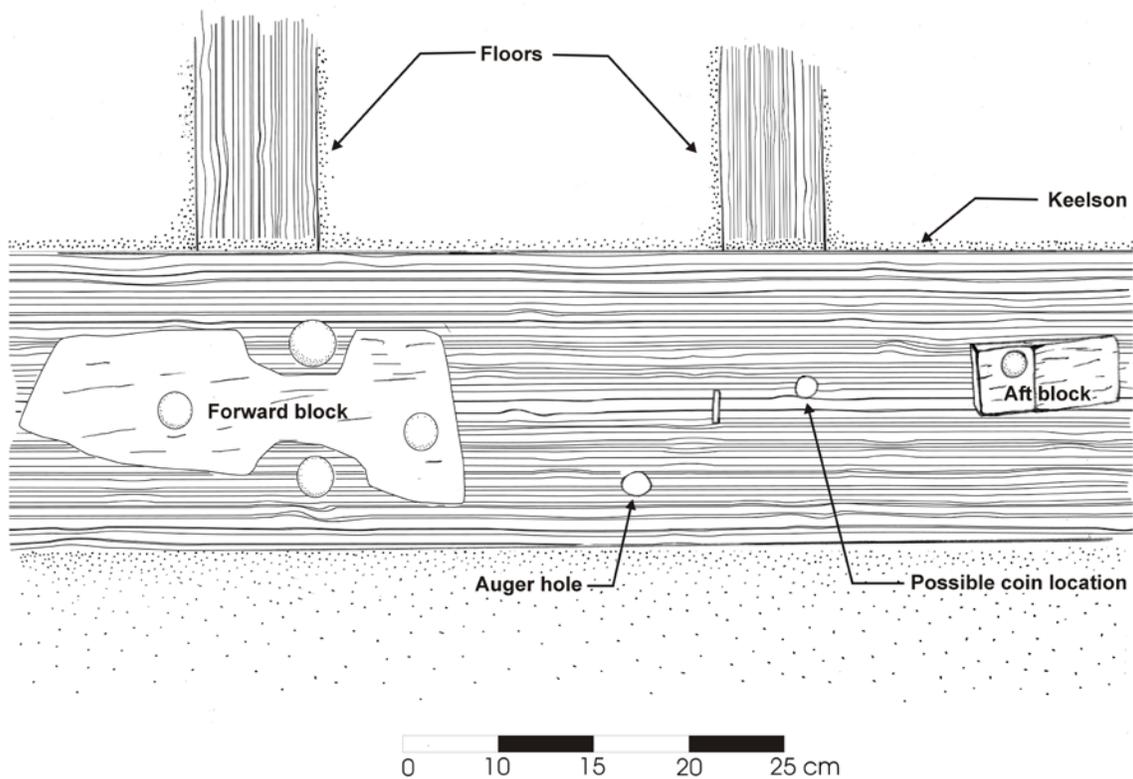
Figure 6-6: Navy Bay Wreck mainmast step (Kopp 2011).

Although relatively little remains of the interior structure of the Navy Bay Wreck, two limber boards were still present along the starboard side of the vessel, as well as one portion of ceiling planking. Lower hull planking survives near the stern; however, it is buried by silt. At the bow, some hull planking survives.

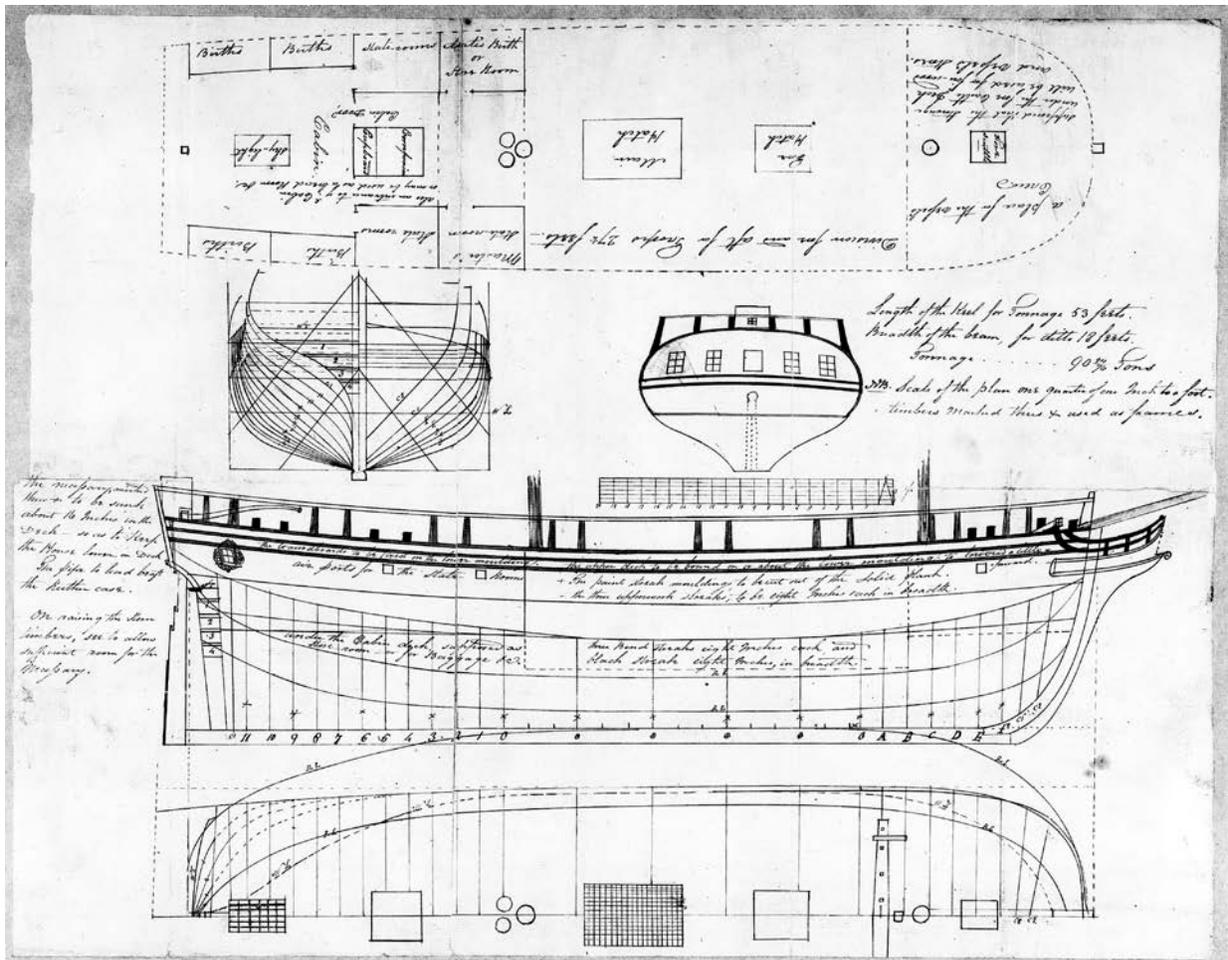
Figure 6-7: Lines plan of *Earl of Moira* (Library and Archives Canada, Ottawa, Ontario, LAC 0018023).

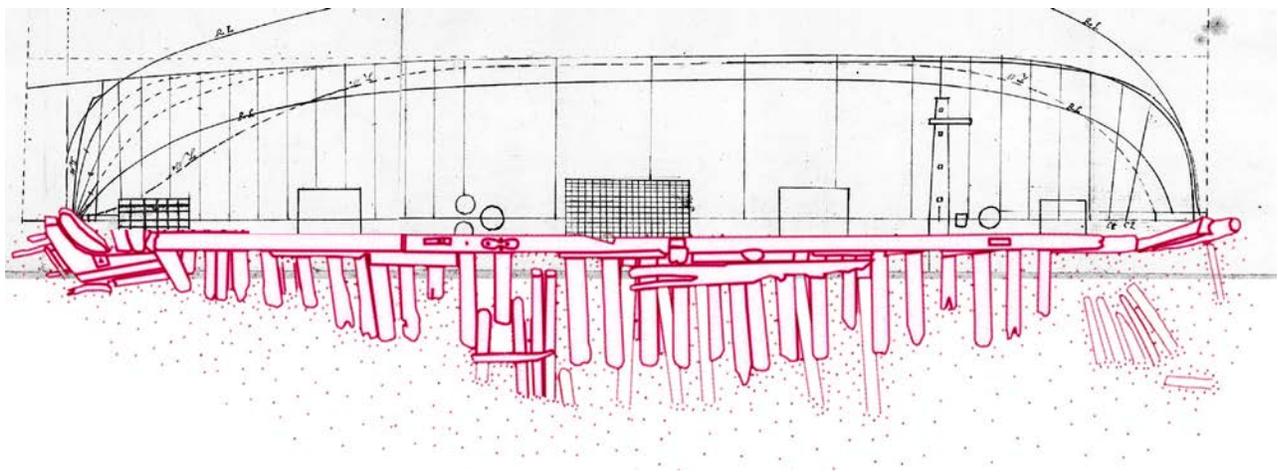
Figure 6-10: Wreck plan of the Navy Bay Wreck superimposed on the lines plan for *Earl of Moira* (Library and Archives Canada, Ottawa, Ontario, LAC 0018023 modified by N. Kopp 2012).
