MATTERS OF STEEL:  
ILLUSTRATING AND ASSESSING THE DETERIORATION OF THE  
WORLDWAR II MERCHANT FREIGHTER *CARIBSEA*

A Thesis Presented to the Faculty of  
The Department of History  
East Carolina University

In Partial Fulfillment  
Of the Requirements for the Degree  
Master of Arts in Maritime Studies

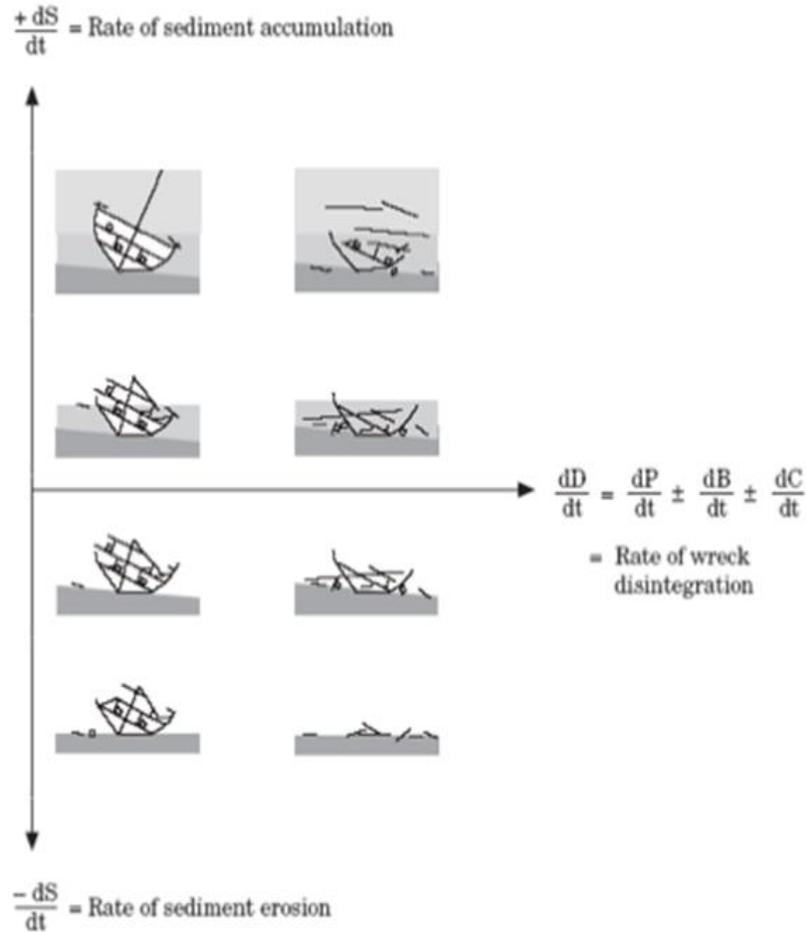
FIGURE 2.1. Diagram showing the disintegration of a shipwreck site (Ward et al. 1999:567).

The Ward, Larcombe, and Veth model effectively linked the physical anomalies of the shipwreck site with the processes controlling the actual shipwreck formations. This clearly defined the multidisciplinary approach that is required for site formation theory, outlining the necessity of future assessment of physical processes affecting the conditions of shipwreck sites.

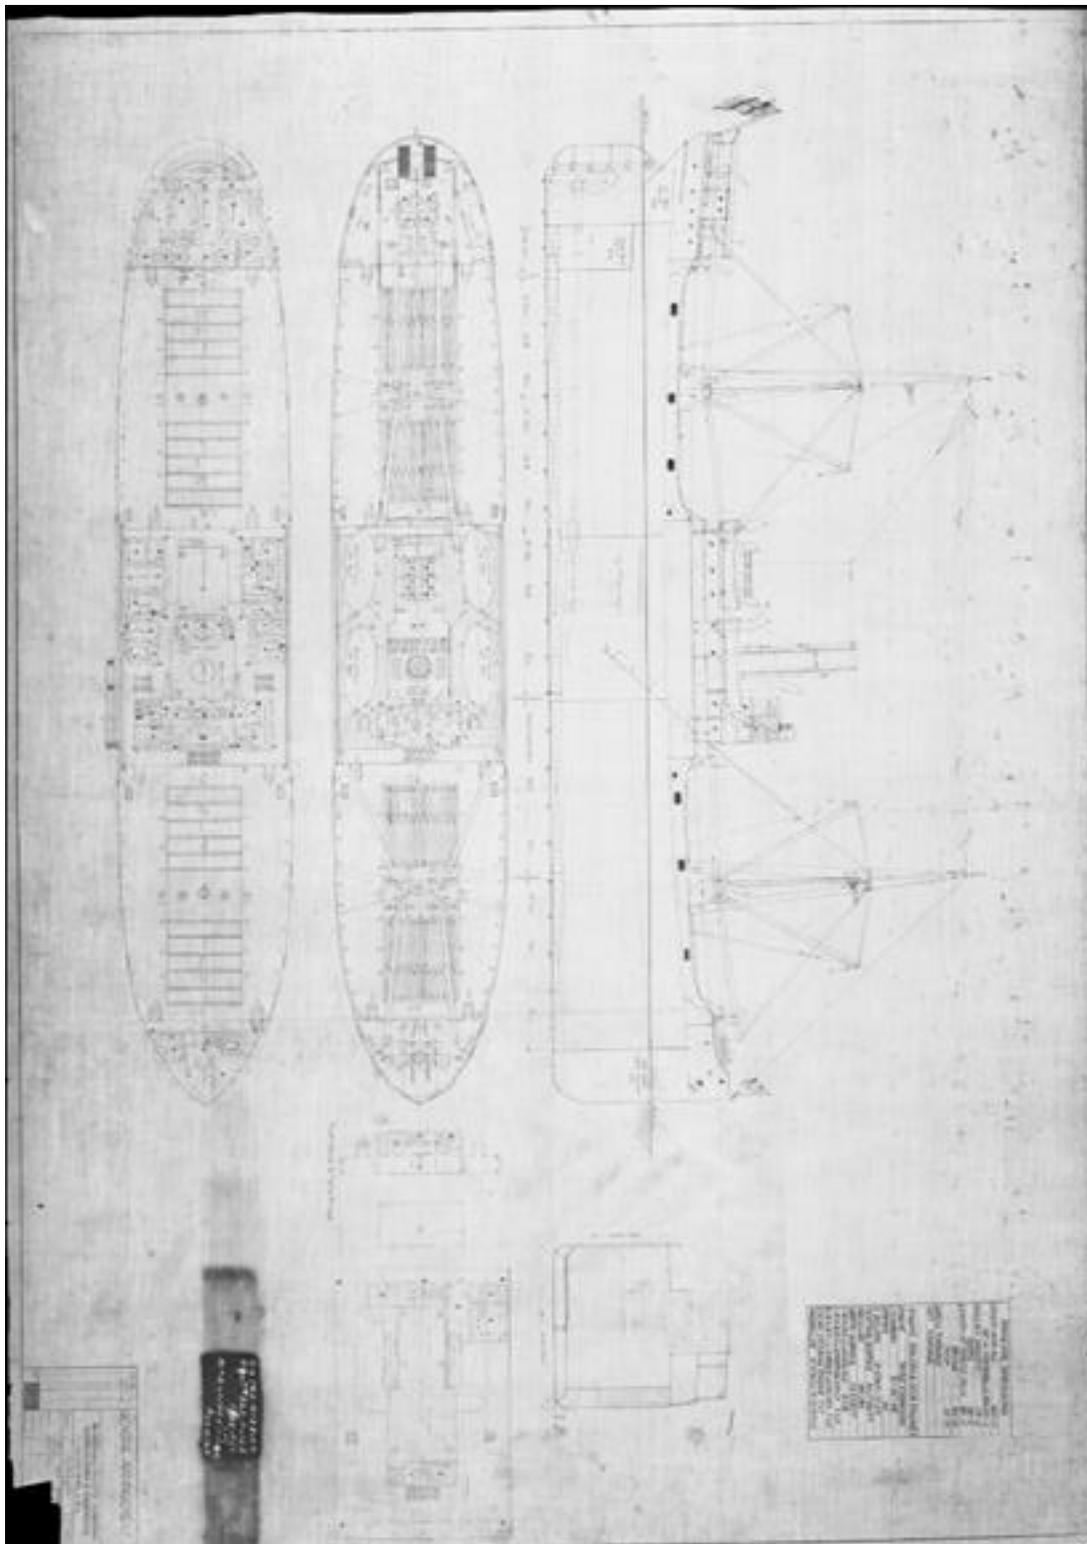
FIGURE 4.1. General Arrangement builder's plan (NARA).

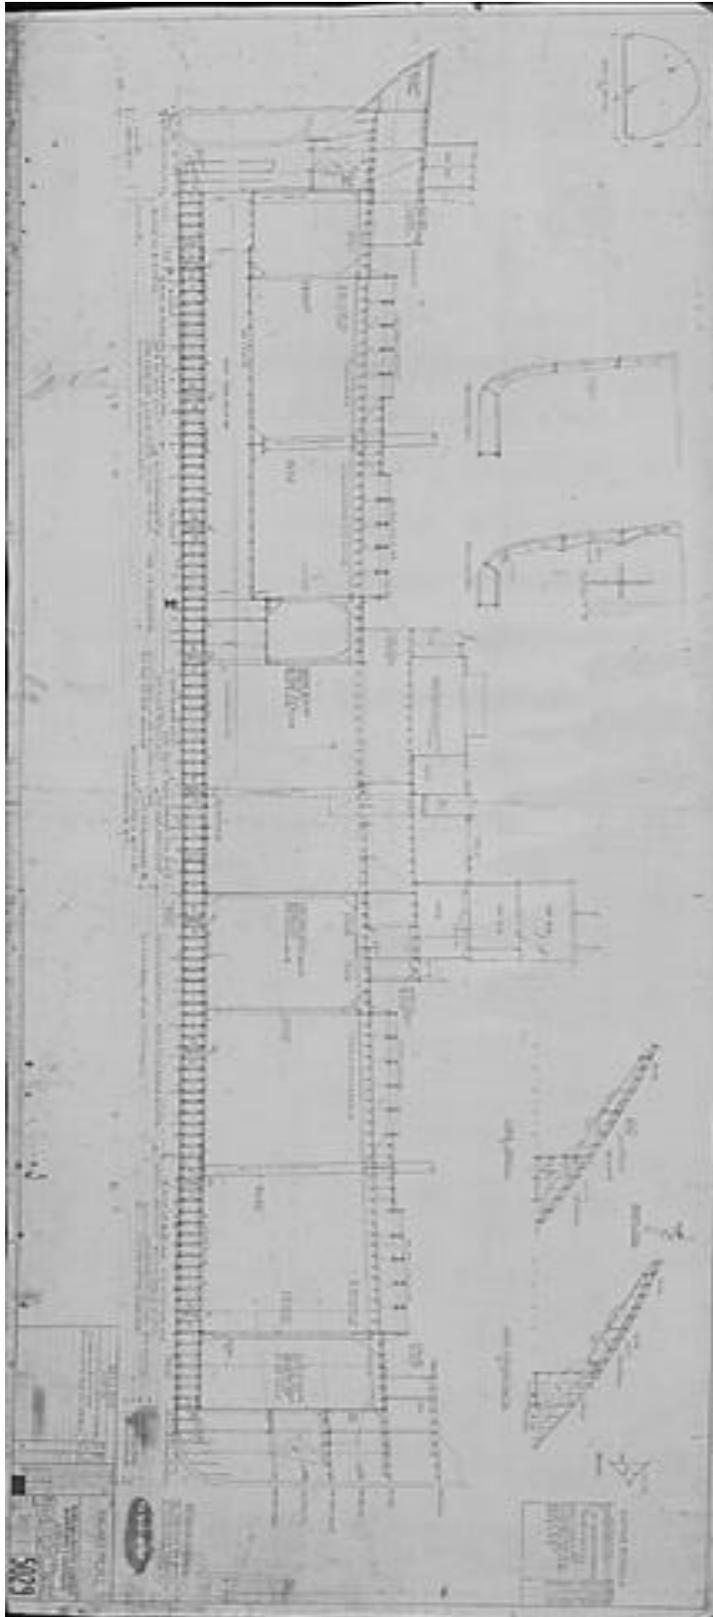
FIGURE 4.2. Inboard Profile builder's plan (NARA).

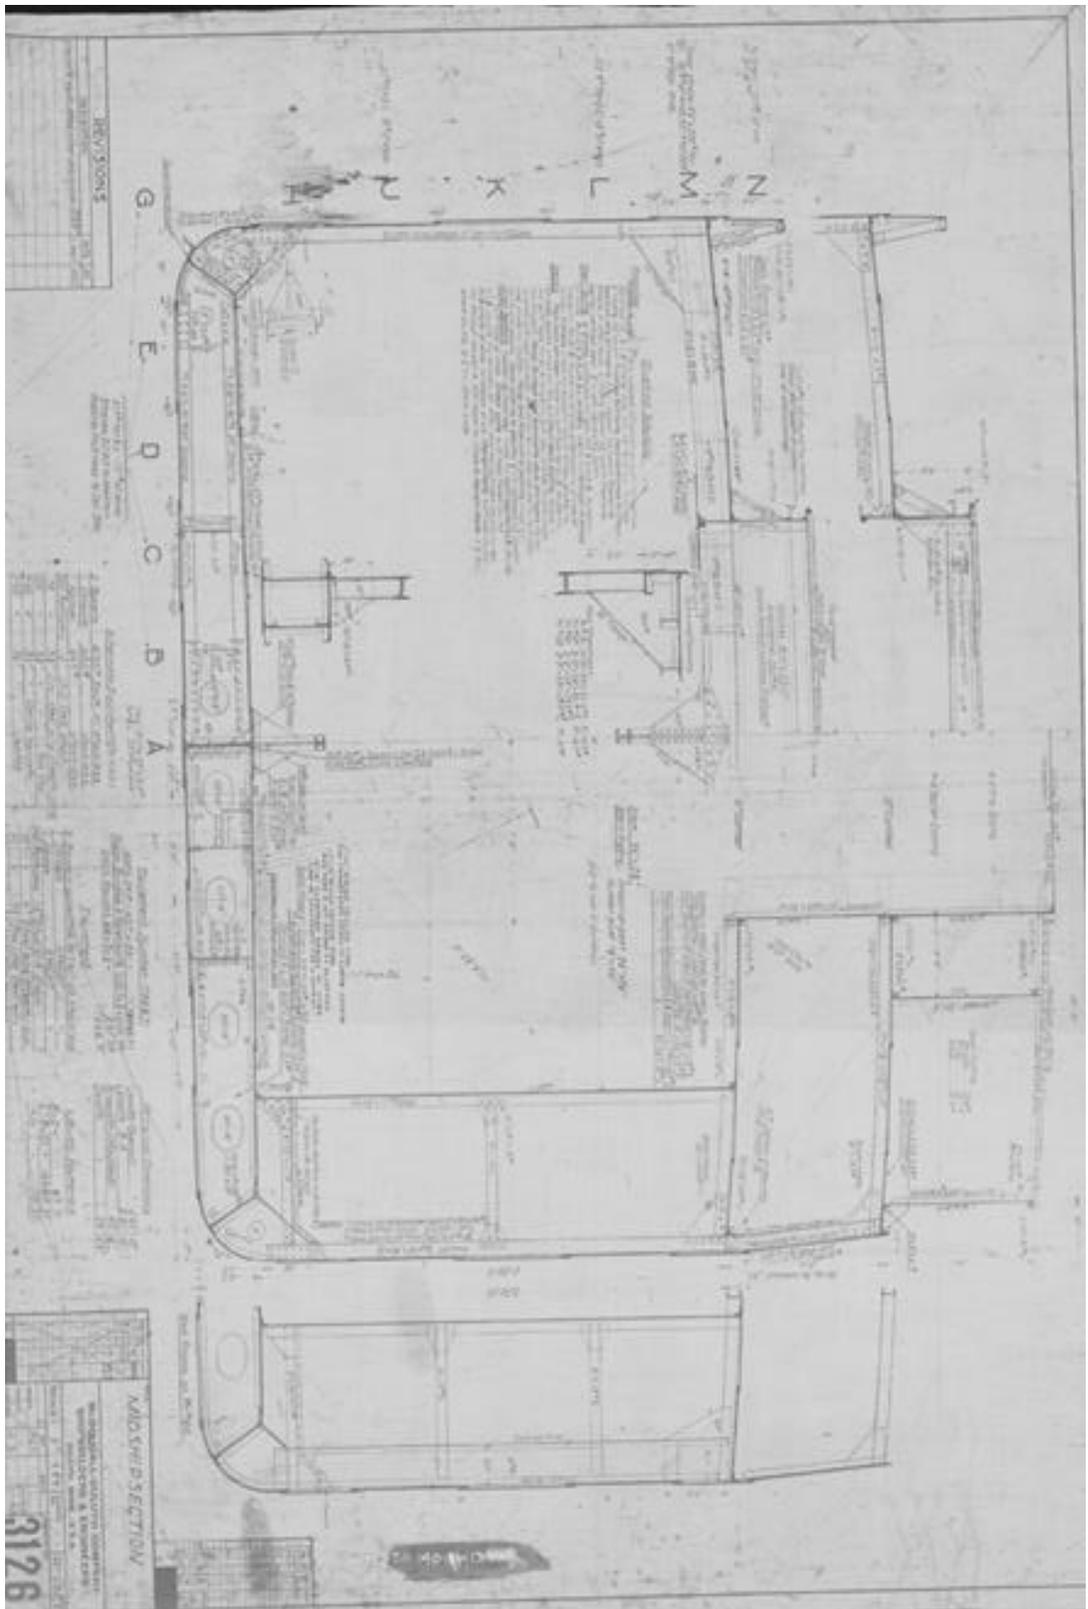
FIGURE 4.3. Midship Section builder's plan (NARA).

Following the construction of the hull, the “backbone” and the major structural components of the ship were assembled. Using the Midship Section builder’s plan (Figure 4.3), to-scale hull components were created including the keel, floor plating, and framing. The location of these features was identified using the General Arrangement (Figure 4.1) and Inboard (Figure 4.2) builder’s plans. After the completed development of the ship’s framework (Figure 5.6 and Figure 5.7), additional components including decking and the superstructure could be created. These features began to give the ship a more authentic appearance, and made it possible to begin development of more auxiliary features like machinery and cargo gear.

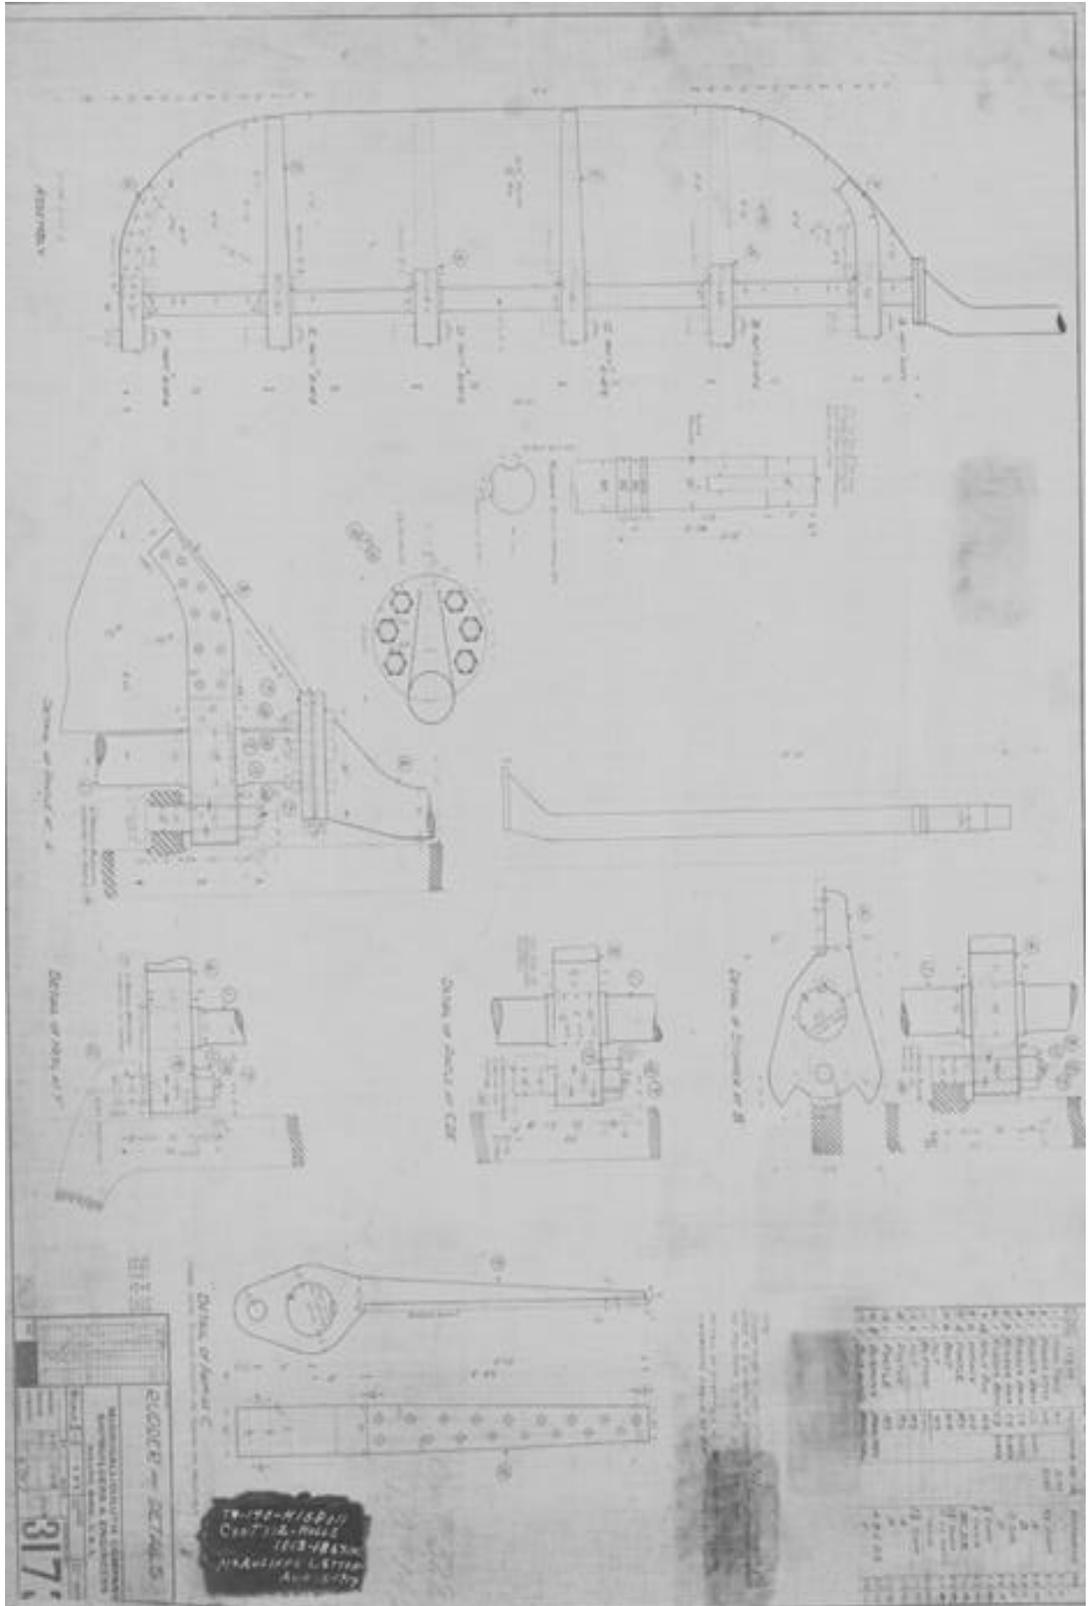
FIGURE 4.5. Rudder and details builder's plan (NARA).

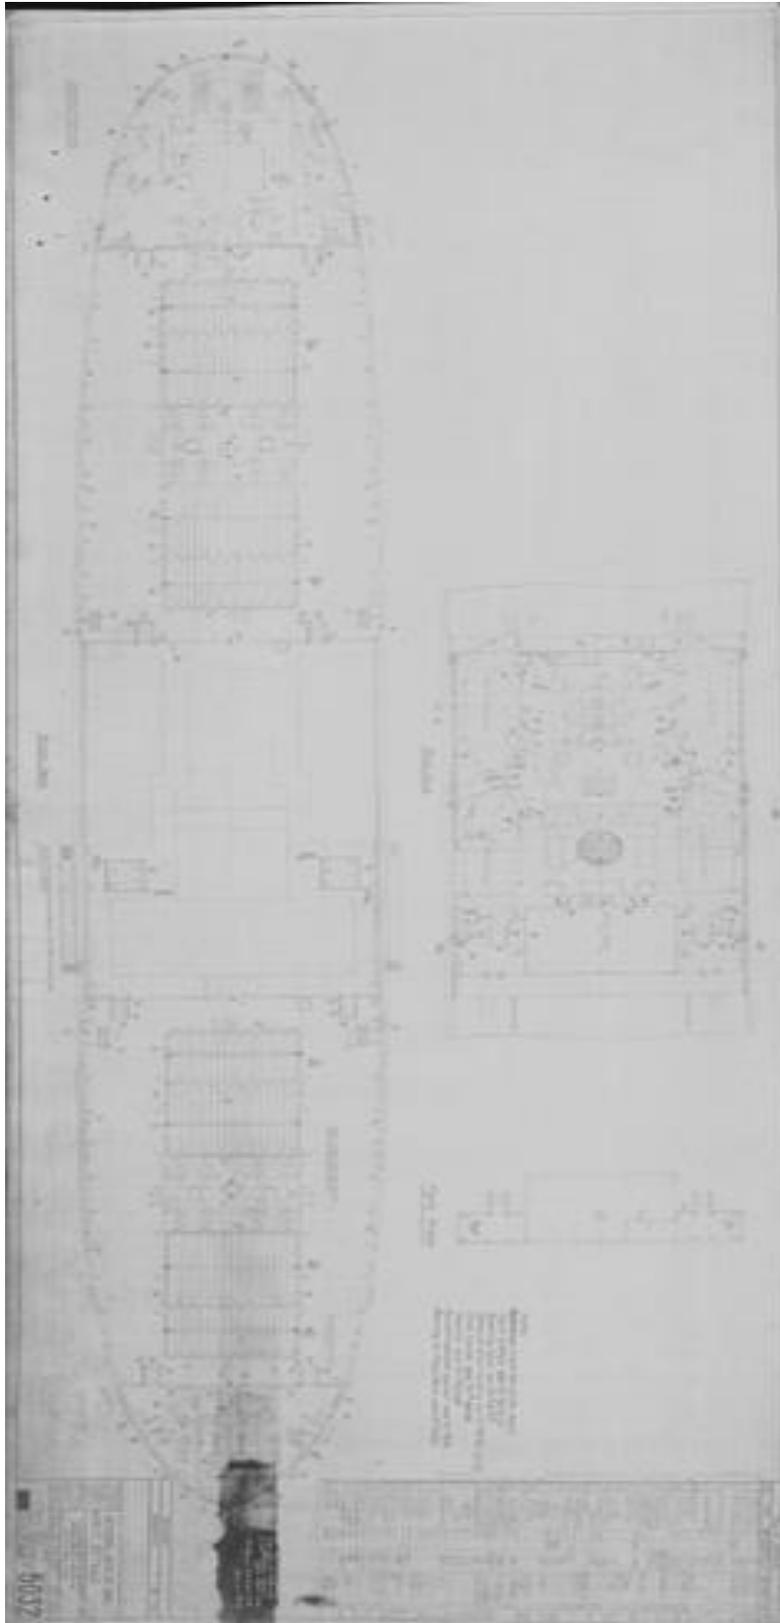
FIGURE 4.6. Arrangement of rail and deck fittings plan (NARA).

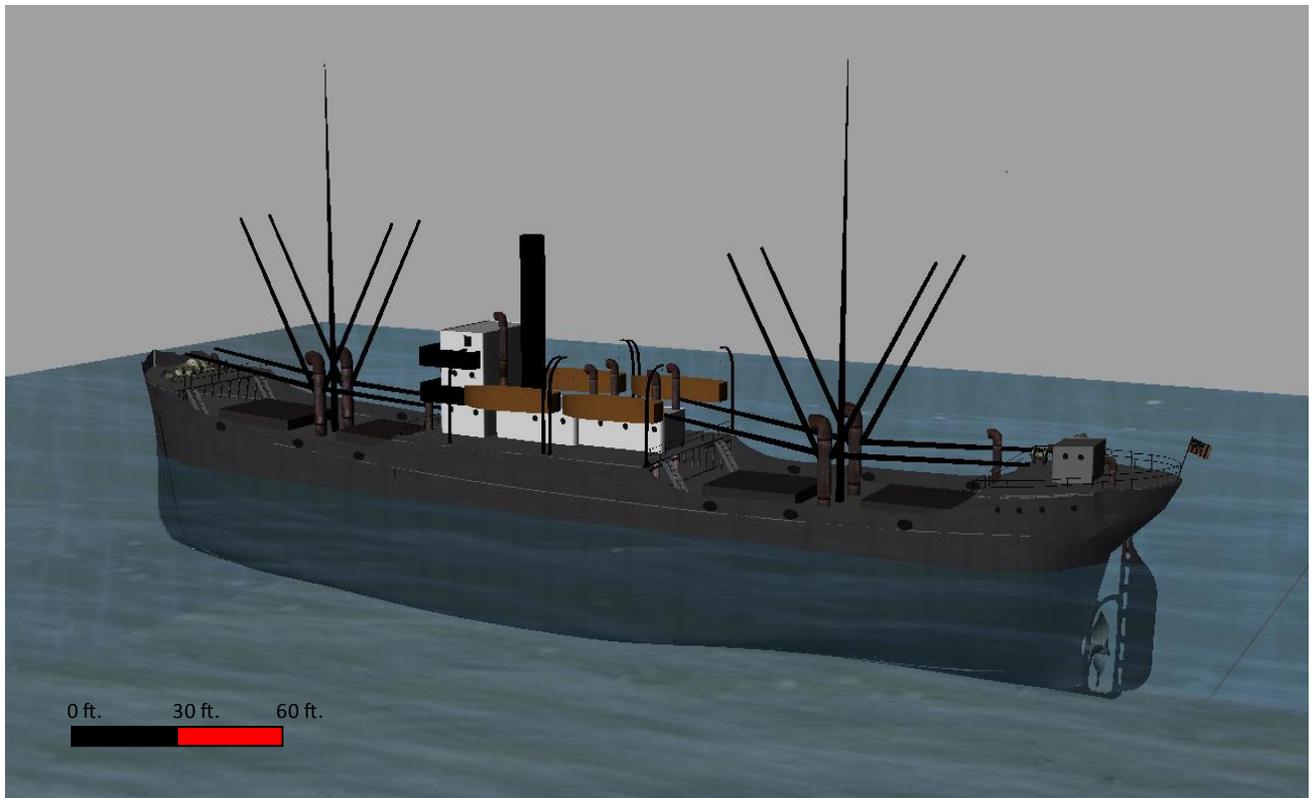
FIGURE 4.10. Example of 3D *Caribsea* model as it was originally built (Image by Kara Fox).

The 3D construction of *Caribsea* was initiated by uploading the acquired 2D builder's plans into *Rhino* and digitizing the virtual plans by outlining one feature at a time. The lines were then extruded into 3D objects and surfaces, slowly creating a 3D model of a ship. The virtual construction of *Caribsea* was done primarily in the same order as the physical construction of a contemporary steel vessel—following a frame-first construction style. Each structural component was organized into a “layer” allowing the user to selectively view and build individual ship components. The ability to color code specific features or shift viewing angles enhanced the experience and interpretation of the user. Following the creation of the historically accurate representation of the vessel, the archaeological data were compiled and integrated into the *Caribsea* shipwreck model (Figure 4.10).

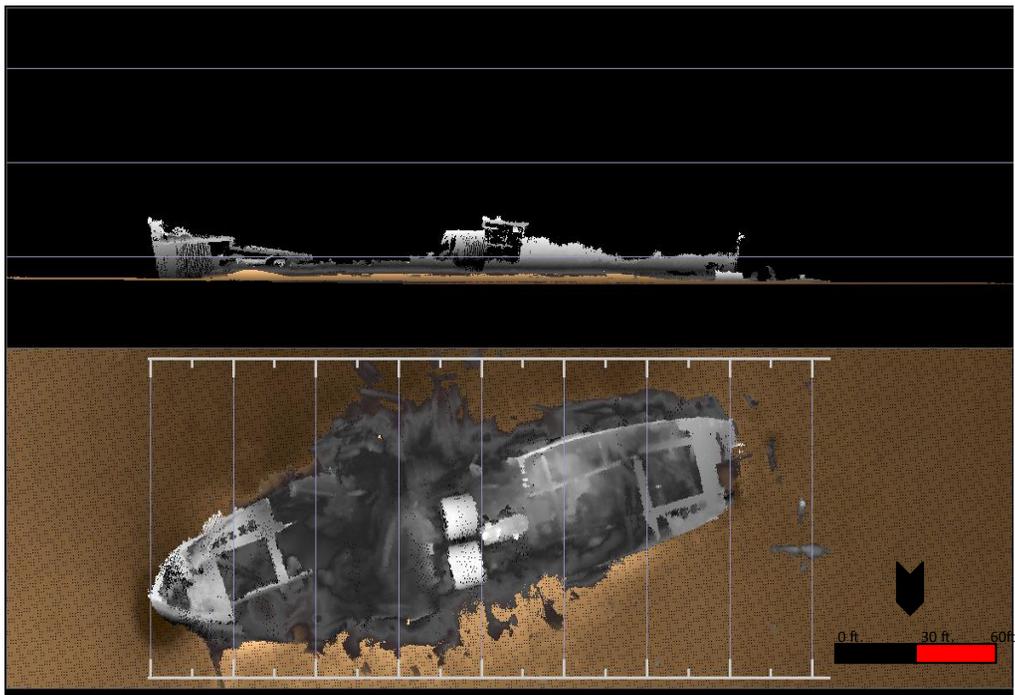
FIGURE 4.11. High resolution, multibeam model of *Caribsea* as seen in *Wrecksight* (ADUS Ltd.)

The advantages of bathymetric multibeam imagery and modeling, is that it can provide accurate measurement capabilities including the distance between any two surveyed points, calculated volumes, and quantifiable deterioration changes. These features proved to be a useful tool in the ongoing analysis of *Caribsea*, also illustrating a clear representation of the seafloor around the site, including any cultural or environmental disturbances (Dean 2010:2). While ADUS 3D multibeam models primarily serve as visual representations, the data can be further manipulated and interpreted using tools within the *Wrecksight* interface. A 3D multibeam model of *Caribsea* was produced in ADUS’ *Wrecksight* software (Figure 4.11).

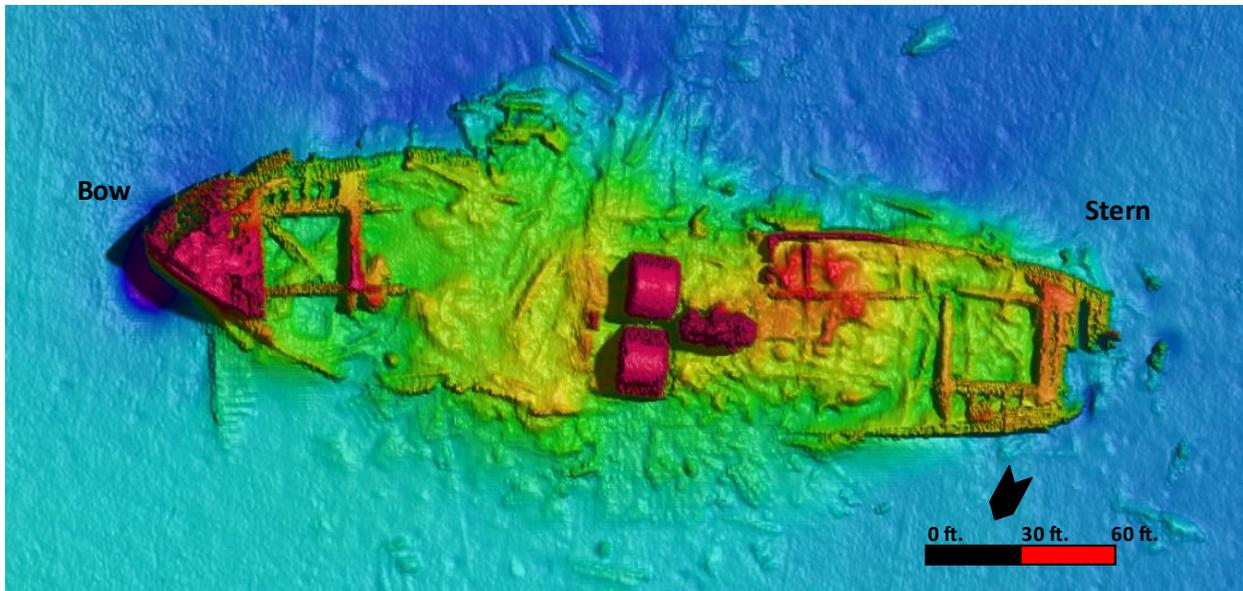
FIGURE 4.14. Example of multibeam imagery used to delineate areas of interest on *Caribsea* (NOAA 2013).

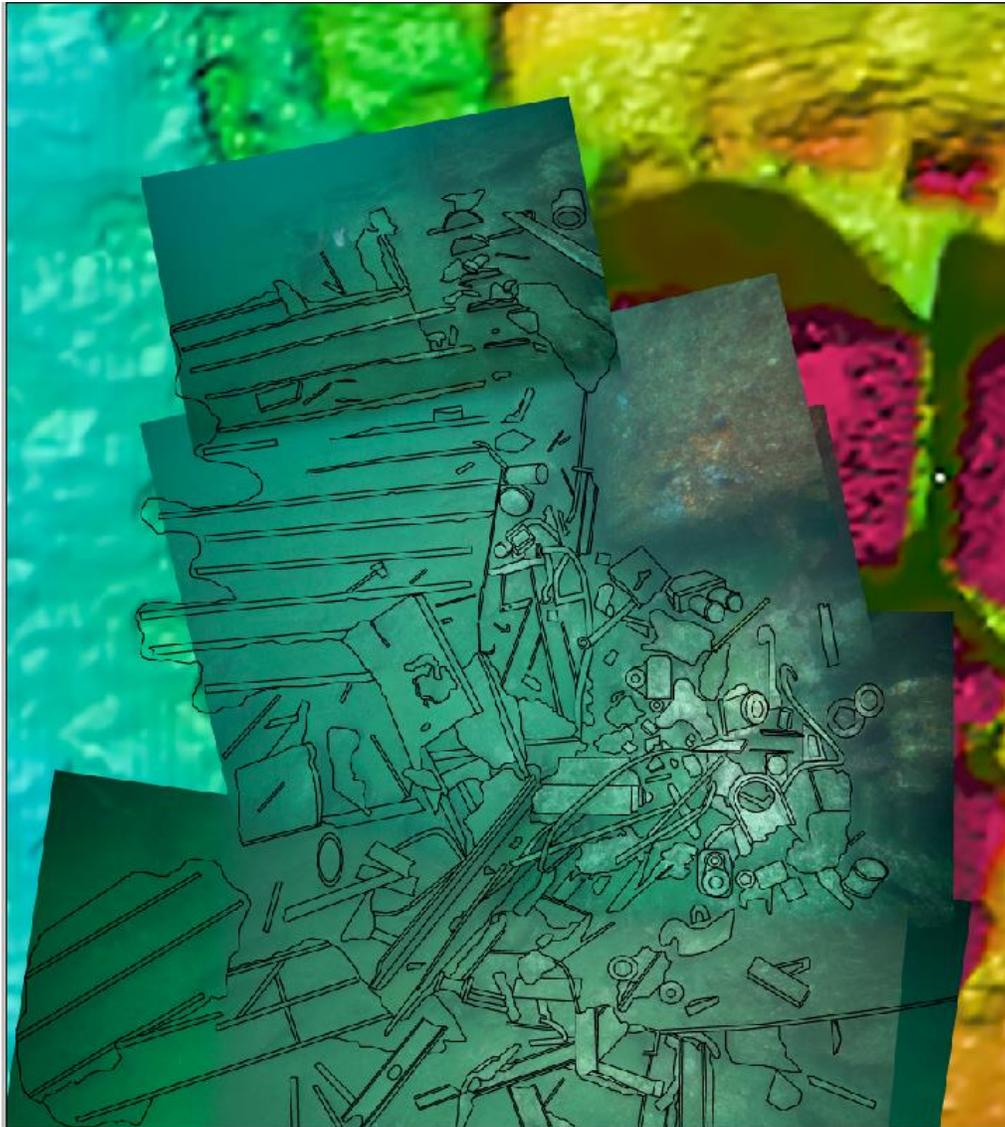
FIGURE 4.15. Example of the hybrid mapping technique using remote sensing imagery and scaled photographs in *Adobe Photoshop* (Image by Kara Fox).

aligned, shipwreck components and corresponding debris were accurately traced using a pen tool in *Adobe Photoshop* and added to the master site plan (Figure 4.15).

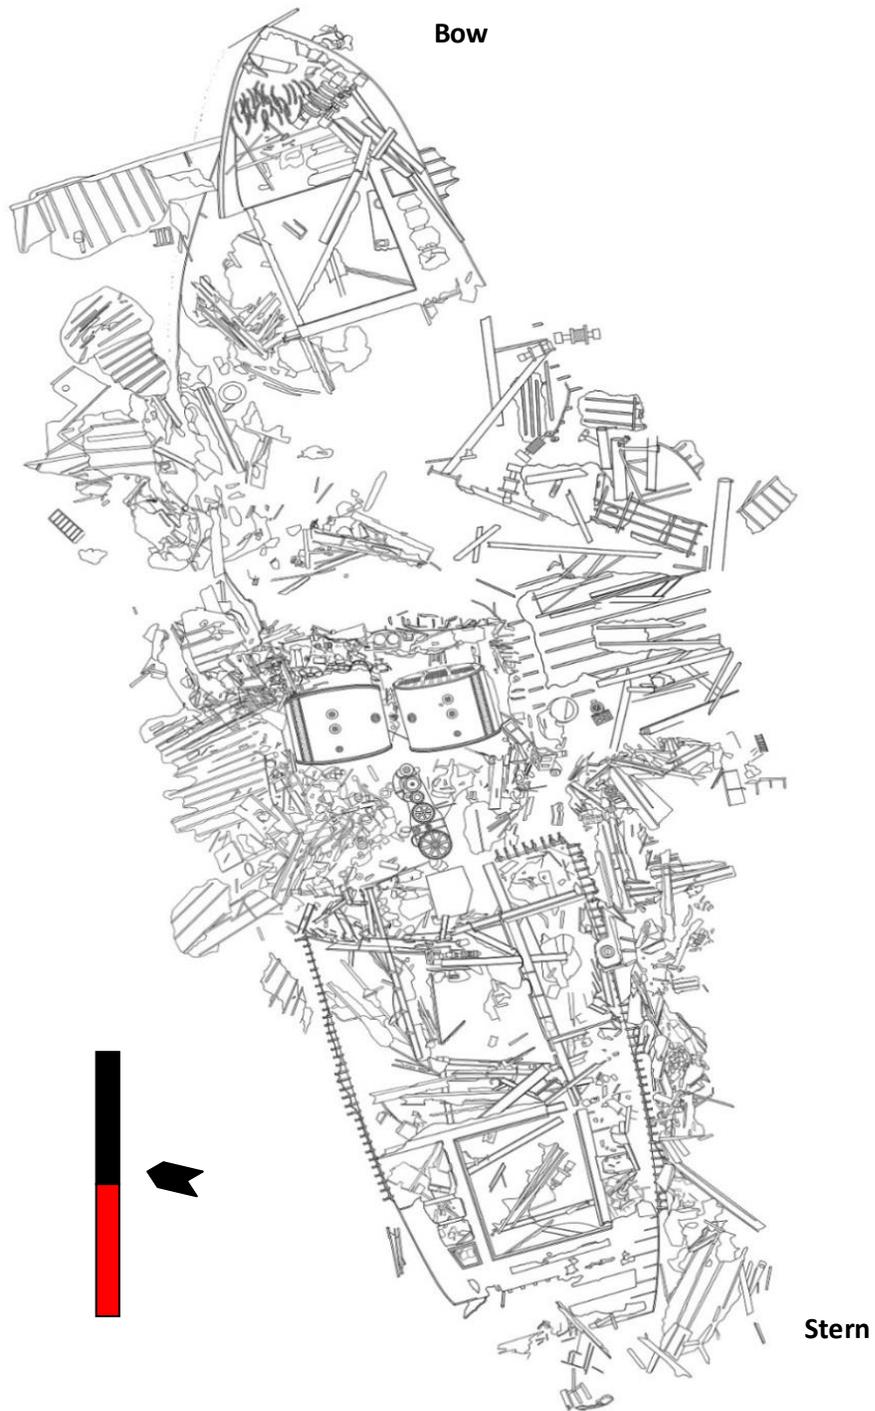
FIGURE 4.16. *Caribsea* site plan (NOAA).

Upon the completion of the site plan, stippling (a pattern simulating varying degrees of solidity or shading using small dots) was achieved to create texture amongst the various shipwreck components and emulate a more representative drawing of *Caribsea*. The culmination of *Caribsea's* field project resulted in a comprehensive site plan of the shipwreck (Figure 4.16).

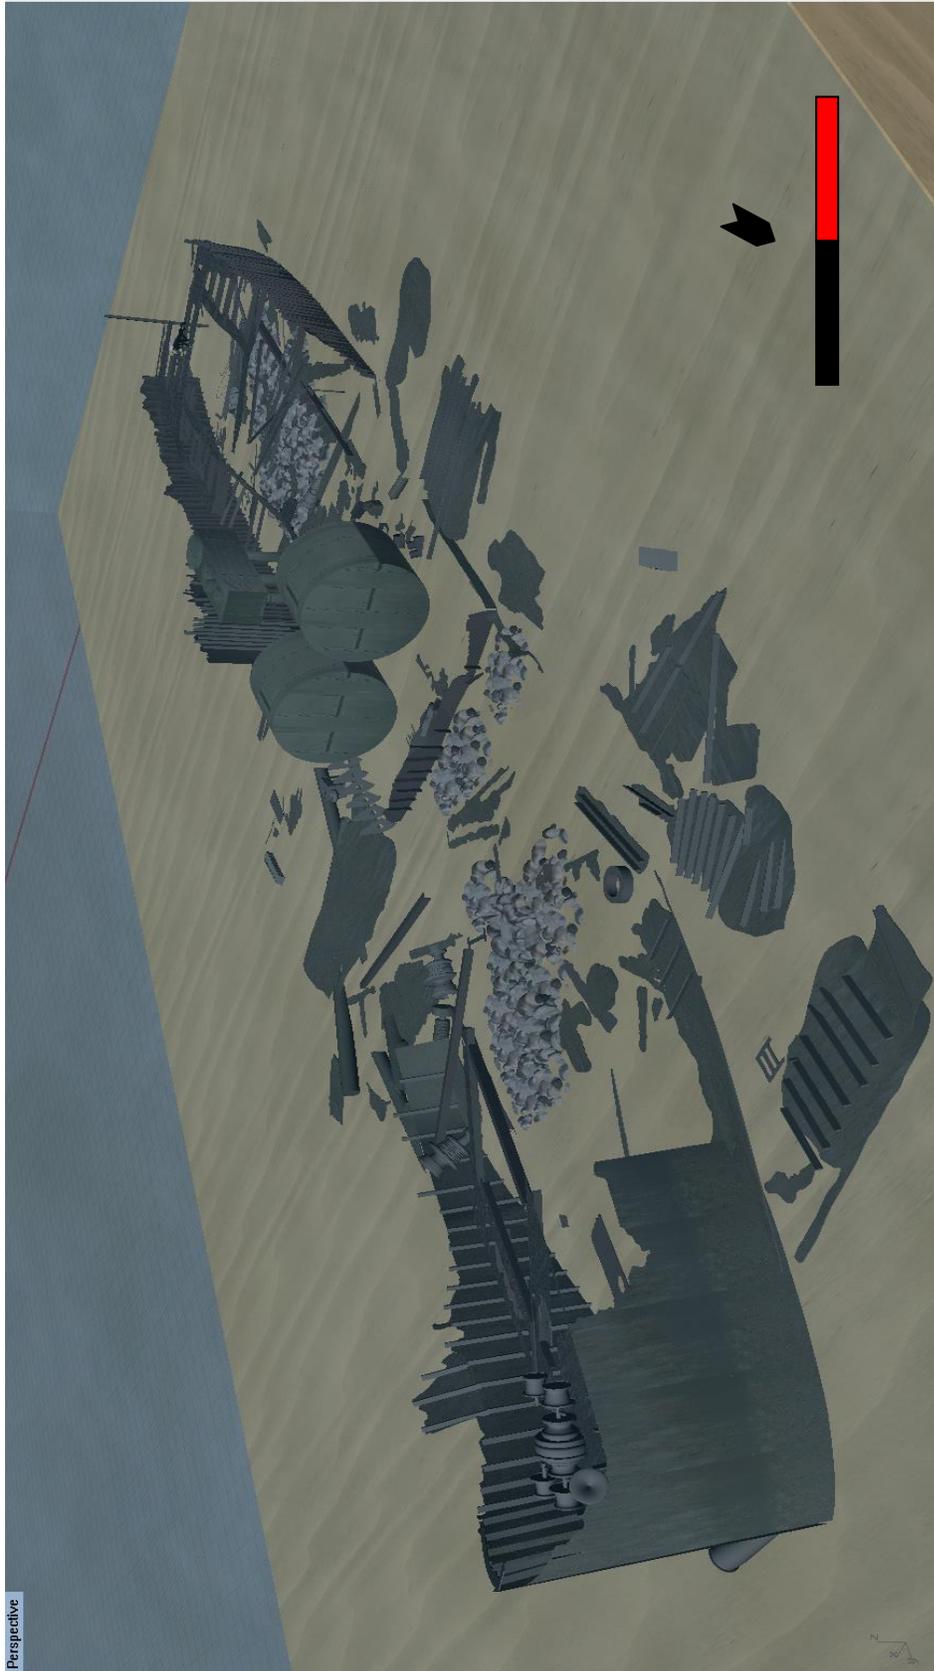
FIGURE 4.17. Example of 3D *Caribsea* shipwreck model (Image by Kara Fox).

After the development of the 3D Current *Caribsea* Shipwreck Model (Figure 4.17) was complete, the objective of the project could begin: a site formation analysis of *Caribsea*. Using historical, cultural, and environmental variables, both the historical and current *Caribsea* models were used to develop a series of accurate 3D models representing the process of deterioration. The development and interpretation of these sequential site formation models is further discussed in Chapter Six.

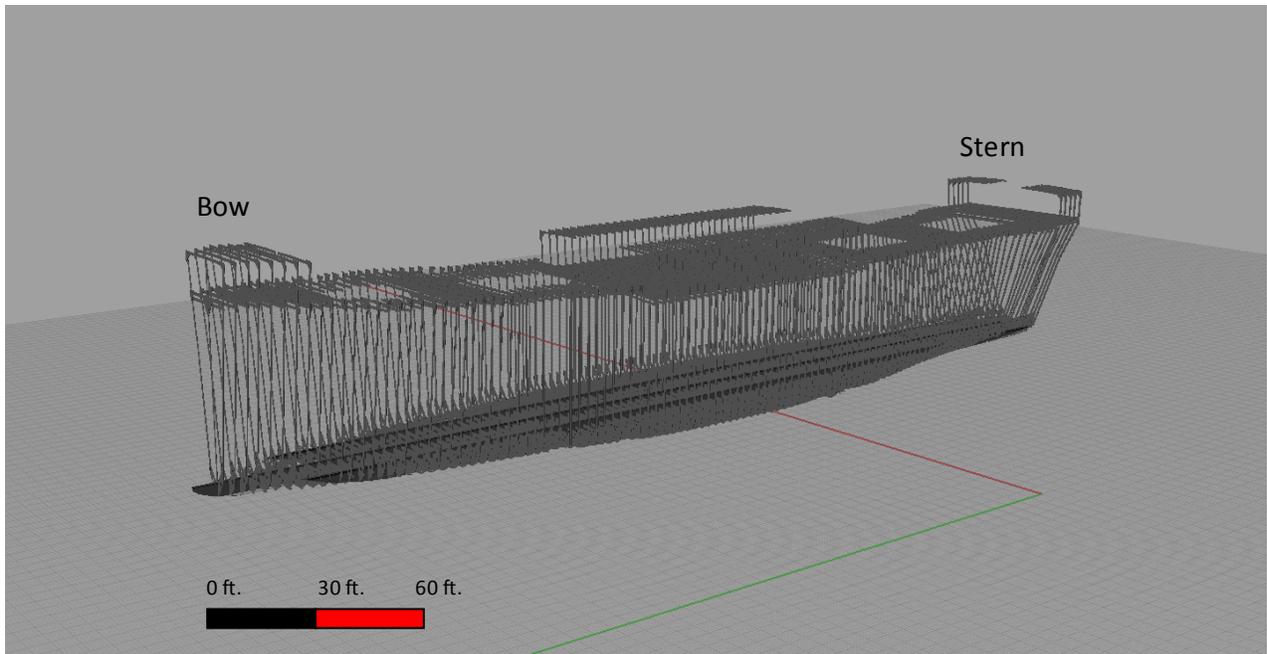
FIGURE 5.6. Example of framing and keel components of 3D *Caribsea* model (Image by Kara Fox).

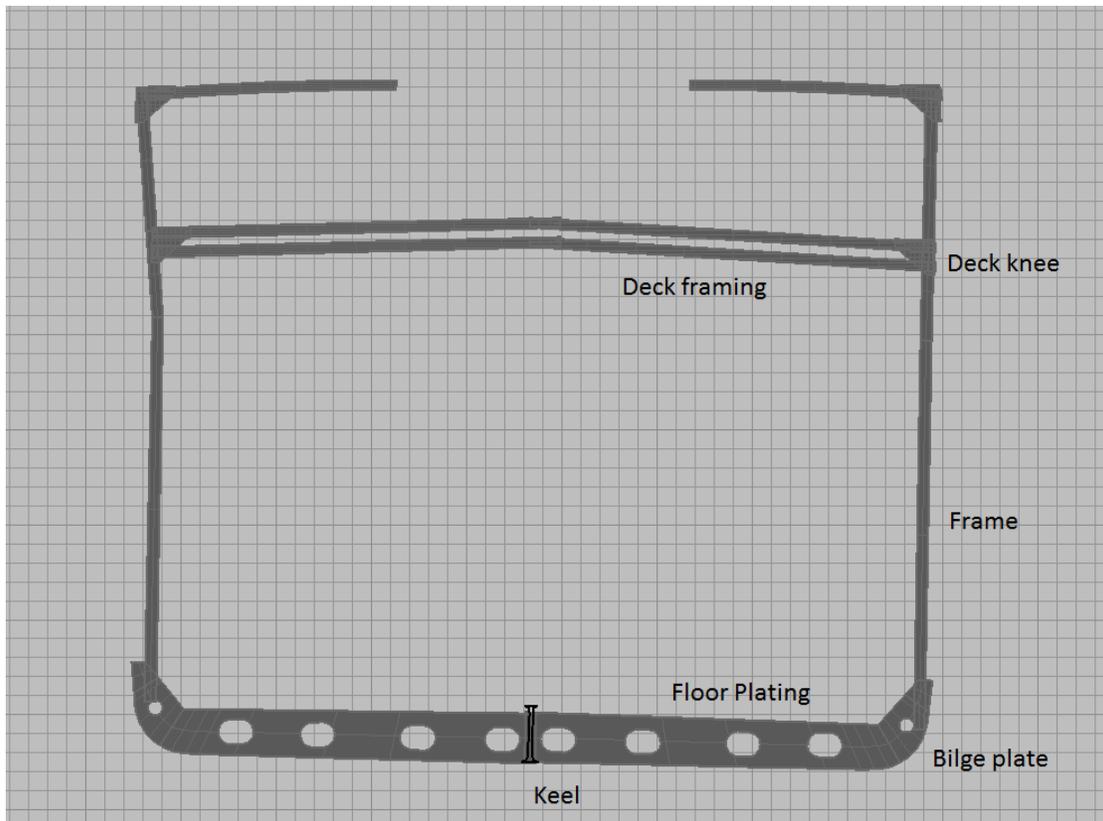
FIGURE 5.7. Midship section of *Caribsea* with labeled ship components (Image by Kara Fox).

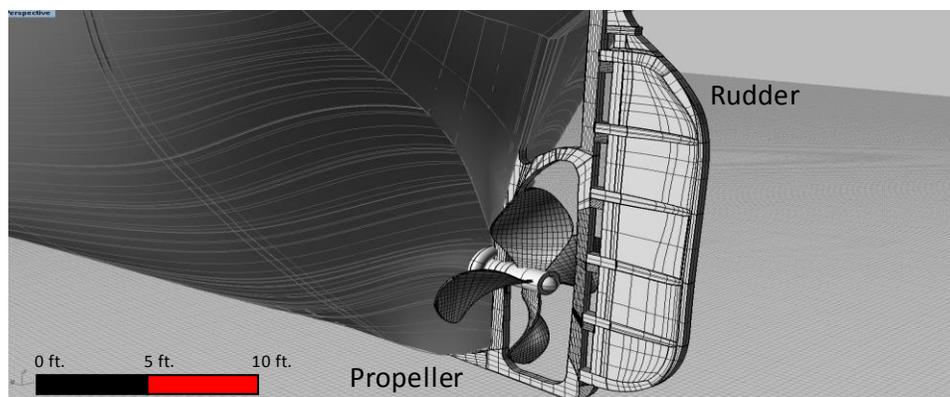
FIGURE 5.11. Image representing the finished rudder of *Caribsea* (Image by Kara Fox).

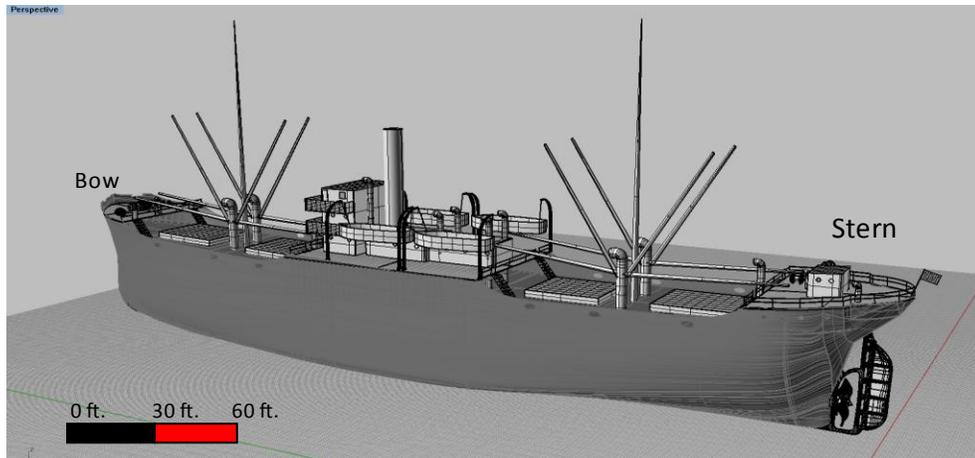
FIGURE 5.12. 3D *Caribsea* model with final auxiliary components (Image by Kara Fox).

Following the creation of the rudder, modeling efforts focused on auxiliary components including the stairs, ladders, cargo gear, hatch covers, lifeboats, piping, capstans, and the windlass. The development of these features required the use of the General Arrangement plans and historical conjecture developed from archival research and background information on steel ship construction. Additionally, based on the historical records, *Caribsea* was transporting 3,600 tons of manganese ore at the time of the shipwrecking event. Because this cargo feature was corroborated within the archaeological record, the 3D representation was established in the historical model—based on artistic ability and inference. The addition of these last features also further enhanced the authentic nature of *Caribsea* (Figure 5.12 and Figure 5.13).

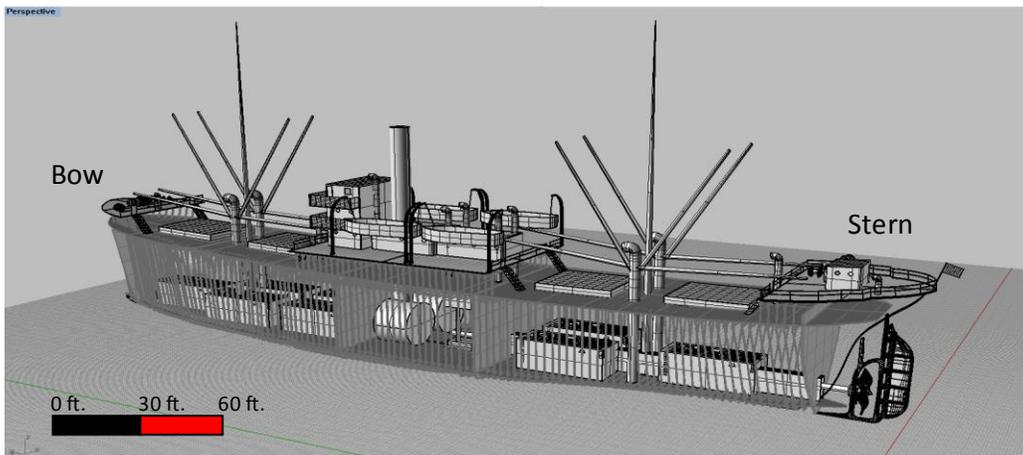
FIGURE 5.13. 3D *Caribsea* model with view of cargo hold (Image by Kara Fox).

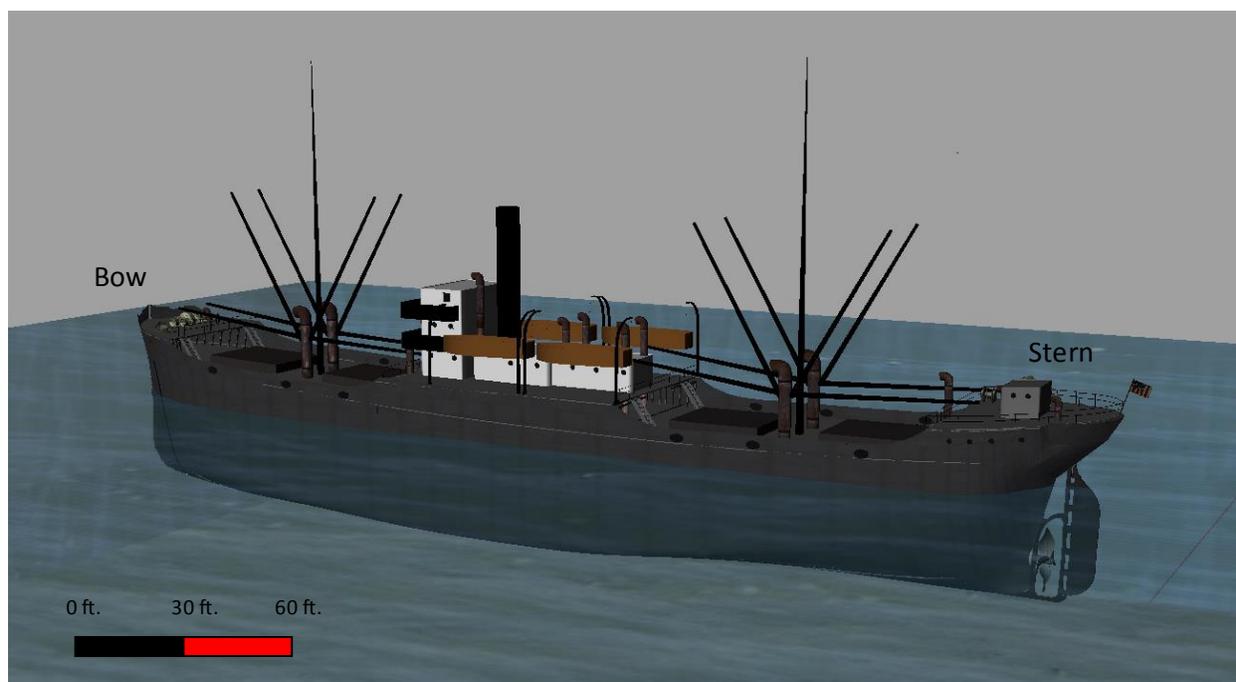
FIGURE 5.14. Image illustrating the final Historical *Caribsea* Model (Image by Kara Fox).

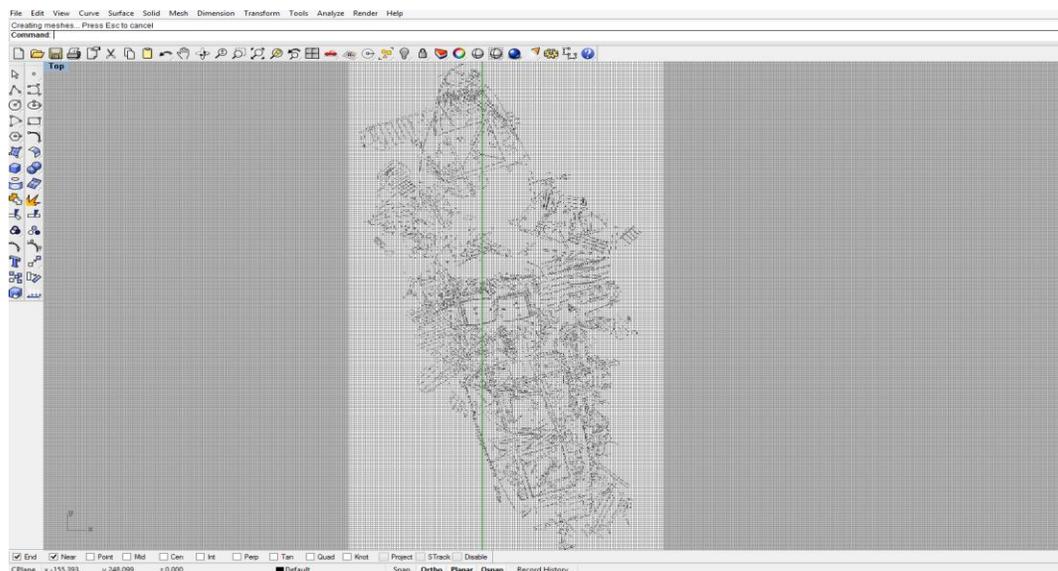
FIGURE 5.15. Site plan of *Caribsea* used as perimeter for shipwreck model (Image by Kara Fox).

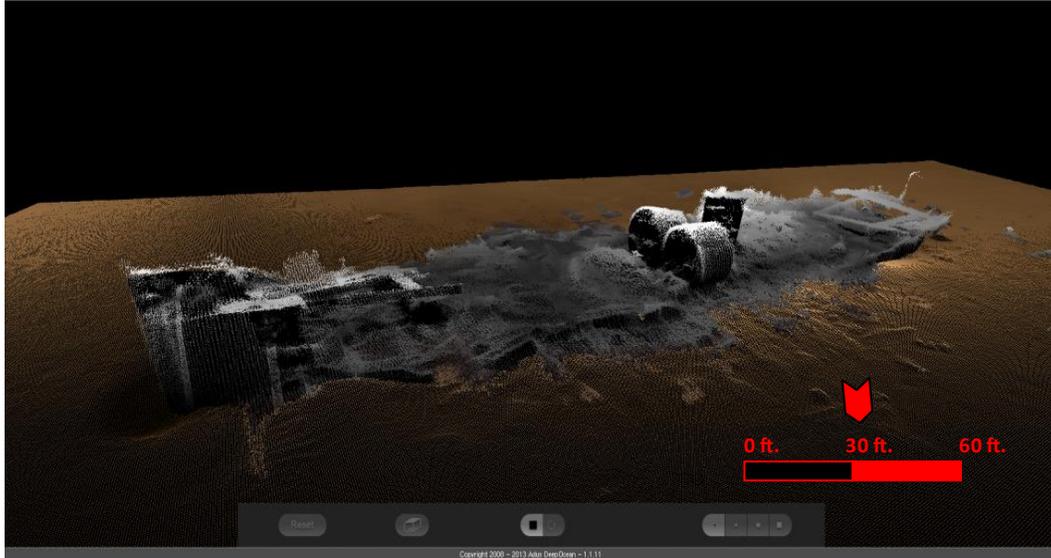
FIGURE 5.16. Example of altitude capability within ADUS *Caribsea* model (ADUS).

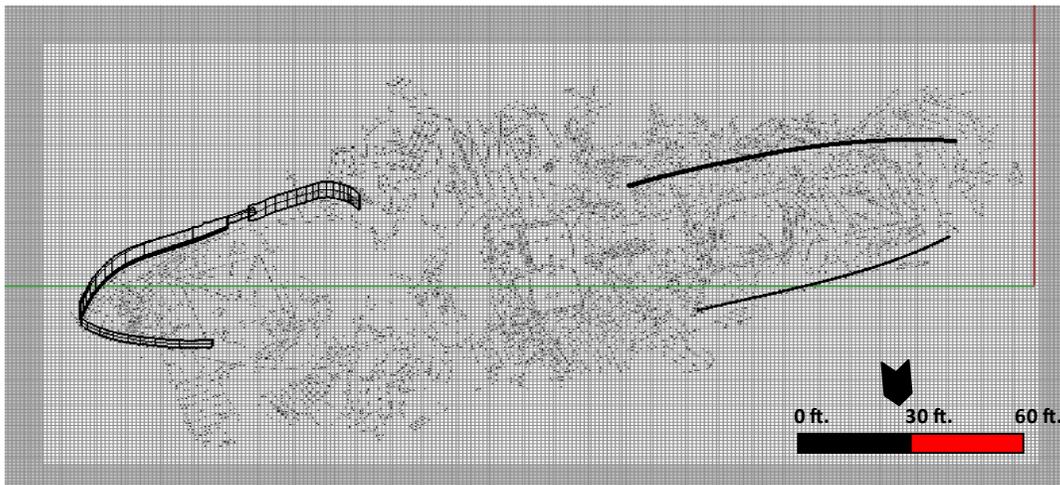
FIGURE 5.17. Plan view demonstrating the outlining of *Caribsea* site plan in *Rhino* (Image by Kara Fox).

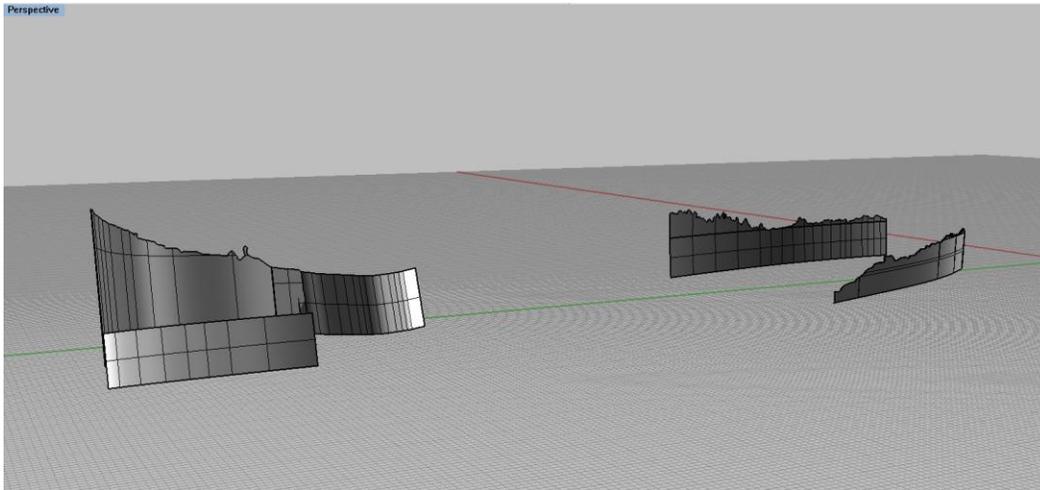
FIGURE 5.18. Perspective view demonstrating the outlining of site plan and the extrusion of the outer hull portions on shipwreck model (Image by Kara Fox).

Once the Rhino interface was prepared, the modeling process began. Reconstruction of the shipwreck model took place in a similar manner to the construction of the historical model of *Caribsea*. The existing outer hull sections were identified, traced, and extruded into surfaces (Figure 5.17). The bow and stern hull sections comprised the only two areas of overhead relief throughout the shipwreck site—and as such, had specific curvature, slope and deterioration. Utilizing the ADUS data and measuring tools, the accurate altitude and curvature of the outer hull was achieved (Figure 5.18).
