MATTERS OF STEEL:  
ILLUSTRATING AND ASSESSING THE DETERIORATION OF THE  
WORLDWAR II MERCHANT FREIGHTER *CARIBSEA*

A Thesis Presented to the Faculty of  
The Department of History  
East Carolina University

In Partial Fulfillment  
Of the Requirements for the Degree  
Master of Arts in Maritime Studies

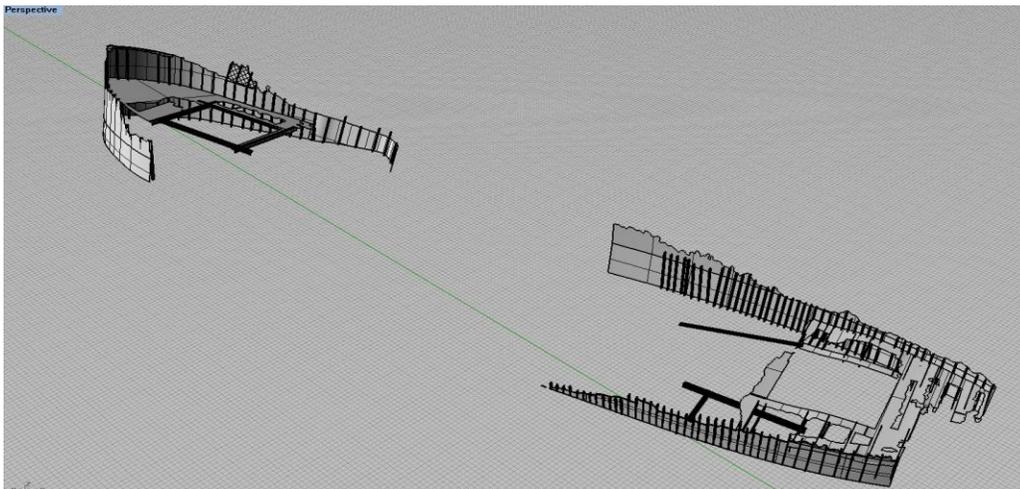
FIGURE 5.19. Example of structural components of *Caribsea* shipwreck model (Image by Kara Fox).

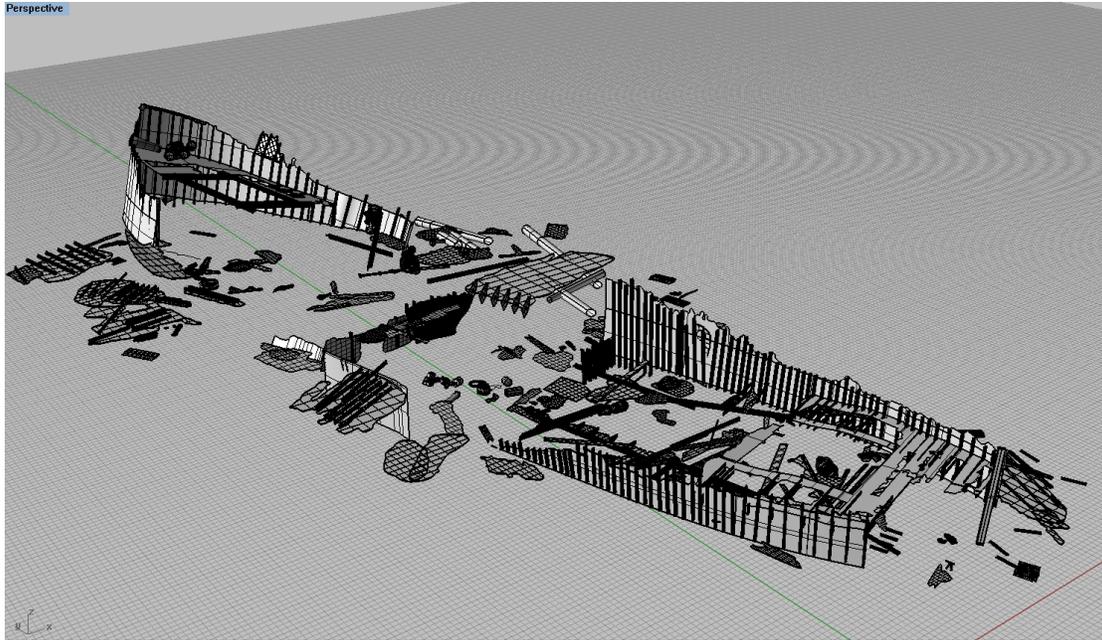
FIGURE 5.20. Example of shipwreck structure with debris field inside and surrounding the site (Image by Kara Fox).

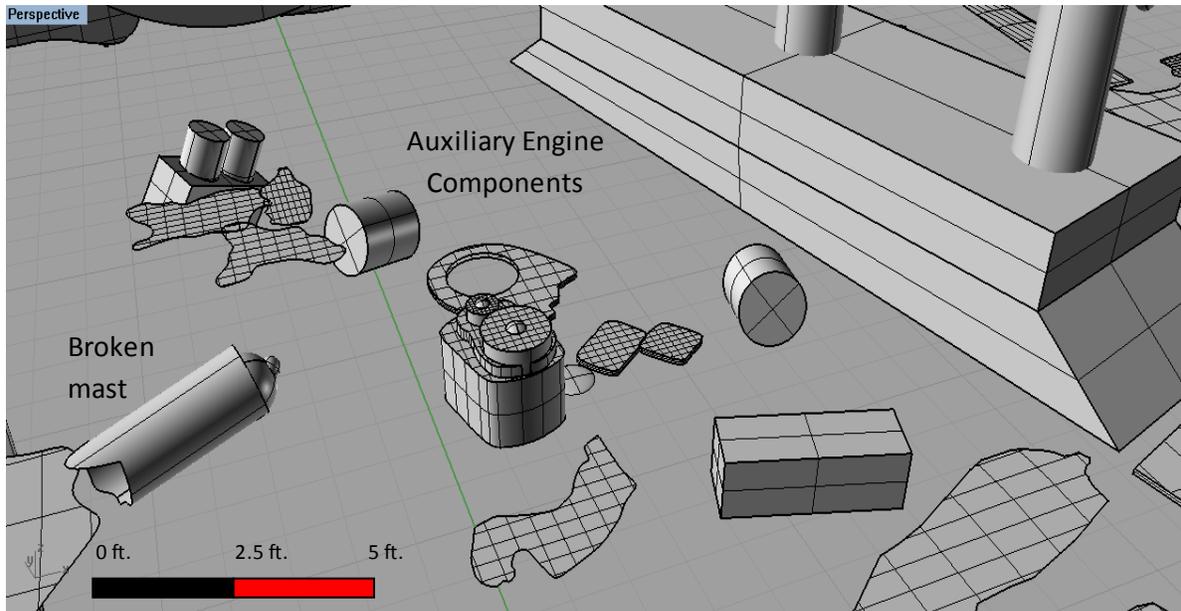
FIGURE 5.21. Engine auxiliary pieces identified and created on the port side of the engine (Image by Kara Fox).

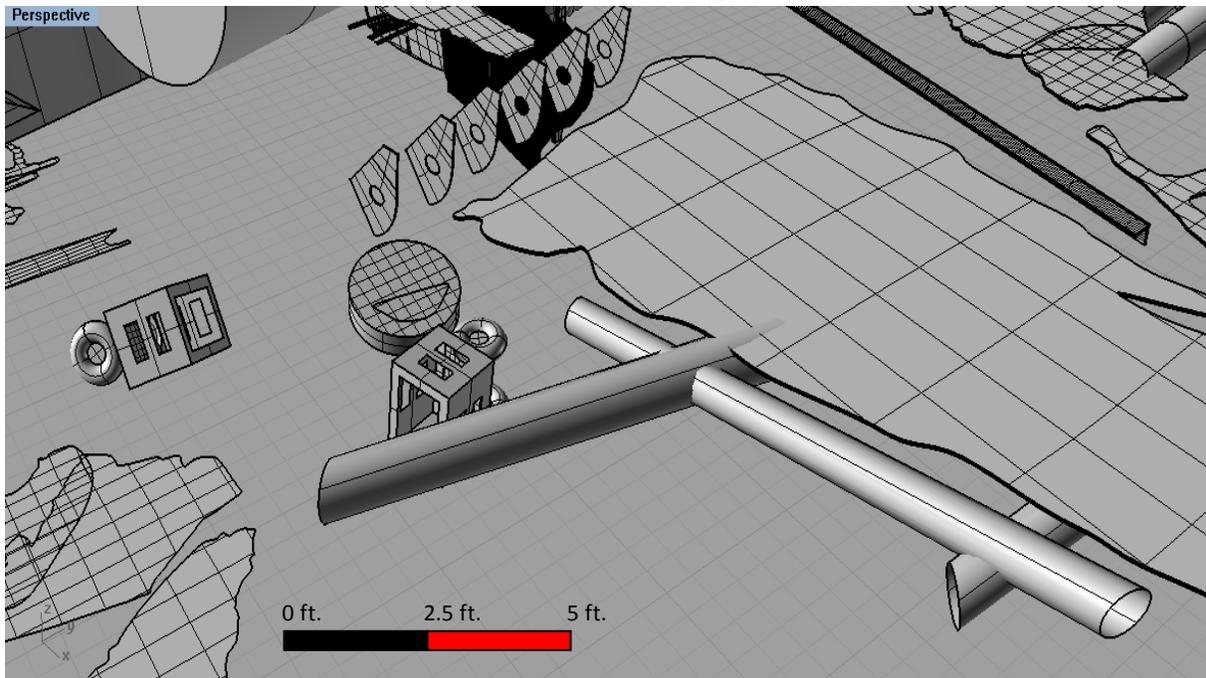
FIGURE 5.22. Cargo gear that was identified and created amongst the debris field on the starboard side (Image by Kara Fox).

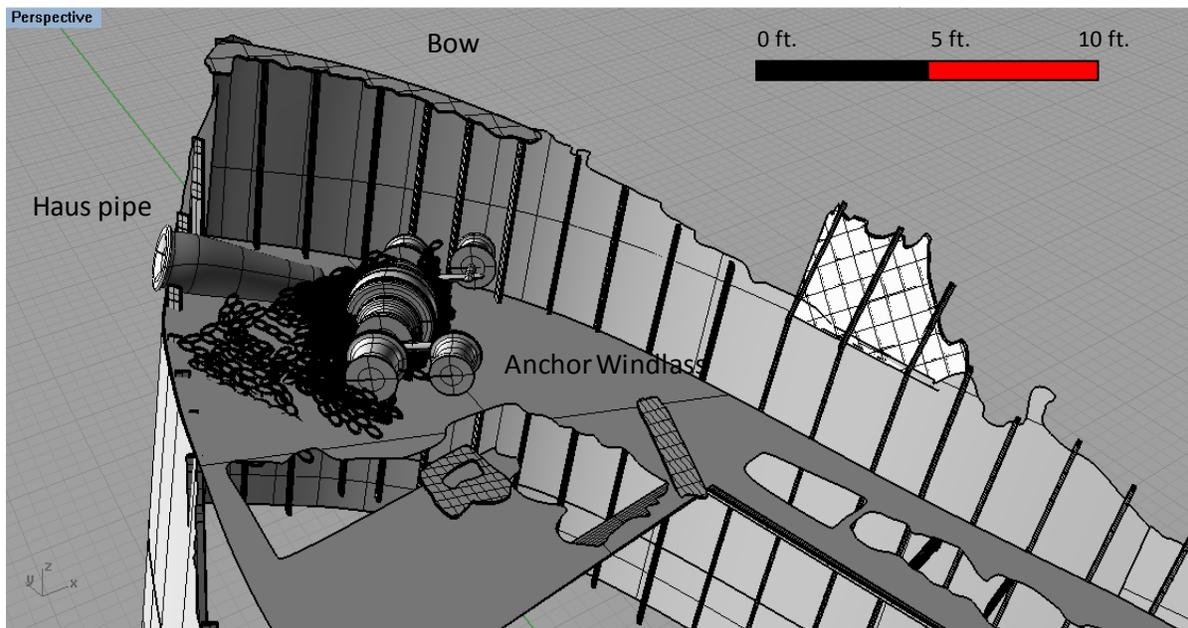
FIGURE 5.23. Large anchor windlass found on the bow section (Image by Kara Fox).

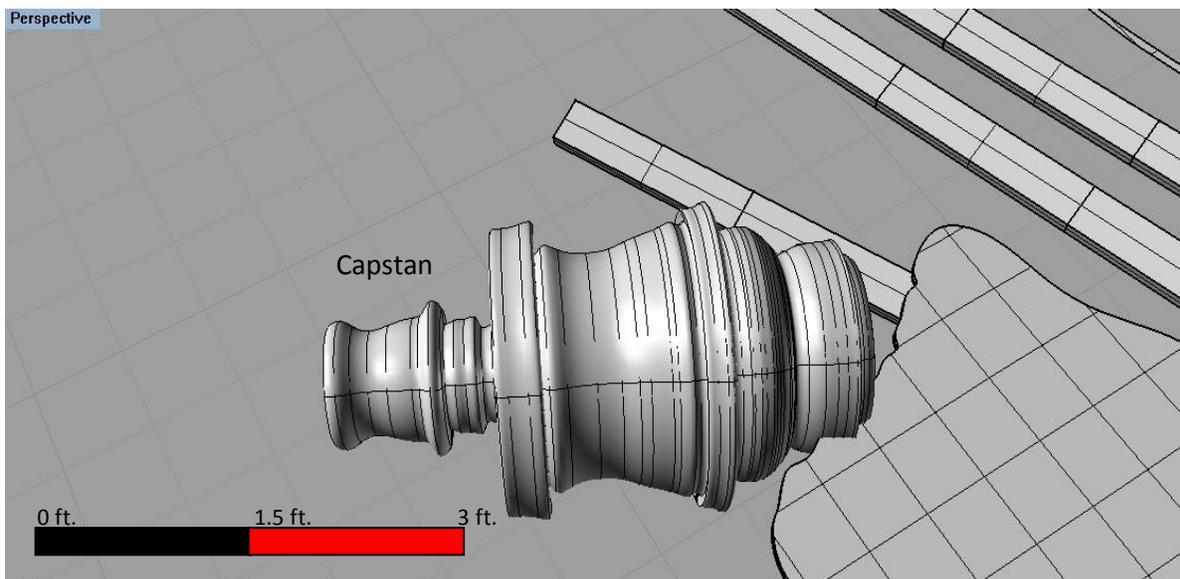
FIGURE 5.24. Example of a type of capstan found throughout the shipwreck site of *Caribsea* (Image by Kara Fox).

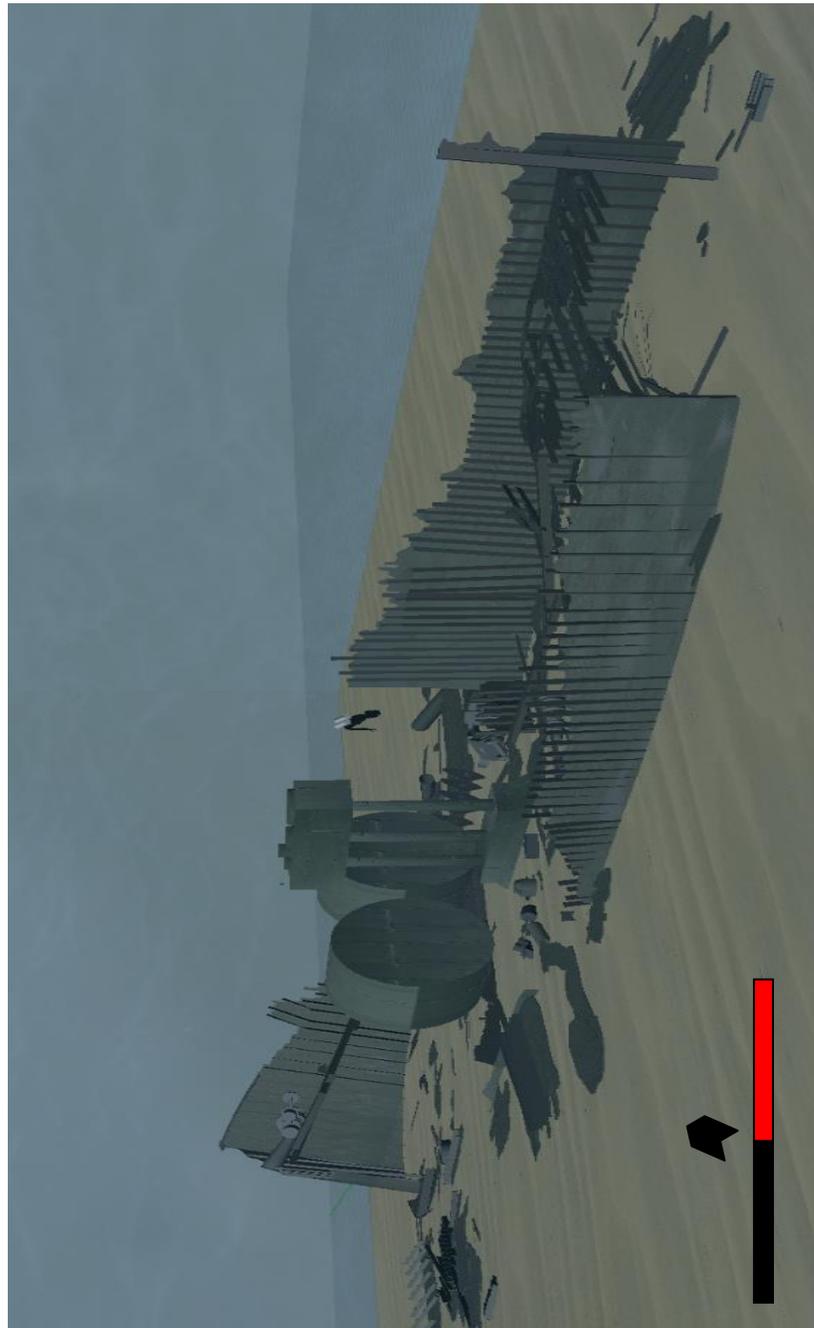
FIGURE 5.25. Example of 3D Current *Caribsea* Shipwreck Model (Image by Kara Fox).

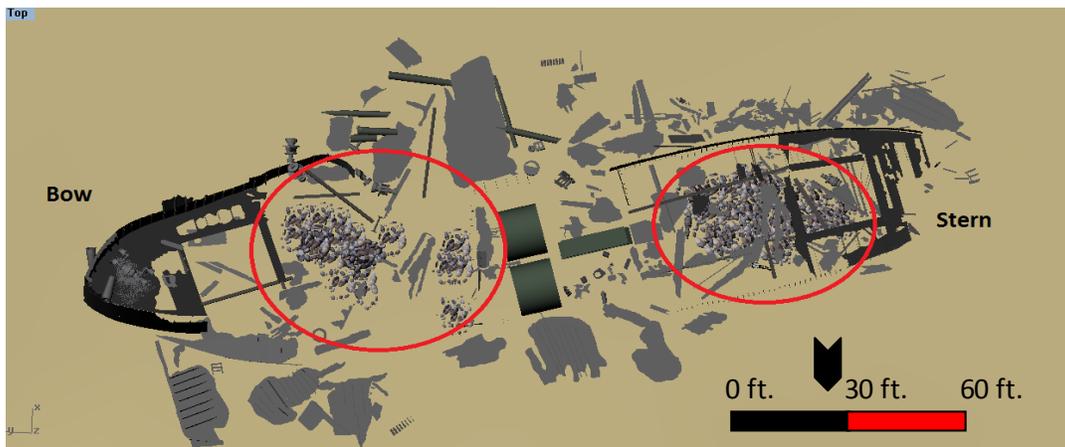
FIGURE 6.5. 3D shipwreck model of *Caribsea* illustrating manganese cargo dispersal within red circles (Image by Kara Fox).

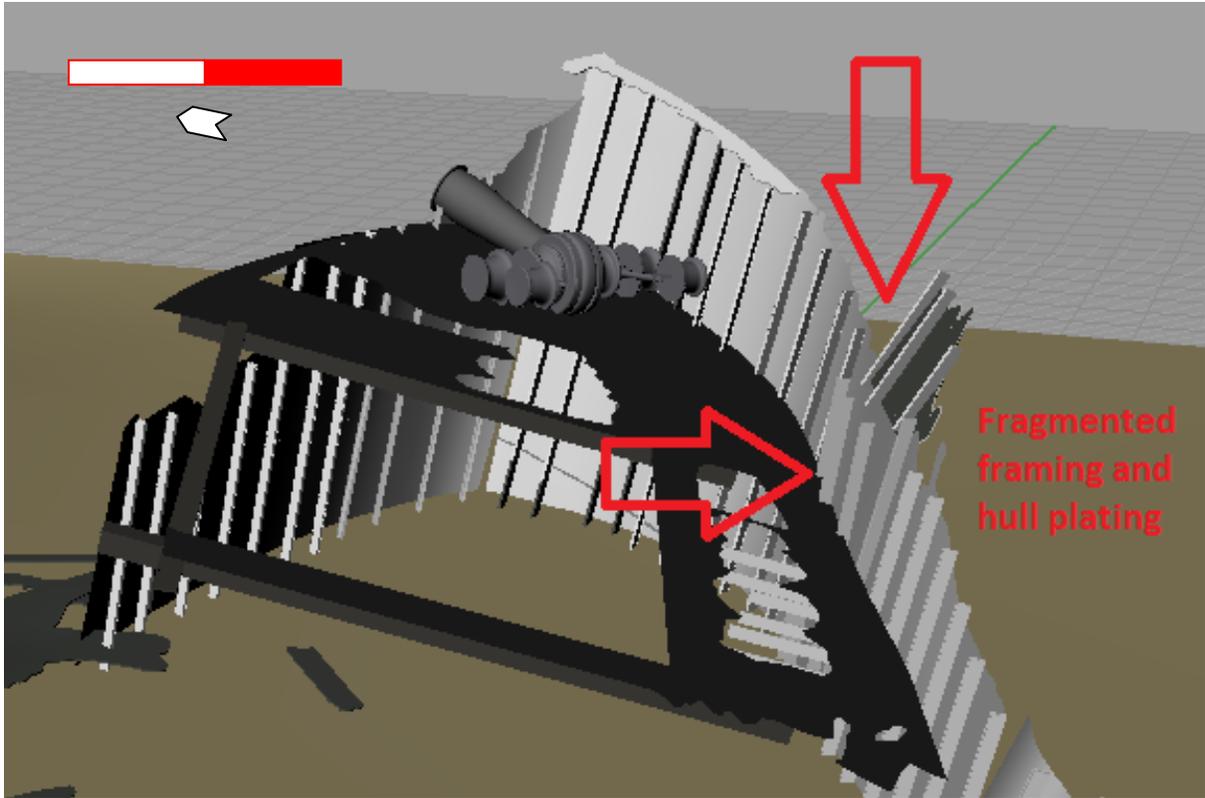
FIGURE 6.9. Image of Current *Caribsea* Shipwreck Model illustrating the fragmentation of starboard hull framing and plating (Image by Kara Fox).

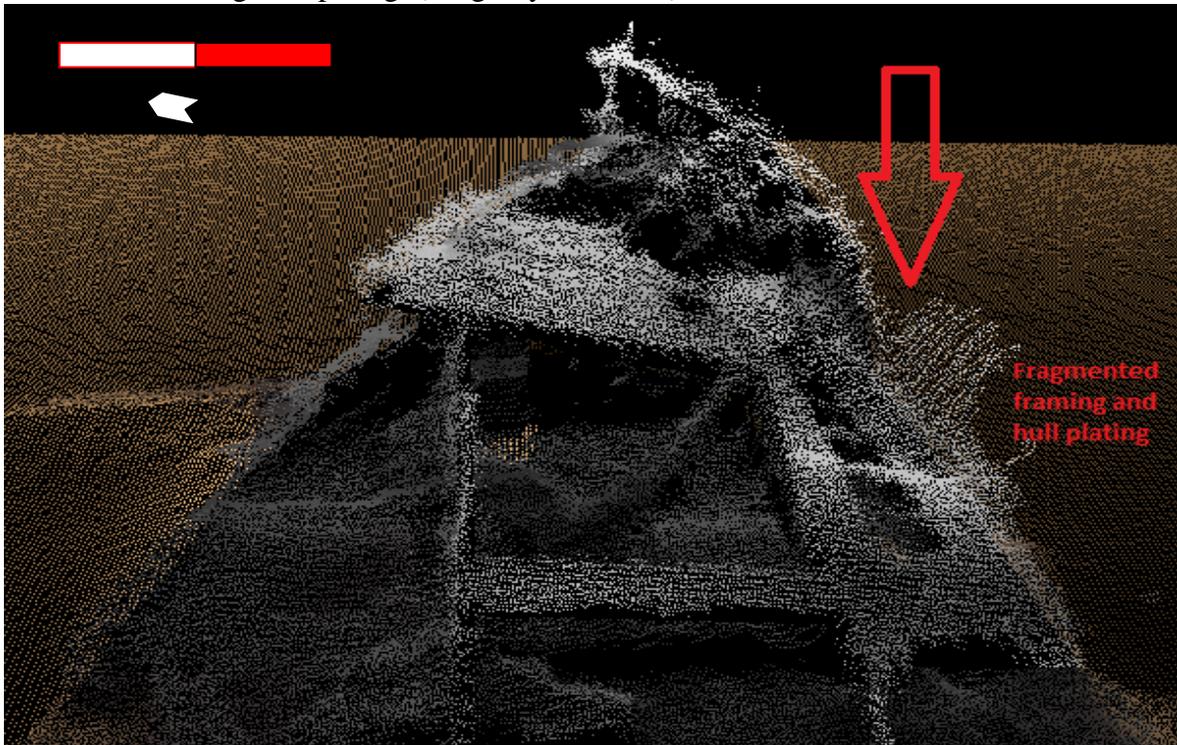
FIGURE 6.10. Multibeam of *Caribsea* illustrating the fragmentation of starboard hull framing and plating (NOAA).

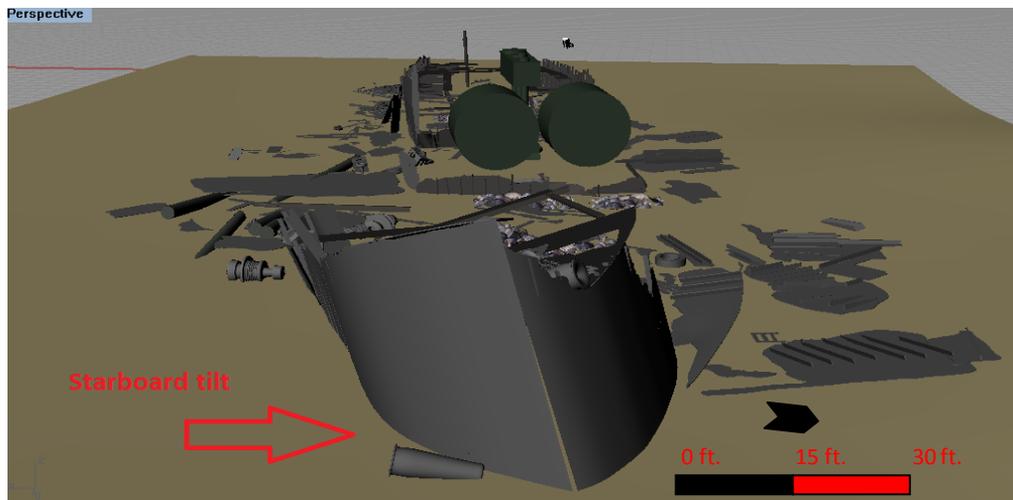
FIGURE 6.11. 3D model of *Caribsea* illustrating the apparent tilt of the hull (Image by Kara Fox).

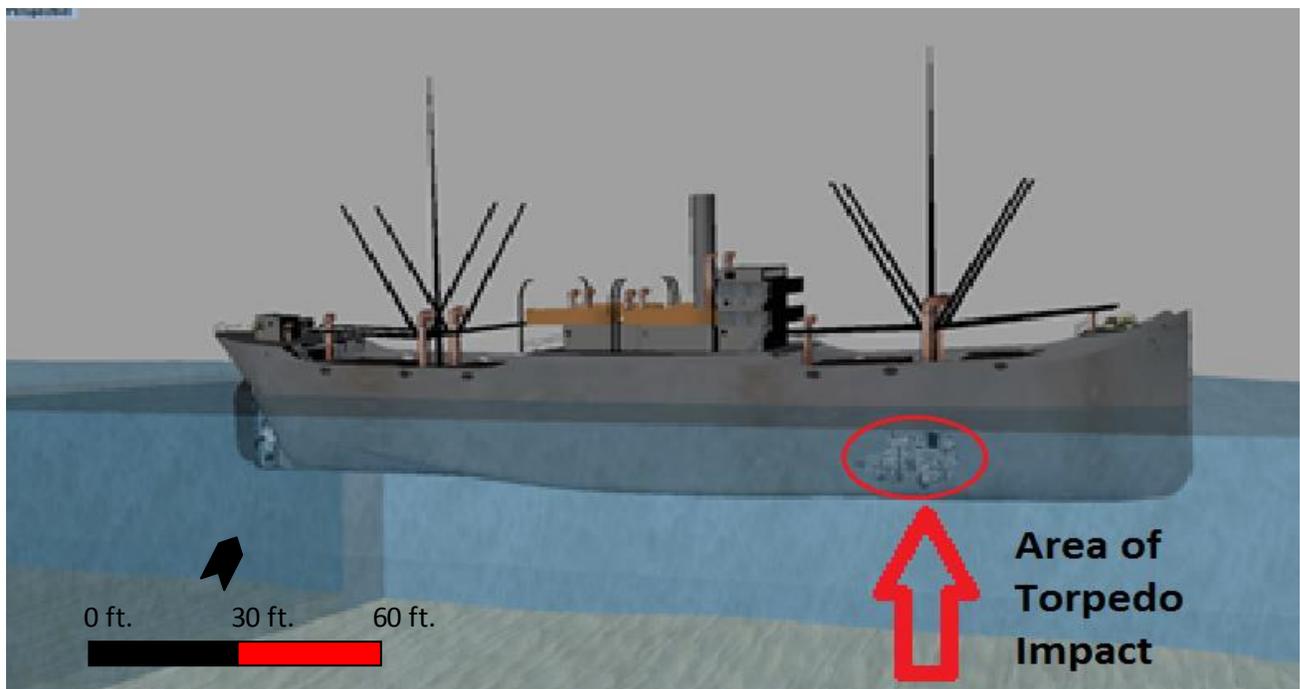
FIGURE 6.13. Image of Torpedoed *Caribsea* Model illustrating the potential location of the torpedo impact (Image by Kara Fox).

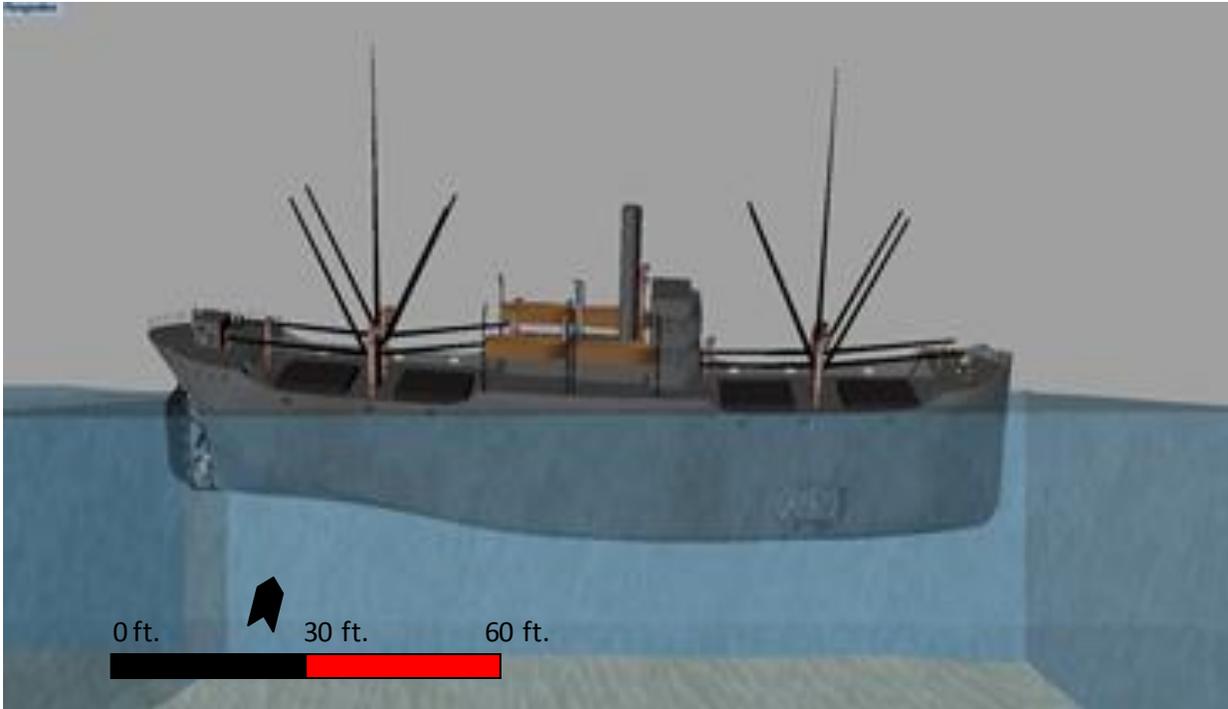
FIGURE 6.14. Hypothesized image of Sinking *Caribsea* Model illustrating the severe listing of the ship as it sank (Image by Kara Fox).

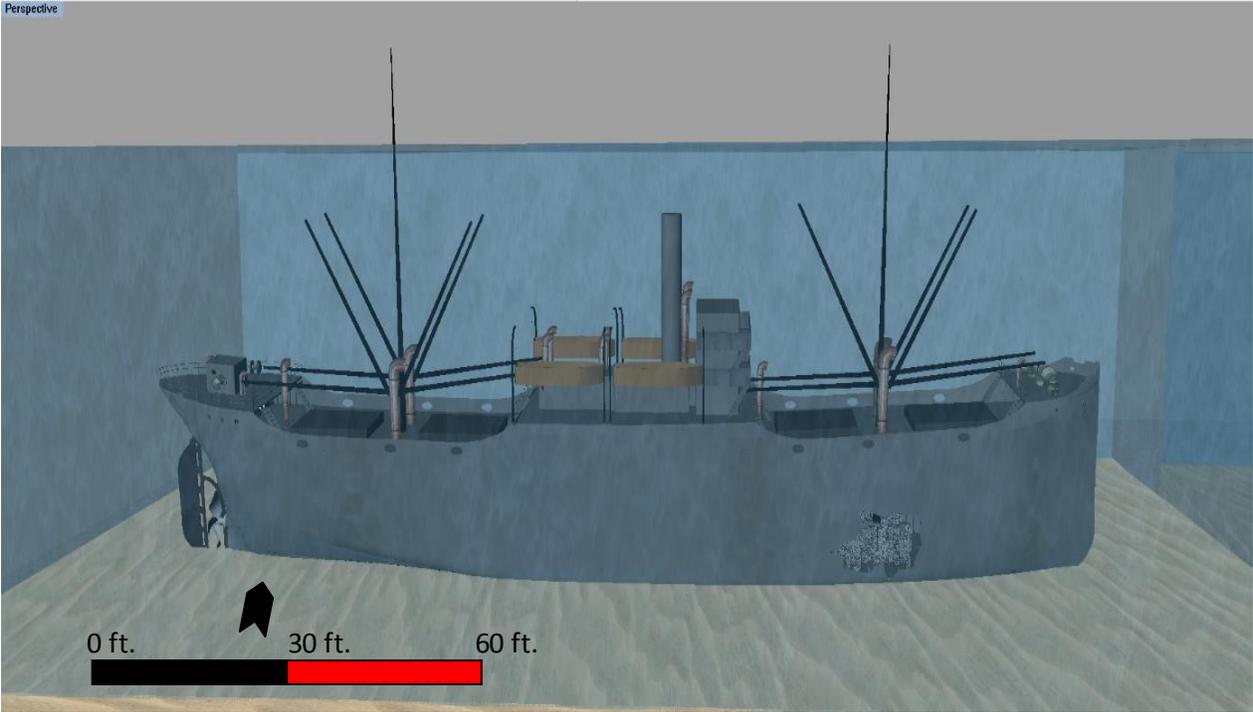
FIGURE 6.15. Hypothesized image of Submerged *Caribsea* Model illustrating the positioning and condition of *Caribsea* upon sinking (Image by Kara Fox).

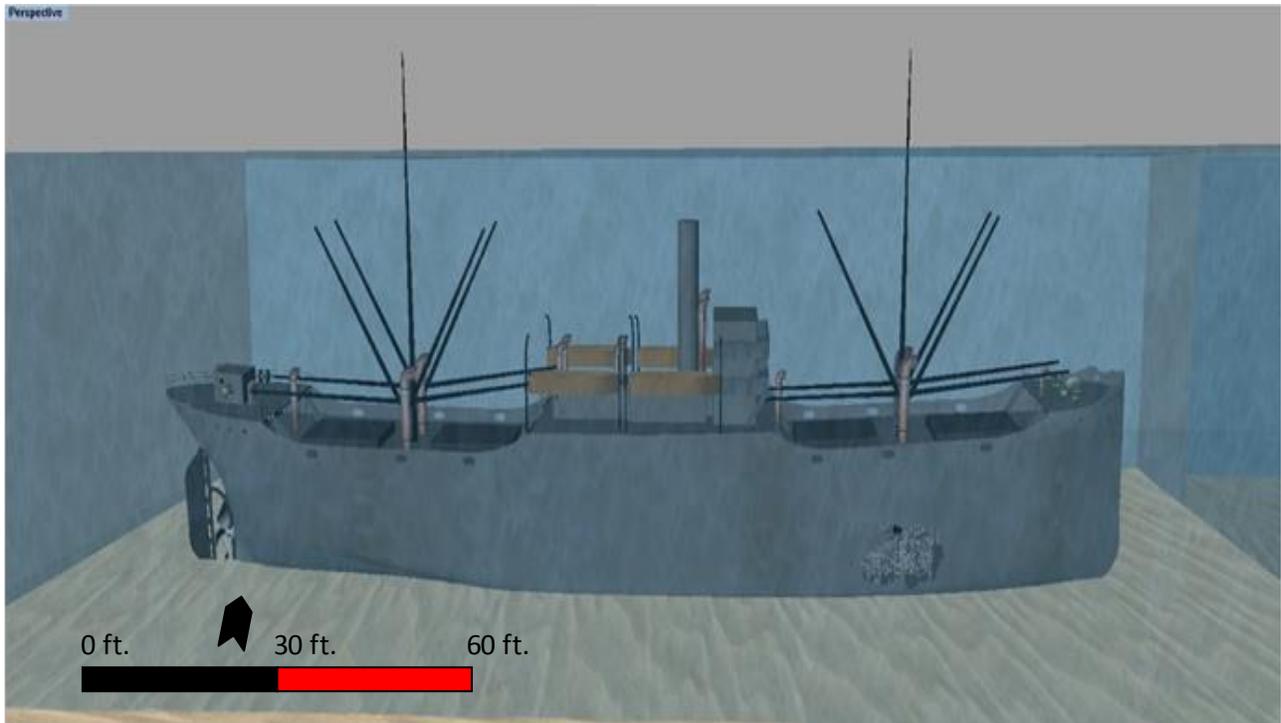
FIGURE 6.16. Image of Submerged *Caribsea* Model illustrating the condition of the shipwreck site prior to extreme site transformation (Image by Kara Fox).

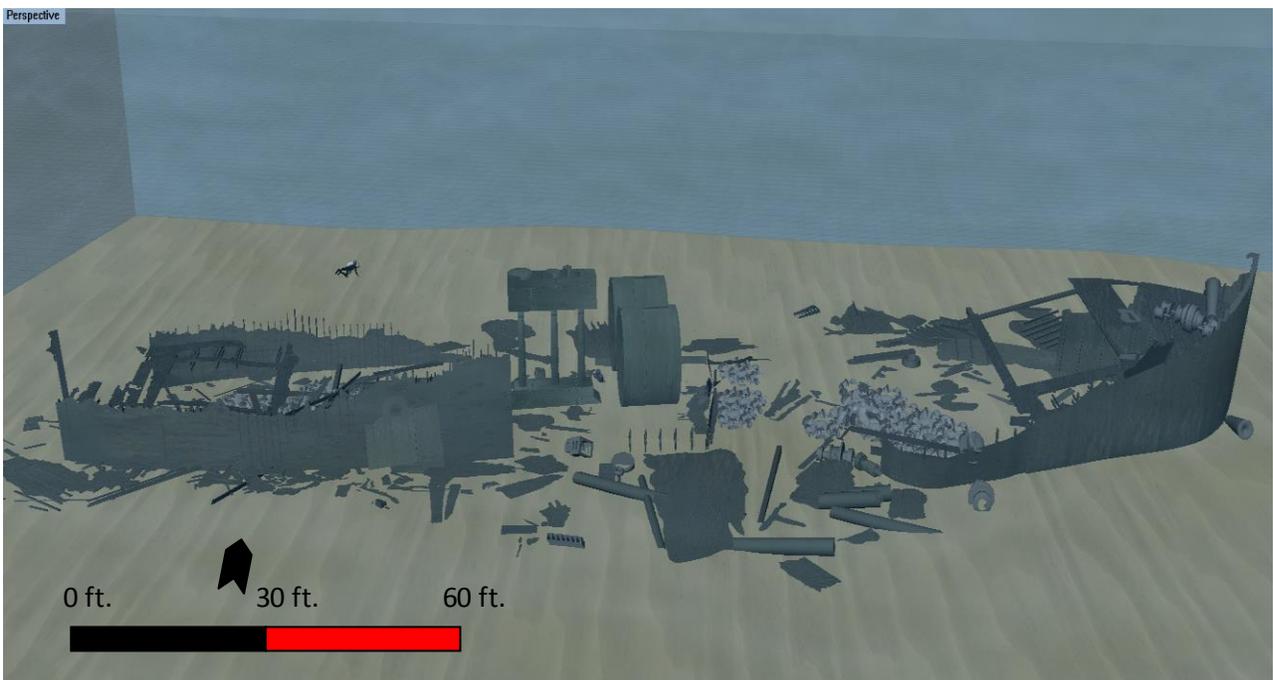
FIGURE 6.17. Image of Current *Caribsea* Model illustrating the current condition of the shipwreck site following site transformations (Image by Kara Fox).

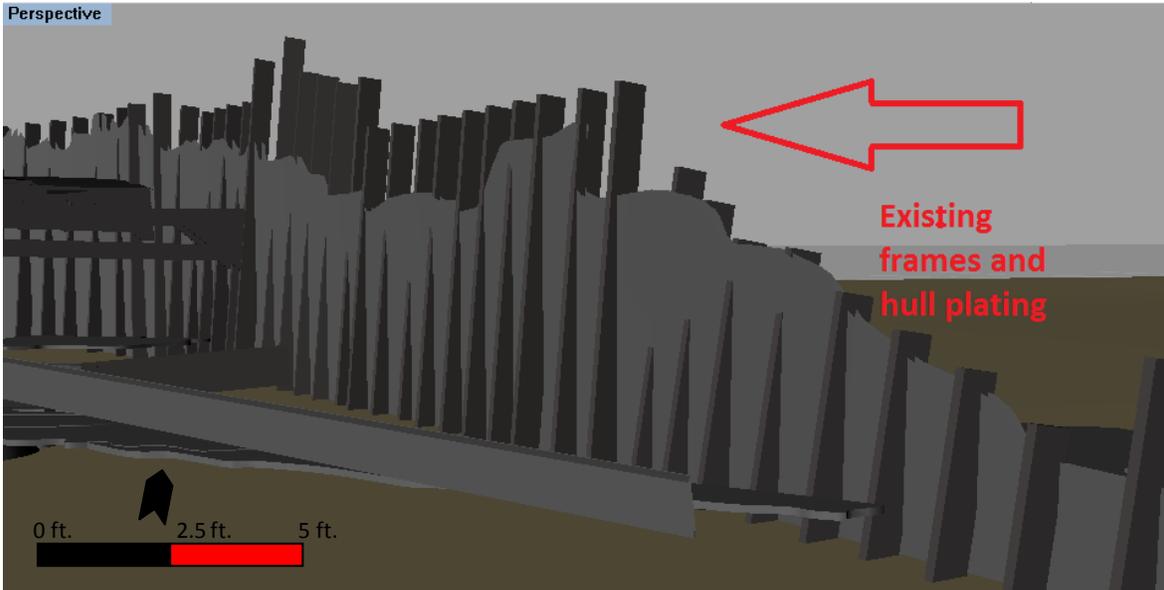
FIGURE 6.18. Image illustrating existing frames and hull plating on starboard side of shipwreck (Image by Kara Fox).

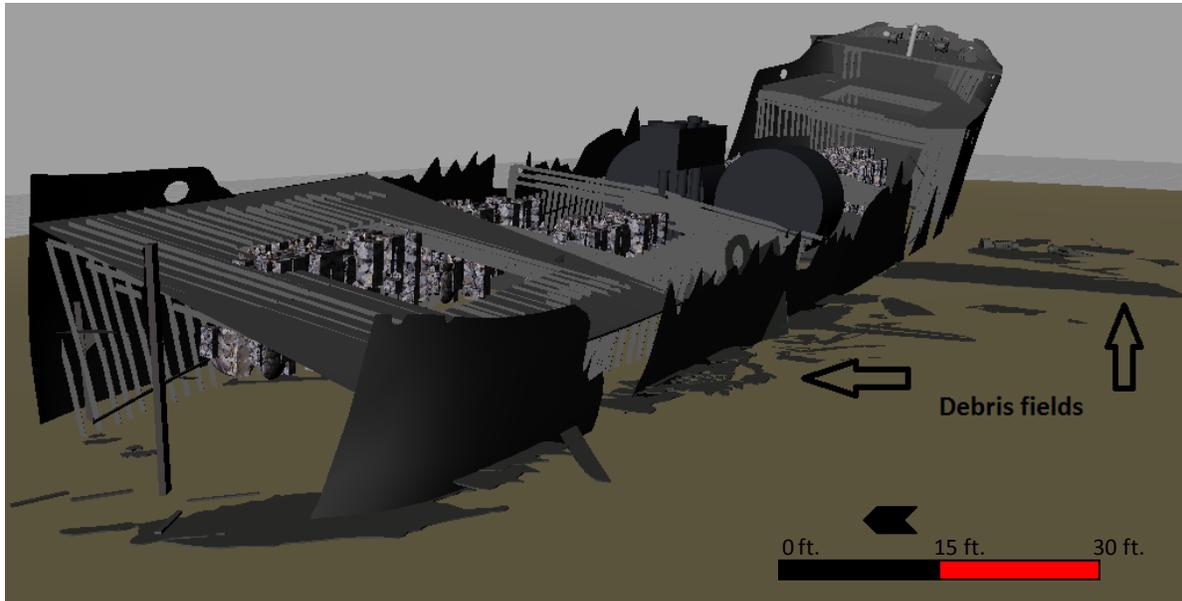
FIGURE 6.20. Image illustrating the debris fields in Post-Salvage *Caribsea* Model (Image by Kara Fox).

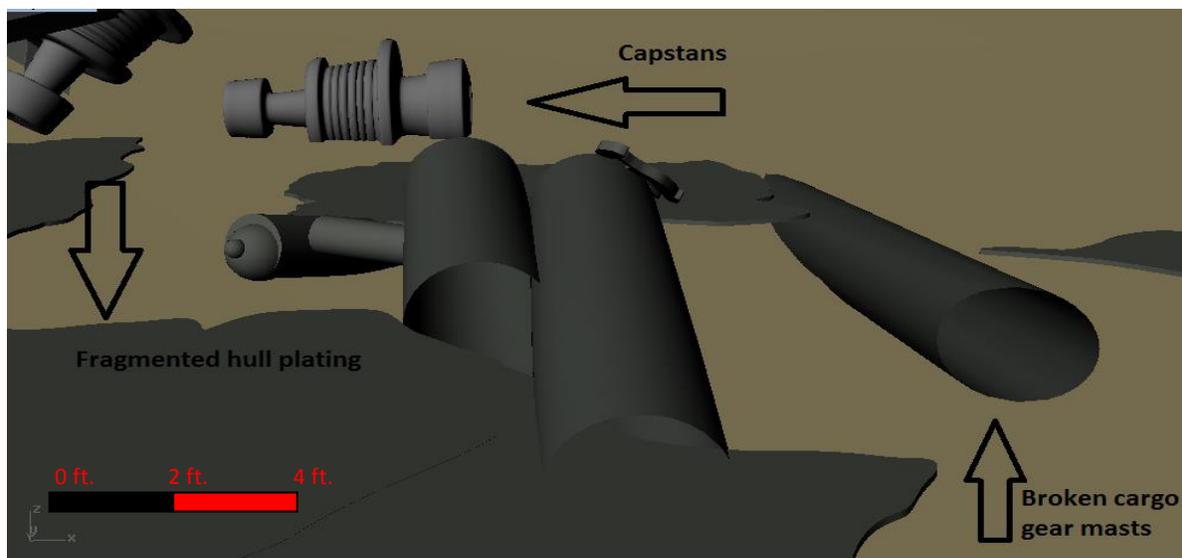
FIGURE 6.21. Image illustrating detailed view of objects in debris field from Post-Salvage *Caribsea* Model (Image by Kara Fox).

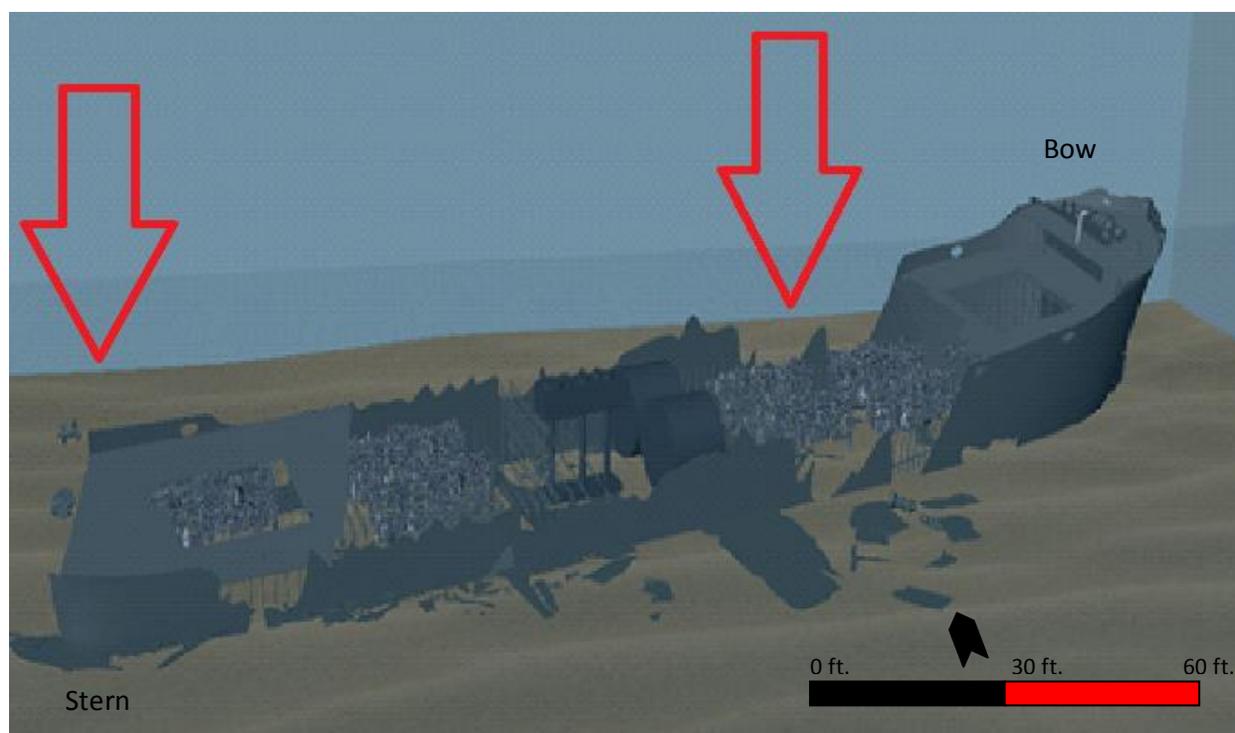
FIGURE 6.22. Image of Post-Salvage *Caribsea* Model illustrating the severe disarticulation caused by hypothesized Navy Salvage Service depth charges (location of damage highlighted by red arrows) (Image by Kara Fox).

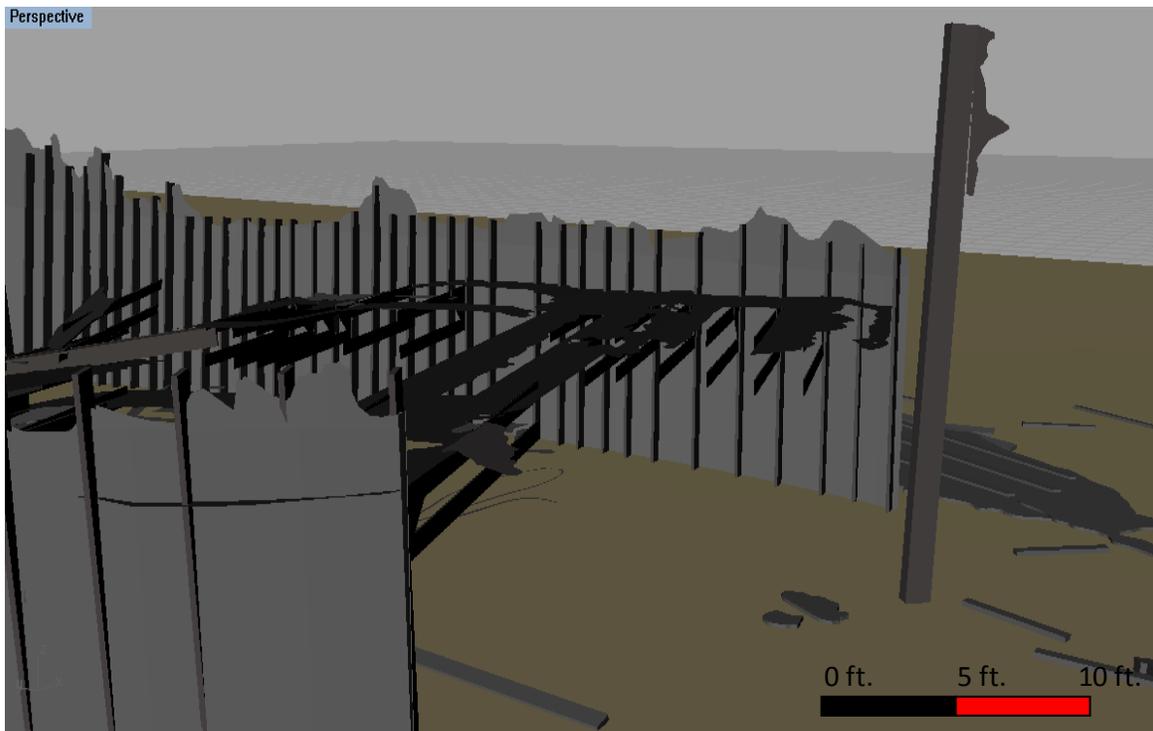
FIGURE 6.23. Image of 3D *Caribsea* Shipwreck Model illustrating the missing stern section of the shipwreck (Image by Kara Fox).

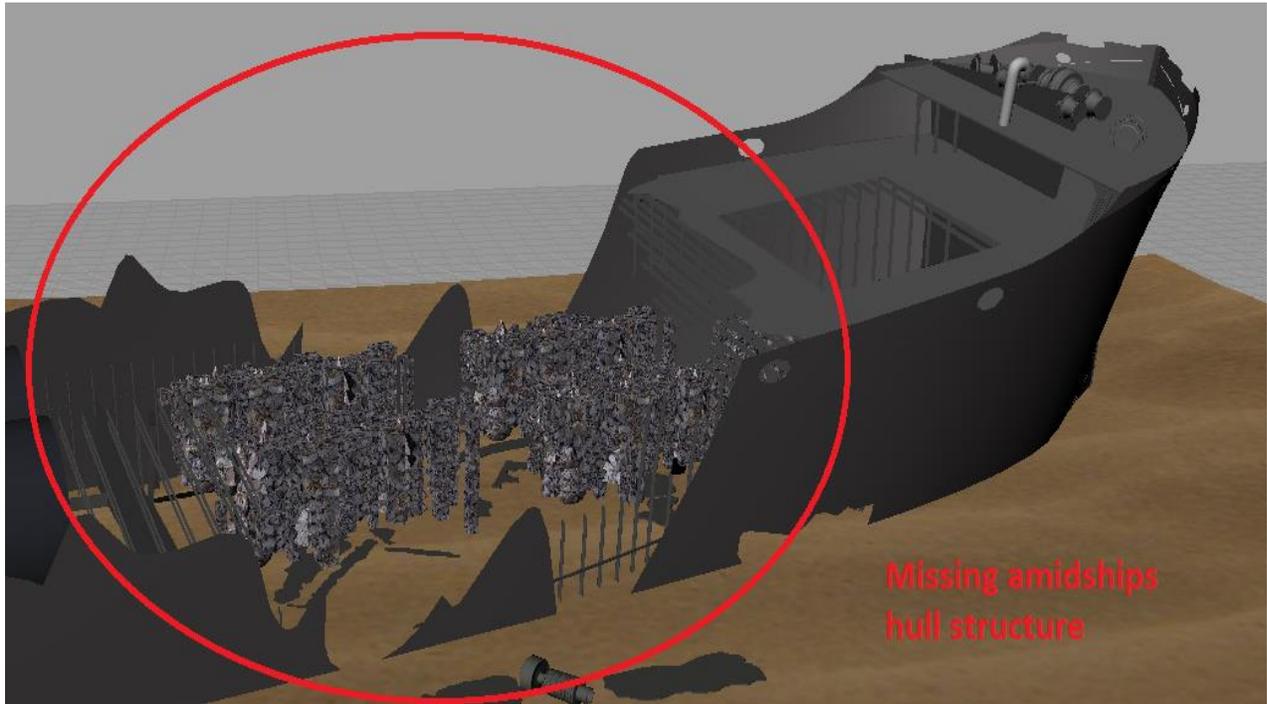
FIGURE 6.25. Image illustrating the missing hull structure on Post-Salvage *Caribsea* Model (Image by Kara Fox).

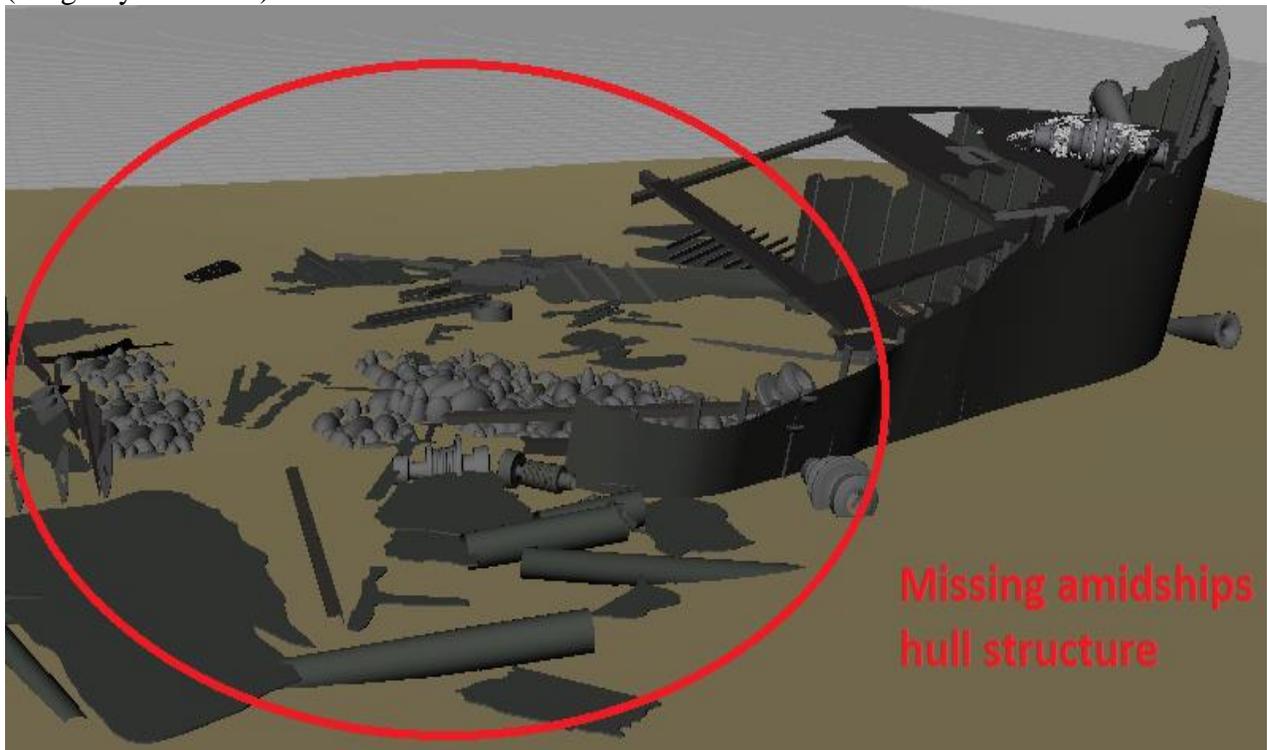
FIGURE 6.26. Image illustrating missing hull structure on Current *Caribsea* Shipwreck Model (Image by Kara Fox).

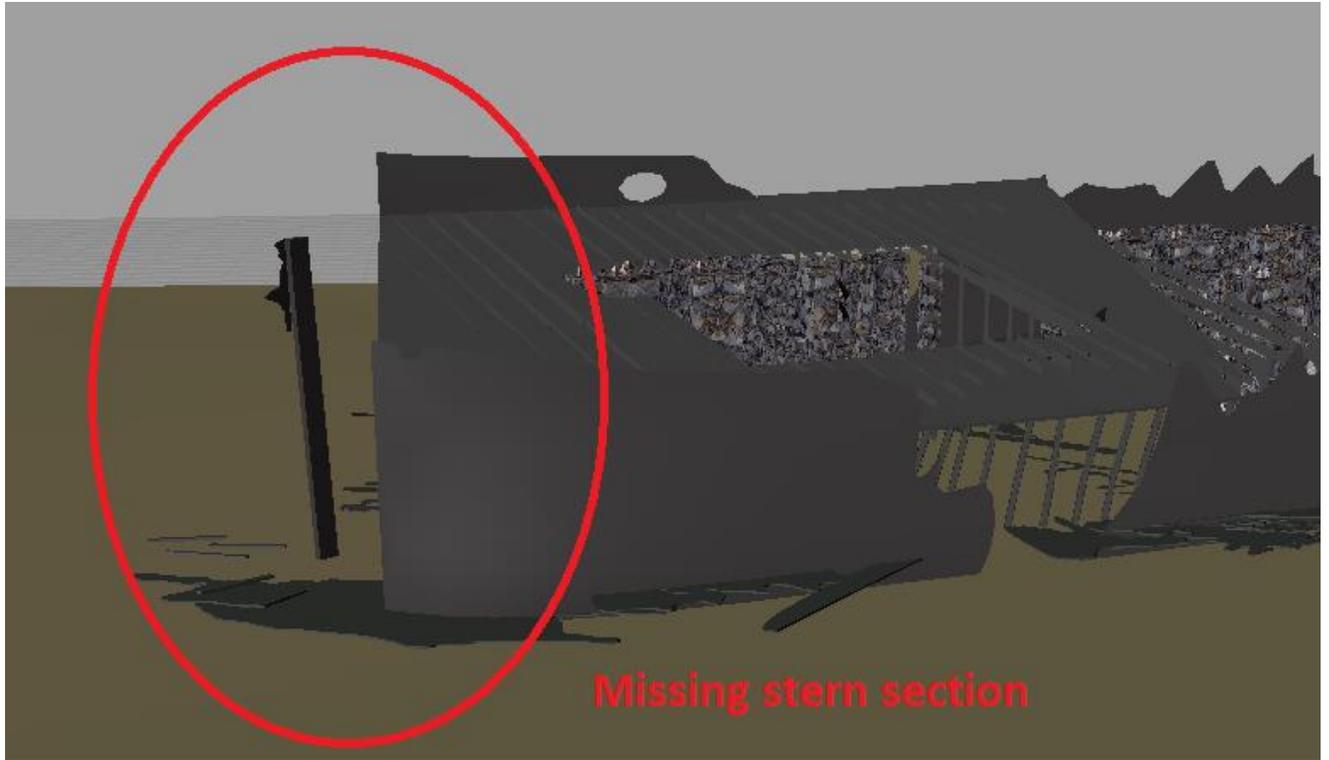
FIGURE 6.27. Image illustrating missing stern structure on Post-Salvage *Caribsea* Shipwreck Model (Image by Kara Fox).

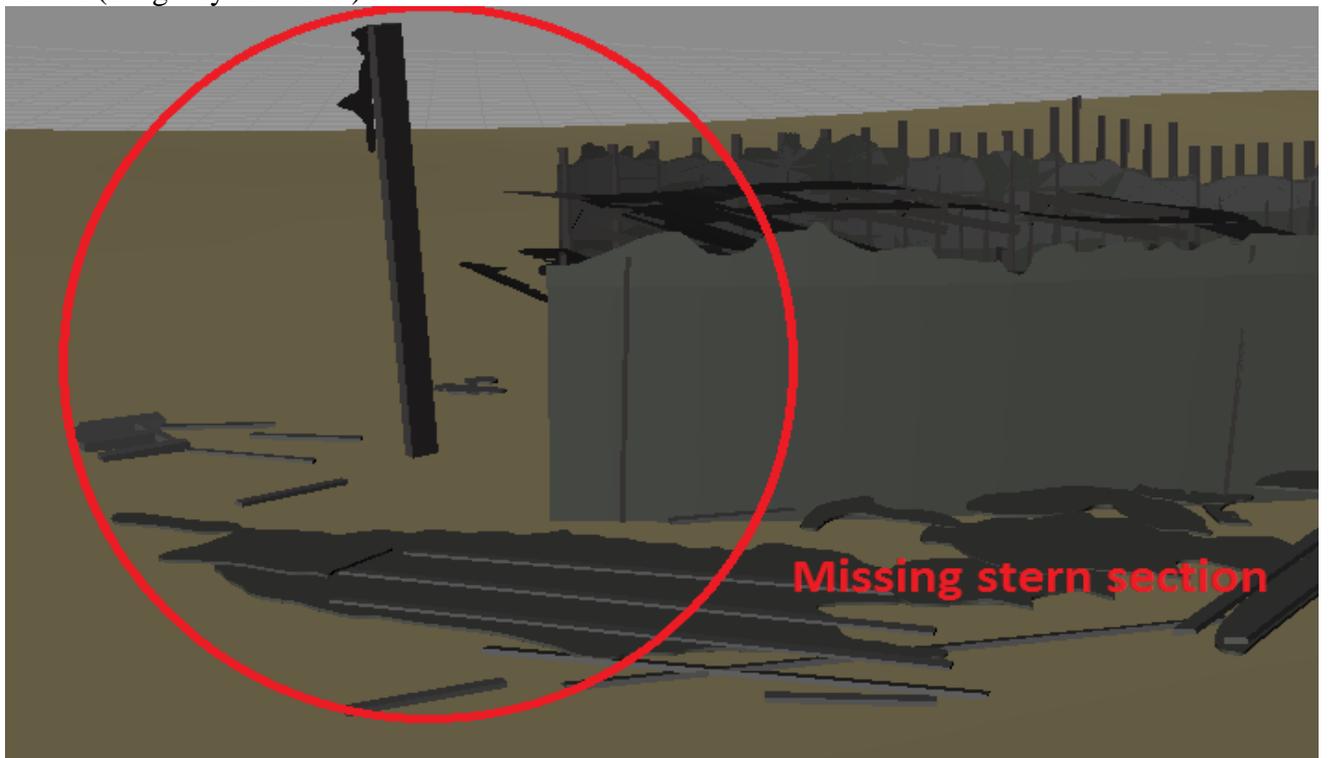
FIGURE 6.28. Image illustrating missing stern structure on Current *Caribsea* Shipwreck Model (Image by Kara Fox).

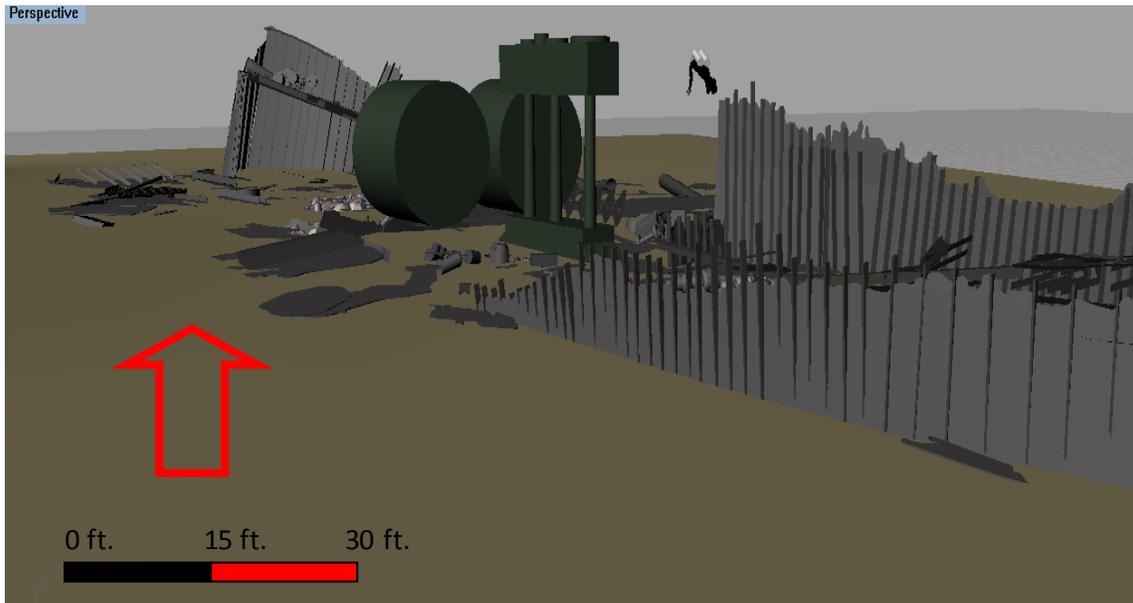
FIGURE 6.29. Port side of shipwreck exhibiting more sand scouring and sediment buildup (Image by Kara Fox).

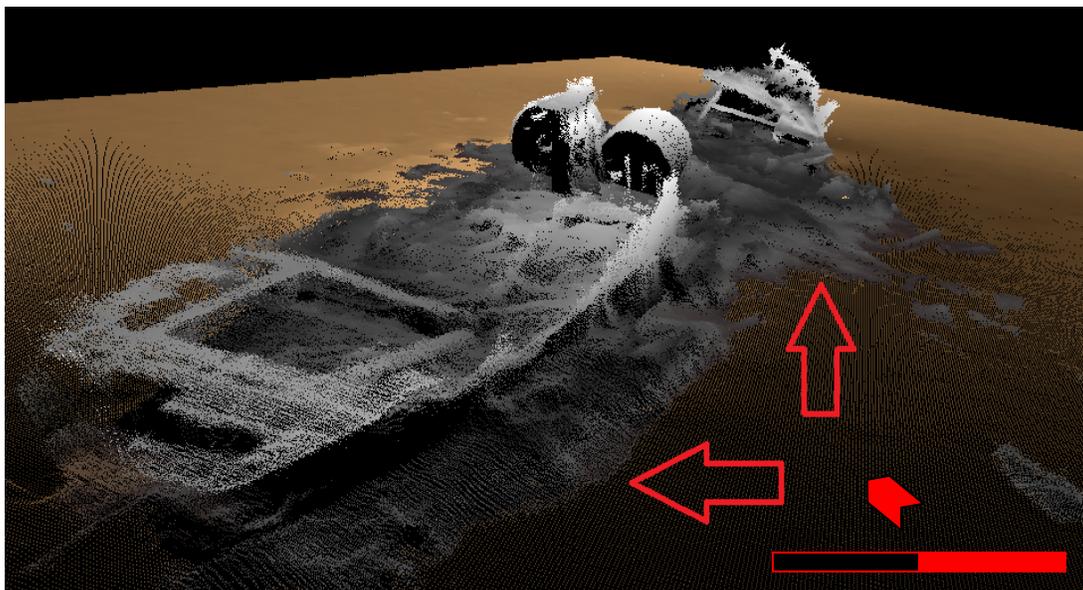
FIGURE 6.32. Multibeam imagery illustrating starboard side of shipwreck site exhibiting a more exposed debris field due to minimalized sedimentation (NOAA).
