MATTERS OF STEEL:  
ILLUSTRATING AND ASSESSING THE DETERIORATION OF THE  
WORLDWAR II MERCHANT FREIGHTER *CARIBSEA*

A Thesis Presented to the Faculty of  
The Department of History  
East Carolina University

In Partial Fulfillment  
Of the Requirements for the Degree  
Master of Arts in Maritime Studies

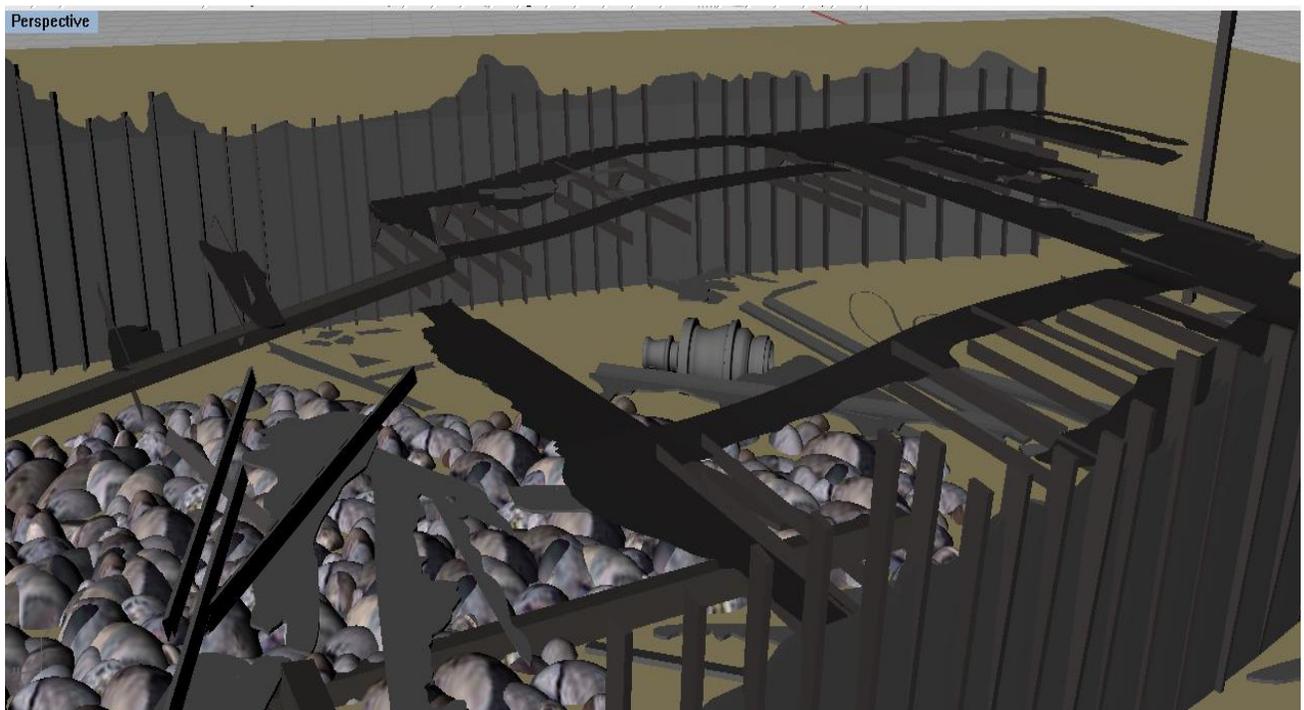
FIGURE 6.33. Image illustrating existing upper decking in stern section (Image by Kara Fox).

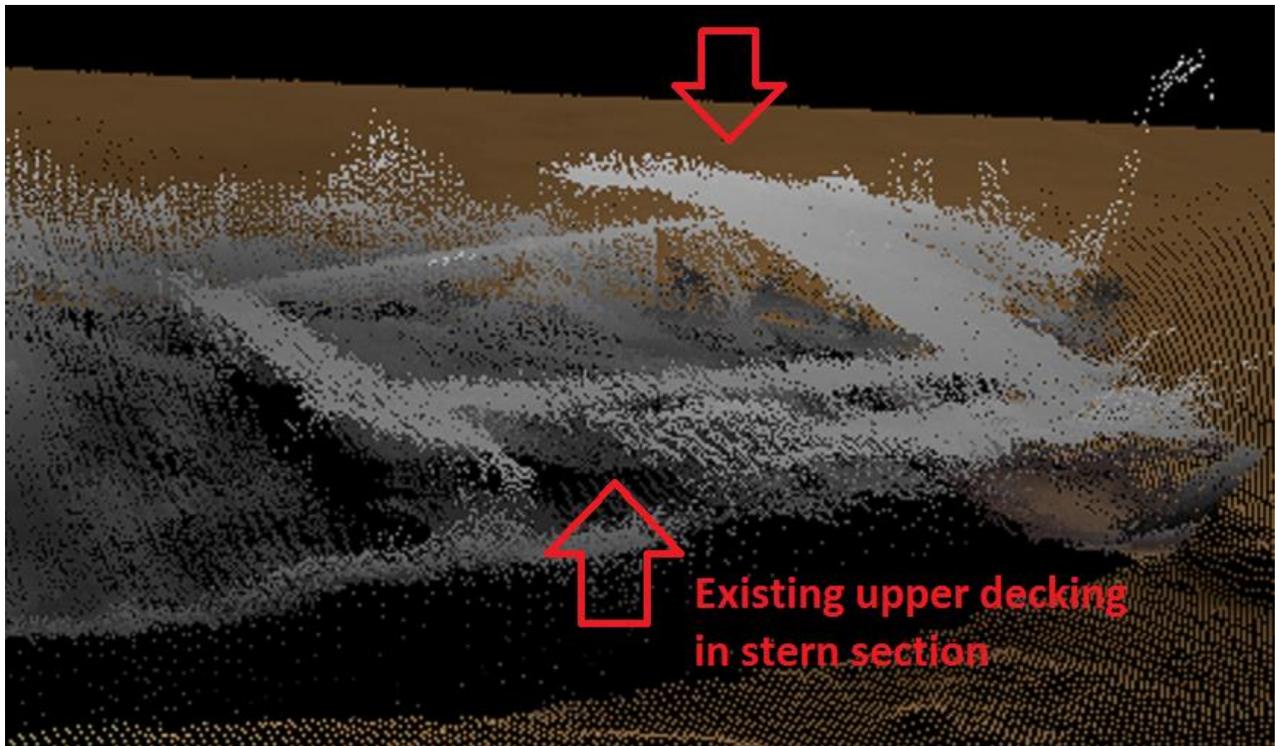
FIGURE 6.34. Multibeam imagery illustrating existing upper decking in stern section (Source: NOAA).

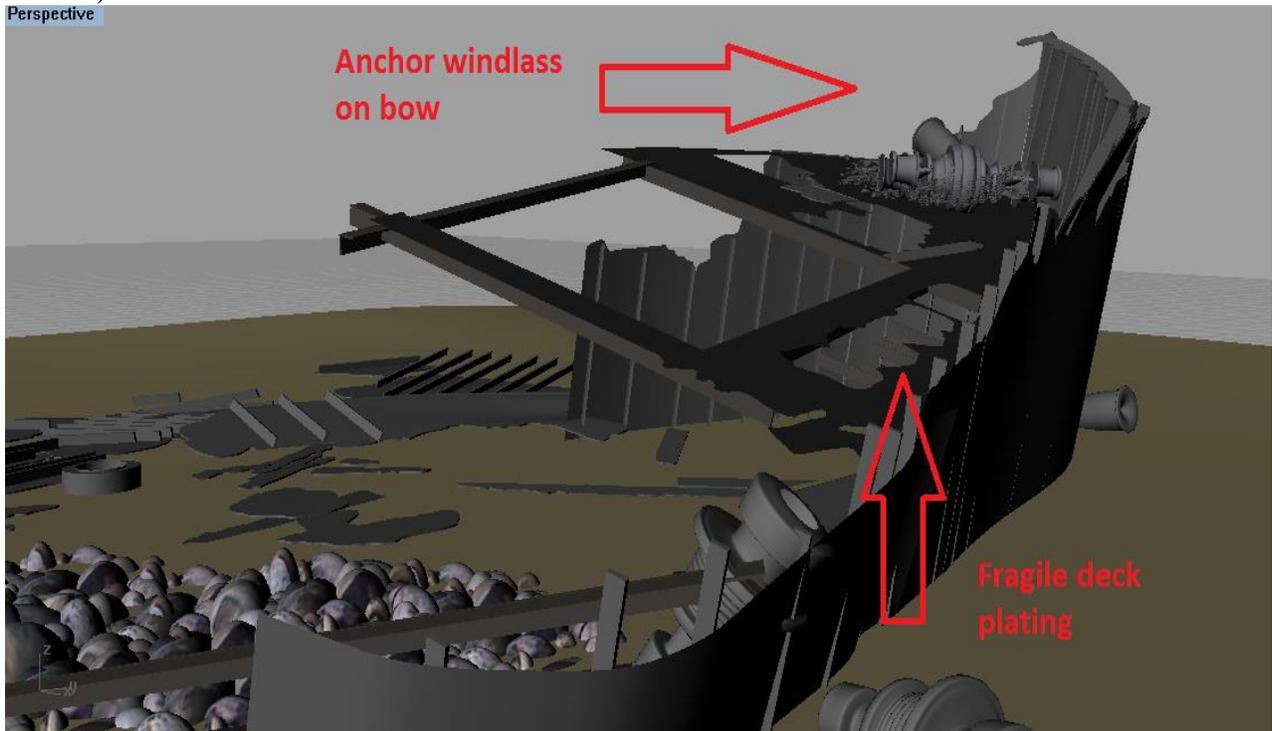
FIGURE 6.35. Image illustrating existing upper decking in bow section (Image by Kara Fox).

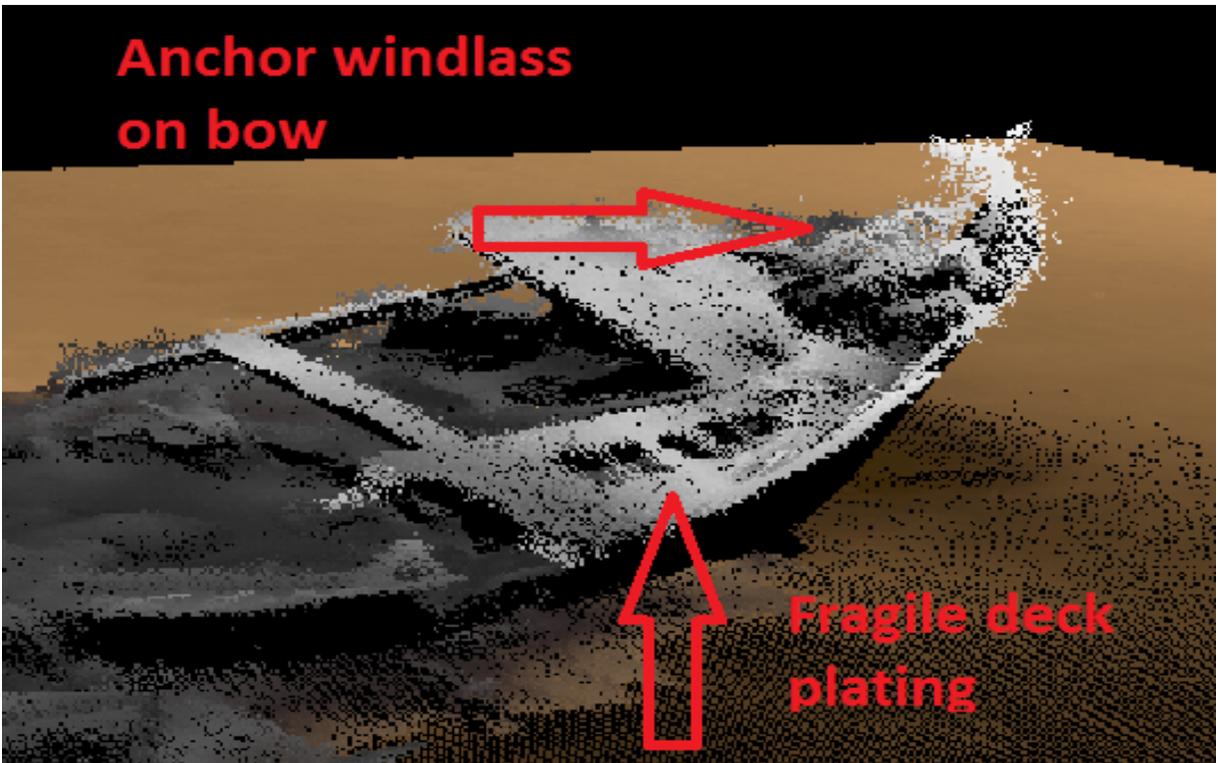
FIGURE 6.36. Multibeam image illustrating existing upper decking in bow stern (Source: NOAA).

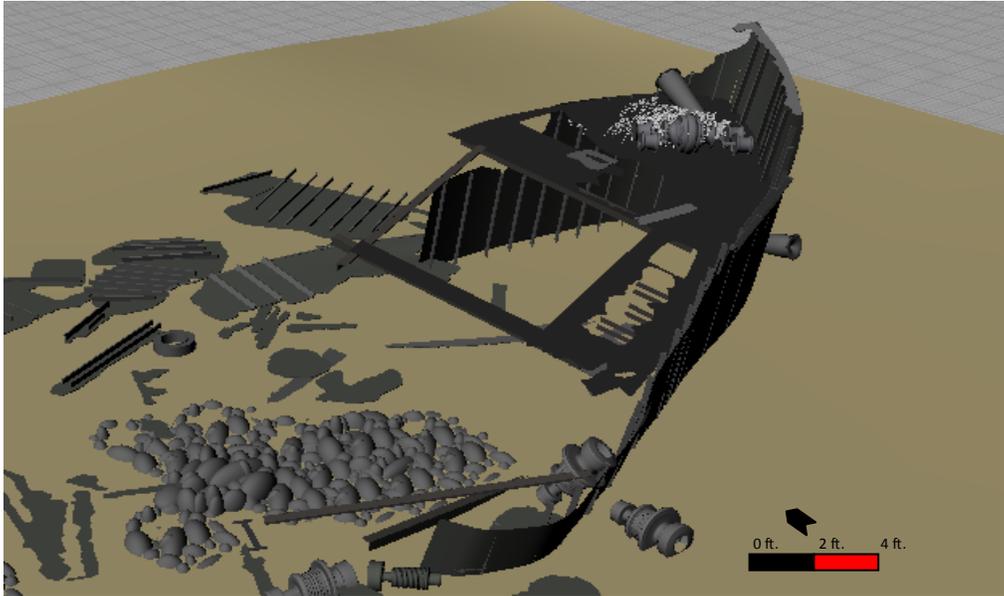
FIGURE 6.37. Image illustrating the existing bow section on Current *Caribsea* Shipwreck Model (Image by Kara Fox).

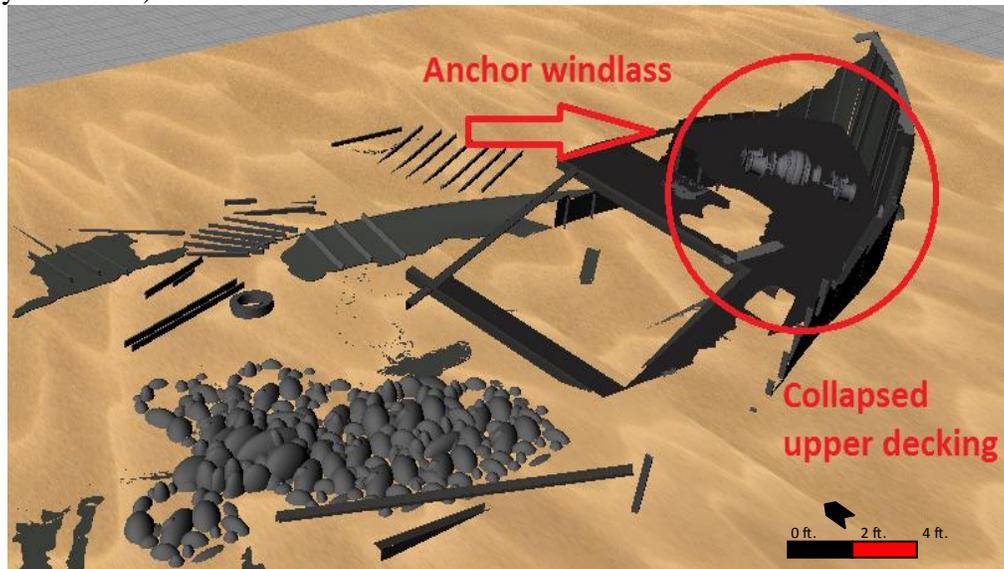
FIGURE 6.38. Image illustrating future collapse of bow area on Predictive *Caribsea* Model (Image by Kara Fox).

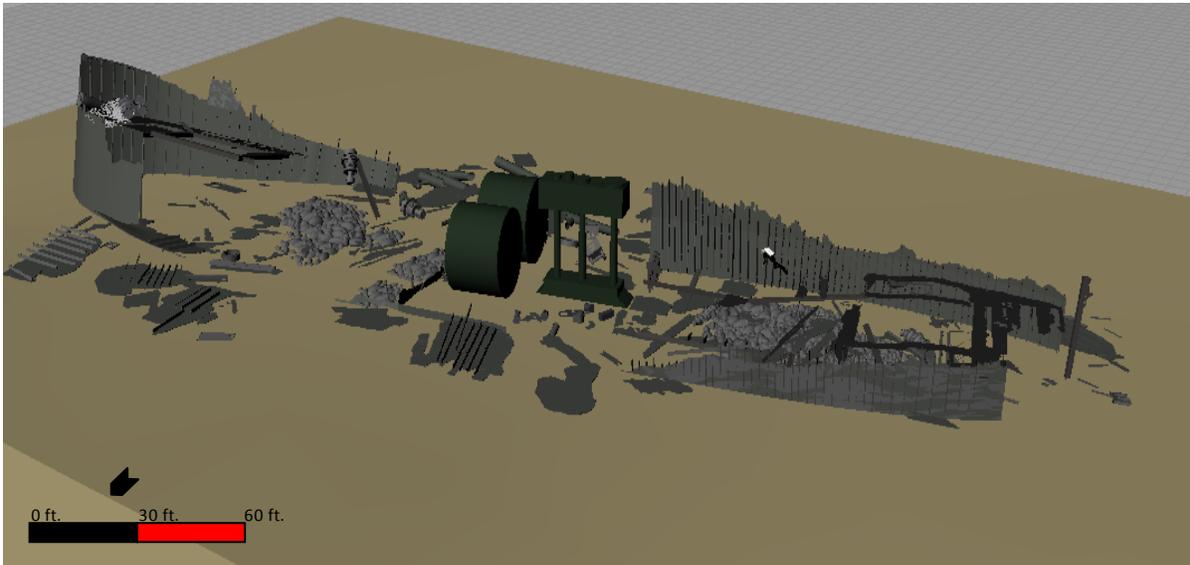
FIGURE 6.41. Image illustrating the existing sedimentation on port side of the Current *Caribsea* Shipwreck Model (Image by Kara Fox).

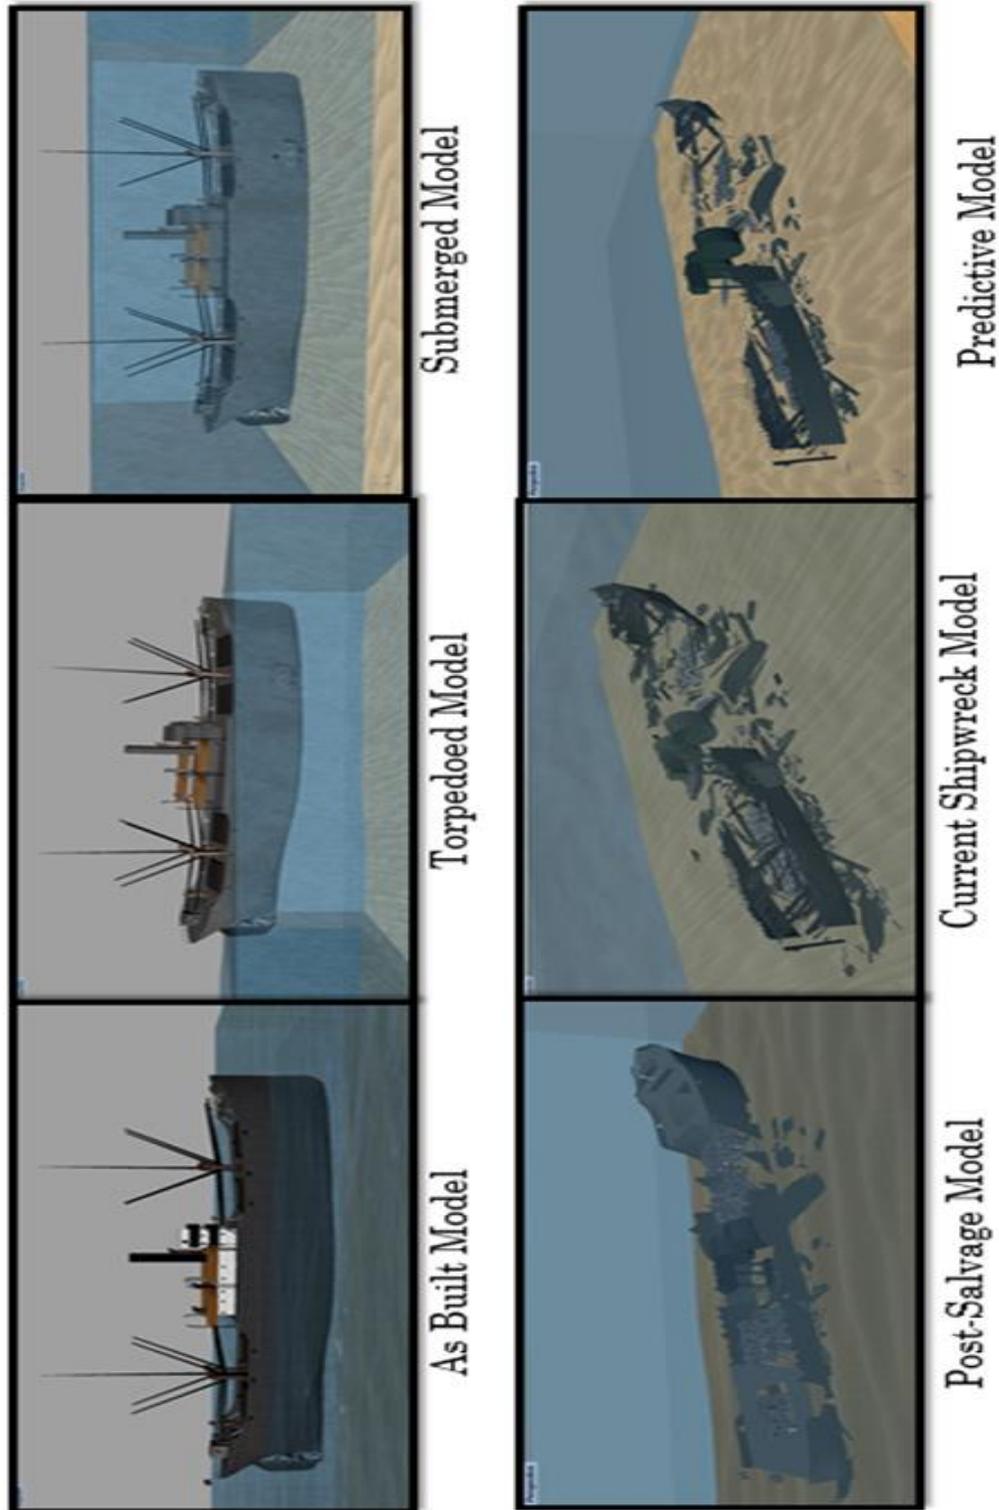
FIGURE 6.43. Image illustrating the sequential transformation of *Caribsea* (Image by Kara Fox).
