Jeffrey D. Morris. A HISTORICAL AND ARCHAEOLOGICAL INVESTIGATION OF THE CHICKAHOMINY SHIPYARD SITE. (Under the Direction of Gordon P. Watts, Jr.) Department of History, July 2000.

A HISTORICAL AND ARCHAEOLOGICAL INVESTIGATION OF
THE CHICKAHOMINY SHIPYARD SITE

A Thesis
Presented to
The Faculty of the Department of History
East Carolina University

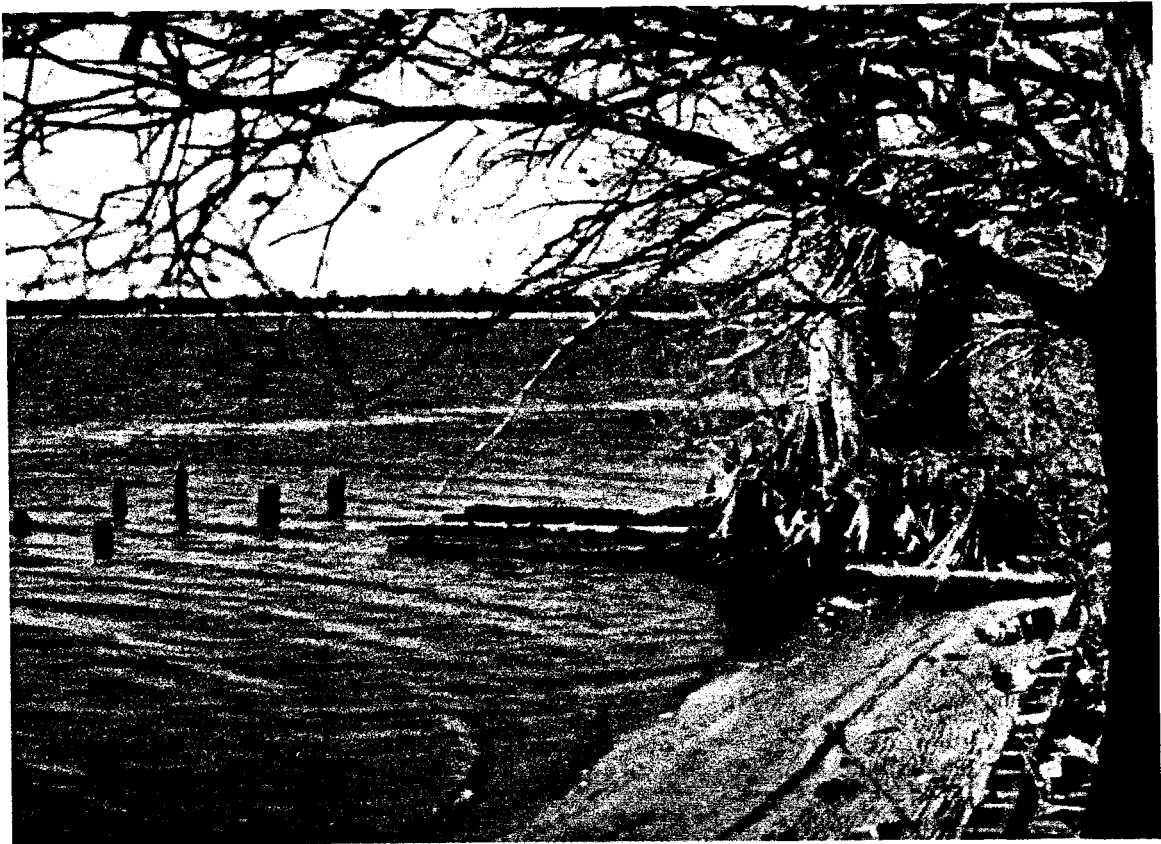
Figure 3: Photograph of the suspected wharf feature north of the modern fish house during lowtide. Photograph by Tanya Scavo.

The remains of the timber structure lie just north of the modern fish house and are visible above the water surface at low tide (Figure 3). The side scan sonar imagery clearly shows pilings driven into the river bottom, an extensive debris pile that begins at the pilings and extends nearly halfway across the river, and a small mound of stone or rubble (Figure 4). Any magnetic signatures generated by components of this feature were masked by the extensive ferrous material contained in the modern fish house just downstream.

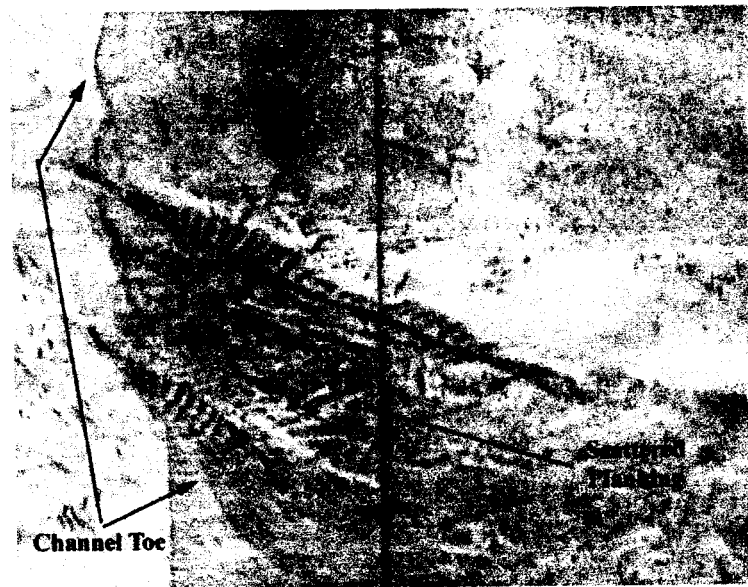
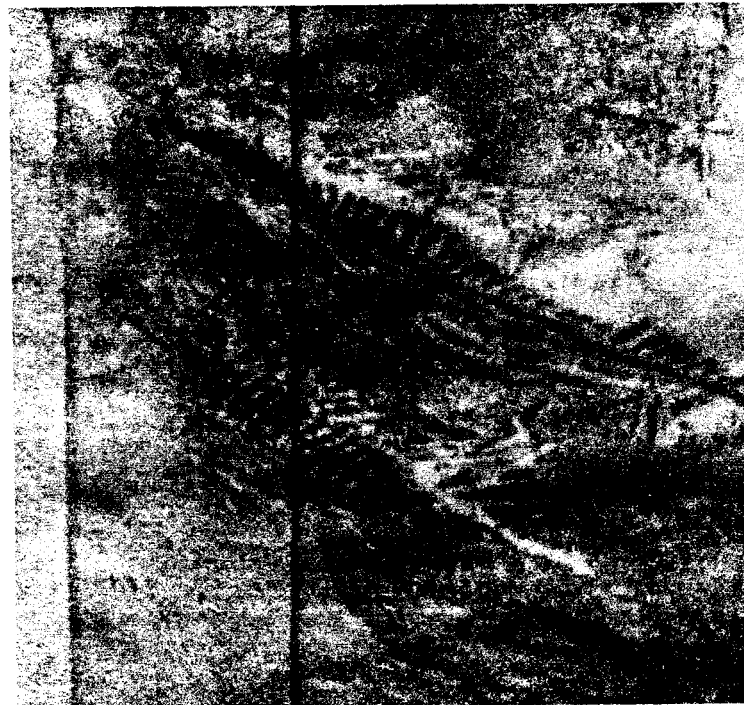
Scuttled Vessel Remains

Figure 5: Side scan sonar imagery of two vessels located off the northern end of the Chickahominy Shipyard Site.

The additional feature detected with the remote sensing equipment proved to be the remains of two vessels lying approximately 230 meters north of the modern fish house on the eastern side of the river (Figure 2). Side scan imagery clearly displayed the remains of hulls lying side by side on the eastern channel side slope (Figure 5). One end of each vessel lies in the vicinity of the toe or bottom of the channel side slope, while the other end lies near the top. Both vessels are exposed above the bottom with little sediment inside. The frames of each vessel can be counted on the side scan sonar imagery. Hull planks and disarticulated timbers that have fallen away lie scattered around each vessel. Magnetometer data collected over the site of the vessel remains indicated the presence of a large ferrous object near the southeastern end of the larger vessel. That

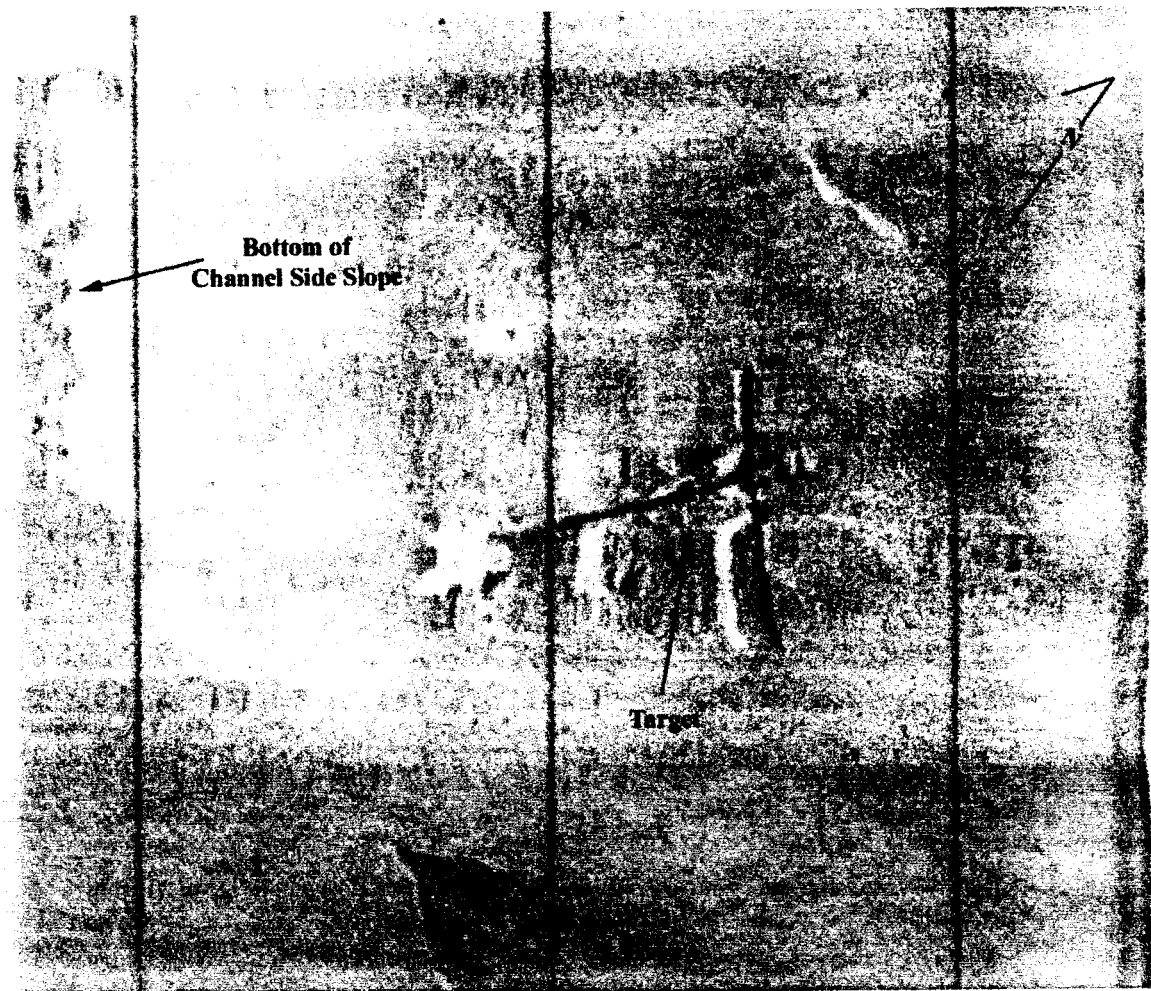
Figure 6: Side scan sonar imagery of an unidentified target lying near the western channel toe across the river from the vessel remains.

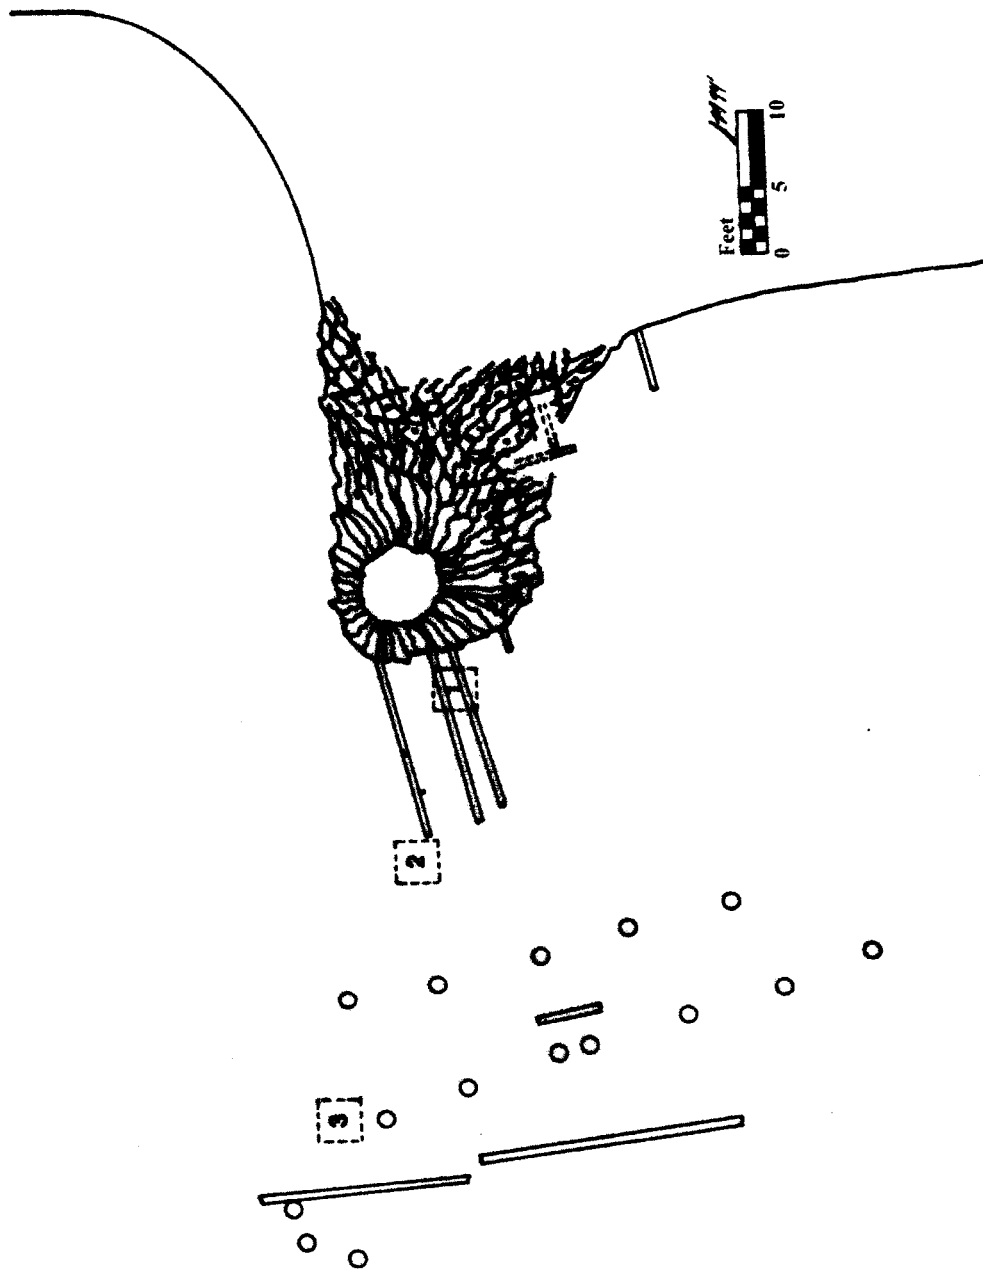
Figure 8: Detailed drawing of the timber feature north of the modern fish house believed to be a historic wharf.

Twelve pilings in two parallel lines formed the offshore portion of this feature (Figure 8). No stringers, beams, or braces were found connecting the pilings together.

The pilings all had diameters between eight and ten inches. In addition to the pilings in line, there were three pilings grouped together at the northwest end of the feature (Figure 8). Those pilings appeared to form some other structure such as a "dolphin," which is used to keep large vessels from coming into direct contact with a wharf and damaging it.

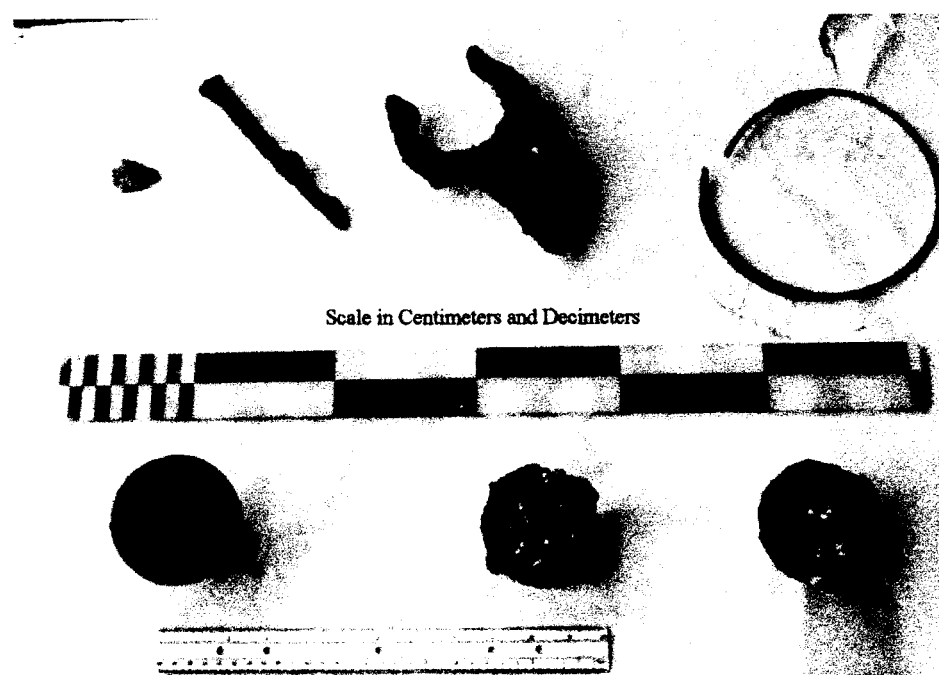
Figure 9: Photograph of artifacts located during the shoreline survey south of the modern fish house. Those artifacts include three cannon ball, an oarlock, an iron spike, an iron hoop, and a prehistoric projectile point. Photograph by William Utley.

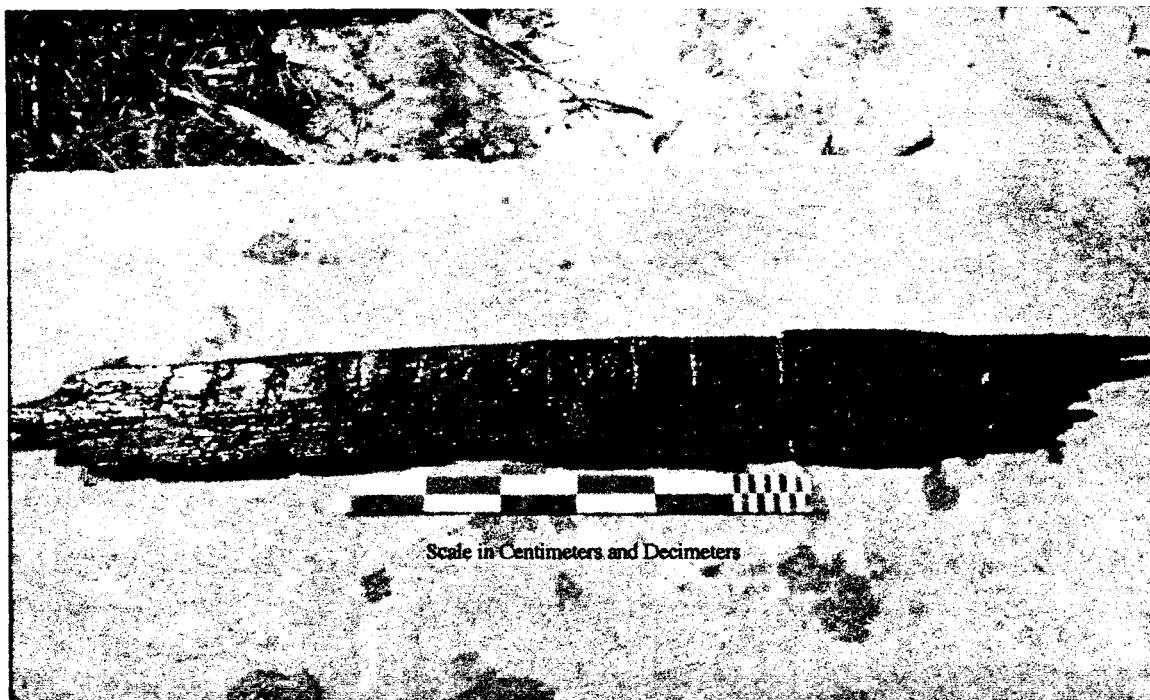
Figure 11: Plank located during the shoreline survey south of the modern fish house that displays adze marks and treenail holes. Photograph by William Utley.

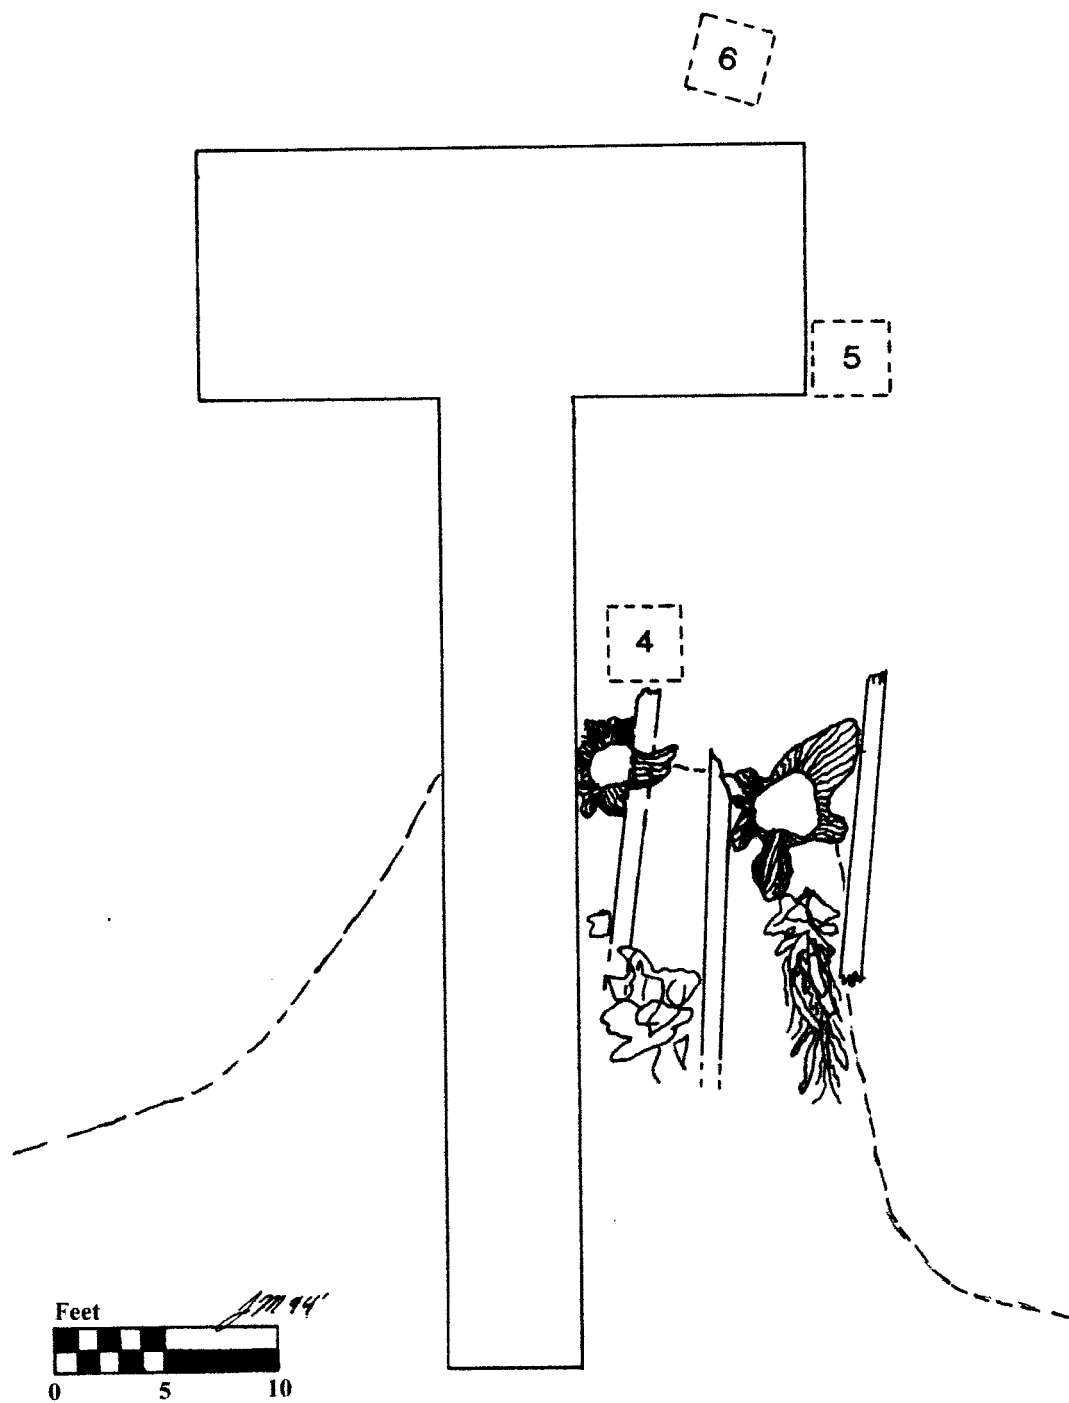
Figure 12: Detailed drawing of the possible slipway structure south of the modern fish house.

width of the feature was eleven feet three and a half inches. All three timbers were round and appear to have been broken or sawn off at their channel-ward end. They extended from the bank between twelve feet six inches and fifteen feet ten inches. Conversation with the property owner revealed that the timbers extended much further channel-ward, but were sawn off when the modern "T" shaped pier was constructed in the early 1970's.¹³ The northernmost timber was also broken or sawn off at its shore-ward end while the middle and southernmost timbers extend into the riverbank for an undetermined distance. Two large cypress trees grew around these timbers. The middle timber appeared displaced by one of those trees. Using a transit and stadia rod, slopes were calculated for each of the three timbers. Those measurements determined that the timbers slope downward into the river between approximately four and five degrees.

The field-crew used metal probes to investigate around and between the timbers in an attempt to locate other structural members and any possible foundation remains. There is a dense scatter of brick near the channel-ward end of the timbers, but no other structural members. While the property owner did not indicate that other parts of the structure were removed, it is evident that the construction of the modern pier heavily impacted the archaeological remains there.

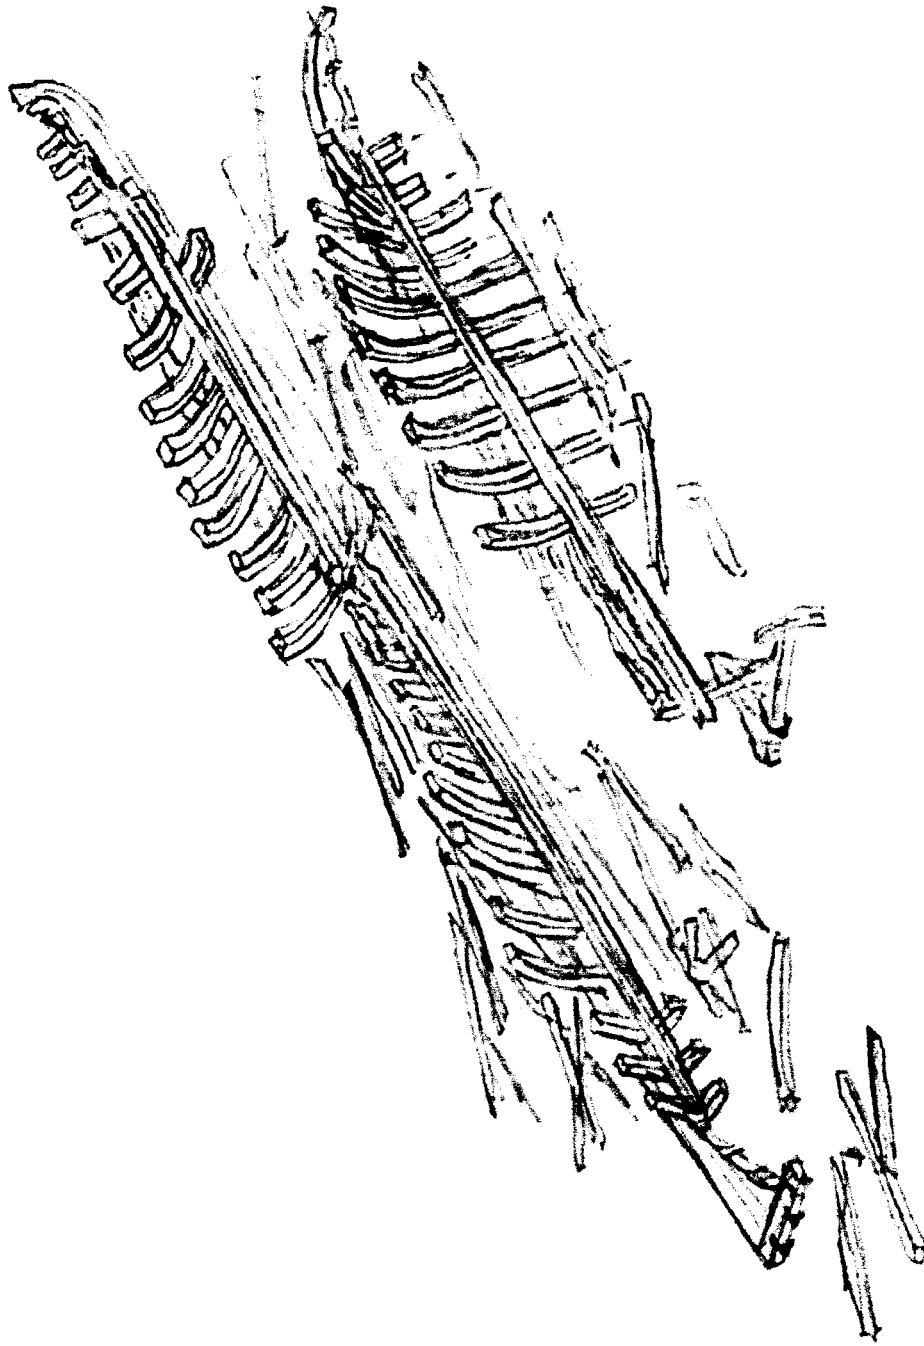
Figure 13: Artist interpretation of the the vessel remains located off the northern end of the Chickahominy Shipyard Archaeological Site. Drawing by Gordon P. Watts.

Because the wrecks are located in a tidal river with strong currents and near zero underwater water visibility, it was important, yet difficult, to develop an overall plan of the wreck sites without expending a significant amount of time. To develop a conceptualized overall site plan relatively quickly, the field crew used a high resolution side scan sonar imagery in conjunction with drawings of specific construction features. The result is an artistic interpretation of the wreck sites (Figure 13).

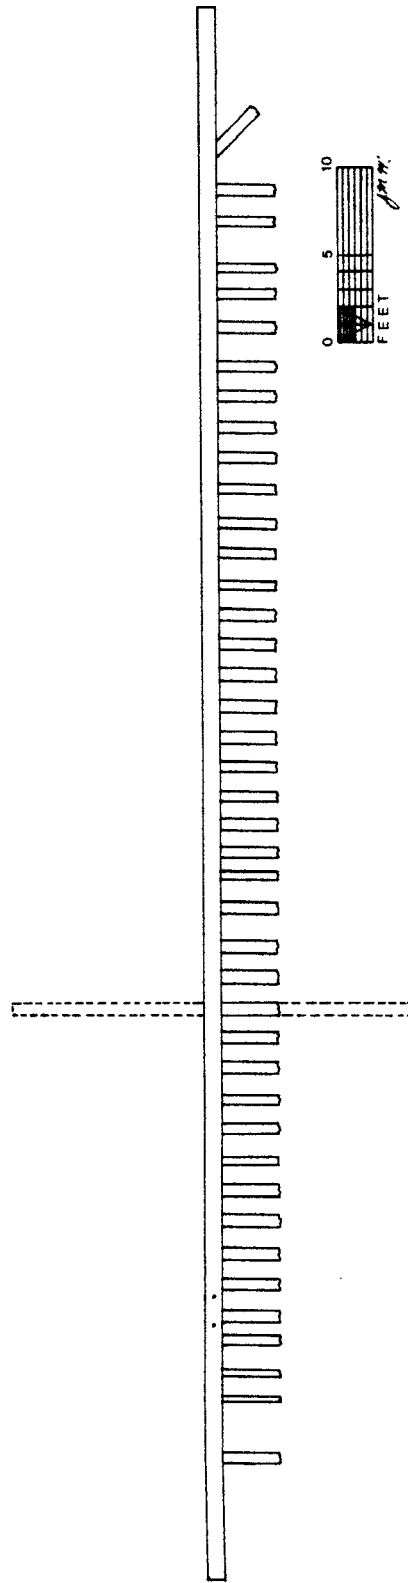
Figure 14: Floor plan for vessel "A" .

The vessel was constructed principally of American white oak using traditional plank on frame construction techniques.³ The keel is a single piece of white oak measuring eighty-three feet eleven inches long, sixteen inches molded, and ten inches sided at its forward end, twelve inches molded and twelve inches sided near the midship, and twelve inches molded and nine and a half inches sided at the stempost. A rabbet for the garboard strake is let into the keel creating a two and a half inch bearding line. Attached to the bottom of the keel is a shoe measuring two inches thick.

Frames on vessel "A" consist of white oak floor timbers and futtucks joined together with trunnels. First futtucks are attached to the sides of the floor timbers six inches outboard of the keelson. A total of forty-two floor timbers are in place (Figure 14). Sided dimensions of the floors measured between five and nine inches, while the molded dimension is eleven inches between the keel and keelson at frame fifteen. Space between the frames varies from nine to eighteen inches. Limber holes on the floor timber at frame fifteen are eight inches from the side of the keelson and are three and half inches wide and two inches deep.

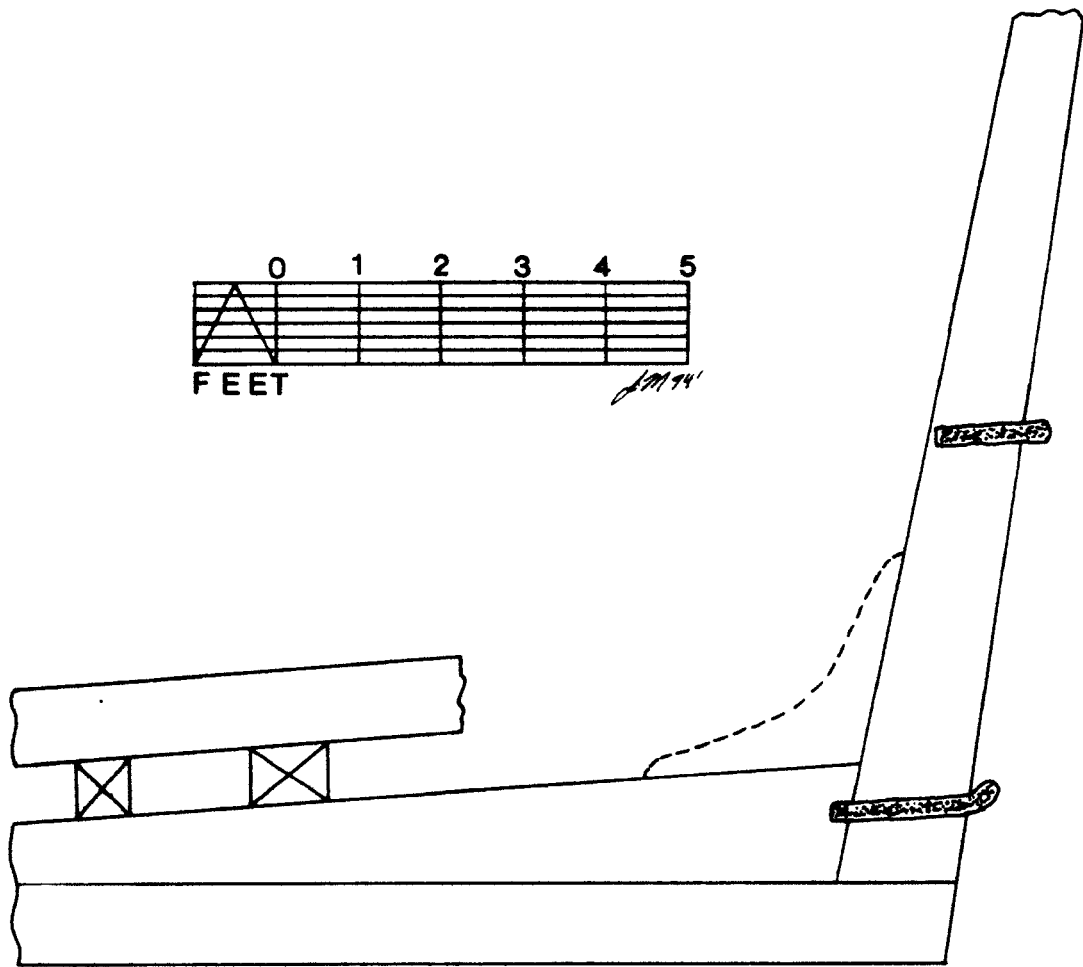
Figure 15: Detailed drawing of the stern configuration for vessel "A".

The stern of vessel "A" consists of the sternpost, keel, and deadwood (Figure 15). Approximately eleven feet three inches of the white oak sternpost is intact complete with two iron gudgeon straps. Iron pins extending from the inside face of the sternpost and from the top of the deadwood suggest the location of a stern knee that is no longer in place. The sternpost measures eighteen inches molded and ten inches sided at its base and tapers to a molded dimension of thirteen inches and five and a half inches sided just above the second gudgeon strap. Triangulation of the surviving timbers in the stern of vessel "A" indicate that the stern post is raked backwards at an inclination of twelve degrees.

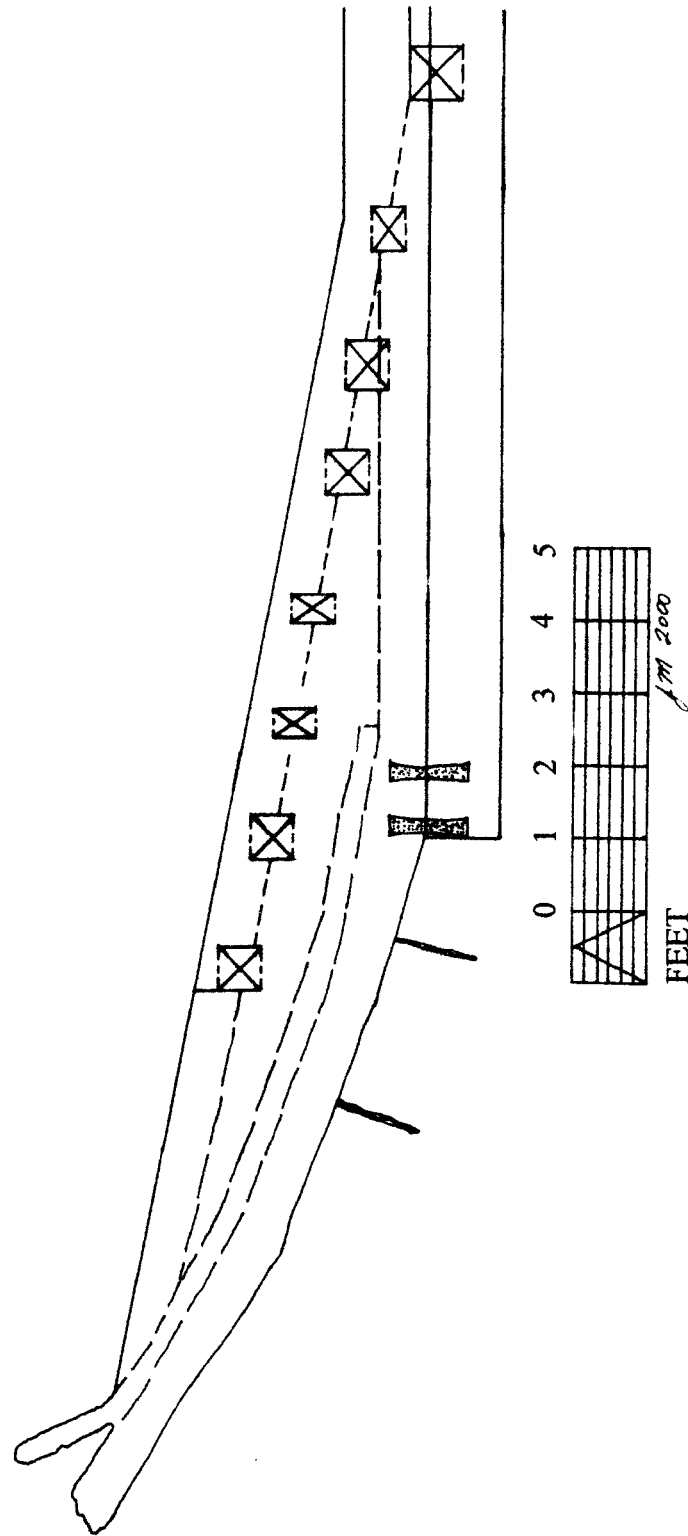
Figure 16: Detailed drawing of the stem configuration of vessel "A".

The stem of vessel "A" began ten feet two inches behind the forward end of the keel and extended forward approximately another nine feet five inches (Figure 16). The stempost is made from white oak and measured eight inches molded and ten inches sided. An inner post is present behind the stempost that measures three inches molded and ten inches sided. At the forward end of the keel there are two iron fish plates thirteen inches long and three inches wide fastening the keel, stempost, and deadwood together. Two fourteen inch long iron bolts extend from the outer face of the stempost one foot six inches from the end of the keel that probably fastened the gripe. Frames in the bow of vessel "A" are let into the deadwood five inches and the keelson is rebated to fit over them. No cant frames or hawse pieces are present in vessel remains.

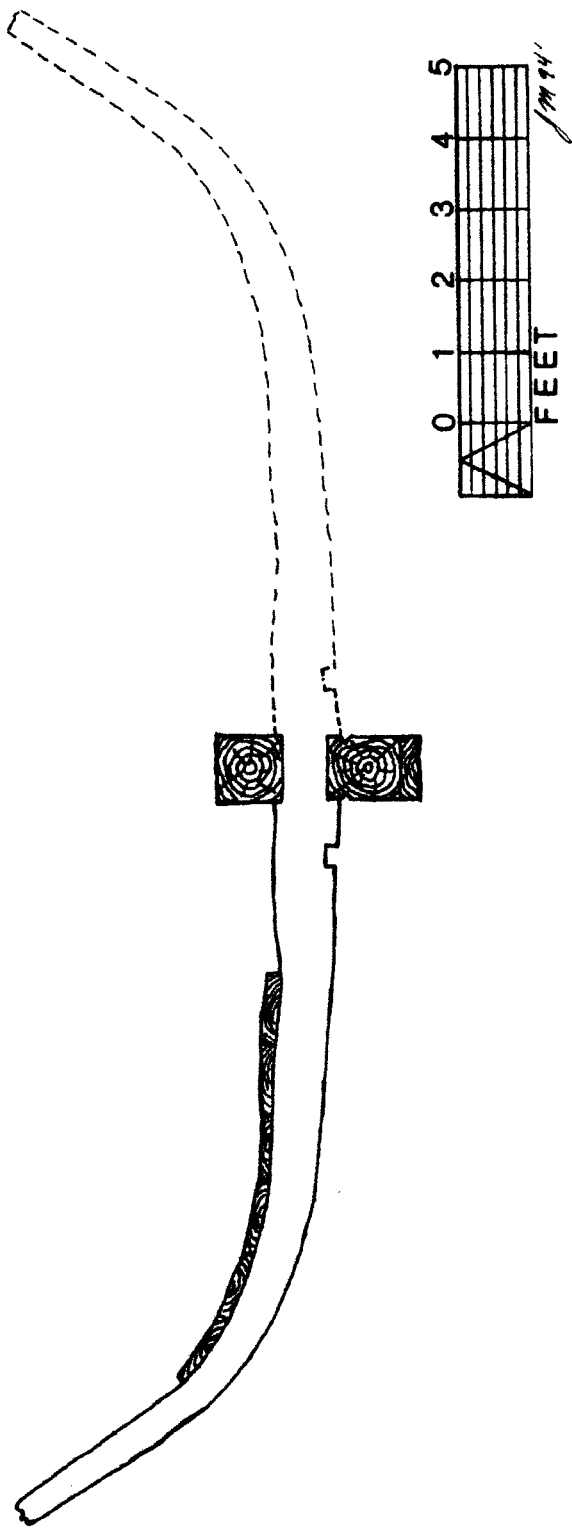
Figure 17: Profile of vessel "A" at frame 15. The measurements for this drawing were recorded for only half the profile, then projected to complete the image.

The starboard half of frame fifteen, located thirty-two feet three inches aft of the stempost, was the only portion of a frame still intact beyond the turn of the bilge. A profile of that frame was taken using triangulation techniques in order to project the beam of the vessel and record the hull shape at this section (Figure 17). The frame profile was produced by generating a half profile and then mirroring it along the centerline of the vessel. That exercise produced a hull profile with a maximum beam measurement of twenty-one feet four inches, two feet eleven inches above the bottom of the hold.

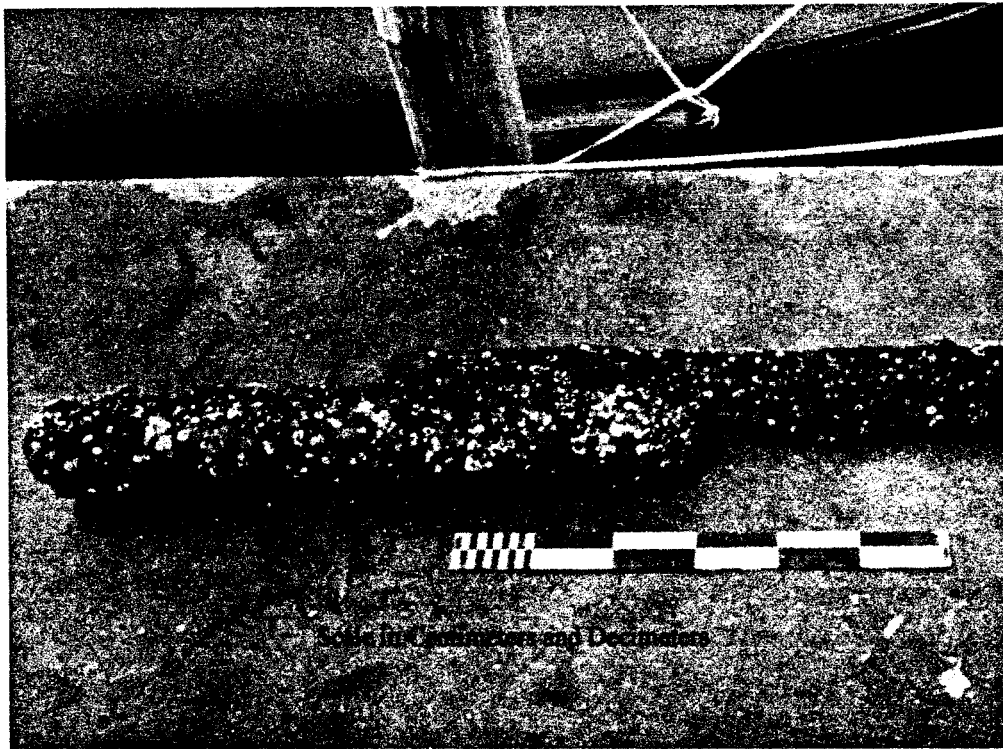
Figure 18: Photograph of pig iron ballast with attached ceiling plank discovered on the starboard side of vessel "A". This artifact was recovered from the vessel, documented and returned. Photograph by William Utely.

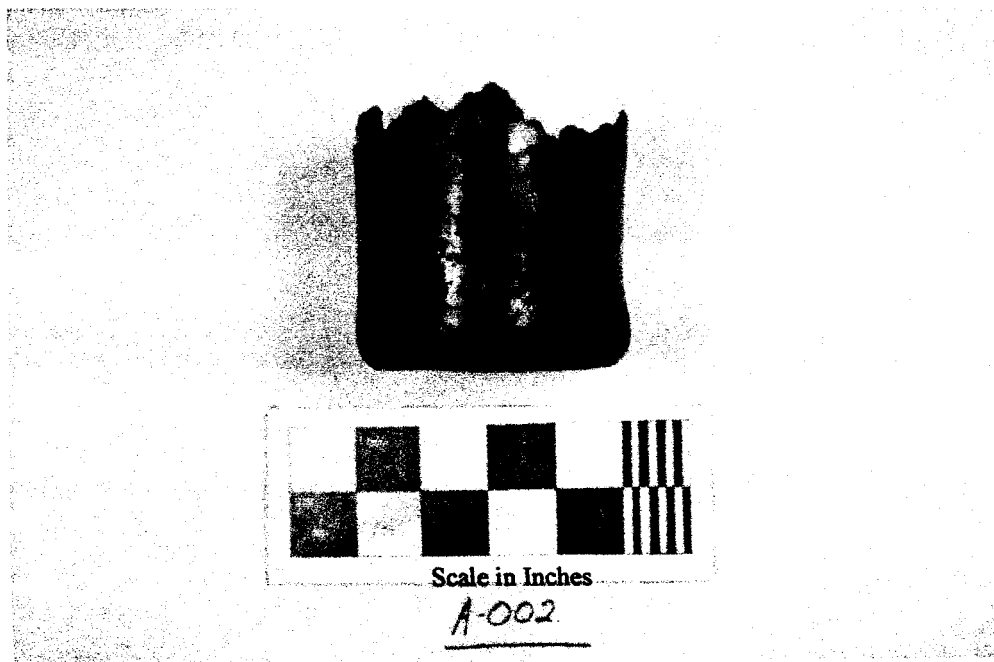
Figure 19: Photograph of mold blown wine bottle base found on vessel "A".

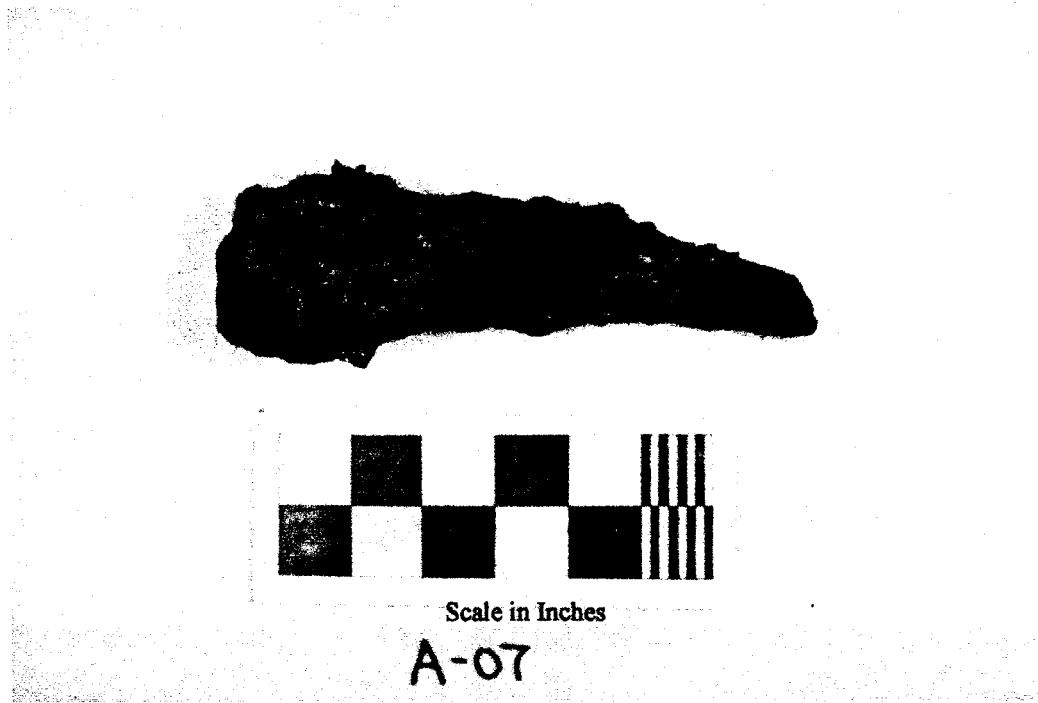
Figure 20: Photograph of iron adze head discovered on vessel "A" wedged between the fifteenth and sixteenth floor timbers.

The investigation of vessel "A" at the Chickahominy Shipyard located numerous artifacts. The artifacts included several six pound cannonballs, pig iron ballast, a dark green glass wine bottle base, a wrought iron hook, and the head of an adze. The crew located cannonballs near the bow of the vessel in the bottom sediment no longer in-situ. They also located pig iron ballast on top of the bilge ceiling on the starboard side of the vessel at frames eighteen, nineteen, and twenty (Figure 18). It was recovered from the vessel, documented, and then returned. The crew located a wine bottle base and the wrought iron hook lying on the bilge ceiling on the starboard side of the vessel (Figure 19). They also found an adze head lodged between the fifteenth and sixteenth floor timbers underneath the keelson (Figure 20).

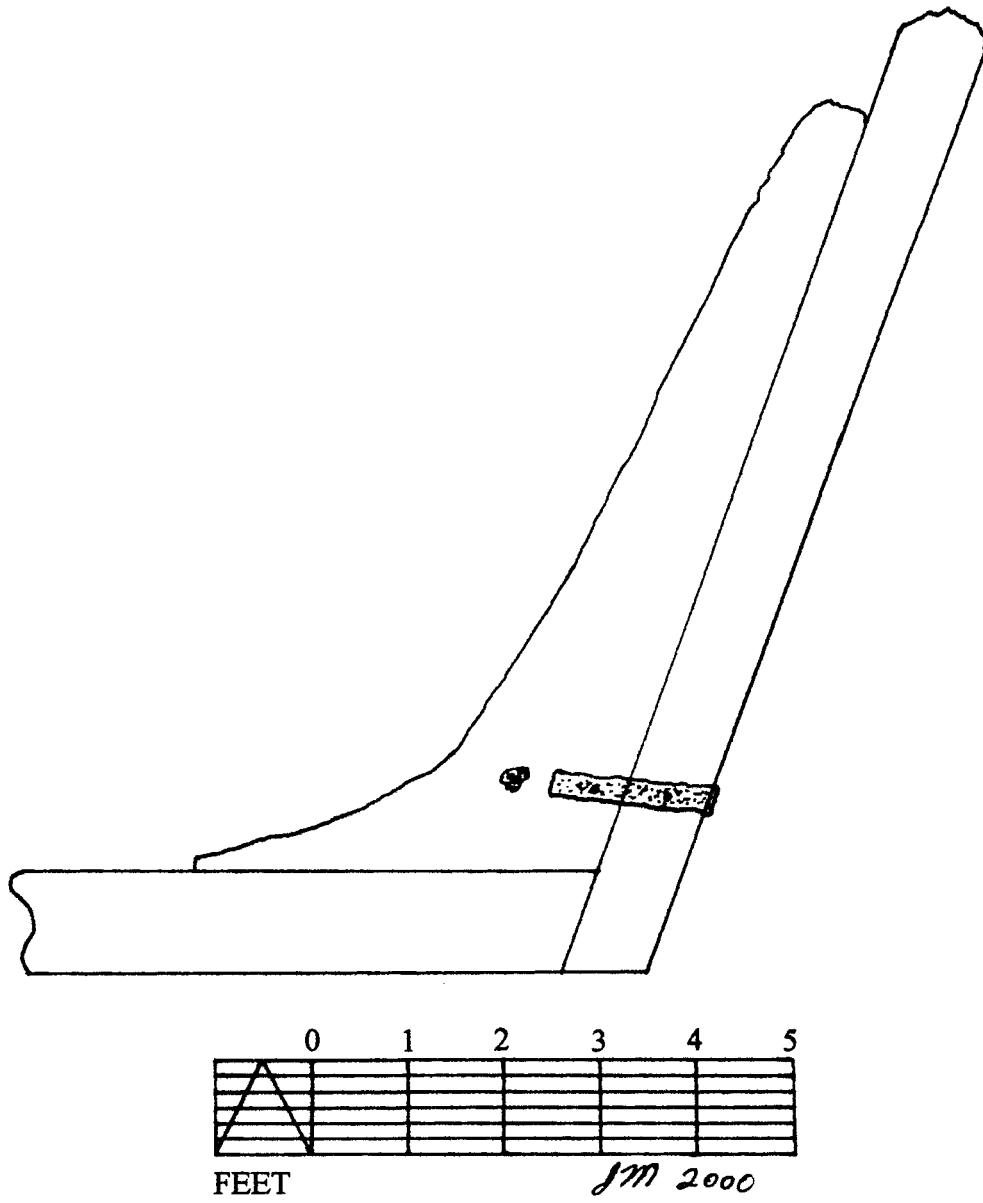
Figure 22: Stern Configuration for vessel "B".

The projected stern configuration of vessel "B" consists of the sternpost, keel, and stern knee (Figure 22). Approximately nine feet five inches of the white oak sternpost is present complete with the attached stern knee and a single iron gudgeon strap. The sternpost measures eight inches molded and seven inches sided throughout. Neither the sternpost nor the stern knee are still articulated with the keel.

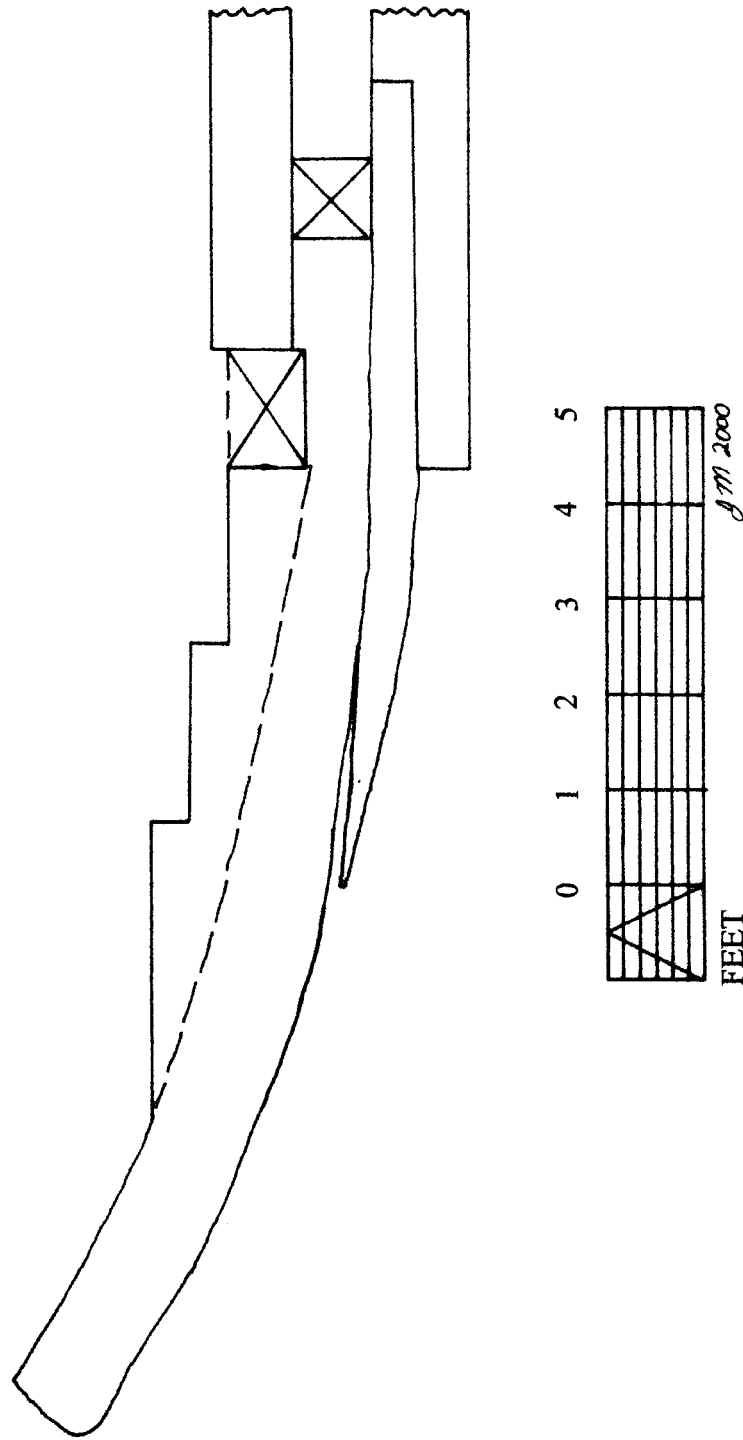
Figure 23: Stem configuration for vessel "B".

The stempost of vessel "B" began two feet five inches behind the forward end of the keel and extended forward approximately another ten feet four inches (Figure 23). It is made from white oak and measures twelve inches molded and six inches sided at its forward end. A gripe is lapped to the keel four feet one inch behind its forward end and extends along the stem four feet four inches. Fastened to the top upper surface of the stempost is deadwood that is stepped to accept frames that are no longer present. No cant frames or hawse pieces are articulated in the vessel remains.
