DISCOVERED REPEATEDLY: ARCHAEOLOGICAL DOCUMENTATION AND SITE  
RESTORATION OF PACIFIC REEF WRECK (BISC-29, 8DA11953)

A Thesis

East Carolina University

Master of Arts in Maritime Studies

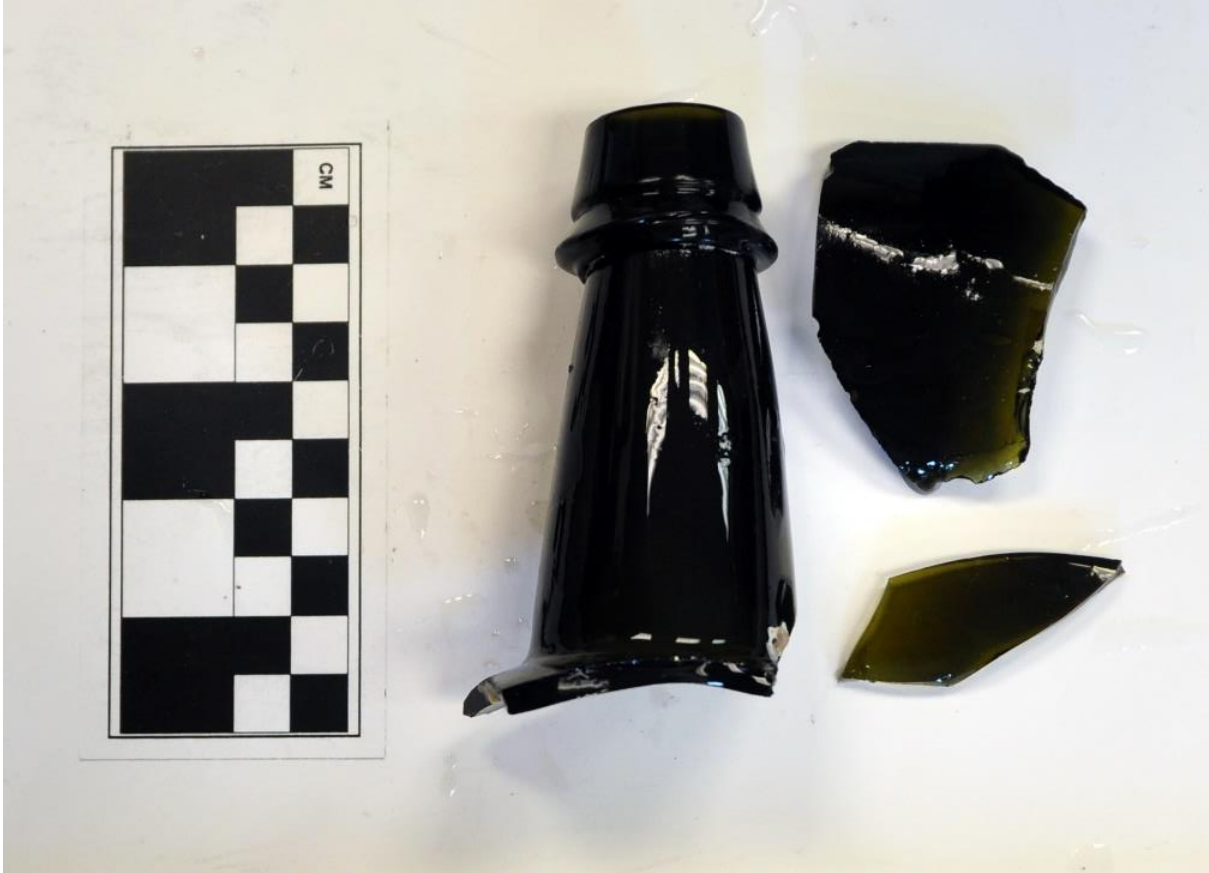
FIGURE 4.11. Bottle neck with double collar two-part finish (FS 17.5). (Image from NPS, 2016).

The neck features a mold seam which ends at the lip. The mouth of the bottle features a two part finish referred to as double collar (Figure 4.11) (Schulz et al. 2016:303,312; Lindsey 2018). Lindsey (2018) states “this finish style appears to have originated in the 1820s with its most frequent use from the 1840s into the 1880s.”

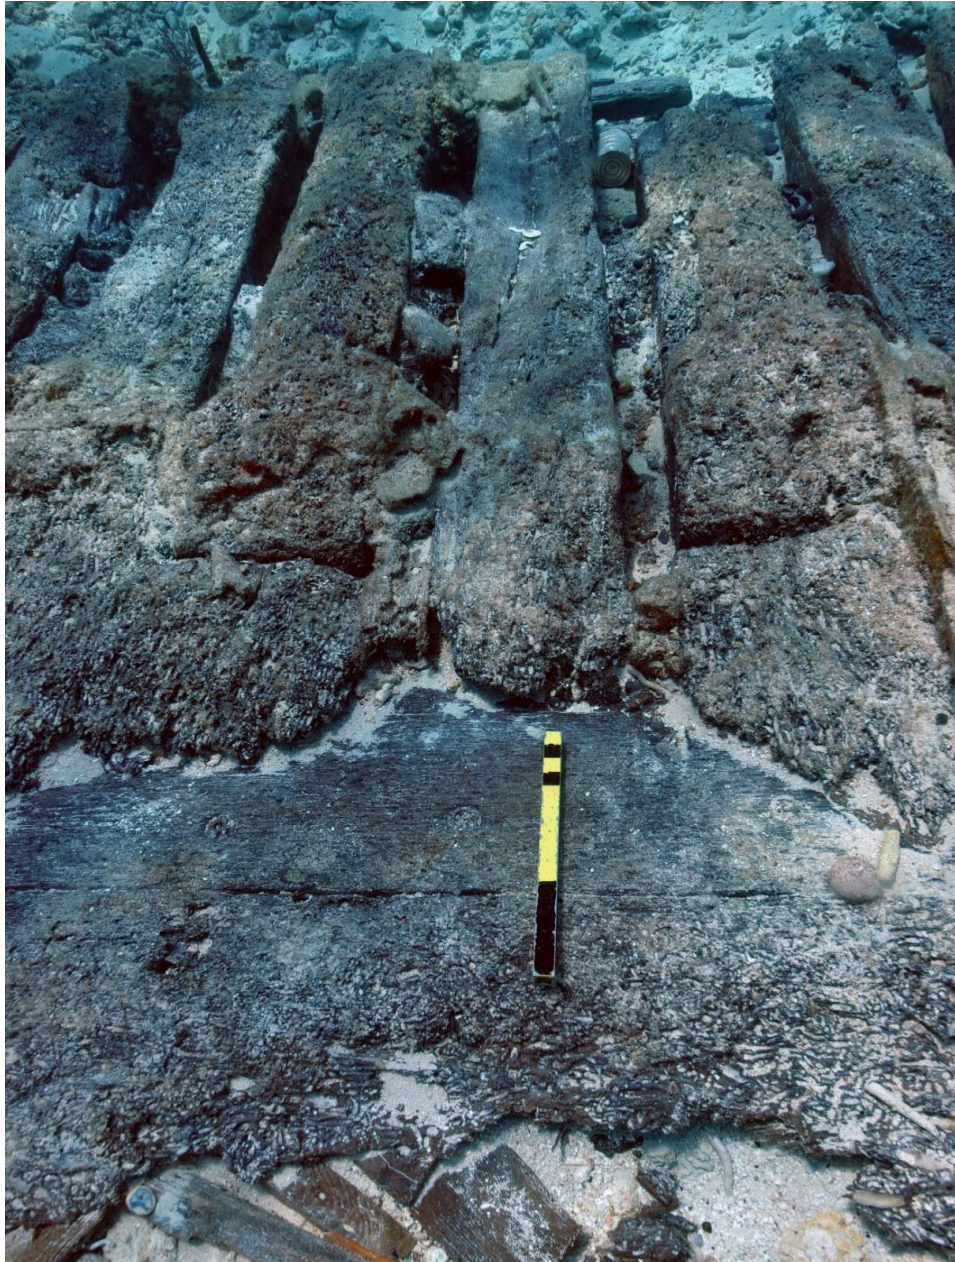
FIGURE 5.6. Additional futtocks (T48 and T49) with squared butt joints. Scale is 15 in. (38 cm) and in line with T39. (Image from NPS, 2016).

The futtock ends are squared to butt against other timbers in the frame. As the squared ends found on site are not adjacent in each frame pair, the futtock and floor spacing was hypothesized to alternate. On the western end of the site, second timbers (T48-T51) with a larger sided dimension (11.8 in./30 cm) were identified butt joined to the frame timbers T36, T38, T40, and T42 (see Figure 5.4 and Figure 5.6).

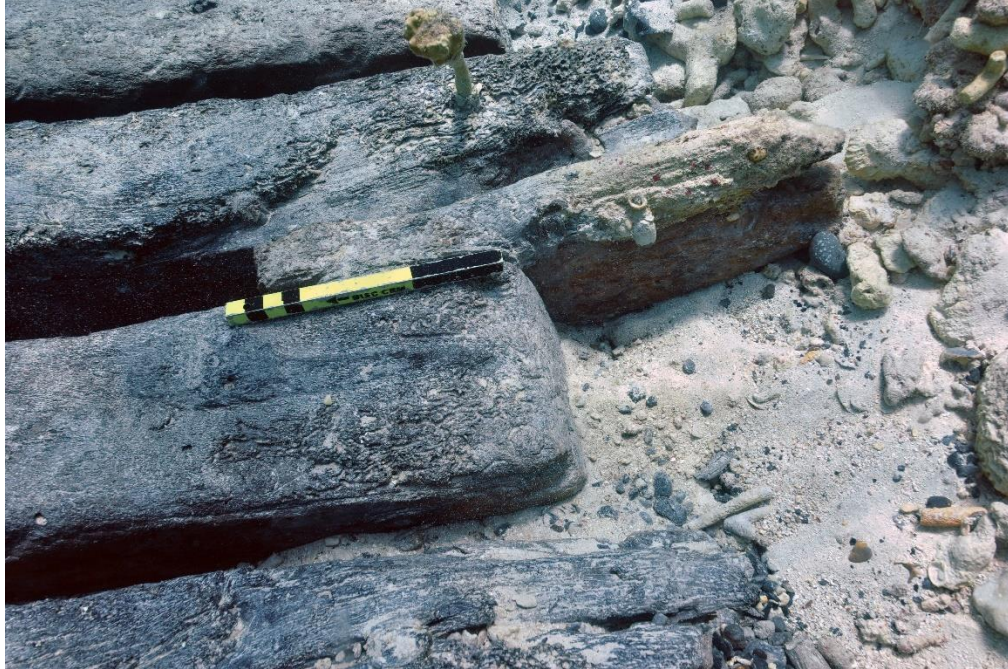
FIGURE 5.8. Example of filling chock seen on site. (Image from NPS, 2016).

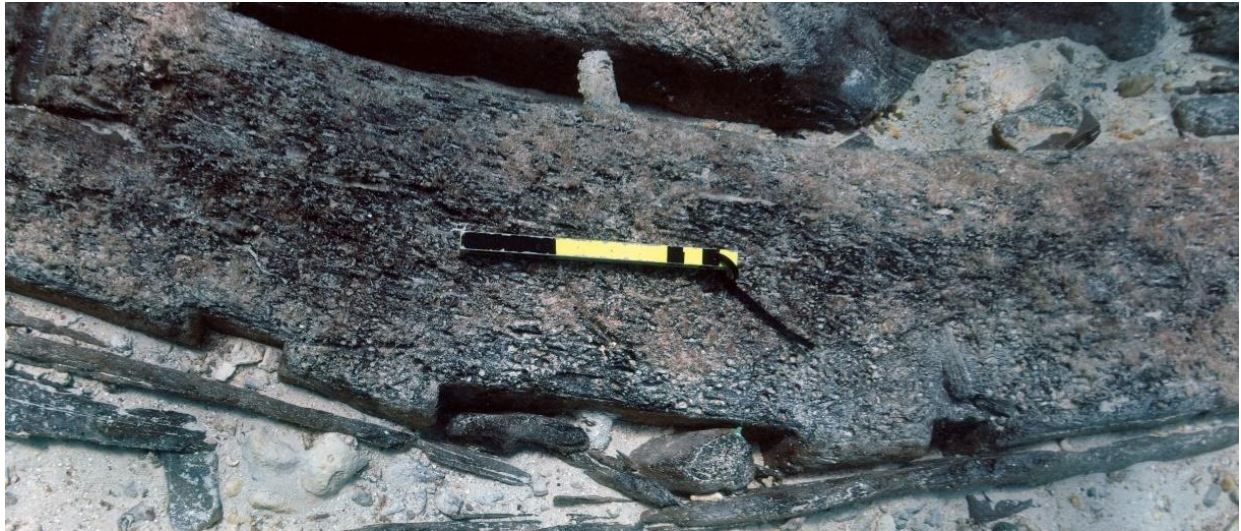
FIGURE 5.10. Keel step in T1, scale bar is 15 in. (38 cm). (Image from NPS, 2016).

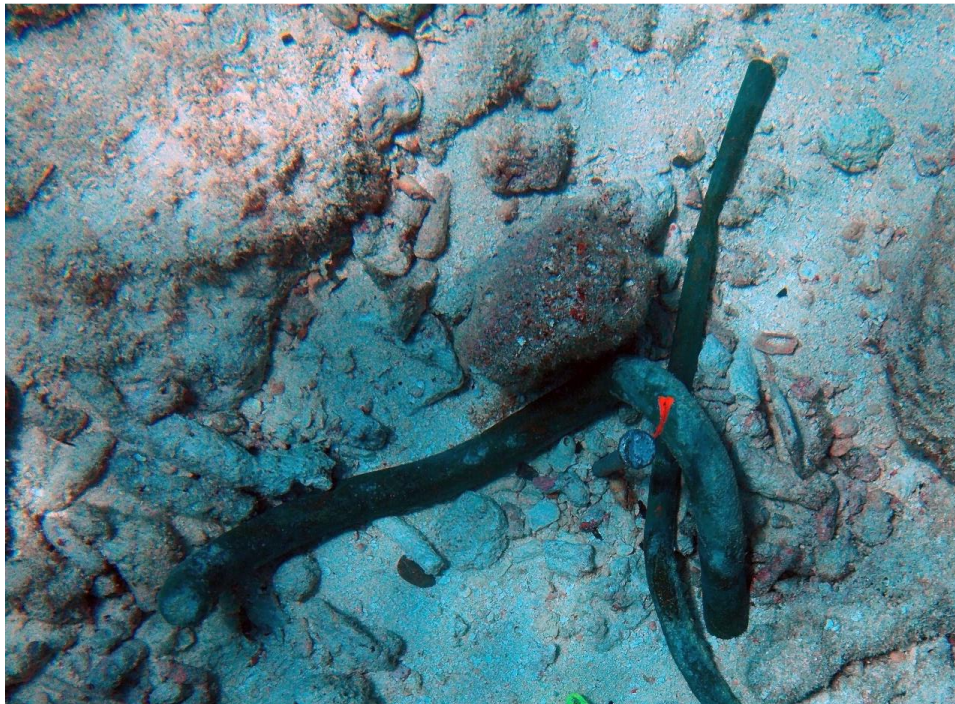
FIGURE 5.11. Copper drift pins located during metal detection survey. (Image from NPS, 2016).

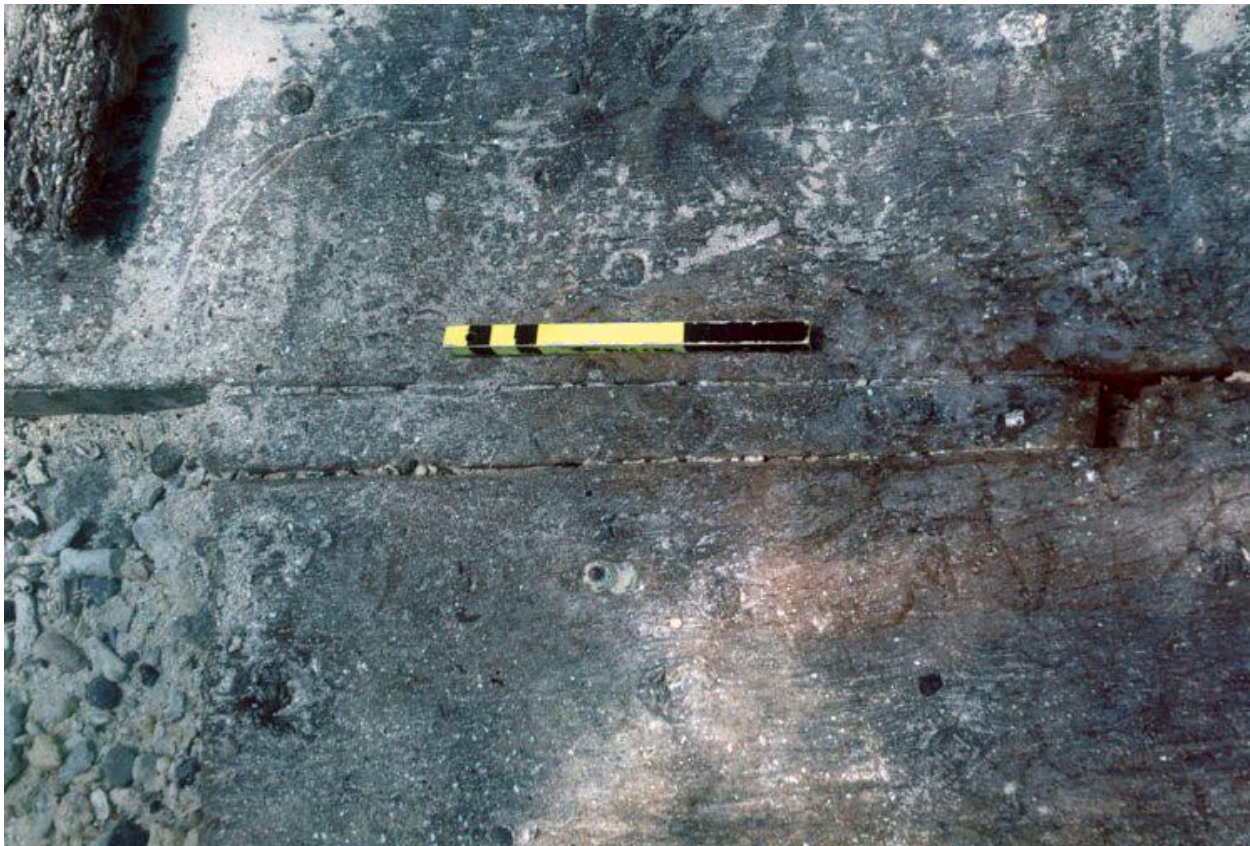
FIGURE 5.12. Repaired Outer Hull Planking. Scale is 12 in. (30 cm). (Image from NPS, 2016).

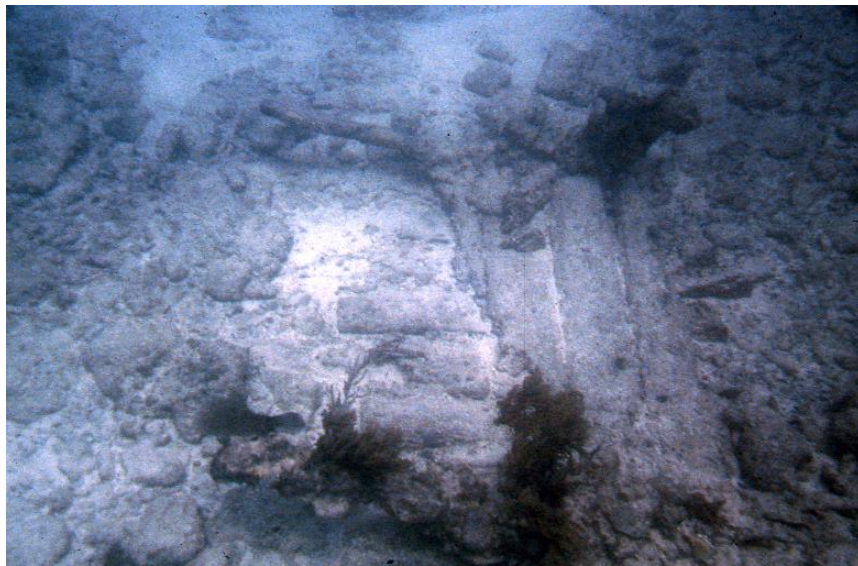
FIGURE 5.14. Ceiling visible during the 1988 survey. (Image from NPS, 1988).

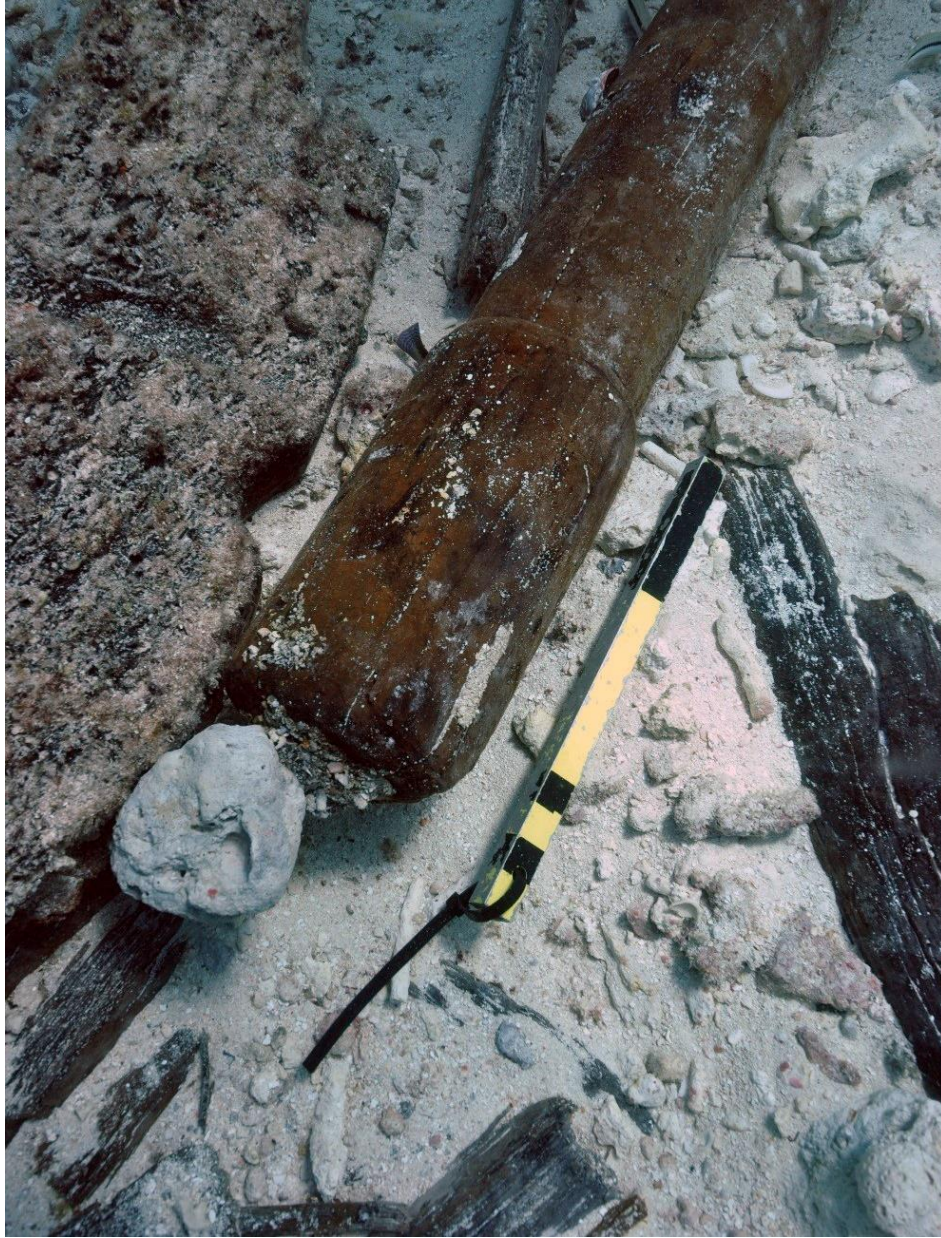
FIGURE 5.16. Stanchion post with finished decoration. (Image from NPS, 2016).

The only visible damage in Area I consisted of the deck stanchion (see Chapter 4) recorded during the 2016 fieldwork. Surge and wave action dislodged the stanchion, which remains on site in a poor condition (Marano et al. 2017a). Considering the damage to other

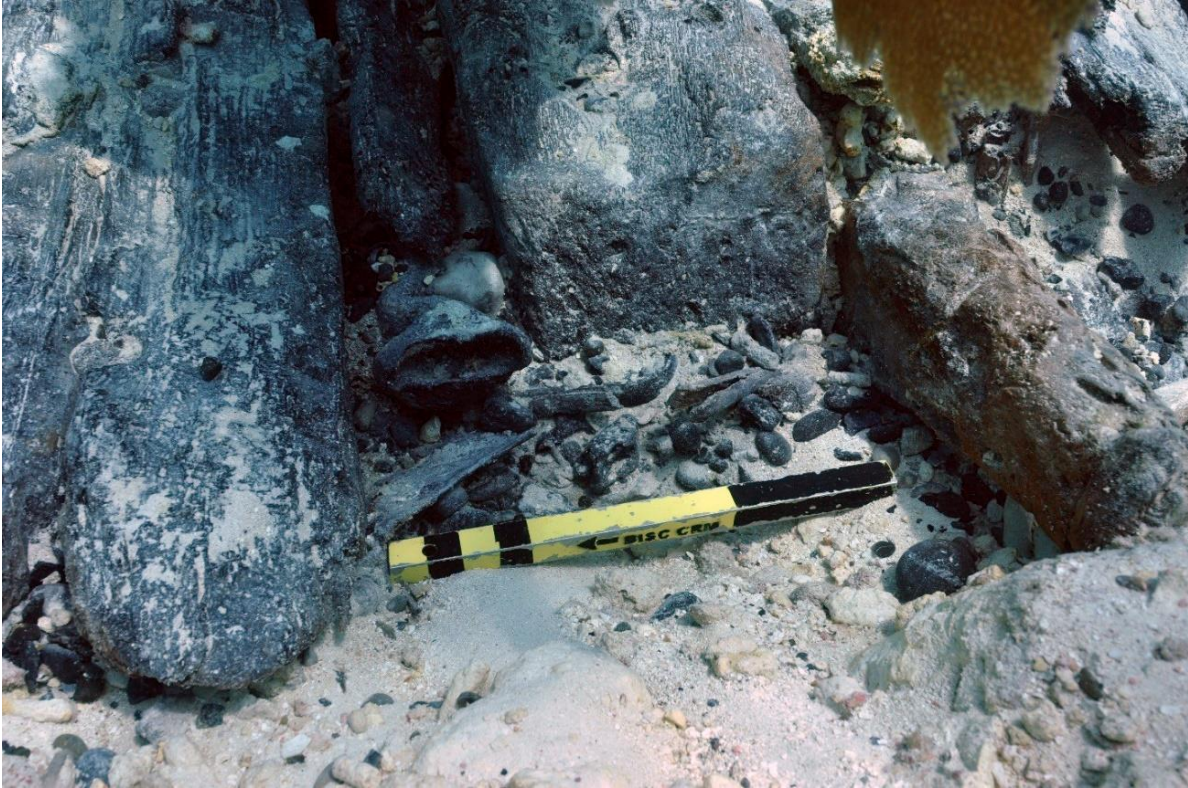
FIGURE 5.17. Southern end of lead tube. (Image from NPS, 2016).

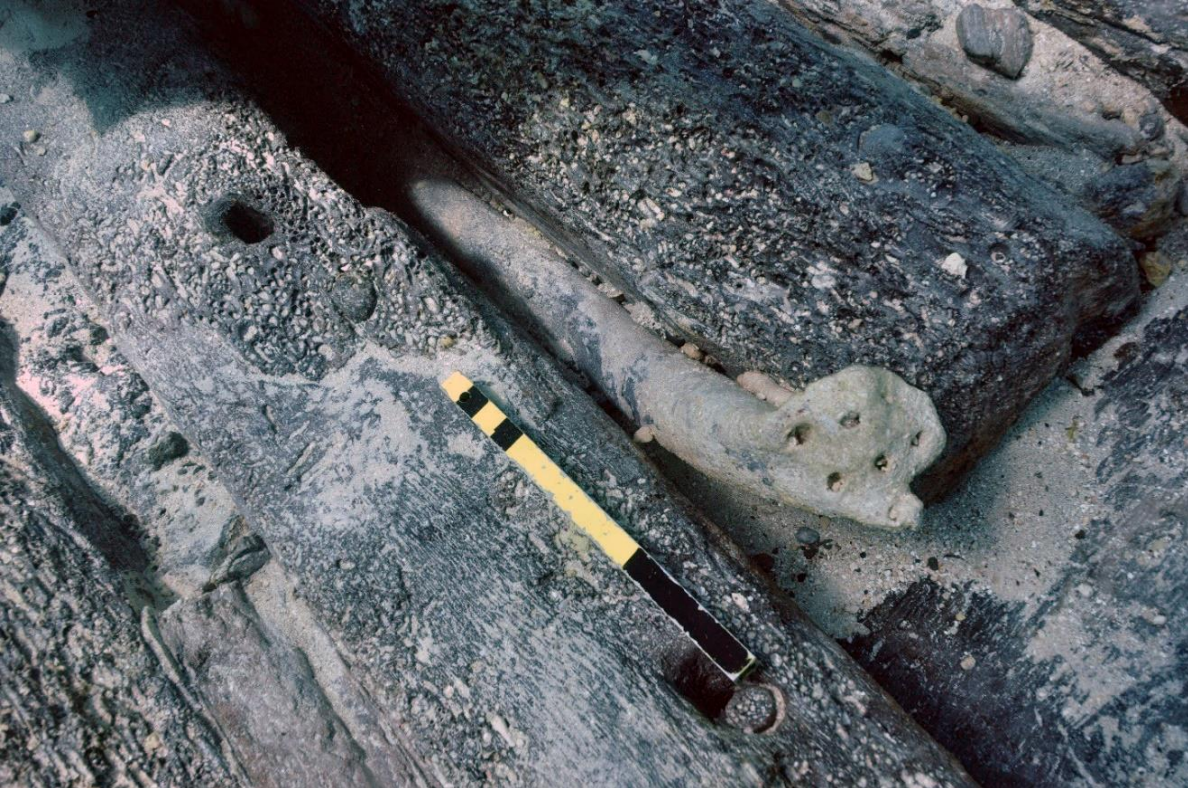
FIGURE 5.18. Northern end of lead tube. (Image from NPS, 2016).

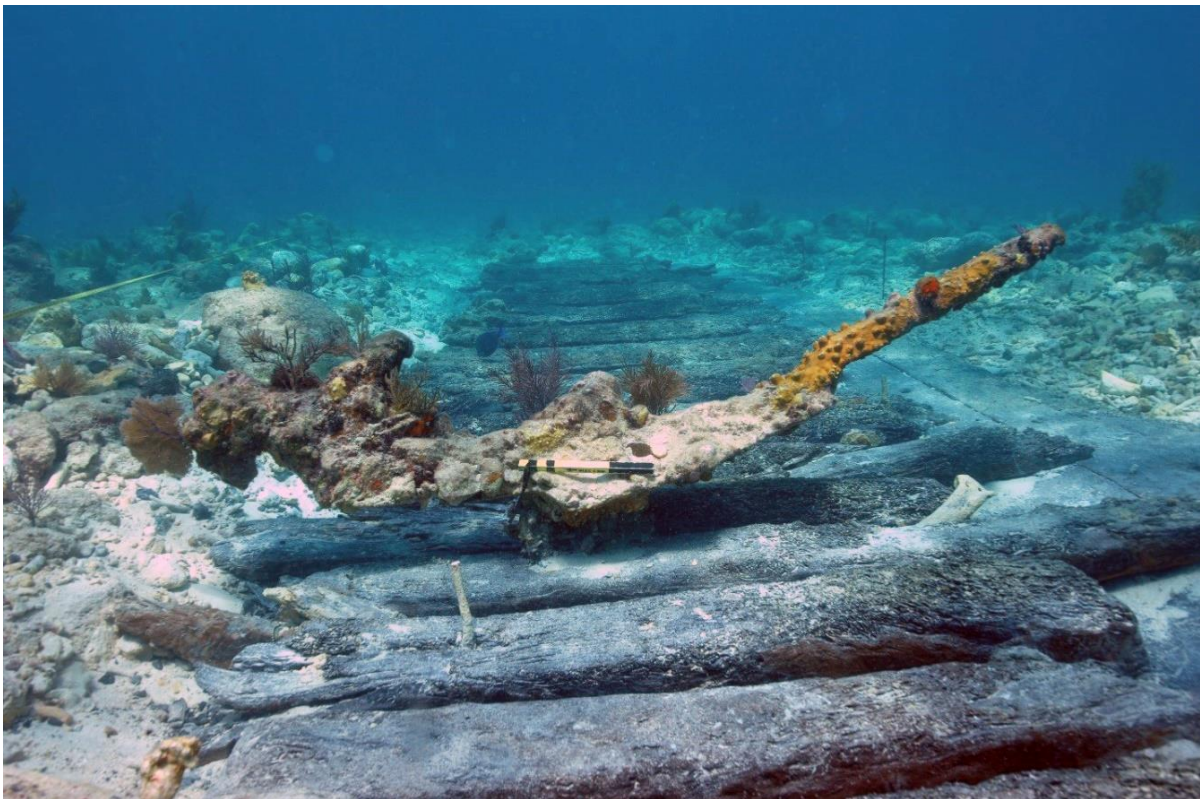
FIGURE 5.19. Western framing element. Note arc and deliberate bend. (Image from NPS, 2016).

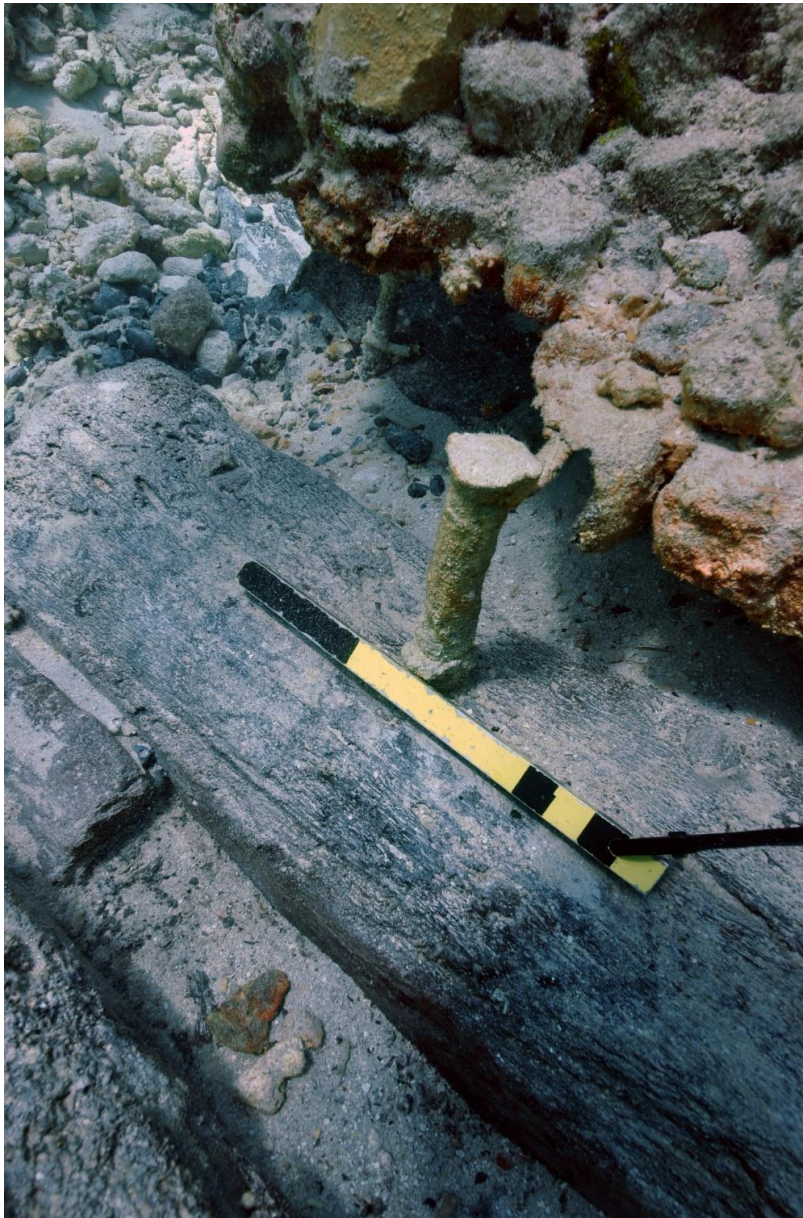
FIGURE 5.20. Copper alloy bolt with clench rings in T19. (Image from NPS, 2016).

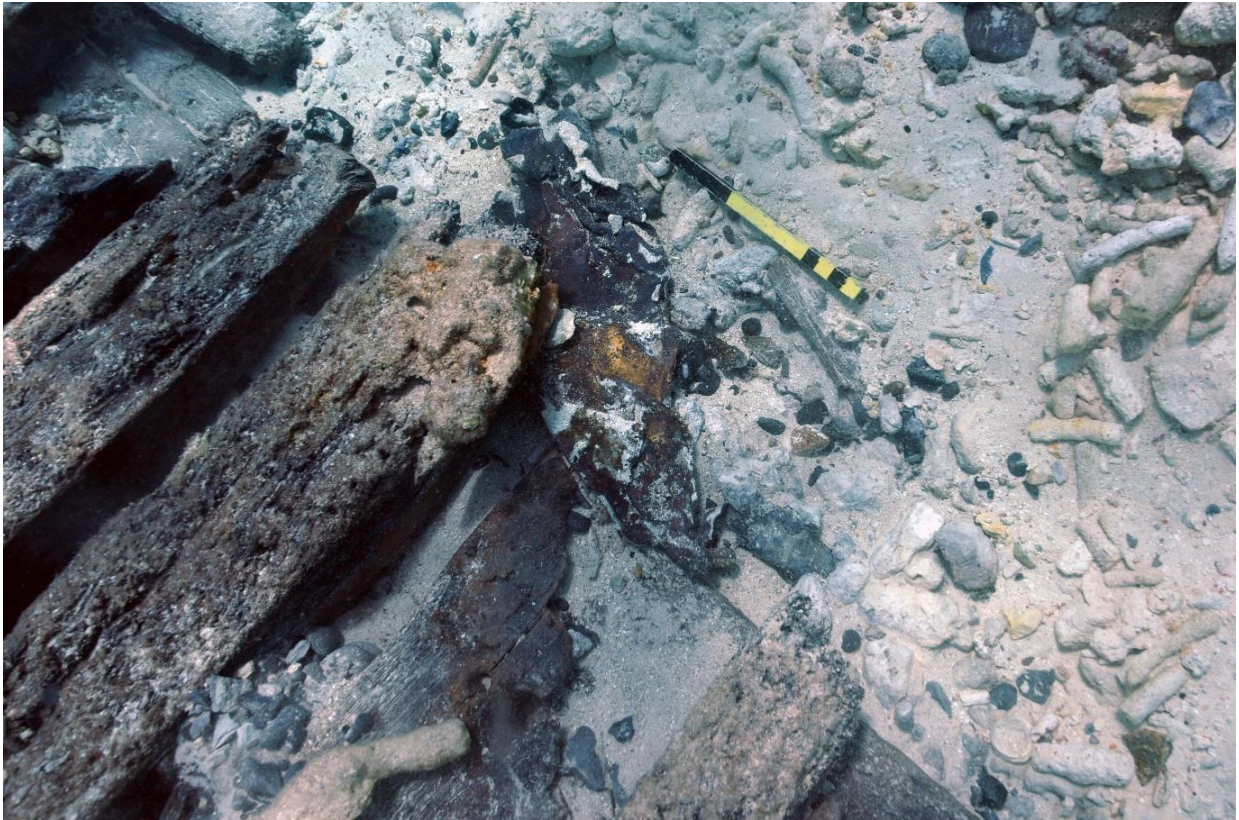
FIGURE 5.22. Sheathing seen on site adjacent to southern end of T57. (Image from NPS, 2016).

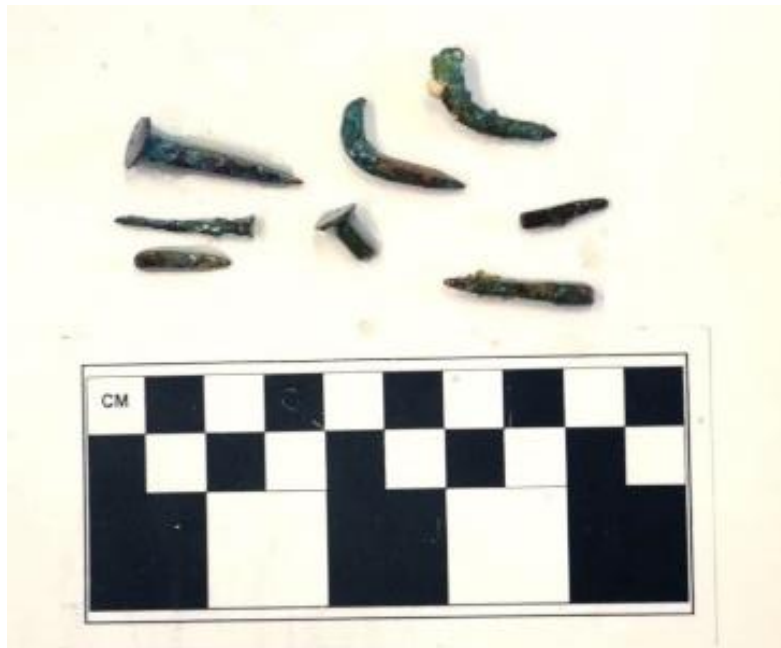
FIGURE 5.23. Sheathing nails and tacks (FS 22.7) recovered from site. Note variations in size and degree of deterioration. (Image from NPS, 2016).

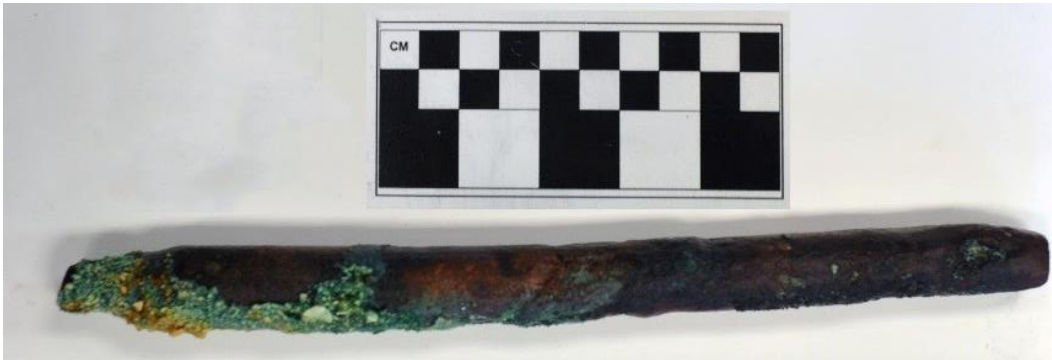
FIGURE 5.24. Copper bolt. (Image from NPS, 2016).

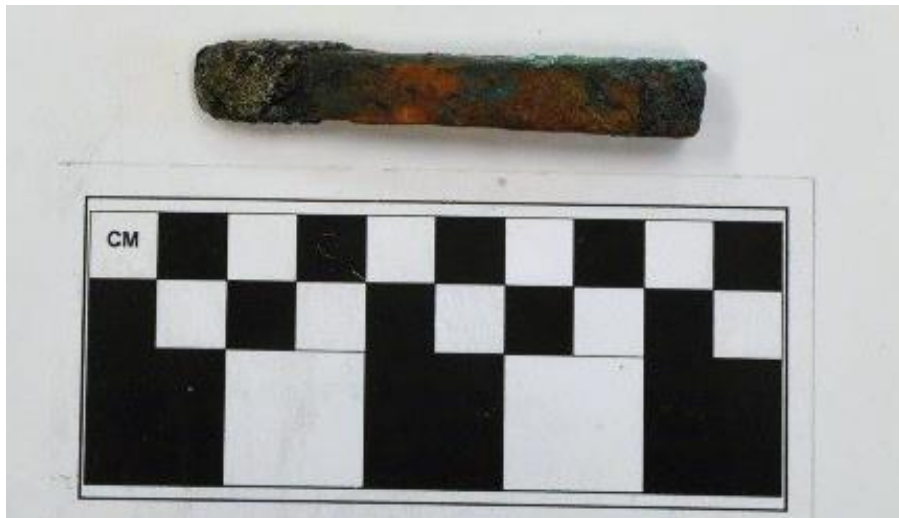
FIGURE 5.25. Spike (FS 11.5) recovered from site. (Image from NPS, 2016).
