THE DEVELOPMENT OF THE NAVAL TRUCK GUN CARRIAGE: HISTORY, ARCHAEOLOGY, AND DESIGN

By
Katrina Bunyard
March 2019

Director of Thesis: Dr. Donald Parkerson
Major Department: Program in Maritime Studies

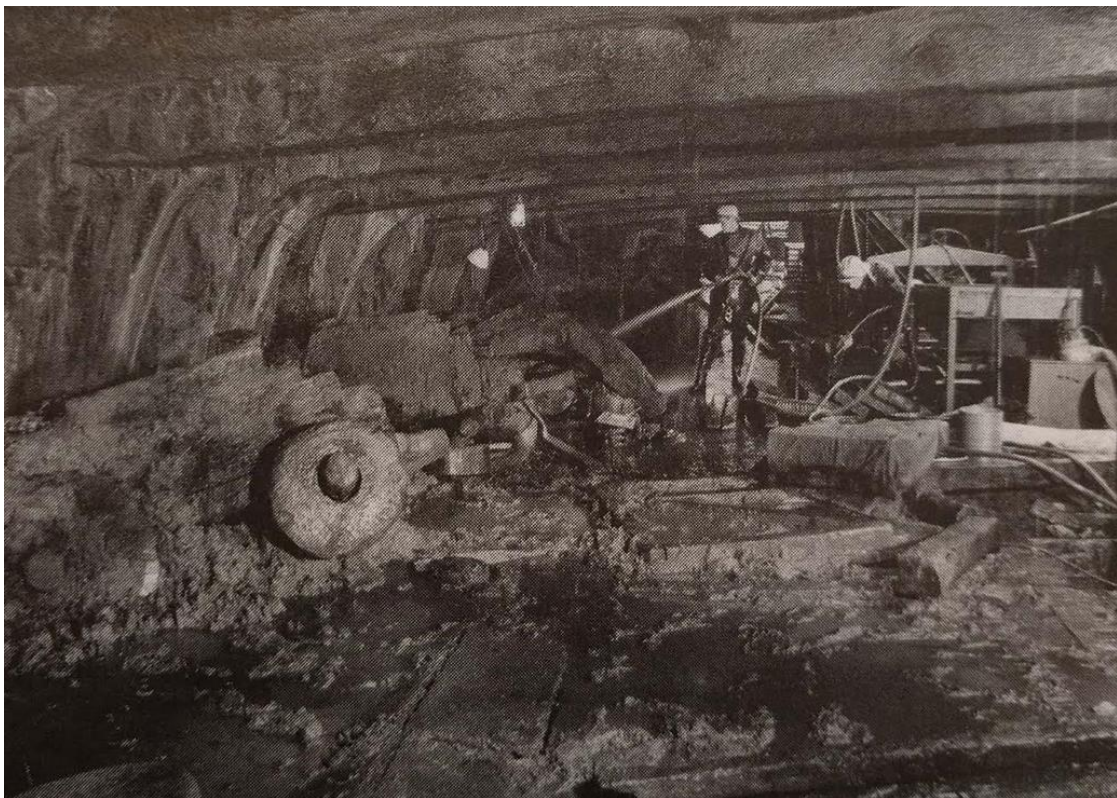
Figure 3.14 shows the lower gundeck with the carriages in place prior to excavation and Figure 3.15 shows the deck cleaned up prior to the removal of the carriages.

FIGURE 3.14: *Vasa's* lower gundeck before excavation (Cederlund 2006:343).

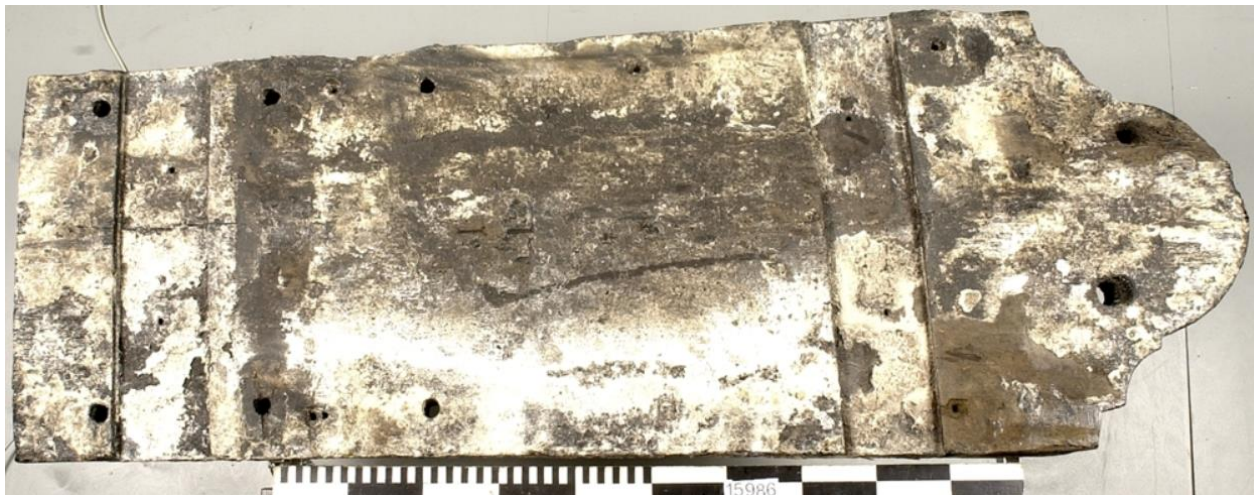
Though not the primary focus of current publications, some information on the construction of *Vasa* carriages can be gleaned from an examination of their remains. The carriage beds consist of single planks, which match the taper between the second reinforce and base ring of the gun. They are squared at the front and decoratively rounded at the rear, which extends out past the cheeks a short distance (Vasa Museet 2018a). Figure 3.16 shows a plan view of the bottom of the bed for VASA 15986.

FIGURE 3.16: Bottom face of VASA 15986 bed (Vasa Museet).

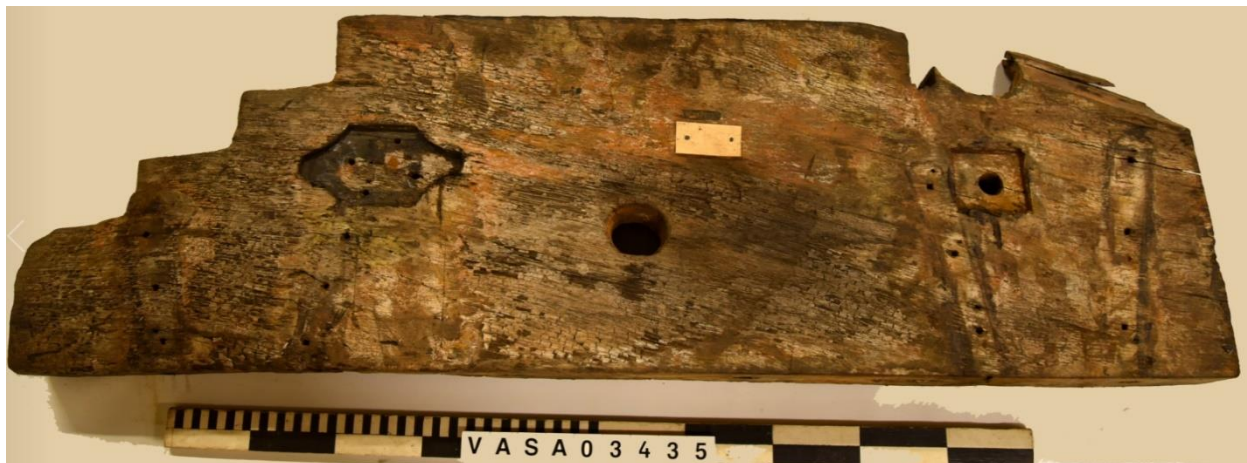
At some point between the *Mary Rose* and *Vasa*, carriage builders transitioned to a continuous cheek construction, as seen in Figure 3.17. The new single plank is of uniform thickness and cut square with a rounded upper corner; the rear half descends to bed level through a series of squared steps, the last of which has decorative molding (Vasa Museet 2018a). The trunnion rest (also called trunnion notch by *Vasa* researchers) consists of a semicircular cut in the top face of the cheek with a rectangular rebate directly behind it, which houses a small metal wedge to help secure the trunnion (Vasa Museet 2018a). The outside face of the cheek contains two additional rebates: one for the single transom bolt securing the front of the two cheeks together, and another towards the back for the iron hook for the breech and train tackles, visible in Figure 3.17 (Vasa Museet 2018a). The center of the cheek contains a large hole to accommodate breeching, a feature Moody observed in the carriage of the 17th century frigate *Enighedden* (Moody 1952:304). Nail holes for the iron straps securing the axletrees are also visible on the outer face of the cheek (Vasa Museet 2018a).

FIGURE 3.17: Profile view of right cheek for VASA 03234 (Vasa Museet).

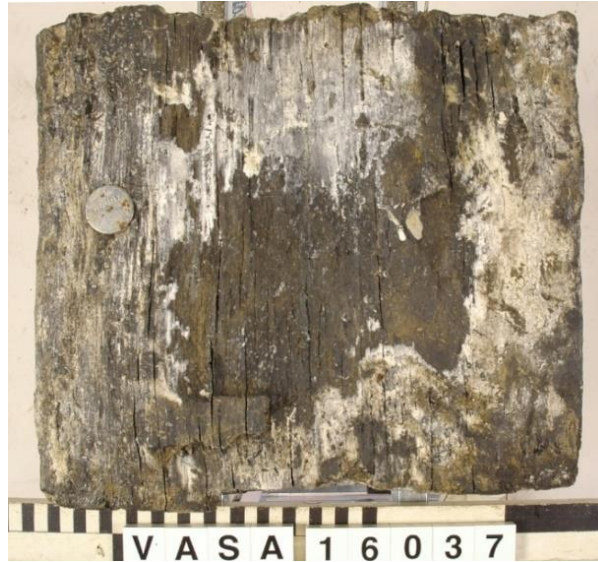
FIGURE 3.18: overhead view of transom for VASA 16033 (Vasa Museet).

The *Vasa* carriages all have transoms, blocks of wood nestled between the cheeks in the front of the carriage; they feature a uniform thickness, angled ends, and chamfered upper edges (Vasa Museet 2018a). Figures 3.18 and 3.19 present two views of a transom. While *Mary Rose* contains isolated cases of light transoms in its carriages, typically in those with both jointed beds and trunnion support cheeks taller than rear stepped cheeks (Hildred 2011:86), it is a uniform feature aboard the *Vasa*. Its presence indicates that at least for Swedish carriages, there was a brief overlap between carriage beds and thicker transoms, before the carriage bed was replaced with the stool bed and the bottom faces of the cheeks were arced. The exact progression of these events is not well studied and likely occurred at different rates (and in different orders) across Europe. A carriage recovered from *Stirling Castle* some eighty years later, for instance, possesses a carriage bed but has no preserved evidence of a transom. Some later carriages have the top of the transom carved to follow the curve of the cannon. Some will also be placed at an angle or have protrusions in front of them, extending past the front faces of the cheeks.

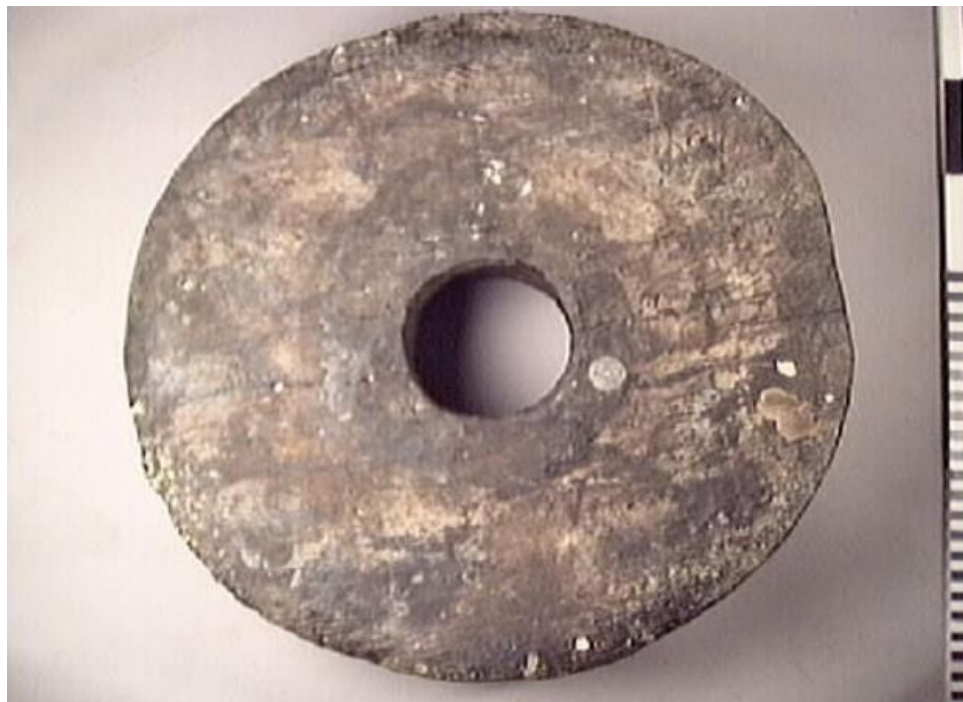
Researchers discovered evidence of adaptable trucks in the *Vasa* carriages. Many are thick wooden disks with their centers hollowed out to accept axletree arms, reinforced with an iron ring, and slightly chamfered edges (Vasa Museet 2018a). Others consist of two disks: one larger than the other, held together with nails. Researchers believe these could indicate cases in which the truck for a lighter carriage was adapted for use on a heavy carriage (Vasa Museet 2018a). The trucks do not come in the same variety of sizes as those aboard the *Mary Rose*. Figure 3.21 is an example of a truck from Carriage 03234.

FIGURE 3.21: Truck for VASA 03234 (Vasa Museet 2018a).

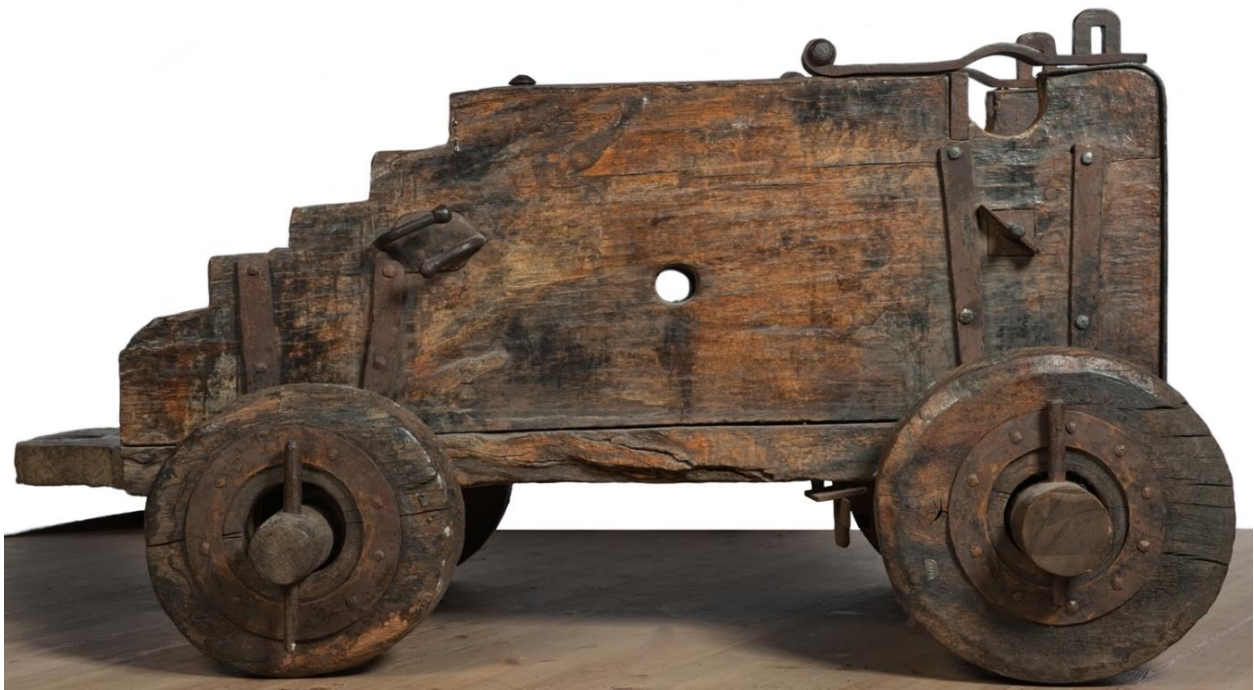
FIGURE 3.22: VASA 04394 reassembled (Vasa Museet).

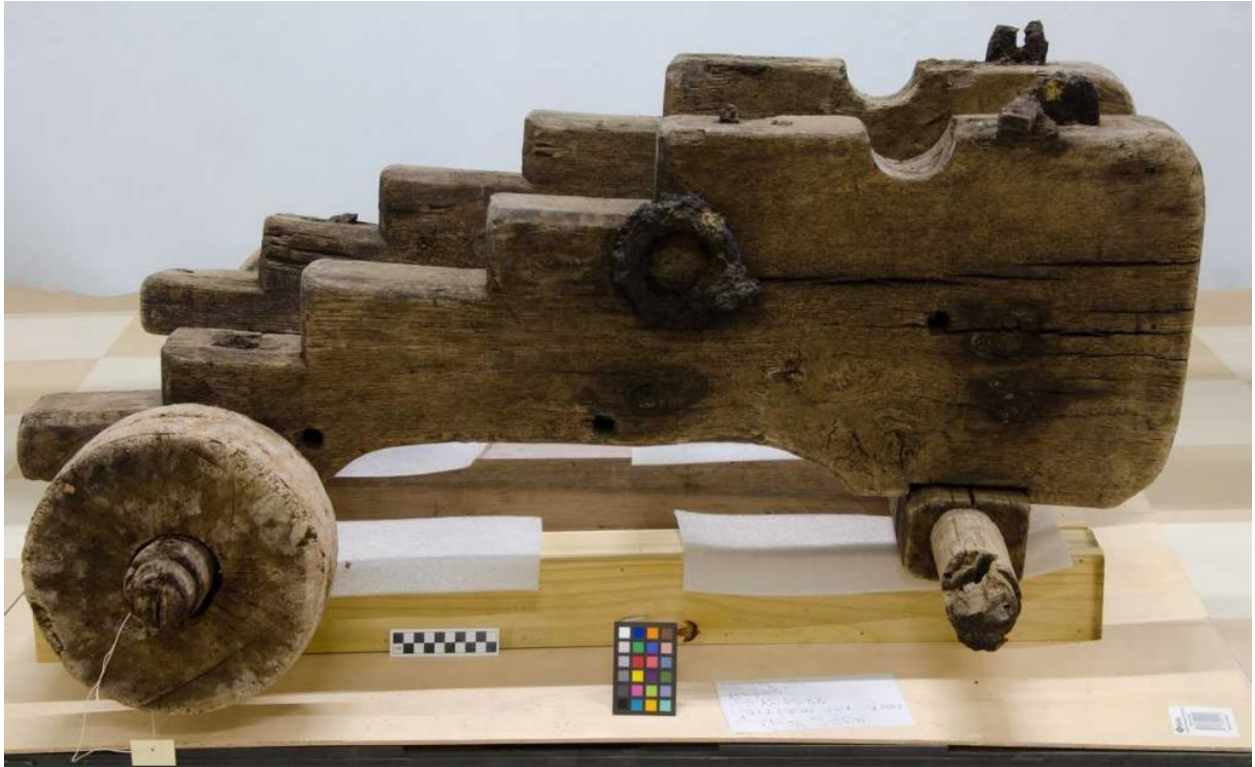
Archaeologists found the gun carriage in *Betsy's* hold, along with an assortment of seemingly incomplete objects (Broadwater 1996: P-1). The carriage lacked any sign of wear and was missing two bolts and a truck, suggesting to researchers that it was being constructed aboard the ship at the time of its scuttling (Broadwater 1996:P-1 and P-2). In conjunction with the other partially assembled artifacts and raw materials, the *Betsy* team hypothesized that the ship served as a floating factory to help free up space at Yorktown's docks (Broadwater 1996:144-145). Figure 3.26 shows the right side of the carriage.

FIGURE 3.26: Betsy carriage (2303) from right side. Courtesy of the Virginia Department of Historic Resources.

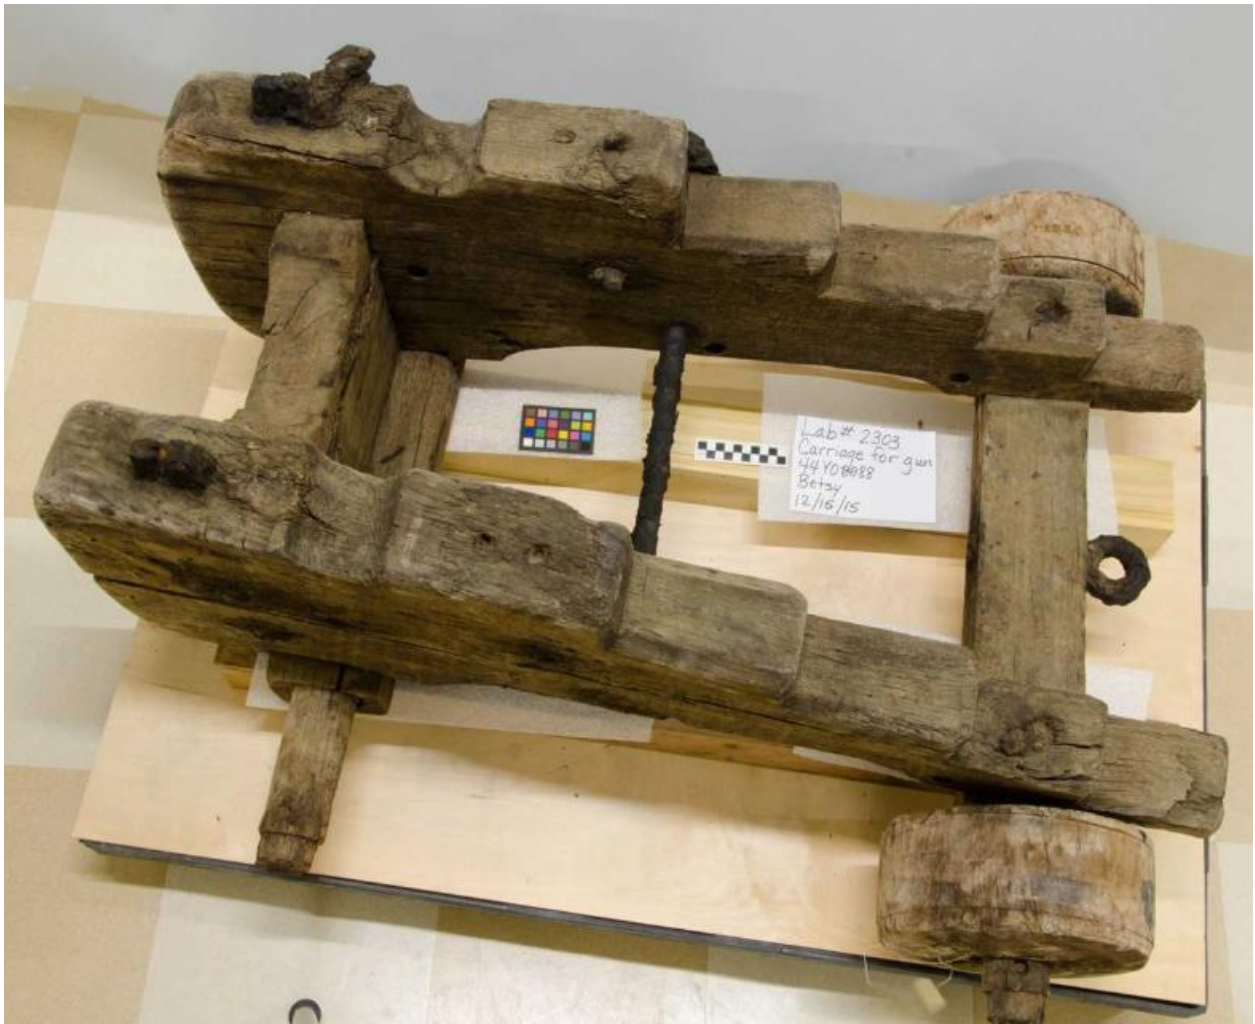
breeching would run. The rearmost hole aligns with this feature and the two would have intersected each other. The builders seemingly opted to move the eye bolt to compensate.

FIGURE 3.27: Top view of Carriage 2303 from Betsy. Courtesy of the Virginia Department of Historic Resources.

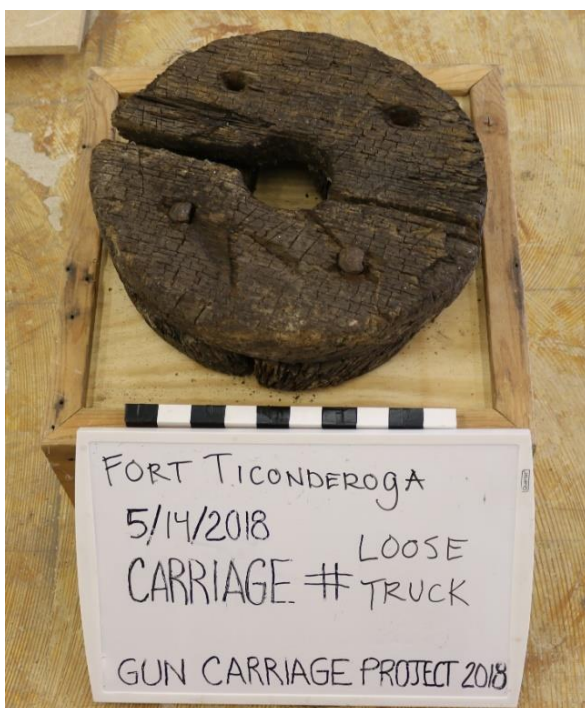
FIGURE 3.30: Truck from *Royal Savage*, at Fort Ticonderoga. Photograph taken by author May 2018.

One of the biggest differences between the Great Lakes carriages and that from *Betsy* lie in the trucks. *Betsy's* trucks, visible in Figures 3.26 and 3.27, are built from single pieces of timber, with two grooves carved on the edges of the tread. Based on a technical drawing by John Broadwater, the front truck for *Betsy* is of a greater diameter than those in the rear, causing the carriage to rest at an angle. Conversely, the carriages pulled from the Great Lakes exhibit trucks constructed from multiple disks, secured with a series of pins. There exists some slight variation between the Great Lakes carriages as well. The trucks pulled from *Royal Savage* consist of two, two-part disks held together with four pins. One gap was carved between two of the disk parts, which can also be seen in the rear truck for Carriage 14 (Figure 3.28), off the *Philadelphia II*. Figures 3.30 and 3.31 show a truck from *Royal Savage*. The trucks from *Philadelphia* use eight wooden pins to secure the disks together and have a greater variation in size.

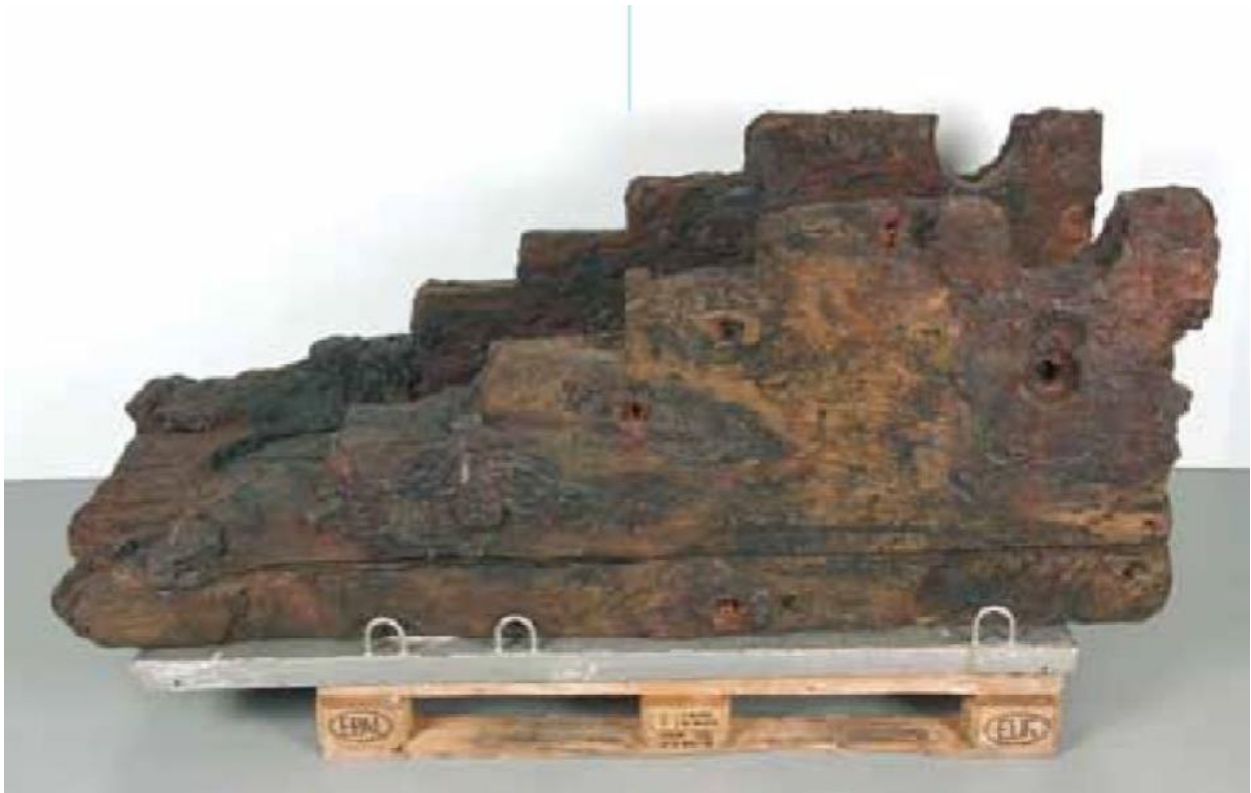
FIGURE 3.32: Stirling Castle Carriage after preservation (ARC-Nucléart 2010).

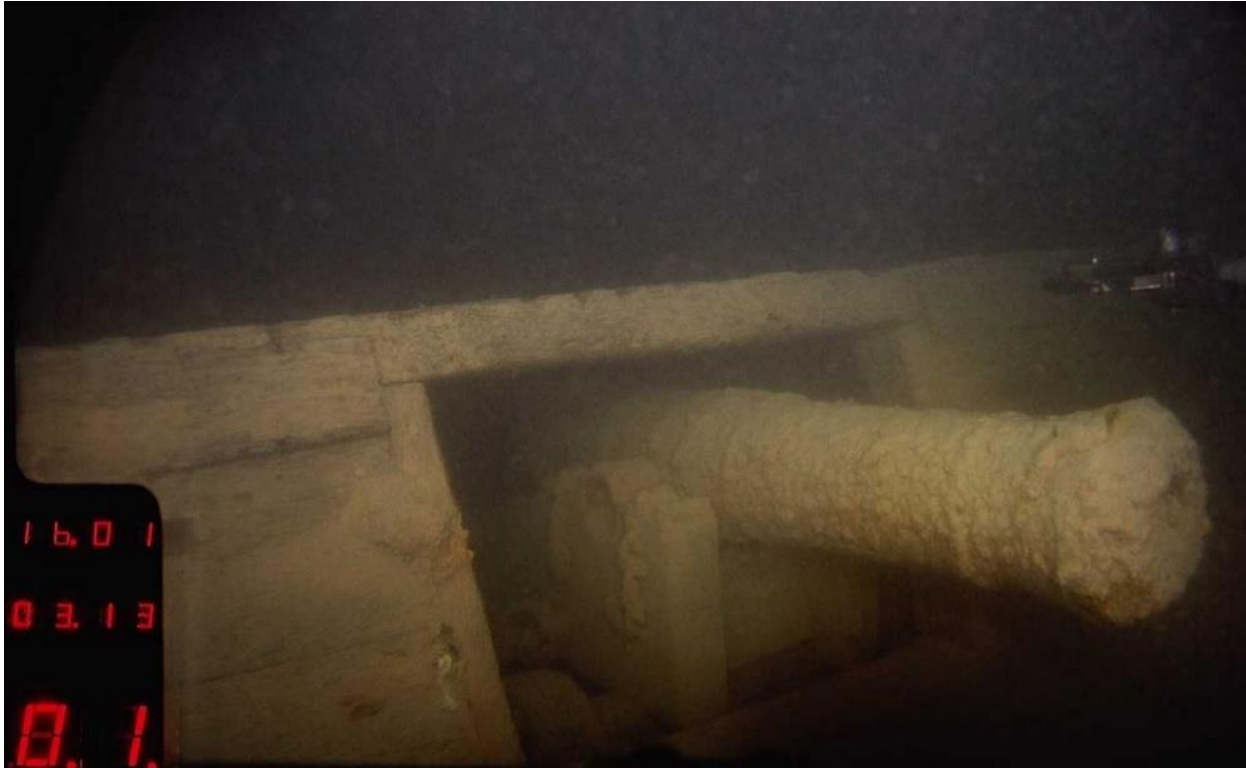
preserved, along with some of the equipment at the gun ports, paving the way for a study of the organization of open-air gun decks. Should more intact ships with guns at their stations be found, it may be possible to gain a better understanding of the changes gundeck organization underwent over time. Figure 3.33 shows one of the starboard carriages still at its gun port aboard *Scourge*.

FIGURE 3.33: Starboard gun aboard the Scourge. Photograph by Emory Kristof (City of Hamilton).

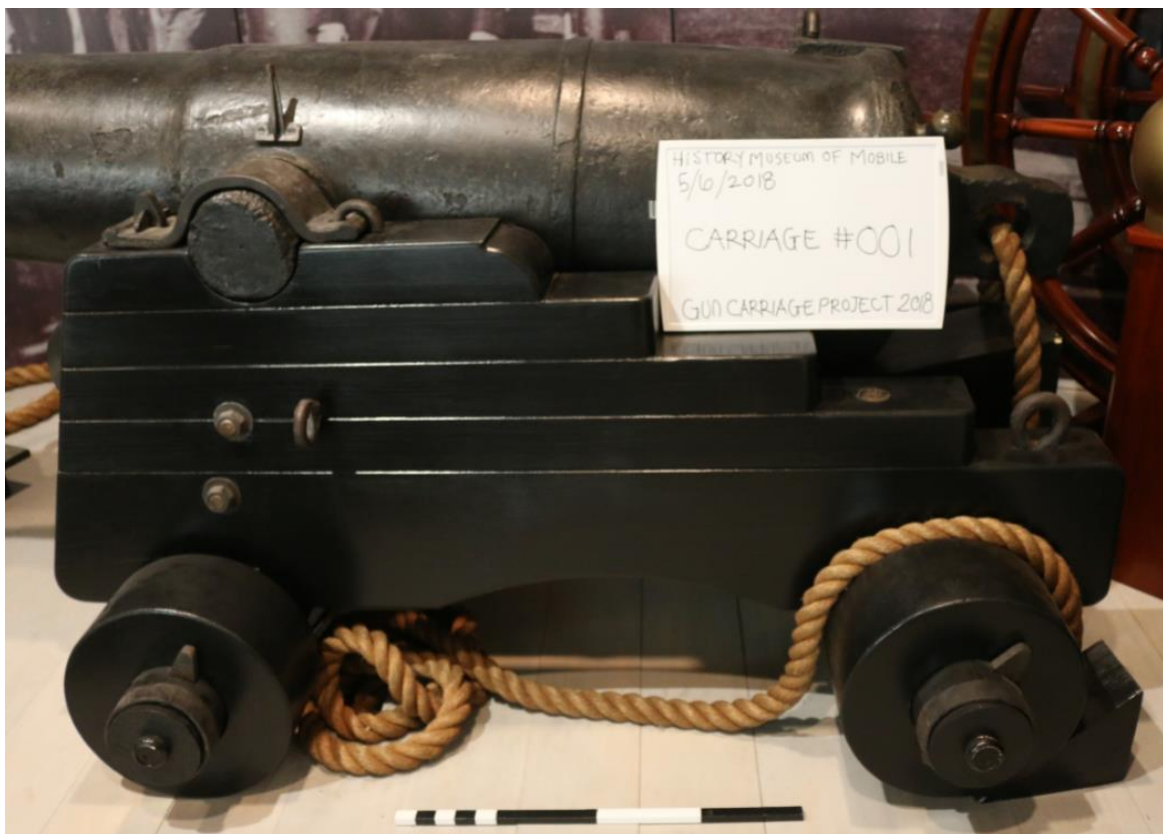
2002), and *C.S.S. Alabama: Builder, Captain, and Plans* by Charles Grayson Summersell (Philip Nassar 2018, pers. comm). Mr. Bowcock based his work upon a series of plans and blueprints related to the *Alabama* from the John Laird Shipyard, which he saved from being discarded after the shipyard closed. Among the *Alabama* documents were plans for naval carriages dated to 1862 (Philip Nassar 2018, elec. comm). The work by Mr. Summersell also contains line drawings and blueprints. These plans were followed exactly in the design of Carriage One (Philip Nassar 2018, elec. comm). City carpenters in Mobile undertook actual construction of the carriage, with the assistance of an engineer (Philip Nassar 2018, elec. comm). Because it was created directly from original Royal Navy blueprints found in the Laird Shipyard, amongst papers related to the *Alabama*, it is likely Carriage One closely mirrors the gun's original mounting. Figure 4.1 shows the carriage.

FIGURE 4.1: Carriage 1, housed in the History Museum of Mobile. Photograph taken by author in May 2018.

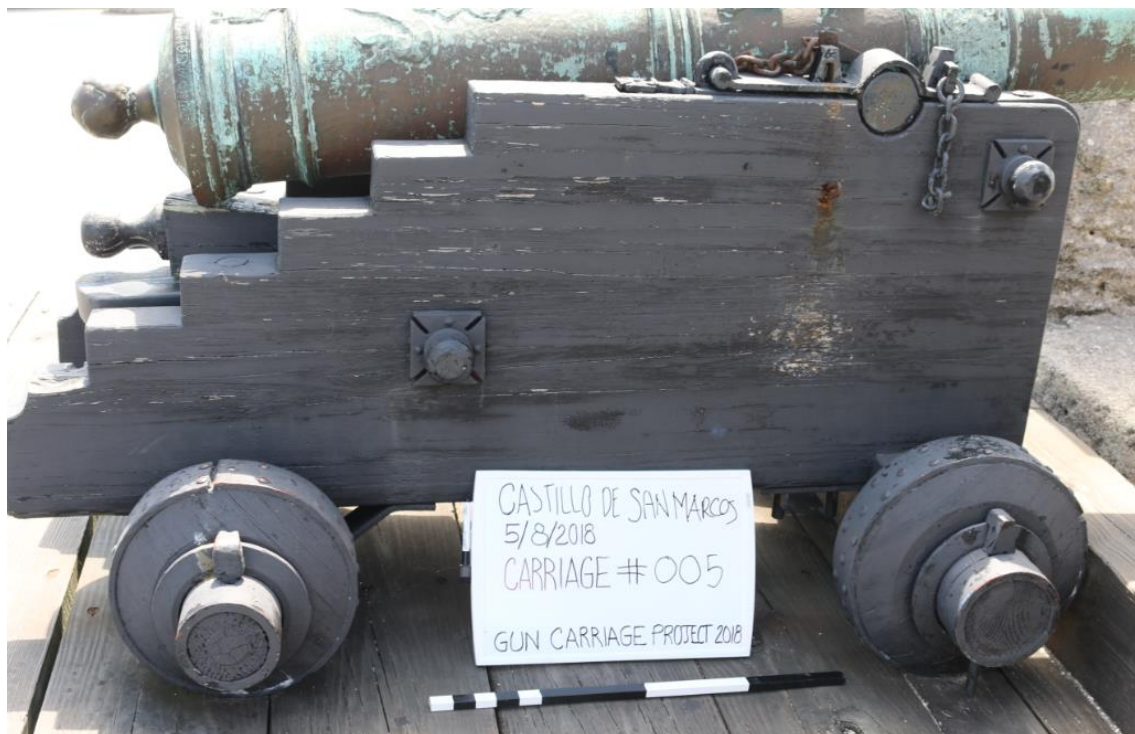
FIGURE 4.2: Carriage 5, housed at the Castillo de San Marcos. Photograph taken by author in May 2018.

The historians completed the majority of research for the project in 1944 (National Park Service 1968), at which point attention turned to finding funding and a company for construction. The Castillo initially reached out to Lorton Industries, in Lorton, Virginia for aid in constructing the carriages. Communication with Lorton began as early as 1955, and they agreed to aid in the project so long as the materials were wood or iron (Peterson 1955). The historians at the Castillo advocated for pressure treated wood with wrought iron hardware (Peterson 1955). Lorton took the contract and built the carriages, completing and delivering them by April 1967 (National Park Service 1968). Figure 4.2 shows Carriage 5, while Appendix E contains photographs of the rest of the Spanish carriage recorded at the Castillo.

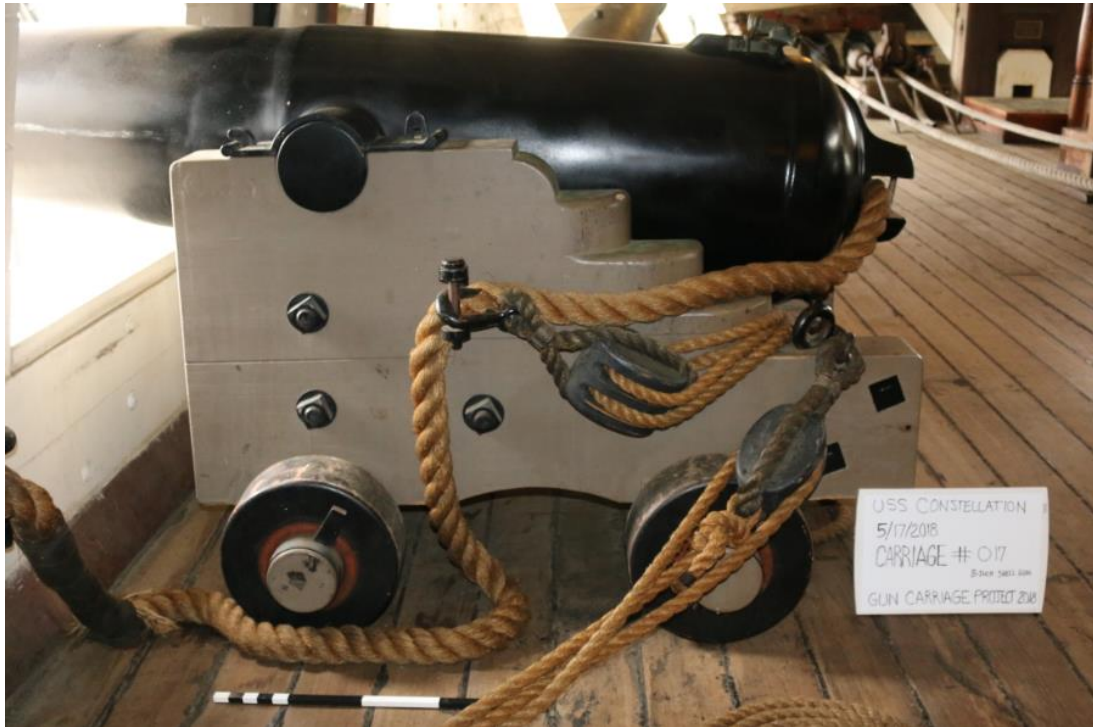
FIGURE 4.3: Carriage 17, *U.S.S. Constellation*, Historic Ships in Baltimore. Photograph taken by author in May 2018.

Carriage 16 is the donated 32-pounder and for the purposes of general display, it is well suited. It contains the correct general shape of a typical mid-19 century gun carriage. Due to some inaccuracies in small details, it could not be included in the database. Carriage 17 belongs to one of the replica VIII inch shell guns, and is accurate in proportionality and construction details, having been based directly off original naval plans. Carriage 18 supports a small parrot gun, housed on the upper deck of the sloop. Figures 4.3 and 4.4 show Carriages 17 and 18 respectively.

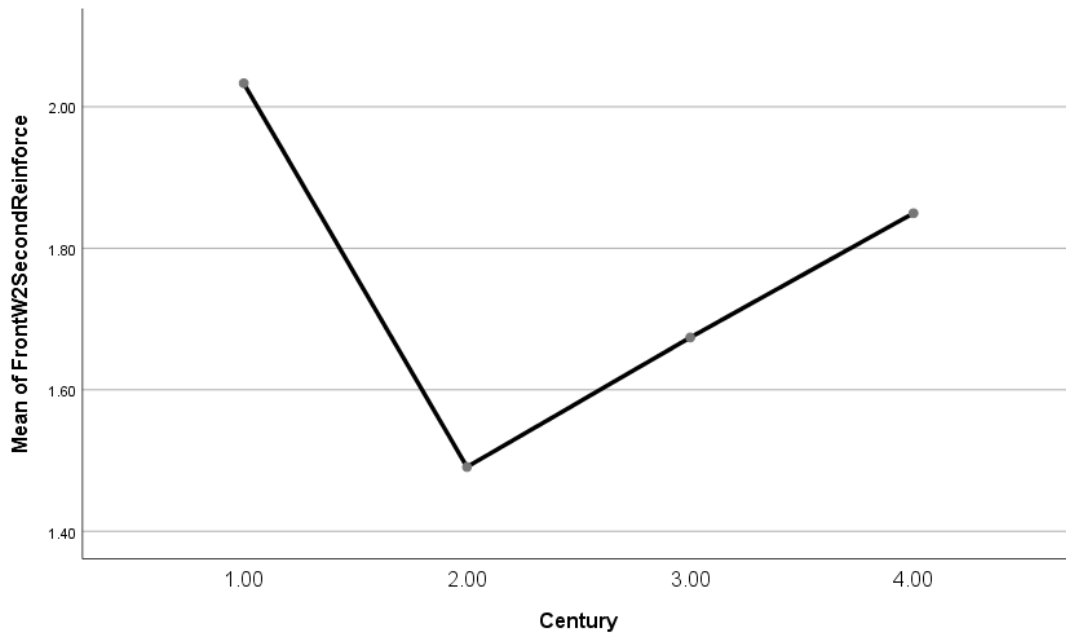
FIGURE 4.9: Changes in between the front with and second reinforce ring. The “1” stands for the 1500s and “4” for 1800s. Figure by author 2018.

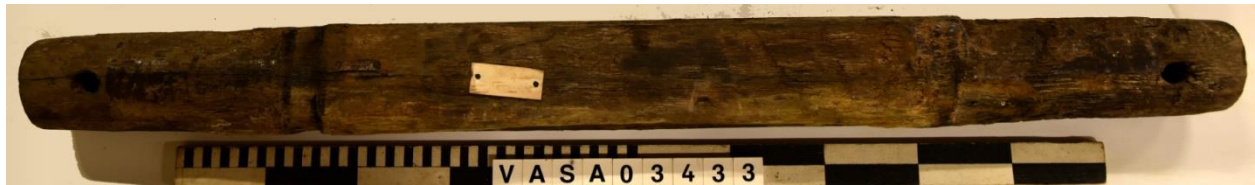
FIGURE 4.20: Rear axletree body for Carriage 19 from *Vasa* (Vasa Museet)

Beginning in the 17th century, the height of the axletree body and the diameter of the arm possessed an almost one to one relationship. During this time, as seen by the *Vasa*, the axletree arm was essentially the same size as the body, only slightly tapered and curved to accommodate the truck. The increase in height suggests that the axletree body underwent some changes, moving towards a more rectangular shape. The rear axletree body grew more distinct from the rear axletree arm. Figures 4.20 and 4.21 highlight this growing distinction. Figure 4.20 is the rear axletree for Carriage 19 off the *Vasa* and Figure 4.21 is part of the rear axletree body, arm, and truck from Carriage 17, from *Constellation*.

In Figure 4.20, there is not much distinction between the body of the axletree and the arm; they possess virtually the same dimensions, with the body being square and the arm being circular. By the mid-19th century, the axletree arm diameter is smaller than the height or width of the body, as seen in Figure 4.21. Increased axletree size could relate to the removal of carriage beds from general design. The beds helped evenly distribute the weight of the gun across the entire axletree. Without it, the weight of the gun goes directly down the cheeks into the outer ends of the axletree body, rather than being evenly distributed. In other carriages with carriage beds, the rear axletree body and arm retain relatively the same dimensions. However, in all the carriages without beds, the rear axletree is larger than the axletree arm, no matter the nationality. This suggests that after the carriage bed was removed, the axletrees were reinforced to support the weight of the gun.

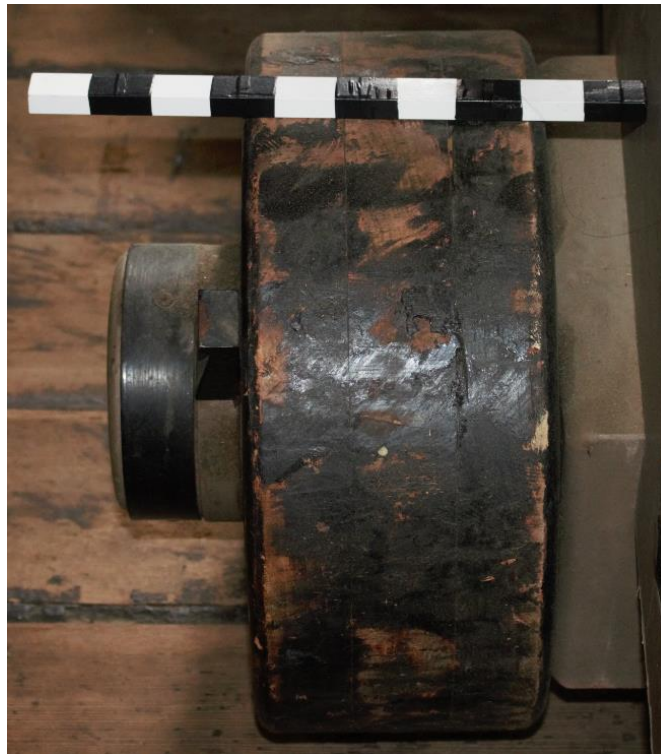
FIGURE 4.21: Rear Axletree arm and truck for Carriage 17, *U.S.S. Constellation*. Photograph taken by author in 2018.

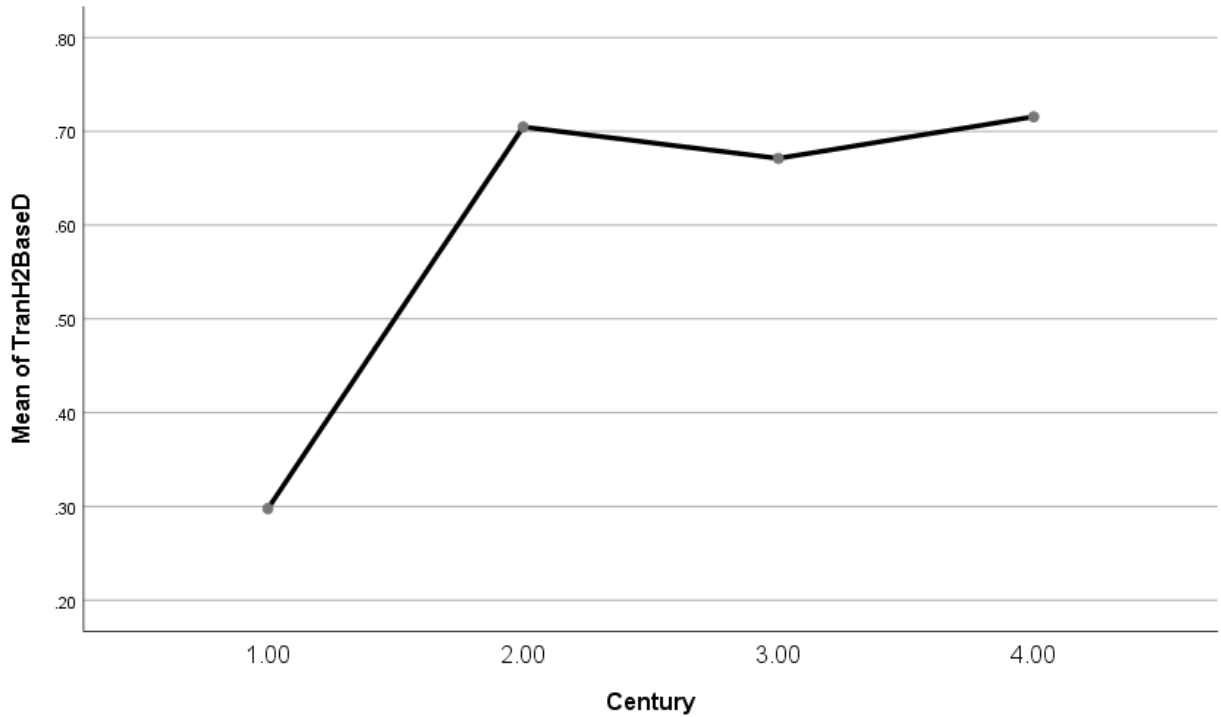
FIGURE 4.22: transom height to base ring diameter over time. Figure by author 2018.
