A SPATIAL ANALYSIS OF USCG VESSEL *LILAC*:
AN ARCHAEOLOGICAL APPLICATION OF ACCESS ANALYSIS

A Thesis

Master of Arts in Maritime Studies

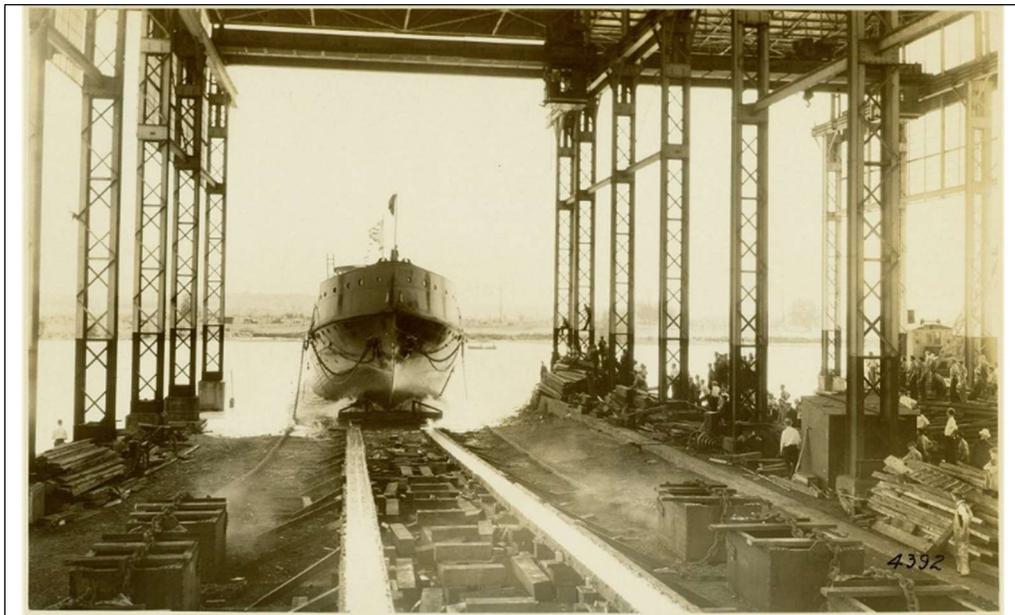
Figure 2.3. *Lilac* launching at the Pusey & Jones Shipyard, 1933 (Hagley Digital Archives 2018).

After careful planning and construction, *Lilac* was launched on May 26, 1933 (Figure 2.3). As per the prohibition laws of the time, government boats could not be christened with bottles of champagne. Kristie Areszk Putnam christened *Lilac* by breaking a bottle of water against the vessel's bow (Figure 2.4). Her sister, Elizabeth Duncan Putnam, had christened *Arbutus* a few months before (*The Morning News* 1933:8). George R. Putnam, their father, served as Commissioner of the USLS from its creation in 1910 until his retirement in 1935 and authored several books on navigational aids. *Lilac* was subsequently assigned to serve as a buoy tender in the Fourth Lighthouse District (this region would later become the Fifth Coast Guard District), which covered the Delaware River, from Trenton, New Jersey south to the Delaware Bay (Scheina 1982:123-24, 1990:171). Intended to replace *Iris* (a tender originally

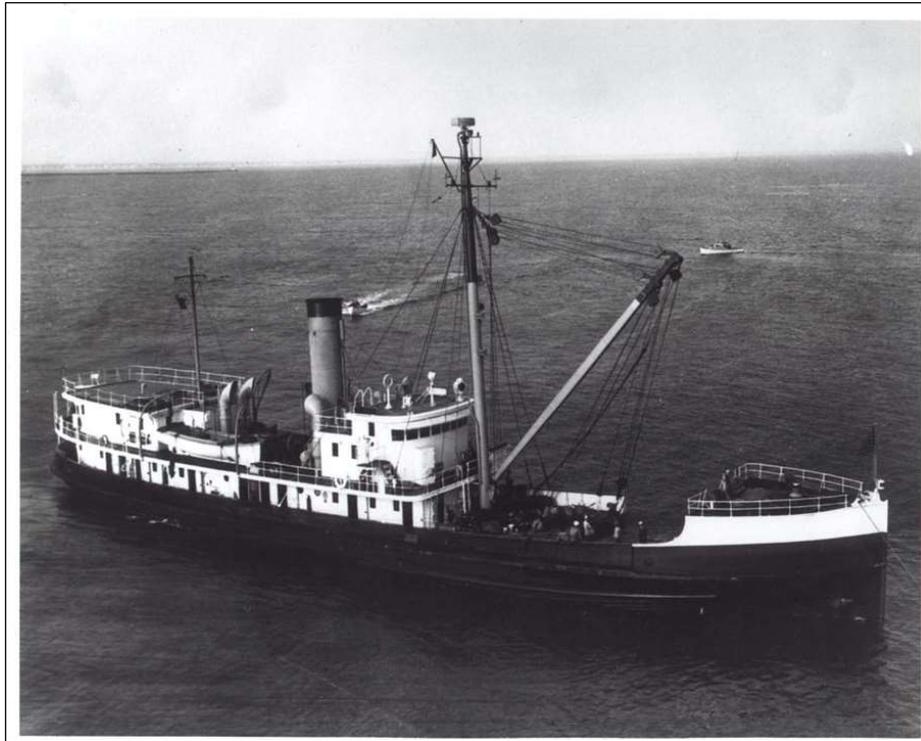
Figure 2.6. *Lilac* at sea after incorporation into the USCG, prior to 1942 (*Lilac* Preservation Project 2018).

The USCG took over all the responsibilities for maintained aids to navigation previously handled by the USLS, including the operation of roughly 30,000 aids to navigation, ranging from the more than 400 lighthouses and 30 lightships to the numerous unlighted buoys and shore marks, throughout the harbors and navigable waterways in the U.S. and its territories (Johnson 1987:161-65; Marshall 1998:152-156). While serving under the USLS, *Lilac* had a crew consisting of six officers and twenty seamen. Following the 1939 incorporation of the USLS into the USCG, the Coast Guard increased *Lilac's* crew to two officers, two warrant officers, and 34 seamen. As such, *Lilac's* crew and responsibilities correspondingly grew in size. The ship and its crew continued to be based in Edgemoor, Delaware. Nevertheless, *Lilac's* internal structure and outward appearance underwent change. *Lilac's* appearance was altered so that the all black stack, typical of USLS tenders, was repainted to Coast Guard buff with a black top (Figure 2.6).

Additionally, the brass lighthouse emblems bolted to either side of the bow were removed, and the triangular USLS pennant was changed to the USCG flag (Brouwer 2004: Section 8-2).

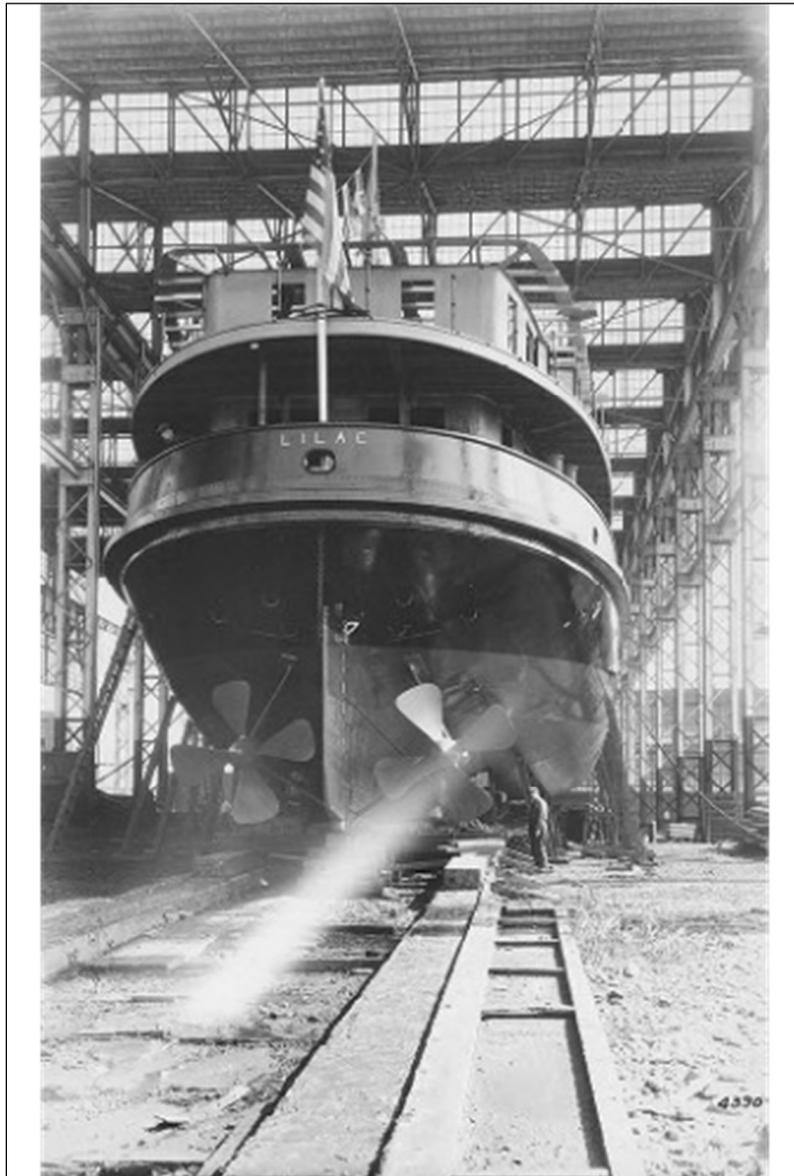
Figure 5.1. *Lilac*'s twin four-bladed propellers, Pusey & Jones Shipyard, 1933 (Hagley Digital Archives 2018).

as fast forward as backward, providing *Lilac* with extra maneuverability. Built by Pusey & Jones, *Lilac*'s engines had high, intermediate, and low-pressure cylinders, with 11½, 19, and 32-inch diameters and a 24-inch stroke. Two Babcock & Wilcox oil-fired, water-tube boilers supplied the steam to operate the engines at 200 pounds per square inch. The designed speed of *Lilac* was approximately 13.7 knots, but this changed depending on mechanical upgrades (Scheina 1990:171; Brouwer 2004:Section 7:1-4).
