# Automated Pavement Condition Assessment using Unmanned Aerial Vehicles (UAVs) and Convolutional Neural Network (CNN)

A Thesis

Master of Science in Construction Management

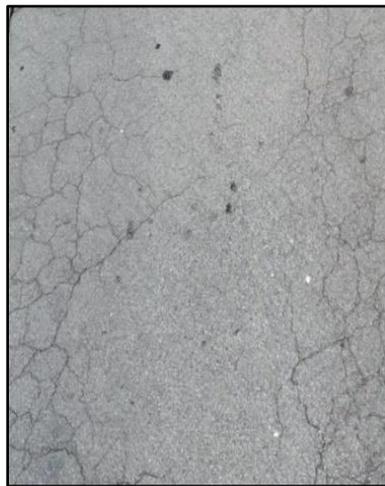
This thesis focuses on two types of flexible pavements distresses (i.e., alligator and longitudinal cracking). Alligator (fatigue) cracking is a consequence of repeated traffic loading, appearing in the form of a series of interconnected cracks (fatigue failure), a pattern resembling the skin of an alligator (Figure 2.2).

Figure 2.2: Alligator Cracking in Flexible Pavements

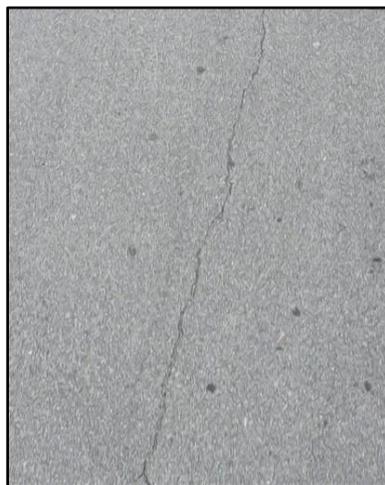
Longitudinal cracking can either be wheel path or non-wheel path and appears lengthwise along the centerline of the pavement (Figure 2.3). The longitudinal cracks eventually turn into alligator cracking under repeated traffic loading.

Figure 2.3: Longitudinal Cracking in Flexible Pavements

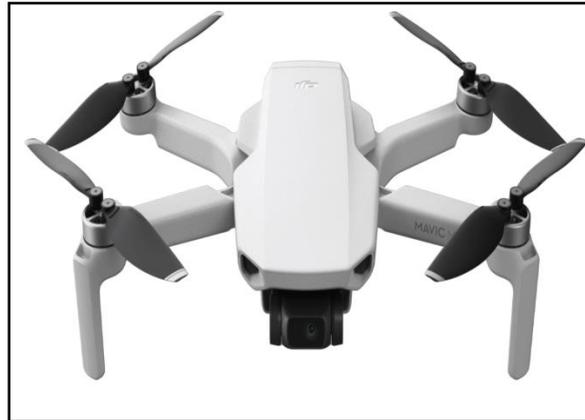
camera attached recorded the video for the whole span of the streets and the images were then extracted from the collected videos. The aerial imagery obtained was cropped to represent the distresses in post-processing to get the desired results. The collected aerial images were manually labeled and classified into the two categories before inputting them into the model.

Figure 3.3: DJI Mavic Mini Used for Data Collection

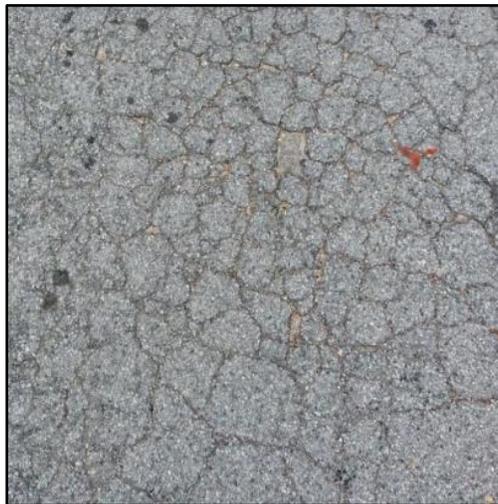
1.1 Alligator cracking: It is also known as fatigue cracking which occurs in the form of a series of interconnected cracks, a pattern resembling the skin of an alligator. These cracks result from repeated traffic loading (fatigue failure) forming many-sided and sharp-angled pieces with the longest side usually measuring up to 0.3 m or 1 foot. The severity of these cracks is identified as low, moderate, or high based on the area covered by the cracks (Miller et al., 2003; Rashid et al., 2017).

Figure A1: Alligator Cracking in Flexible Pavements

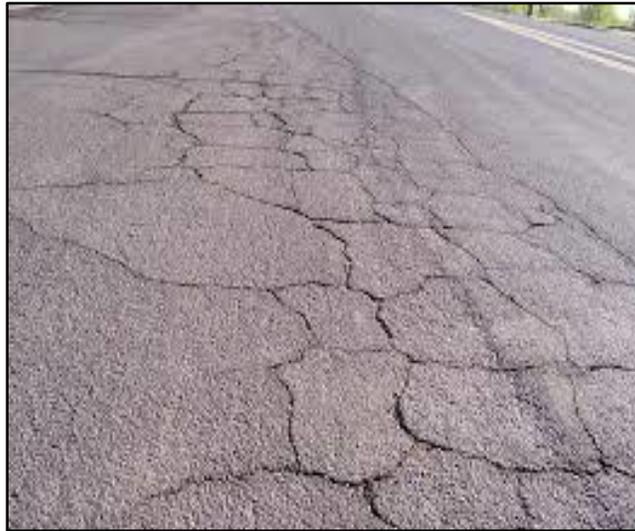
1.2 Block cracking: It occurs in the pattern of interconnected square or rectangular blocks on the surface of the pavement. These blocks are usually in the size range of 0.1 to 10 m<sup>2</sup> extending over a large part of the pavement surface area. The cracked area is measured in order to determine the severity of the cracking (Miller et al., 2003; Pierce et al., 2013; Rashid et al., 2017).

Figure A2: Block Cracking in Flexible Pavements

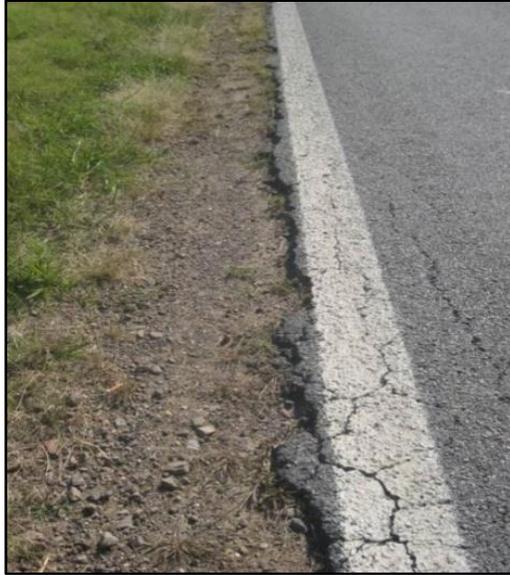
1.3 Edge Cracking: It occurs along the edges of the pavement surface as a result of poor drainage and lack of appropriate support at the pavement edges. Continuous or crescent shaped cracks intersecting the pavement edges are formed at the edge of pavement alongside the shoulder usually within 0.6 m (Miller et al., 2003).

Figure A3: Edge Cracking in Flexible Pavements

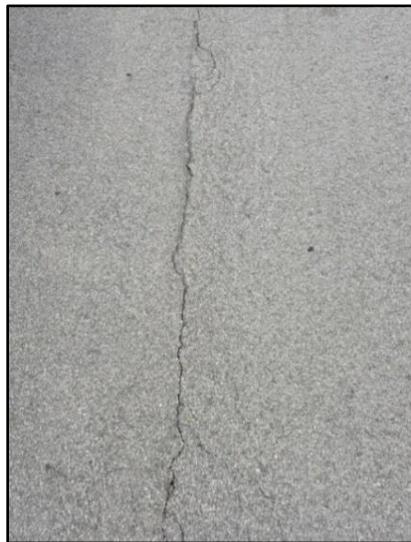
1.4 Longitudinal Cracking: It occurs along the centerline of the pavement. Depending on the location at which it appears in the lane, it can either be the wheel path or non-wheel path. Longitudinal cracks ultimately develop into alligator cracks under repeated traffic loading. The severity of these cracks is identified as low, moderate, or high based on the linear measurement of the cracks. (Miller et al., 2003; Rashid et al., 2017).

Figure A4: Longitudinal Cracking in Flexible Pavements

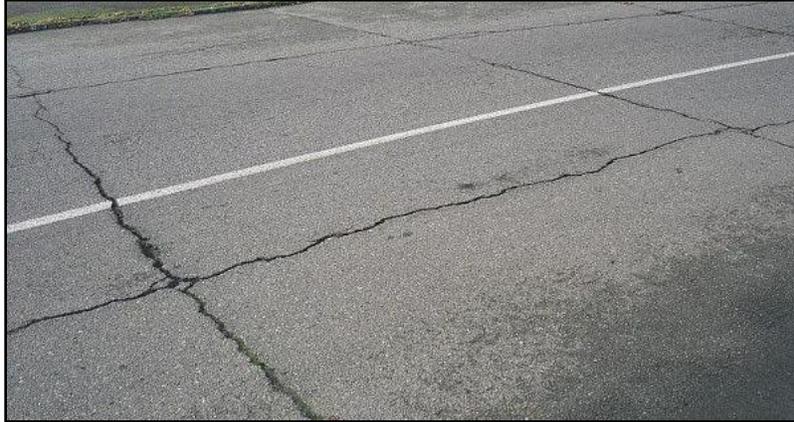
1.5 Reflection Cracking: It occurs in the flexible overlays of concrete pavements over the joints due to the joint movement. Reflective cracks also appear in asphalt pavements over other cracks or pavements with a stabilized base.

Figure A5: Reflection Cracking in Flexible Pavements

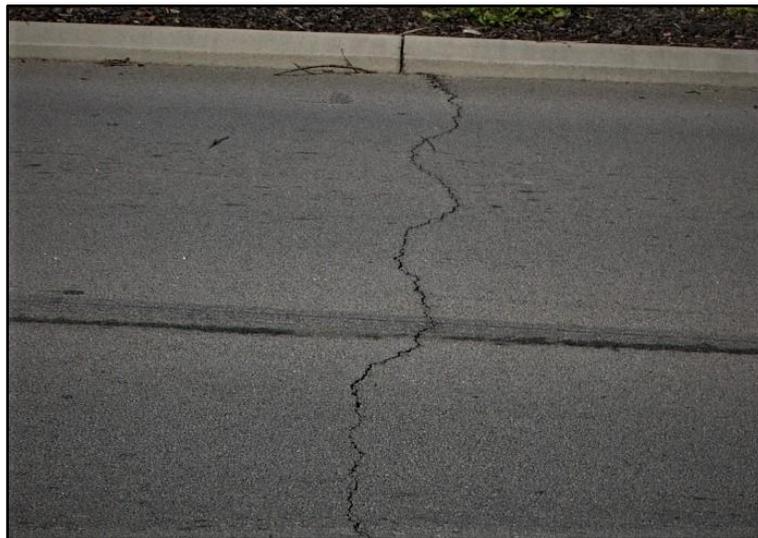
1.6 Transverse Cracking: It occurs along the width or perpendicular to the centerline of the pavement. It is caused by hardening of asphalt binder or the shrinkage of the surface layer due to low temperatures (Miller et al., 2003).

Figure A6: Transverse Cracking in Flexible Pavements

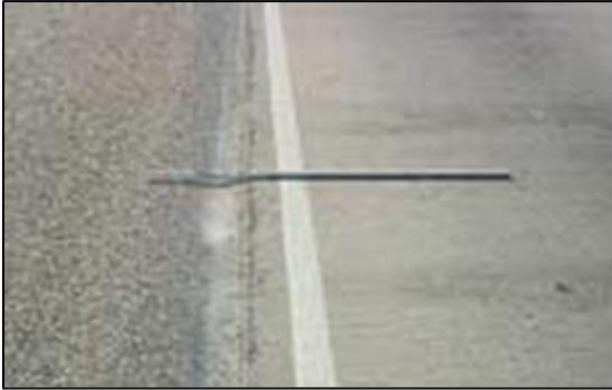
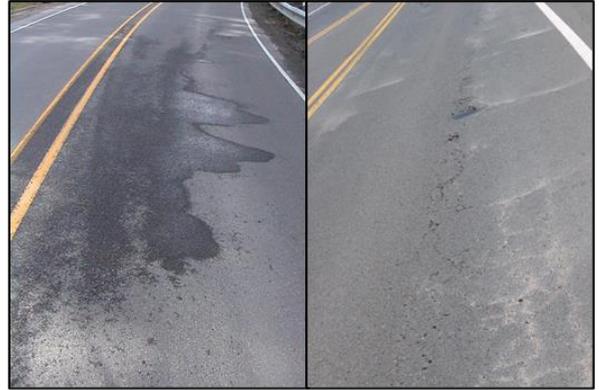
**5. Miscellaneous Distresses:** These include lane-to-shoulder dropoff and water bleeding and pumping. The lane-to-shoulder dropoff is also called edge dropoff is a result of the difference in elevation between the traveled surface and the outside shoulder due to the settlement of the shoulder because of lack of subgrade support (Figure A10a). Water bleeding and pumping occurs when the water beneath the pavement either seeps or is discharged through the joints and cracks, typically encountered on the surface through deposits of water and fine material eroded from the underlying layers of the pavement (Figure A10b) (Coenen et al., 2017; Miller et al., 2003).

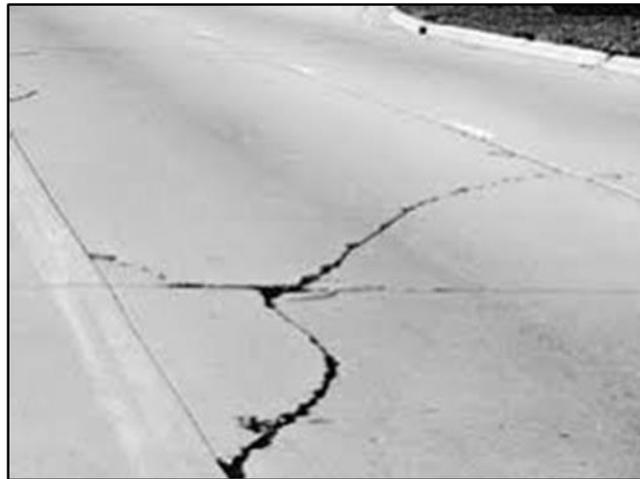
1.1 Corner Breaks: They occur as a result of high corner stresses in concrete pavements. These extend from the corners of the pavement intersecting the adjacent transverse and longitudinal joints at an angle of approximately  $45^\circ$  widthwise (Figure A11). Their length measures from 0.3 m to half the size of the width of the pavement (Miller et al., 2003).

Figure A11: Corner Breaks in Rigid Pavements

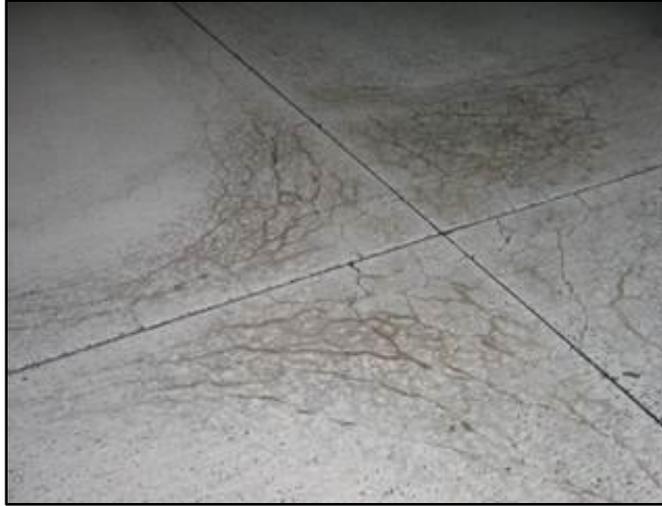
1.2 Durability “D” Cracking: It occurs in the form of closely spaced, crescent-shaped cracks due to the contraction and expansion of the large aggregate within the pavement. It usually initiates from slab corners and appears near the joints, cracks, or free edges of the pavements in a hairline cracking pattern (Figure A12). (Miller et al., 2003).

Figure A12: Durability “D” Cracking in Rigid Pavements

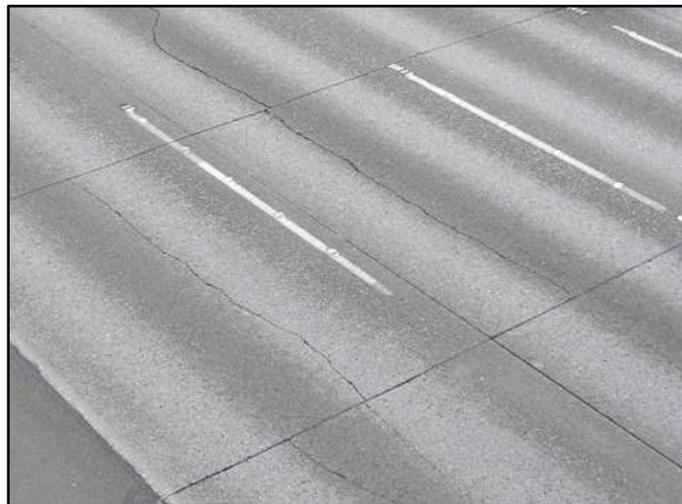
1.3 Longitudinal Cracking: It is similar to the flexible pavements. The cracks appear primarily in the direction of the traffic, along the centerline of the pavement (Figure A13). The severity of the cracks is determined based on the width of the cracks and the corresponding spalling (Miller et al., 2003).

Figure A13: Longitudinal Cracking in Rigid Pavements

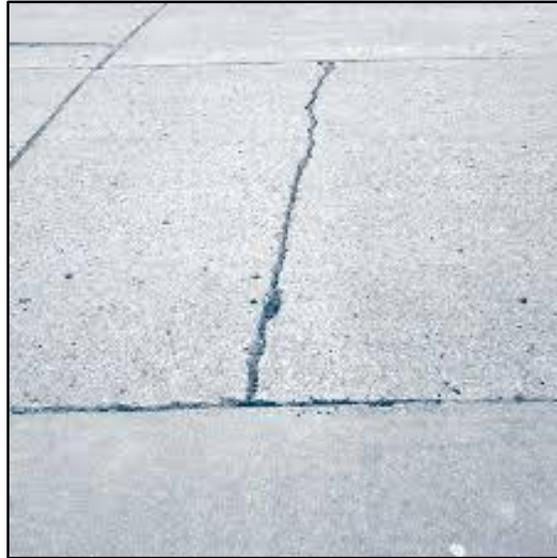
Like longitudinal cracks in rigid pavements, the severity of the cracks is determined based on the width of the cracks and the corresponding spalling (Miller et al., 2003).

Figure A14: Transverse Cracking in Rigid Pavements

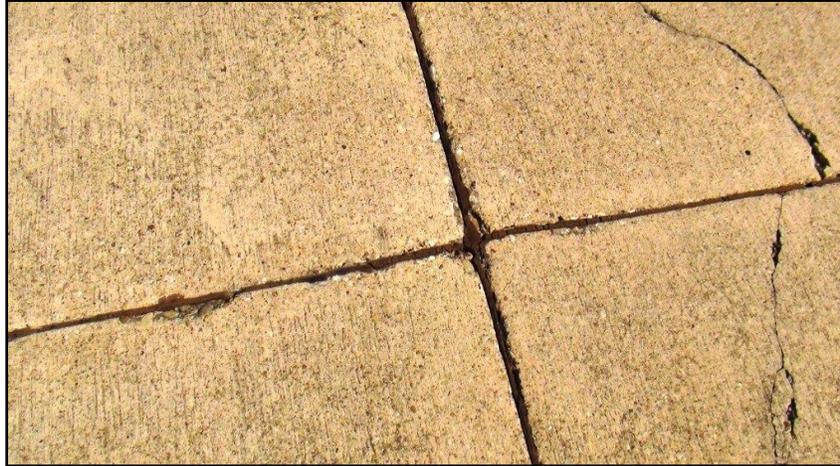
2.1 Joint Seal Damage: It occurs due to the infiltration of water or incompressible material through the pavement joints from the surface. It can appear in both longitudinal and transverse joints and includes extrusion, hardening, adhesive failure (bonding), cohesive failure (splitting), complete loss of sealant, intrusion of foreign material into the joint or grass or weed growth in the joint (Figure A15) (Miller et al., 2003).

Figure A15: Joint Seal Damage in Rigid Pavements

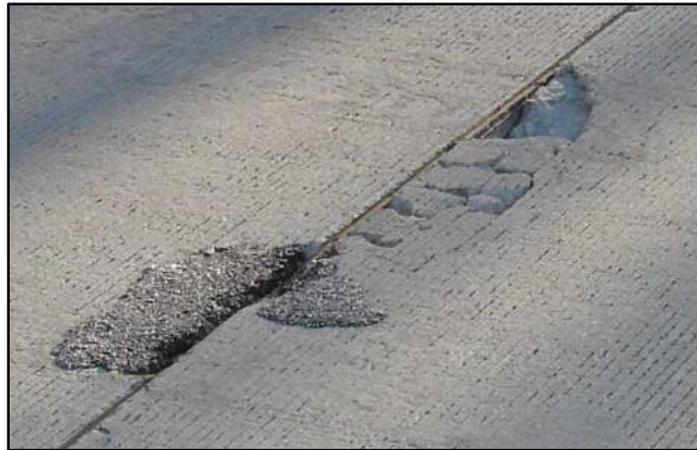
2.1 Spalling of Longitudinal Joints: It refers to the cracks or breaks on the surface of the pavement at longitudinal joints. It may also occur as chipping or fraying of pavement edges usually within 0.3 m from the face of the longitudinal joint (Figure A16) (Miller et al., 2003).

Figure A16: Spalling of Longitudinal Joints in Rigid Pavements

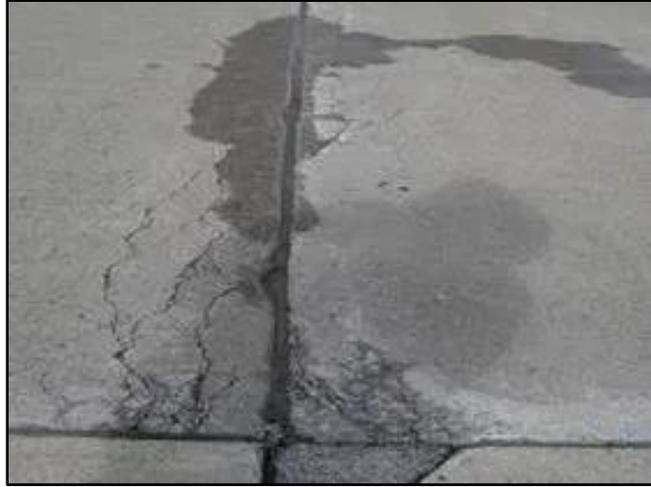
2.3 Spalling of Transverse Joints: It is identical to the spalling of longitudinal joints except it occurs along laterally appearing as cracks or breaks on the surface of the pavement along the transverse joints. It may also occur as chipping or fraying of pavement edges usually within 0.3 m from the face of the transverse joint (Figure A17) (Miller et al., 2003).

Figure A17: Spalling of Transverse Joints in Rigid Pavements

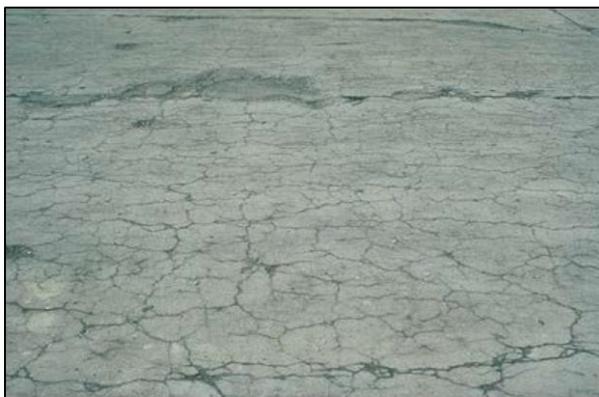
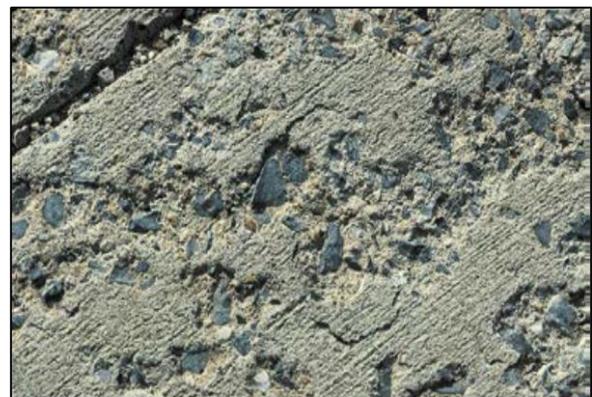
3.1 Map Cracking and Scaling: Map Cracking appears as a series of interconnected cracks on the surface of the pavement, usually longer in length in the longitudinal direction along with smaller or finer cracks in the transverse or random cracks (Figure A18a). Scaling occurs in the form of deterioration of the upper surface of the pavement usually 3 to 13 mm (Figure A18b) (Miller et al., 2003).

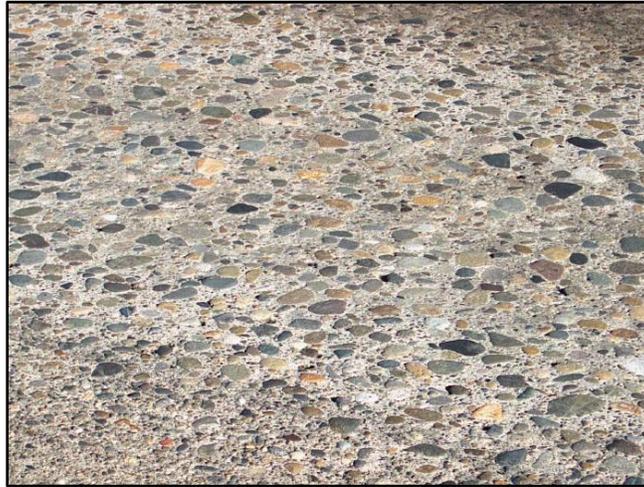
3.2 Polished Aggregate: It is the exposure of coarse aggregate on the surface of the pavement due to loss of surface mortar and texturing (Figure A19). It results in decreased skid resistance or surface friction of pavements (Miller et al., 2003).

Figure A19: Polished Aggregate in Rigid Pavements

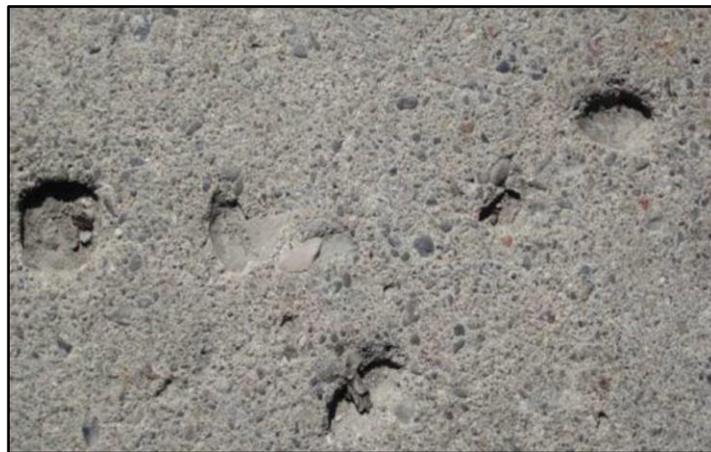
3.3 Popouts: They occur due to surface material being broken loose into small pieces leaving empty pockets on the surface of the pavement (Figure A20). These usually range from 25 to 100 mm in diameter and 13 to 50 mm in depth (Miller et al., 2003).

Figure A20: Popouts in Rigid Pavements

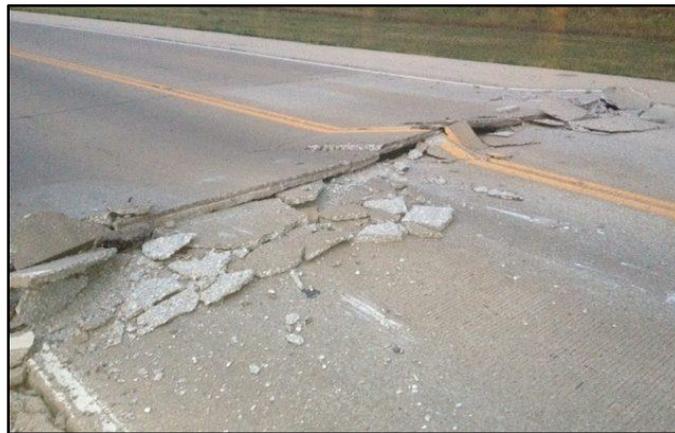
4.1 Blowup: It occurs due to the insufficient room for expansion of the slab during hot weather seasons in the form of a localized upward movement of pavement surface at the transverse joints, consequently, the concrete is shattered in that area (Figure A21) (Miller et al., 2003).

Figure A21: Blowups in Rigid Pavements

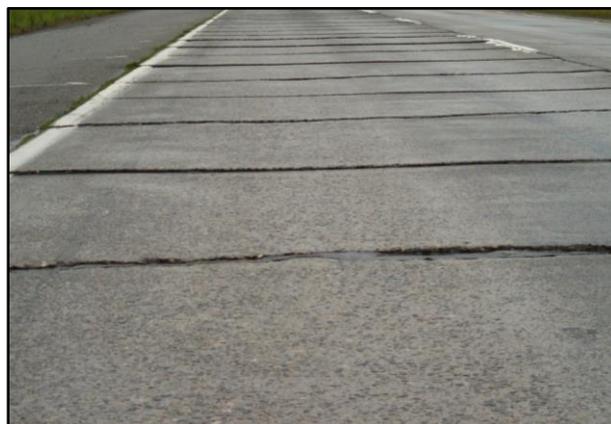
4.2 Faulting of Transverse Joints and Cracks: It occurs as a result of the difference in elevation across a joint or a slab due to slab pumping, settlement, curling or warping (Figure A22) (Miller et al., 2003).

Figure A22: Faulting of Transverse Joints and Cracks in Rigid Pavements

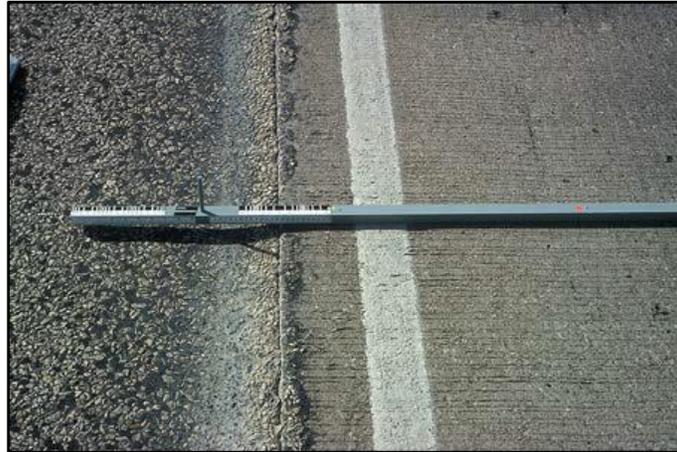
4.3 Lane-to-Shoulder Dropoff: It is identical to flexible pavements and occurs due to the difference in elevation between the edge of the slab and the outside shoulder because of the settlement of the shoulder (Figure A23) (Miller et al., 2003).

Figure A23: Lane-to-Shoulder Dropoff in Rigid Pavements

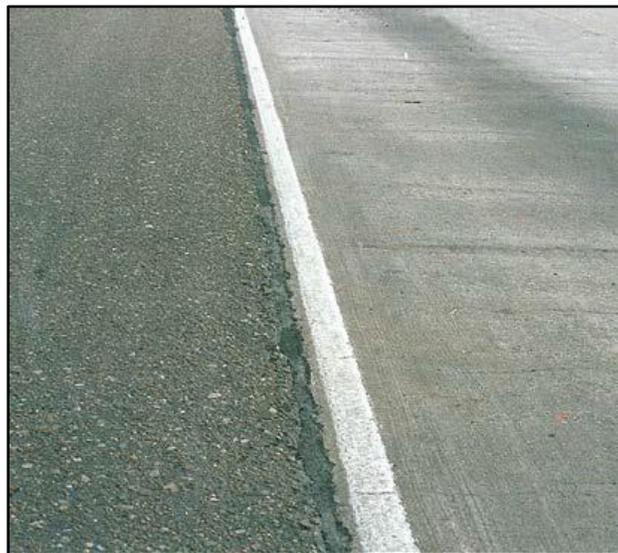
4.4 Lane-to-Shoulder Separation: It occurs when the joint between the edge of the slab and the adjacent shoulder widens (Figure A24) (Miller et al., 2003).

Figure A24: Lane-to-Shoulder Separation in Rigid Pavements

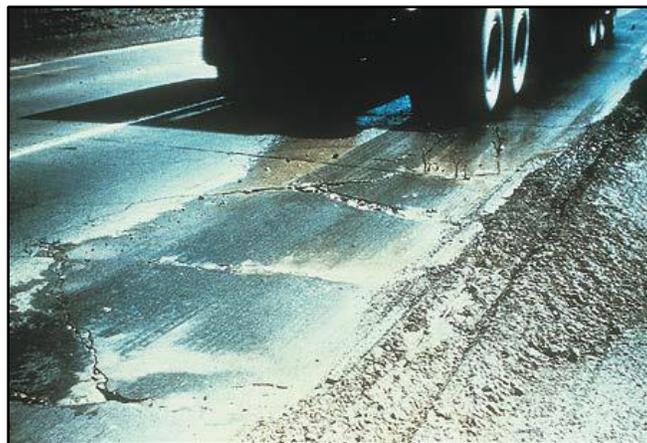
4.6 Water Bleeding and Pumping : occur similar to the flexible pavements where the water beneath the pavement either seeps or is discharged through the joints and cracks, typically encountered on the surface through deposits of water and fine material eroded from the underlying layers of the pavement (Figure A26) (Miller et al., 2003).

Figure A26: Water Bleeding and Pumping in Rigid Pavements
