An Approach Using Low-Cost Drone Imagery with an Image Analysis Model to Evaluate Disaster Recoveries

A Thesis

Presented to the Faculty of the Department of Construction Management

East Carolina University

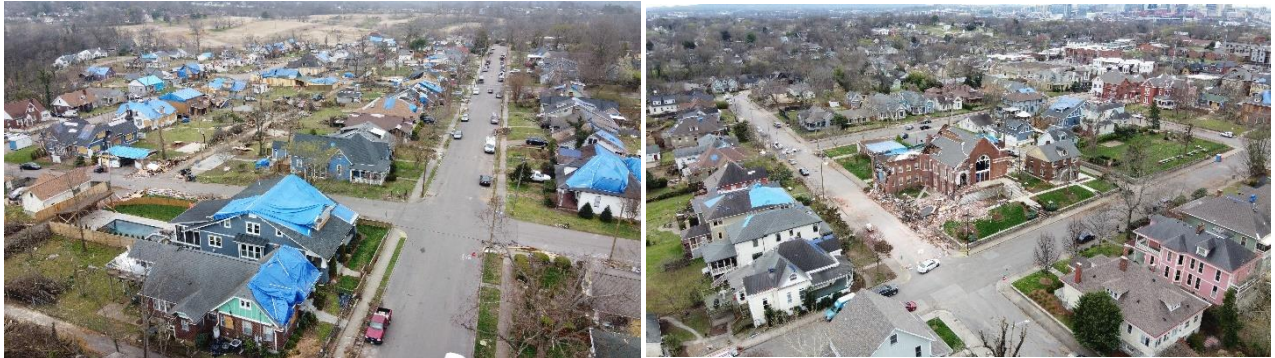
Figure 1: East Nashville Tornado Damage

Figure 1 illustrates East Nashville (EF-3) post-natural hazard affected zone, displaying two different angles of the damaged infrastructure and the ongoing recovery effort process of the affected community.

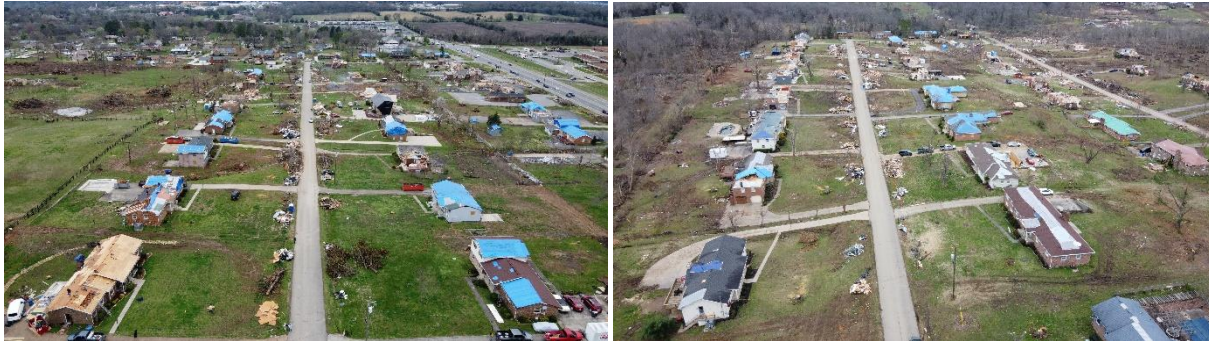
Figure 2: Mt. Juliet Tornado Damages

Figure 2 provides the aftermath of the tornado in Mt Juliet (EF-3) posing a comparative perspective on the extent damage and recovery process.

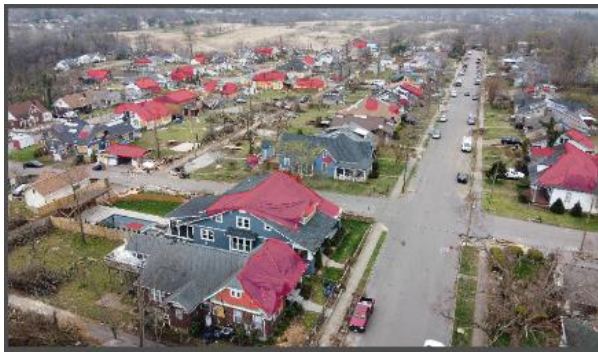
Figure 3: Drone Image Analysis Implementation to Identify Tarped Roofs

The process of quantifying roof damage in images is conducted on a model with a training set of six representative images and a set of twelve testing images. Within these images, nine distinct categories or layers were defined, each designated by unique colors. These categories encompassed elements such as houses, blue roofs, grass, cars, yards, sky, roads, debris, and trees. The primary objective of this model was to estimate the change in roofing damage over time. On implementation, this model efficiently identifies blue roofs, marked in red and quantifies these areas in pixel units. Corrective actions are possible if classification is inaccurate. The output of the automated identification and potential false positives are shown in Figure 3.

The image analysis software is made by the 4k image resolution and utilizes a pixel-level analysis of each image in the iterative collection to identify tarped roofing. The analysis quantifies pixel density within an area, with each pixel representing a single point within that image. By employing this pixel analysis with iterative image collection, the pixel area, and change over time can be quantified and analyzed as a metric for disaster recovery.

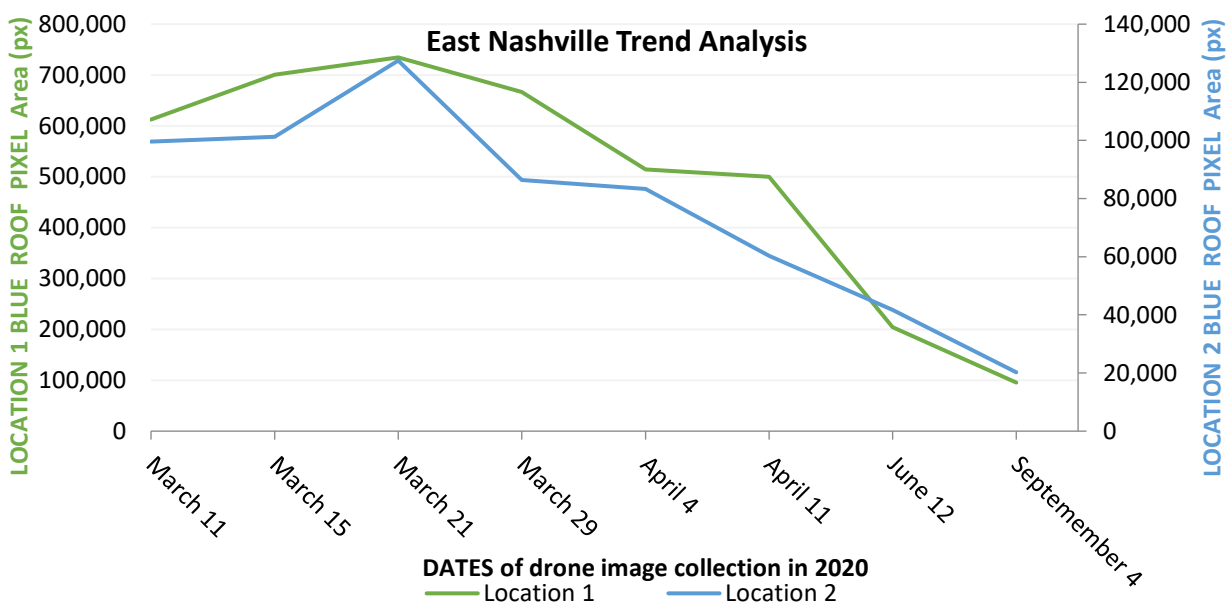
Figure 4: East Nashville Preliminary Trends

In Figure 4 and Figure 5, the y-axis of the graph shows the number of pixels that form a blue roof in each photo taken on the dates expressed on the x-axis. The graph shows a reducing trend in the number of “blue roofs” towards the end of those seven months, highlighting that the quantified results from automated analyses of post-disaster UAV imagery can act as an effective metric for progress towards recovery. These results show a trend in the reduction of “blue roofs” up to that seven-month period. The same approach is applied to Mt. Juliet, TN for the image set.

An analysis conducted in this study has founded several findings that underscore the effectiveness and possible tests associated with automated disaster recovery assessment, Firstly, the trends observed in the "blue roof" pixel area analysis, as depicted in Figure 4 and Figure 5,

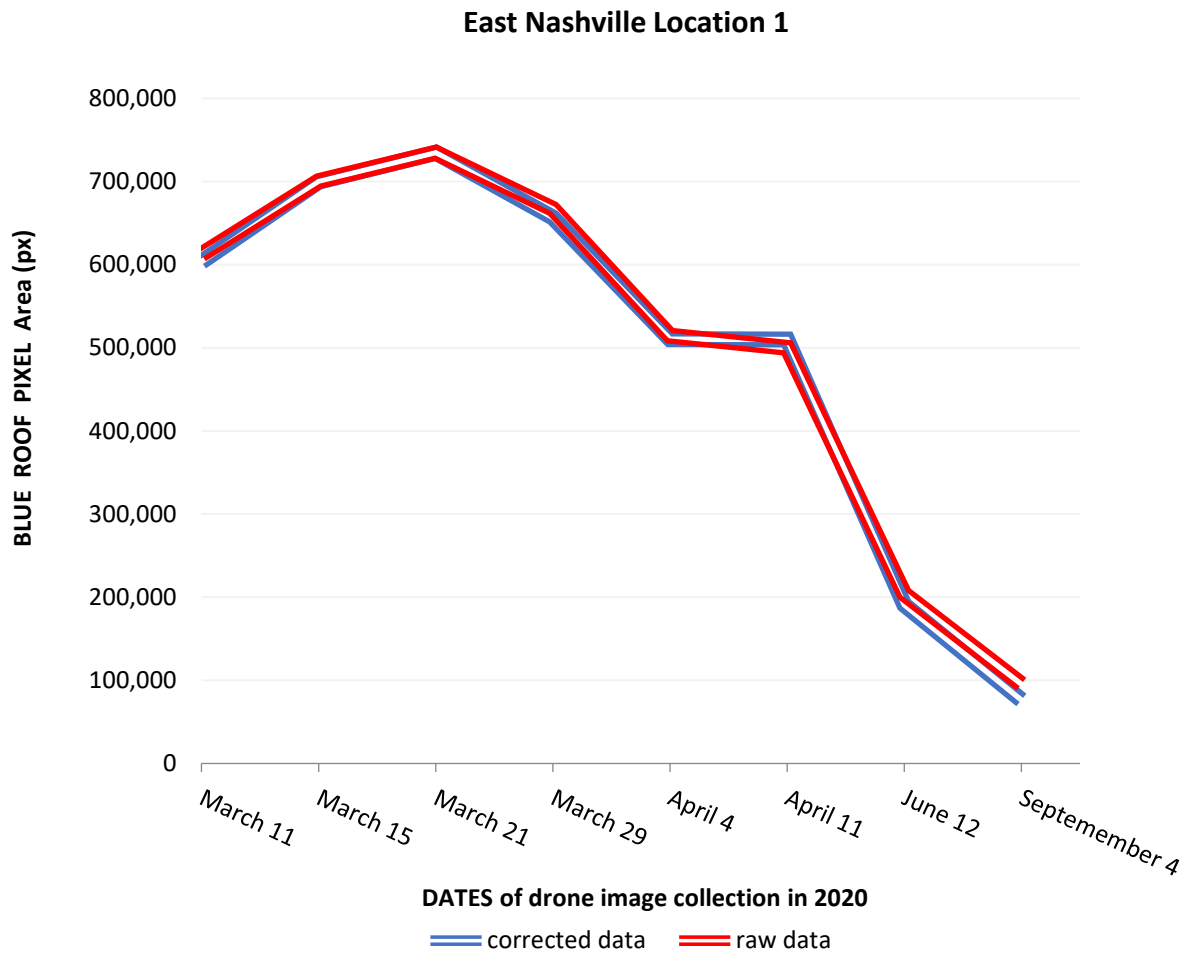
Figure 6 presents the data that provides a visual representation of the “Blue Roof Pixel Area” on the y-axis with area quantification, including false positives in blue and a corrected area with false positives removed in red.

This initial view of the raw and corrected “blue roof” areas reveals minimal deviation, with a false positive impact only growing in the last two months.

The plot Figure 6: Fixed data & Raw data East Nashville Location 1 illustrates the graphical representation of both data types over the seven-month period. The results for this location exhibit similarities, suggesting minimal impact from false positives.

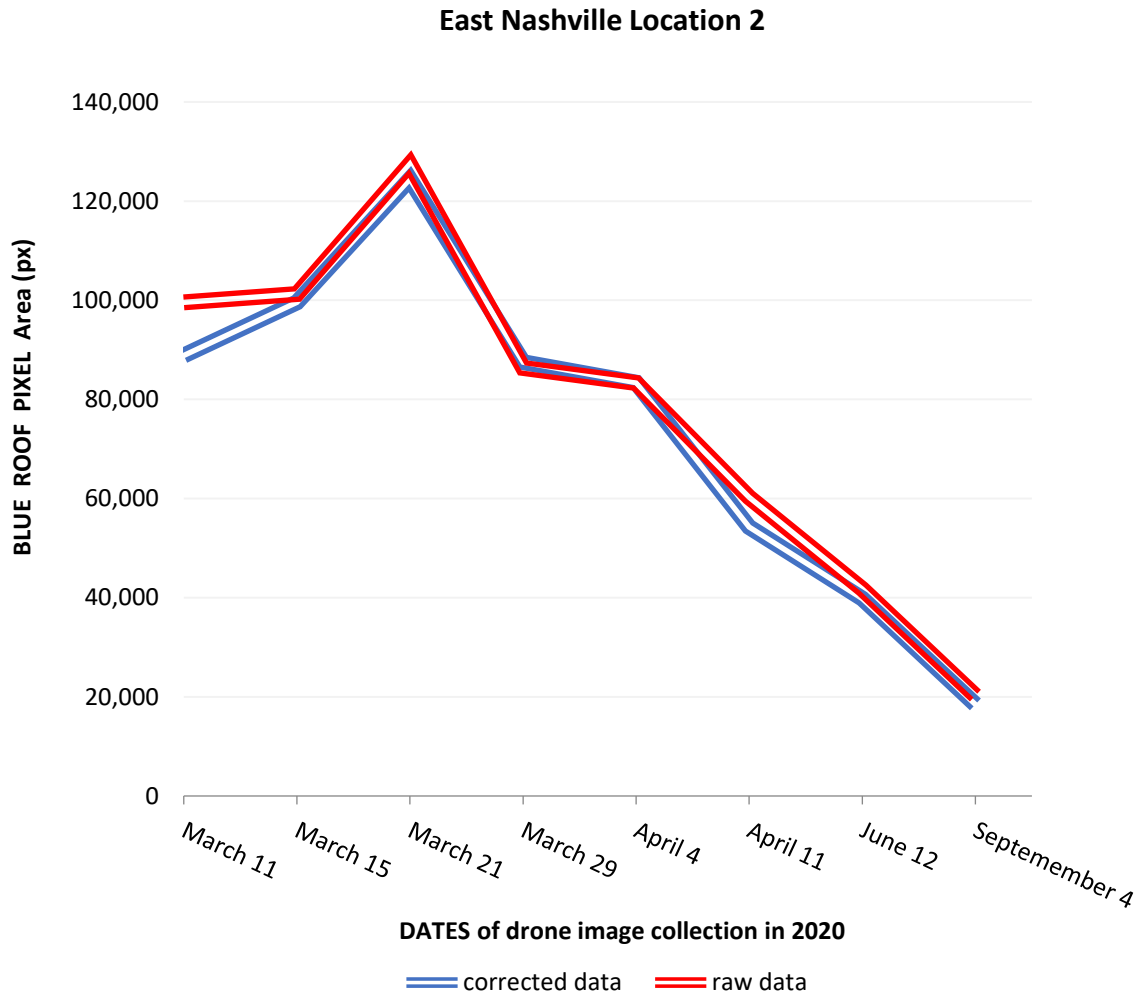
On analyzing Figure 7: Raw Data and Corrected Data East Nashville Location 2 which illustrates the recovery process after the natural hazard, distinct patterns emerge. A notable alteration in the values on the first date of the evaluation process, this difference in values will be quantified and

elaborated in the subsequent subsection of the results section, where various methodologies are employed to assess this differentiation comprehensively. Although the initial differences, the curves illustrating fixed (blue) and raw (red) data exhibit alike behavior across the majority of evaluated dates, suggesting consistent trends in the recovery dynamics over time. Moreover, the reduction in the number of pixels associated with blue roofs highlights a recovery trend that, predominantly for this location, increases the false positives influence as the “blue roof” recovery finalizes.

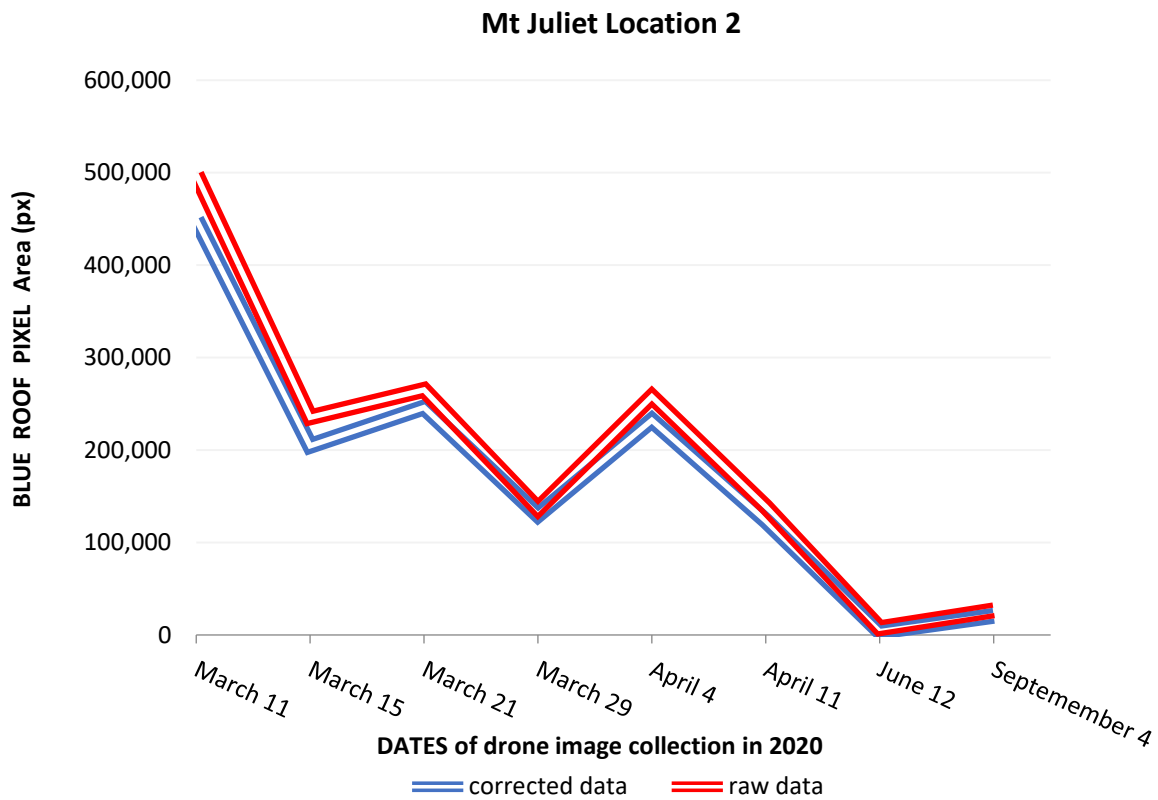
Figure 9: Raw Data and Corrected Data Mt Juliet Location 2

Figure 9: Raw Data and Corrected Data Mt Juliet Location 2, suggests a close orientation between the raw data and corrected data. The aligned variations in blue roof trends may be attributed to distinct phases within the recovery process. For instance, the fluctuations may correspond to phases where houses are assigned for demolition (i.e., blue roof reduction) or where reconstruction efforts commence (i.e., blue roof increase).

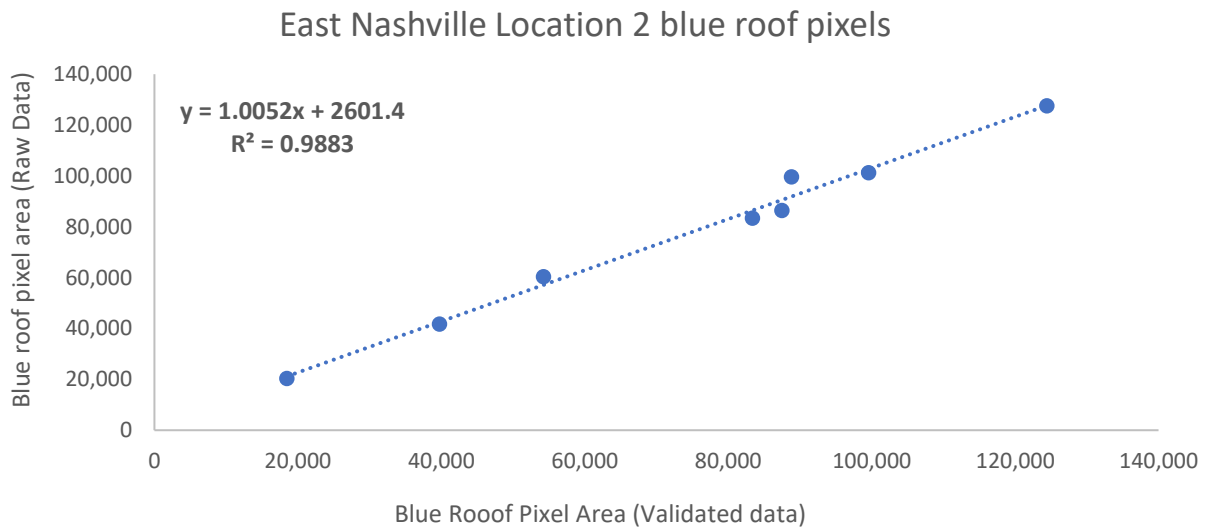
Figure 11: Linear Regression East Nashville Location 2

The linear regression analysis for East Nashville’s second location is represented in Figure 11. The R-squared value is 0.988, indicating that approximately 98.8% of the variability observed in the raw data is also observed in the fixed data. These results show a desirable R-squared values but do show minor deviations between raw and corrected data.

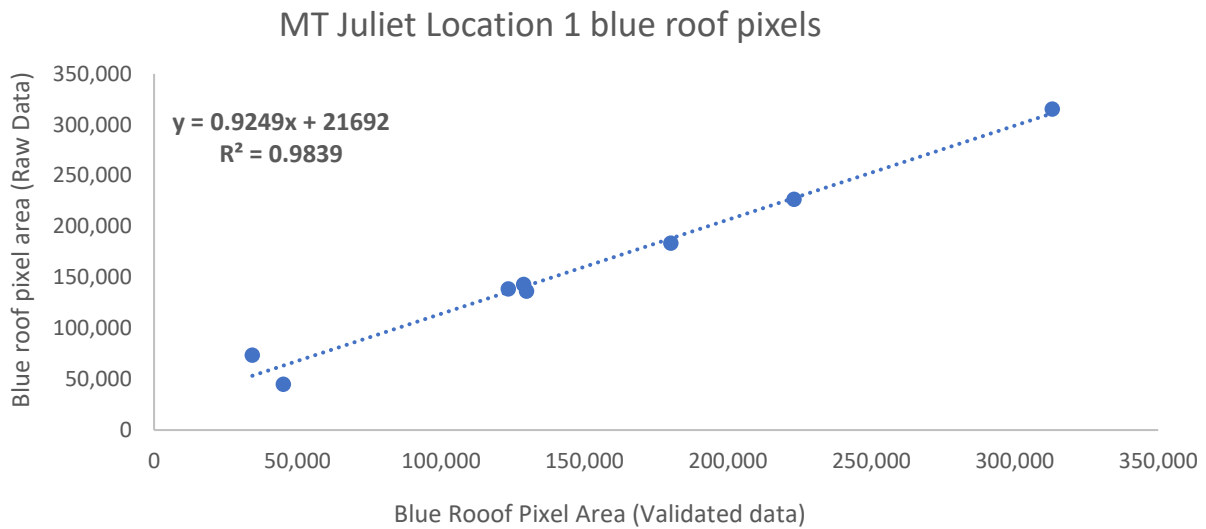
Figure 12: Linear Regression Mt Juliet Location 1

The linear regression analysis for Mt. Juliet's first location is represented in Figure 12. The R-squared value is 0.983, indicating that approximately 98.3% of the variability observed in the raw data is also observed in the fixed data. It is important to note, the calculation of percent error for this location reached as high as 50% at the final collation period but the r-squared value of 0.983 mitigates overall trend accuracy concerns.

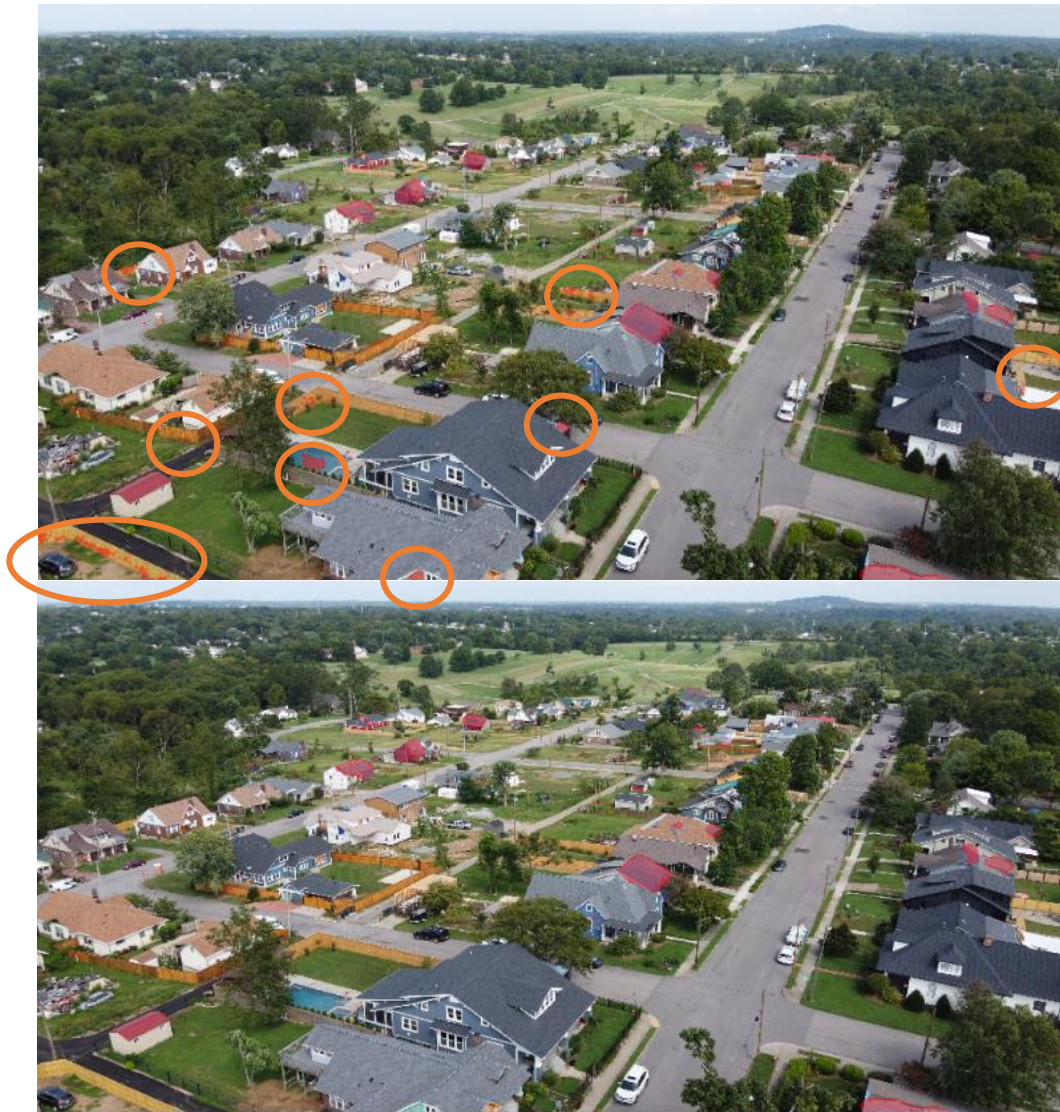
Figure 14: East Nashville, location 1, 4th September.

To enable the discussion, Figure 14 represent the location before and after the correction process, highlighting the detection and rectification of false positives. As is indicated in Table 2, this specific date exhibits a percentage error of 24.98%, marking it as the most crucial date within the evaluation period for this specific location.

The initial image highlights areas where the software faced challenges in identifying the blue roofs, particularly around features like pools, blue facades of houses and fences dividing the property areas. In this set of images, the specific number of pixels identified as part of a blue roof before and after the correction process is shown in Table 4.

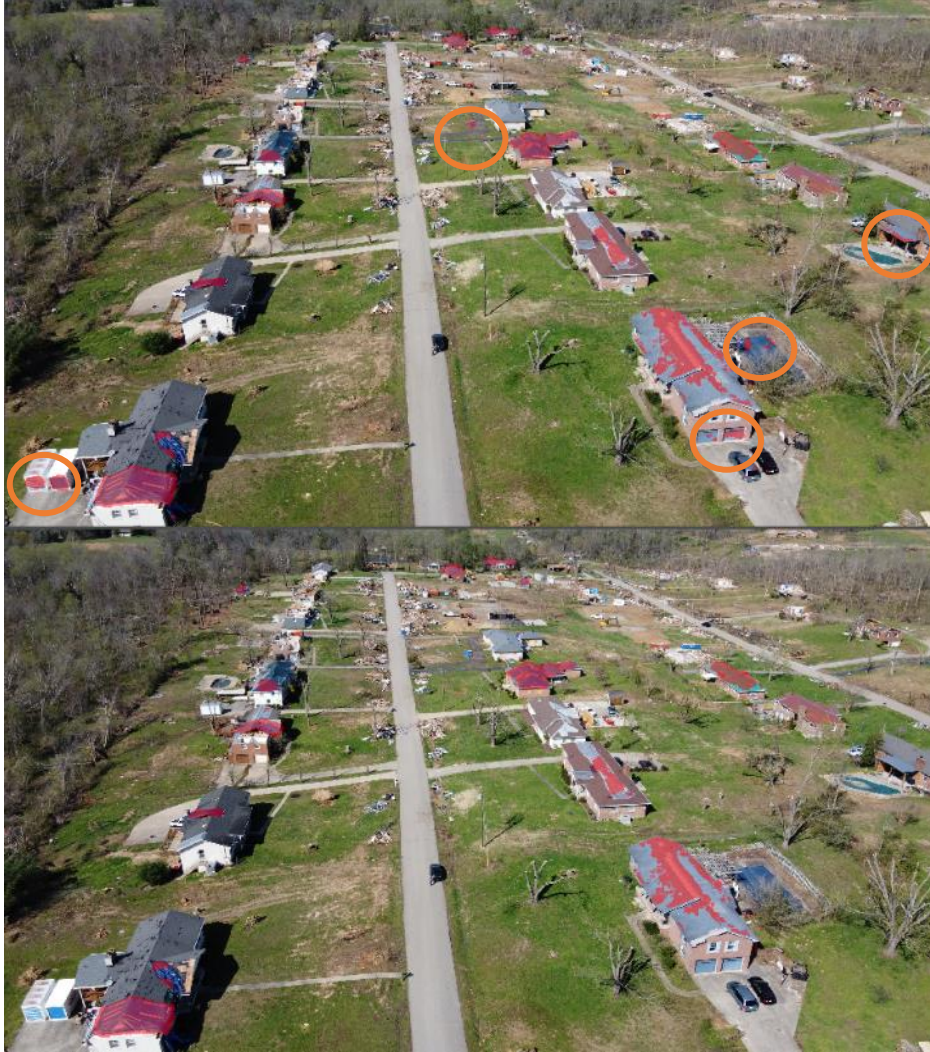
Figure 15: Mt Juliet, Location 1, March 29, 2020.

Mt. Juliet Location 1 presents various challenges for the software's identification of blue roofs, as evident in Figure 15. The percentage error for this specific date and location is 5.12%, making it the location with the highest percentage error values; however, the R2 value for the evaluation period remains high at 0.983 as is shown in Table 2. This high error rate can be attributed to the presence of different colors of debris in the area due to the ongoing recovery process. The diverse range of debris colors poses a significant challenge for the software's accurate identification of blue roof sheeting in this location.

The software struggled in discriminate between blue roofs and other blue-toned elements during the recovery processes, directing to a increase in false positives in its estimations. One notable example is the consistent misclassification of pool covers on certain houses as blue roofs across multiple dates. Another commonly misinterpreted is the blue doors of containers situated beside the first house on the left side of the street. Although not being actual roofing materials, these blue doors consistently are considered as false positives in the software's analysis. Overall, the

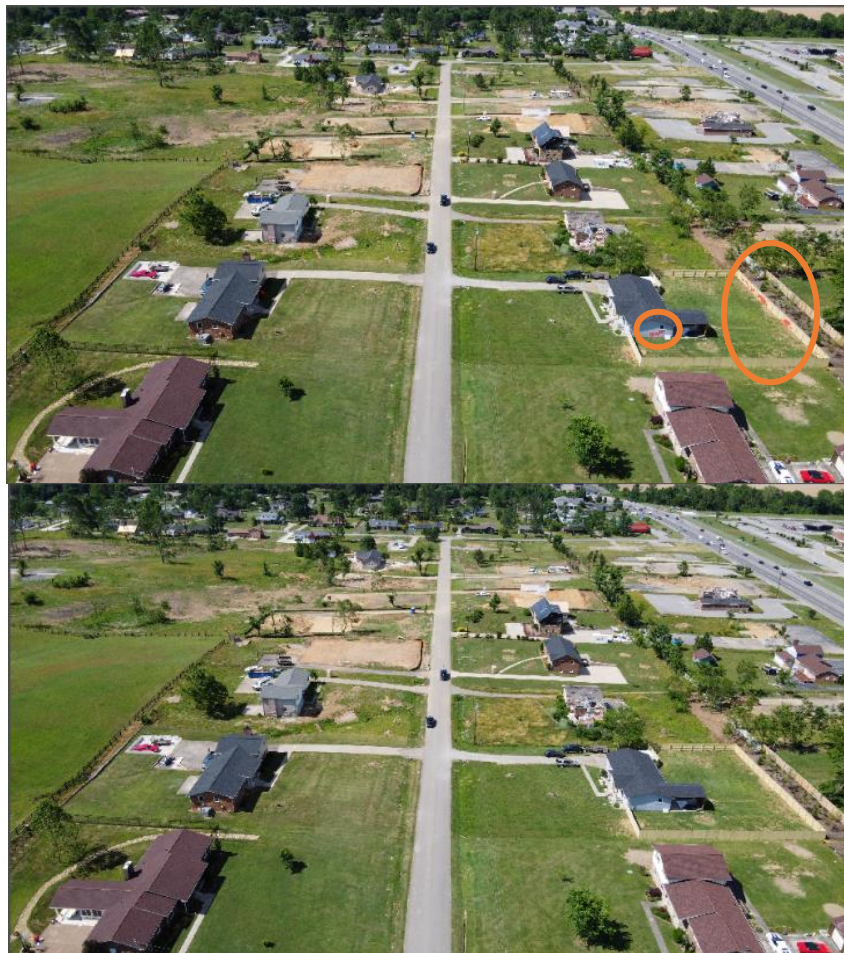
Figure 16: Mt Juliet, Location 2, 12th June 2020.

This location experiences different processes during the recovery phase. Some houses were demolished, while others were nearly finished by the end of the 7-month evaluation period. With fewer houses in this area, the methodology offers a clearer insight into how effectively it analyzes recovery trends after a natural disaster.

The percentage error for the Location 2 in Mt. Juliet is detailed in Table 2. On June 12th, Mt. Juliet (location 2) has a percent error of 18.27%. It's evident that the recovery process for the houses undergoing repairs is nearing completion. Consequently, contributing to the observed low pixel area values. Despite the substantial error percentage, it is predominantly from false positives. The software erroneously identifies a small section of the blue facade of the second house and interprets the fence as a blue roof.

Furthermore, it's important to note that the R-squared value for this location stands at 99.8%. This high R-squared value indicates a strong correlation between the observed and predicted values, showcasing the effectiveness of the software's analysis. Although encountering with false positives, the software demonstrates precise detection of blue roof areas.
