Matthew A. Russell. AN HISTORICAL AND ARCHAEOLOGICAL INVESTIGATION OF THREE BEACHED SHIPWRECK SCATTERS AT CHANNEL ISLANDS NATIONAL PARK. (Under the direction of Dr. Bradley A. Rodgers) Department of History, January 1996.

AN HISTORICAL AND ARCHAEOLOGICAL INVESTIGATION
OF THREE BEACHED SHIPWRECK SCATTERS AT
CHANNEL ISLANDS NATIONAL PARK

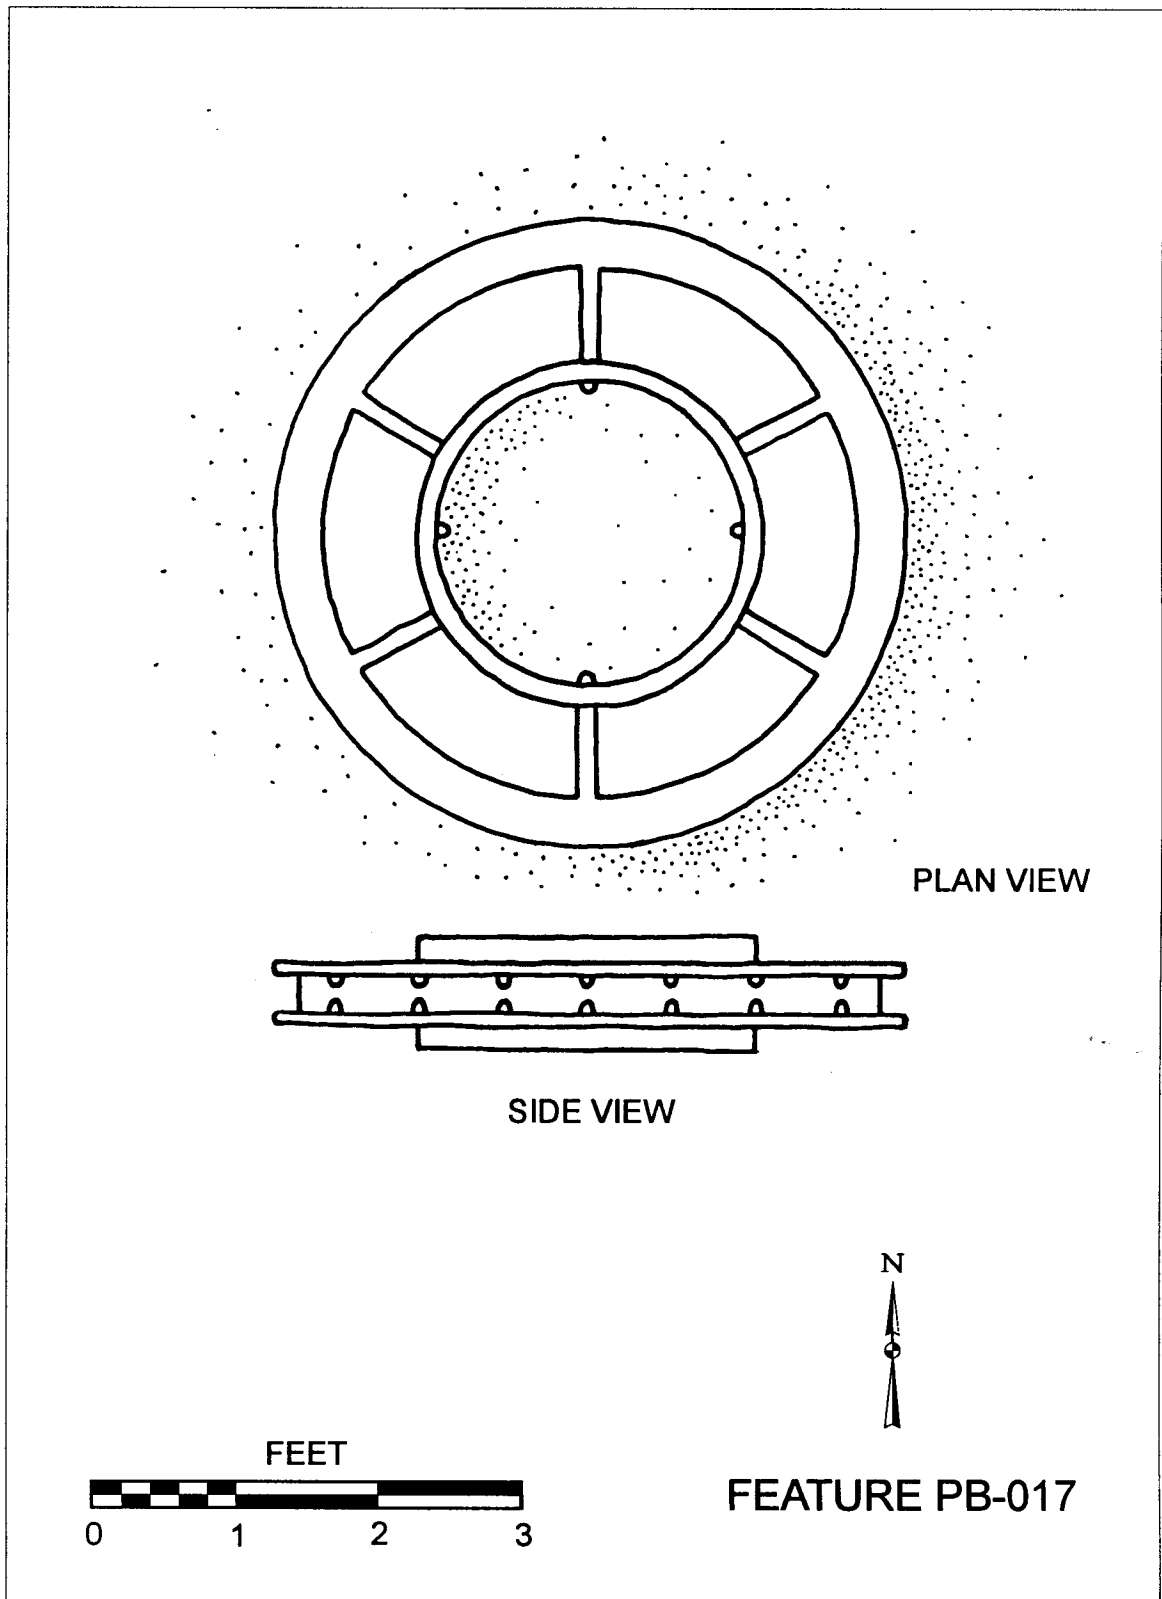
Figure 11

Features PB-017, 018, and 023 are all similar objects. PB-017 and PB-018 are iron ring-like objects. PB-017 has an outside diameter of 4 feet 4 inches, an inside diameter of 2 feet 1 inch, with the thickness of the main part of the ring 5 inches. An inner flange adds 2 inches in thickness to either side (Figure 11). PB-018 has an outside diameter of 3 feet, an inside diameter of 2 feet 2 inches, and is 4 inches thick (Figure 12). PB-023 is a solid circular iron object 2 feet 1 1/2 inches in diameter and 4 inches thick (Figure 13). All three features have notched edges. The edges of PB-018 and PB-023 have a gear-like appearance, while the edge of PB-017 has teeth spaced about every 7 inches. The geared edges of PB-018 and PB-023 resemble the purchase rims or pawl rim of a windlass. The 7-inch-spaced teeth of PB-017 resemble a wildcat or cable lifter, which is the portion of a windlass that actually grabs each link of chain, thus pulling in the chain when rotated.

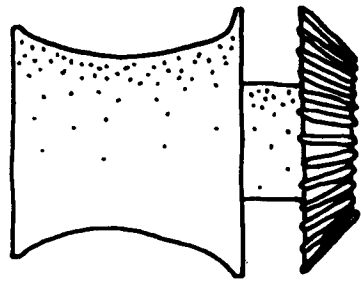
Figure 15

Features PB-026, 027, and 029 are also likely parts to either a windlass or a donkey engine. Both PB-027 (Figure 14) and PB-029 (Figure 15) contain warping hubs and geared mechanisms on shafts, likely parts from a windlass, a deck winch, or a donkey engine. PB-027 is 3 feet 9 inches in length, while PB-029 is 2 feet long. The warping hubs on each one are identical, each 1 foot 4 inches long, and 1

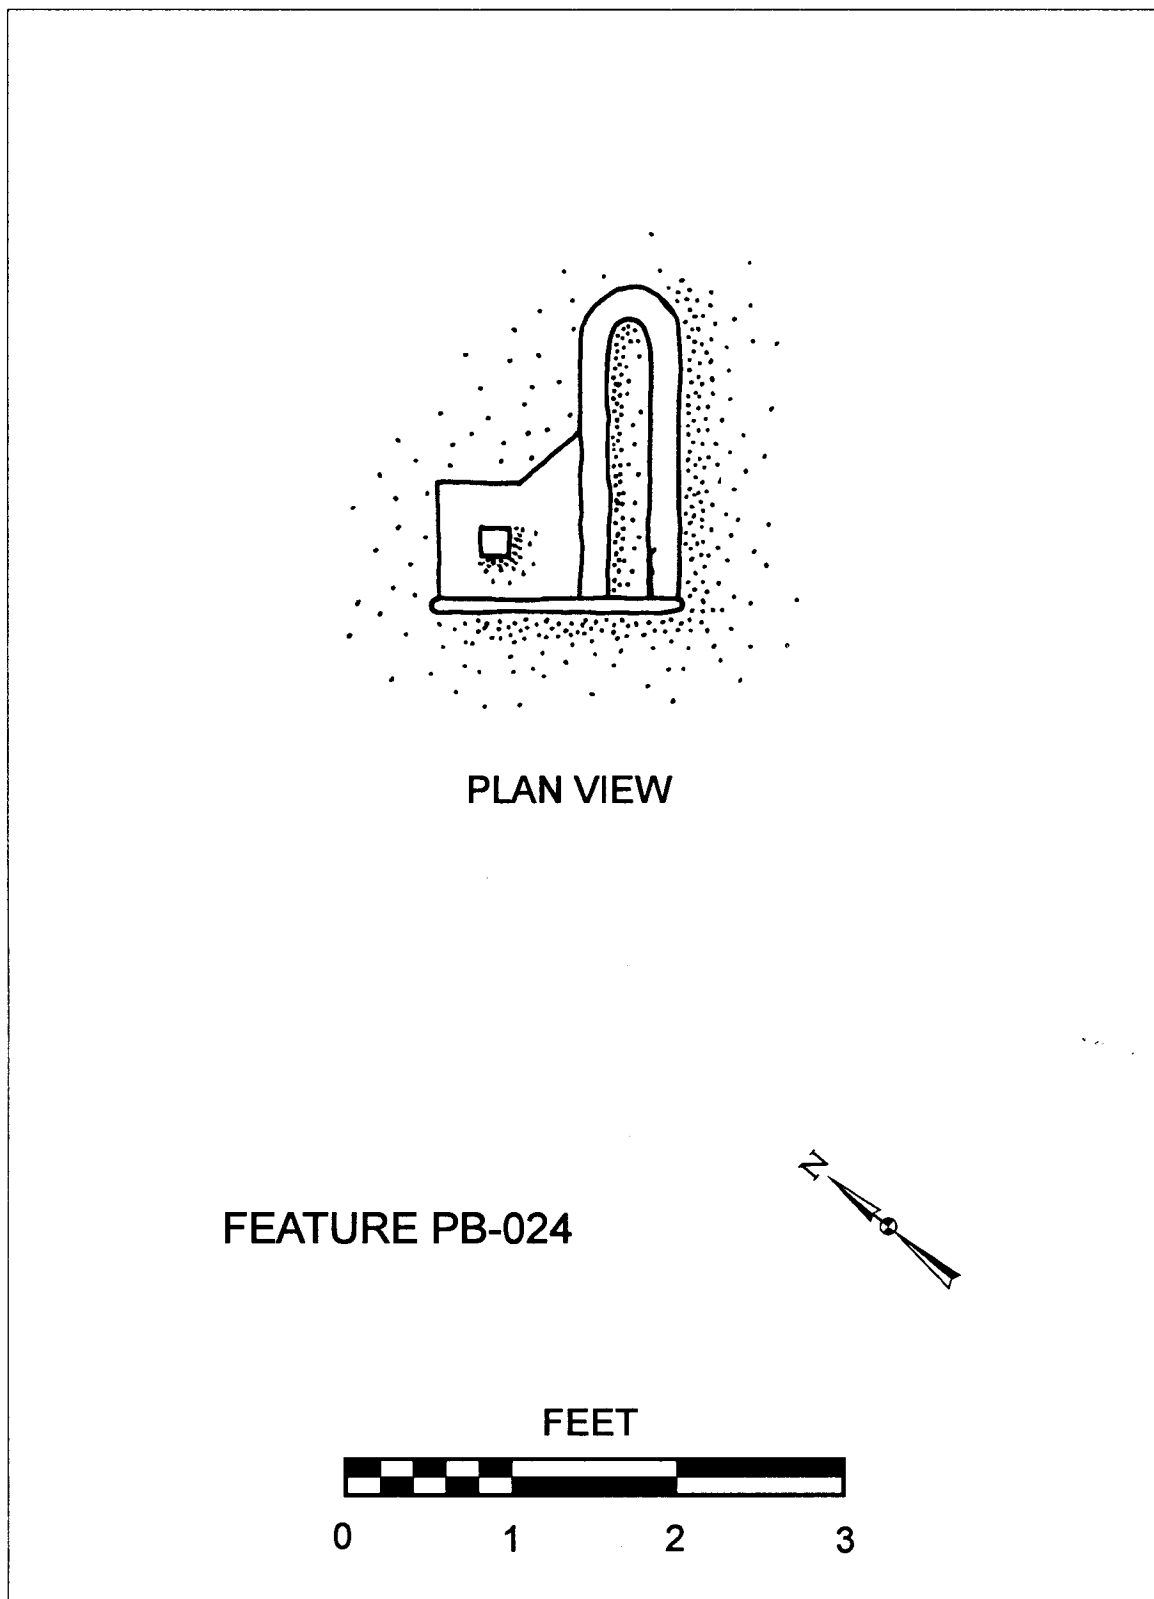
Figure 18

Feature PB-024 is an oddly shaped iron object, with rough dimensions of 1 foot 11 inches by 1 foot 6 inches (Figure 18). The main attribute is a U-shaped piece of iron attached to a base. The object was only drawn in two dimensions because it is encrusted into the bottom with thick marine growth surrounding it.

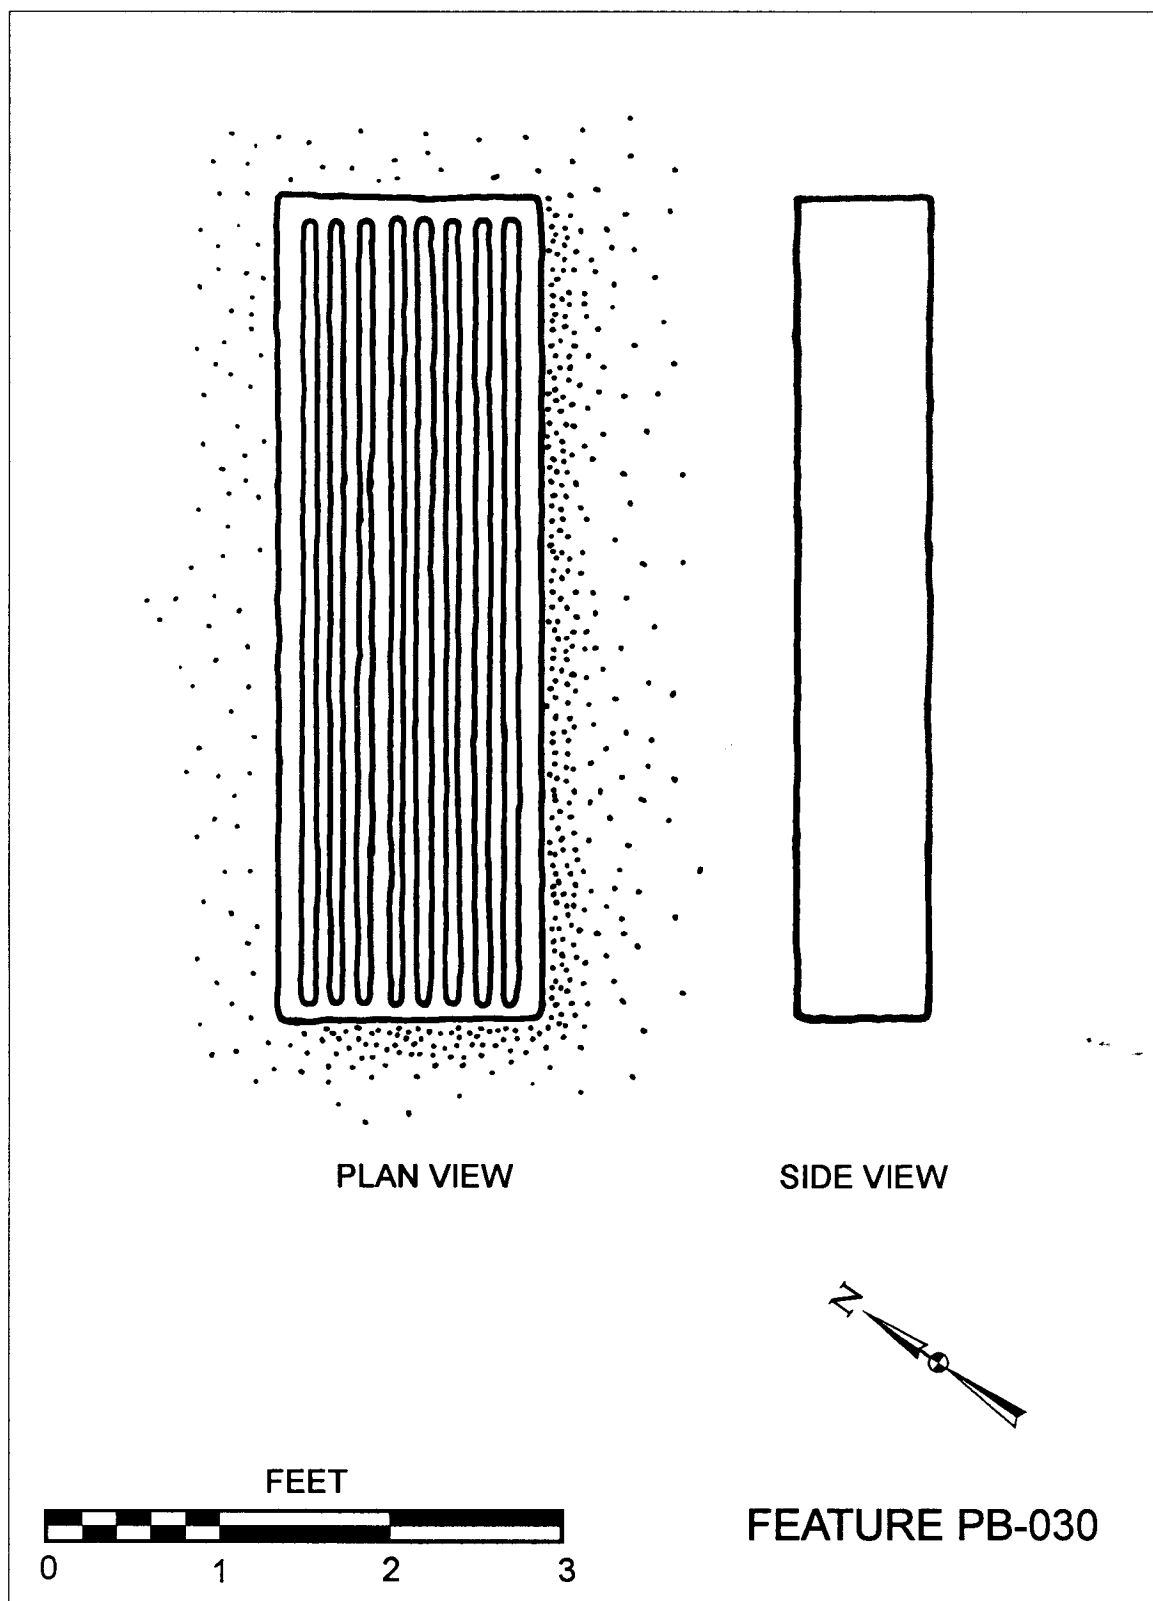
Figure 19

Feature PB-030 is an iron block 2 feet 4 1/2 inches long, 9 inches wide, and 4 1/2 inches thick (Figure 19). The top (exposed) surface has shallow grooves 1/2 inch wide and 1/2 inch apart running lengthwise for the whole width of the piece.

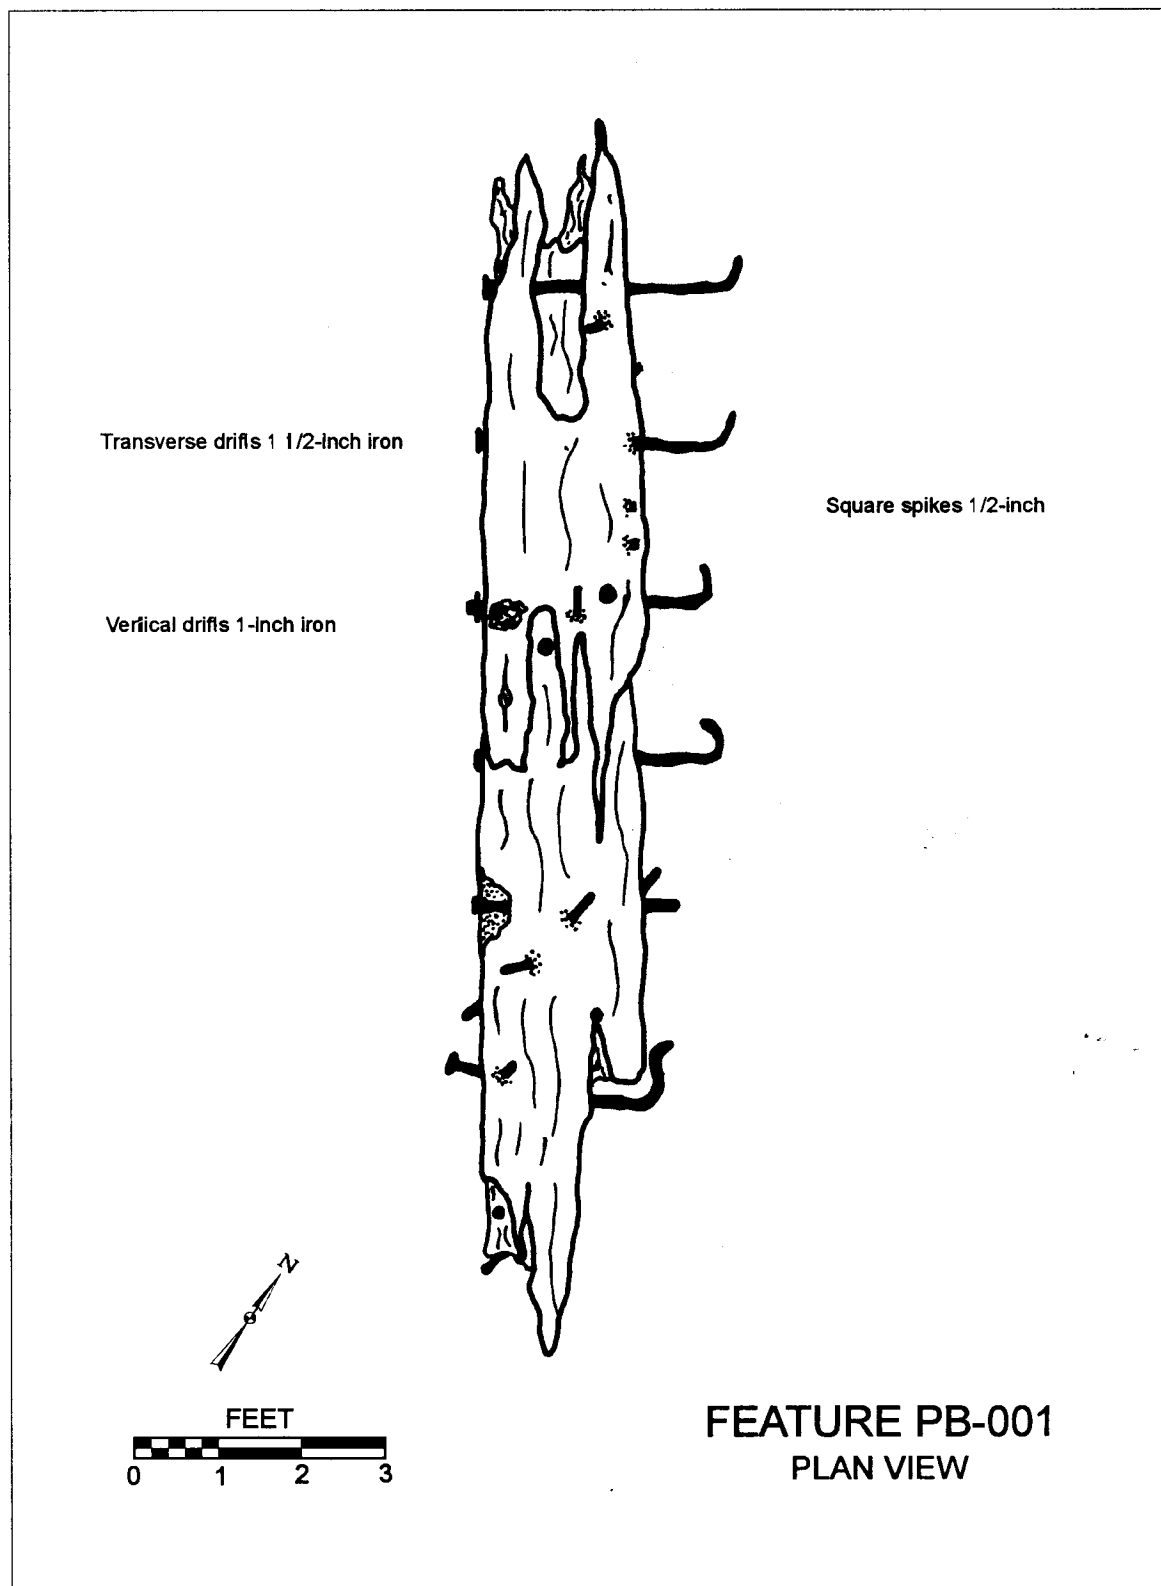
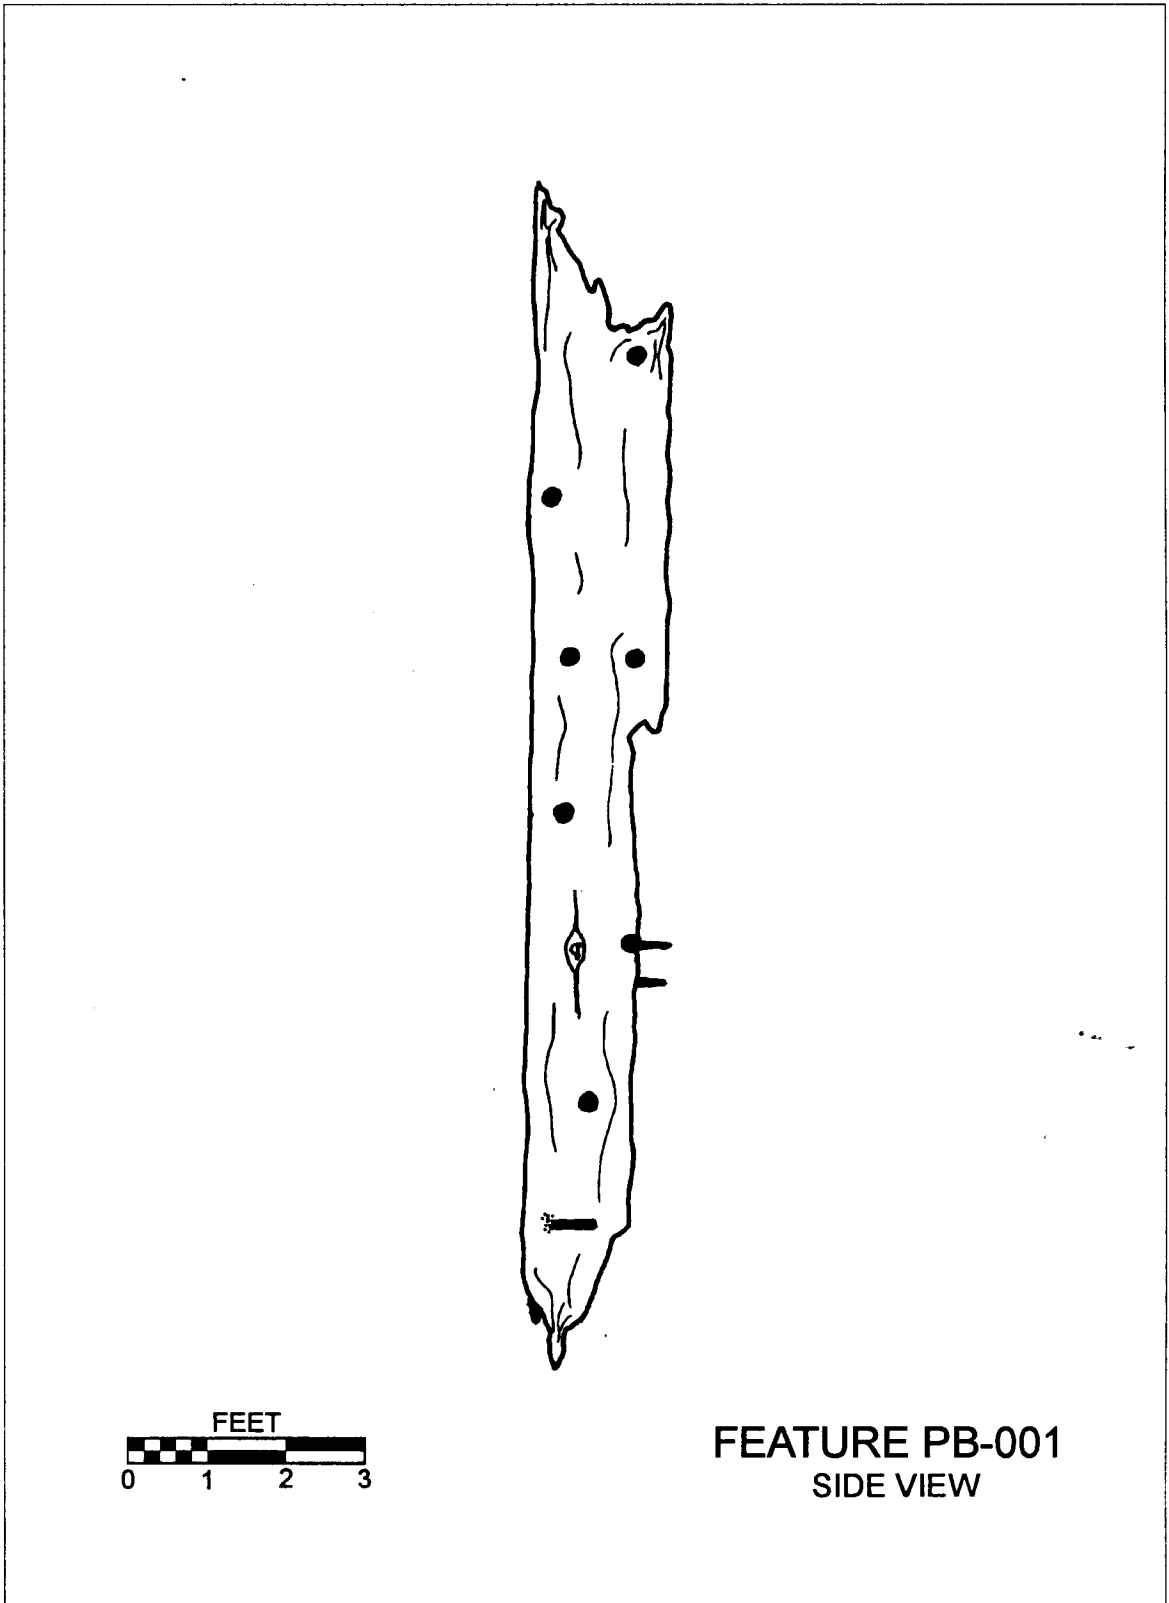
The first, feature PB-001, is a large, Douglas-fir timber measuring 14 feet 10 inches long, with maximum width and height of 23 inches by 21 inches (Figures 21 and 22). Both ends are broken off, so it is impossible to determine the timber's original length. All extant surfaces are badly worn and deteriorated, so the sided and moulded dimensions are approximate. The timber's most conspicuous characteristics are the size and number of iron fasteners. There are six large, iron drift pins driven through and protruding from the side. These drifts are approximately 1 1/2 inches in diameter (though exfoliating badly) and range in length from 2 feet 2 inches (broken) to 4 feet 2 inches long. They are spaced an average of 2 feet apart. There are also nine 1-inch diameter iron drifts and five spikes 1/2-inch square protruding from the timber's top surface. All are broken off close to the surface.

The timber's size and fasteners make it likely this feature is a structural element from an ocean-going vessel. Furthermore, because of the timber's large size and configuration of the iron fasteners, it is most likely PB-001 is a portion of a vessel's centerline structure. The lack of rabbet, fasteners driven through both axis of the piece, and the observation that the large drifts were first driven through this piece and then, probably, into another makes it impossible for this piece to be a portion of a

keel. On the other hand, these same characteristics make it probable that PB-001 is a piece of either a main, sister, rider, or assistant keelson, which now rests on its moulded face. The timber's western face, from which the large iron drifts were driven, is likely the top, or sided, surface. If this is a piece of the main keelson, then the six 1 1/2-inch diameter drifts were probably driven through this piece, through the floors, and into the vessel's keel. If it is from a sister keelson, then the large drifts were probably driven through this timber into the floors or first futtock of the vessel. If this timber is from a rider or assistant keelson, then the large iron fasteners were probably driven through the piece into the main or sister keelson. In all cases, the 1-inch diameter fasteners driven through the opposite axis of the timber probably edge-bolted this timber to its adjacent keelson component, indicating multiple keelson elements.

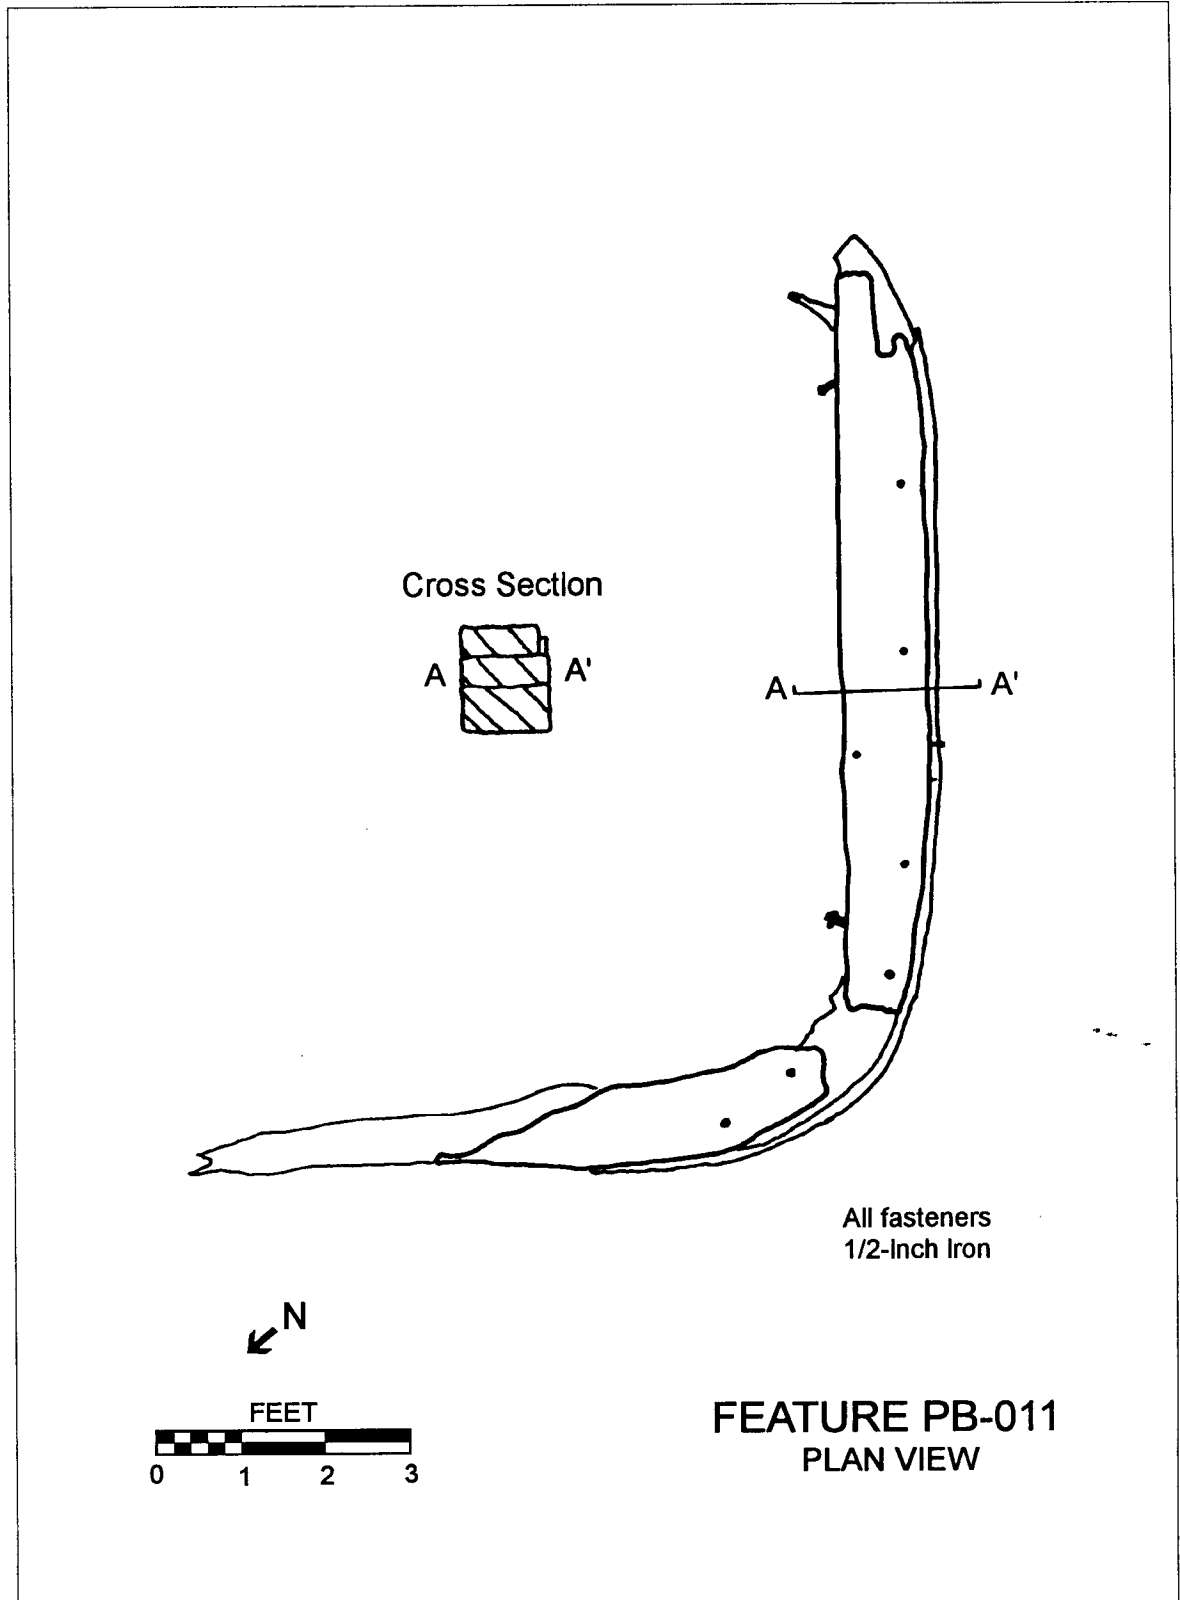
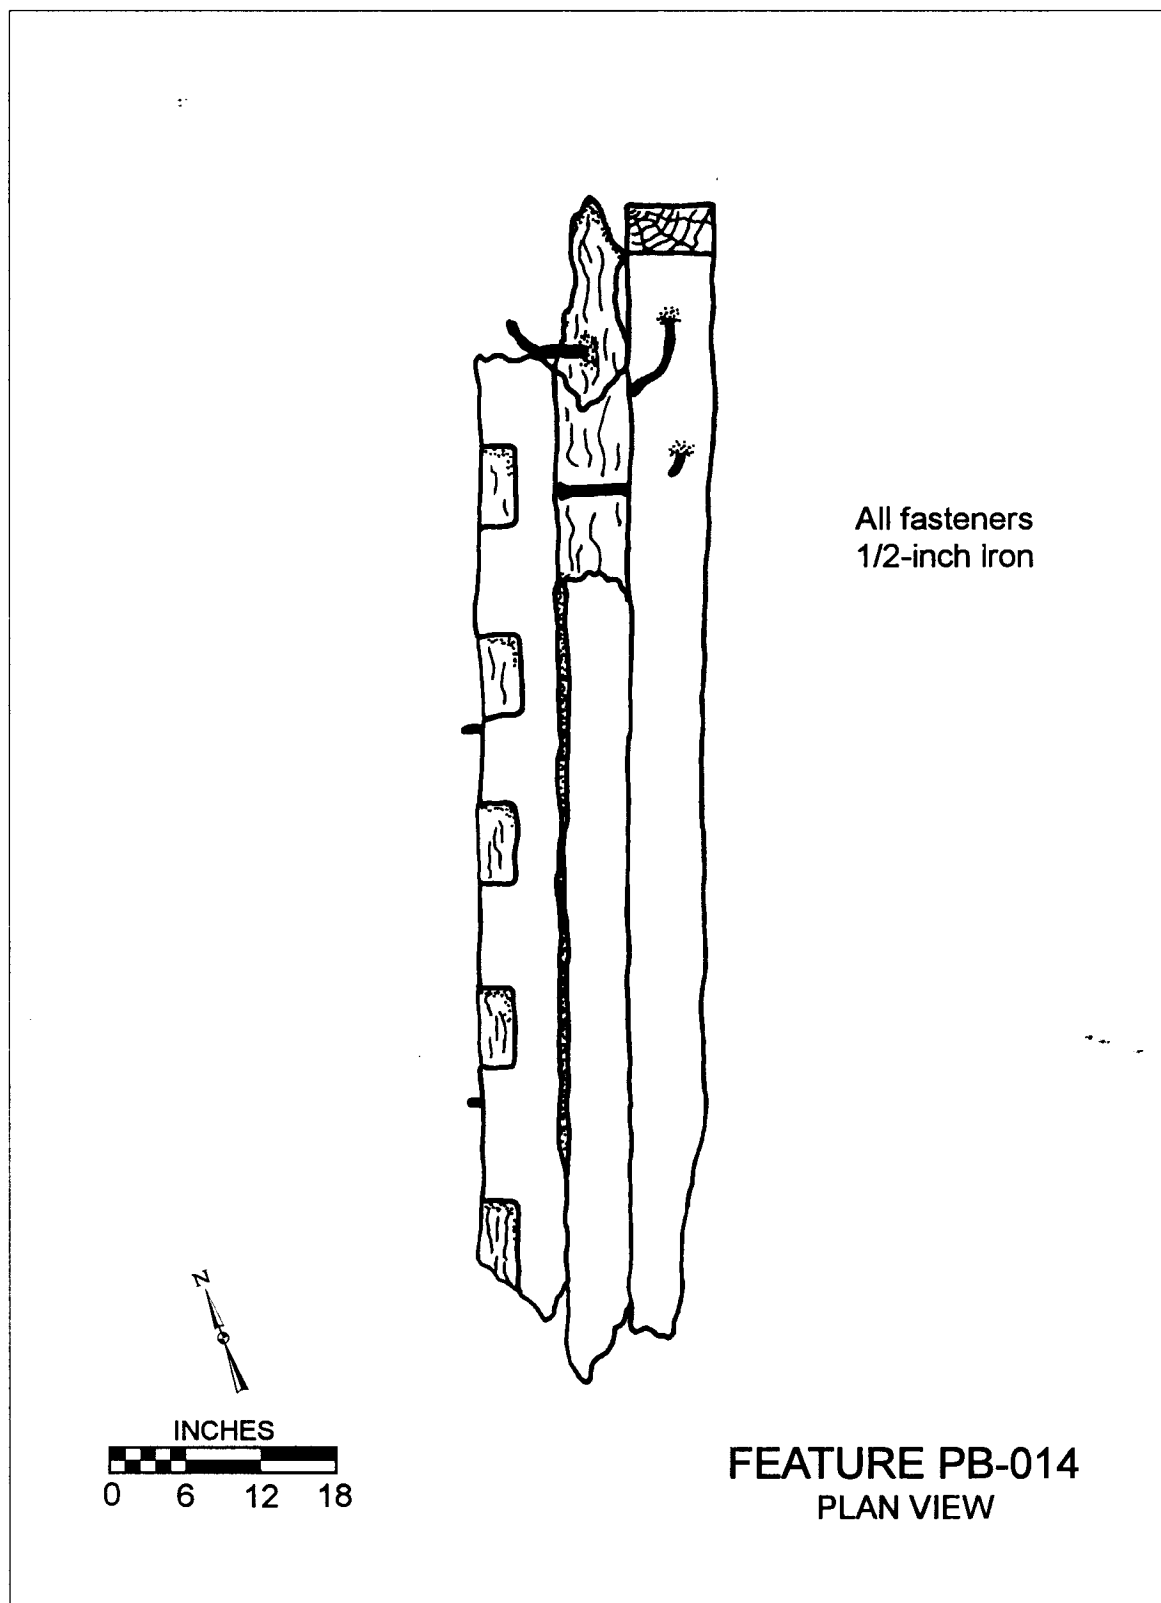
Features PB-011 and PB-014, constructed in the same manner, likely represent pieces of a wooden hatch coaming (Figures 25 and 26). The two features each have three layers of timbers, fastened together with 1/2-inch diameter, round iron fasteners. Originally, the structure was either U-shaped or, more likely, rectangular with rounded corners. PB-011 is sitting upright, with the three layers stacked, while PB-014 is laying face-down with the three layers side by side.

Feature PB-011's bottom timber is 6 1/2 inches thick, the middle timber is 5 inches thick, and the top timber is 7 inches thick, giving PB-011 a total height of 18 1/2 inches. Each of the timbers is 1 foot wide. Feature PB-011 is roughly L-shaped, with the longest side 11 feet long, and

the shorter 8 feet long; both ends are broken. The end of the longer side exhibits the beginning of a curve before the fracture. Feature PB-014 shows the beginning of a curve on one end before it is broken off, as well. In the one intact curve on PB-011, the two timbers forming the bottom layer meet in the middle of the curve. The timbers of the two top layers, on the other hand, are joined in the curve by a chock. Feature PB-014 has shallow mortises along what would be the inside edge of the top timber, if it were standing upright. These mortises are 6 inches long, 3 inches wide, with a maximum depth of 1 1/2 inches. The shorter length of PB-011 exhibits identical mortises on its inside face, suggesting that PB-014 was originally connected to PB-011 opposite of the shorter length.

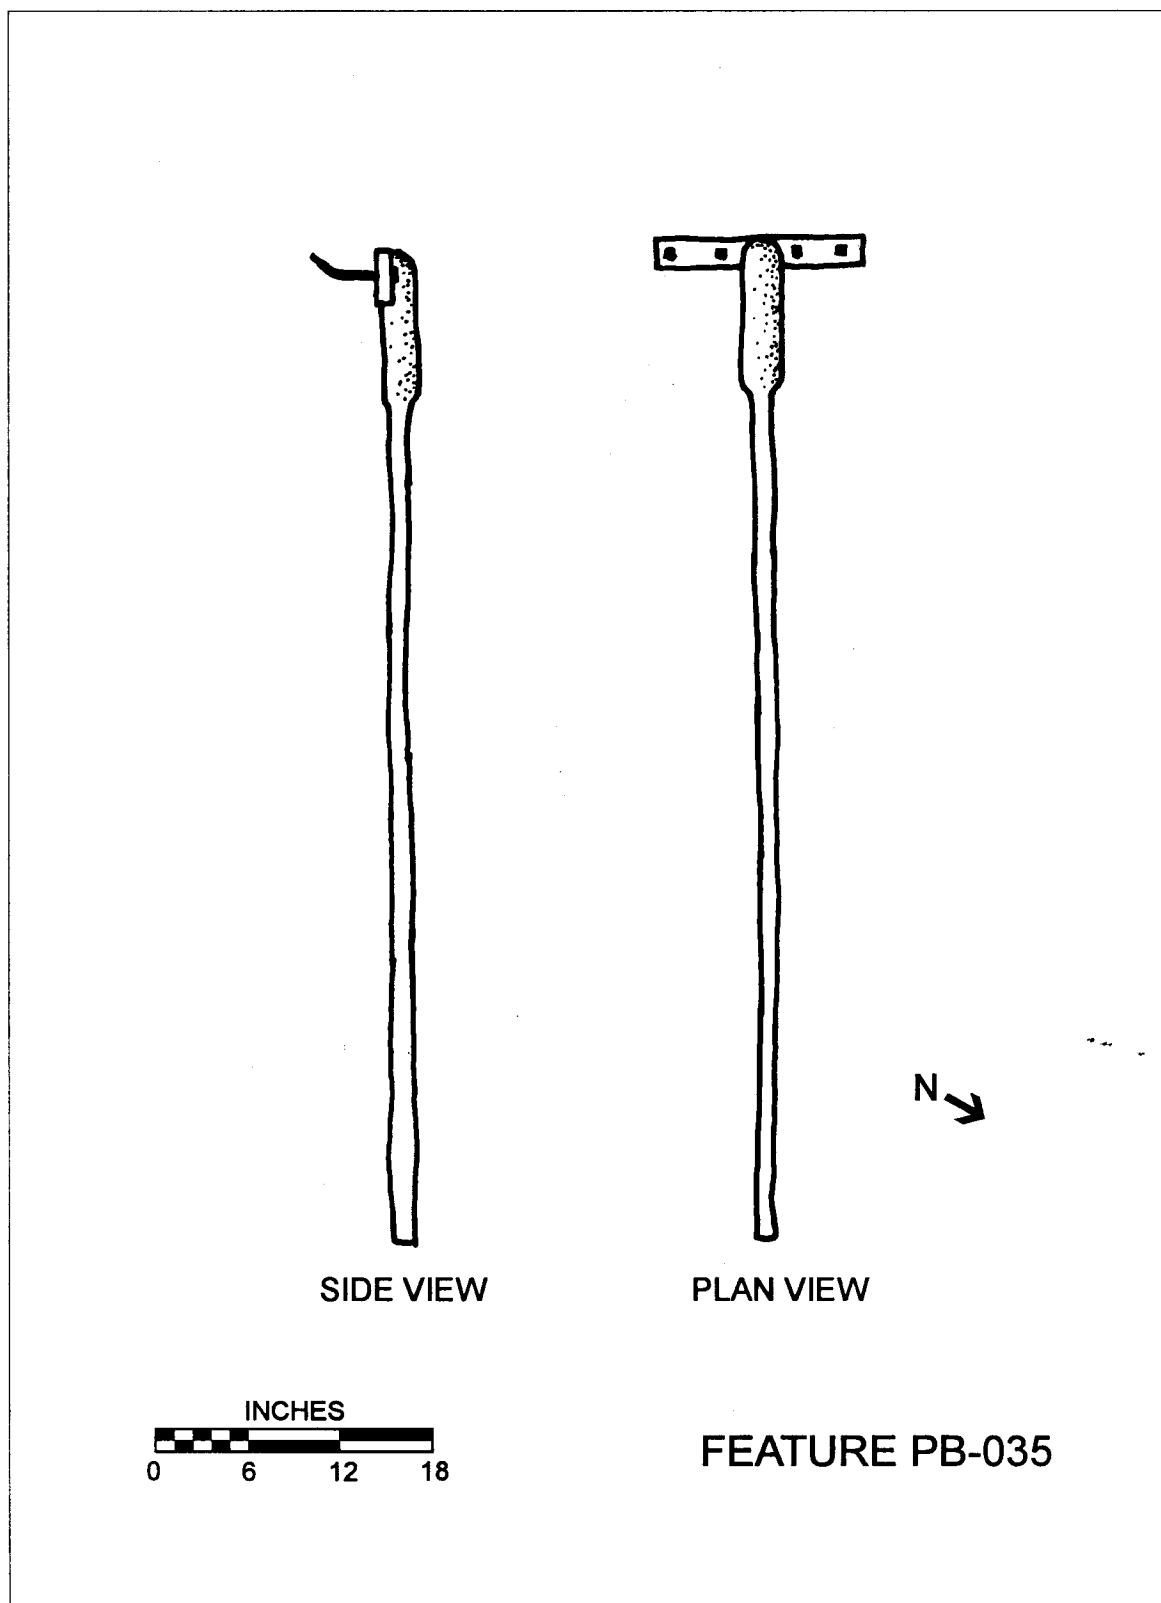
Figure 27

As mentioned earlier, a single, unidentified iron piece, feature PB-035, was recorded above the high-tide line at Northwest Cove (Figure 27). This feature is a 4 foot 8 inch long, 1 3/4-inch square iron bar, which ends in a 2-inch diameter, 10-inch long round portion. Connected to the bottom of the round end is a 1 foot 3 inch by 3 1/2-inch rectangular piece, so that the whole object forms a "T." This rectangular piece has four 1/2-inch square spikes through it. This object has not been identified.

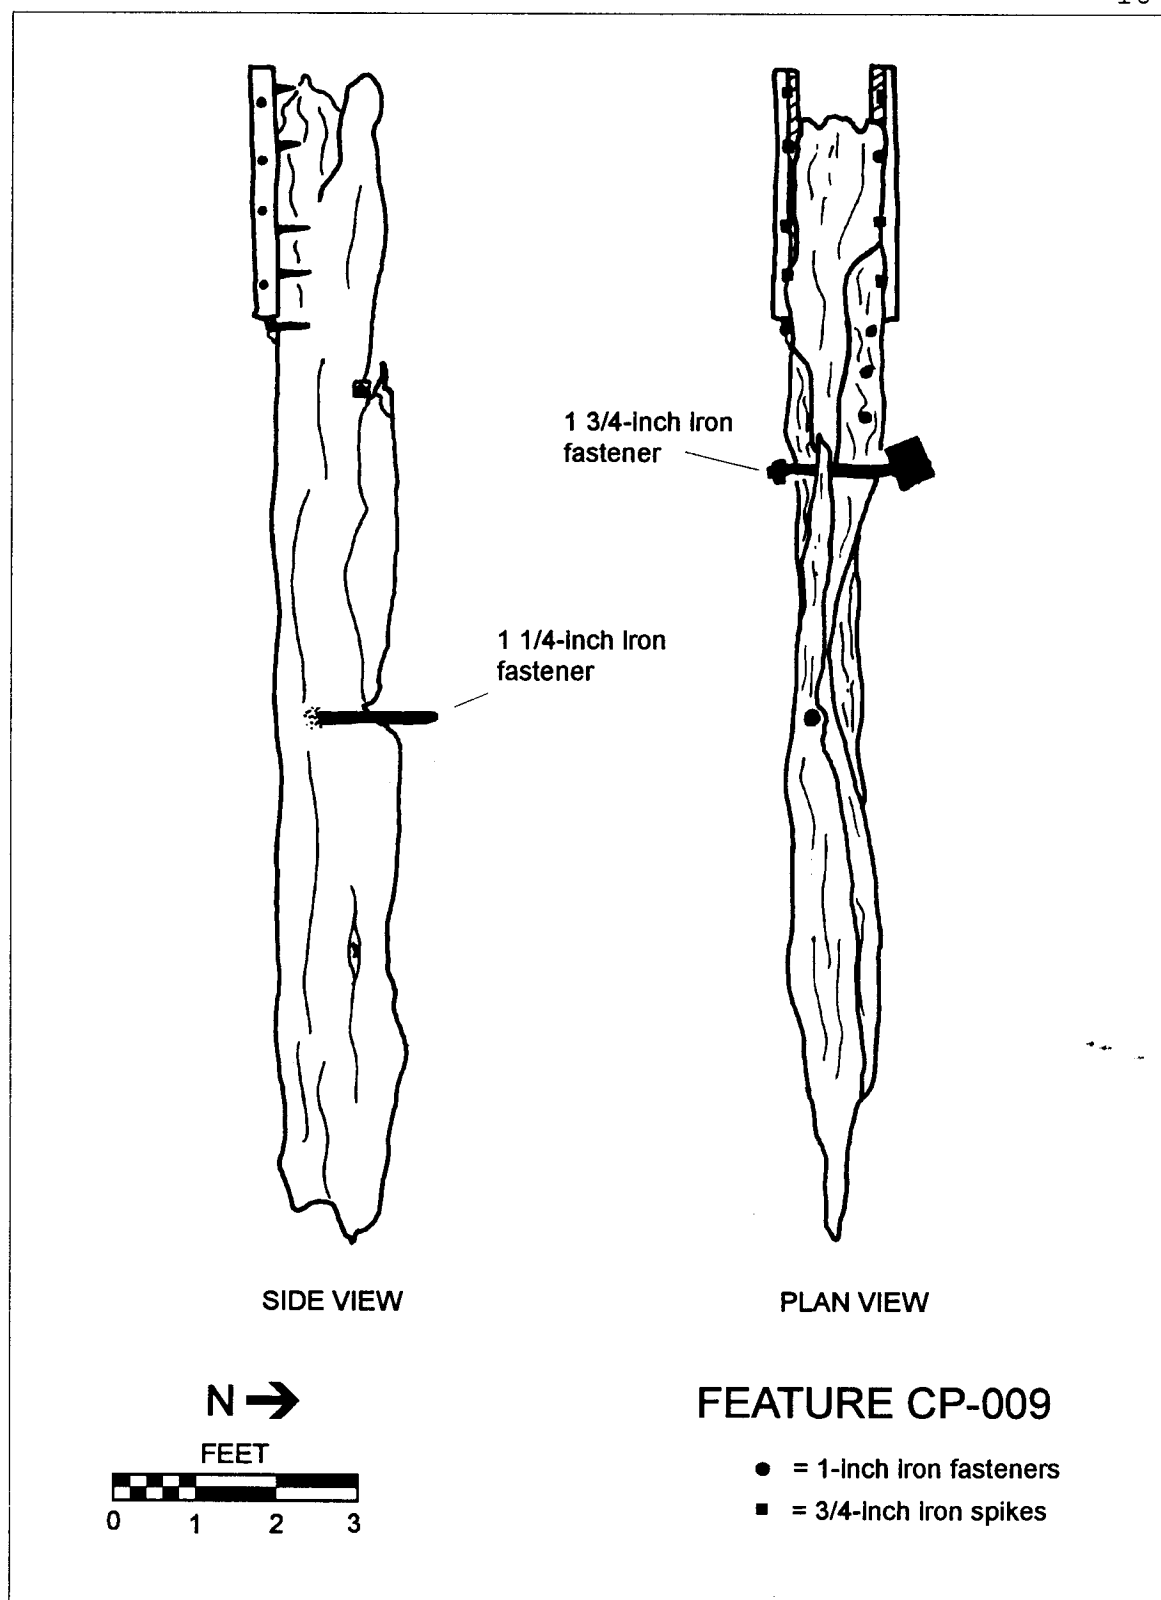
Figure 29

The remaining analysis focuses on features recorded during this study. All twenty-two timbers analyzed and sampled were found to be Douglas fir, so none could be discounted immediately, as with the Northwest Cove Site.²⁵ One timber, however, feature CP-009 (Figure 29), has a wooden component identified as a member of the Fabaceae family, probably ironwood.²⁶ This is not a wood usually used in ship construction. The ironwood pieces are two narrow planks 3 feet 2 inches long, 3 1/2 inches wide, and 3 1/2 inches thick, which are fastened to either side of a large, extremely deteriorated Douglas fir timber measuring 14 feet 8 inches by 17 inches by 16 inches. As the timber lies in the sand, the ironwood planks are fastened along the bottom edge, on the western end. Each piece is fastened by

four horizontal spikes, driven from the outside face and four vertical spikes, driven from the bottom. Each iron spike is countersunk into the ironwood, and plugged with an ironwood plug. The main Douglas fir timber contains four vertical 1-inch diameter drift pins, which are grouped near the ironwood planks; one 7/8-inch square spike; one 1 1/4-inch diameter vertical drift pin; and one horizontal 1 3/4-inch diameter bolt, with a 1 3/4-inch square nut on one end, and a 6-inch square spacer on the other. It is not known what the latter fastener was for, but it is not consistent with common late-nineteenth-century ship construction. This, coupled with the relative few number of fasteners in a timber of this size, and the unusual ironwood pieces, make this feature's association with *Dora Bluhm* unlikely.
