Matthew A. Russell. AN HISTORICAL AND ARCHAEOLOGICAL INVESTIGATION OF THREE BEACHED SHIPWRECK SCATTERS AT CHANNEL ISLANDS NATIONAL PARK. (Under the direction of Dr. Bradley A. Rodgers) Department of History, January 1996.

AN HISTORICAL AND ARCHAEOLOGICAL INVESTIGATION
OF THREE BEACHED SHIPWRECK SCATTERS AT
CHANNEL ISLANDS NATIONAL PARK

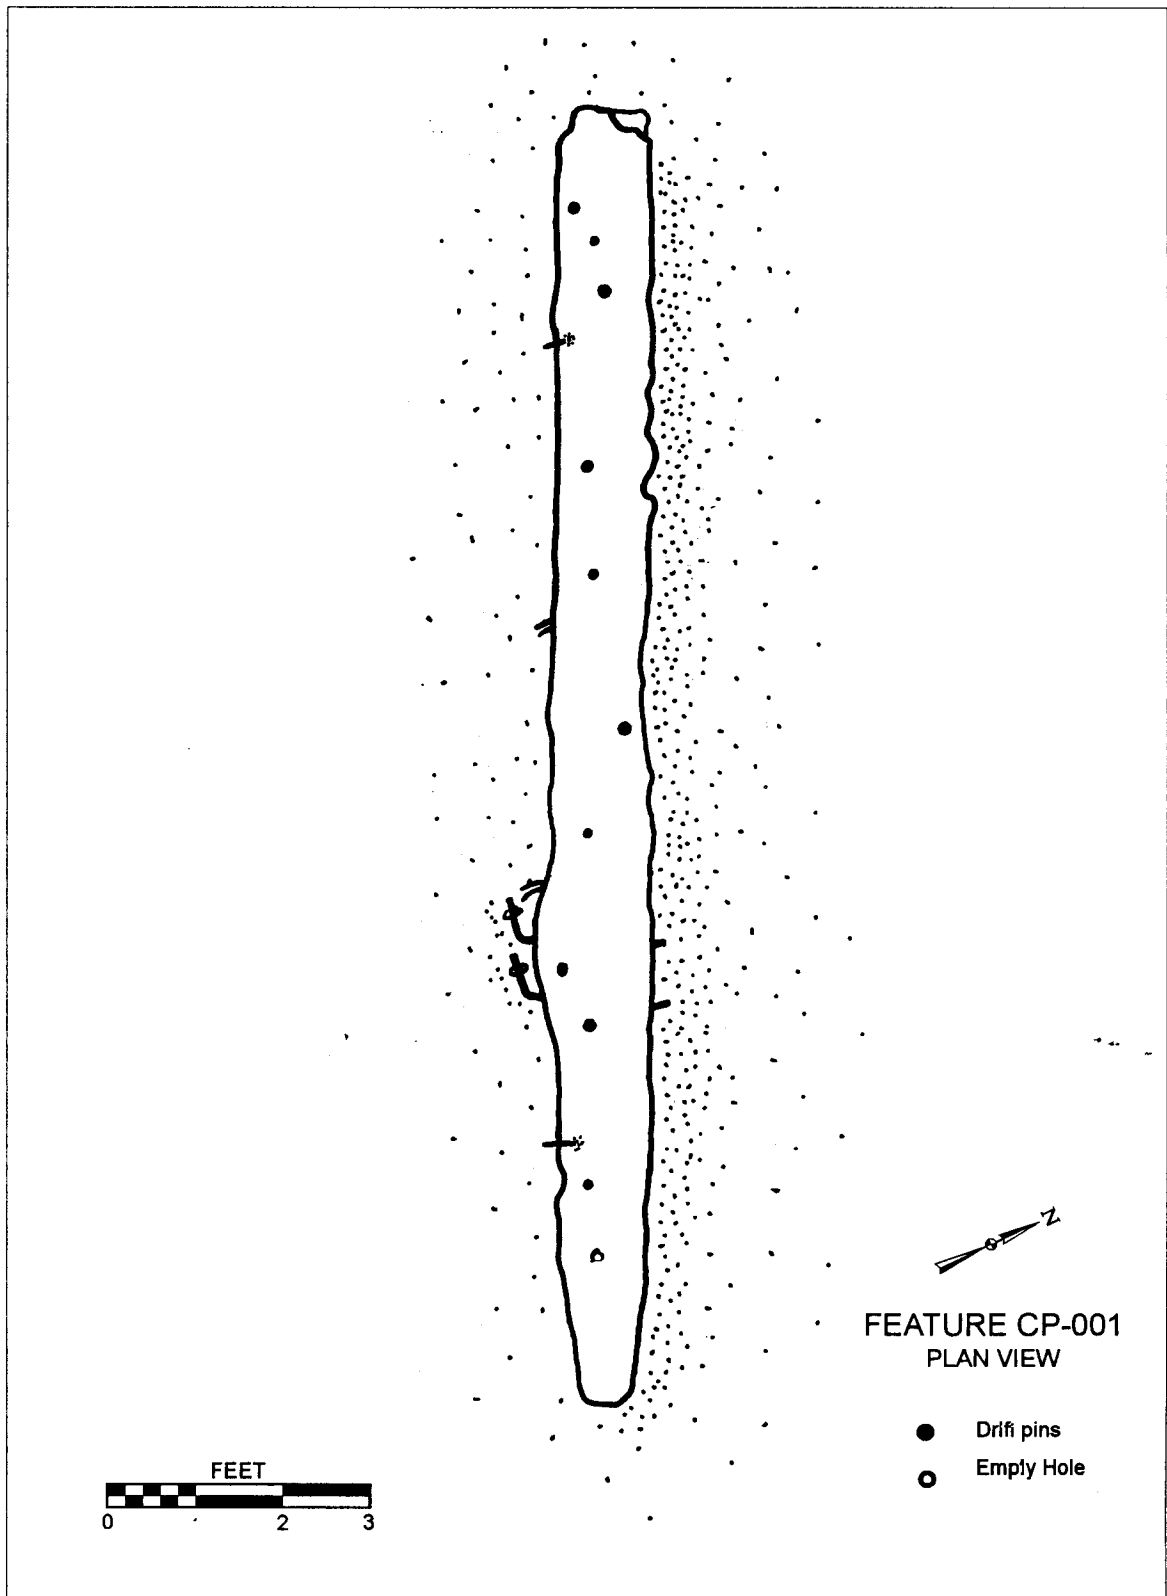
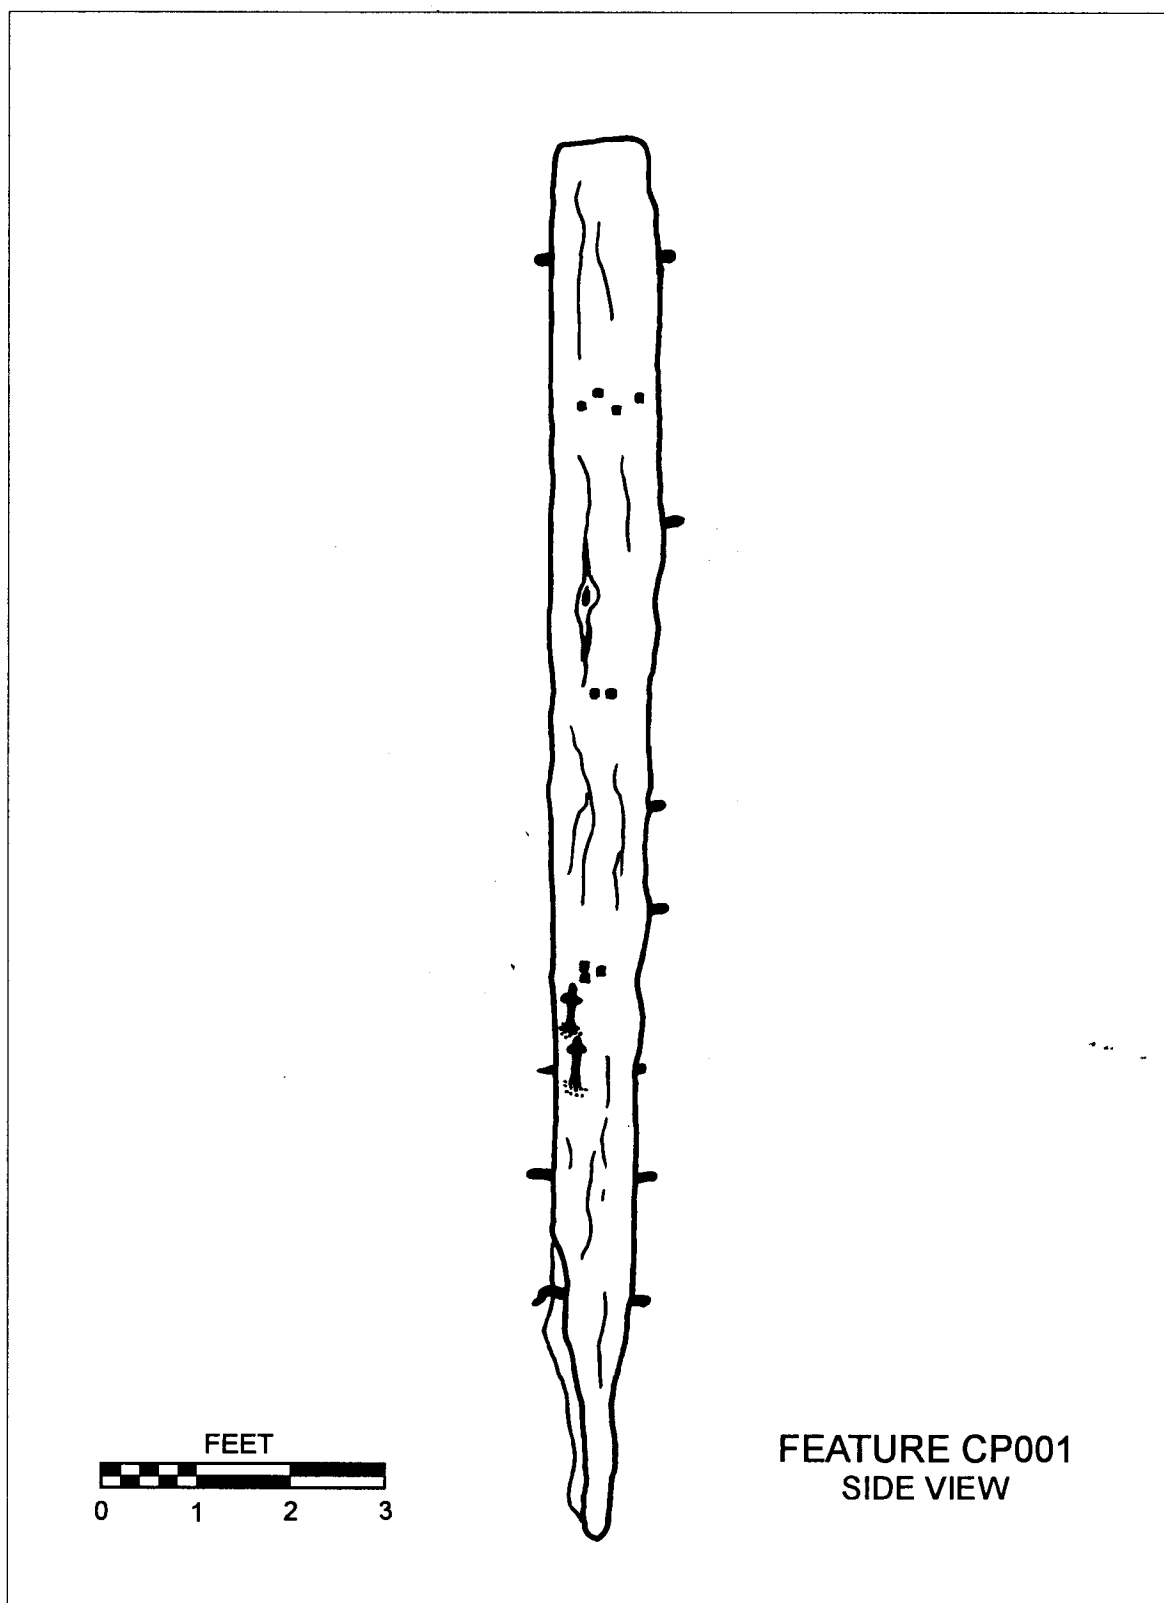
Of nine structural elements, features CP-001, 010, and 012 are all similar Douglas fir timbers with large, iron fasteners. The first (CP-001), heavily abraded and worn, is 14 feet 10 inches long, with maximum dimensions of about 15 inches by 13 inches (Figures 30 and 31). Both ends of the timber are broken; original length is indeterminate. There are ten vertical, iron drift pins along its length, and the empty hole of an eleventh. Six drift pins are 1 1/4 inches in diameter (though slightly expanded by corrosion), four measure 1 inch in diameter, and the empty hole is 1 1/8 inch in diameter. These fasteners are grouped roughly in pairs (including the empty hole): the paired pins are approximately 1 foot apart, and the pairs are about 2 feet apart. One pair has an additional 1-inch diameter drift between them. These vertical fasteners are broken close to the timber on both sides. In addition to the vertical fasteners, there are several transverse drift pins and spikes. These include four 1/2-inch square spikes and two 3/4-inch diameter drift pins with 2-inch diameter (possible) clinch rings on one end. The two drifts are paired and 9 inches apart. The drifts protrude from the timber 7 inches on the ends with the clinch rings. There is no other evidence of fasteners on the timber's side faces.

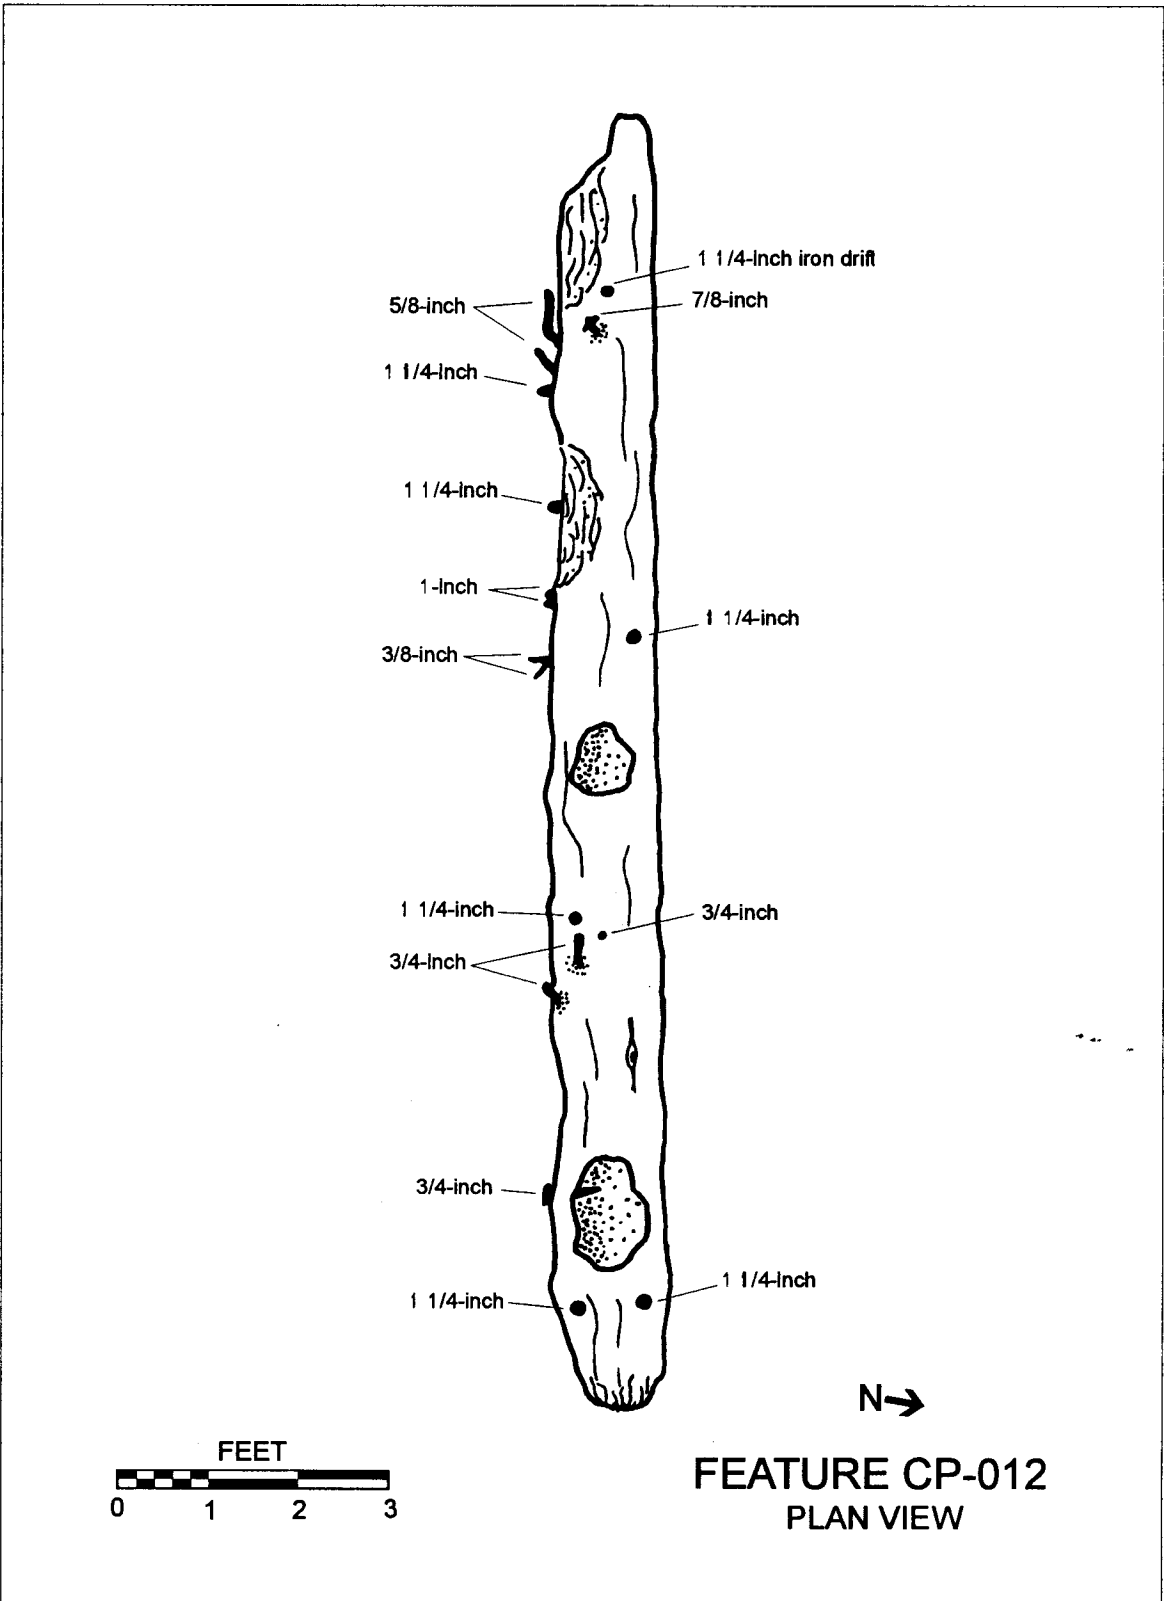
Figure 33

Feature CP-012 is a similar timber, measuring 14 feet 3 inches in length (broken at both ends), with maximum dimensions of 14 inches by 13 inches, again with some deterioration (Figure 33). The most conspicuous features of this piece, besides the fasteners, are two large holes penetrating all the way through the timber, apparently caused by some kind of differential deterioration. There are no large fasteners in or around these holes, so it is unknown if the deterioration was centered around iron drift pins, as seen in feature PB-001. Like the two previous features, CP-012 has several vertical, as well as transverse, iron fasteners. The vertical fasteners include five 1 1/4-inch diameter drift pins, three 3/4-inch diameter drifts, and a single 7/8-inch diameter bolt with a 1-inch square nut on the end. The transverse fasteners consist of two 5/8-inch diameter round drifts, two 1 1/4-inch diameter

drifts, two 1-inch diameter drifts, two 3/8-inch diameter round spikes, and a single 3/4-inch diameter round drift.

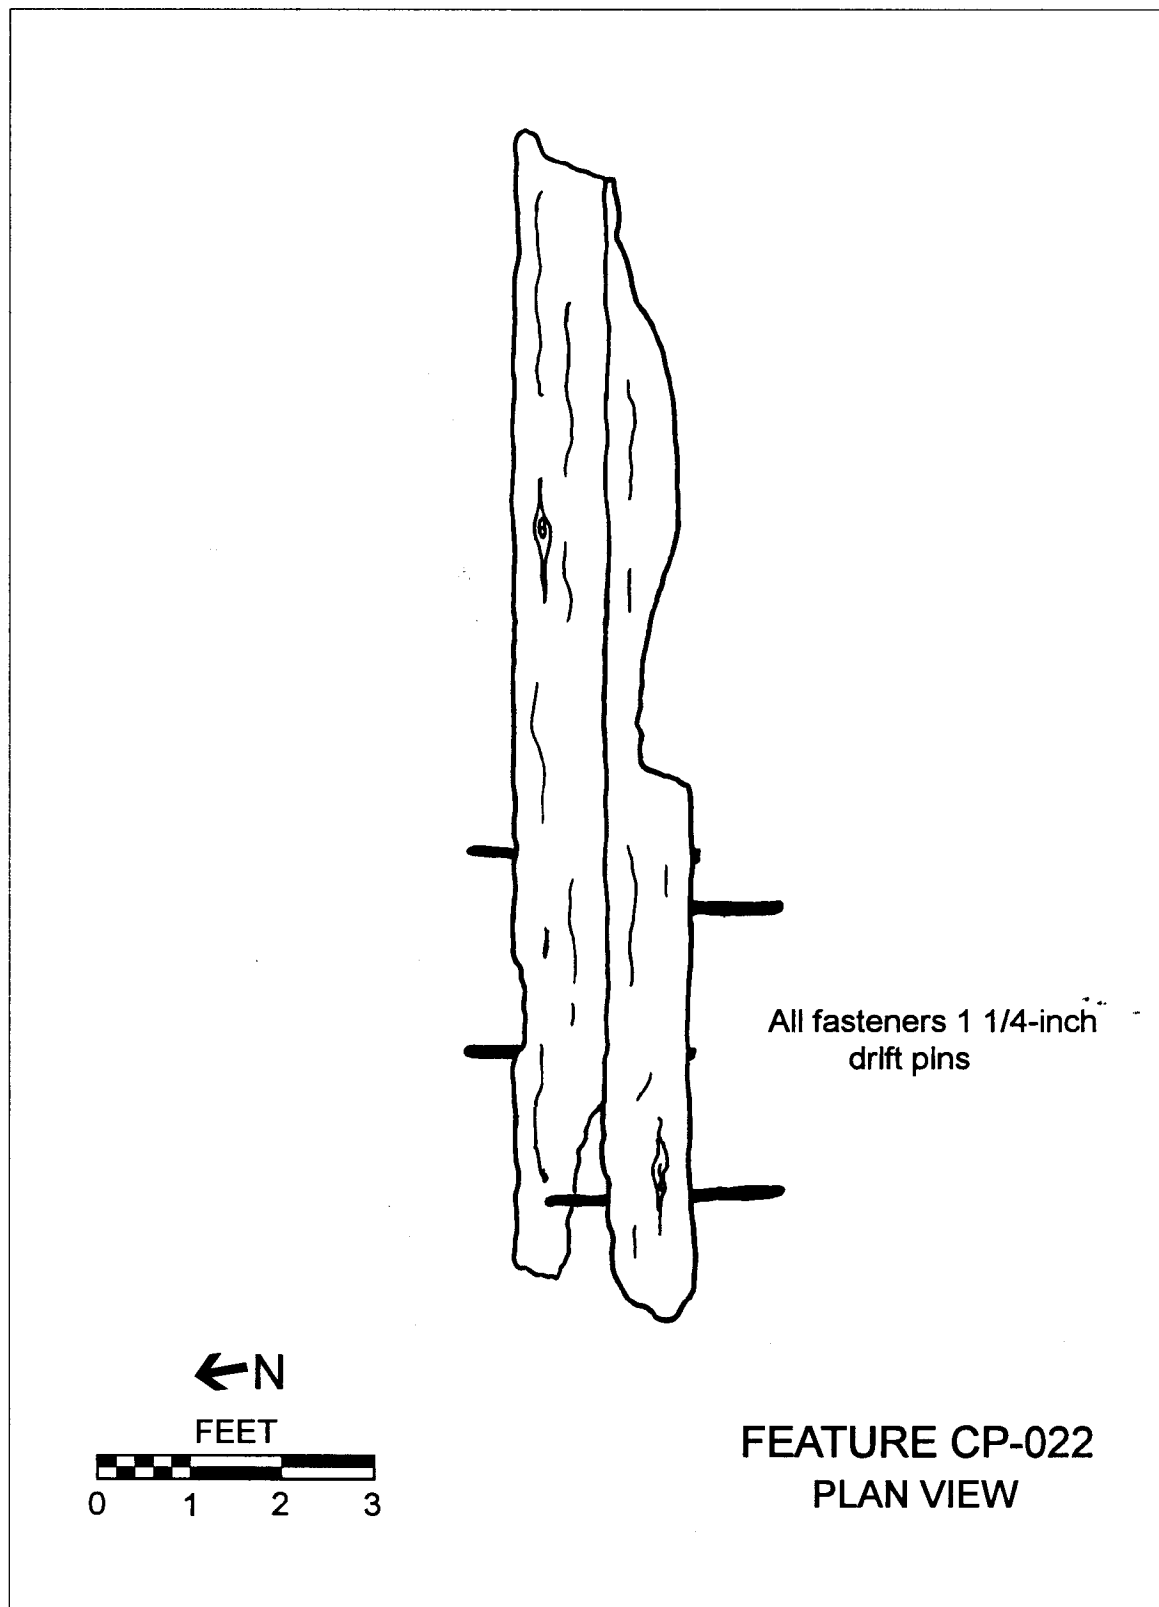
Figure 36

The next feature probably a structural member of *Dora Bluhm* is CP-022 (Figure 36). This feature is composed of two timbers, each with an original width of 12 inches and surviving lengths of 12 feet 10 inches. The timbers are edge-bolted together with four 1 1/4-inch diameter drift bolts. The four fasteners originally edge-bolted at least two more timbers to the two surviving pieces, one on each side. The timbers have a present thickness of 5 inches, but the undersides are extremely deteriorated, so they were originally thicker. The fasteners are slightly expanded, so they were probably originally 1 or 1 1/8 inch in diameter.

At first glance, it appears this piece may be a portion of ceiling or outer-hull planking, both of which were often edge-bolted.²⁹ But this feature does not have evidence of fasteners coming through the face, while both ceiling and outer hull planking would have numerous large fasteners attaching them to every frame. Another possibility, since *Dora Bluhm* was built with a centerboard, is that feature CP-022 is a fragment of the centercase. The vessel's contract specifies the centercase was to be constructed of 8-inch thick timber and fastened with 1-inch iron.³⁰ With the severe deterioration on the underside of this feature, these timbers may have originally been 8 inches thick. The fasteners also may have originally been 1 inch in diameter.

Furthermore, the centercase would have been entirely edge-fastened, which CP-022 clearly displays.³¹ This feature can be distinguished from the centerboard itself, which would have been more heavily fastened. Therefore, feature CP-022 is most likely a portion of the centercase, or centerboard trunk, of *Dora Bluhm*.

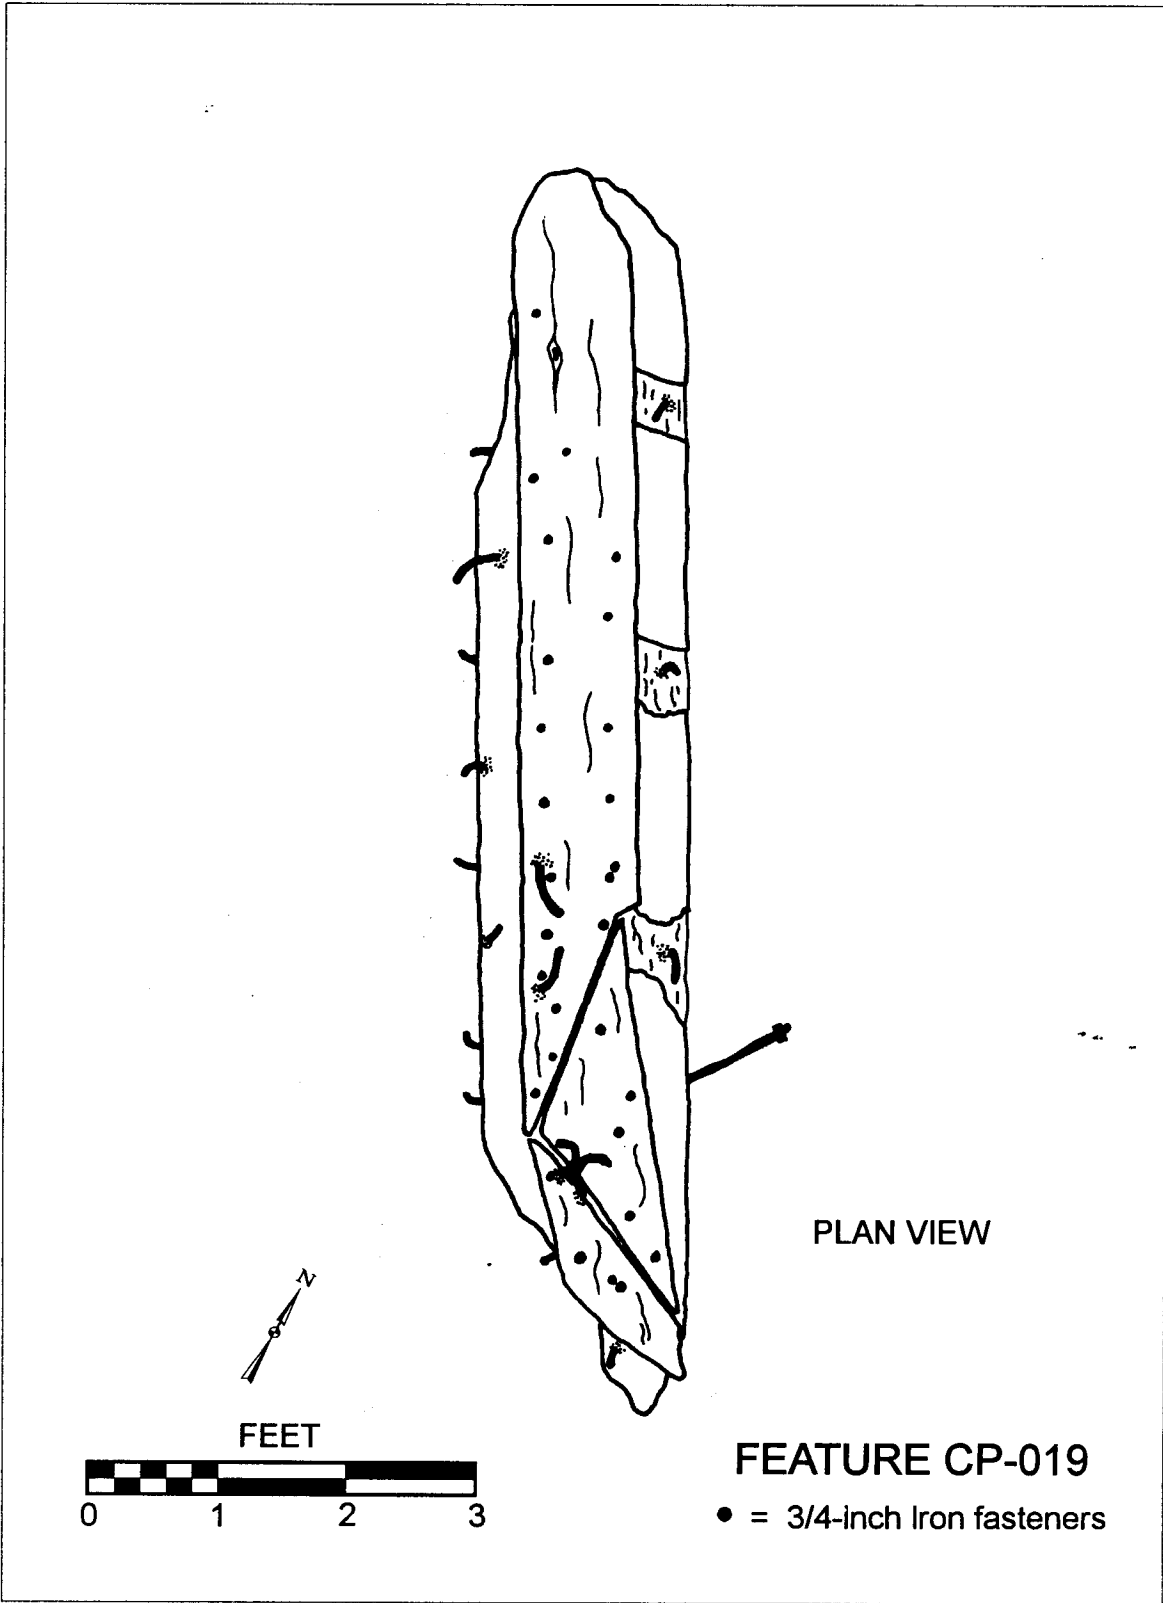
Figure 37

Feature CP-019 is an oddly shaped piece that exhibits characteristics that are clearly from a large, wooden vessel (Figure 37). The feature itself is sizable and contains forty-seven iron fasteners, all of which are 3/4-inch diameter round drifts. The piece is composed of two components: a large, lower timber with three mortises along one edge, and a top portion made up of three different sections. These segments include a long piece joined to a fragment by a triangular chock. These three sections are fastened to the lower timber by thirty-three fasteners. The bottom part of the feature is 9 feet long, 18 inches wide, and 12 inches thick. The top timbers are 10 1/2 inches wide and 3 inches thick. Like most of the other features, both ends are broken, so original length and configuration are unknown.

Dora Bluhm's contract does not go into sufficient detail to identify this feature based on the size of fasteners alone. This is clearly a unique piece, however, and could not have been incorporated into very many areas on a sailing vessel. In addition, its size and number of

fasteners denote a major structural function. The mortises suggest beams were fitted into the side of the timber, making that piece a deck shelf. Obviously the mortises are too small to have received main-deck beams. In addition, if this piece is a main-deck shelf, then it would have been fastened to the frames using much larger fasteners than the 3/4-inch diameter fasteners present. The chock and the angle of the smaller fragment indicate this piece was at one time part of a curved portion of a vessel.

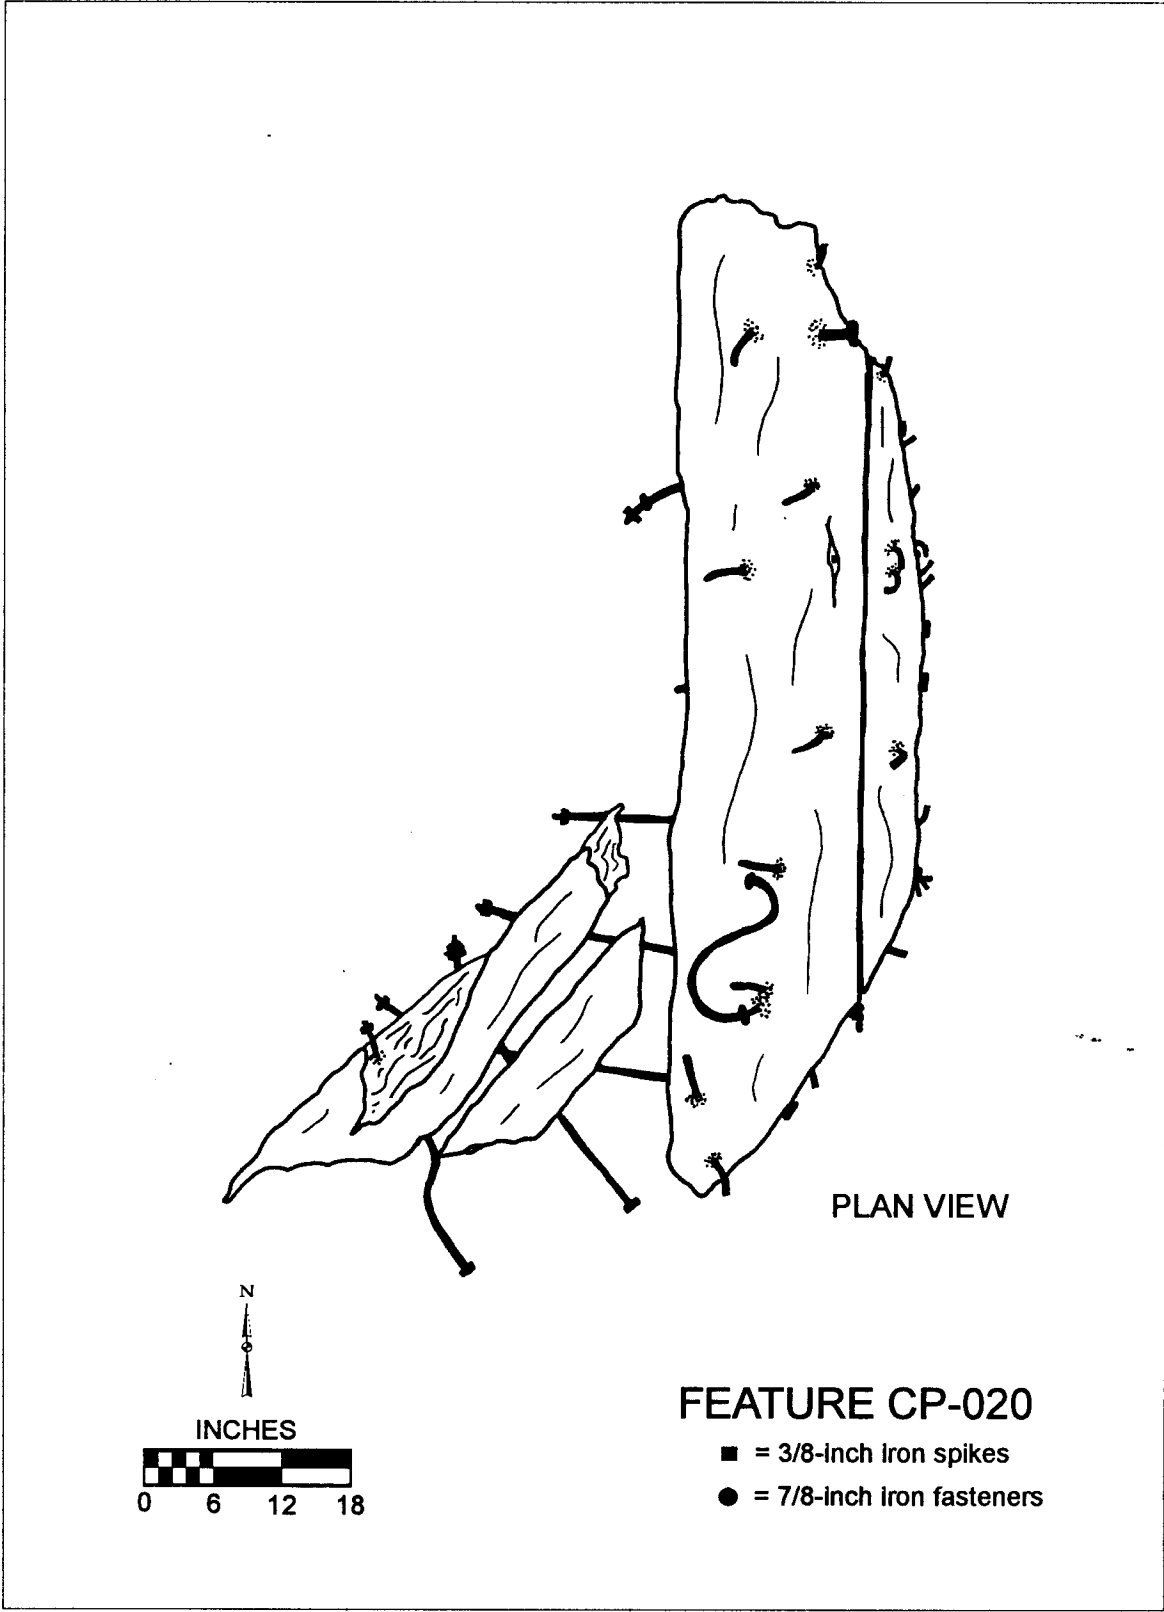
Figure 38

The last structural member discussed is feature CP-020 (Figure 38). It is a relatively flat piece, with a uniform thickness of 8 1/2 inches. The main timber is 7 feet 3 inches long (though broken at the ends) and 1 foot 9 inches wide, while a smaller 4-foot by 1-foot 4-inch fragment is fastened to it at an angle. The feature contains nineteen 3/8-inch square spikes and seventeen 7/8-inch diameter drifts. Timber and fastener configuration suggest this piece represents a portion of the "rim" of a large, wooden vessel, while the smaller fragment attached to it is a component known as the anchor stock.³² The rim circled the stern of the vessel and formed the knuckle line, or main-deck line. The rim was generally composed of three sections, joined by two chocks called anchor stocks. The upper ends of the stern frames ended at the bottom of the rim, and the solid work was directly above it. It was a major stern structural element.

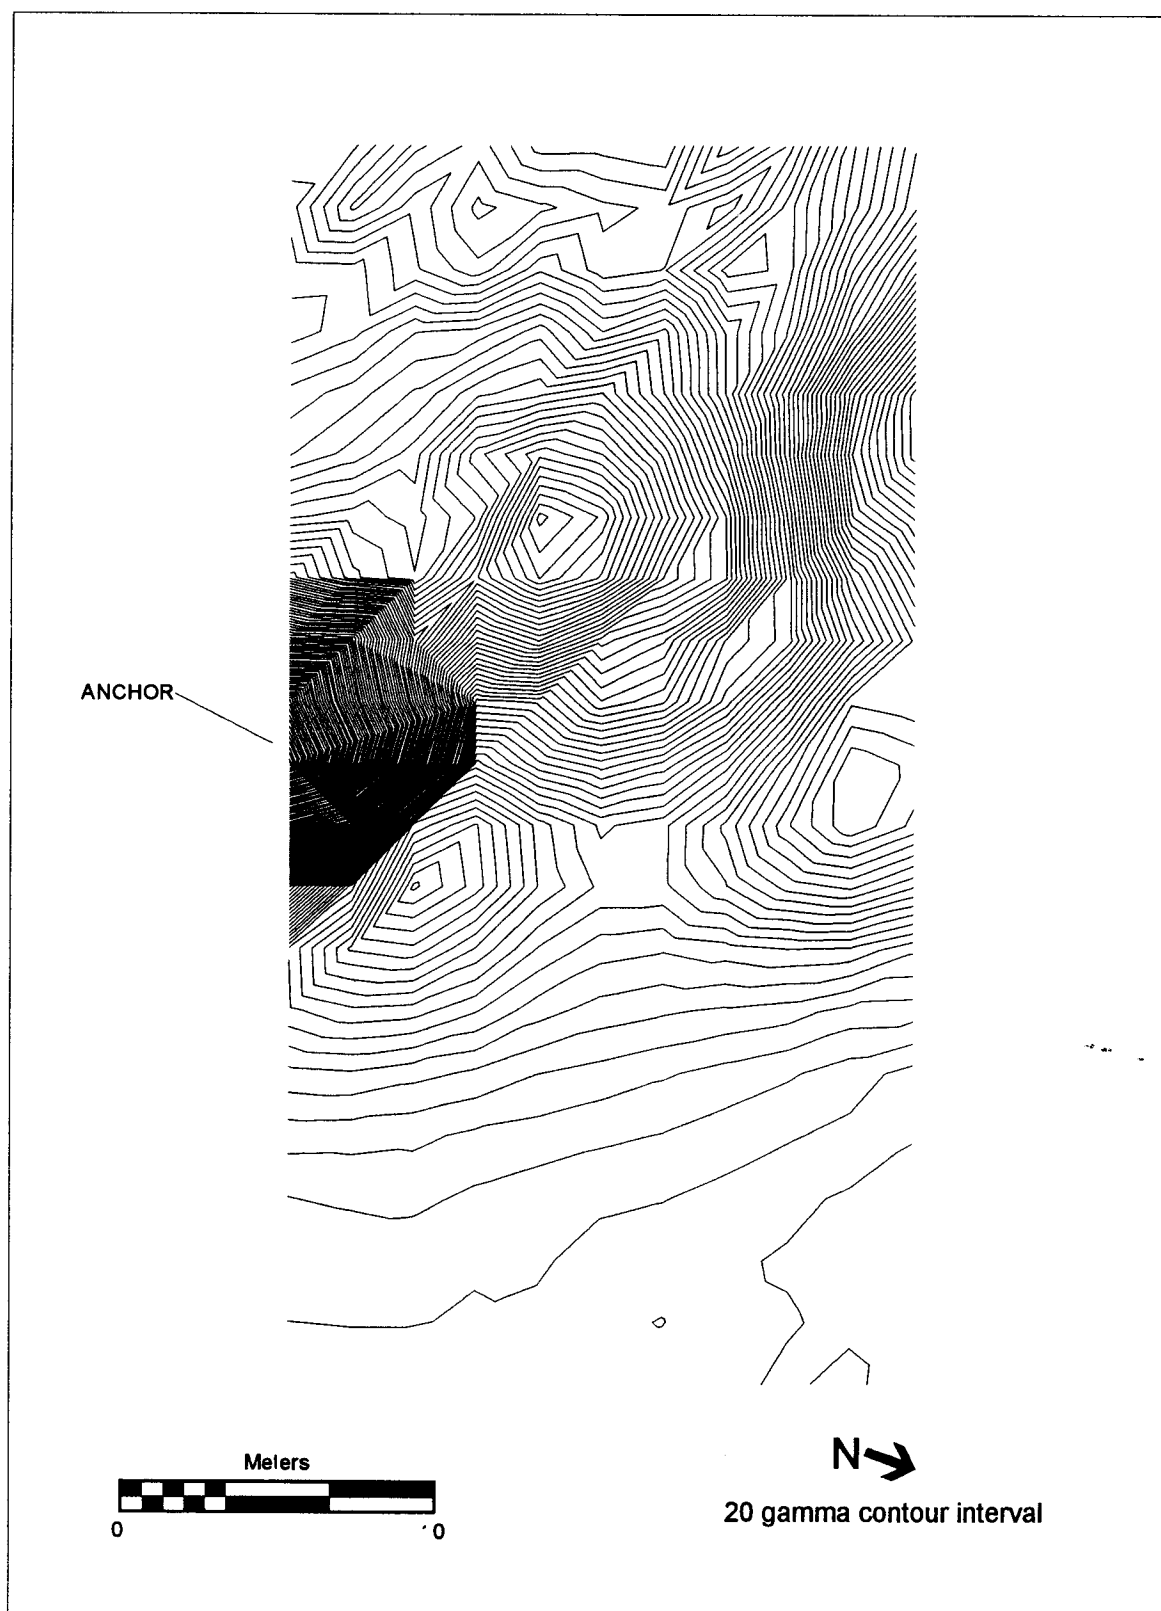
Figure 39. Comet site magnetometer data

Very little of *Comet* was observed during this project. The 1984 photographs and the terrestrial magnetometer survey conducted during this study suggest, however, that the remains may well be extensive. This magnetic survey, which covered a forty-meter by twenty-meter area around the exposed anchor, showed a very active magnetic zone (Figure 39). The region just east of the anchor is relatively

quiet. The anchor itself shows up as a very large anomaly, greater than two thousand gammas. Adjacent to it to the north is another smaller, distinct anomaly of several hundred gammas. The area to the northwest shows a series of large anomalies that extend throughout the rest of the survey area. Although it is impossible now to determine exactly what caused the anomalies, the contour map represents a highly concentrated area of magnetic intensity in the vicinity of visible shipwreck remains attributable to *Comet*. Although exposing this area is the only way to confirm association, the magnetometer survey indicates that extensive buried structure remains.

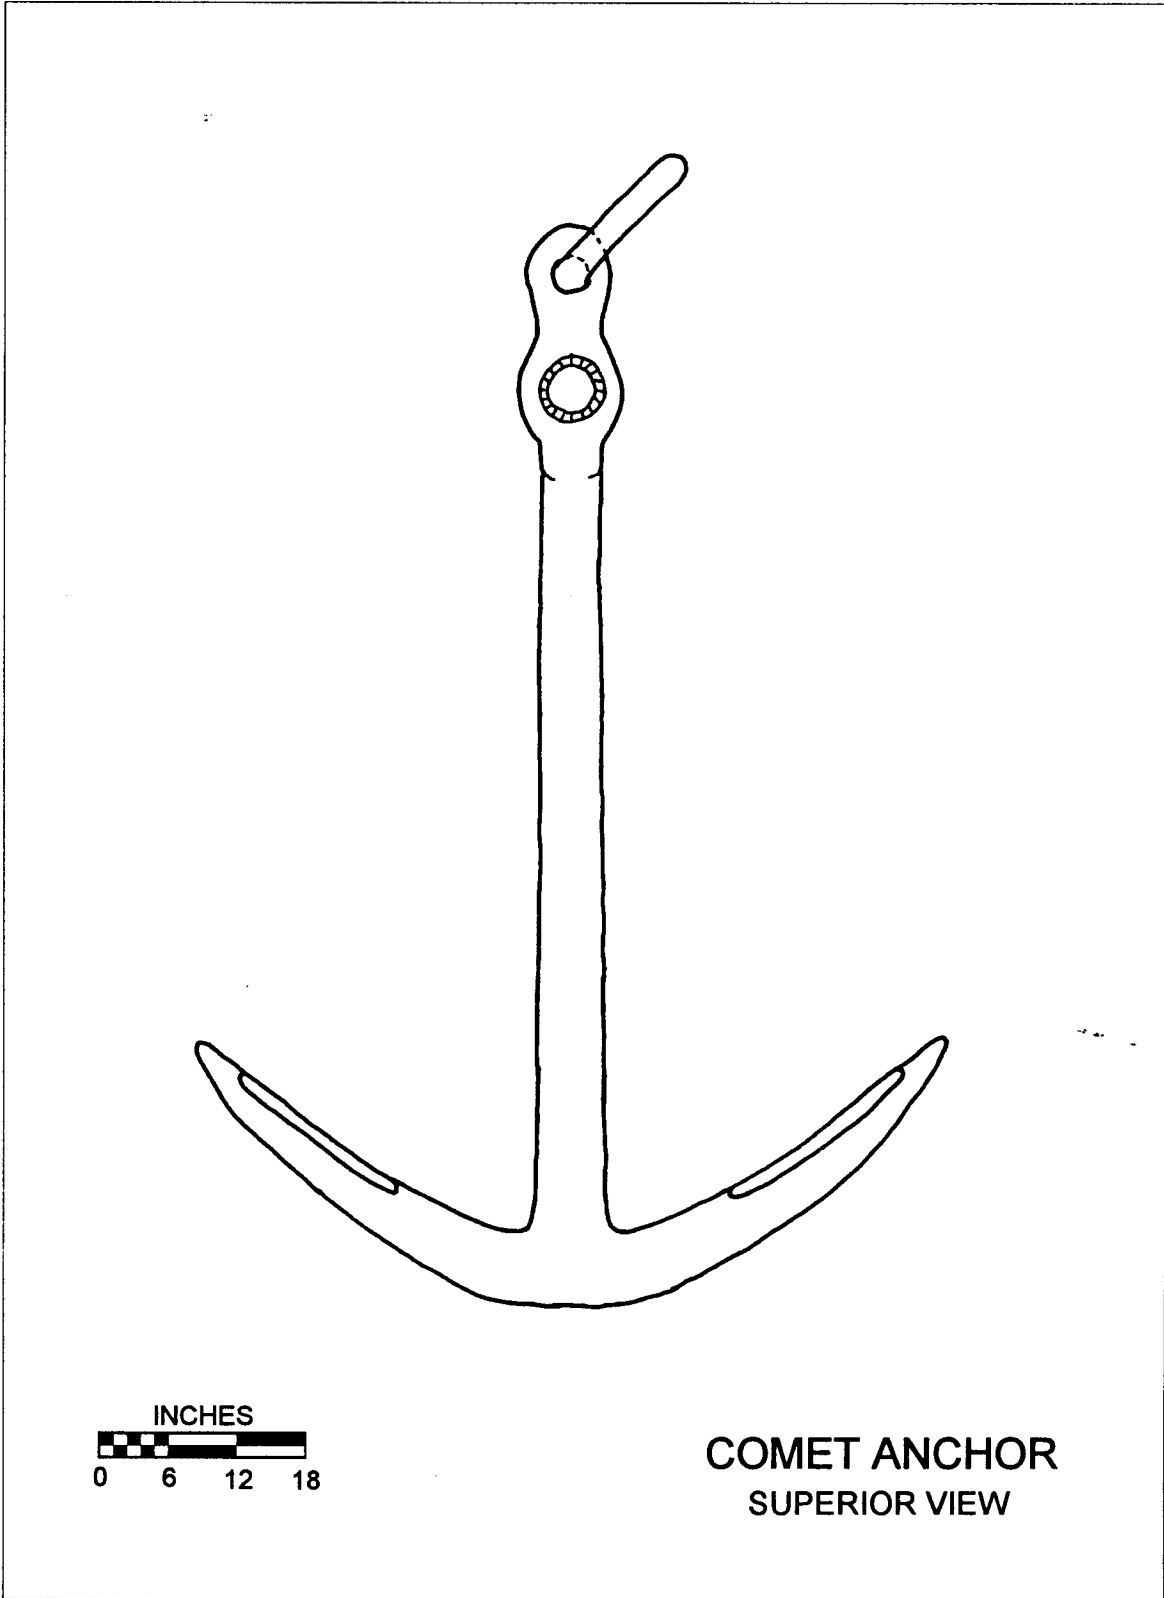
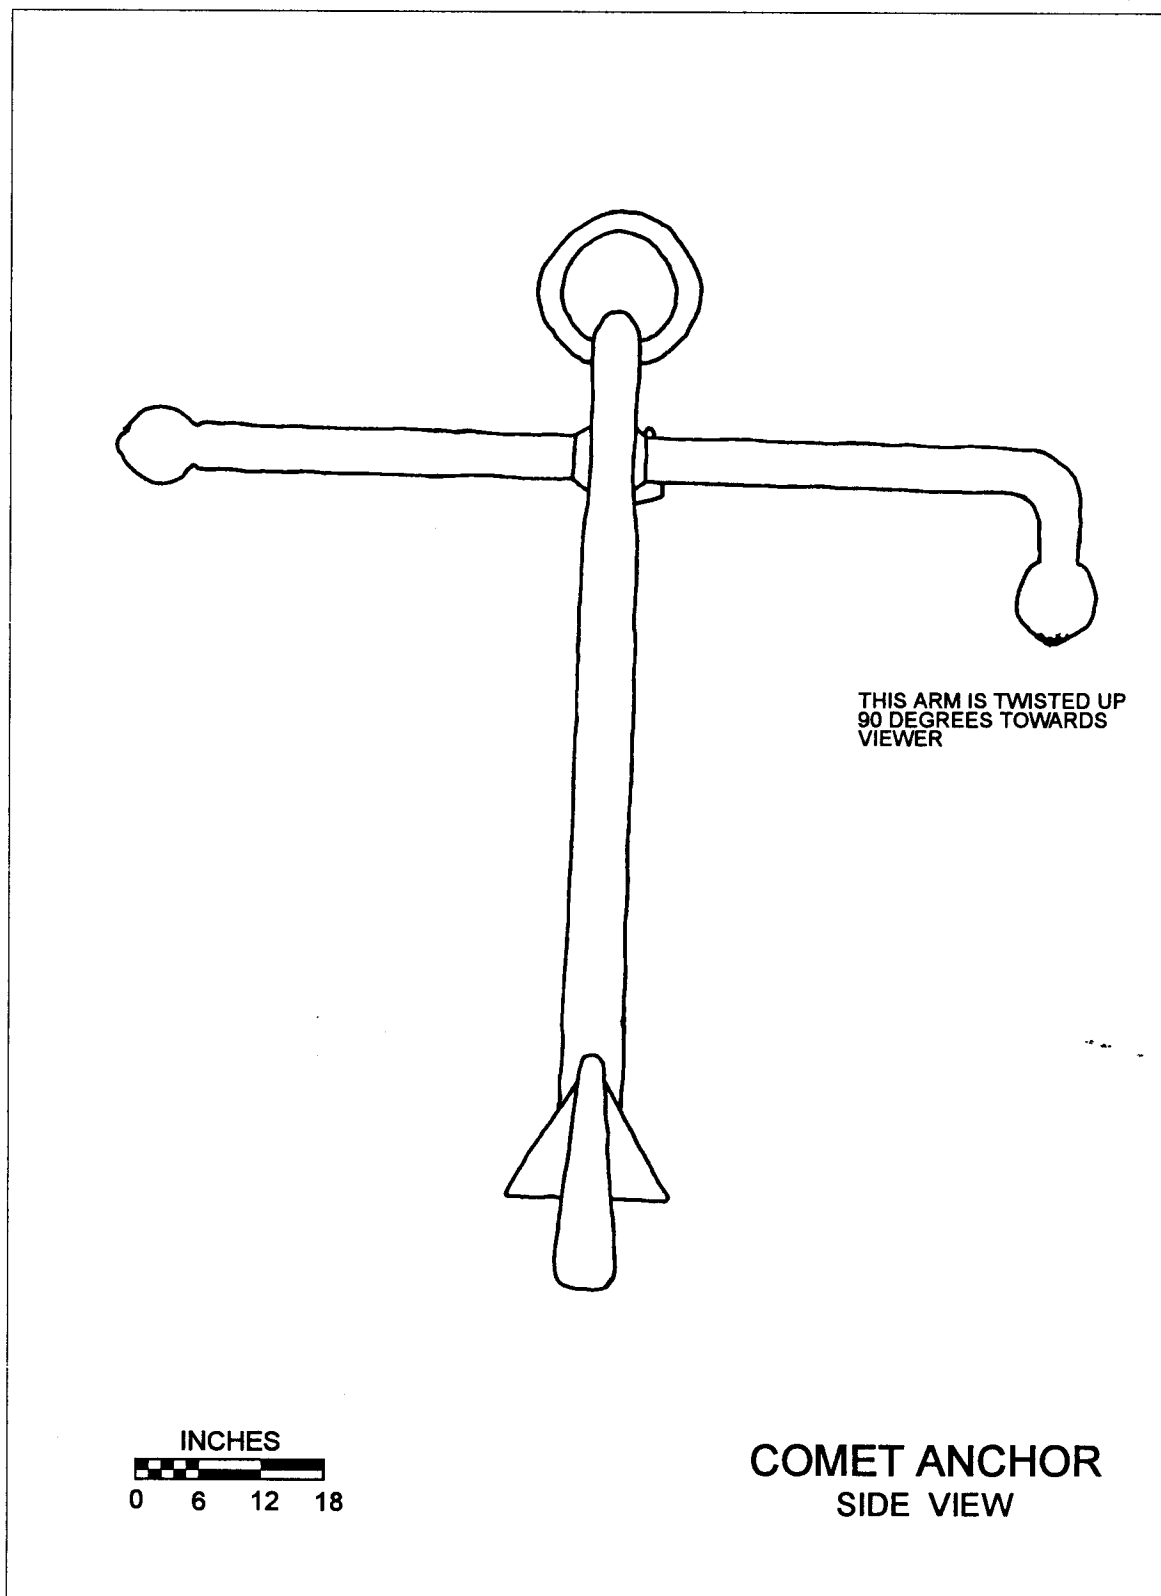
Unfortunately, these remains were not accessible during this study, however, the most prominent site feature, the anchor, was totally exposed and recorded (Figures 40 and 41). Examination of the anchor reveals probable association with *Comet*.

The anchor on the *Comet* Site is iron, with a collapsible iron stock. The anchor is fitted with a ring, but no cable is present. The overall length is 7 feet 11 inches; stock length is 7 feet 9 1/2 inches. Anchor arms are 3 feet long, with 5 feet 6 inches between palm tips. The palms measure 1 foot 3 3/4 inches wide by 1 foot 6 inches long, and 1 1/4 inches thick.
