Determining Seasonal Corrosion Rates in Ferrous-Hulled Shipwrecks:  
A Case Study of the USS *Huron*

DETERMINING SEASONAL CORROSION RATES IN FERROUS-HULLED  
SHIPWRECKS: A CASE STUDY OF THE USS *HURON*

A Thesis

East Carolina University

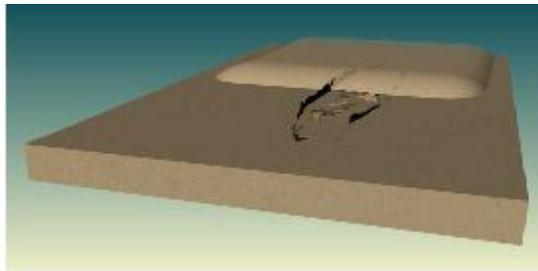
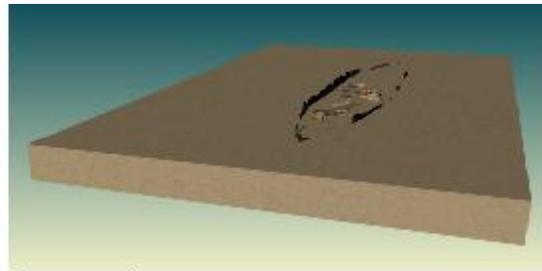
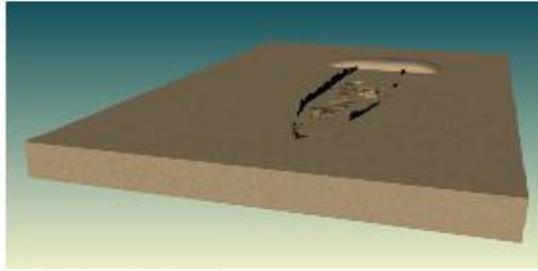
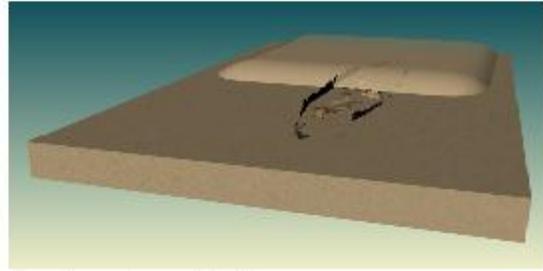
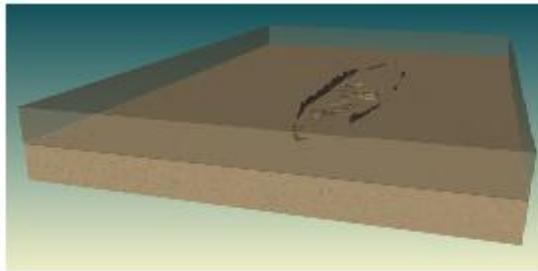
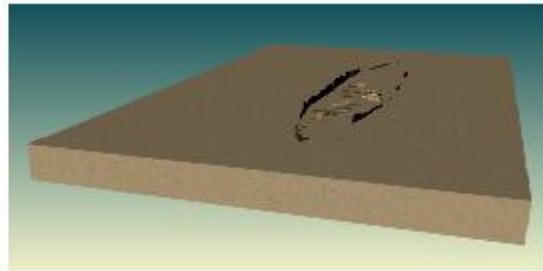
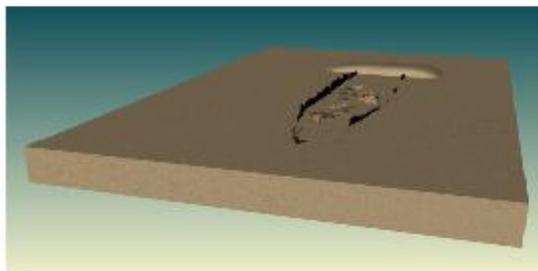
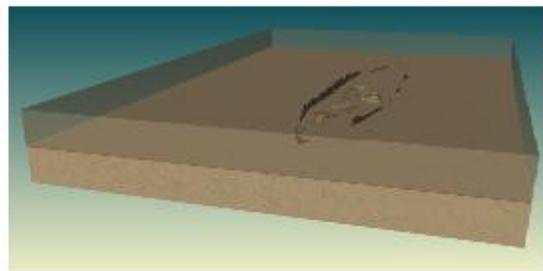
**Figure 38. Sedimentation time series taken from the *Huron* wreck preserve yearly reports (Lawrence 2004, 2005, 2006, 2007, 2008, 2009; Zorc 2010). (Image by author, 2013.)**

The sediment time series shown in Chapter 5 (Figure 38) clearly shows an irregular pattern of reoccurring burial of the site from stern to stem, often leaving the bow exposed. This time series illustrates the highly dynamic state of sedimentation of the wreck site that also potentially has a major effect on the corrosion rate of the site.
