SOUTH AFRICA'S BATTLE OF THE ATLANTIC: 1939-1945
A SURVEY OF THE CAPE PENINSULA'S WWII HERITAGE

February, 2019

Presented To the Faculty of the Department of History
East Carolina University

In Partial Fulfillment of the Requirements for the Degree
Master of Arts in Maritime Studies

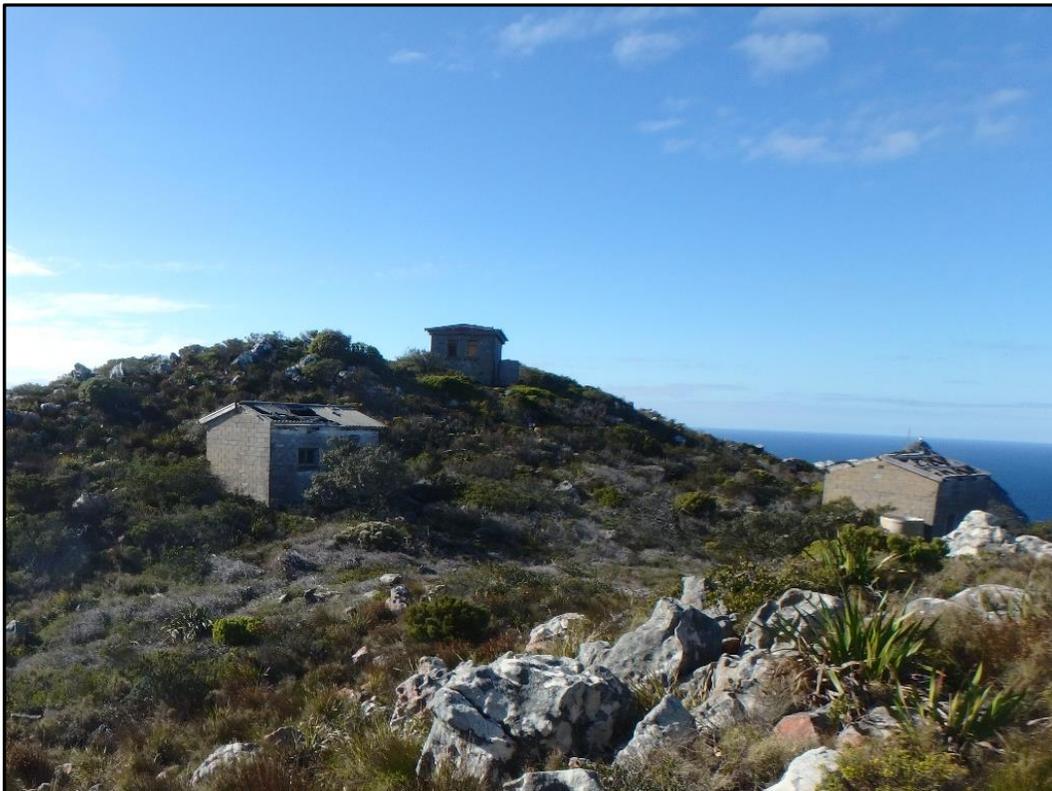
In terms of features, the main operations building still possesses much of the electrical wiring and equipment mounting locations that would have housed the RDF machinery. In

addition, this site is particularly unique in that each of the upper site structures has a dedicated rainwater barrel. Further, each of these collectors is connected to the others by a network of pipes, creating a complex plumbing system running throughout the site. Surprisingly, these pipes remain in excellent condition, with most of the pipe runs still considerably intact. It should be noted as well that this elaborate water system is unique among the sites surveyed, most of which possess a small number of dedicated cisterns that pipe water to one or two central structures.

Figure 20: Photo of the Rooikrans RDF station upper site. Structures: 908 Building (left), main operations building (center), and wash-house (right). Image by author, 2017.

The site's location in the Cape Point National Park provides it with passive legal protection, though it does not receive any form of conservation. Further, the distance of this location from nearby population centers certainly limits the number of casual visitors to the site, reducing the impact of cultural processes. Despite its location nearby the Cape Point Lighthouse, an extremely popular tourist destination, it seems to be far enough off the beaten path so as to not attract much foot traffic.

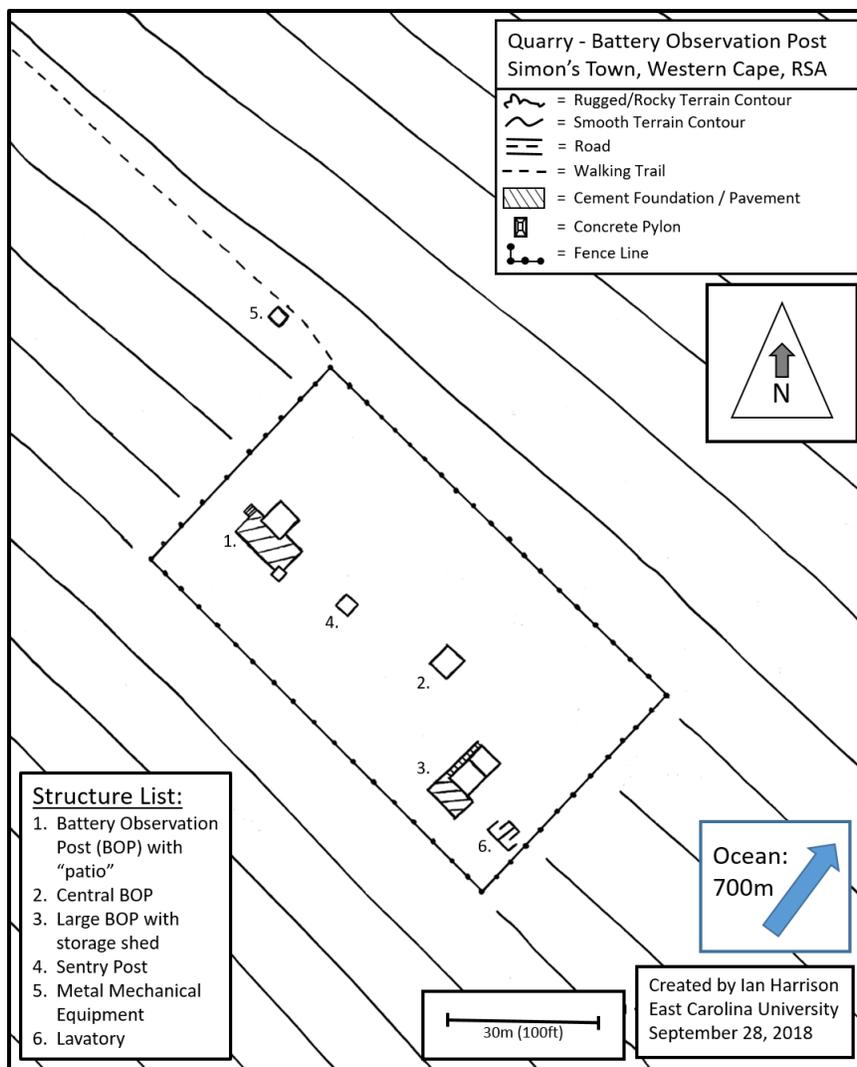
Following the trail uphill from a neighborhood street in Simon's Town eventually leads to a small pile of metal debris. The largest piece is in the shape of a box, roughly 1m square. Its purpose is unclear but may once have been part of the site's range finding equipment. Past this debris, and through a narrow gap in the barbed-wire fence leads into the site proper.

Figure 21: Map of the Simons Town Quarry Battery Observation Post (BOP), also known as the Froggy Lake BOP. Image by author 2018, background landform data from Google Earth satellite imagery.

The condition of the structures on site is moderate, and is influenced by a combination of natural and cultural factors (Table 10). The average condition of structures on site is 22.6 out of 35, a somewhat low score indicating moderate damage in two or more areas. The most common problem is light to moderate structural damage to walls and roofs. BOP #1 has sustained the

most severe damage, with structural cracks in its sub-surface walls. The storage shed attached to BOP #3 has collapsed in on itself, leaving a pile of rubble and metal sheeting. BOP #2 is in fairly good structural condition, though as with the others, the metal storm shutters have been heavily corroded.

In addition to the moderate amount of physical damage throughout the site, there have been some notable cultural impacts as well. There is a minor amount of graffiti and modern litter throughout the site, but more importantly, the survey of BOP #2 revealed a person living inside. In the photo above, BOP #2 can be seen with its storm shutters drawn up, and an impromptu piece of metal sheeting placed over an empty section of window. The site's close proximity to town, as well as its classification as NHRA >60 only have certainly contributed to these cultural impacts.

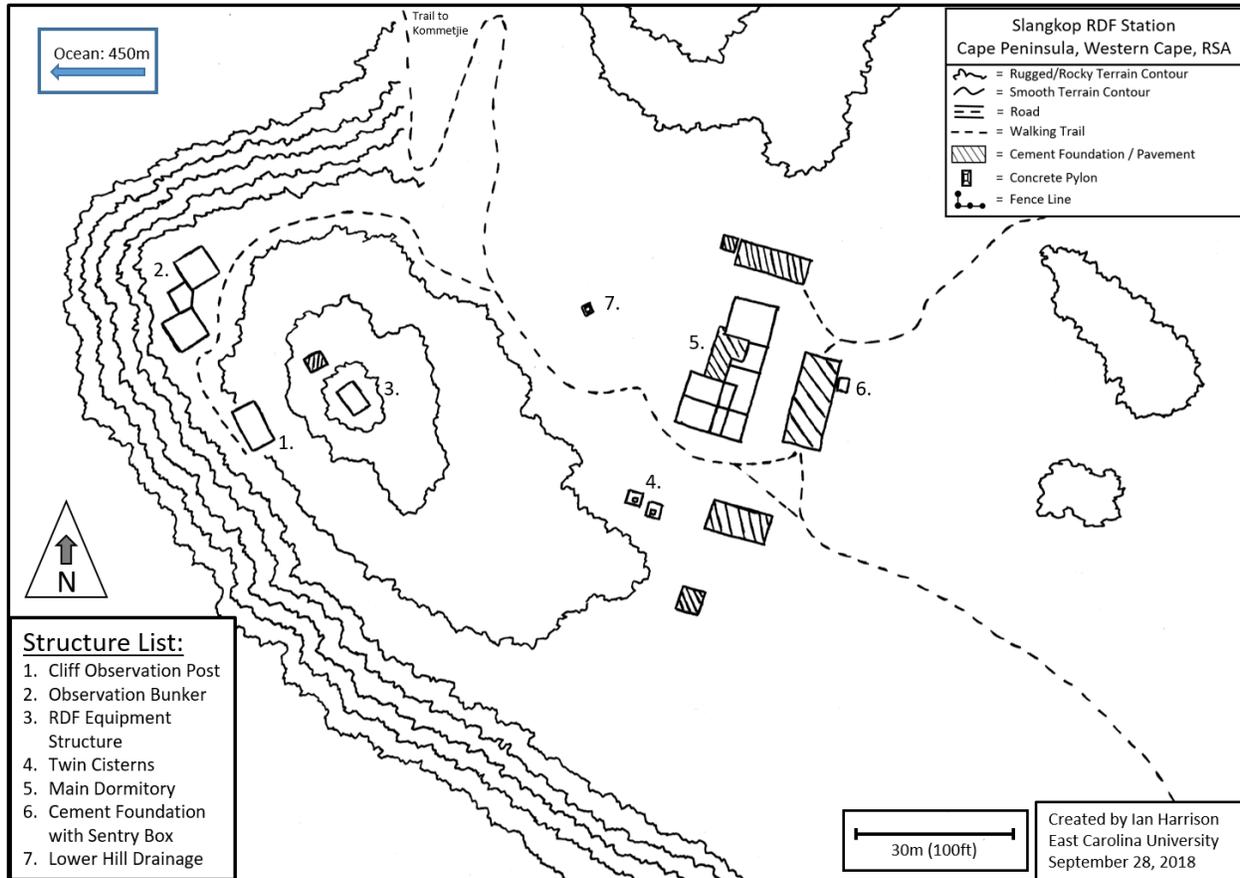
Figure 23: Map of the Slangkop RDF Station near the town of Kommetjie, Western Cape RSA. Image by author 2018, background landform data from Google Earth satellite imagery.

In terms of preservation the site has sustained some significant damage (Table 11). The average structure score for the site is 22.2 of 35, or 20.2 of 35 if the cisterns are excluded from

the calculation. This is rather low and indicates two or more areas of significant degradation. Structurally, most all of the buildings on site have sustained significant damage to crucial features such as roofs, walls, and floors. The main dormitory structure has lost its roof as well as most all of its windows and doors. The specially designed BOP is in extreme danger of collapse. The reinforced cement roofing slabs have already collapsed in over the windows, while the other load-bearing beams and supports are extensively cracked. The cliffside operations building is in better condition, though has still developed a network of cracks in its concrete façade. Meanwhile, the RDF structure is one of the better preserved, and shows little structural damage.

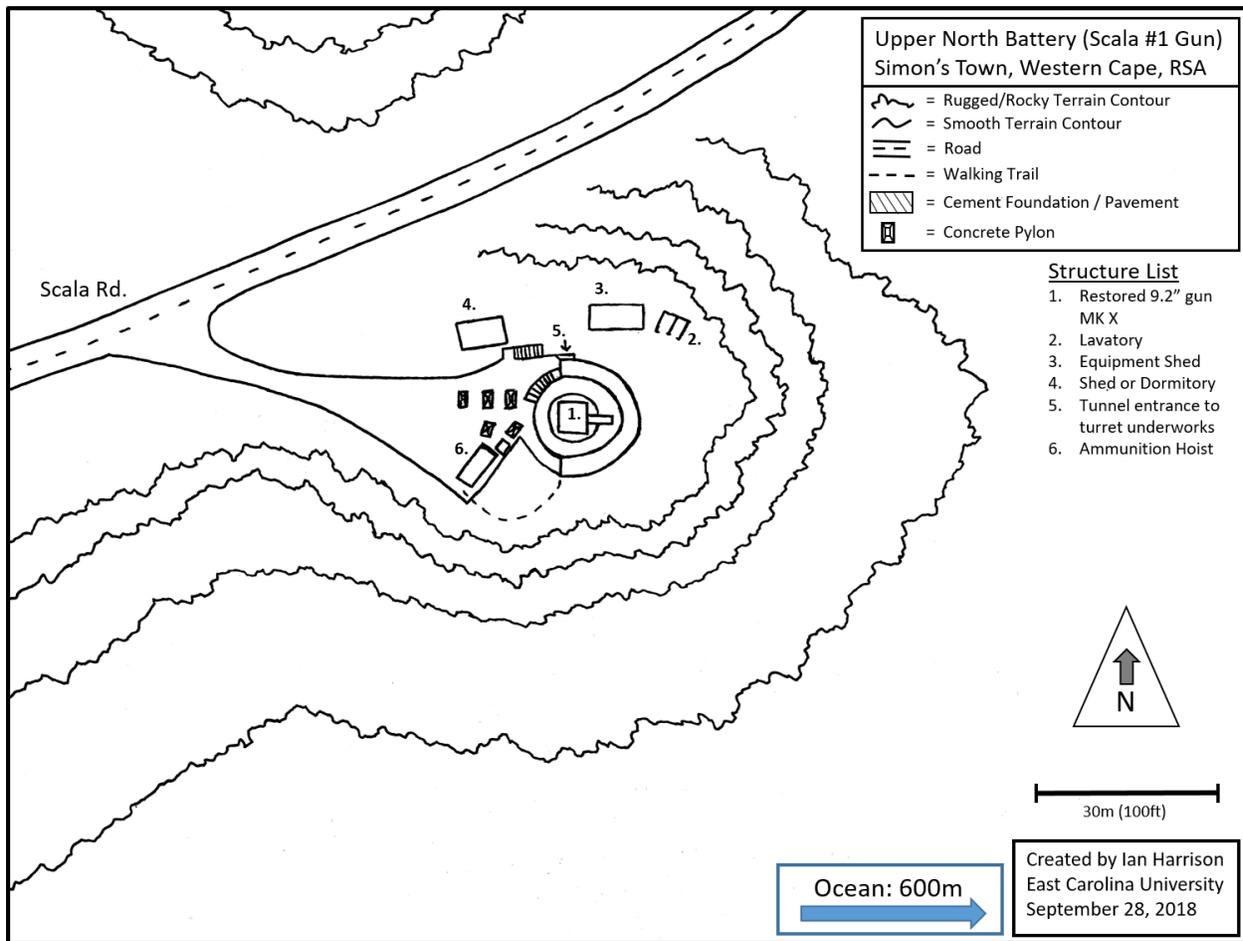
Figure 25: Map of the Upper North Battery (SCALA #1 Gun). Image by author 2018. Background landform data from Google Earth satellite imagery.

In terms of preservation the site is in overall moderate condition (Table 12). The average structure score for the site is 23.7 of 35, indicating some light weathering with one or two areas of moderate damage. Generally speaking, the site’s masonry and stonework are in fair condition, with the primary source of damage resulting from the corrosion of metallic features such as windows and doors. The gun itself is in fairly good condition, certainly in large part to the site’s

active maintenance and restoration by the Simon's Town Naval Museum and Naval Heritage Trust. The gun appears to be corroding substantially underneath its camouflage paint, but it is nevertheless well intact. The metal pivot on which the gun rests however has corroded significantly however, opening up a small gap in the metal plates. During the survey, this gap was used by a group of local children to (dangerously) crawl into the turret underworks. The two operations structures are in fair condition, with some cracking in the concrete in addition to several missing doors and windows. The lavatory has lost its roof, but the brickwork and electrical features remain largely intact. Thanks to the site's active management, (and perhaps proximity to the nearby military base) there are only limited amounts of cultural defacement throughout the site, primarily in the lower operations buildings.
