FIRE IN THE HOLD:

CONSTRUCTION AND USE OF THE 1628 SWEDISH WARSHIP *VASA*'S GALLEY

A Thesis Presented To the Faculty of
the Department of History, East Carolina University

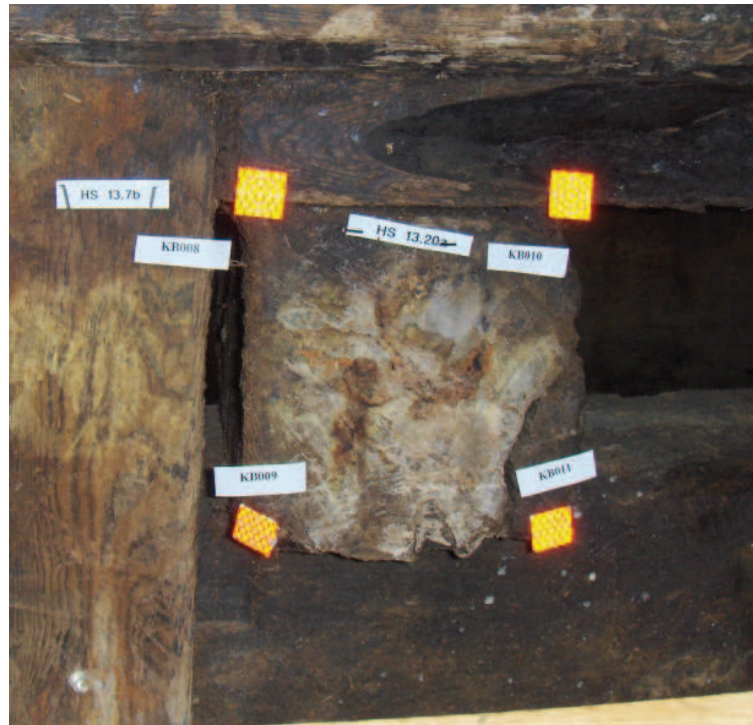
Figure 3-2: Reflective tape and labels on a galley sill.

When recording with the total station, corners of timbers, fastener holes, empty holes, and intersections of timbers were identified. Where possible, a piece of reflective tape (10 mm x 10 mm) marked the point. Each point was labeled with a unique identification number: a three digit number preceded by an alphabetical prefix (Figure 3-2). This tagging system follows the system used on other *Vasa* recording projects, ensuring no point on the ship can be confused with any other. In this case, the prefix was KB, for *kabyss*, the Swed-

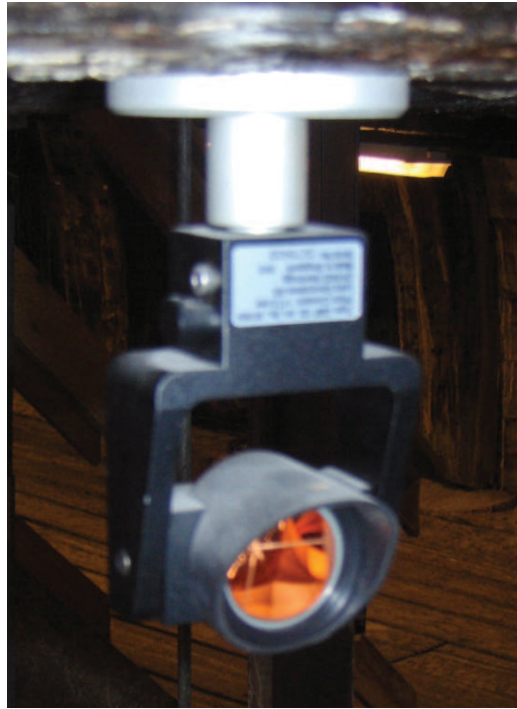
Figure 3-3: A fixed prism mounted on the lower gundeck.

The total station used was a Leica TDM-5005. This machine was used in conjunction with the museum's existing geodesy system, which is a system of fixed prisms (Figure 3-3) with highly-accurate known positions. Backsights to these permanent prisms created a known reference point for the total station, which in turn allowed the integration of points into the museum's coordinate system.

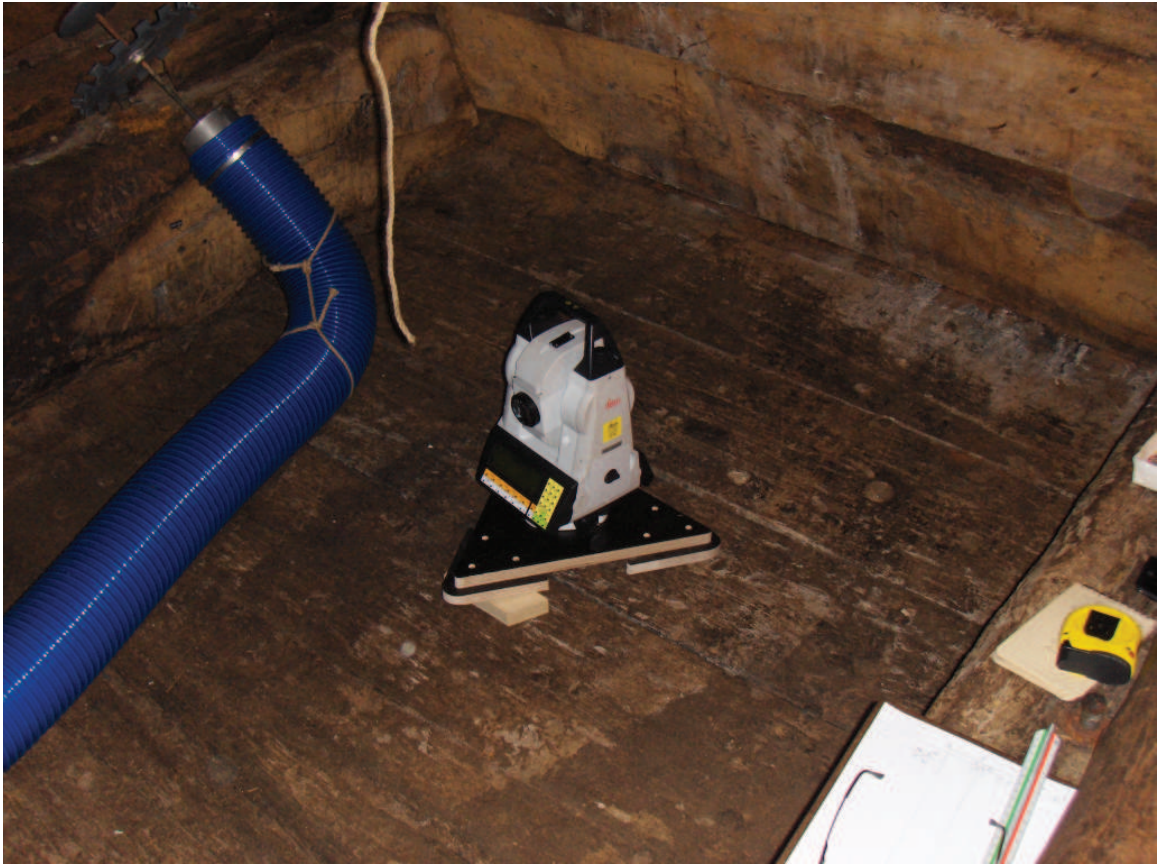
**Figure 3-4: The total station, set up on its plate base in the ship's hold.
The blue tubing is part of the museum's air handling system.**

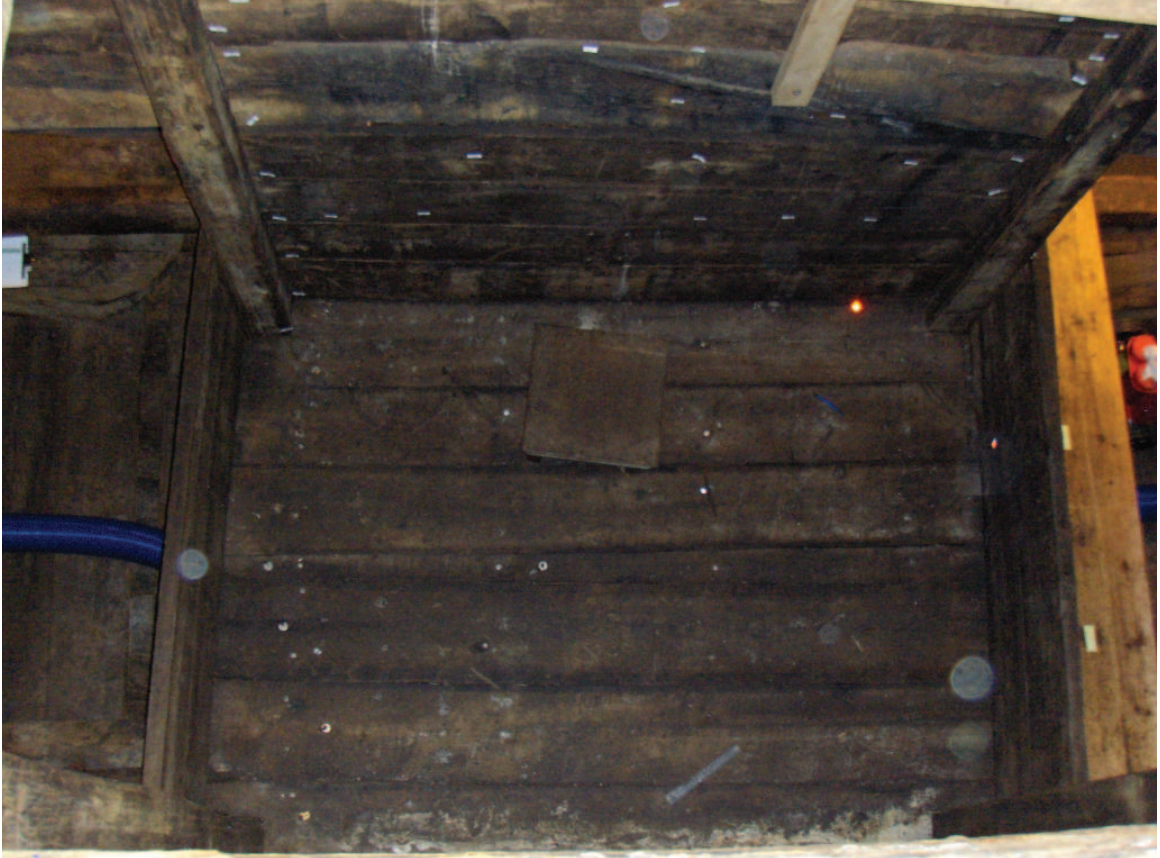
**Figure 4-1. The galley's firebox, seen from above.
This photograph is taken from aft, looking forward.**

The galley is a rectangular structure, extending the entire vertical distance of the hold and orlop decks. The main portion of the structure is at the hold level, while the portion of the galley on the orlop is primarily a large smoke bay, which funneled smoke from the fires up through the large hatch and into the gundecks where it could escape through the gunports or continue up to the weather deck. The main structure, the firebox, was filled with bricks, and is shown in Figure 4-1.

port and starboard are significantly shorter than the forward and aft walls (as seen in Figure 4-1). The port and starboard walls consist of three planks each, and are approximately 67 cm high.

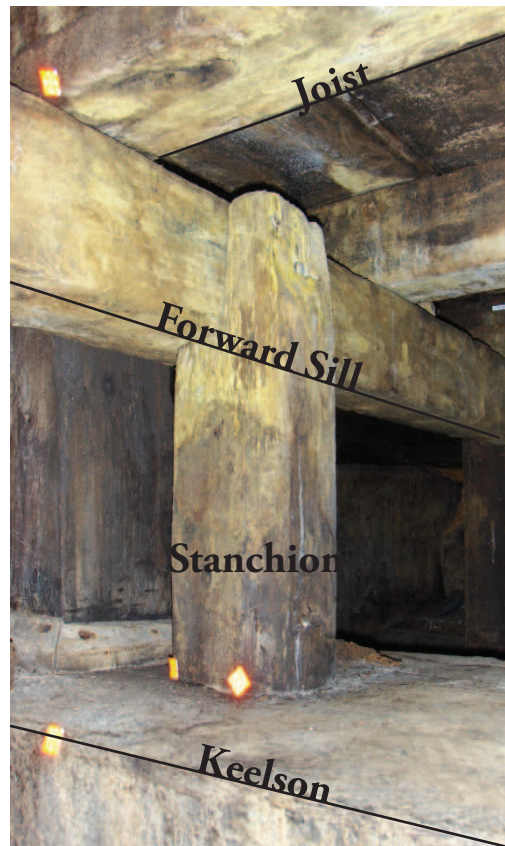
Figure 4-2. The small stanchion atop the keelson, just behind a sill.

Notched into the forward stanchions, 45 cm above the ceiling, there is a sill running athwartships. This timber has a length of 2.9 m, and is 14x15 cm on the ends. It is notched 5.5 cm into the stanchions, and is fastened with a single bolt. Amidships, it is supported by a small stanchion that sits on the keelson (figure 4-2). This stanchion is 14x15 cm, just as the sill is, and runs from the keelson to the top of the beam, a distance of 47 cm. The sill is notched and fastened into the small stanchion, which sits aft of the sill. Thus, the sill's

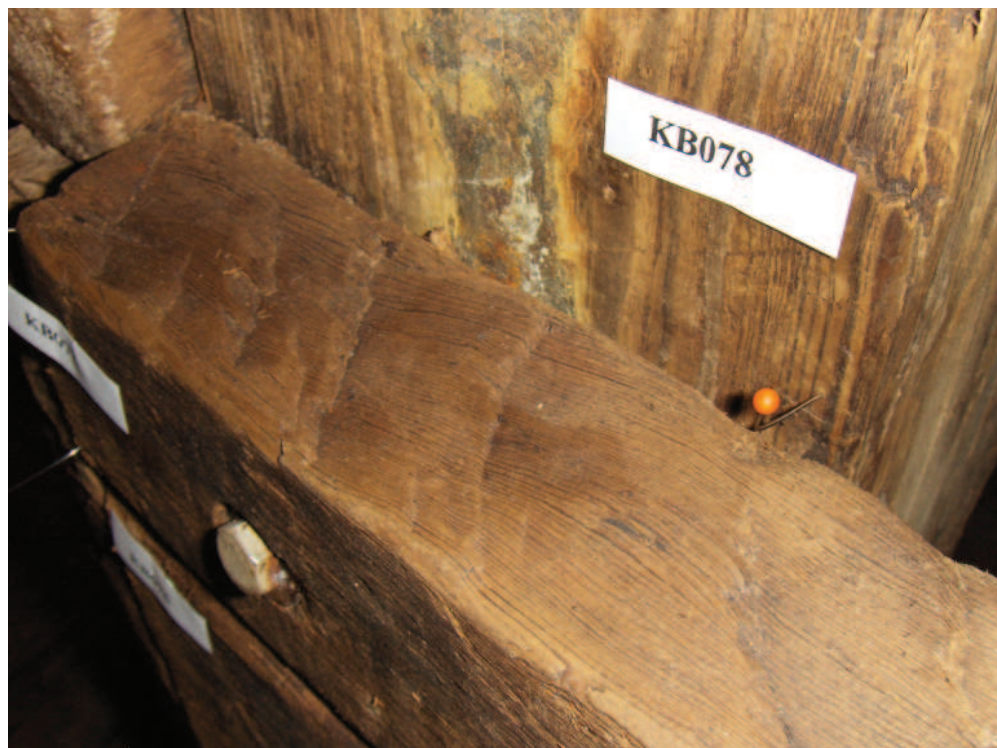
Figure 4-4: Tool marks on the forward port galley wall.

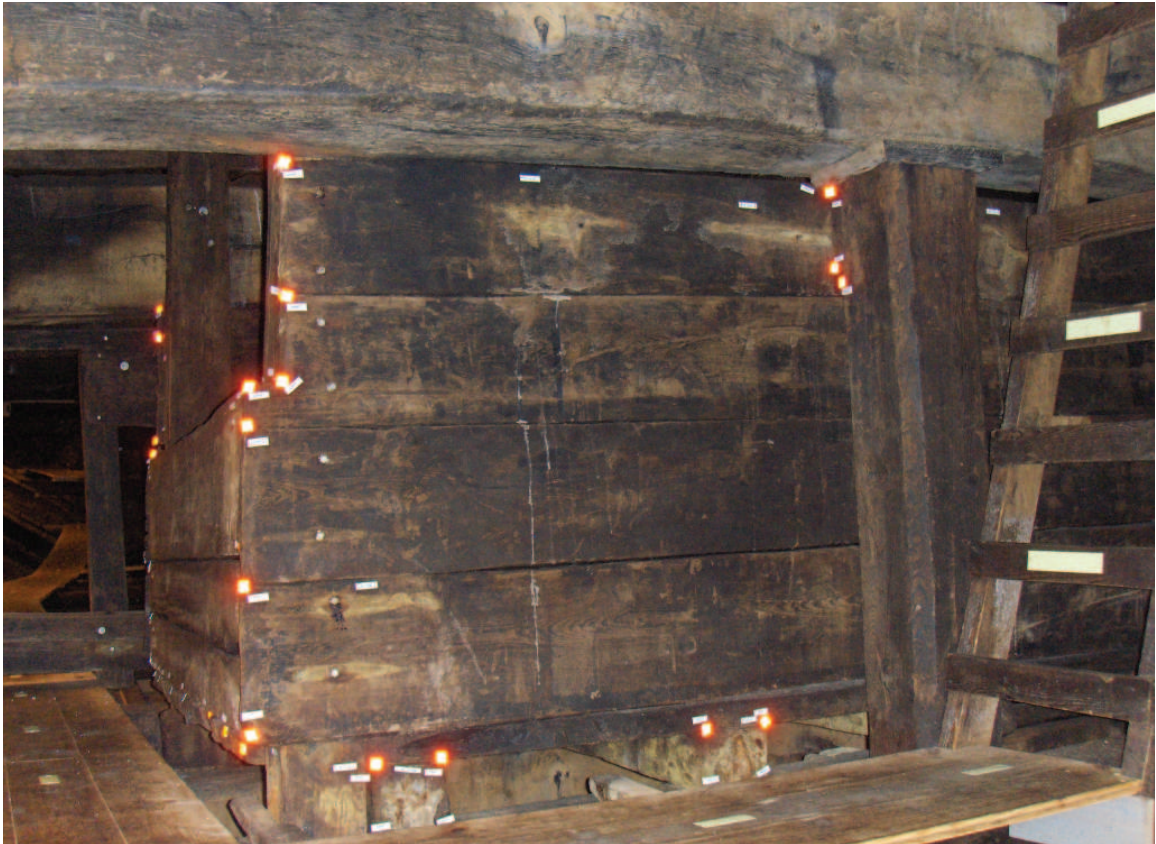
Figure 4-5: The jog in the starboard side of the forward wall. It is outlined by the bright reflective tape along the forward edge. The shorter side wall of the galley can be seen in the left side of the photograph.

Six centimeters of this 12 cm difference are accounted for by a jog cut out of the wall on the starboard side. To starboard the walls follow the profile of the stanchion with attached side-wall. Thus, there is a jog in the forward wall at the top of the side-wall (figure 4-5). To

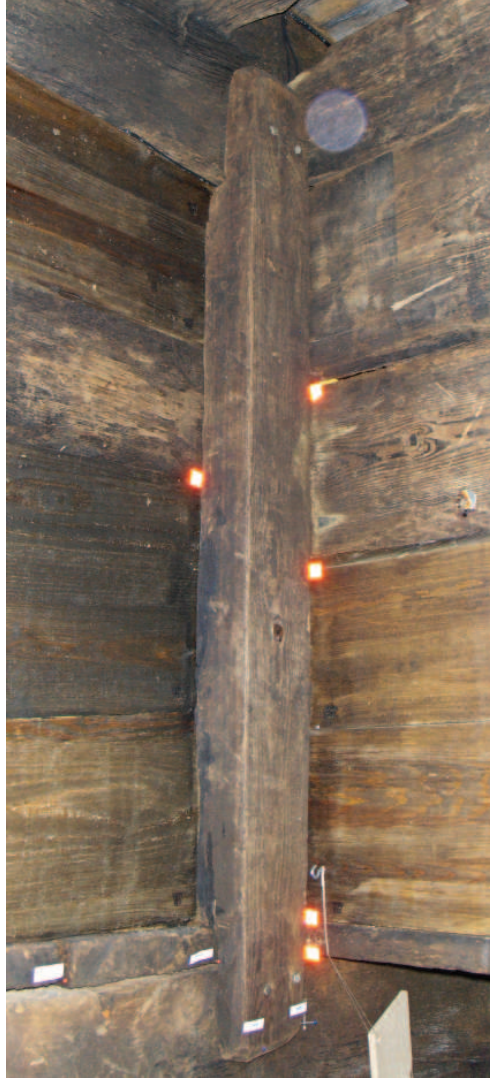
Figure 4-10: The forward starboard smoke bay stanchion.

Essentially, the smoke bay resembles the main galley structure in that it is primarily built around four stanchions. The stanchions are 14 cm wide and roughly 11 cm thick. They are attached to the orlop deck beams, and are notched so that a portion sits on the orlop deck itself. At the top of the stanchion, a similar notch is employed so that they can be fastened to

the lower gundeck beam (Figure 4-10).

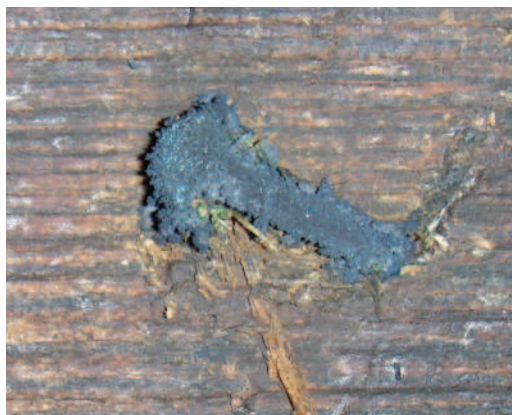
Figure 4-11: A copper tack, found *in situ* during the 2008 survey.

During the survey, thirteen previously undiscovered copper tacks were found driven into the galley walls. Seven tacks were found in the aft wall: five in the forward wall, and one in the starboard wall. These small tacks had been flattened against the wood, and are deformed (figure 4-11). Their length is less than the plank thickness, as they do not protrude from the other side. Their heads are 5 mm in diameter. Several tacks are flush with the galley walls, while several others are bent over. There is no evidence of any material caught under the tacks. Those in the fore and aft walls are all approximately 60 cm above the galley floor and are remarkably evenly spaced.

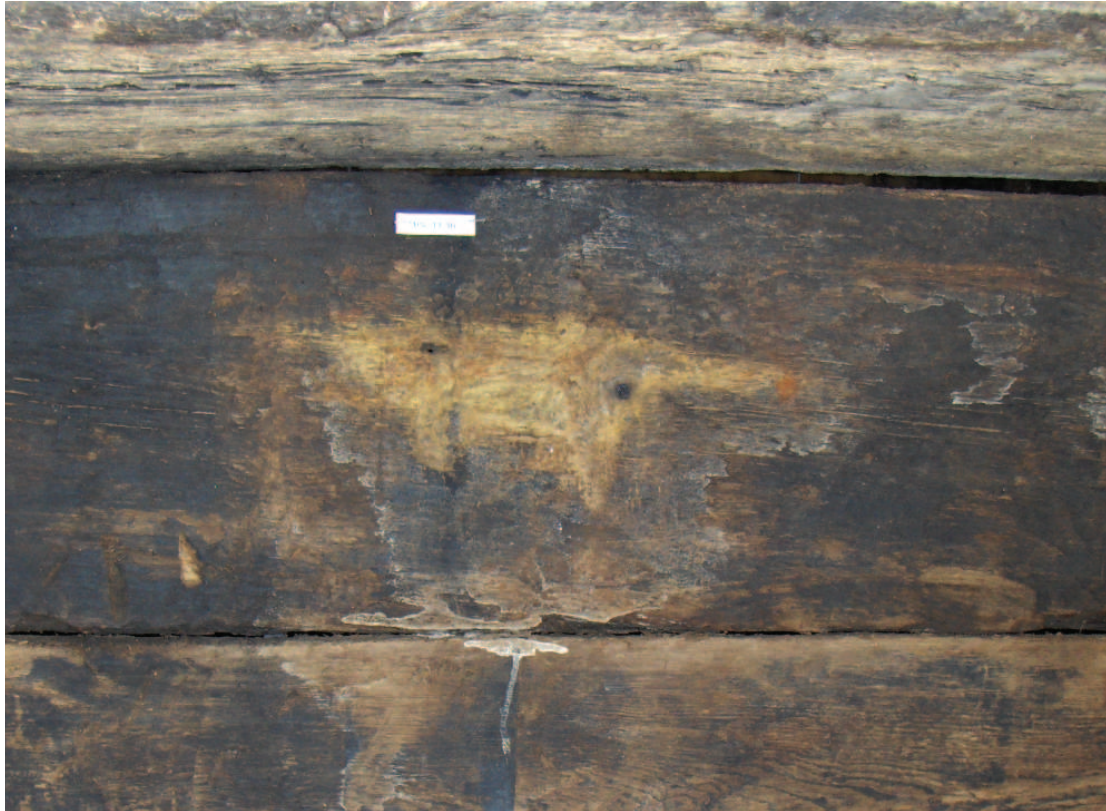
**Figure 4-13: Stains left in the wood from iron corrosion products.
Such stains leave evidence of fasteners and artifacts.**

Many of the holes are evident even without close examination or a search for an actual fastener hole. Most exhibit a yellow stain on the surrounding wood caused by iron salts deposited as the iron fasteners corroded while the wreck was under water. While the fasteners themselves are gone, their evidence remains in the wood (Figure 4-13).

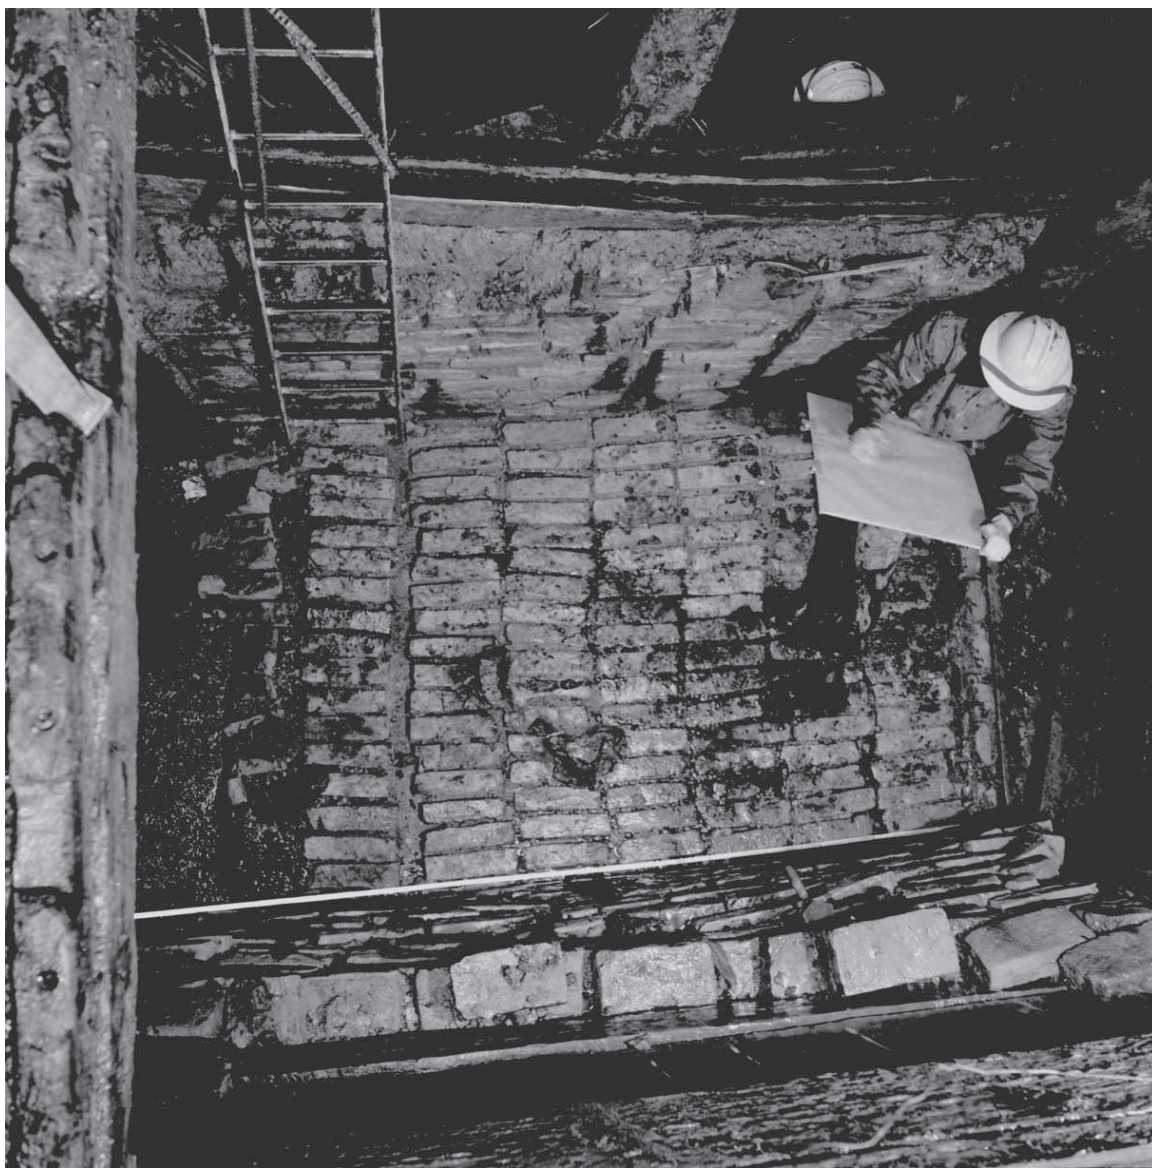
Figure 5-1: This photo, taken during the excavation, shows the galley fire box. The empty hole where the forward smoke bay should be is visible at the top of the photo. Photograph courtesy SMM.

Many of the excavation photographs are of limited utility as far as the wooden construction is concerned. The wood is mostly covered by mud, water, or brick, with little structure visible. Likely, this contributed to the excellent preservation of the softwood galley walls. Since the photos are mostly concentrated on the lower (brick-lined) portion, it is hard to see details of the smoke bay. One picture (Figure 5-1) shows that the forward smoke bay wall above the bricks was missing at the time of the photo.

From the photograph and the drawing (Figures 5-1 and 5-2), it is apparent that the galley's wooden structure was in very good shape when it was excavated. Though some pieces had fallen, the wood was mostly intact and in place. Because the wooden structure was *in situ* when the ship was recovered, there has been little restoration or recreation, aside from prop-

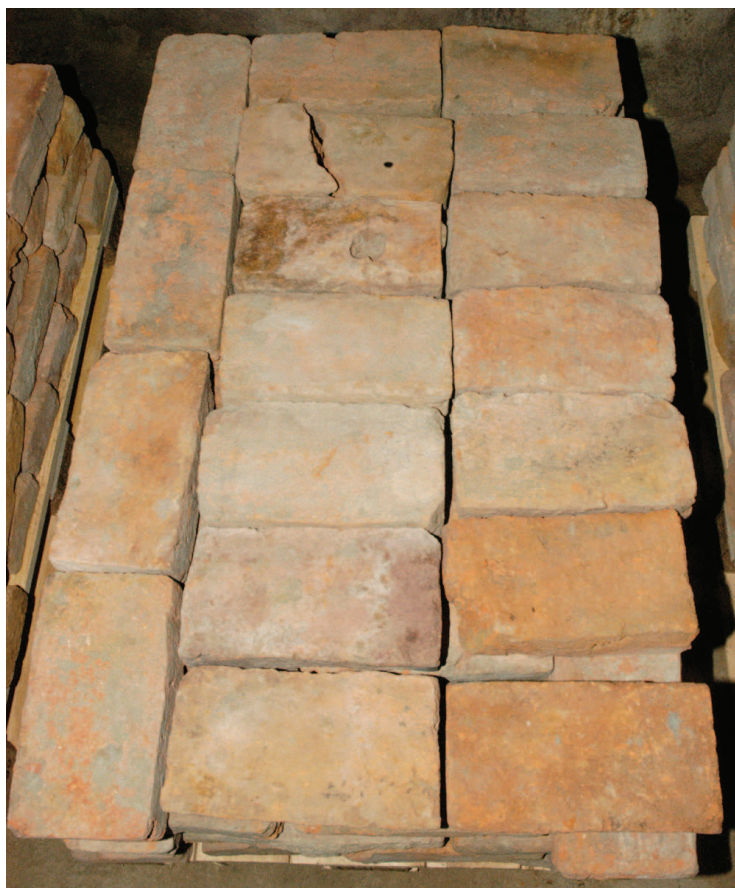
Figure 5-3. This pallet of bricks (find 27621) is one of the galley brick collections. (SMM).

There are approximately 750 bricks in the *Vasa* Museum's collection. When found, the port side of the galley floor was smashed, and these fragments make an exact brick count difficult. The bricks are stored stacked on pallets in the museum's collection storage facility (Figure 5-3).

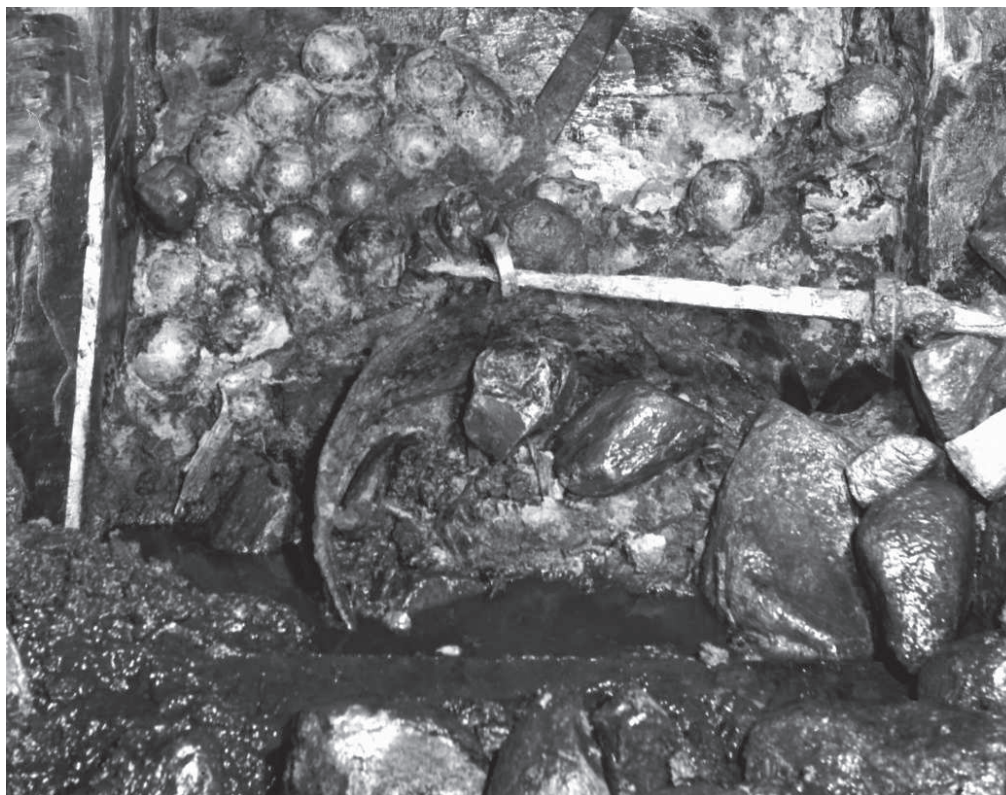
Figure 5-8: *Vasa* photo 0661-2. Cauldron *in situ*, with hooks and bar. (SMM)

Photographs taken of the cauldron *in situ* (Figures 5-8 and 5-9) show one of the

iron bars and two hooks. The photo shows a long bar threaded through a handle attached to the cauldron, and some sort of fitting further down the bar. This may be another cauldron handle, or it may be some other sort of fitting. Unfortunately, none of the hooks or bars have survived. A search of the artifact magazine during the 2008 survey did not locate any iron hardware or fittings associated with the cauldron.

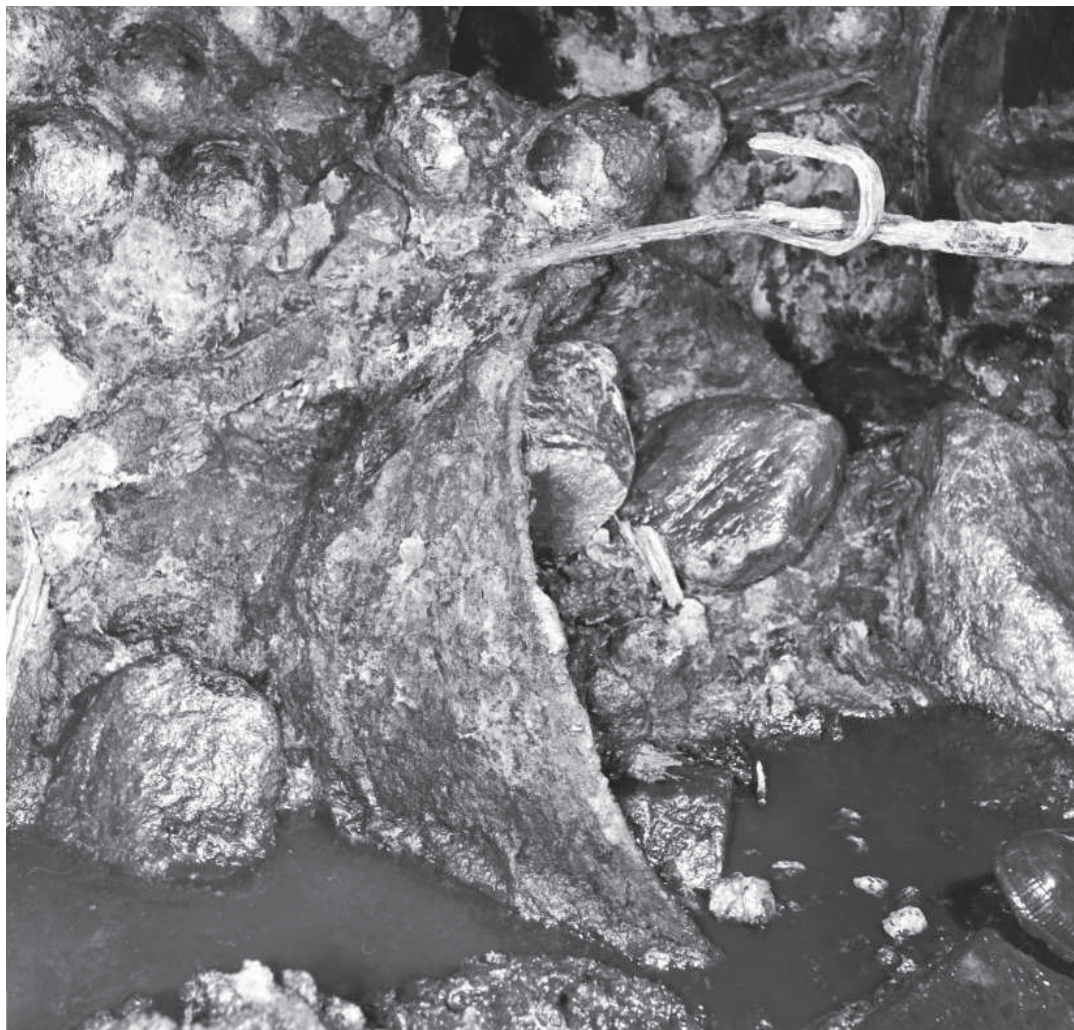
Figure 5-9: *Vasa* photo 661-5. Cauldron with iron hangers. (SMM)

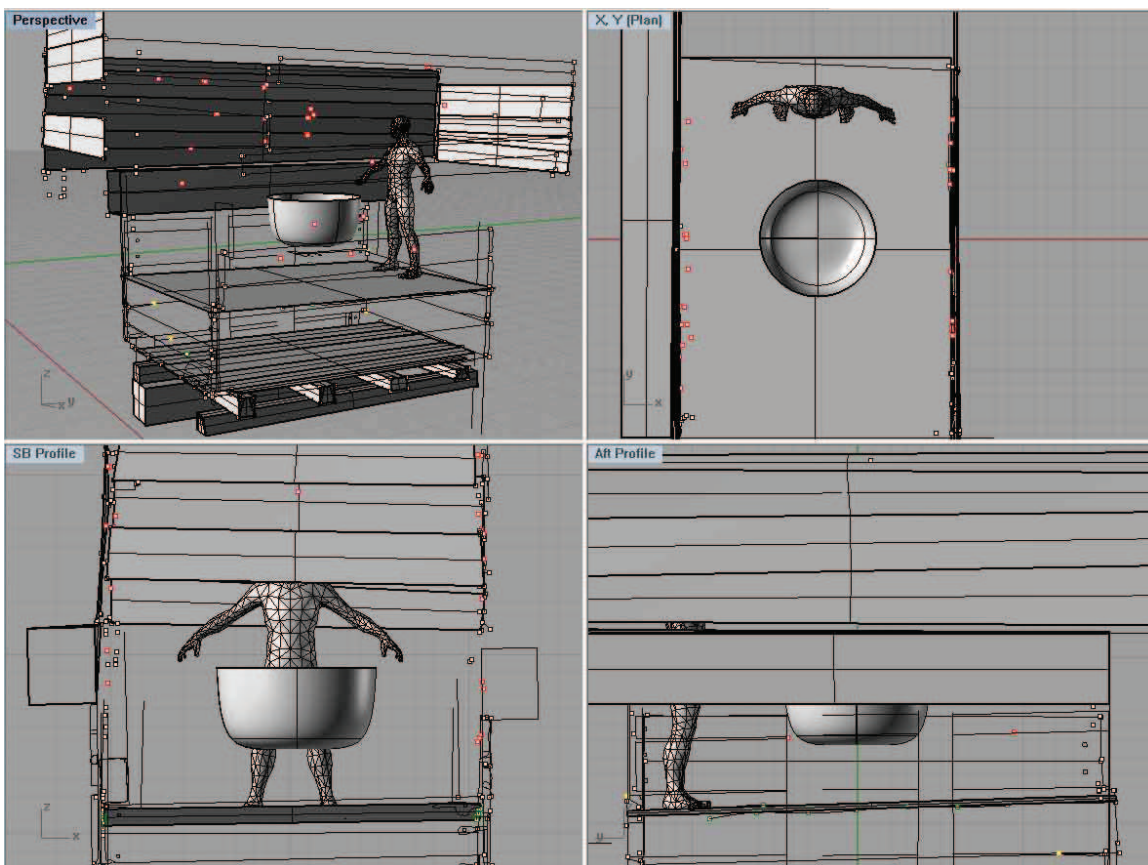
Figure 5-15. This screenshot from Rhinoceros shows the galley model in progress. As can be seen, the digital cook stands at a representation of *Vasa's* iron cauldron.

The location of the cauldron fasteners depends on the location of the cauldron. For it to be used effectively, its mouth would need to be about waist-high for someone standing on the galley floor. To solve this puzzle, the "digital cook" was created. This 3D human model was sized to fit the average *Vasa* sailor – about 5'4" (1.6 m) (Fred Hocker 2008 pers. comm.). The digital cook, placed into the model, provided an instant sense of scale for the model (Figure 5-15).
