David V. Beard. H.M.S. *DEBRAAK*: A TREASURE DEBUNKED, A TREASURE REVEALED. (Under the direction of Dr. William N. Still, Jr.) Department of History, July 1989.

The purpose of this study is to document the history, salvage and architecture of the brig-of-war H.M.S. *DeBraak*. Since the day that she sank in a sudden squall off the coast of Delaware on May 25, 1798 a legend of an immense treasure filling her holds has been widely circulated. As could have been expected, such a legend would attract those who would have this treasure for their own. Between 1984 and 1986 a Reno, Nevada-based commercial salvage firm, Sub-Sal, Inc., excavated the vessel's wreck site. These operations climaxed on August 11, 1986 with the raising of *DeBraak's* articulated hull remains, and the subsequent clamshelling of the site to recover artifacts.

H.M.S. *DEBRAAK*: A TREASURE DEBUNKED,
A TREASURE REVEALED

A thesis
Presented to
the Faculty of the Department of History
East Carolina University

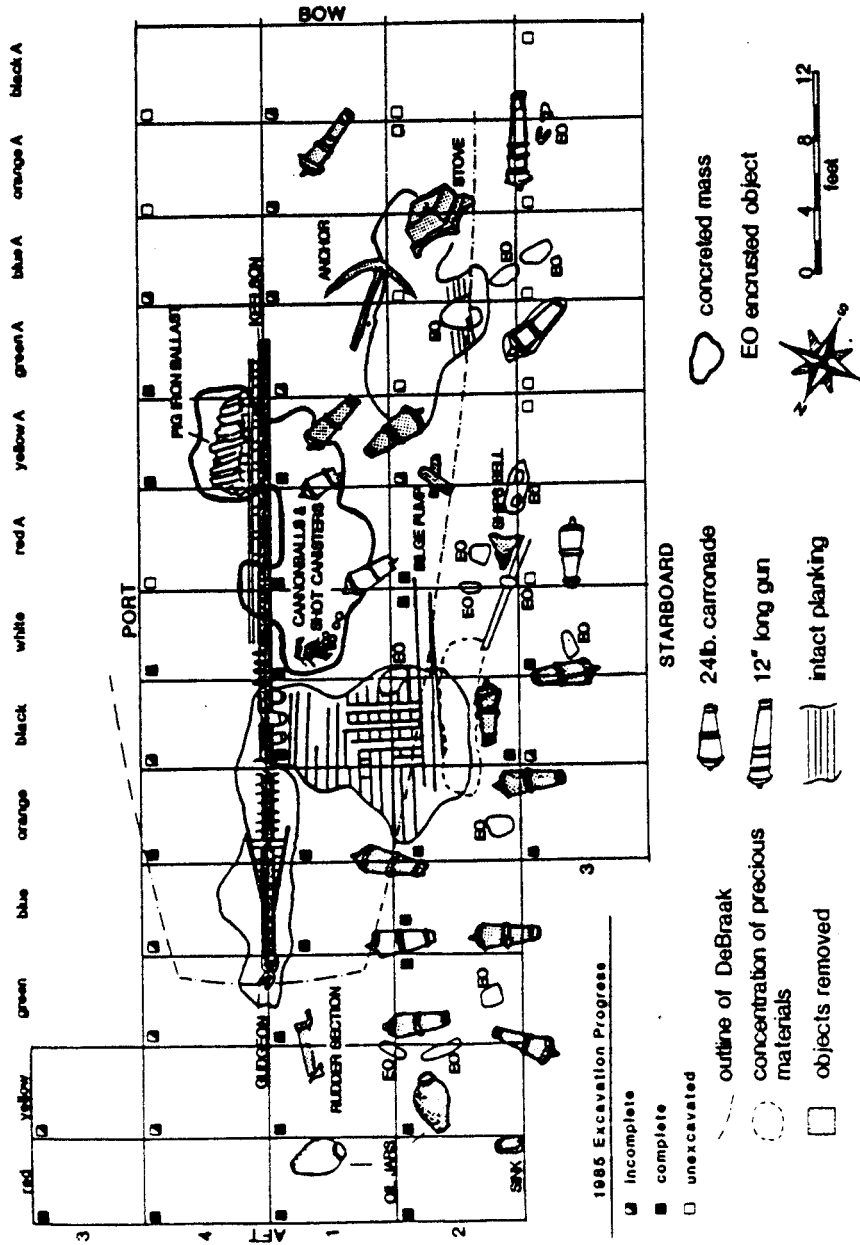
FIGURE 5

DeBraak Site Map of 1985 Season Updated and Redrawn from 1984 Base Map

The grid system used in 1985 was also upgraded over the previous year's grid. Using *DeBraak's* keelson as the baseline, a system of interlocking 6-by-4-foot grid units was laid out over portions of the site which were being excavated. Once a unit was completed the grids could be moved to another part of the site. The grid units were given a trinomial identification code

using a color, number and letter (i.e. Red 1A) (Fig. 5). This grid allowed for horizontal control of artifact recovery, but not vertical provenience.⁹

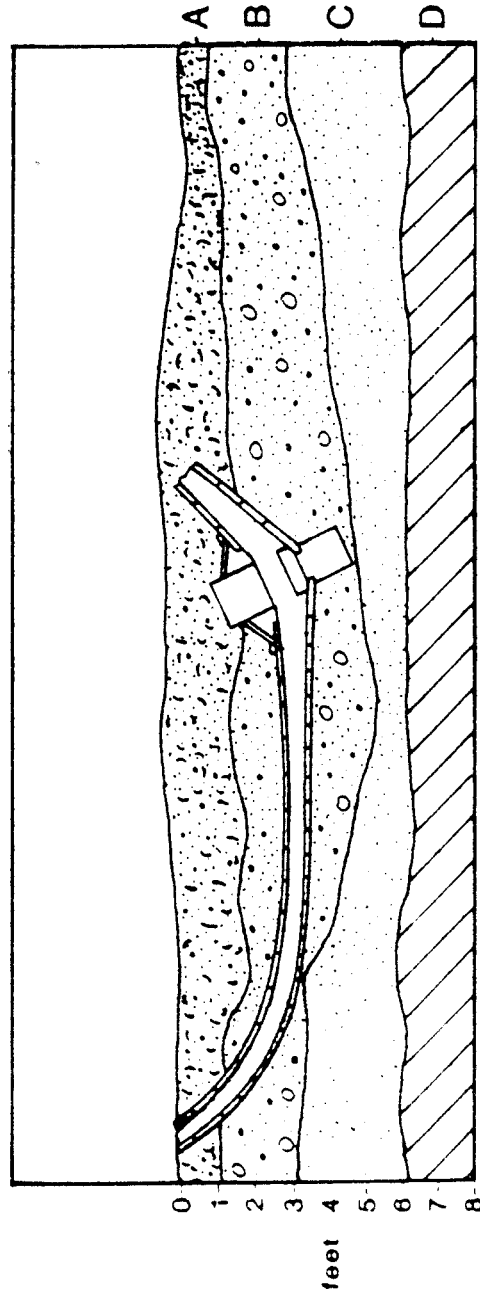
FIGURE 7

Schematic Cross Section of Wreck Site Indicating Relationship of Wreck Remains With Bottom Sediment Layers

- A "Muck" Layer- highly organic, grey sandy silt with concentrations of mussel shell and small gravels.
Interior of wreck- majority of sediment composed of hull fill.
Exterior of wreck- sediments contain scattered artifacts.
- B "Gravel" Layer- grey sand with larger cobbles.
Interior of wreck- lesser amount of hull fill as A layer.
Exterior of wreck- lesser amount of scattered artifacts than A layer.
- C "Sand" Layer- yellow coarse sand.
Exterior of wreck- few scattered artifacts.
- D "Clay" Layer- compact yellow sandy clay.
No artifacts in this layer.

The vertical stratigraphy of the site was difficult to describe accurately, as there was no attempt on the part of the salvors to excavate the site according to any natural or arbitrary level system. In addition, the complexity of a submerged alluvial environment and the effect that the wreck had on the deposition of bottom sediments, produced an often bewildering variability in the quantity of and relationship between sedimentary layers. The following discussion of site stratigraphy, and the schematic site profile (Fig. 7) are conjectural and based on highly qualitative diver observation.

The sea floor matrix in which the remains of *DeBraak* were buried consists of an upper layer of highly organic dark grey sandy silt mixed with variable concentrations of mussel shell and small gravels (Level A). Below this "muck" layer, as the salvage divers called it, lies a level of greyish sandy clay containing larger cobbles (Level B). Although the deposition history of these upper two layers is unclear, they appear to be of relatively recent deposition, as they appear to have been deposited over the wreck remains. It is the finer silty fractions of these levels that appear to have filled the interior spaces of the ship's hull, resulting in the mucky "soft spots" that were found to contain the best preserved organic remains. The next layer is a thick one of yellow sand, and it is on this (Level C) that the wreck appears to have initially come to rest. Finally, there is a layer of compact yellow sandy clay (Level D), probably of early Holocene age, into which no artifacts seem to have intruded (Fig. 7).²

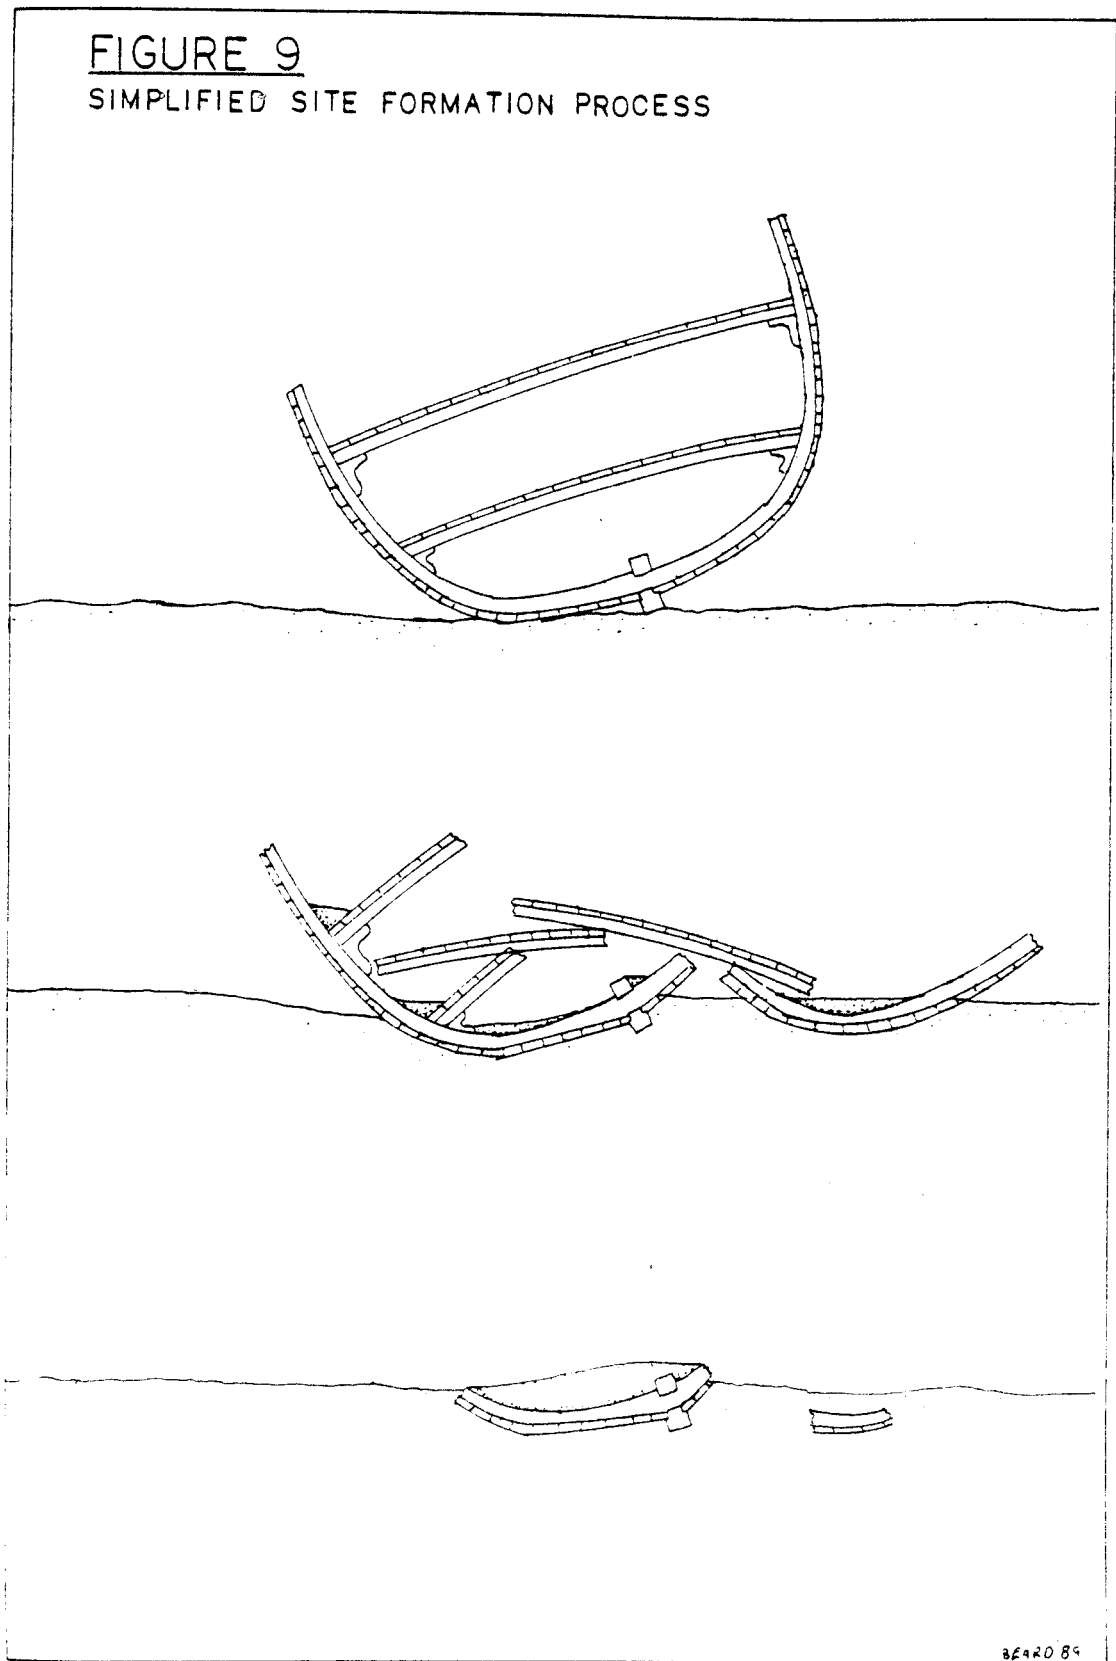
FIGURE 9
SIMPLIFIED SITE FORMATION PROCESS

Due to the incomplete understanding of the wreck site, it is unclear if this disintegration resulted solely from a gradual decomposition, or a more violent disturbance from subsequent net, anchor or dredge impact. If the existing wreck was the result of a gradual disintegration process, and the data from the site would seem to bear this out, the rate and sequence of the structural collapse may have approximated the model illustrated in Figure 9.⁴ Further filling with sediments would then occur as scouring around the wreck caused it to settle into the seabed, eventually coming to rest on the hard sandy clay of the natural substratum.

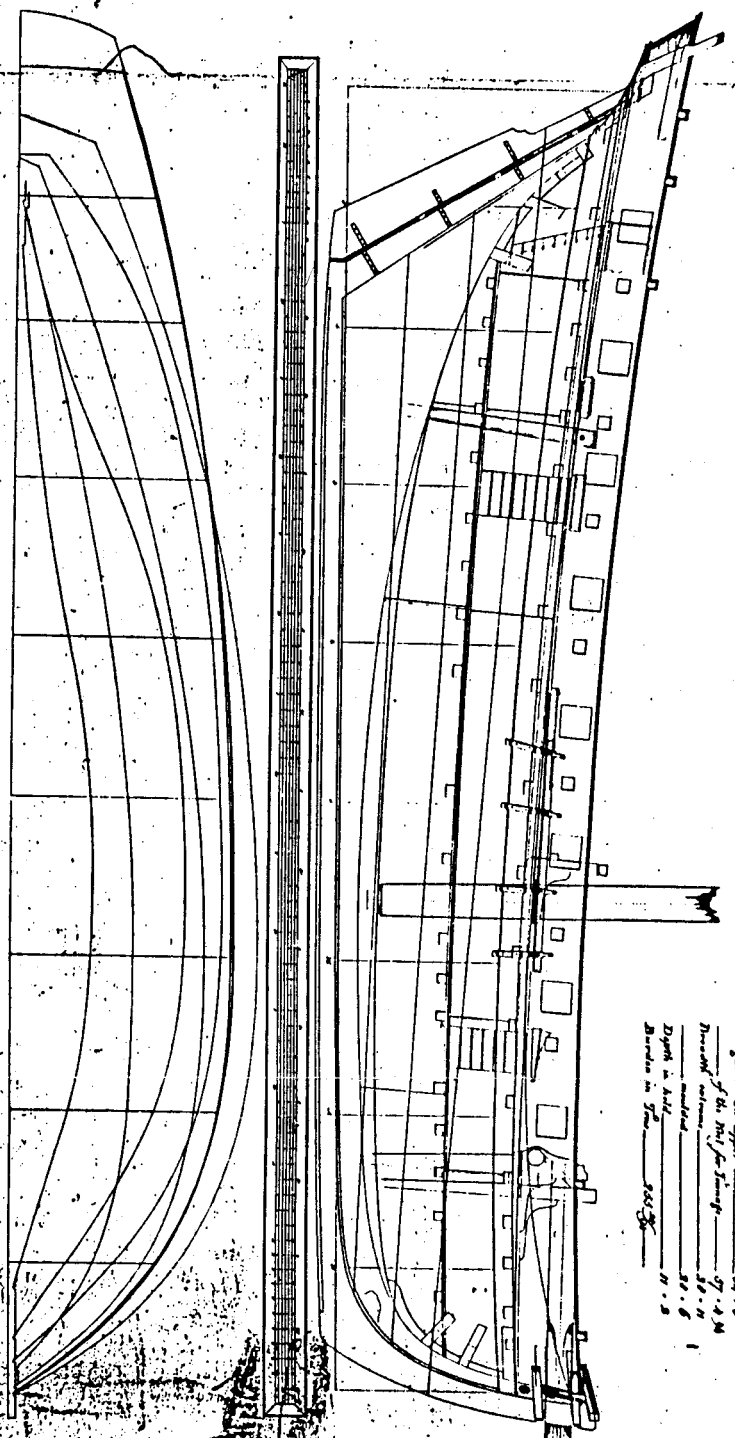
FIGURE II

DE BRASCO - also known as
Length - 46 ft. 0 in.
Breadth - 10 ft. 0 in.
Depth - 4 ft. 0 in.
Displacement - 1000 lbs.

Before *DeBraak* was taken into dry dock for refitting, she presumably was stripped of all of her guns, stores and furnishings. Most of her rigging, including her mast, were also removed. Once the ship was in dry dock, John Marshall, Surveyor of the Navy, drew up a set of plans labeled "as when taken" showing her hull and decks (Fig. 11). Using these plans as a base,

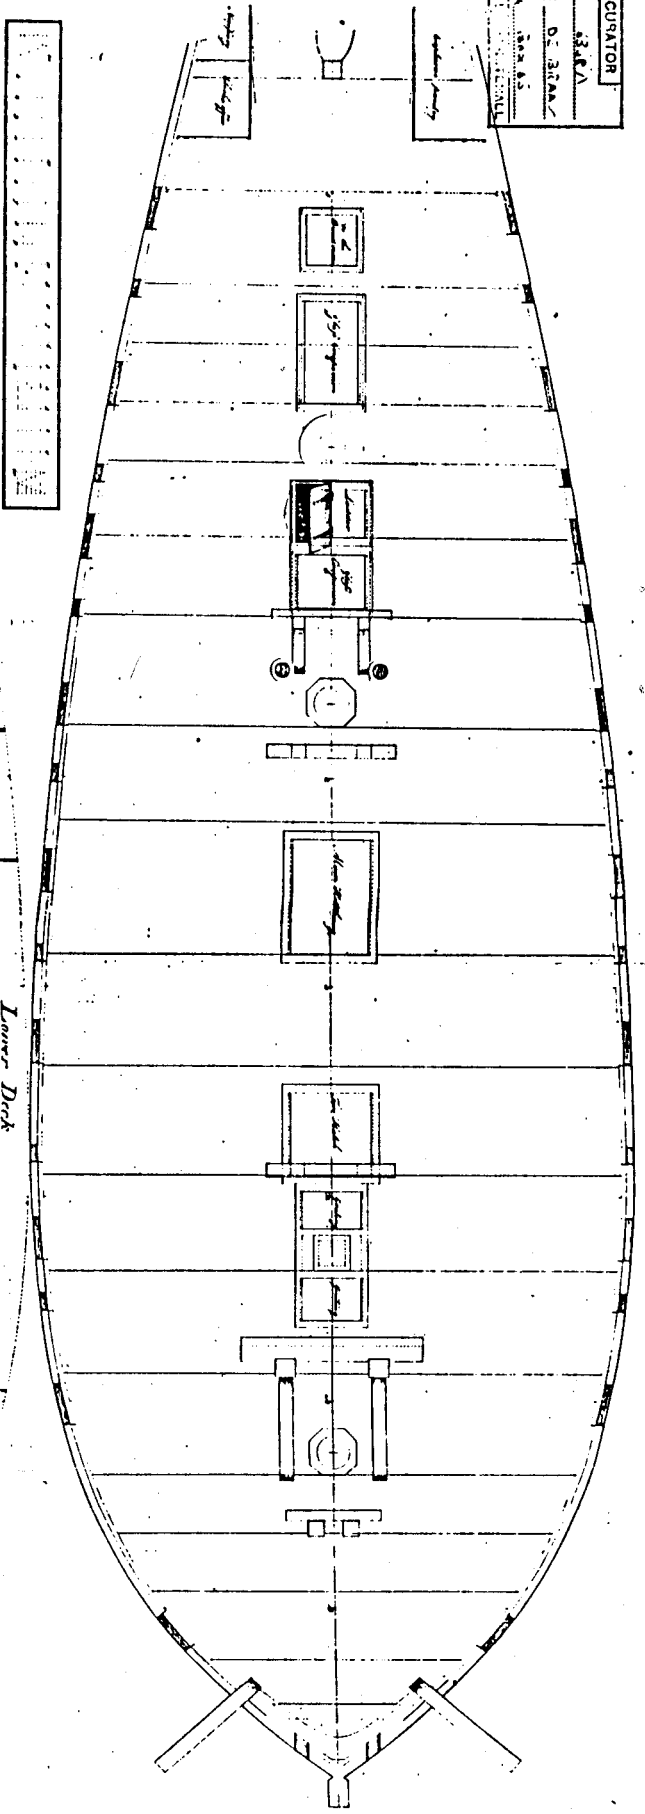
FIGURE 13

PLANS OF DE BRAN at Fitch

Upper Deck

Lower Deck

Marshal then drew the needed alterations for the ship's conversion into a Royal Navy brig and produced a set of "as fitted" drawings (Figs. 12 & 13). Figure 14 shows the "as built" plans of H.M.S. *Raven*, an eighteen-gun brig of 1797, which gives the reader a good idea of what the shipwrights were trying to accomplish in their conversion of *DeBraak*.⁸

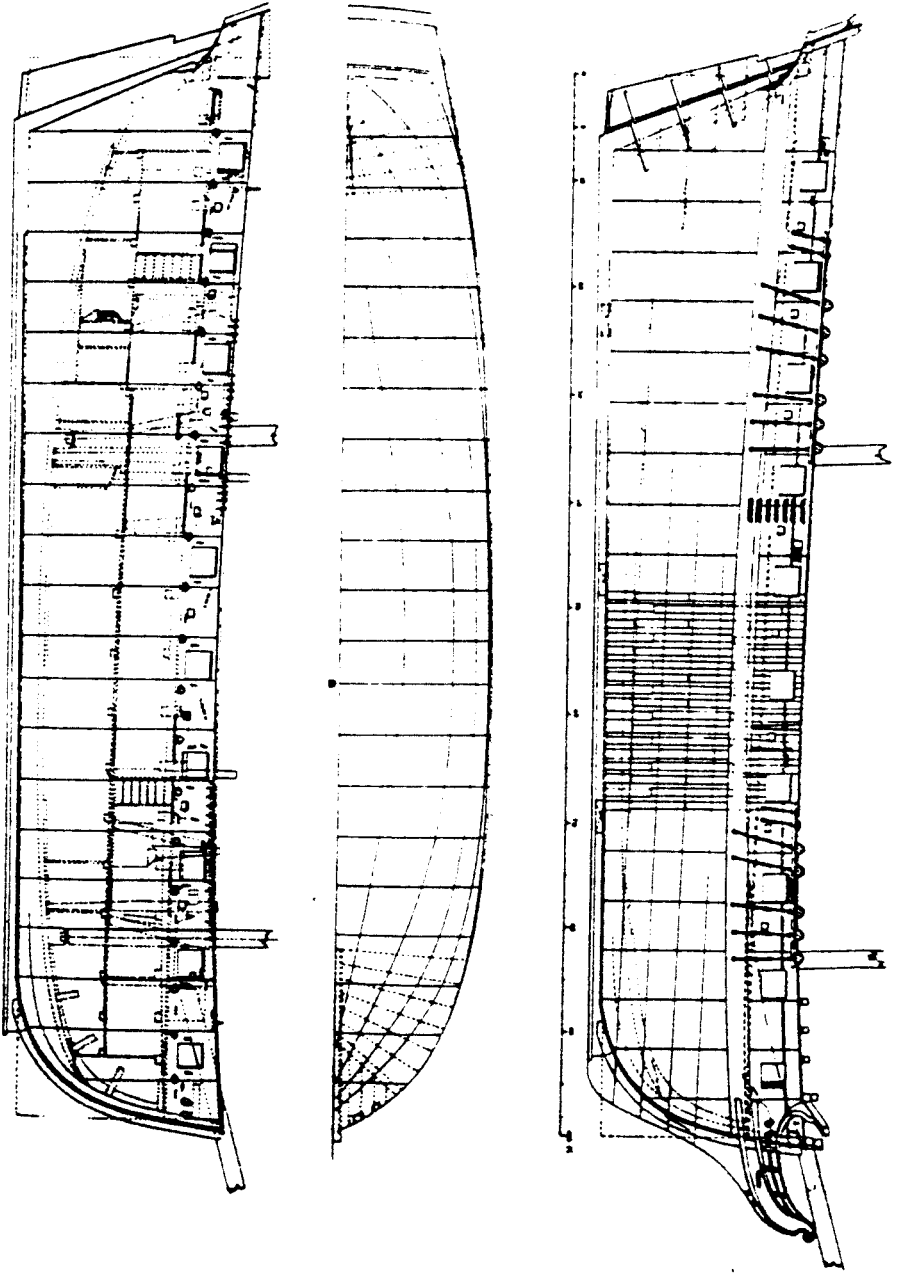
FIGURE 1A

HMS RAVEN, 1797

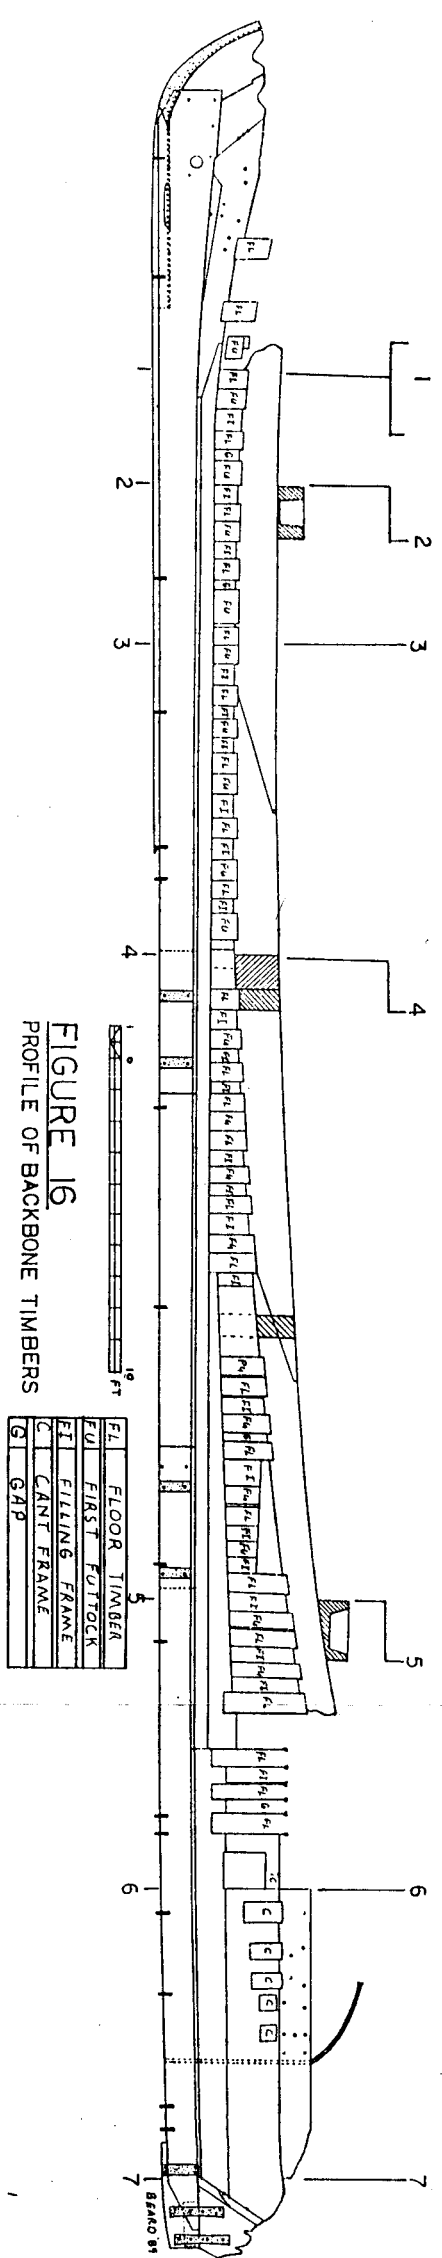
FIGURE 16
PROFILE OF BACKBONE TIMBERS

FL	FLOOR TIMBER
FJ	FIRST JOIST
FJ	FILLING FRAME
C	CANT FRAME
G	GAP

DeBraak's keel is constructed of three baulks (sections) of elm with a total length of 68 feet, 9 inches (Fig. 16). It was considered standard that a ship of *DeBraak's* size should have a keel made up of four baulks.¹⁰ The forwardmost baulk of the keel is 31 feet, 8-1/2 inches long, including the scarph. Both the sided and molded dimensions of this timber vary over its length. At its forward most end this baulk is sided 10 inches and molded 24-1/2 inches.¹¹ At its after end (including the scarph) it is sided 12 inches and molded 13-1/2 inches including the rabbet.

Although most of the false keel was torn loose from the keel and lost when the hull was raised, data indicates that it consisted of three sections, probably scarphed, attached to the keel with large copper staples (Fig. 16). These staples were generally 5-1/2 inches long, 3/4 inch wide, 1/8 inch

As has been previously mentioned, the square frames of *DeBraak* cross the keel or butt together on its center line. The cant frames, however, are fayed into the sides of the apron (forward) and the deadwoods (aft). The cant frames in the stern are trunneled to the deadwoods and the hull planking while, those in the bow are fastened only to the hull planking (Figs. 16 & 21).

DeBraak's keelson, like her keel, is made up of three baulks (Fig. 16). These baulks are locked together at two horizontal flat scarph joints, which give shift to the scarphs of the keel. "Giving shift" means staggering joints, much like the bricks of a wall, to increase the strength of the structure.²² The keelson scarphs are 3 feet, 7 inches long with ends nibbed 1-1/2 inches. These scarphs are somewhat shorter than Admiralty specifications (Fig. 28 a & b).²³ This may be a result of an individual shipwright's personal preference, or the keelson may have been replaced during a refit by the French or Dutch.

keelson's molded dimension decreases to the point where it scarphs into the bow and stern deadwoods. Data recovered from the hull seems to bear this out (Figs. 12 & 16).

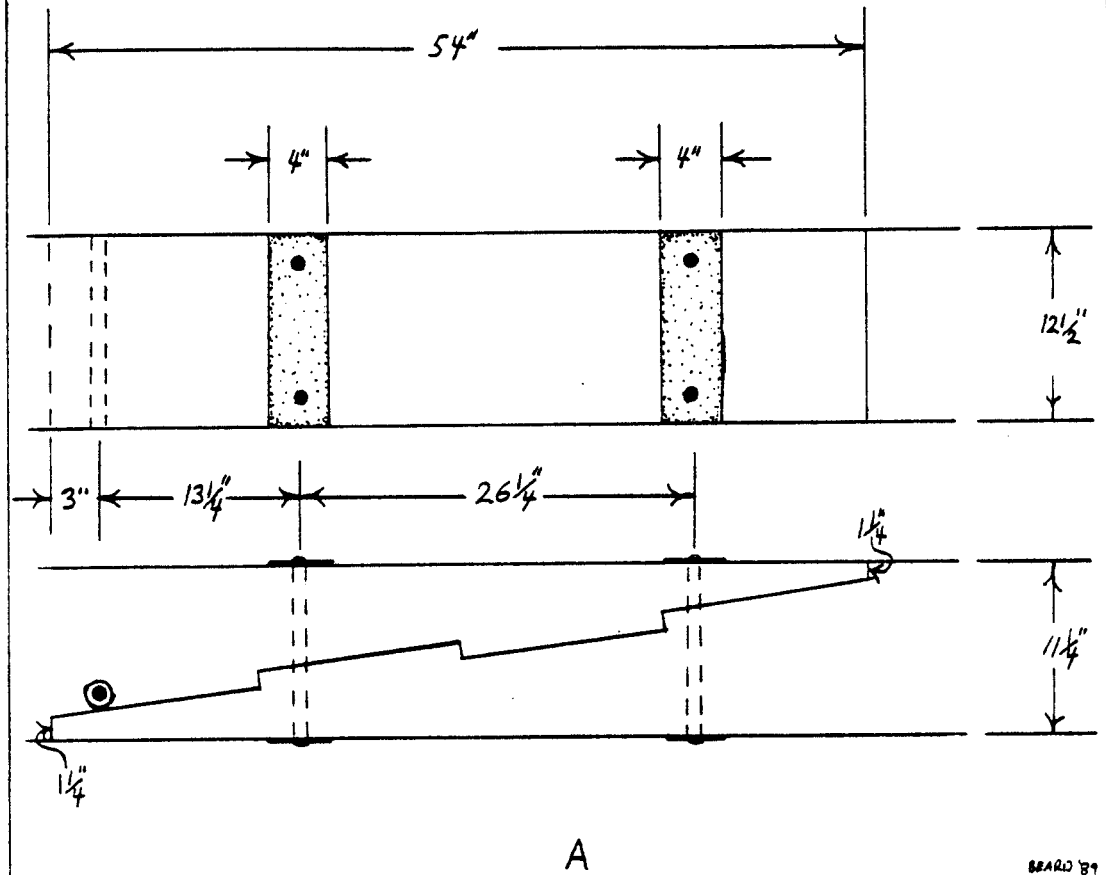
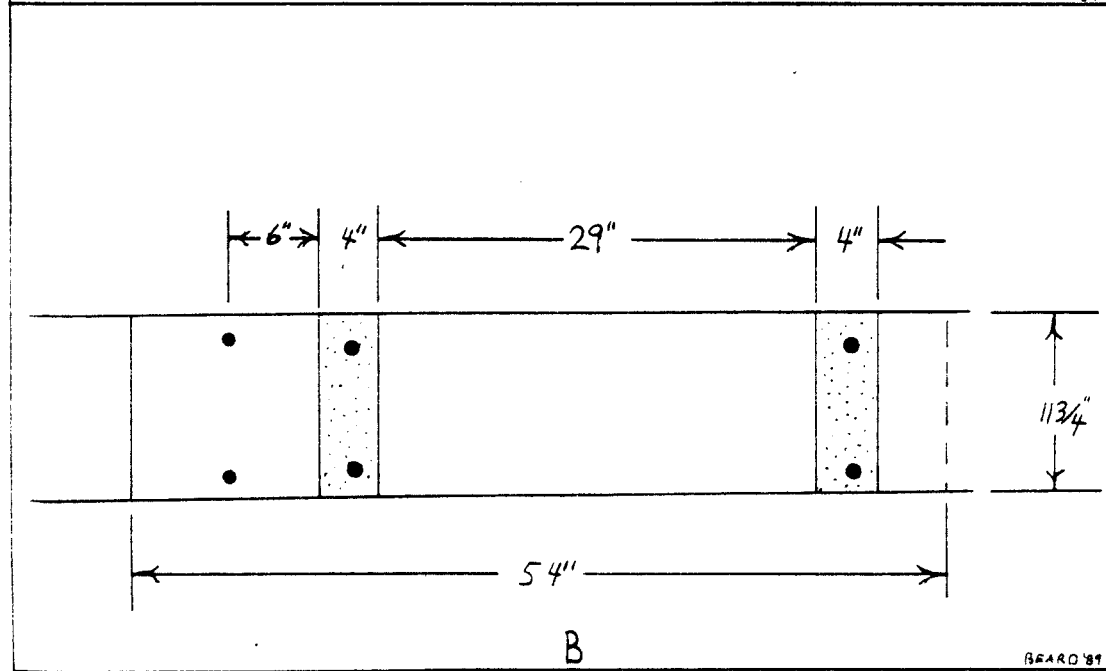
FIGURE 17: KEEL SCARPHS

The keel baulks are fastened together at two vertical scarph joints, each 4 feet, 6 inches long and having ends nibbed 1-1/4 inches. This dimension

corresponds exactly with the British Admiralty specifications for keel scarph joints.¹² These are a variation of hook-scarphing, with each face having four distinct plane surfaces, each approximately 13-1/2 inches long. Each scarph is held together by six 1-7/8 inches copper bolts, four of which pass through copper "fish plates" which are 4 inches wide and 3/8 inch thick, and whose lengths depend upon the dimension of the keel from base to garboard strake (Figs. 16 & 17).

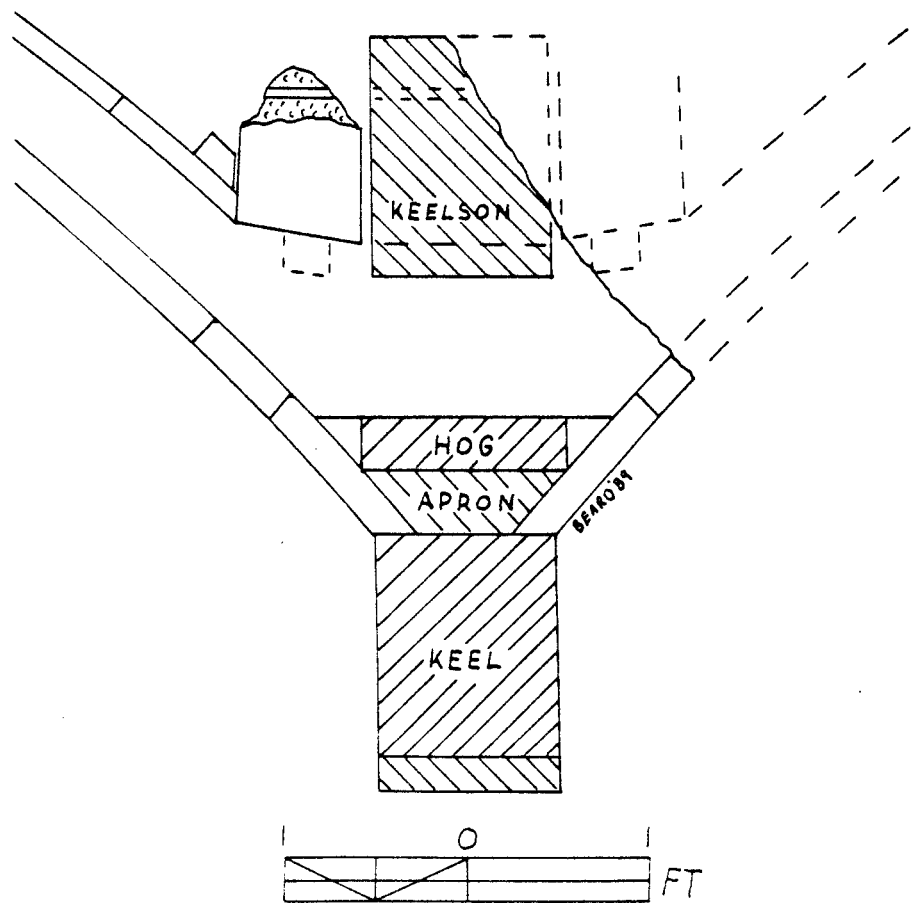
FIGURE 20

SECTION I ON BACKBONE TIMBER PROFILE

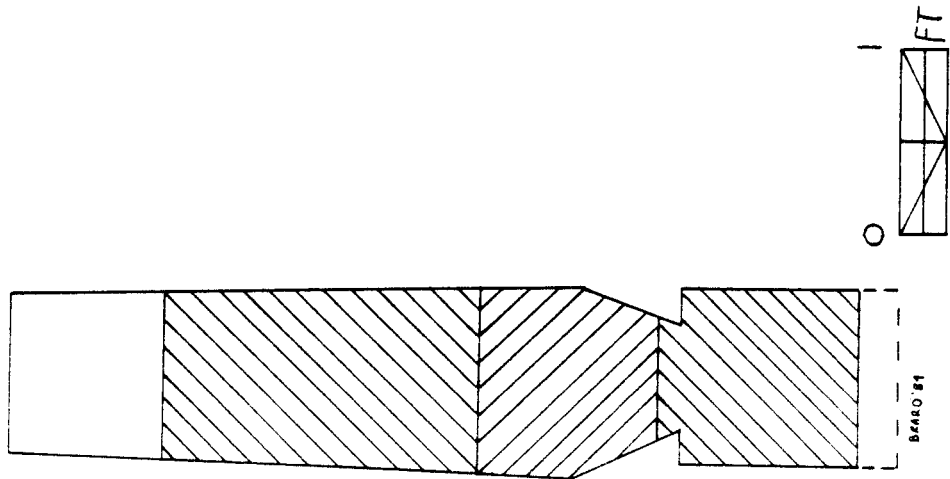
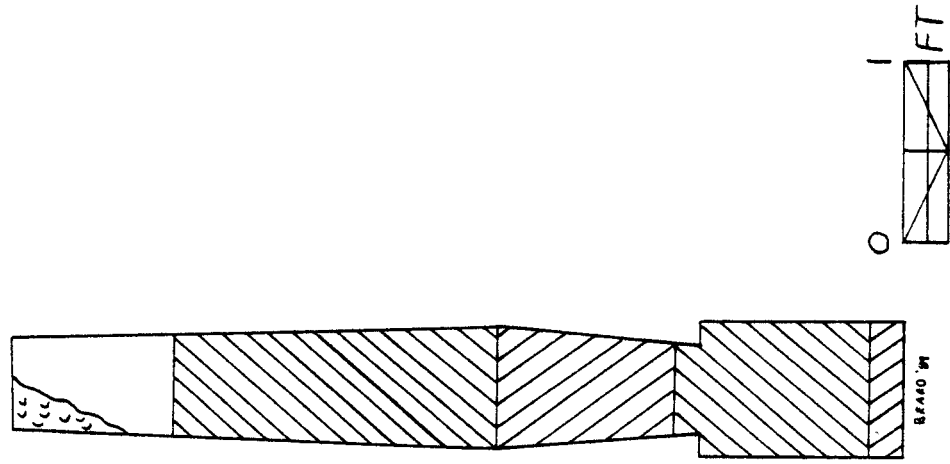
FIGURE 22

A. SECTION 6 ON BACKBONE TIMBER PROFILE

B. SECTION 7 ON BACKBONE TIMBER PROFILE

All of the deadwoods taper to reduced dimensions from fore to aft and from the keel up (Figs. 22). The Admiralty drafts and an extant drift pin through the deadwoods suggest that there were originally two or three more of these timbers, which have not survived (Fig. 21).

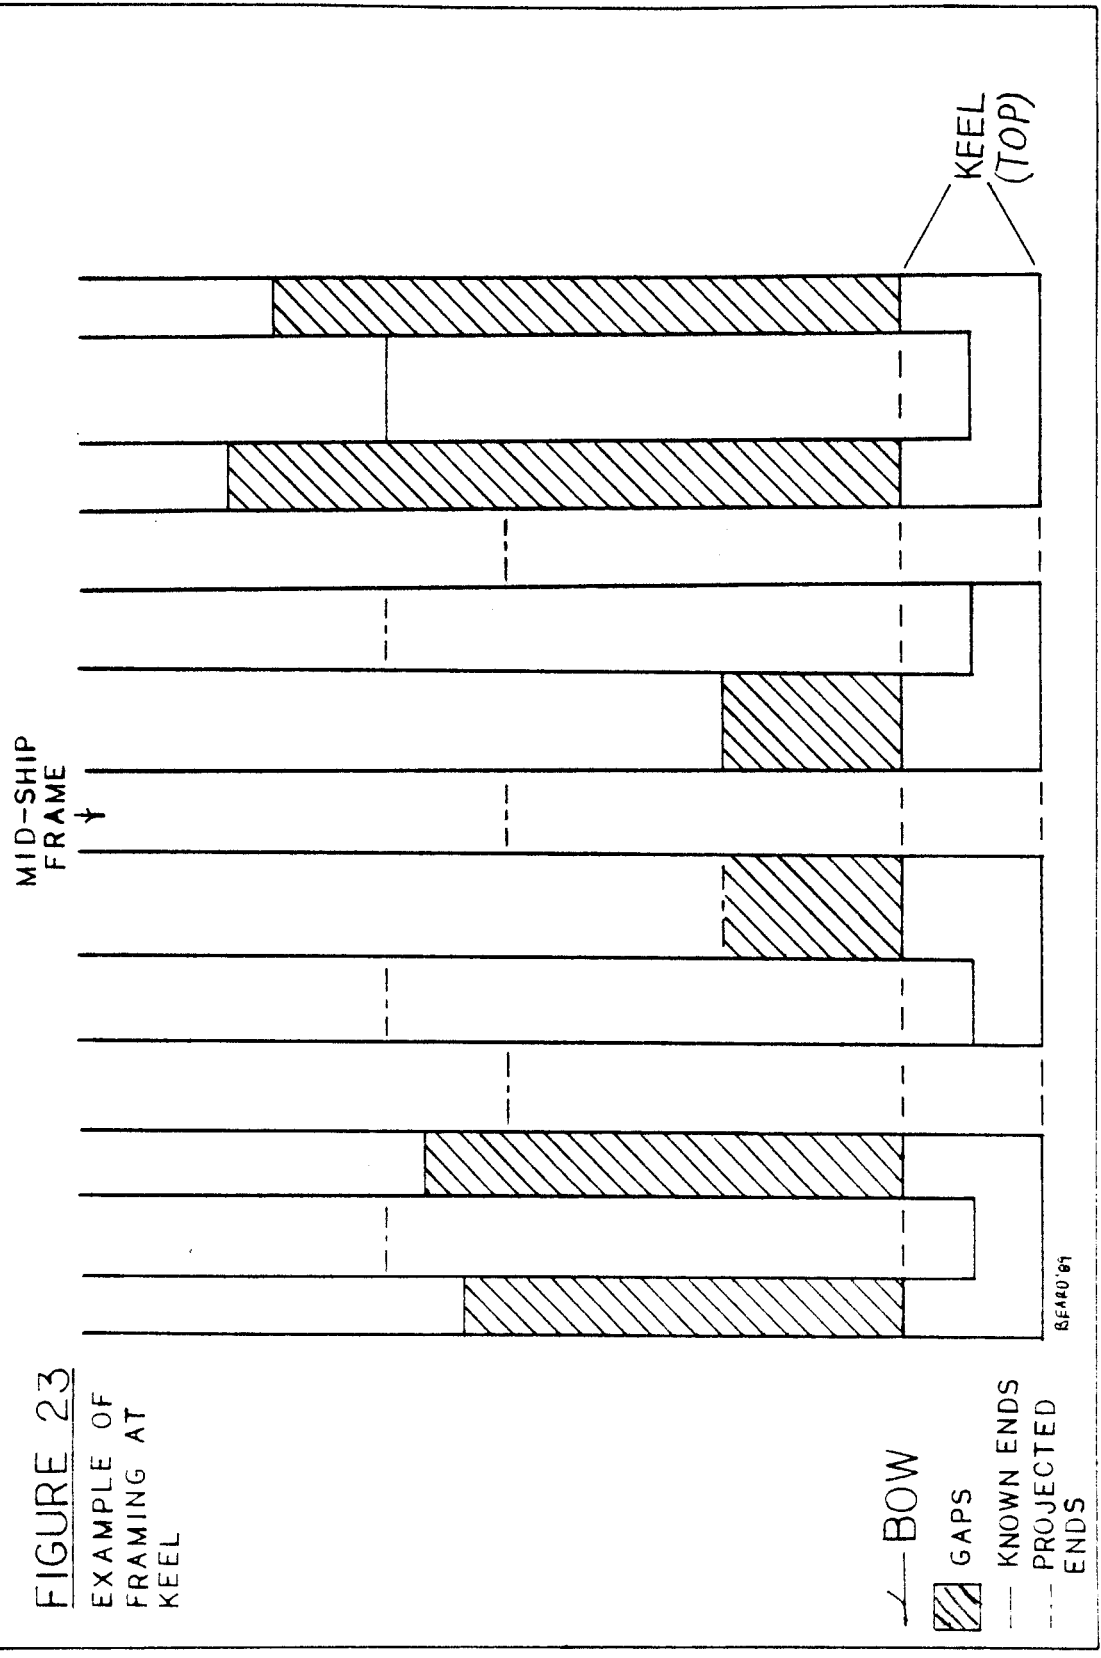
FIGURE 23
 EXAMPLE OF
 FRAMING AT
 KEEL

— BOW
 ▨ GAPS
 — KNOWN ENDS
 - - - PROJECTED ENDS

One of the "non-standard" aspects of *DeBraak's* framing is the lack of consistent room and space dimensions. Room and space is described as "the distance between the face edge of one complete (or main) frame and the equivalent face edge of the next frame."¹⁸ Although *DeBraak's* room and space is not of a constant, the arrangement of floor timbers, first futtocks and filling timbers generally is (Fig. 23). Ideally there would be a gap between the main and filling frames sufficient to allow proper ventilation to prevent dryrot. This technique apparently was not always followed in *DeBraak*, either during her construction or subsequent refits; there are sections, both at the floor timbers and at the futtocks above

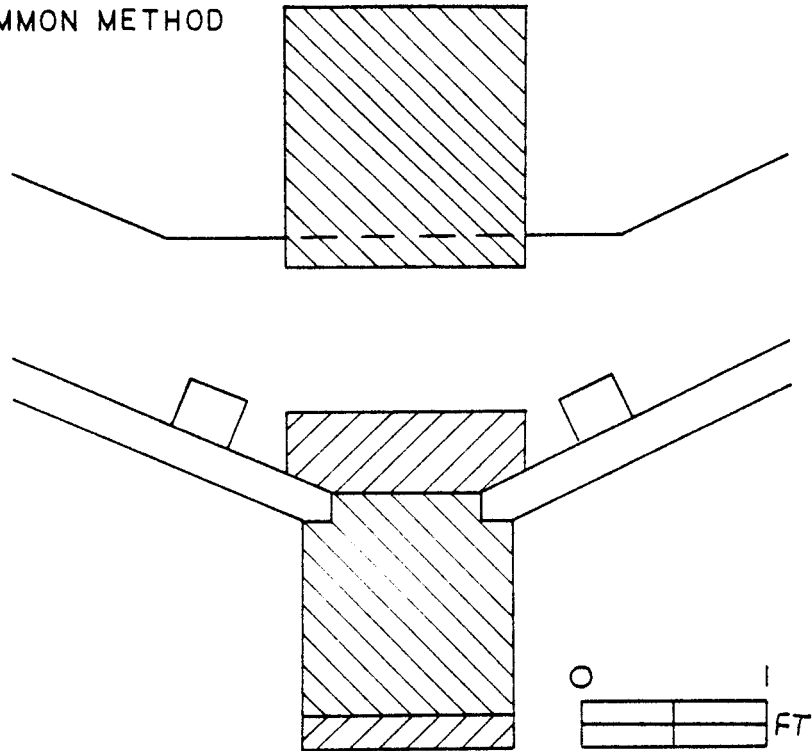
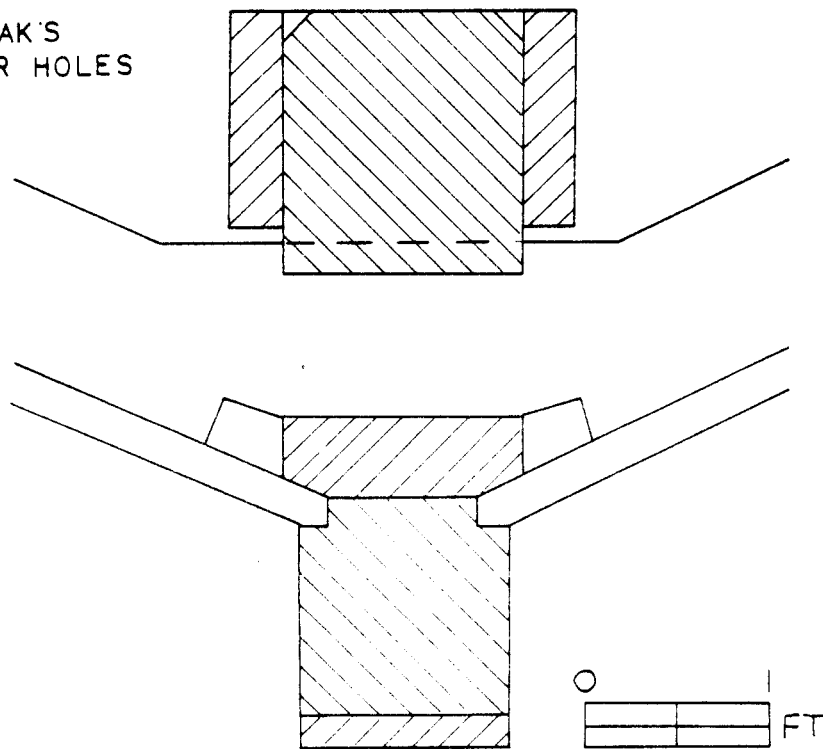
FIGURE 25: LIMBER HOLES

A ONE COMMON METHOD

B DEBRAAK'S
LIMBER HOLES

The sided dimensions of these timbers vary from approximately 5 inches to 10 inches. Most of the floors are notched with limber holes, which allow water to flow along the sides of the hog and to the bilge pumps. *DeBraak's* limber holes are essentially extensions of the floors' inletting to straddle the hog. Another common British practice was to cut separate holes in the floors and futtocks slightly outboard of the keel (Fig. 25).²⁰

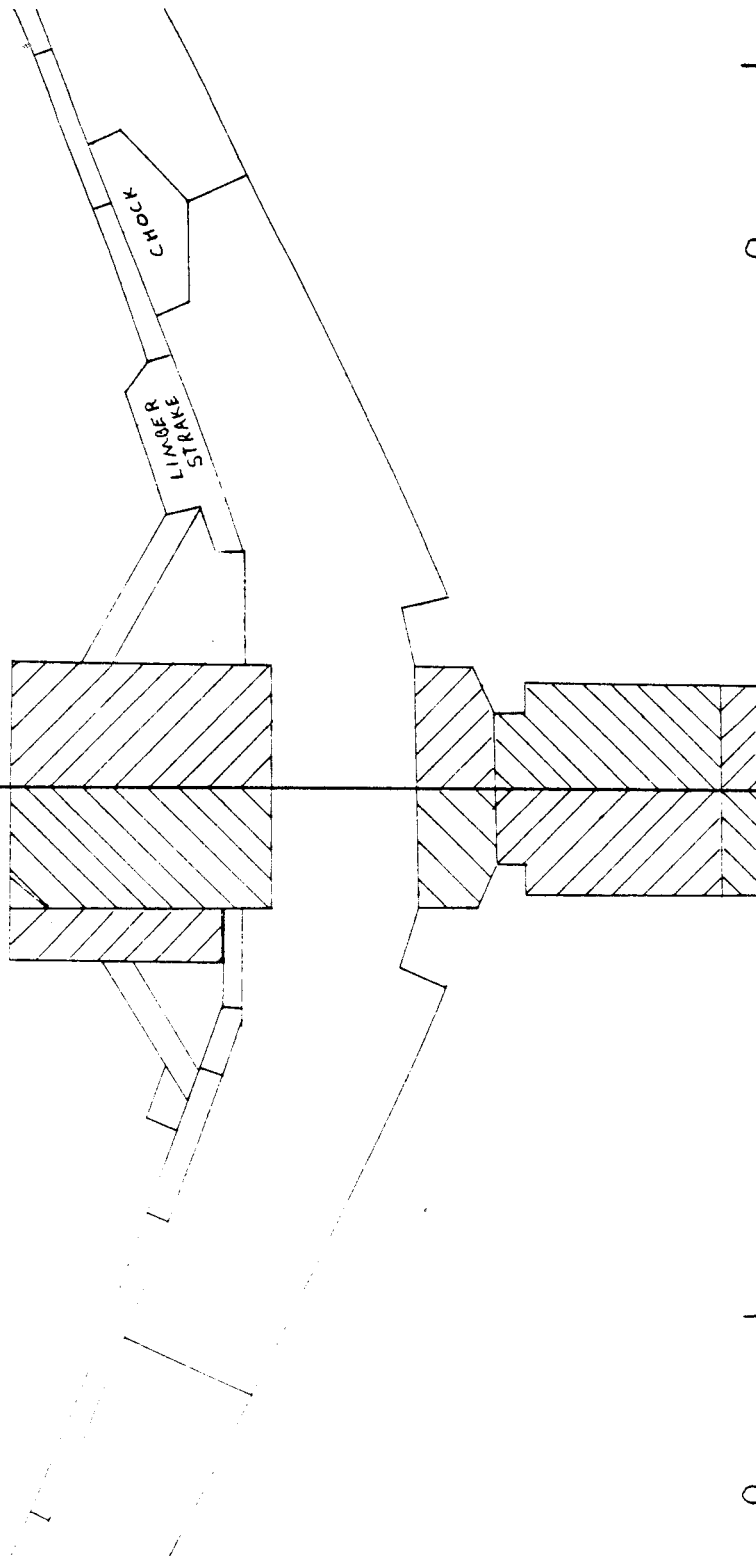
FIGURE 26. EXAMPLES OF FUTTOCKS BUTTING AND CHOCKING

A BUTTING

B CHOCKING

butt chocks where the futtocks join (Fig. 26).²¹

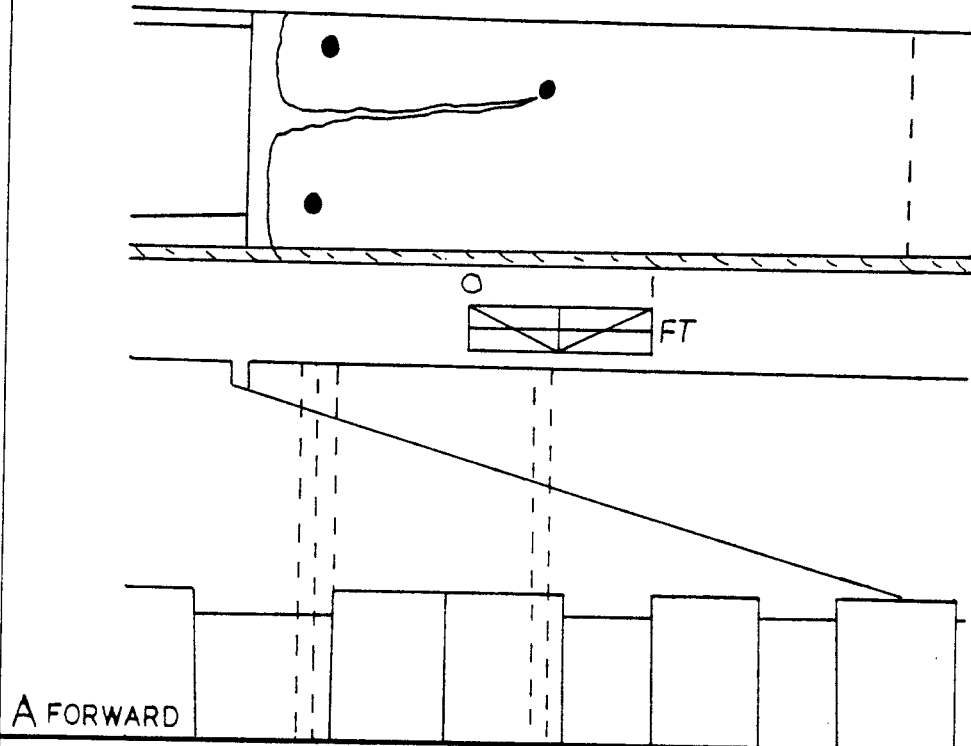
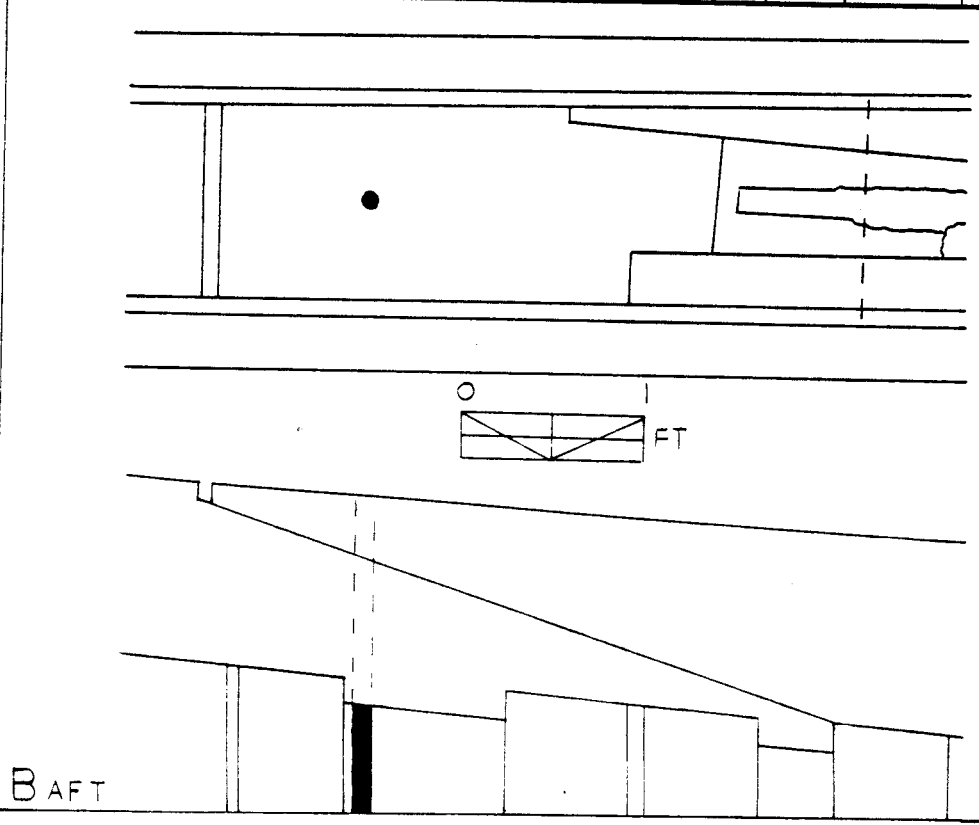
FIGURE 27: KEELSON SCARPHS

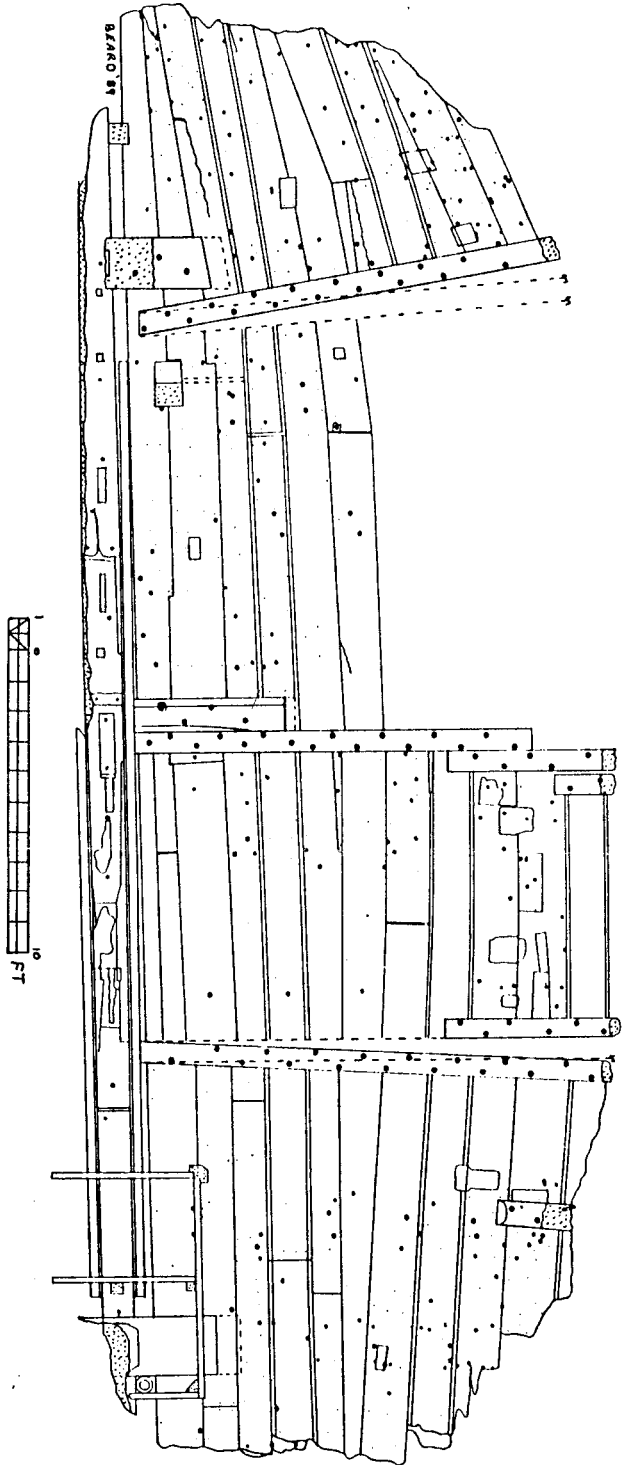
FIGURE 28. PLAN VIEW OF KEELSON AND CEILING PLANKING EXPANSION

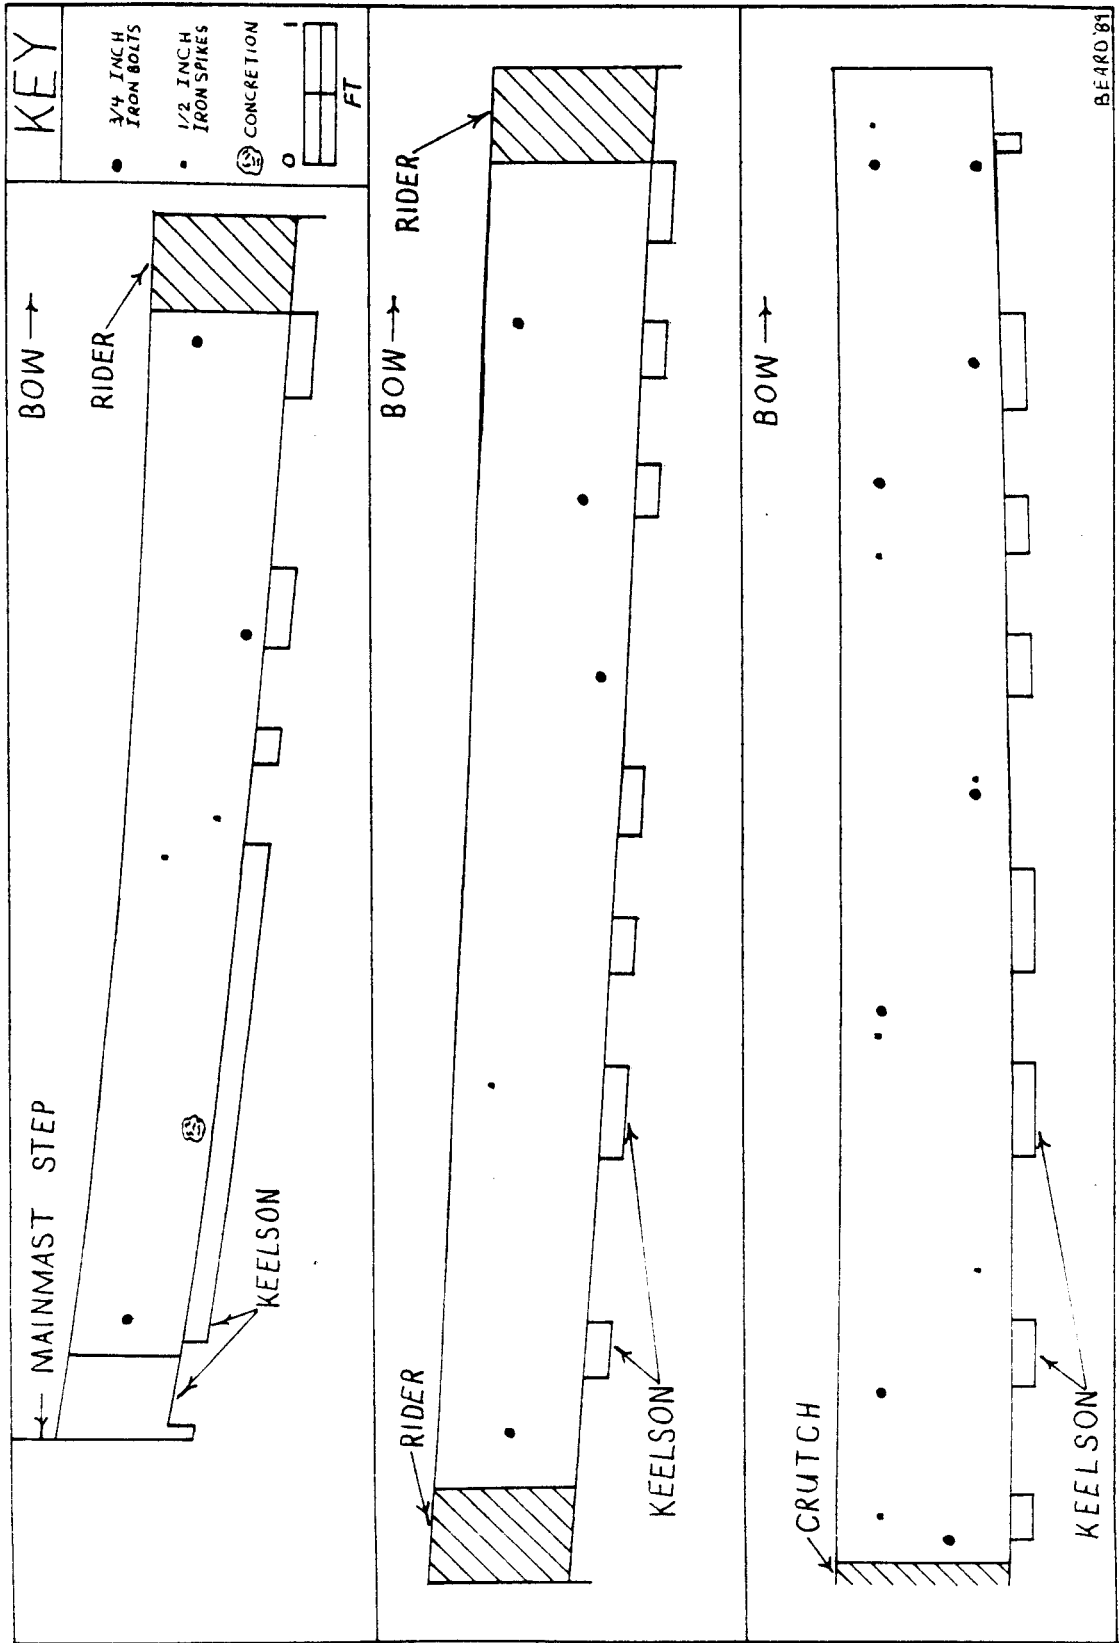
FIGURE 29: CHEEK FASTENER PATTERN
