David V. Beard. H.M.S. *DEBRAAK*: A TREASURE DEBUNKED, A TREASURE REVEALED. (Under the direction of Dr. William N. Still, Jr.) Department of History, July 1989.

The purpose of this study is to document the history, salvage and architecture of the brig-of-war H.M.S. *DeBraak*. Since the day that she sank in a sudden squall off the coast of Delaware on May 25, 1798 a legend of an immense treasure filling her holds has been widely circulated. As could have been expected, such a legend would attract those who would have this treasure for their own. Between 1984 and 1986 a Reno, Nevada-based commercial salvage firm, Sub-Sal, Inc., excavated the vessel's wreck site. These operations climaxed on August 11, 1986 with the raising of *DeBraak's* articulated hull remains, and the subsequent clamshelling of the site to recover artifacts.

H.M.S. *DEBRAAK*: A TREASURE DEBUNKED,
A TREASURE REVEALED

A thesis
Presented to
the Faculty of the Department of History
East Carolina University

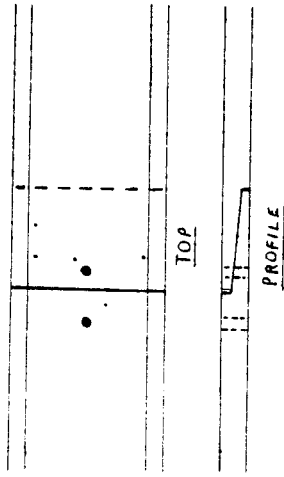
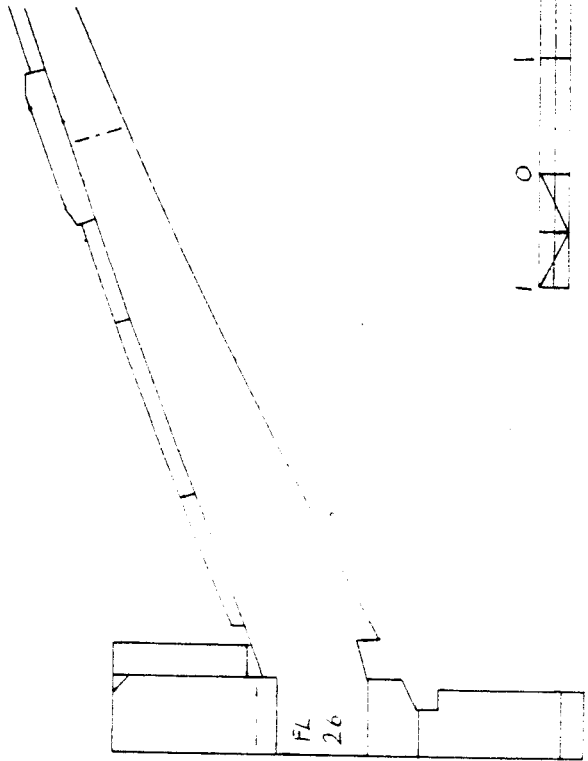
FIGURE 30
THICKSTUFF

Besides the basic ceiling planks, several "thick stuff" planks survive on *DeBraak's* hull. These planks average 2-1/2 inches thick, have chamfered top edges, and add additional strength where one futtock butts the next. These timbers are sometimes referred to as fore and aft longitudinals, or stringers.²⁶ While the rest of the ceiling planks is butt-joined end-to-end over frames, the thickstuff is joined fore and aft with scarph joints about 10-1/2 inches long, fastened with 1-inch diameter iron bolts (Fig. 30).

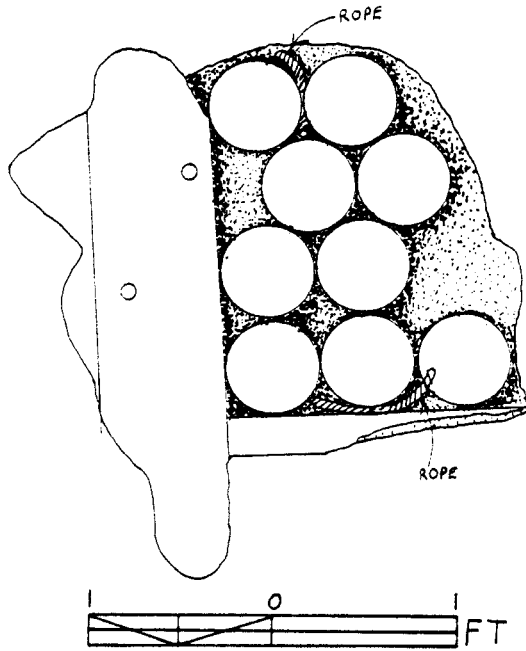
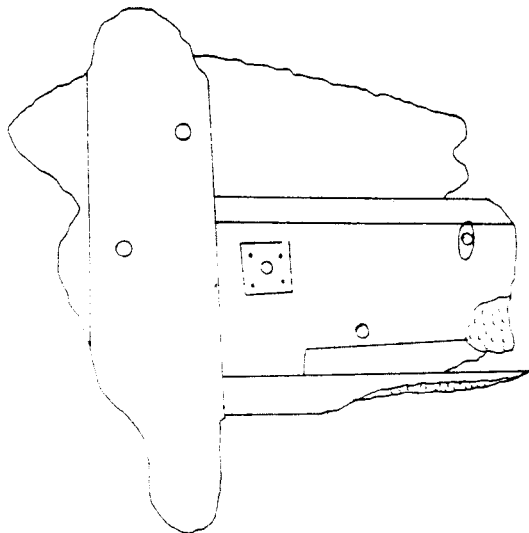
FIGURE 31: BULWARK FRAGMENT

A. WITH CONCRETED SOLID SHOT IN-SITU

B. WITH SHOT REMOVED

Surprisingly, one small section of deck bulwark ceiling planking survived. This section, which is about 2 feet, 9 inches wide and 2 feet, 1 inch high, consists of part of an upper rider, waterway plank, spirketing, a concreted ring-bolt for serving and restraining a gun, and badly degraded top-timber (Fig. 31b). The reason for the survival of this piece is that when the ship heeled over and sank, seven 24-pounder solid shot rolled from a shot garland and settled in a cluster against the rider (Fig. 31a). Iron oxide from the shot penetrated the wood to such an extent that it became unpalatable to the toredo worms, which then ate around it, leaving the piece to be buried in

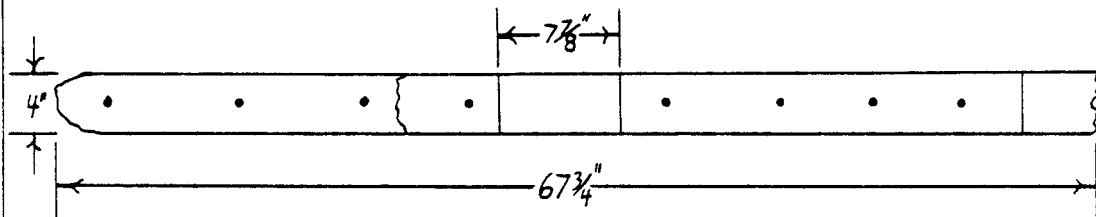
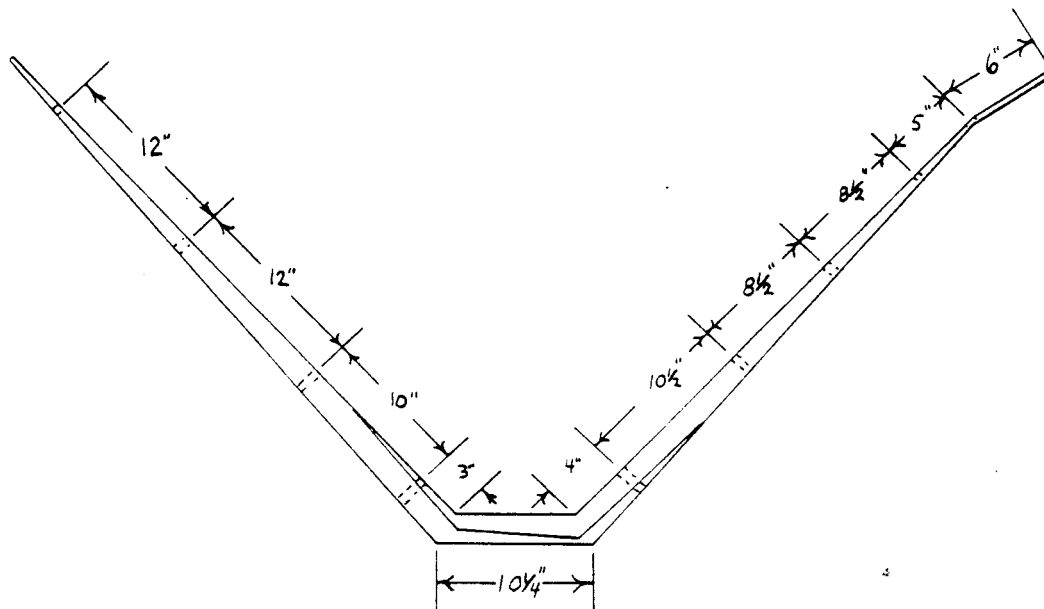
FIGURE 32: IRON BREASTHOOK

There are no extant breasthooks in *DeBraak's* hull. There is, however, some evidence that at least one of her breast hooks was reinforced with iron, a relatively new method in 1798. Figure 32 shows a wrought-iron fitting recovered from near *DeBraak's* bow. Although this fitting was badly degraded, examination revealed that it consists of two pieces of iron which are laminated together at its crotch. The fasteners are not evenly spaced, but appear to have been 5/8 inch in diameter iron drift pins. Its dimensions and the spacing of the fastener holes suggests that this fitting served either as a breast hook in itself or as part of a composite breasthook. Iron reinforcing of ship timbers did not become standard practice in the Royal Navy until the early nineteenth century.

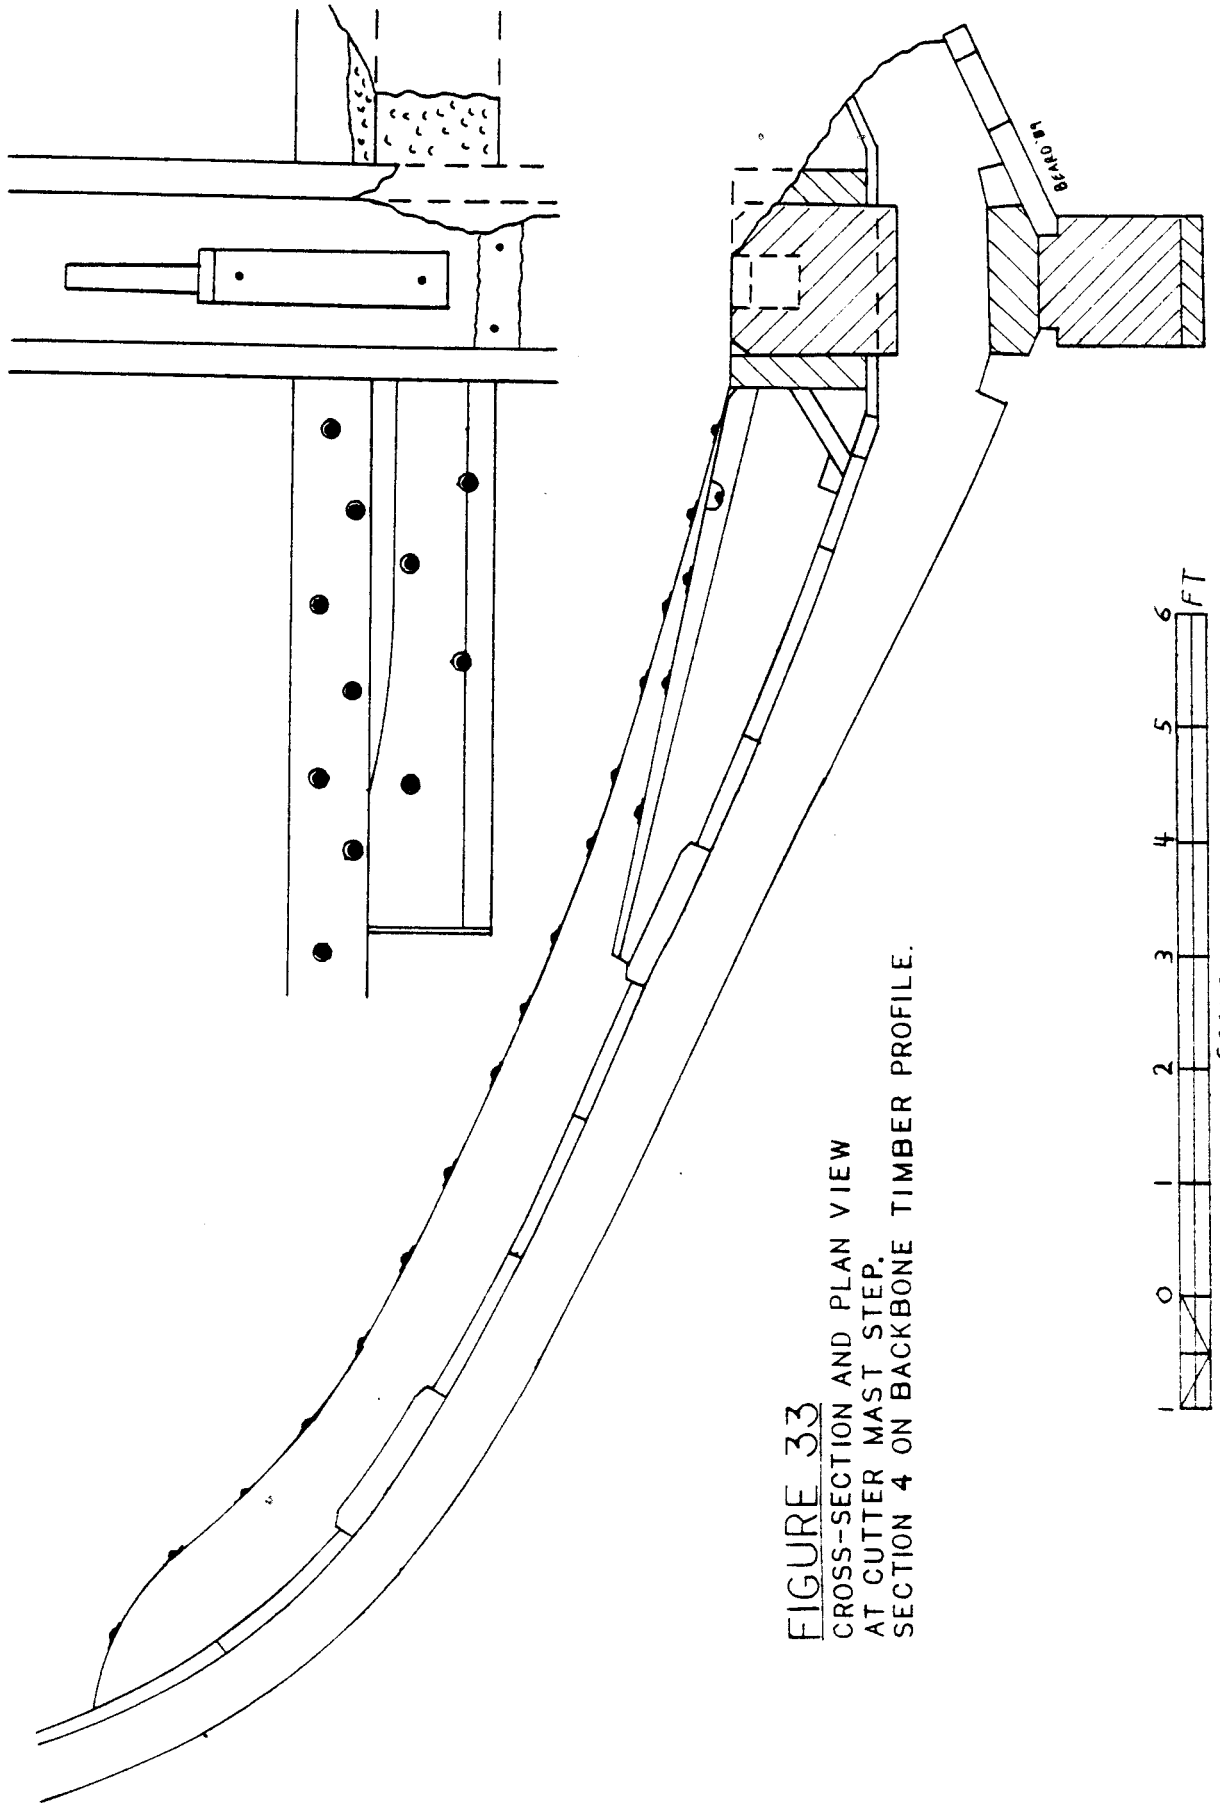
The cutter mast step was simply a mortice cut directly into the keelson. This mortice is 25-1/2 inches long, 5-1/2 inches wide and 7 inches deep. Besides one of the long lower riders for lateral support, there is a short

FIGURE 33
 CROSS-SECTION AND PLAN VIEW
 AT CUTTER MAST STEP.
 SECTION 4 ON BACKBONE TIMBER PROFILE.

wedge-shaped crutch or sister timber placed on both sides of this step, just forward of the central lower rider (Figs. 27 & 33). These crutches are similar to those supporting the mainmast step of the American privateer *Defence*, which was scuttled in Penobscot Bay, Maine in 1779 (Figs. 34 & 47b).²⁸

Remnants of two hanging knees are extant in *DeBraak's* hull. A third knee was recovered during the dredging operation and appears to have been torn loose from the portion of the hull which was heavily damaged by the lifting cables. Also fastened with drift pins, the foremost surviving knee remnant is molded and sided 8 inches, while the aftermost knee is sided 9-1/2 inches and molded 9 inches. Their lower ends are rounded in profile like the rider ends (Figs. 27 & 33). The top edges of the knees are

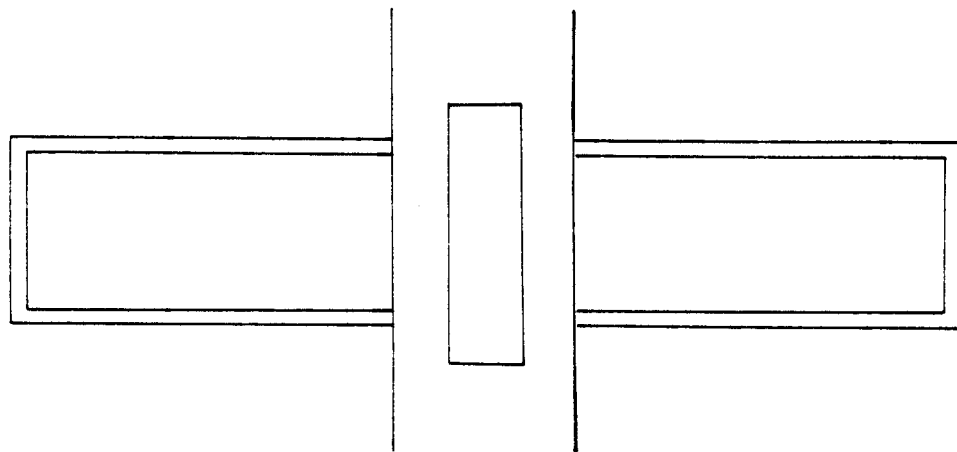
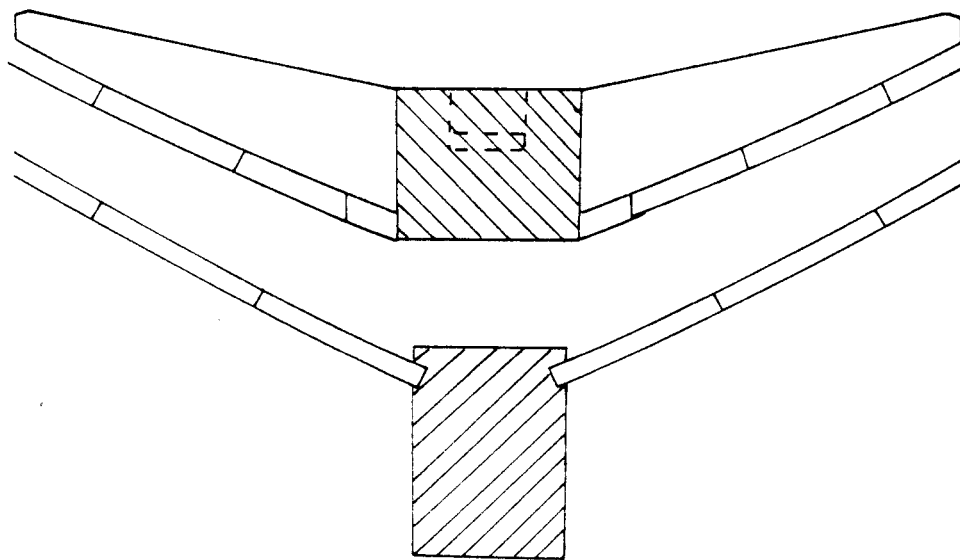
FIGURE 34

CROSS-SECTION AND PLAN VIEW
OF DEFENSE MAINMAST STEP

(REDRAWN COURTESY OF DAVID SWITZER)

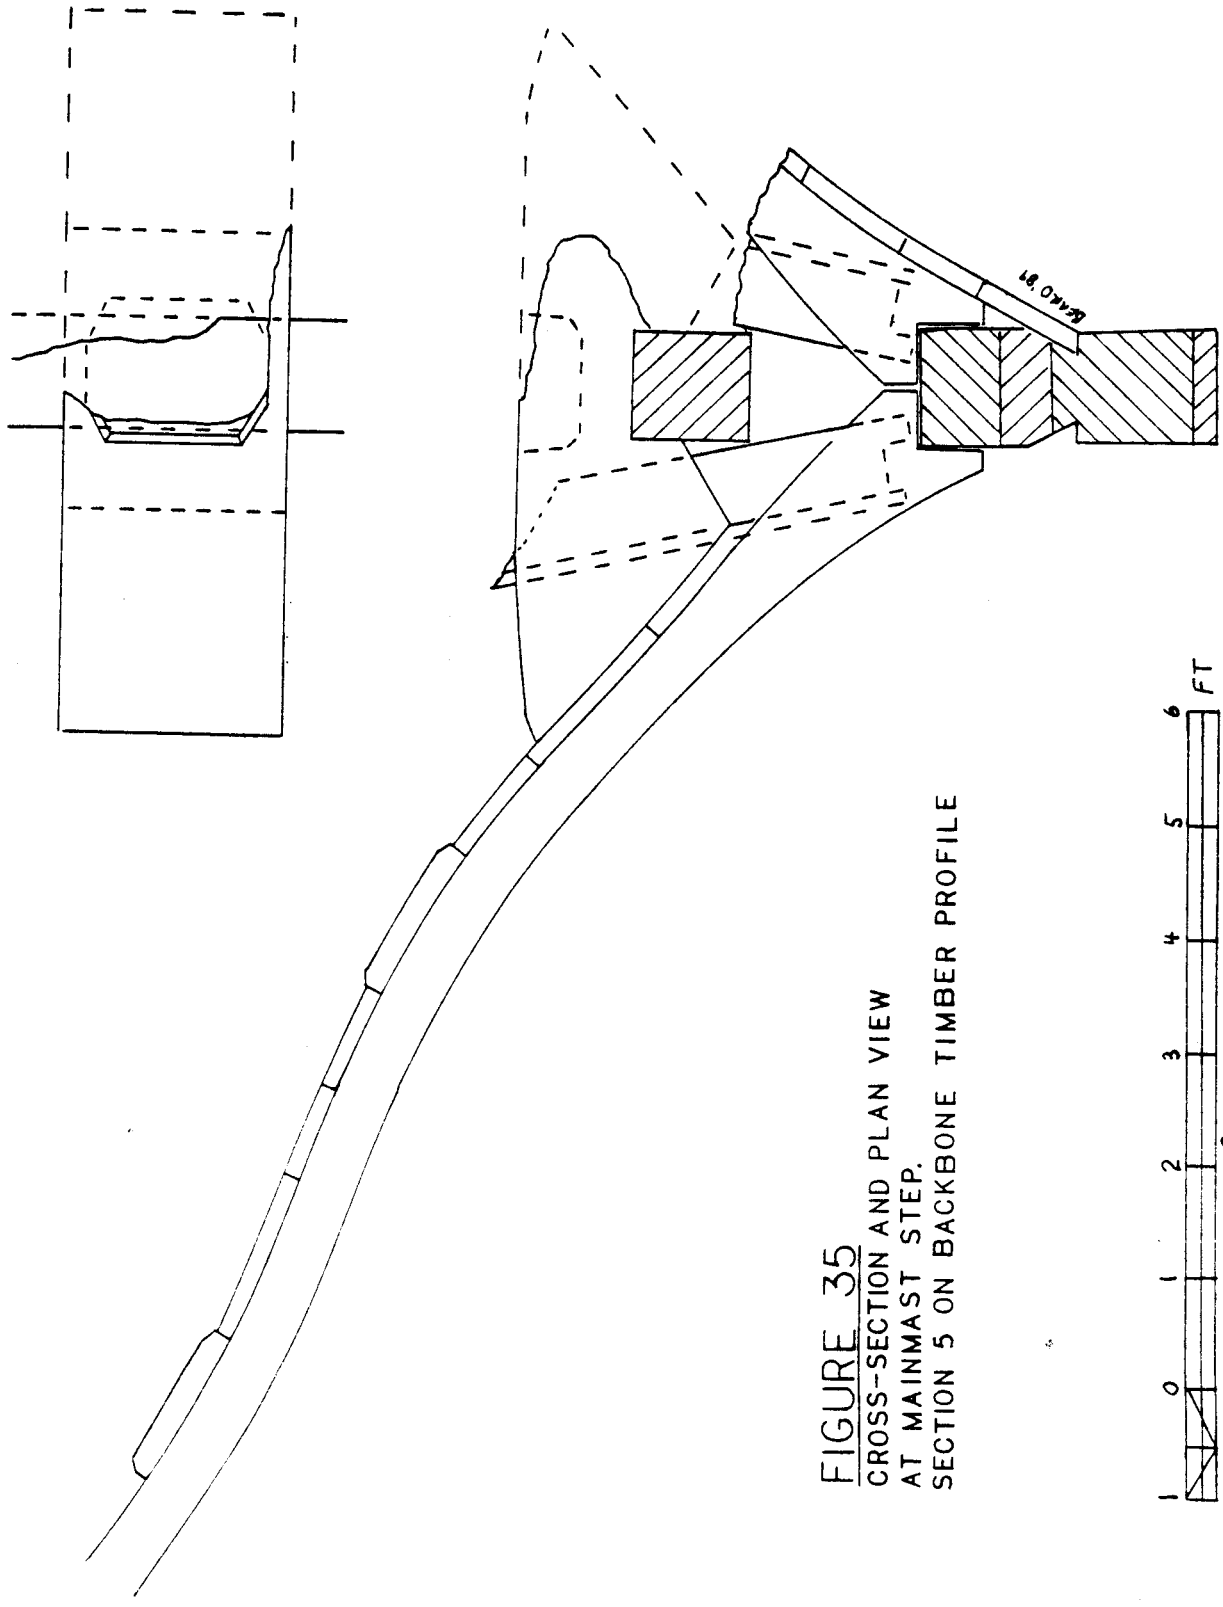
FIGURE 35
 CROSS-SECTION AND PLAN VIEW
 AT MAINMAST STEP.
 SECTION 5 ON BACKBONE TIMBER PROFILE

The mainmast step is centered 20 feet, 1 inch forward of the aft end of the keel, and is surrounded by the shot lockers (Figs. 16, 27 & 47a). It is cut from a single piece of oak and is straddles the keelson. Its maximum athwartship dimension is 6 feet, 4 inches. The sided dimension is 1 foot 11-1/4 inches and its maximum molded dimension is 1 foot, 10 inches. It has an octagonal mortice to receive the mast's tenon which is 1 foot, 10 inches long (fore and aft), 1 foot, 3-1/2 inches wide (athwartships) and 6 inches deep.²⁹ Its top edges are chamfered (Fig. 35).

One interesting point about the mainmast step is the absence of fasteners of any kind holding it in place (Fig. 35). It may be that in the event of the mainmast becoming unstepped, as it did on at least one documented occasion during *DeBraak's* career as a brig, it was considered preferable to have the step itself slip out of place as opposed to putting stress on through-hull fasteners which could conceivably rip a hole in the ship's hull. Another equally practical reason for not having through-hull fasteners at this point in the ship's hull is that the constant wiggling of the heel of the mast would eventually cause the vessel to leak around these fasteners.

rising wood without blocking them (Figs.35 & 52). Except for their arrangement, *DeBraak's* pumps are also similar to those found in *Defence* (Fig. 47b).³³

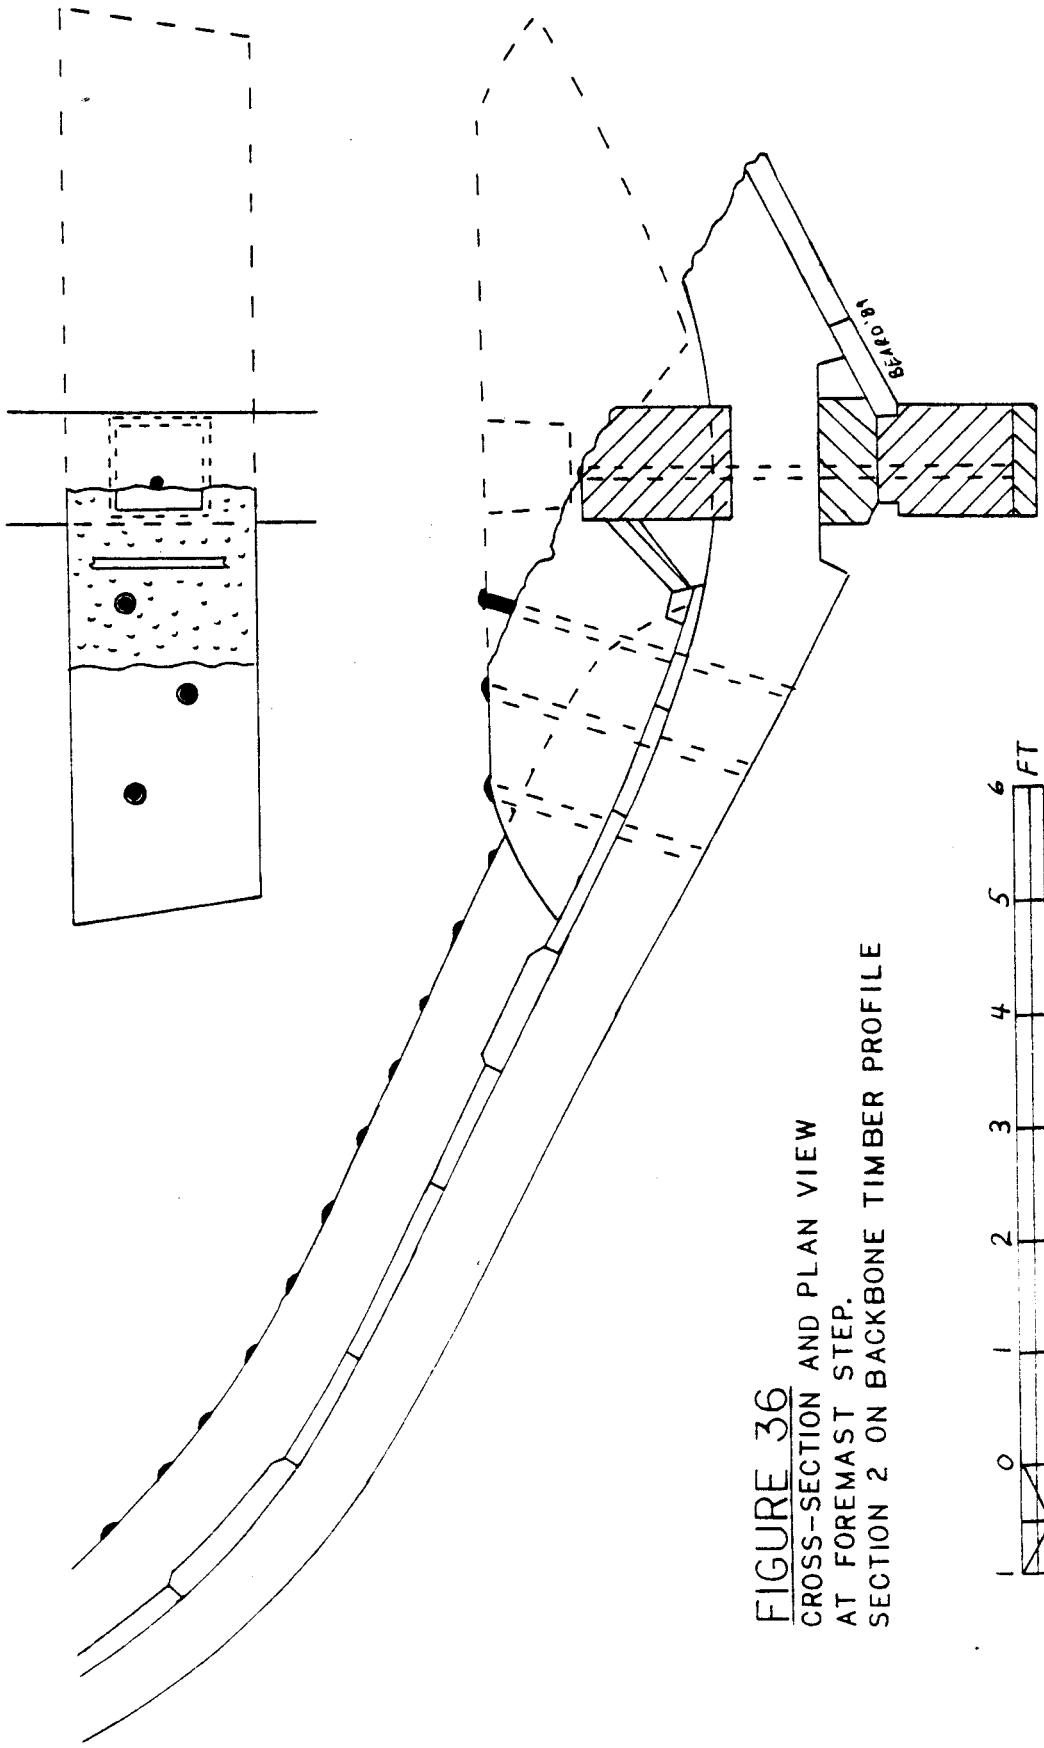
FIGURE 36
 CROSS-SECTION AND PLAN VIEW
 AT FOREMAST STEP.
 SECTION 2 ON BACKBONE TIMBER PROFILE

sided 1 foot, 7-1/2 inches, and molded (maximum) one foot, nine and one-half inches. Like the mainmast step, the top edges of the foremast step are chamfered. It was originally fastened into place with six copper drift pins (three survive in a staggered pattern on the starboard side). The mortice for the mast tenon is so badly degraded that no physical data remains. For the purpose of illustration it has been recreated based on the Admiralty drafts (Fig. 36).

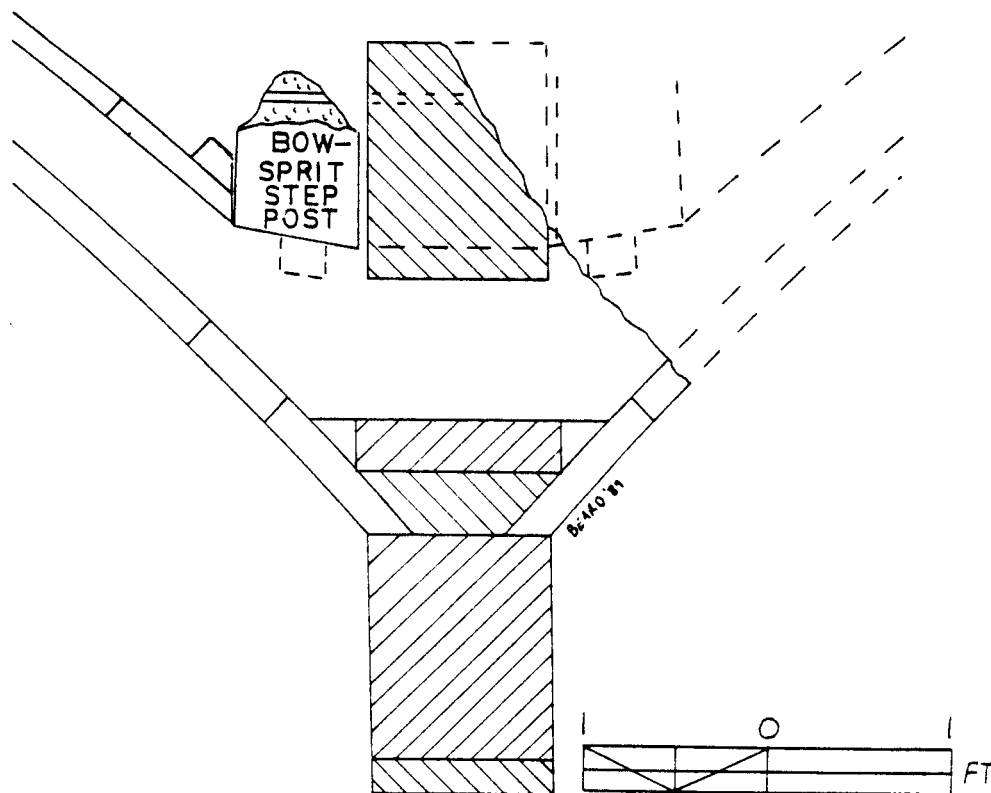
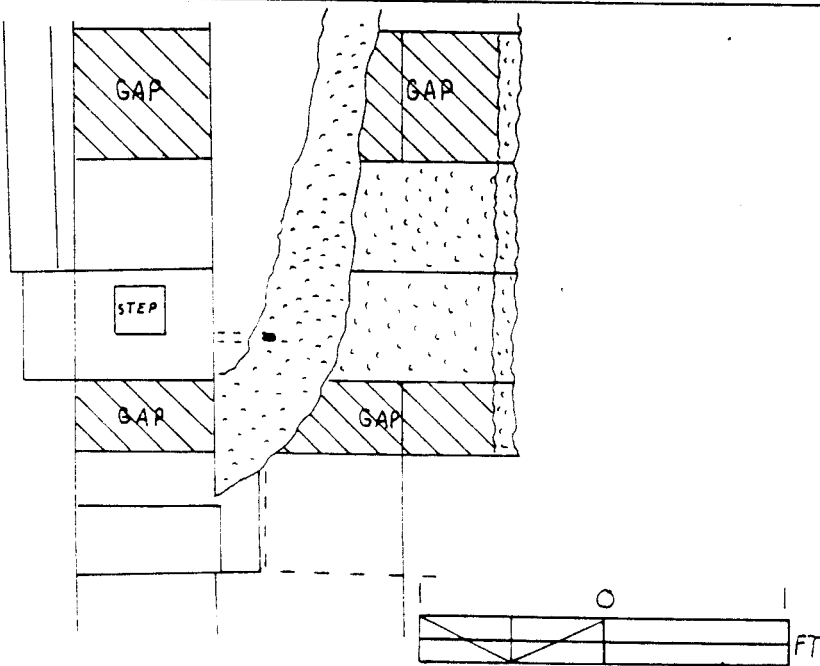
FIGURE 38: BOWSPRIT STEP POST

A SECTION I ON BACKBONE TIMBER PROFILE

B
PLAN
VIEW

The base of the bowsprit step post is centered 3 feet, 4 inches forward of the foremast step, and against the side of the keelson. It is 8 inches square and, like the riding bitt post, has a beaded edge. The tenon on this post is 3 inches square and 2-3/4 inches deep, and is stepped into frame 11 (Figs. 27 & 38 a & b).

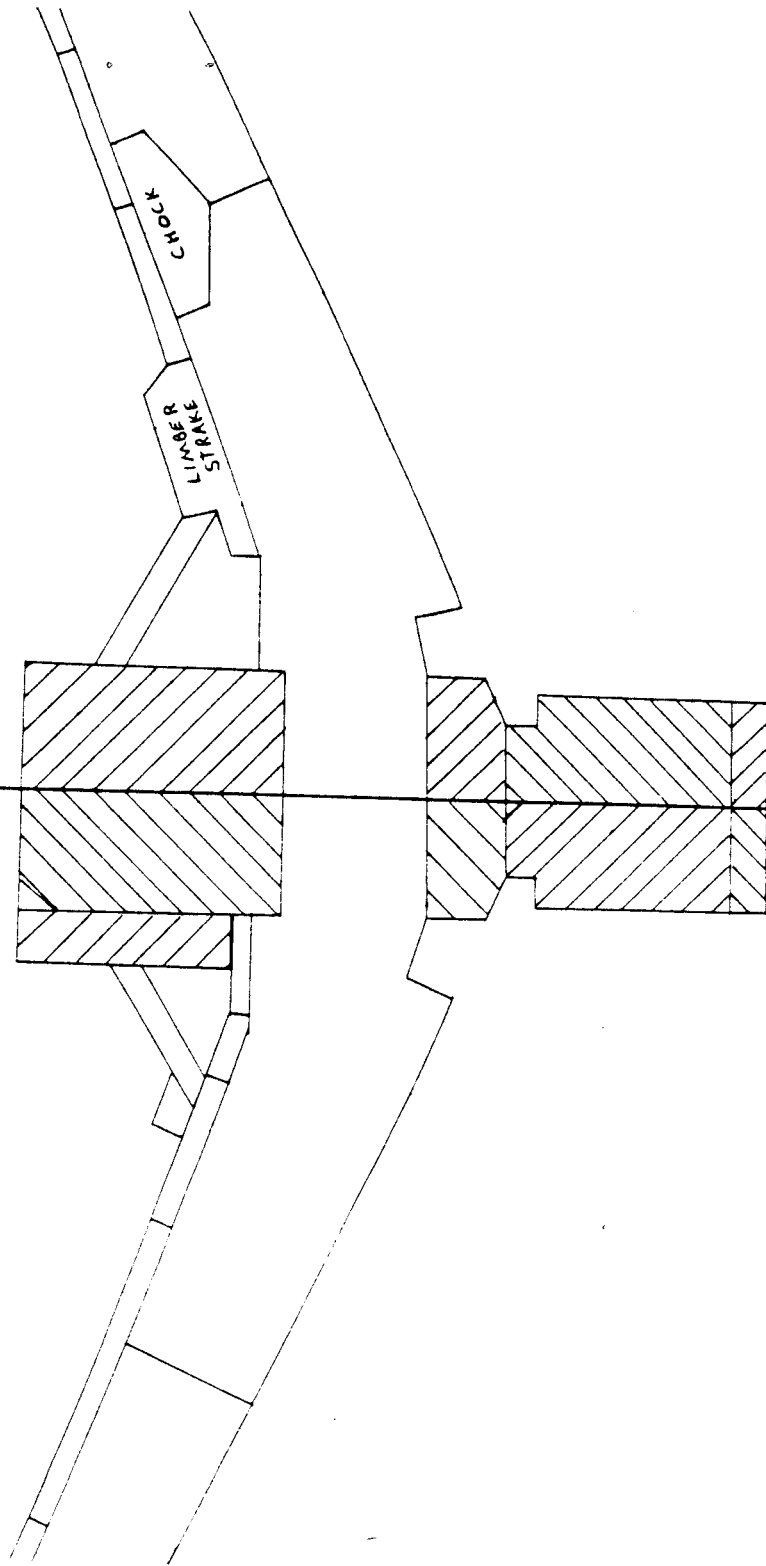
FIGURE 39

A DEBRAAK'S LIMBER BOARD RETAINER STRAKE B RABBETED LIMBER STRAKE

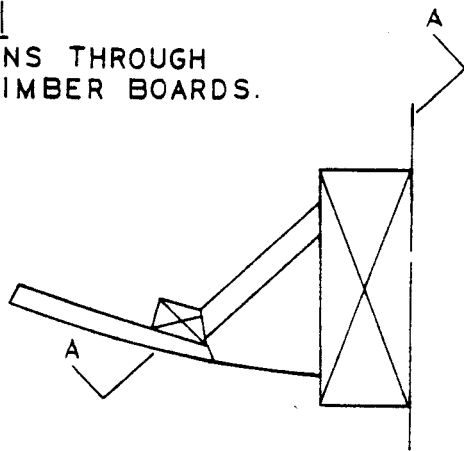
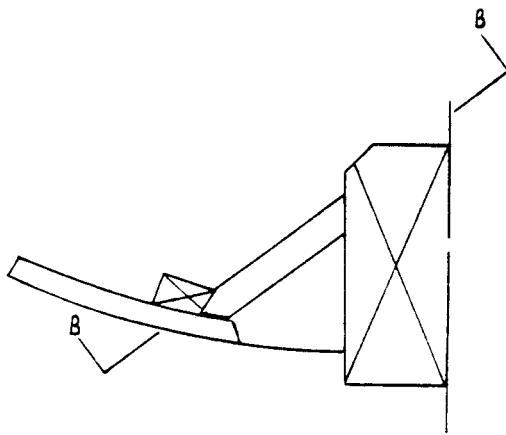
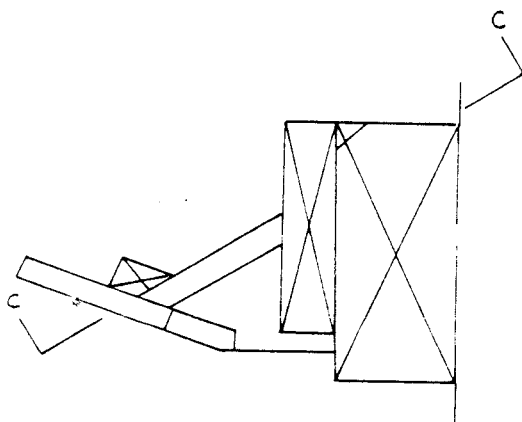
FIGURE 41
CROSS-SECTIONS THROUGH
STARBOARD LIMBER BOARDS.
(SEE FIG. 40)

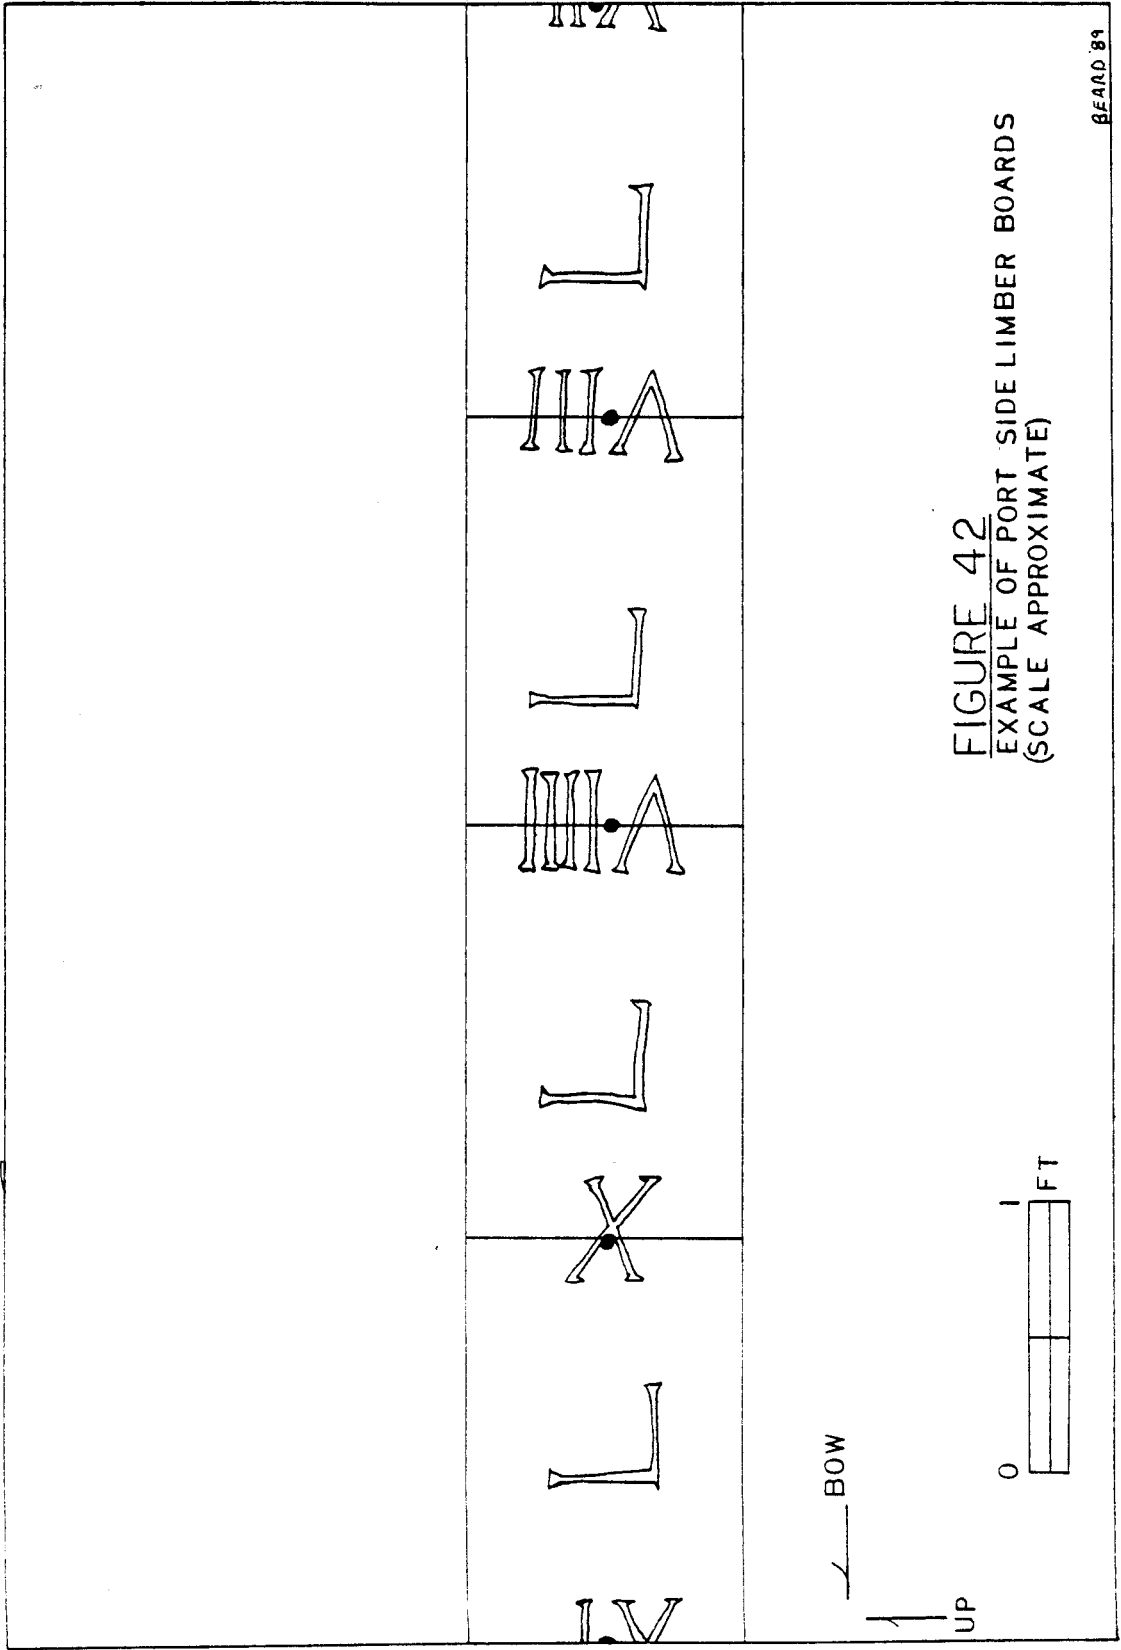
The port side limber boards are somewhat different. Each board is longer, averaging between 16 and 18 inches. Roman numerals have been carved into the boards, overlapping the seams between them, presumably to allow them to be placed back in their proper order. The letter "L" is also cut into several of these boards and may stand for "Larboard," another word for port or as an indication that these were limber boards and not to be thrown out

FIGURE 42
 EXAMPLE OF PORT SIDE LIMBER BOARDS
 (SCALE APPROXIMATE)

when the ship was rummaged (Fig. 42). The limber boards on both sides have holes drilled at certain seams between them. This is presumably to allow a finger or special tool to be inserted for easier removal (Figs. 40 & 42).

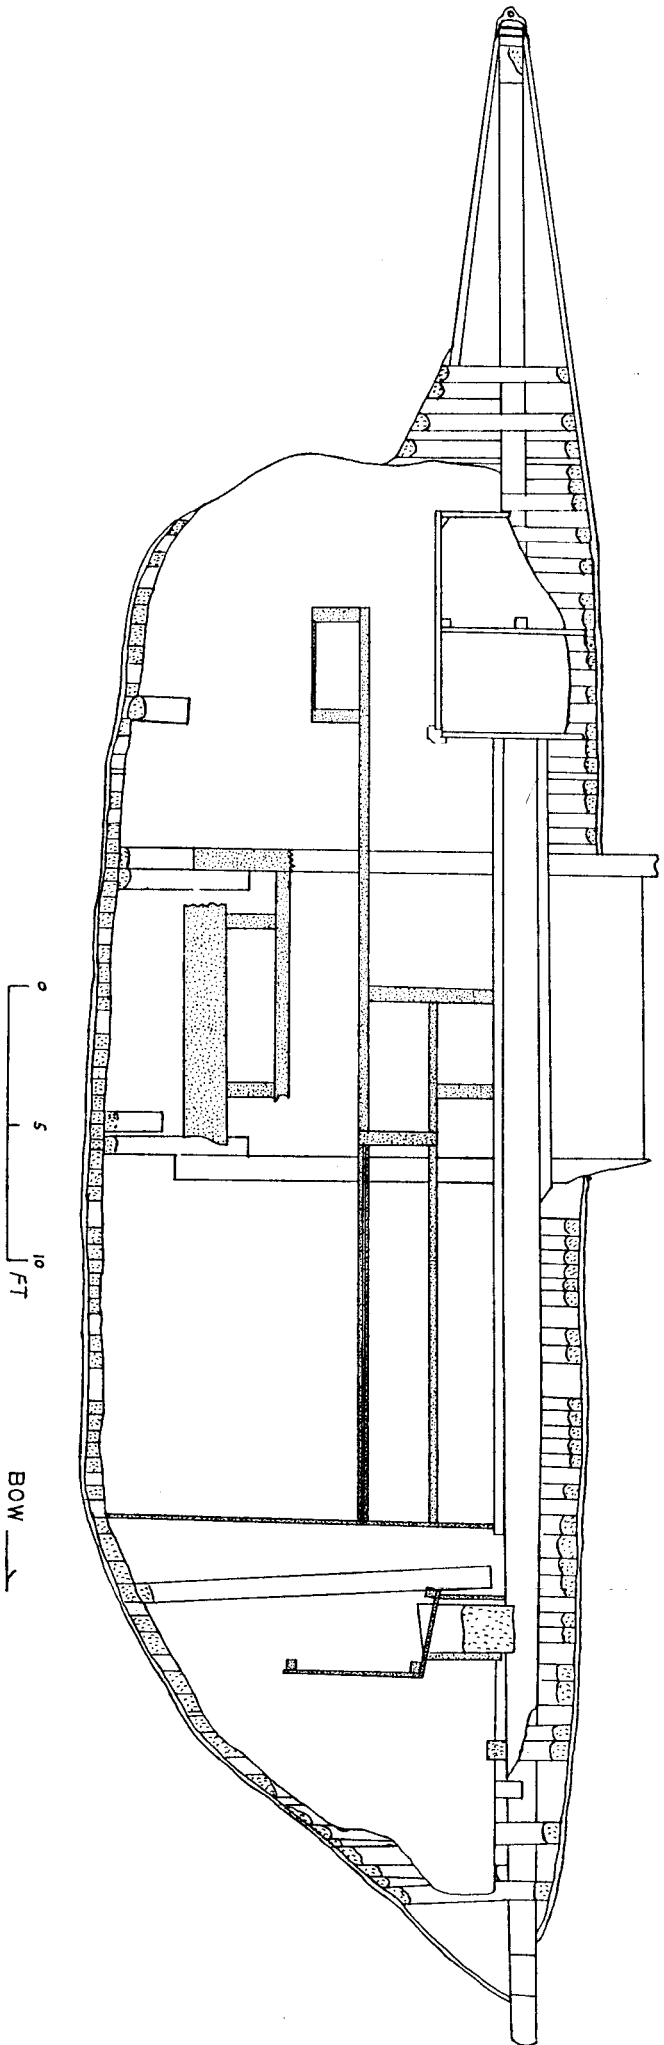
FIGURE 43: SIMPLIFIED SITE PLAN SHOWING LOST TIMBERS

stringers ran along the surface of the ceiling planks, as is evidenced by the concreted impression of a ballast bar on the side of one of them (Fig. 45). While much of this timber was heavily concreted when mapped, making recording difficult, in one spot it was apparent that the upright planking consisted of two parallel planks divided by upright fillers (Fig. 43). The height of these structures is impossible to determine from the data available.

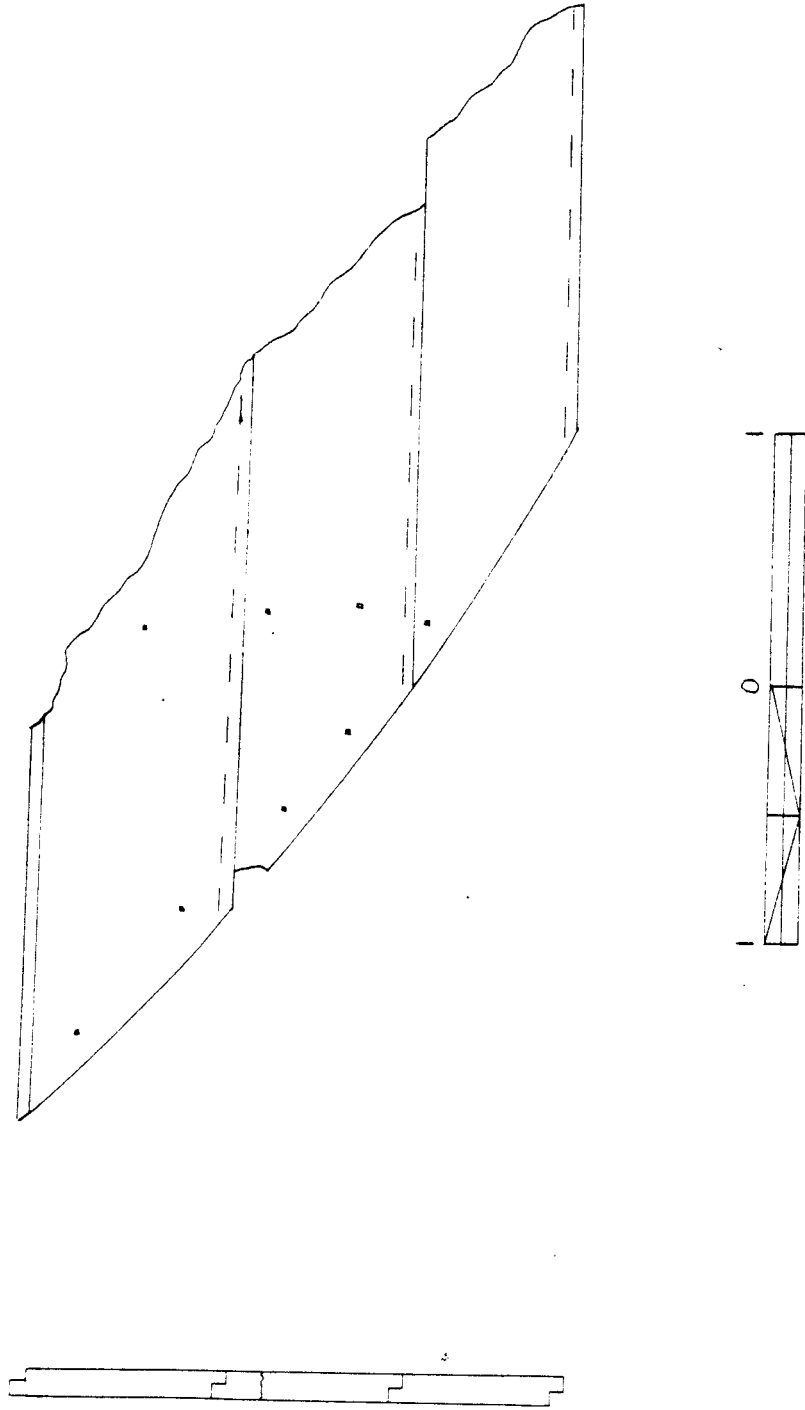
The remains of the forward bulkhead have been partially reconstructed by the "jigsaw puzzle" method described in an earlier chapter. It was constructed of a series of horizontal red pine strakes, ranging from 7-1/2 to 9 inches wide, which were fitted together with a half lap or "ship lap" rabbet.³⁰ These strakes are generally 1-1/4 inches thick (Fig. 44). The bulkhead was held up by a set of vertical stanchions. A number of stanchion fragments were recovered during the salvage, but at this time none have been positively matched with the surviving bulkheads.

FIGURE 44
RECONSTRUCTED FORWARD ATHWARTSHIP BULKHEAD SECTION

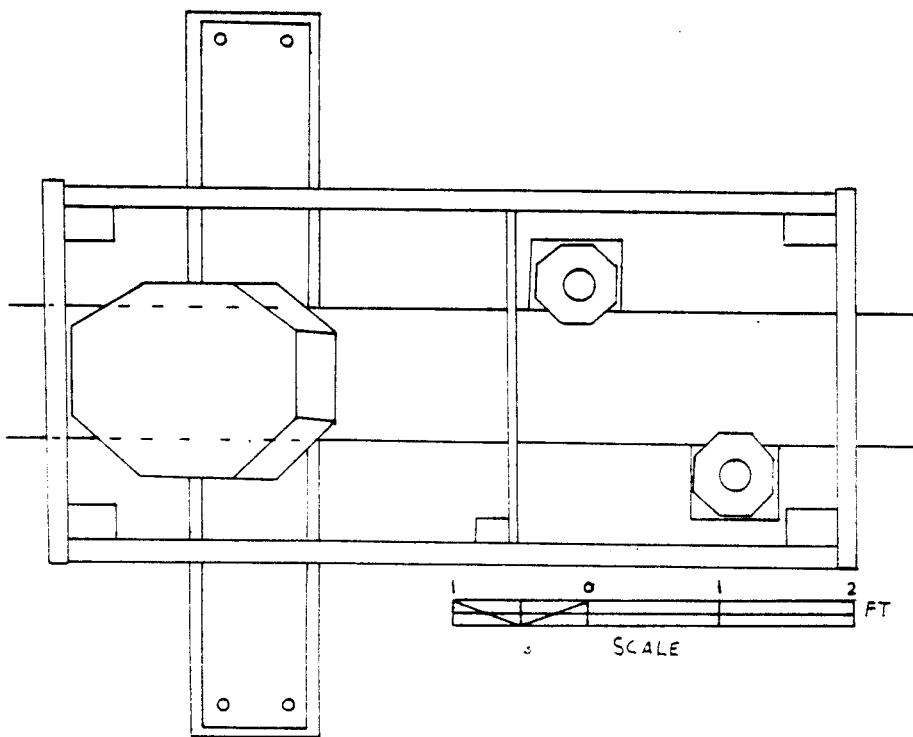
B DEFENSE (REDRAWN COURTESY OF DAVID SWITZER)

FIGURE 48
PROFILE OF DEBRAAK SHOT LOCKERS

The planks are also made of red pine and average 2-1/4 inches thick. The lower-most planks on the surviving starboard side of the shot locker diminish in width with the run aft of the hull. One long plank is inlet to straddle over the mainmast step (Fig. 48). The lower-most athwartship planks are cut to fit over the keelson and conform to the shape of the limber boards, limber board retainer and the contour of the hull (Fig. 49). This arrangement is also similar to the shot lockers of *Defence* (Figs. 47b & 50).³¹

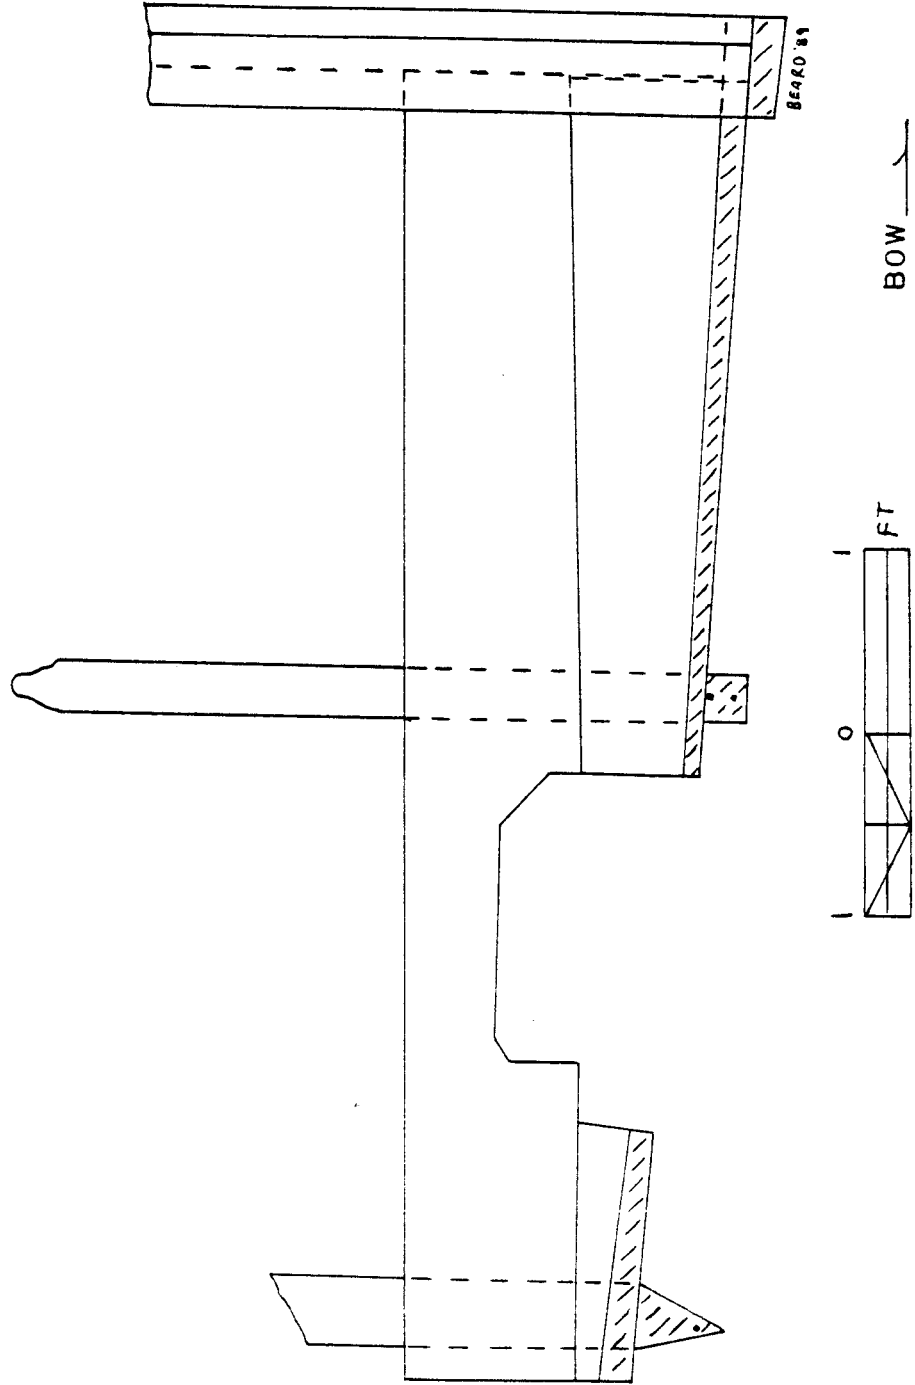
FIGURE 49. ATHWARTSHIP SECTIONS: DEBRAAK SHOT LOCKER

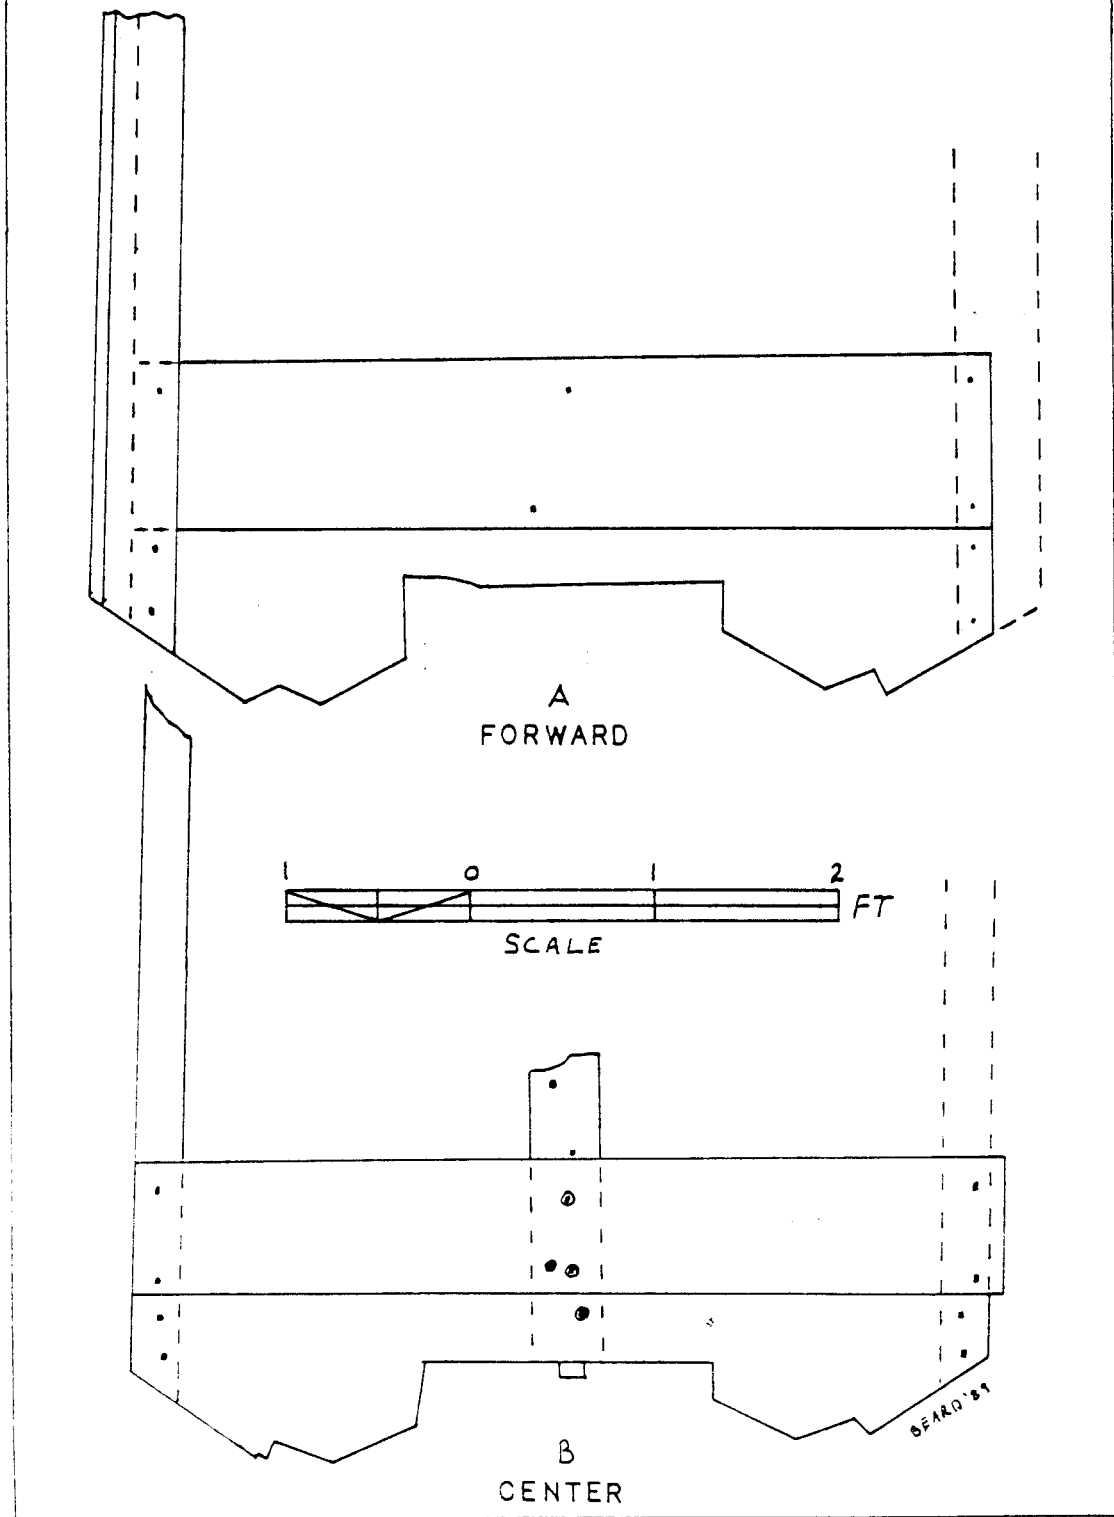
FIGURE 50: PROFILE AND ATHWARTSHIP SECTIONS OF DEFENSE SHOT LOCKERS
