David V. Beard. H.M.S. *DEBRAAK*: A TREASURE DEBUNKED, A TREASURE REVEALED. (Under the direction of Dr. William N. Still, Jr.) Department of History, July 1989.

The purpose of this study is to document the history, salvage and architecture of the brig-of-war H.M.S. *DeBraak*. Since the day that she sank in a sudden squall off the coast of Delaware on May 25, 1798 a legend of an immense treasure filling her holds has been widely circulated. As could have been expected, such a legend would attract those who would have this treasure for their own. Between 1984 and 1986 a Reno, Nevada-based commercial salvage firm, Sub-Sal, Inc., excavated the vessel's wreck site. These operations climaxed on August 11, 1986 with the raising of *DeBraak's* articulated hull remains, and the subsequent clamshelling of the site to recover artifacts.

H.M.S. *DEBRAAK*: A TREASURE DEBUNKED,
A TREASURE REVEALED

A thesis
Presented to
the Faculty of the Department of History
East Carolina University

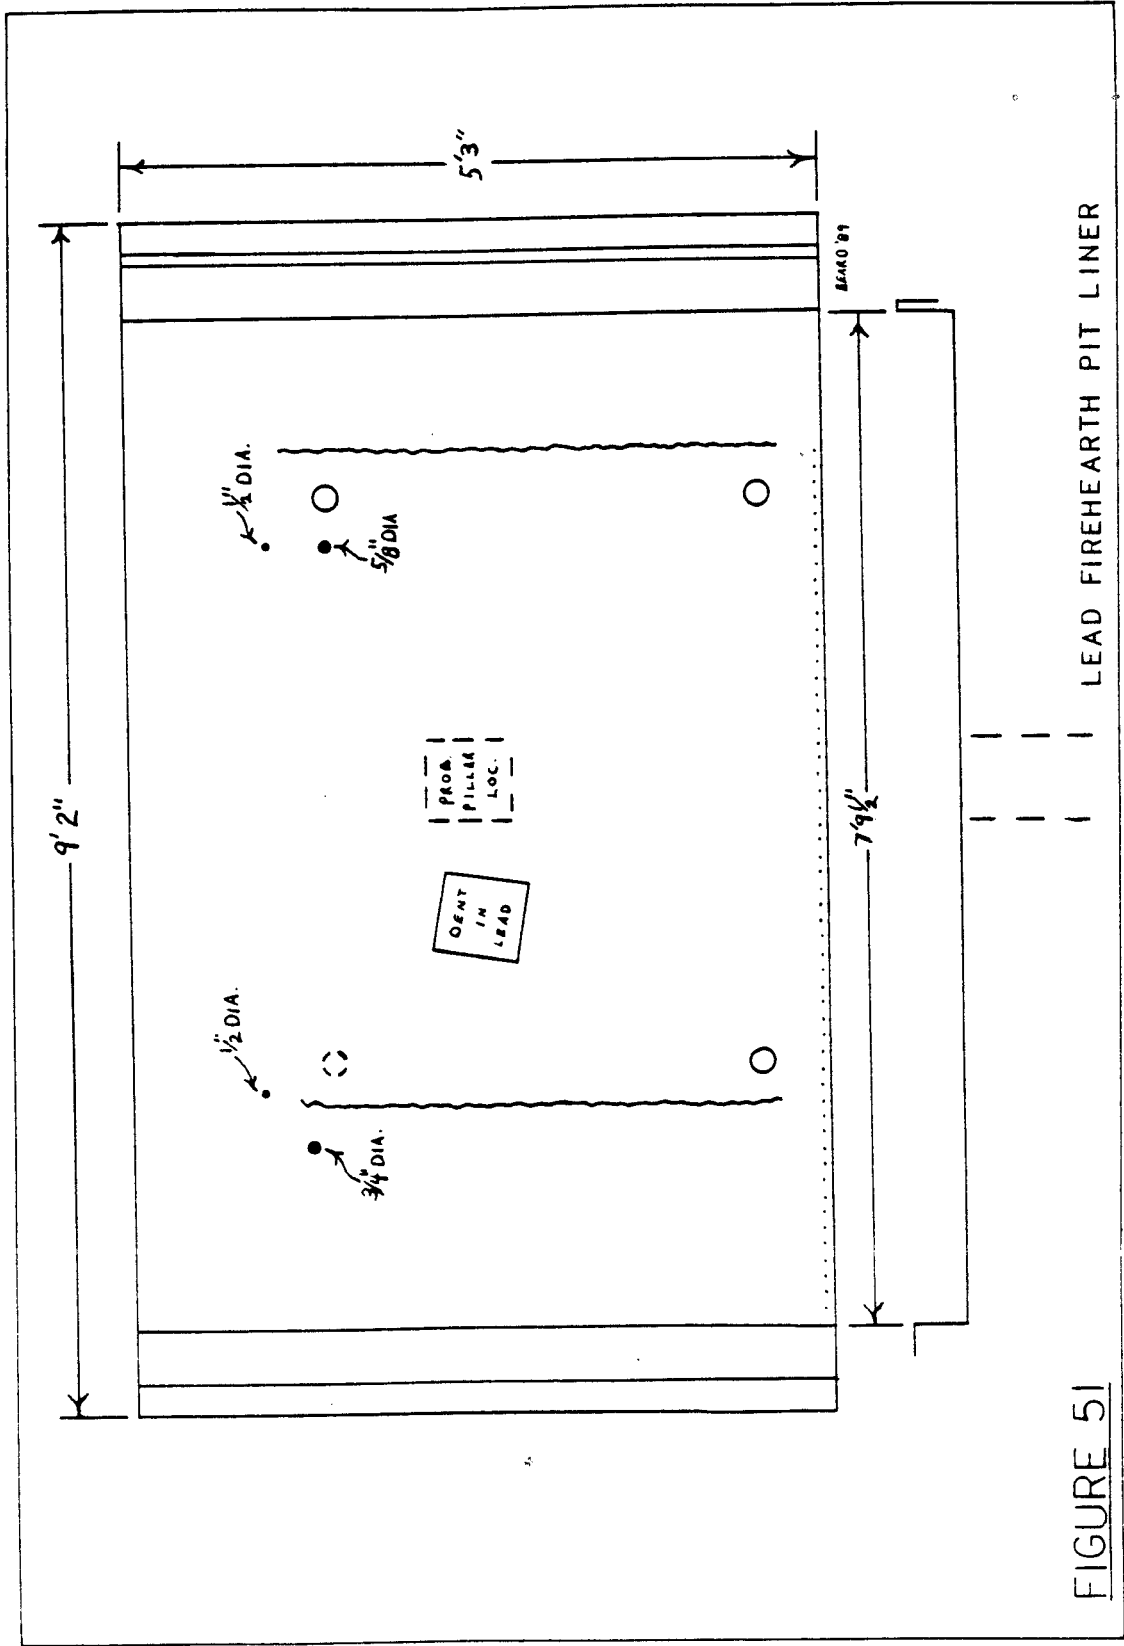
FIGURE 5J

LEAD FIREHEARTH PIT LINER

Once the tedious task of flattening out this lead was completed (there was the risk of it cracking along any of the many bent seams) a clearer picture of its probable function emerged. The sheet was rectangular and measured 9 feet, 2 inches by 5 feet, 3 inches and was 1/8 of an inch thick. There was no indication that it had been shaped at the angles that would be expected for the magazine liner, although the ends had obviously been shaped over timbers (Fig. 51).

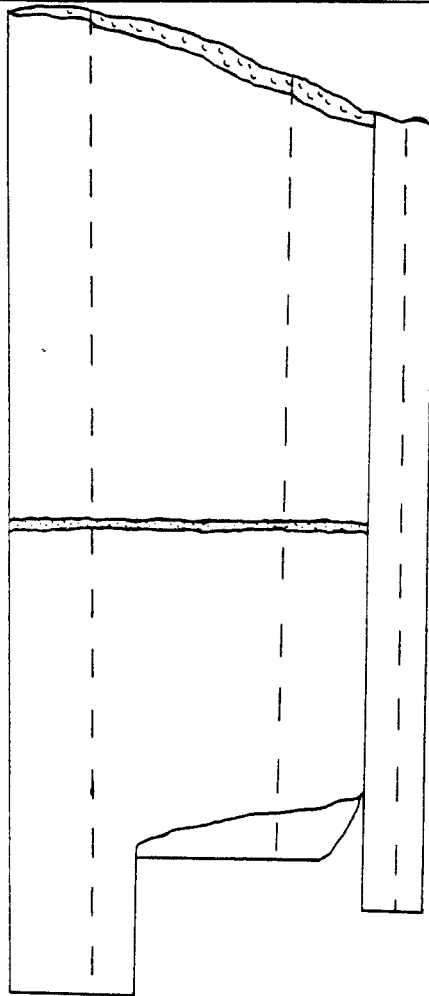
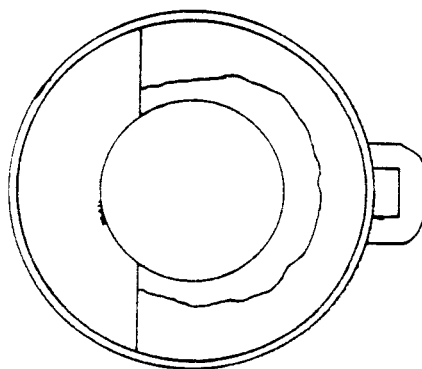
The outside diameter of the elm tubes at their bases is 7-7/8 inches (the diameter diminishes from top to bottom) and the inside diameter is 4 inches. They are "L" shaped in profile at their bases, so the tubes set against the

FIGURE 52: BASE OF PORT BILGE PUMP TUBE

An interesting feature of the tubes is the presence of smaller "U" shaped tubes running down their outboard sides. Their function has not been definitely determined, but they may be the guides for some sort of mechanism for clearing the base of the pump of debris without a man having to enter the bilge (Fig. 52).

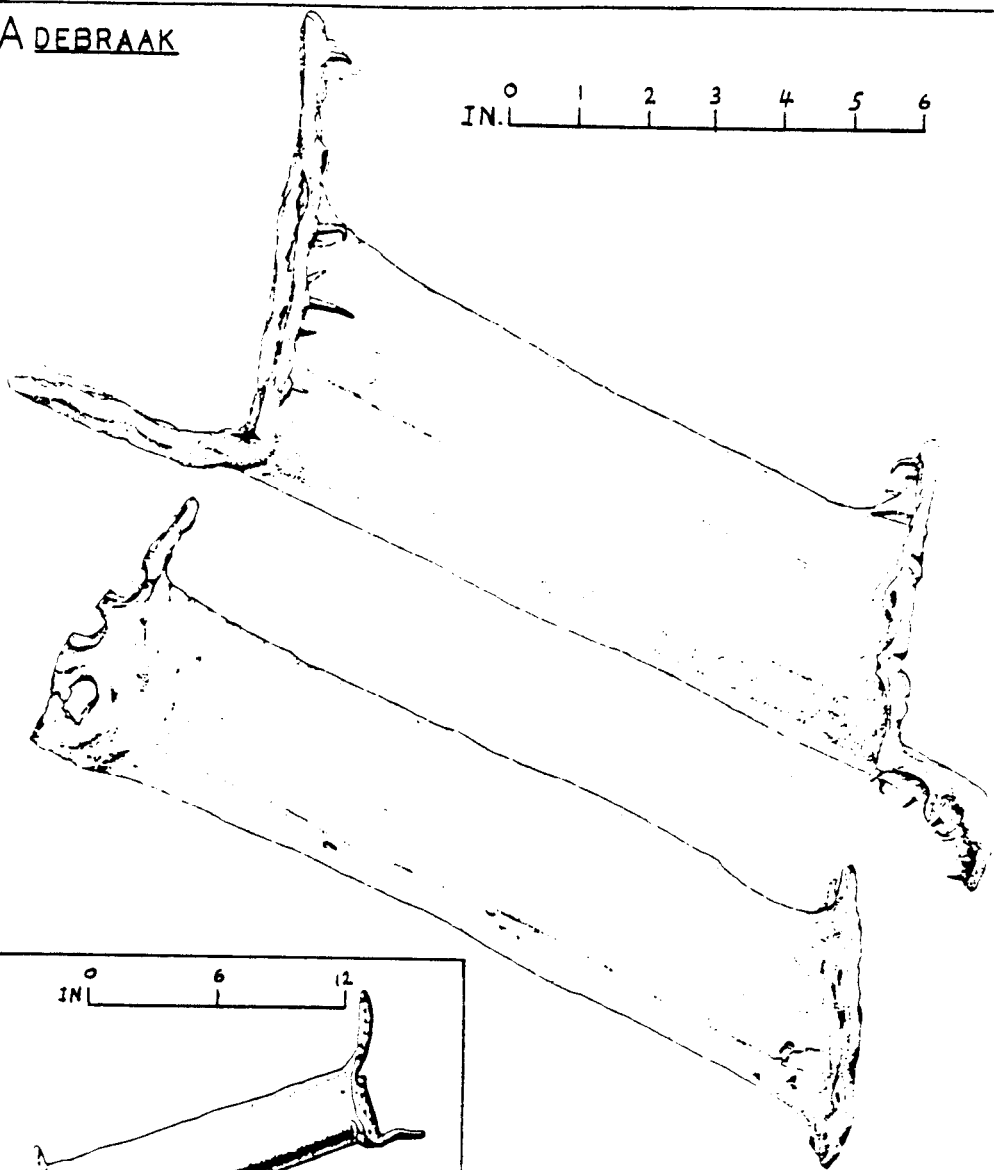
FIGURE 53: SCUPPERS

A DEBRAAK

Associated with the bilge pumps are the ship's scupper pipes. A ship's scuppers are drain pipes that allow water to run off the decks. Two types of large lead scupper pipes (two of each type) have been recovered from *DeBraak's* wreck site (Fig. 53a). These are similar to scupper pipes recovered from the wreck of H.M.S. *Dartmouth*, a ship launched in 1655. The similarity between the scuppers recovered from these two shipwrecks suggests that there was little change in form during the intervening century (Fig. 53b).³⁴ Figure 54 illustrates the likely method in which *DeBraak's* scuppers pierced her hull.

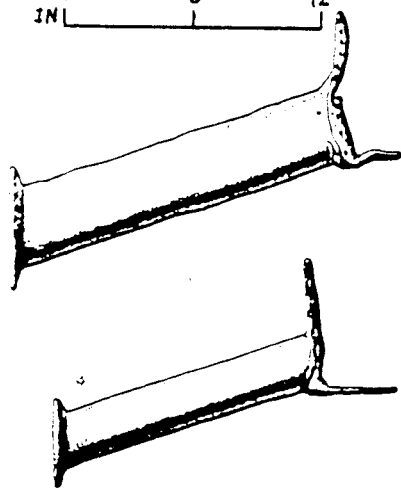
B DARTMOUTH, 1655
(FROM GOODWIN, p. 66)

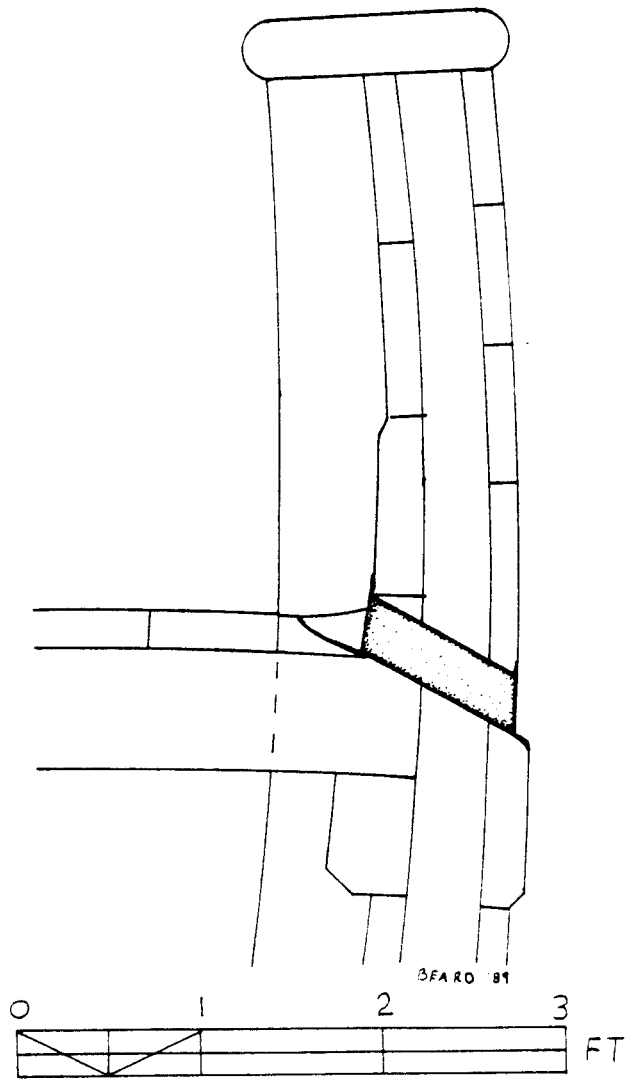
FIGURE 54: POSSIBLE ATTACHMENT FOR DEBRAAK SCUPPERS

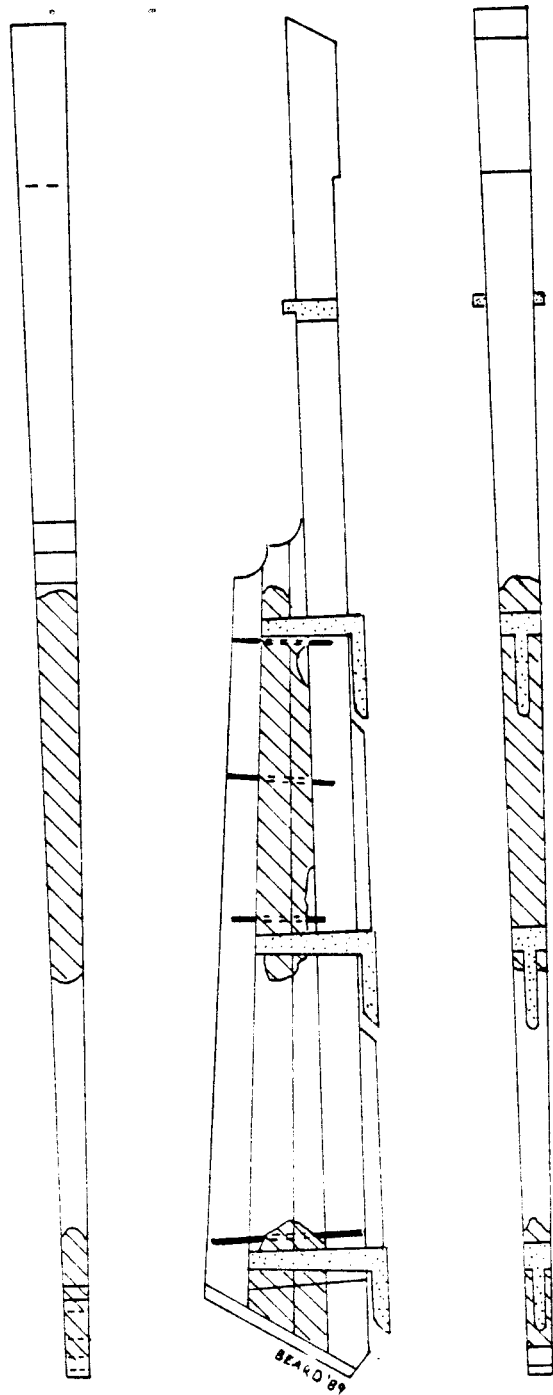
The rudder is 5 inches wide at its bottom, but gets wider toward the top. The main piece where it accepts the tiller is 10-1/2 inches wide. The sided dimension at the top of the rudder is 11-1/2 inches (Fig. 55).

FIGURE 55
RUDDER
RECONSTRUCTION

EXTANT
WOOD

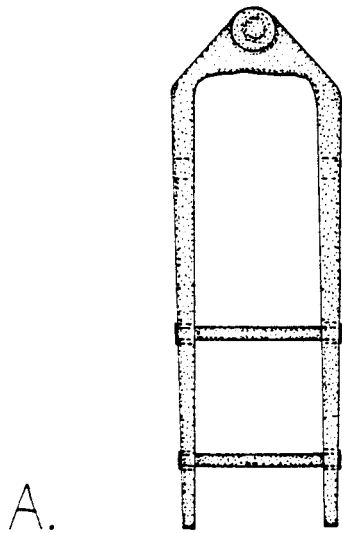
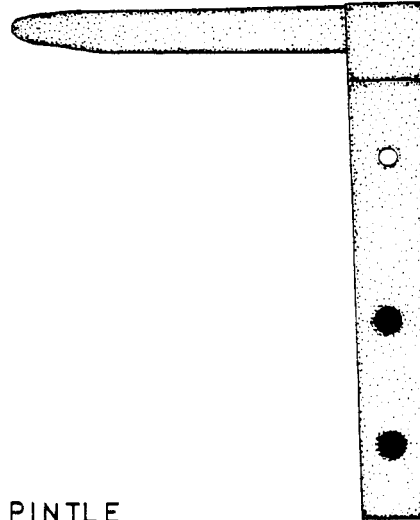
FIGURE 56: RUDDER FITTINGS

A.

PINTLE

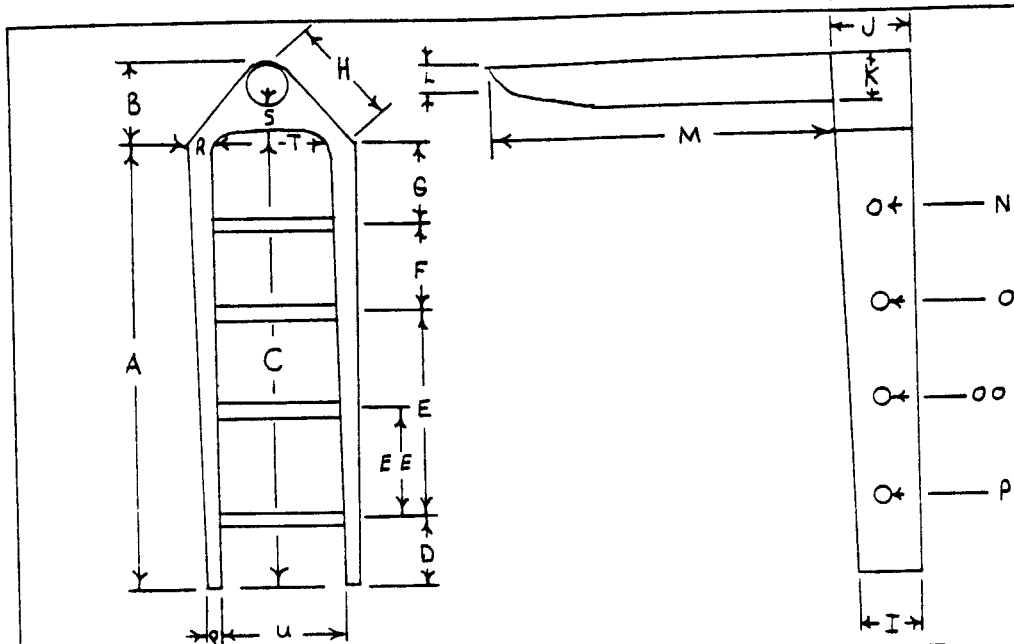
FIGURE 57: PINTLE DATA

BOTTOM	MIDDLE	TOP
A	20 5/8"	19 1/8"	15 3/4"
B	2"	3 3/4"	4 3/4"
C	NO DATA	19 7/8"	16 1/2"
D	3 1/2"	3"	2 1/4"
E	5 1/4"	5 1/2"	5"
F	4 3/4"	7 1/4"	5 7/8"
G	3 3/4"	3 1/2"	2 5/8"
H	3 3/4"	5 1/2"	6 1/2"
I	2 5/8"	2 3/4"	3"
J	3 3/4"	3 3/8"	3 1/2"
K	2"	2"	2"
L	N/A	1 1/4"	1 1/4"
M	13 3/4"	14 1/8"	13 1/4"
N	1" HEAD DIA.	7/8" HOLE DIA.	7/8" HOLE DIA.
O	1" HEAD DIA.	1 1/8" HEAD DIA.	7/8" HEAD DIA.
P	1" HEAD DIA.	1" HEAD DIA.	1" HEAD DIA.
Q	5/8"	1/2"	1/2"
R	1"	1 1/8"	1"
S	2 3/4"	3 1/4"	4"
T	3 3/4"	5 3/8"	7"
U	NO DATA	5 5/8"	7 5/8"
EE	4 1/2"	N/A	N/A
OO	1" DIA.	N/A	N/A

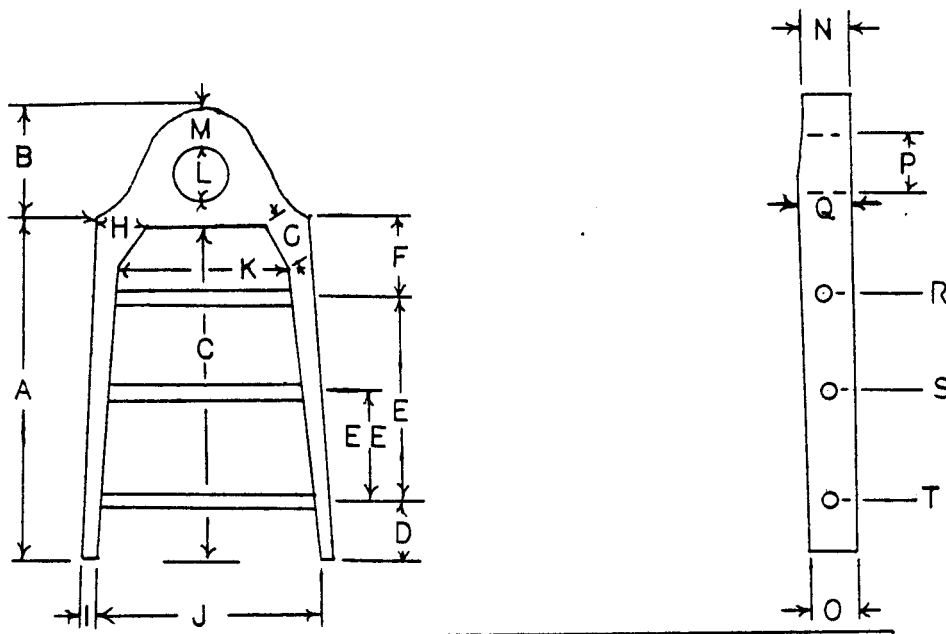
FIGURE 58 GUDGEON DATA

BOTTOM	MIDDLE	TOP
A	19 1/2"	14 3/8"	9 7/16"
B	4 5/8"	4 9/16"	4 1/4"
C	19 5/8"	14"	9 1/16"
D	2 1/8"	2 3/8"	1 5/8"
E	14 7/8"	8 1/2"	5 3/4"
F	2 5/8"	3 5/8"	2"
G	2 1/2"	2 1/8"	1 5/8"
H	2 1/4"	1 7/8"	2 1/4"
I	3/4"	1/2"	9/16"
J	9 1/8"	9 3/8"	9/4"
K	7 3/8"	7 3/4"	6 7/8"
L	2 3/8"	2 7/16"	2 1/2"
M	1 1/4"	1 9/16"	1 1/8"
N	-	-	-
O	-	3"	-
P	2 3/8"	2 7/16"	2 1/2"
Q	-	3 5/16"	-
R	5/8" DIA	5/8" DIA	1/16"
S	11/16" DIA	N/A	N/A
T	5/8" DIA	5/8" DIA	3/4"
EE	7"	N/A	N/A

The gudgeons are all of different lengths and widths (Fig. 58). This is due to a reduction in the dimensions of the sternpost, to which they were attached, as it rose from the keel to its upper terminus. Each was attached to the sternpost with either two or three 5/8 inch copper drift pins (Fig. 55b).

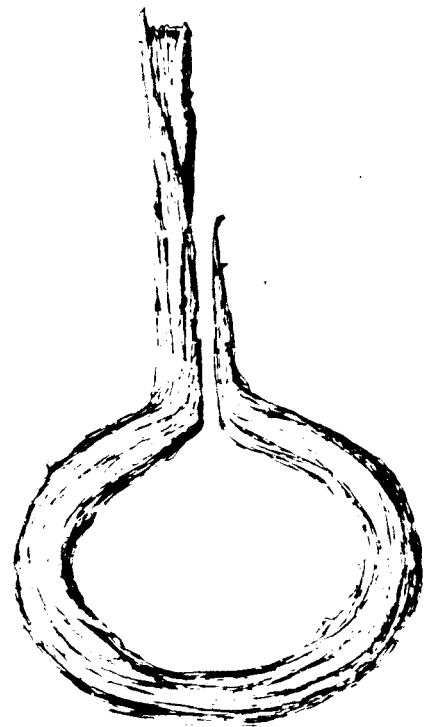
FIGURE 60: COPPER AND IRON BOLTS

(BY WALT LENNINGTON)

Copper "jag bolts," spikes and nails in a variety of sizes were used throughout the hull. Hull planking was fastened with copper jag bolts, spikes, and wooden trunnels. Copper sheathing and the lead sheathing on the gripe were fastened with smaller copper nails. A number of copper finishing nails were also recovered. Also made of copper were the large staples used to attach the false keel to the keel. Figures 60 and 61 illustrate examples of some of the types of copper and iron fasteners recovered from *DeBraak's* wreck site.

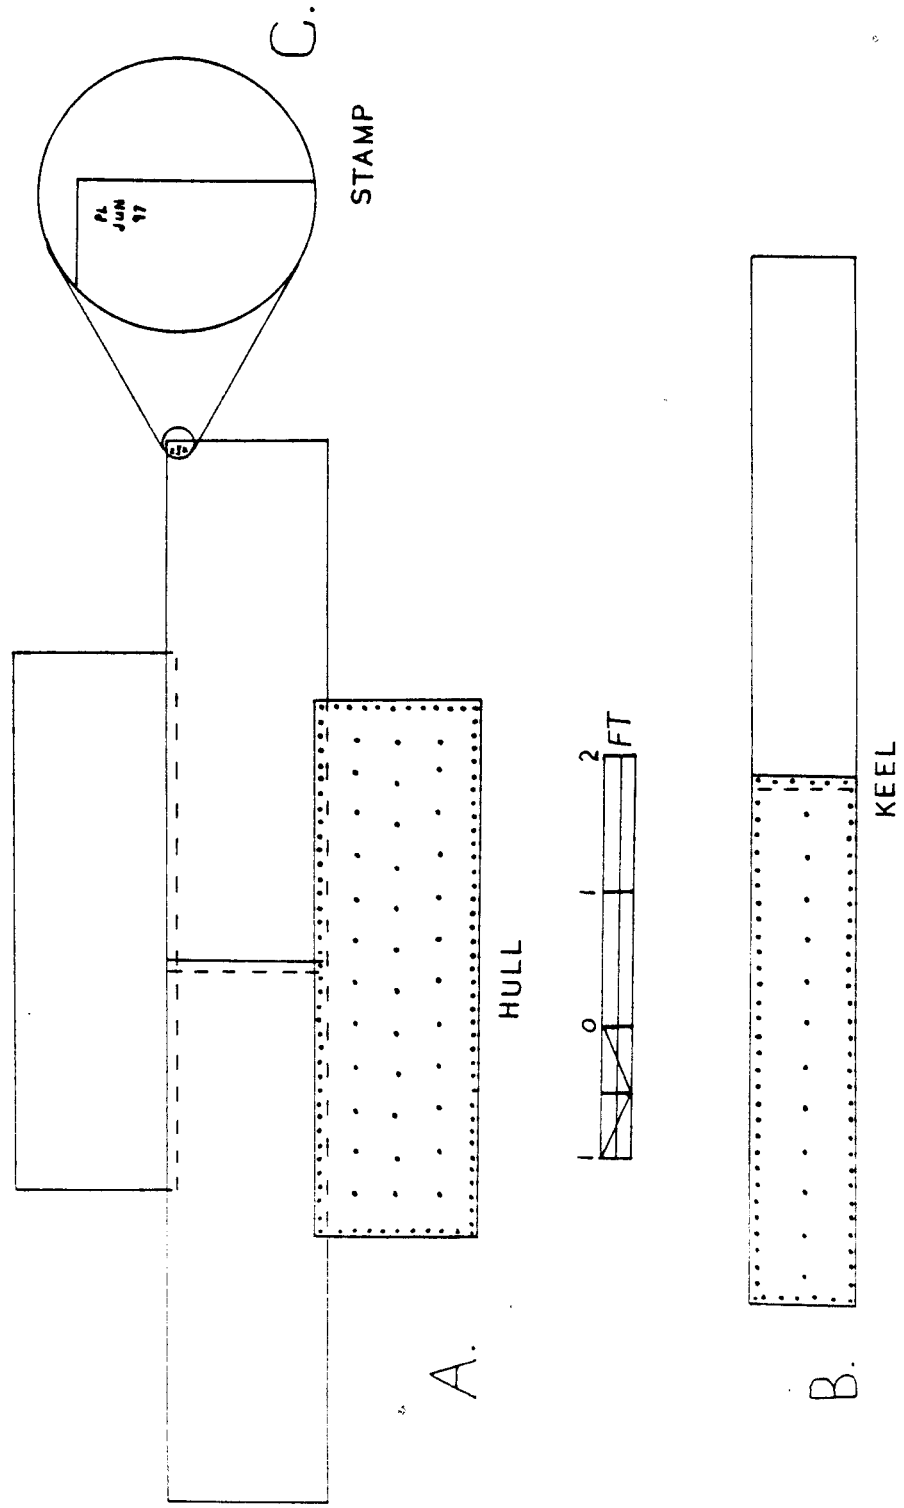
FIGURE 66: EXAMPLES OF DEBRAAK SHEATHING

A. 32 OZ. PER SQ. FT.
B. 28 " " " "
C. 22 " " " "

The copper sheets on *DeBraak* average 4 feet long and 14 inches wide. Each sheet is fastened with 134 copper nails, each about 1-1/2 inches long. The nails are spaced 1-1/4 inches on center around the perimeter and 3-3/4 inches on center for the three middle rows. The sheets overlap about 1 inch, with each sheet overlapping the ones above and aft (Fig. 66a).

The sheathing on the sides of the keel consists of sheets 4 feet long and 9 inches wide. These overlap other sheets which cover the bottom of the keel between it and the false keel. Each of the side sheets is fastened with 87 nails, centered 1-1/2 inches on center around the perimeter and 3-3/4 inches down the middle row (Fig. 66b). Many of the copper sheets have stamps in their upper right hand corners indicating that the copper was laid on at Plymouth Yard during June of 1797 (Fig. 66c).
